75 & 77 arden street  
coogee

# planning report

tree removal

# Arboricultural Report

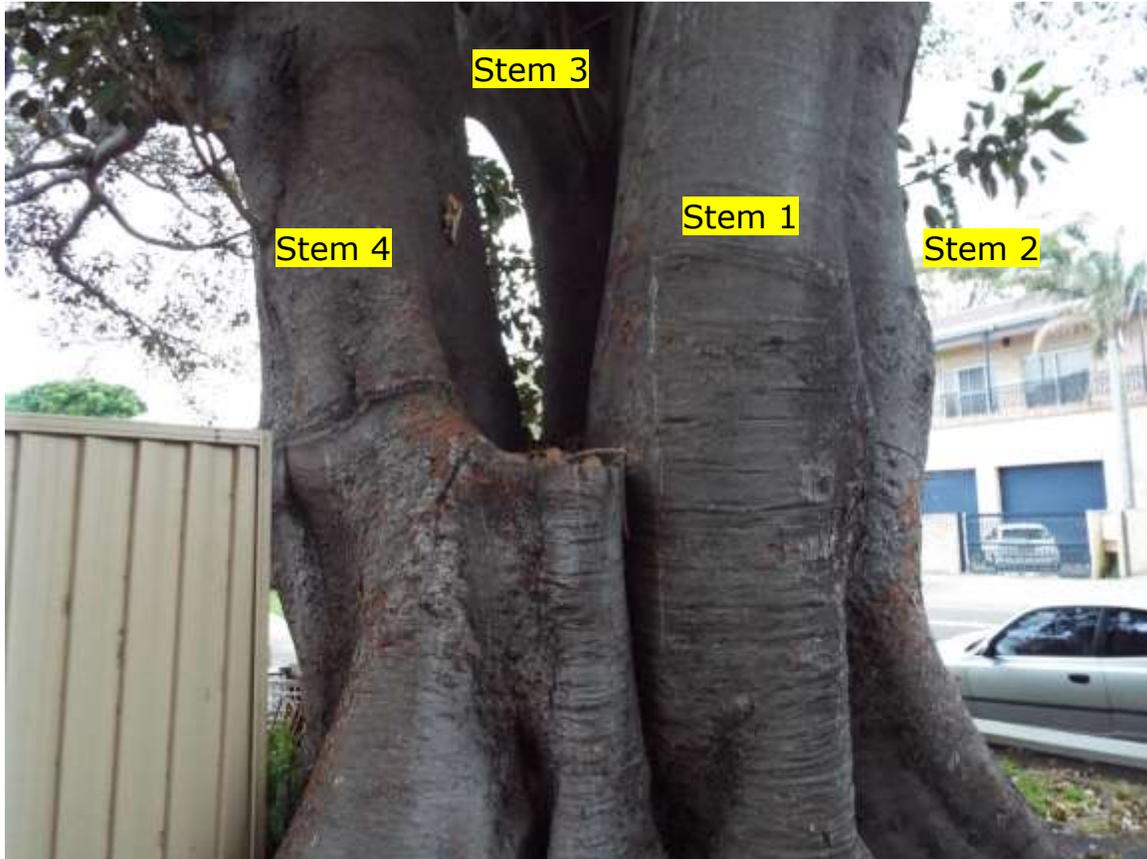
Photo 2. Base of tree showing stems.

Stem inclusions are located between stems 1 – 2, stems 3 – 4 and stems 1 – 4. No sign of any separation within the inclusions was observed at the time of inspection. The stem inclusions within this tree have been there for the majority of the trees life and at this stage there is no indication that they are likely to fail in the near future. Ongoing monitoring of the inclusions can be made during regular inspections of the tree.

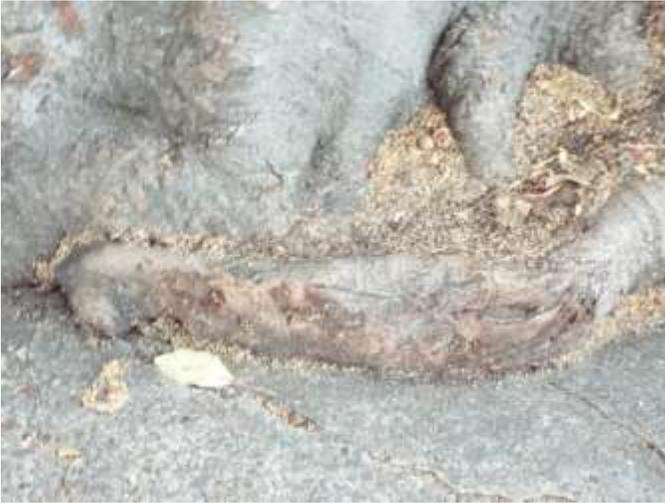
At the base of the tree buttress roots have grown into the driveway of No. 75 Arden St. Minor amounts of surface vehicular damage have occurred to these buttress roots. At the time of inspection this damage was considered to be minor. No other mechanical damage from vehicular traffic was sighted on the lower trunk area.

Photo 3. Minor root damage caused by tree entering and exiting No. 75 Arden St.

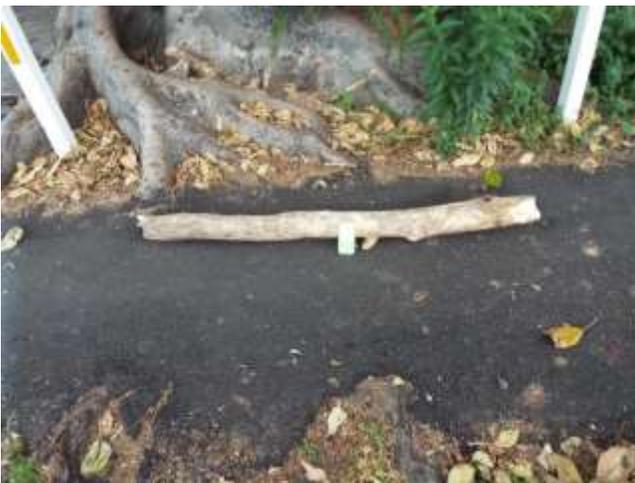
Retained deadwood was no greater than 10cm in diameter size with less than 5% of total canopy of retained deadwood throughout the tree. It appears that there has been no recent removal of retained deadwood. A small section of deadwood was placed against the tree at the time of inspection. This piece of deadwood was old and had been in the tree for some time. Regular removal of deadwood would limit the amount of deadwood falling from the tree. There were no signs of canopy dieback and the foliage coverage was at normal levels expected for a tree of this age.

Photo 4. Piece of fallen deadwood from the subject tree.

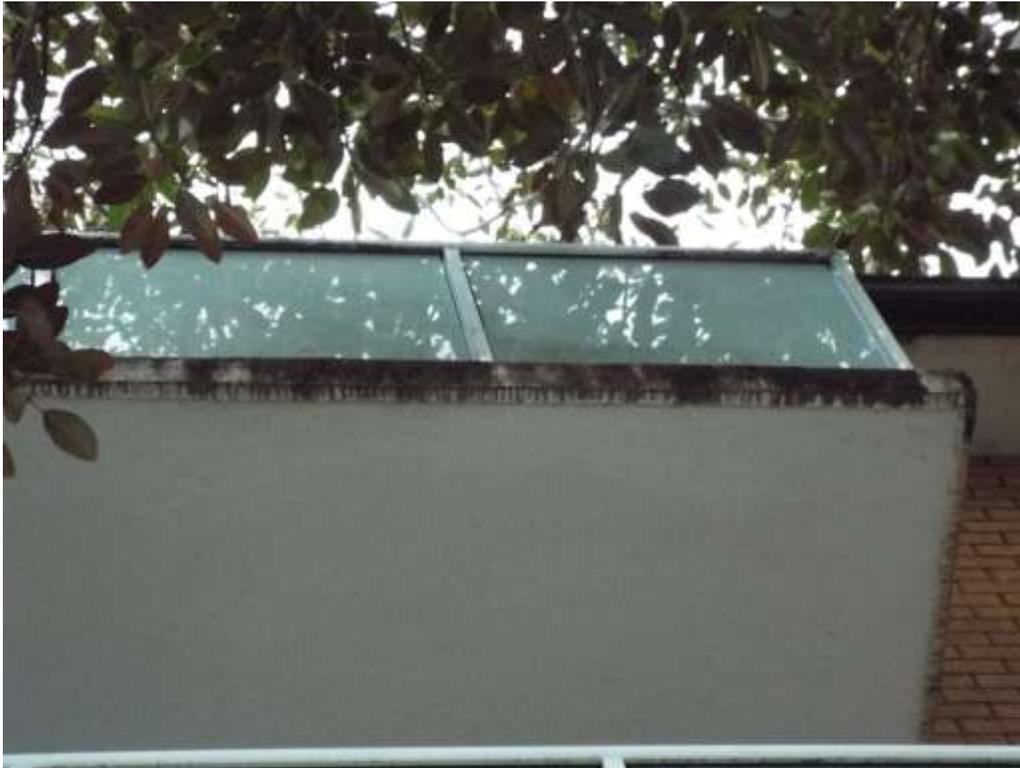
Three (3) branches overhang the property of No. 77 and two (2) branches overhand No. 75. No recent pruning works were sighted on any of the overhanging branches. Recent lopping of branches that were growing towards No. 73 was observed. Branches are almost touching and overhang the front balconies of No 75. Black mould was sighted on all three (3) front balconies of No 75. Other balconies within the complex also have black mould but not at the levels of the front three (3) units. It is reasonable to assume that the gutters in the front of the Unit complex are filling up with material from the Ficus tree.

Photo 5. Black mould on upper balcony front of No. 75.

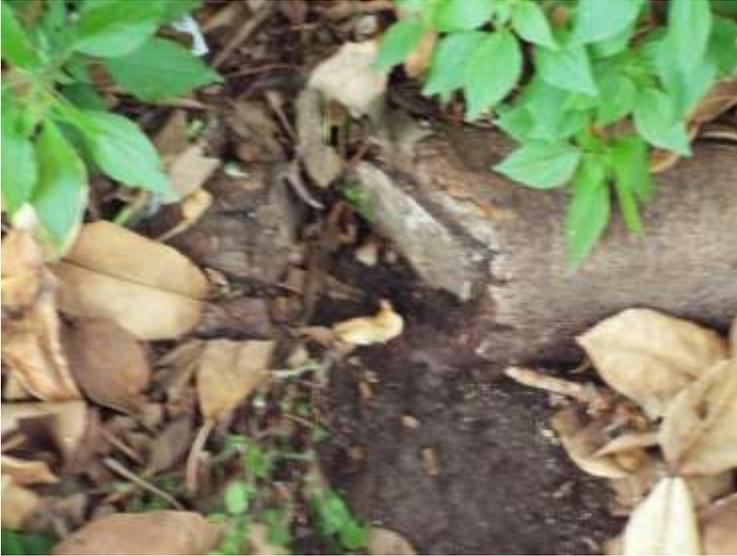
Like most *Ficus* trees this *Ficus macrophylla* tree has extensive buttress and root system. A large 25cm root growing within No 77 has been severed some time ago.

Photo 6. Surface root in No. 77 which has been cut.

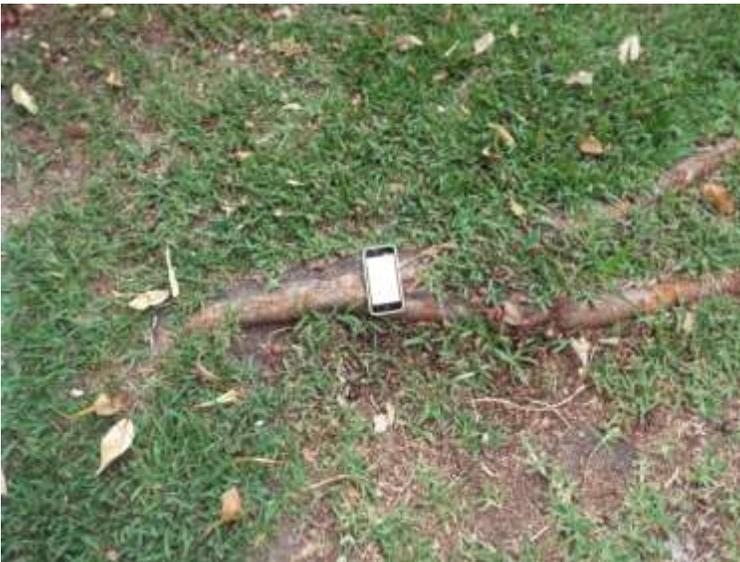
The root buttresses have exerted pressure against the front brick wall of Nos. 75 & 77 and the brick walls are now not straight. Roots from *Ficus* trees can distort single brick walls due to root pressure. Small diameter surface roots from the *Ficus* tree growing within the front grass area of No. 75 are being impacted by regular mowing activities.

Photo 7. Surface roots front yard of No. 75.

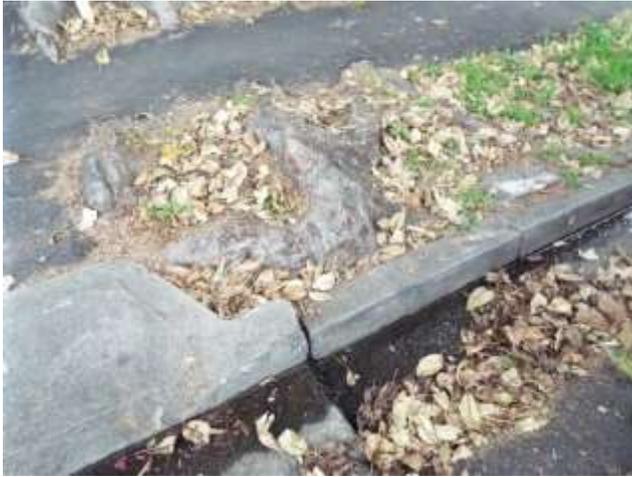
The bitumen footpath in front of the Ficus has replaced the concrete footpath surface as a repair from the result of root pressure lifting the concrete surface. This area of bitumen is now uneven with root pressure lifting the bitumen surface directly above roots. This unevenness has already become a slight trip hazard and may continue to increase. Ongoing maintenance of this section of footpath is required whilst the tree is retained. Other surface roots from the tree are located on the western side of the footpath and these roots are being damaged by vehicles and mowers.

Photo 8. Surface roots between footpath and gutter.

In the above Photo 8 it can be seen that the curb at the crossover has dropped. There is also a crack to the south of the exposed roots.

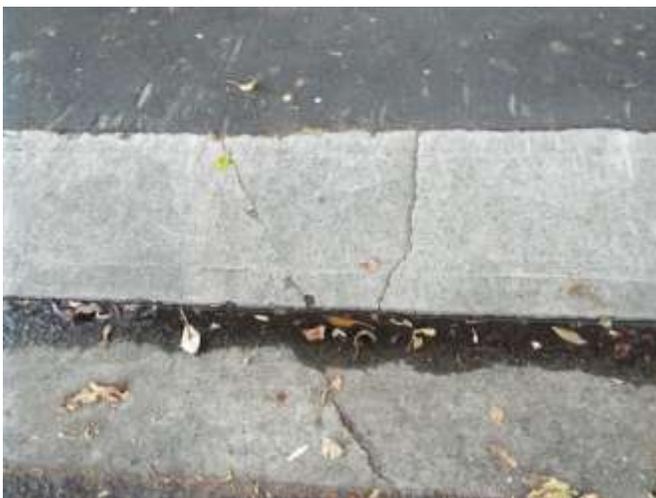
The crossover from the street to the Unit complex has lifted and no cars are impacting the raised concrete when entering and exiting the complex. The concrete crossover also has minor cracks which are most probably due to root pressure from the Ficus tree.

Photo 9. Cracks and impact from cars entering and exiting the Unit complex.

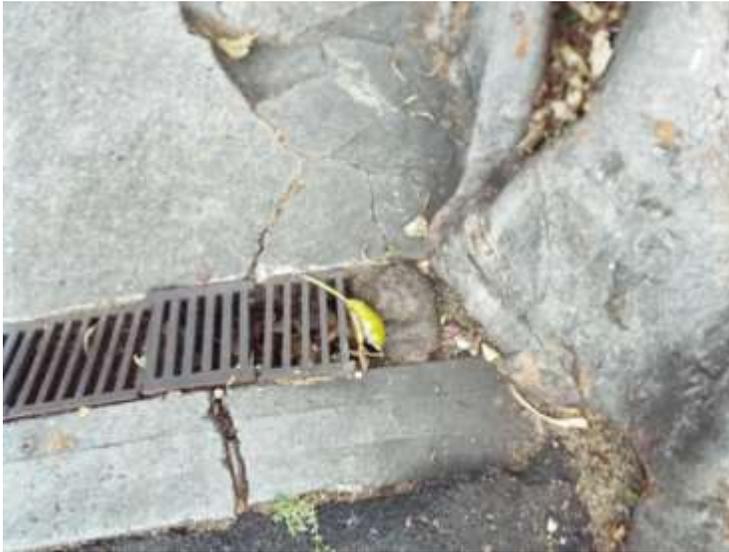
Between the crossover and the driveway into the units is a storm grid drain. This has been broken and at this stage no repairs have been made. At the time of the inspection only minor amounts of Ficus tree material was noted inside the drain, as it had recently been cleaned out. The representatives from the body corporate indicated that this requires almost daily clearing.

Photo 10. Broken storm drain next to Ficus tree.

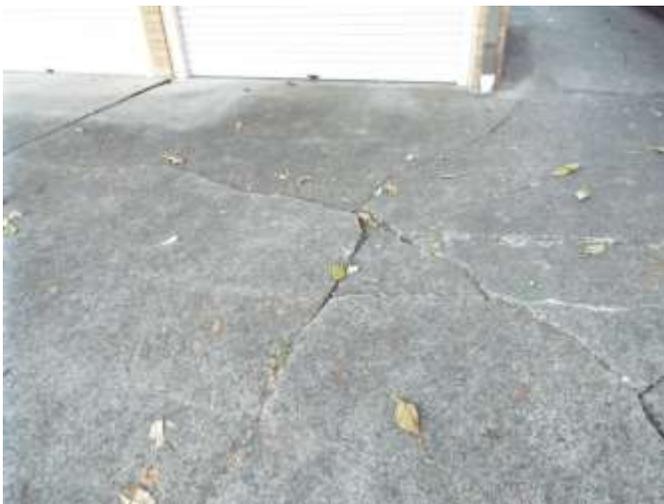
At the front of No. 77 two (2) concrete slabs have been laid. Only the concrete slab nearest to the Ficus tree has broken and has cracked. The other more distant slab has no damage. No repairs of the broken and cracked concrete were observed at the time of this inspection. The damage that has occurred to the concrete at this stage has not restricted the use of the driveway for vehicles entering or exiting the driveway. Whilst on site while inspecting the tree a Landrover 4WD vehicle entered the complex with no problem and did not touch the tree or the buttress roots.

Photo 11. Cracking of concrete slab near to the Ficus tree.

- Undertake repairs to the concrete at the front of the property and explore the use of different materials that is not so easily impacted by tree roots.

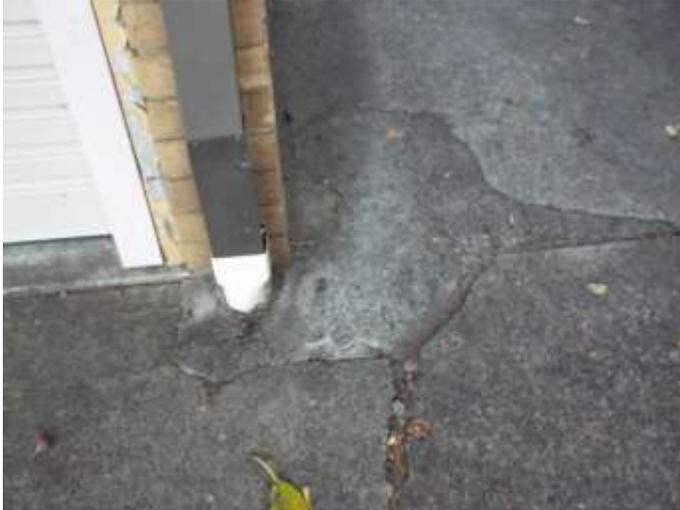
The representatives from the Body Corporate of No. 75, stated that the down pipe from the block of units often blocks and repairs have been done to the downpipe to stop water damage to the upper Units. Repairs to the concrete around the base of the down pipe on the south-western side of the building can be seen. In addition to this down pipe blocking they indicated that the drain to the street is also blocked and does not work. They indicated that localized pooling of water occurs at the front of the property.

Photo 11. Previous repairs to the down pipe and concrete at base.

- Explore different types of guttering that will catch debris and not allow it to block up drains.
  - The down pipes could be replaced by chains which would stop any blockages in pipes.

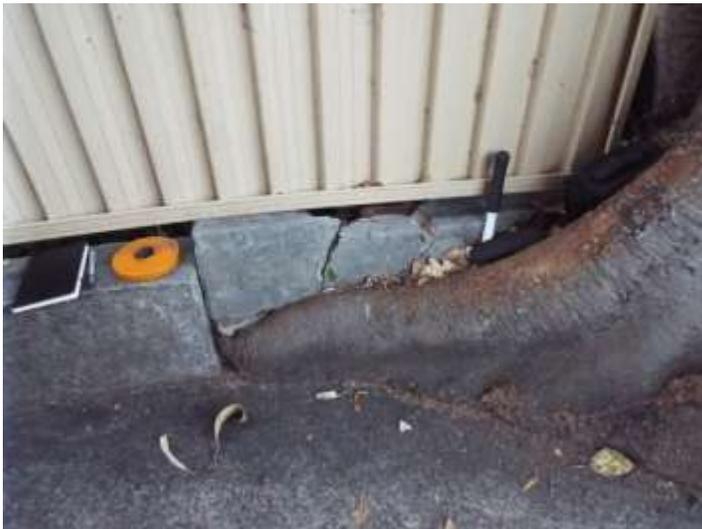
The small retaining hob between Nos. 75 & 77 with a colour bond fence that is on top of the hob has been lifted by the buttress roots from the Ficus tree. At the time of inspection no repair works have been undertaken to rectify the broken sections of the hob.

Photo 12. Concrete hob being damaged by buttress root.
