# Asbestos Containing Material Clearance Inspection

20 December 2022

<b>Site:</b>	Little Bay Beach
<b>Location:</b>	Southern, Western and Northern Little Bay Beach

<b>Requested by:</b>	
Name	Joe Santangelo
Contact	0436839760
Email	joe.santangelo@randwick.nsw.gov.au
<b>Site Details:</b>	
Address	2 Coast Hospital Rd, Little Bay NSW 2036
Local Government Area	Randwick City Council

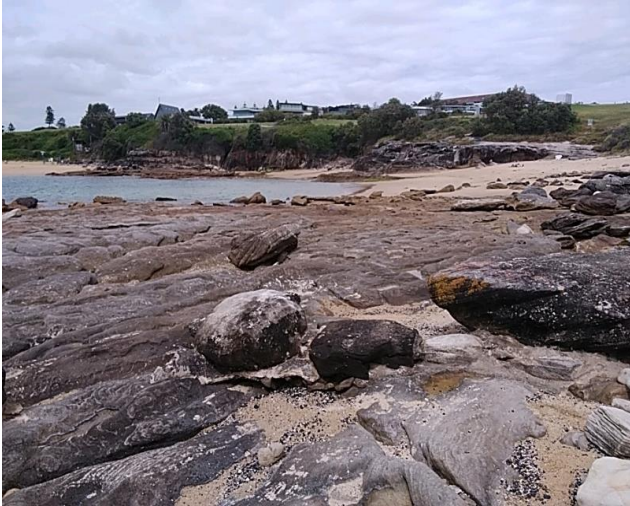
**Notes:** Overview of the Northern beach

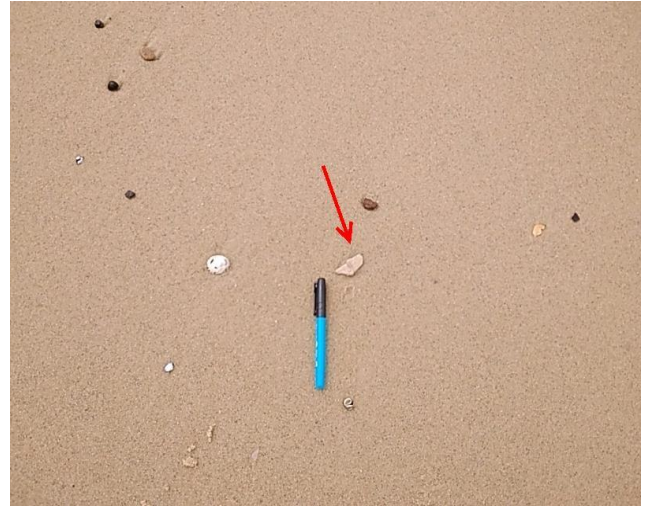
**Notes:** Overview of removal item within Northern beach prior to removal

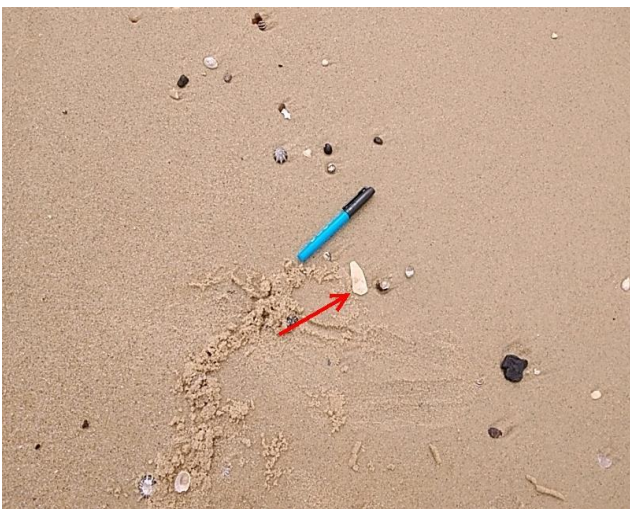
**Notes:** Overview of removal item within Northern beach prior to removal

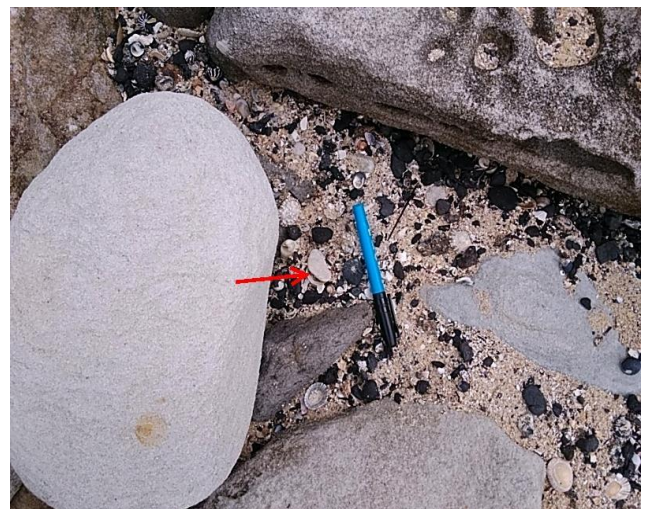
**Notes:** Overview of removal item within Northern beach prior to removal

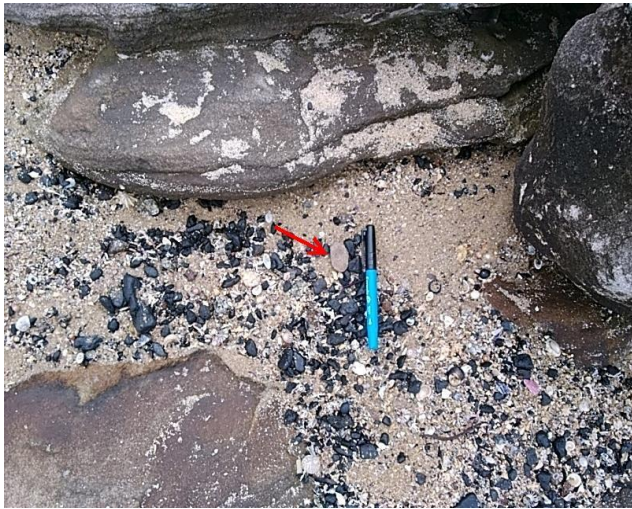
**Notes:** Overview of removal item within Northern beach prior to removal

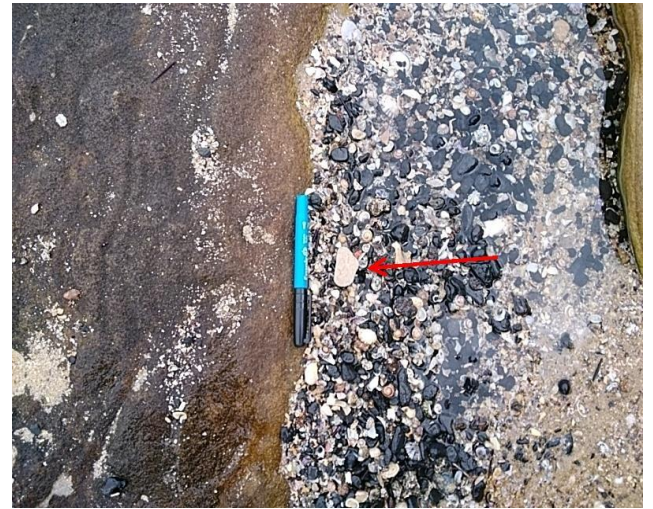
**Notes:** Overview of removal item within Northern beach prior to removal

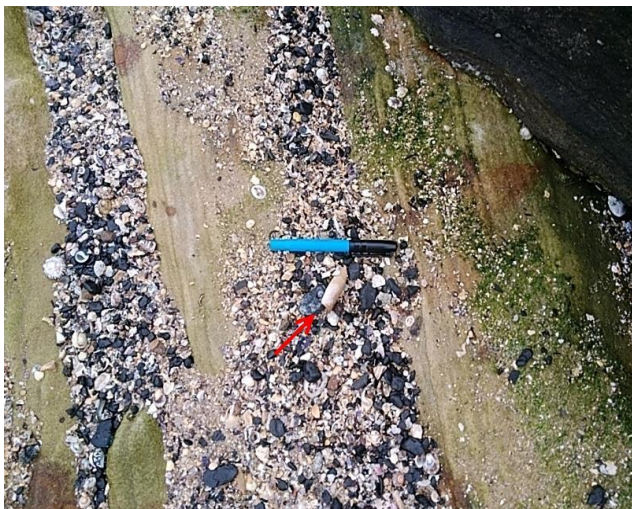
**Notes:** Overview of removal item within Northern beach prior to removal

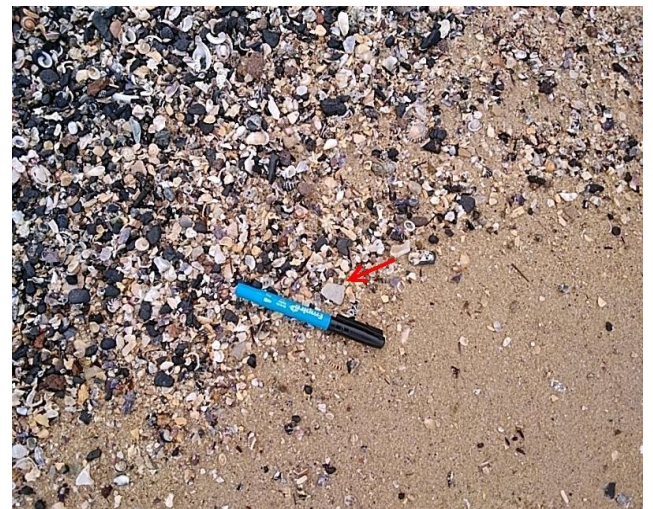
**Notes:** Overview of removal item within Northern beach prior to removal

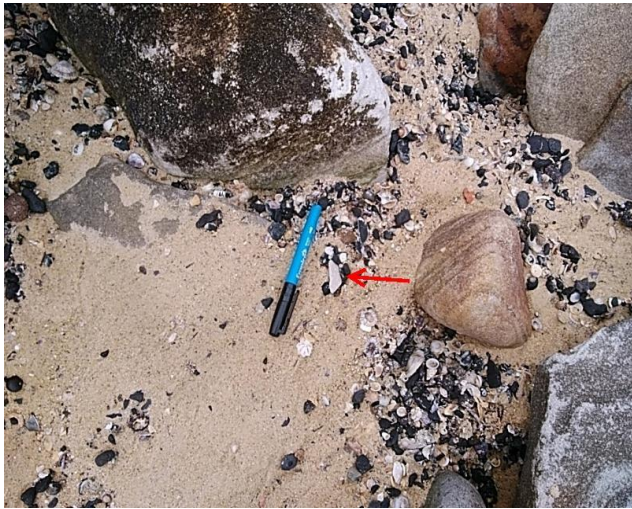
**Notes:** Overview of removal item within Northern beach prior to removal

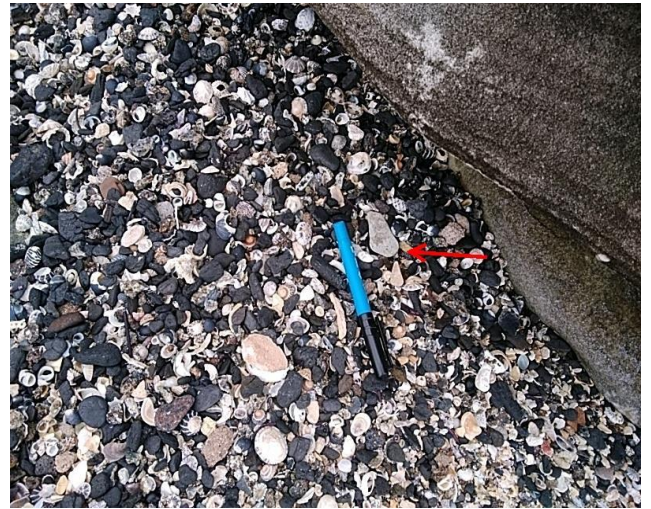
**Notes:** Overview of removal item within Northern beach prior to removal

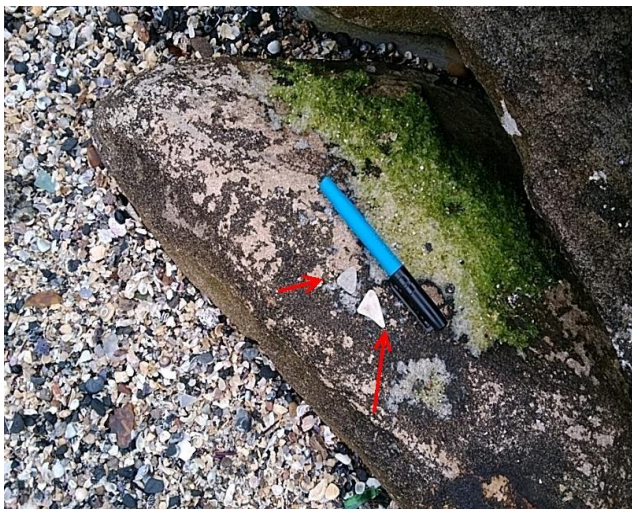
**Notes:** Overview of removal item within Northern beach prior to removal

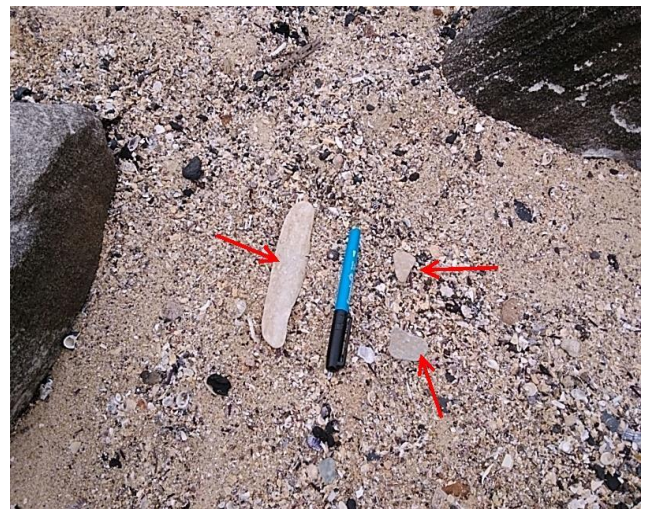
**Notes:** Overview of removal item within Northern beach prior to removal

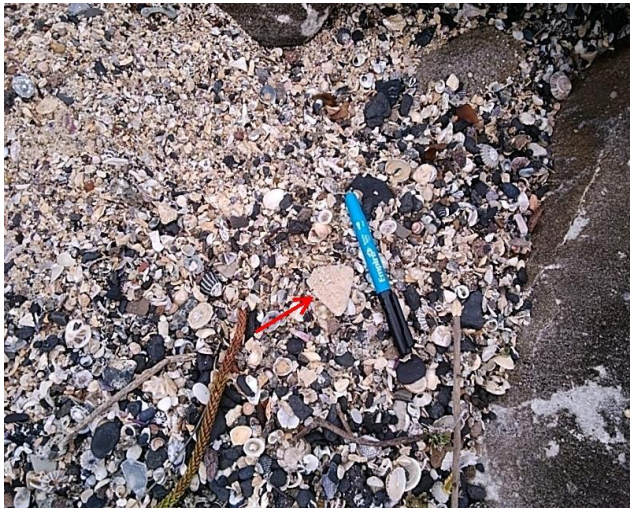
**Notes:** Overview of removal item within Northern beach prior to removal

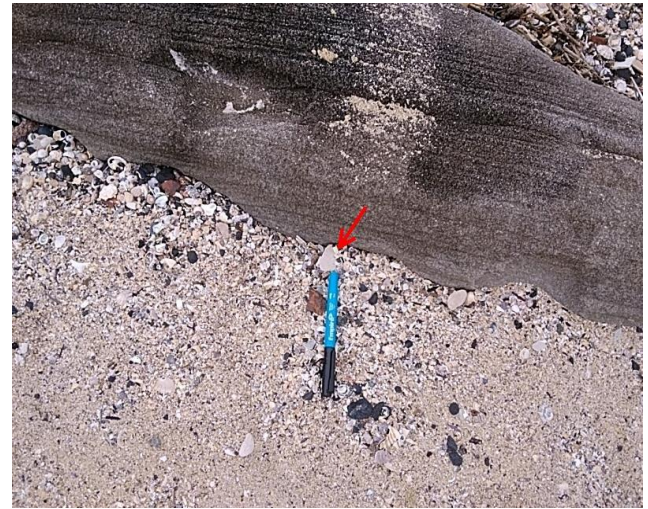
**Notes:** Overview of removal item within Northern beach prior to removal

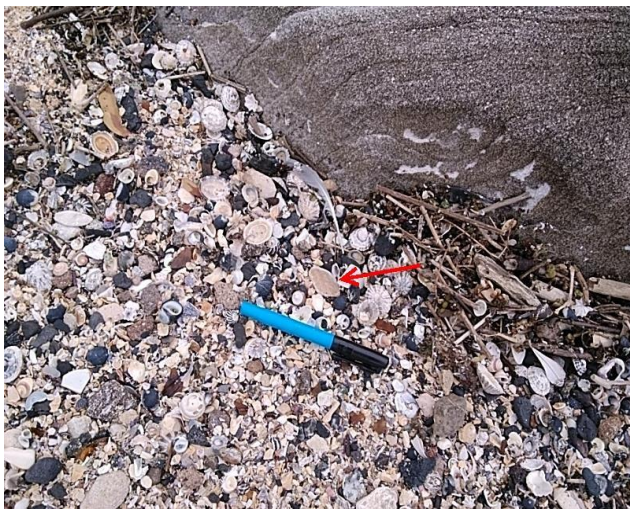
**Notes:** Overview of removal item within Northern beach prior to removal

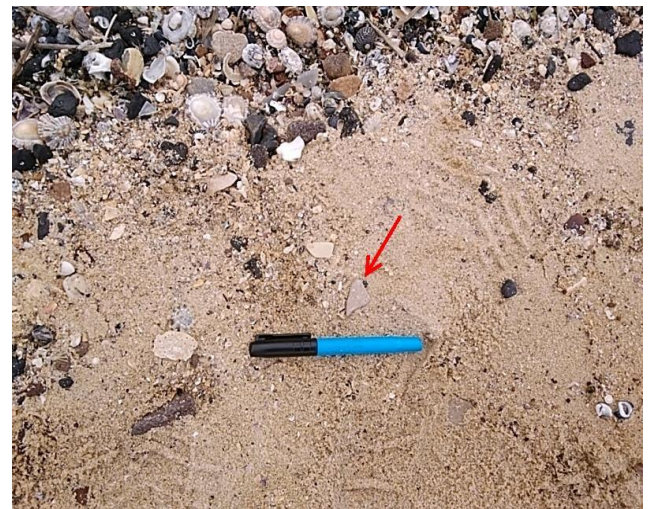
**Notes:** Overview of removal item within Northern beach prior to removal

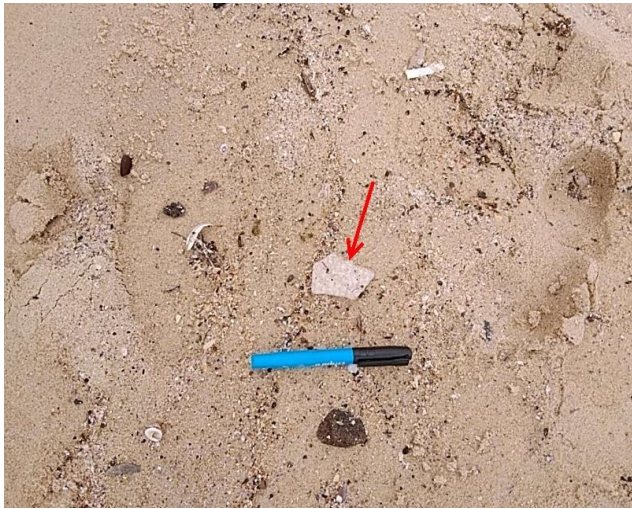
**Notes:** Overview of removal item within Northern beach prior to removal

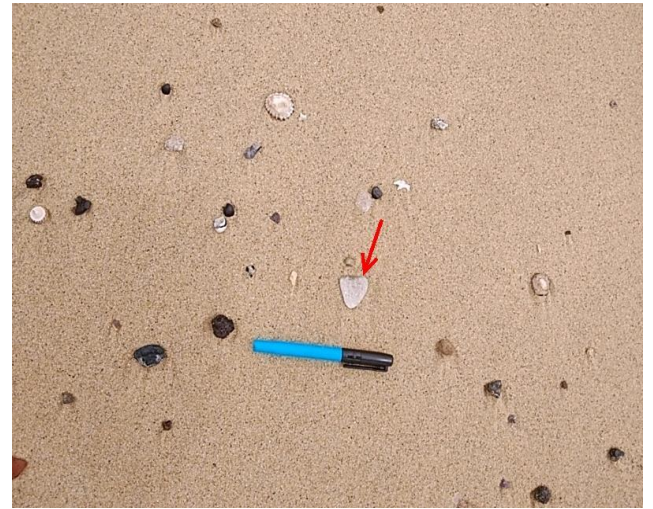
**Notes:** Overview of removal item within Northern beach prior to removal

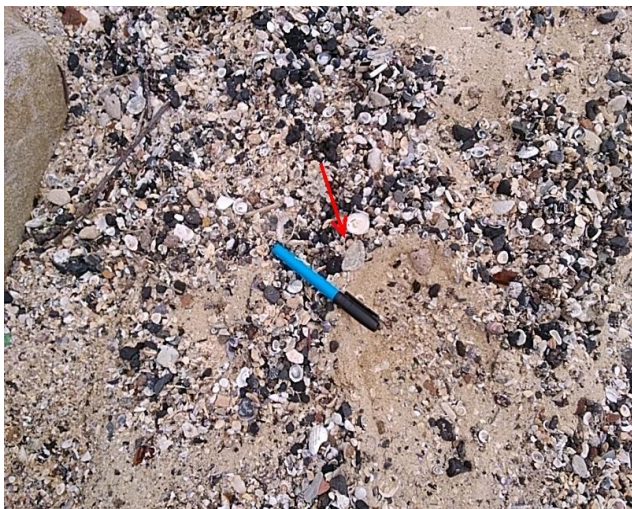
**Notes:** Overview of removal item within Northern beach prior to removal

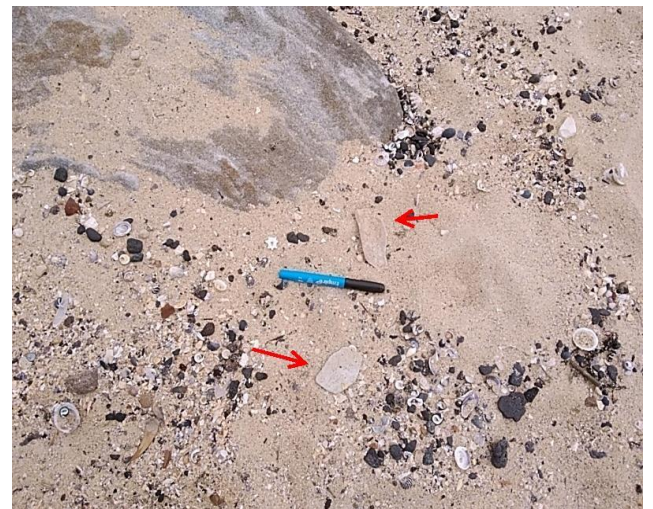
**Notes:** Overview of removal item within Northern beach prior to removal

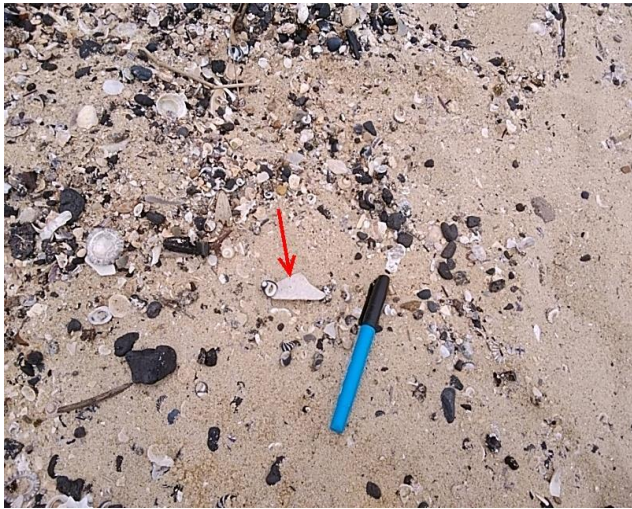
**Notes:** Overview of removal item within Northern beach prior to removal

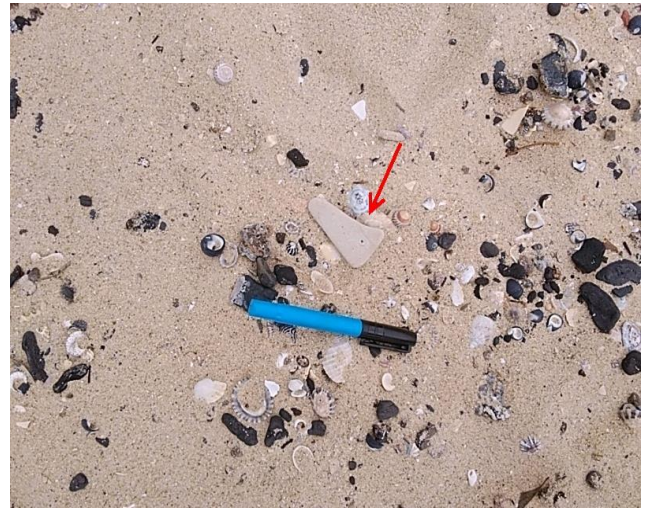
**Notes:** Overview of removal item within Northern beach prior to removal

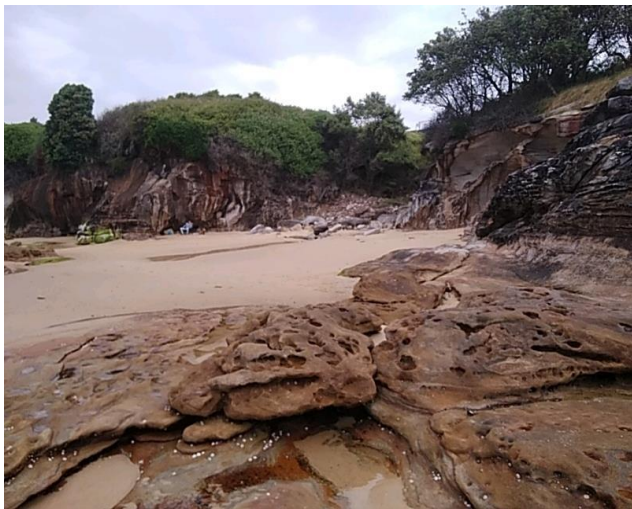
**Notes:** Overview of the Western beach

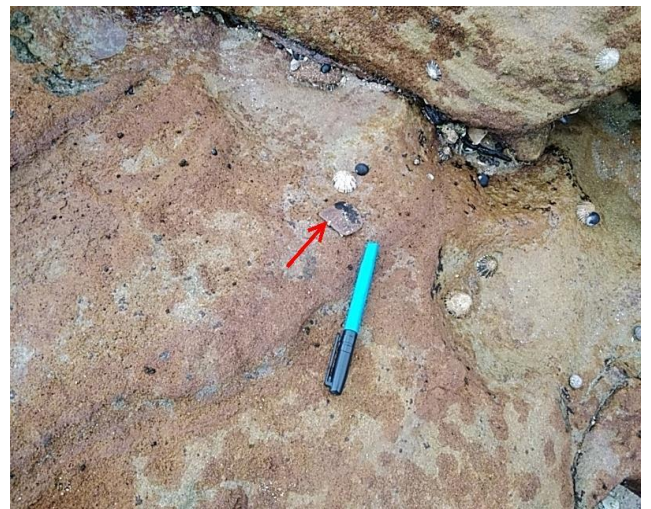
**Notes:** Overview of removal item within Western beach prior to removal

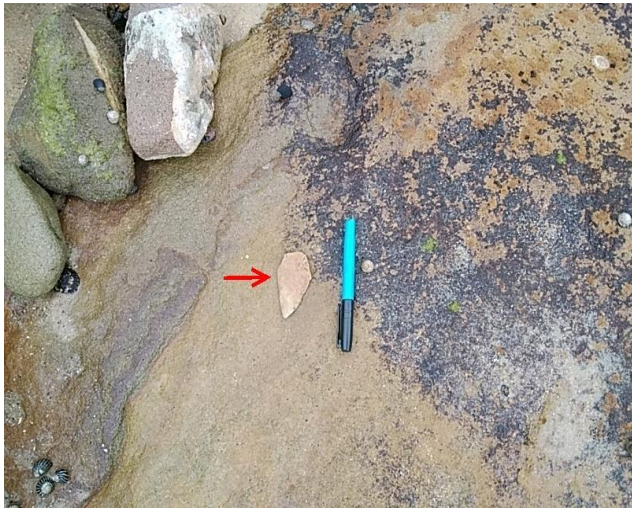
**Notes:** Overview of removal item within Western beach prior to removal

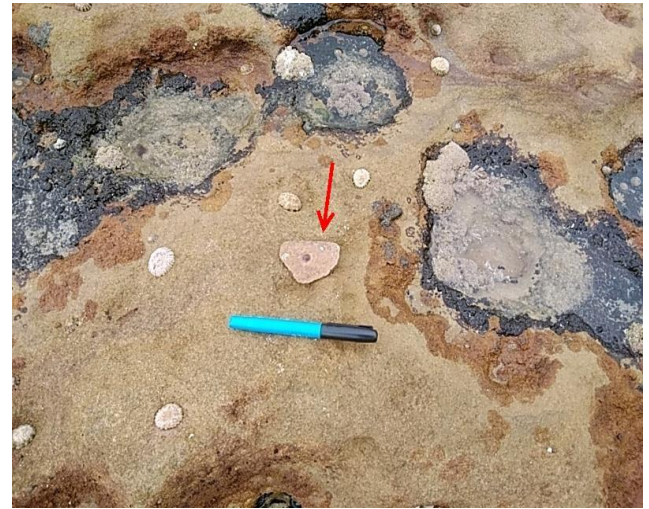
**Notes:** Overview of removal item within Western beach prior to removal

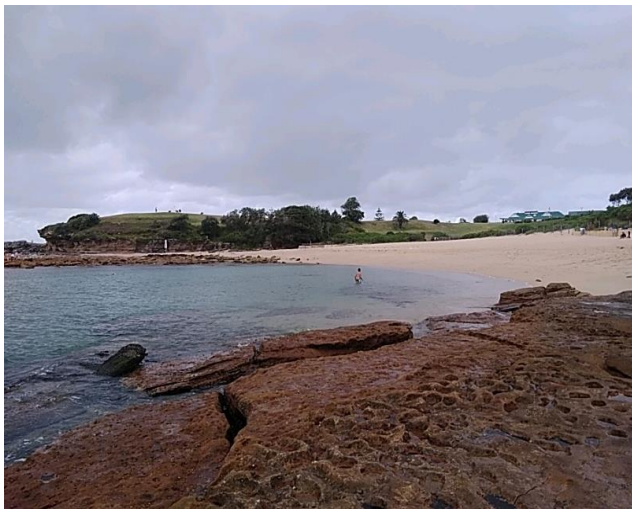
**Notes:** Overview of the Southern beach

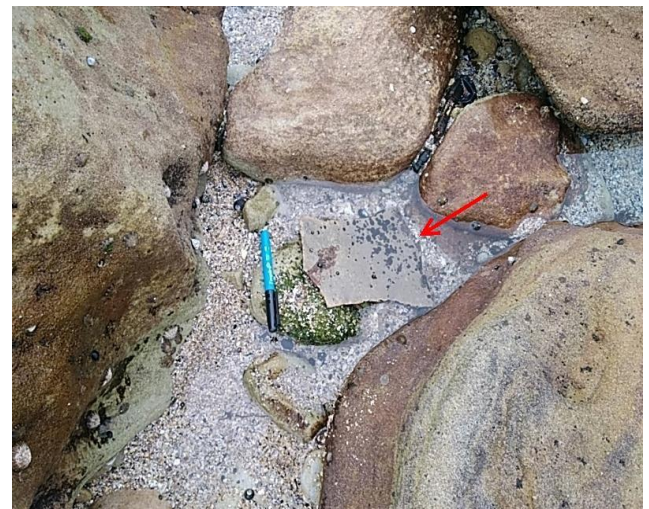
**Notes:** Overview of removal item within Southern beach prior to removal

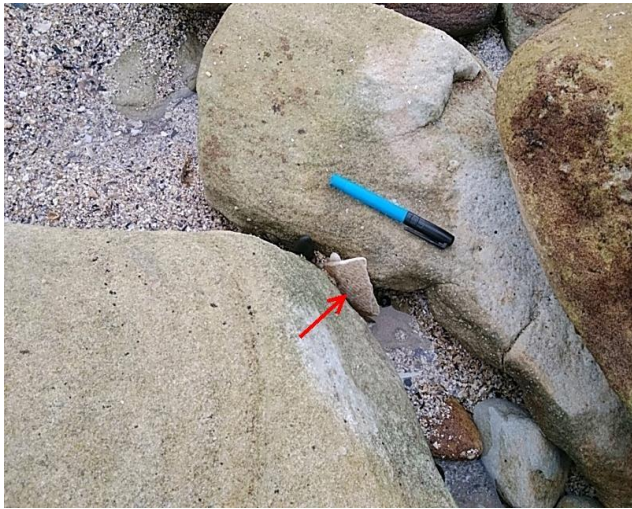
**Notes:** Overview of removal item within Southern beach prior to removal

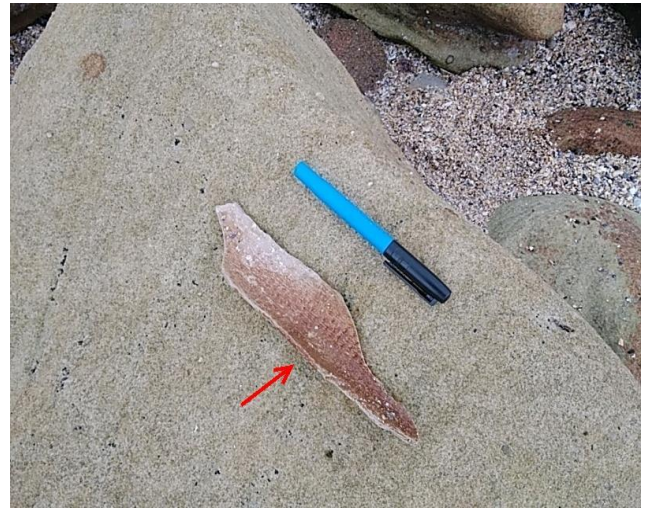
**Notes:** Overview of removal item within Southern beach prior to removal

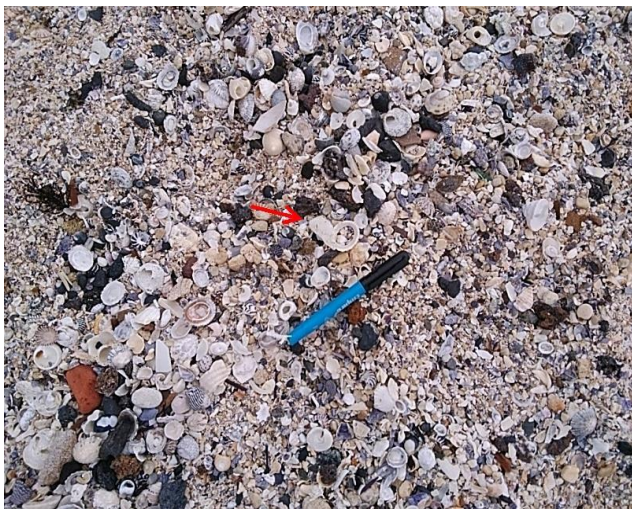
**Notes:** Overview of removal item within Southern beach prior to removal

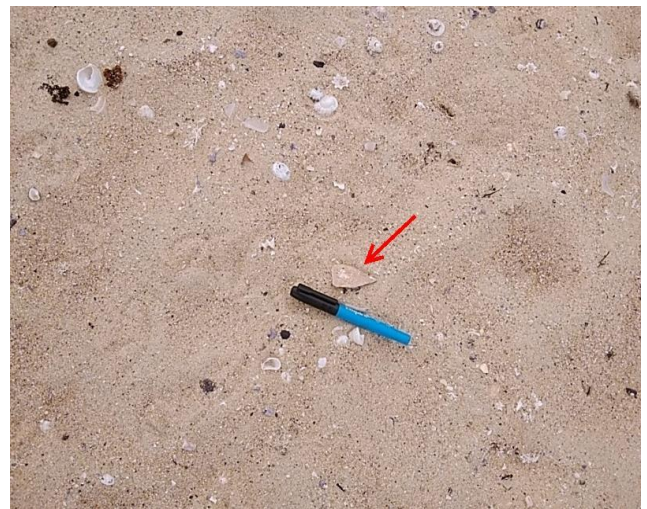
**Notes:** Overview of removal item within Southern beach prior to removal

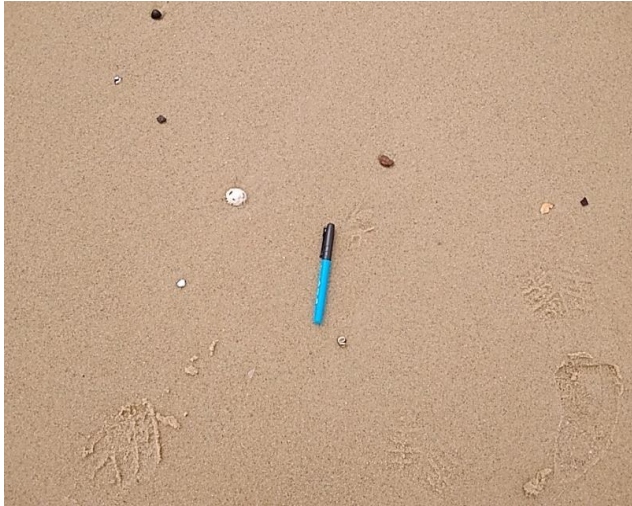
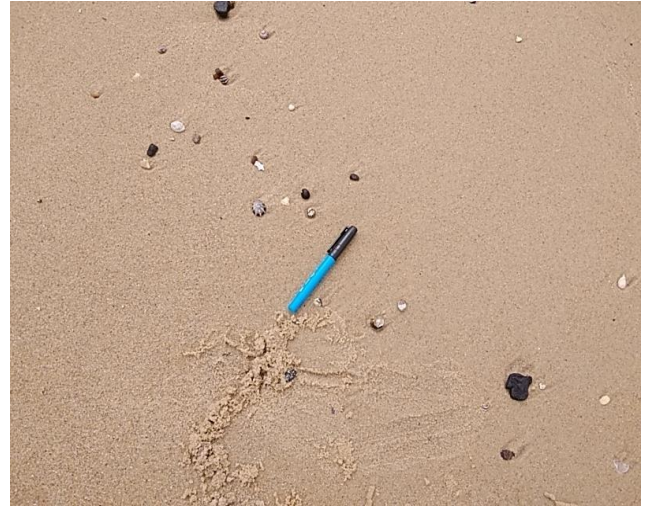
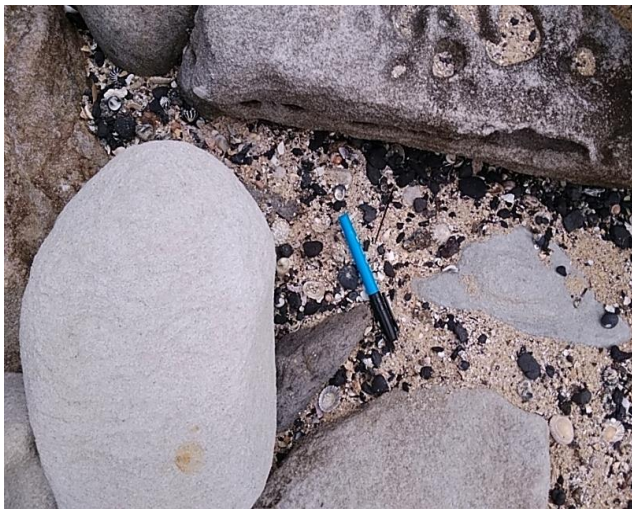
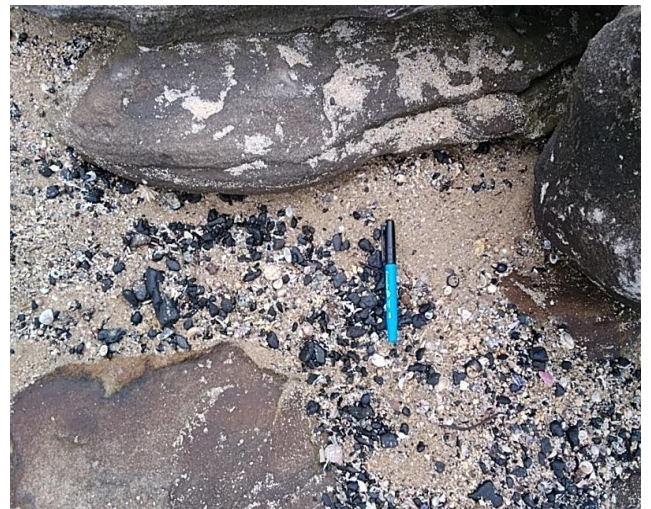
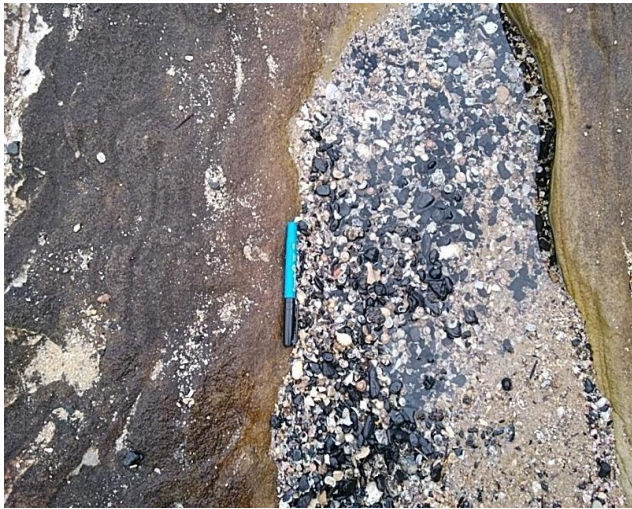
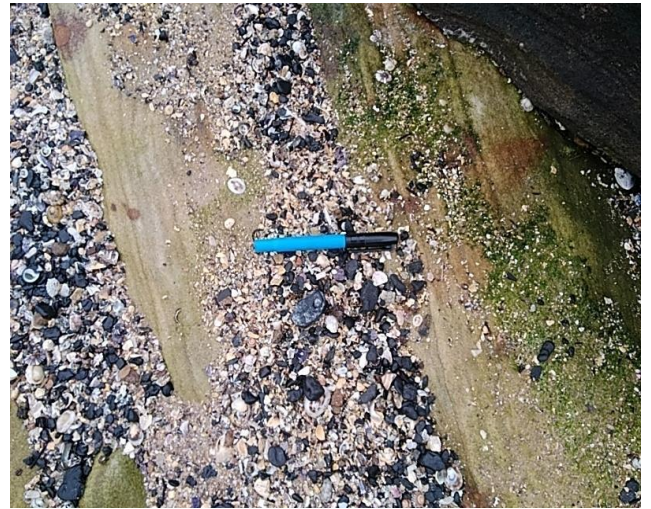
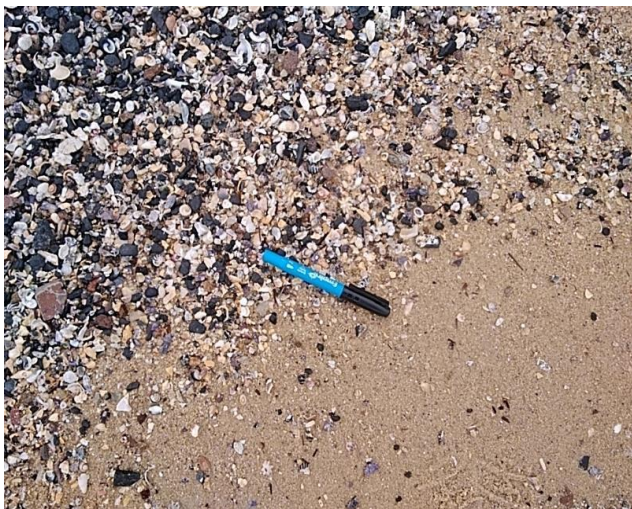
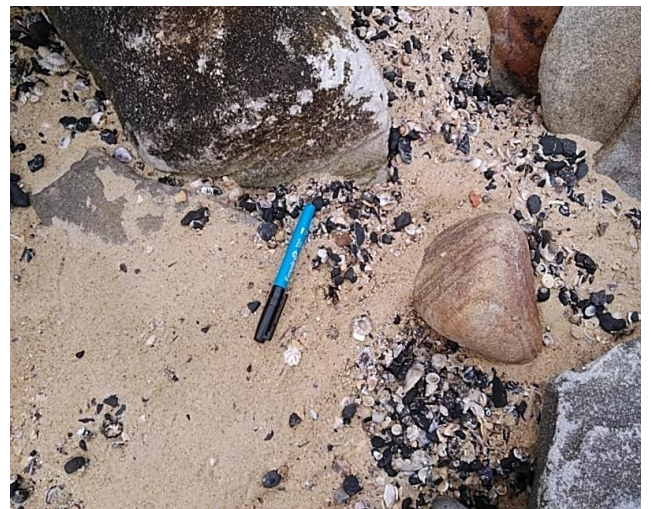
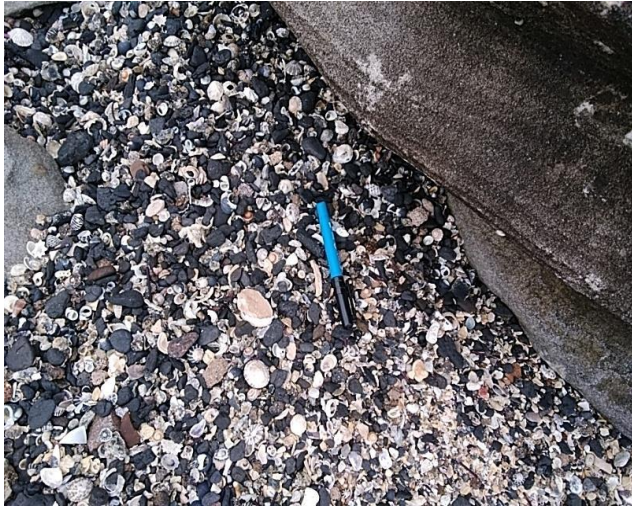
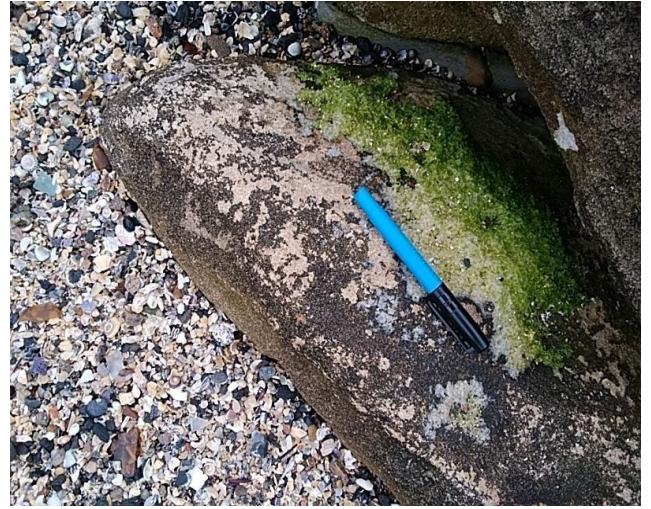
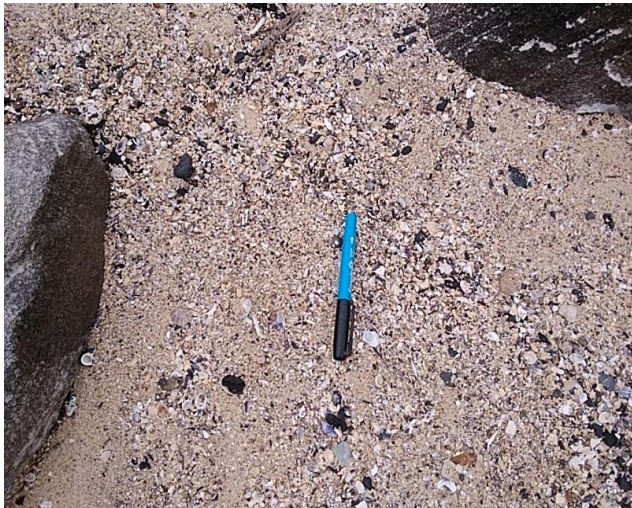
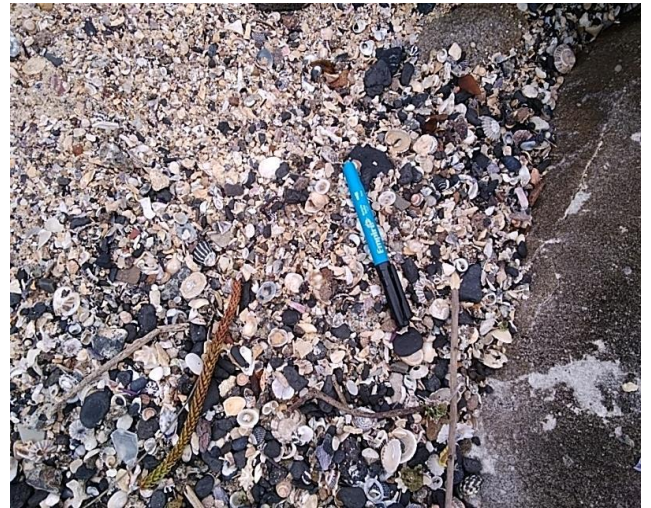
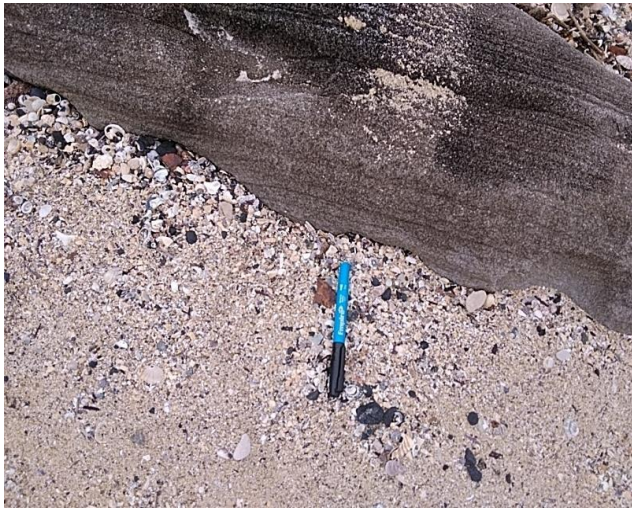
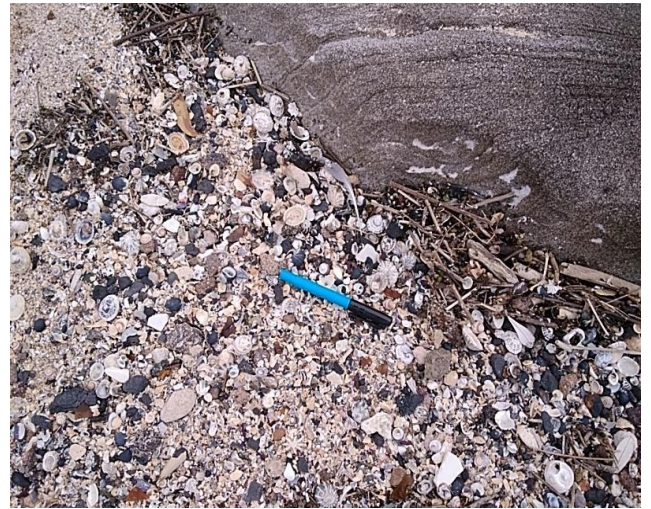
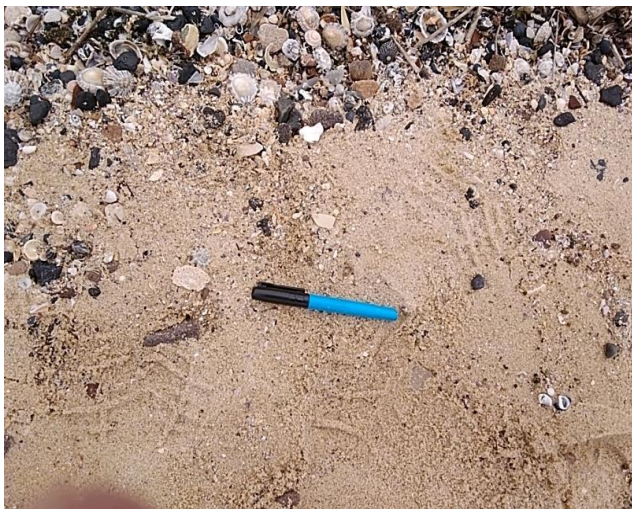
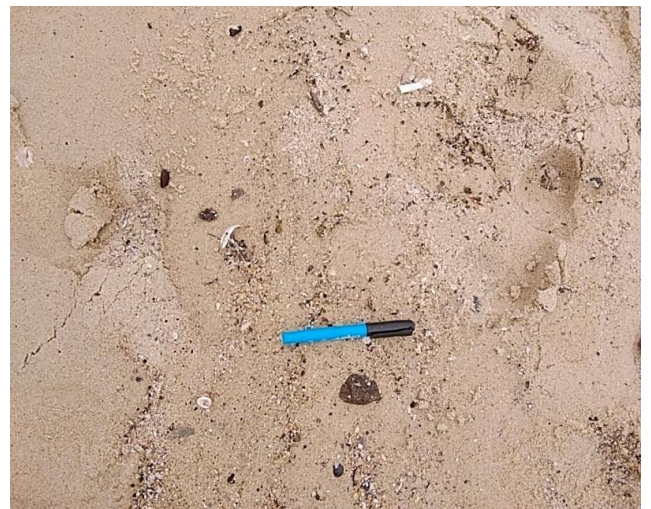
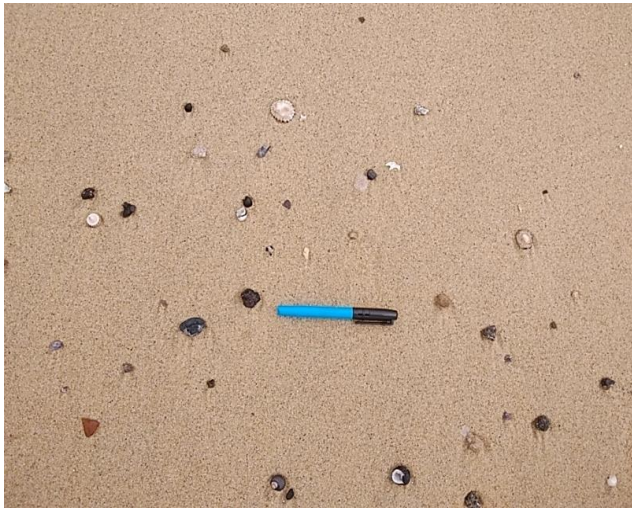
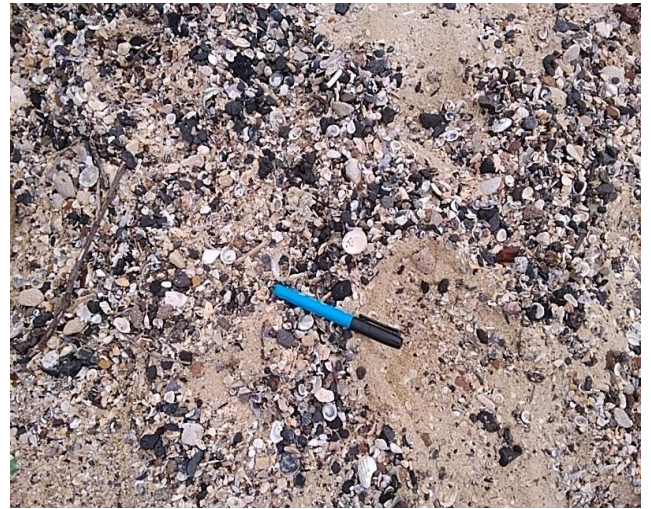
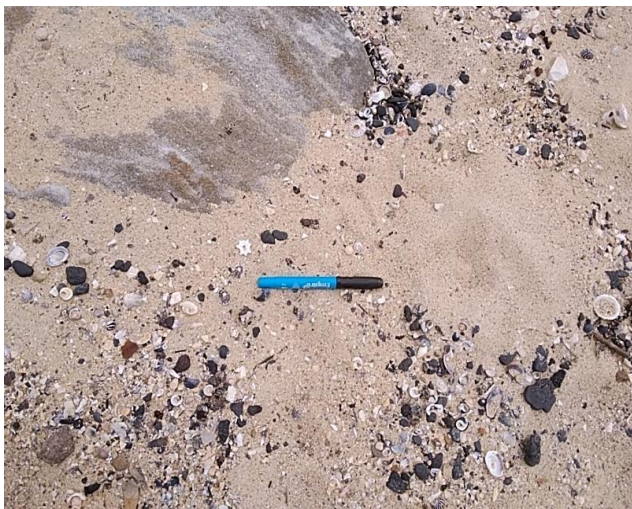
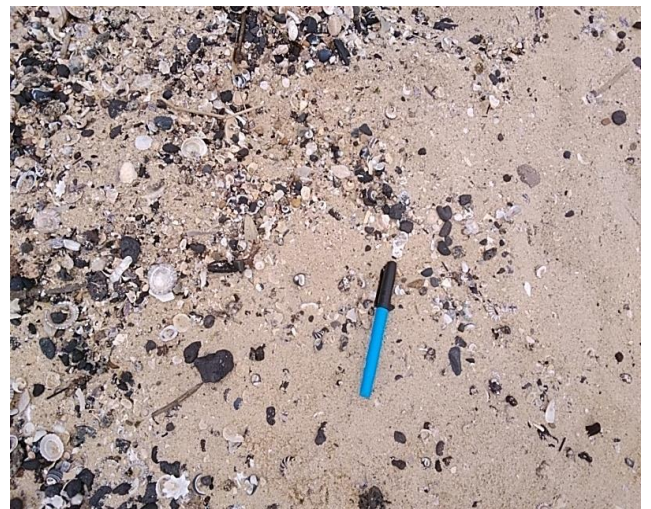
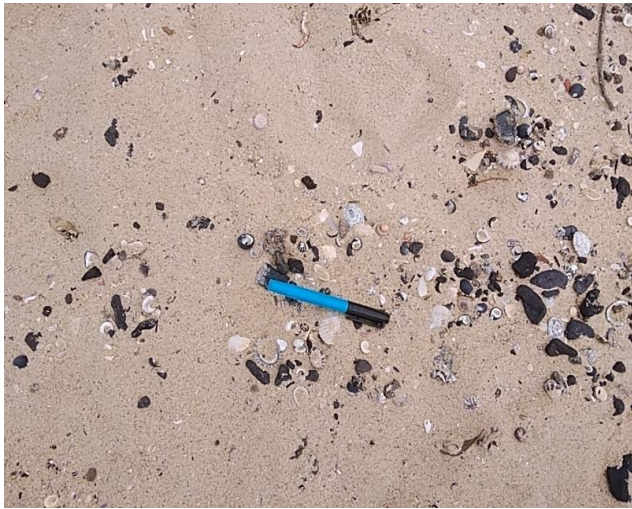
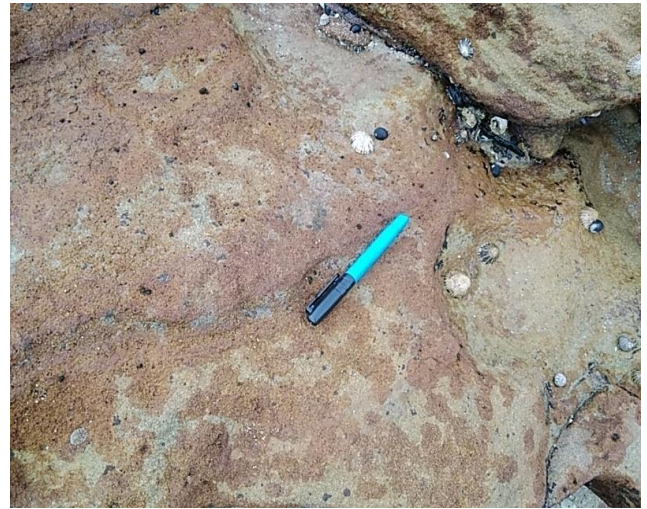
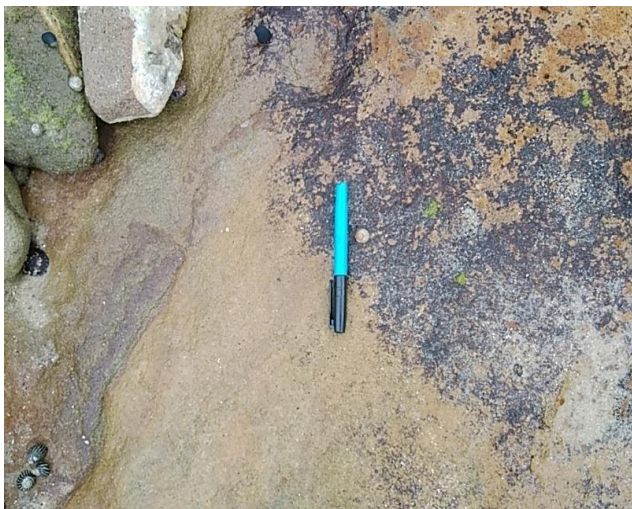
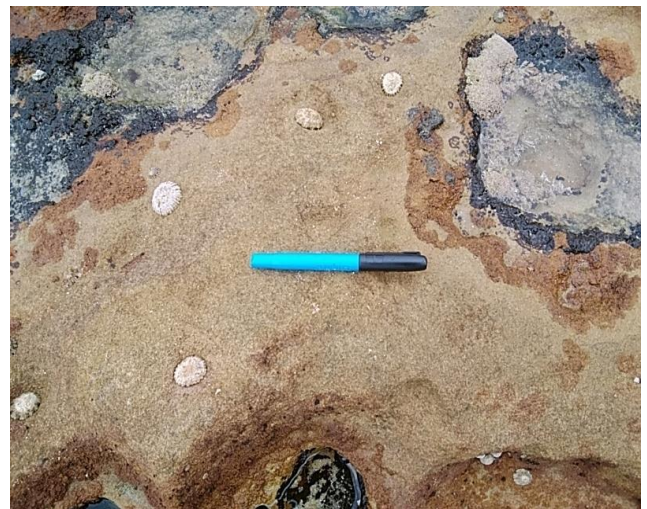
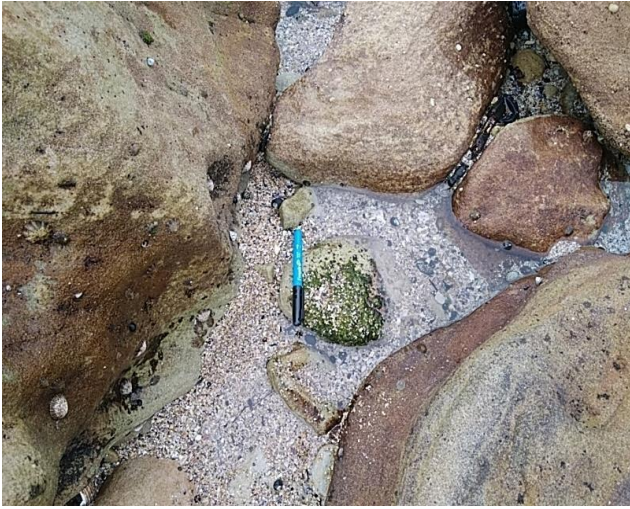
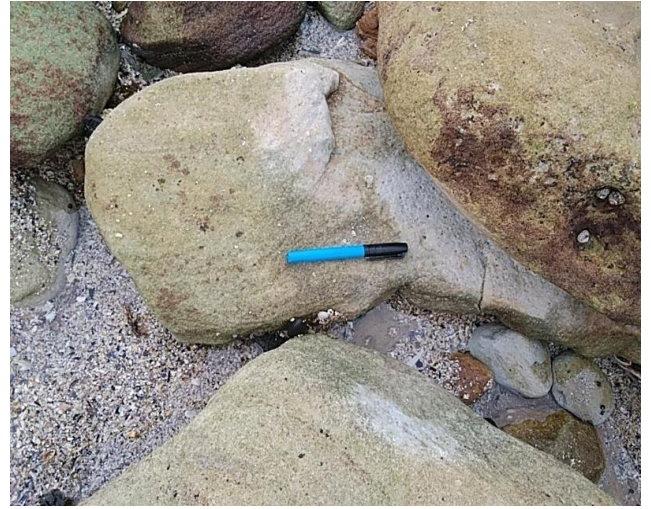
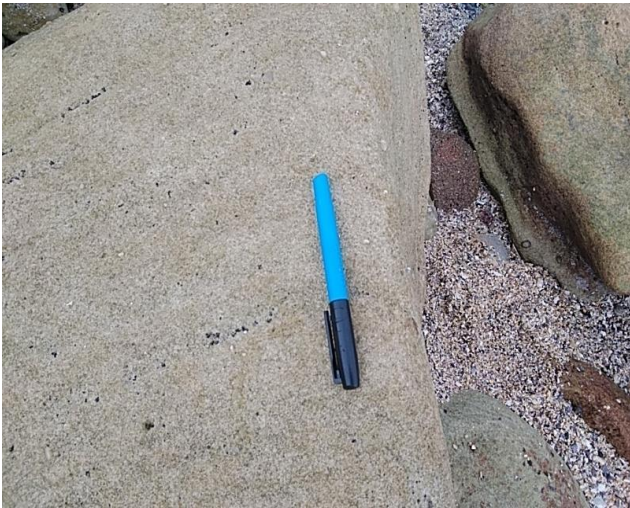
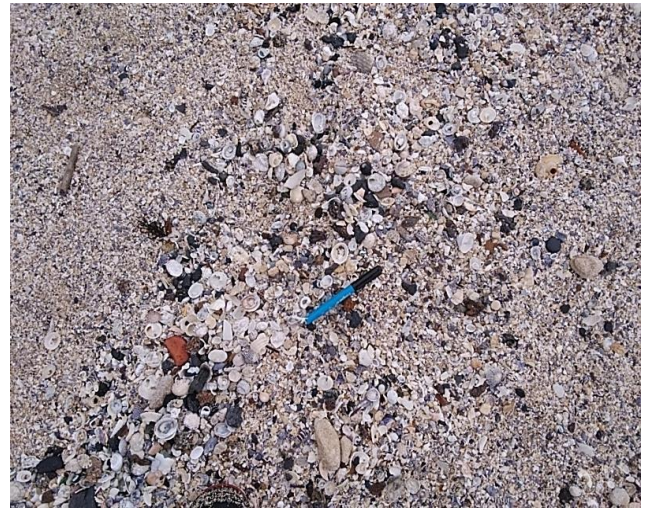
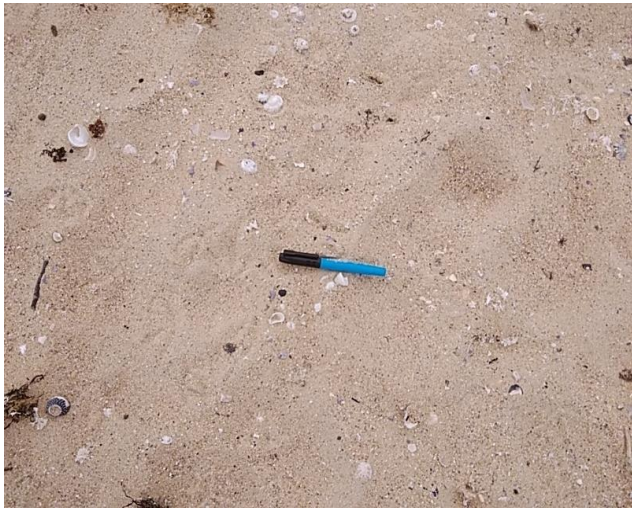
**Notes:** Visual inspection of removal item following removal

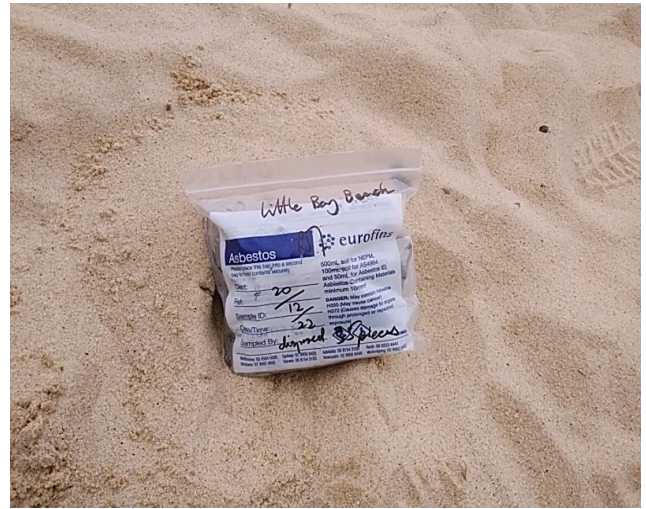
**Notes:** Waste disposal management (disposed 35 pieces)
