Asbestos Containing Material Clearance Inspection

8 December 2022

Site:	Little Bay Beach
Location:	Southern, Western and Northern Little Bay Beach

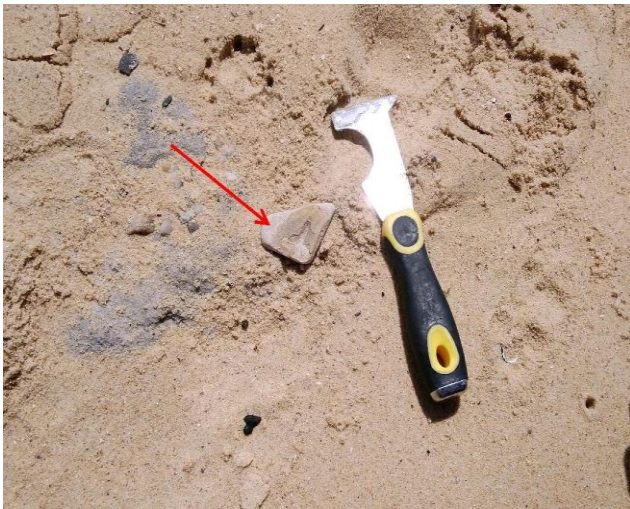
Notes: FC fragment identified on sand surface prior to emu pick - Northern section

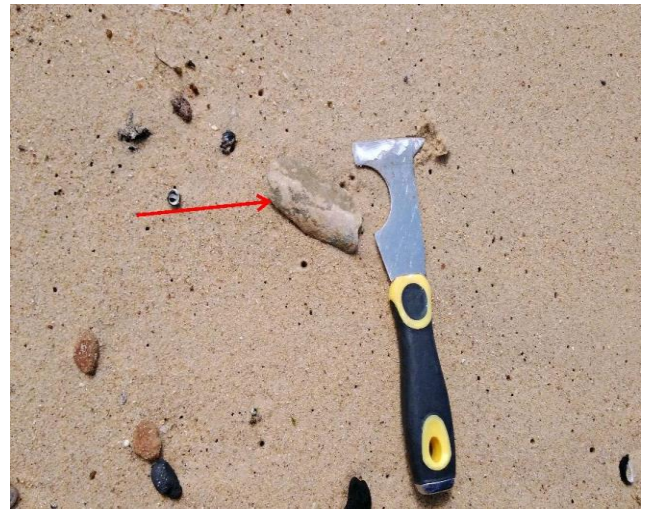
Notes: FC fragment identified on sand surface prior to emu pick - Northern section

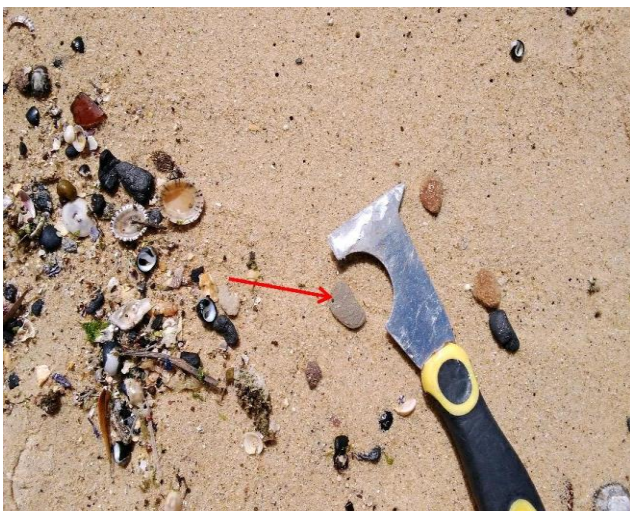
Notes: FC fragment identified on sand surface prior to emu pick - Northern section

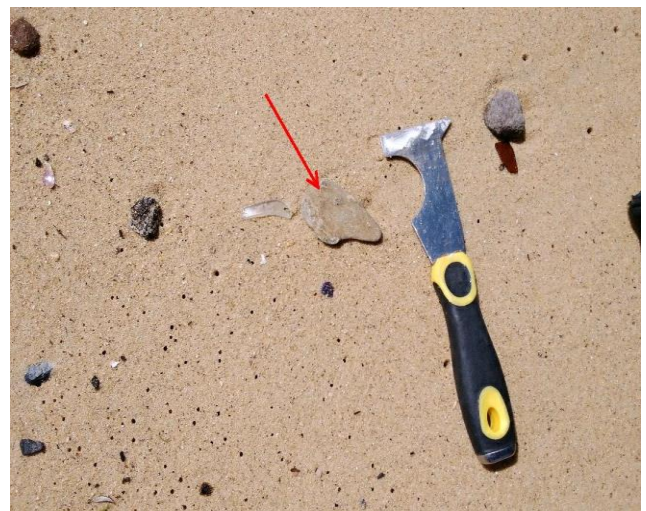
Notes: FC fragment identified on sand surface prior to emu pick - Northern section

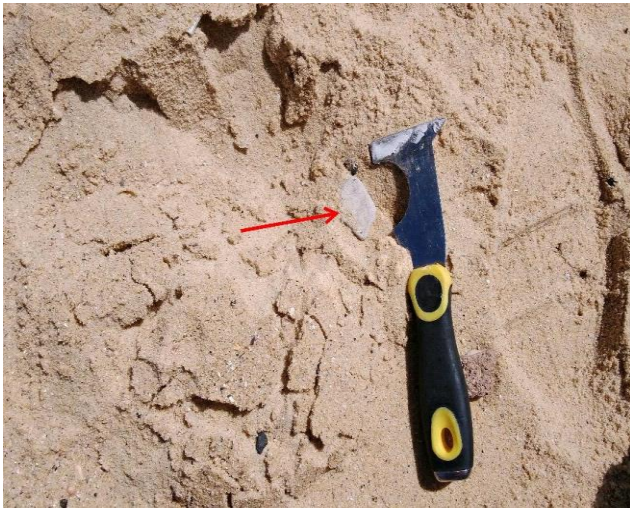
Notes: FC fragment identified on sand surface prior to emu pick - Northern section

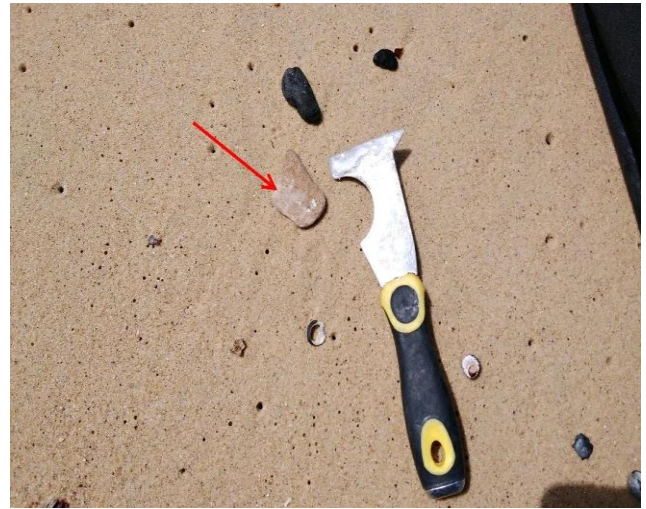
Notes: FC fragment identified on sand surface prior to emu pick - Northern section

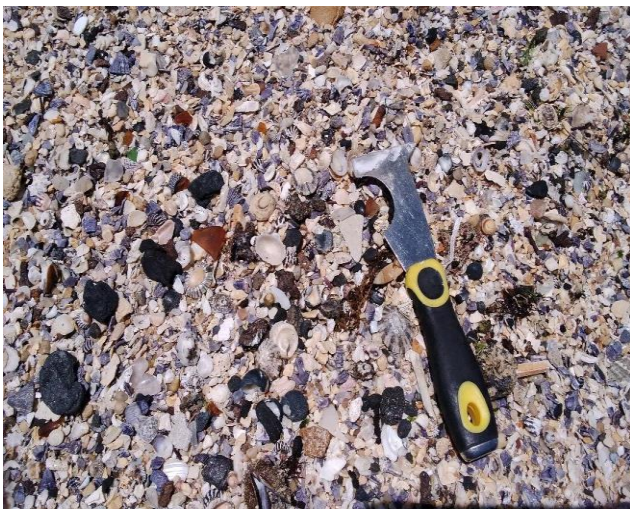
Notes: FC fragment identified on sand surface prior to emu pick - Southern section

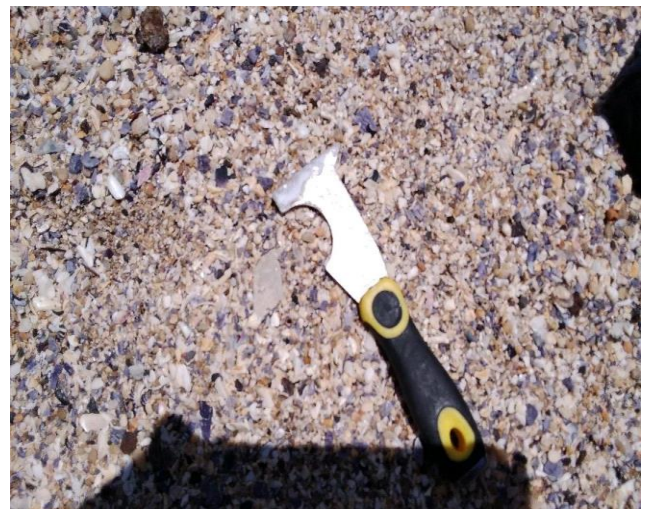
Notes: FC fragment identified on sand surface prior to emu pick - Southern section

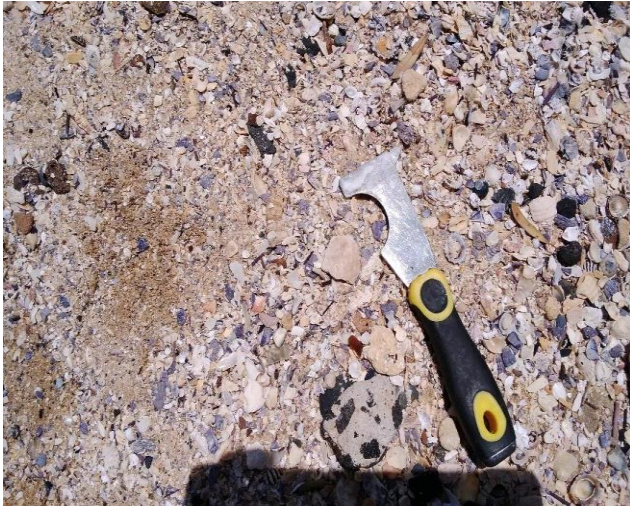
Notes: FC fragment identified on sand surface prior to emu pick - Southern section

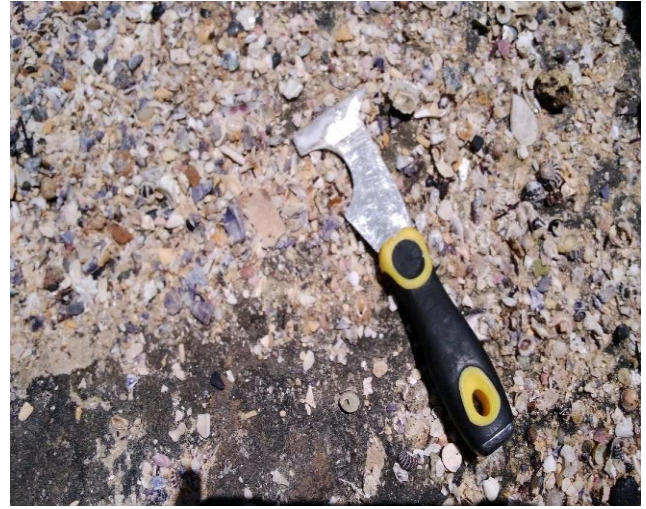
Notes: FC fragment identified on sand surface prior to emu pick - Southern section

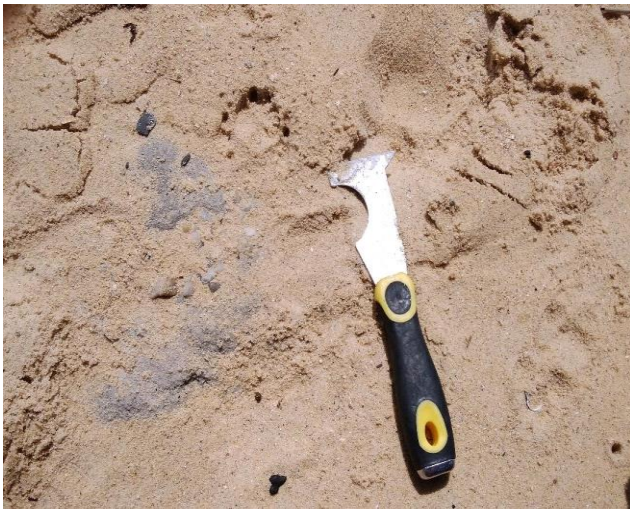
Notes: Sand surface following emu pick - Northern section

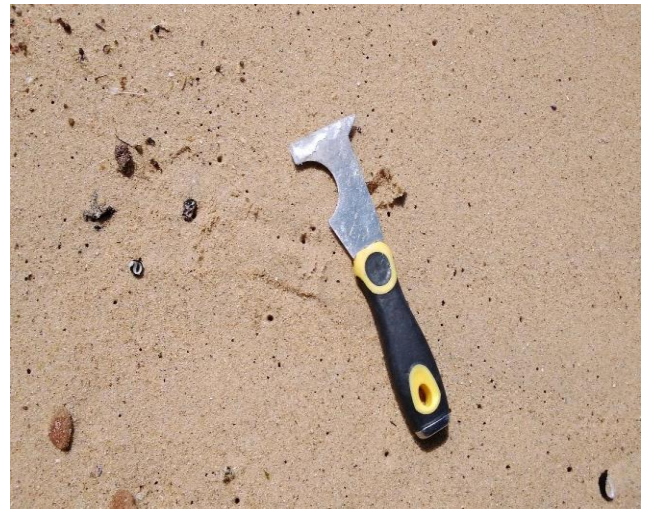
Notes: Sand surface following emu pick - Northern section

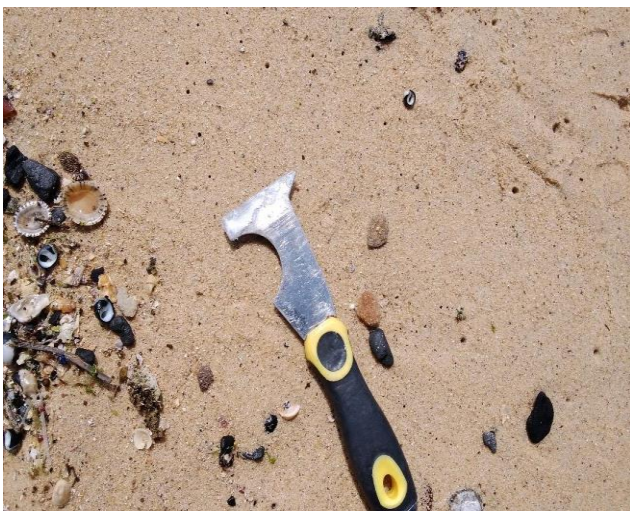
Notes: Sand surface following emu pick - Northern section

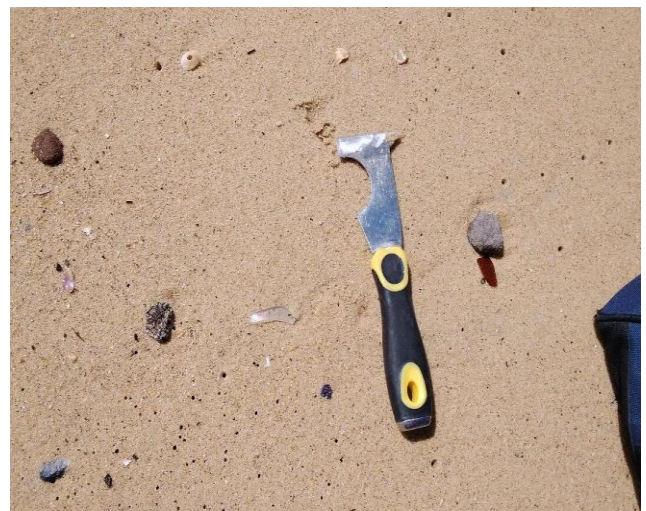
Notes: Sand surface following emu pick - Northern section

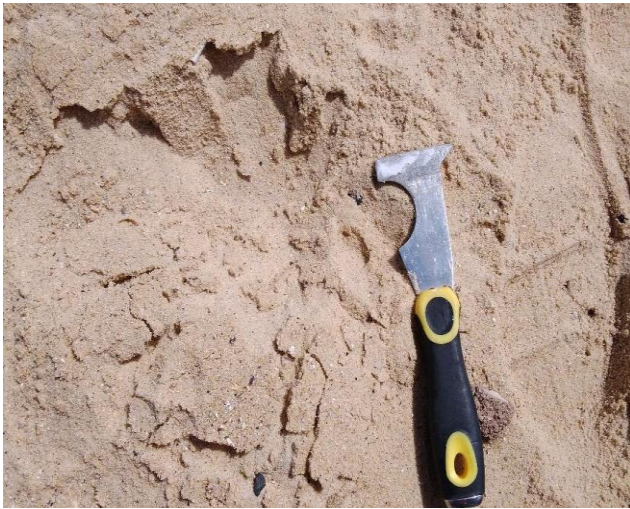
Notes: Sand surface following emu pick - Northern section

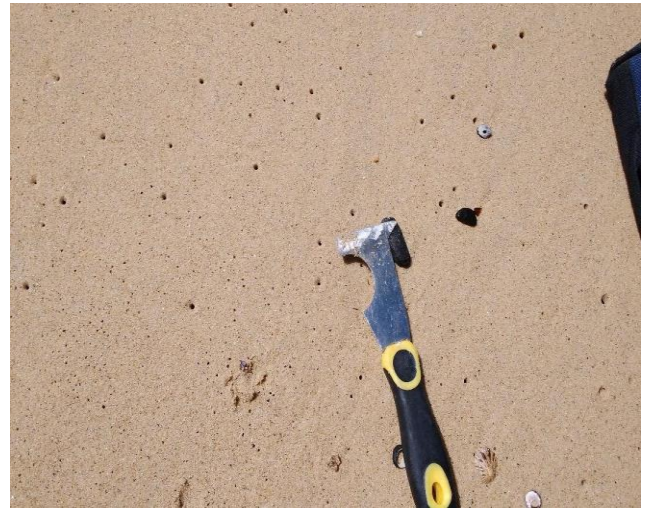
Notes: Sand surface following emu pick - Northern section

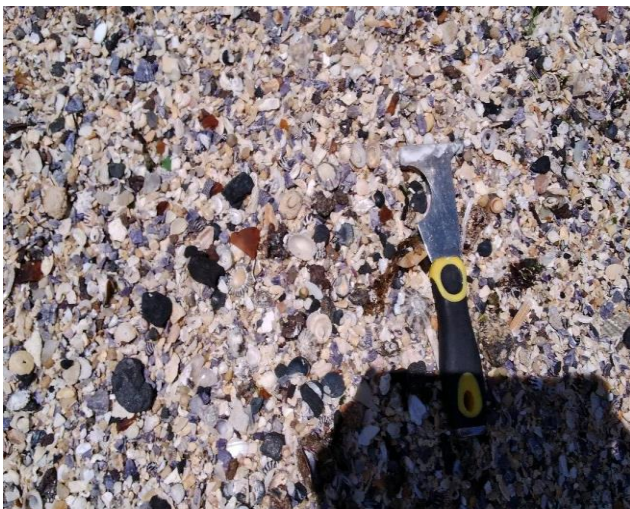
Notes: Sand surface following emu pick - Southern section

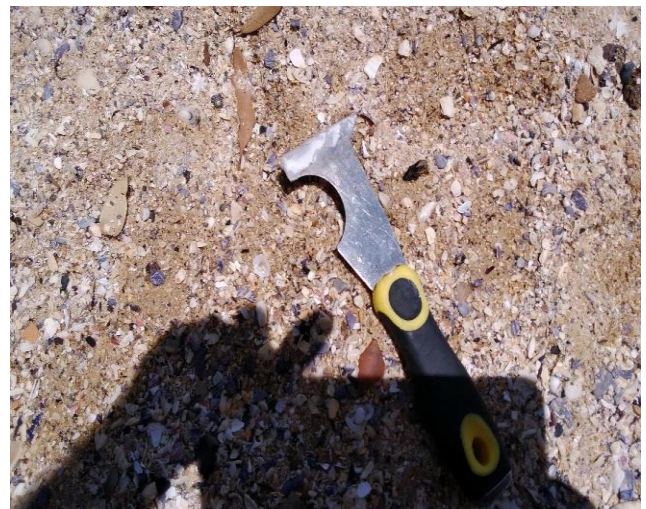
Notes: Sand surface following emu pick - Southern section

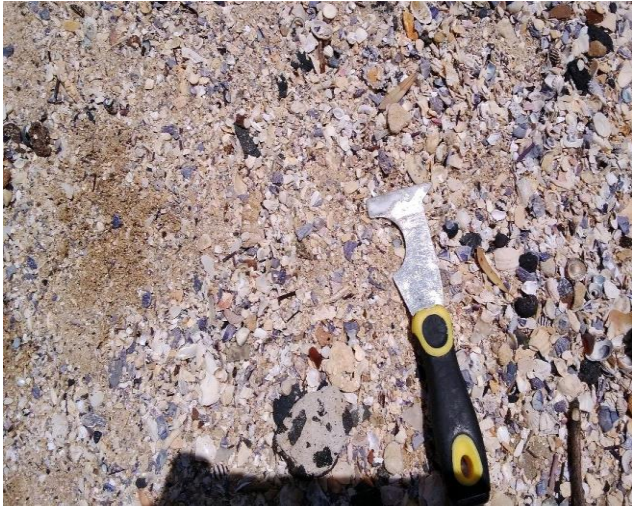
Notes: Sand surface following emu pick - Southern section

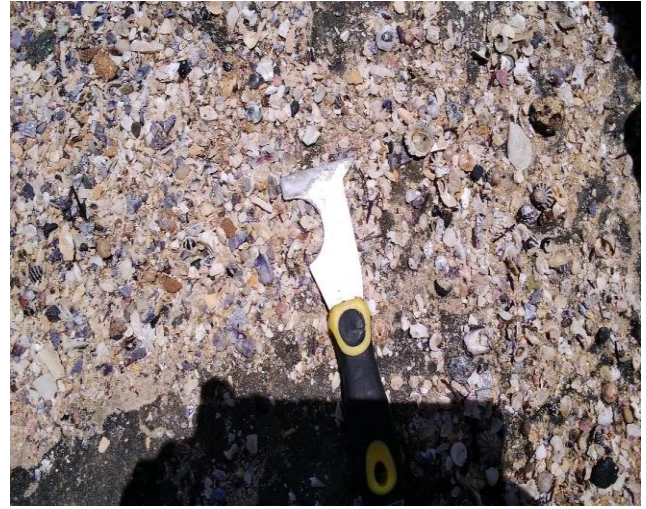
Notes: Sand surface following emu pick - Southern section
