Asbestos Containing Material Clearance Inspection

27 January 2023

Site:	Little Bay Beach
Location:	Southern, Western and Northern Little Bay Beach

Requested by:	
Name	Joe Santangelo
Contact	0436839760
Email	joe.santangelo@randwick.nsw.gov.au
Site Details:	
Address	2 Coast Hospital Rd, Little Bay NSW 2036
Local Government Area	Randwick City Council

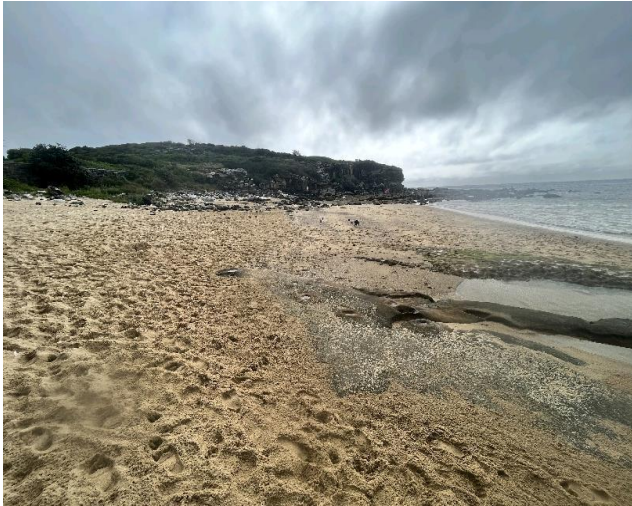
Notes: Overview of the Northern Beach.

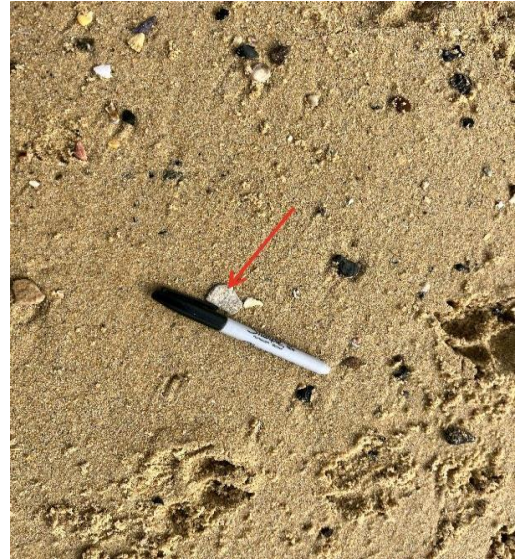
Notes: Overview of the FC Sheeting fragment within Northern Beach.

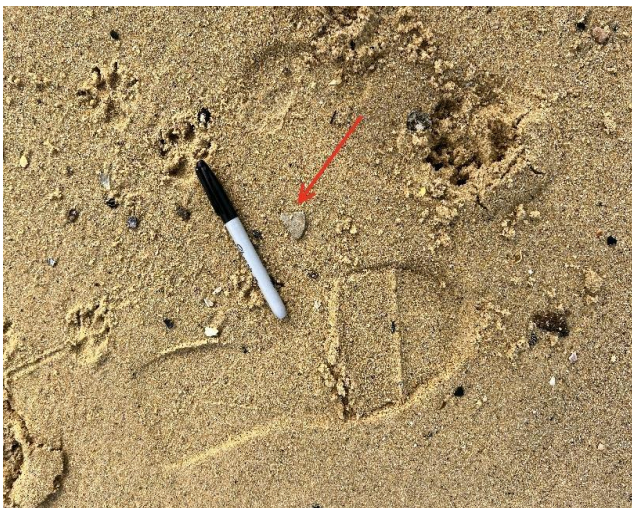
Notes: Overview of the FC Sheeting fragment within Northern Beach.

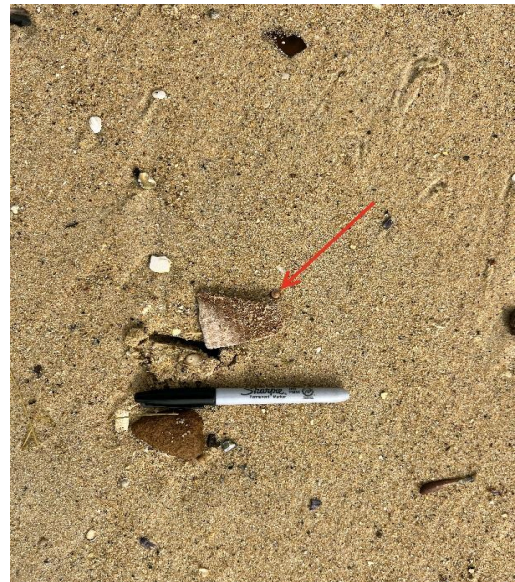
Notes: Overview of the FC Sheeting fragment within Northern Beach.

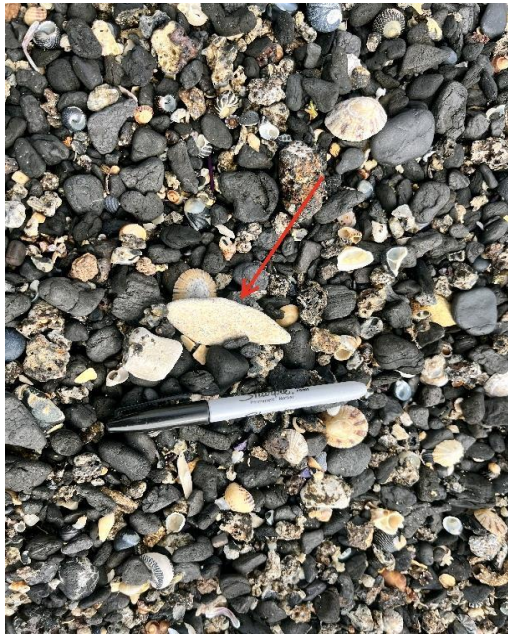
Notes: Overview of the FC Sheeting fragment within Northern Beach.

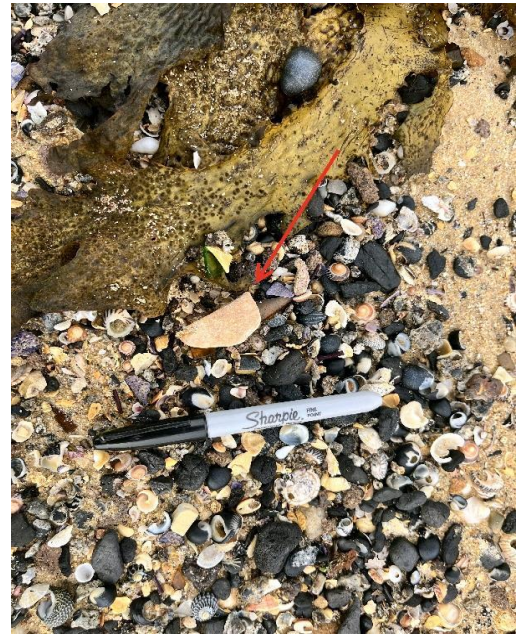
Notes: Overview of the FC Sheeting fragment within Northern Beach.

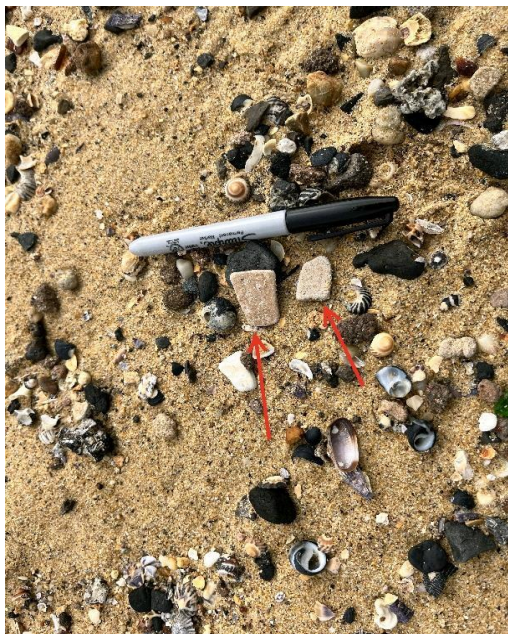
Notes: Overview of the FC Sheeting fragment within Northern Beach.

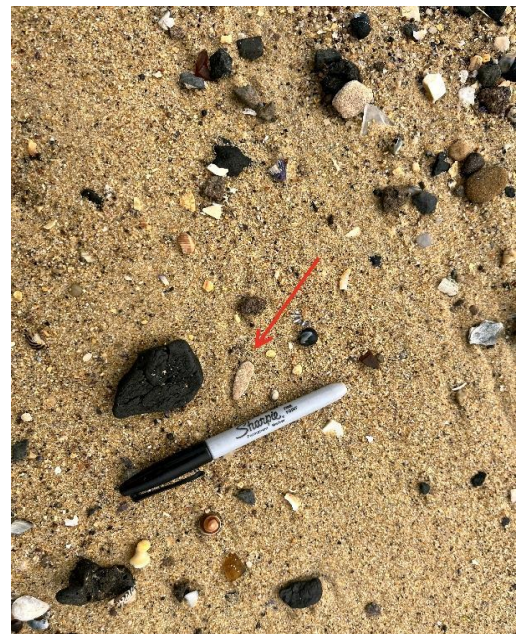
Notes: Overview of the FC Sheeting fragment within Northern Beach.

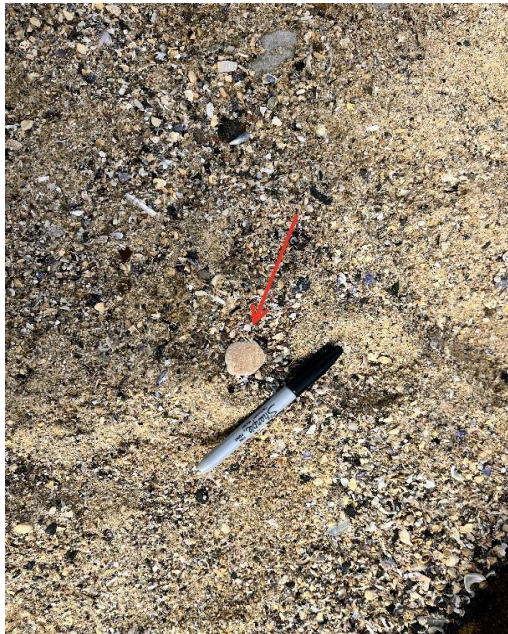
Notes: Overview of the FC Sheeting fragment within Northern Beach.

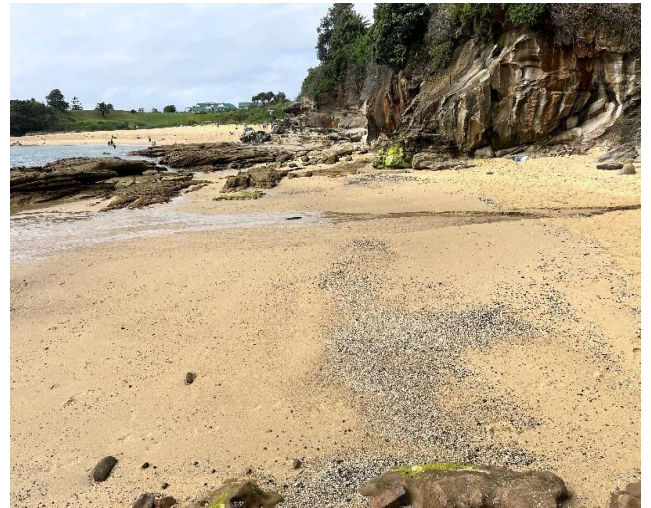
Notes: Overview of Western Beach.

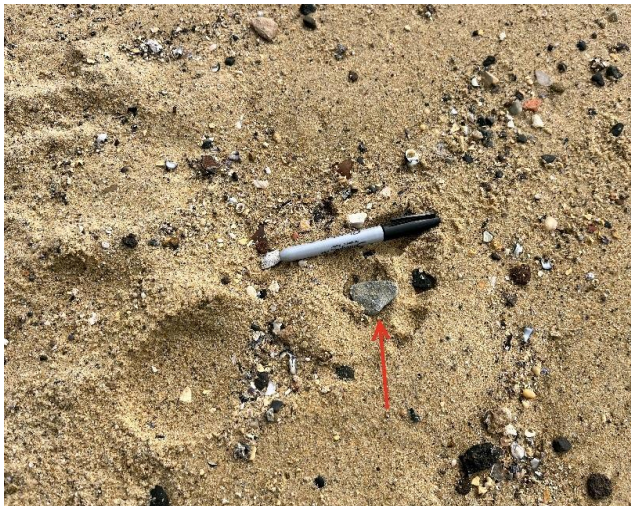
Notes: Overview of the FC Sheeting fragment within Western Beach.

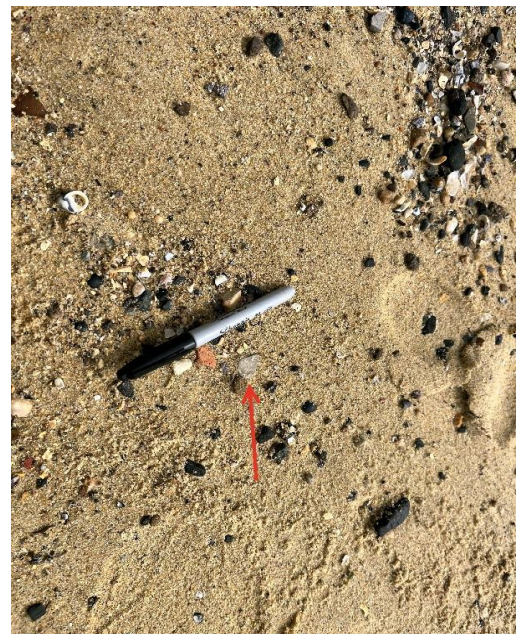
Notes: Overview of the FC Sheeting fragment within Western Beach.

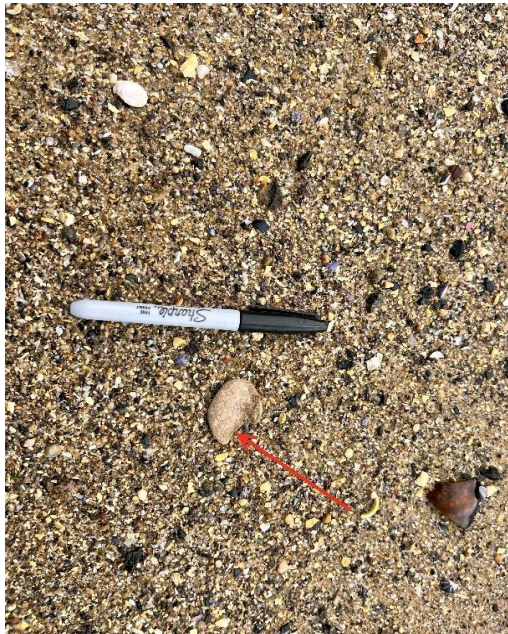
Notes: Overview of the FC Sheeting fragment within Western Beach.

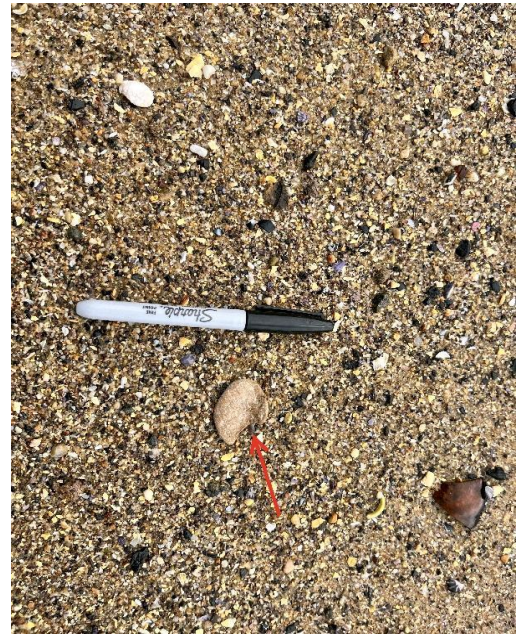
Notes: Overview of the FC Sheeting fragment within Western Beach.

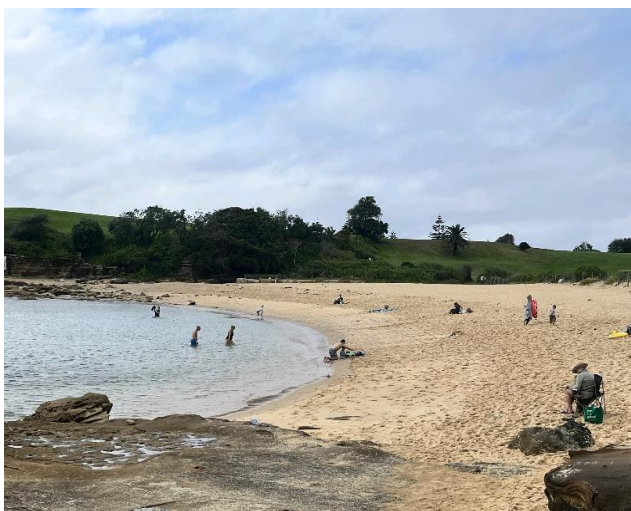
Notes: Overview of Southern Beach.

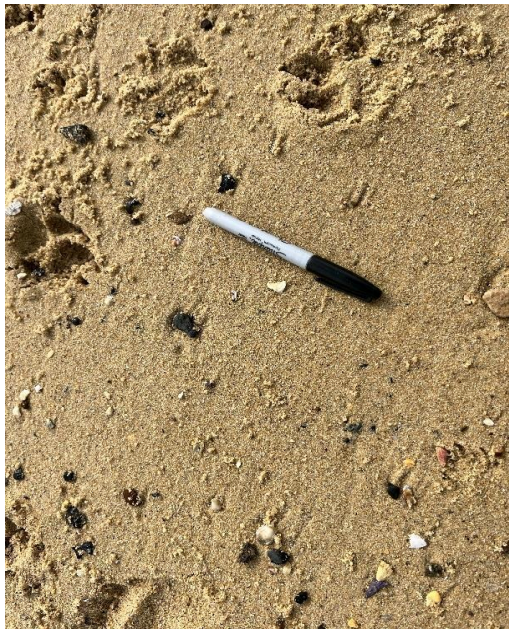
Notes: Visual clearance inspection following removal of asbestos containing FC Sheeting fragment.

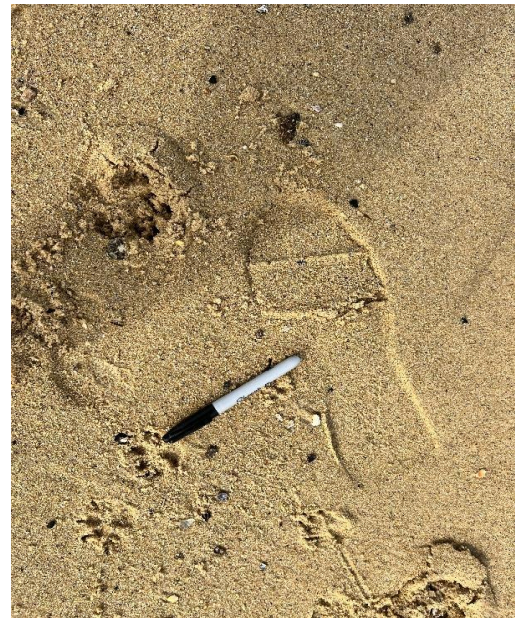
Notes: Visual clearance inspection following removal of asbestos containing FC Sheeting fragment.

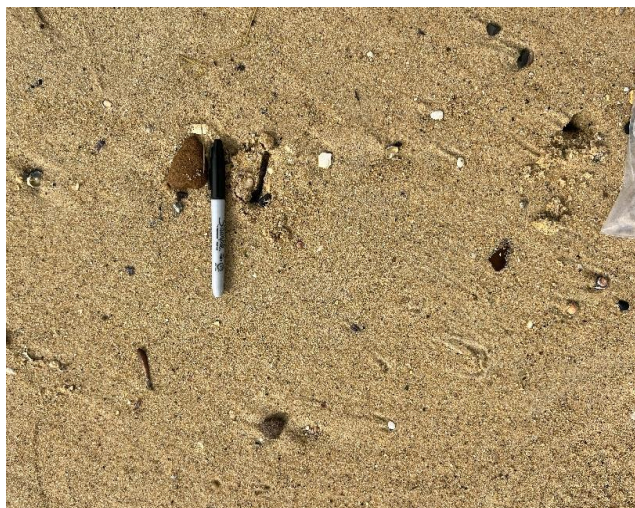
Notes: Visual clearance inspection following removal of asbestos containing FC Sheeting fragment.

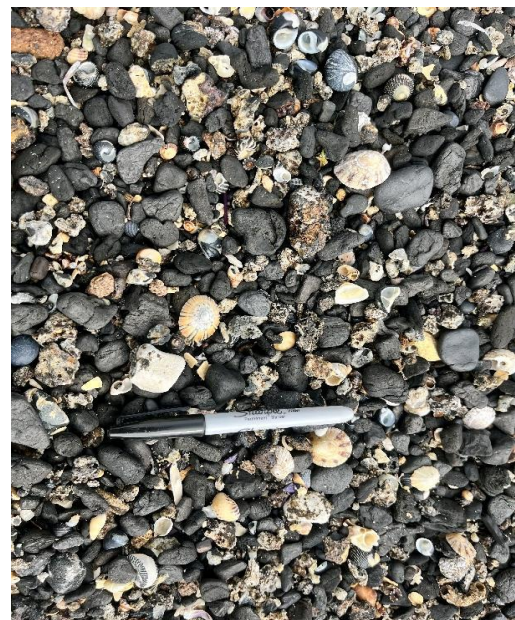
Notes: Visual clearance inspection following removal of asbestos containing FC Sheeting fragment.

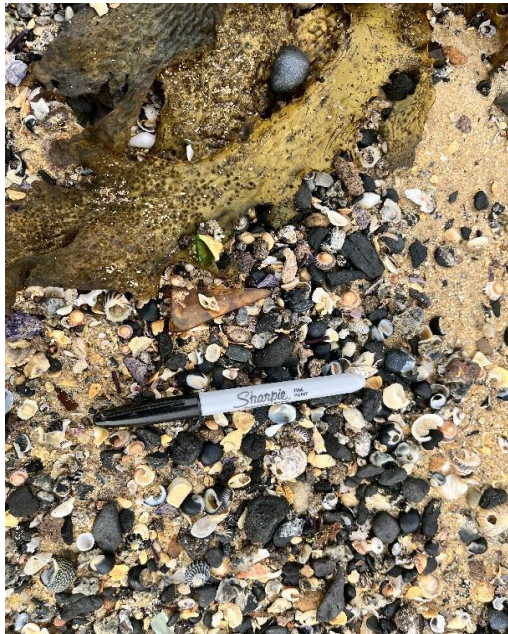
Notes: Visual clearance inspection following removal of asbestos containing FC Sheeting fragment.

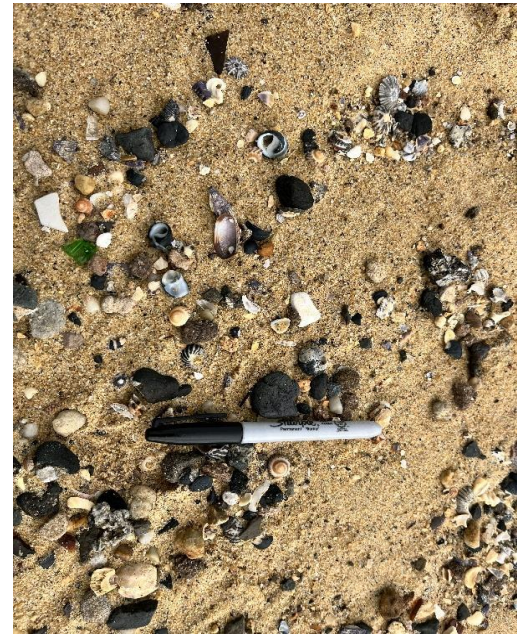
Notes: Visual clearance inspection following removal of asbestos containing FC Sheeting fragment.

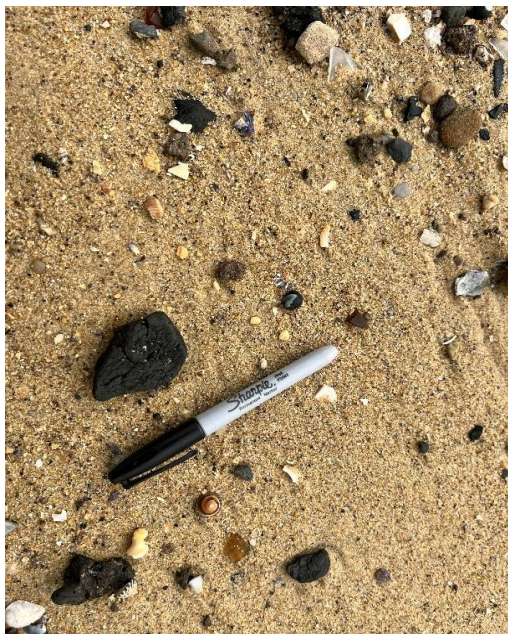
Notes: Visual clearance inspection following removal of asbestos containing FC Sheeting fragment.

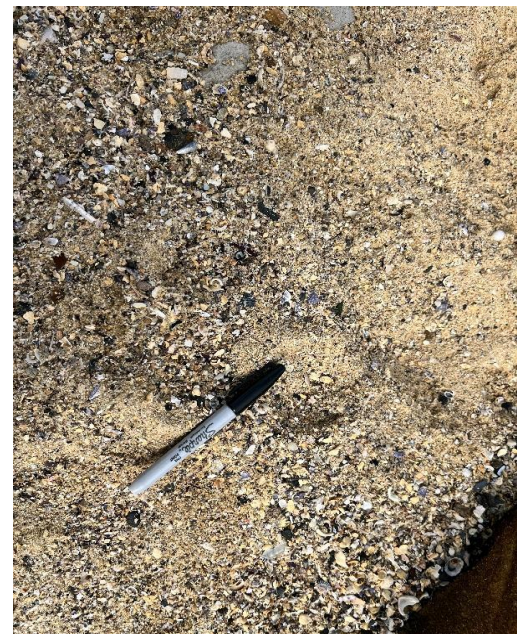
Notes: Visual clearance inspection following removal of asbestos containing FC Sheeting fragment.

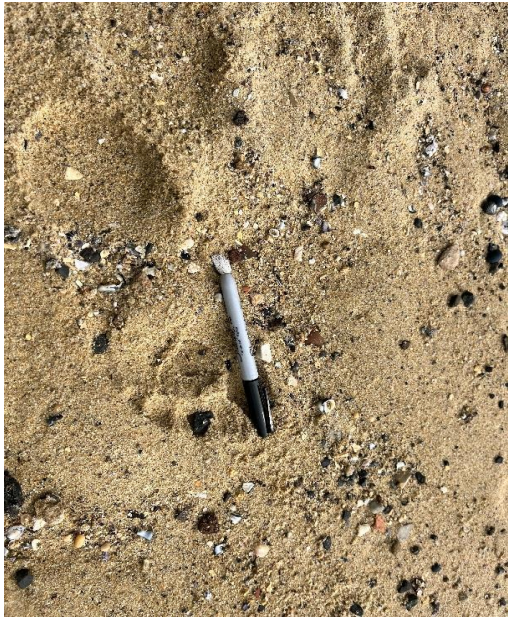
Notes: Visual clearance inspection following removal of asbestos containing FC Sheeting fragment.

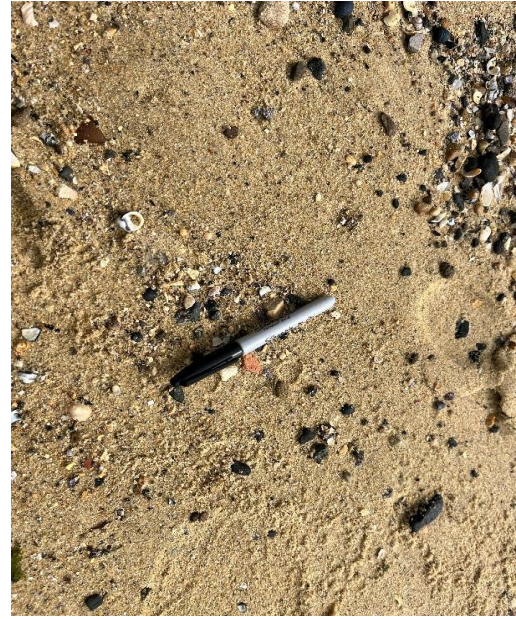
Notes: Visual clearance inspection following removal of asbestos containing FC Sheeting fragment.

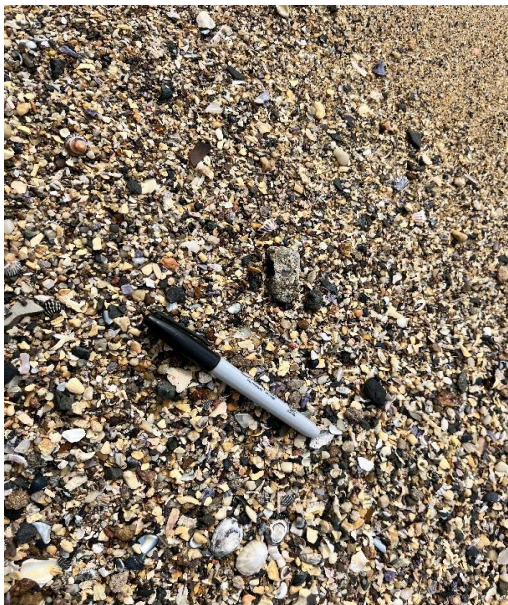
Notes: Visual clearance inspection following removal of asbestos containing FC Sheeting fragment.

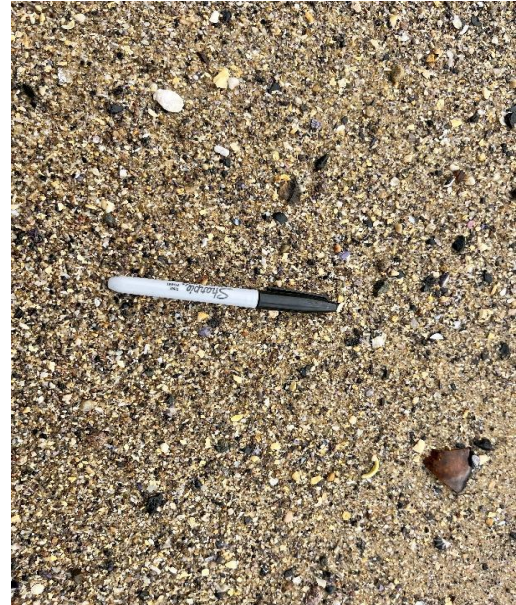
Notes: Visual clearance inspection following removal of asbestos containing FC Sheeting fragment.
