Asbestos Containing Material Clearance Inspection

10 March 2023

Site:	Little Bay Beach
Location:	Southern, Western and Northern Little Bay Beach

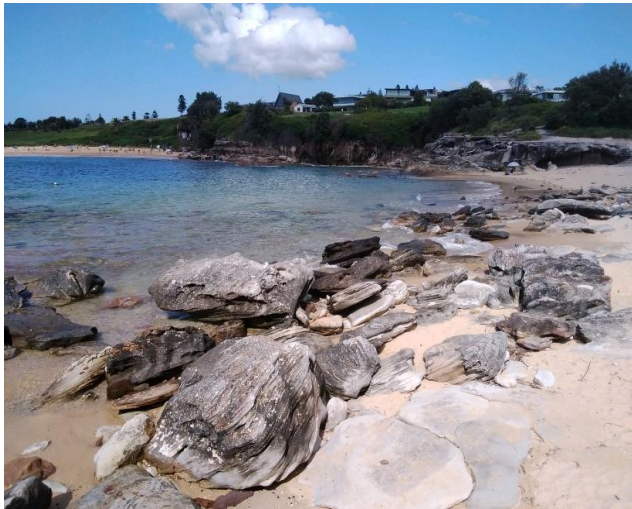
Notes: Overview of the Beach prior to removal works

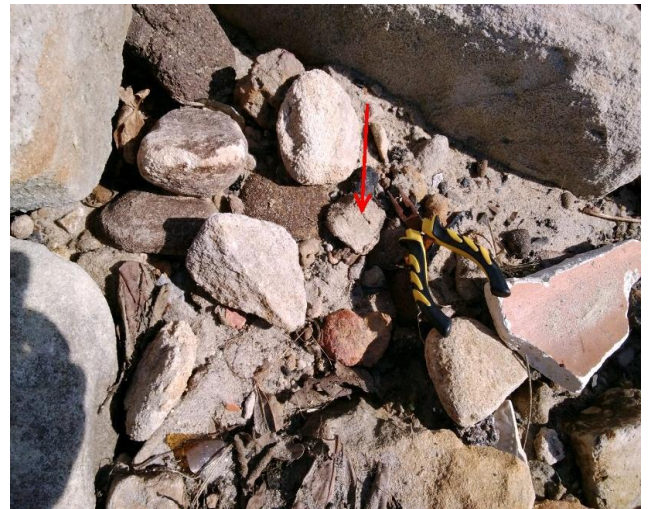
Notes: FC fragment identified on sand surface prior to emu pick - Northern section

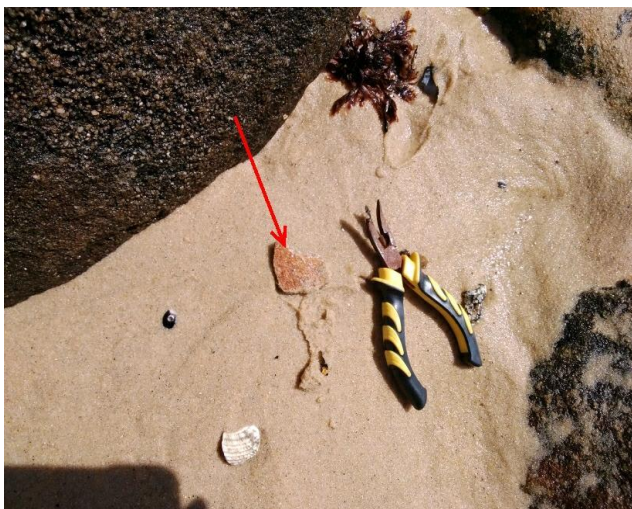
Notes: FC fragment identified on sand surface prior to emu pick - Northern section

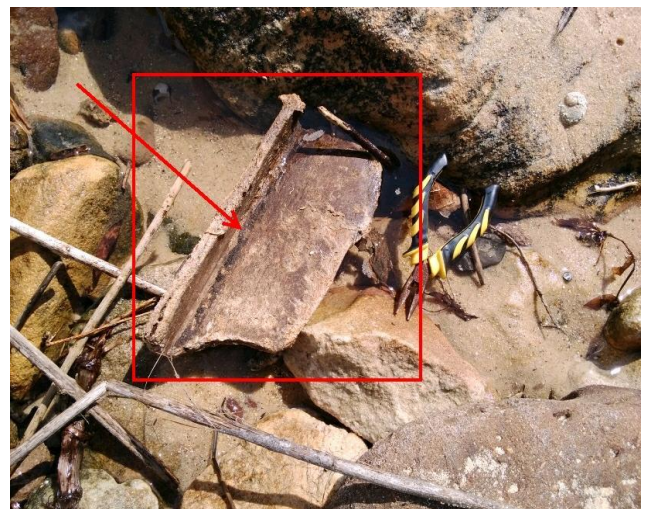
Notes: FC fragment identified on sand surface prior to emu pick - Northern section

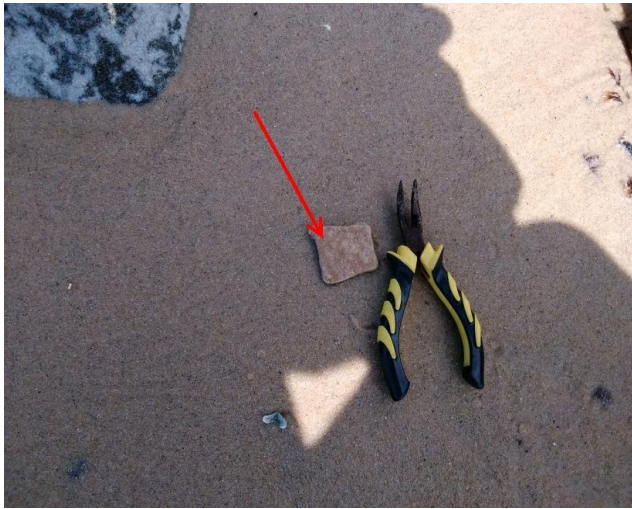
Notes: FC fragment identified on sand surface prior to emu pick - Northern section

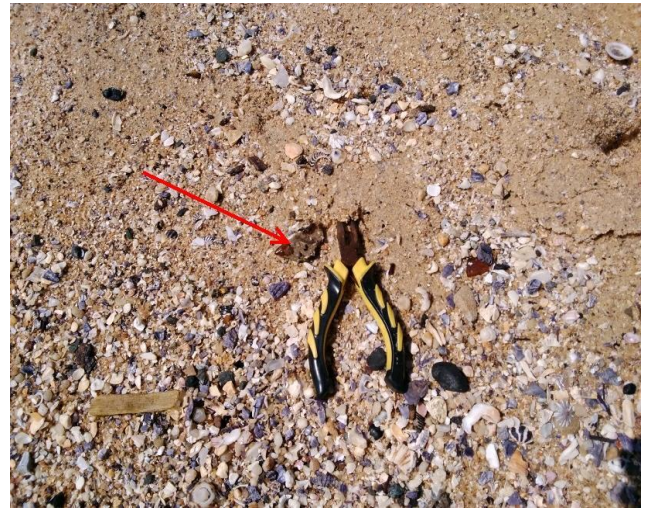
Notes: FC fragment identified on sand surface prior to emu pick - Northern section

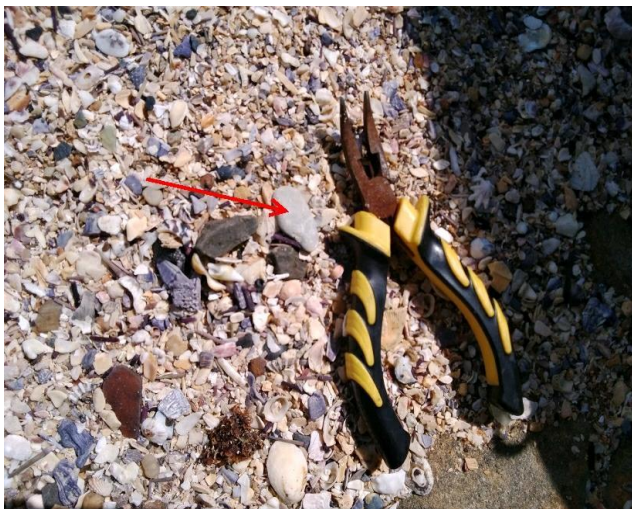
Notes: FC fragment identified on sand surface prior to emu pick - Northern section

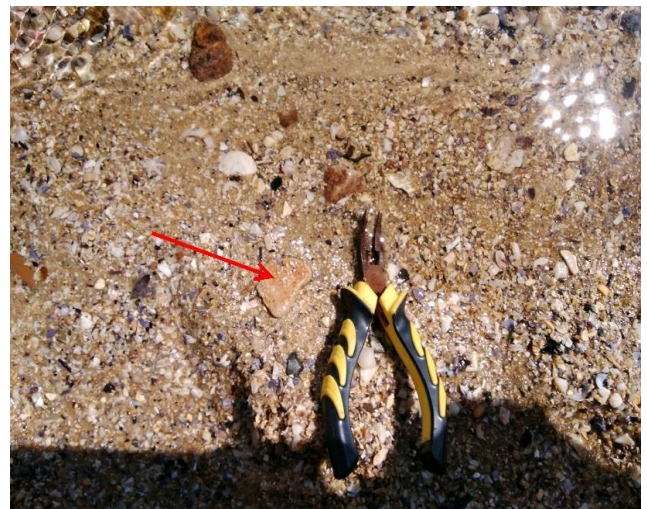
Notes: FC fragment identified on sand surface prior to emu pick - Southern section

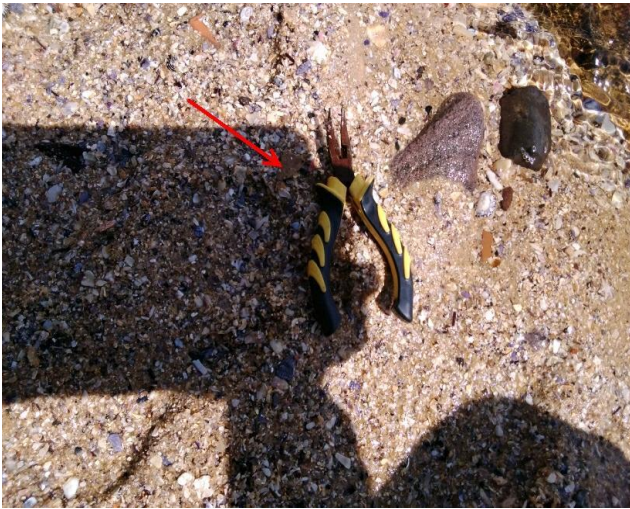
Notes: FC fragment identified on sand surface prior to emu pick - Southern section

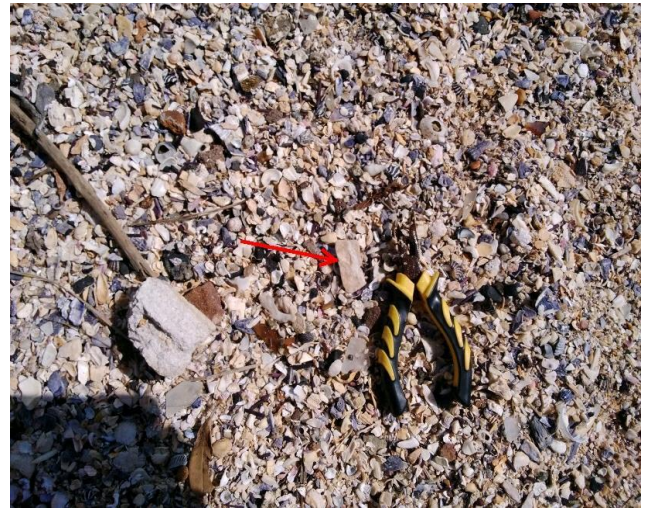
Notes: FC fragment identified on sand surface prior to emu pick - Southern section

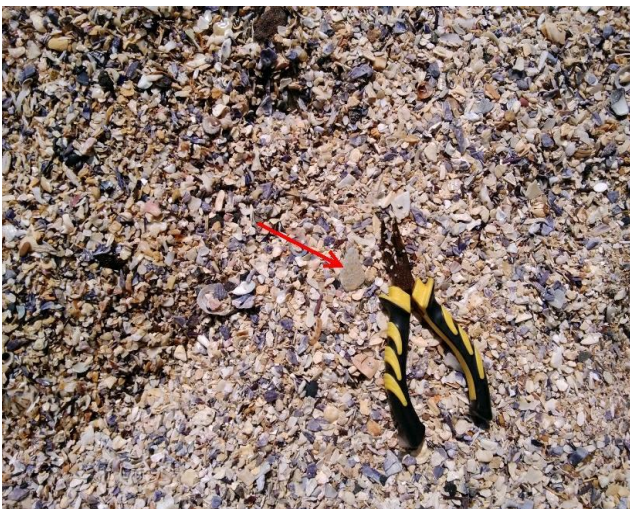
Notes: FC fragment identified on sand surface prior to emu pick - Southern section

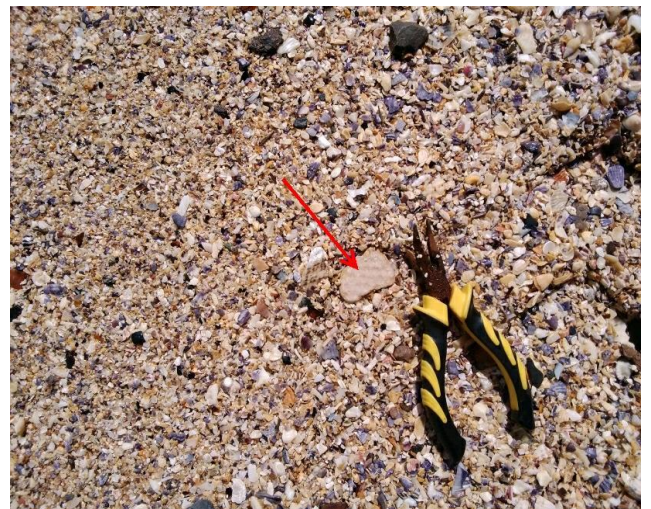
Notes: FC fragment identified on sand surface prior to emu pick - Southern section

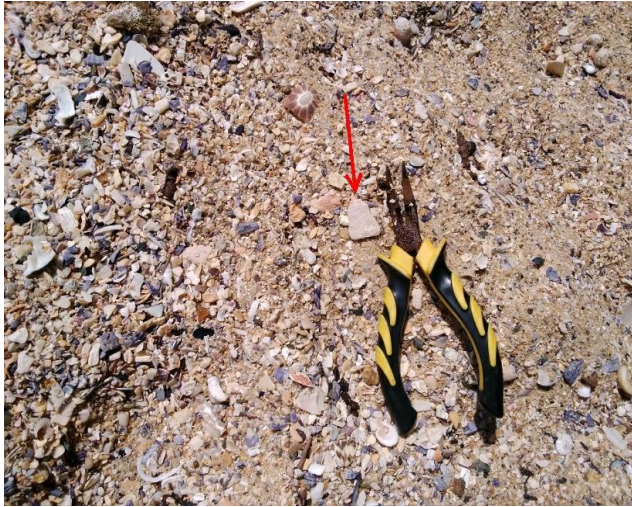
Notes: FC fragment identified on sand surface prior to emu pick - Southern section

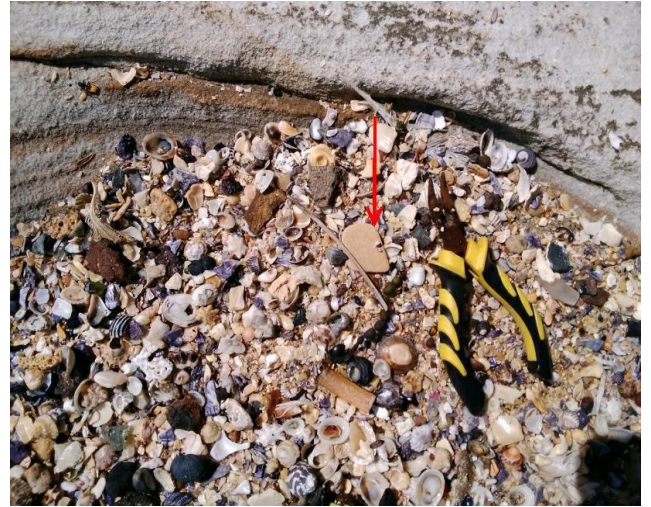
Notes: FC fragment identified on sand surface prior to emu pick - Southern section

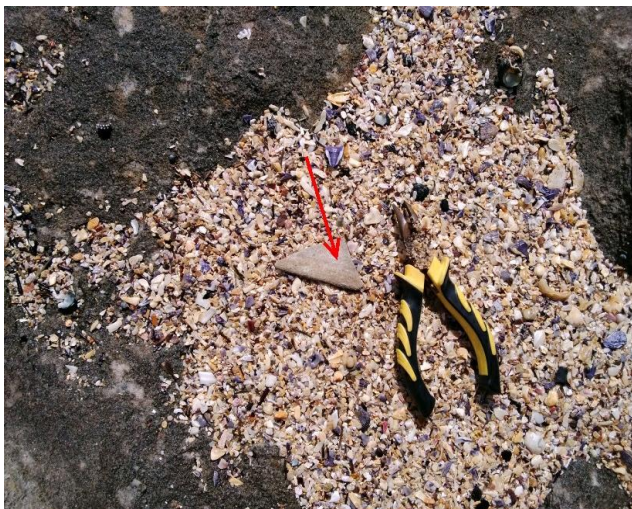
Notes: FC fragment identified on sand surface prior to emu pick - Southern section

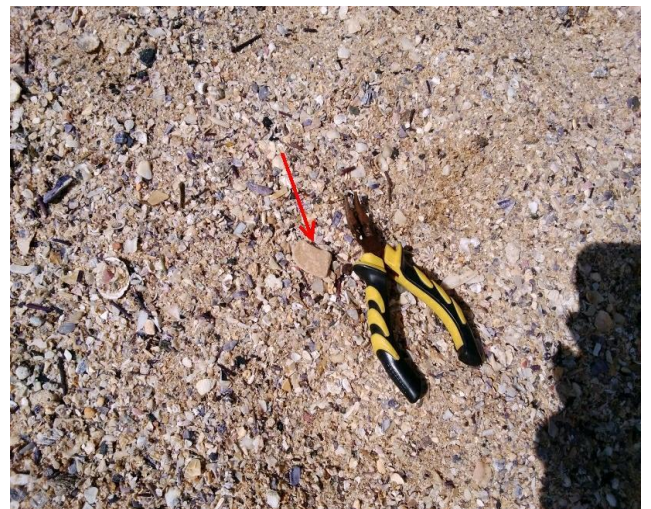
Notes: FC fragment identified on sand surface prior to emu pick - Southern section

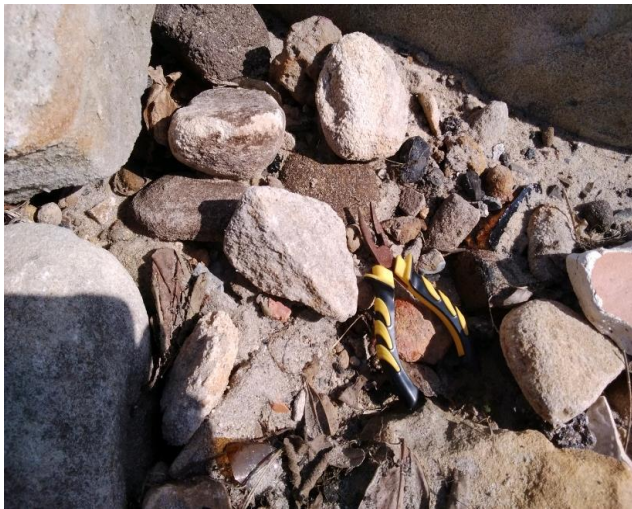
Notes: Sand surface following emu pick - Northern section

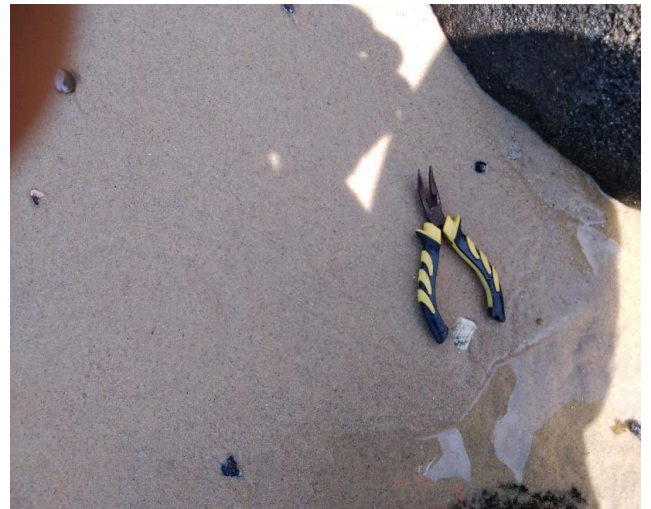
Notes: Sand surface following emu pick - Northern section

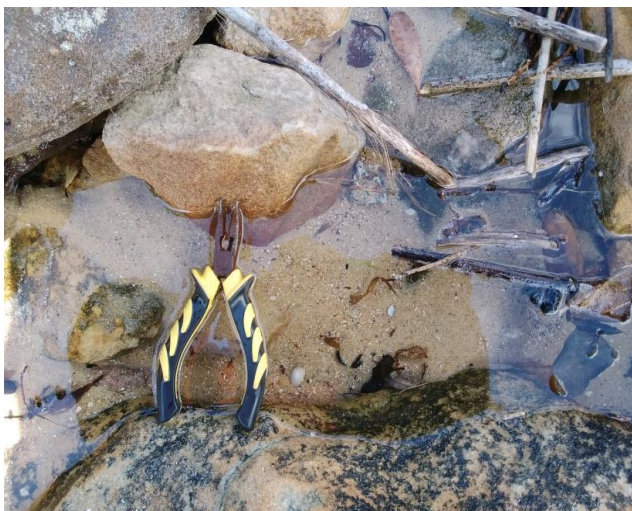
Notes: Sand surface following emu pick - Northern section

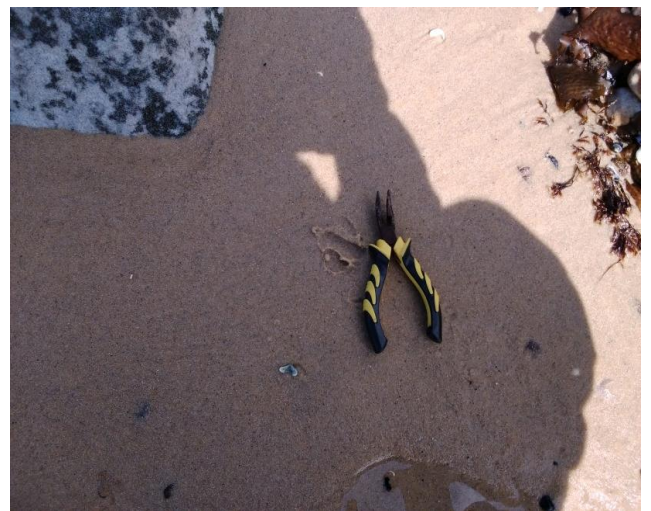
Notes: Sand surface following emu pick - Northern section

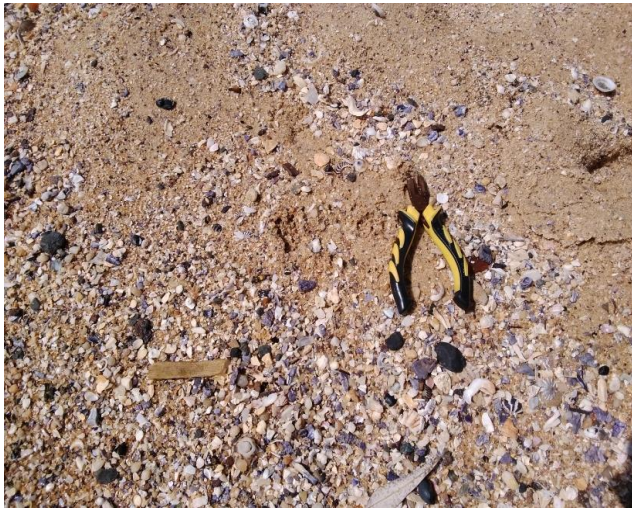
Notes: Sand surface following emu pick - Northern section

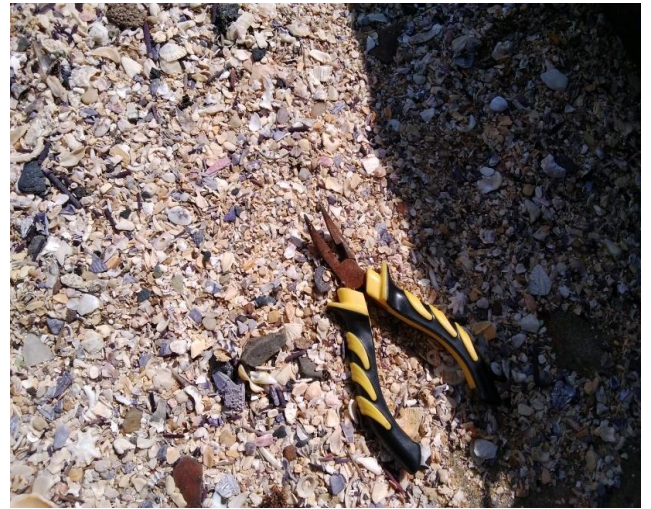
Notes: Sand surface following emu pick - Northern section

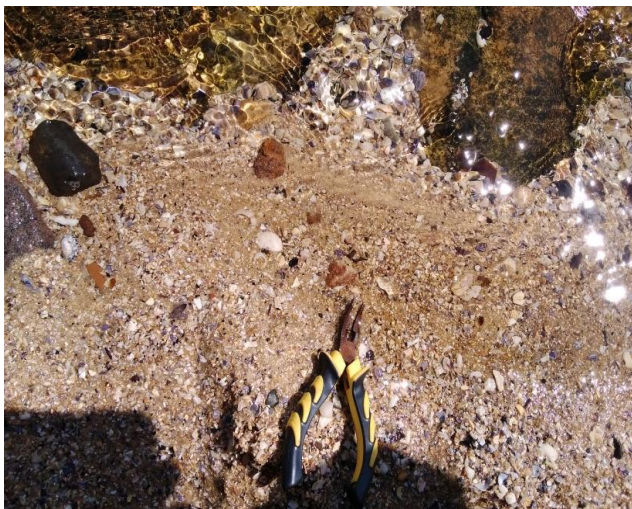
Notes: Sand surface following emu pick - Southern section

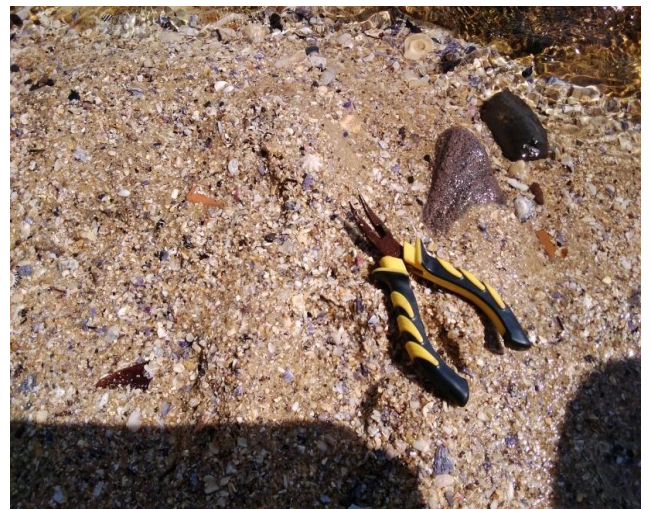
Notes: Sand surface following emu pick - Southern section

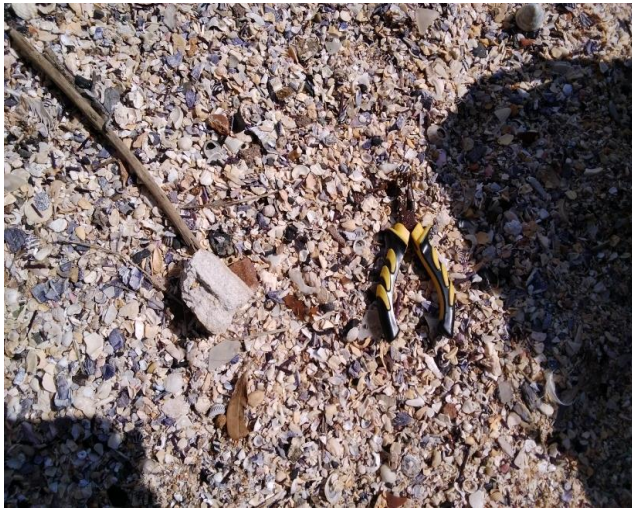
Notes: Sand surface following emu pick - Southern section

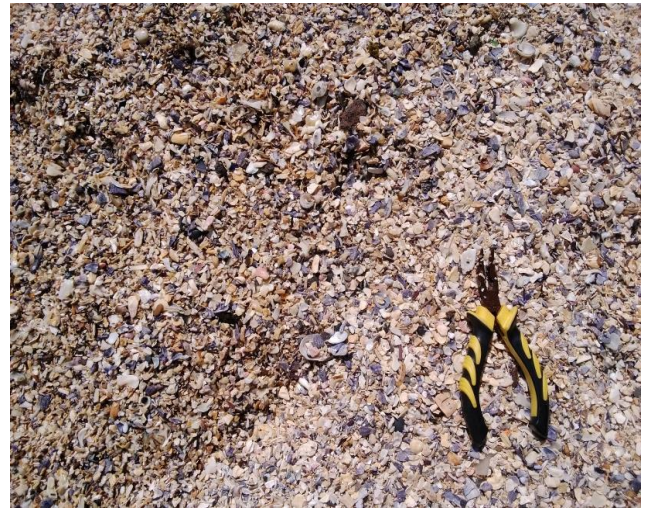
Notes: Sand surface following emu pick - Southern section

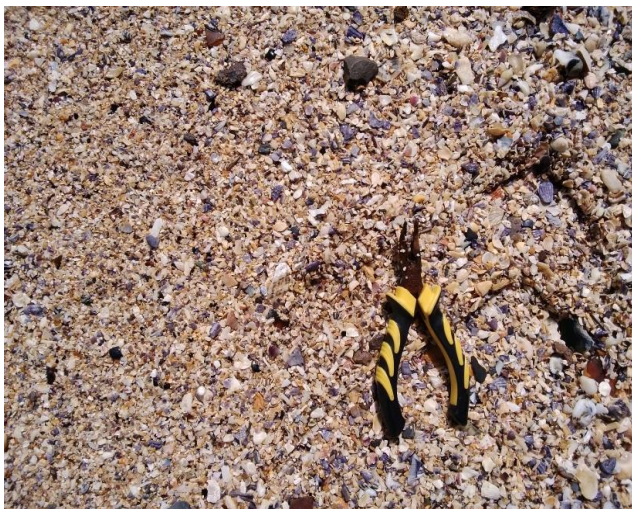
Notes: Sand surface following emu pick - Southern section

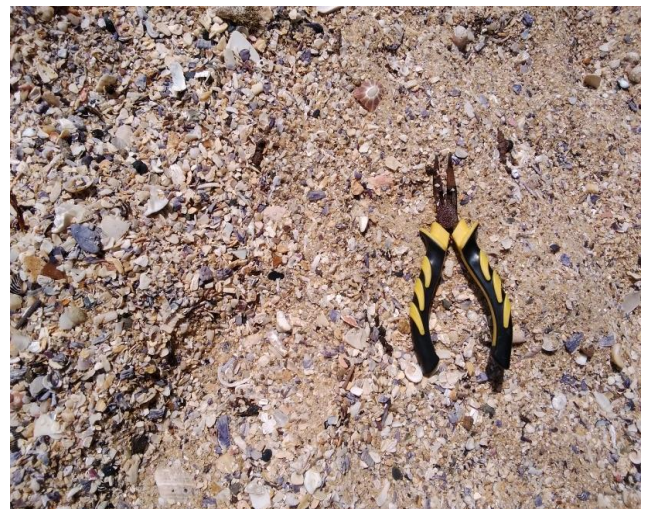
Notes: Sand surface following emu pick - Southern section

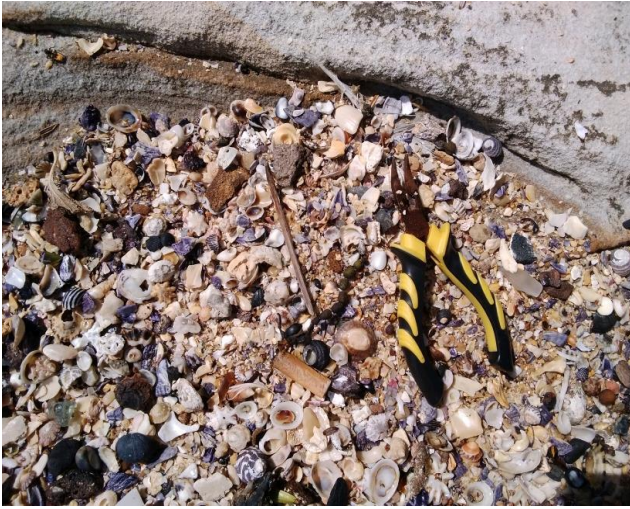
Notes: Sand surface following emu pick - Southern section

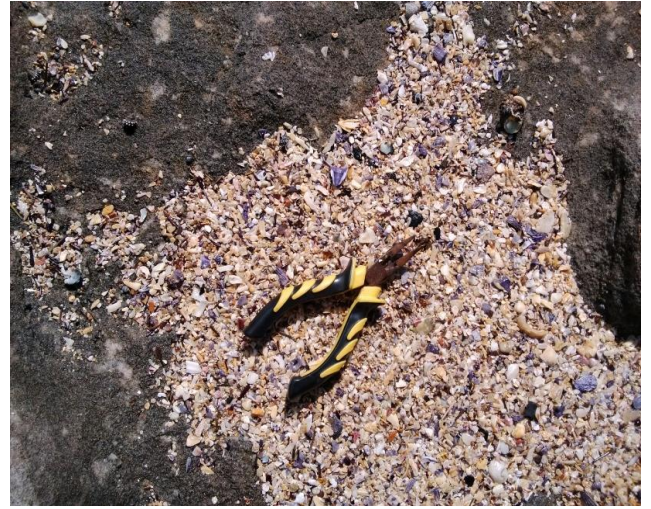
Notes: Sand surface following emu pick - Southern section

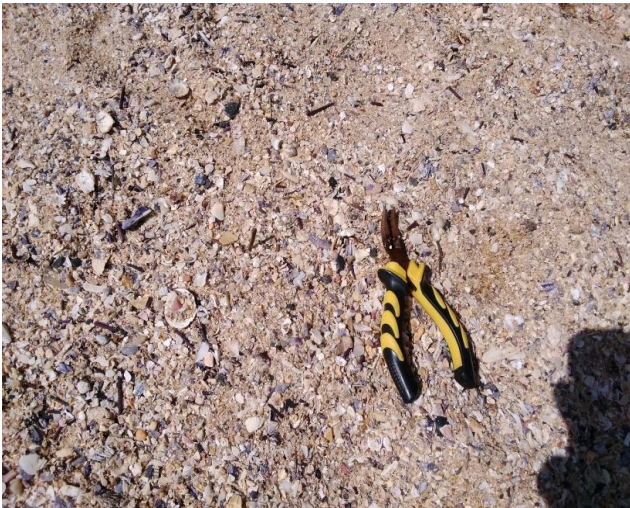
Notes: Sand surface following emu pick - Southern section
