Asbestos Containing Material Clearance Inspection

20 April 2023

Randwick City Council
30 Frances Street
Randwick NSW 2031

Site:	Little Bay Beach
Location:	Southern, Western and Northern Little Bay Beach

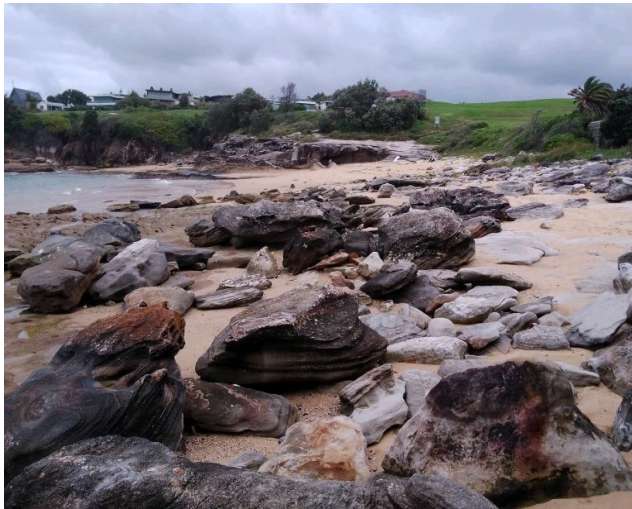
Notes: Overview of the Northern beach

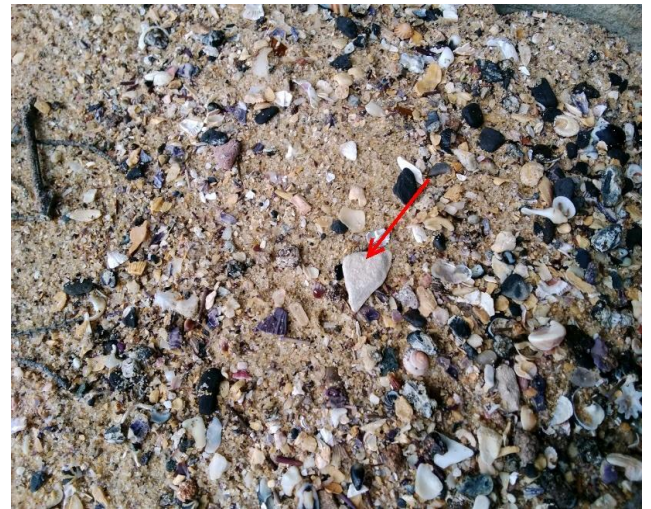
Notes: Overview of removal item within Northern beach prior to removal

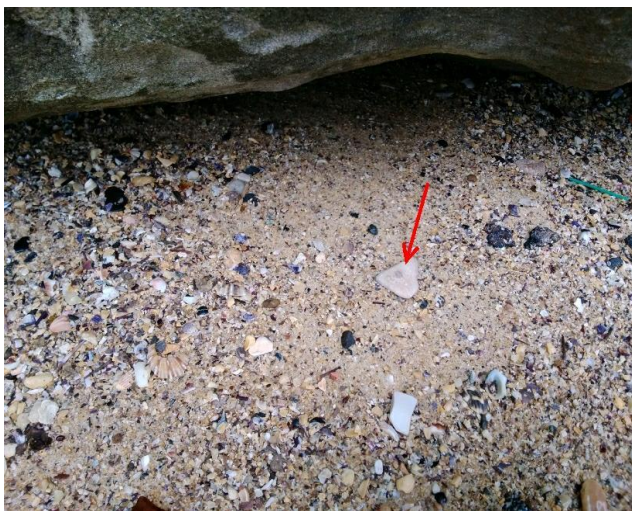
Notes: Overview of removal item within Northern beach prior to removal

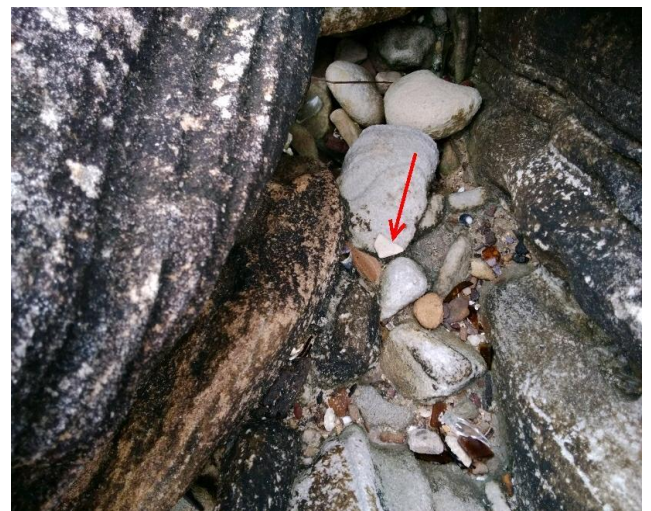
Notes: Overview of removal item within Northern beach prior to removal

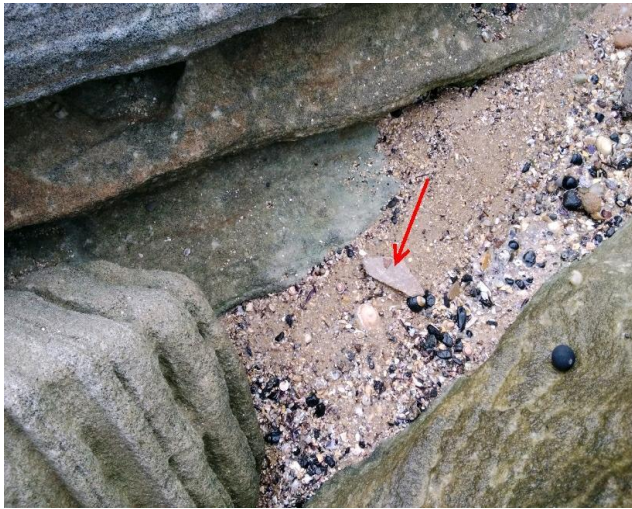
Notes: Overview of removal item within Northern beach prior to removal

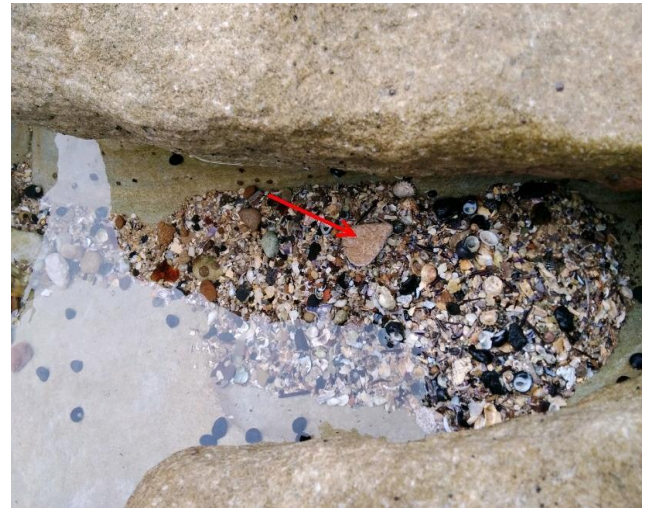
Notes: Overview of removal item within Northern beach prior to removal

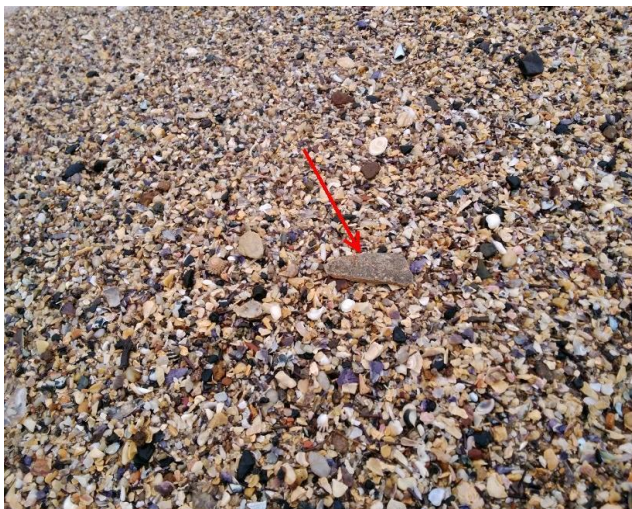
Notes: Overview of removal item within Northern beach prior to removal

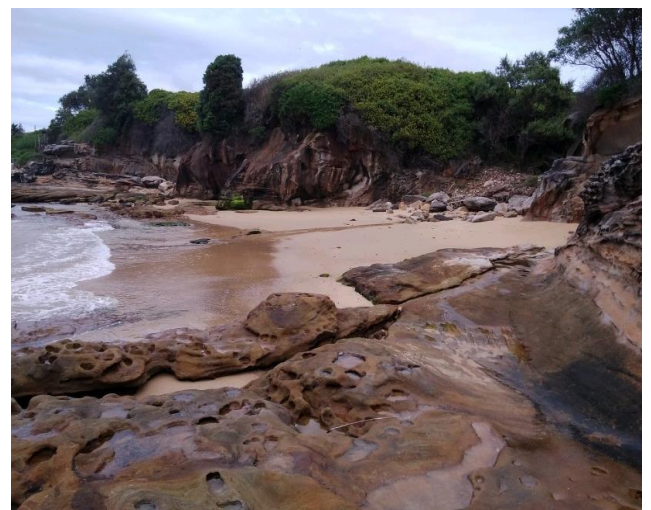
Notes: Overview of the Western beach

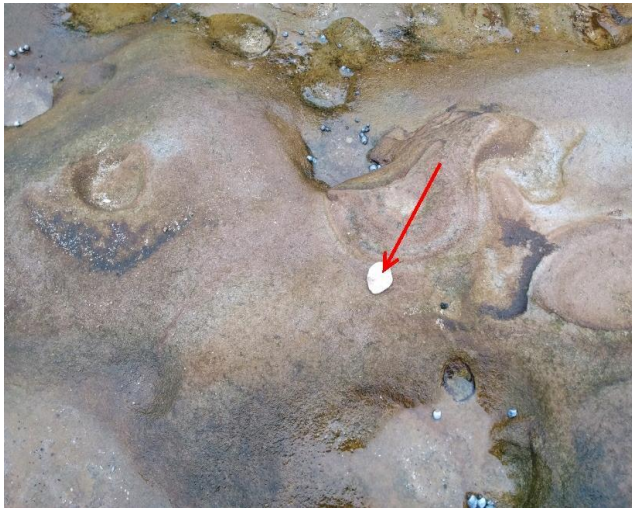
Notes: Overview of removal item within Western beach prior to removal

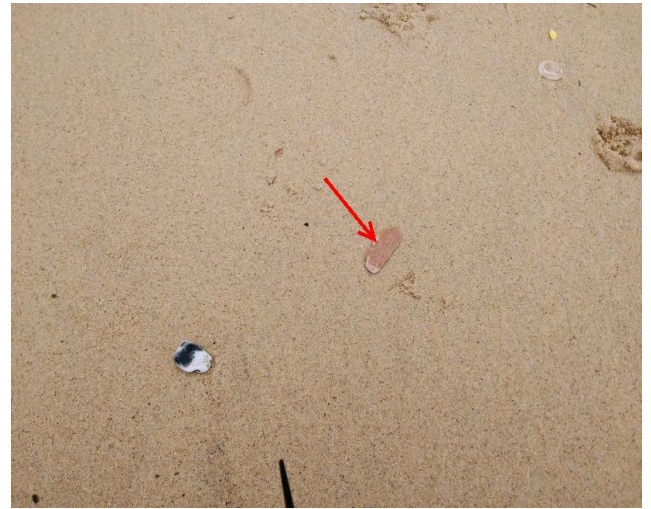
Notes: Overview of removal item within Western beach prior to removal

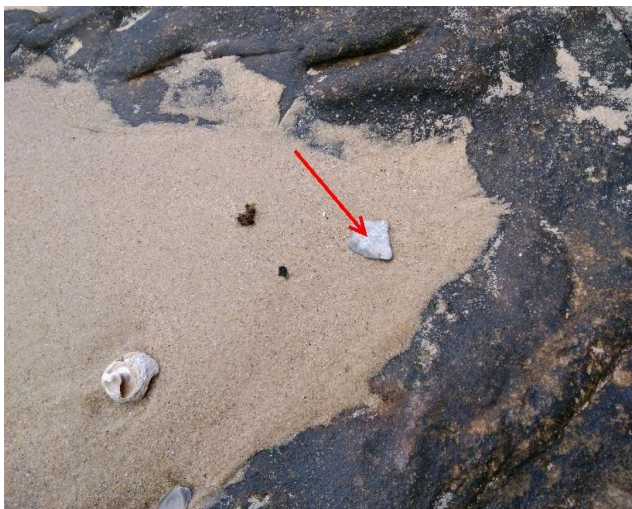
Notes: Overview of removal item within Western beach prior to removal

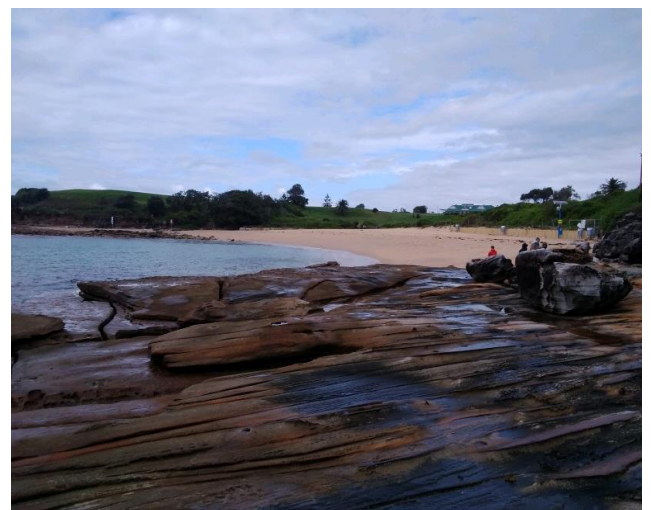
Notes: Overview of the Southern beach

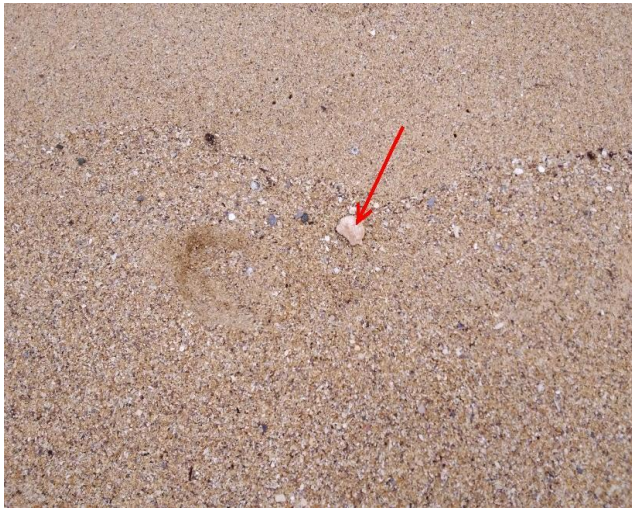
Notes: Overview of removal item within Southern beach prior to removal

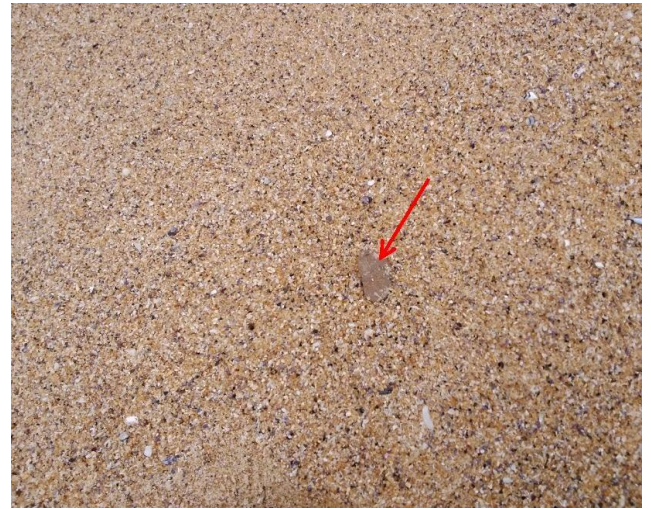
Notes: Overview of removal item within Southern beach prior to removal

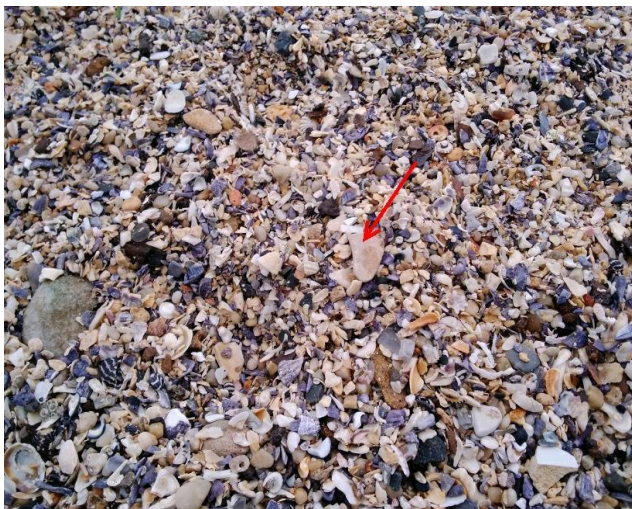
Notes: Overview of removal item within Southern beach prior to removal

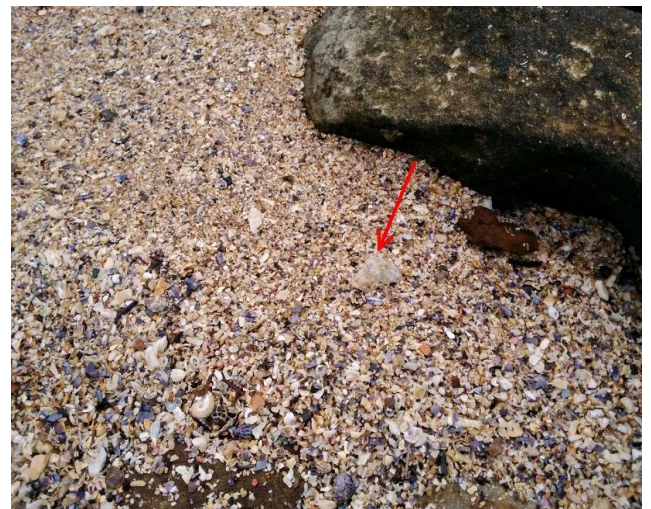
Notes: Overview of removal item within Southern beach prior to removal

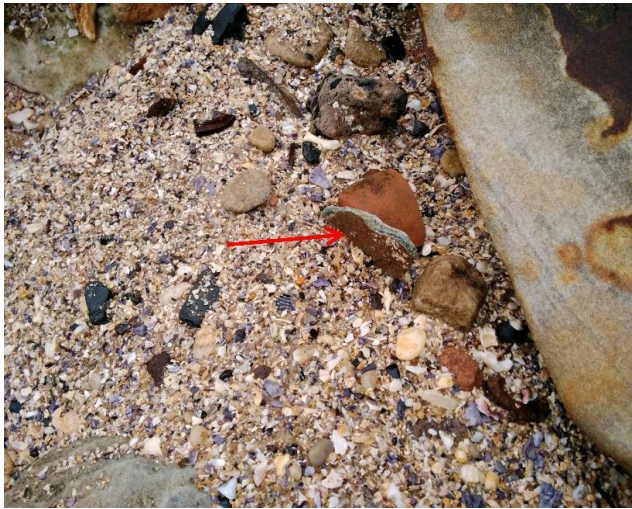
Notes: Overview of removal item within Southern beach prior to removal

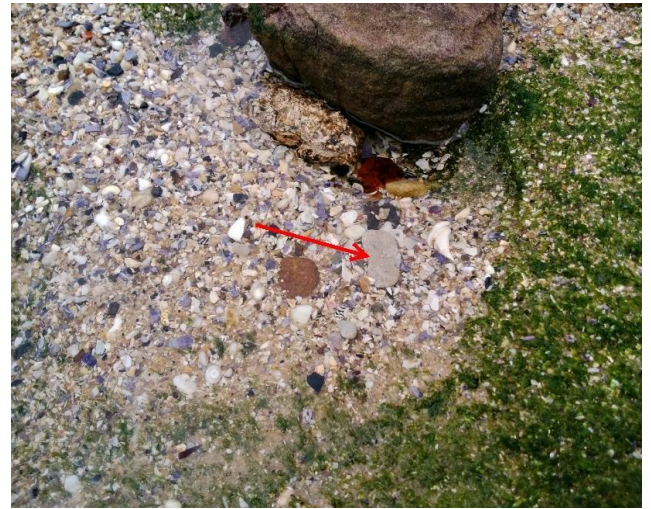
Notes: Overview of removal item within Southern beach prior to removal

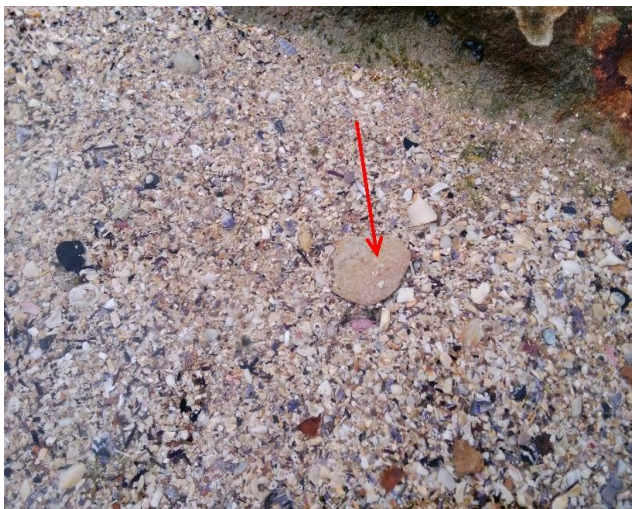
Notes: Overview of removal item within Southern beach prior to removal

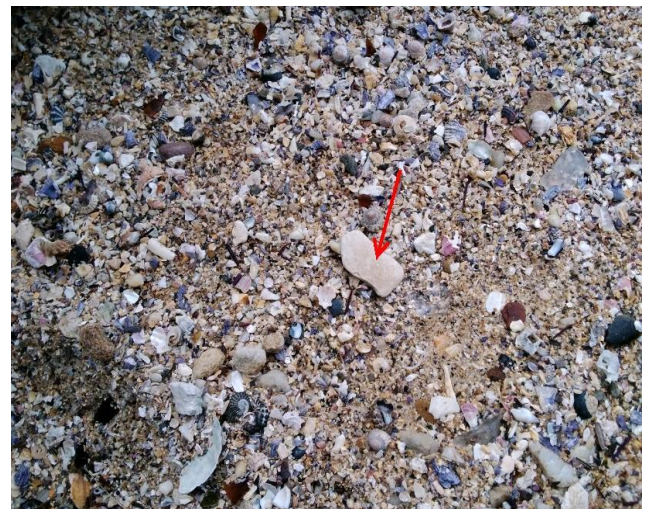
Notes: Overview of removal item within Southern beach prior to removal

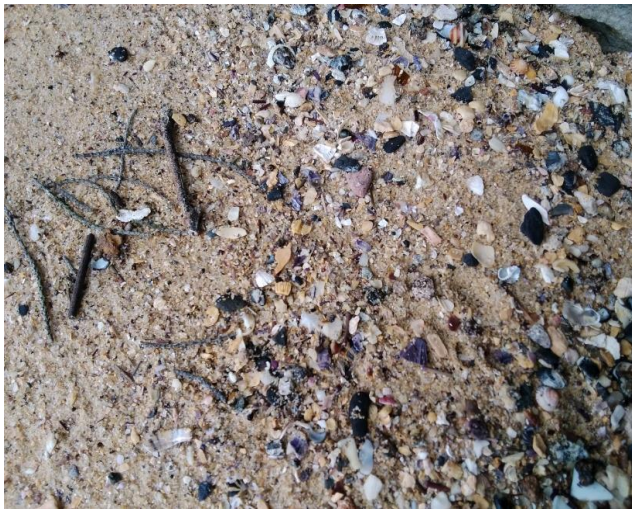
Notes: Visual surface clearance inspection following emu picking of suspected FC Sheeting fragment within Northern Beach.

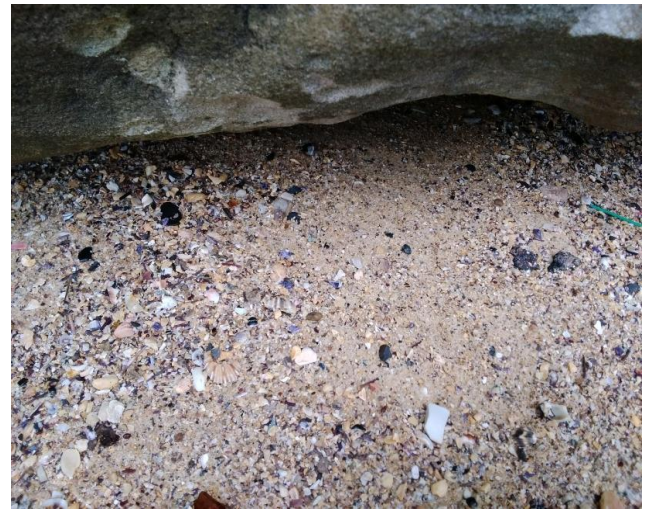
Notes: Visual surface clearance inspection following emu picking of suspected FC Sheeting fragment within Northern Beach.

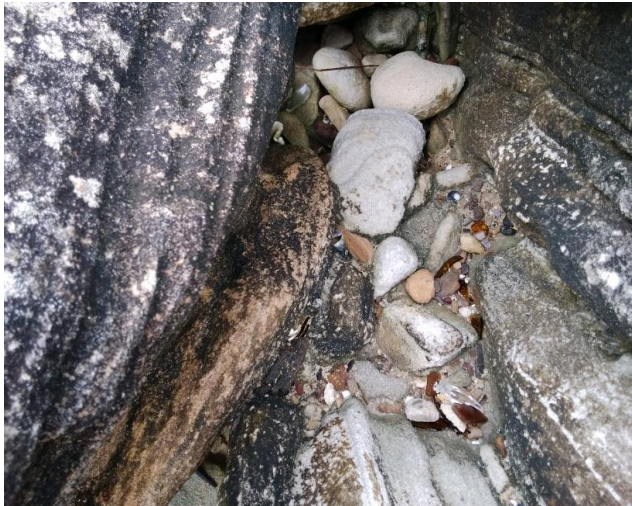
Notes: Visual surface clearance inspection following emu picking of suspected FC Sheeting fragment within Northern Beach.

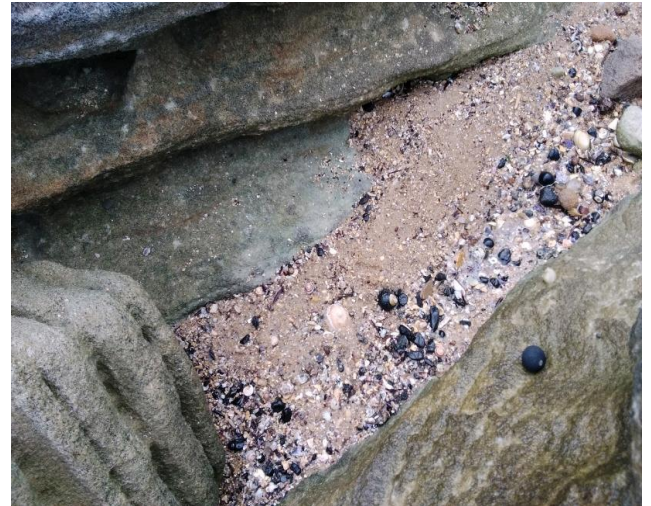
Notes: Visual surface clearance inspection following emu picking of suspected FC Sheeting fragment within Northern Beach.

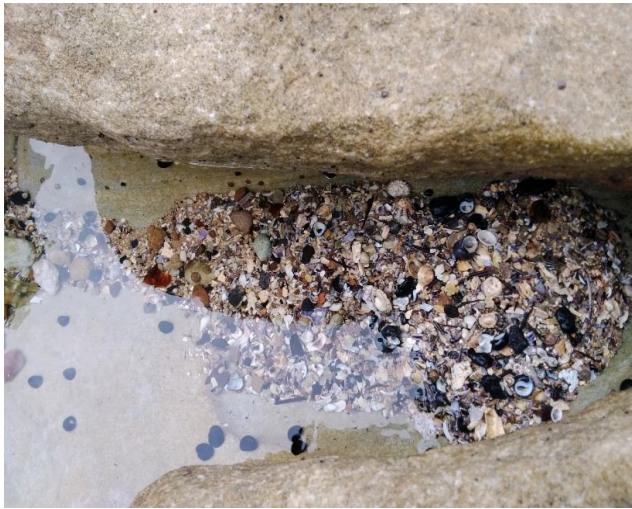
Notes: Visual surface clearance inspection following emu picking of suspected FC Sheeting fragment within Northern Beach.

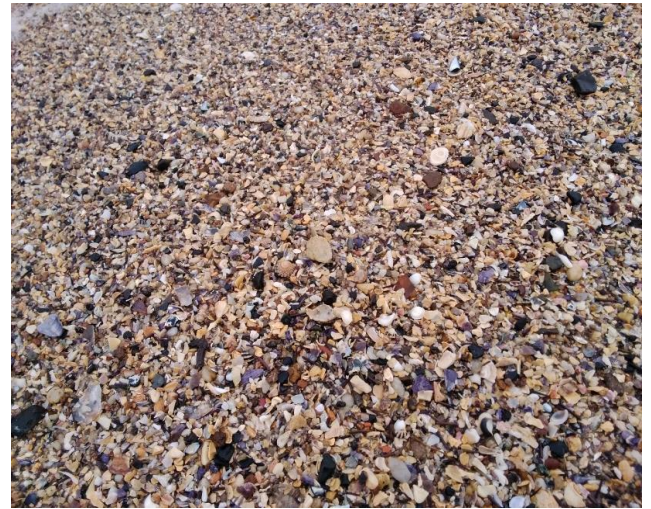
Notes: Visual surface clearance inspection following emu picking of suspected FC Sheeting fragment within Northern Beach.

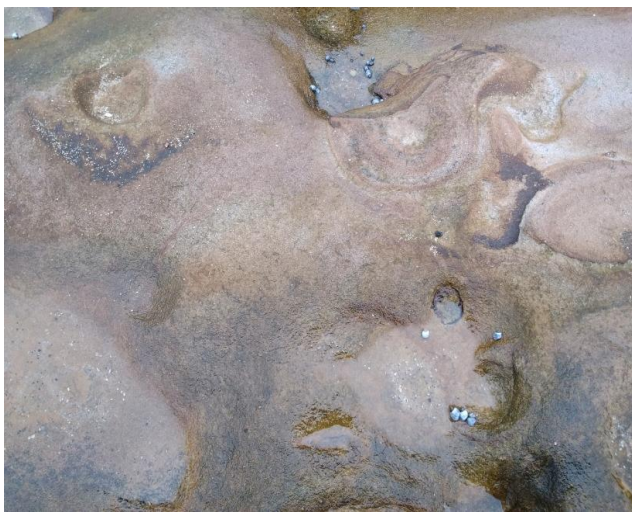
Notes: Visual surface clearance inspection following emu picking of suspected FC Sheeting fragment within Western Beach.

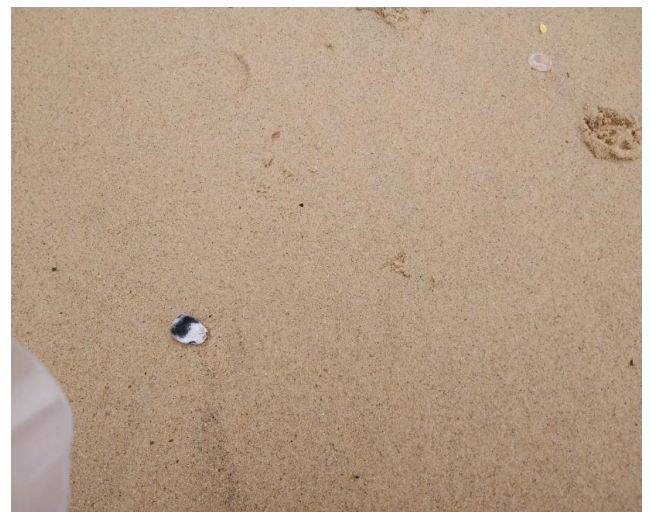
Notes: Visual surface clearance inspection following emu picking of suspected FC Sheeting fragment within Western Beach.

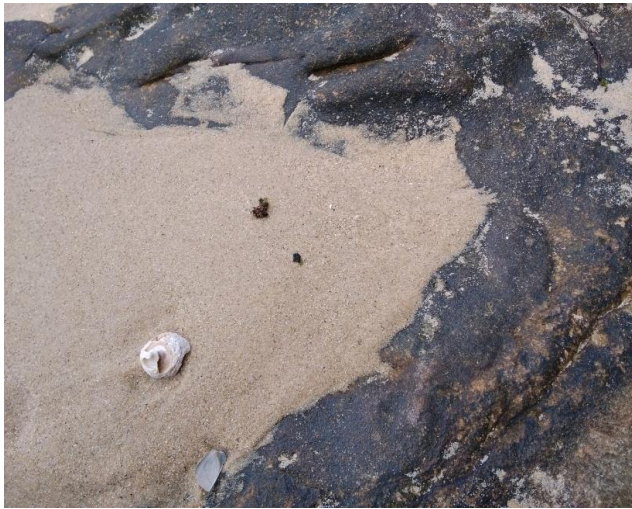
Notes: Visual surface clearance inspection following emu picking of suspected FC Sheeting fragment within Western Beach.

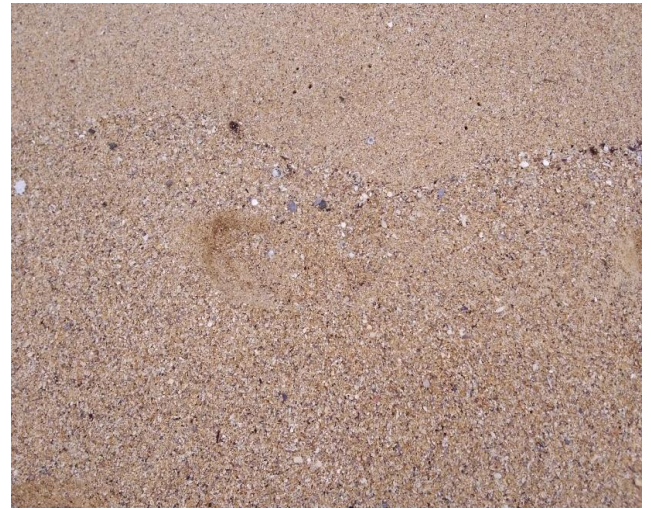
Notes: Visual surface clearance inspection following emu picking of suspected FC Sheeting fragment within Southern Beach.

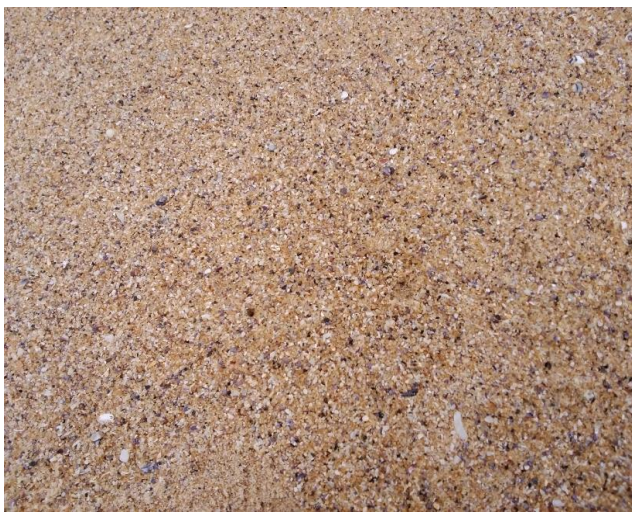
Notes: Visual surface clearance inspection following emu picking of suspected FC Sheeting fragment within Southern Beach.

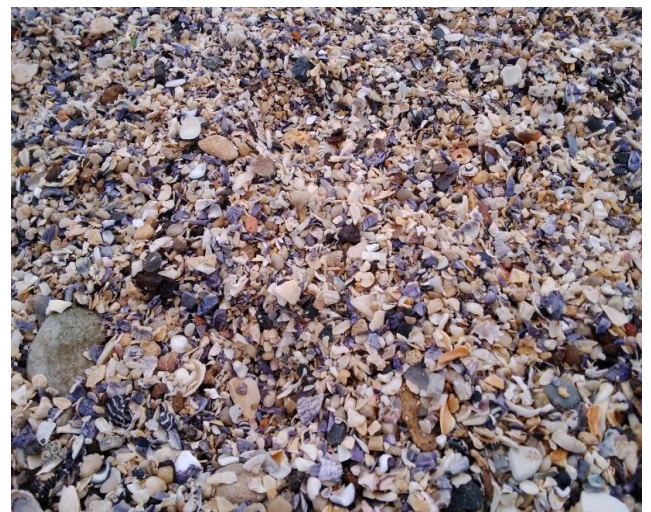
Notes: Visual surface clearance inspection following emu picking of suspected FC Sheeting fragment within Southern Beach.

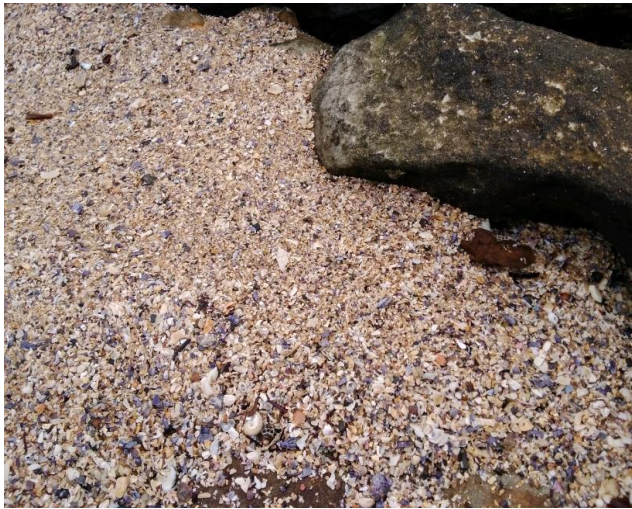
Notes: Visual surface clearance inspection following emu picking of suspected FC Sheeting fragment within Southern Beach.

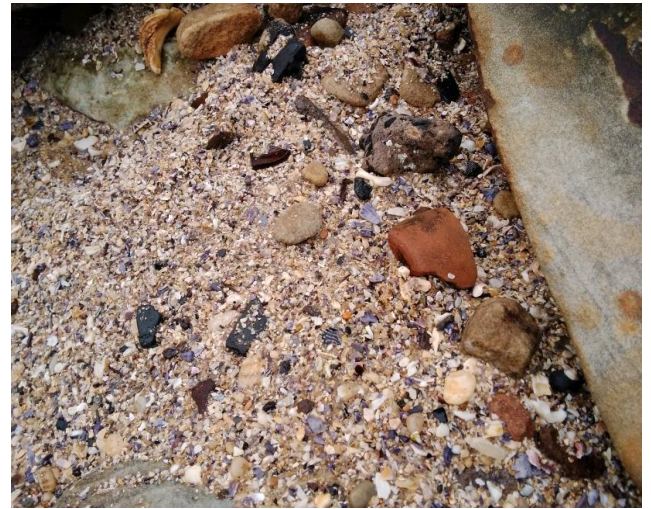
Notes: Visual surface clearance inspection following emu picking of suspected FC Sheeting fragment within Southern Beach.

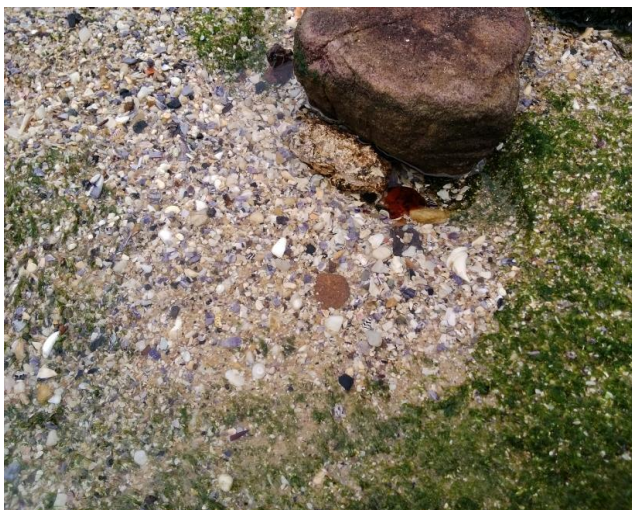
Notes: Visual surface clearance inspection following emu picking of suspected FC Sheeting fragment within Southern Beach.

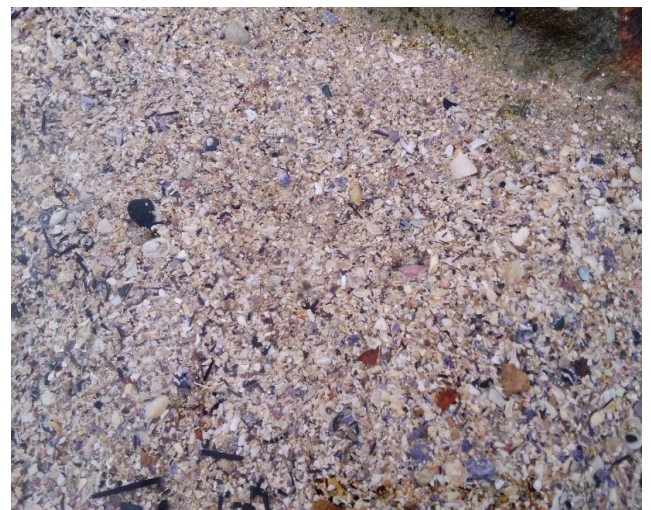
Notes: Visual surface clearance inspection following emu picking of suspected FC Sheeting fragment within Southern Beach.

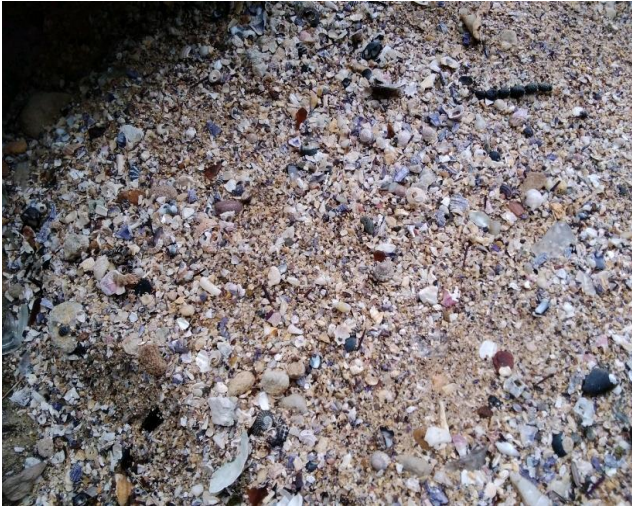
Notes: Visual surface clearance inspection following emu picking of suspected FC Sheeting fragment within Southern Beach.
