Asbestos Containing Material Clearance Inspection

4 May 2023

RE: Asbestos Containing Material Clearance Inspection

Site:	Little Bay Beach
Location:	Southern, Western and Northern Little Bay Beach

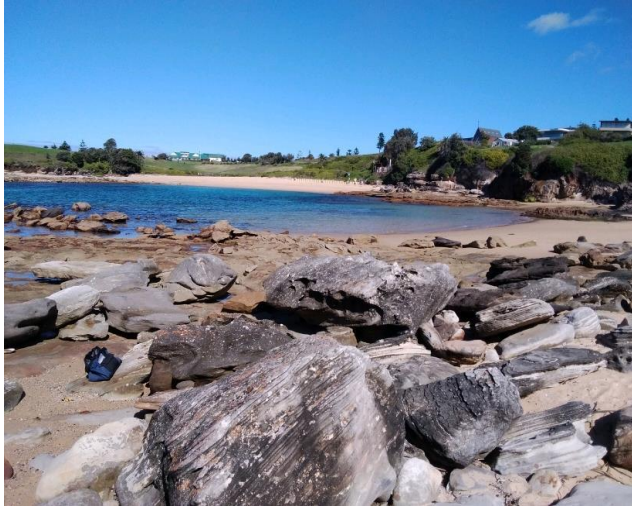
Notes: Overview of the Beach during the inspection

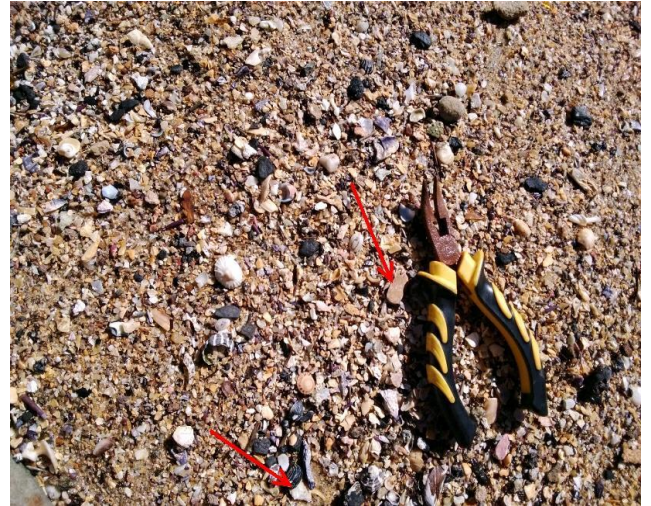
Notes: FC fragment identified on sand surface prior to emu pick - Northern section

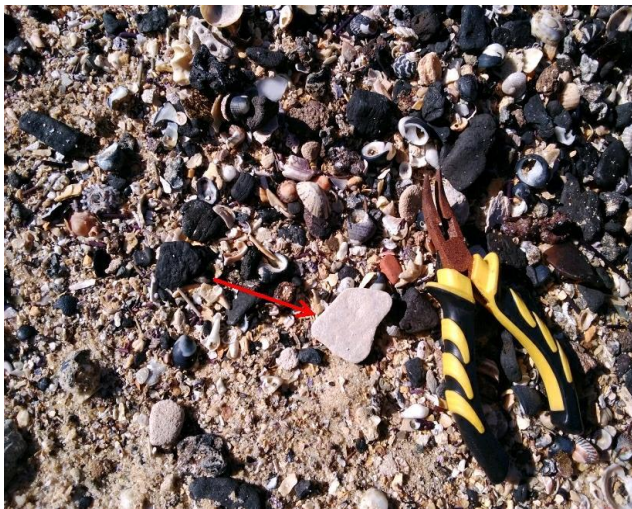
Notes: FC fragment identified on sand surface prior to emu pick - Northern section

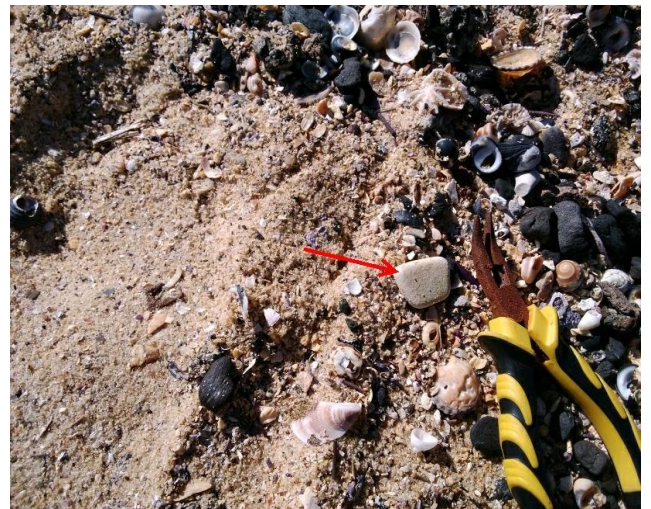
Notes: FC fragment identified on sand surface prior to emu pick - Northern section

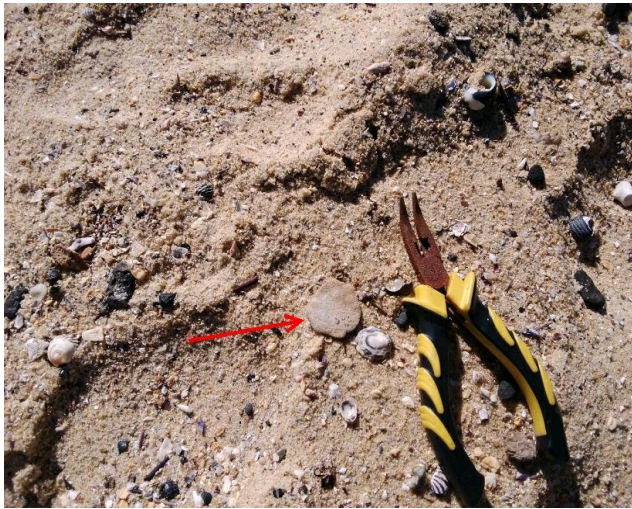
Notes: FC fragment identified on sand surface prior to emu pick - Northern section

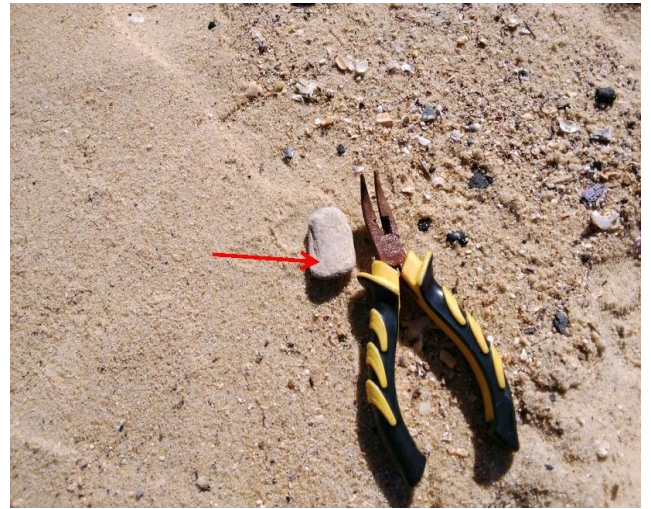
Notes: FC fragment identified on sand surface prior to emu pick - Northern section

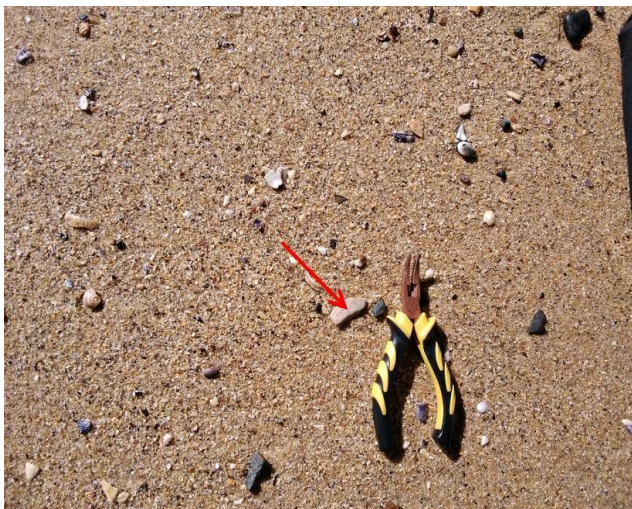
Notes: FC fragment identified on sand surface prior to emu pick - Northern section

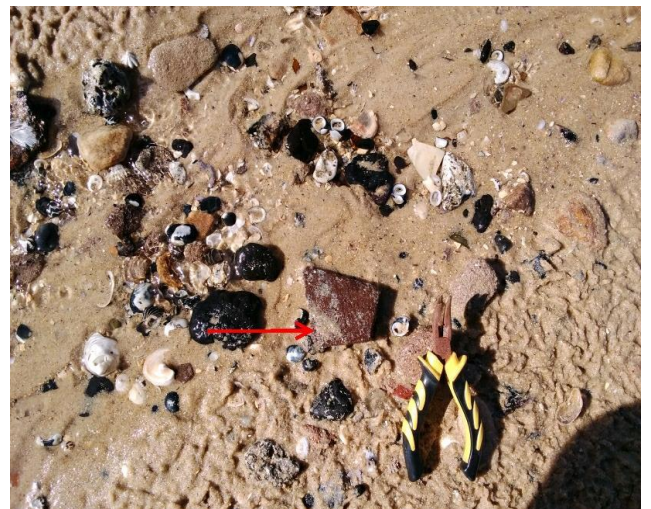
Notes: FC fragment identified on sand surface prior to emu pick - Northern section

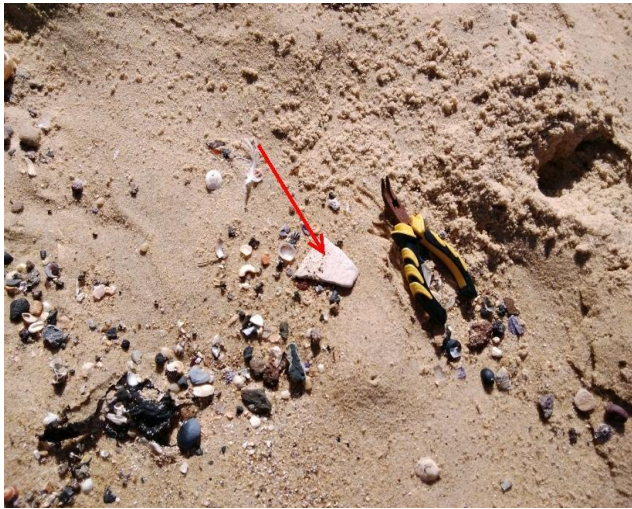
Notes: FC fragment identified on sand surface prior to emu pick - Northern section

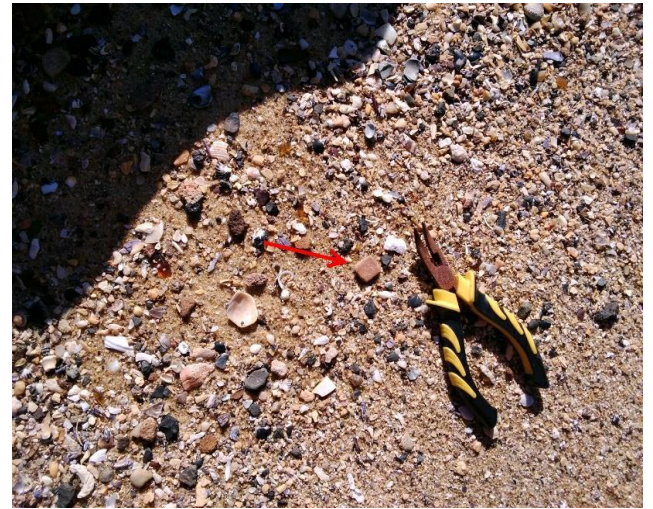
Notes: FC fragment identified on sand surface prior to emu pick - Western section

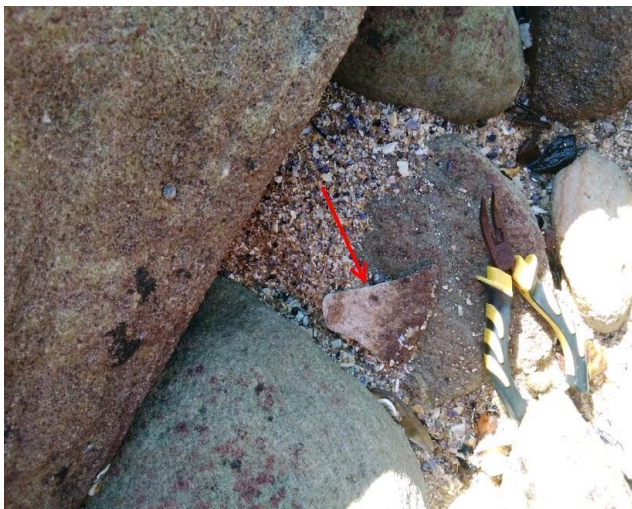
Notes: FC fragment identified on sand surface prior to emu pick - Western section

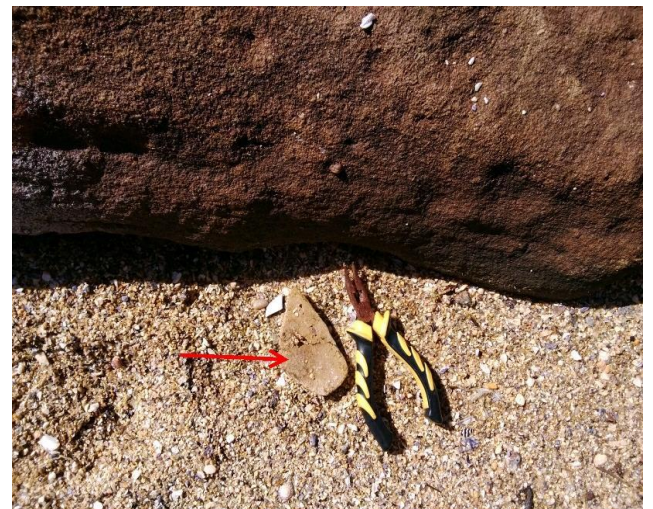
Notes: FC fragment identified on sand surface prior to emu pick - Southern section

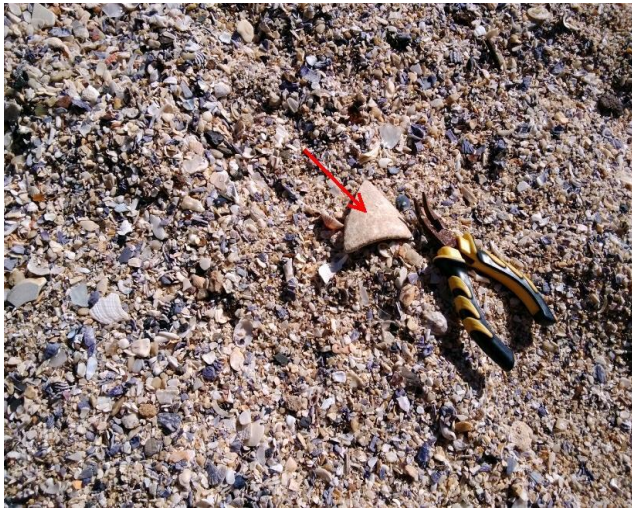
Notes: FC fragment identified on sand surface prior to emu pick - Southern section

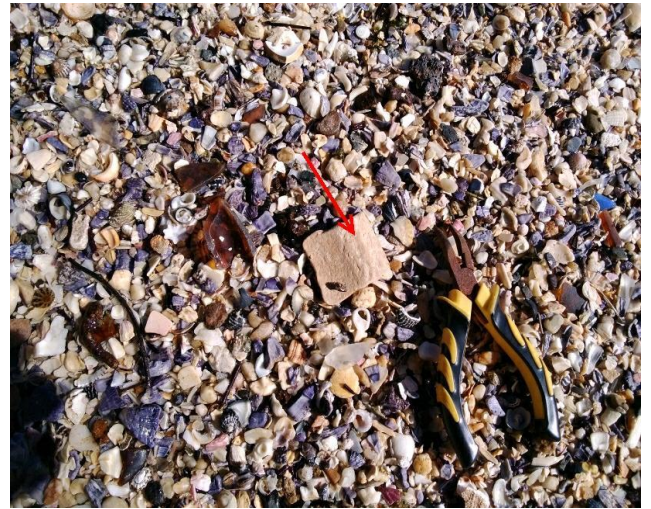
Notes: FC fragment identified on sand surface prior to emu pick - Southern section

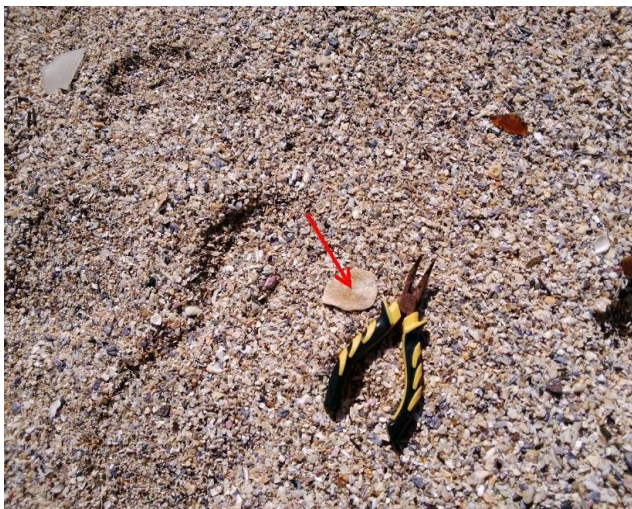
Notes: FC fragment identified on sand surface prior to emu pick - Southern section

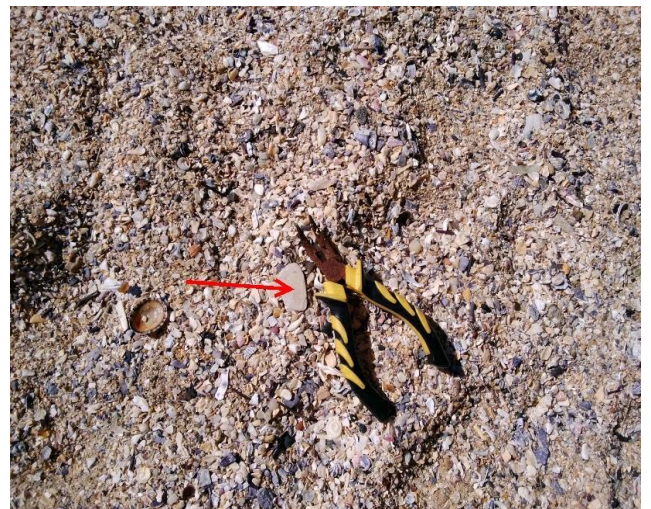
Notes: FC fragment identified on sand surface prior to emu pick - Southern section

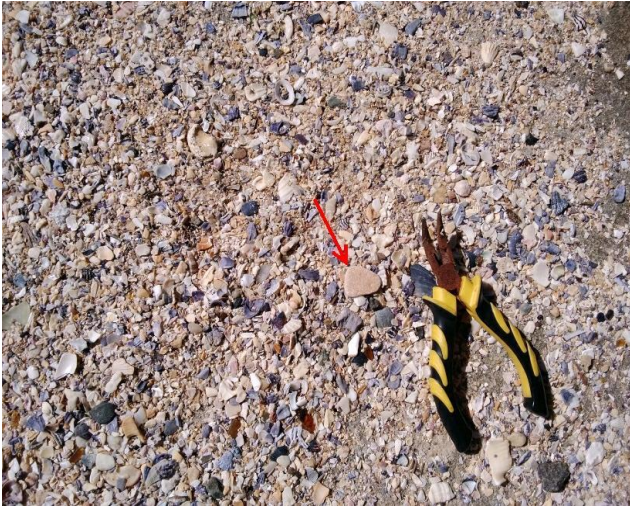
Notes: FC fragment identified on sand surface prior to emu pick - Southern section

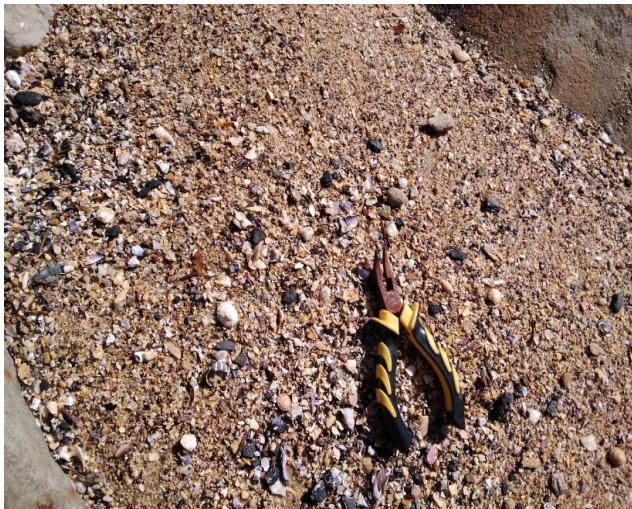
Notes: Sand surface following emu pick - Northern section

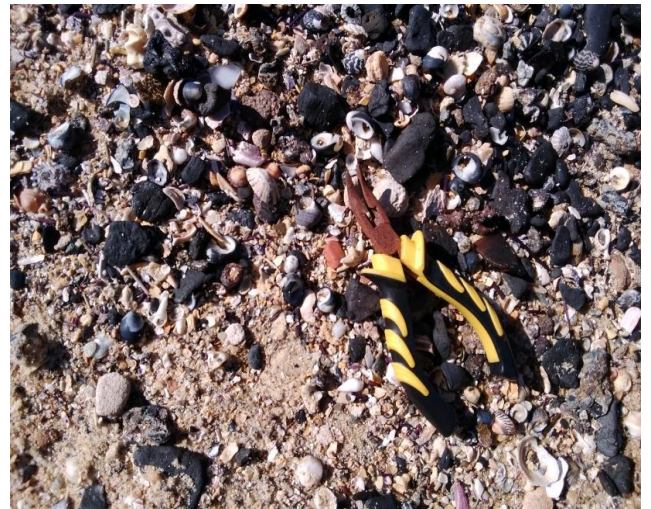
Notes: Sand surface following emu pick - Northern section

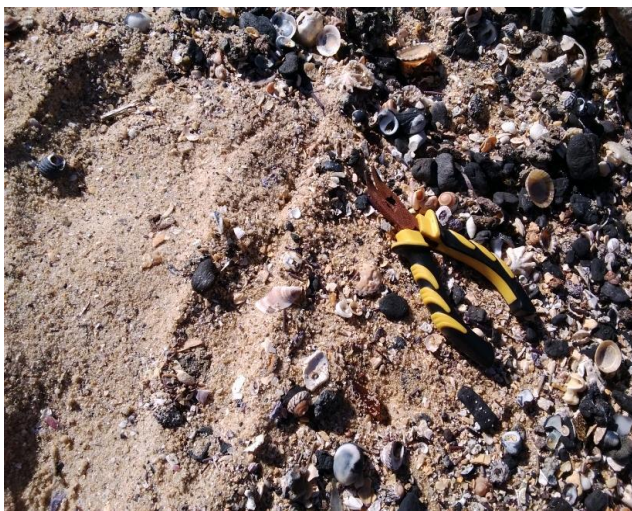
Notes: Sand surface following emu pick - Northern section

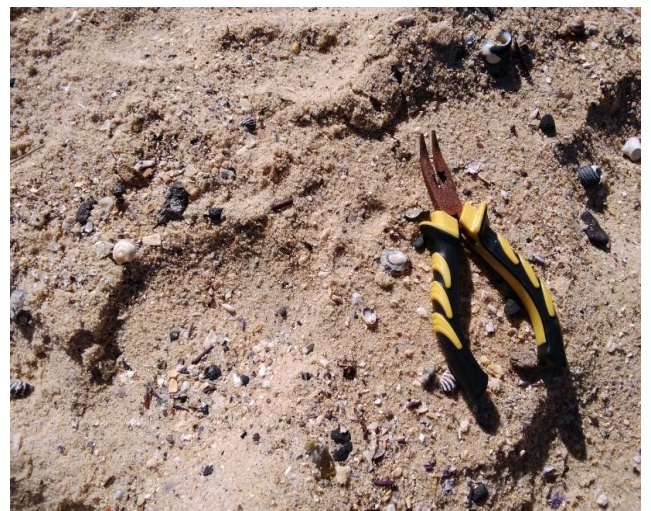
Notes: Sand surface following emu pick - Northern section

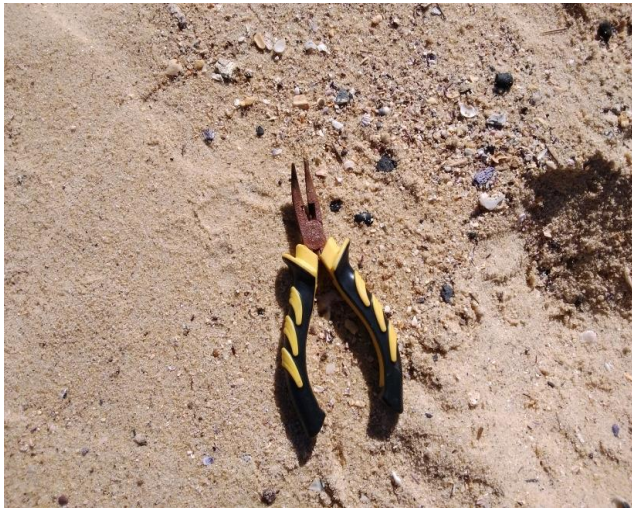
Notes: Sand surface following emu pick - Northern section

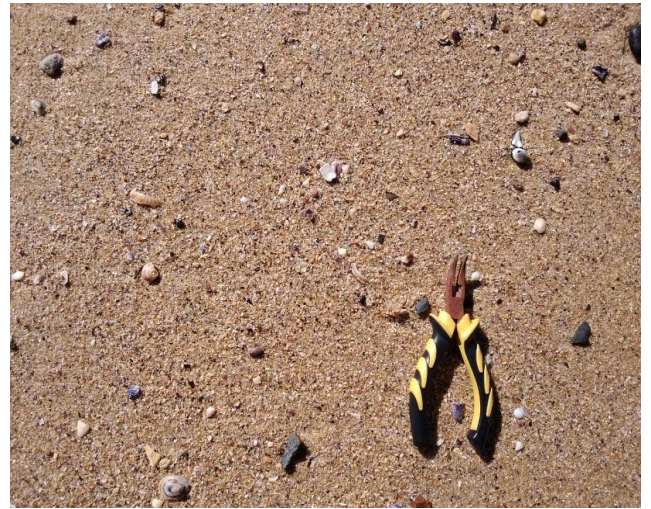
Notes: Sand surface following emu pick - Northern section

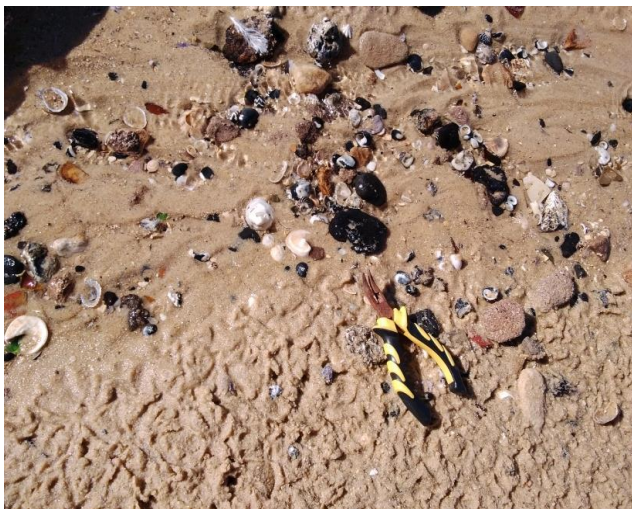
Notes: Sand surface following emu pick - Northern section

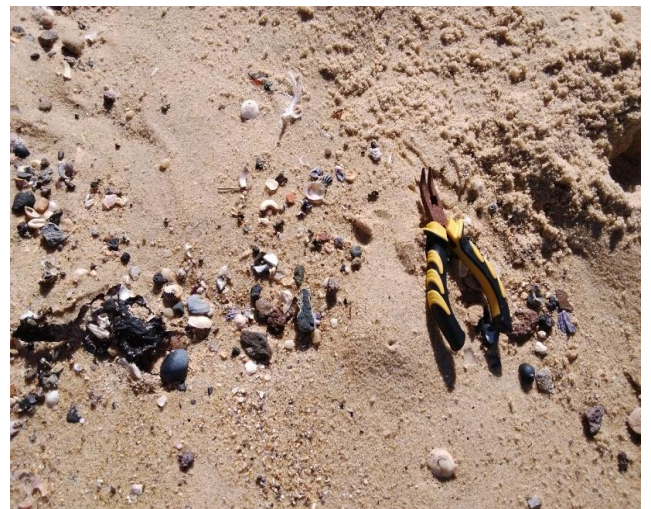
Notes: Sand surface following emu pick - Northern section

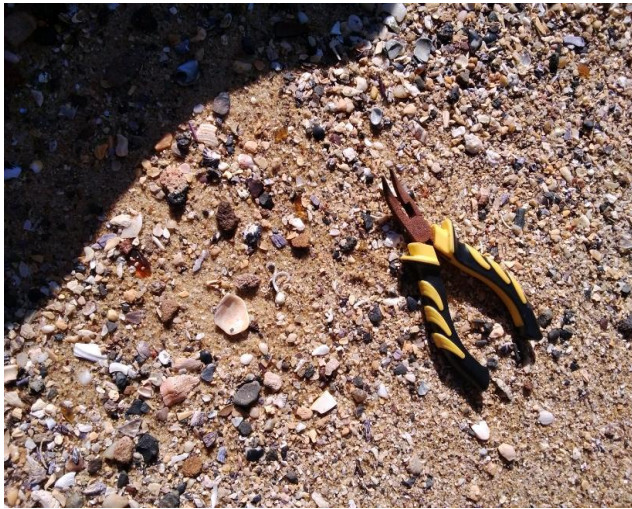
Notes: Sand surface following emu pick - Western section

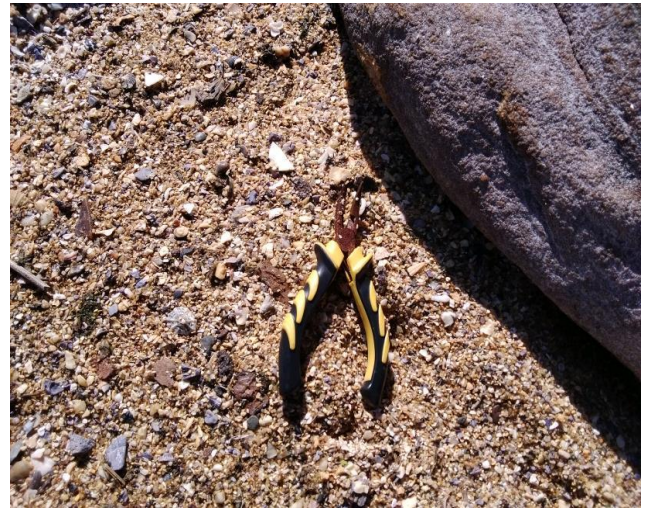
Notes: Sand surface following emu pick - Western section

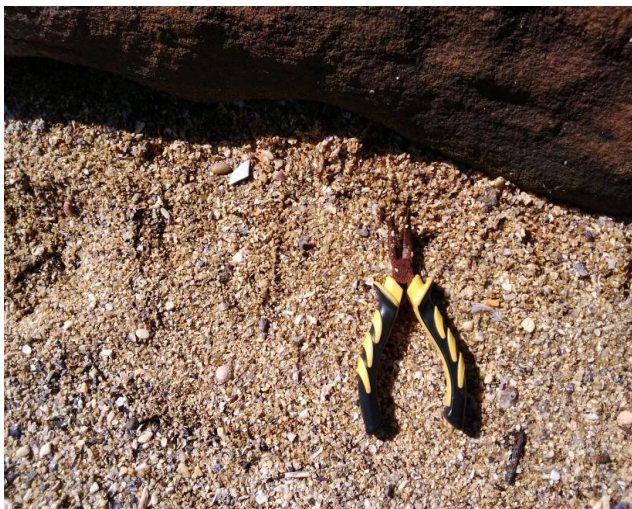
Notes: Sand surface following emu pick - Southern section

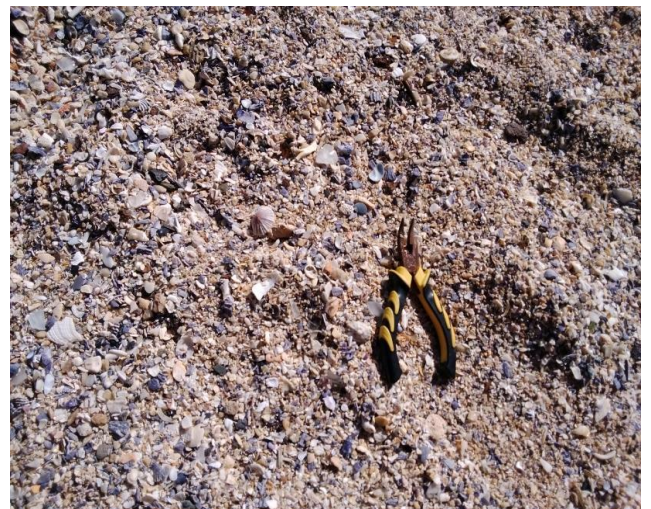
Notes: Sand surface following emu pick - Southern section

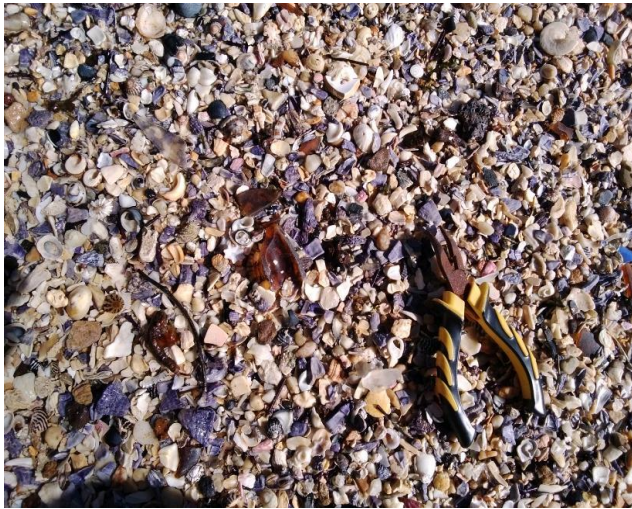
Notes: Sand surface following emu pick - Southern section

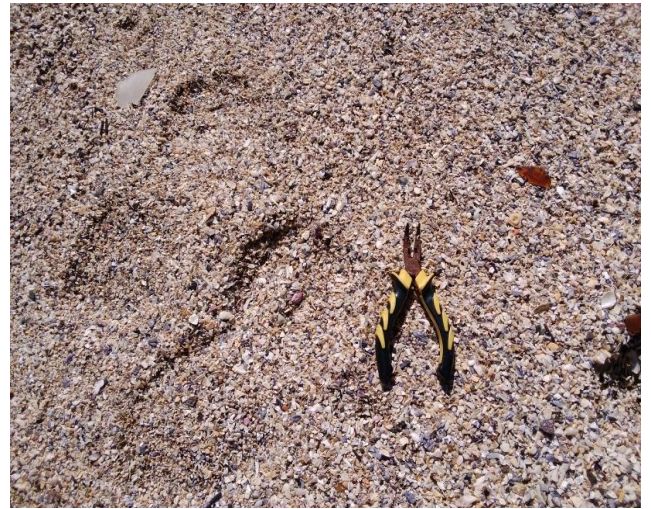
Notes: Sand surface following emu pick - Southern section

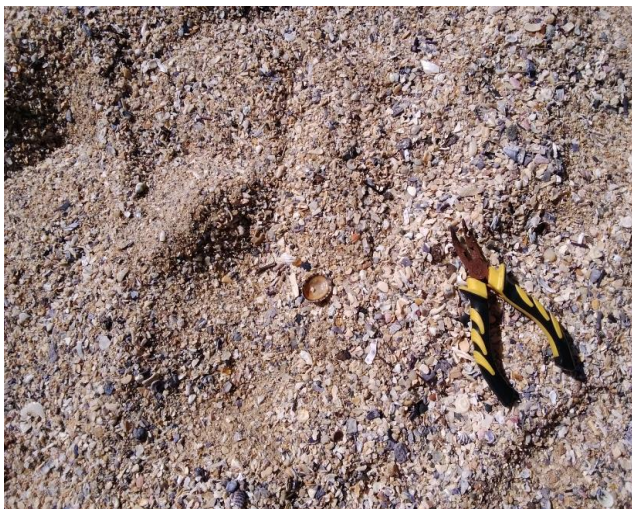
Notes: Sand surface following emu pick - Southern section

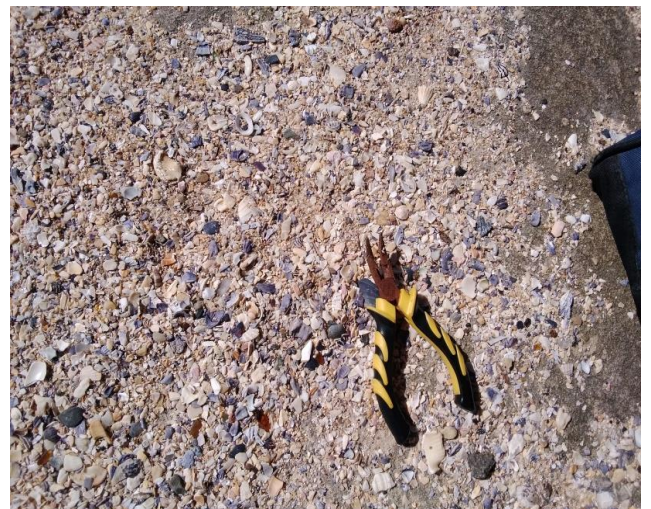
Notes: Sand surface following emu pick - Southern section
