# Asbestos Containing Material Clearance Inspection

26 May 2023

**Randwick City Council**  
30 Frances Street  
Randwick NSW 2031

<b>Site:</b>	Little Bay Beach
<b>Location:</b>	Southern, Western and Northern Little Bay Beach

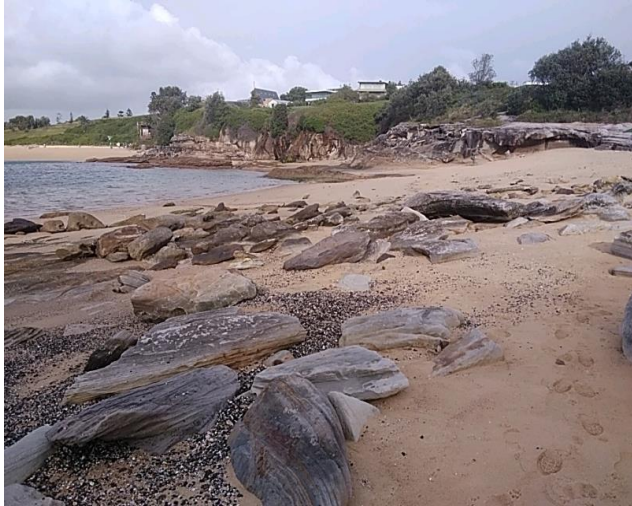
**Notes:** Overview of the Northern beach

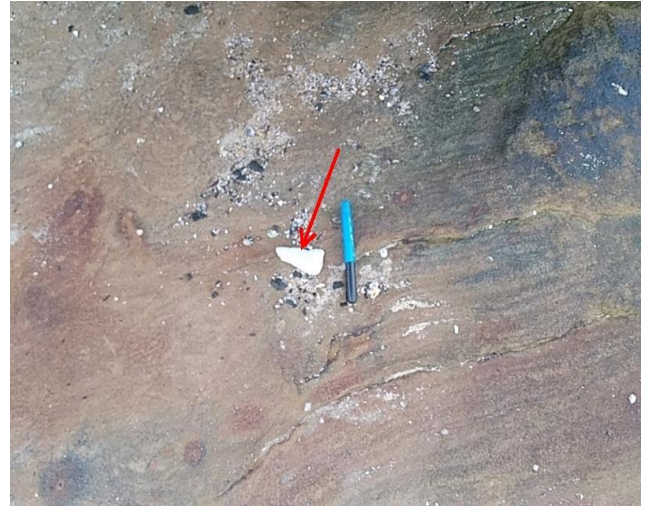
**Notes:** Overview of removal item within Northern beach prior to removal

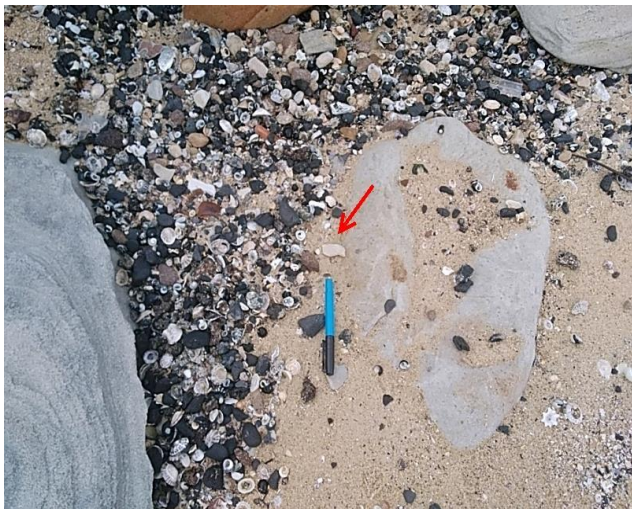
**Notes:** Overview of removal item within Northern beach prior to removal

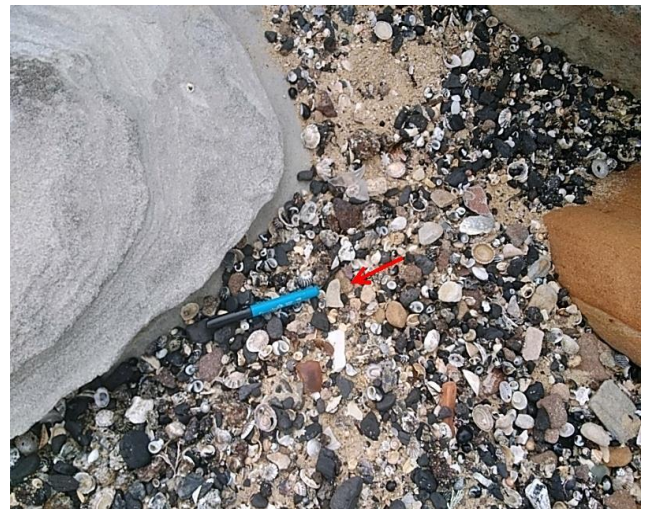
**Notes:** Overview of removal item within Northern beach prior to removal

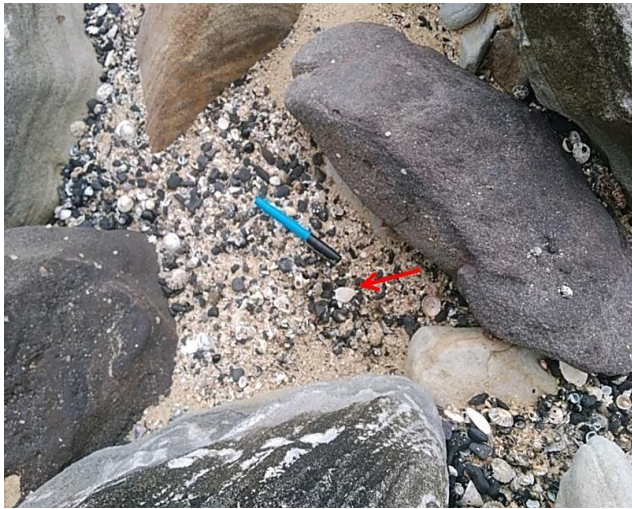
**Notes:** Overview of removal item within Northern beach prior to removal

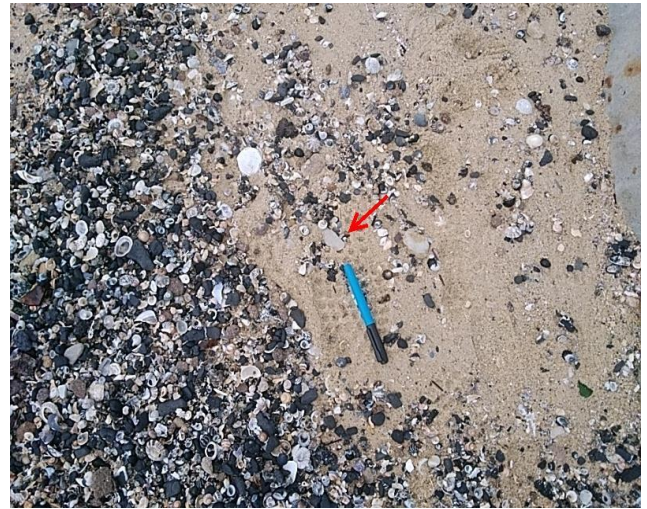
**Notes:** Overview of removal item within Northern beach prior to removal

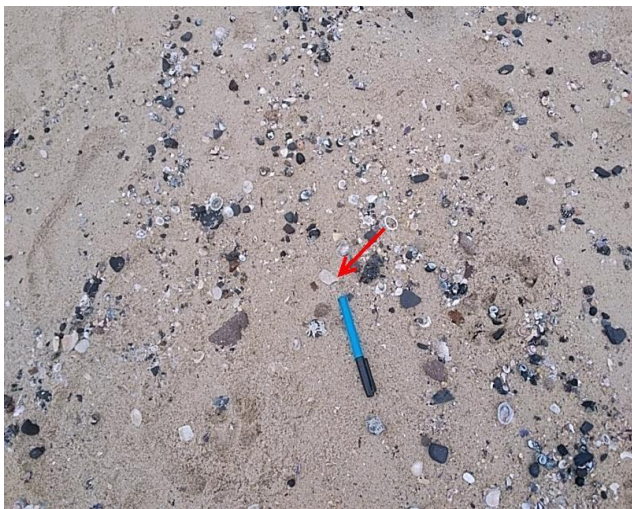
**Notes:** Overview of removal item within Northern beach prior to removal

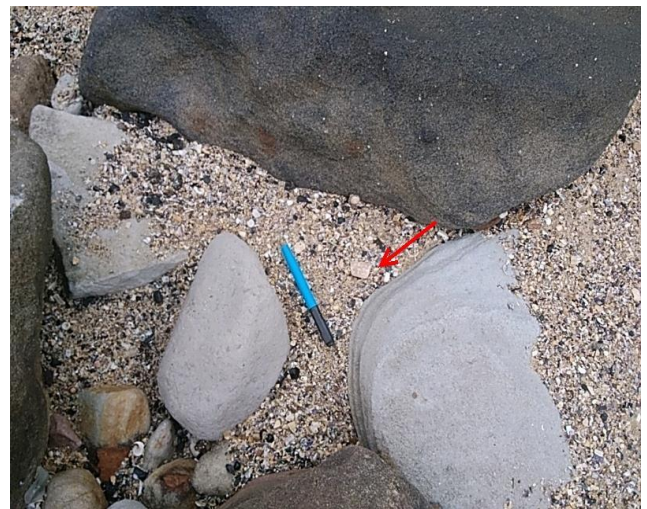
**Notes:** Overview of removal item within Northern beach prior to removal

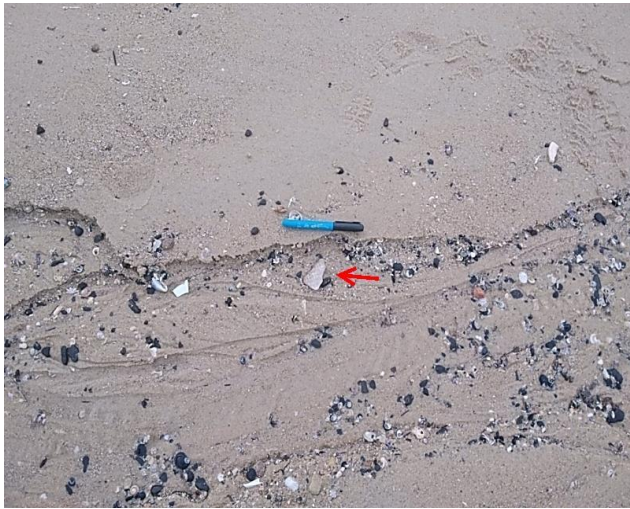
**Notes:** Overview of removal item within Northern beach prior to removal

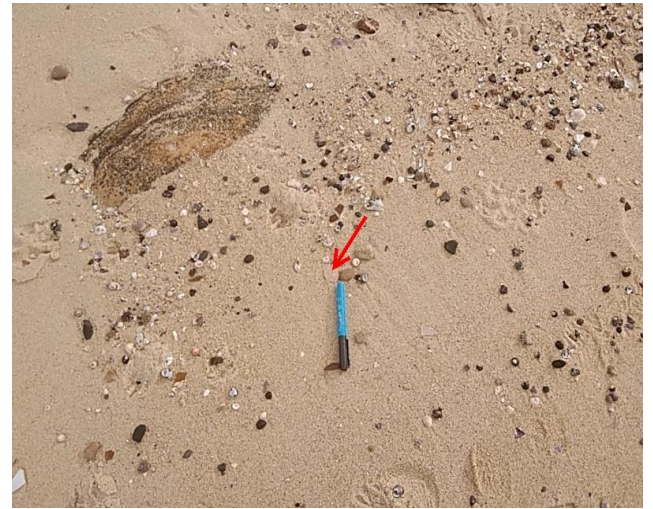
**Notes:** Overview of removal item within Northern beach prior to removal

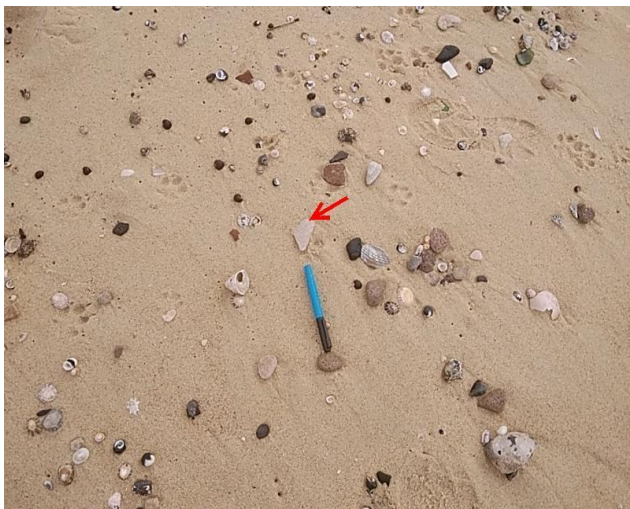
**Notes:** Overview of removal item within Northern beach prior to removal

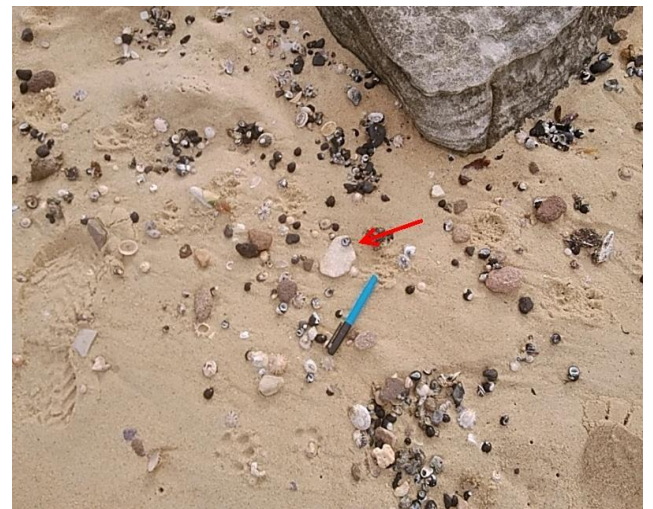
**Notes:** Overview of removal item within Northern beach prior to removal

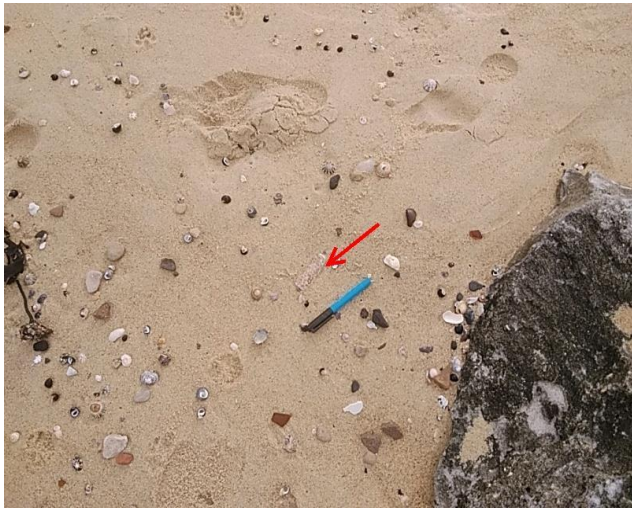
**Notes:** Overview of removal item within Northern beach prior to removal

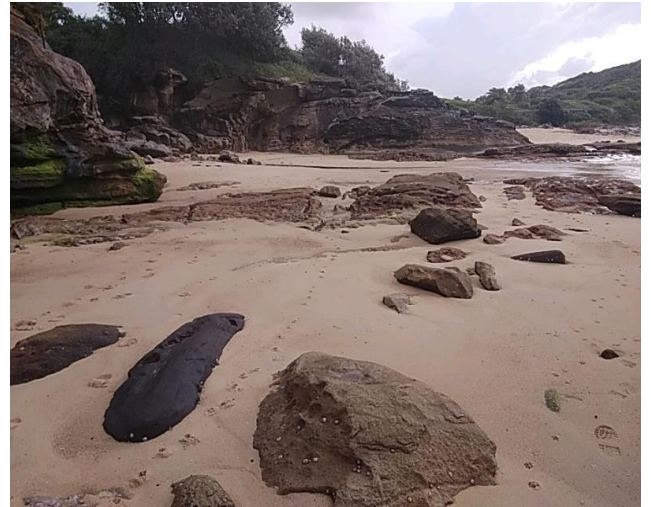
**Notes:** Overview of the Western beach

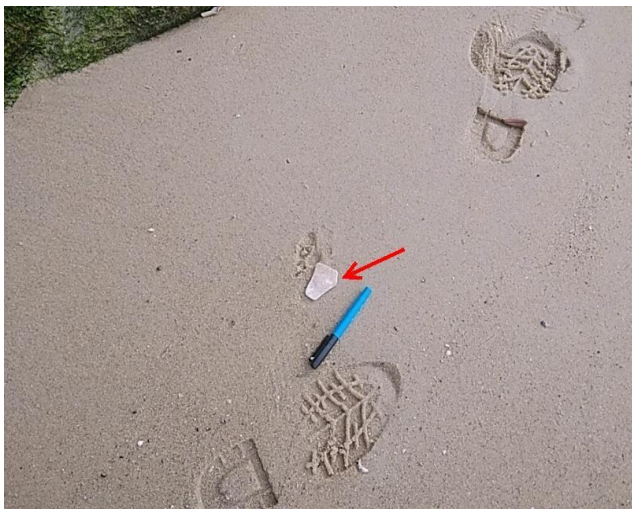
**Notes:** Overview of removal item within Northern beach prior to removal

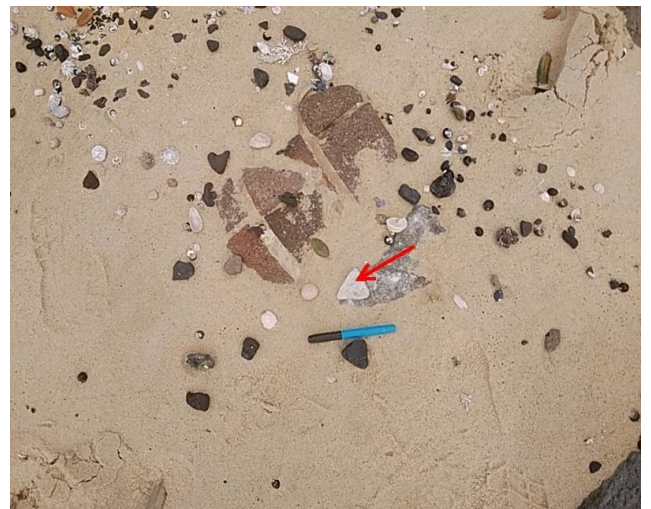
**Notes:** Overview of removal item within Northern beach prior to removal

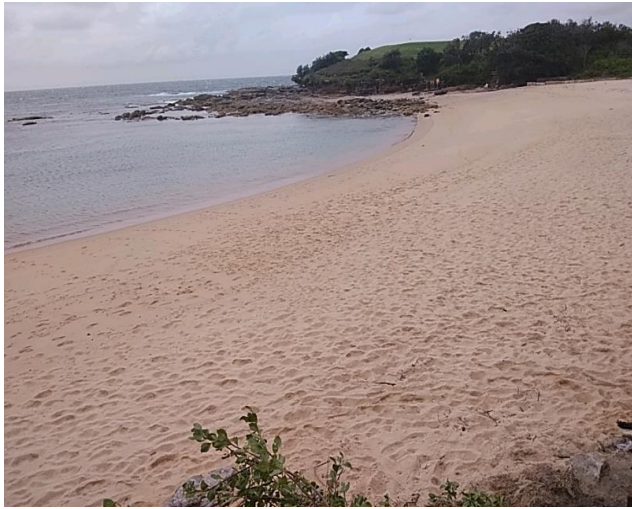
**Notes:** Overview of the Southern beach

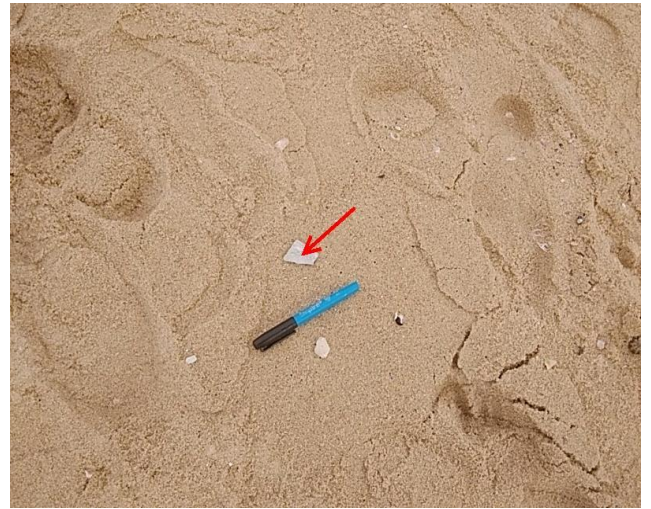
**Notes:** Overview of removal item within Northern beach prior to removal

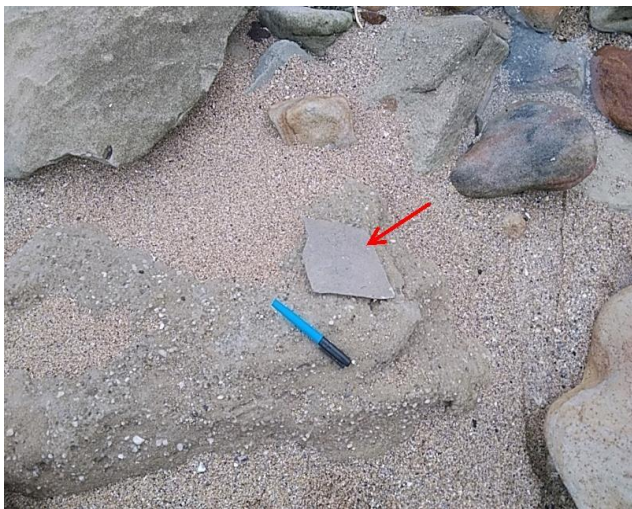
**Notes:** Overview of removal item within Northern beach prior to removal

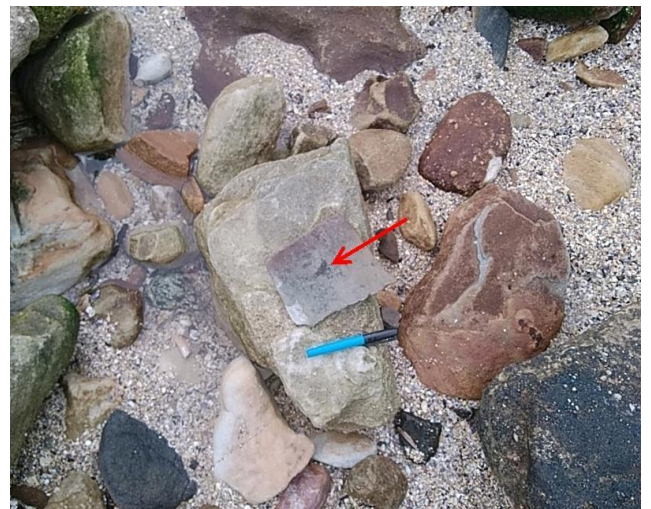
**Notes:** Overview of removal item within Northern beach prior to removal

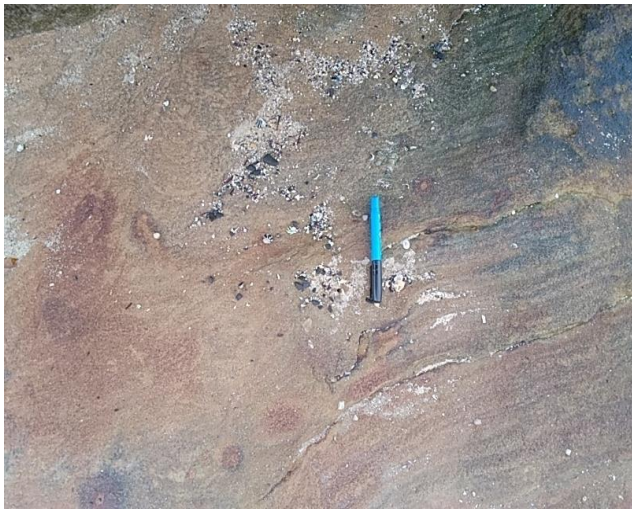
**Notes:** Visual inspection of removal item following removal

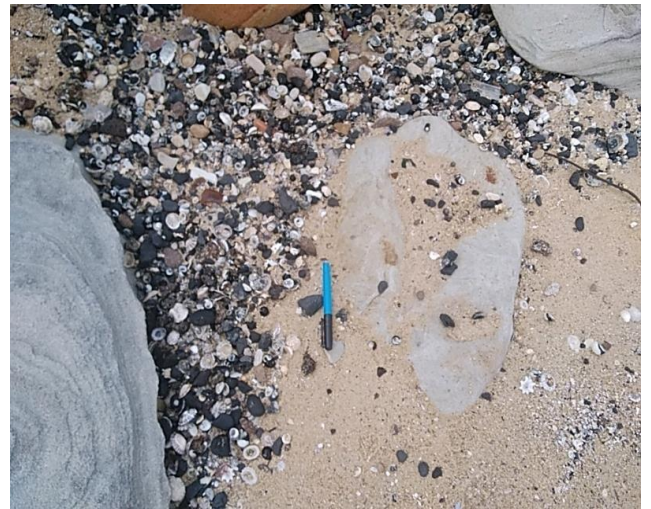
**Notes:** Visual inspection of removal item following removal

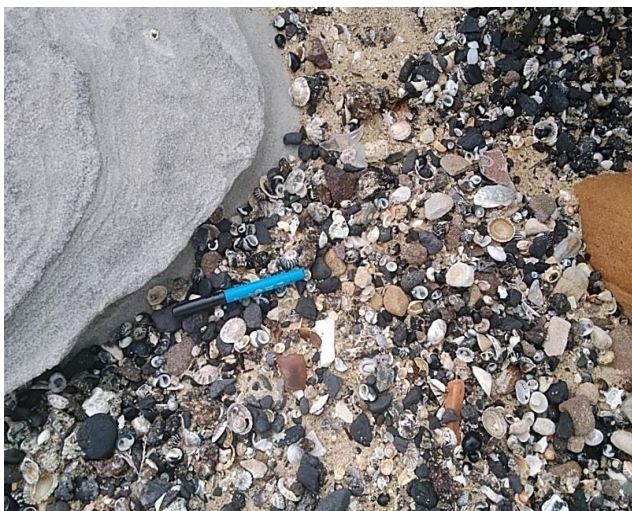
**Notes:** Visual inspection of removal item following removal

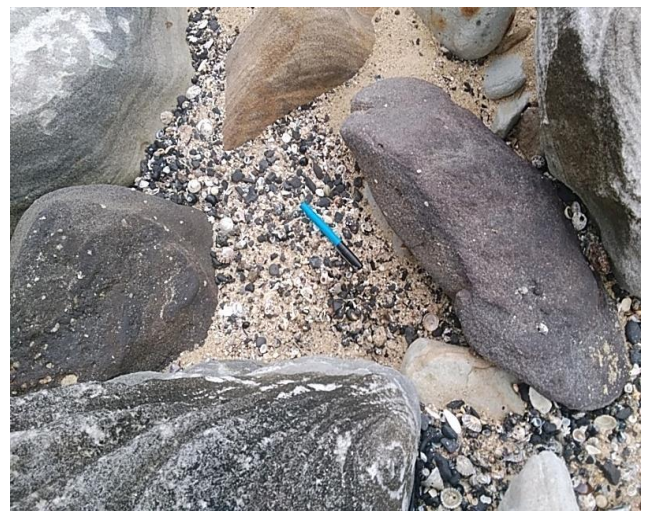
**Notes:** Visual inspection of removal item following removal

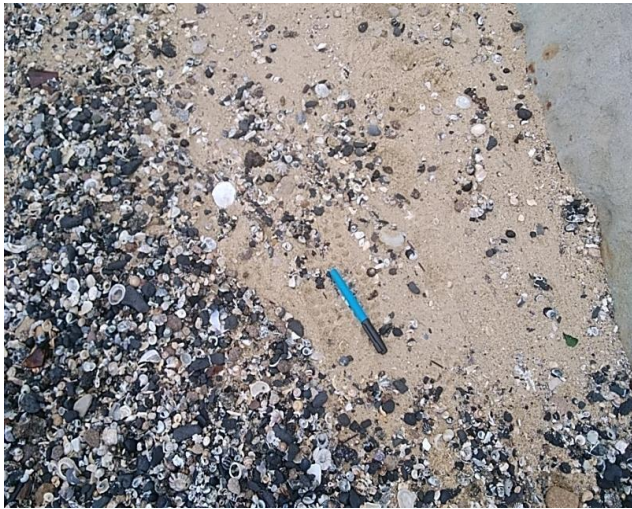
**Notes:** Visual inspection of removal item following removal

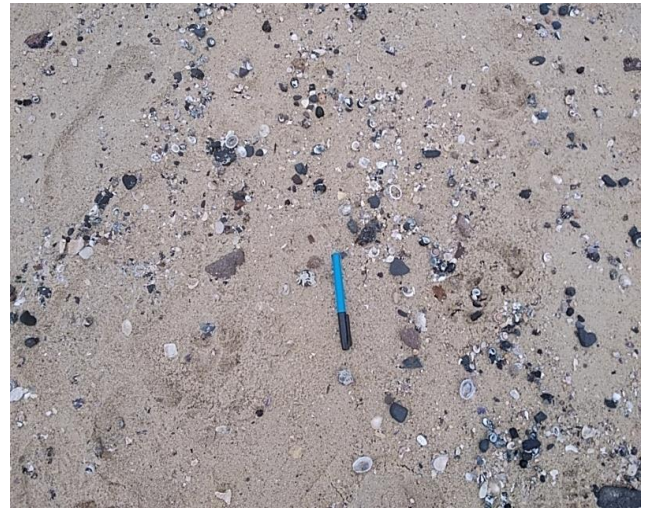
**Notes:** Visual inspection of removal item following removal

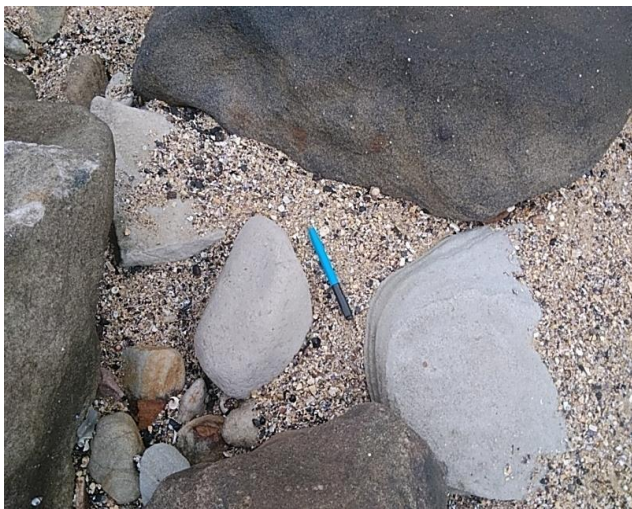
**Notes:** Visual inspection of removal item following removal

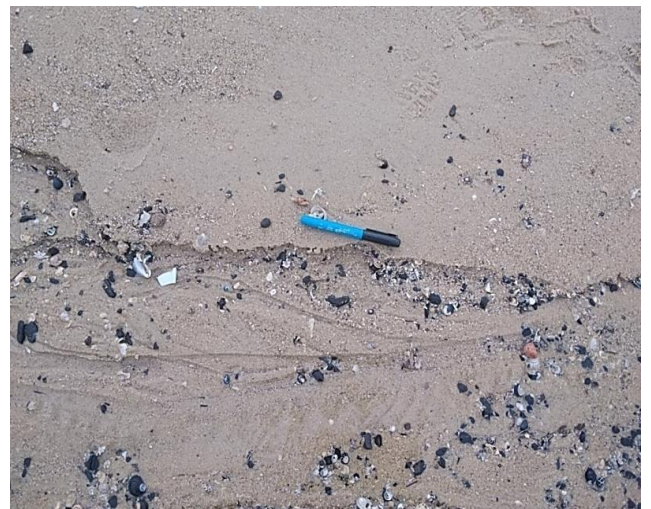
**Notes:** Visual inspection of removal item following removal

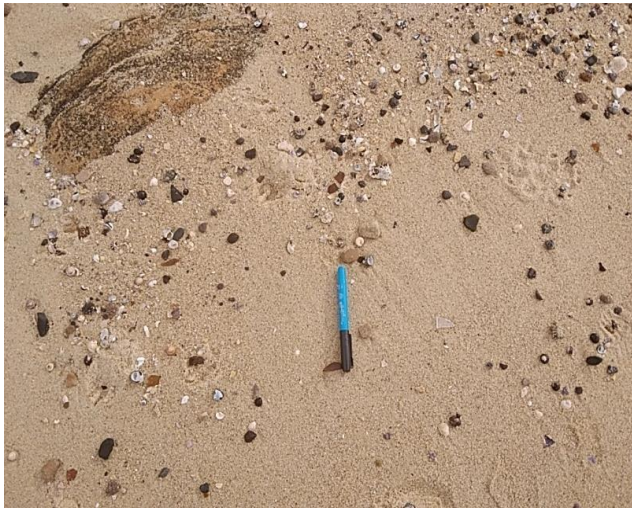
**Notes:** Visual inspection of removal item following removal

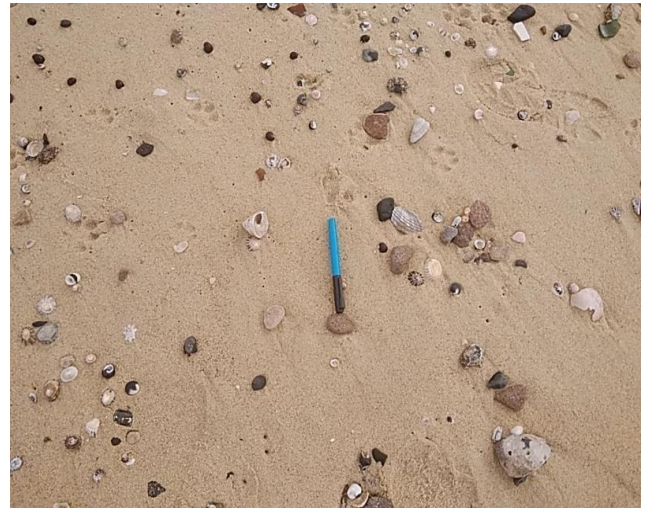
**Notes:** Visual inspection of removal item following removal

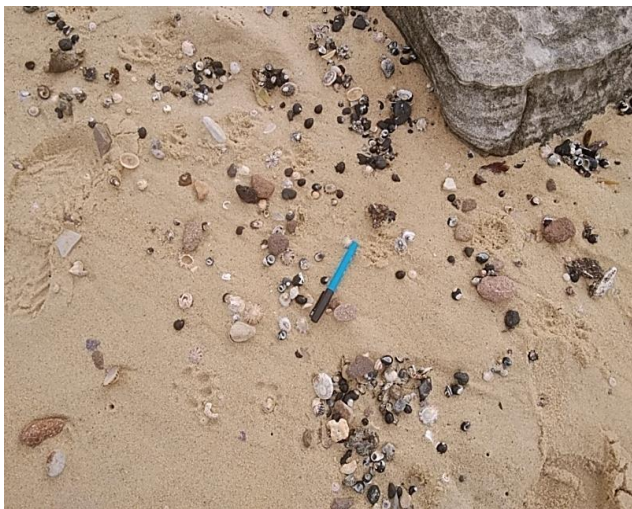
**Notes:** Visual inspection of removal item following removal

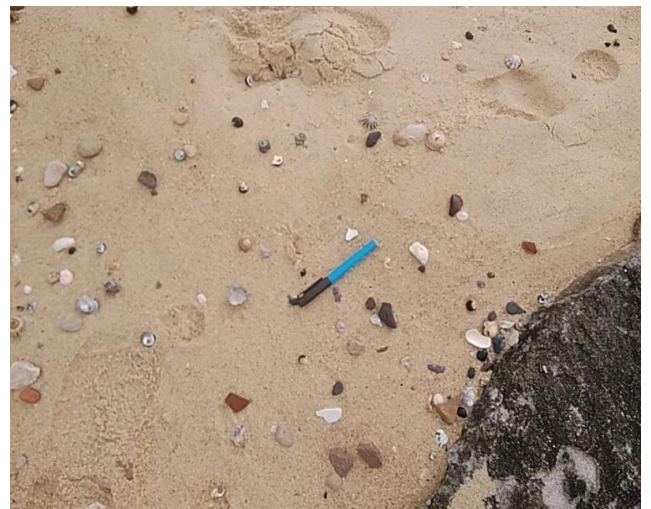
**Notes:** Visual inspection of removal item following removal

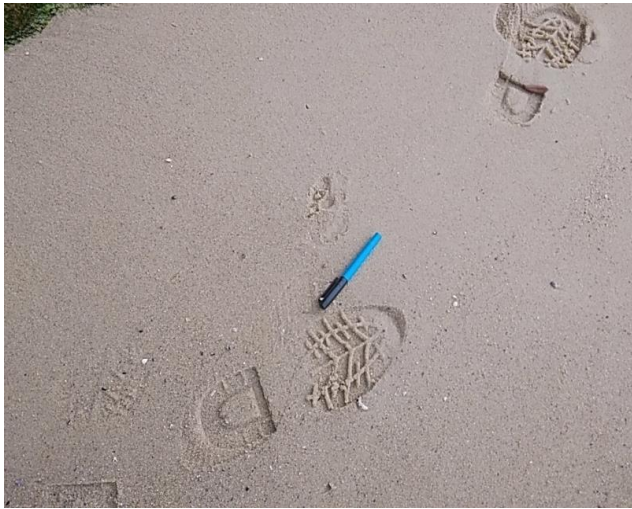
**Notes:** Visual inspection of removal item following removal

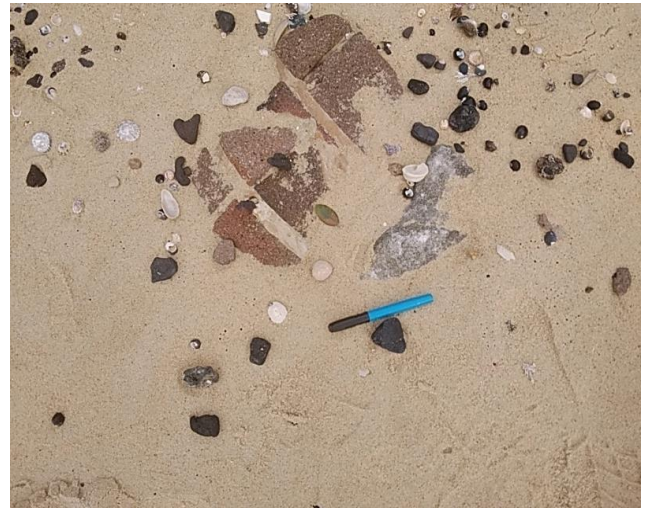
**Notes:** Visual inspection of removal item following removal

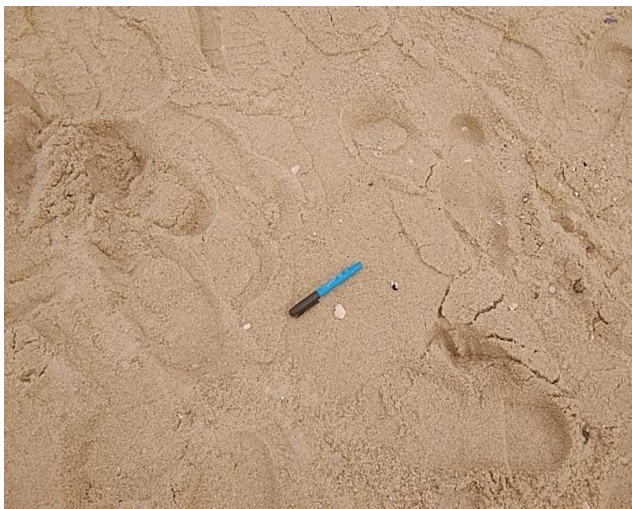
**Notes:** Visual inspection of removal item following removal

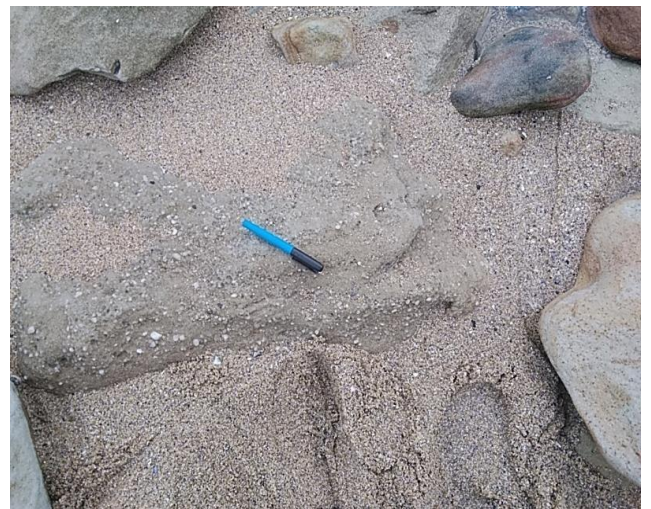
**Notes:** Visual inspection of removal item following removal

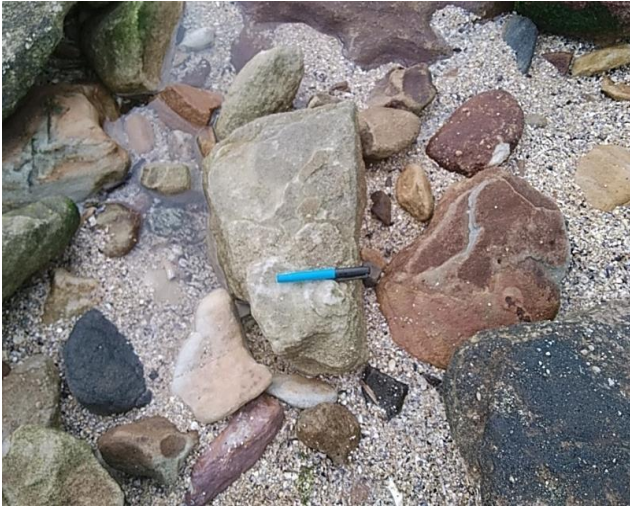
**Notes:** Visual inspection of removal item following removal

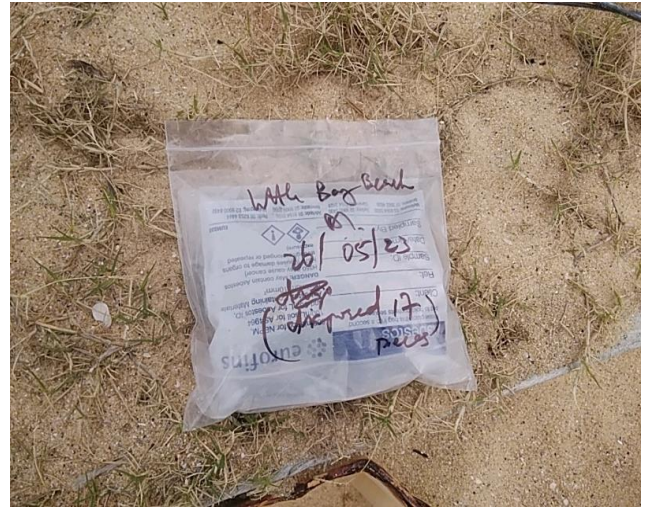
**Notes:** Waste disposal management
