# Asbestos Containing Material Clearance Inspection

7 July 2023

<b>Site:</b>	Little Bay Beach
<b>Location:</b>	Southern, Western and Northern Little Bay Beach

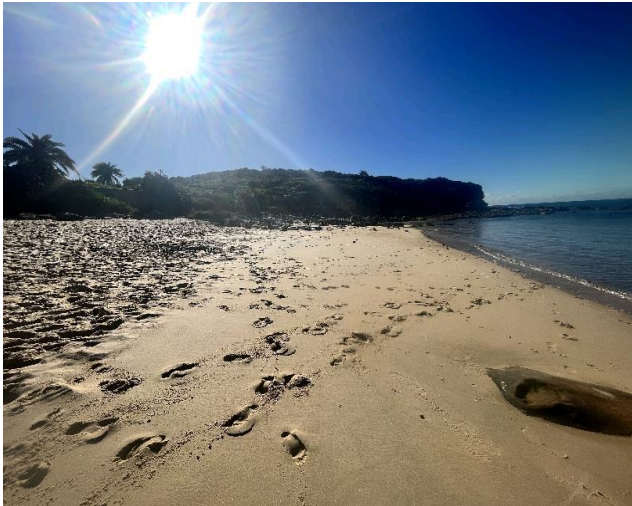
**Notes:** Overview of the Northern Beach.

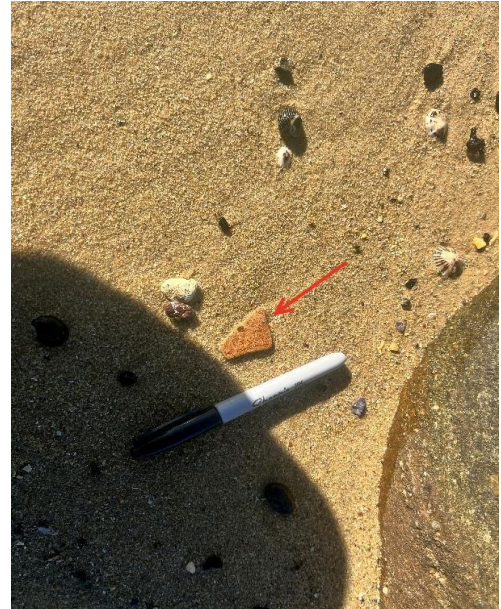
**Notes:** Overview of the FC Fragment within Northern Beach prior to emu picking.

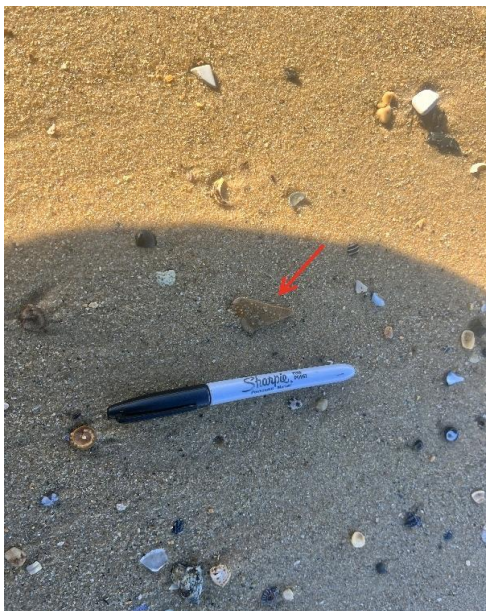
**Notes:** Overview of the FC Fragment within Northern Beach prior to emu picking

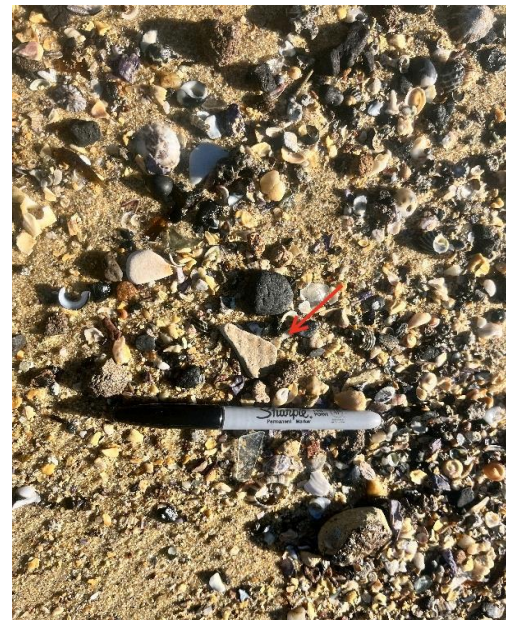
**Notes:** Overview of the FC Fragment within Northern Beach prior to emu picking

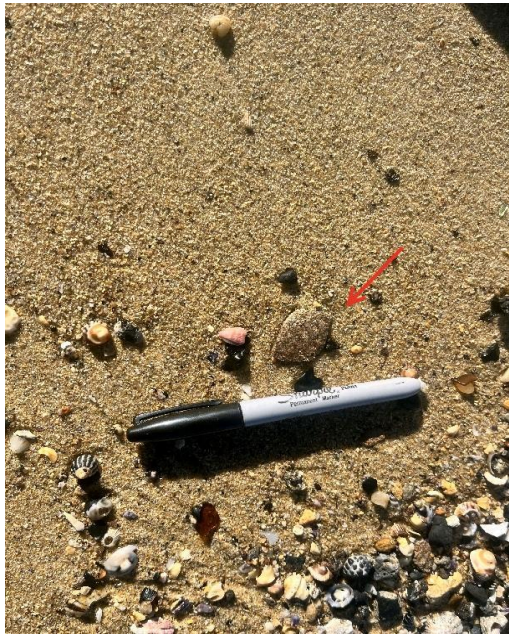
**Notes:** Overview of the FC Fragment within Northern Beach prior to emu picking

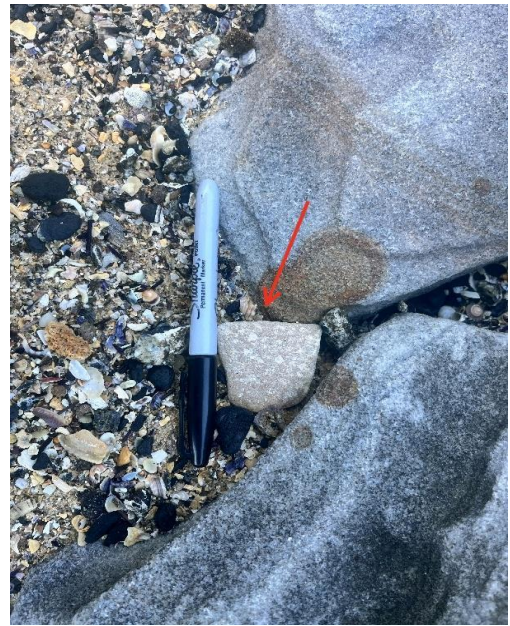
**Notes:** Overview of the FC Fragment within Northern Beach prior to emu picking

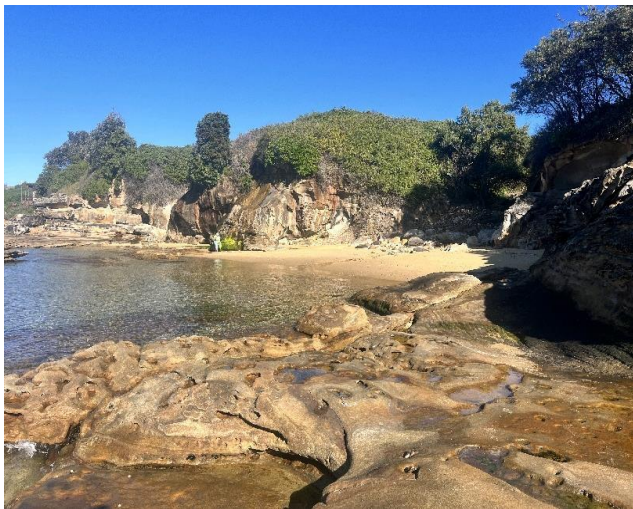
**Notes:** Overview of Western Beach.

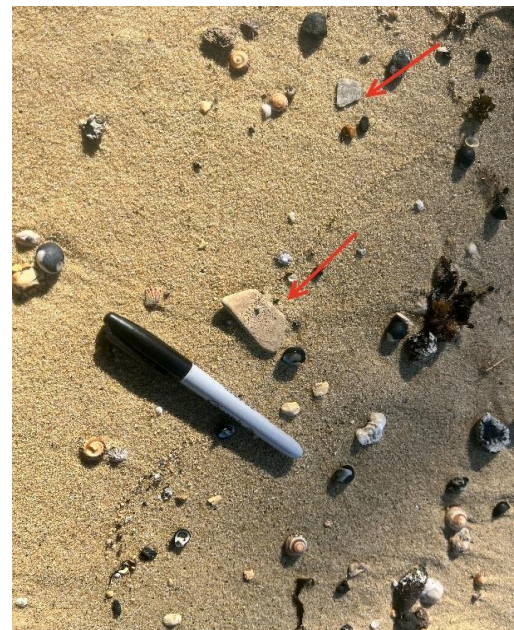
**Notes:** Overview of the FC Fragments within Western Beach prior to emu picking

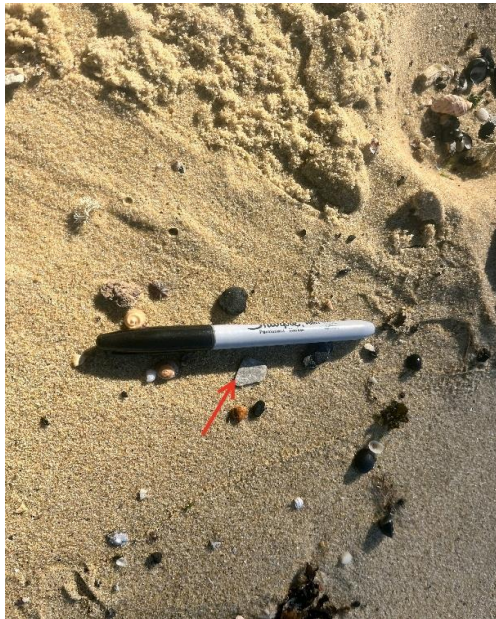
**Notes:** Overview of the FC Fragment within Western Beach prior to emu picking

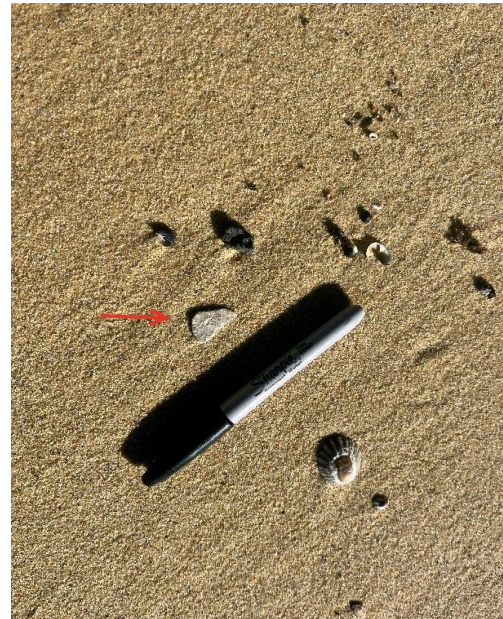
**Notes:** Overview of the FC Fragment within Western Beach prior to emu picking

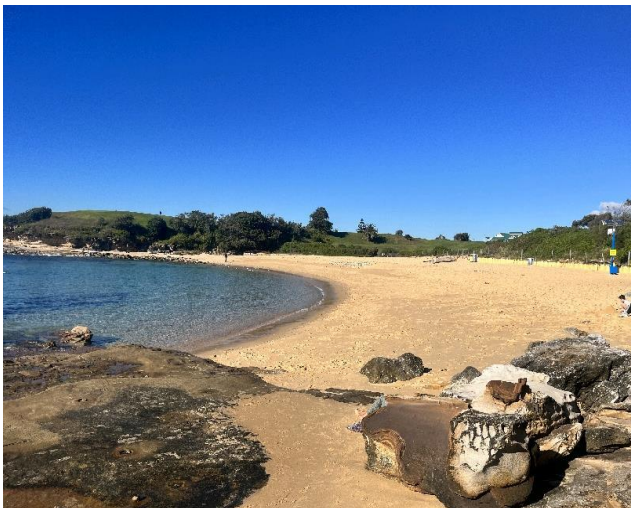
**Notes:** Overview of Southern Beach.

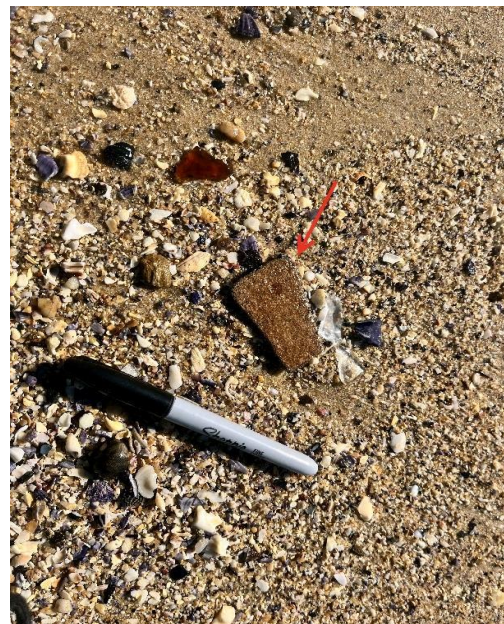
**Notes:** Overview of the FC Fragment within Southern Beach prior to emu picking

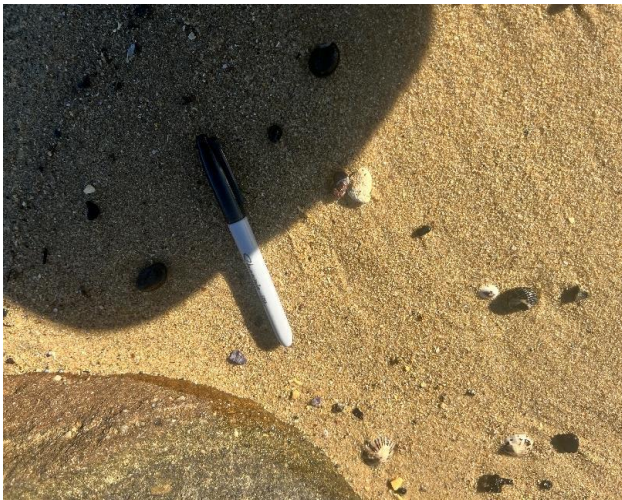
**Notes:** Visual surface clearance inspection following removal of suspected asbestos containing Fragment.

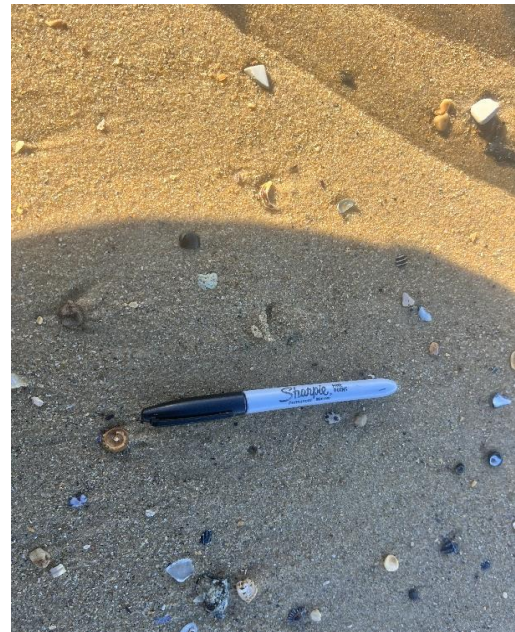
**Notes:** Visual surface clearance inspection following removal of suspected asbestos containing Fragment.

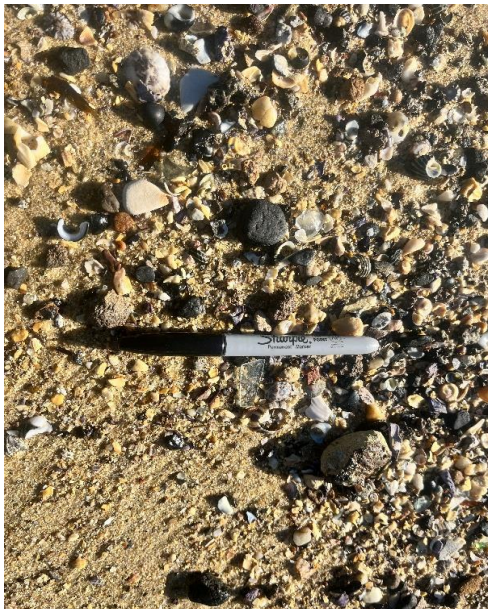
**Notes:** Visual surface clearance inspection following removal of suspected asbestos containing Fragment.

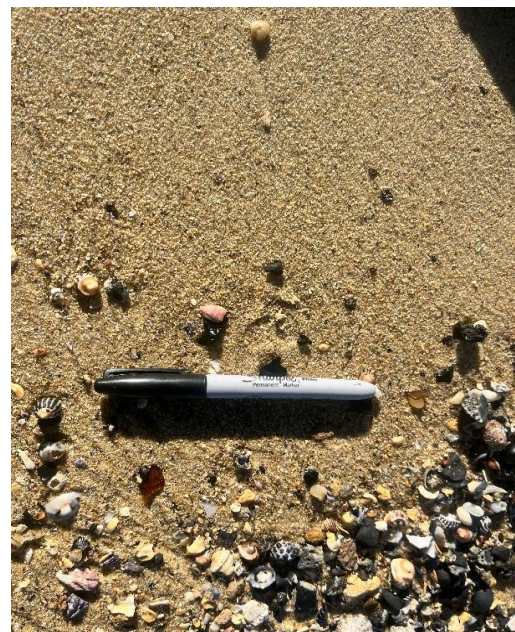
**Notes:** Visual surface clearance inspection following removal of suspected asbestos containing Fragment.

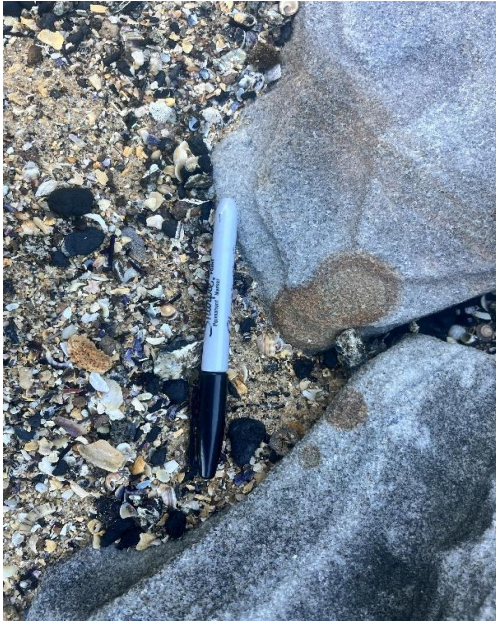
**Notes:** Visual surface clearance inspection following removal of suspected asbestos containing Fragment.

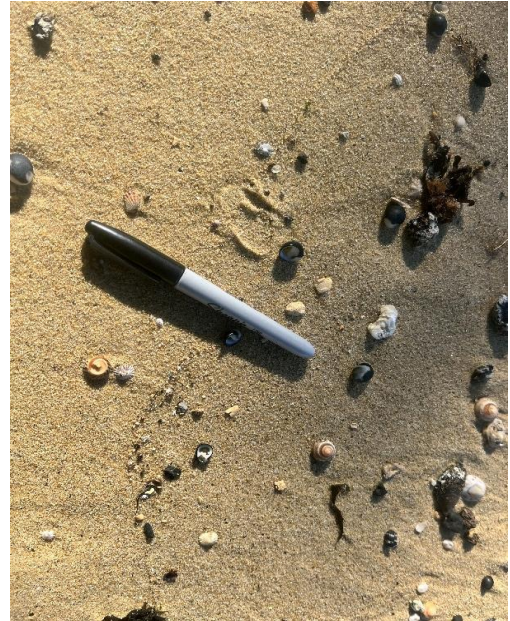
**Notes:** Visual surface clearance inspection following removal of suspected asbestos containing Fragment.

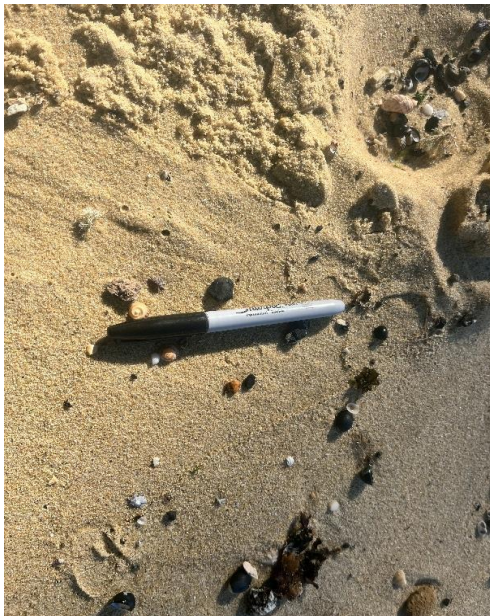
**Notes:** Visual surface clearance inspection following removal of suspected asbestos containing Fragment.

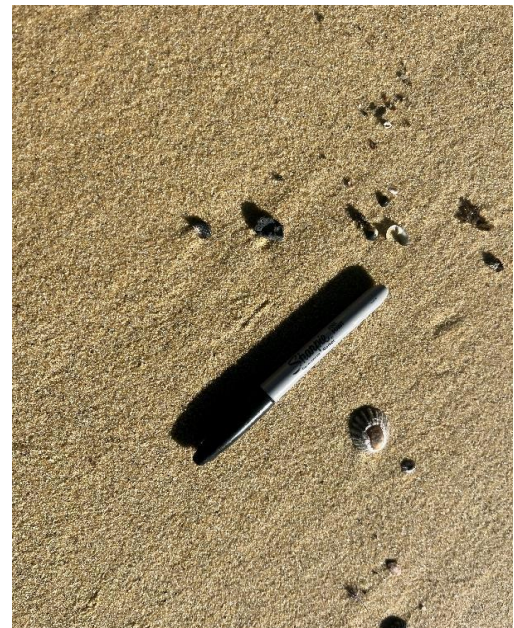
**Notes:** Visual surface clearance inspection following removal of suspected asbestos containing Fragment.

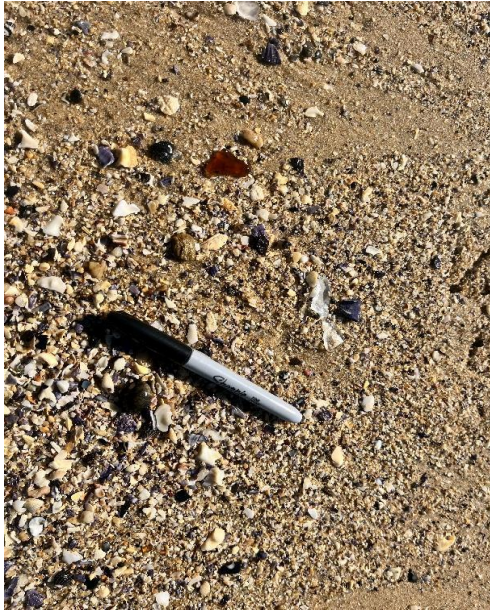
**Notes:** Visual surface clearance inspection following removal of suspected asbestos containing Fragment.
