Asbestos Clearance Certificate

RE: Asbestos Clearance Inspection and Clearance Certificate

Site:	Little Bay Beach
--------------	------------------

Requested by:	
Name	Ryan Zammit
Contact	90936744
Email	ryan.zammit@randwick.nsw.gov.au
Site Details:	
Address	2 Coast Hospital Rd, Little Bay NSW 2036
Local Government Area	Randwick City Council

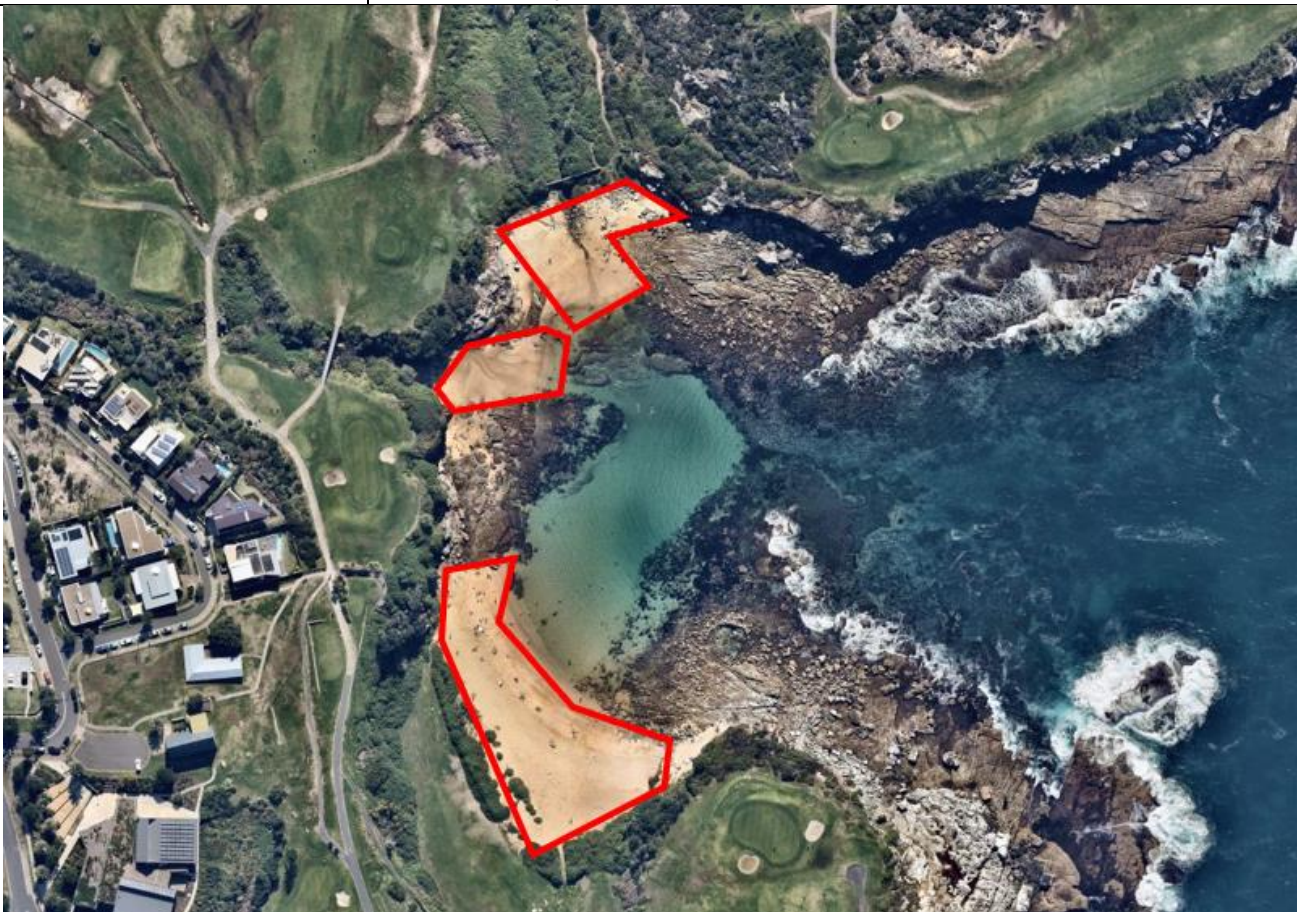
Clearance Area

Scope of Removal Work:	
Location of Removal Work	Southern, western and southern Little Bay Beach
Asbestos Material	Bonded asbestos
Bonded / Friable	Non-Friable
Scope of Asbestos Remediation	Emu picking of suspected fragments on sand surfaces
Date of Removal work	08/10/2020
Documents Reviewed	NA
Asbestos Removalist	NA
License Number	NA

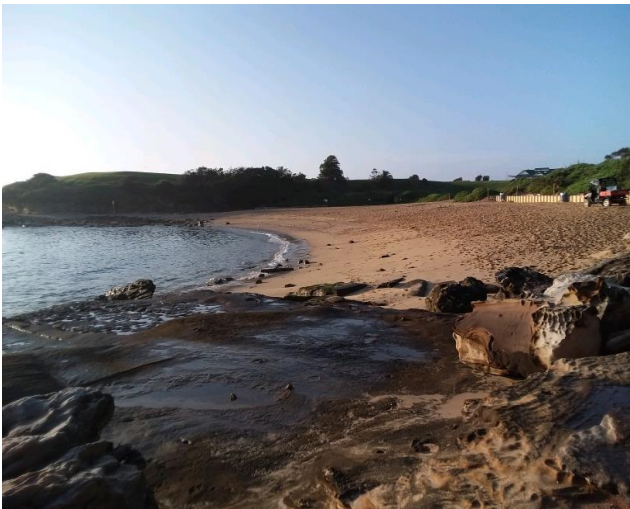
Notes: Overview of northern beach during low tide

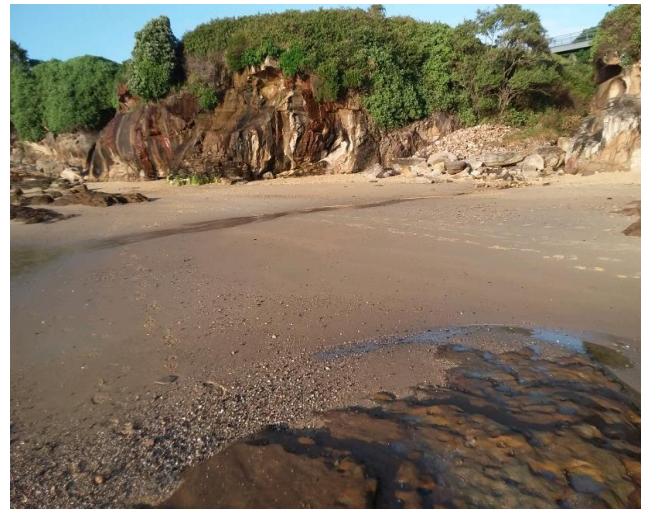
Notes: Overview of western beach during low tide

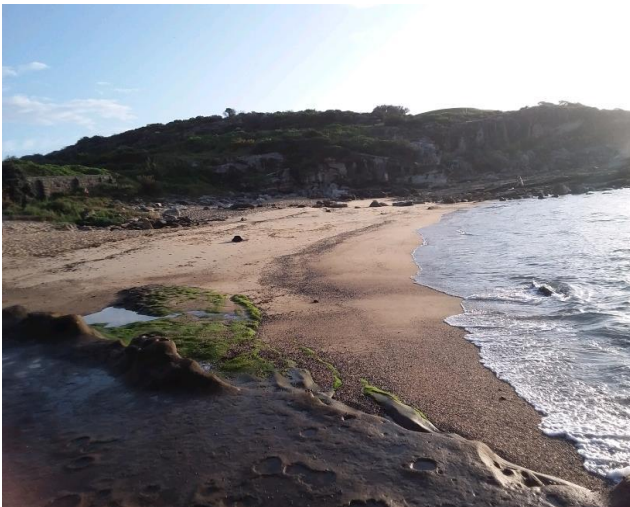
Notes: Overview of southern beach during low tide

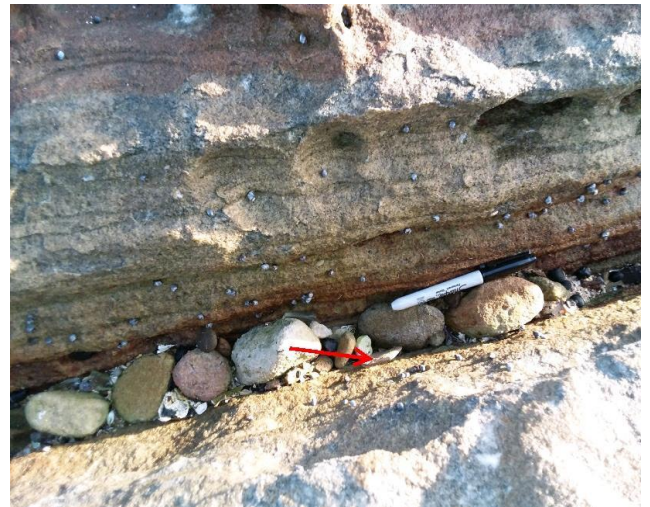
Notes: Overview of the removal item within northern beach during low tide

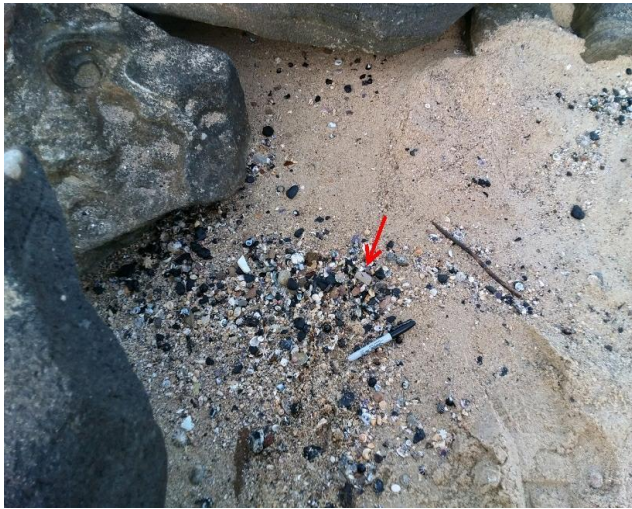
Notes: Overview of the removal item within northern beach during low tide

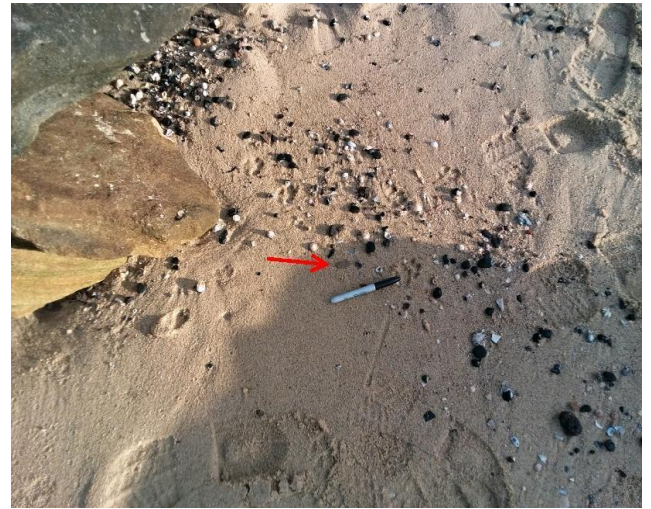
Notes: Overview of the removal item within northern beach during low tide

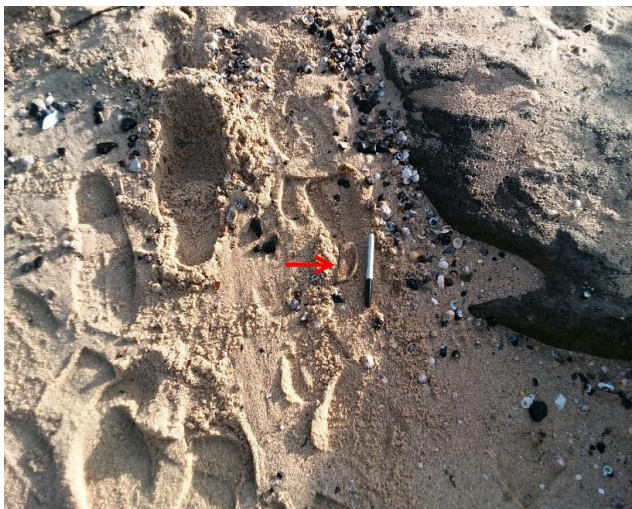
Notes: Overview of the removal item within northern beach during low tide

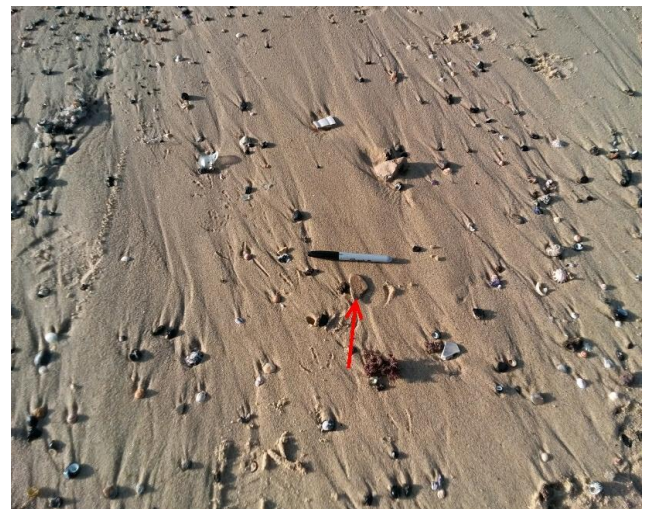
Notes: Overview of the removal item within northern beach during low tide

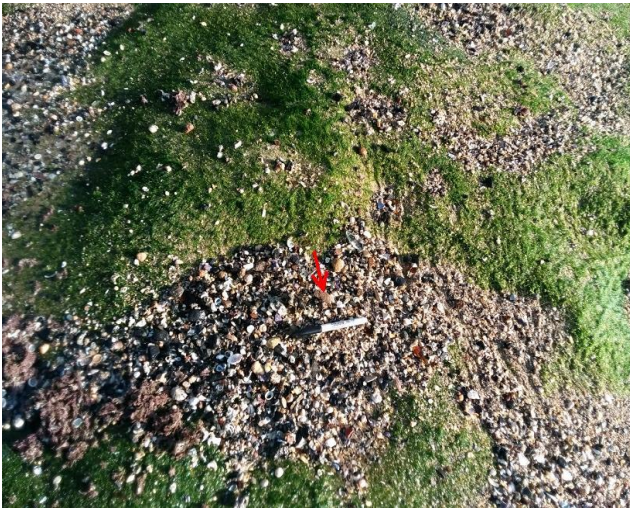
Notes: Overview of the removal item within northern beach during low tide

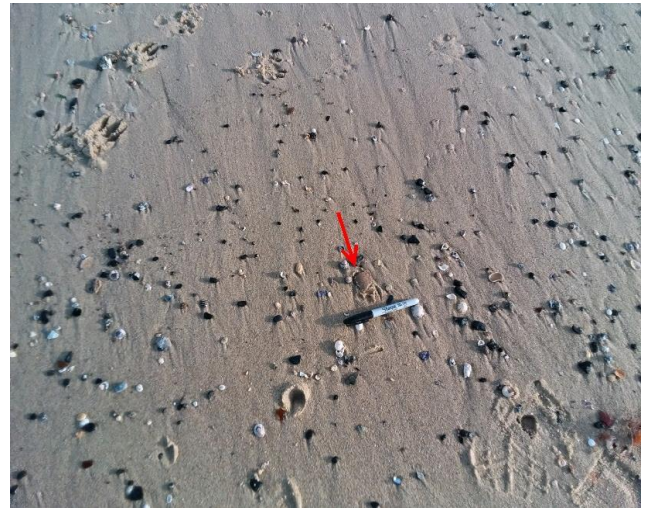
Notes: Overview of the removal item within northern beach during low tide

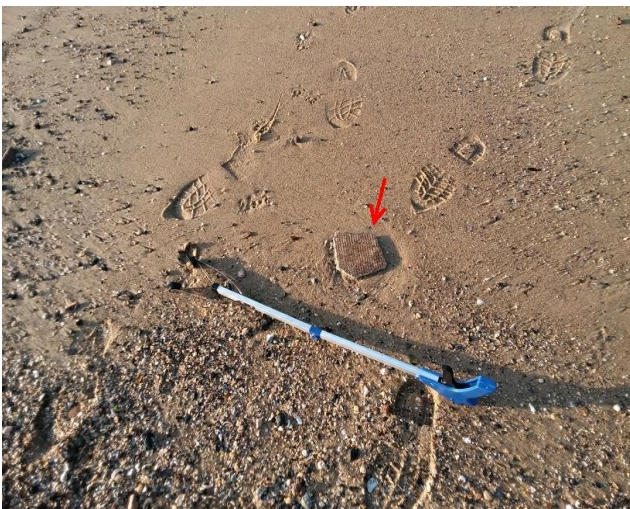
Notes: Overview of the removal item within western beach during low tide

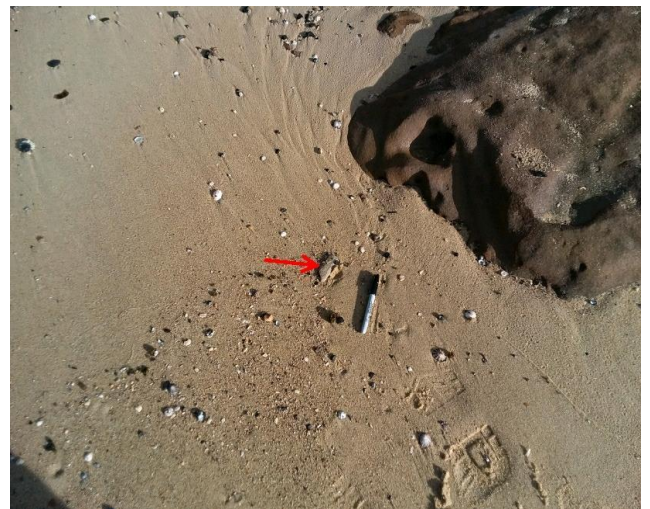
Notes: Visual inspection to the removal item within northern beach area following removal

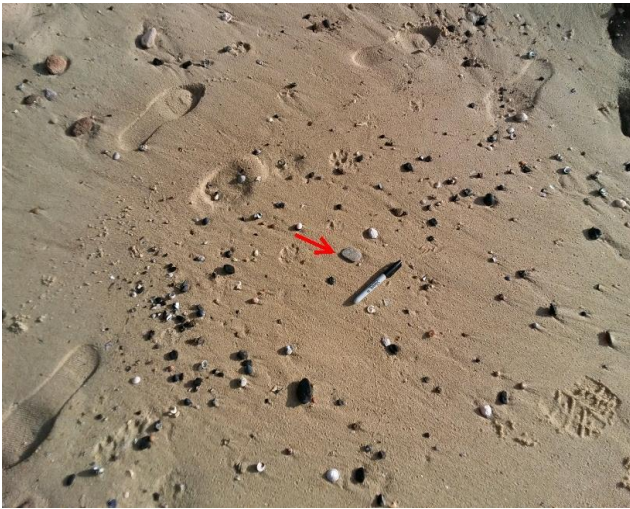
Notes: Visual inspection to the removal item within western beach area following removal

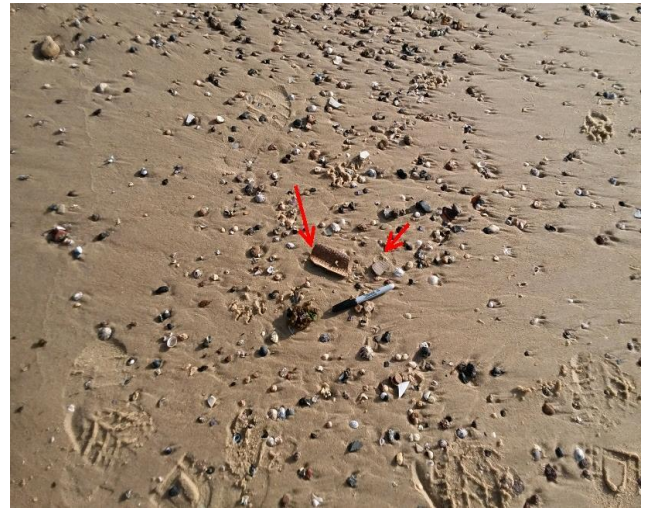
Notes: Visual inspection to the removal items within western beach area following removal

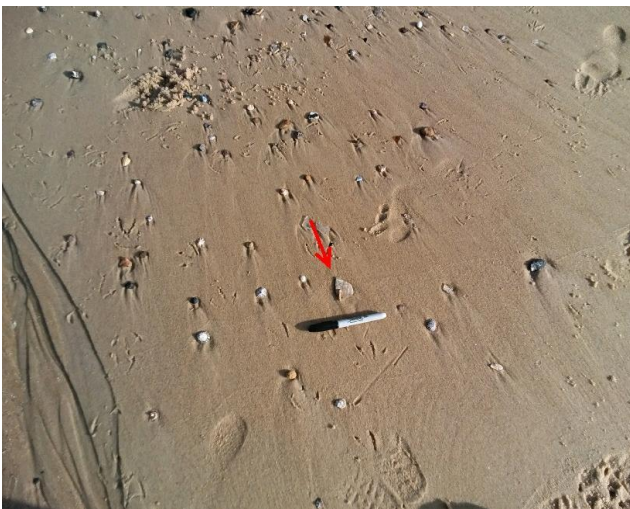
Notes: Visual inspection to the removal item within western beach area following removal

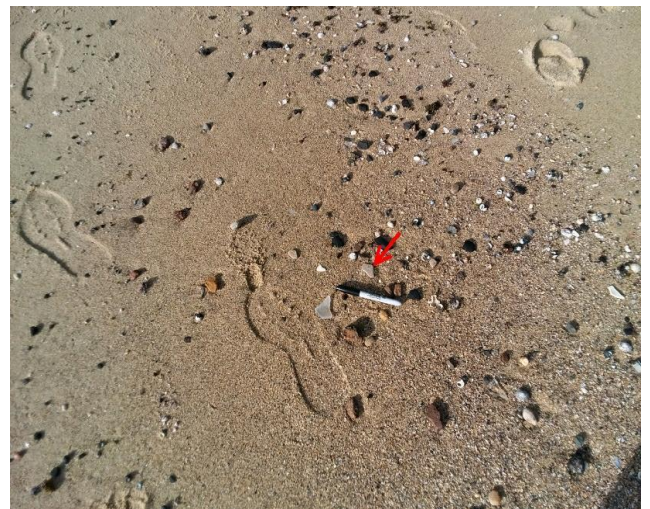
Notes: Visual inspection to the removal item within western beach area following removal

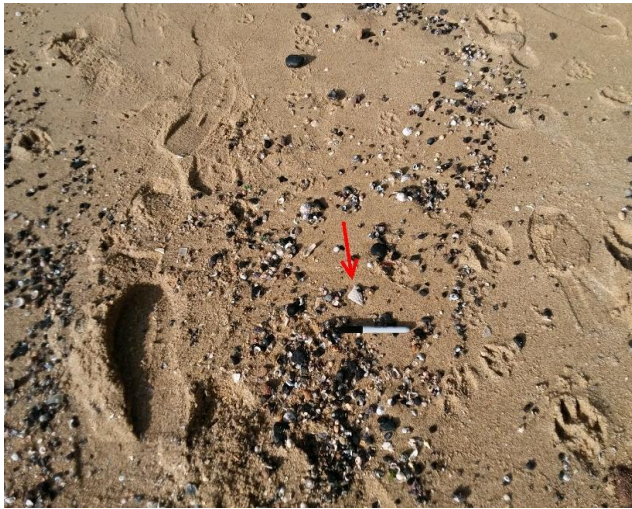
Notes: Visual inspection to the removal item within western beach area following removal

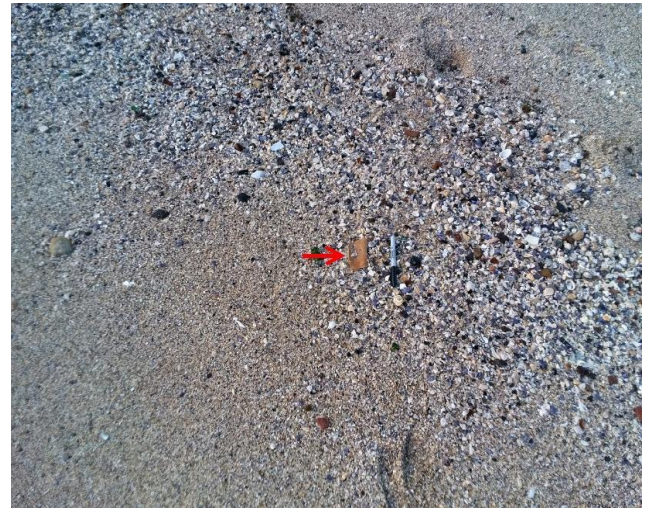
Notes: Visual inspection to the removal item within northern beach area following removal

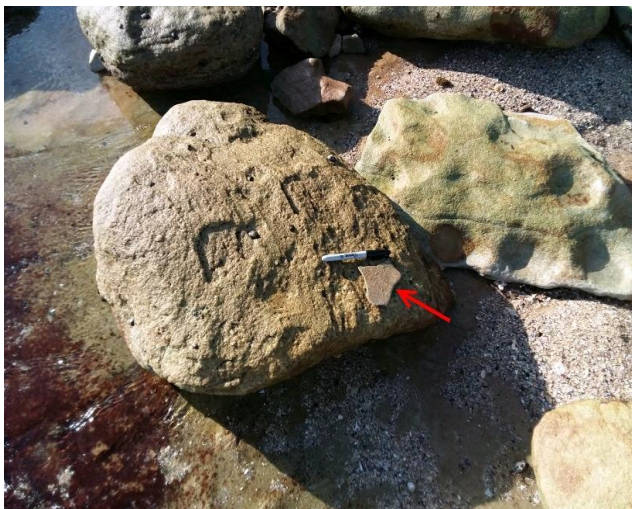
Notes: Visual inspection to the removal item within northern beach area following removal

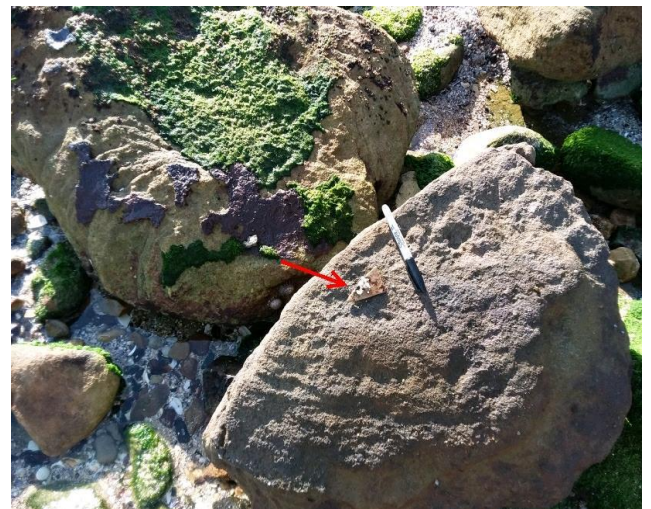
Notes: Visual inspection to the removal item within northern beach area following removal

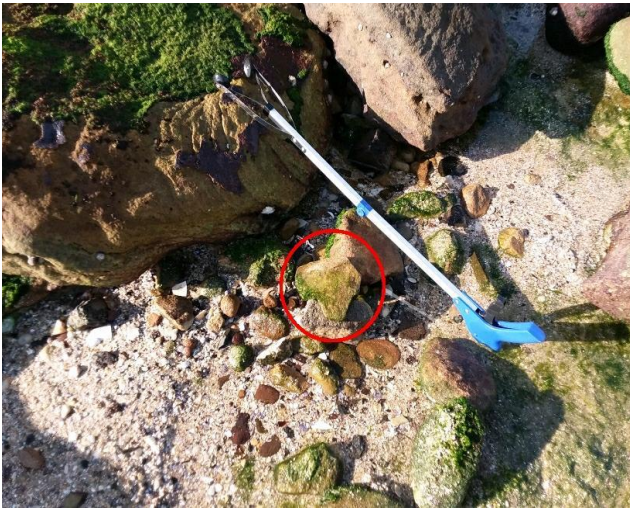
Notes: Visual inspection to the removal item within northern beach area following removal

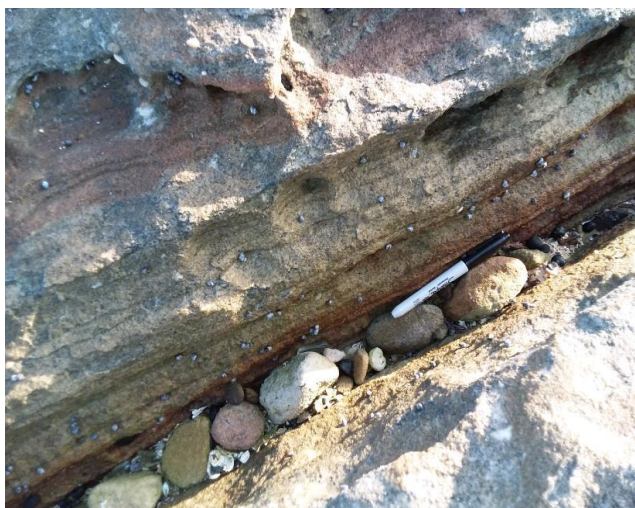
Notes: Visual inspection to the removal item within northern beach area following removal

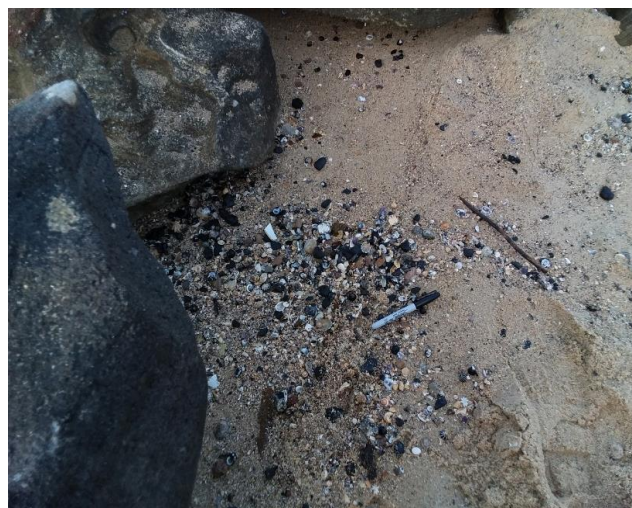
Notes: Visual inspection to the removal item within northern beach area following removal

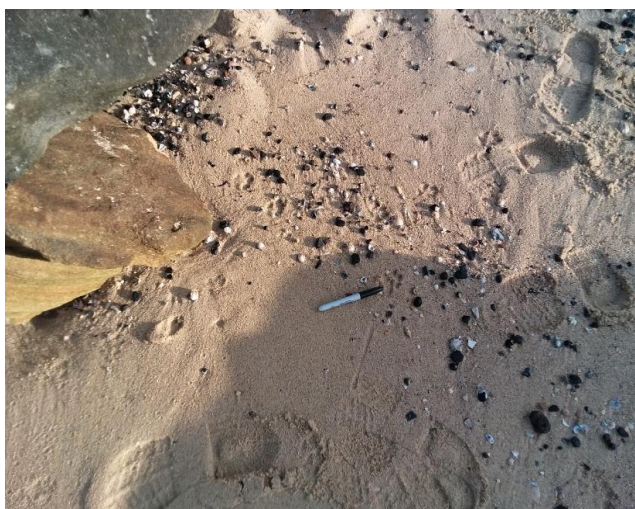
Notes: Visual inspection to the removal item within northern beach area following removal

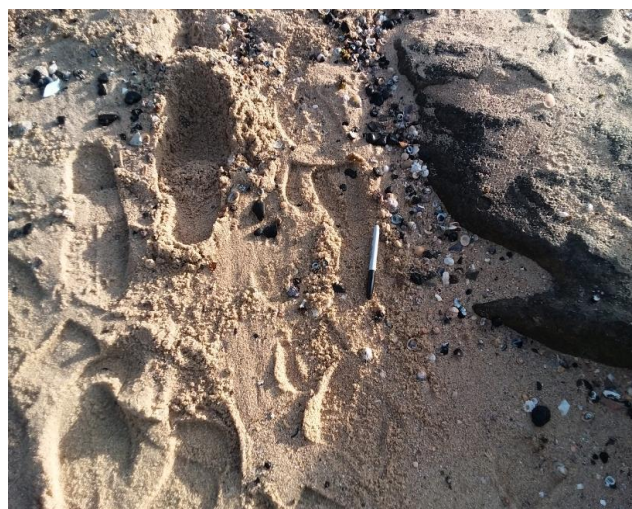
Notes: Visual inspection to the removal item within northern beach area following removal

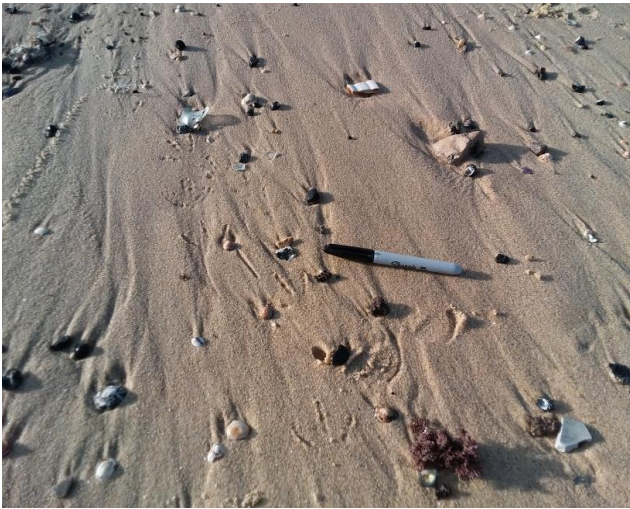
Notes: Visual inspection to the removal item within northern beach area following removal

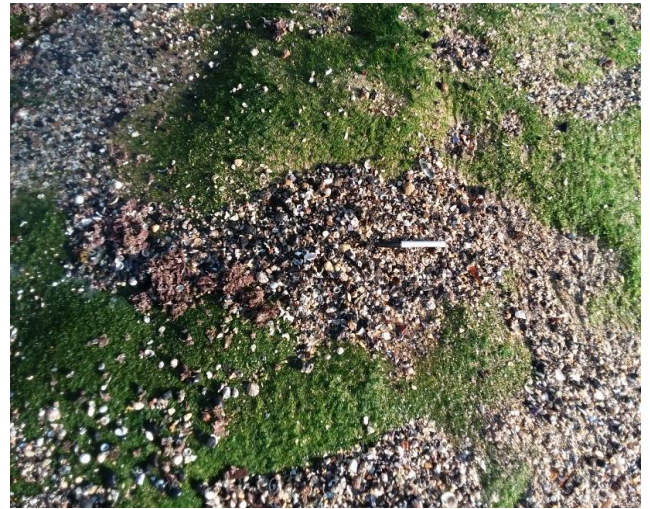
Notes: Visual inspection to the removal item within northern beach area following removal

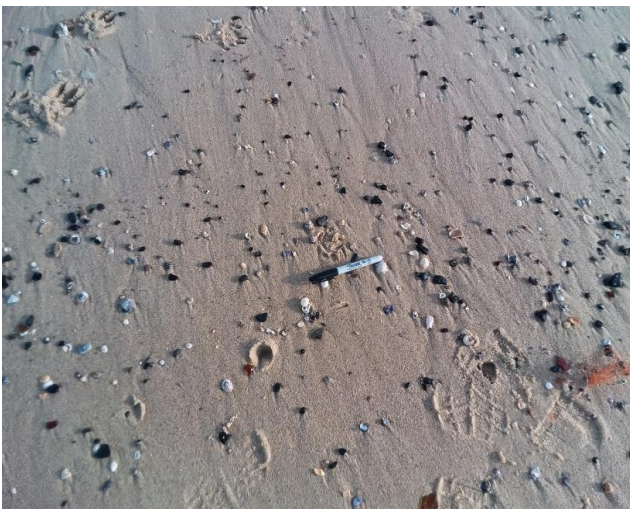
Notes: Visual inspection to the removal item within northern beach area following removal

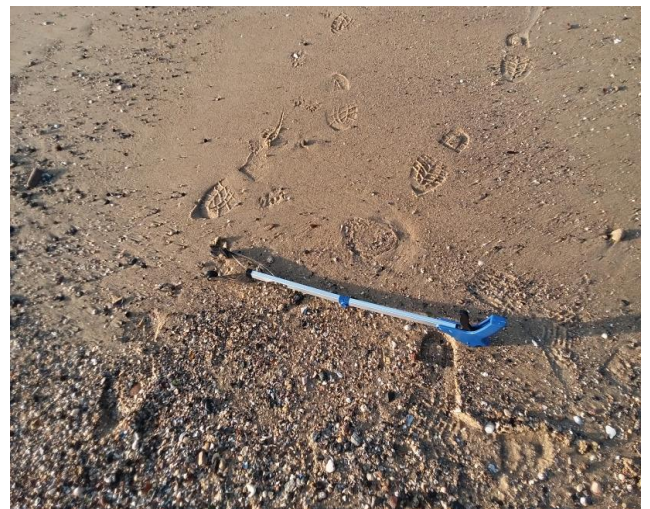
Notes: Visual inspection to the removal item within western beach area following removal

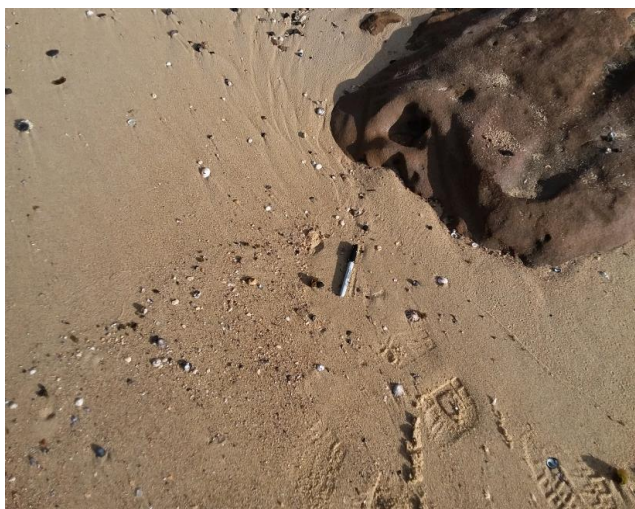
Notes: Visual inspection to the removal item within western beach area following removal

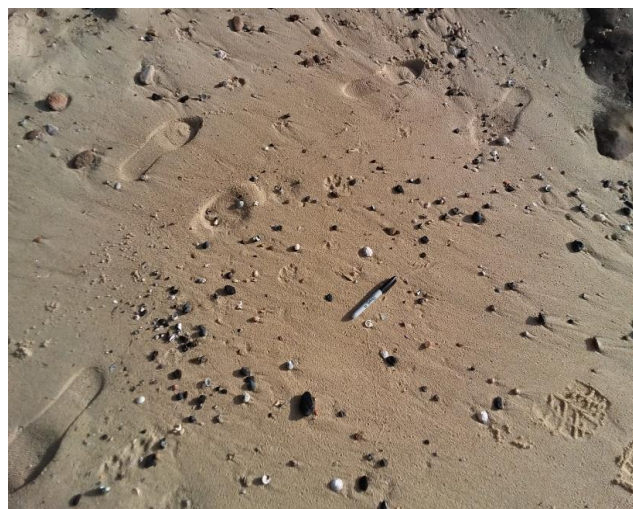
Notes: Visual inspection to the removal item within western beach area following removal

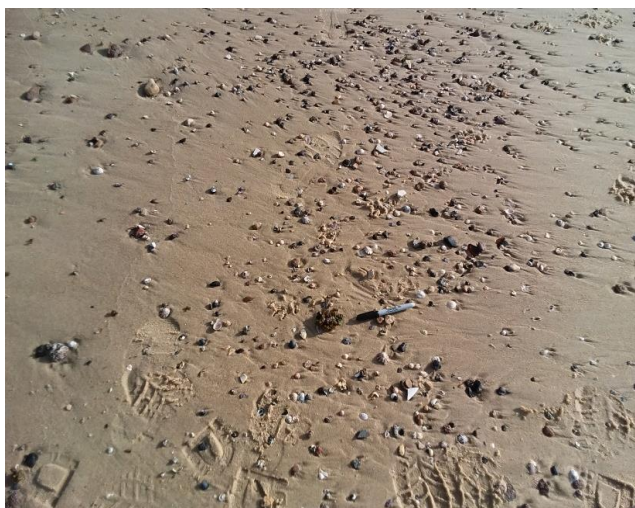
Notes: Visual inspection to the removal item within western beach area following removal

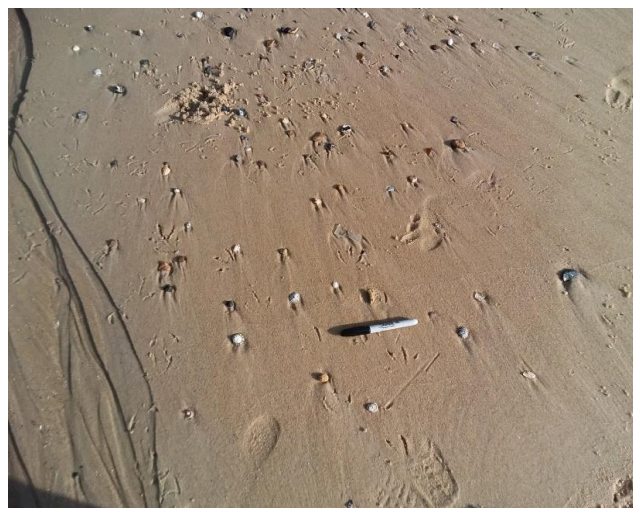
Notes: Visual inspection to the removal item within western beach area following removal

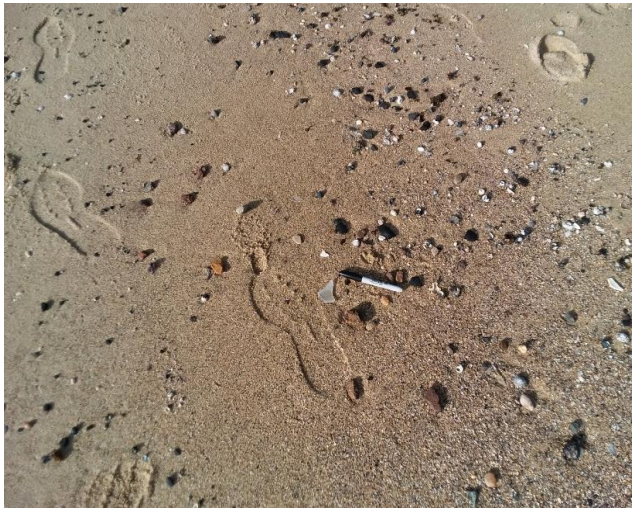
Notes: Visual inspection to the removal item within western beach area following removal

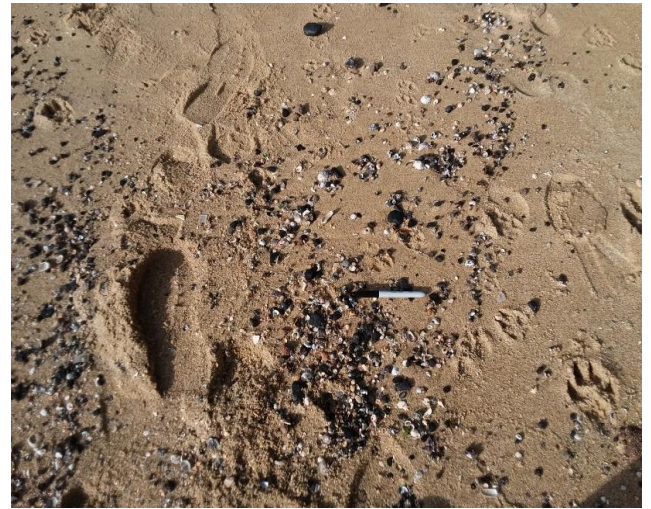
Notes: Visual inspection to the removal item within western beach area following removal

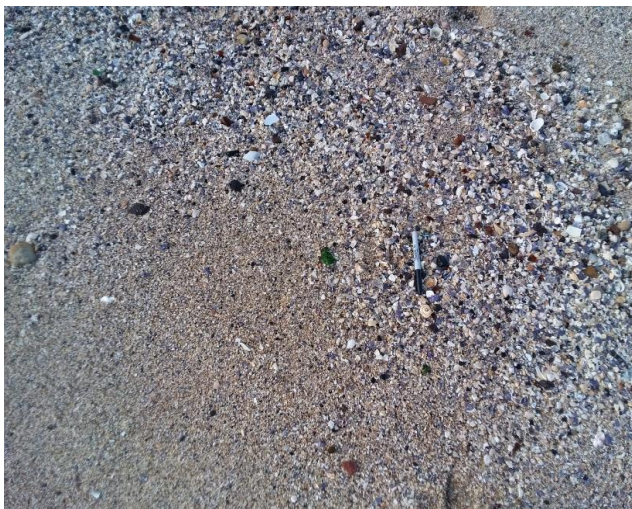
Notes: Visual inspection to the removal item within southern beach area following removal

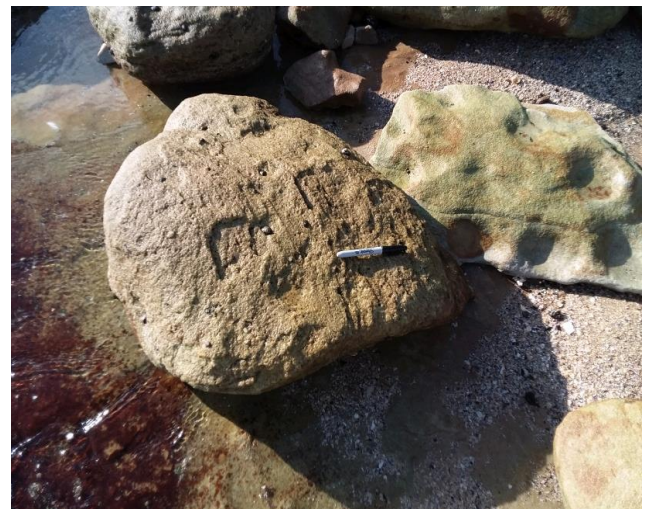
Notes: Visual inspection to the removal item within southern beach area following removal

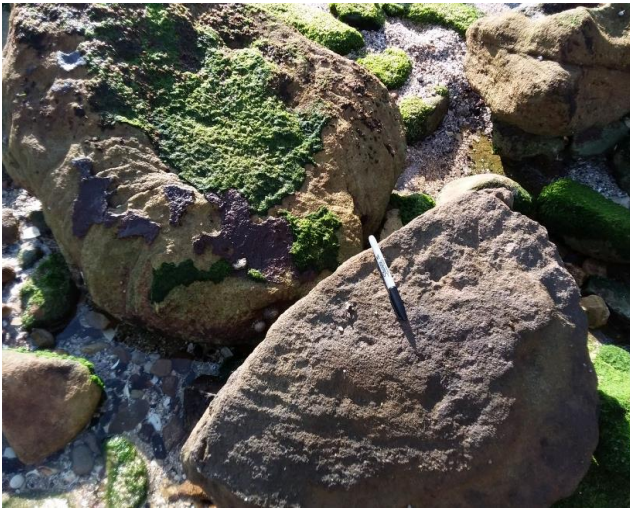
Notes: Visual inspection to the removal item within southern beach area following removal

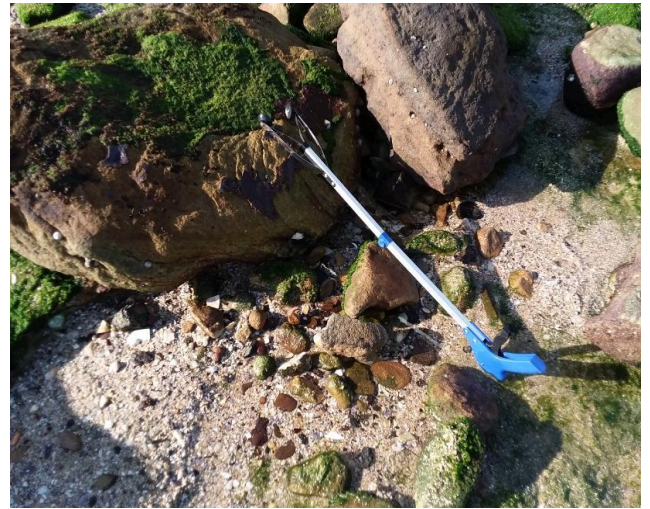
Notes: Visual inspection to the removal item within southern beach area following removal
