Asbestos Clearance Certificate

Report Number: 40-15092-09-CL

Site Address: 307-327R Fitzgerald Avenue, Maroubra NSW 2035

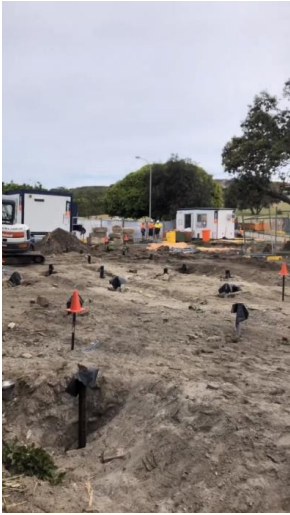
Photograph 1:

Representative image of the area inspected at the time of inspection (southern perspective).
