# Asbestos Containing Material Clearance Inspection

## RE: Asbestos Containing Material Clearance Inspection

<b>Site:</b>	Little Bay Beach
<b>Location:</b>	Southern, Western and Northern Little Bay Beach

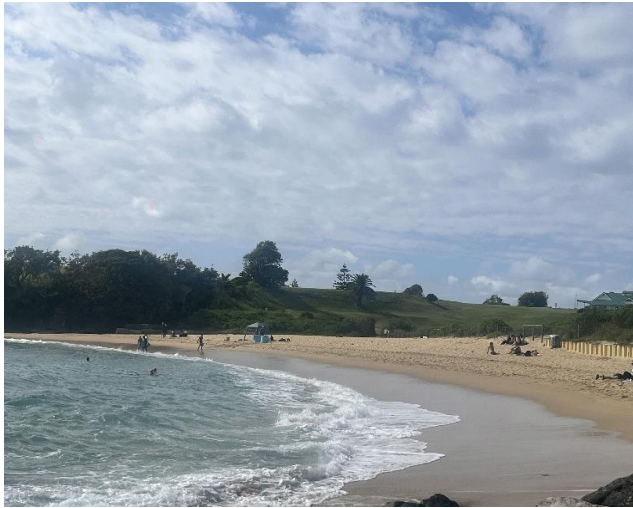
**Notes:** Overview of Southern beach.

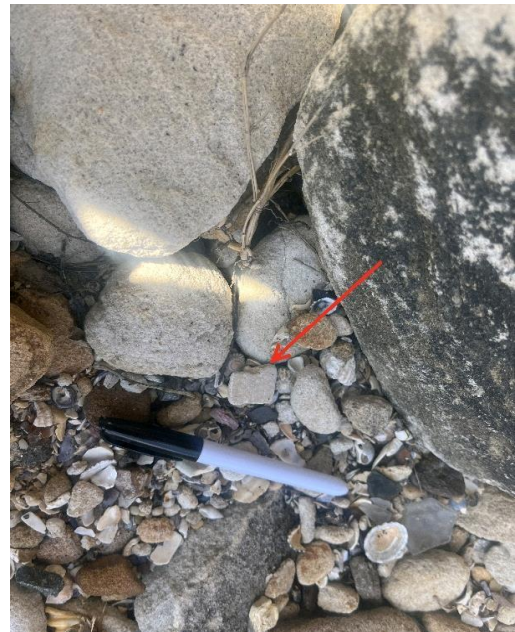
**Notes:** Overview of ACM fragment within Southern beach.

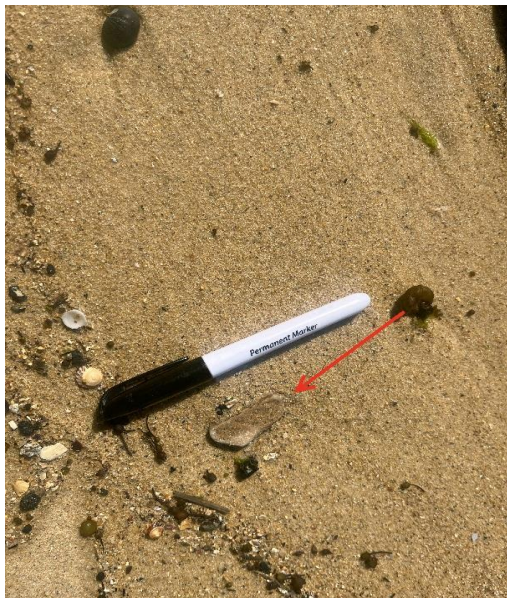
**Notes:** Overview of ACM fragment within Southern beach.

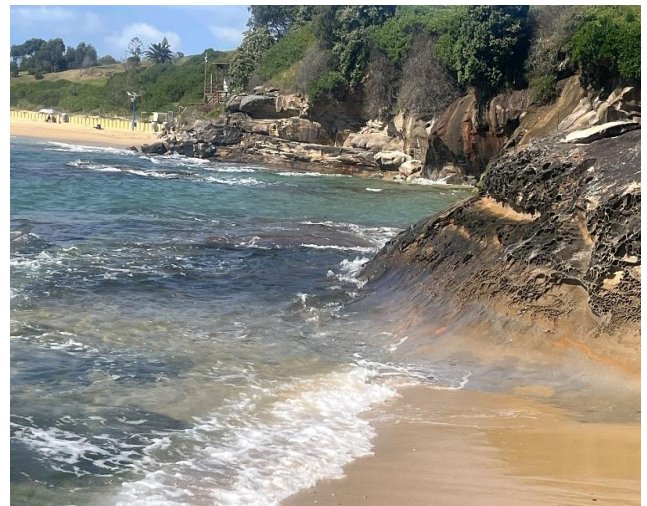
**Notes:** Overview of Western beach.

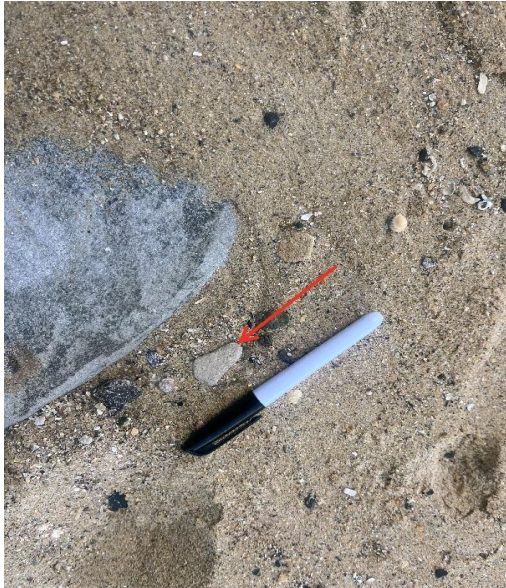
**Notes:** Overview of ACM fragment within Western beach.

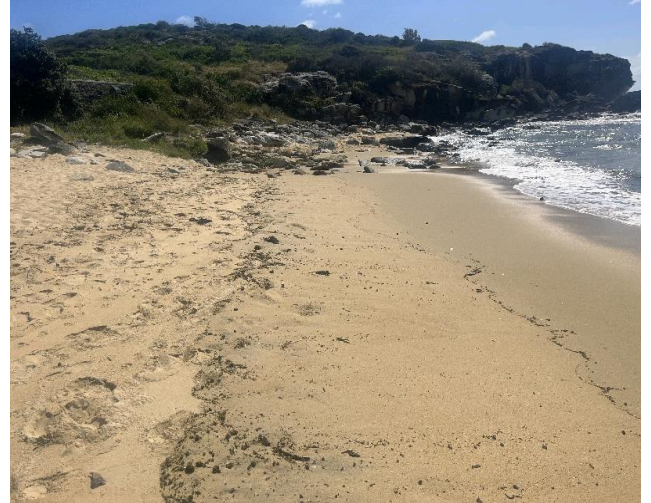
**Notes:** Overview of Northern beach.

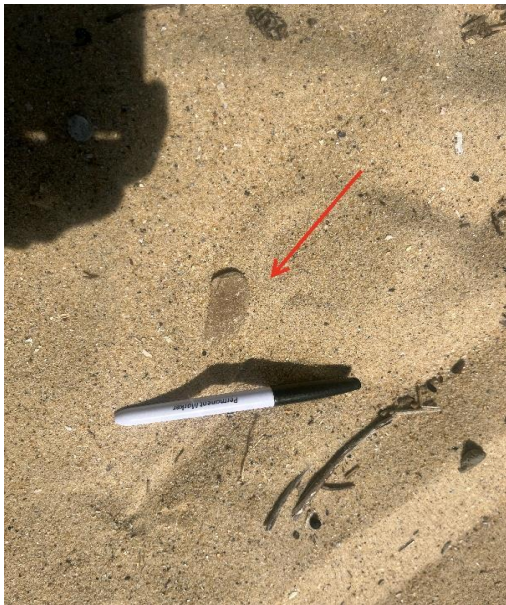
**Notes:** Overview of ACM fragment within Northern beach.

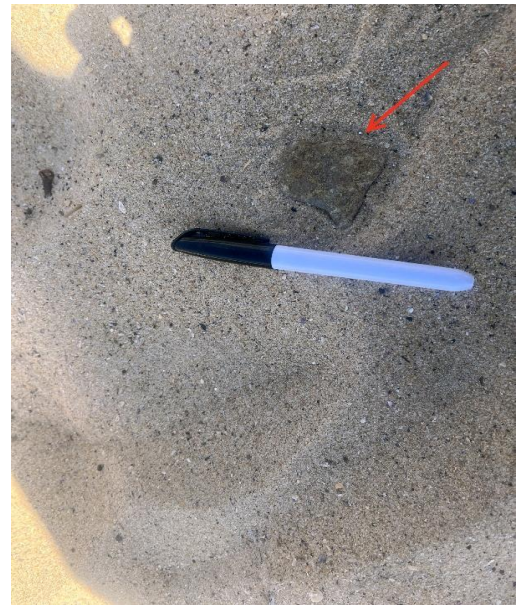
**Notes:** Overview of ACM fragment within Northern beach.

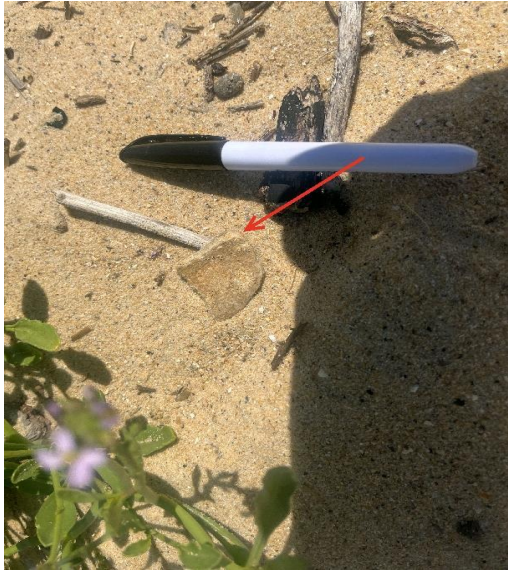
**Notes:** Overview of ACM fragment within Northern beach.

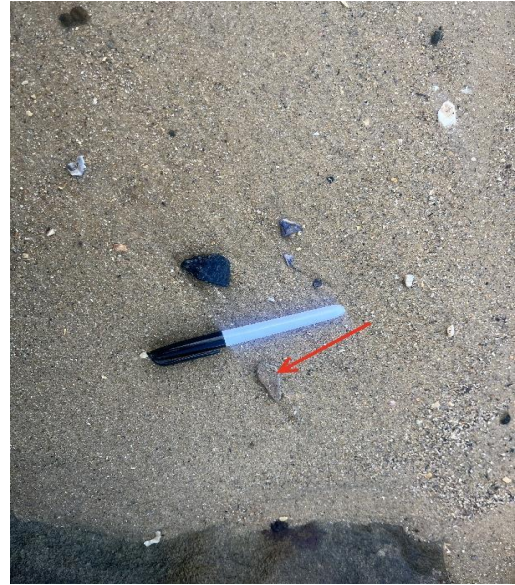
**Notes:** Overview of ACM fragment within Northern beach.

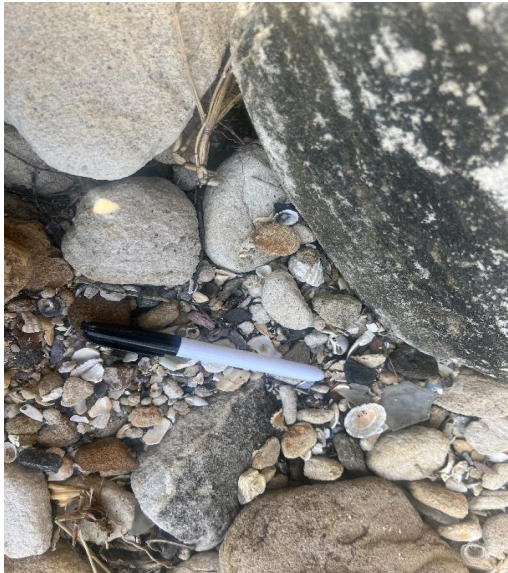
**Notes:** Visual surface inspection following removal of ACM fragment.

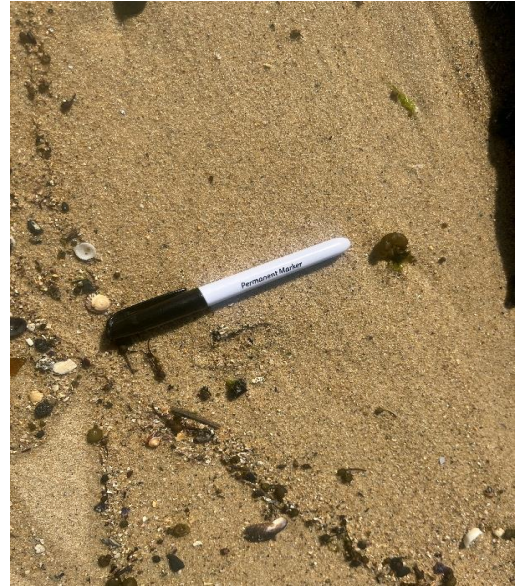
**Notes:** Visual surface inspection following removal of ACM fragment.

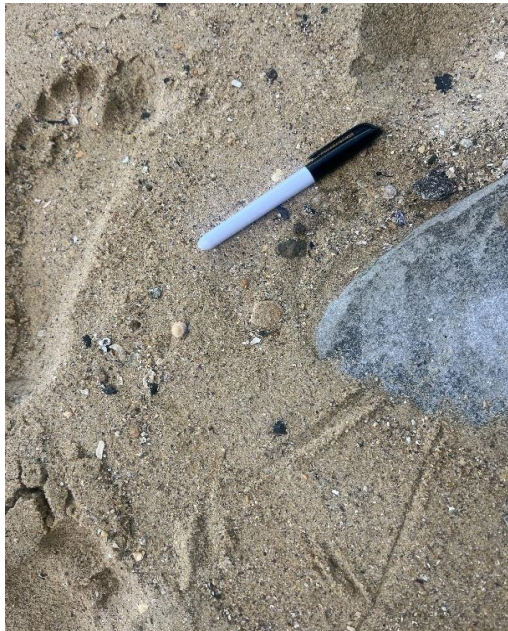
**Notes:** Visual surface inspection following removal of ACM fragment.

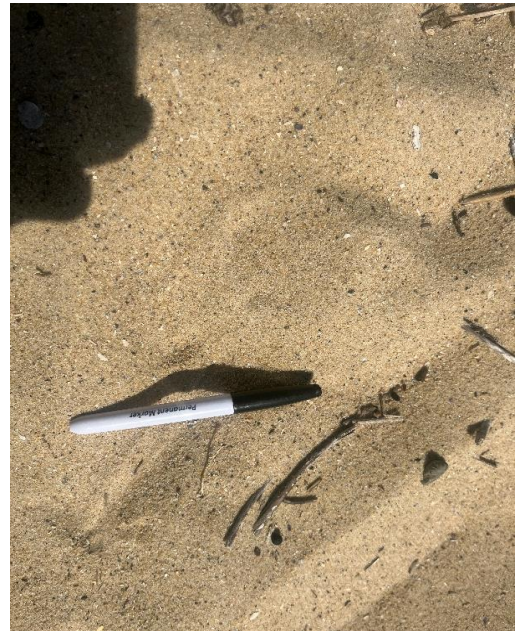
**Notes:** Visual surface inspection following removal of ACM fragment.

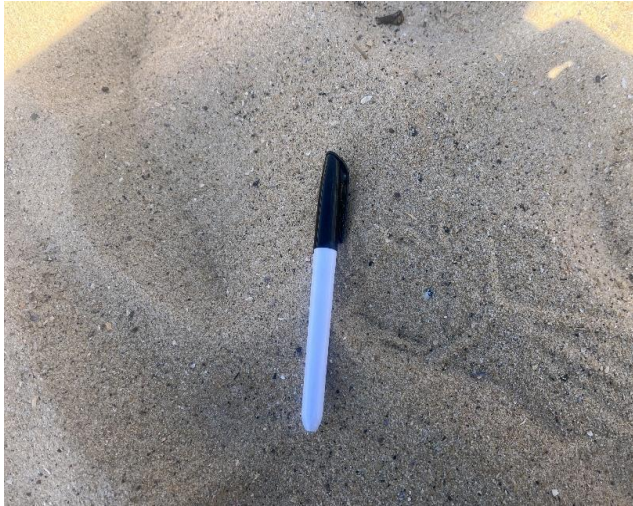
**Notes:** Visual surface inspection following removal of ACM fragment.

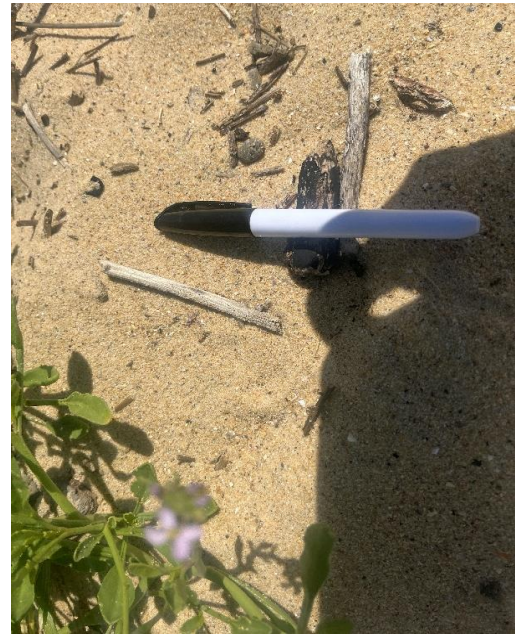
**Notes:** Visual surface inspection following removal of ACM fragment.

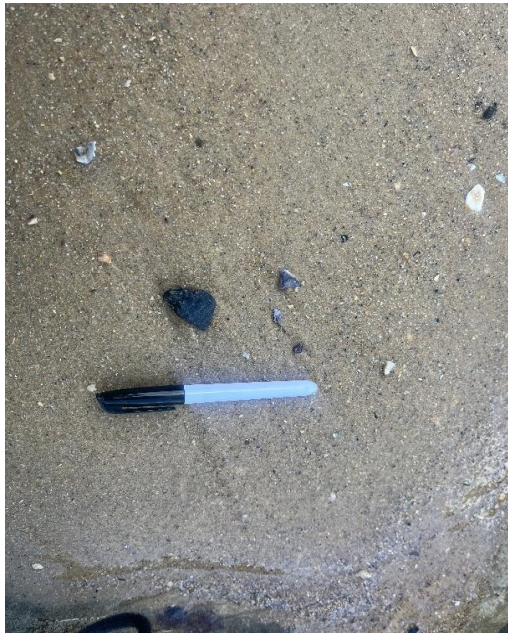
**Notes:** Visual surface inspection following removal of ACM fragment.
