Asbestos Containing Material Clearance Inspection

Site:	Little Bay Beach
Location:	Southern, Western and Northern Little Bay Beach

Requested by:	
Name	Ryan Zammit
Contact	90936744
Email	ryan.zammit@randwick.nsw.gov.au
Site Details:	
Address	2 Coast Hospital Rd, Little Bay NSW 2036
Local Government Area	Randwick City Council

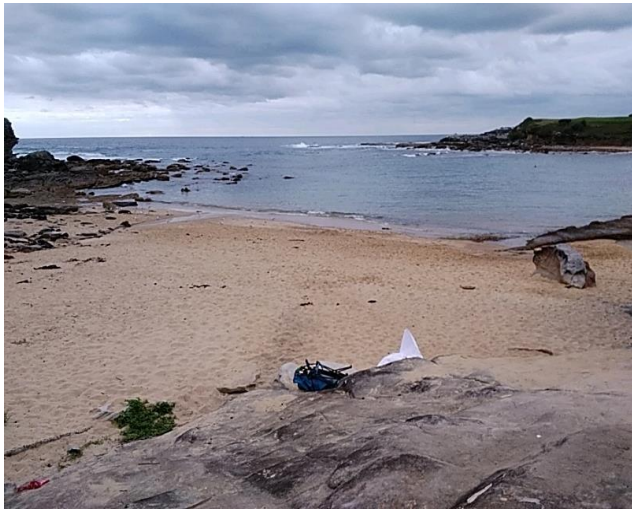
Notes: Overview of the Northern beach

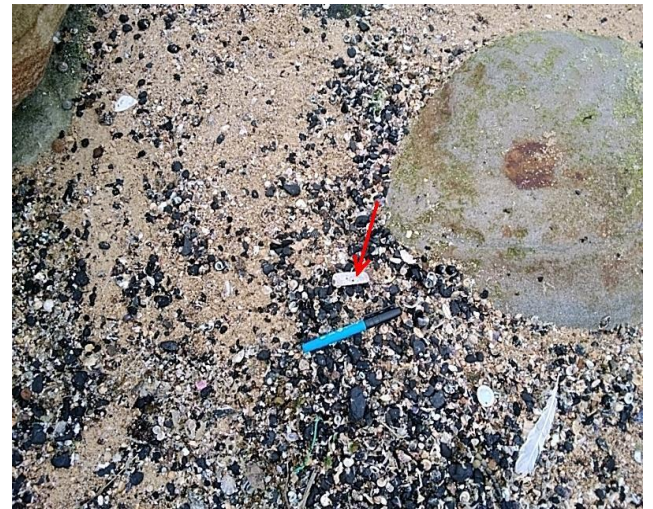
Notes: Overview of removal item within Northern beach prior to removal

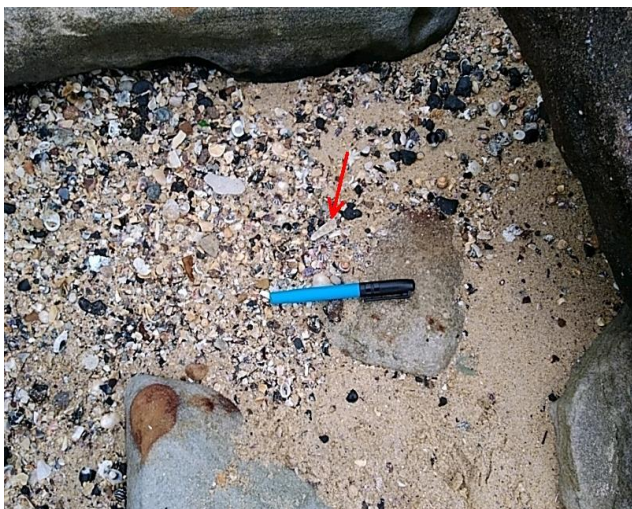
Notes: Overview of removal item within Northern beach prior to removal

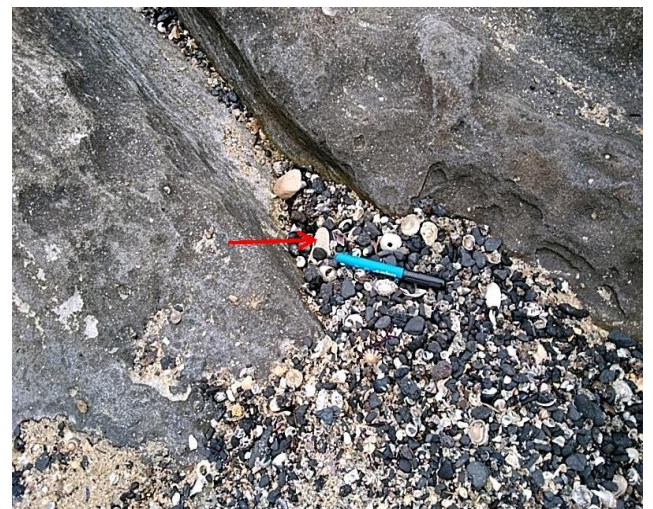
Notes: Overview of removal item within Northern beach prior to removal

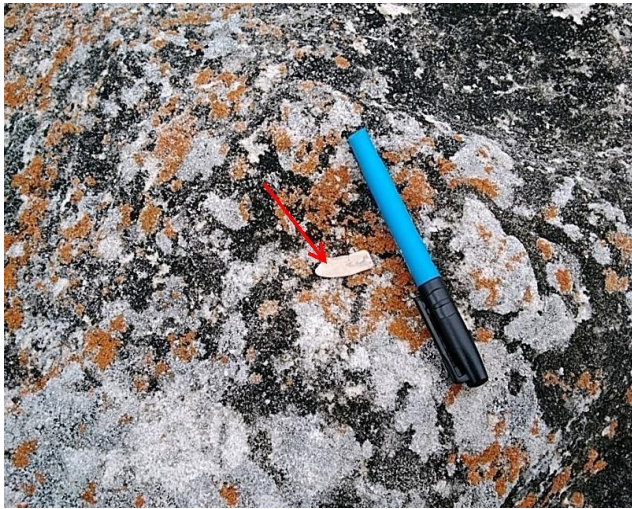
Notes: Overview of removal item within Northern beach prior to removal

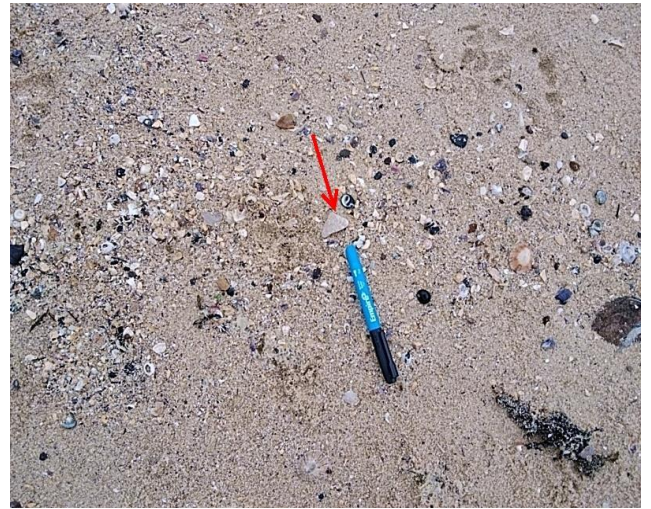
Notes: Overview of removal item within Northern beach prior to removal

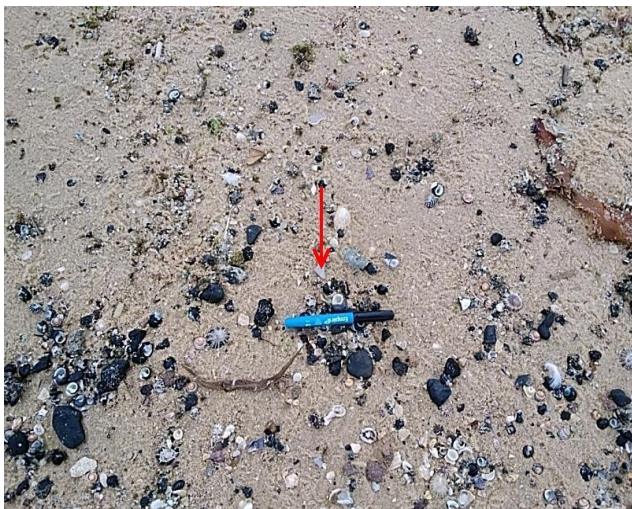
Notes: Overview of removal item within Northern beach prior to removal

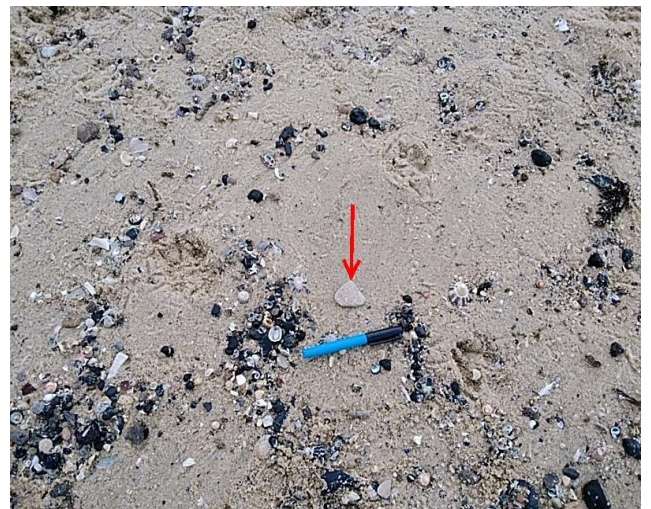
Notes: Overview of removal item within Northern beach prior to removal

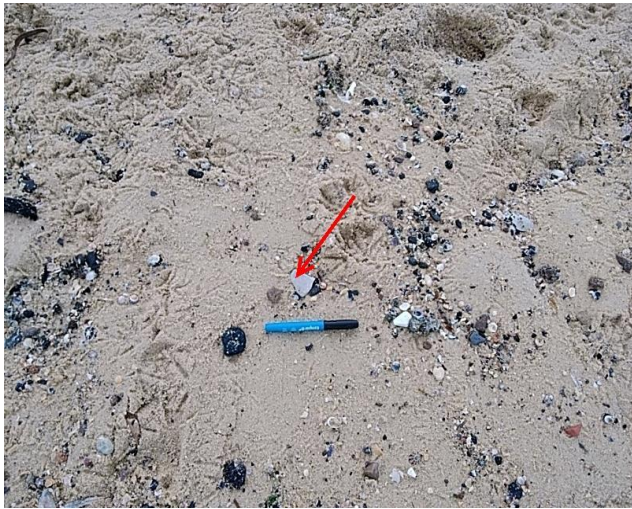
Notes: Overview of removal item within Northern beach prior to removal

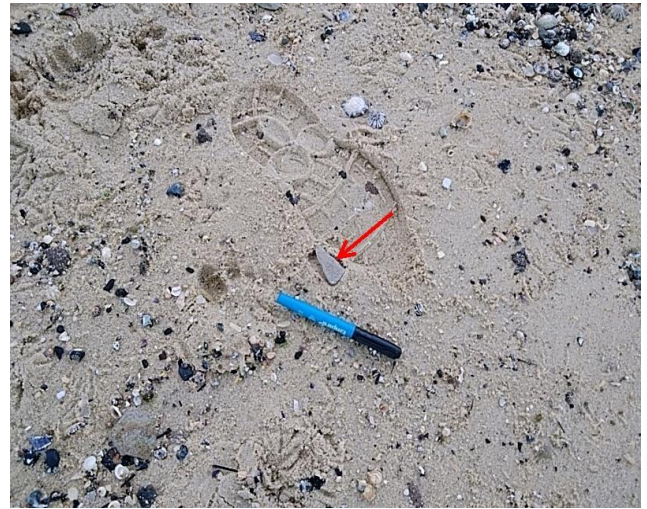
Notes: Overview of removal item within Northern beach prior to removal

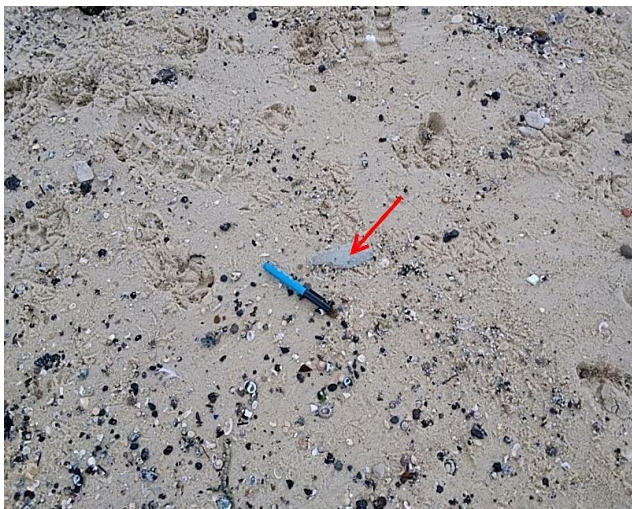
Notes: Overview of removal item within Northern beach prior to removal

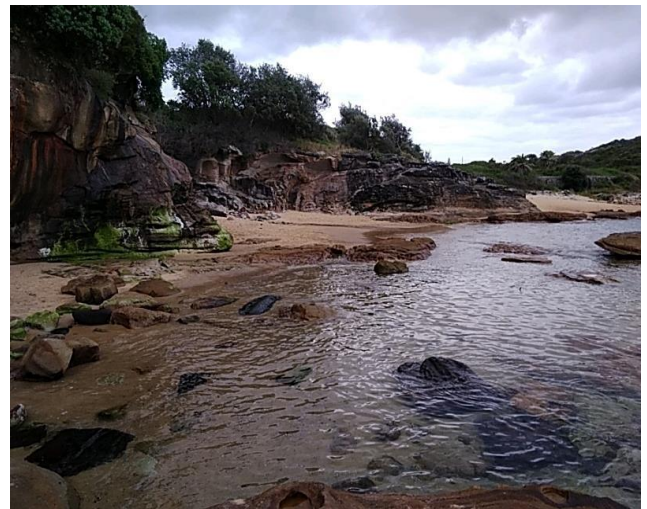
Notes: Overview of the Western beach

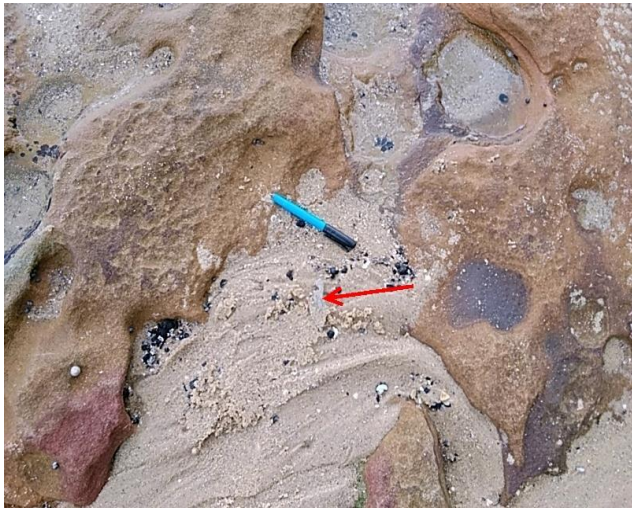
Notes: Overview of removal item within Western beach prior to removal

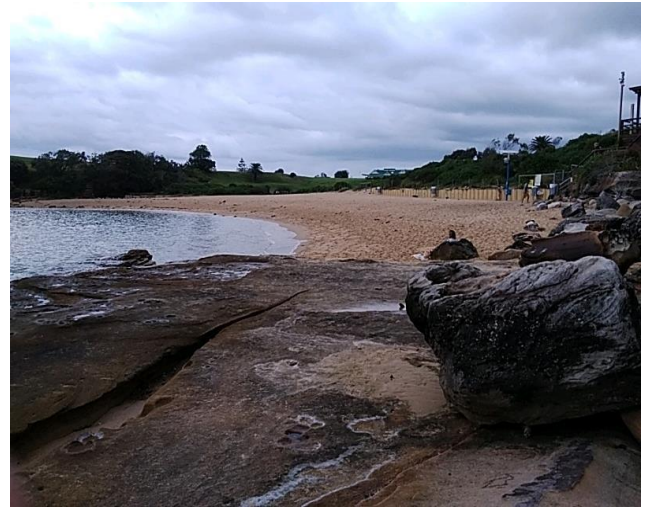
Notes: Overview of the Southern beach

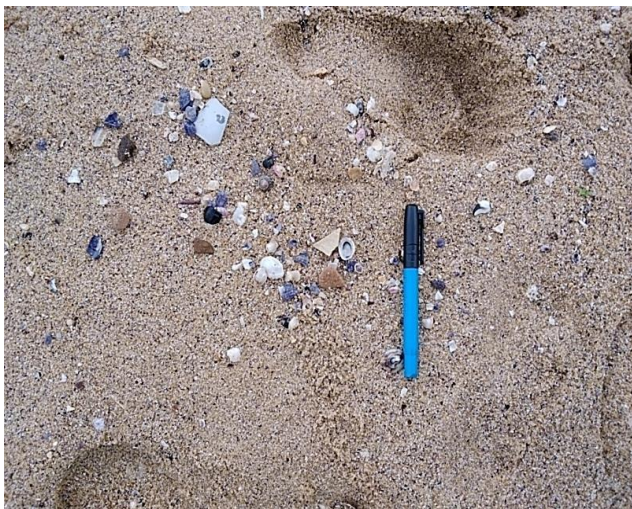
Notes: Overview of removal item within Southern beach prior to removal

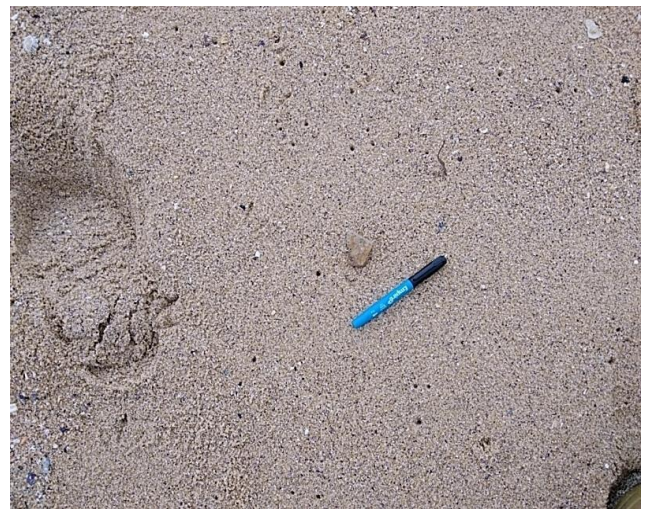
Notes: Overview of removal item within Southern beach prior to removal

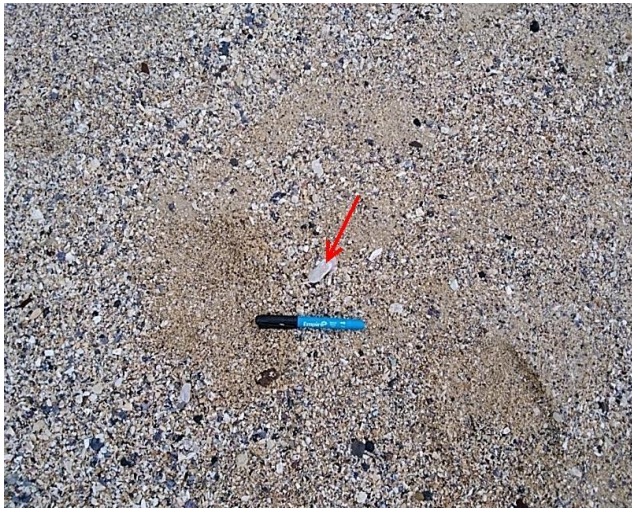
Notes: Overview of removal item within Southern beach prior to removal

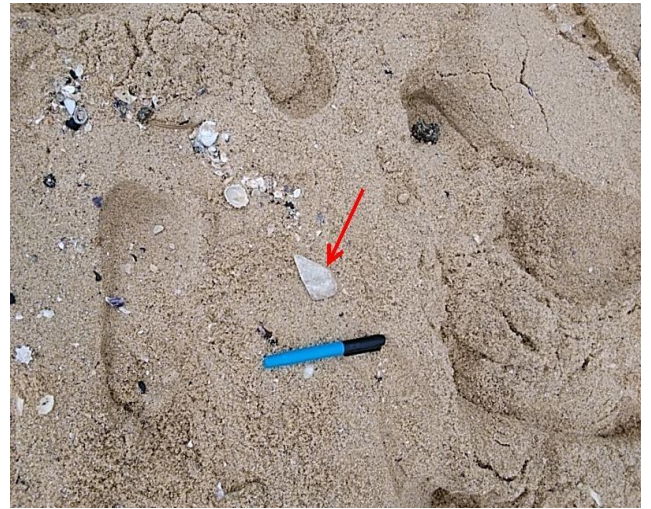
Notes: Overview of removal item within Southern beach prior to removal

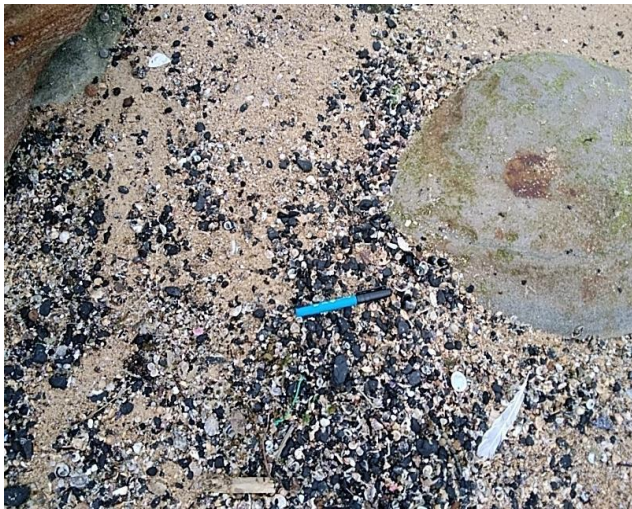
Notes: Visual inspection of removal item following removal

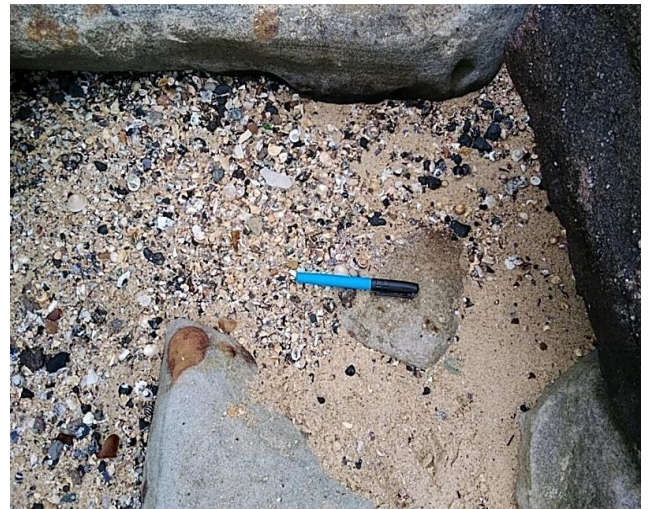
Notes: Visual inspection of removal item following removal

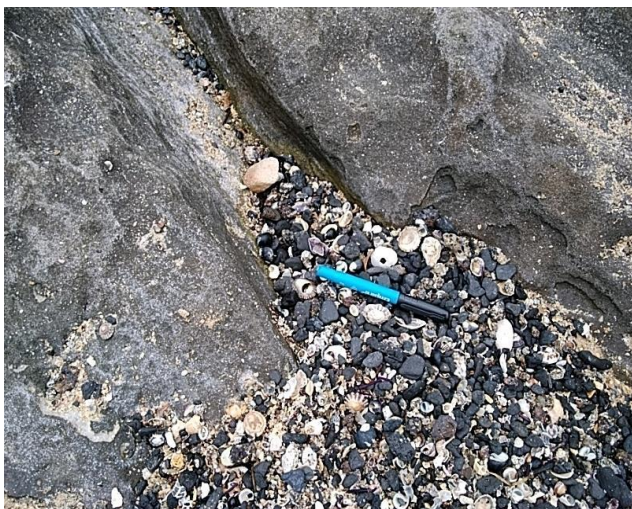
Notes: Visual inspection of removal item following removal

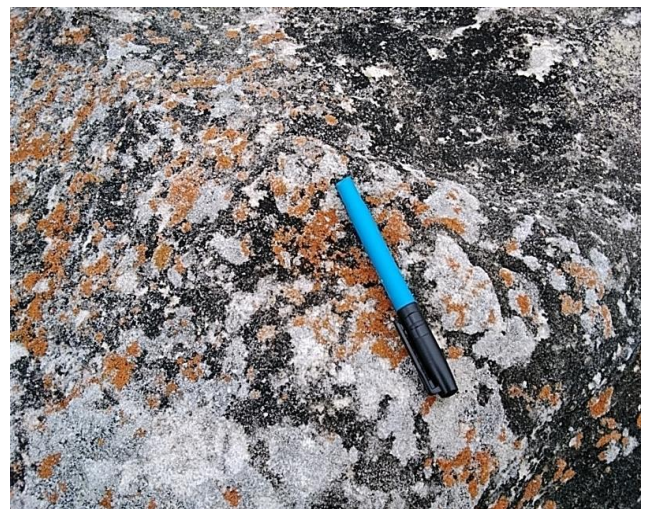
Notes: Visual inspection of removal item following removal

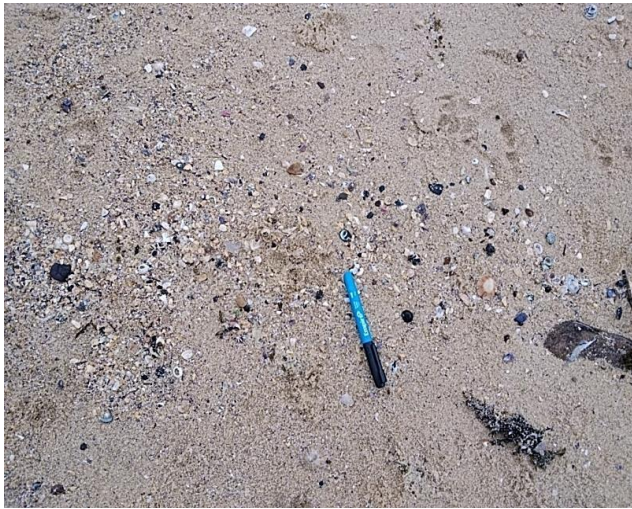
Notes: Visual inspection of removal item following removal

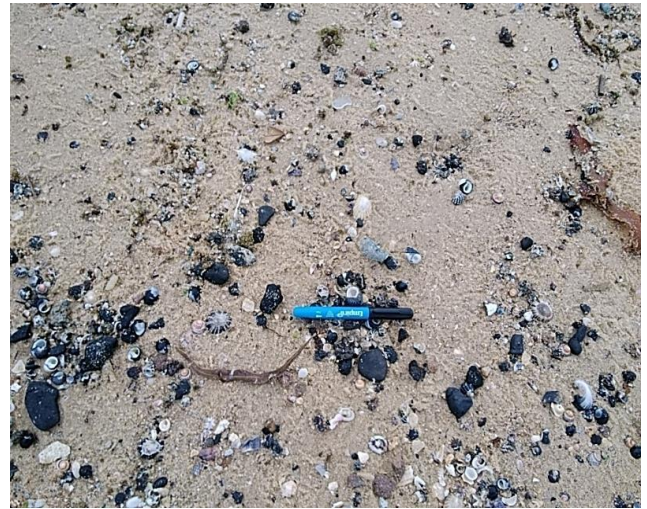
Notes: Visual inspection of removal item following removal

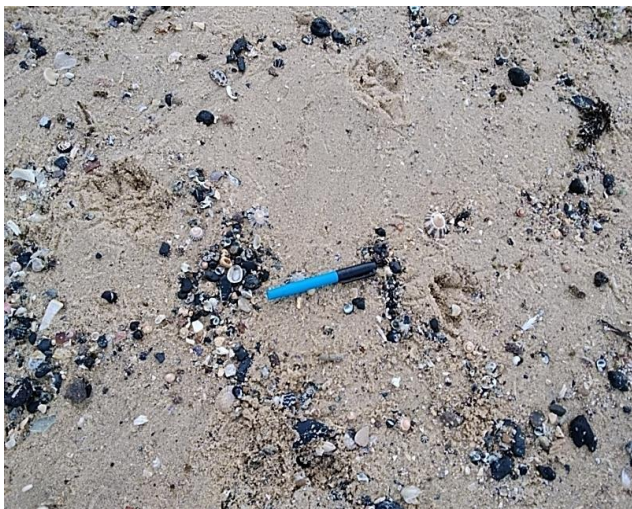
Notes: Visual inspection of removal item following removal

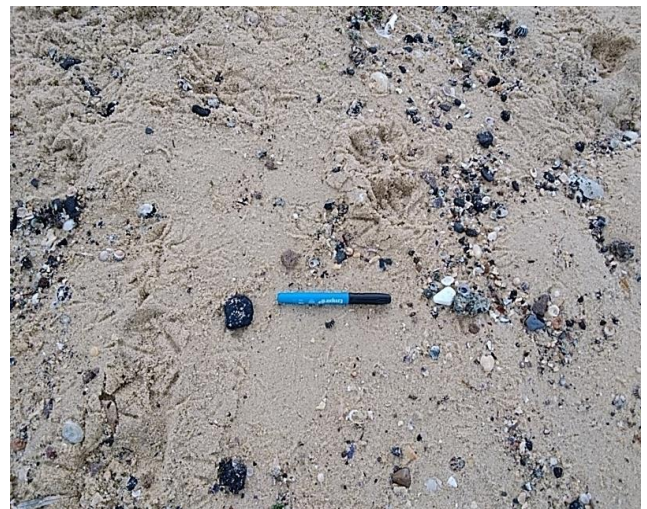
Notes: Visual inspection of removal item following removal

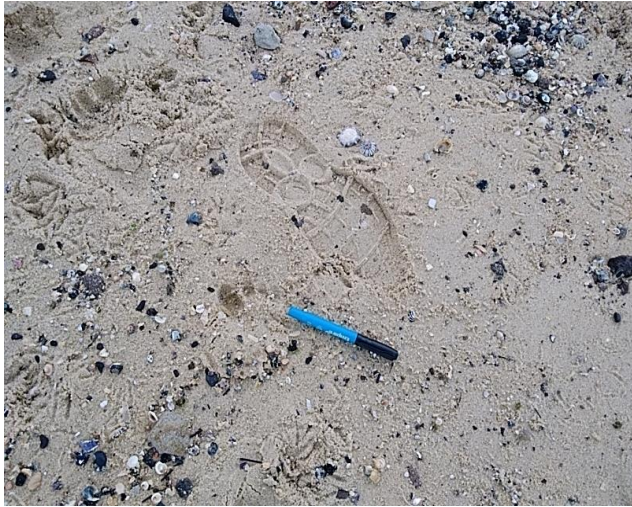
Notes: Visual inspection of removal item following removal

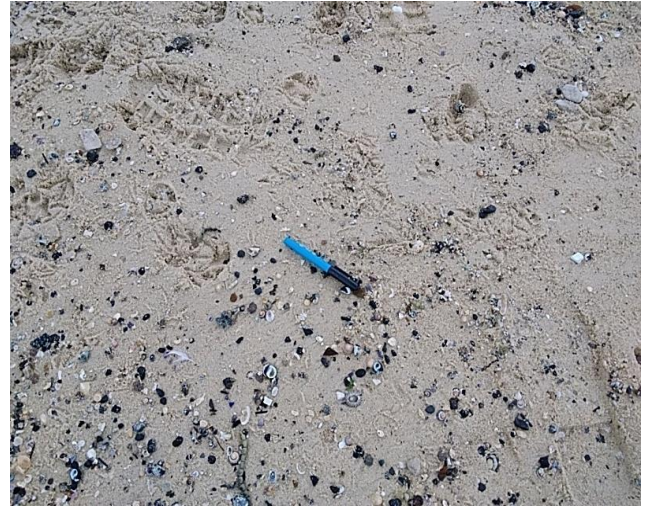
Notes: Visual inspection of removal item following removal

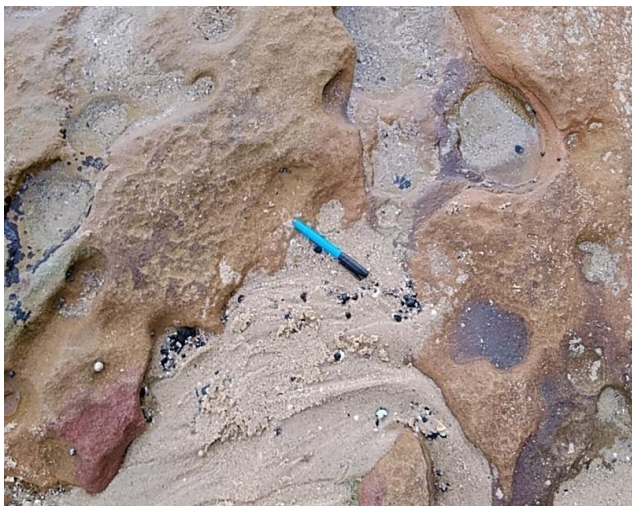
Notes: Visual inspection of removal item following removal

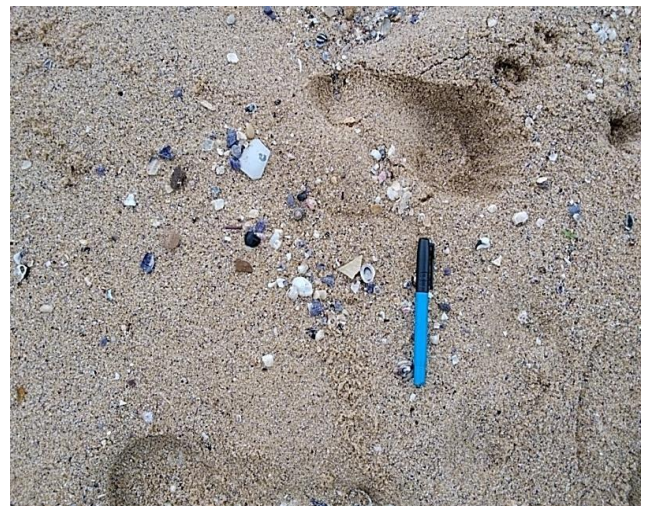
Notes: Visual inspection of removal item following removal

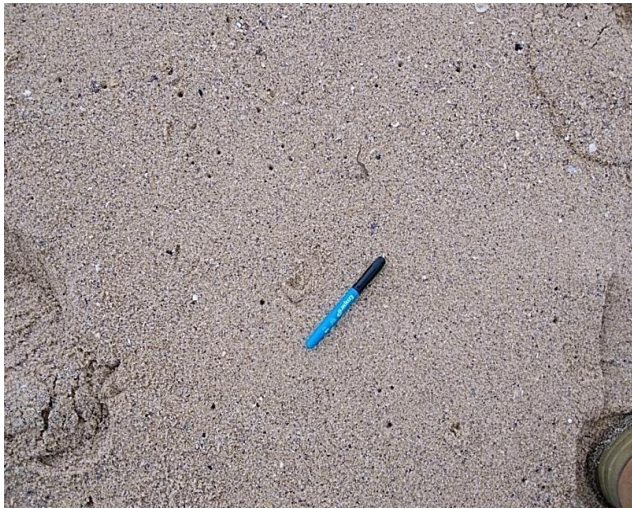
Notes: Visual inspection of removal item following removal

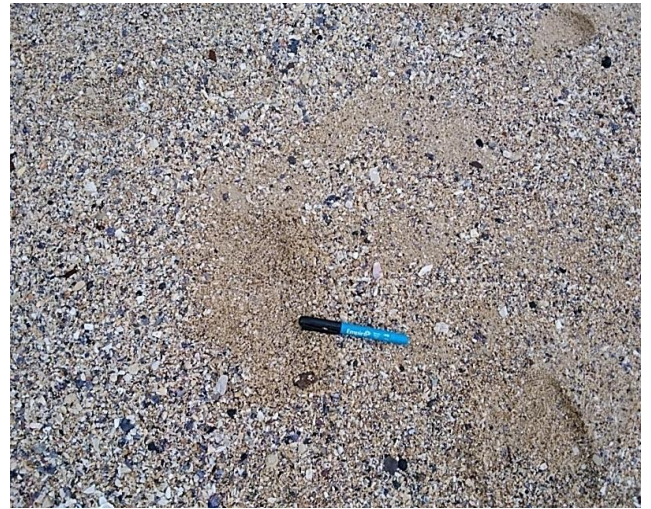
Notes: Visual inspection of removal item following removal

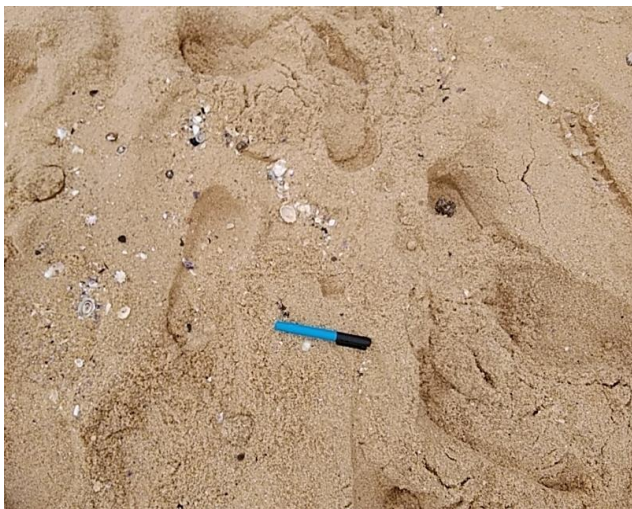
Notes: Visual inspection of removal item following removal

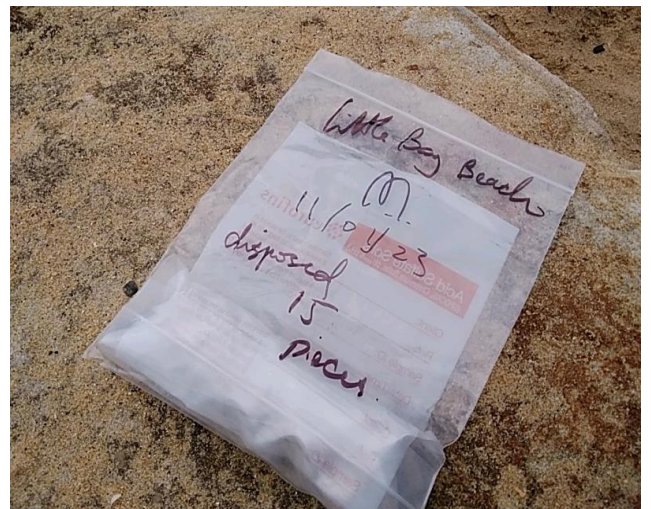
Notes: Waste disposal management (disposed of 15 pieces)
