# Asbestos Containing Material Clearance Inspection

## RE: Asbestos Containing Material Clearance Inspection

<b>Site:</b>	Little Bay Beach
<b>Location:</b>	Southern, Western and Northern Little Bay Beach

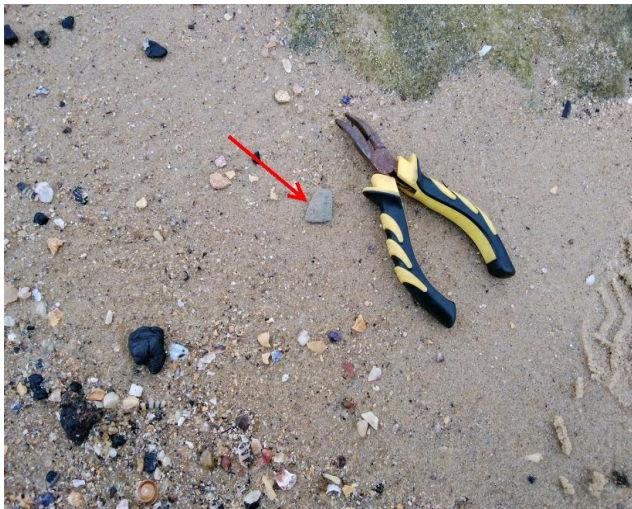
**Notes:** FC fragment identified on sand surface prior to emu pick - Northern section

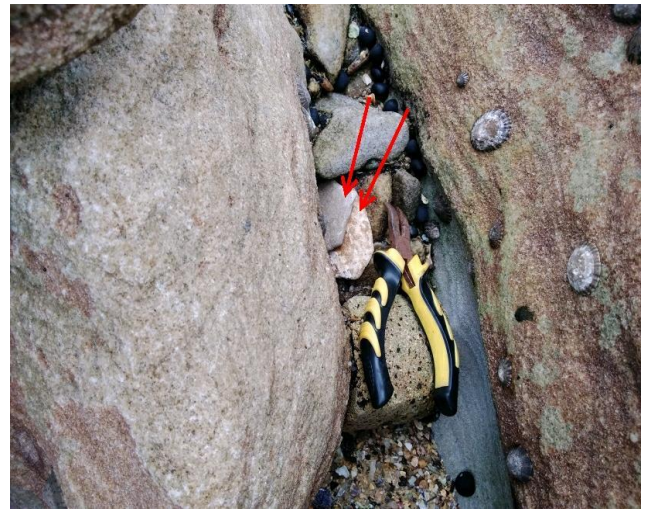
**Notes:** FC fragment identified on sand surface prior to emu pick - Northern section

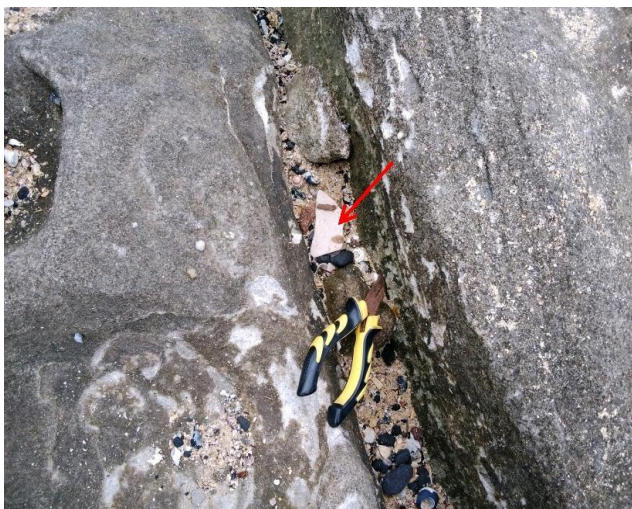
**Notes:** FC fragment identified on sand surface prior to emu pick - Northern section

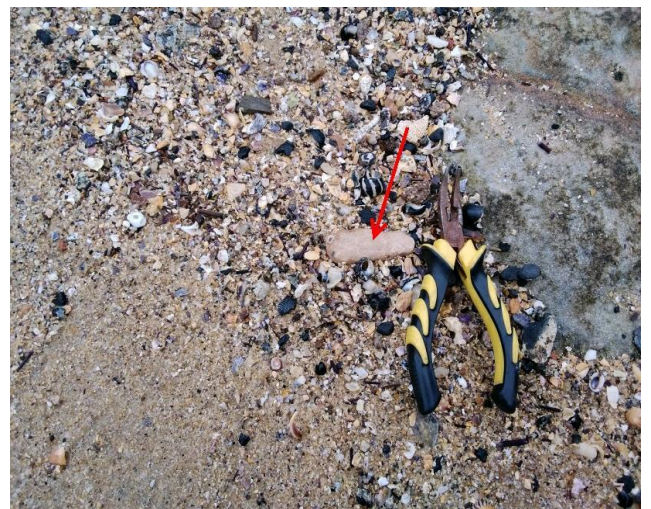
**Notes:** FC fragment identified on sand surface prior to emu pick - Northern section

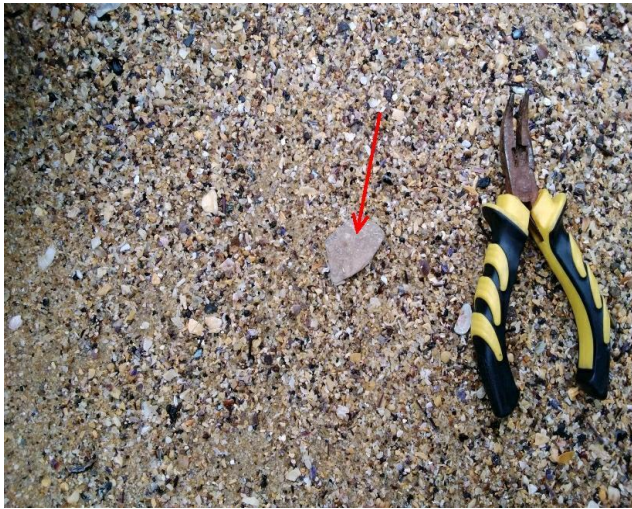
**Notes:** FC fragment identified on sand surface prior to emu pick - Northern section

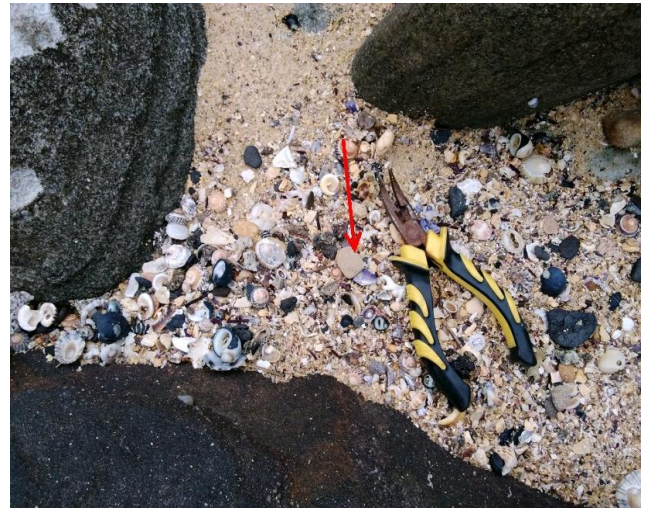
**Notes:** FC fragment identified on sand surface prior to emu pick - Northern section

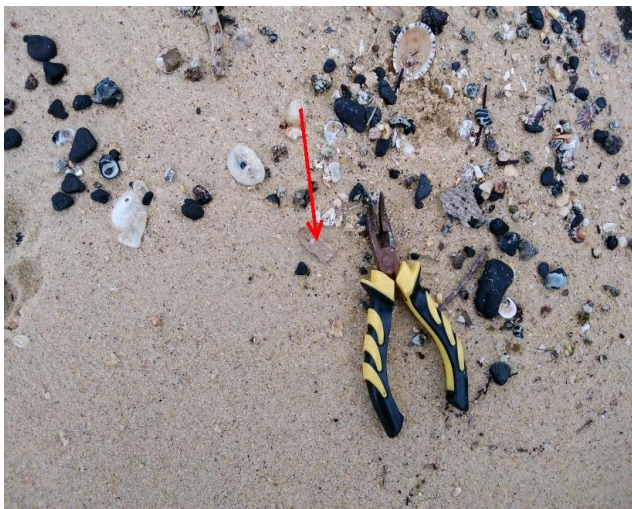
**Notes:** FC fragment identified on sand surface prior to emu pick - Northern section

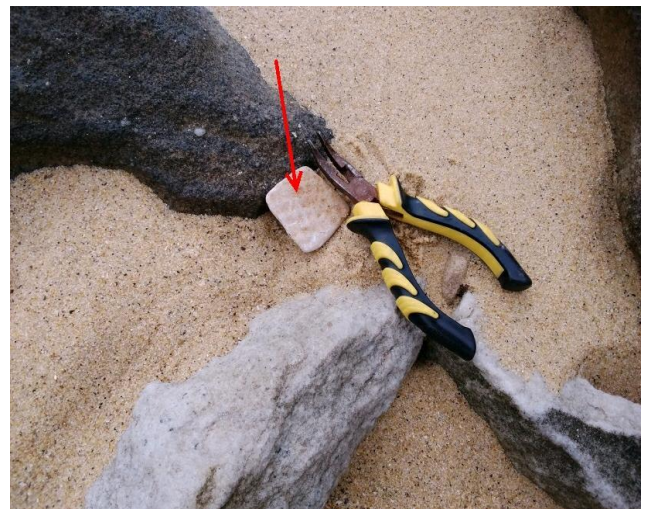
**Notes:** FC fragment identified on sand surface prior to emu pick - Northern section

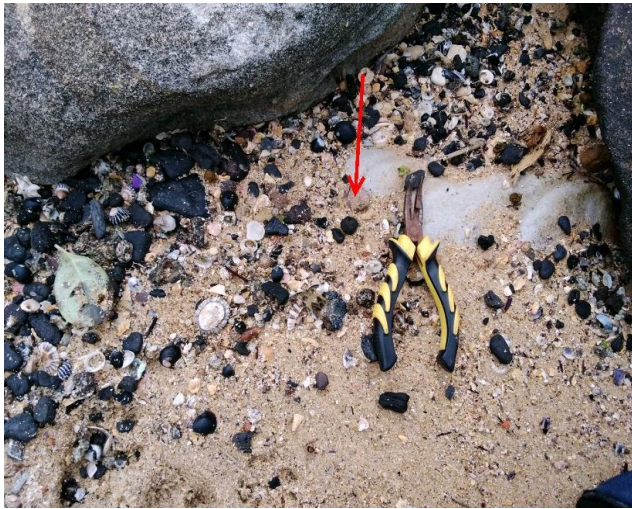
**Notes:** FC fragment identified on sand surface prior to emu pick - Northern section

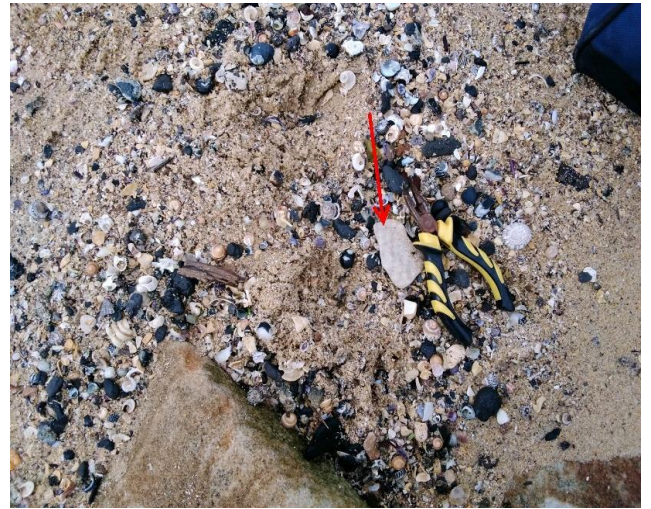
**Notes:** FC fragment identified on sand surface prior to emu pick - Northern section

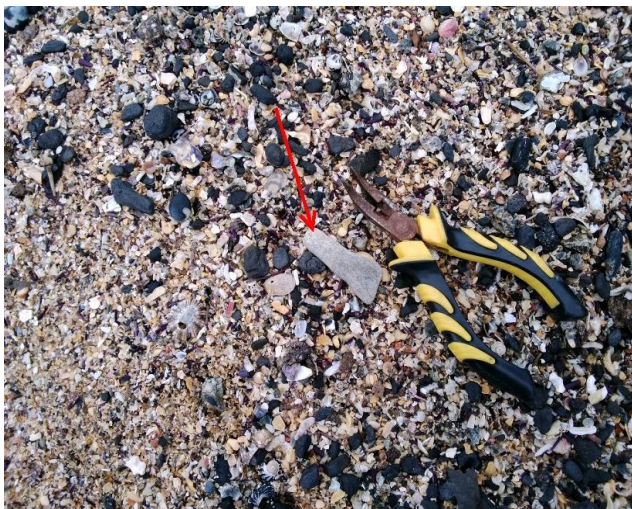
**Notes:** FC fragment identified on sand surface prior to emu pick - Northern section

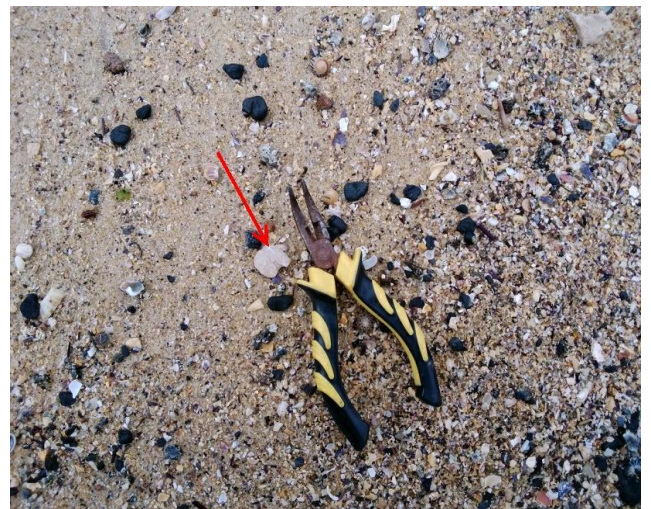
**Notes:** FC fragment identified on sand surface prior to emu pick - Northern section

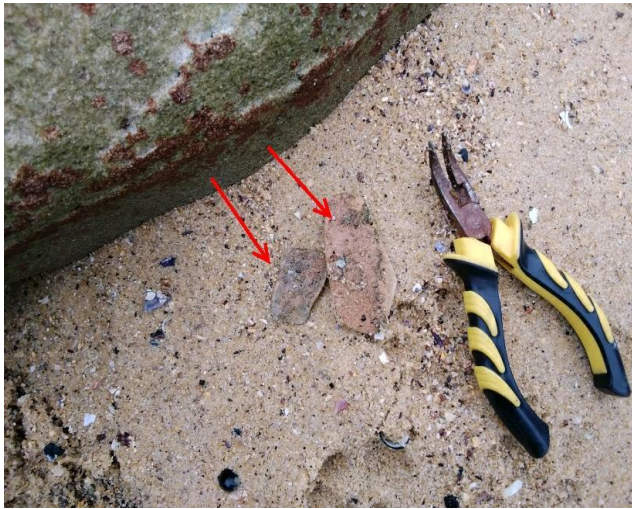
**Notes:** FC fragment identified on sand surface prior to emu pick - Northern section

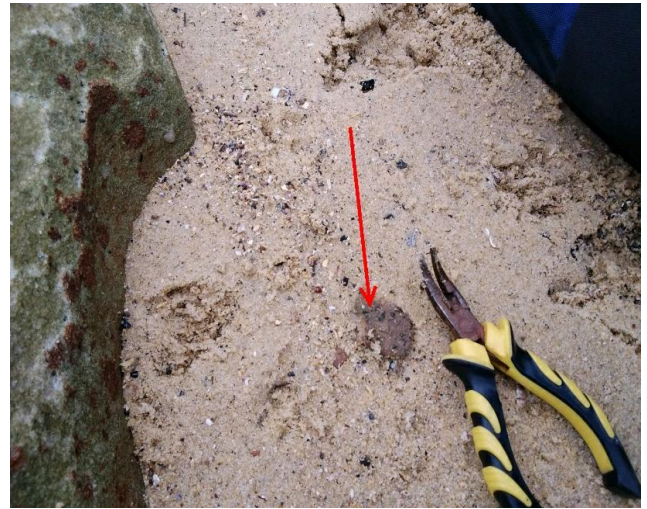
**Notes:** FC fragment identified on sand surface prior to emu pick - Northern section

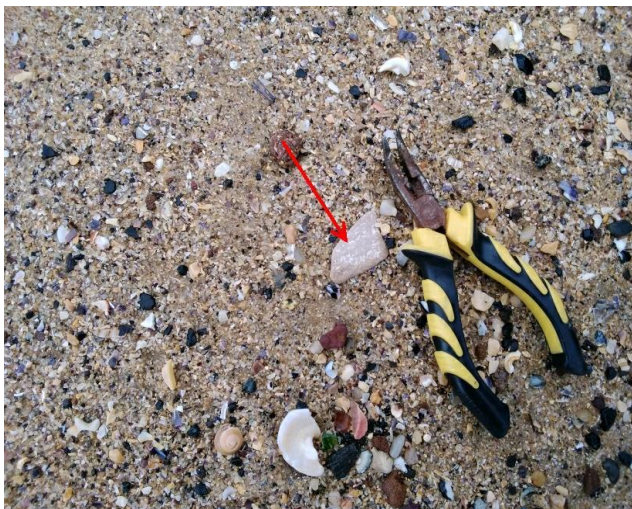
**Notes:** FC fragment identified on sand surface prior to emu pick - Northern section

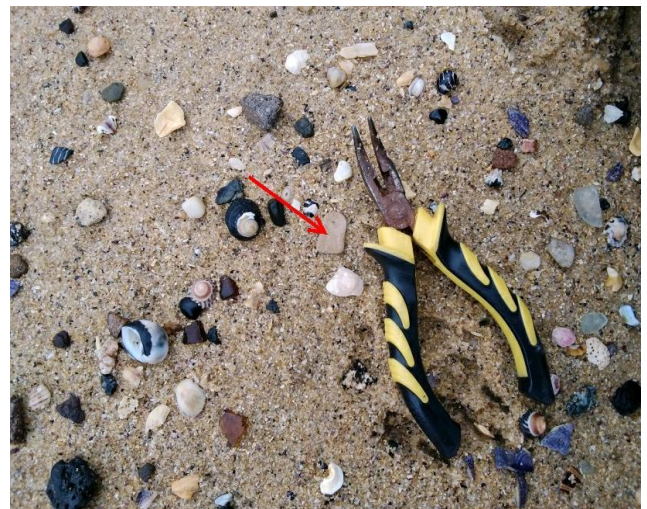
**Notes:** FC fragment identified on sand surface prior to emu pick - Northern section

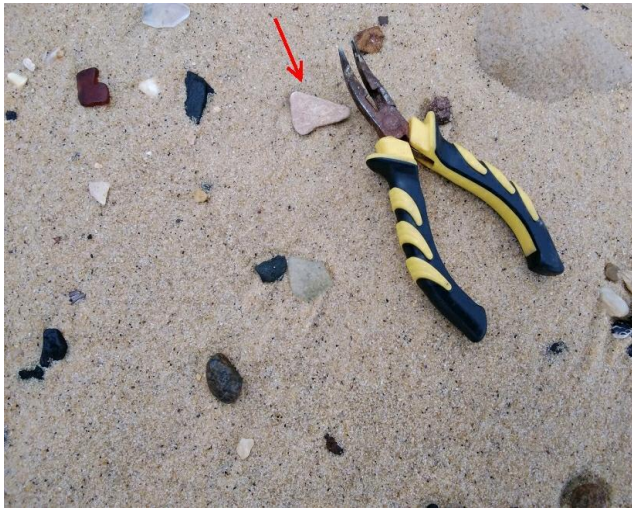
**Notes:** FC fragment identified on sand surface prior to emu pick - Northern section

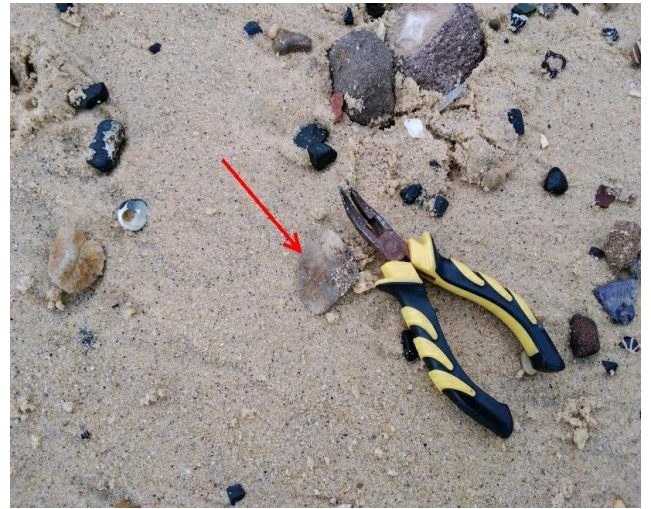
**Notes:** FC fragment identified on sand surface prior to emu pick - Northern section

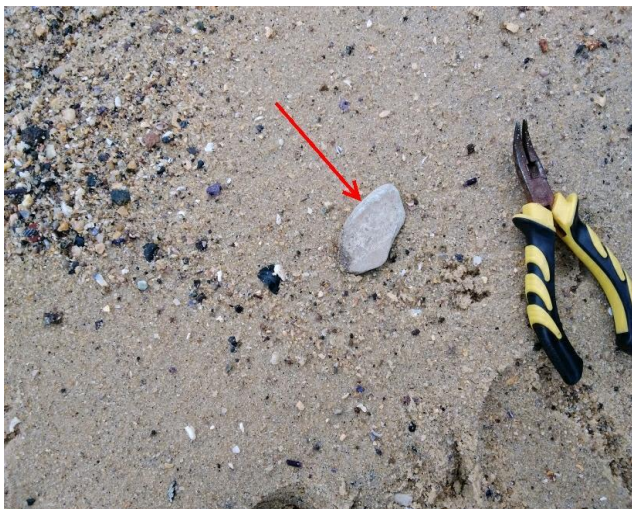
**Notes:** FC fragment identified on sand surface prior to emu pick - Western section

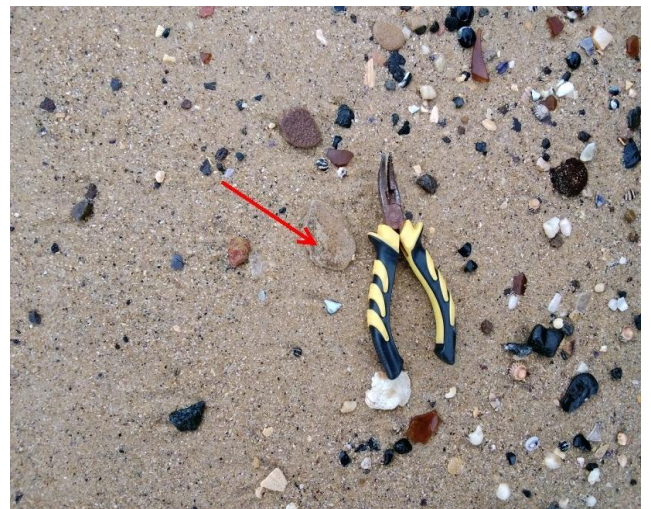
**Notes:** FC fragment identified on sand surface prior to emu pick - Western section

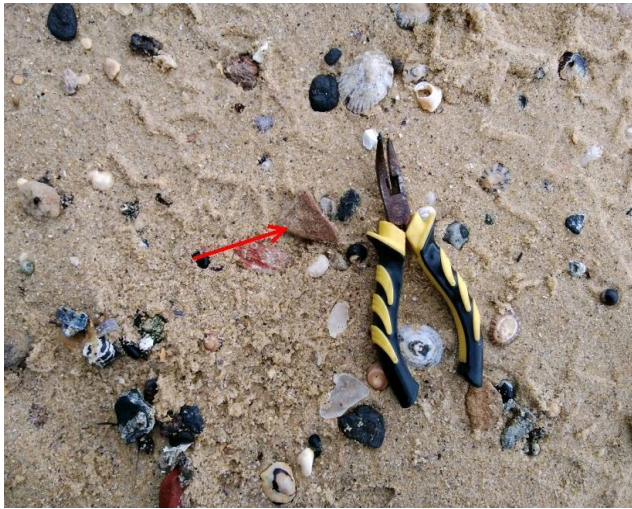
**Notes:** FC fragment identified on sand surface prior to emu pick - Western section

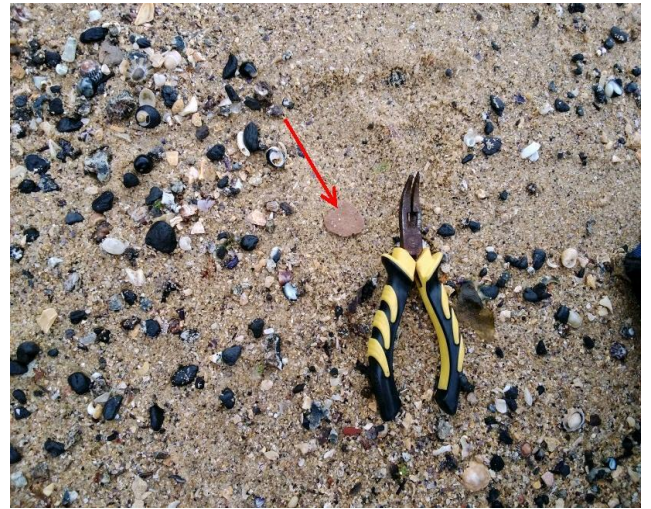
**Notes:** FC fragment identified on sand surface prior to emu pick - Western section

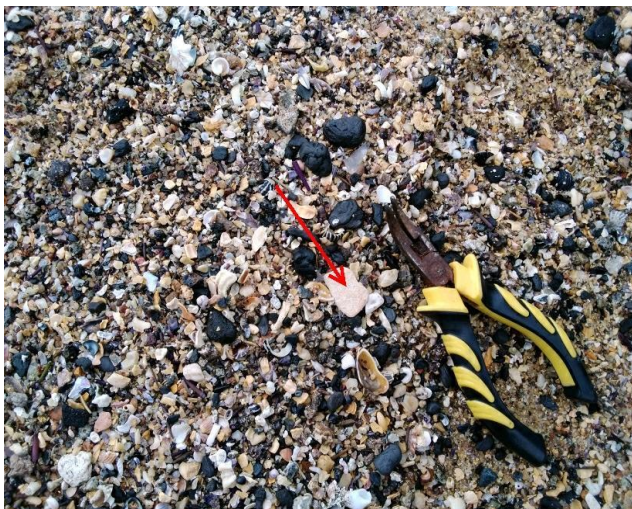
**Notes:** FC fragment identified on sand surface prior to emu pick - Western section

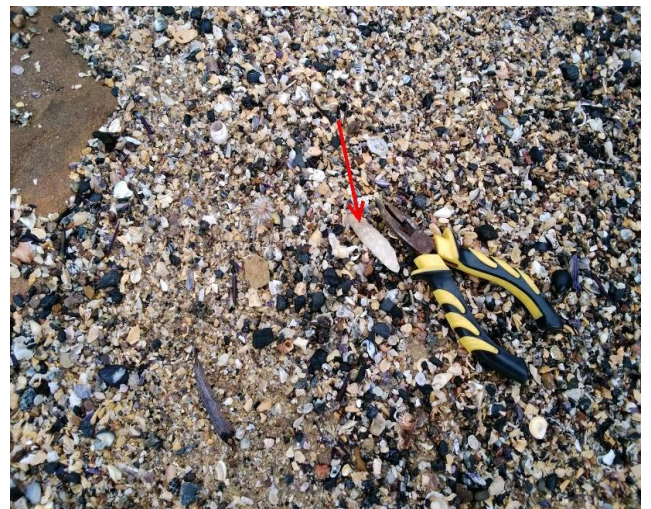
**Notes:** FC fragment identified on sand surface prior to emu pick - Western section

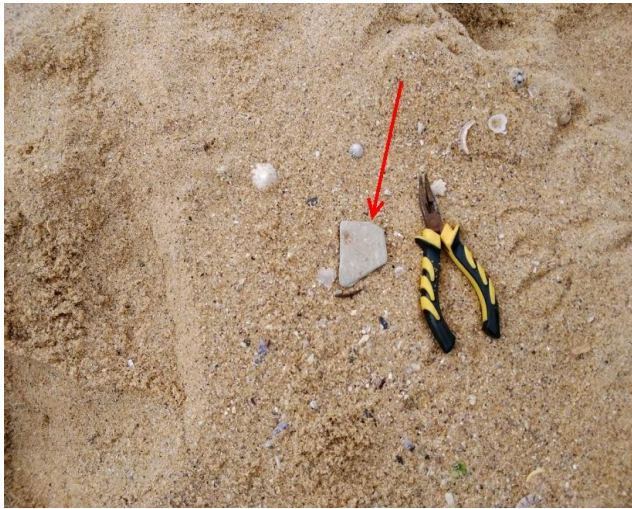
**Notes:** FC fragment identified on sand surface prior to emu pick - Southern section

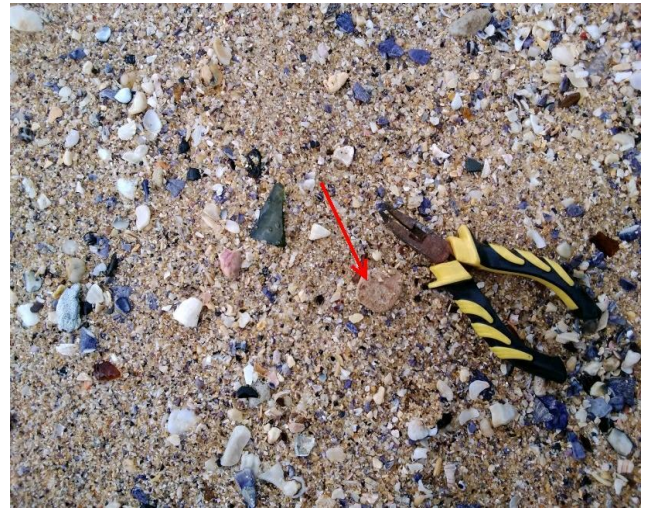
**Notes:** FC fragment identified on sand surface prior to emu pick - Southern section

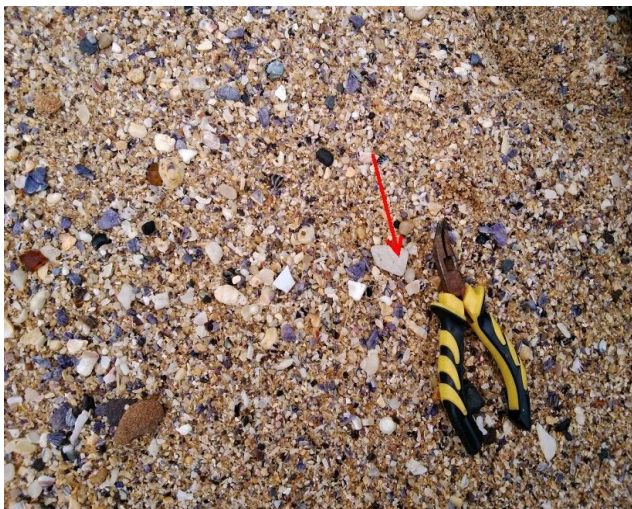
**Notes:** FC fragment identified on sand surface prior to emu pick - Southern section

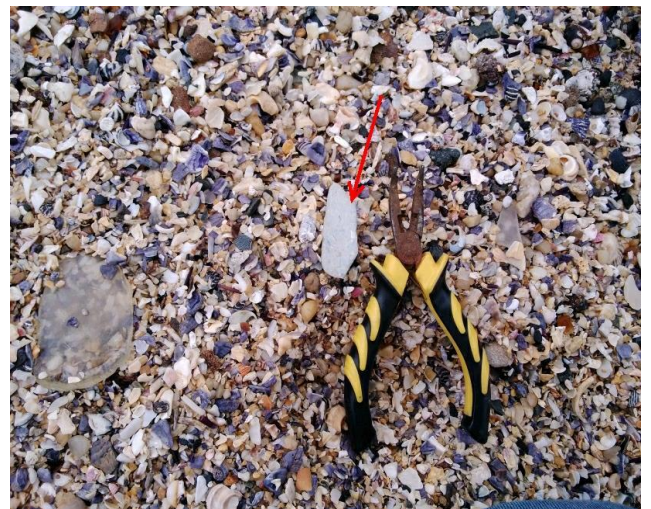
**Notes:** FC fragment identified on sand surface prior to emu pick - Southern section

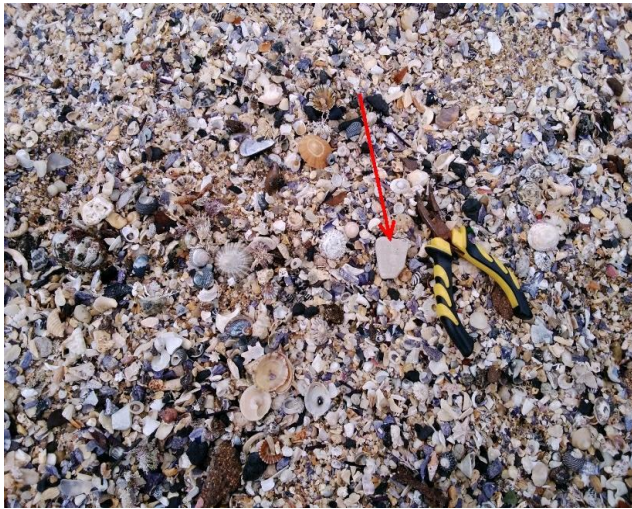
**Notes:** FC fragment identified on sand surface prior to emu pick - Southern section

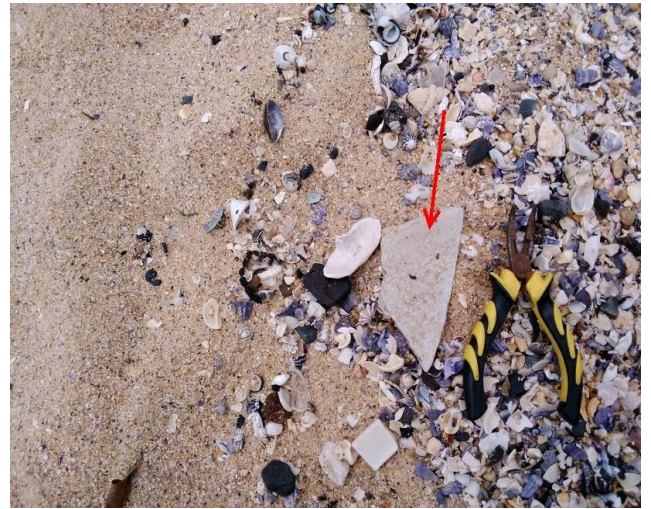
**Notes:** FC fragment identified on sand surface prior to emu pick - Southern section

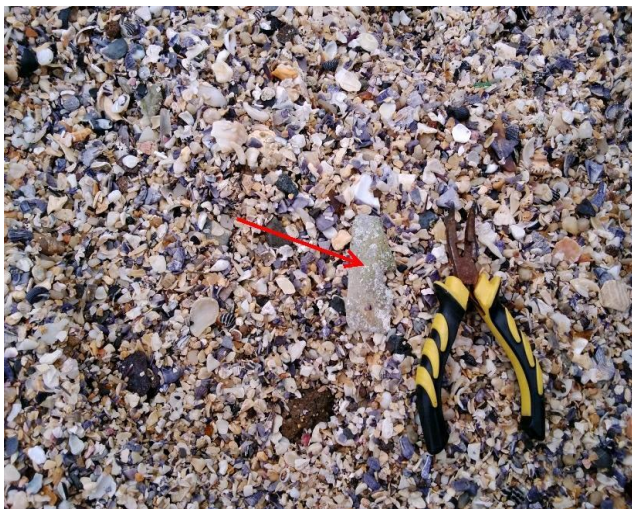
**Notes:** FC fragment identified on sand surface prior to emu pick - Southern section

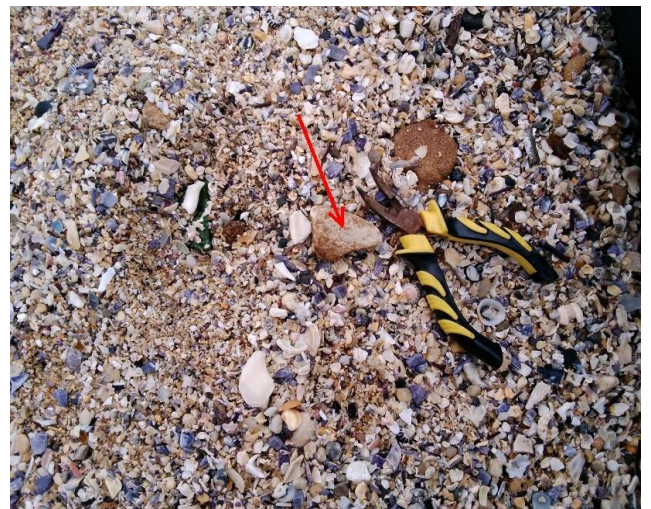
**Notes:** FC fragment identified on sand surface prior to emu pick - Southern section

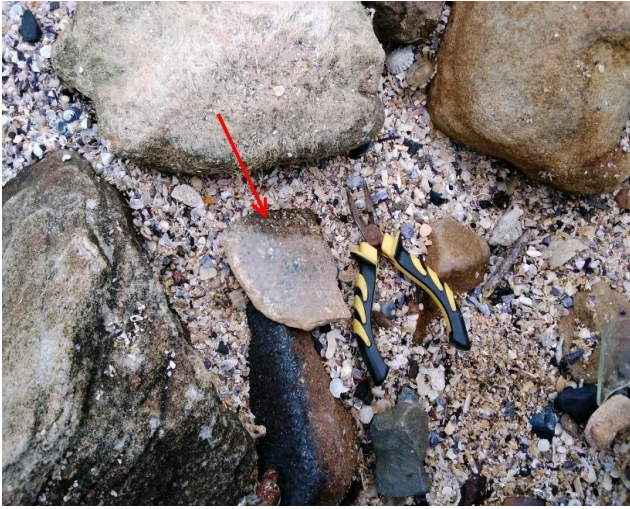
**Notes:** FC fragment identified on sand surface prior to emu pick - Southern section

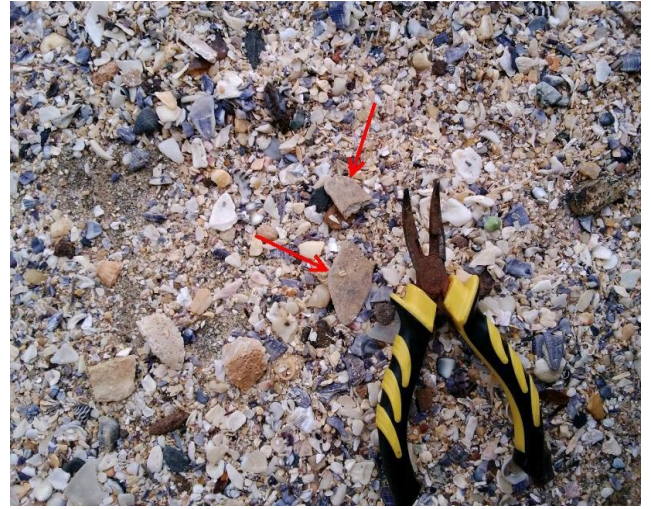
**Notes:** FC fragment identified on sand surface prior to emu pick - Southern section

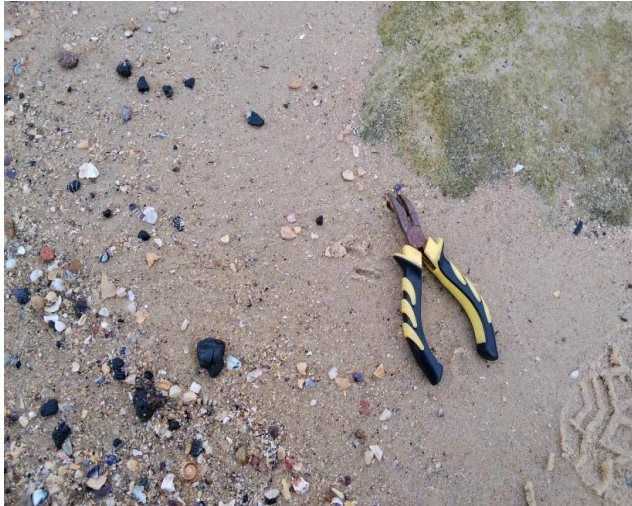
**Notes:** Sand surface following emu pick - Northern section

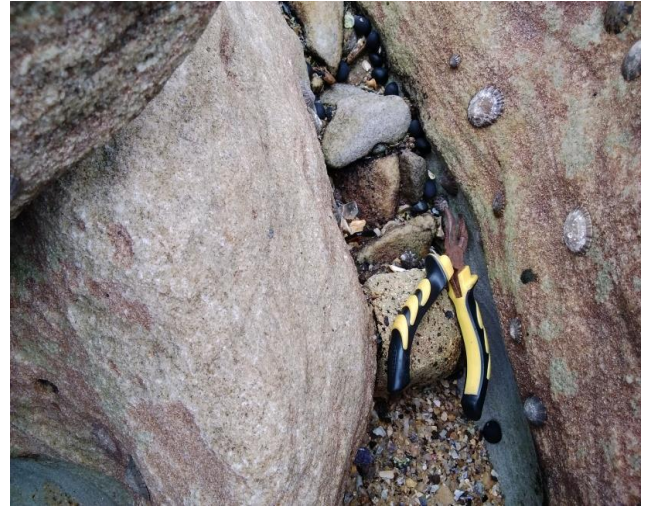
**Notes:** Sand surface following emu pick - Northern section

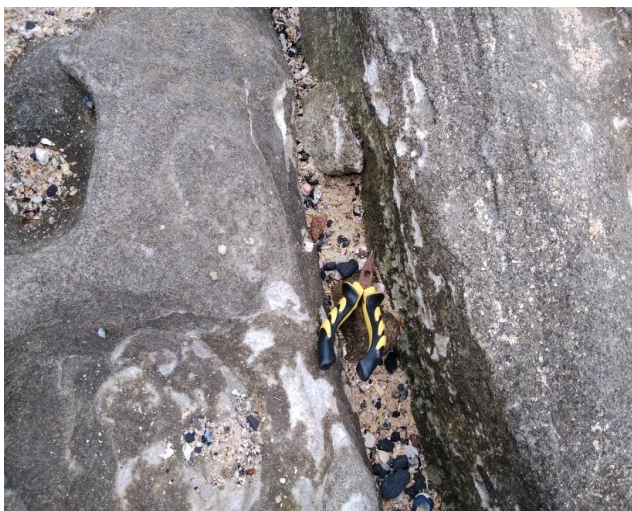
**Notes:** Sand surface following emu pick - Northern section

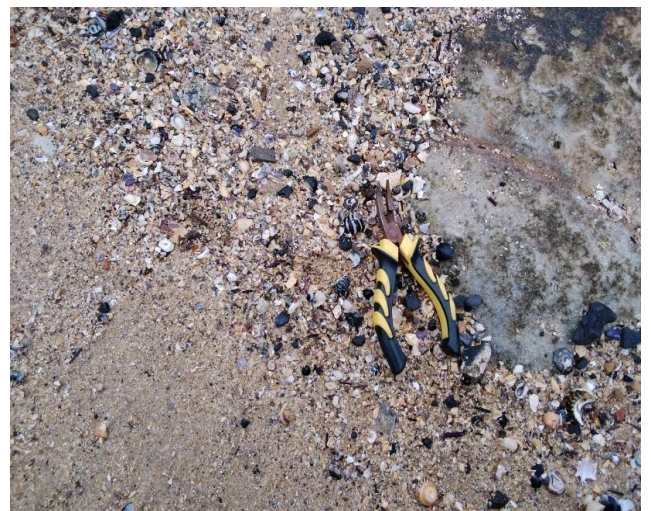
**Notes:** Sand surface following emu pick - Northern section

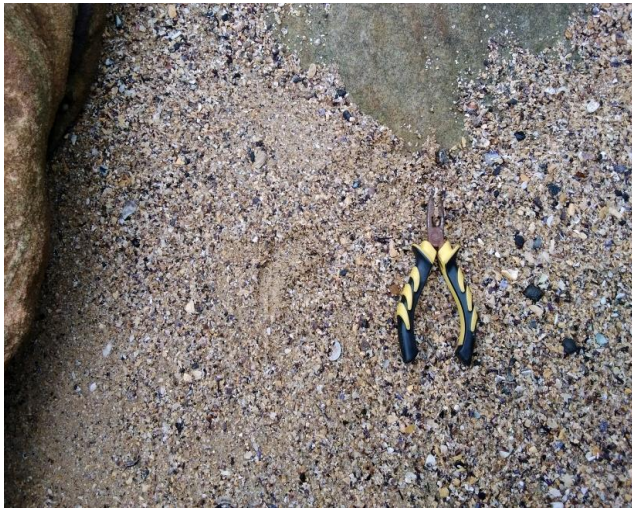
**Notes:** Sand surface following emu pick - Northern section

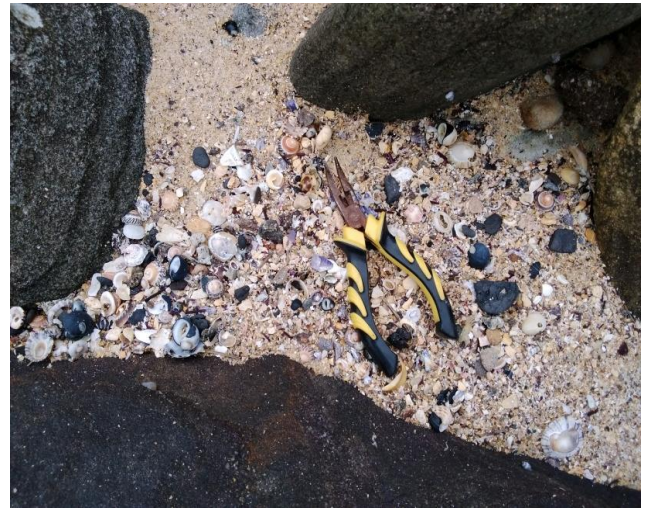
**Notes:** Sand surface following emu pick - Northern section

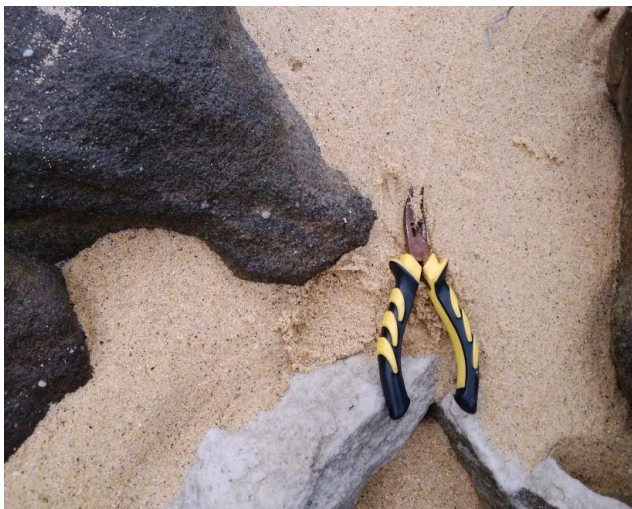
**Notes:** Sand surface following emu pick - Northern section

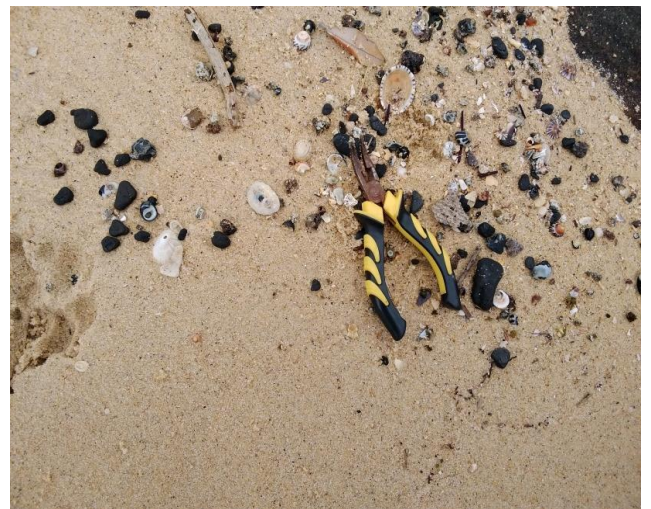
**Notes:** Sand surface following emu pick - Northern section

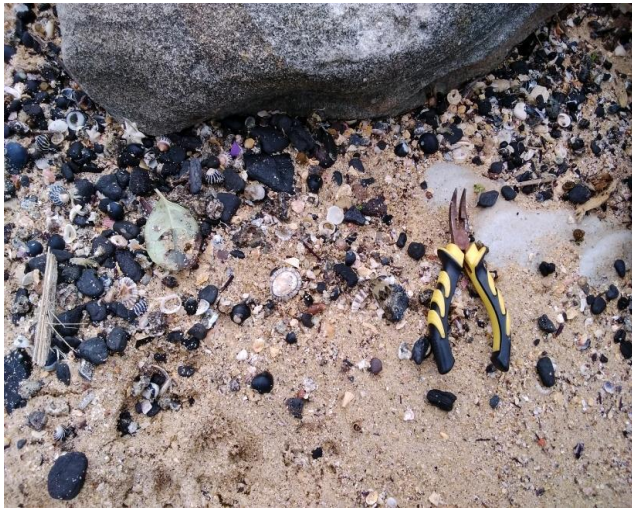
**Notes:** Sand surface following emu pick - Northern section

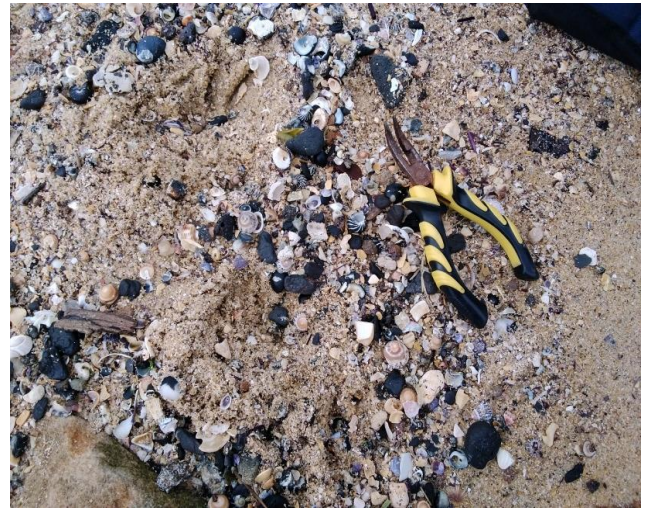
**Notes:** Sand surface following emu pick - Northern section

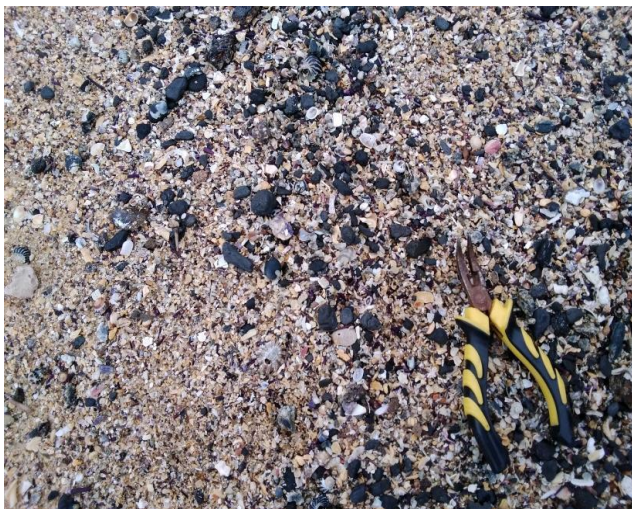
**Notes:** Sand surface following emu pick - Northern section

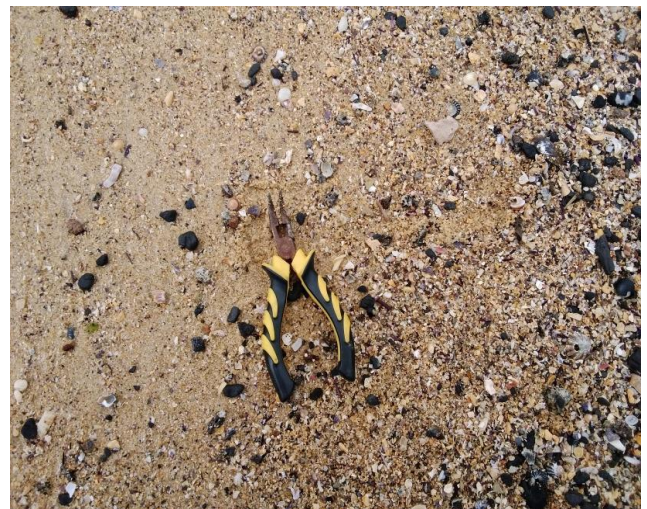
**Notes:** Sand surface following emu pick - Northern section

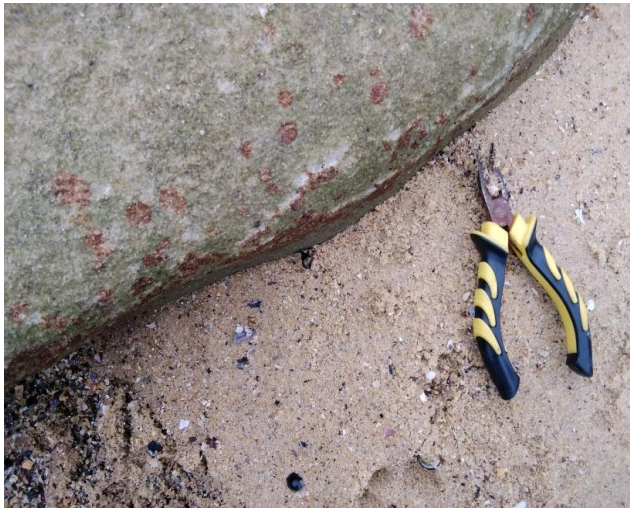
**Notes:** Sand surface following emu pick - Northern section

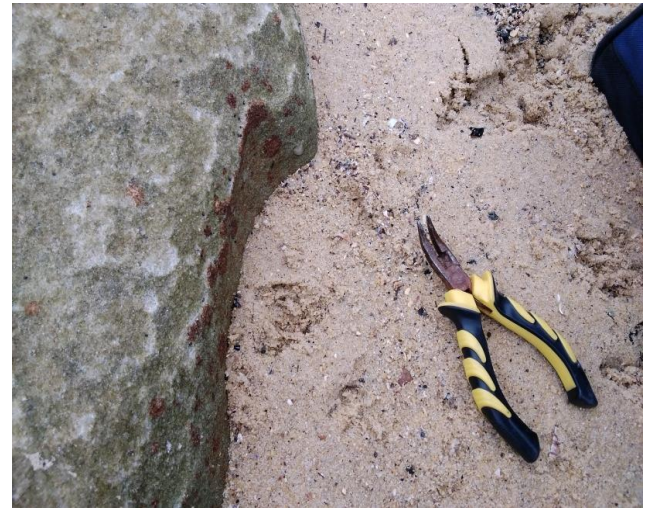
**Notes:** Sand surface following emu pick - Northern section

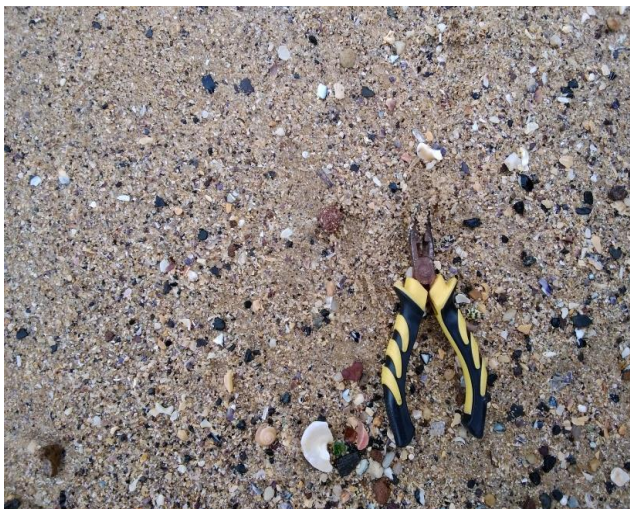
**Notes:** Sand surface following emu pick - Northern section

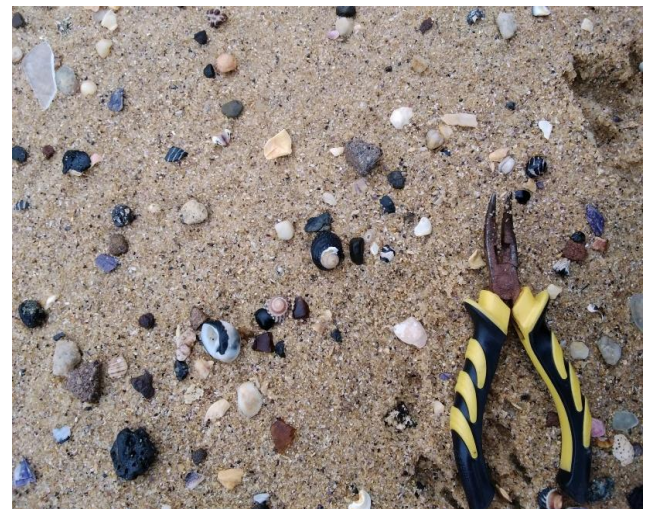
**Notes:** Sand surface following emu pick - Northern section

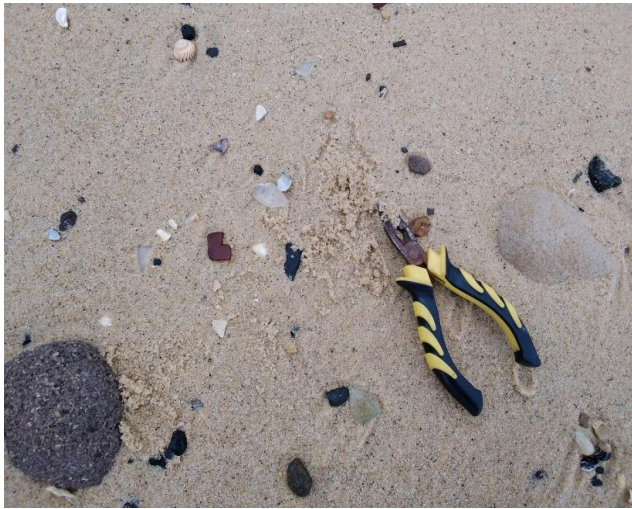
**Notes:** Sand surface following emu pick - Northern section

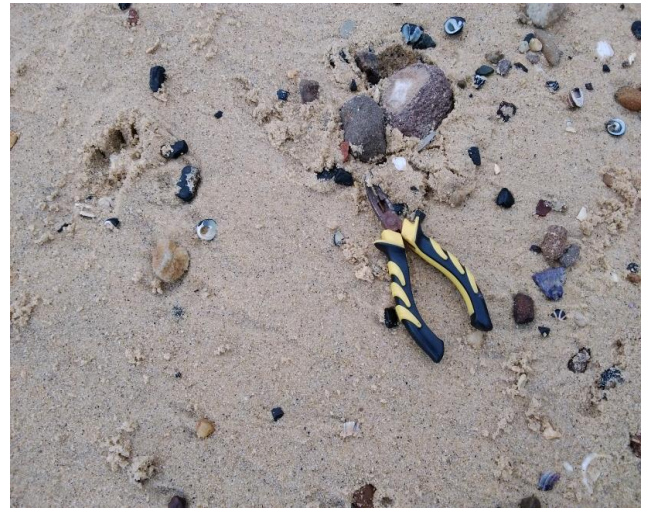
**Notes:** Sand surface following emu pick - Northern section

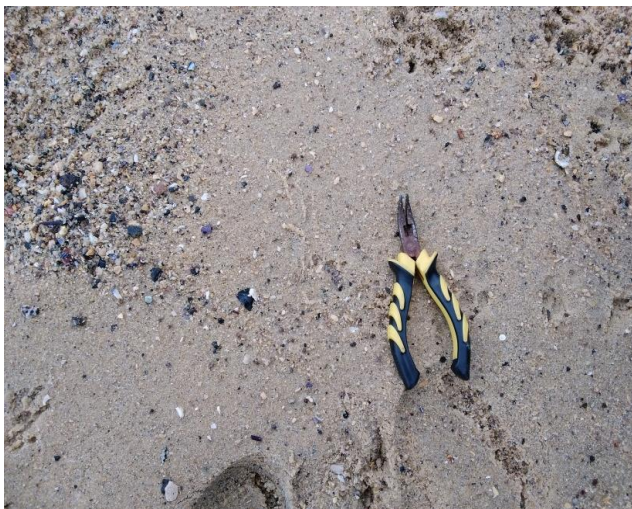
**Notes:** Sand surface following emu pick - Western section

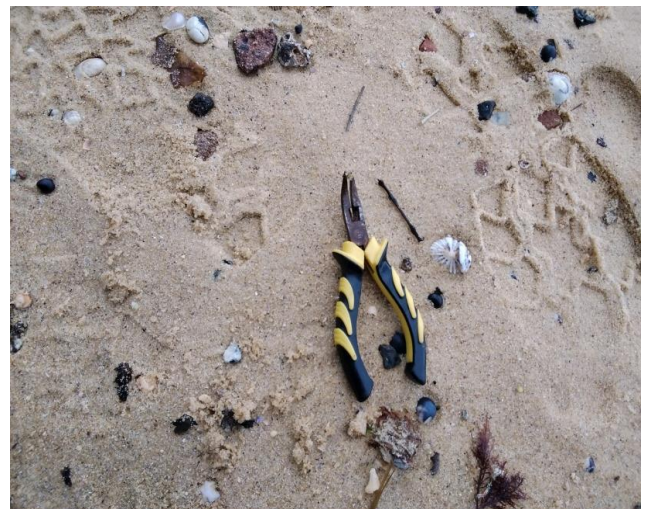
**Notes:** Sand surface following emu pick - Western section

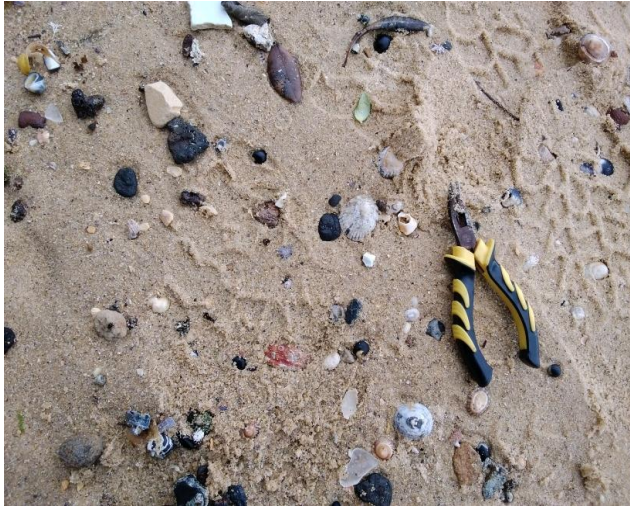
**Notes:** Sand surface following emu pick - Western section

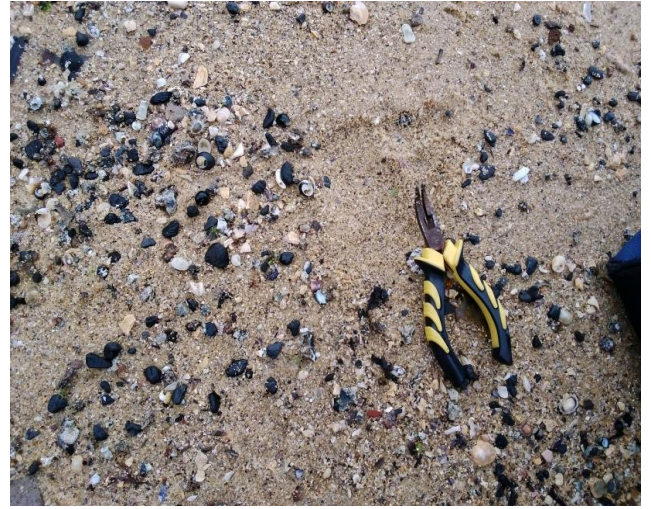
**Notes:** Sand surface following emu pick - Western section

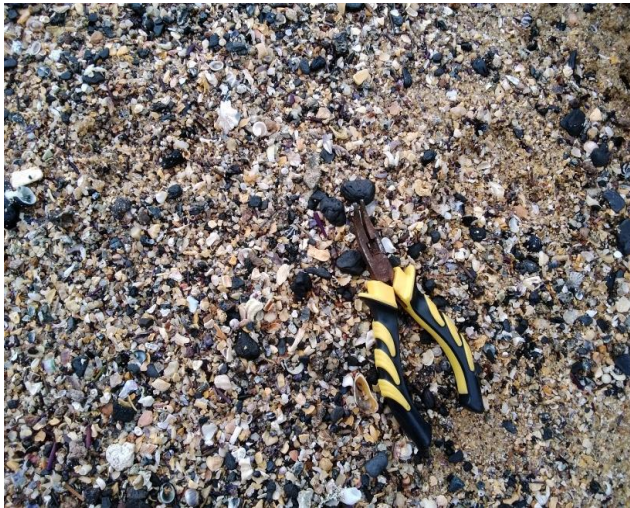
**Notes:** Sand surface following emu pick - Western section

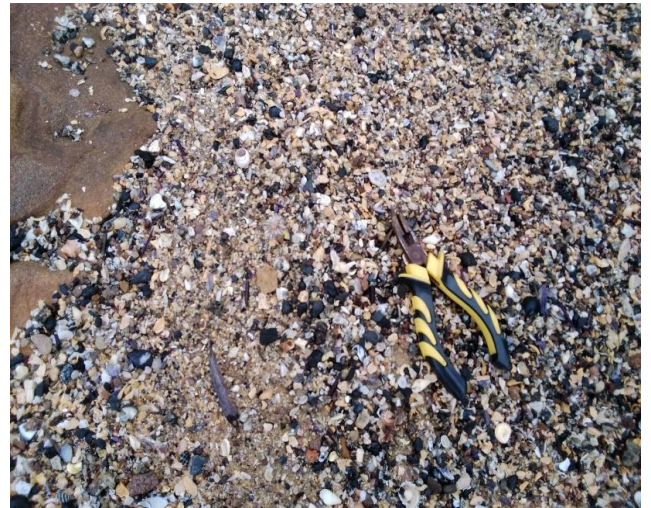
**Notes:** Sand surface following emu pick - Western section

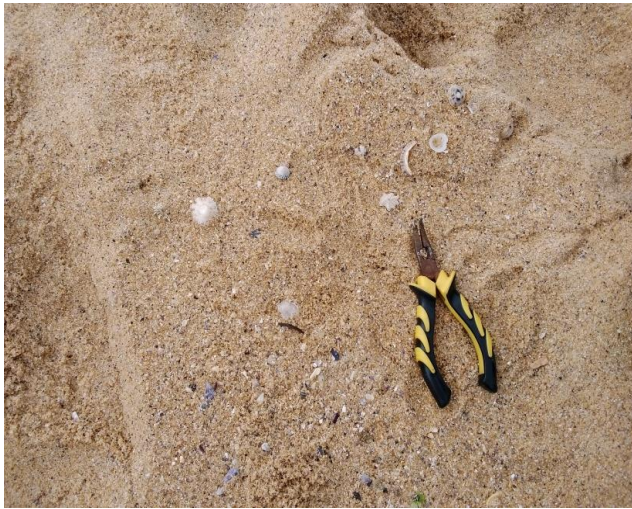
**Notes:** Sand surface following emu pick - Southern section

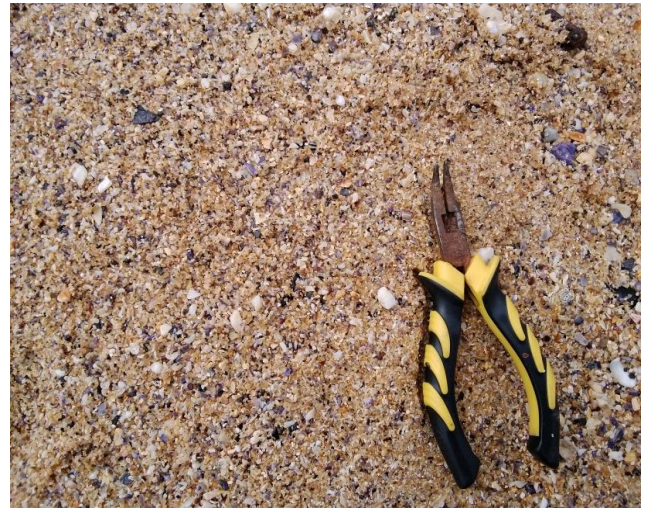
**Notes:** Sand surface following emu pick - Southern section

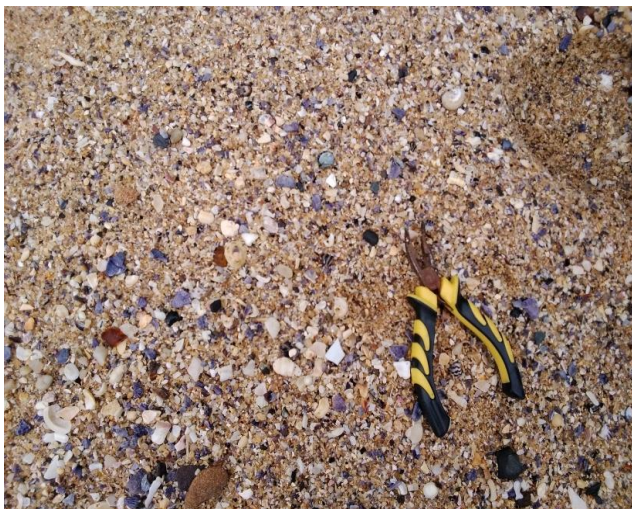
**Notes:** Sand surface following emu pick - Southern section

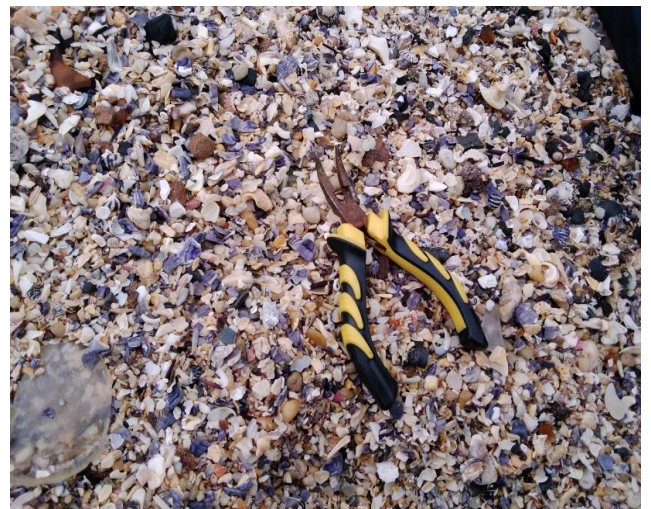
**Notes:** Sand surface following emu pick - Southern section

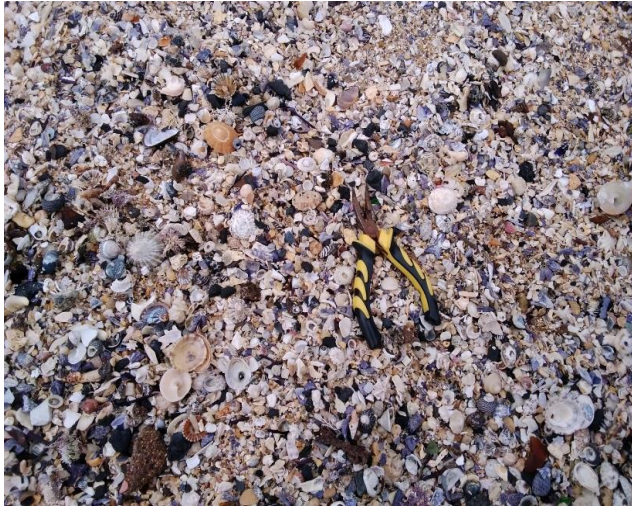
**Notes:** Sand surface following emu pick - Southern section

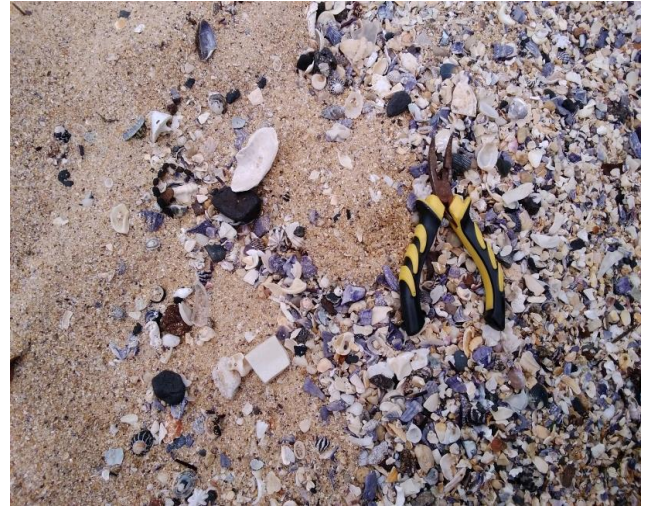
**Notes:** Sand surface following emu pick - Southern section

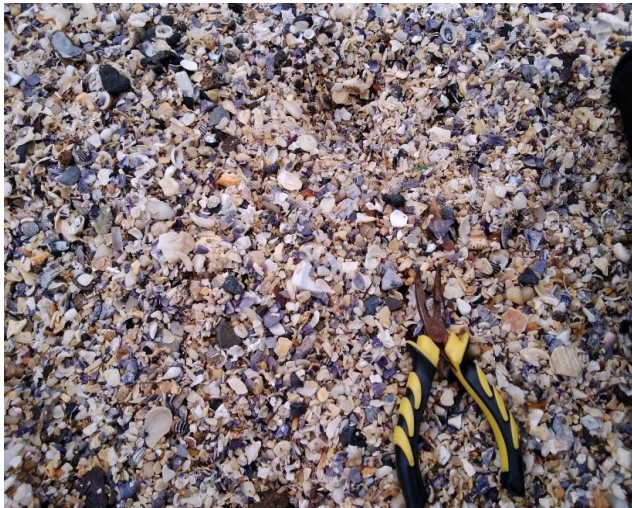
**Notes:** Sand surface following emu pick - Southern section

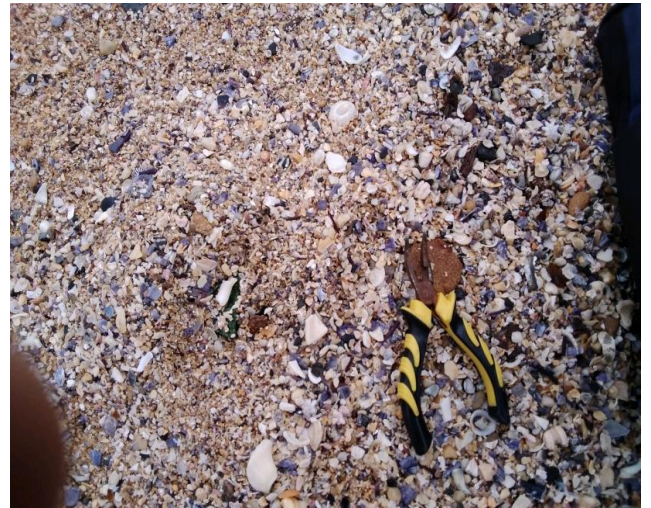
**Notes:** Sand surface following emu pick - Southern section
