# Asbestos Containing Material Clearance Inspection

## RE: Asbestos Containing Material Clearance Inspection

<b>Site:</b>	Little Bay Beach
<b>Location:</b>	Southern, Western and Northern Little Bay Beach

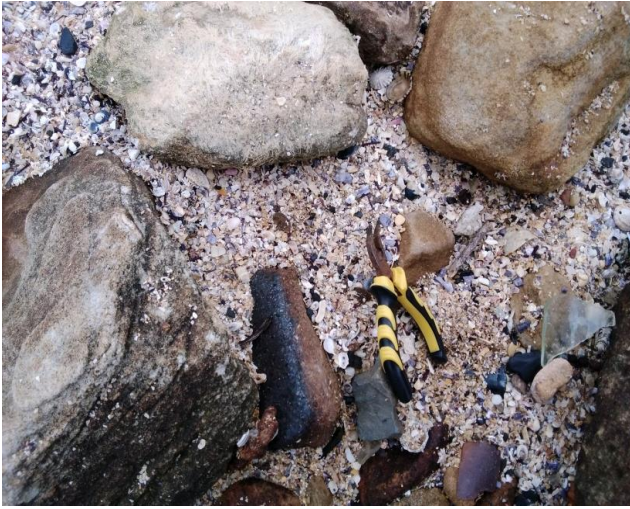
**Notes:** Sand surface following emu pick - Southern section

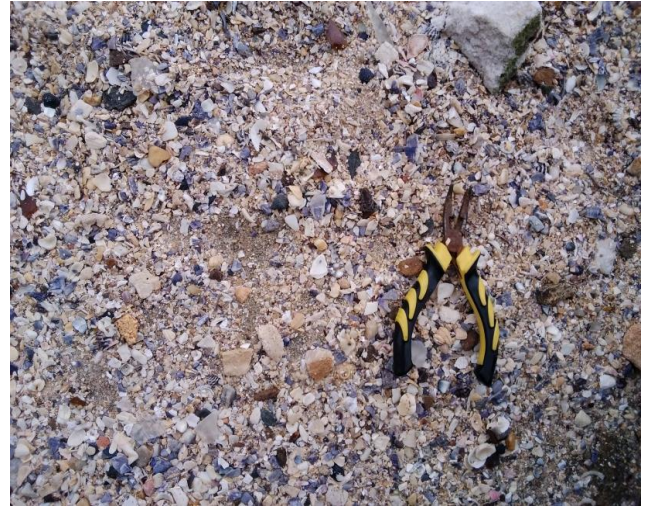
**Notes:** Sand surface following emu pick - Southern section
