Asbestos Containing Material Clearance Inspection

20 March 2023

Randwick City Council
30 Frances Street
Randwick NSW 2031

Site:	Little Bay Beach
Location:	Southern, Western and Northern Little Bay Beach

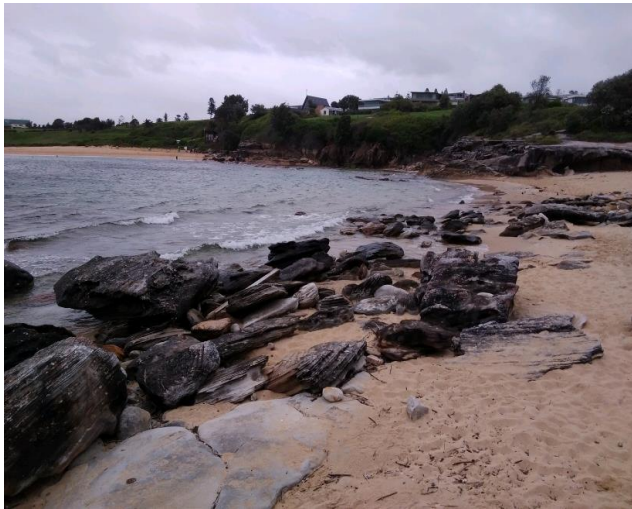
Notes: Overview of the Beach prior to removal works

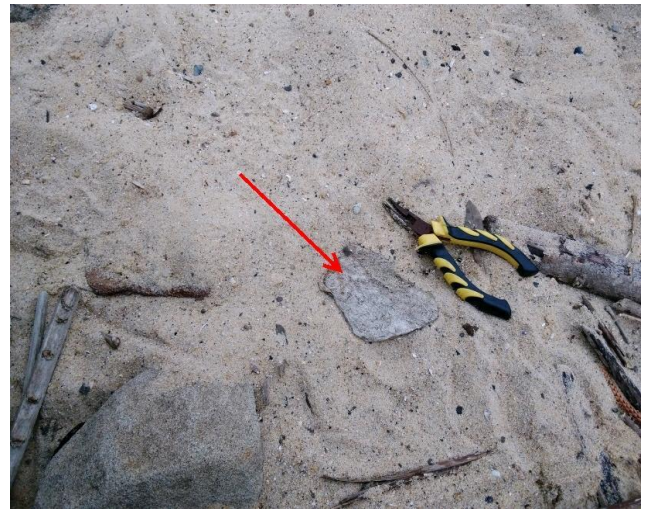
Notes: FC fragment identified on sand surface prior to emu pick - Northern section

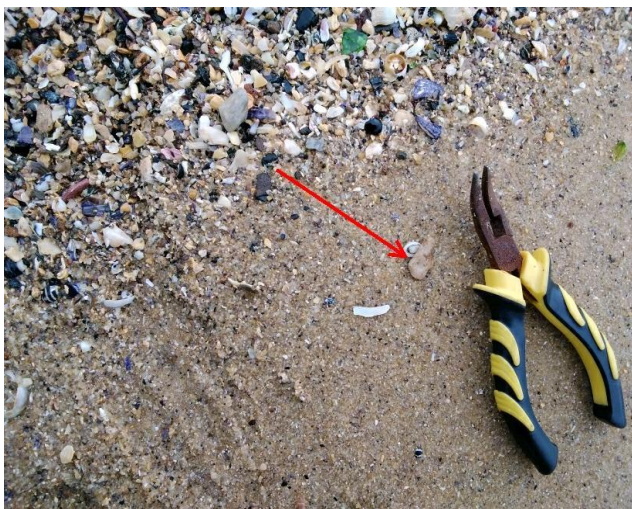
Notes: FC fragment identified on sand surface prior to emu pick - Northern section

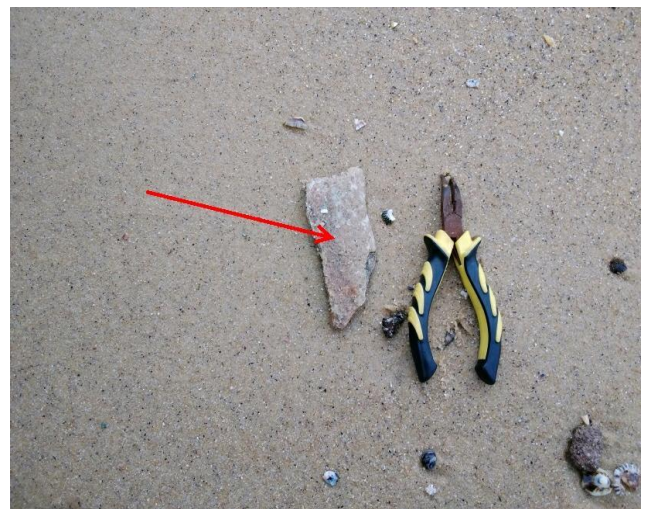
Notes: FC fragment identified on sand surface prior to emu pick - Northern section

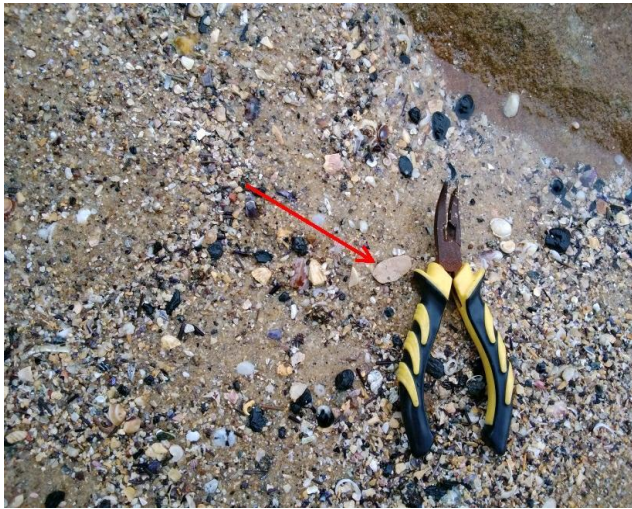
Notes: FC fragment identified on sand surface prior to emu pick - Northern section

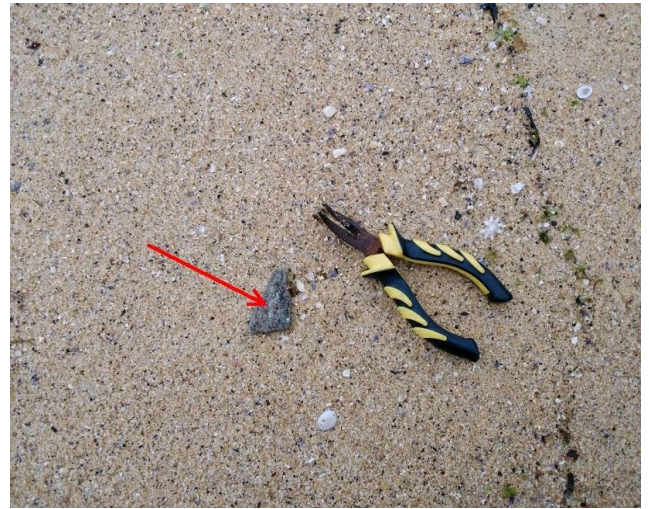
Notes: FC fragment identified on sand surface prior to emu pick - Southern section

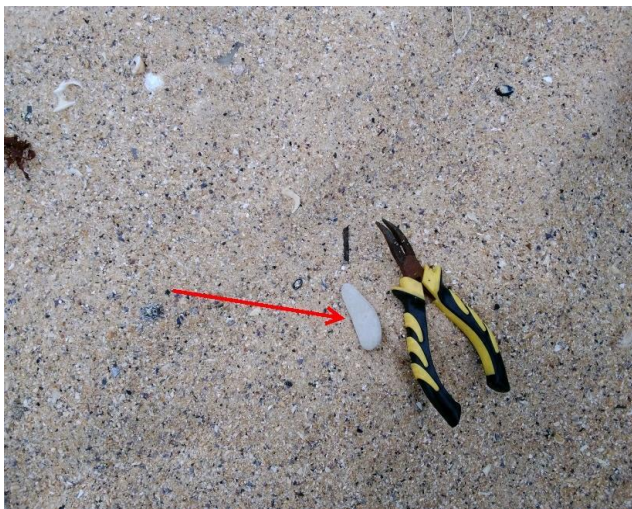
Notes: FC fragment identified on sand surface prior to emu pick - Southern section

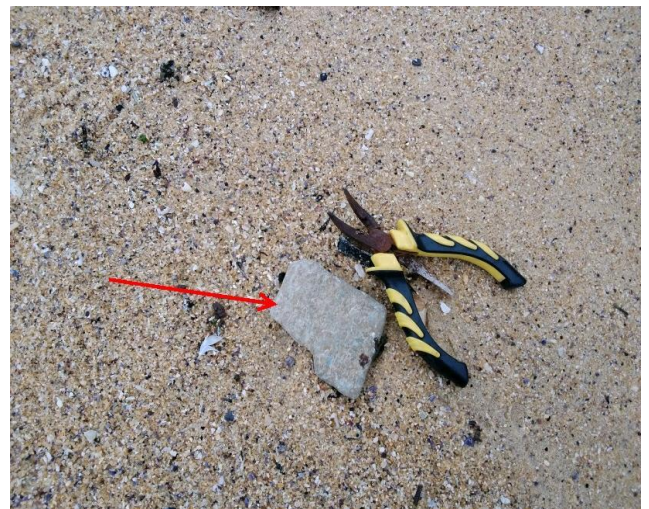
Notes: FC fragment identified on sand surface prior to emu pick - Southern section

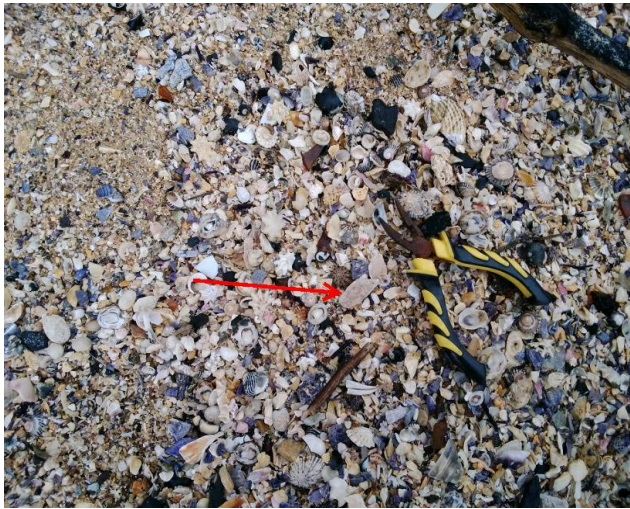
Notes: FC fragment identified on sand surface prior to emu pick - Southern section

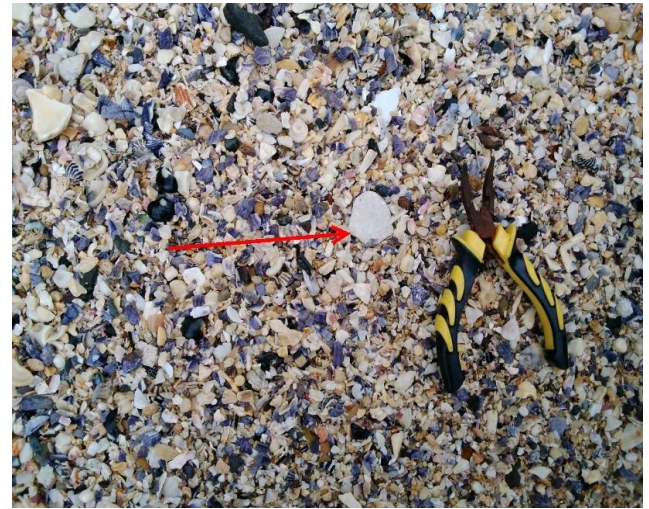
Notes: FC fragment identified on sand surface prior to emu pick - Southern section

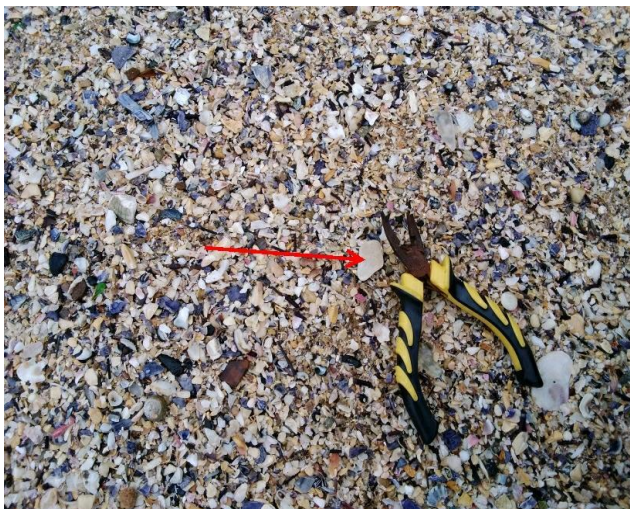
Notes: FC fragment identified on sand surface prior to emu pick - Southern section

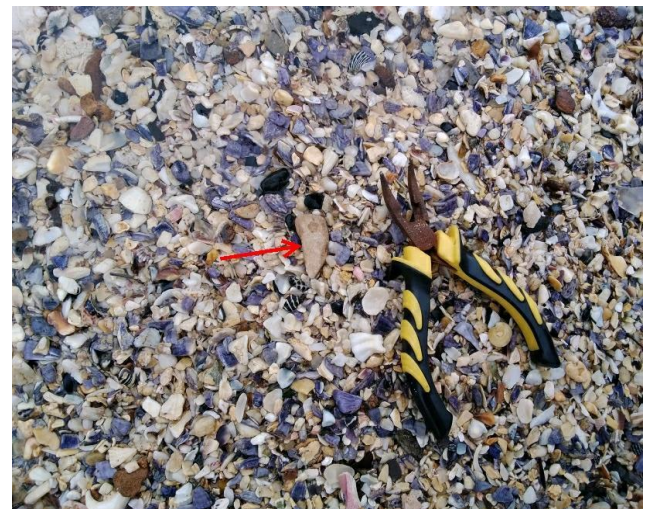
Notes: FC fragment identified on sand surface prior to emu pick - Southern section

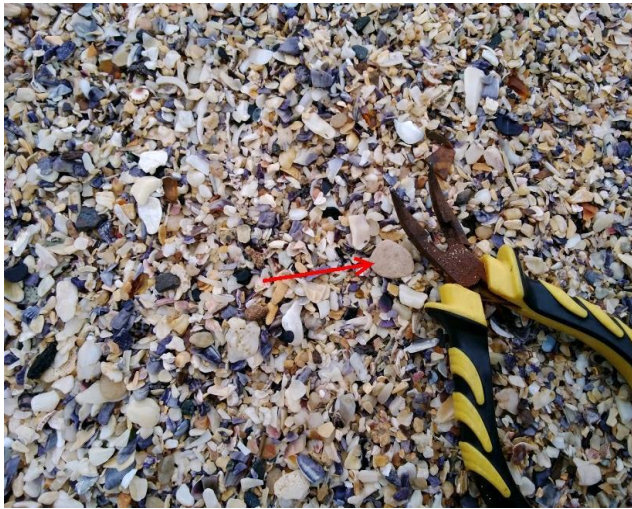
Notes: FC fragment identified on sand surface prior to emu pick - Southern section

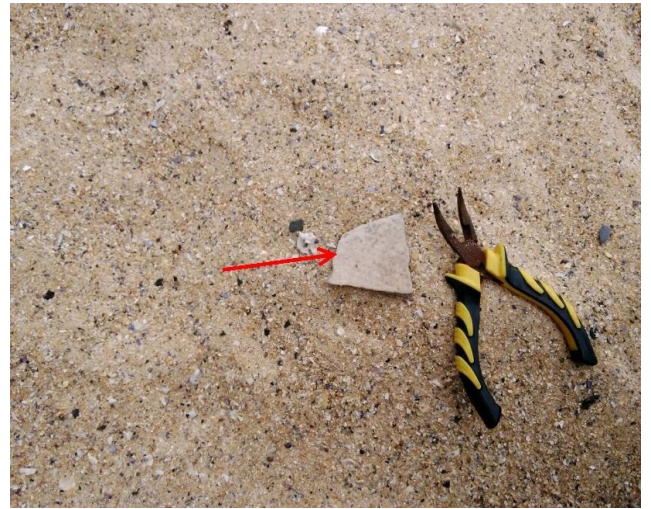
Notes: FC fragment identified on sand surface prior to emu pick - Southern section

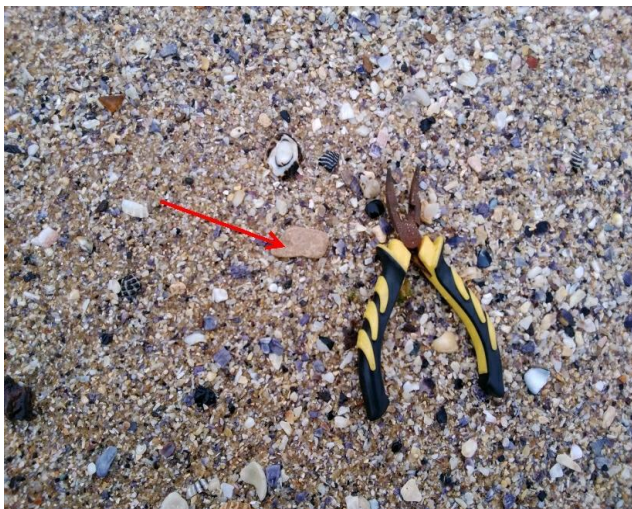
Notes: FC fragment identified on sand surface prior to emu pick - Southern section

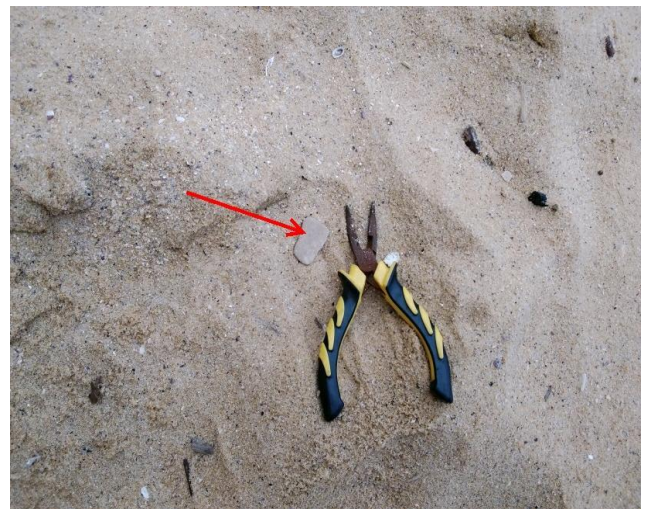
Notes: FC fragment identified on sand surface prior to emu pick - Southern section

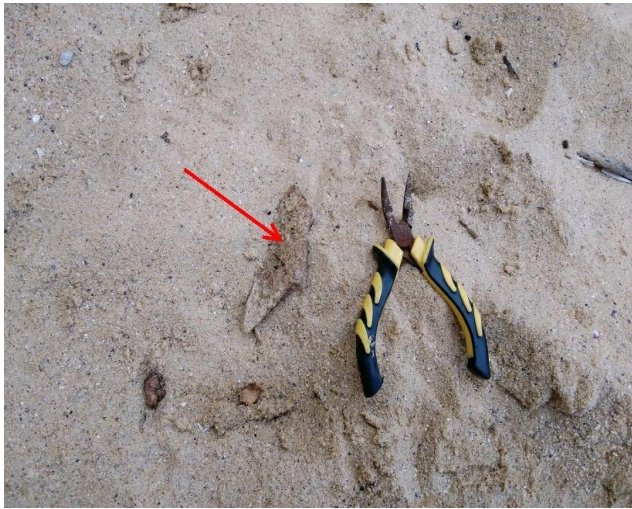
Notes: FC fragment identified on sand surface prior to emu pick - Southern section

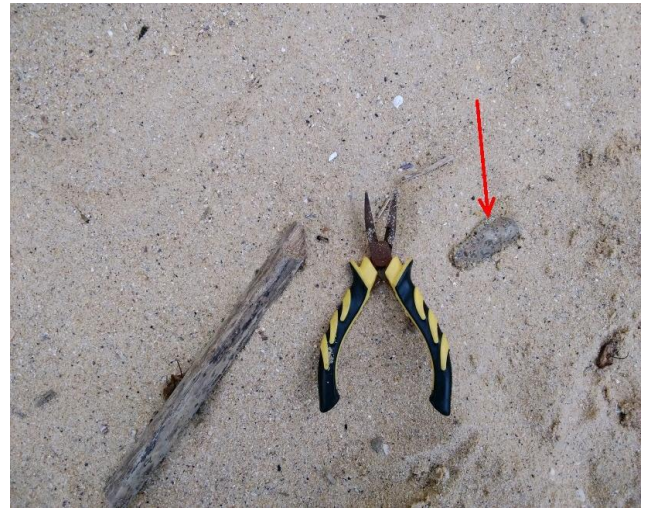
Notes: FC fragment identified on sand surface prior to emu pick - Southern section

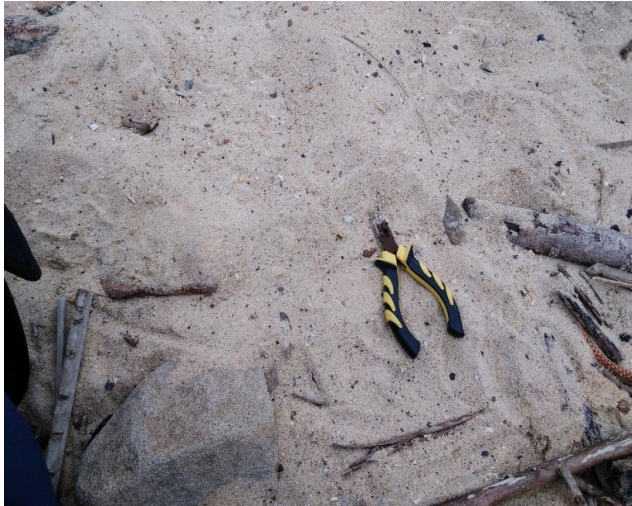
Notes: Sand surface following emu pick - Northern section

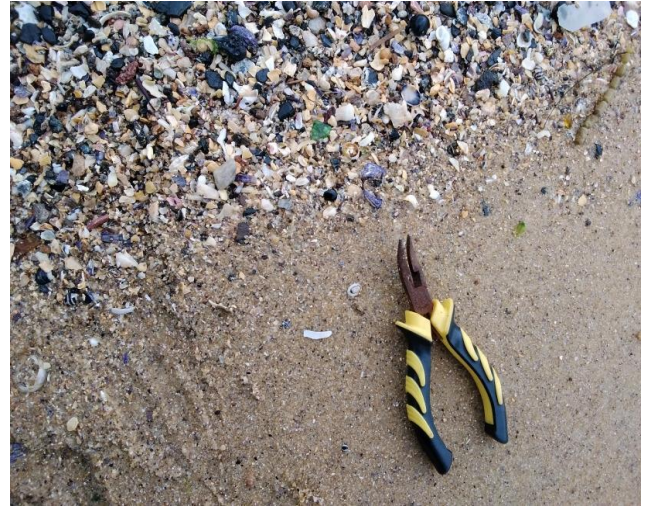
Notes: Sand surface following emu pick - Northern section

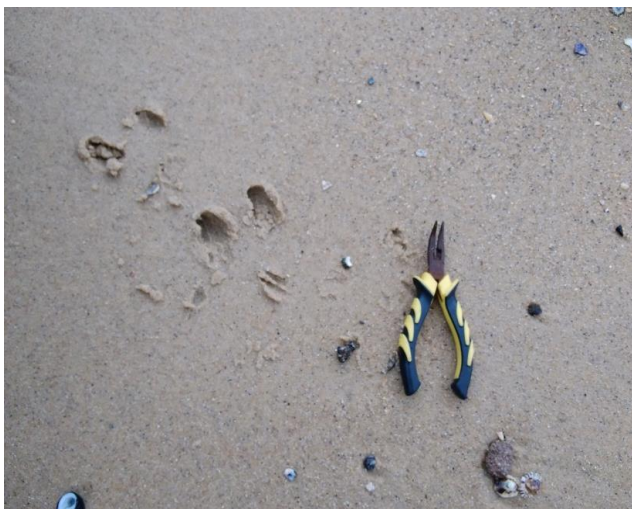
Notes: Sand surface following emu pick - Northern section

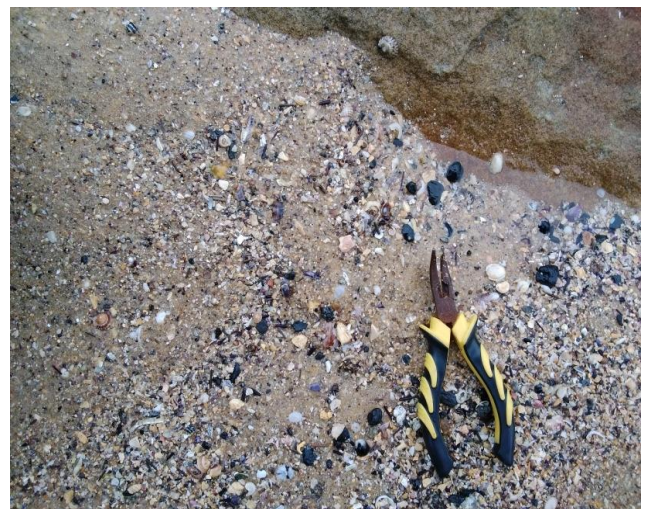
Notes: Sand surface following emu pick - Northern section

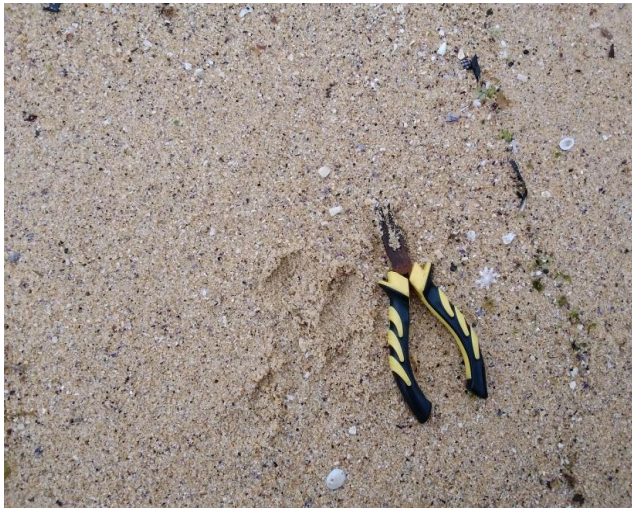
Notes: Sand surface following emu pick - Northern section

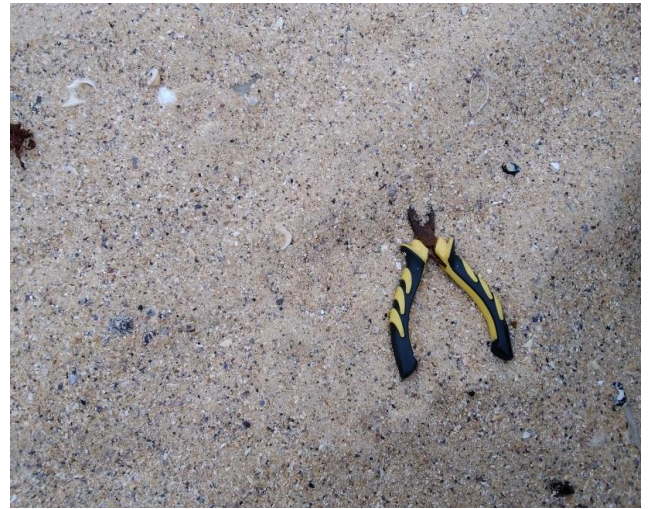
Notes: Sand surface following emu pick - Southern section

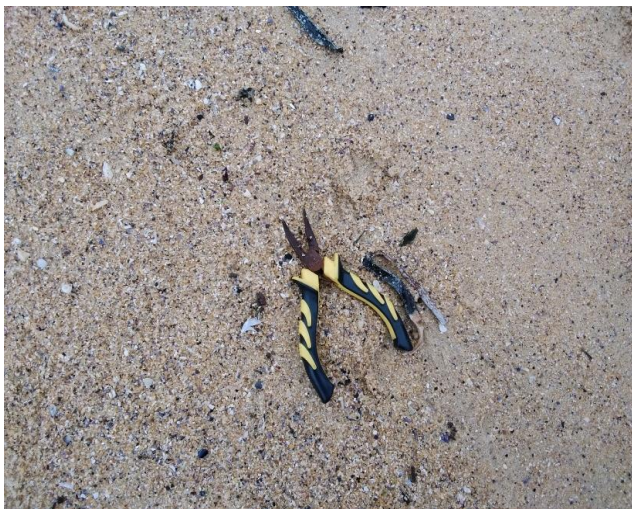
Notes: Sand surface following emu pick - Southern section

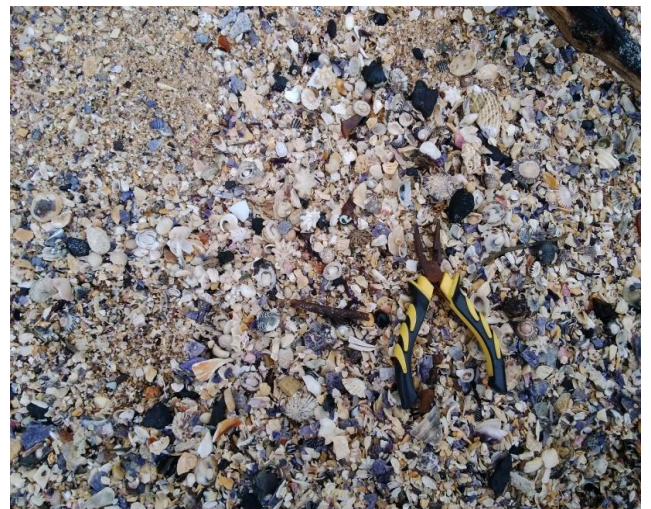
Notes: Sand surface following emu pick - Southern section

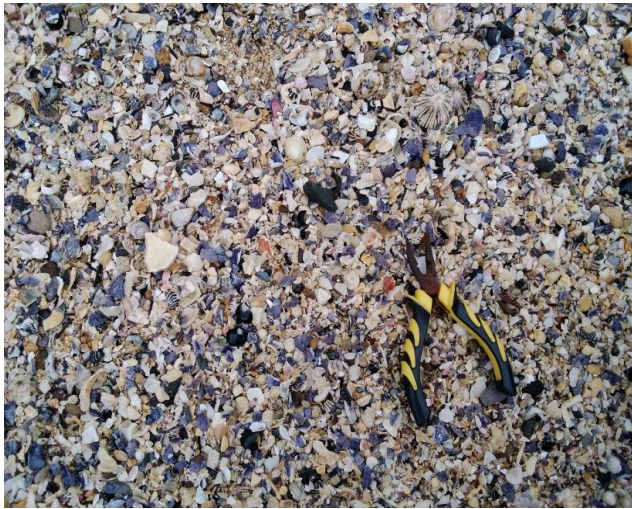
Notes: Sand surface following emu pick - Southern section

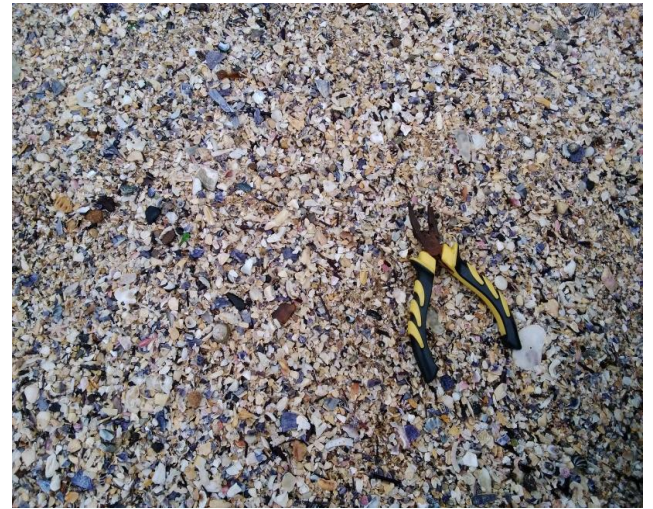
Notes: Sand surface following emu pick - Southern section

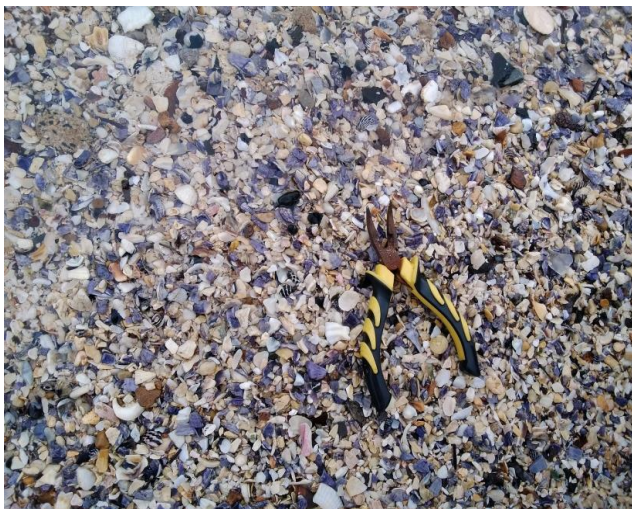
Notes: Sand surface following emu pick - Southern section

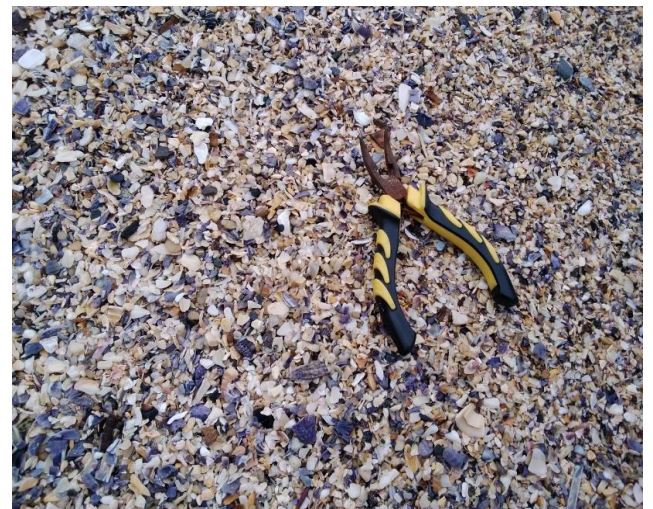
Notes: Sand surface following emu pick - Southern section

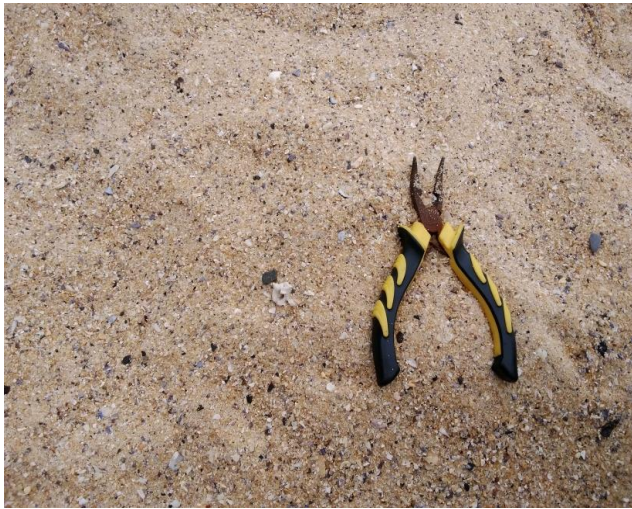
Notes: Sand surface following emu pick - Southern section

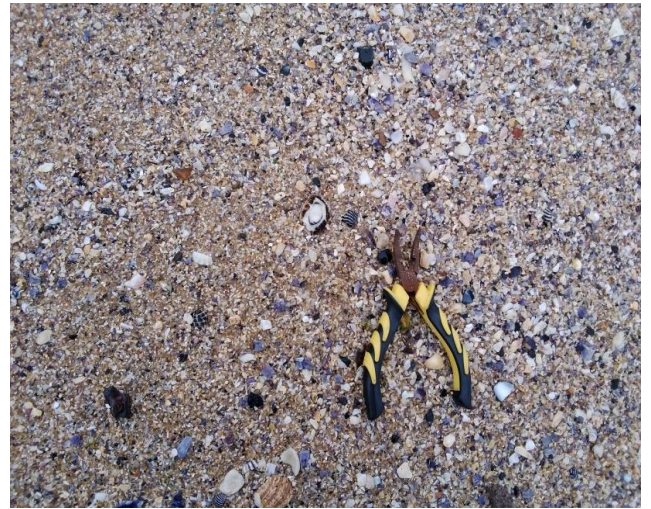
Notes: Sand surface following emu pick - Southern section

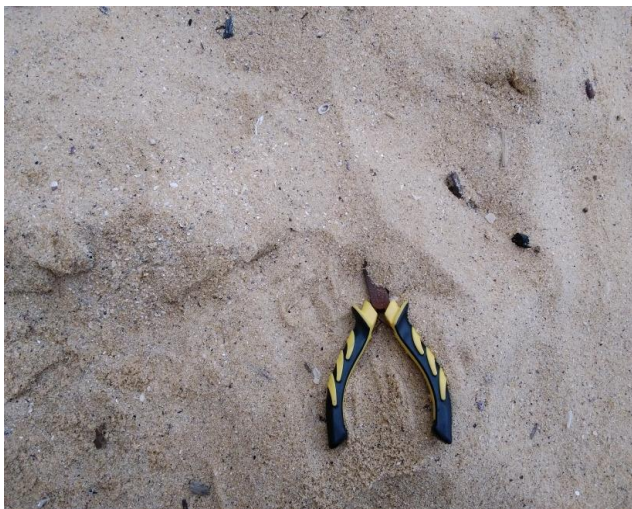
Notes: Sand surface following emu pick - Southern section

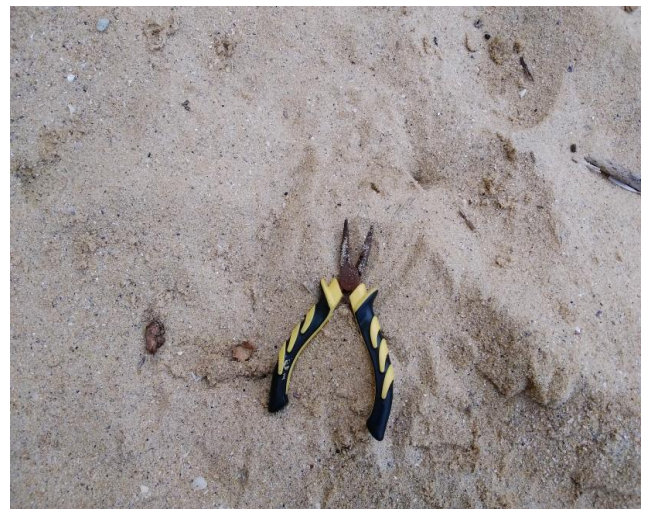
Notes: Sand surface following emu pick - Southern section

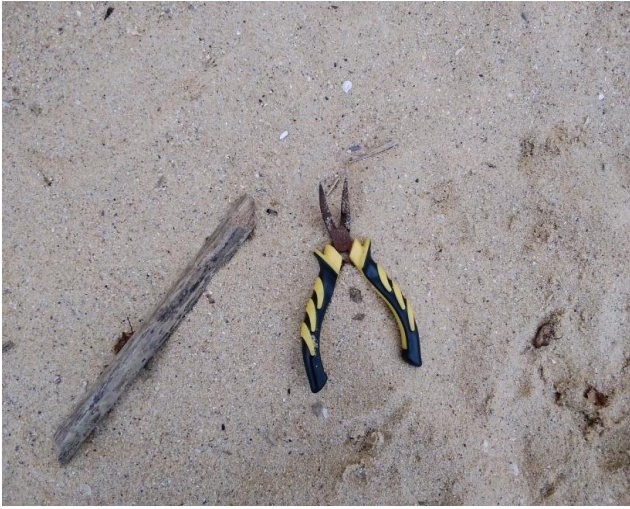
Notes: Sand surface following emu pick - Southern section
