Asbestos Containing Material Clearance Inspection

28 June 2023

Site:	Little Bay Beach
Location:	Sand surfaces of beach

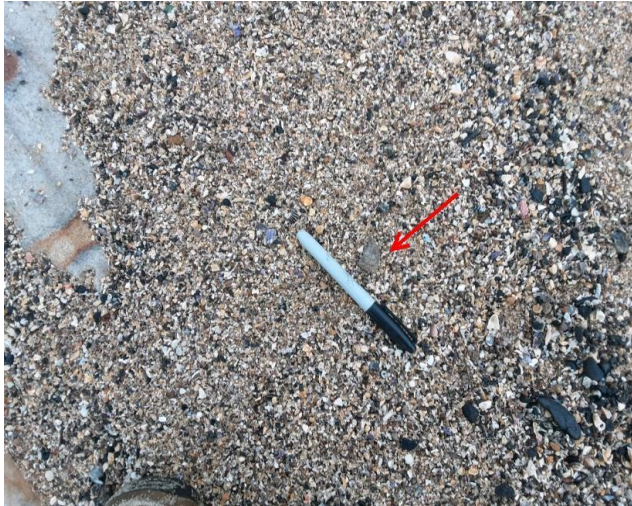
Notes: Fragments identified on Beach surface

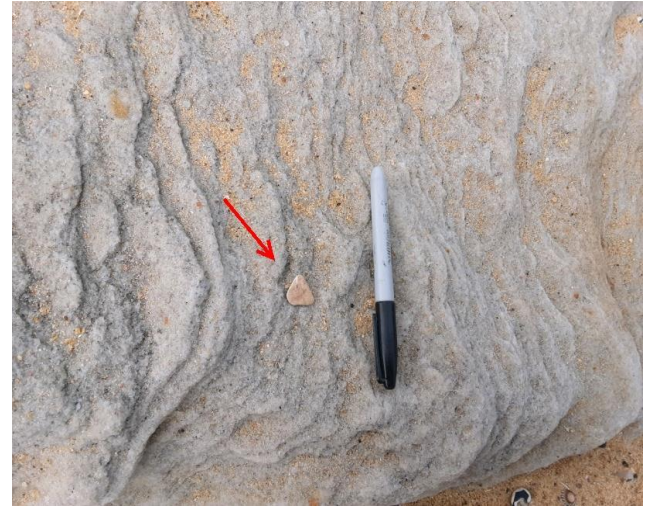
Notes: Fragments identified on Beach surface

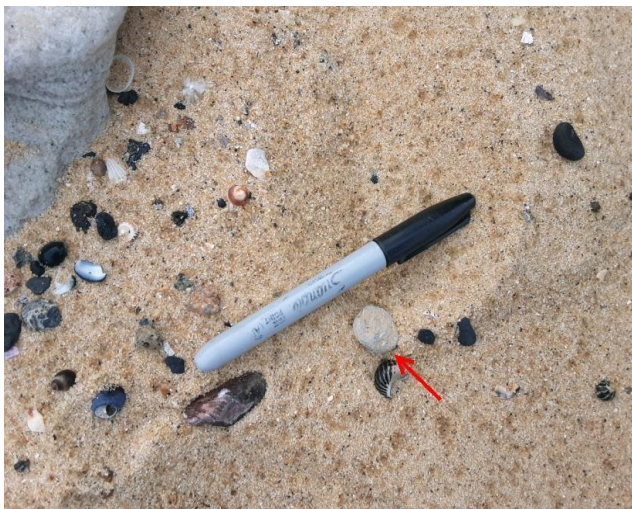
Notes: Fragments identified on Beach surface

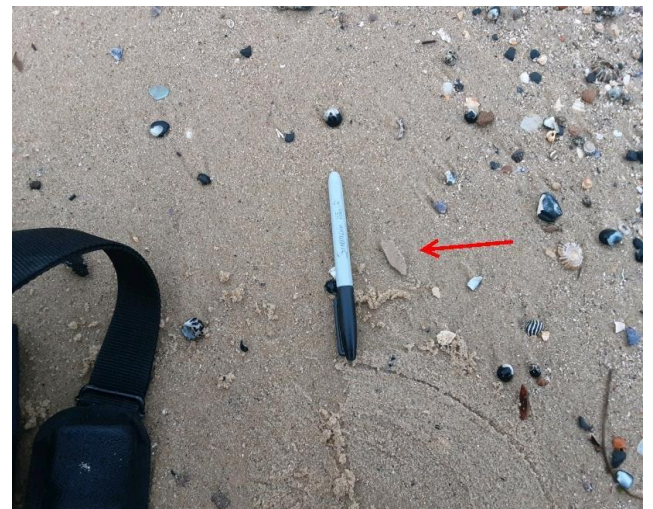
Notes: Fragments identified on Beach surface

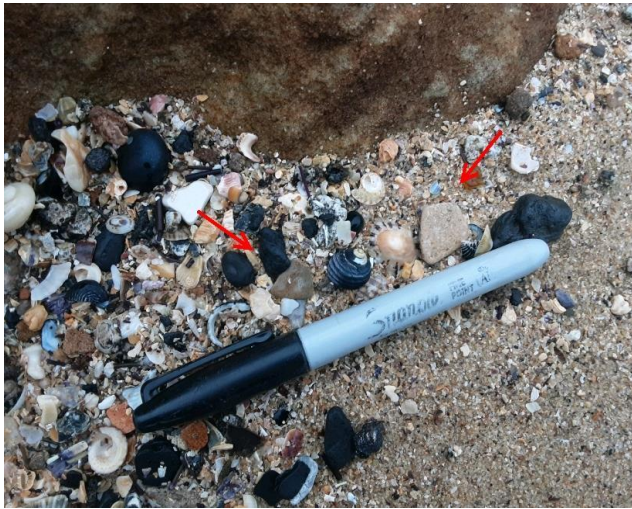
Notes: Fragments identified on Beach surface

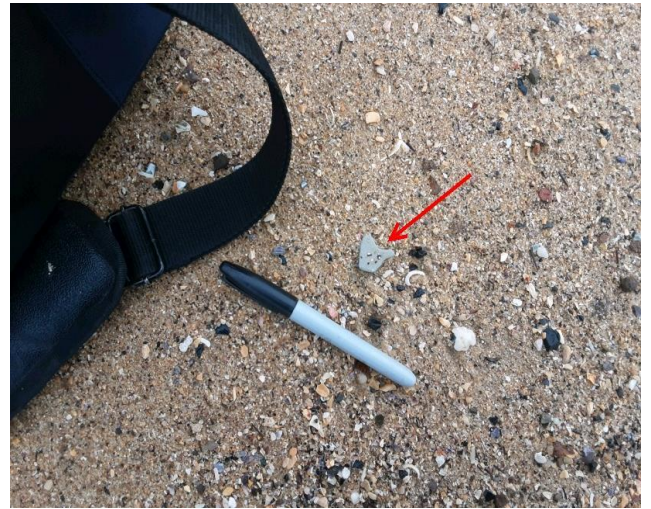
Notes: Fragments identified on Beach surface

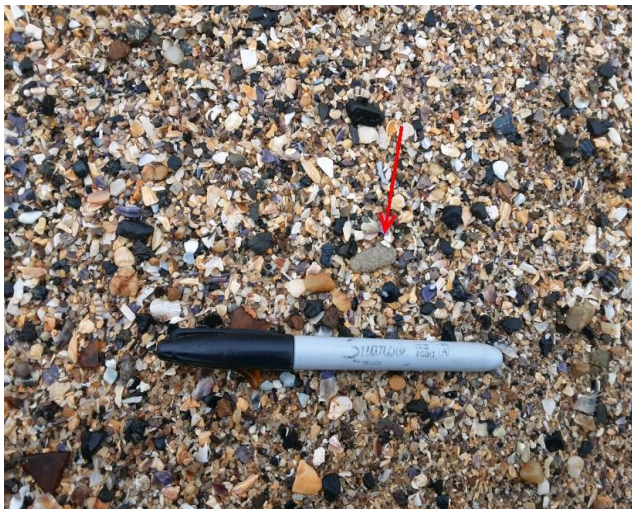
Notes: Fragments identified on Beach surface

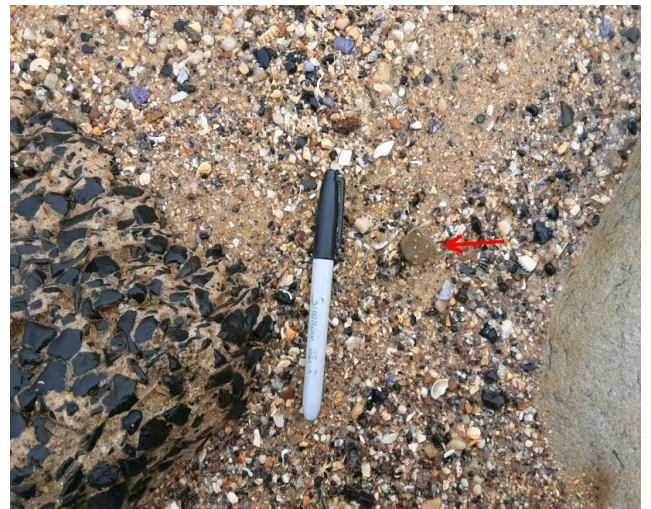
Notes: Fragments identified on Beach surface

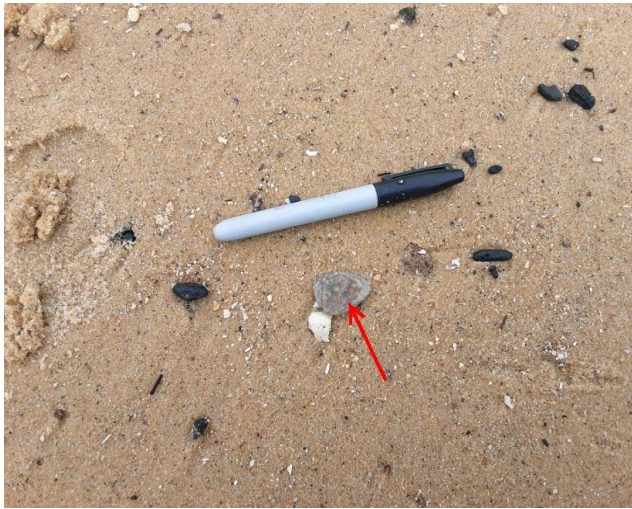
Notes: Fragments identified on Beach surface

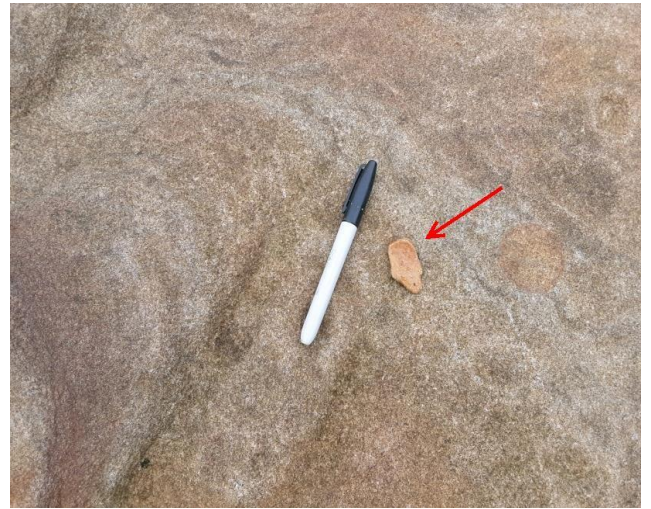
Notes: Fragments identified on Beach surface

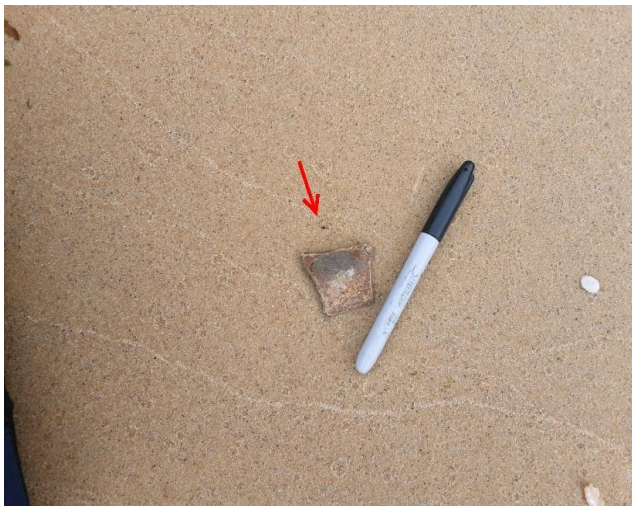
Notes: Fragments identified on Beach surface

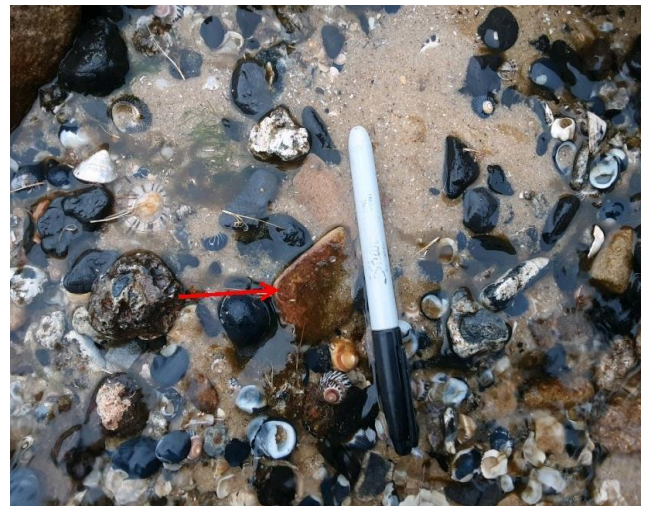
Notes: Fragments identified on Beach surface

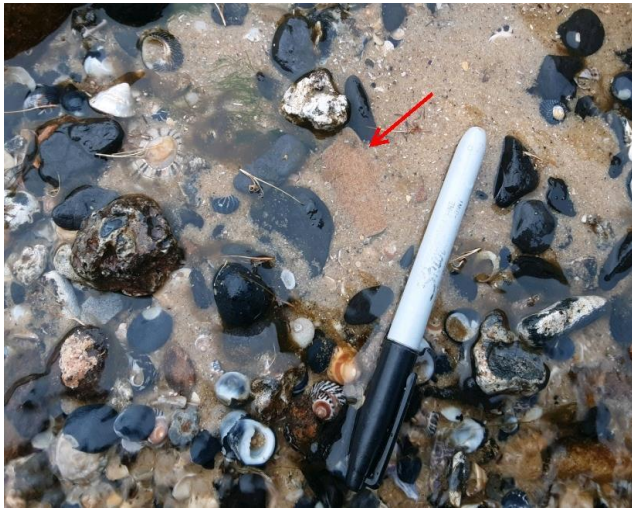
Notes: Fragments identified on Beach surface

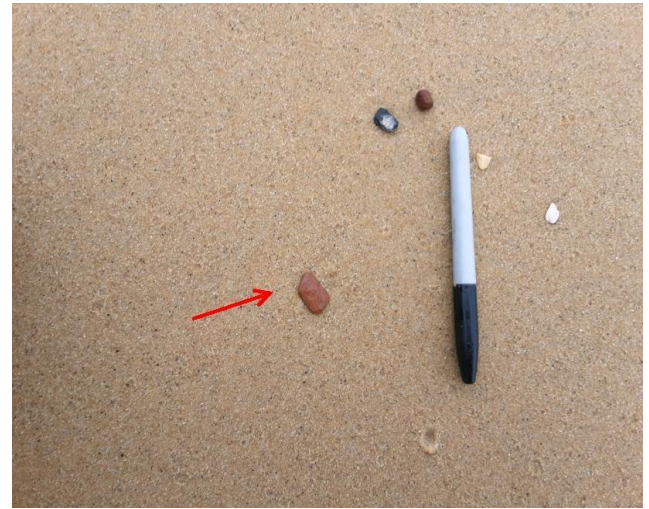
Notes: Fragments identified on Beach surface

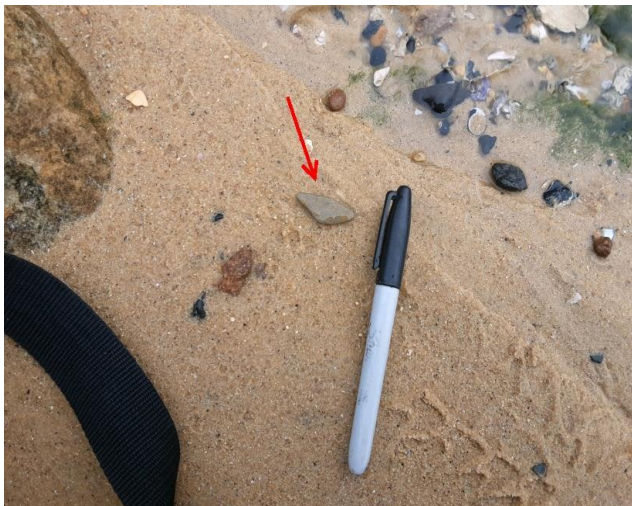
Notes: Fragments identified on Beach surface

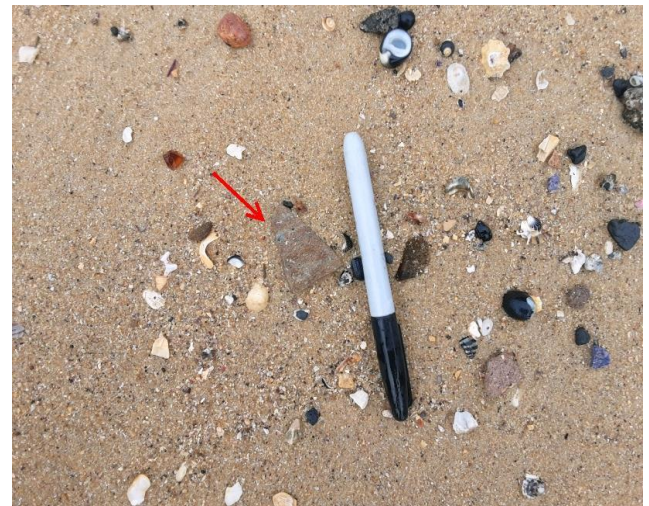
Notes: Fragments identified on Beach surface

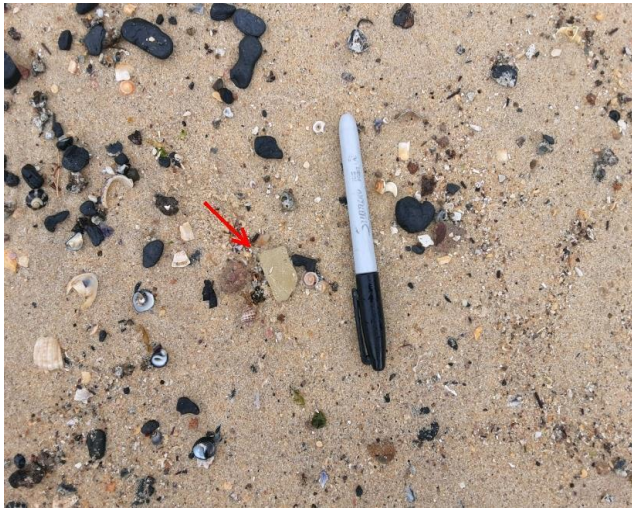
Notes: Fragments identified on Beach surface

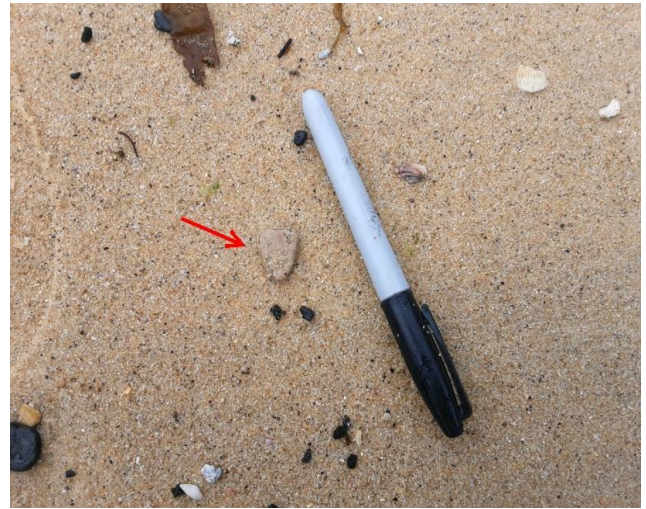
Notes: Fragments identified on Beach surface

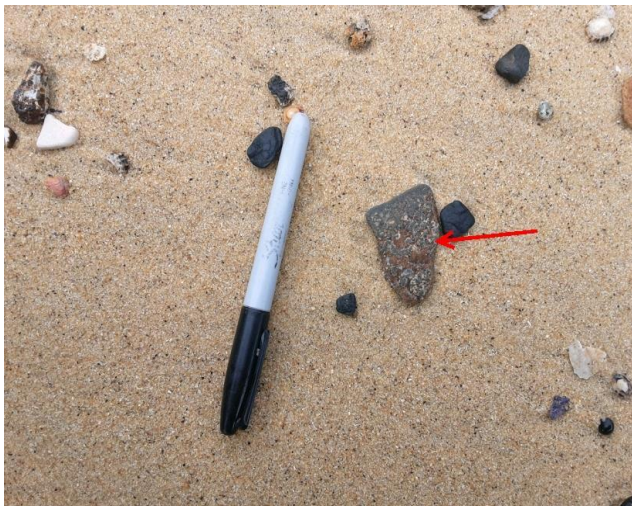
Notes: Fragments identified on Beach surface

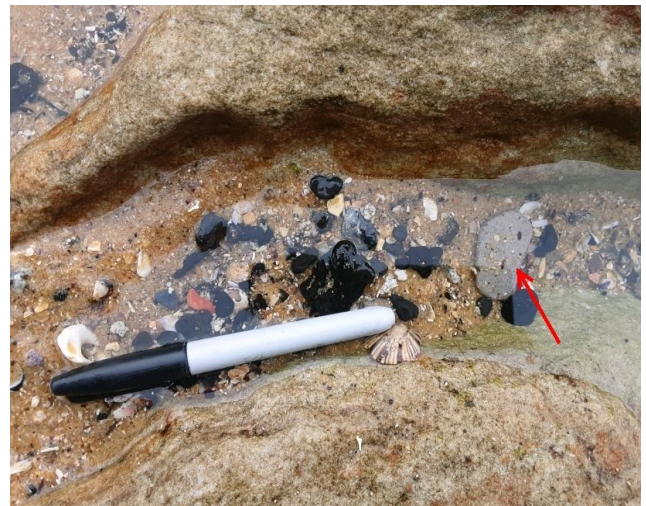
Notes: Fragments identified on Beach surface

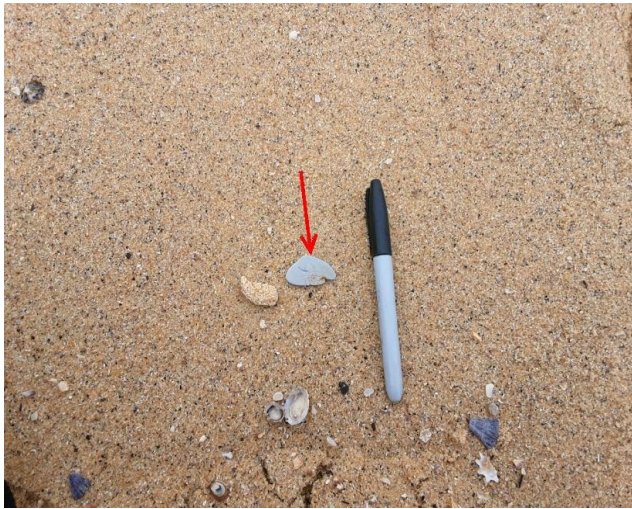
Notes: Fragments identified on Beach surface

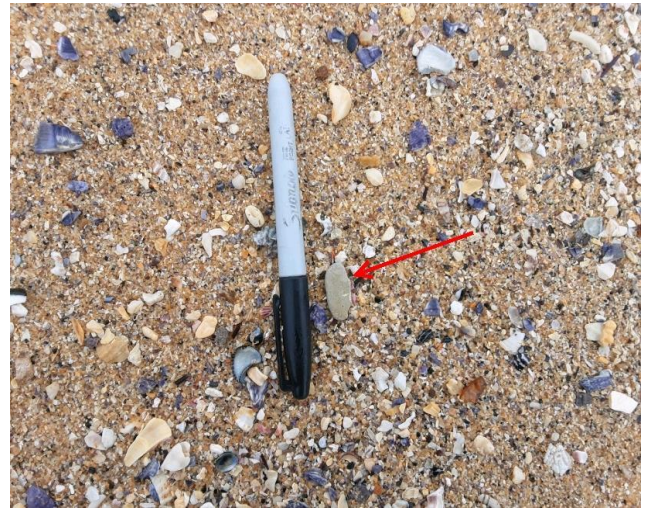
Notes: Fragments identified on Beach surface

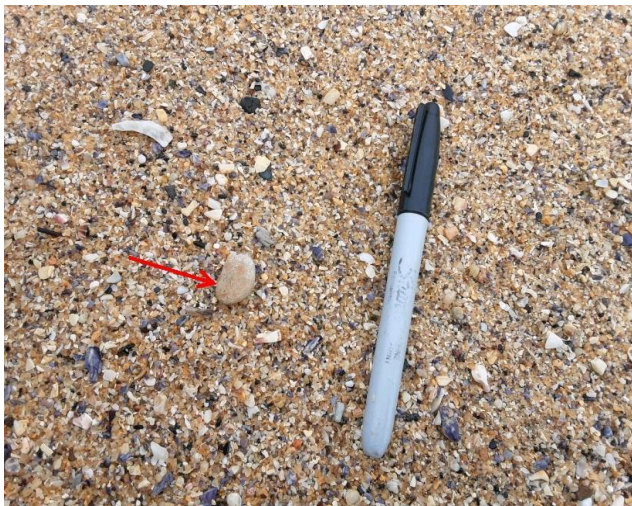
Notes: Fragments identified on Beach surface

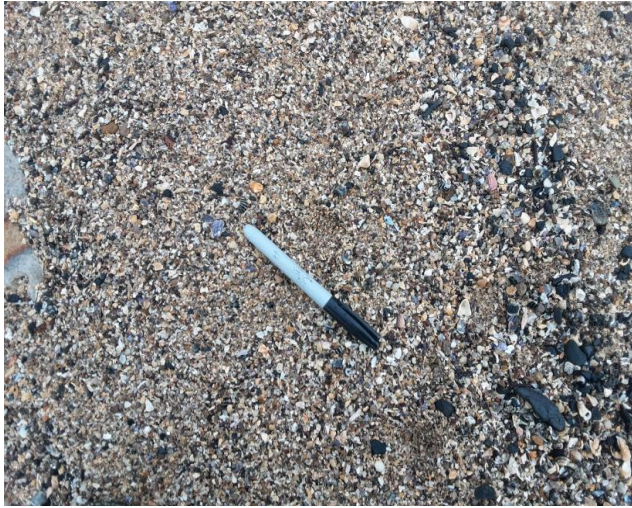
Notes: Beach surface following fragment removal

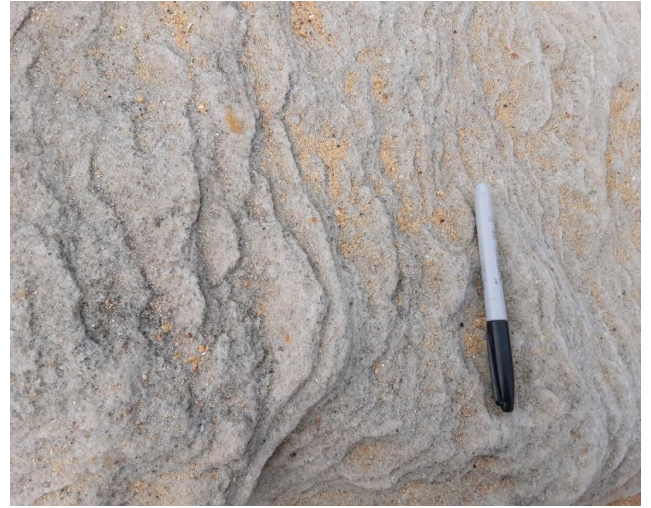
Notes: Beach surface following fragment removal

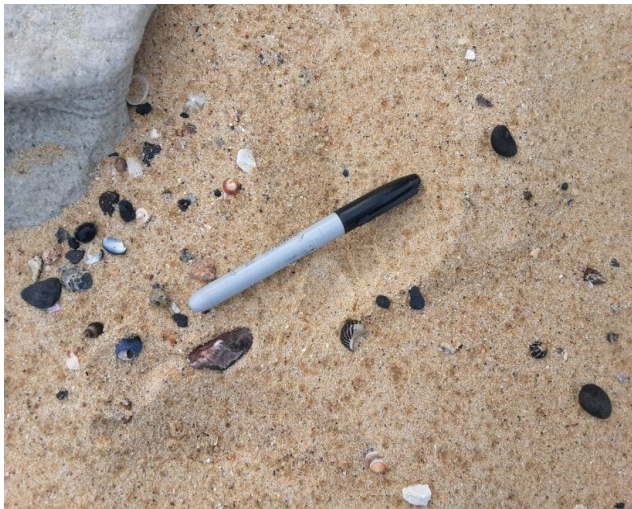
Notes: Beach surface following fragment removal

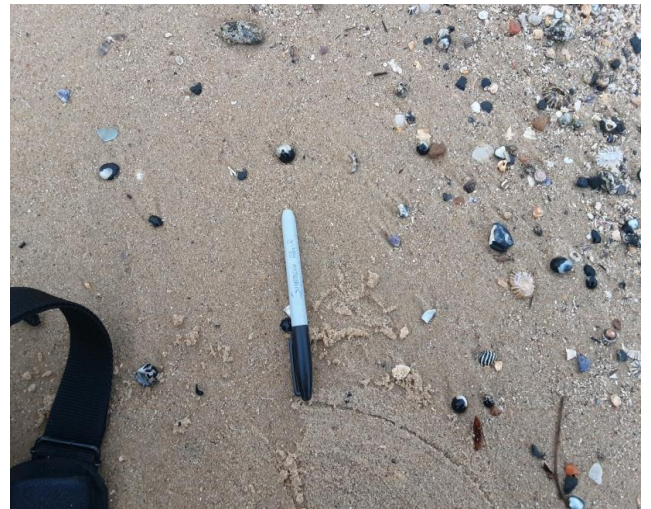
Notes: Beach surface following fragment removal

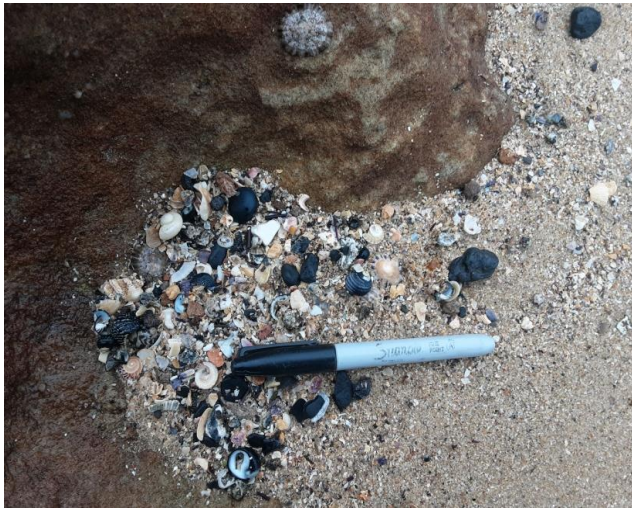
Notes: Beach surface following fragment removal

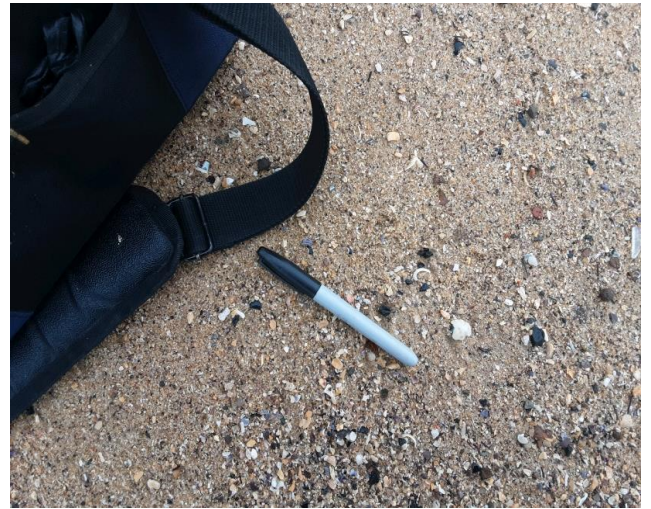
Notes: Beach surface following fragment removal

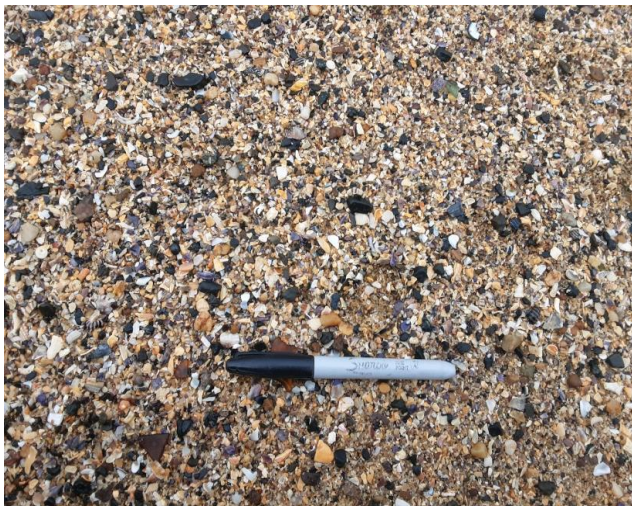
Notes: Beach surface following fragment removal

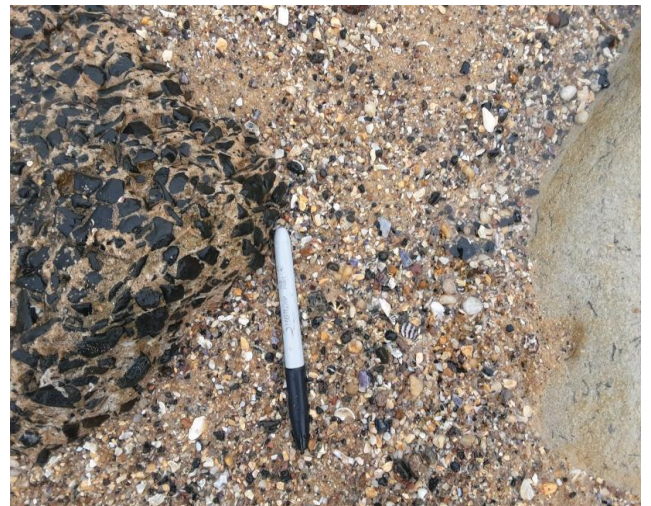
Notes: Beach surface following fragment removal

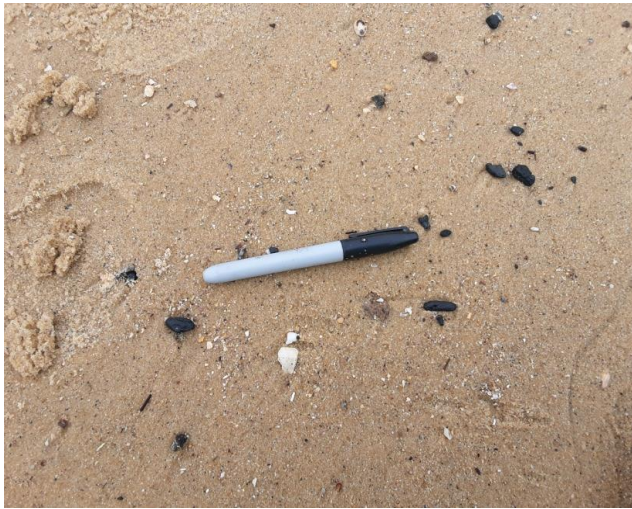
Notes: Beach surface following fragment removal

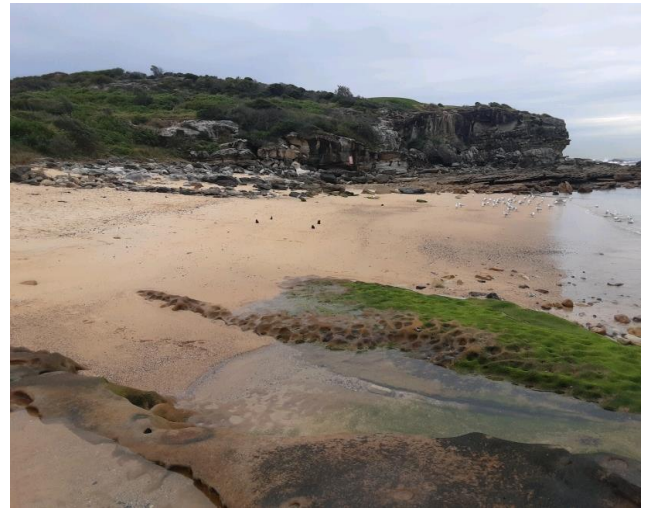
Notes: Northern beach at time of clearance

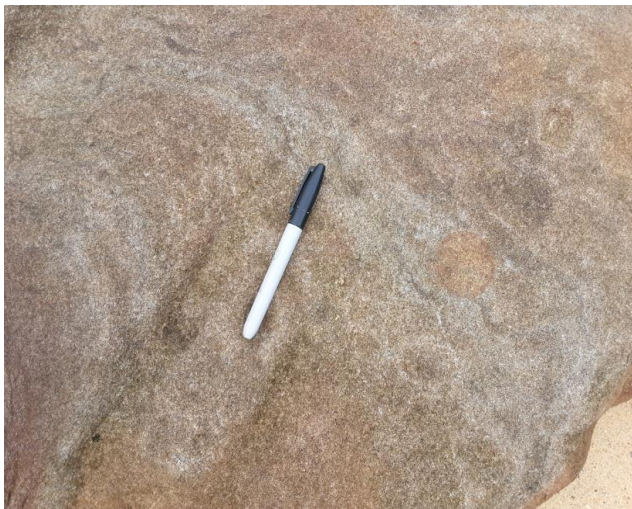
Notes: Beach surface following fragment removal

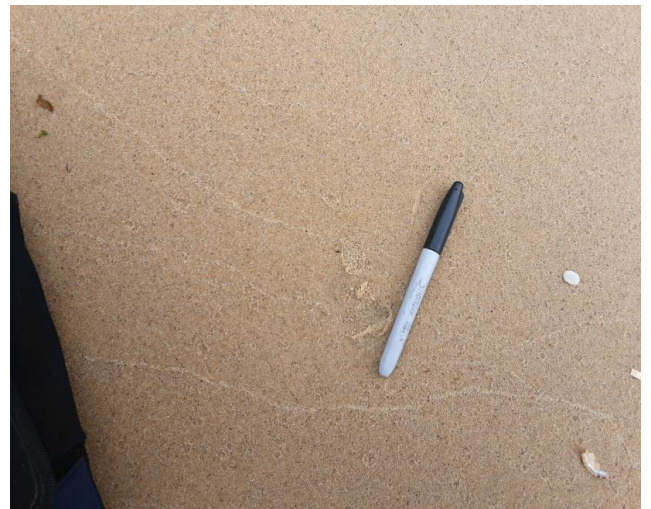
Notes: Beach surface following fragment removal

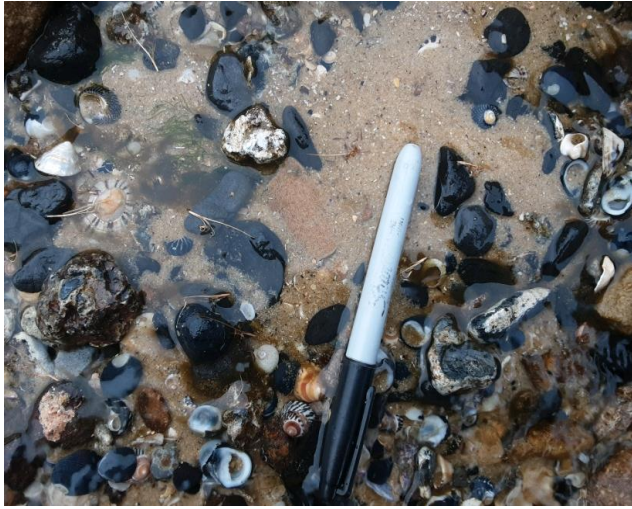
Notes: Beach surface following fragment removal

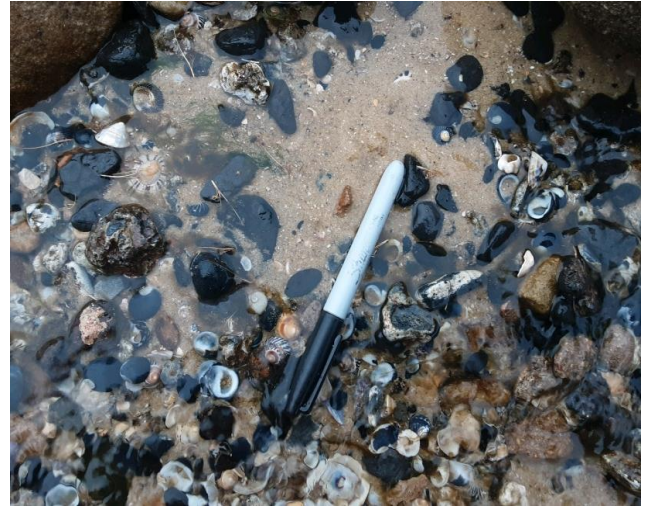
Notes: Beach surface following fragment removal

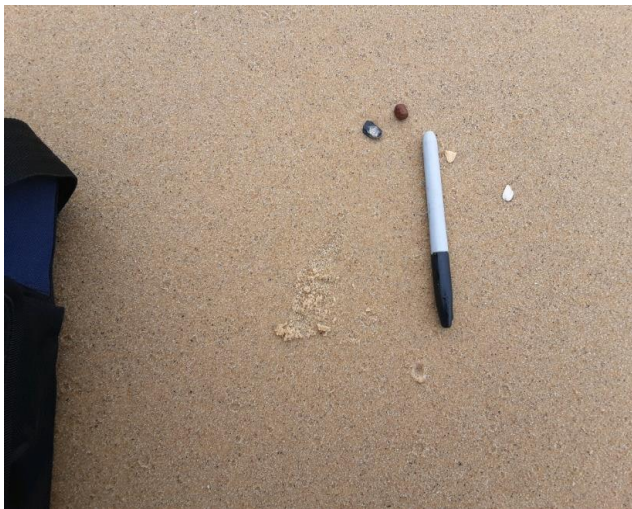
Notes: Beach surface following fragment removal

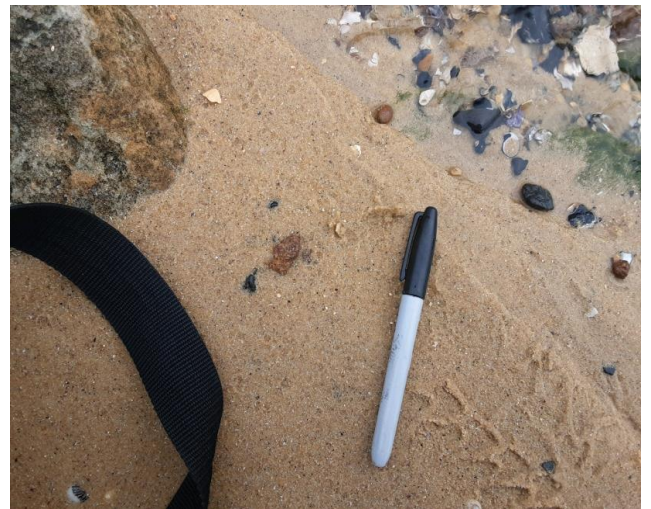
Notes: Beach surface following fragment removal

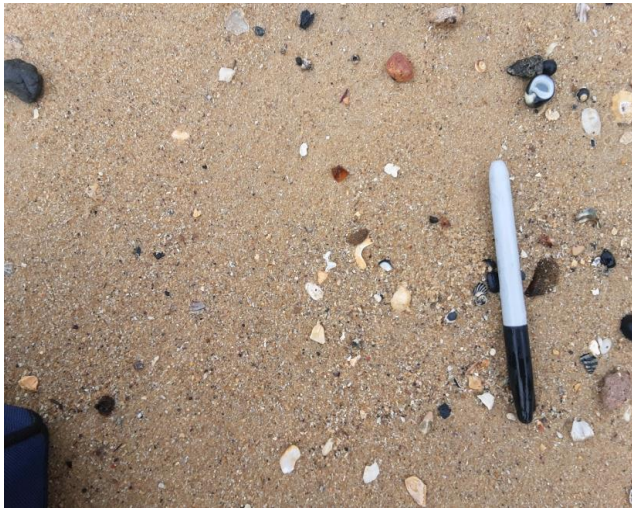
Notes: Beach surface following fragment removal

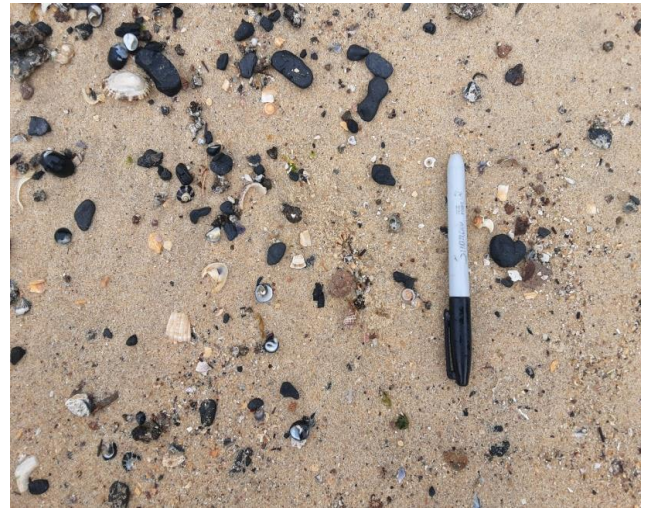
Notes: Beach surface following fragment removal

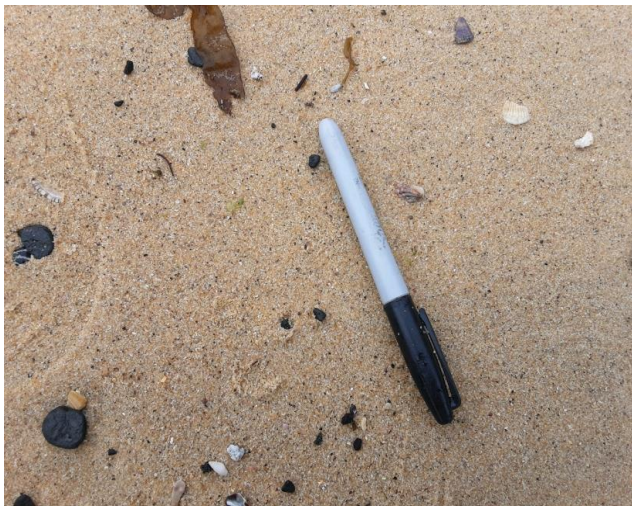
Notes: Beach surface following fragment removal

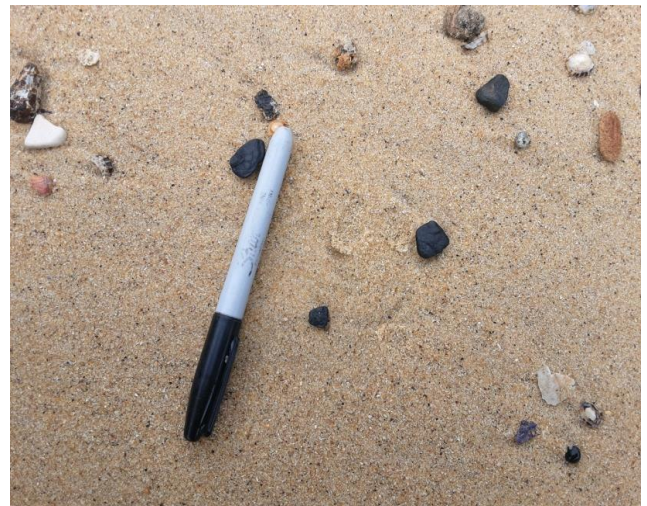
Notes: Beach surface following fragment removal

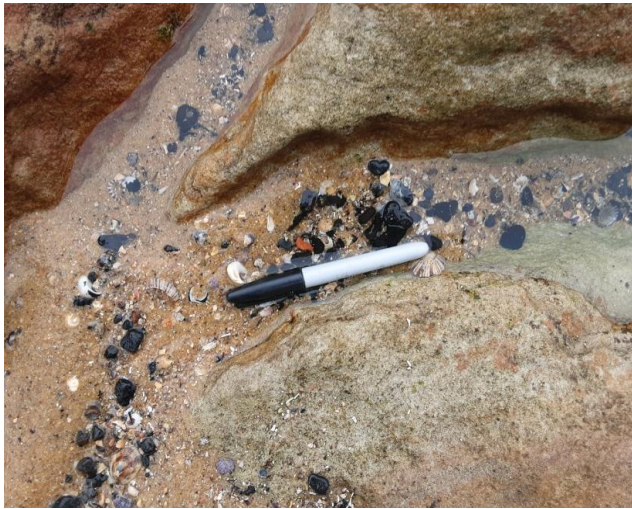
Notes: Beach surface following fragment removal

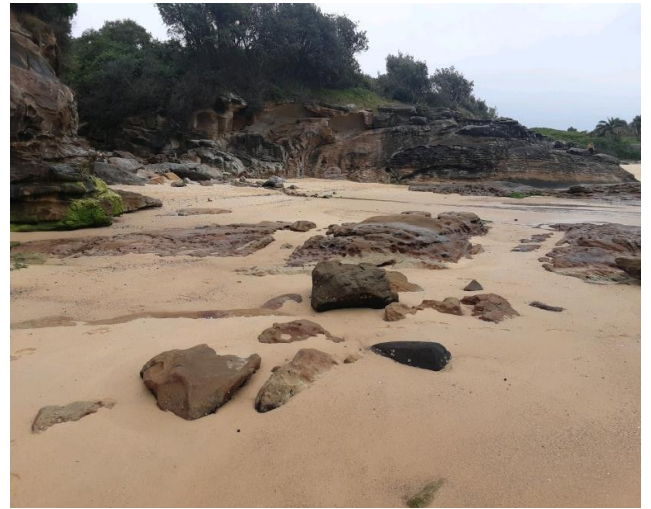
Notes: Western Beach at time of clearance

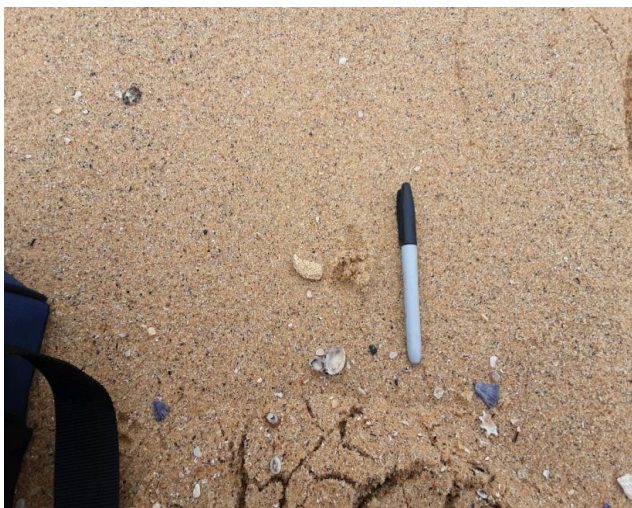
Notes: Beach surface following fragment removal

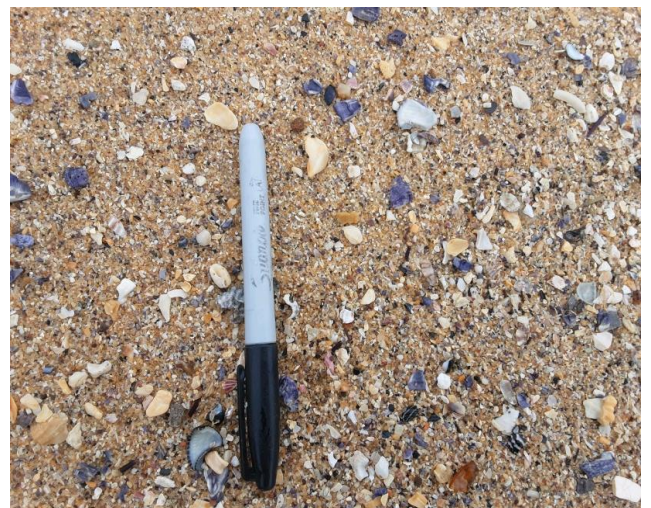
Notes: Beach surface following fragment removal

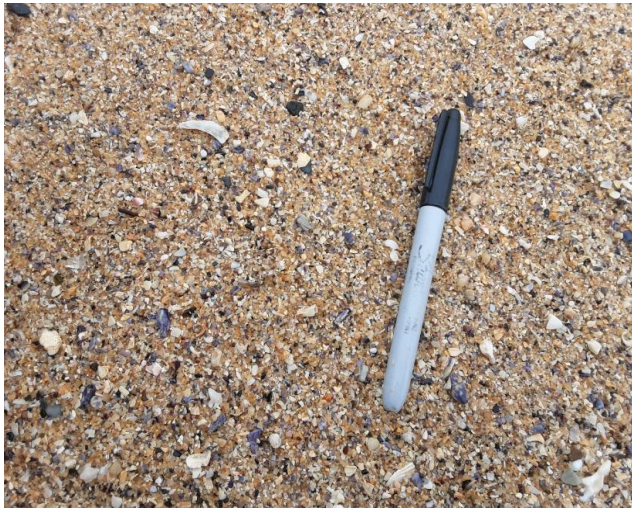
Notes: Beach surface following fragment removal

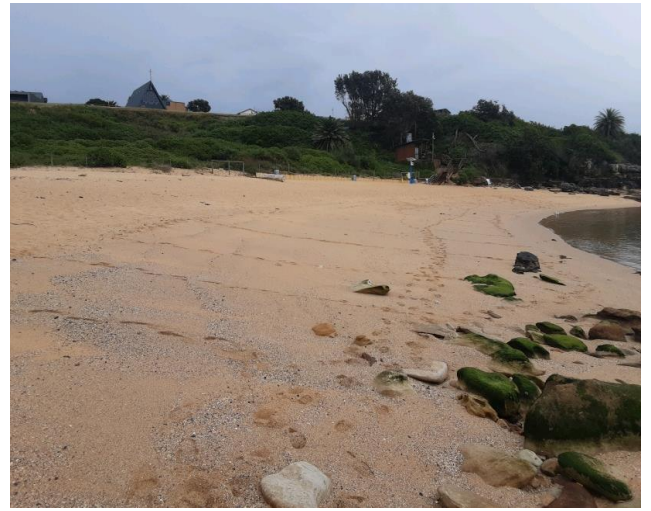
Notes: Southern beach at time of clearance
