Asbestos Containing Material Clearance Inspection

25 December 2022

Site:	Little Bay Beach
Location:	Southern, Western and Northern Little Bay Beach

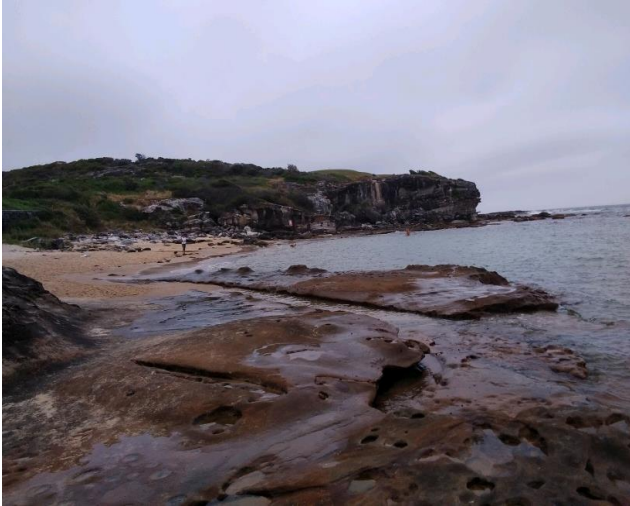
Notes: Overview of Northern beach

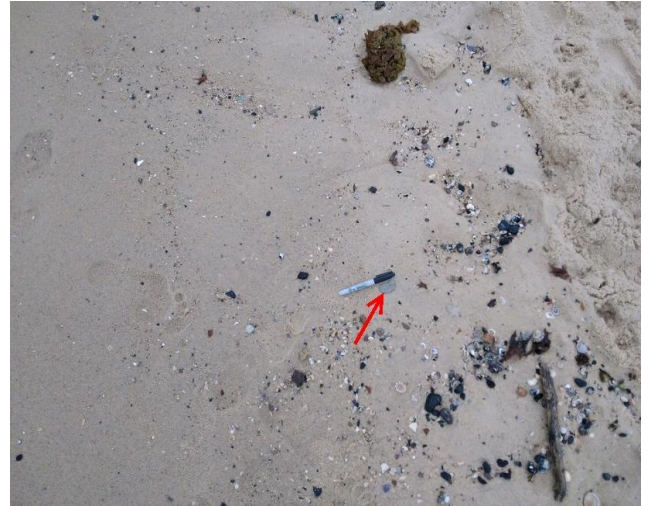
Notes: Overview of removal item within Northern beach prior to removal

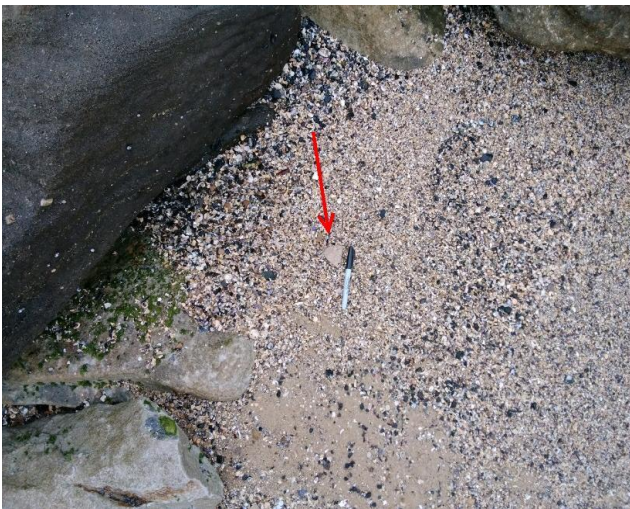
Notes: Overview of removal item within Northern beach prior to removal

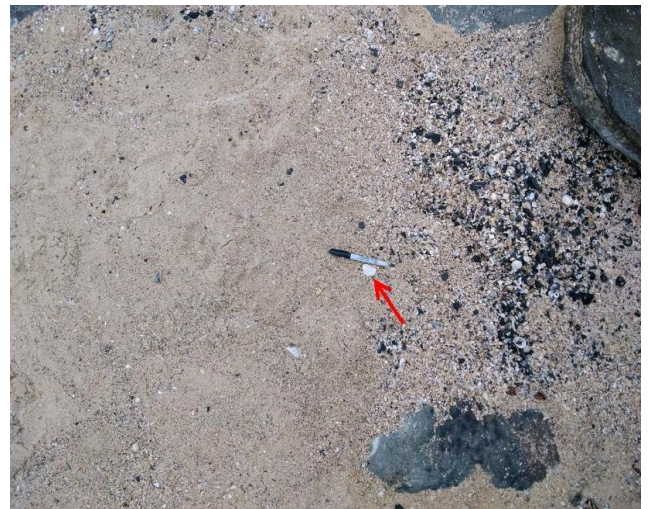
Notes: Overview of removal item within Northern beach prior to removal

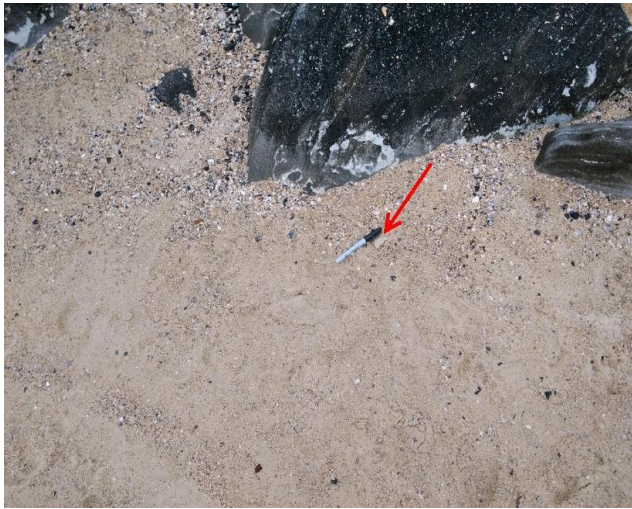
Notes: Overview of removal item within Northern beach prior to removal

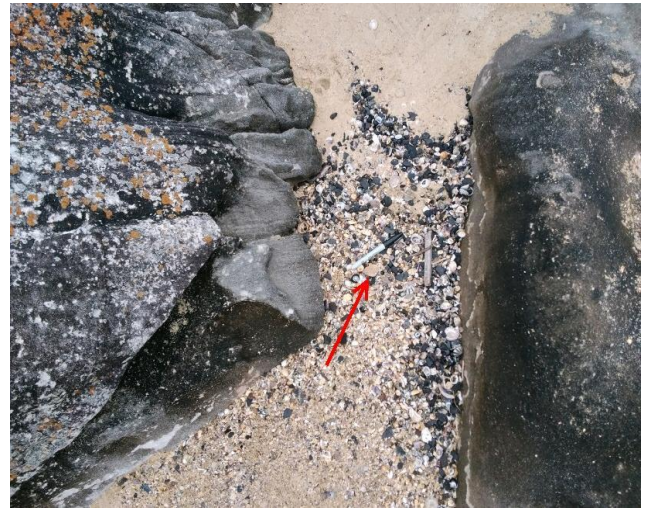
Notes: Overview of removal item within Northern beach prior to removal

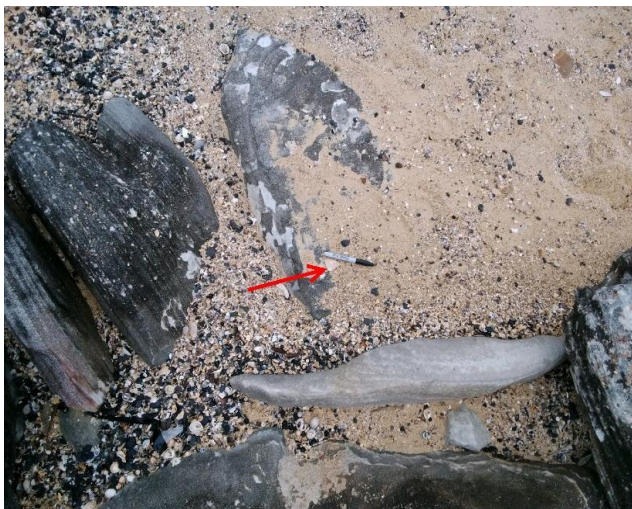
Notes: Overview of removal item within Northern beach prior to removal

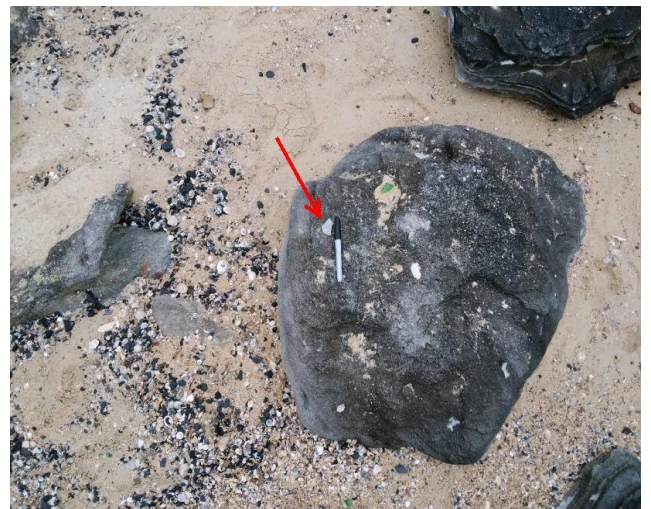
Notes: Overview of removal item within Northern beach prior to removal

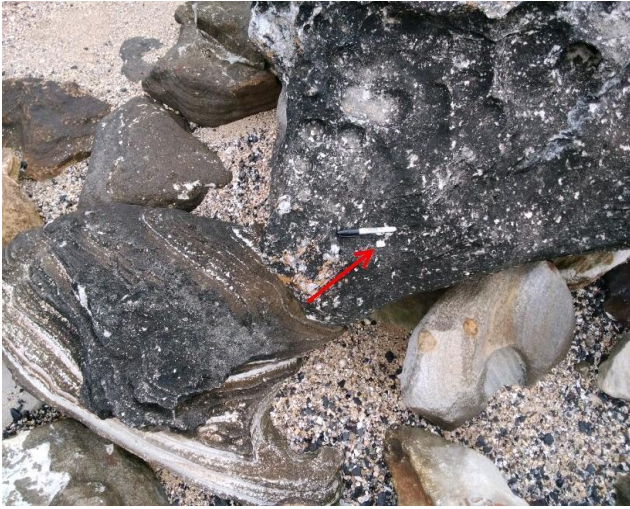
Notes: Overview of removal item within Northern beach prior to removal

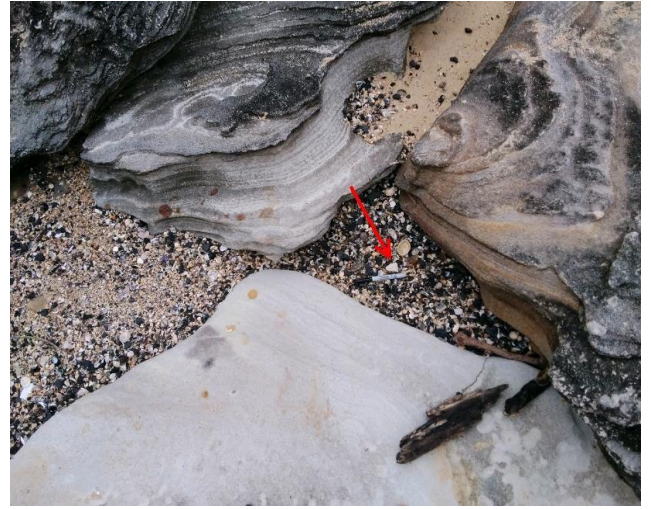
Notes: Overview of removal item within Northern beach prior to removal

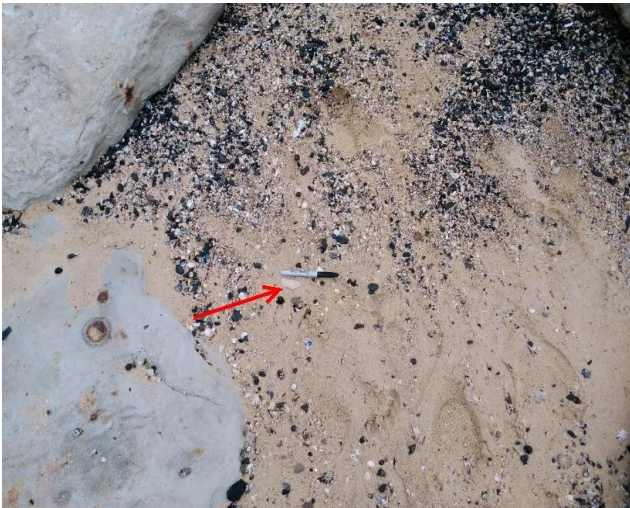
Notes: Overview of removal item within Northern beach prior to removal

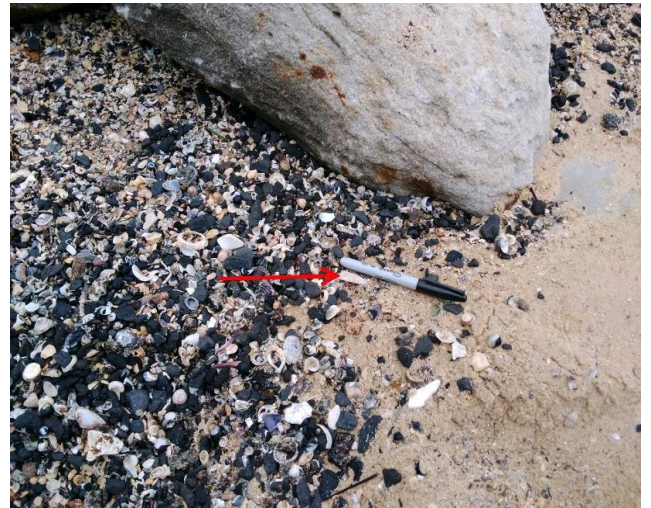
Notes: Overview of removal item within Northern beach prior to removal

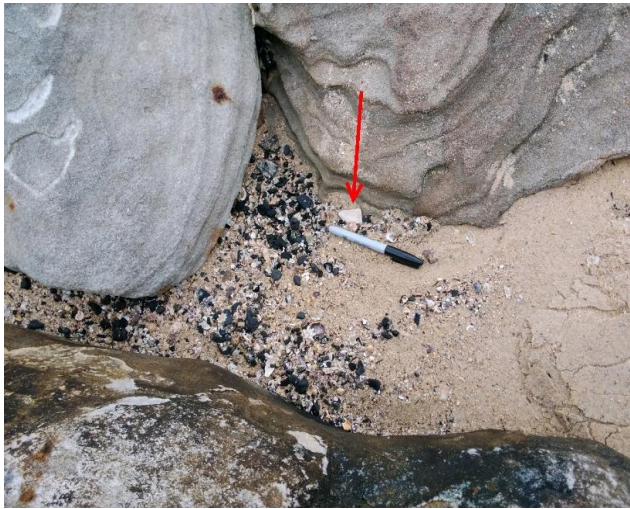
Notes: Overview of removal item within Northern beach prior to removal

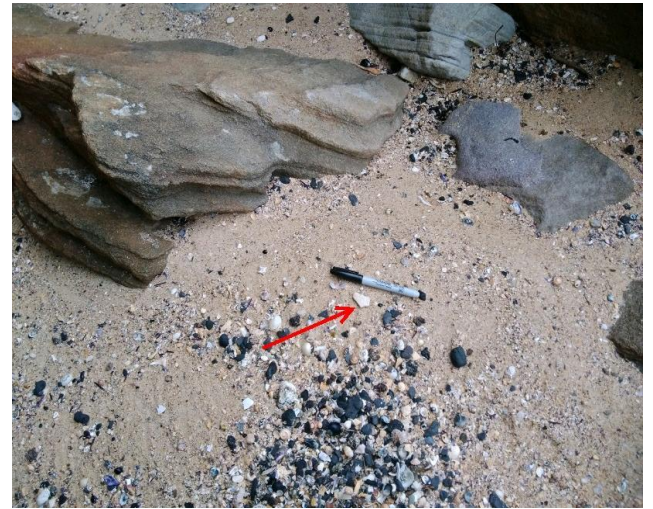
Notes: Overview of removal item within Northern beach prior to removal

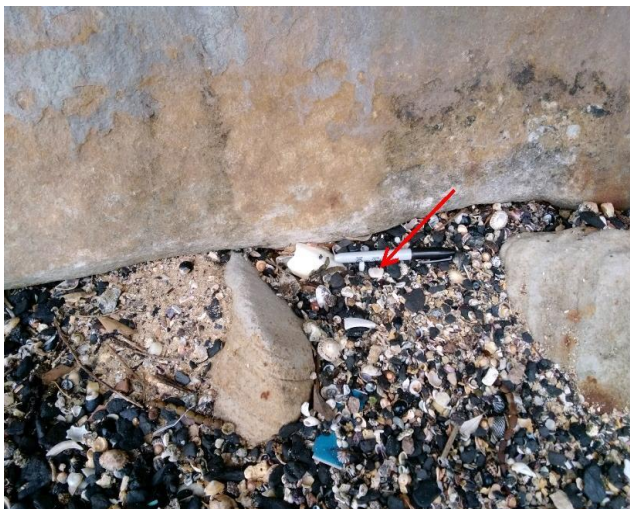
Notes: Overview of removal item within Northern beach prior to removal

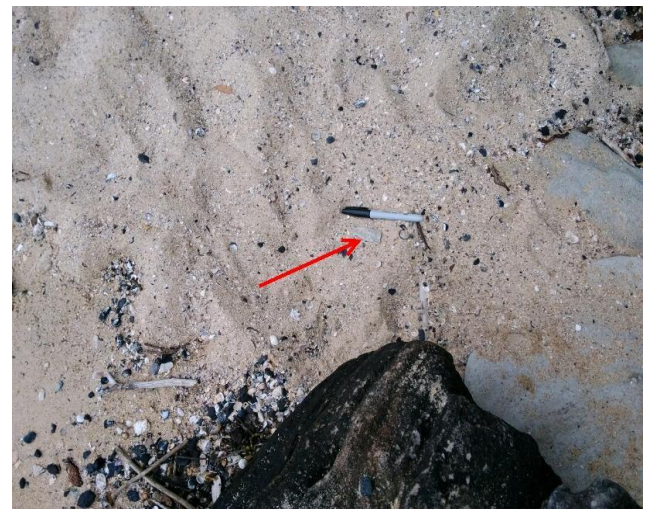
Notes: Overview of removal item within Northern beach prior to removal

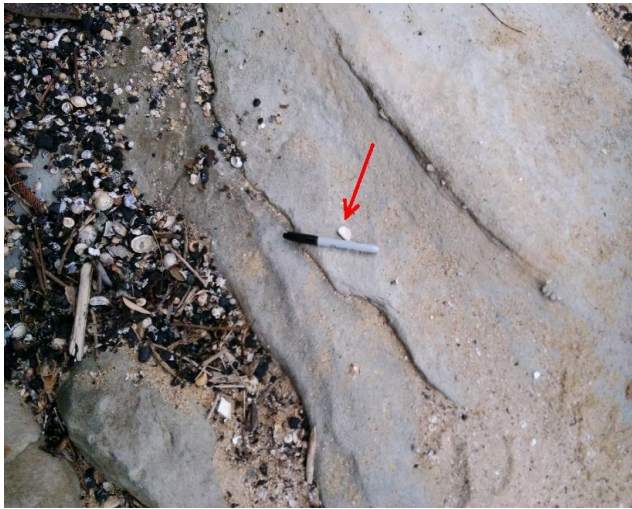
Notes: Overview of removal item within Northern beach prior to removal

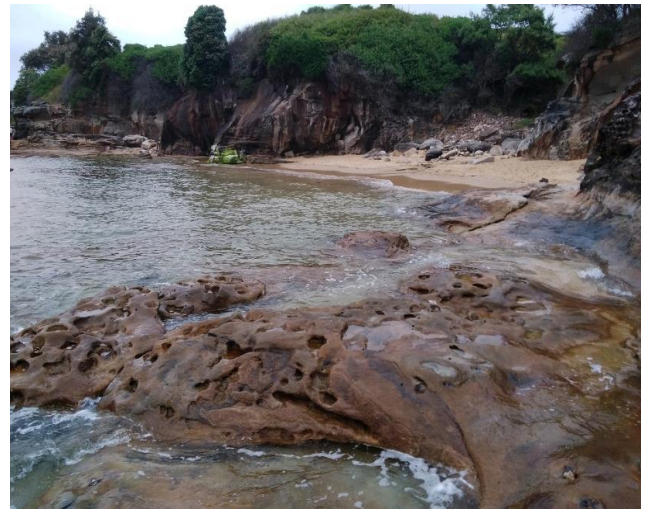
Notes: Overview of Western Beach

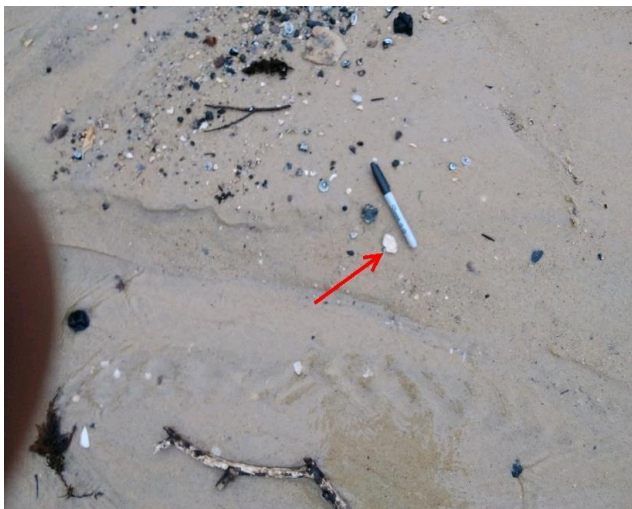
Notes: Overview of removal item within Western beach prior to removal

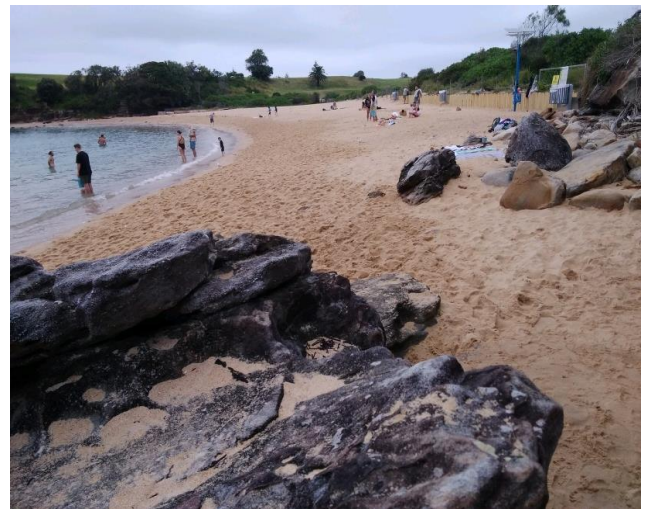
Notes: Overview of Southern beach

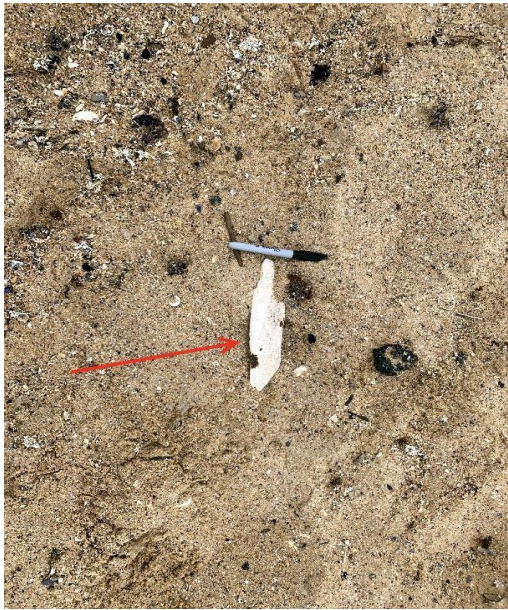
Notes: Overview of removal item within Southern beach prior to removal

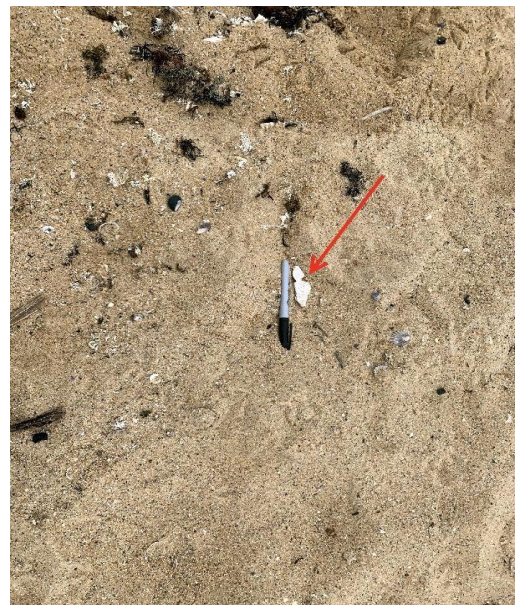
Notes: Overview of removal item within Southern beach prior to removal

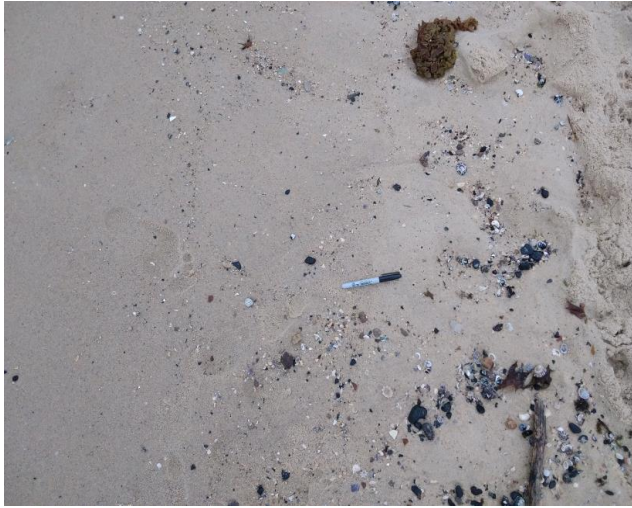
Notes: Visual surface clearance inspection following removal of ACM fragment.

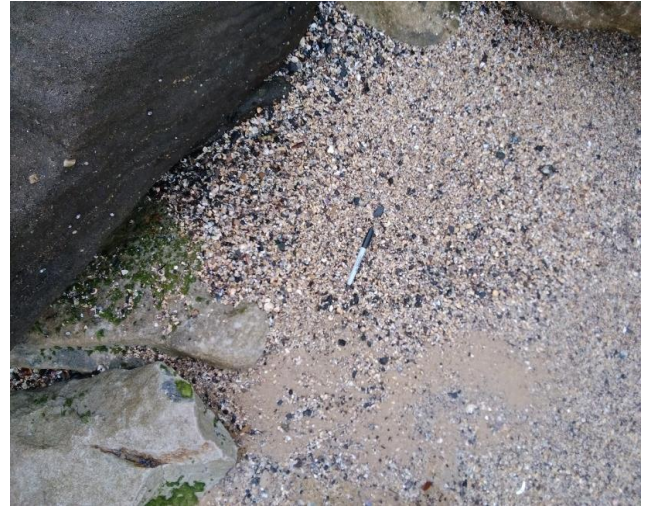
Notes: Visual surface clearance inspection following removal of ACM fragment.

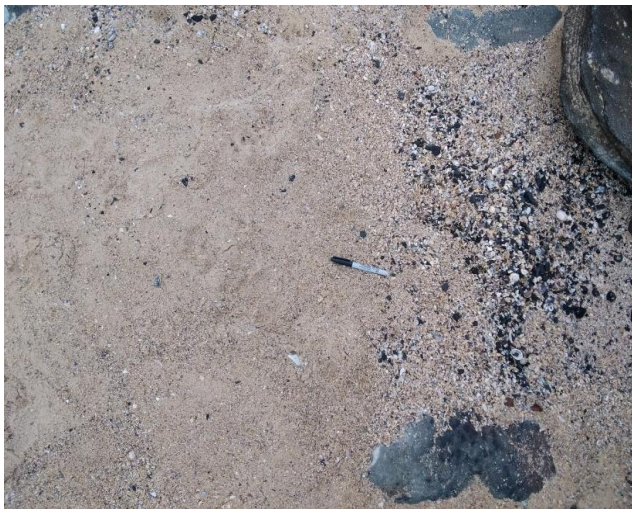
Notes: Visual surface clearance inspection following removal of ACM fragment.

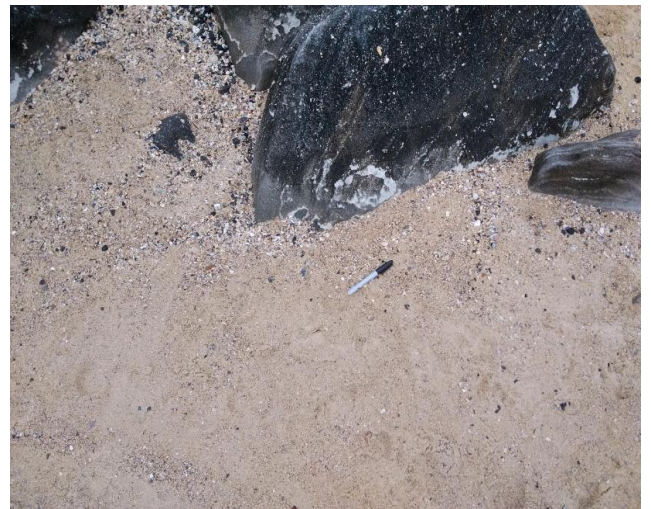
Notes: Visual surface clearance inspection following removal of ACM fragment.

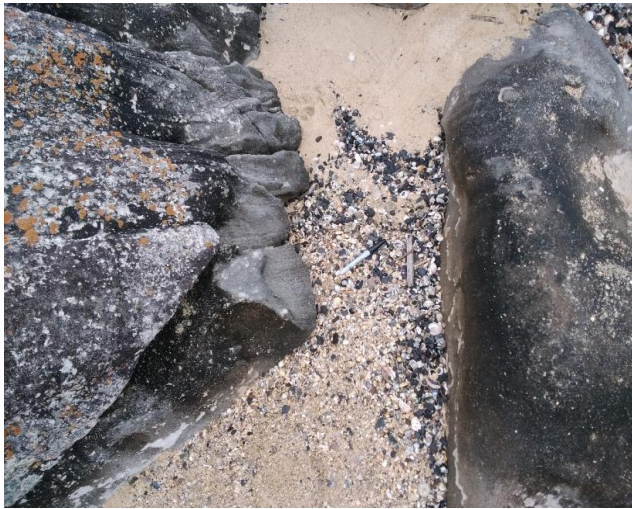
Notes: Visual surface clearance inspection following removal of ACM fragment.

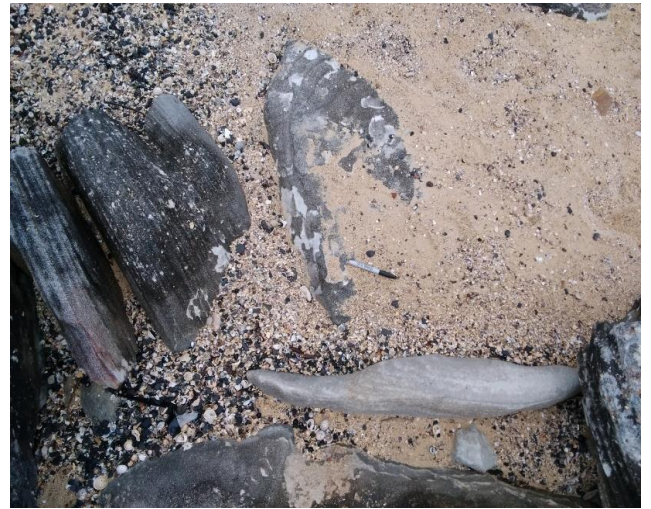
Notes: Visual surface clearance inspection following removal of ACM fragment.

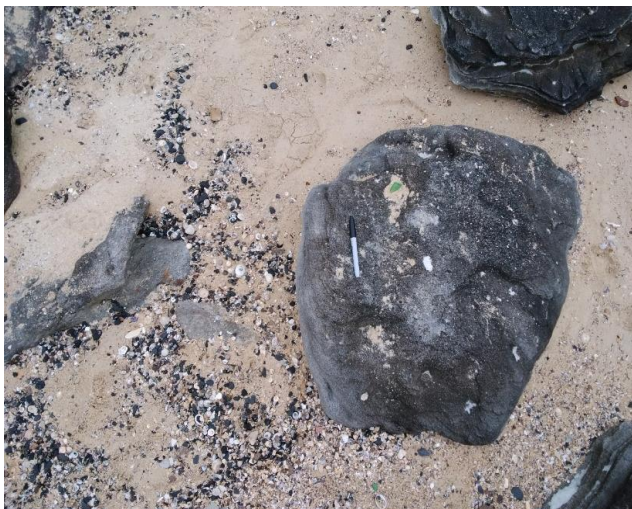
Notes: Visual surface clearance inspection following removal of ACM fragment.

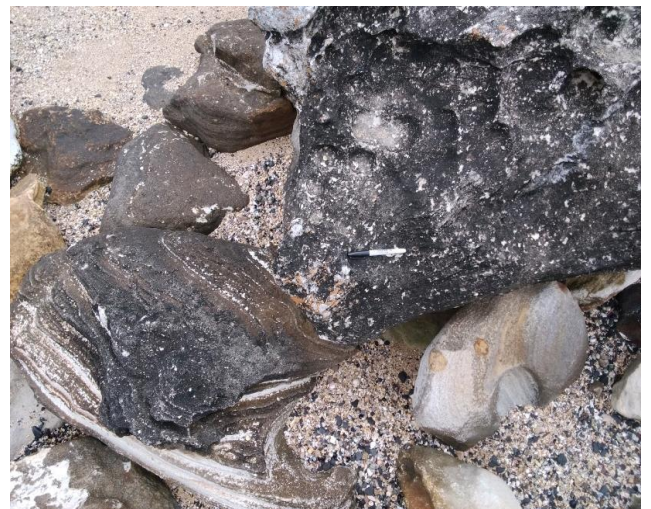
Notes: Visual surface clearance inspection following removal of ACM fragment.

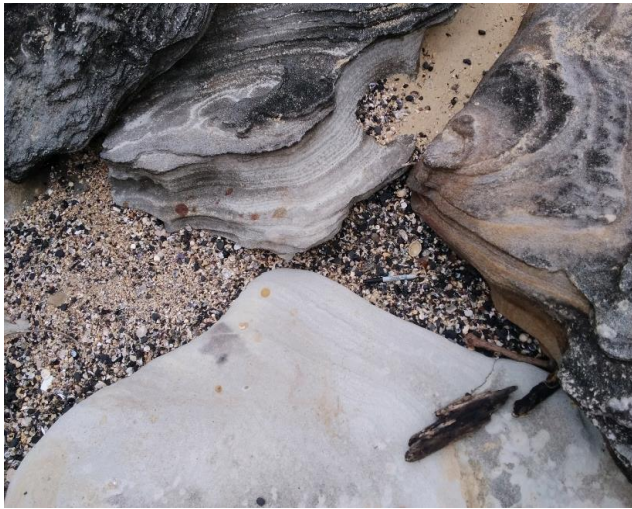
Notes: Visual surface clearance inspection following removal of ACM fragment.

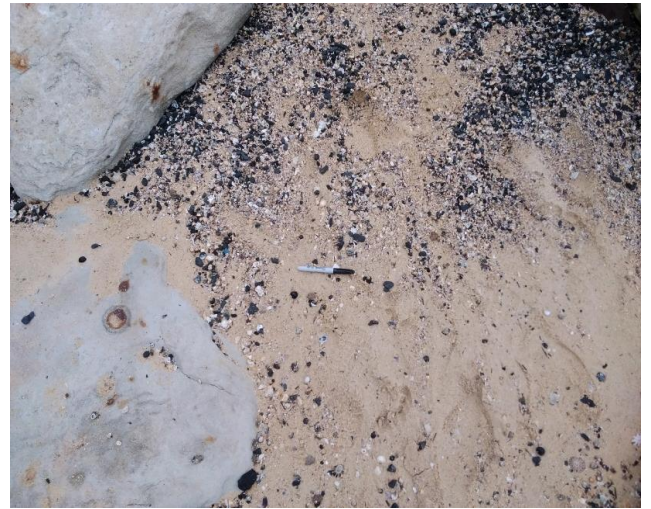
Notes: Visual surface clearance inspection following removal of ACM fragment.

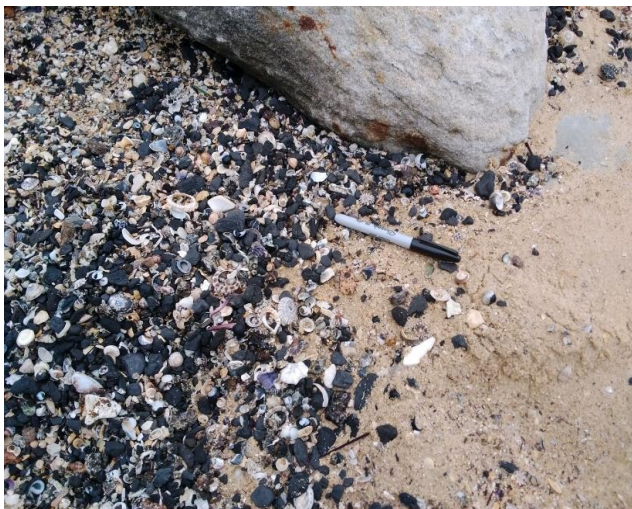
Notes: Visual surface clearance inspection following removal of ACM fragment.

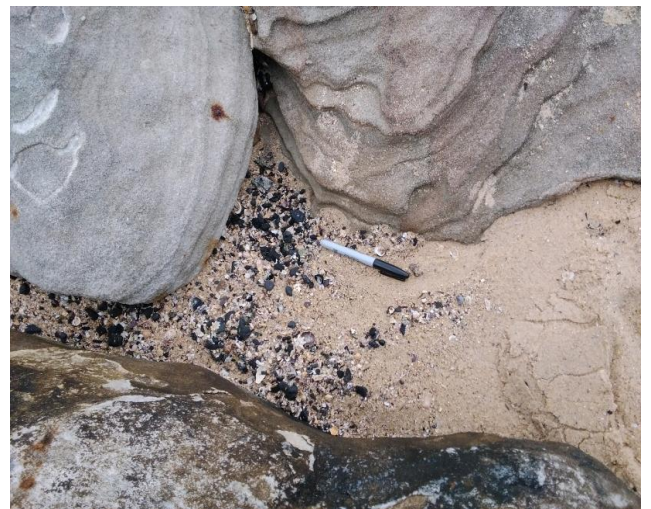
Notes: Visual surface clearance inspection following removal of ACM fragment.

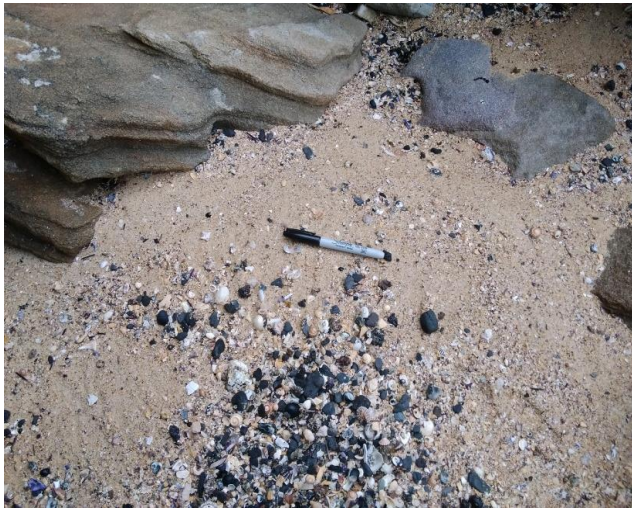
Notes: Visual surface clearance inspection following removal of ACM fragment.

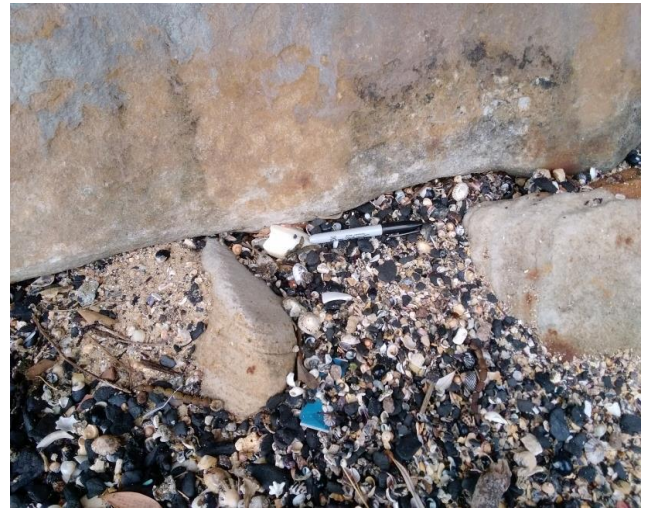
Notes: Visual surface clearance inspection following removal of ACM fragment.

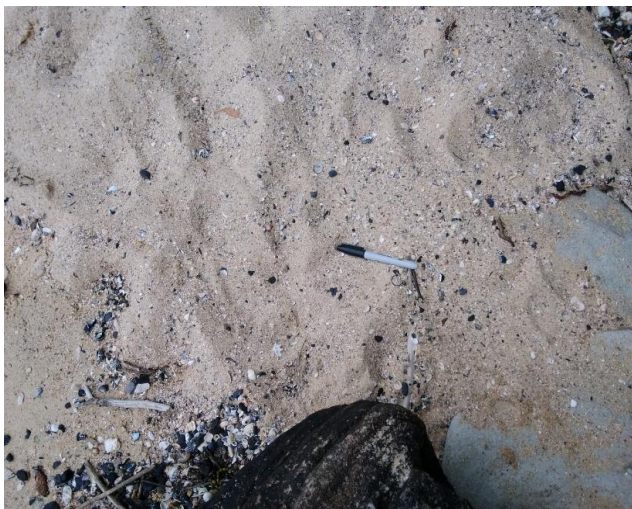
Notes: Visual surface clearance inspection following removal of ACM fragment.

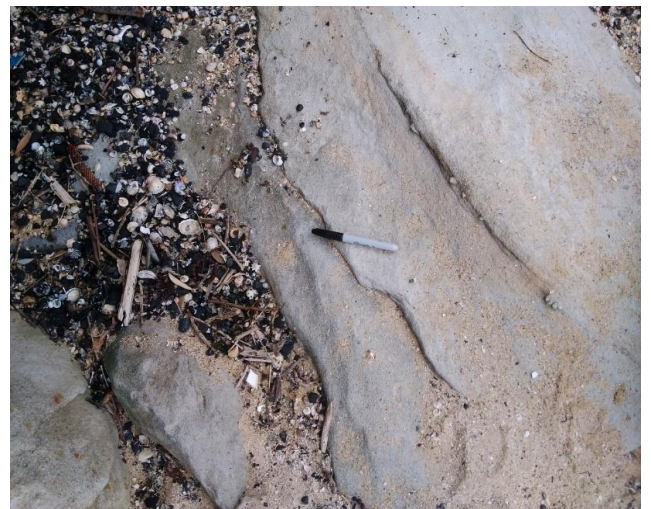
Notes: Visual surface clearance inspection following removal of ACM fragment.

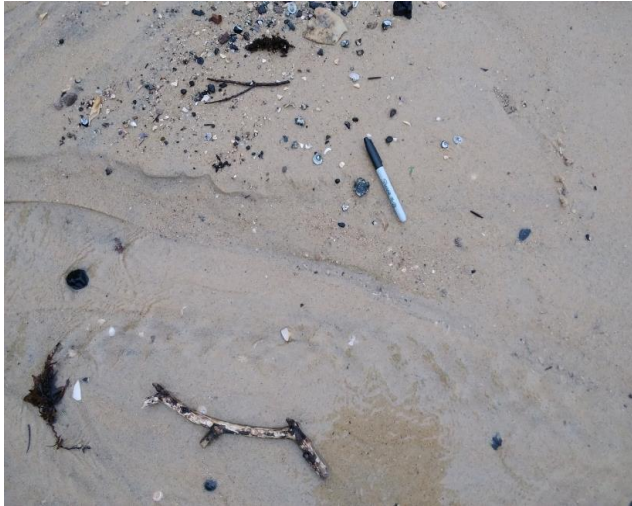
Notes: Visual surface clearance inspection following removal of ACM fragment.

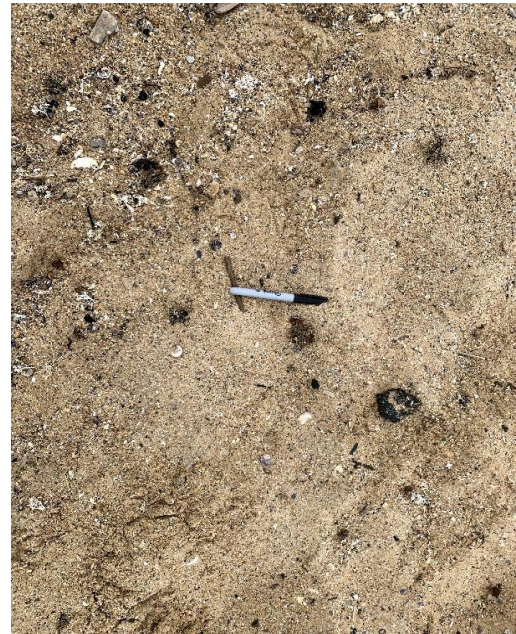
Notes: Visual surface clearance inspection following removal of ACM fragment.

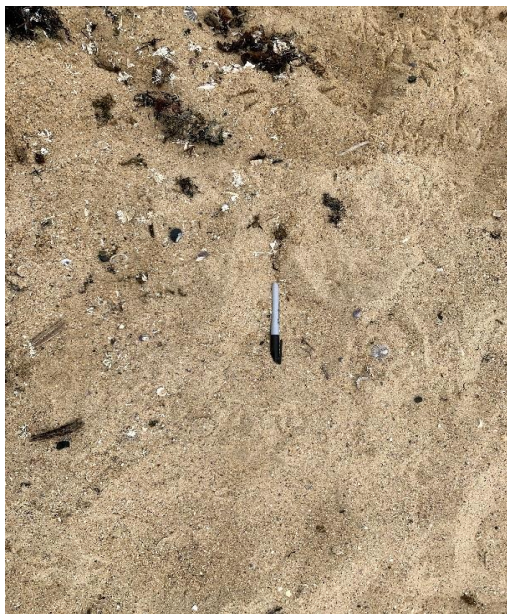
Notes: Visual surface clearance inspection following removal of ACM fragment.

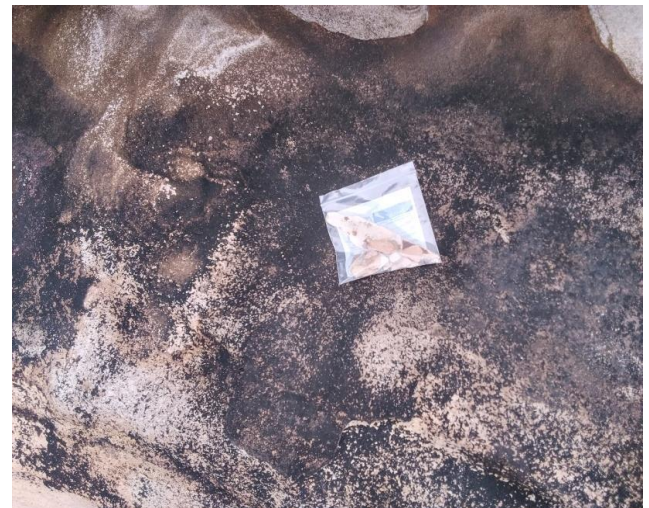
Notes: Waste disposal management.
