Asbestos Containing Material Clearance Inspection

20 January 2023

Site:	Little Bay Beach
Location:	Southern, Western and Northern Little Bay Beach

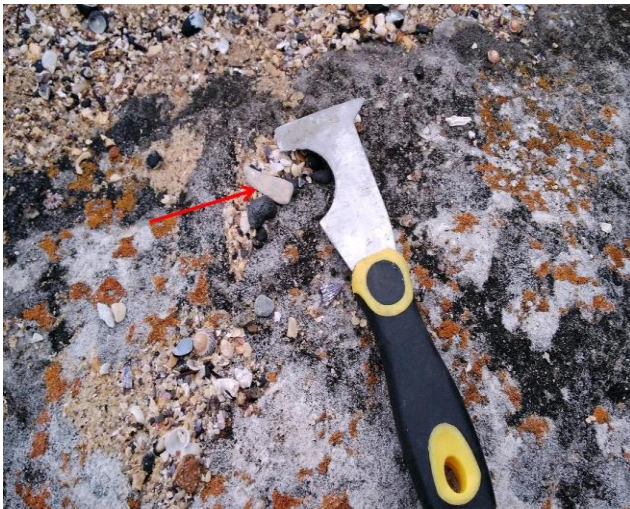
Notes: FC fragment identified on sand surface prior to emu pick - Northern section

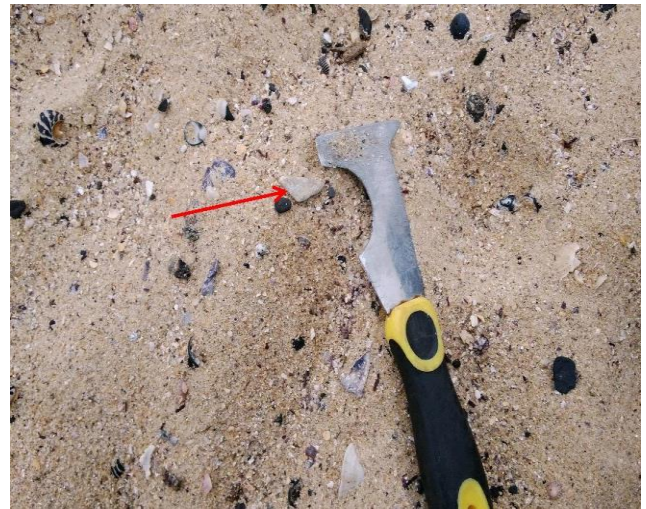
Notes: FC fragment identified on sand surface prior to emu pick - Northern section

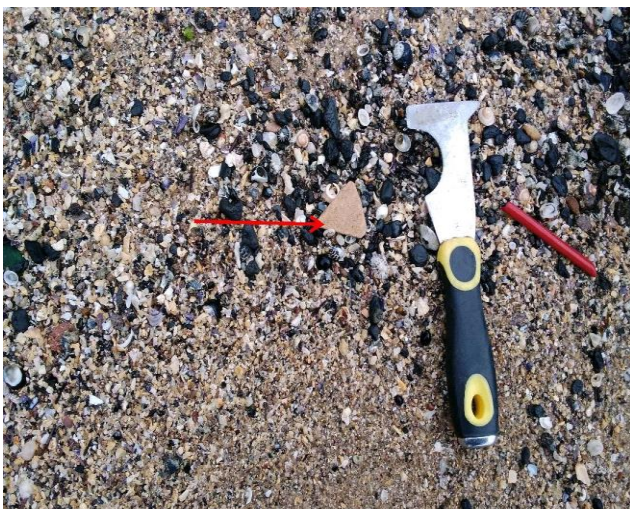
Notes: FC fragment identified on sand surface prior to emu pick - Northern section

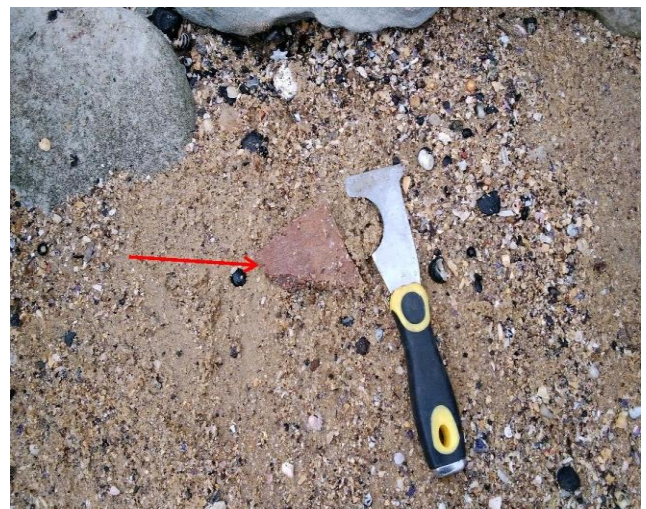
Notes: FC fragment identified on sand surface prior to emu pick - Northern section

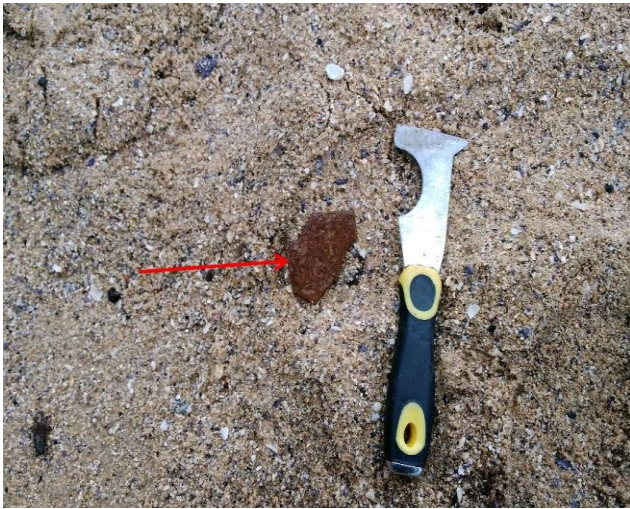
Notes: FC fragment identified on sand surface prior to emu pick - Northern section

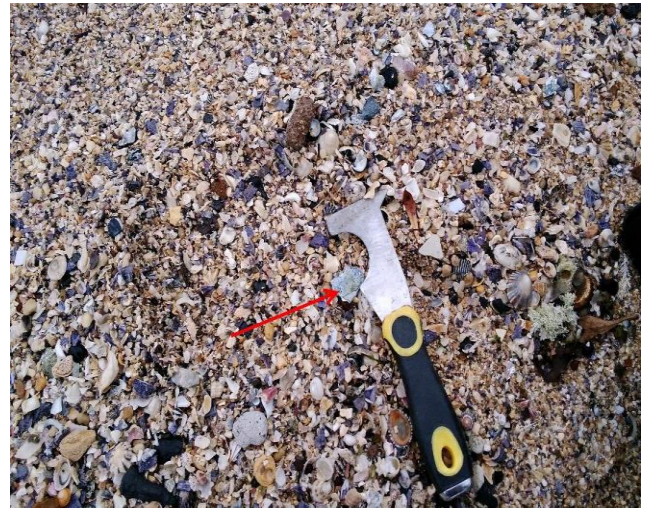
Notes: FC fragment identified on sand surface prior to emu pick - Northern section

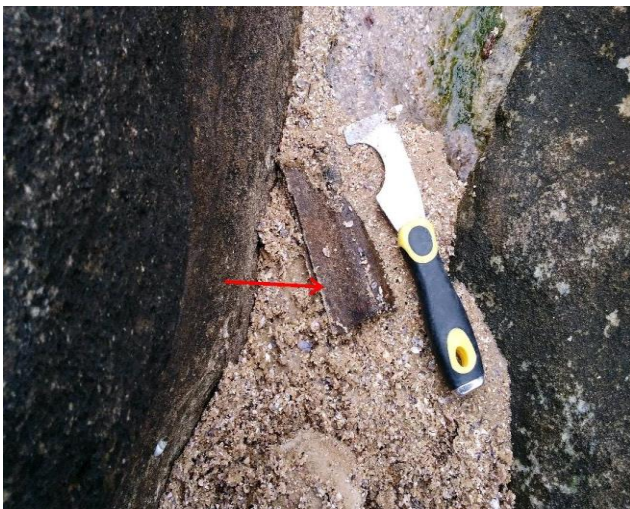
Notes: FC fragment identified on sand surface prior to emu pick - Southern section

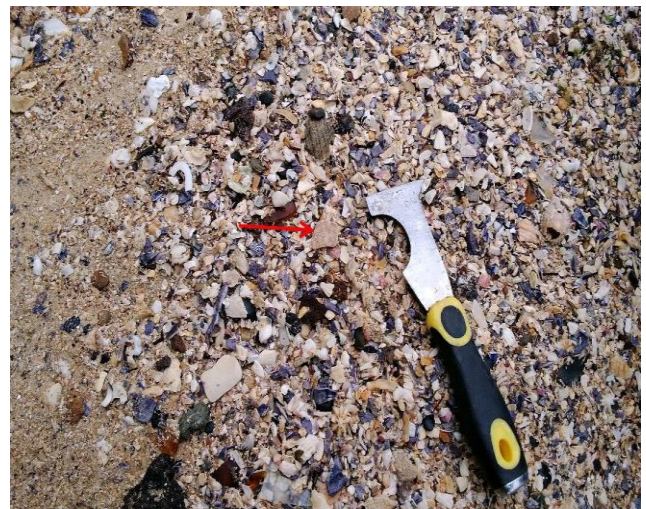
Notes: FC fragment identified on sand surface prior to emu pick - Southern section

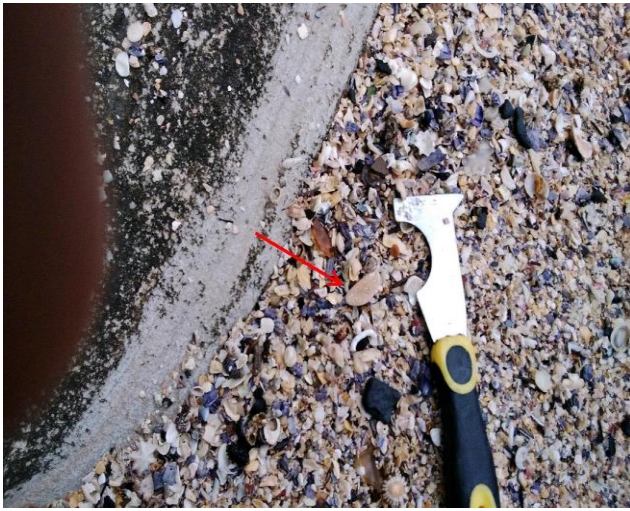
Notes: FC fragment identified on sand surface prior to emu pick - Southern section

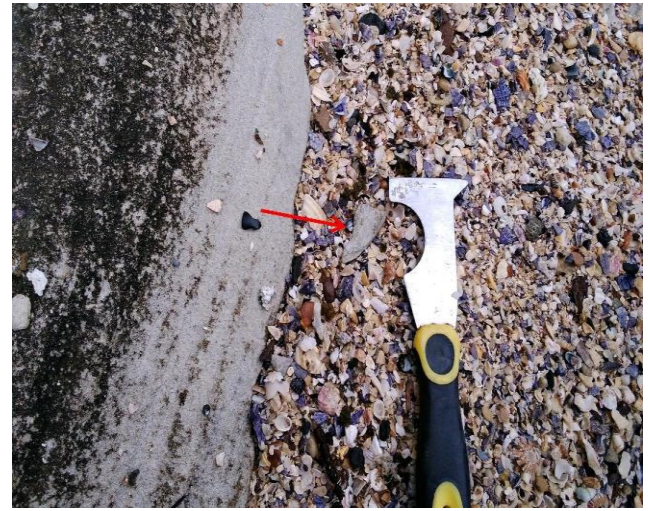
Notes: FC fragment identified on sand surface prior to emu pick - Southern section

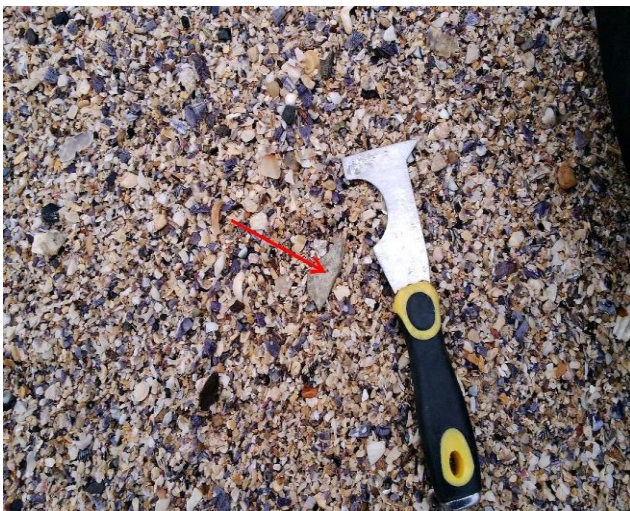
Notes: FC fragment identified on sand surface prior to emu pick - Southern section

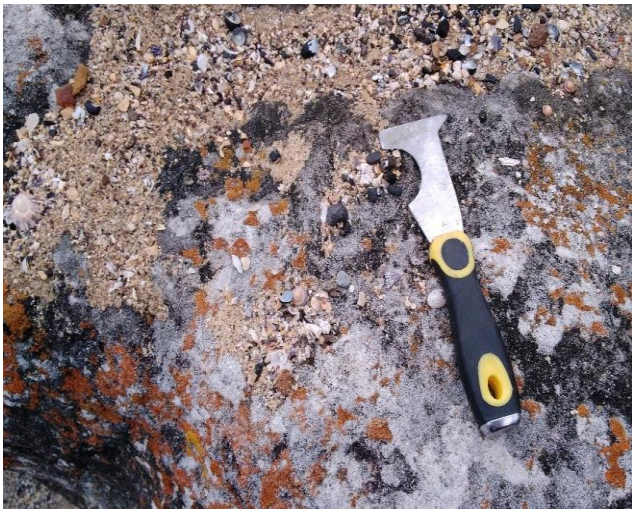
Notes: Sand surface following emu pick - Northern section

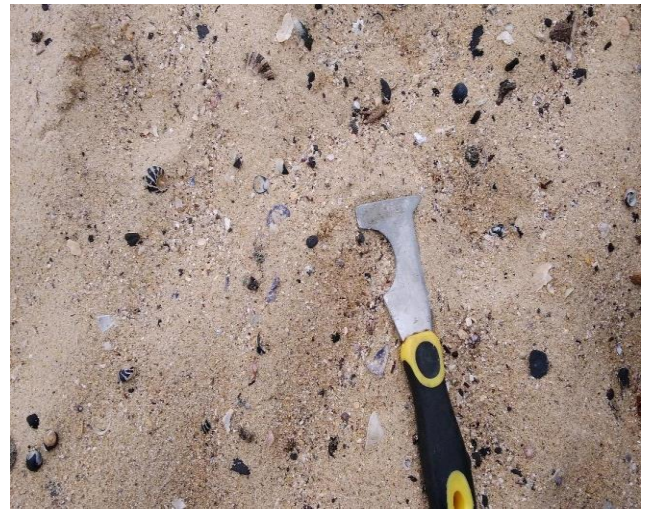
Notes: Sand surface following emu pick - Northern section

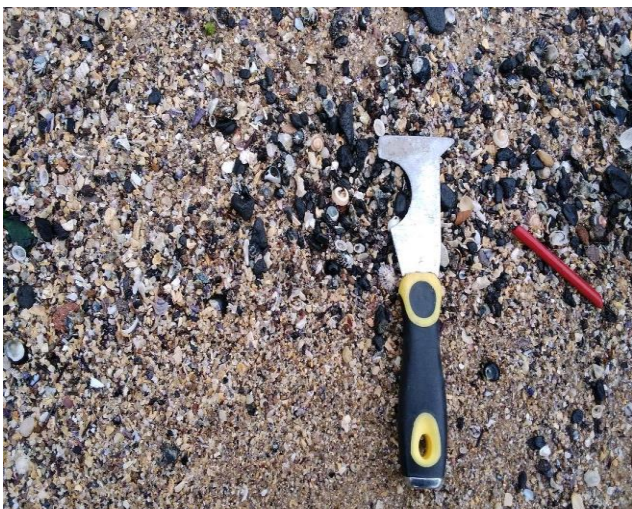
Notes: Sand surface following emu pick - Northern section

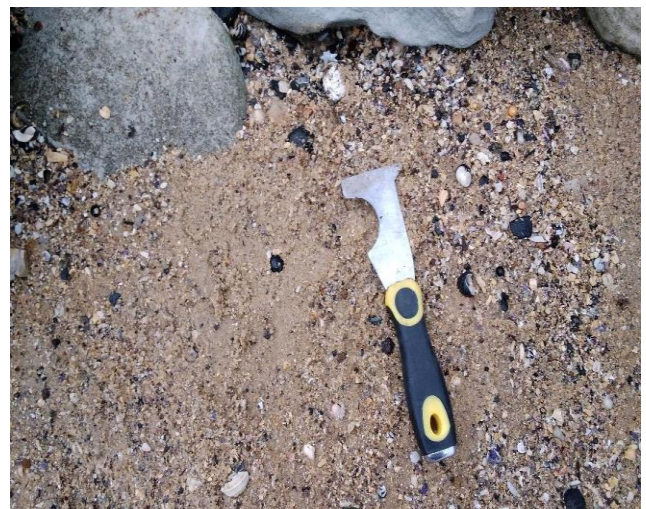
Notes: Sand surface following emu pick - Northern section

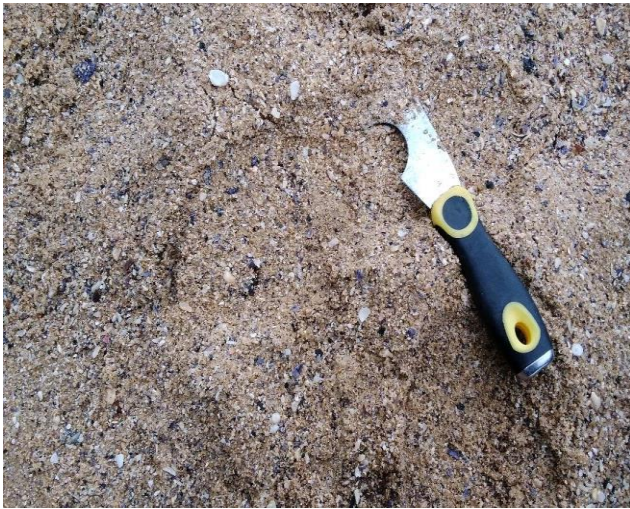
Notes: Sand surface following emu pick - Northern section

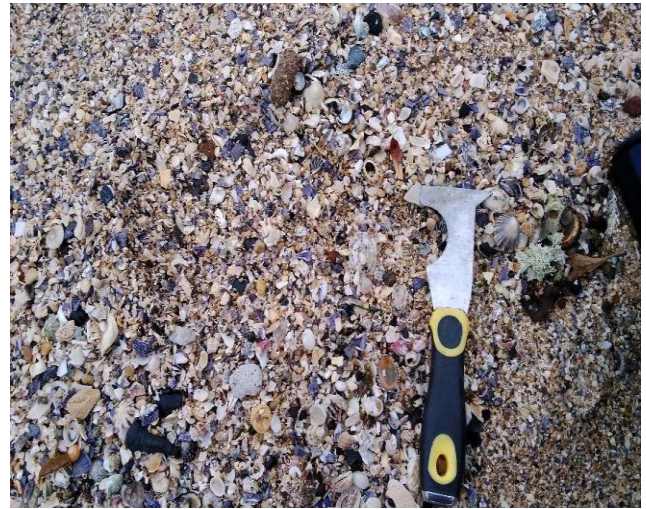
Notes: Sand surface following emu pick - Northern section

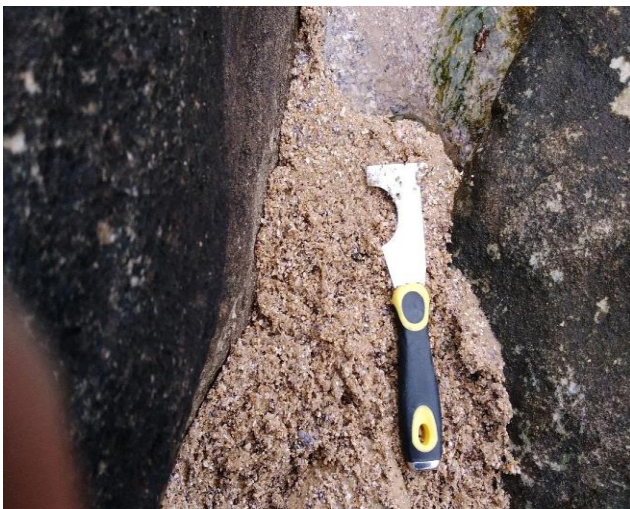
Notes: Sand surface following emu pick - Southern section

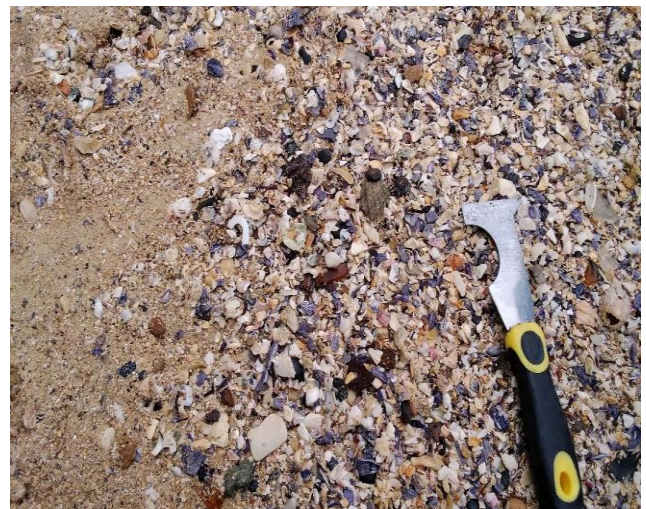
Notes: Sand surface following emu pick - Southern section

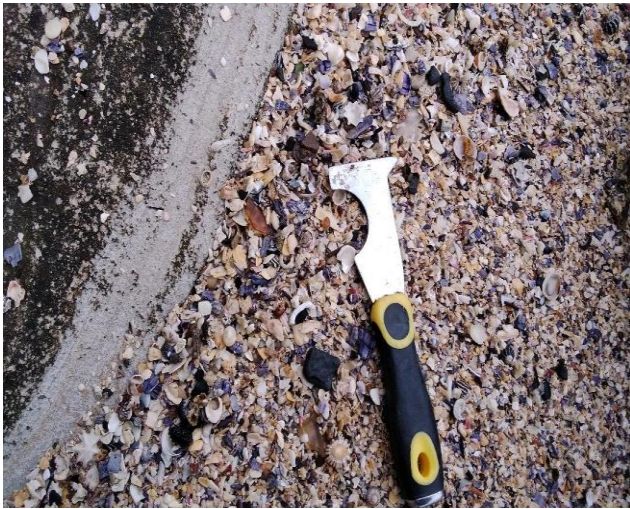
Notes: Sand surface following emu pick - Southern section

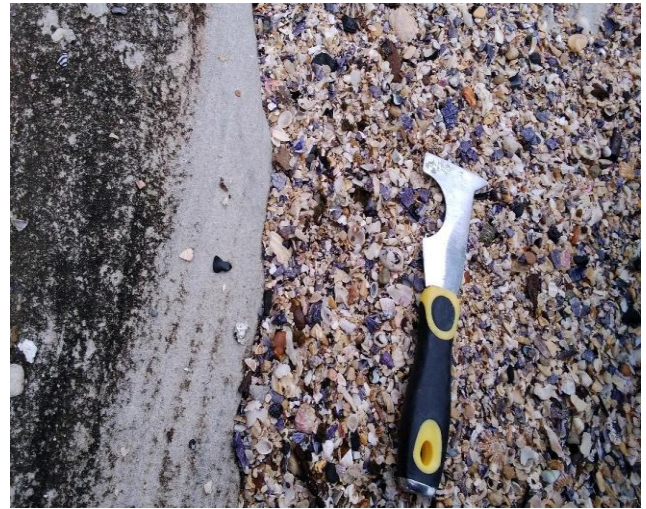
Notes: Sand surface following emu pick - Southern section

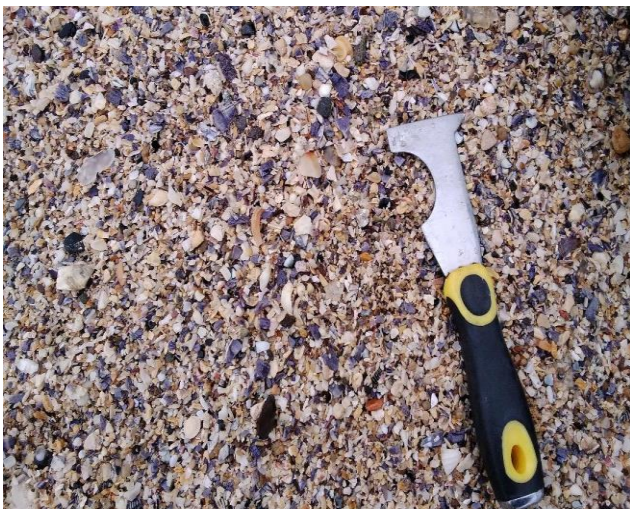
Notes: Sand surface following emu pick - Southern section
