# Asbestos Containing Material Clearance Inspection

3 March 2023

<b>Site:</b>	Little Bay Beach
<b>Location:</b>	Southern, Western and Northern Little Bay Beach

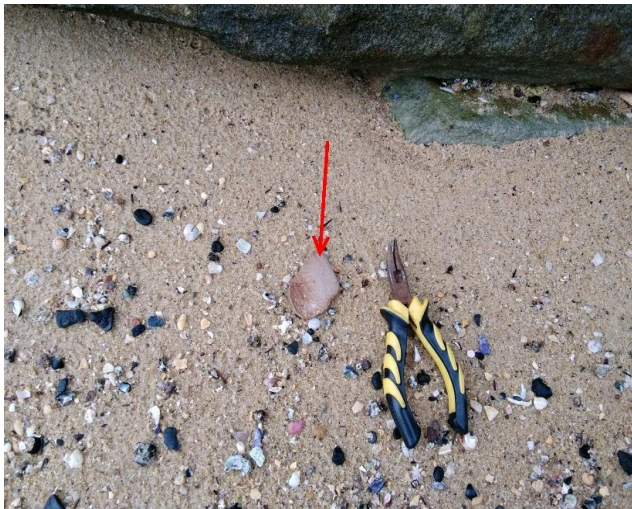
**Notes:** FC fragment identified on sand surface prior to emu pick - Northern section

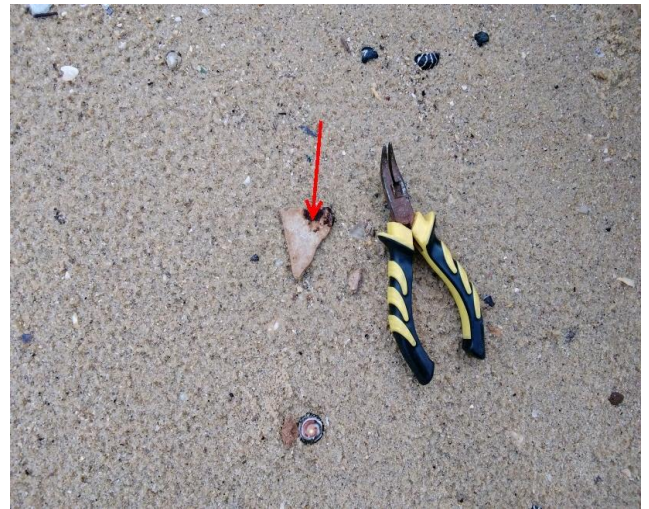
**Notes:** FC fragment identified on sand surface prior to emu pick - Northern section

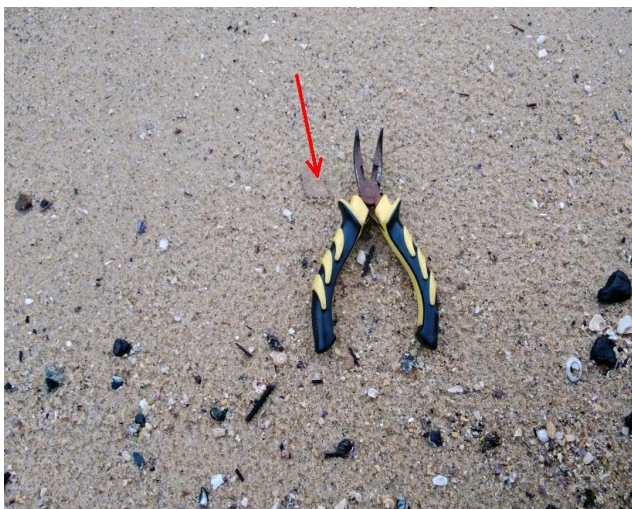
**Notes:** FC fragment identified on sand surface prior to emu pick - Northern section

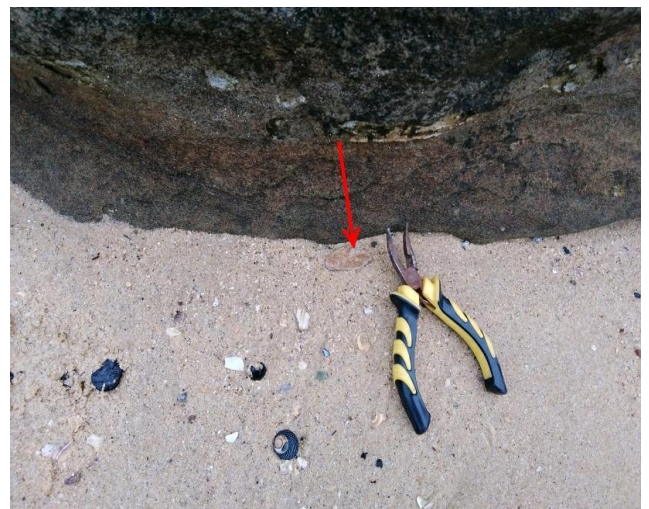
**Notes:** FC fragment identified on sand surface prior to emu pick - Northern section

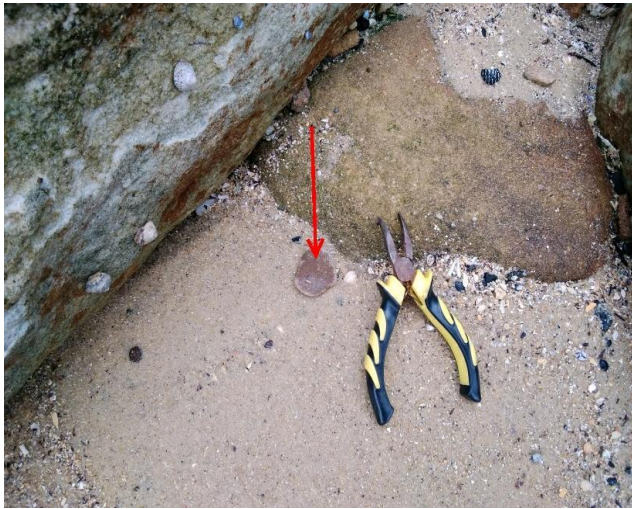
**Notes:** FC fragment identified on sand surface prior to emu pick - Northern section

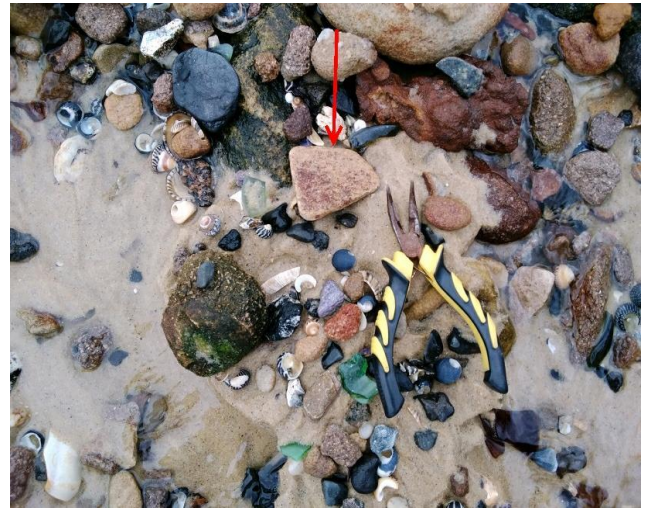
**Notes:** FC fragment identified on sand surface prior to emu pick - Northern section

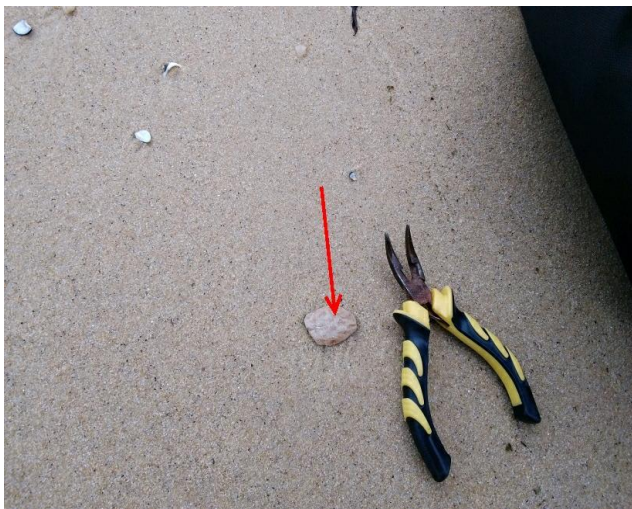
**Notes:** FC fragment identified on sand surface prior to emu pick - Northern section

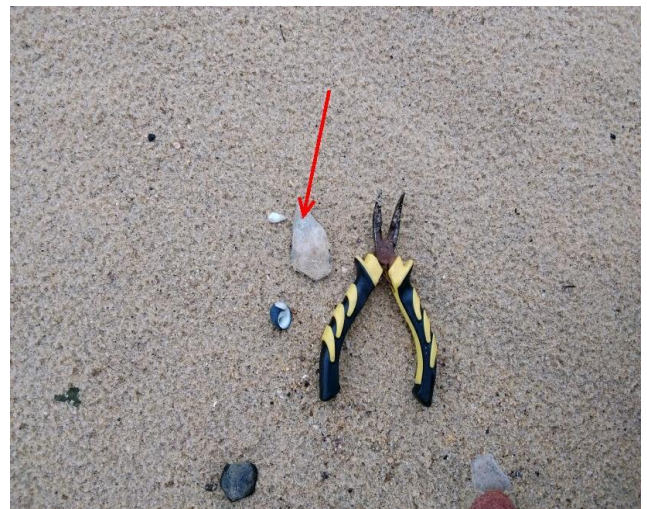
**Notes:** FC fragment identified on sand surface prior to emu pick - Northern section

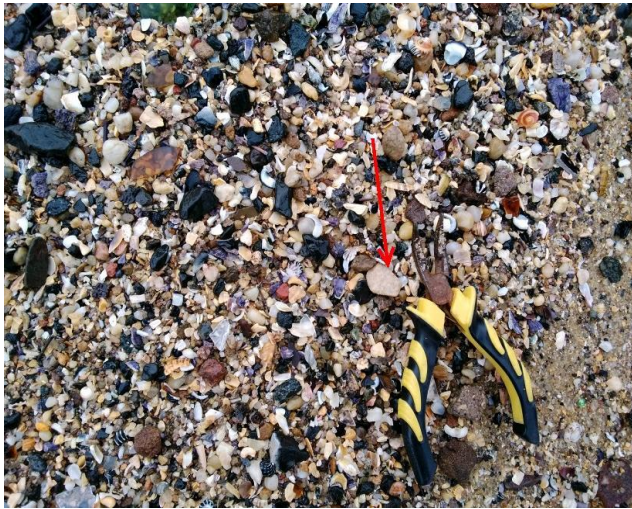
**Notes:** FC fragment identified on sand surface prior to emu pick - Northern section

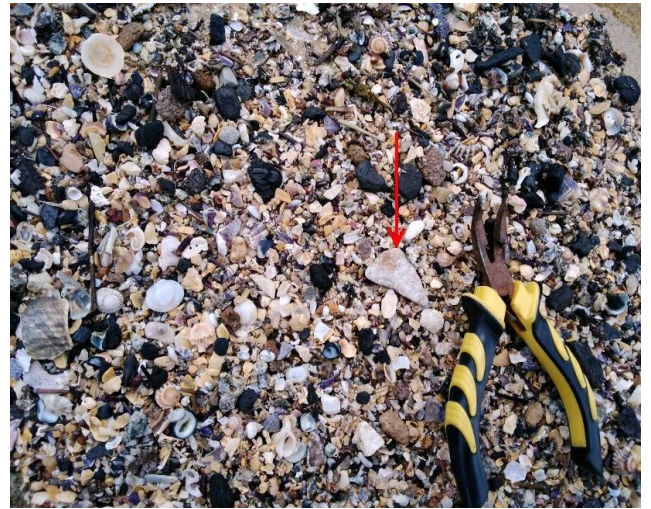
**Notes:** FC fragment identified on sand surface prior to emu pick - Northern section

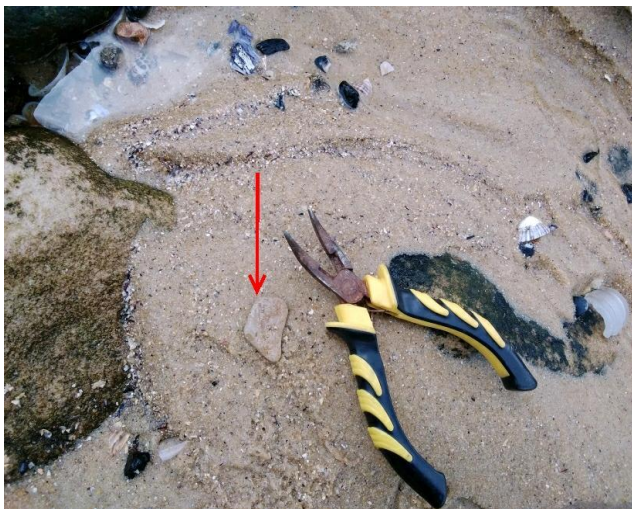
**Notes:** FC fragment identified on sand surface prior to emu pick - Northern section

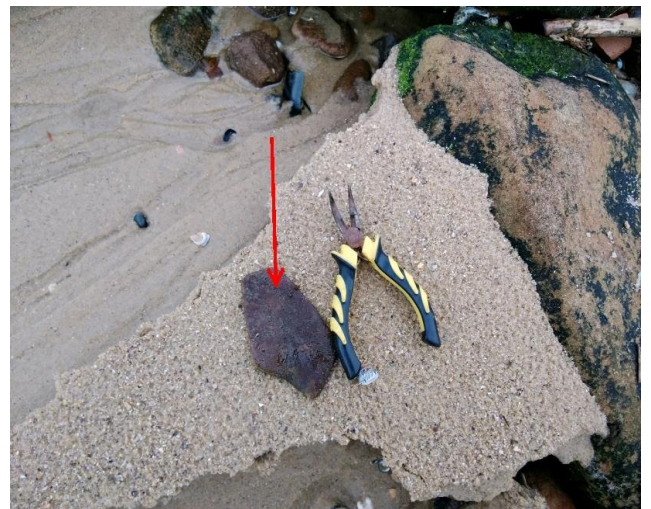
**Notes:** FC fragment identified on sand surface prior to emu pick - Northern section

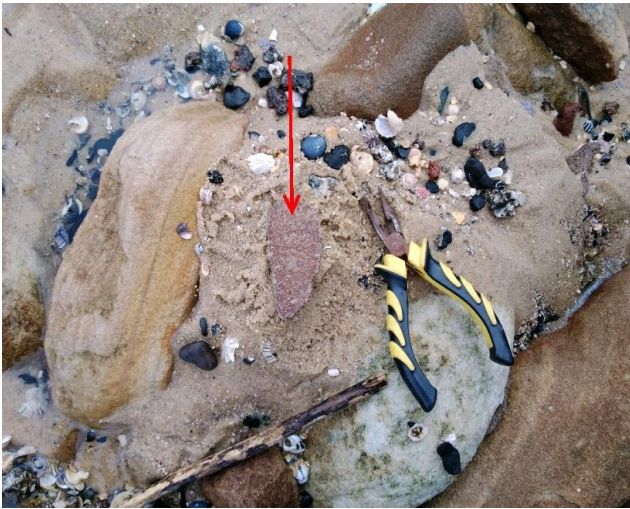
**Notes:** FC fragment identified on sand surface prior to emu pick - Northern section

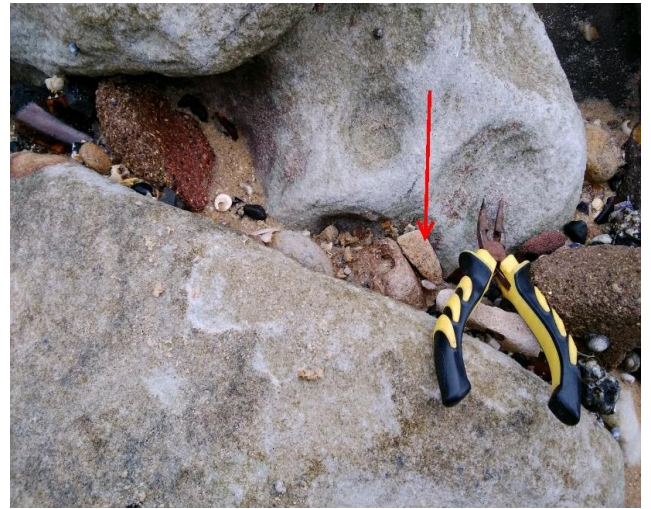
**Notes:** FC fragment identified on sand surface prior to emu pick - Northern section

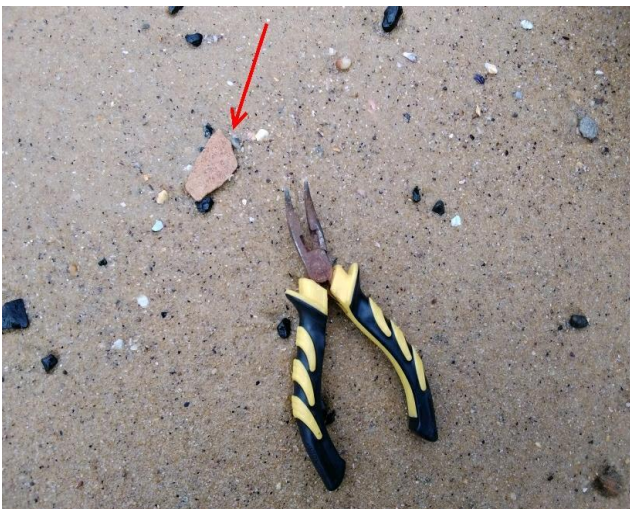
**Notes:** FC fragment identified on sand surface prior to emu pick - Western section

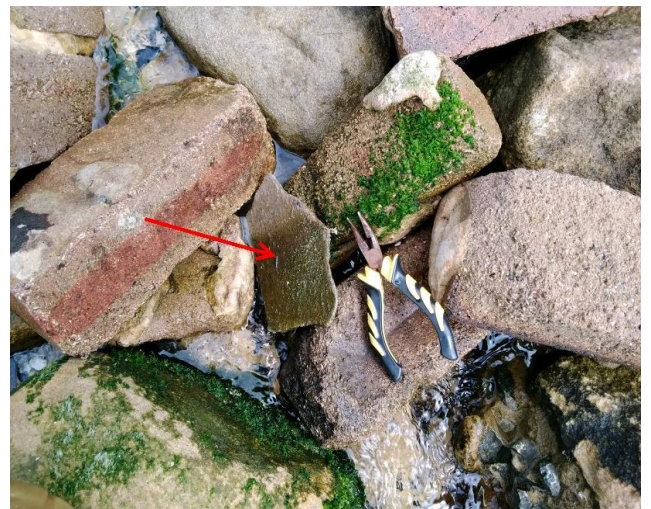
**Notes:** FC fragment identified on sand surface prior to emu pick - Western section

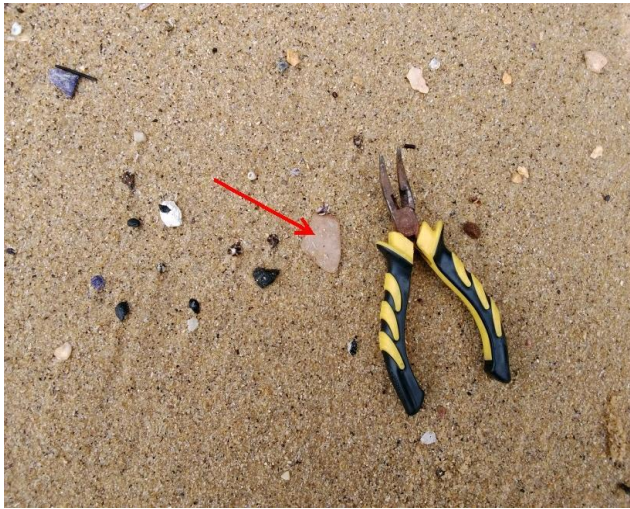
**Notes:** FC fragment identified on sand surface prior to emu pick - Western section

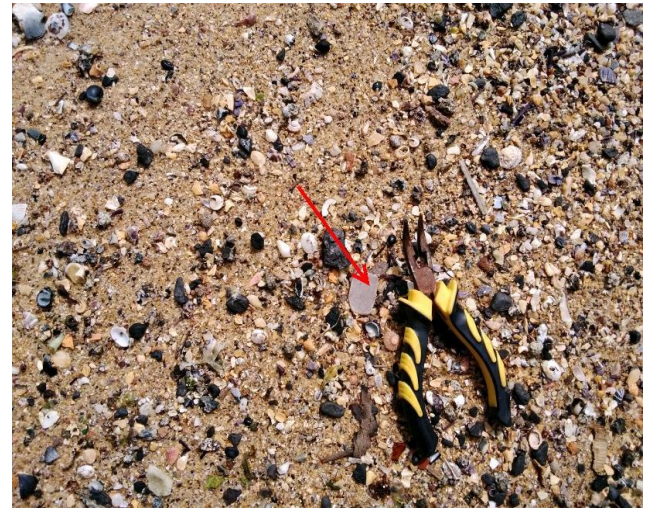
**Notes:** FC fragment identified on sand surface prior to emu pick - Western section

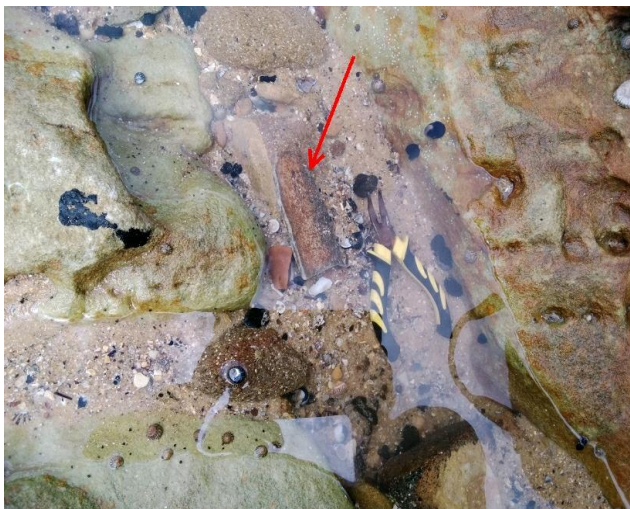
**Notes:** FC fragment identified on sand surface prior to emu pick - Western section

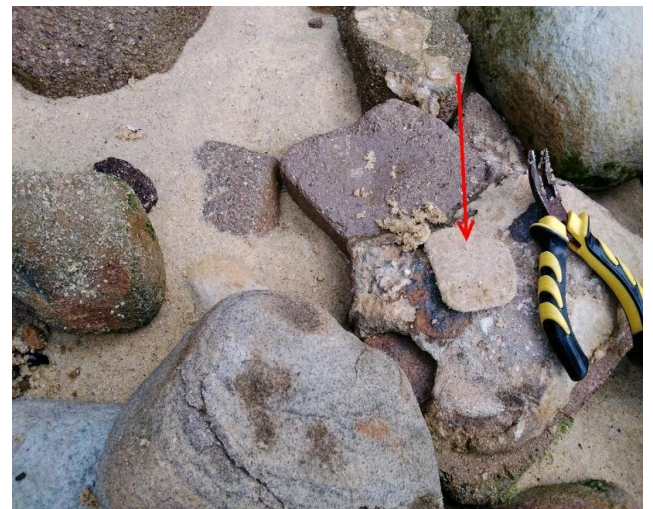
**Notes:** FC fragment identified on sand surface prior to emu pick - Western section

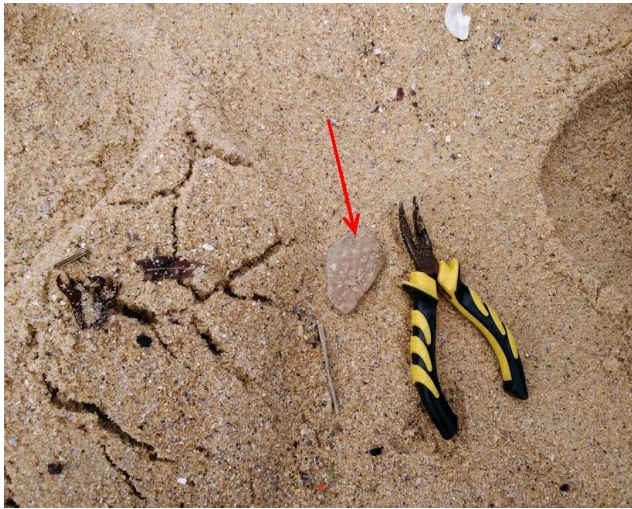
**Notes:** FC fragment identified on sand surface prior to emu pick - Southern section

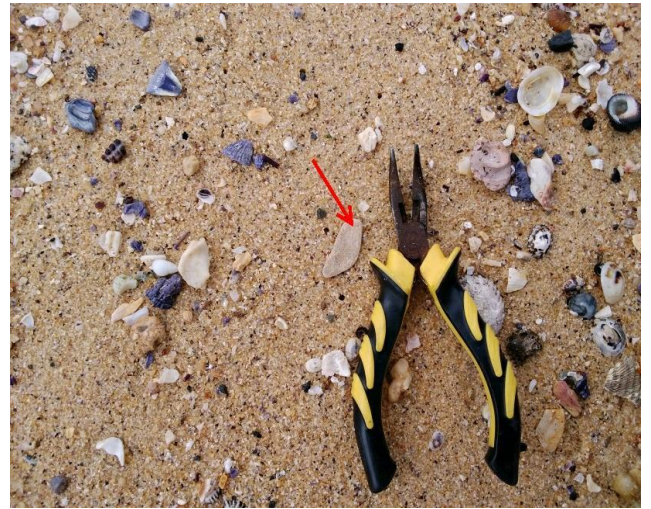
**Notes:** FC fragment identified on sand surface prior to emu pick - Southern section

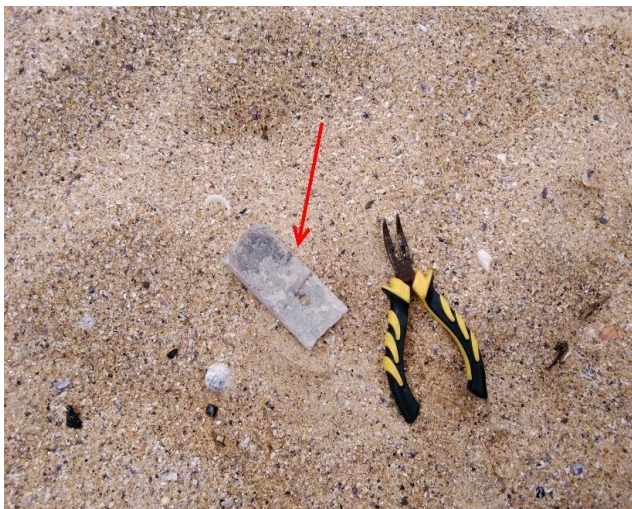
**Notes:** FC fragment identified on sand surface prior to emu pick - Southern section

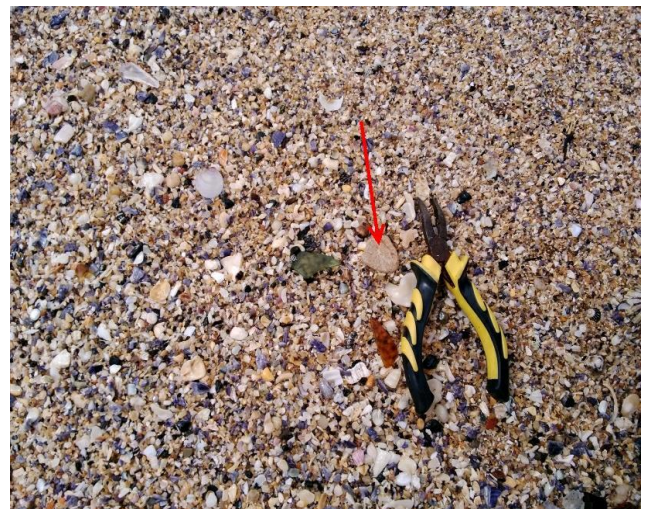
**Notes:** FC fragment identified on sand surface prior to emu pick - Southern section

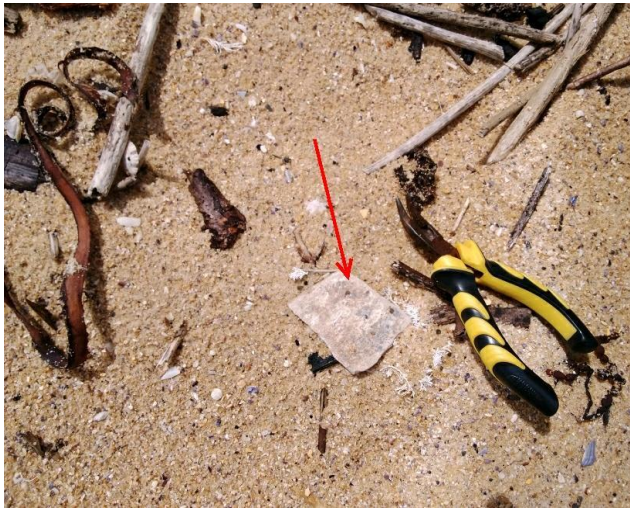
**Notes:** FC fragment identified on sand surface prior to emu pick - Southern section

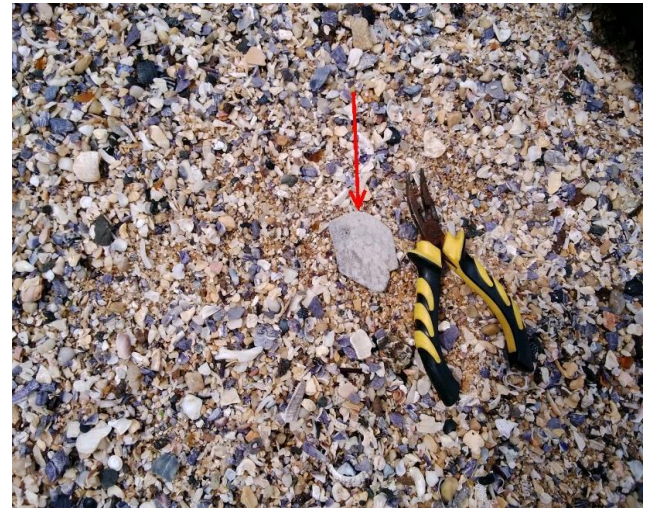
**Notes:** FC fragment identified on sand surface prior to emu pick - Southern section

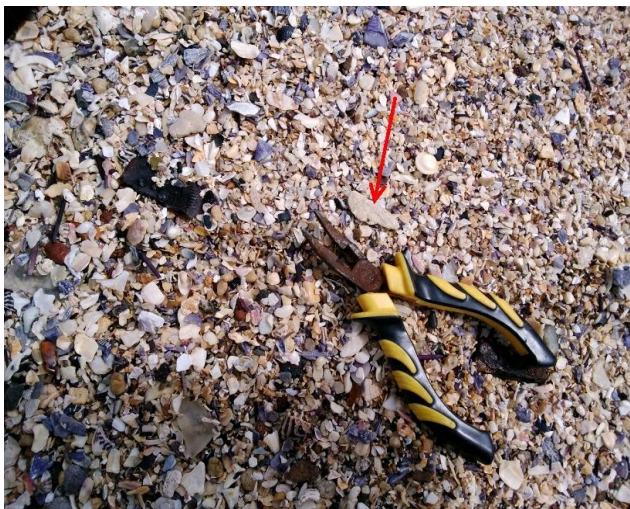
**Notes:** FC fragment identified on sand surface prior to emu pick - Southern section

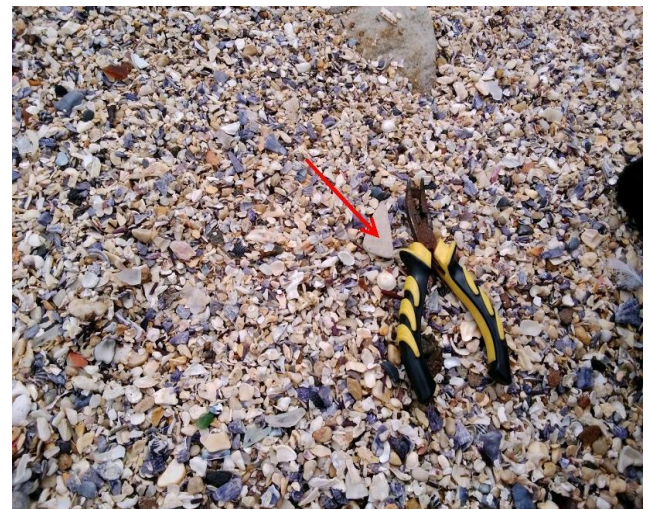
**Notes:** FC fragment identified on sand surface prior to emu pick - Southern section

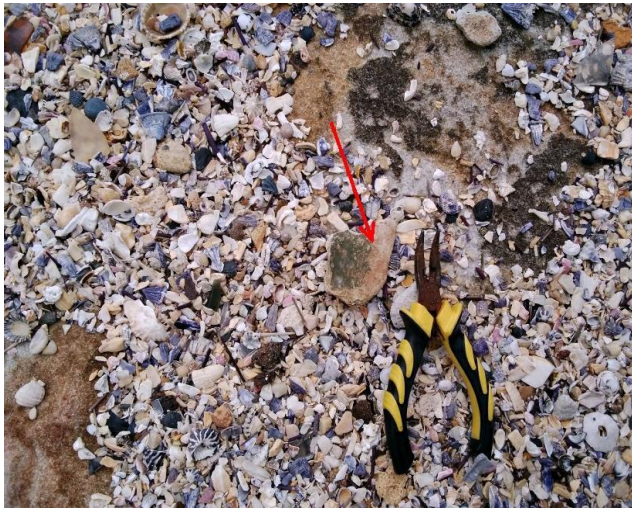
**Notes:** FC fragment identified on sand surface prior to emu pick - Southern section

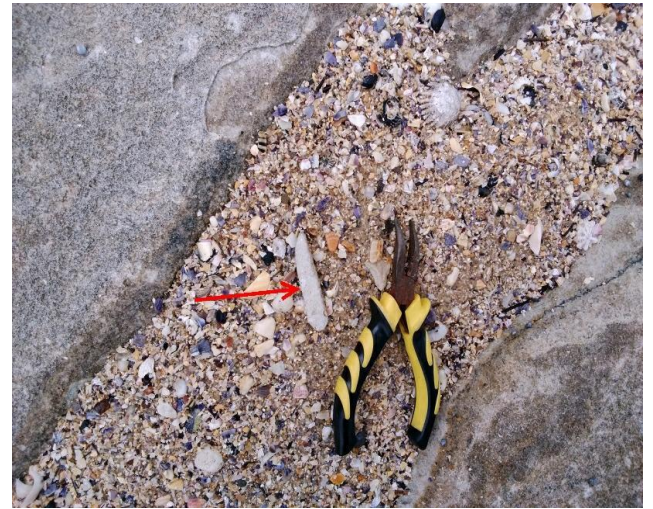
**Notes:** FC fragment identified on sand surface prior to emu pick - Southern section

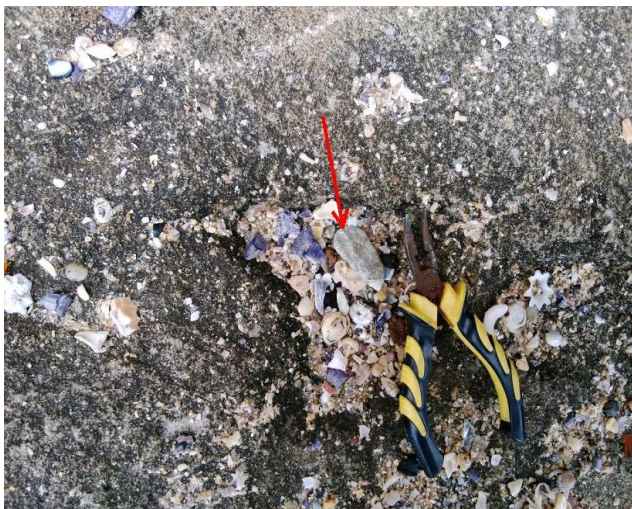
**Notes:** FC fragment identified on sand surface prior to emu pick - Southern section
