Asbestos Containing Material Clearance Inspection

15 April 2023

Randwick City Council
30 Frances Street
Randwick NSW 2031

Site:	Little Bay Beach
Location:	Southern, Western and Northern Little Bay Beach

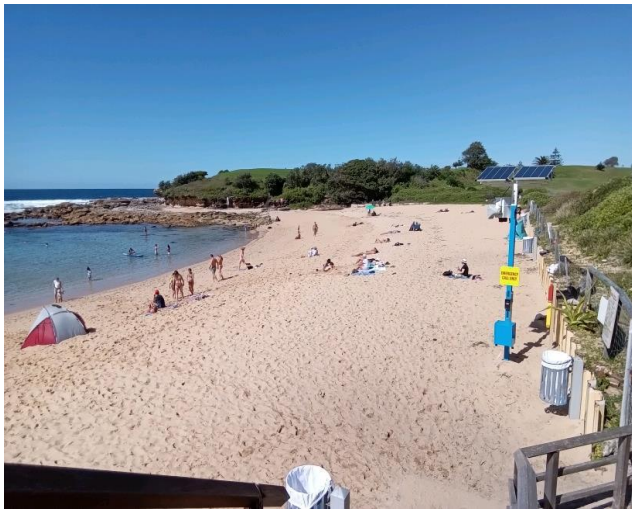
Notes: Overview of Southern Beach.

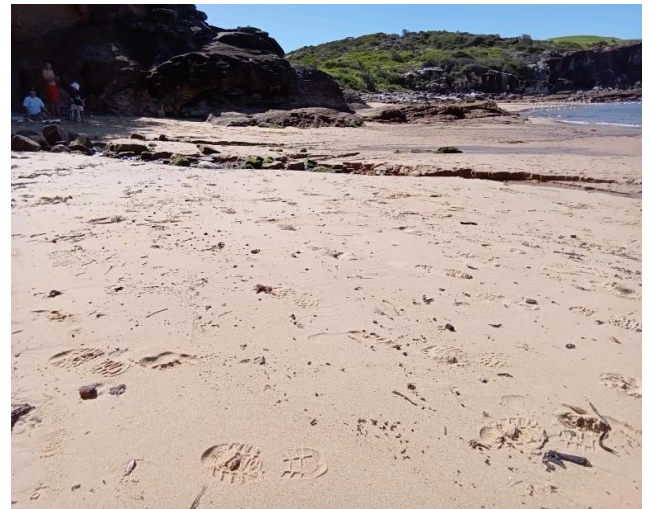
Notes: Overview of Western Beach.

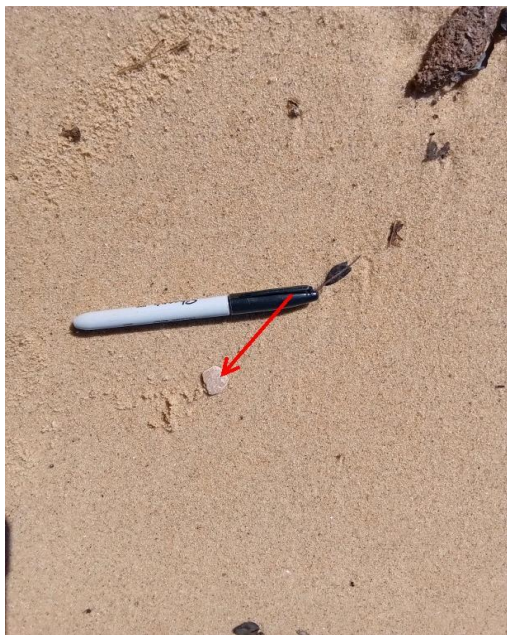
Notes: Overview of FC fragment within Western Beach prior to the removal.

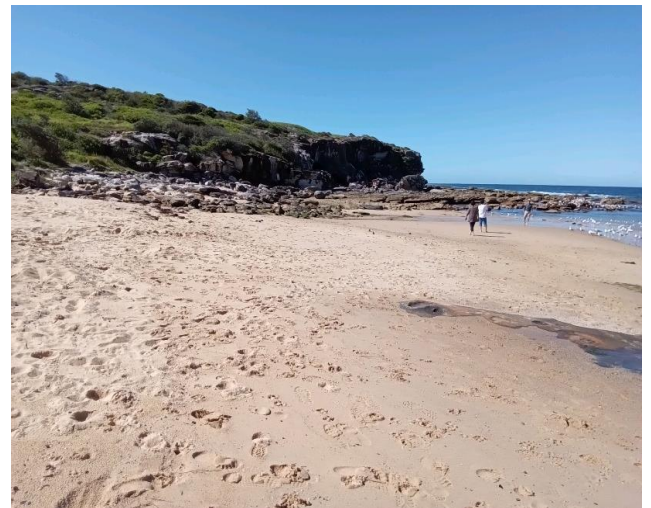
Notes: Overview of Northern Beach.

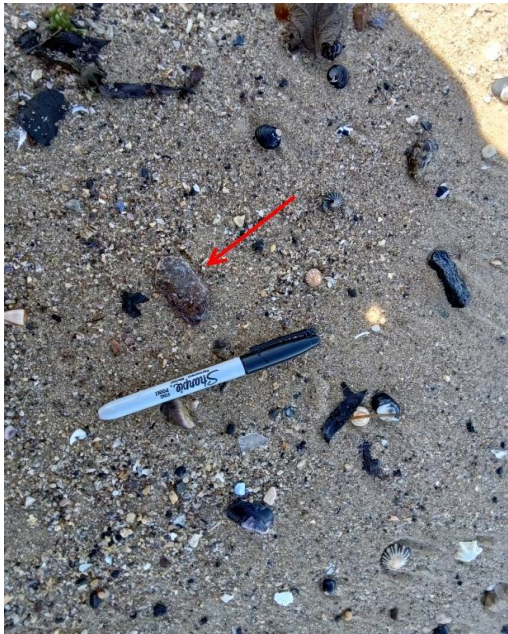
Notes: Overview of FC fragment within Northern Beach prior to the removal.

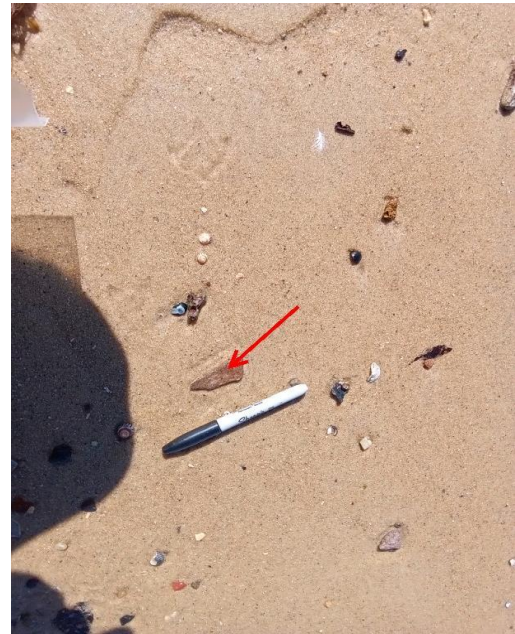
Notes: Overview of FC fragment within Northern Beach prior to the removal.

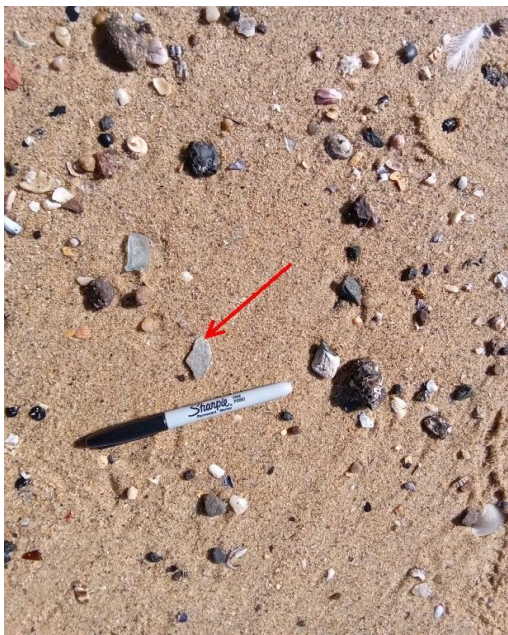
Notes: Overview of FC fragment within Northern Beach prior to the removal.

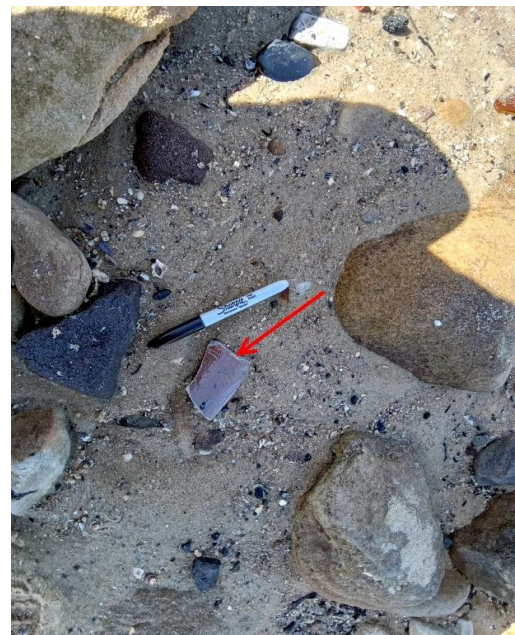
Notes: Overview of FC fragment within Northern Beach prior to the removal.

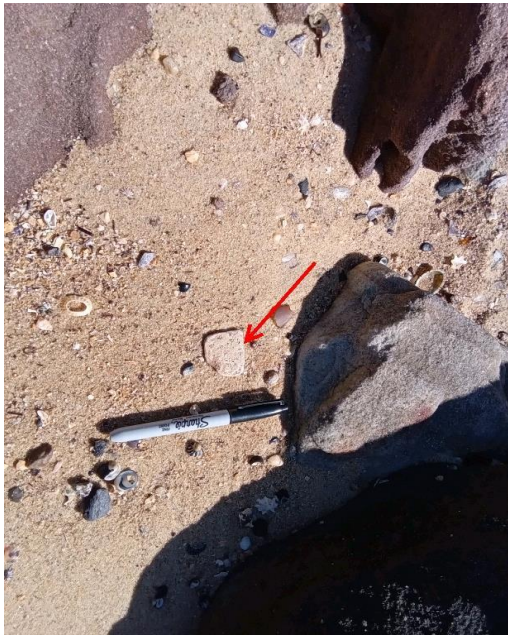
Notes: Overview of FC fragment within Northern Beach prior to the removal.

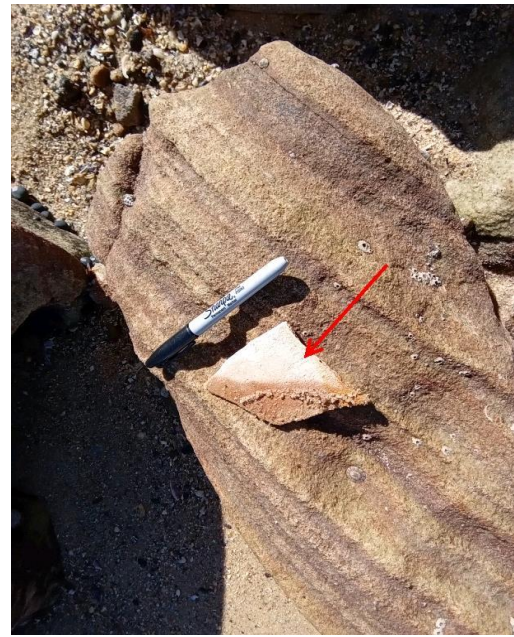
Notes: Overview of FC fragment within Northern Beach prior to the removal.

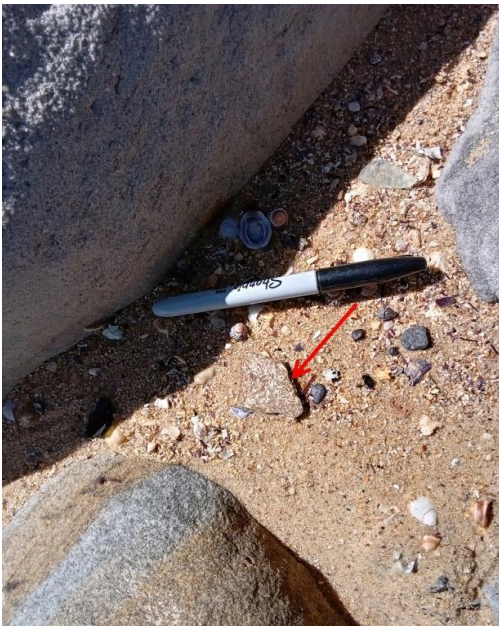
Notes: Overview of FC fragment within Northern Beach prior to the removal.

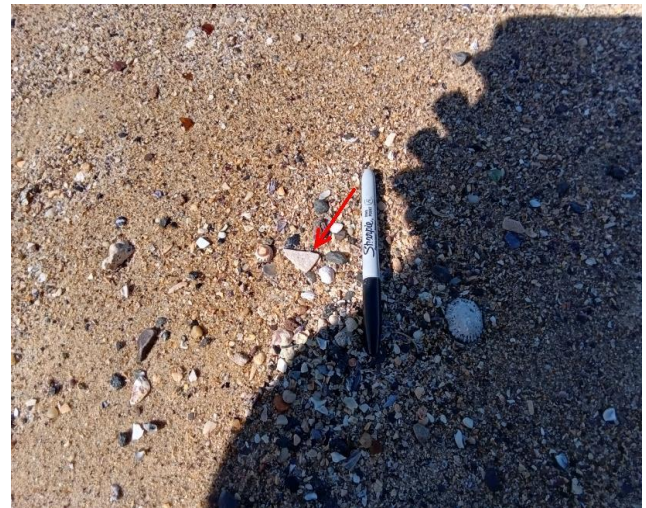
Notes: Overview of FC fragment within Northern Beach prior to the removal.

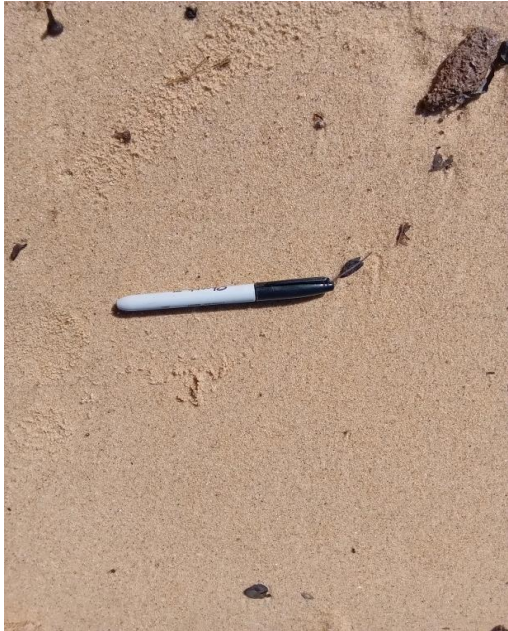
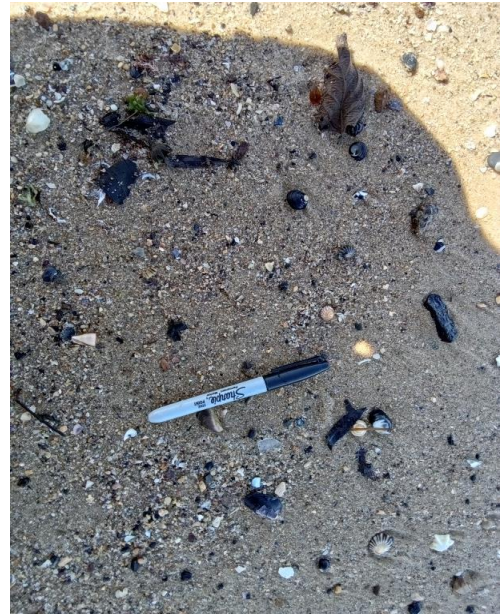
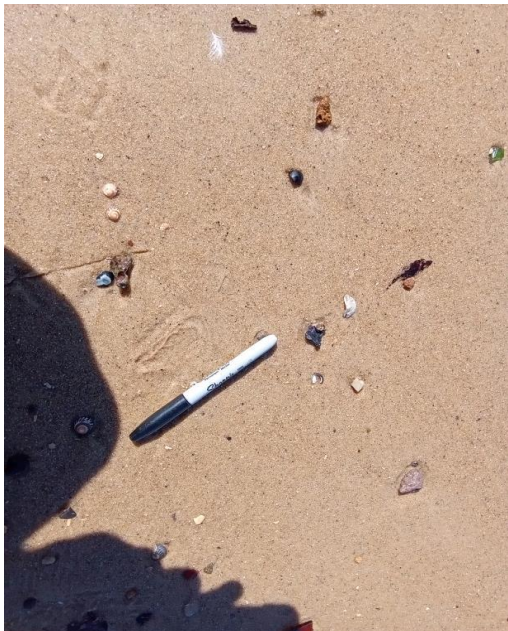
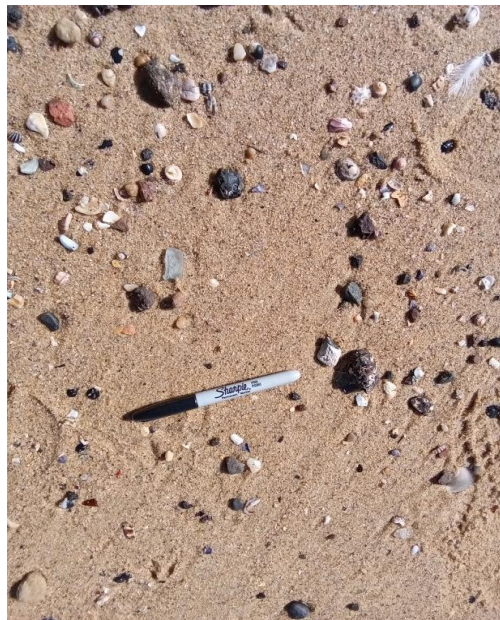
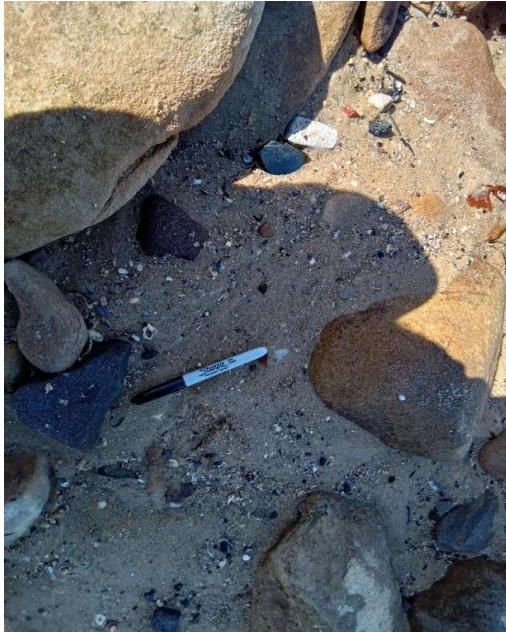
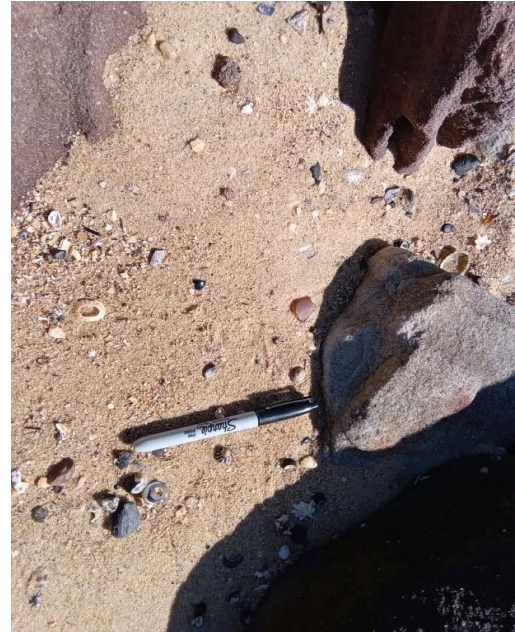
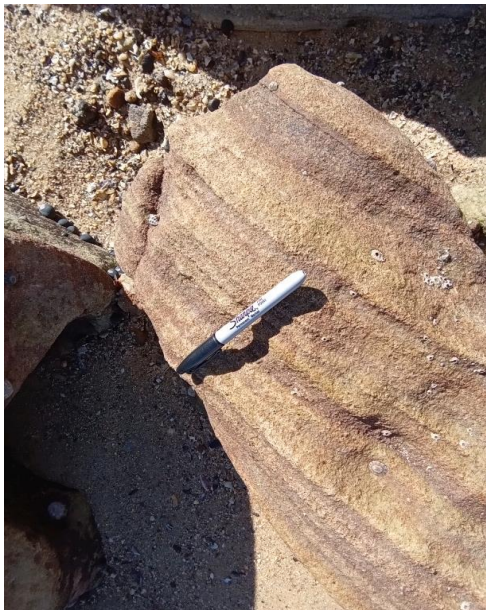
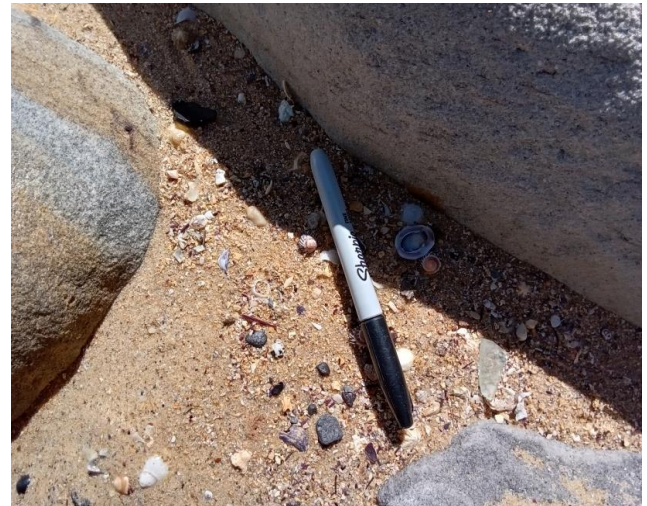
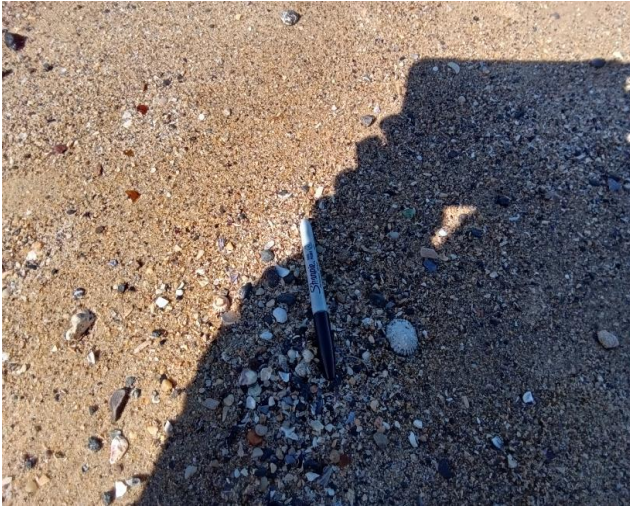
Notes: Visual clearance inspection following removal of suspected asbestos containing FC fragment.
