# Asbestos Containing Material Clearance Inspection

<b>Site:</b>	Little Bay Beach
<b>Location:</b>	Southern, Western and Northern Little Bay Beach

<b>Requested by:</b>	
Name	Joe Santangelo
Contact	0436839760
Email	joe.santangelo@randwick.nsw.gov.au
<b>Site Details:</b>	
Address	2 Coast Hospital Rd, Little Bay NSW 2036
Local Government Area	Randwick City Council

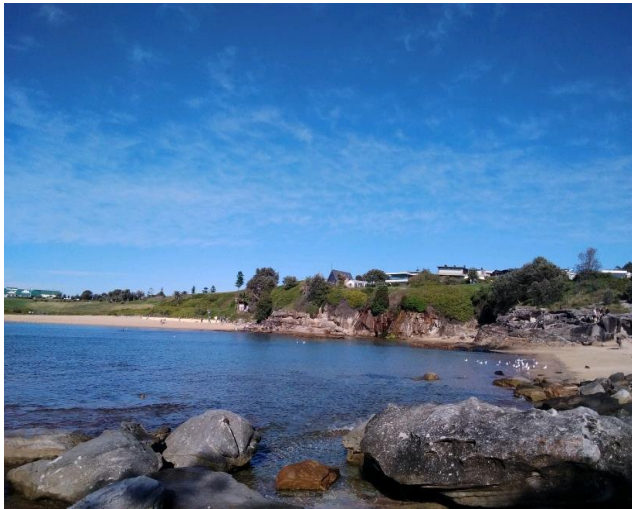
**Notes:** Overview of the Beach during the inspection

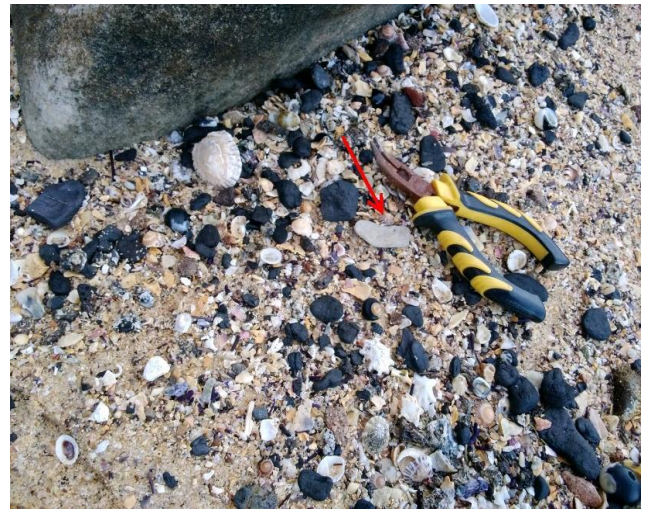
**Notes:** FC fragment identified on sand surface prior to emu pick - Northern section

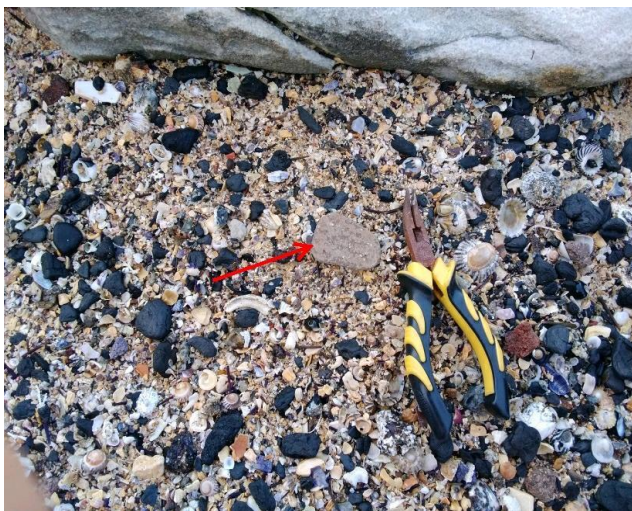
**Notes:** FC fragment identified on sand surface prior to emu pick - Northern section

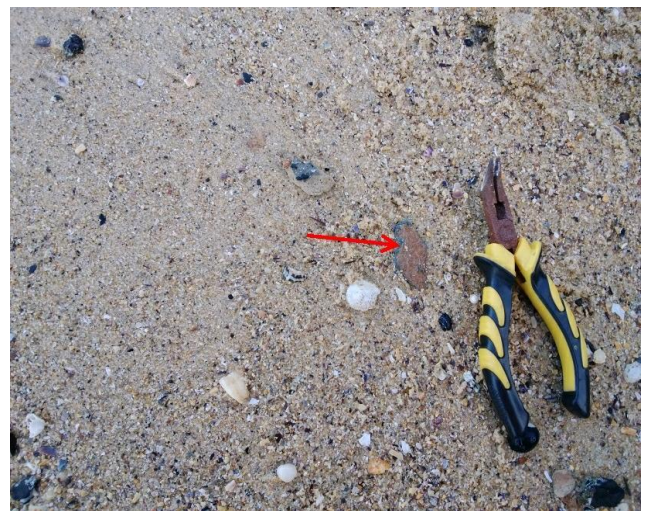
**Notes:** FC fragment identified on sand surface prior to emu pick - Northern section

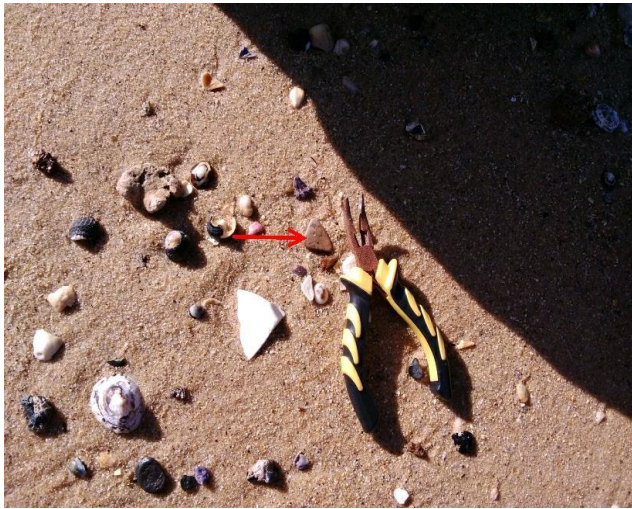
**Notes:** FC fragment identified on sand surface prior to emu pick - Northern section

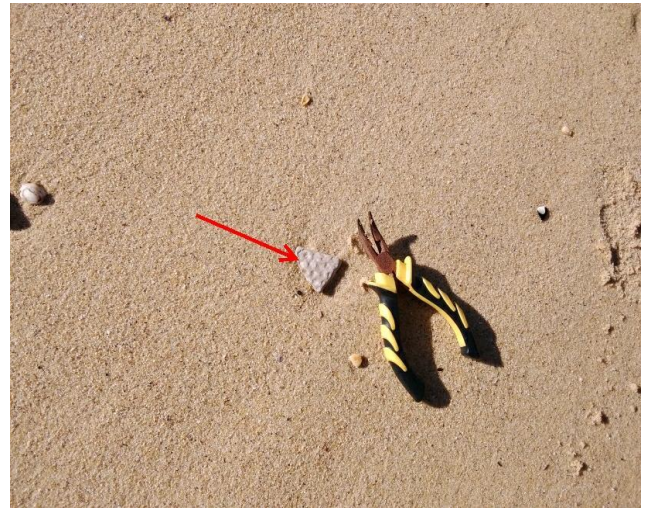
**Notes:** FC fragment identified on sand surface prior to emu pick - Northern section

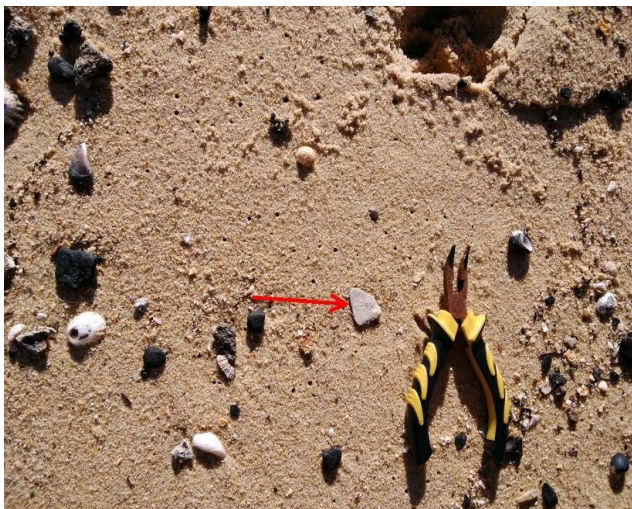
**Notes:** FC fragment identified on sand surface prior to emu pick - Northern section

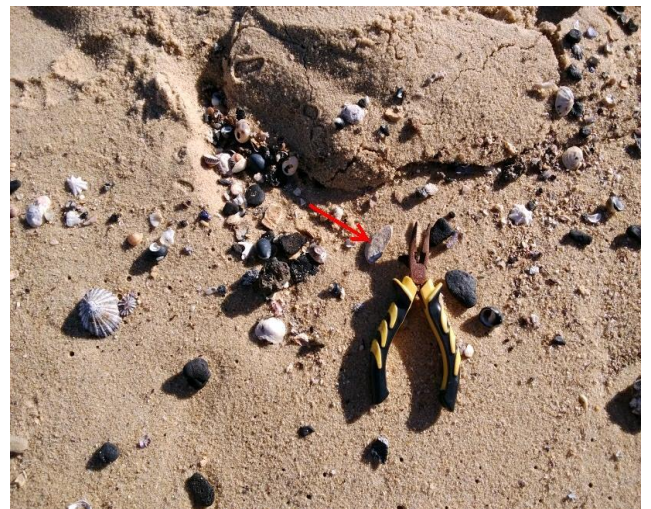
**Notes:** FC fragment identified on sand surface prior to emu pick - Northern section

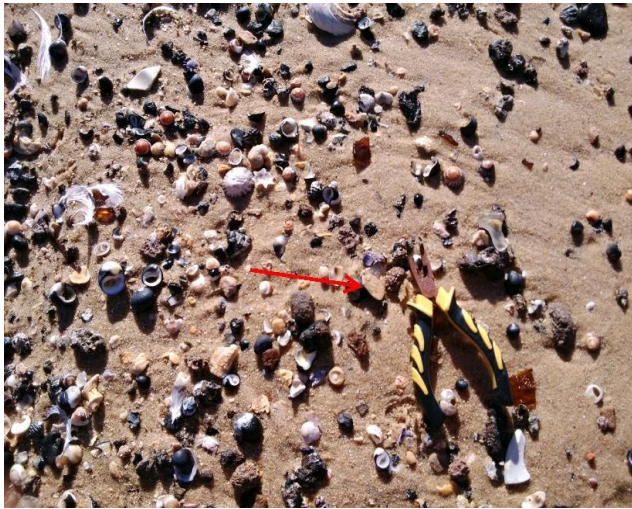
**Notes:** FC fragment identified on sand surface prior to emu pick - Northern section

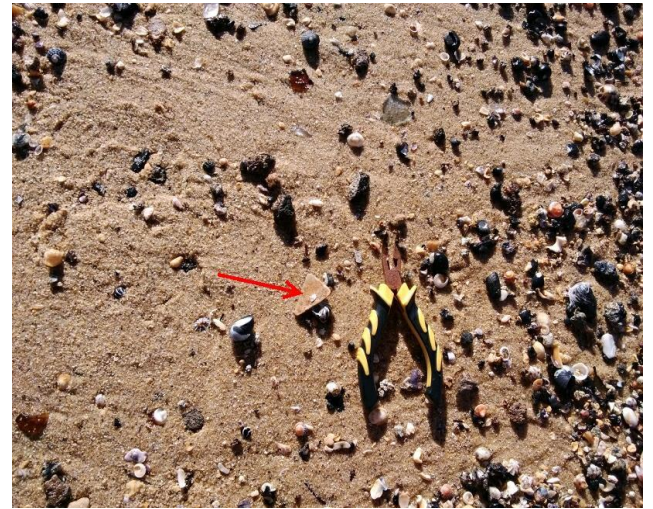
**Notes:** FC fragment identified on sand surface prior to emu pick - Northern section

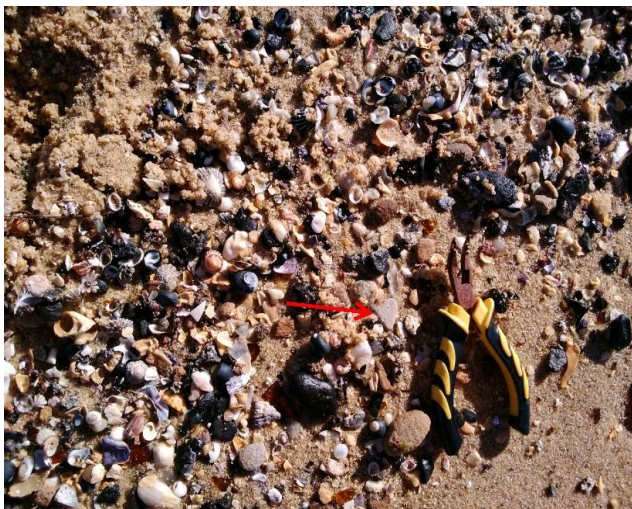
**Notes:** FC fragment identified on sand surface prior to emu pick - Northern section

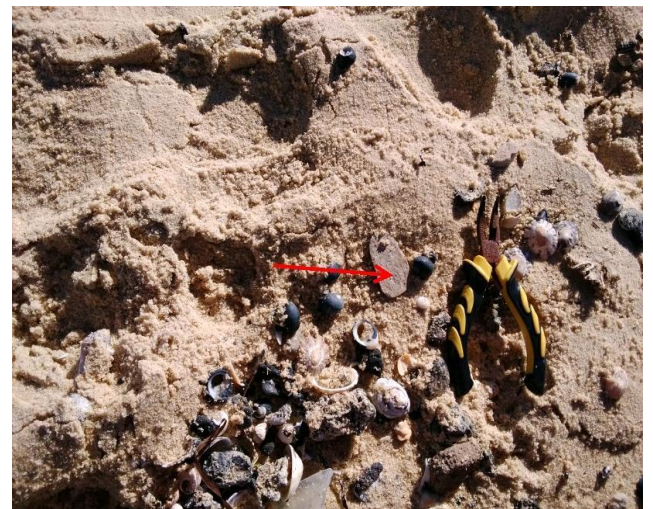
**Notes:** FC fragment identified on sand surface prior to emu pick - Northern section

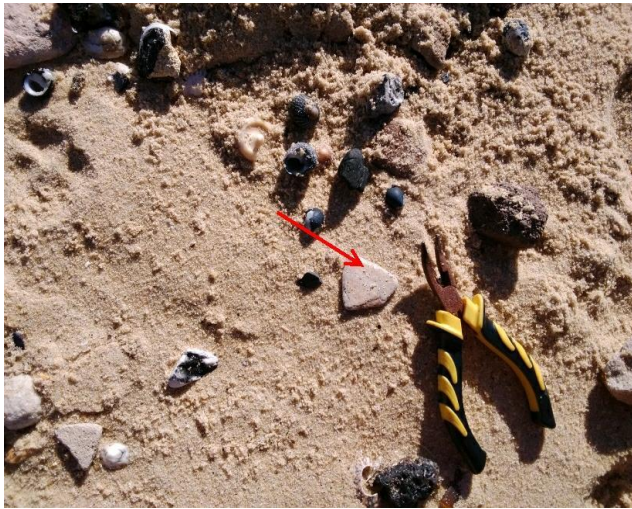
**Notes:** FC fragment identified on sand surface prior to emu pick - Northern section

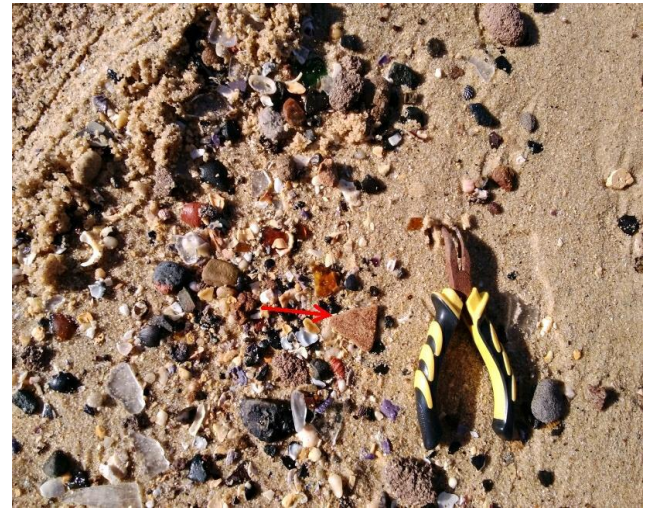
**Notes:** FC fragment identified on sand surface prior to emu pick - Western ern section

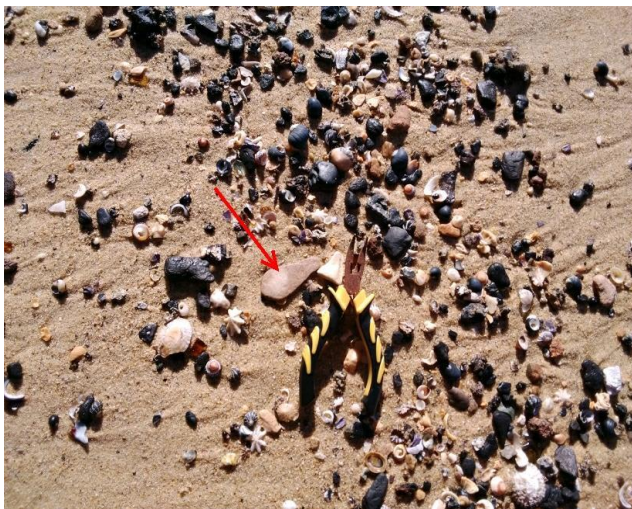
**Notes:** FC fragment identified on sand surface prior to emu pick - Western ern section

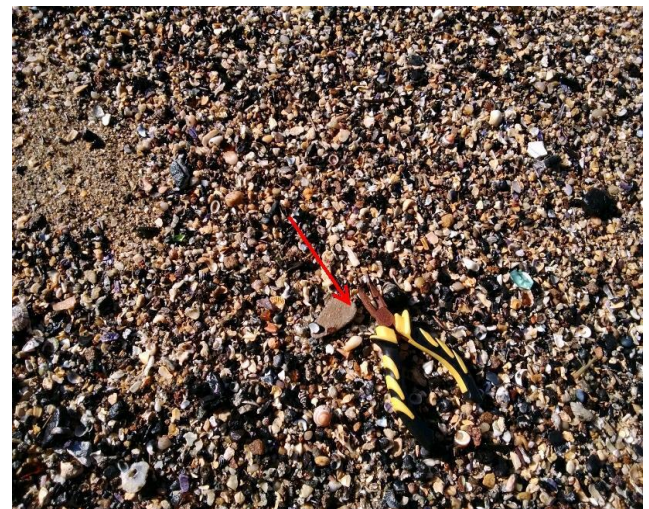
**Notes:** FC fragment identified on sand surface prior to emu pick - Western ern section

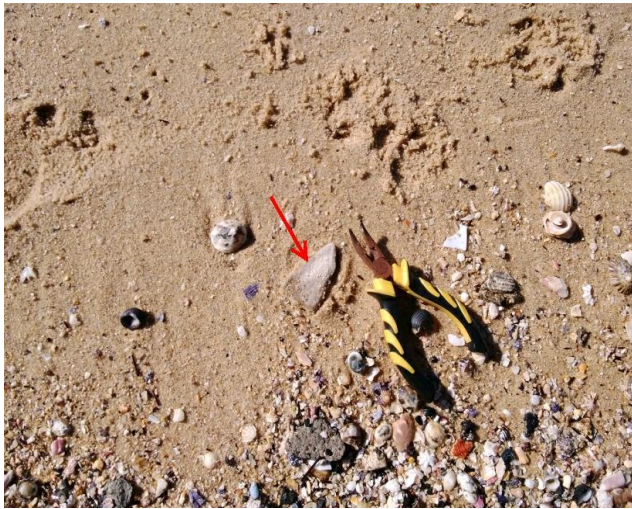
**Notes:** FC fragment identified on sand surface prior to emu pick - Southern section

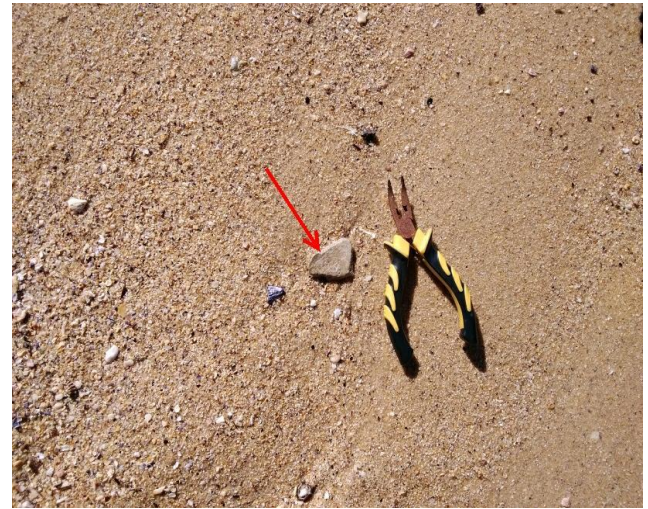
**Notes:** FC fragment identified on sand surface prior to emu pick - Southern section

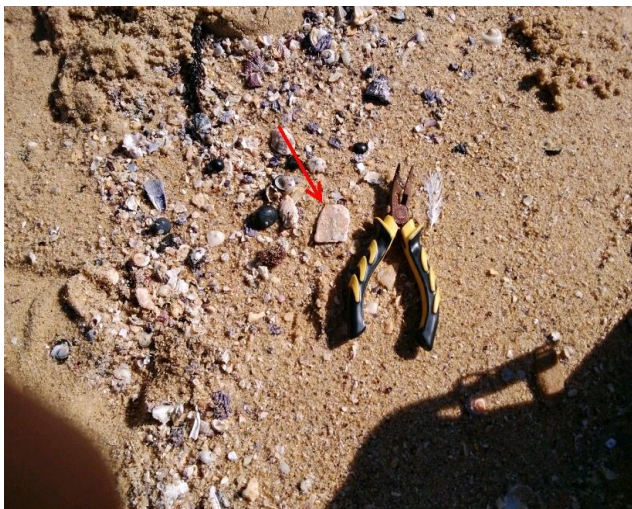
**Notes:** FC fragment identified on sand surface prior to emu pick - Southern section

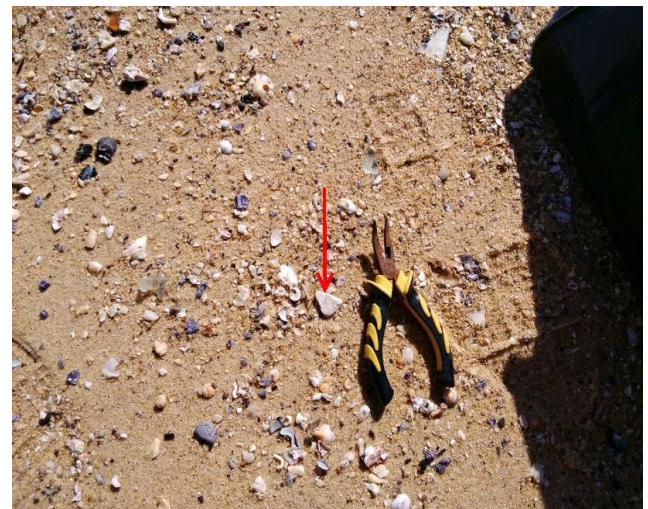
**Notes:** FC fragment identified on sand surface prior to emu pick - Southern section

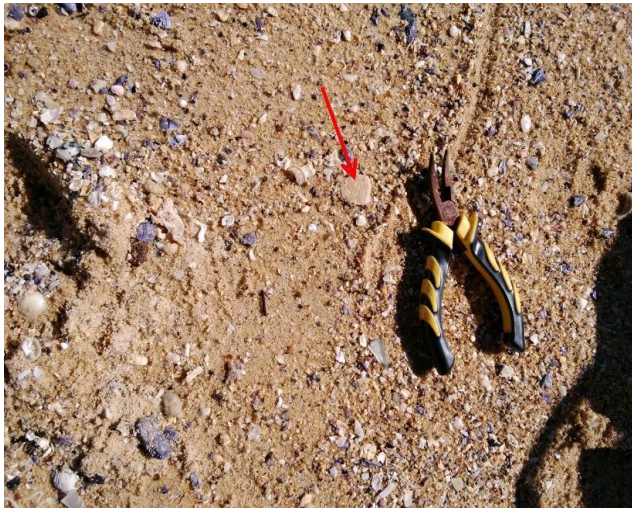
**Notes:** FC fragment identified on sand surface prior to emu pick - Southern section

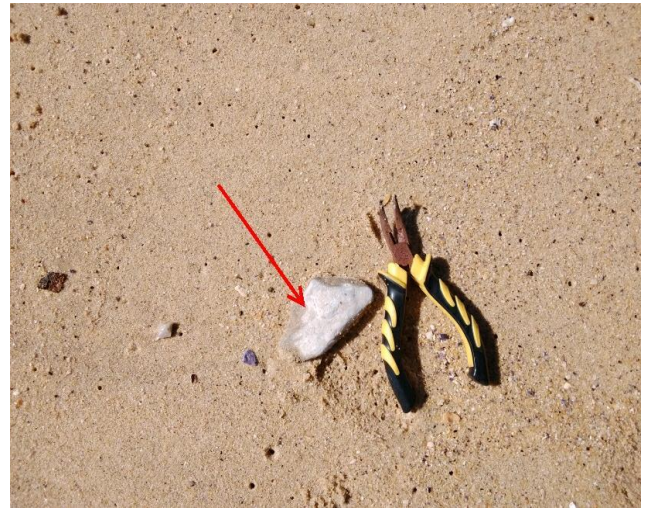
**Notes:** FC fragment identified on sand surface prior to emu pick - Southern section

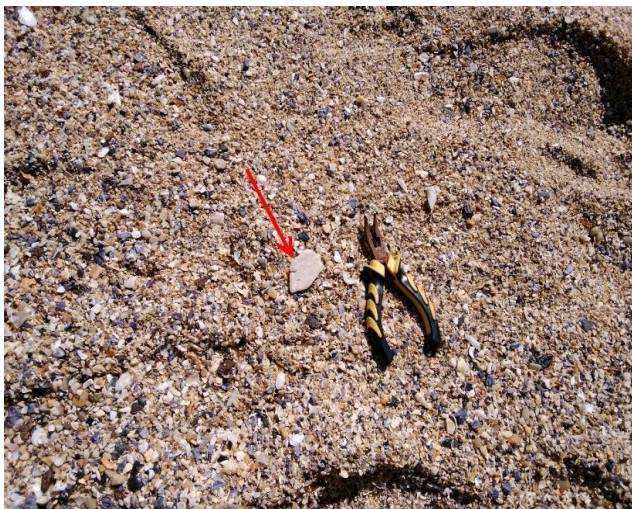
**Notes:** FC fragment identified on sand surface prior to emu pick - Southern section

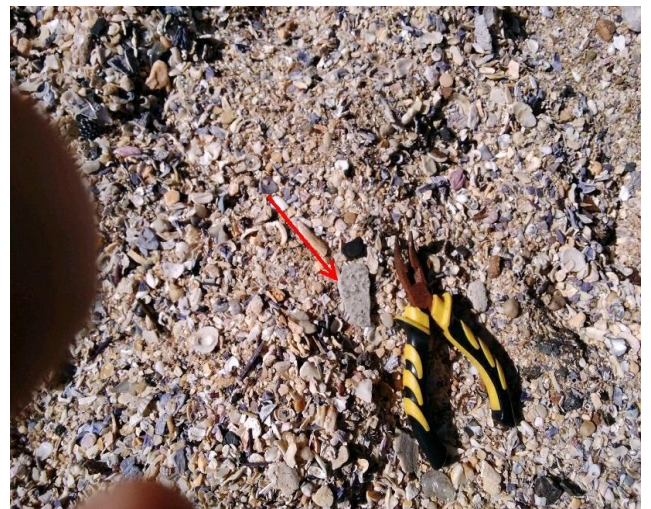
**Notes:** FC fragment identified on sand surface prior to emu pick - Southern section

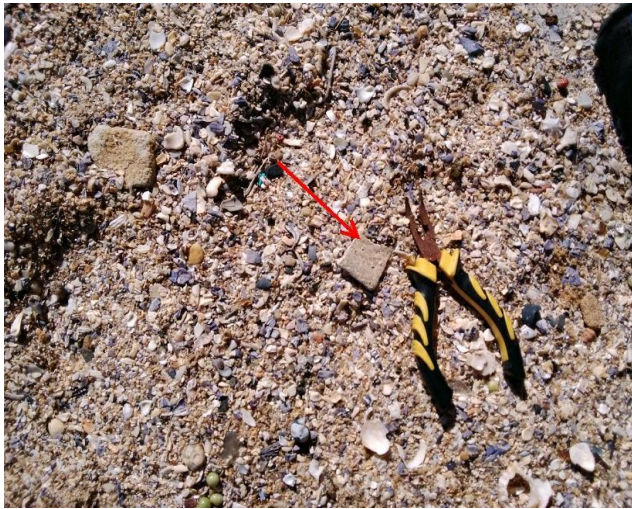
**Notes:** FC fragment identified on sand surface prior to emu pick - Southern section

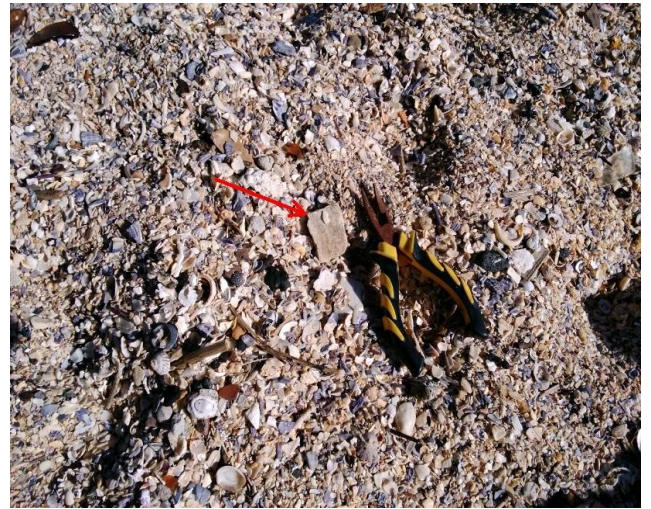
**Notes:** FC fragment identified on sand surface prior to emu pick - Southern section

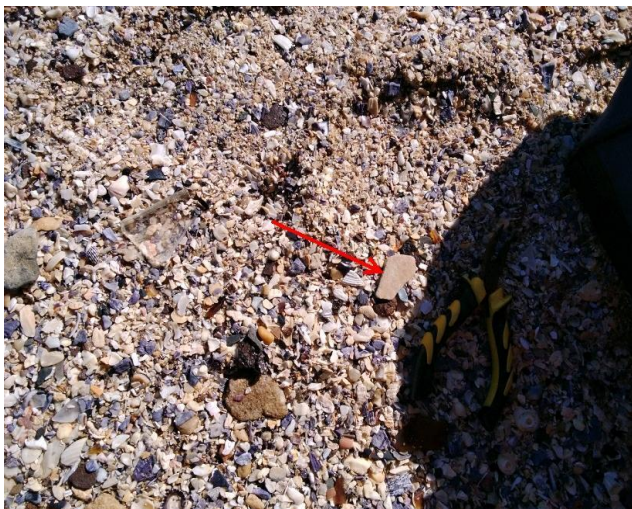
**Notes:** FC fragment identified on sand surface prior to emu pick - Southern section

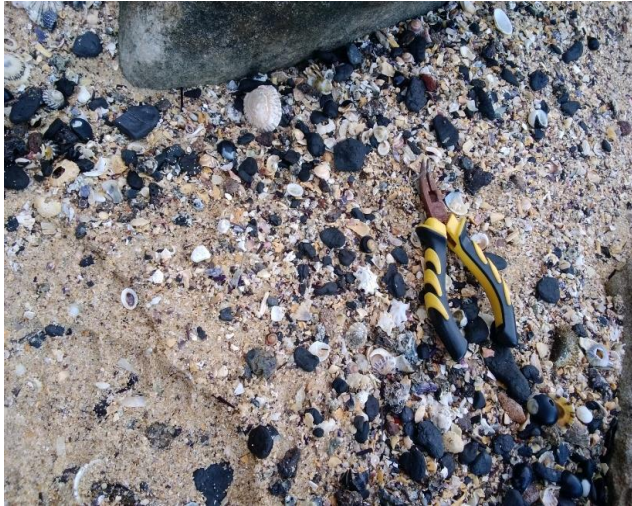
**Notes:** Sand surface following emu pick - Northern section

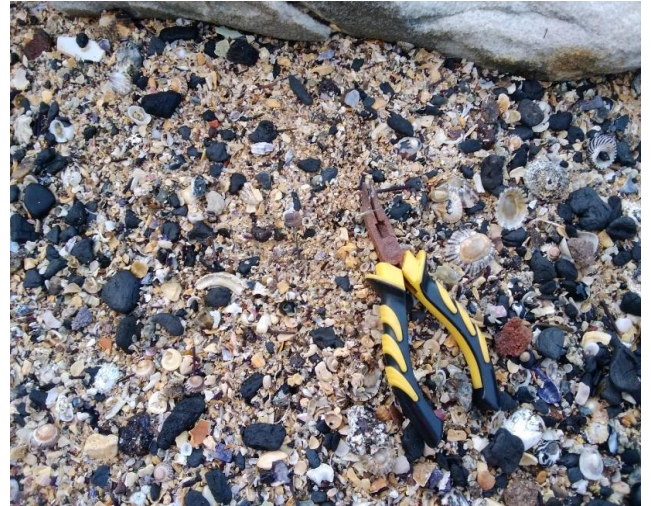
**Notes:** Sand surface following emu pick - Northern section

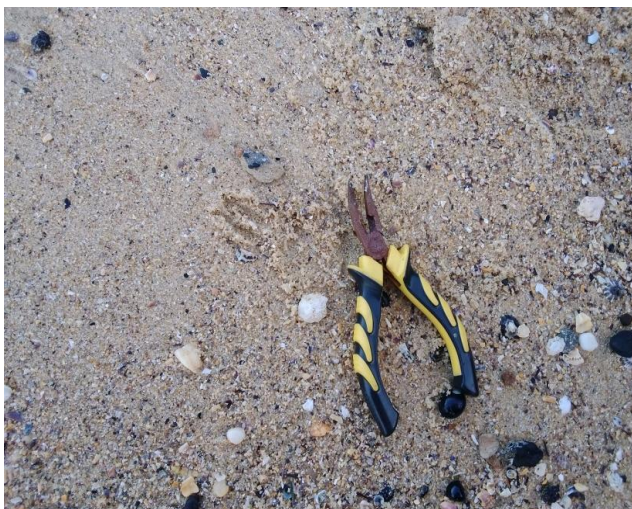
**Notes:** Sand surface following emu pick - Northern section

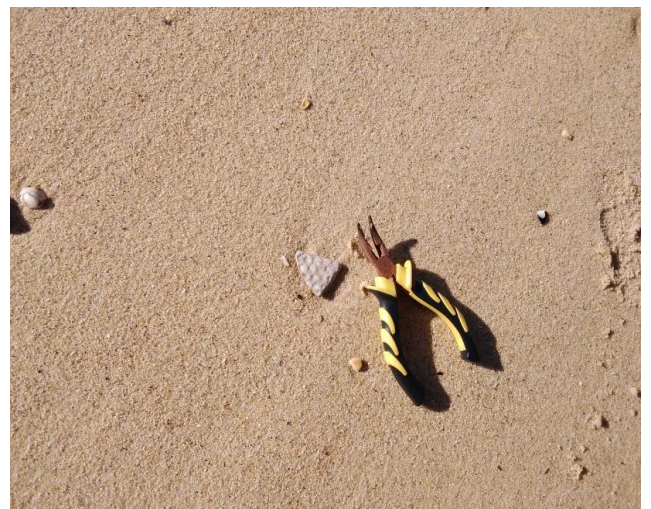
**Notes:** Sand surface following emu pick - Northern section

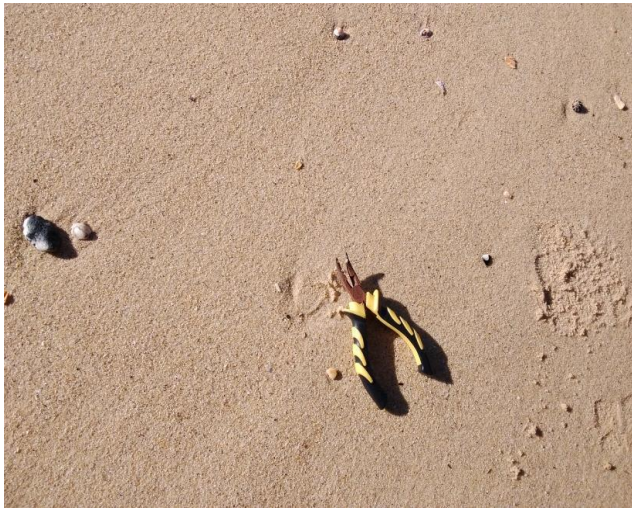
**Notes:** Sand surface following emu pick - Northern section

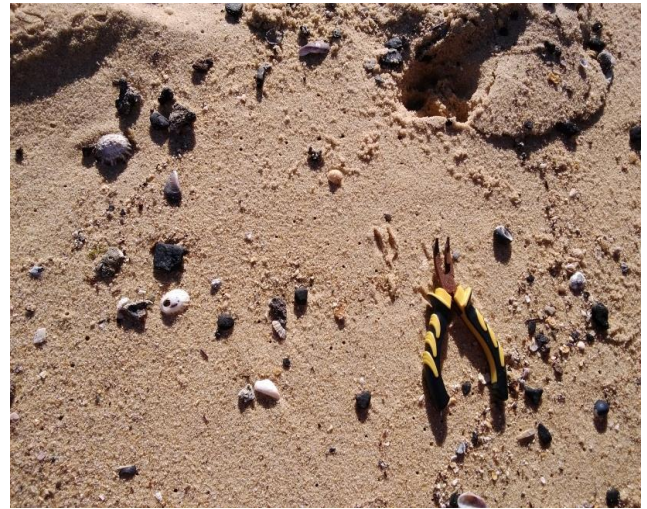
**Notes:** Sand surface following emu pick - Northern section

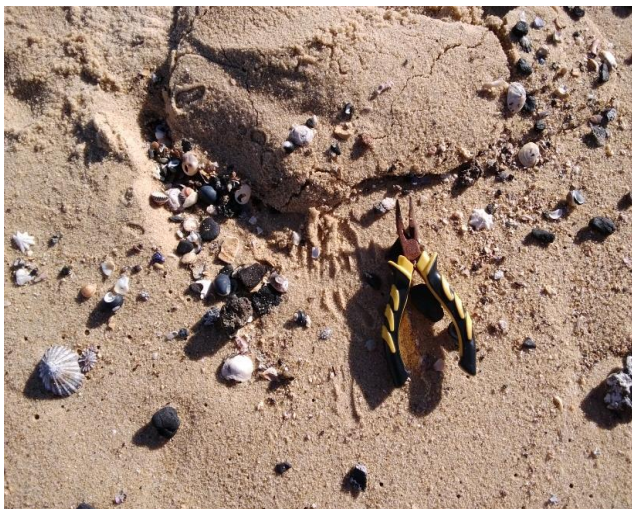
**Notes:** Sand surface following emu pick - Northern section

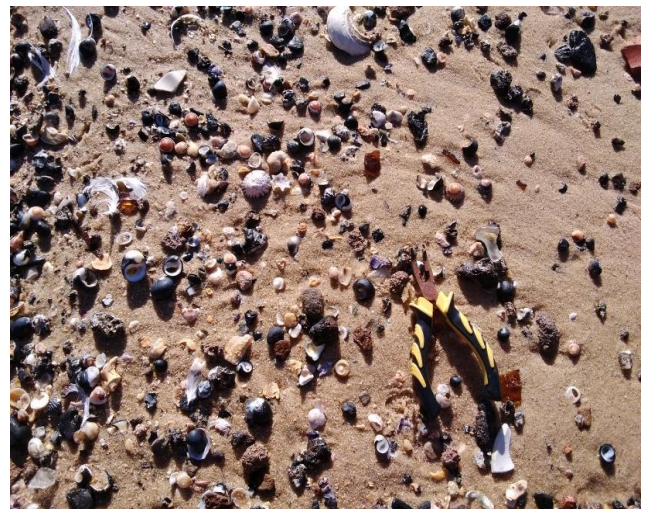
**Notes:** Sand surface following emu pick - Northern section

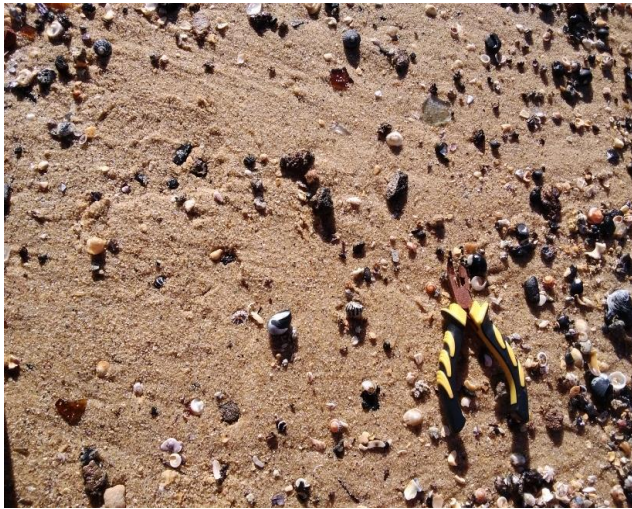
**Notes:** Sand surface following emu pick - Northern section

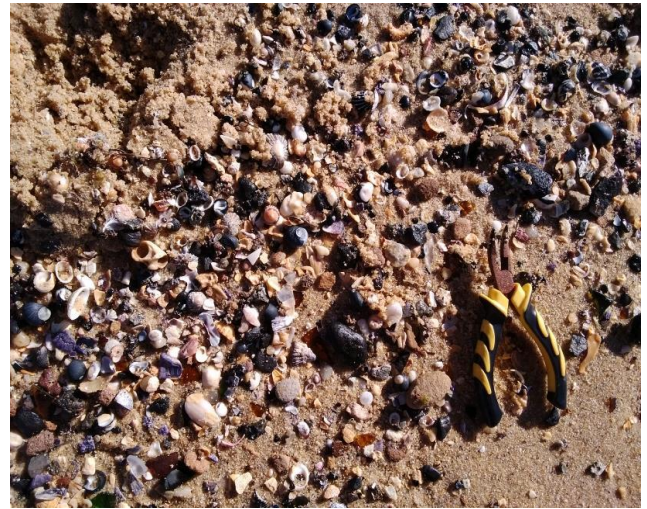
**Notes:** Sand surface following emu pick - Northern section

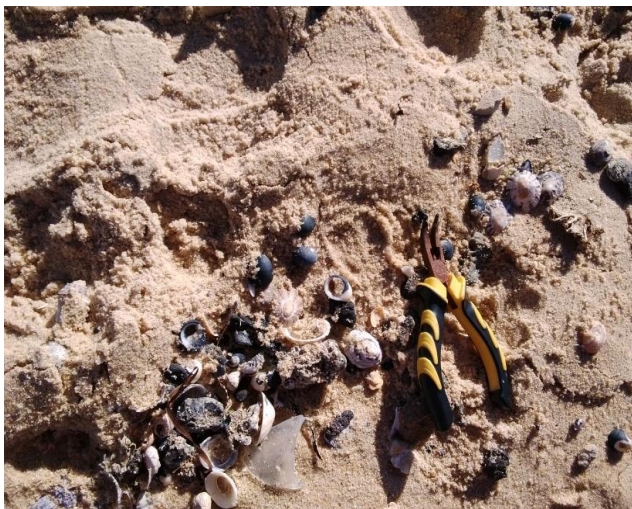
**Notes:** Sand surface following emu pick - Northern section

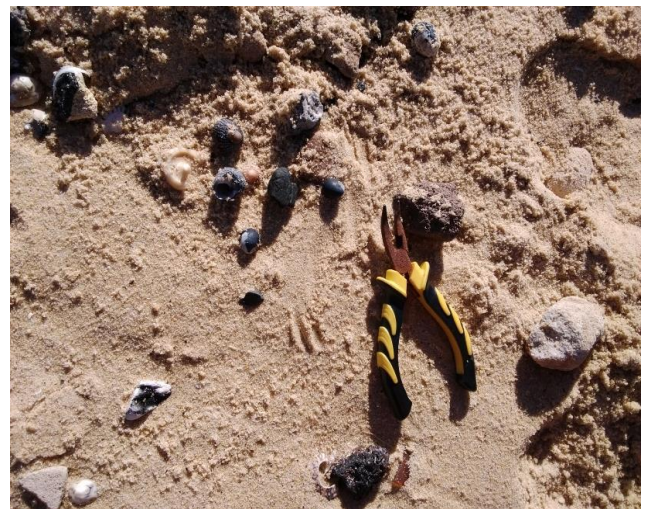
**Notes:** Sand surface following emu pick - Northern section

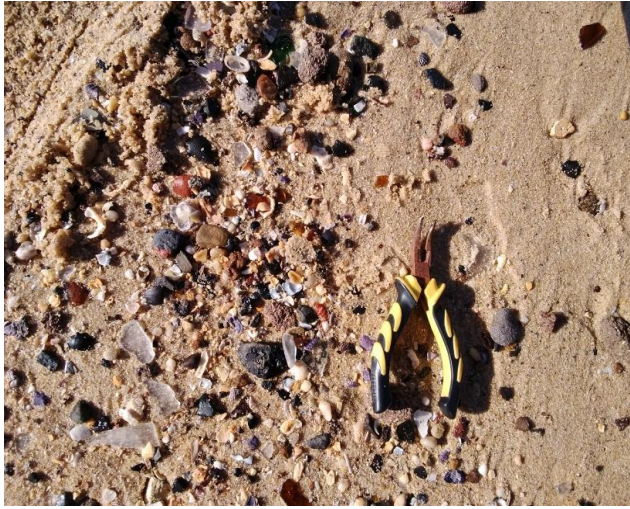
**Notes:** Sand surface following emu pick - Northern section

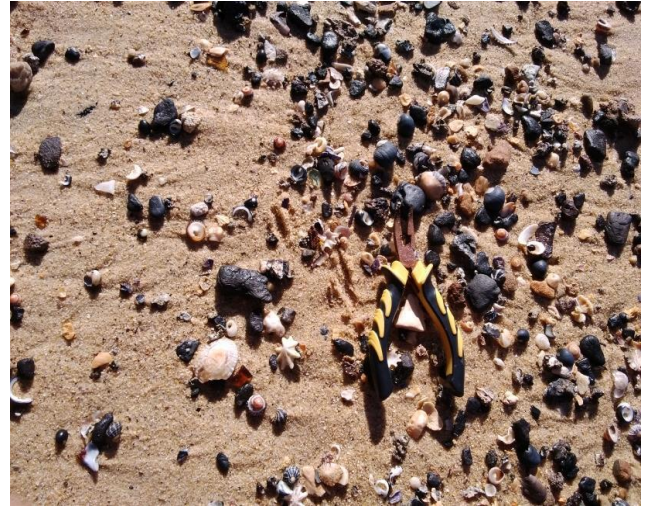
**Notes:** Sand surface following emu pick - Western section

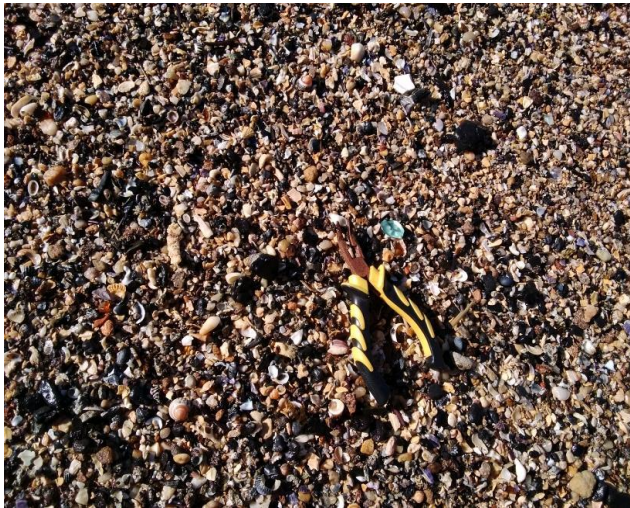
**Notes:** Sand surface following emu pick - Western section

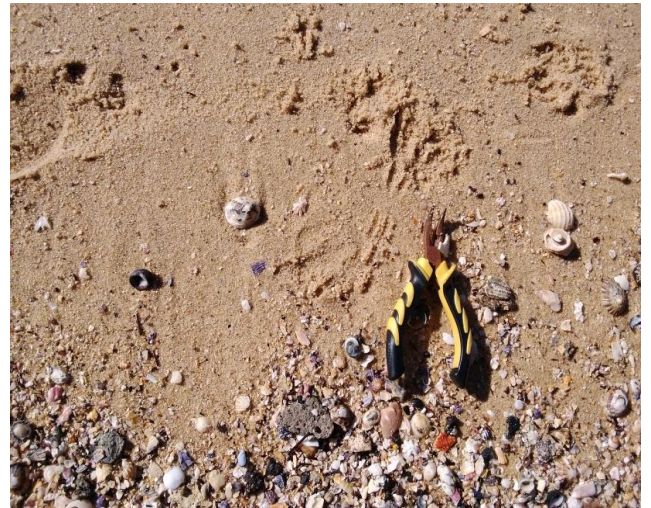
**Notes:** Sand surface following emu pick - Southern section

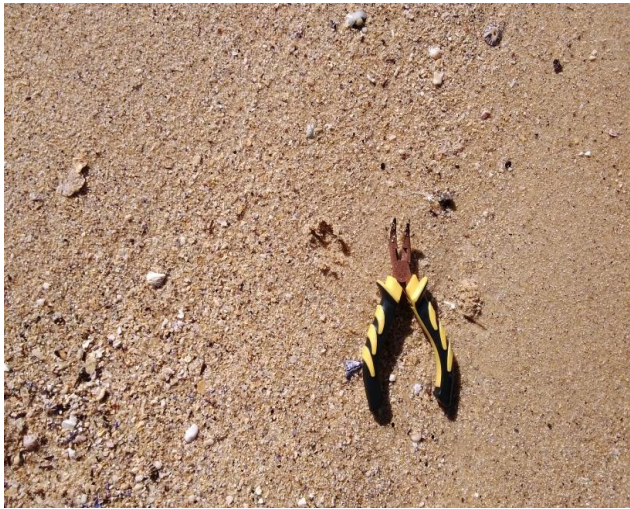
**Notes:** Sand surface following emu pick - Southern section

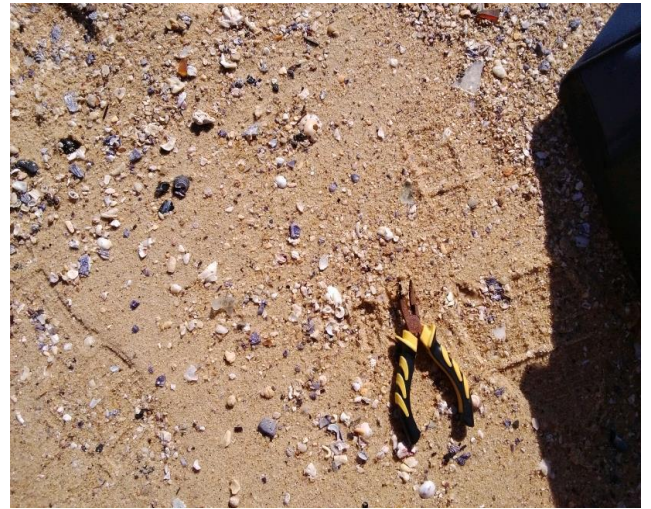
**Notes:** Sand surface following emu pick - Southern section

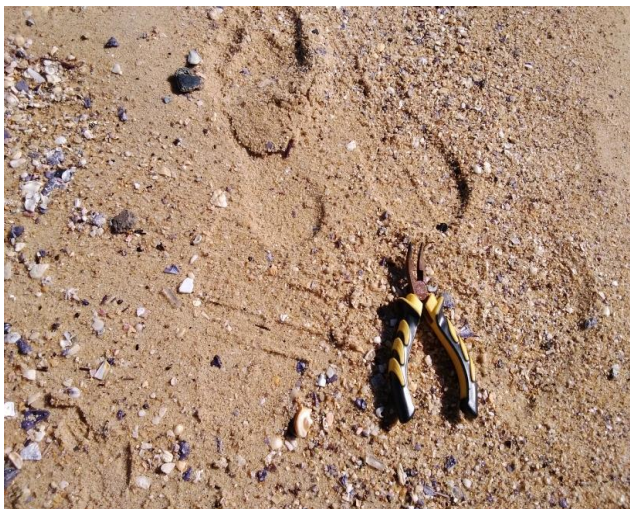
**Notes:** Sand surface following emu pick - Southern section

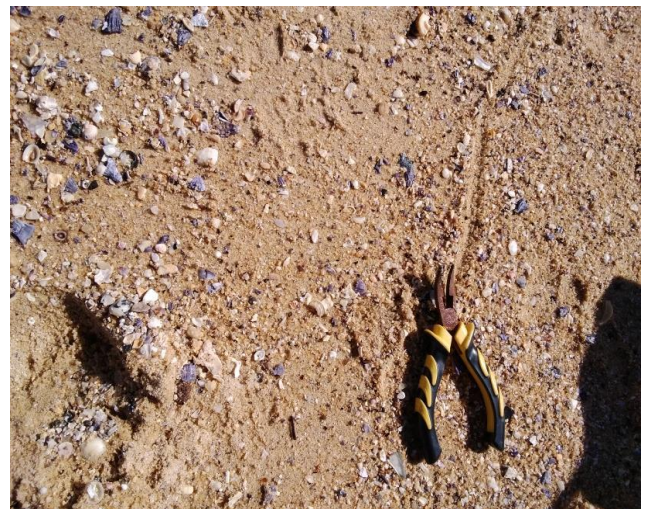
**Notes:** Sand surface following emu pick - Southern section

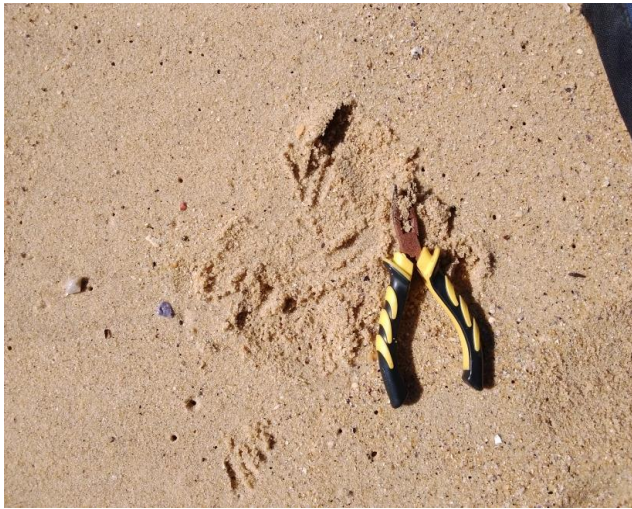
**Notes:** Sand surface following emu pick - Southern section

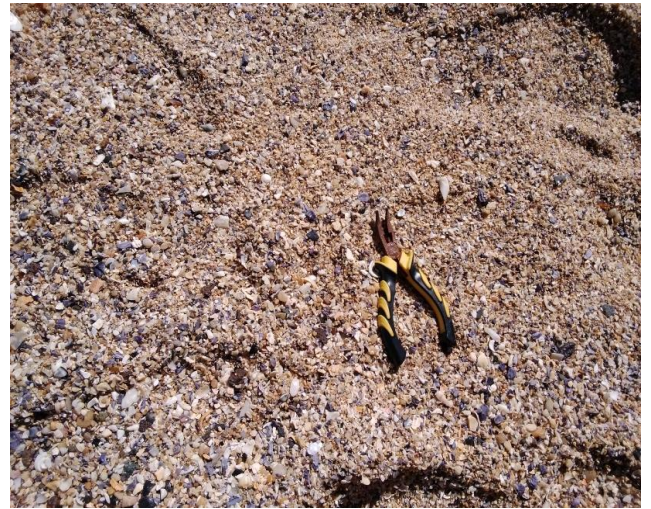
**Notes:** Sand surface following emu pick - Southern section

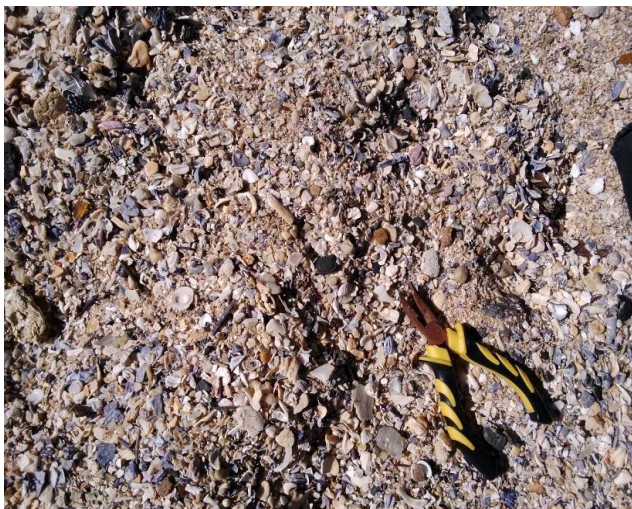
**Notes:** Sand surface following emu pick - Southern section

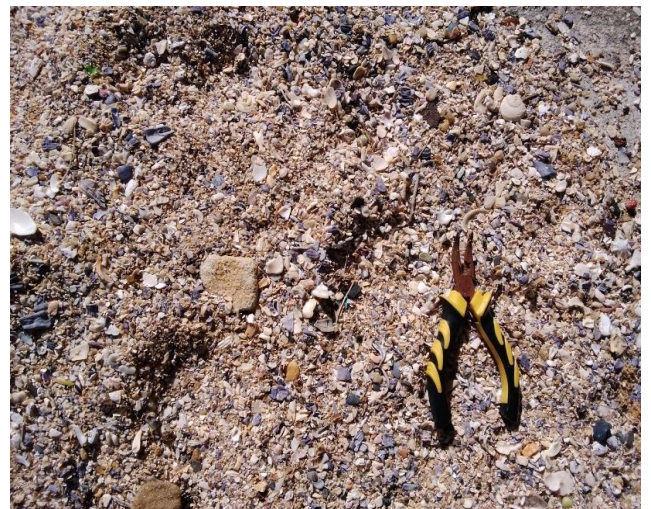
**Notes:** Sand surface following emu pick - Southern section

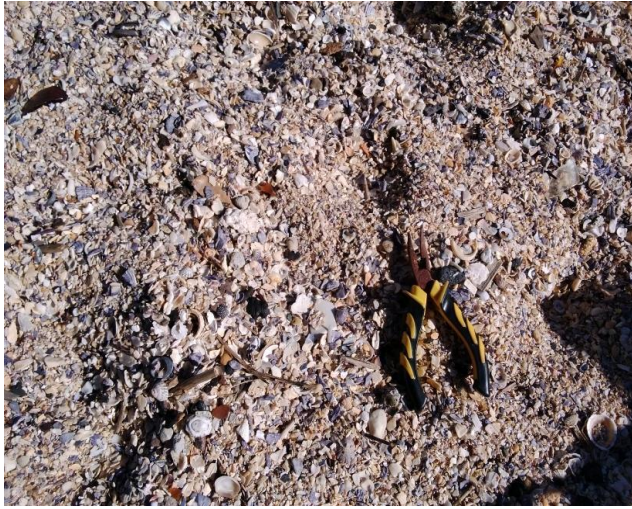
**Notes:** Sand surface following emu pick - Southern section

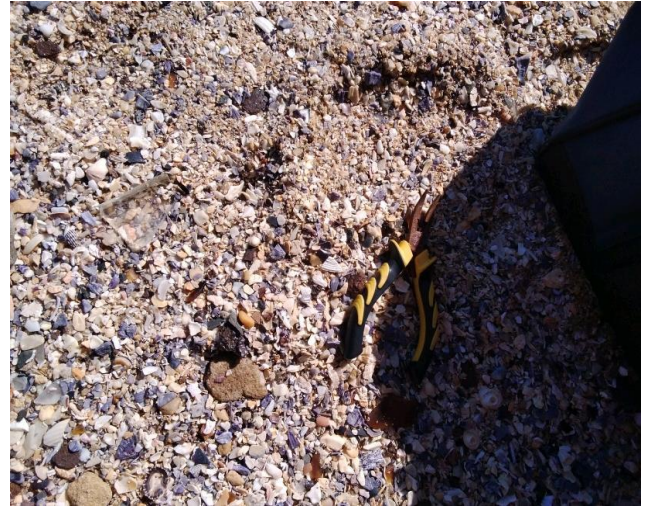
**Notes:** Sand surface following emu pick - Southern section
