Asbestos Containing Material Clearance Inspection

RE: Asbestos Containing Material Clearance Inspection

Site:	Little Bay Beach
Location:	Western, Southern and Northern Little Bay Beach

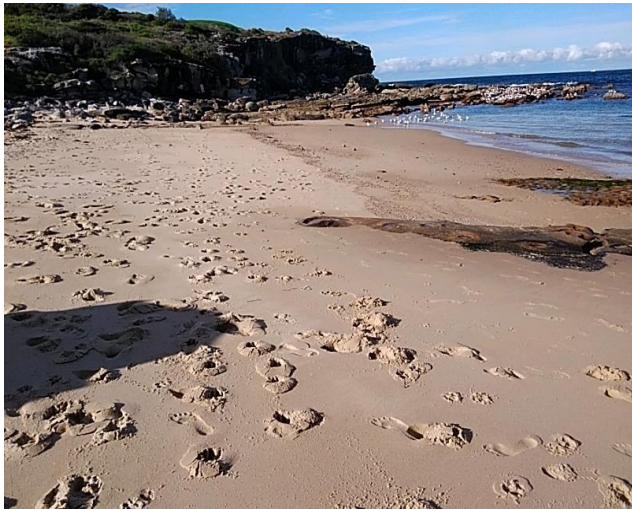
Notes: Overview of the Northern beach

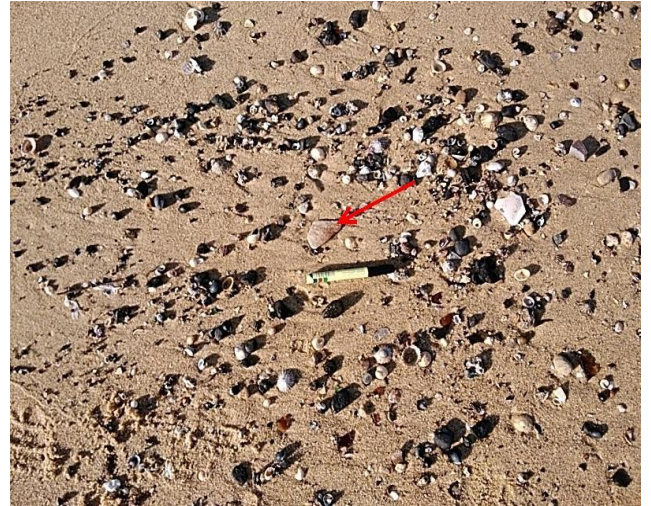
Notes: Overview of removal item within Northern beach prior to removal

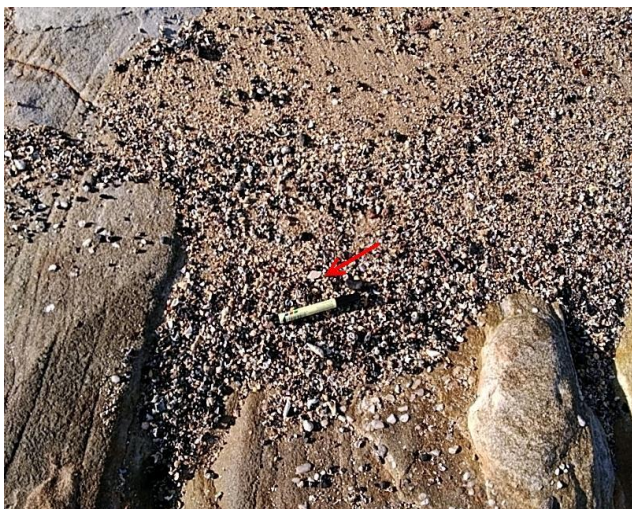
Notes: Overview of removal item within Northern beach prior to removal

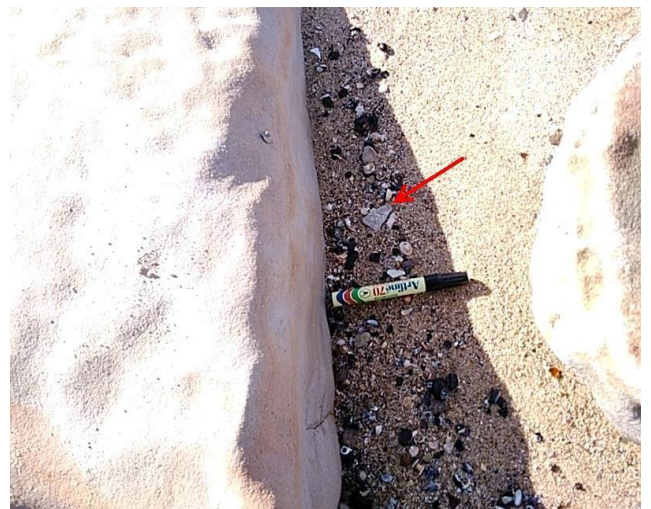
Notes: Overview of removal item within Northern beach prior to removal

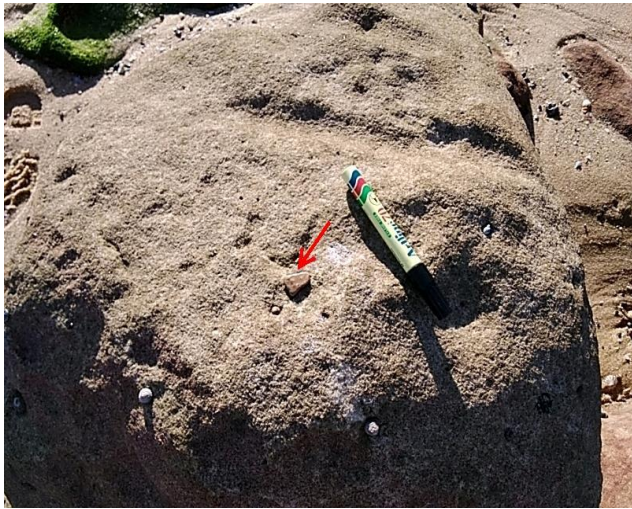
Notes: Overview of removal item within Northern beach prior to removal

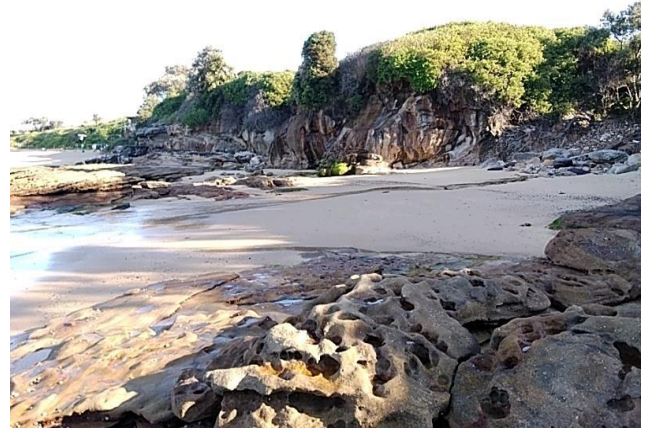
Notes: Overview of the Western beach

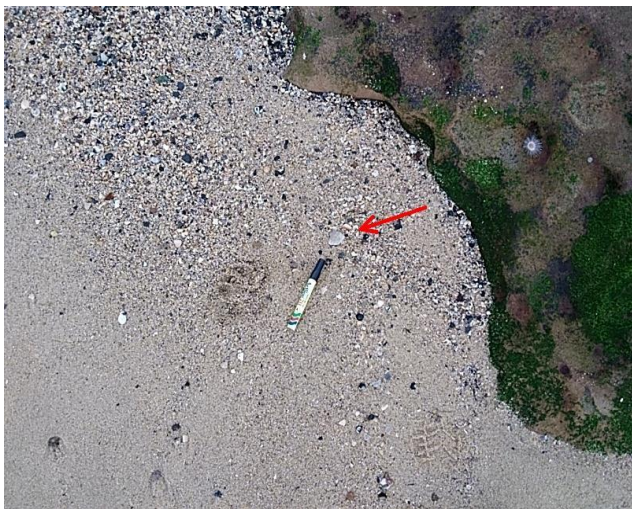
Notes: Overview of removal item within Western beach prior to removal

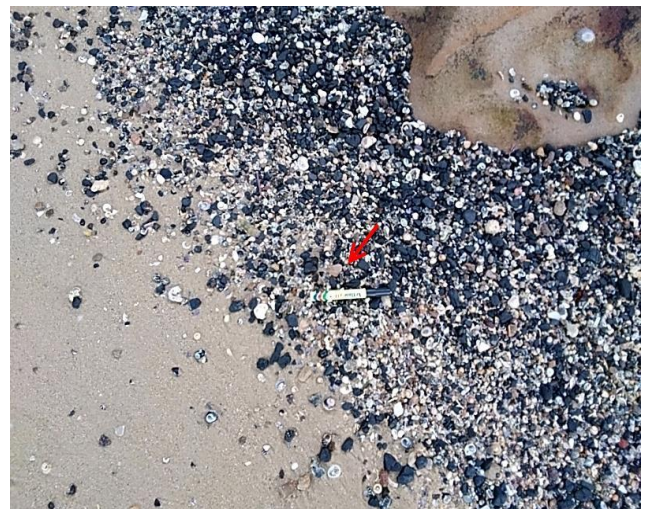
Notes: Overview of removal item within Western beach prior to removal

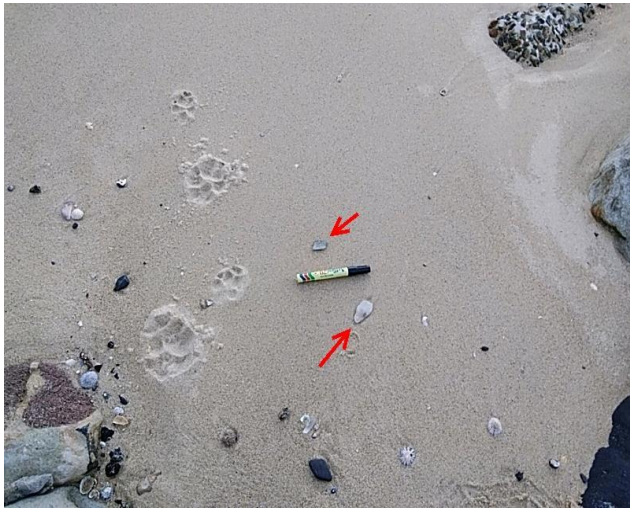
Notes: Overview of removal item within Western beach prior to removal

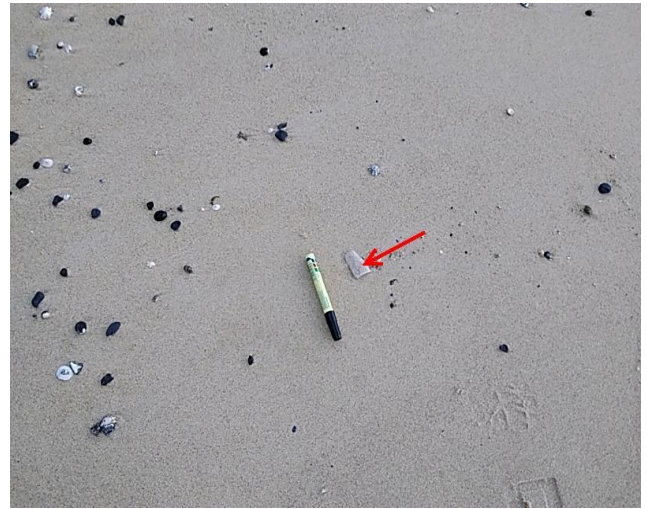
Notes: Overview of removal item within Western beach prior to removal

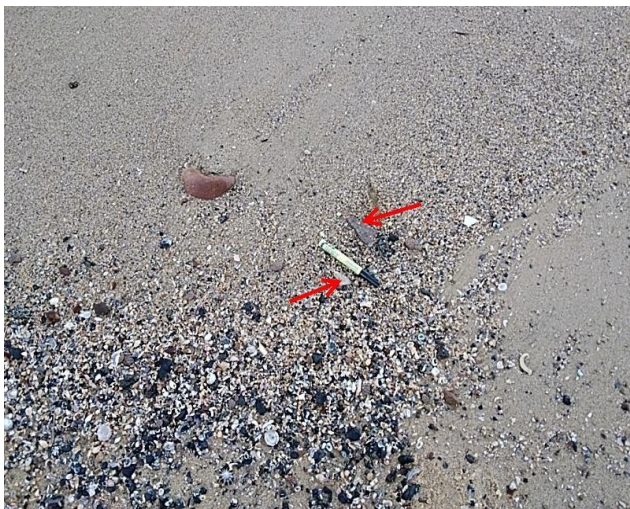
Notes: Overview of removal item within Western beach prior to removal

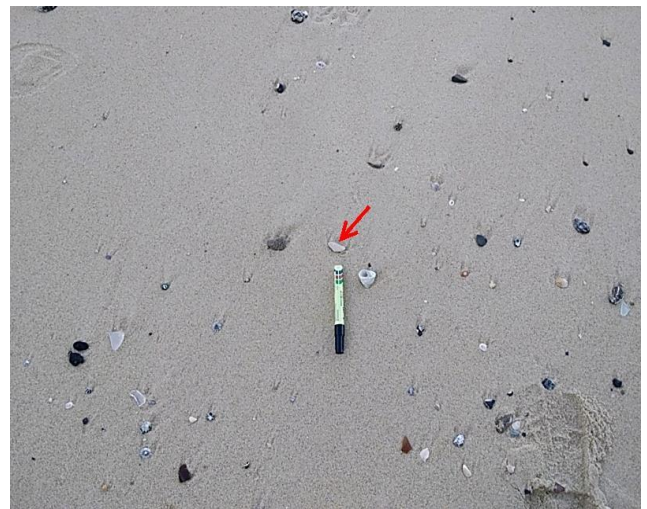
Notes: Overview of removal item within Western beach prior to removal

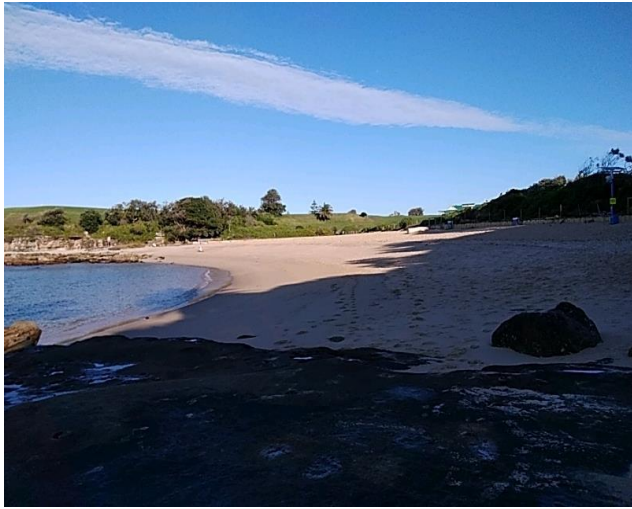
Notes: Overview of the Southern beach

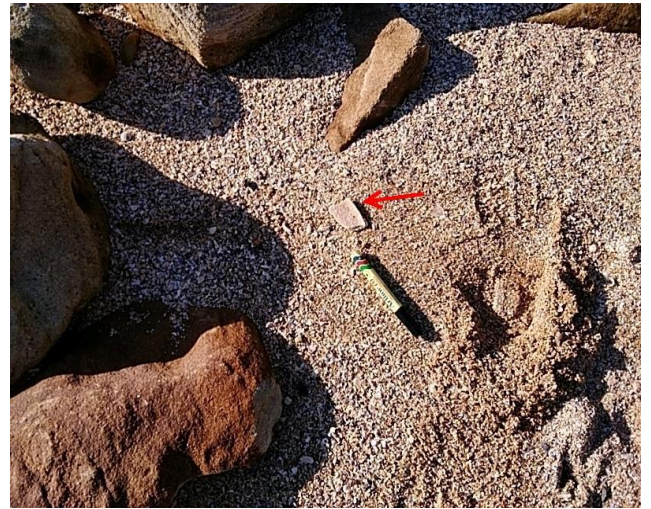
Notes: Overview of removal item within Southern beach prior to removal

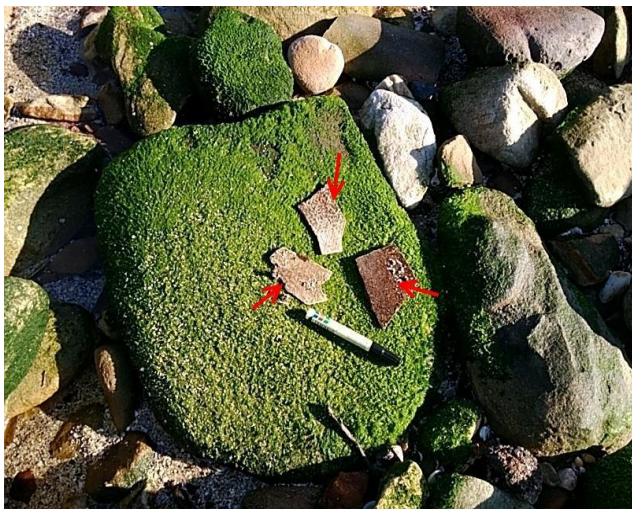
Notes: Overview of removal item within Southern beach prior to removal

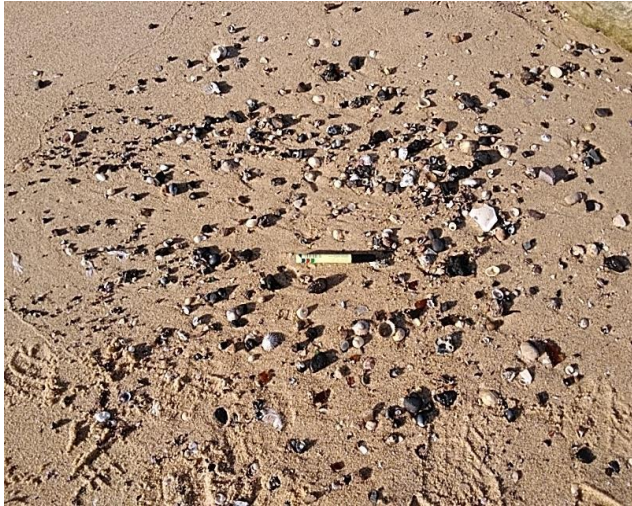
Notes: Visual inspection of removal item following removal

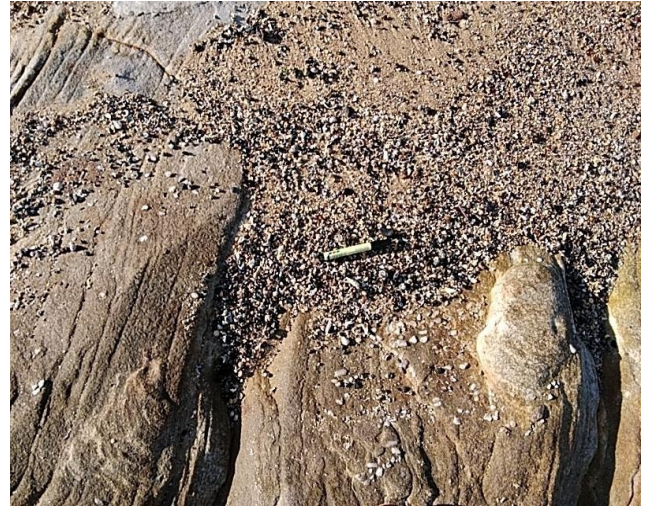
Notes: Visual inspection of removal item following removal

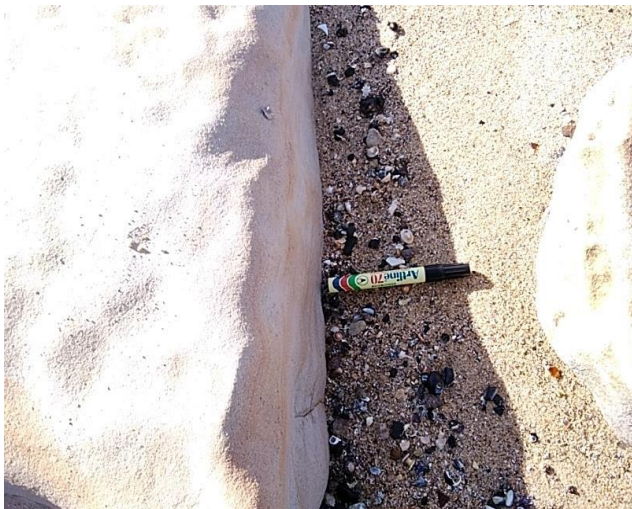
Notes: Visual inspection of removal item following removal

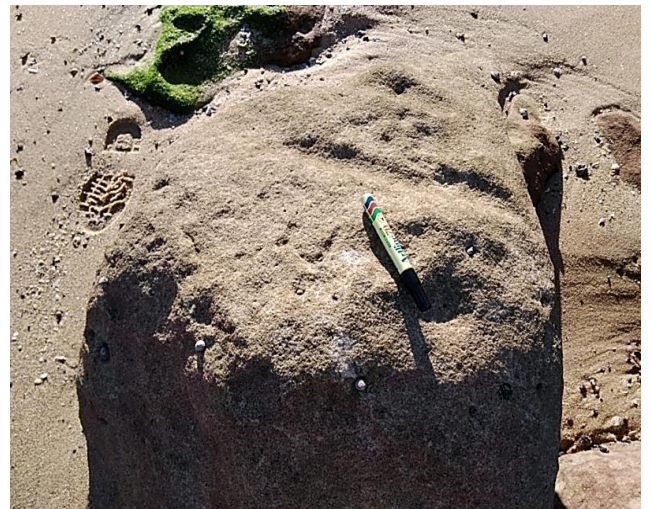
Notes: Visual inspection of removal item following removal

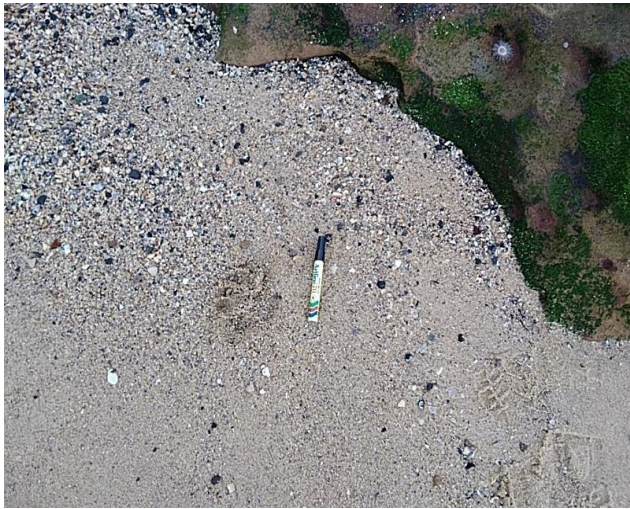
Notes: Visual inspection of removal item following removal

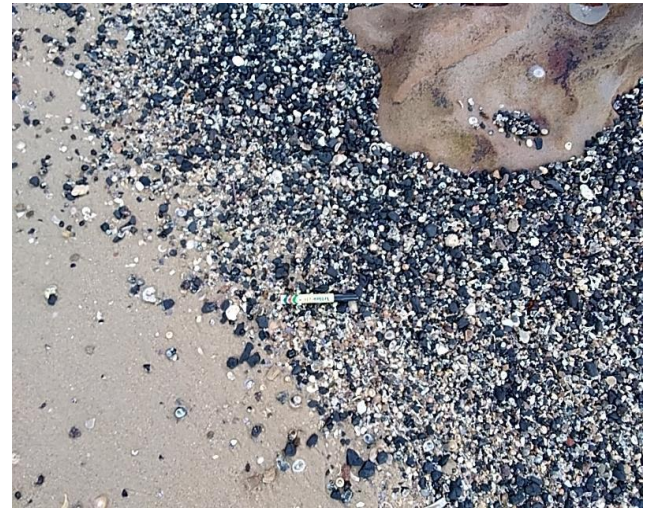
Notes: Visual inspection of removal item following removal

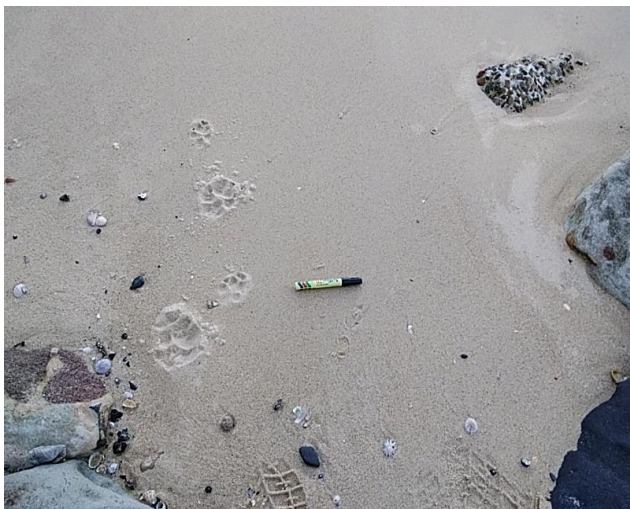
Notes: Visual inspection of removal item following removal

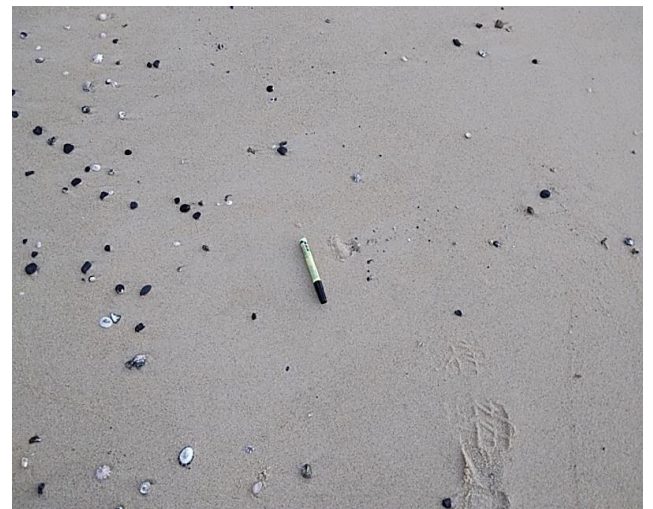
Notes: Visual inspection of removal item following removal

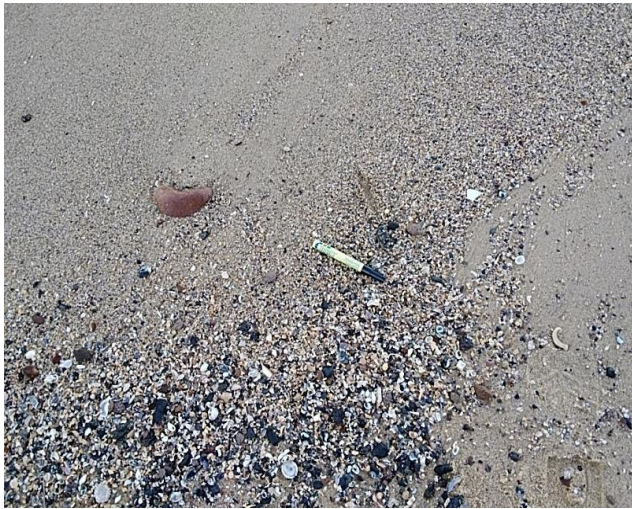
Notes: Visual inspection of removal item following removal

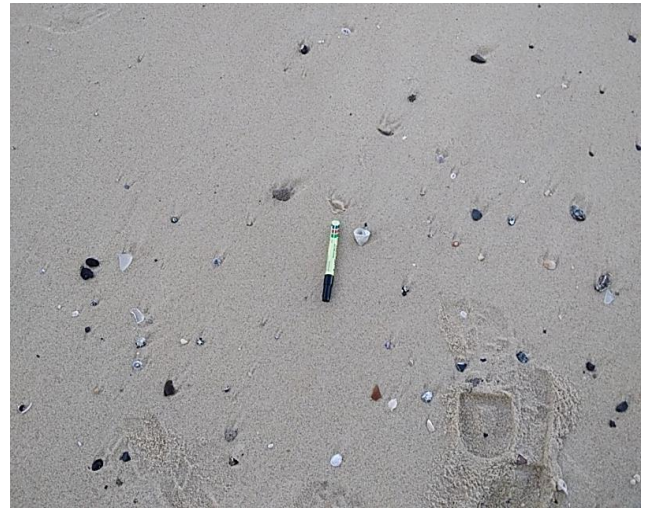
Notes: Visual inspection of removal item following removal

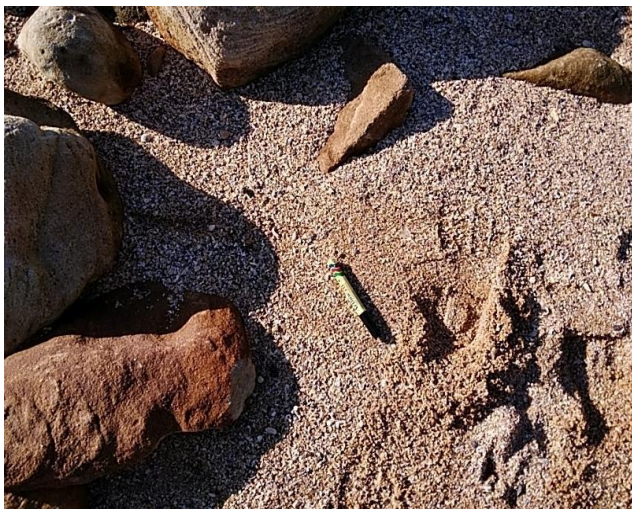
Notes: Visual inspection of removal item following removal

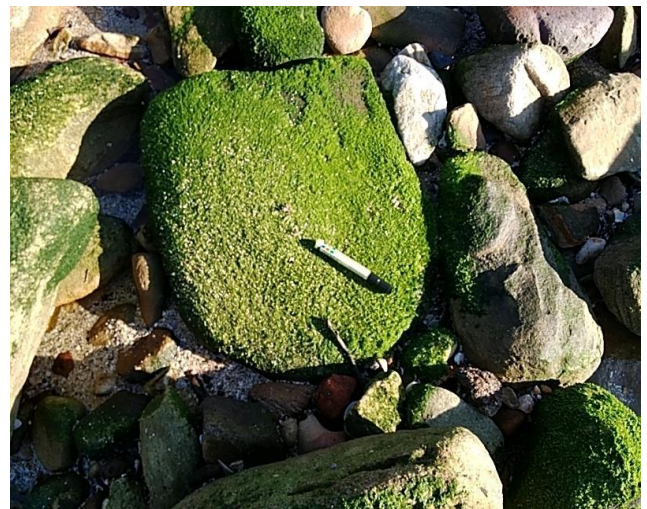
Notes: Visual inspection of removal item following removal

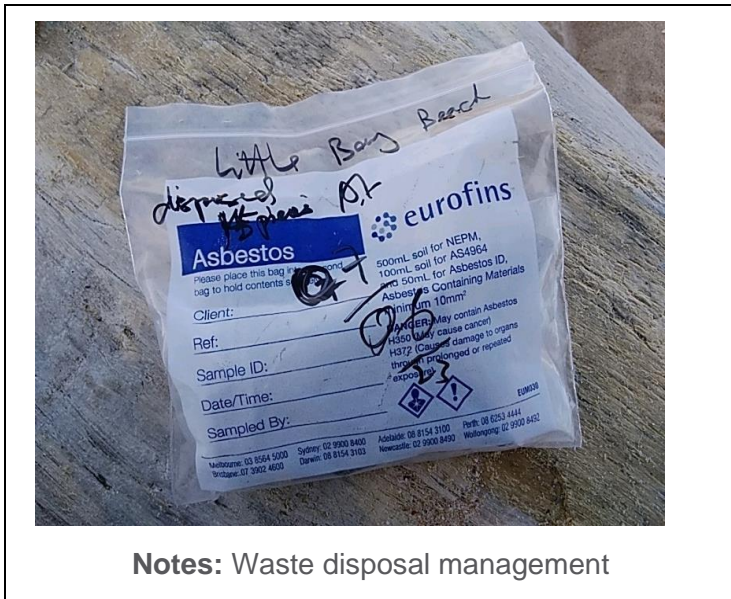
Notes: Waste disposal management
