# Asbestos Containing Material Clearance Inspection

29 December 2022

<b>Site:</b>	Little Bay Beach
<b>Location:</b>	Southern, Western and Northern Little Bay Beach

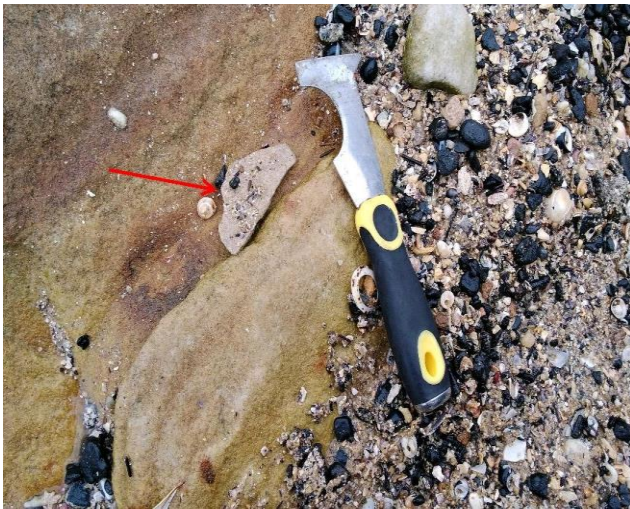
**Notes:** FC fragment identified on sand surface prior to emu pick - Northern section

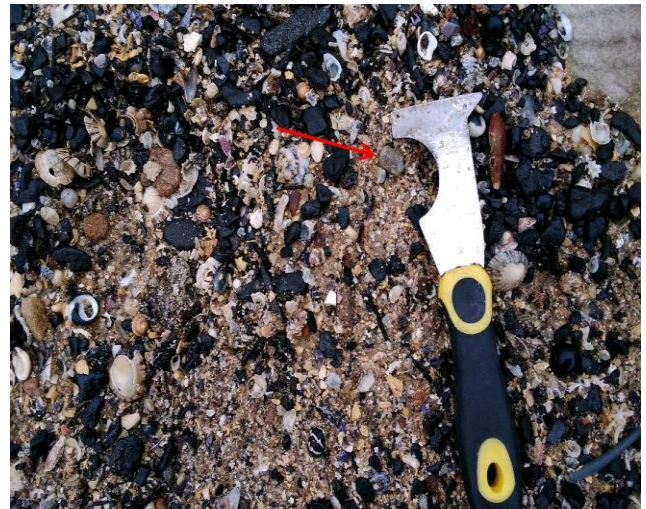
**Notes:** FC fragment identified on sand surface prior to emu pick - Northern section

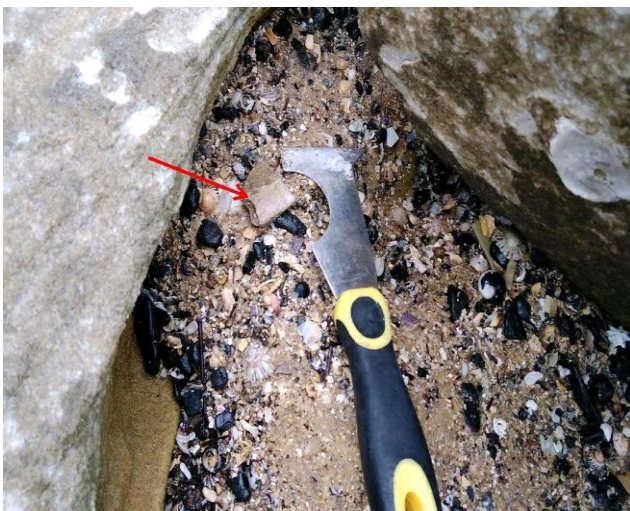
**Notes:** FC fragment identified on sand surface prior to emu pick - Northern section

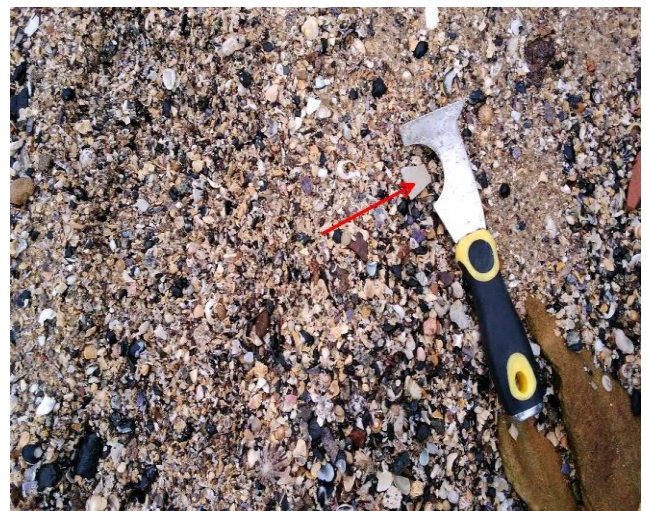
**Notes:** FC fragment identified on sand surface prior to emu pick - Northern section

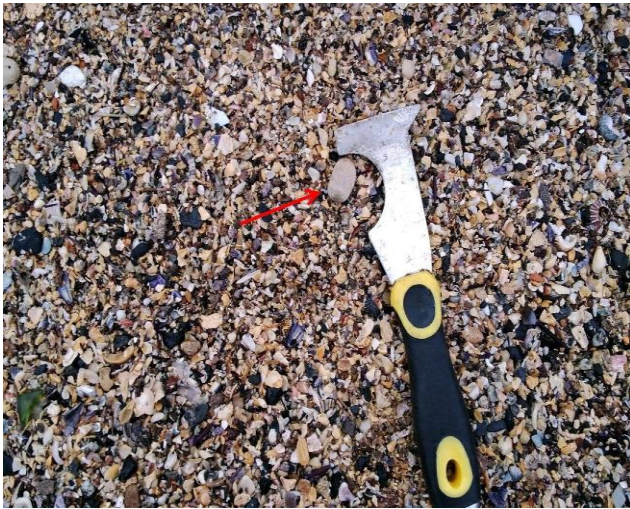
**Notes:** FC fragment identified on sand surface prior to emu pick - Northern section

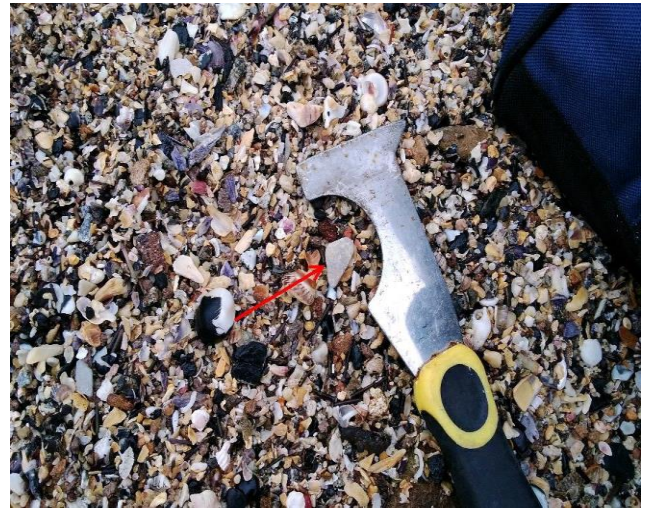
**Notes:** FC fragment identified on sand surface prior to emu pick - Northern section

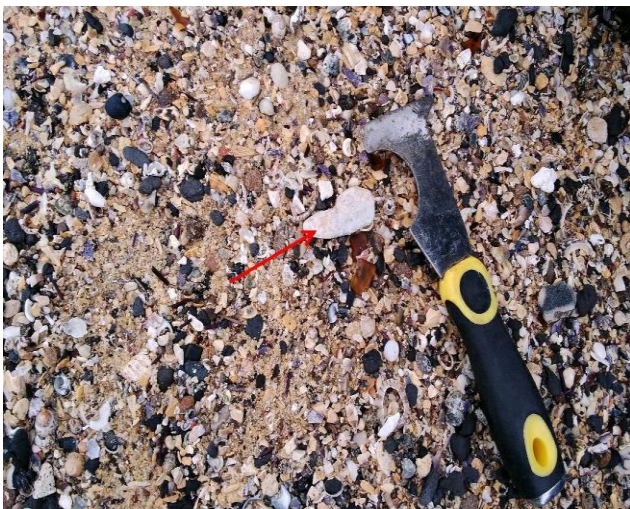
**Notes:** FC fragment identified on sand surface prior to emu pick - Northern section

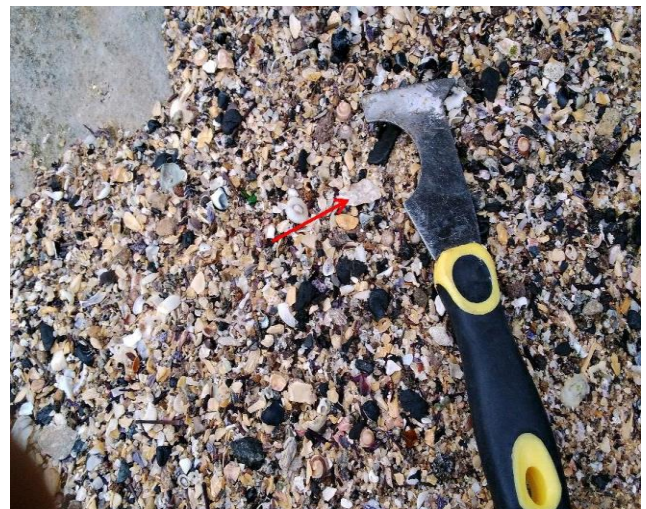
**Notes:** FC fragment identified on sand surface prior to emu pick - Northern section

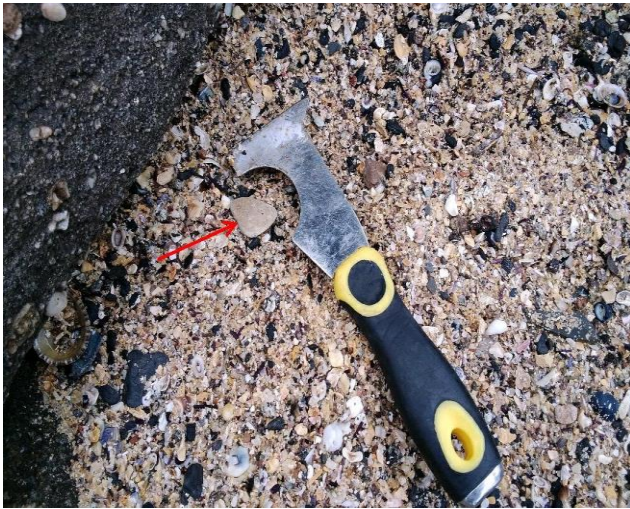
**Notes:** FC fragment identified on sand surface prior to emu pick - Northern section

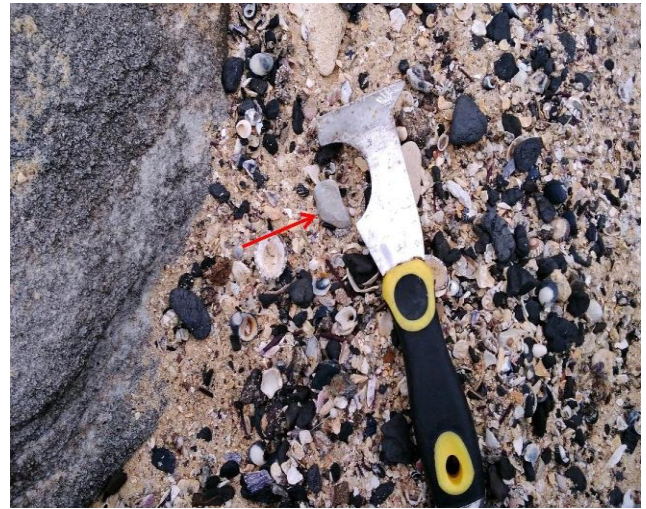
**Notes:** FC fragment identified on sand surface prior to emu pick - Northern section

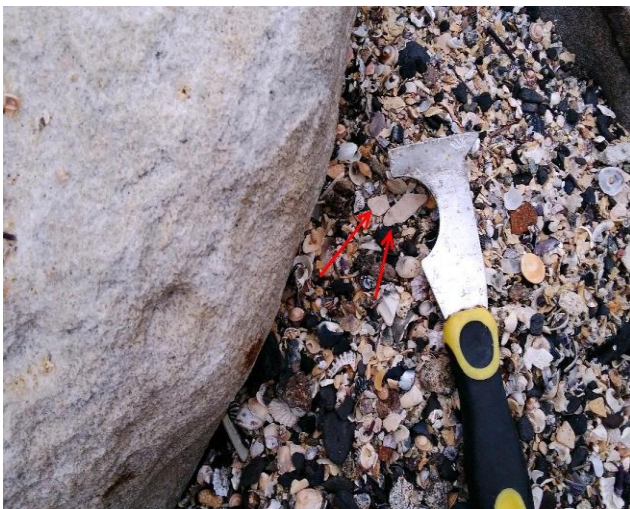
**Notes:** FC fragment identified on sand surface prior to emu pick - Northern section

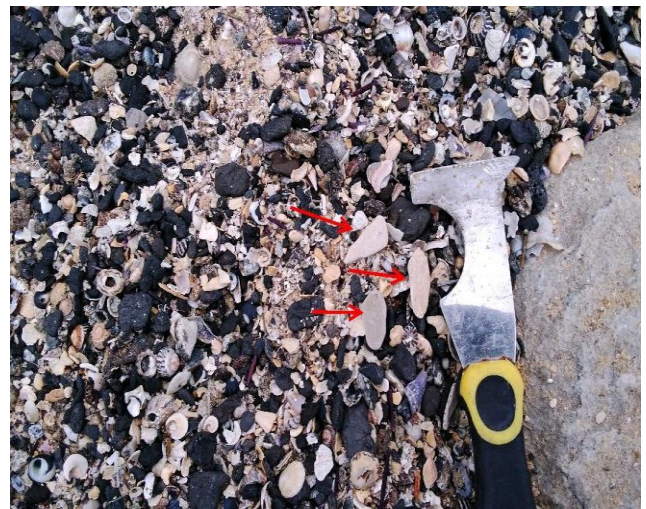
**Notes:** FC fragment identified on sand surface prior to emu pick - Northern section

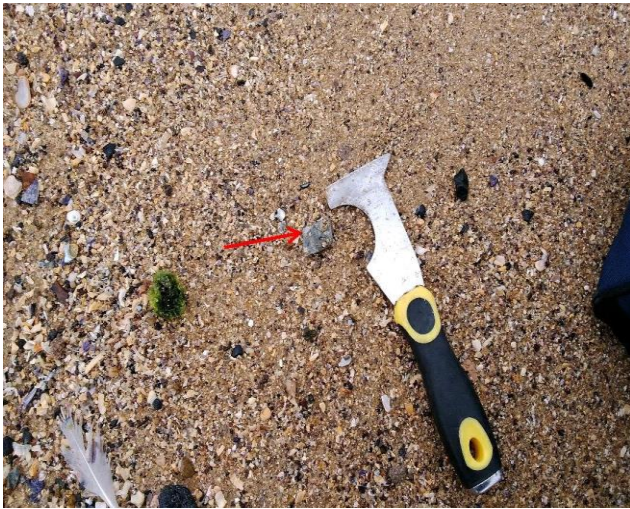
**Notes:** FC fragment identified on sand surface prior to emu pick - Northern section

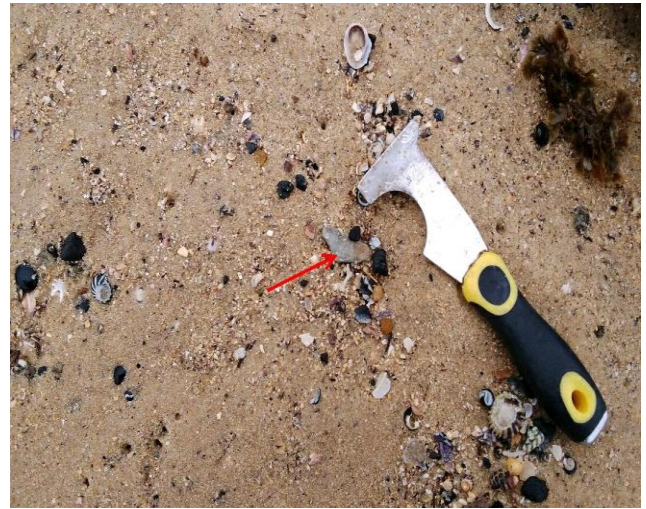
**Notes:** FC fragment identified on sand surface prior to emu pick - Northern section

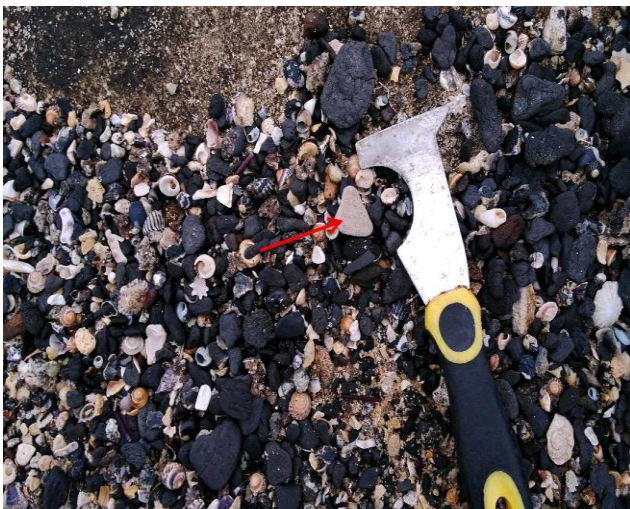
**Notes:** FC fragment identified on sand surface prior to emu pick - Northern section

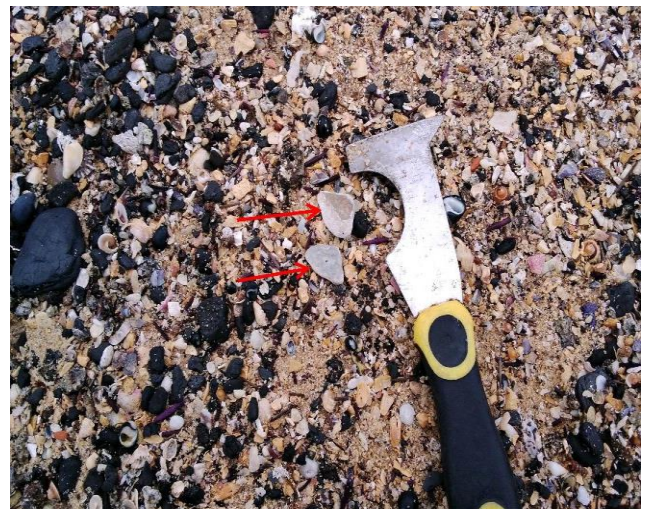
**Notes:** FC fragment identified on sand surface prior to emu pick - Northern section

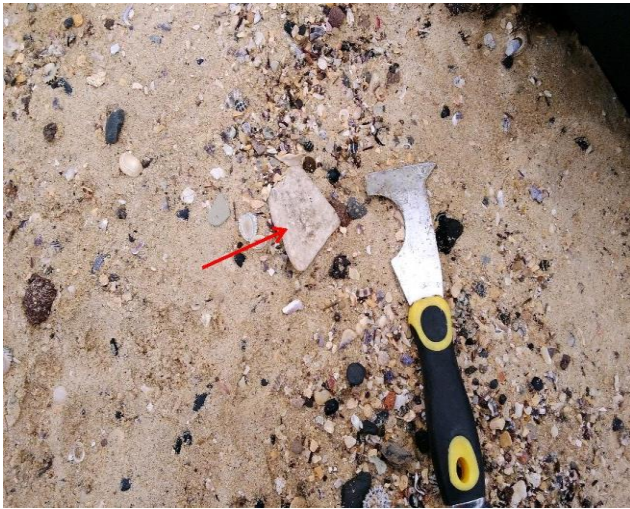
**Notes:** FC fragment identified on sand surface prior to emu pick - Northern section

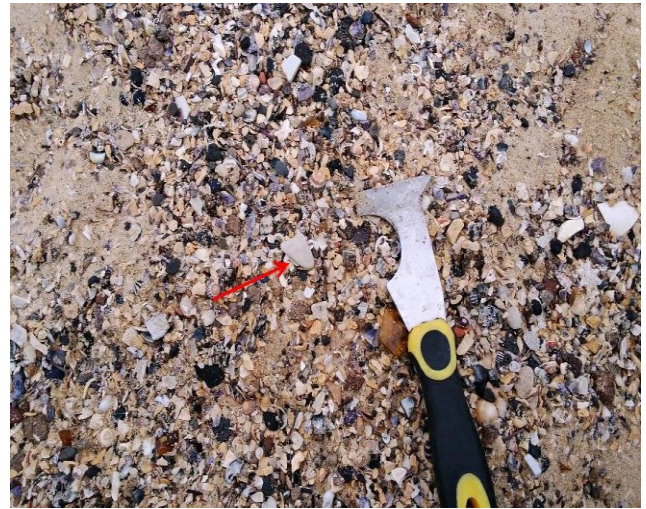
**Notes:** FC fragment identified on sand surface prior to emu pick - Southern section

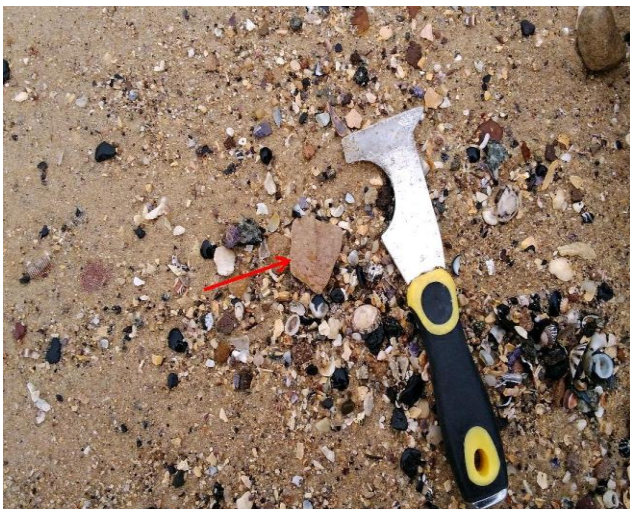
**Notes:** FC fragment identified on sand surface prior to emu pick - Southern section

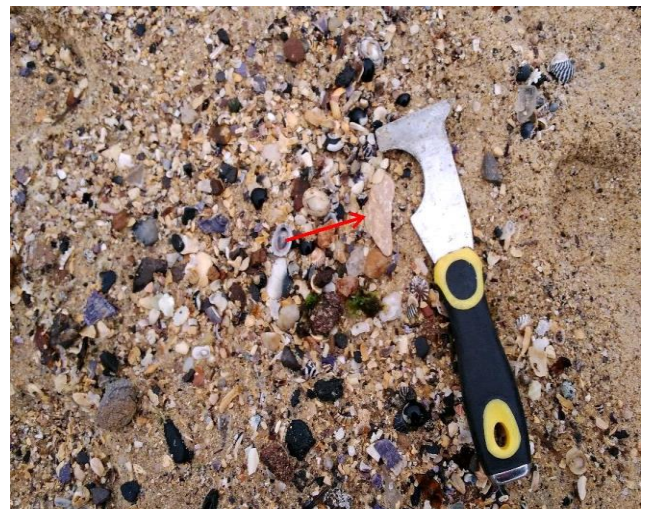
**Notes:** FC fragment identified on sand surface prior to emu pick - Southern section

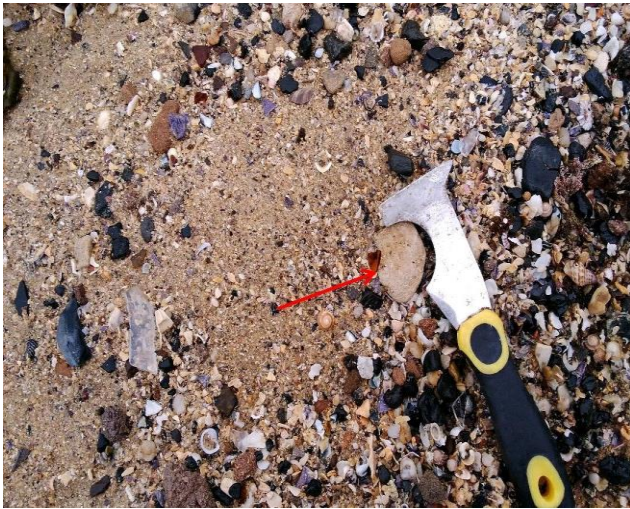
**Notes:** FC fragment identified on sand surface prior to emu pick - Southern section

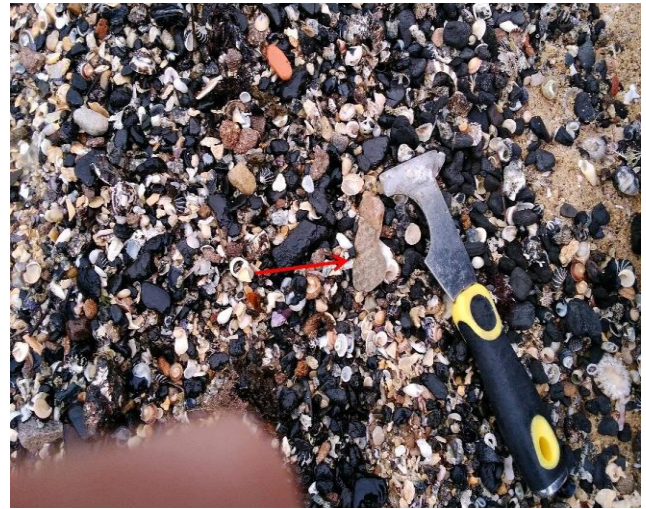
**Notes:** FC fragment identified on sand surface prior to emu pick - Southern section

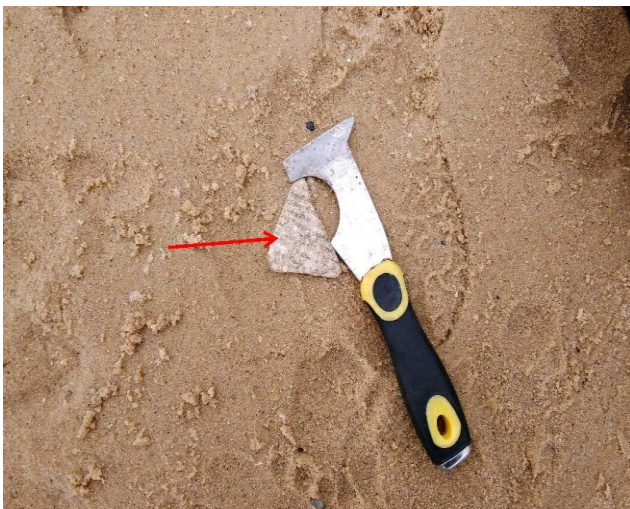
**Notes:** FC fragment identified on sand surface prior to emu pick - Southern section

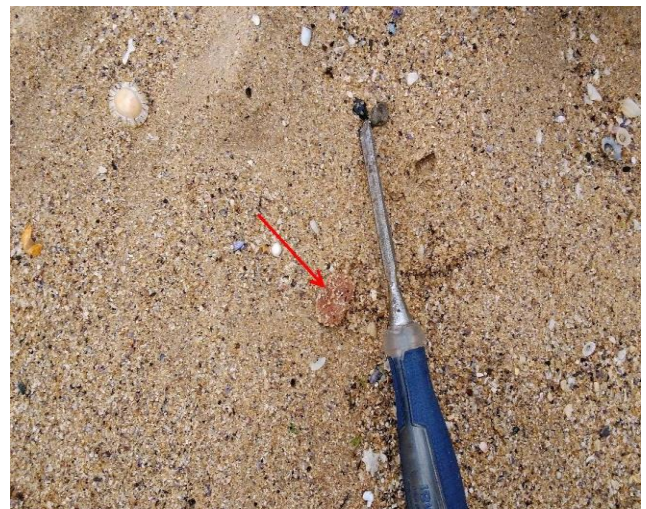
**Notes:** FC fragment identified on sand surface prior to emu pick - Southern section

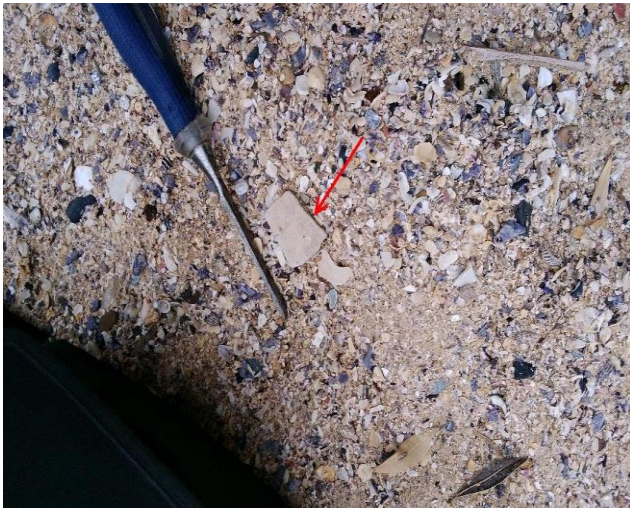
**Notes:** FC fragment identified on sand surface prior to emu pick - Southern section

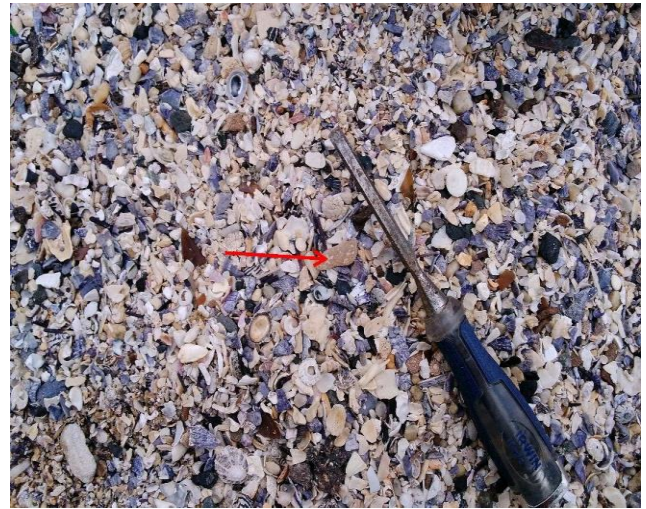
**Notes:** FC fragment identified on sand surface prior to emu pick - Southern section

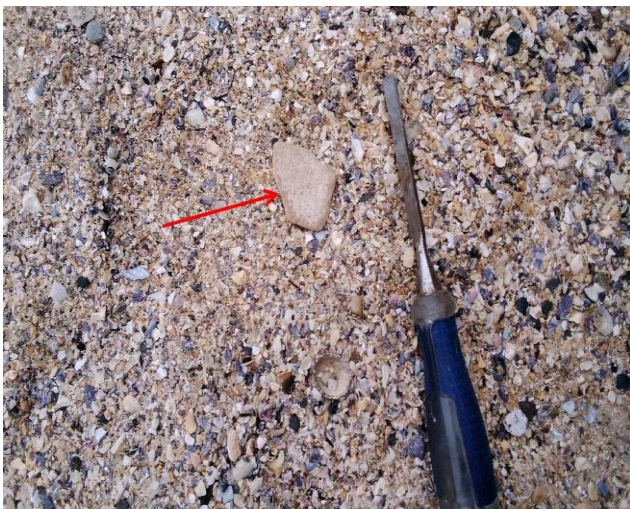
**Notes:** FC fragment identified on sand surface prior to emu pick - Southern section

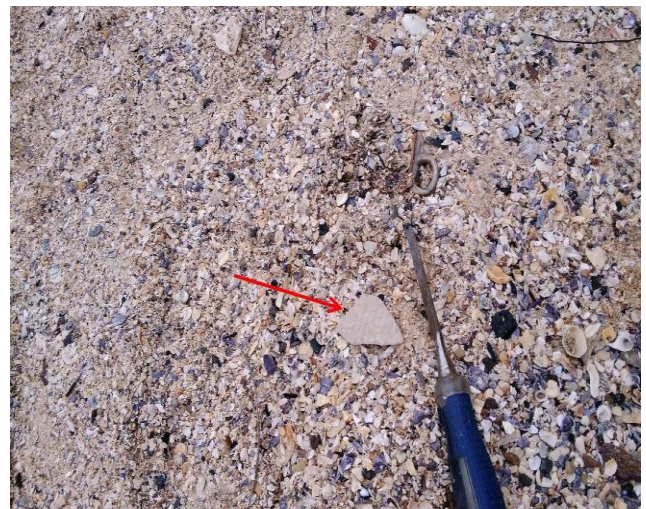
**Notes:** FC fragment identified on sand surface prior to emu pick - Southern section

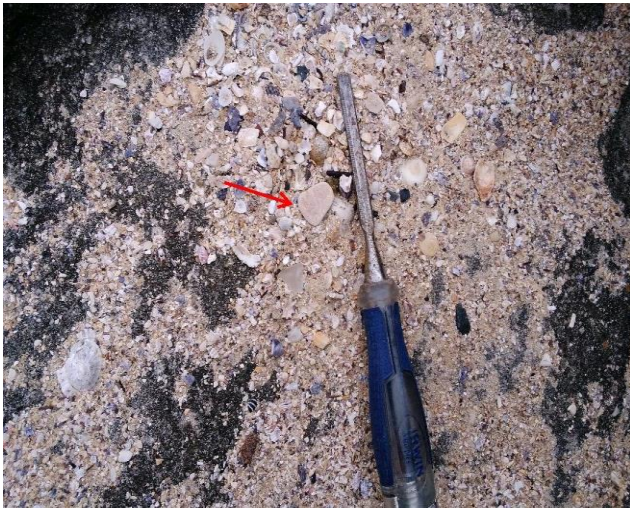
**Notes:** FC fragment identified on sand surface prior to emu pick - Southern section

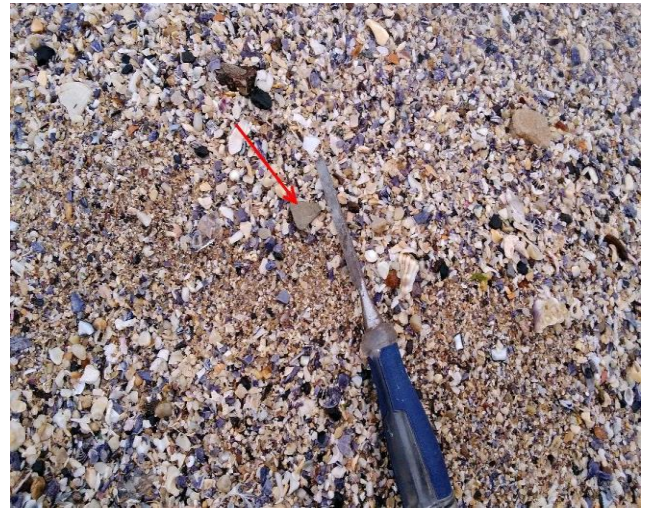
**Notes:** FC fragment identified on sand surface prior to emu pick - Southern section

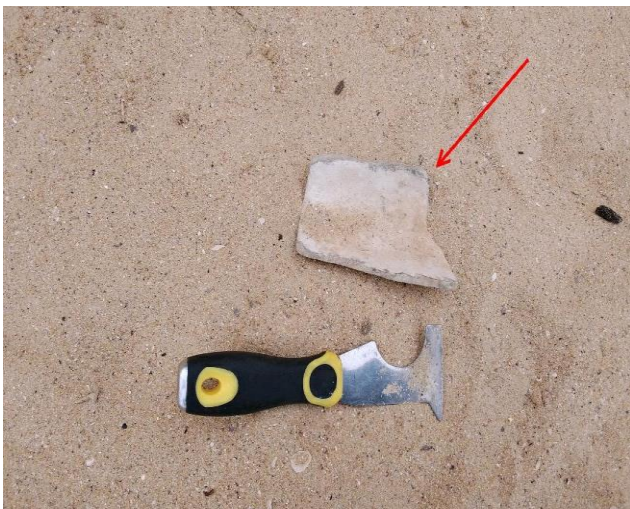
**Notes:** FC fragment identified on sand surface prior to emu pick - Southern section

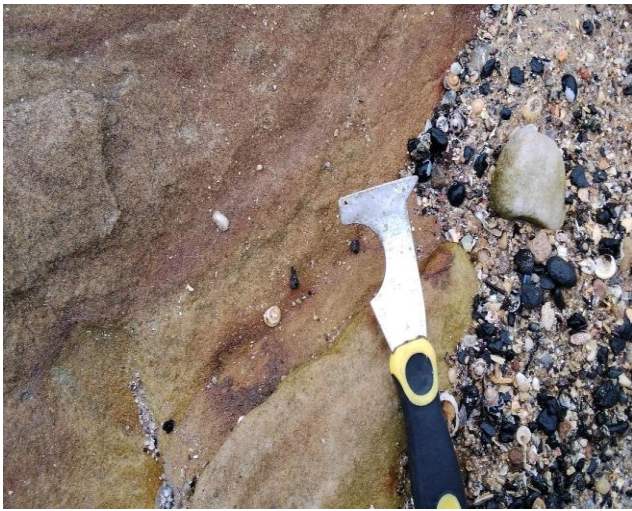
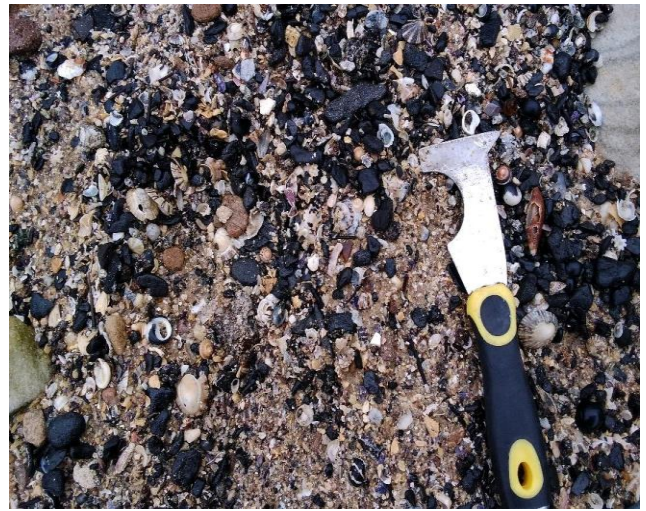
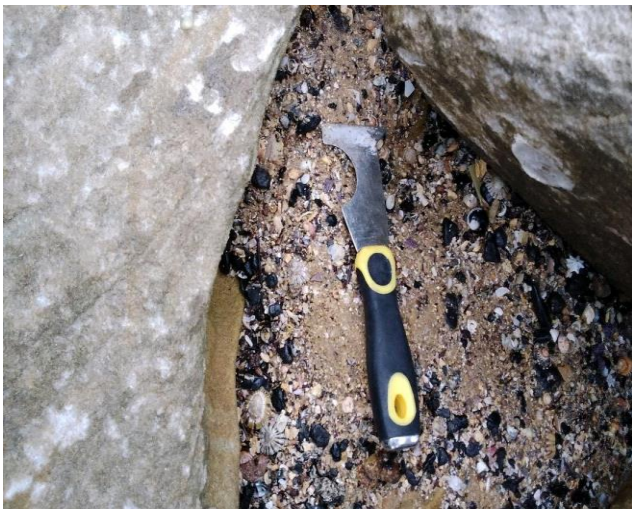
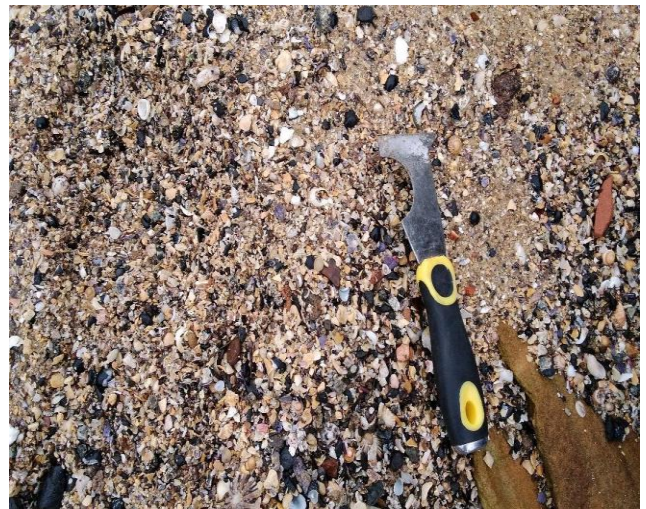
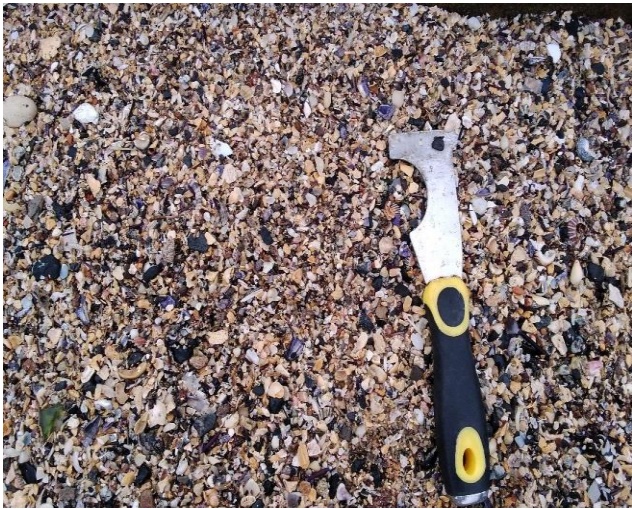
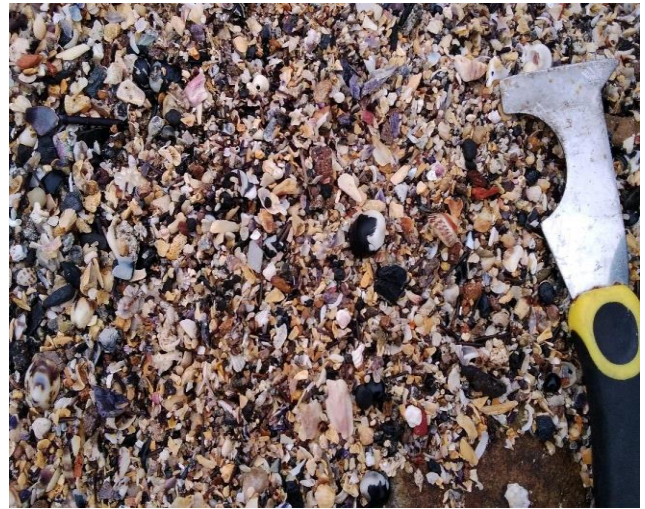
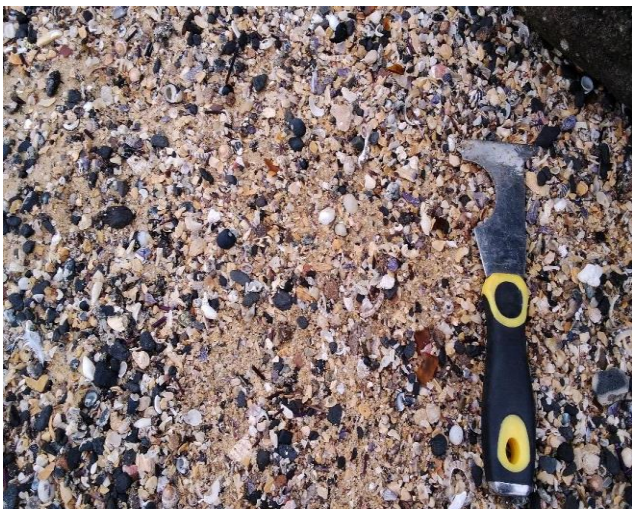
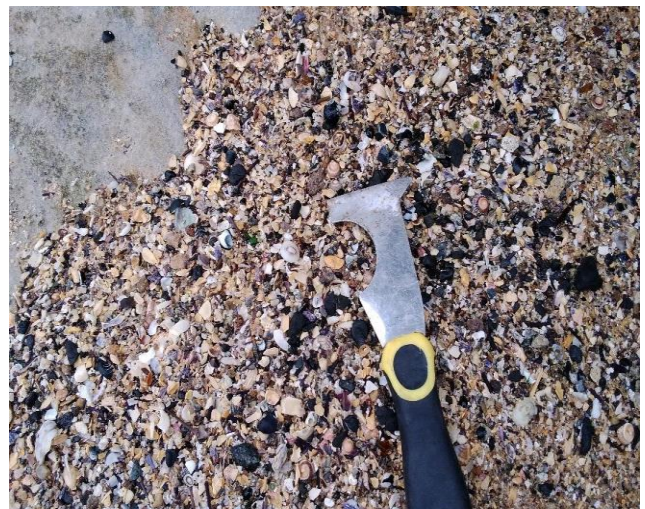
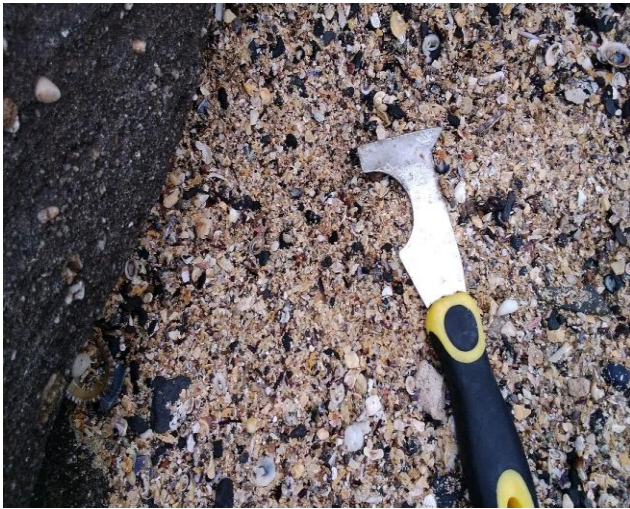
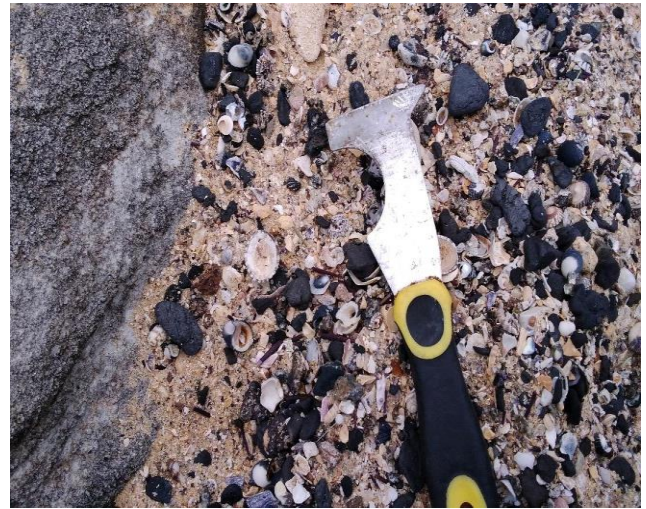
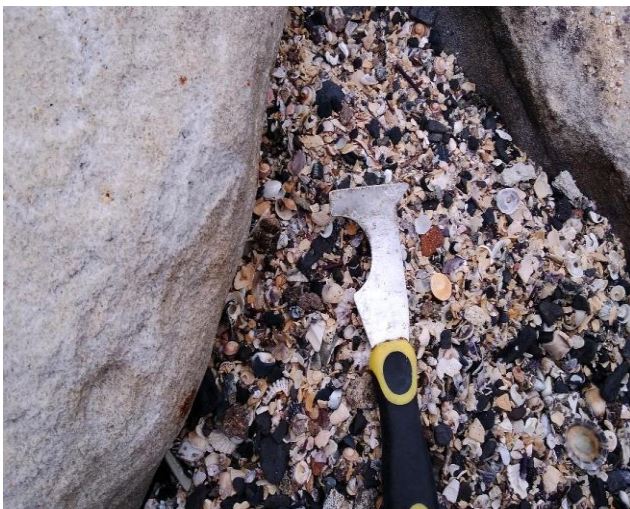
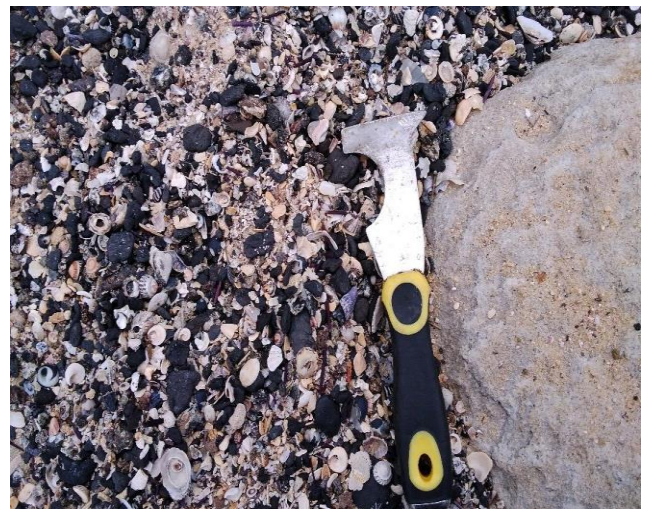
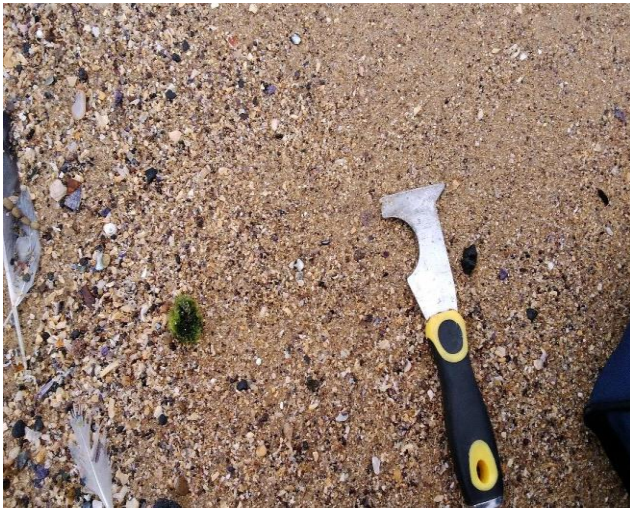
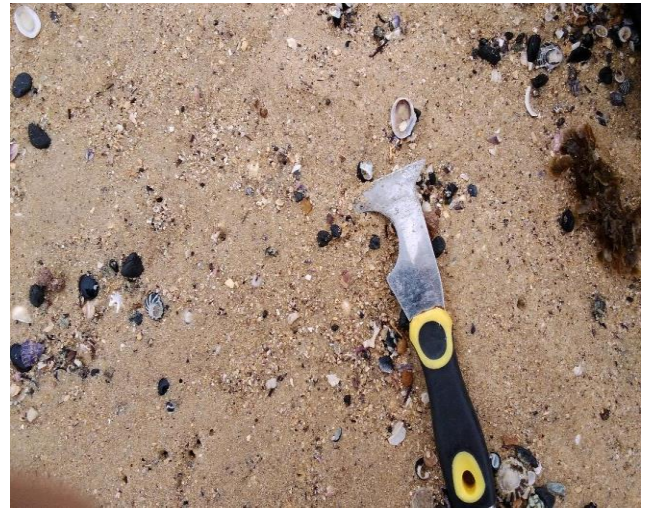
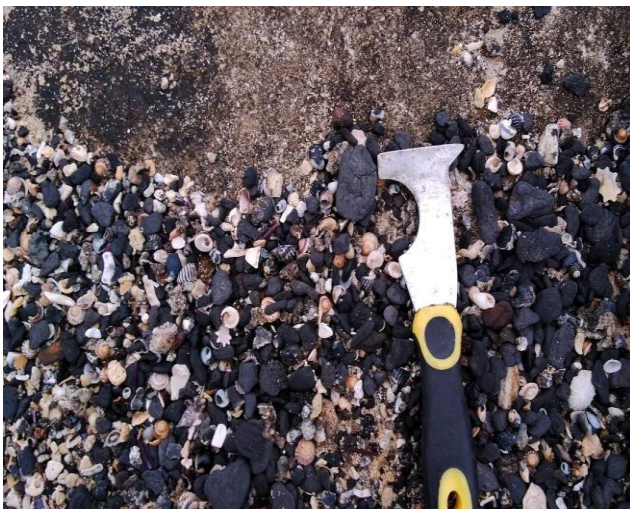
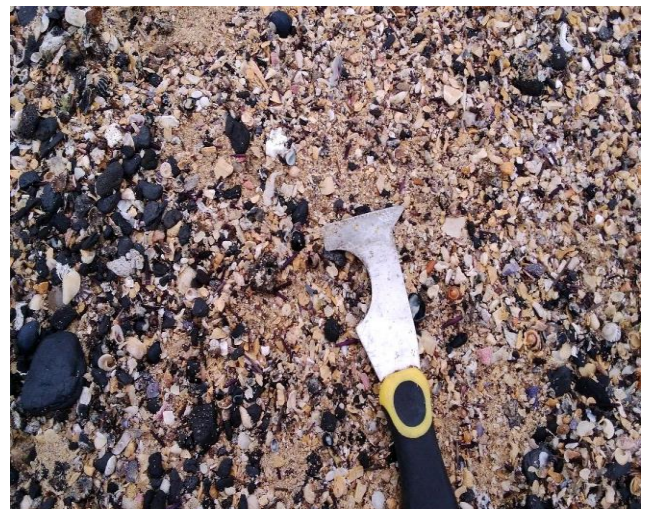
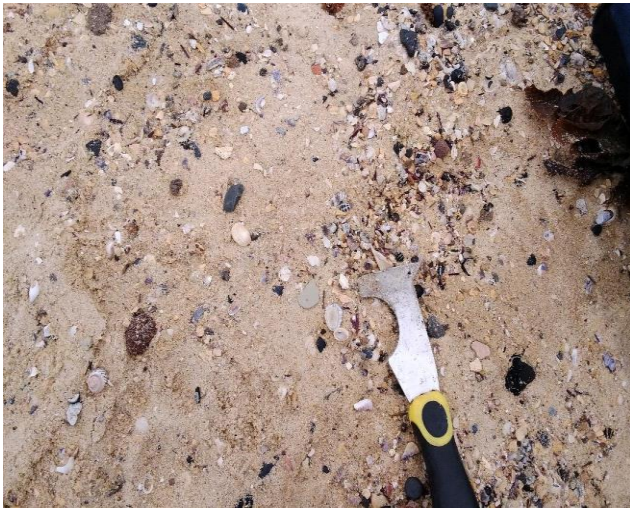
**Notes:** Sand surface following emu pick - Northern section

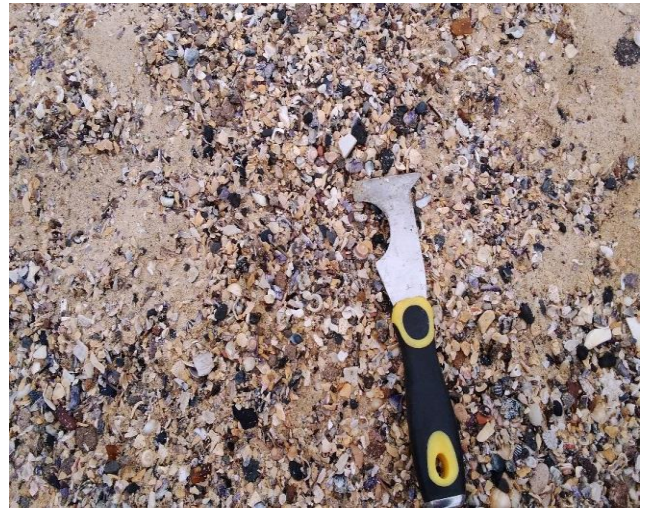
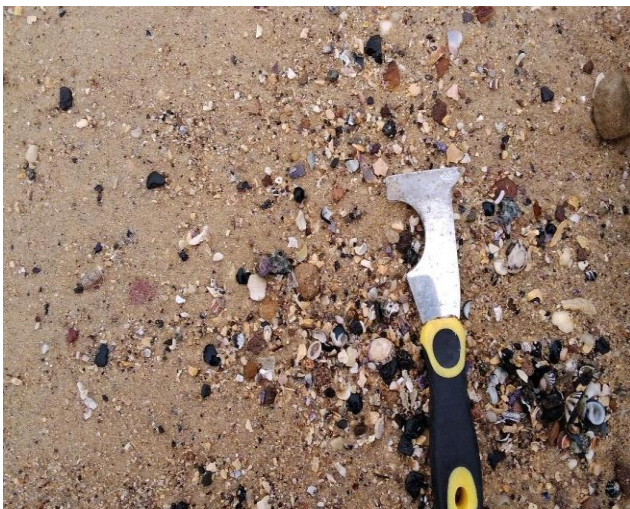
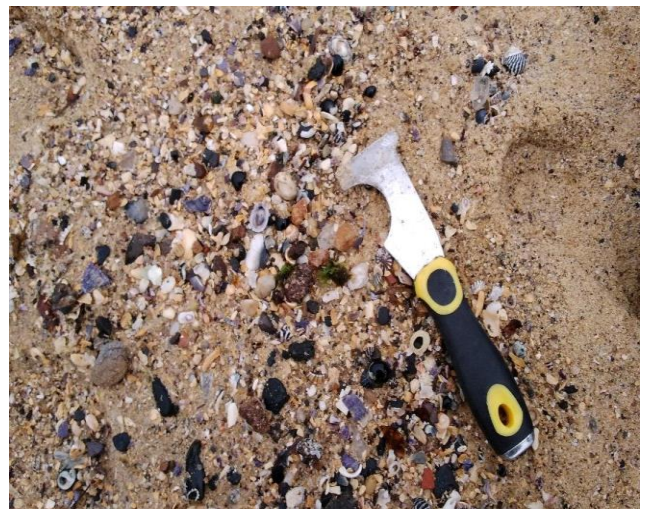
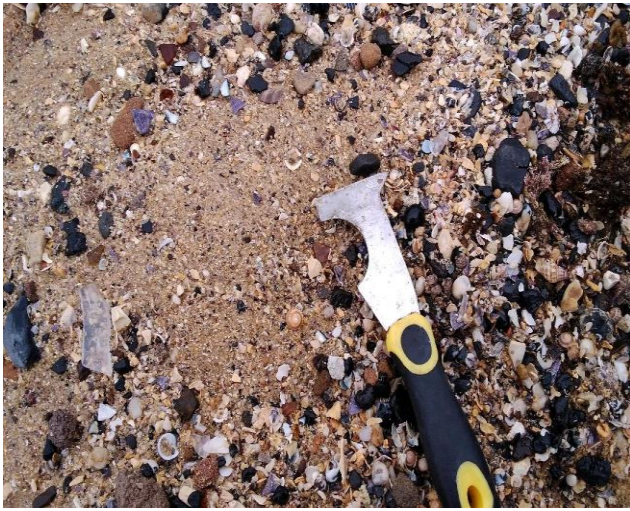
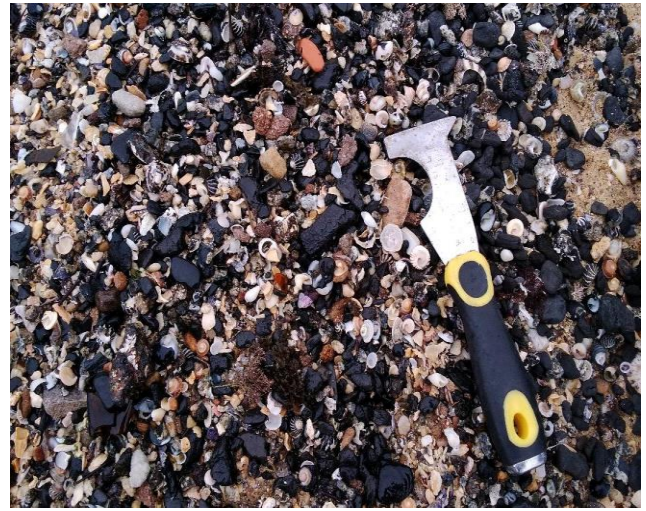
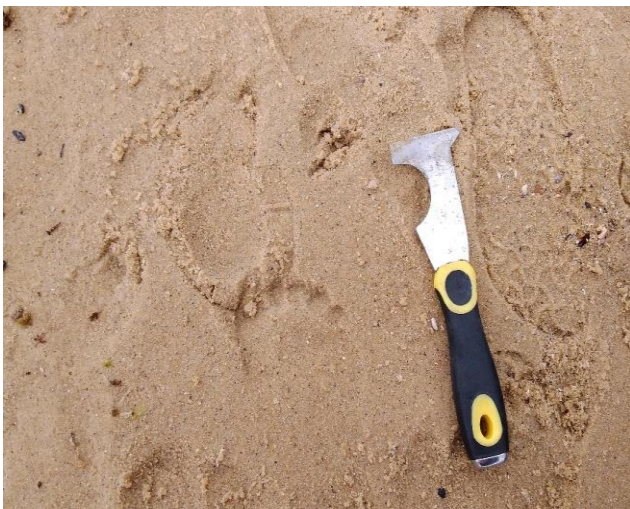
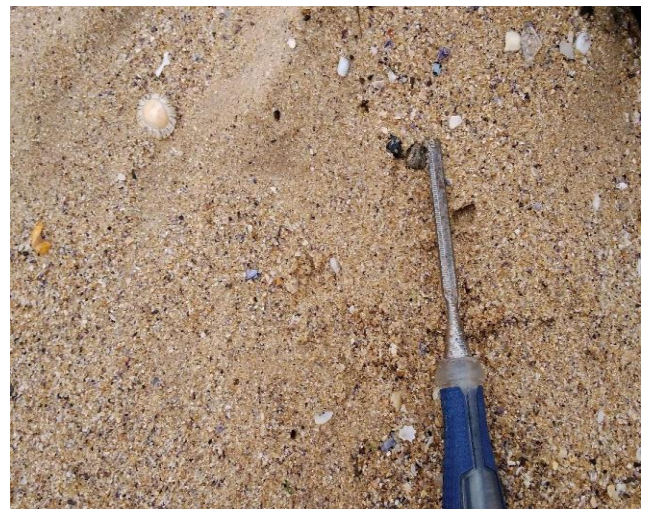
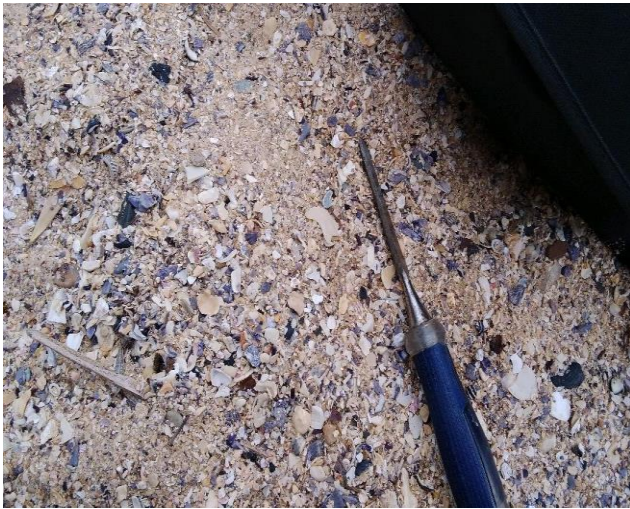
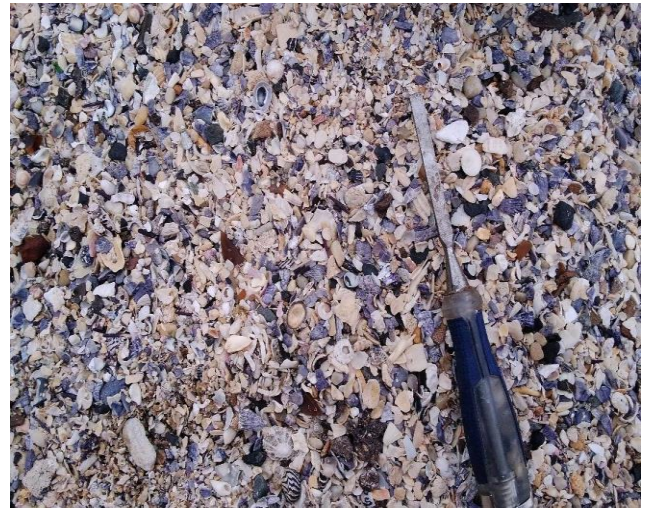
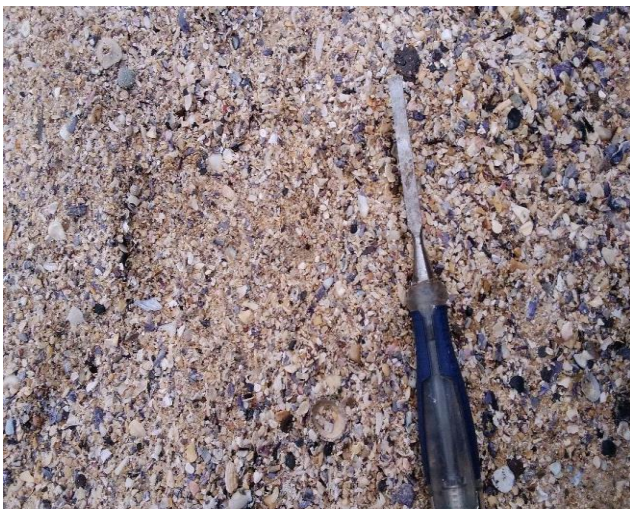
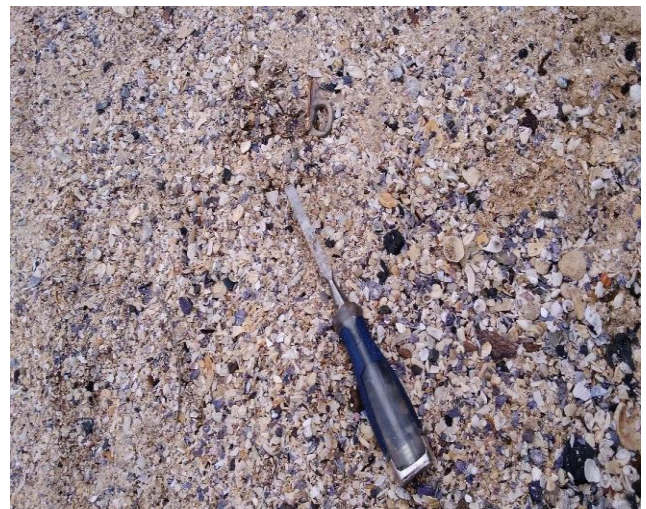
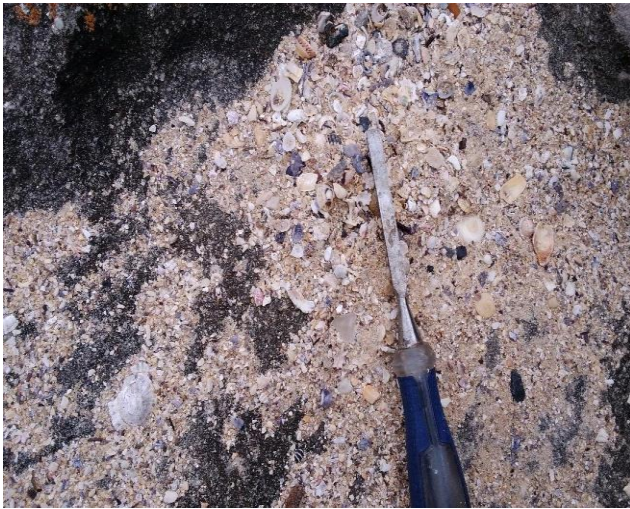
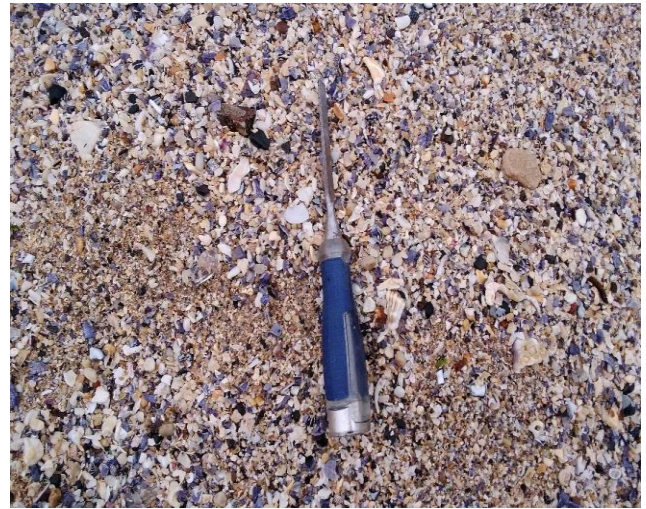
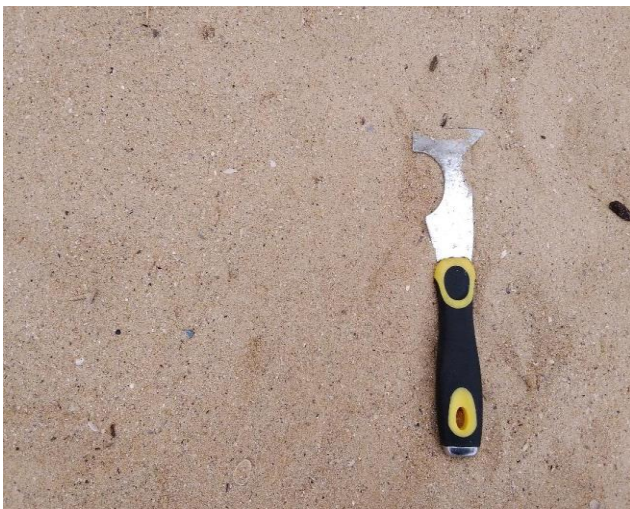
**Notes:** Sand surface following emu pick - Southern section
