Asbestos Containing Material Clearance Inspection

16 January 2023

Site:	Little Bay Beach
Location:	Southern, Western and Northern Little Bay Beach

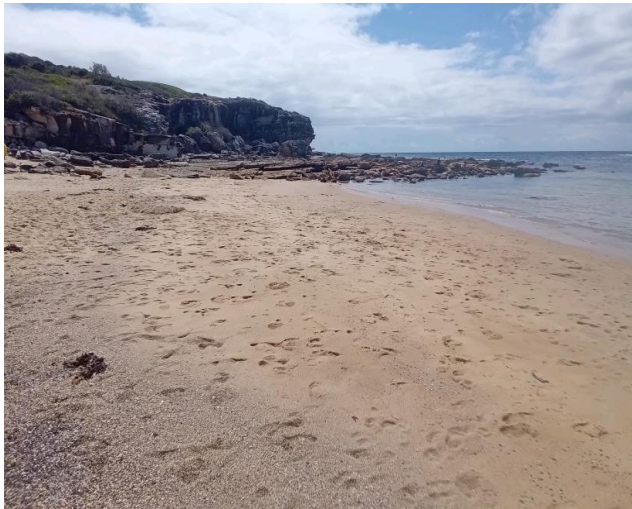
Notes: Overview of Northern beach

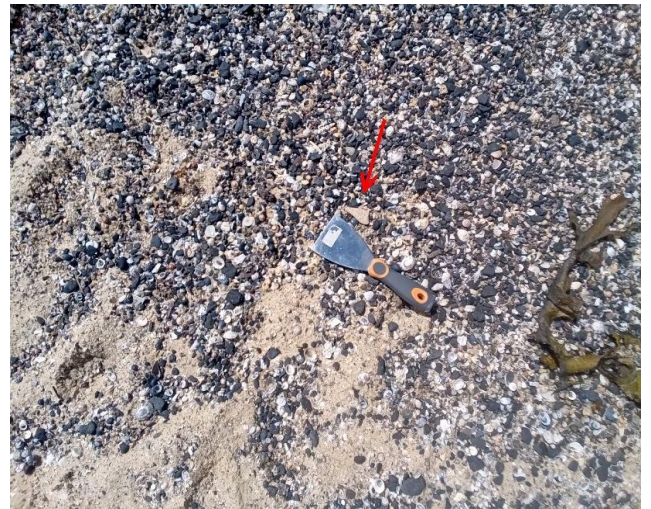
Notes: Overview of the ACM fragment prior to the removal within Northern beach.

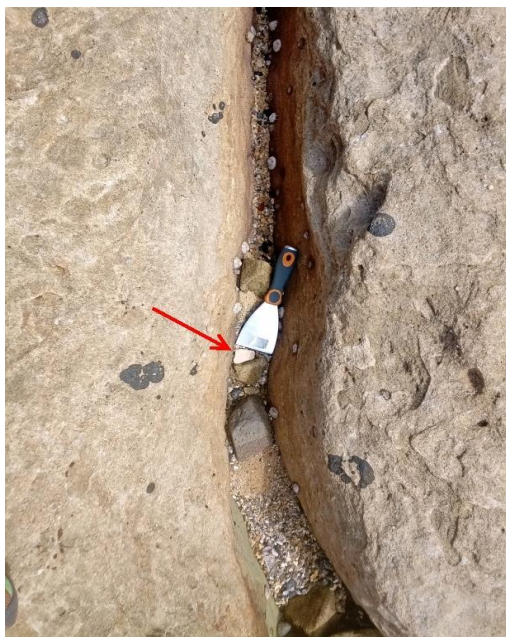
Notes: Overview of the ACM fragment prior to the removal within Northern beach.

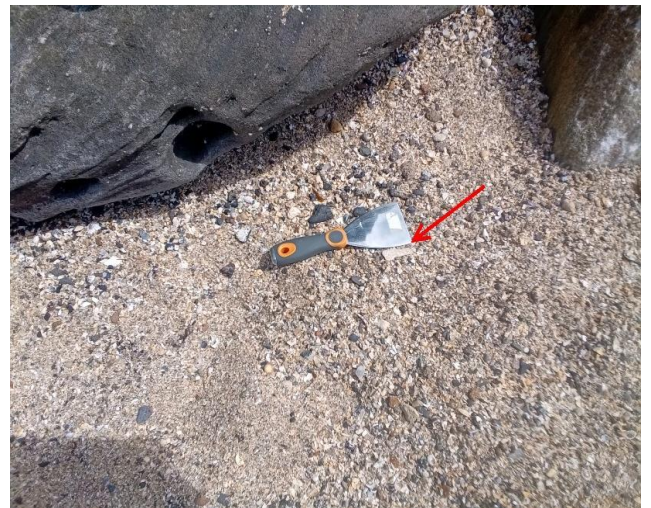
Notes: Overview of the ACM fragment prior to the removal within Northern beach.

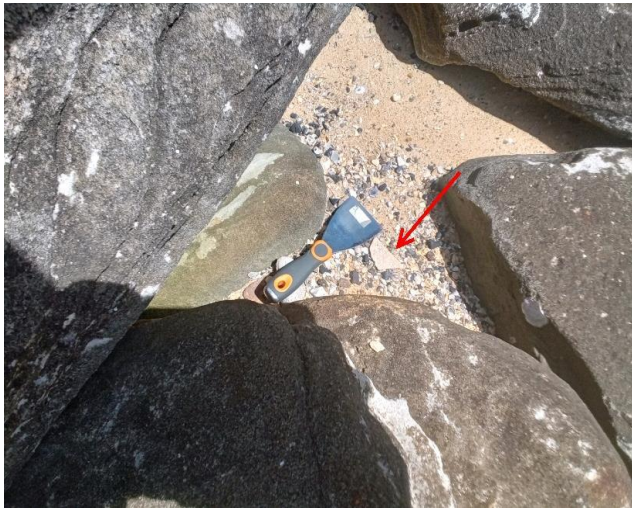
Notes: Overview of the ACM fragment prior to the removal within Northern beach.

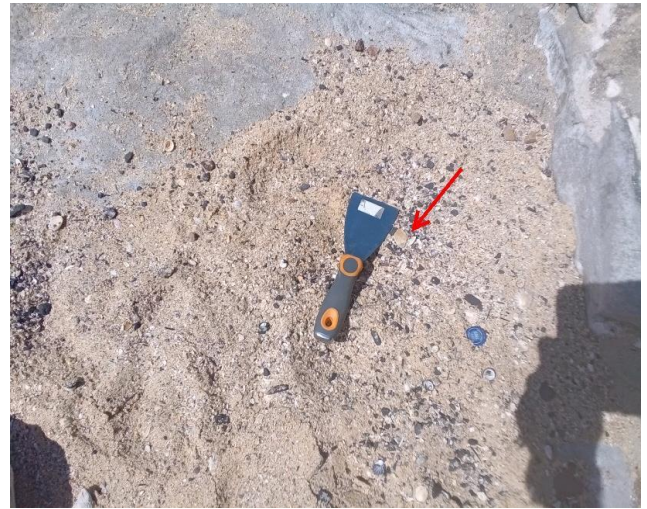
Notes: Overview of the ACM fragment prior to the removal within Northern beach.

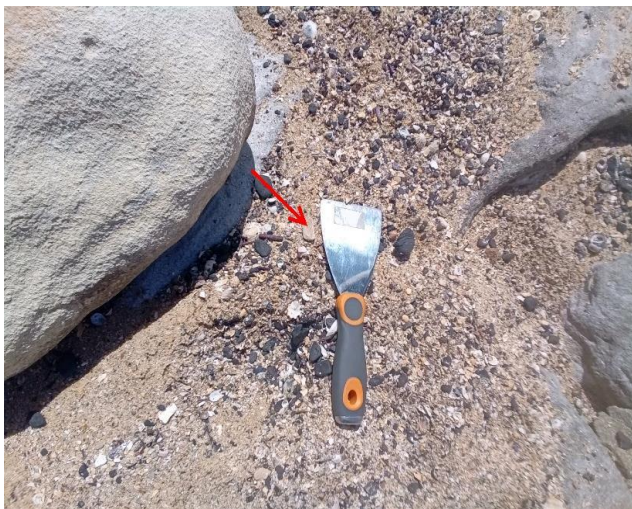
Notes: Overview of the ACM fragment prior to the removal within Northern beach.

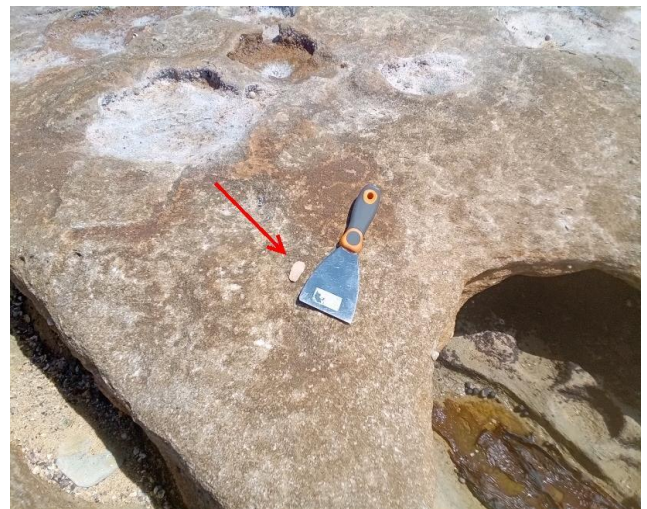
Notes: Overview of the ACM fragment prior to the removal within Northern beach.

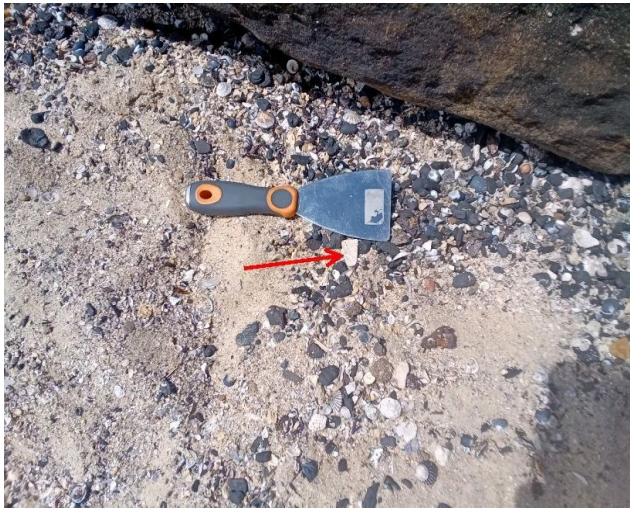
Notes: Overview of the ACM fragment prior to the removal within Northern beach.

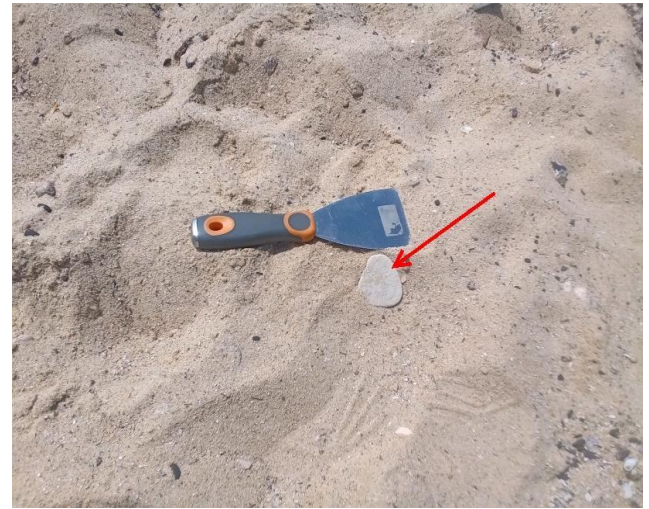
Notes: Overview of the ACM fragment prior to the removal within Northern beach.

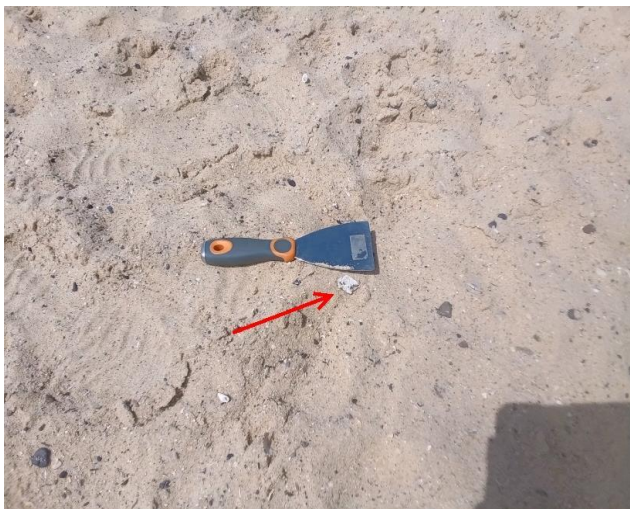
Notes: Overview of the ACM fragment prior to the removal within Northern beach.

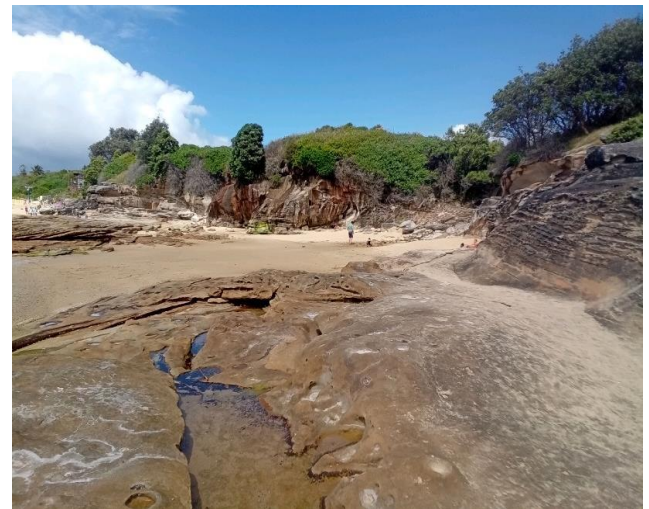
Notes: Overview of Western beach

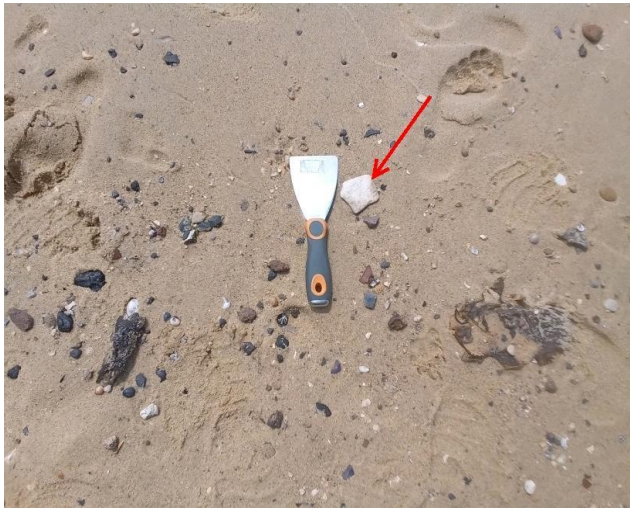
Notes: Overview of the ACM fragment prior to the removal within Western beach.

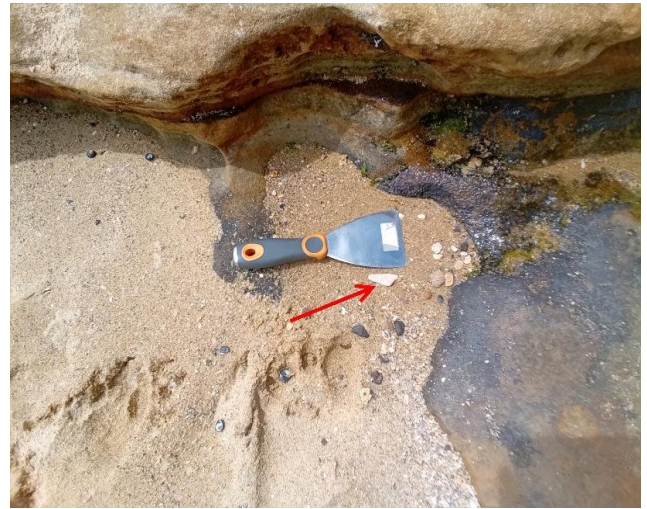
Notes: Overview of the ACM fragment prior to the removal within Western beach.

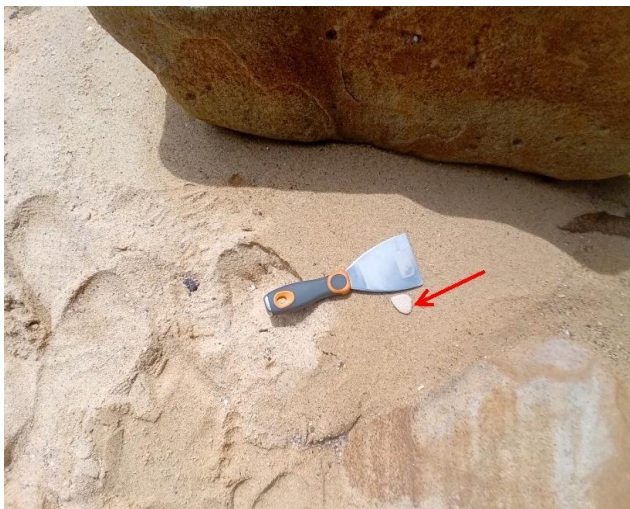
Notes: Overview of the ACM fragment prior to the removal within Western beach.

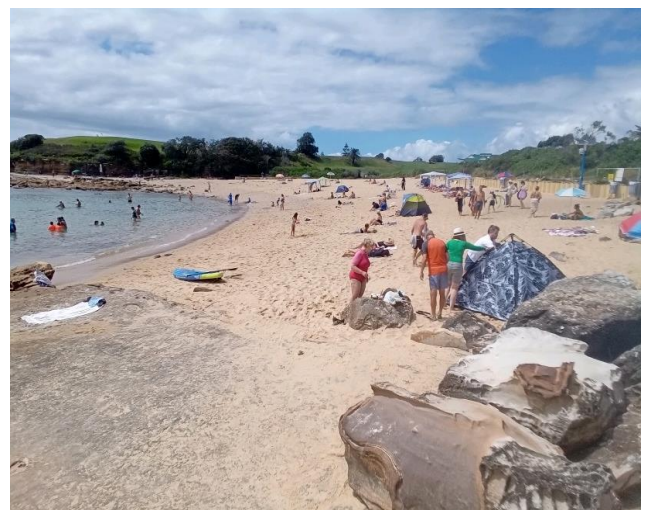
Notes: Overview of Southern beach

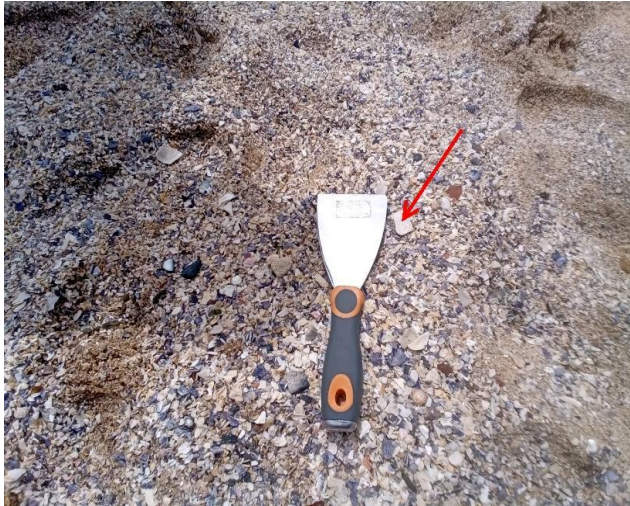
Notes: Overview of the ACM fragment prior to the removal within Southern beach.

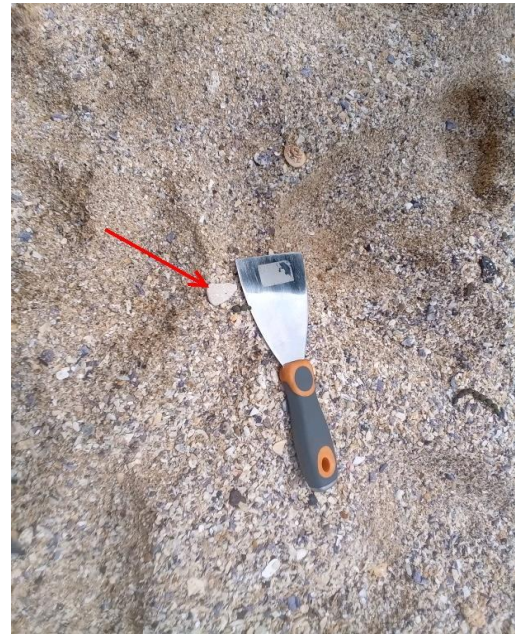
Notes: Overview of the ACM fragment prior to the removal within Southern beach.

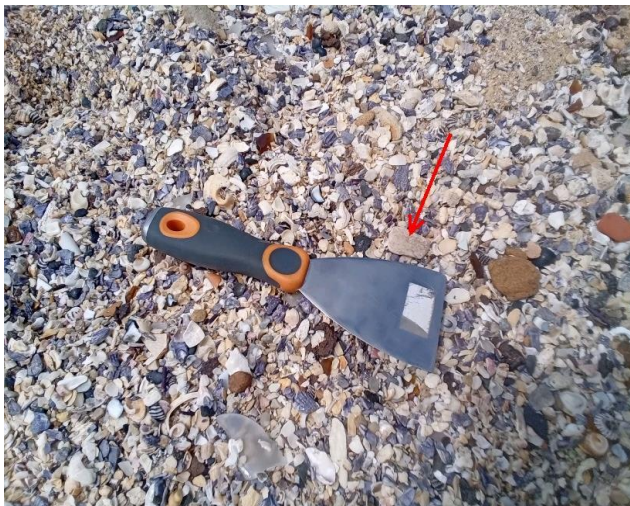
Notes: Overview of the ACM fragment prior to the removal within Southern beach.

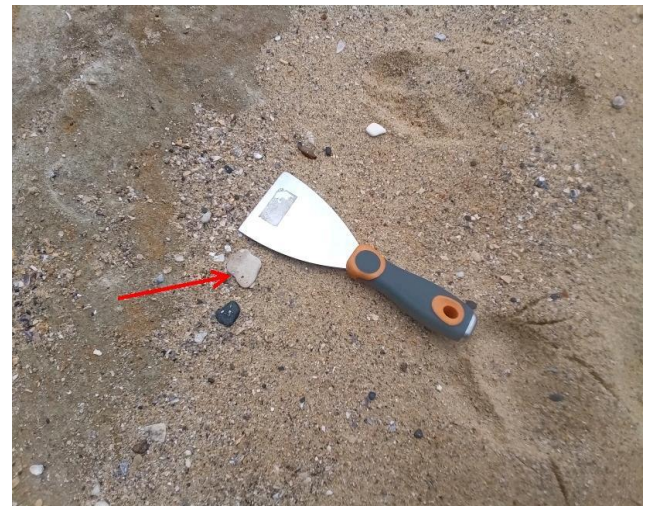
Notes: Overview of the ACM fragment prior to the removal within Southern beach.

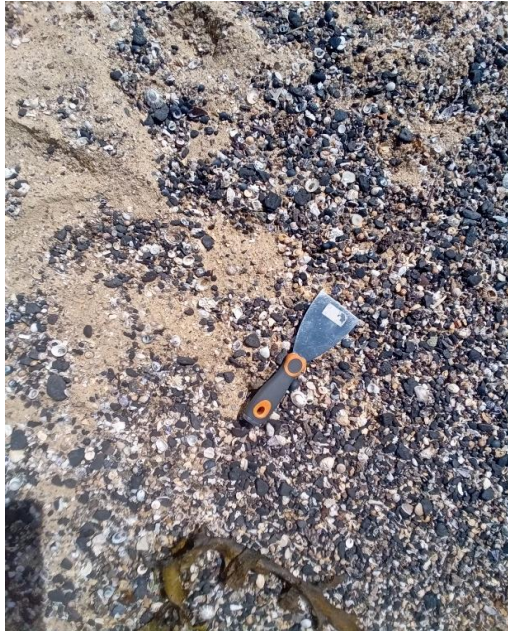
Notes: Visual surface clearance inspection following removal of ACM fragment.

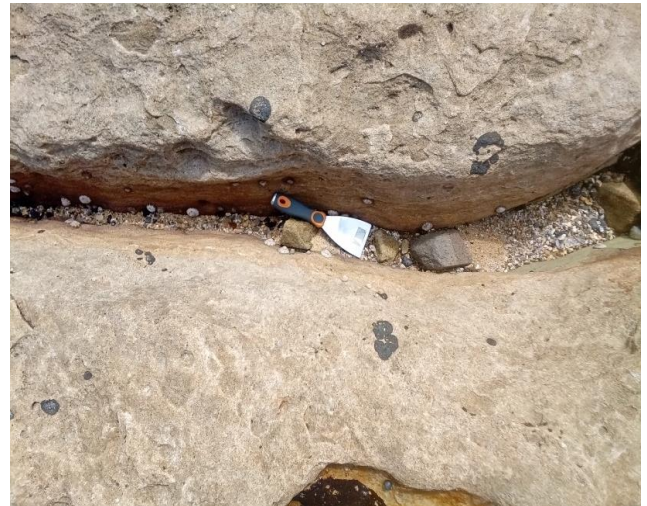
Notes: Visual surface clearance inspection following removal of ACM fragment.

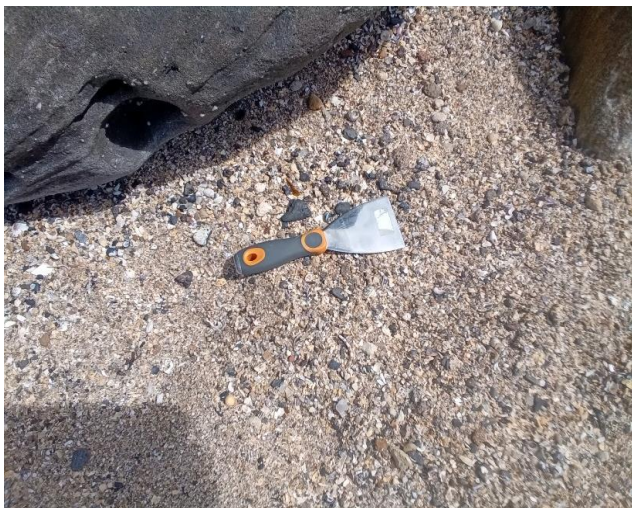
Notes: Visual surface clearance inspection following removal of ACM fragment.

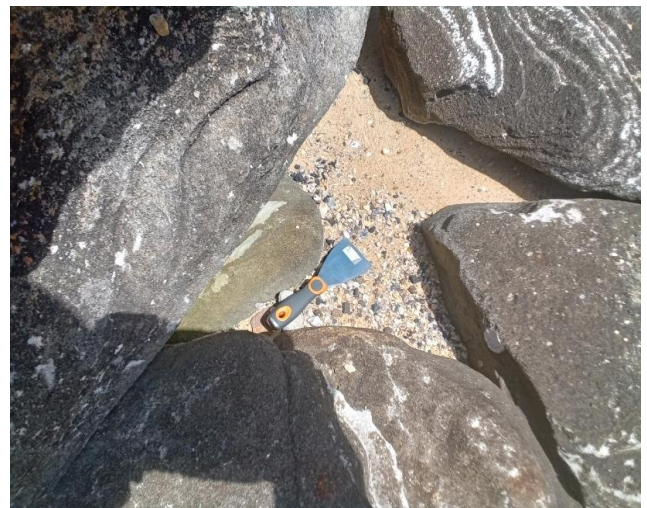
Notes: Visual surface clearance inspection following removal of ACM fragment.

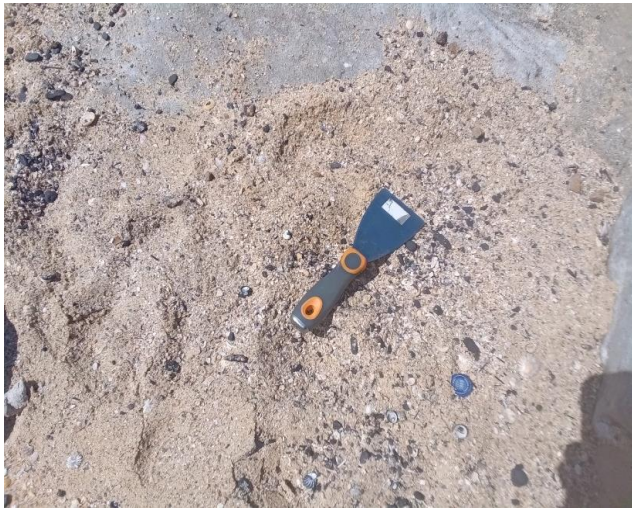
Notes: Visual surface clearance inspection following removal of ACM fragment.

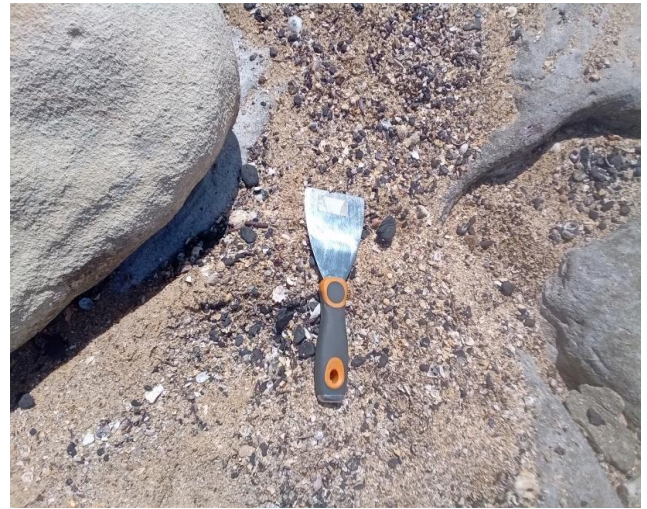
Notes: Visual surface clearance inspection following removal of ACM fragment.

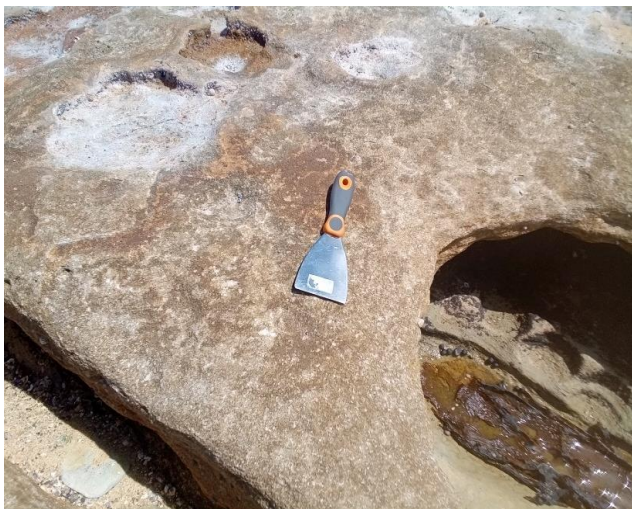
Notes: Visual surface clearance inspection following removal of ACM fragment.

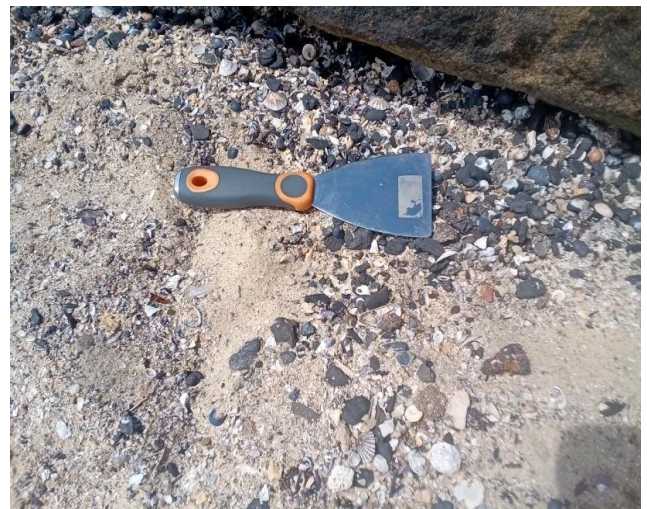
Notes: Visual surface clearance inspection following removal of ACM fragment.

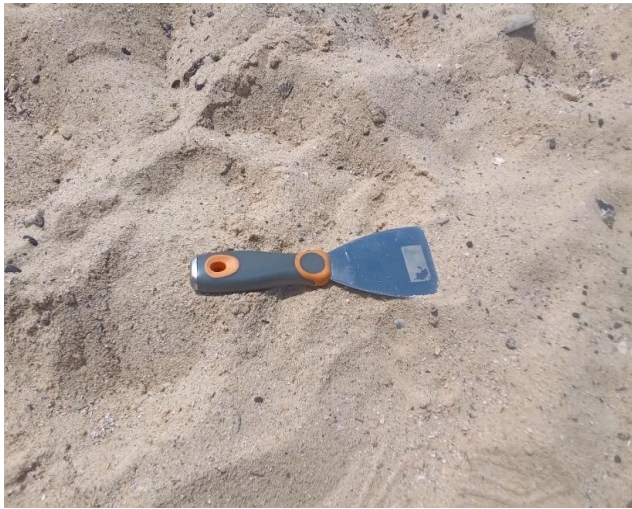
Notes: Visual surface clearance inspection following removal of ACM fragment.

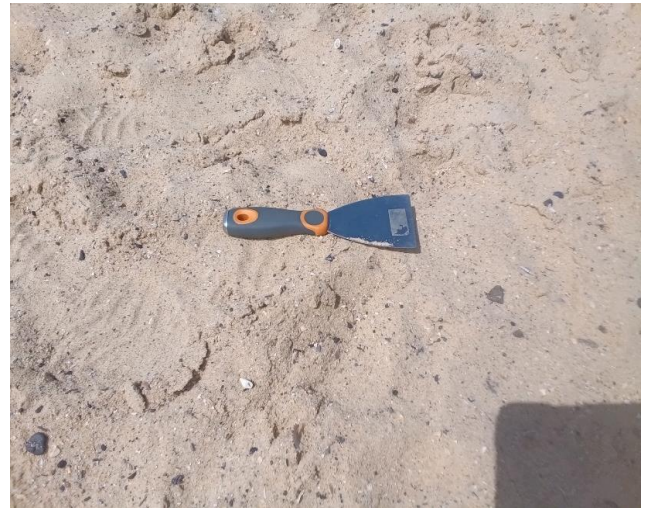
Notes: Visual surface clearance inspection following removal of ACM fragment.

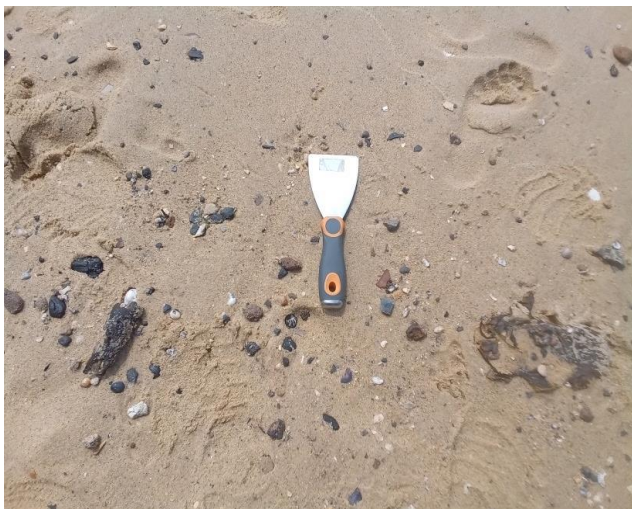
Notes: Visual surface clearance inspection following removal of ACM fragment.

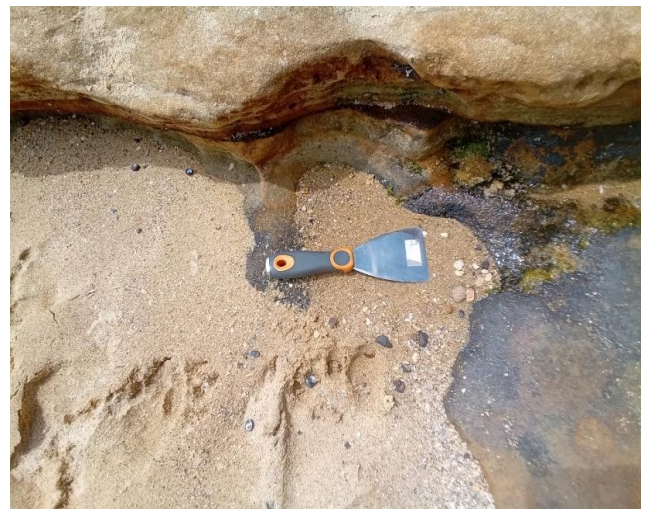
Notes: Visual surface clearance inspection following removal of ACM fragment.

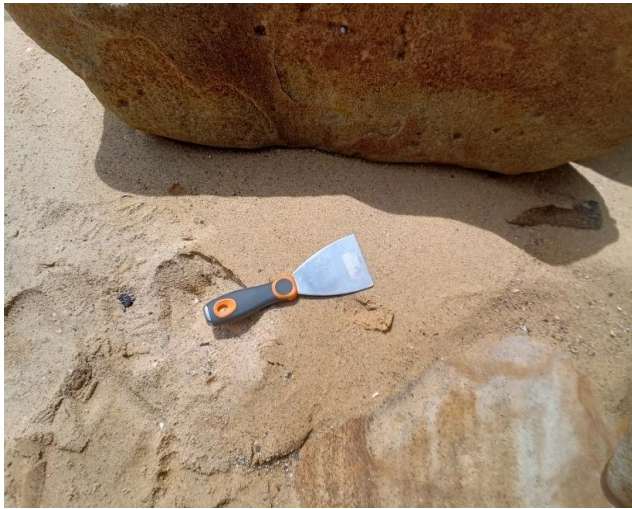
Notes: Visual surface clearance inspection following removal of ACM fragment.

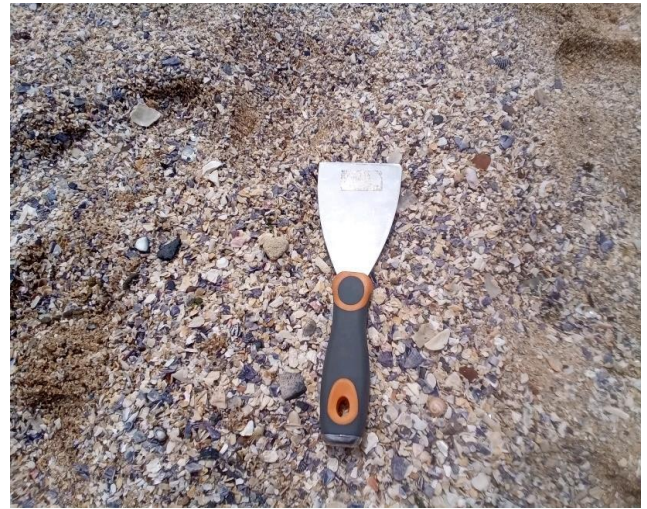
Notes: Visual surface clearance inspection following removal of ACM fragment.

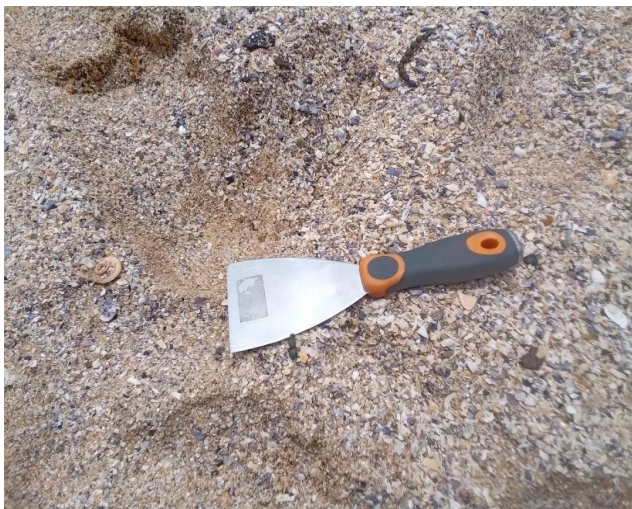
Notes: Visual surface clearance inspection following removal of ACM fragment.

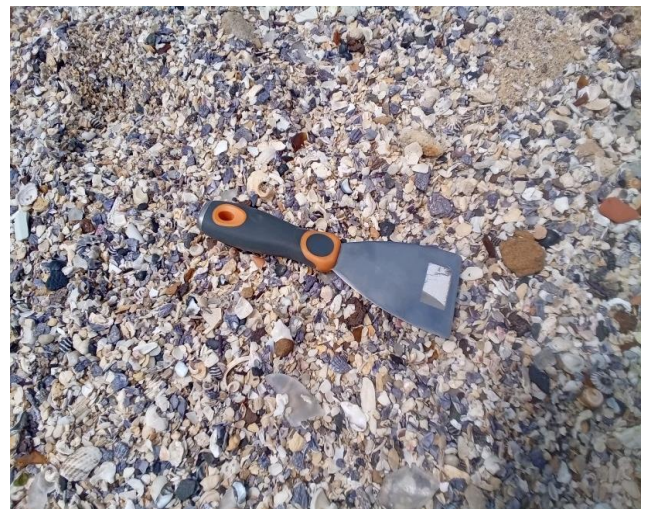
Notes: Visual surface clearance inspection following removal of ACM fragment.

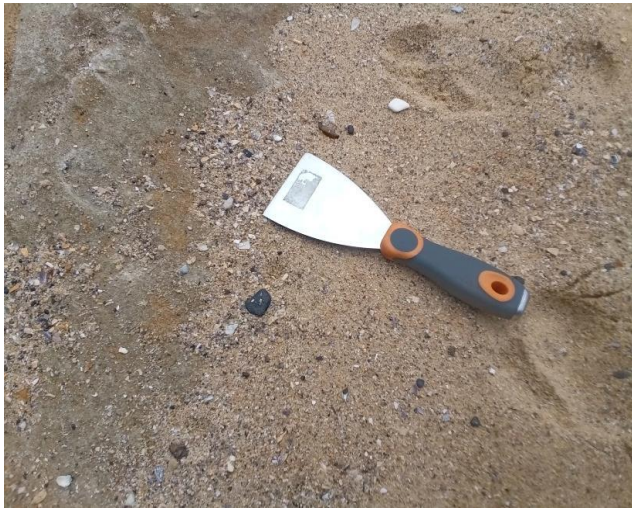
Notes: Visual surface clearance inspection following removal of ACM fragment.
