Asbestos Containing Material Clearance Inspection

20 February 2023

Randwick City Council
30 Frances Street
Randwick NSW 2031

Site:	Little Bay Beach
Location:	Southern, Western and Northern Little Bay Beach

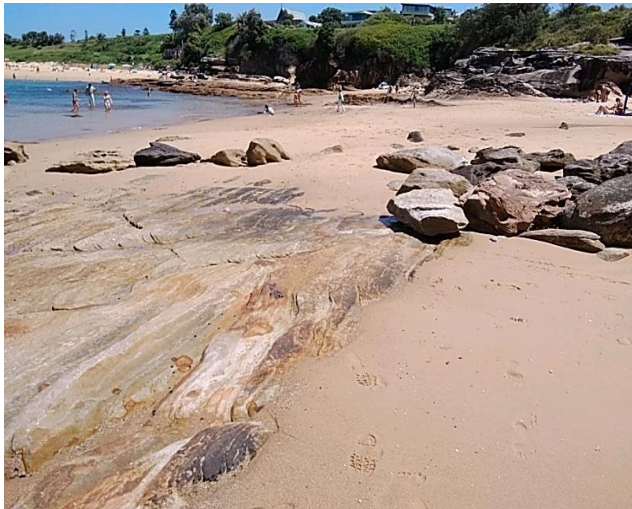
Notes: Overview of the Northern beach

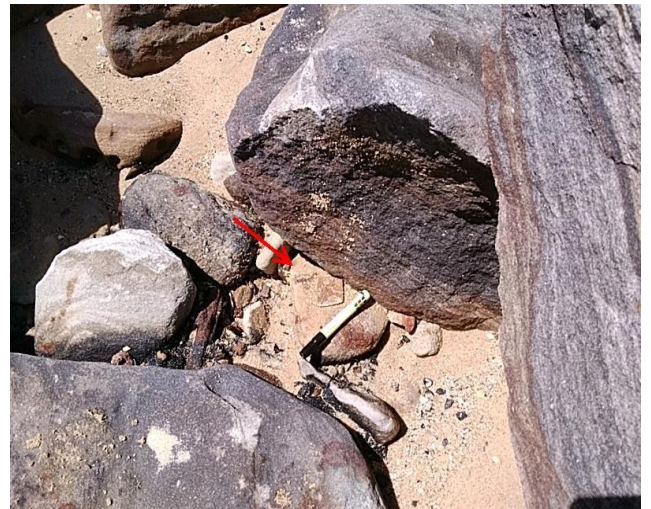
Notes: Overview of removal item within Northern beach prior to removal

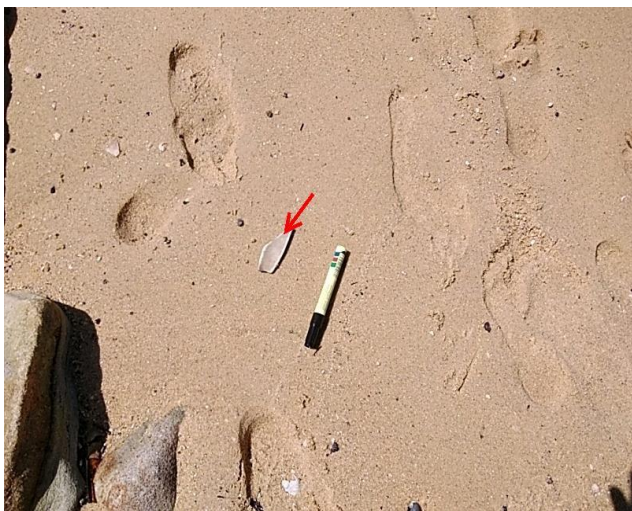
Notes: Overview of removal item within Northern beach prior to removal

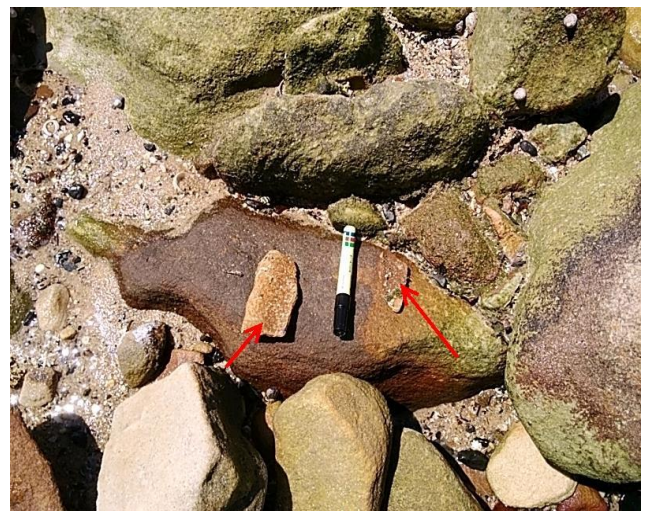
Notes: Overview of removal item within Northern beach prior to removal

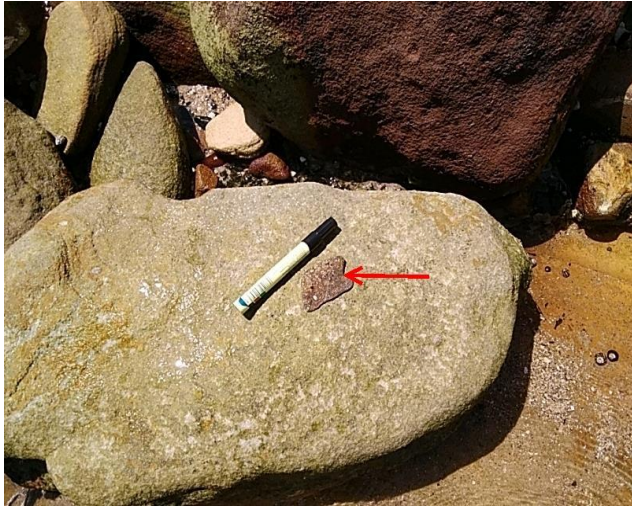
Notes: Overview of removal item within Northern beach prior to removal

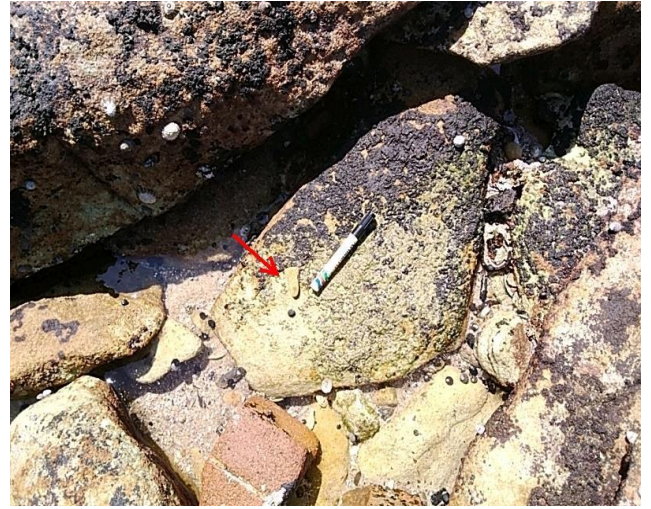
Notes: Overview of removal item within Northern beach prior to removal

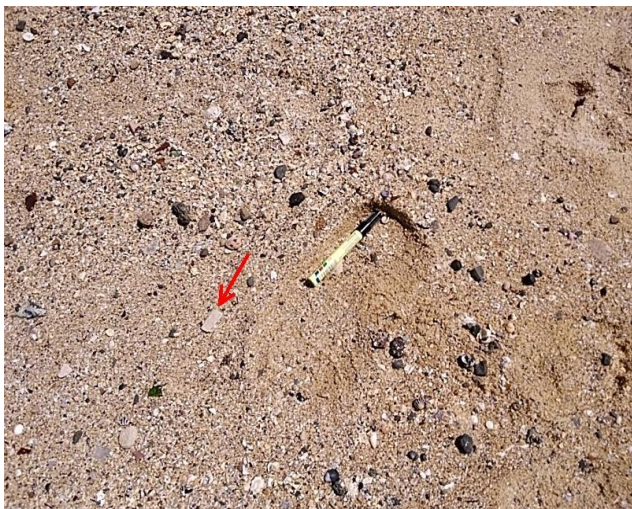
Notes: Overview of removal item within Northern beach prior to removal

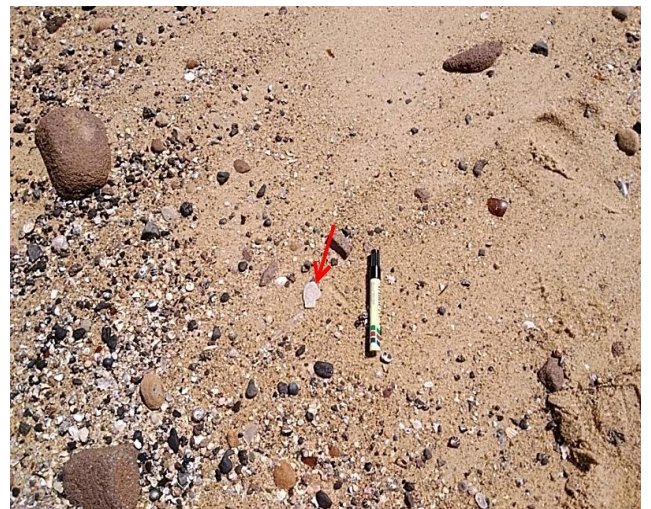
Notes: Overview of removal item within Northern beach prior to removal

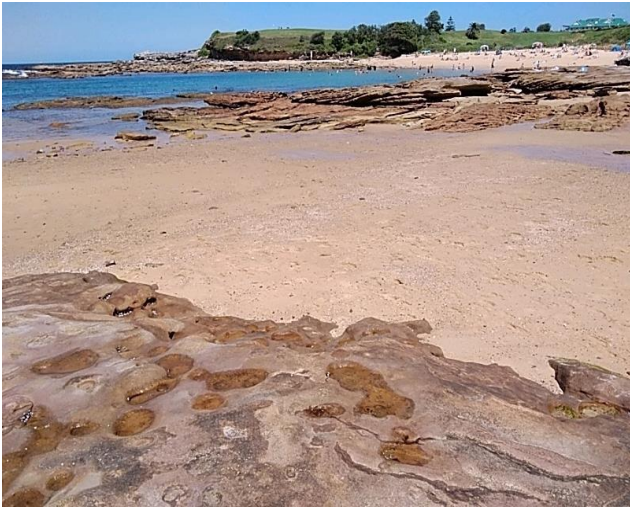
Notes: Overview of the Western beach

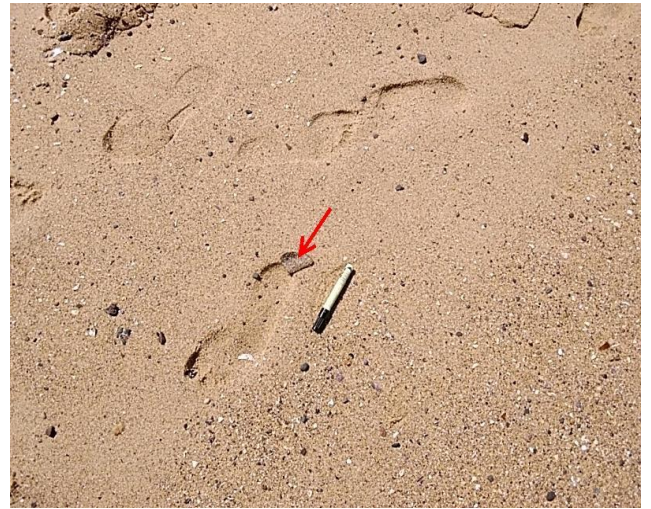
Notes: Overview of removal item within Northern beach prior to removal

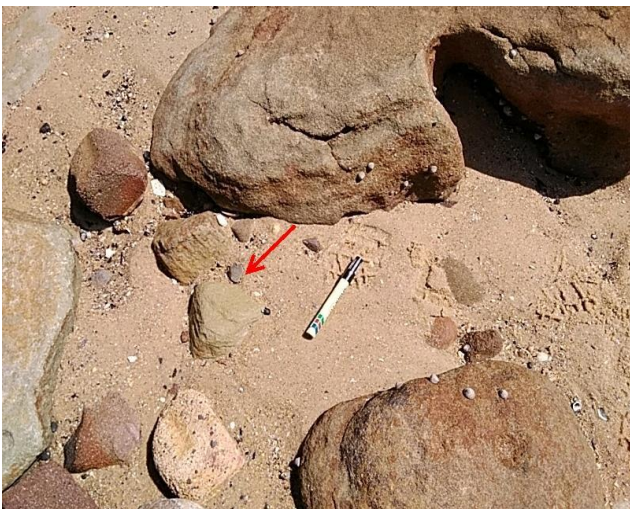
Notes: Overview of removal item within Western beach prior to removal

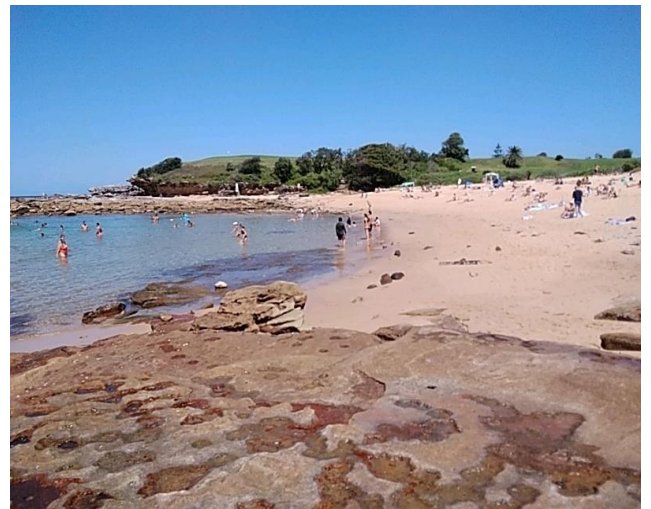
Notes: Overview of the Southern beach

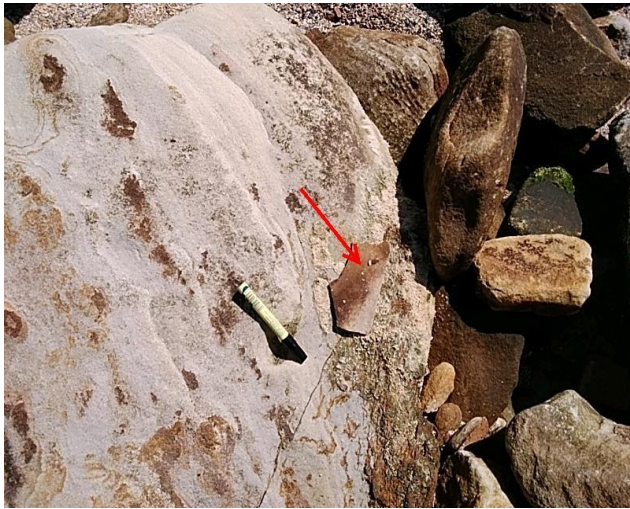
Notes: Overview of removal item within Southern beach prior to removal

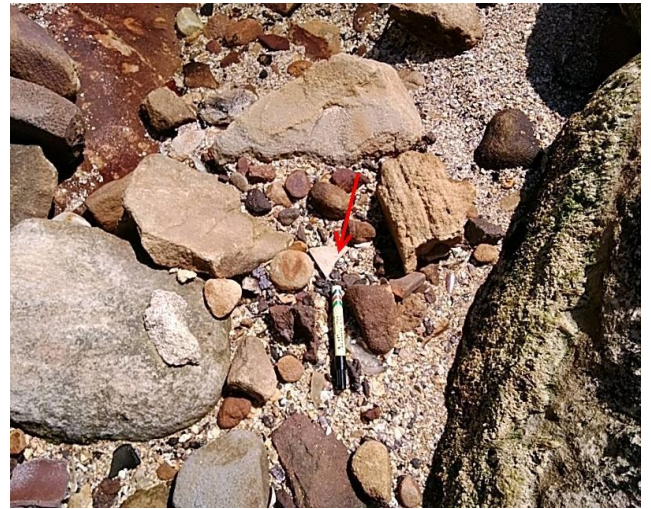
Notes: Overview of removal item within Southern beach prior to removal

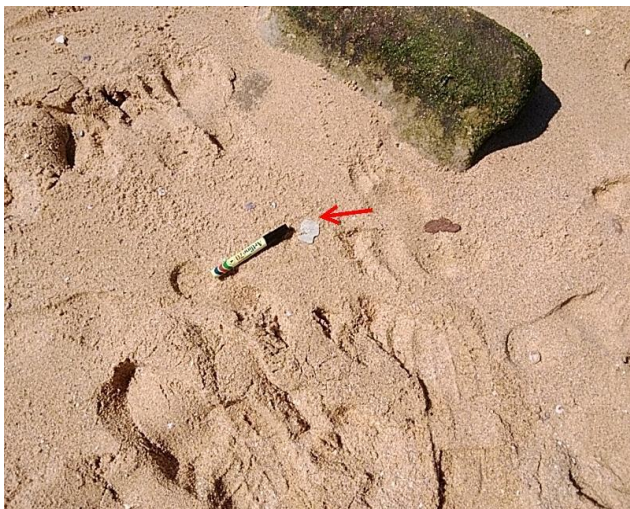
Notes: Overview of removal item within Southern beach prior to removal

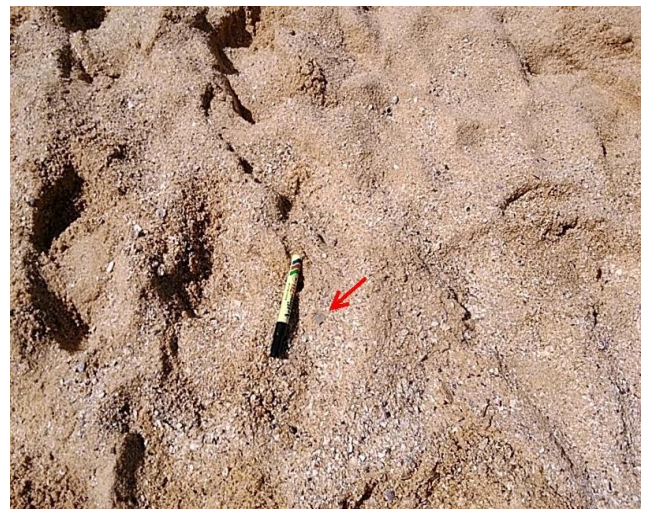
Notes: Overview of removal item within Southern beach prior to removal

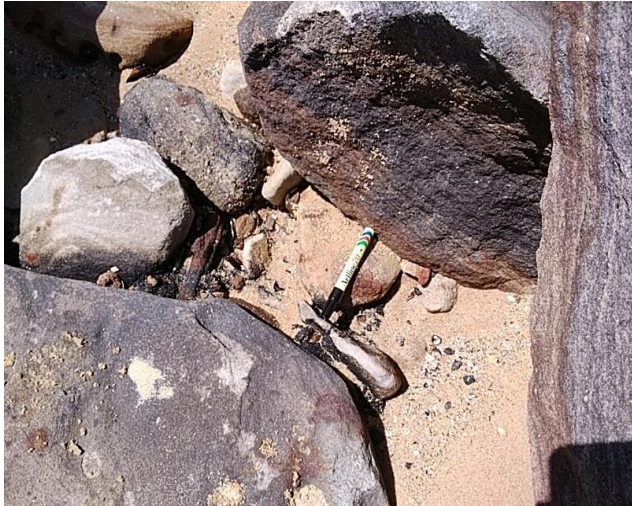
Notes: Visual inspection of removal item following removal

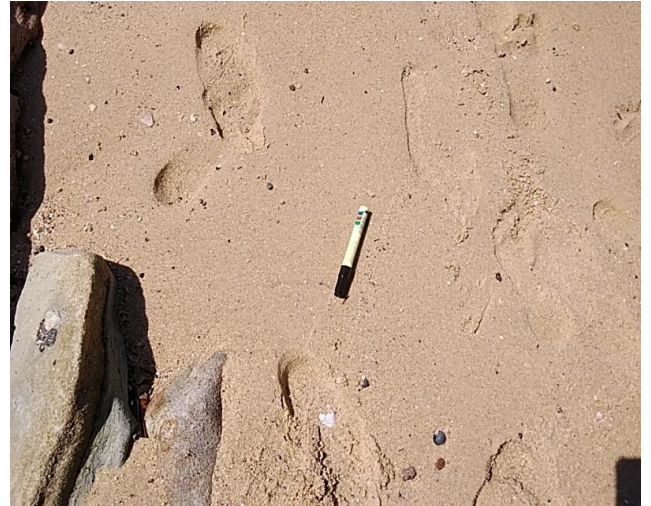
Notes: Visual inspection of removal item following removal

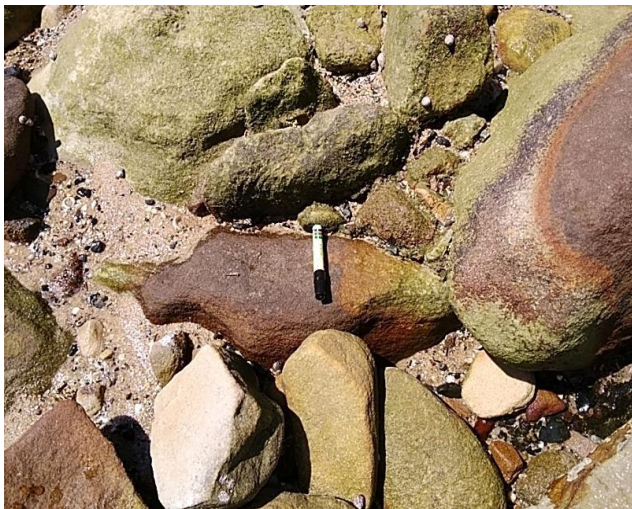
Notes: Visual inspection of removal item following removal

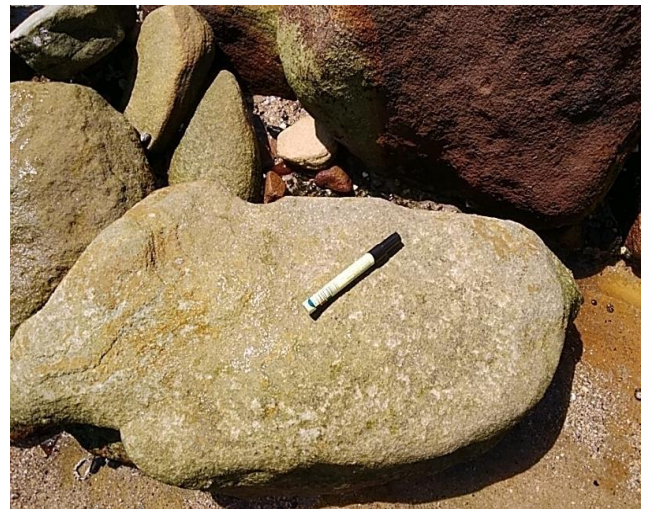
Notes: Visual inspection of removal item following removal

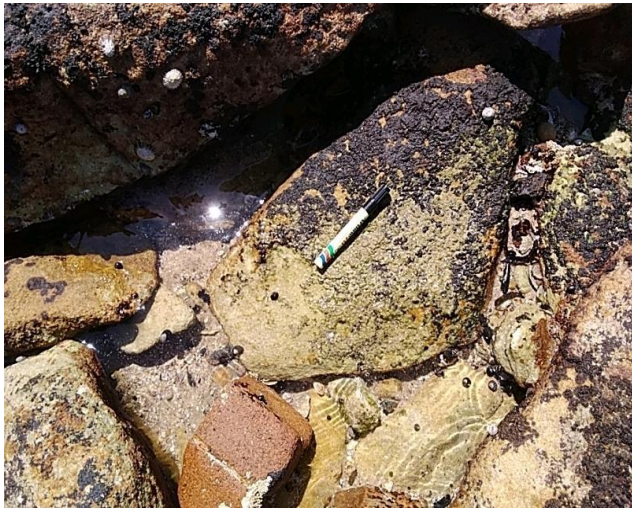
Notes: Visual inspection of removal item following removal

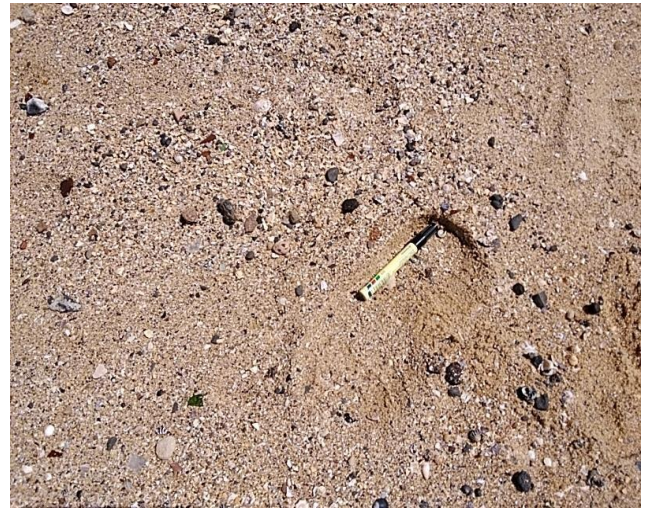
Notes: Visual inspection of removal item following removal

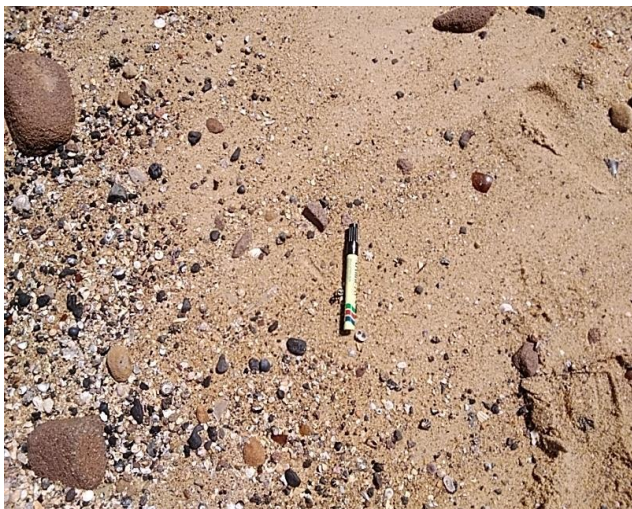
Notes: Visual inspection of removal item following removal

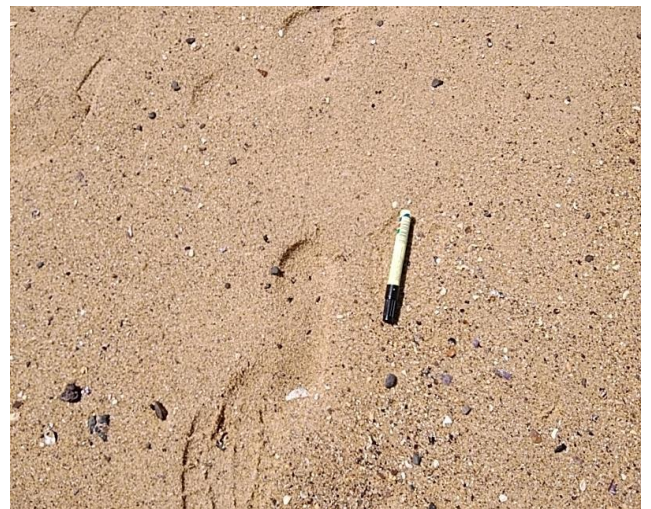
Notes: Visual inspection of removal item following removal

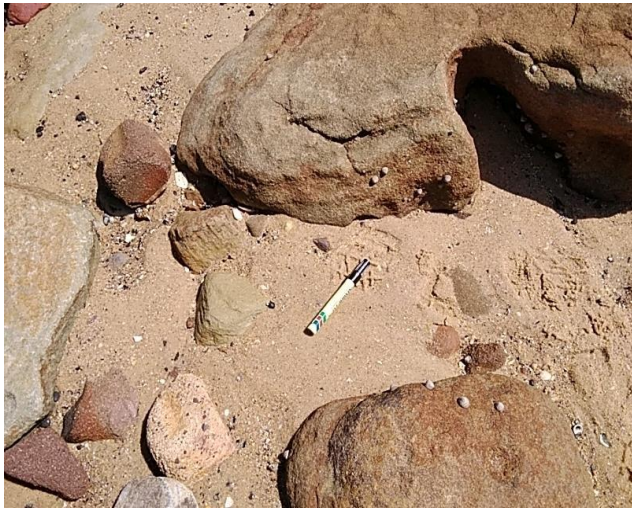
Notes: Visual inspection of removal item following removal

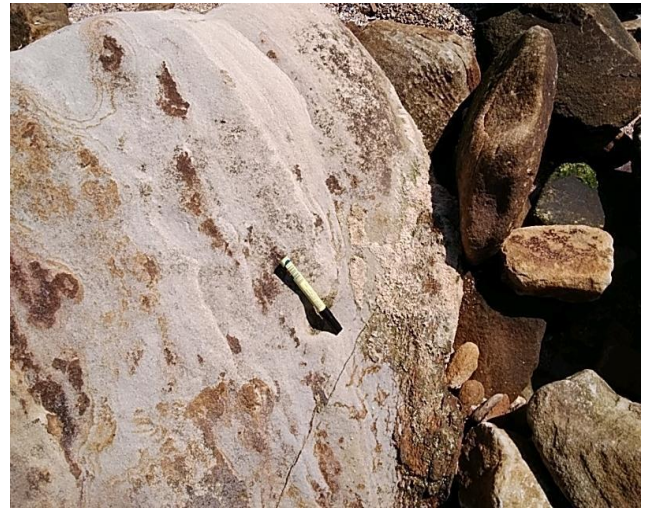
Notes: Visual inspection of removal item following removal

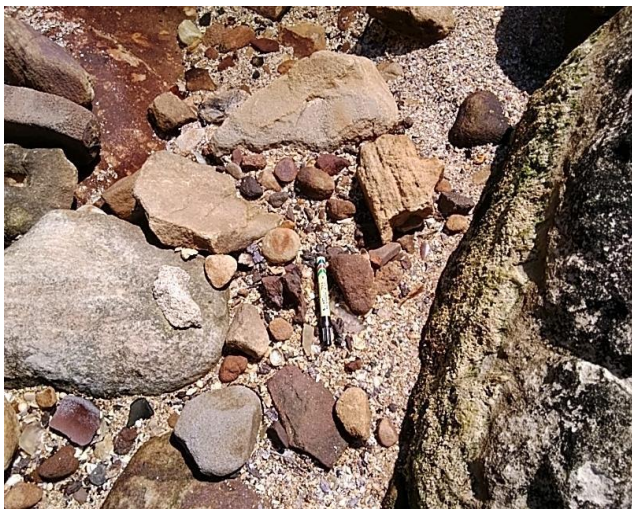
Notes: Visual inspection of removal item following removal

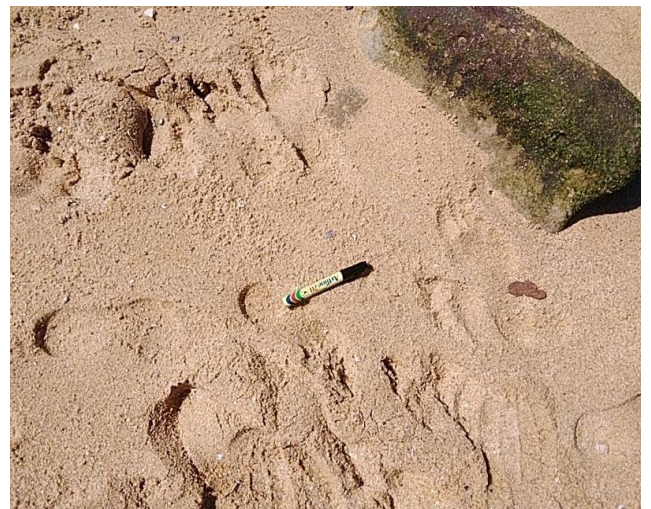
Notes: Visual inspection of removal item following removal

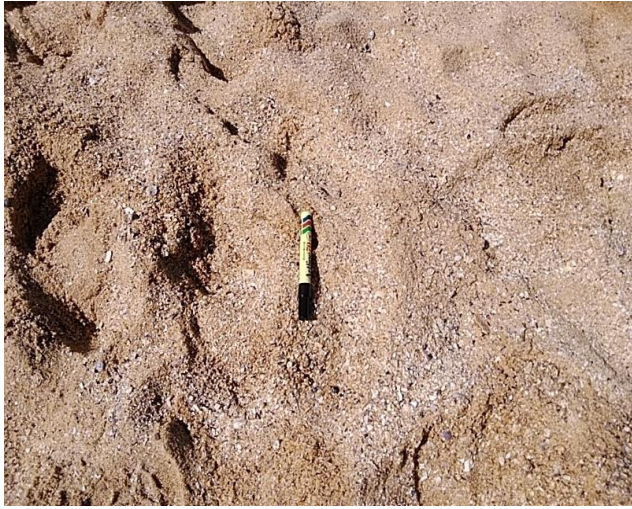
Notes: Visual inspection of removal item following removal

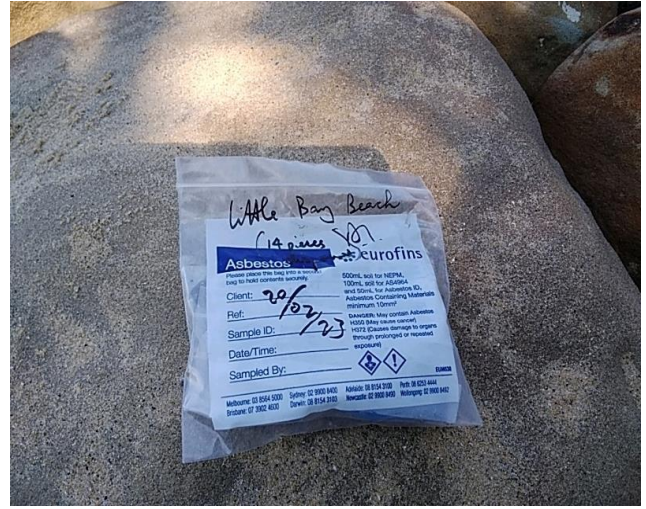
Notes: Waste disposal management (14 pieces disposed)
