Asbestos Containing Material Clearance Inspection

17 March 2023

RE: Asbestos Containing Material Clearance Inspection

Site:	Little Bay Beach
Location:	Southern, Western and Northern Little Bay Beach

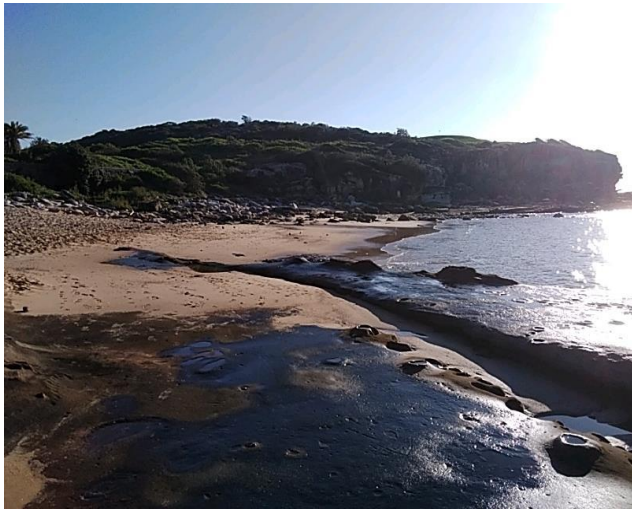
Notes: Overview of the Northern beach

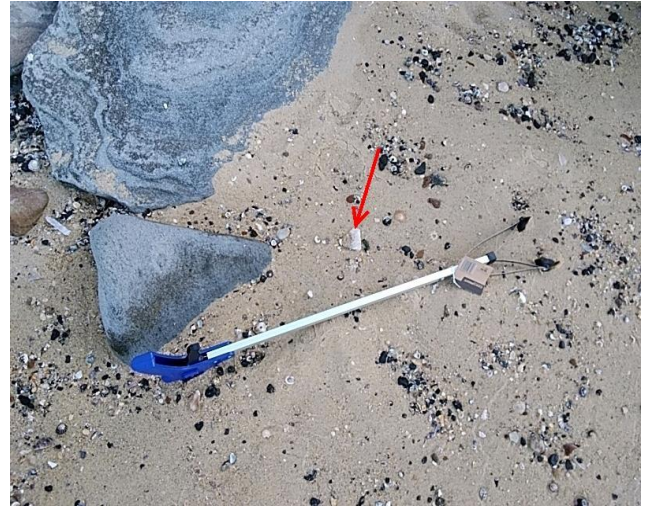
Notes: Overview of removal item within Northern beach prior to removal

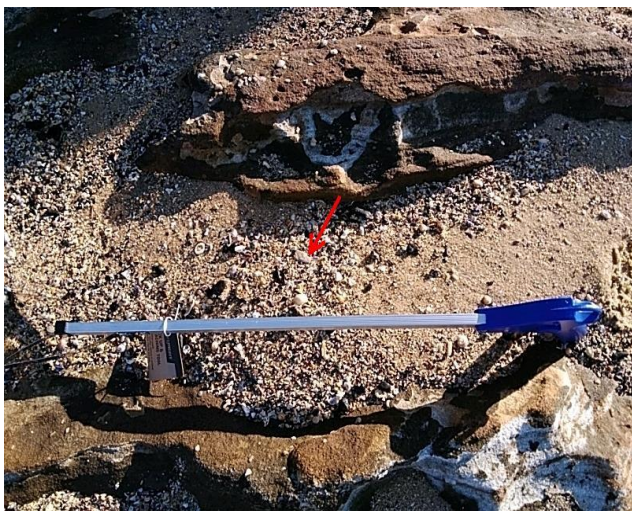
Notes: Overview of removal item within Northern beach prior to removal

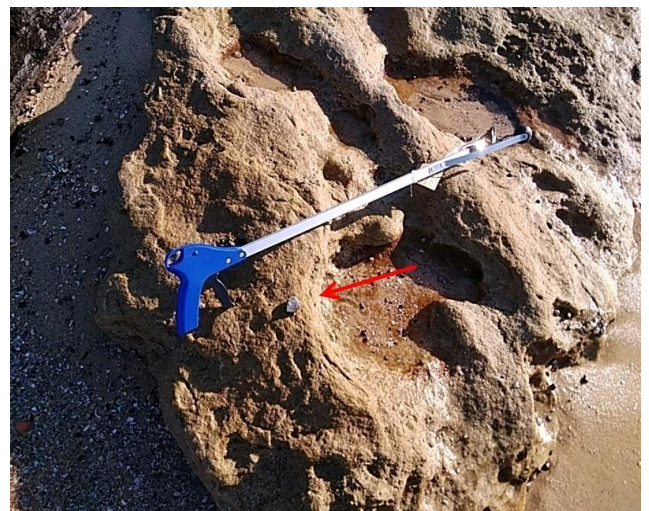
Notes: Overview of removal item within Northern beach prior to removal

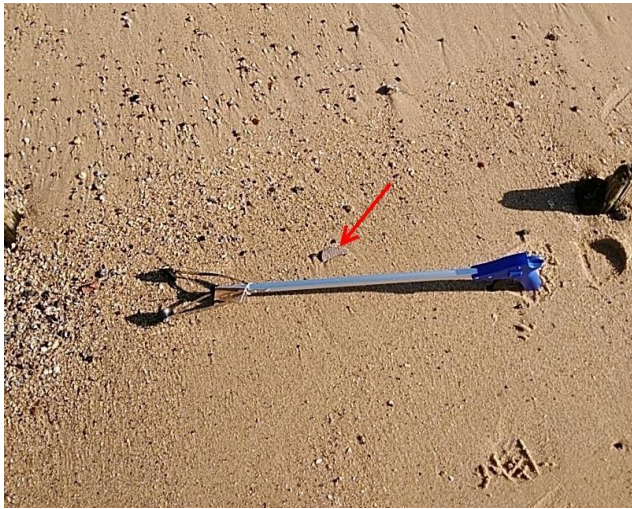
Notes: Overview of removal item within Northern beach prior to removal

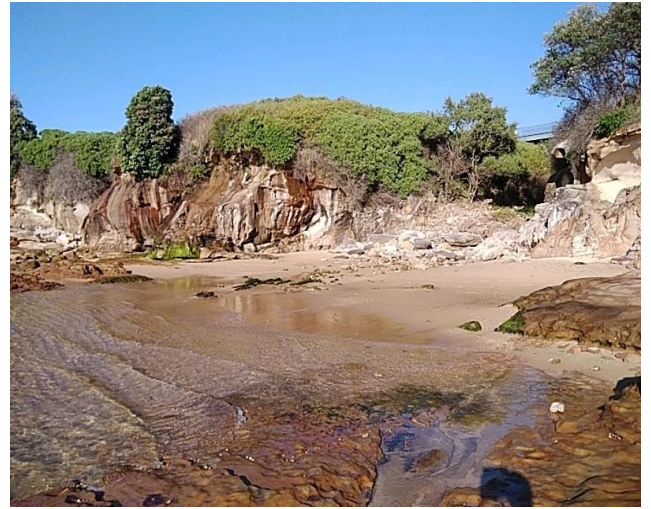
Notes: Overview of the Western beach

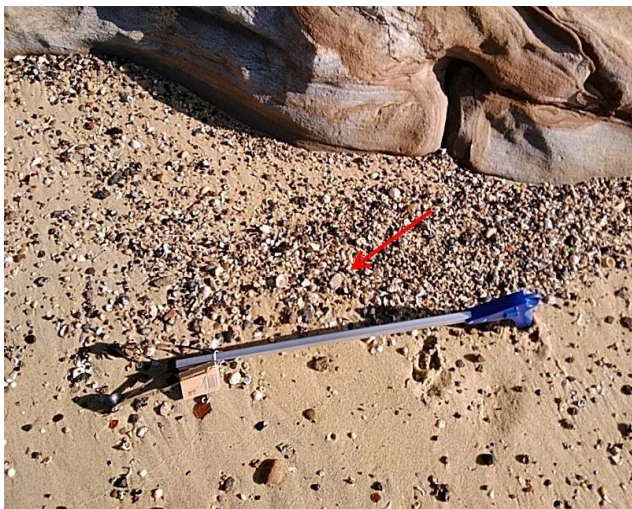
Notes: Overview of removal item within Western beach prior to removal

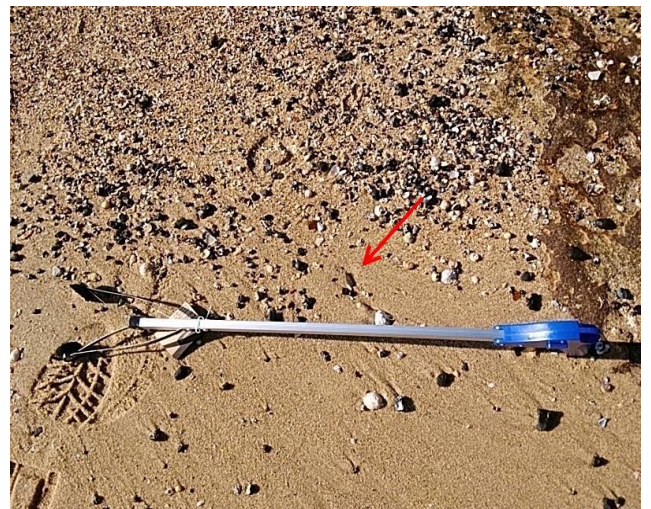
Notes: Overview of removal item within Western beach prior to removal

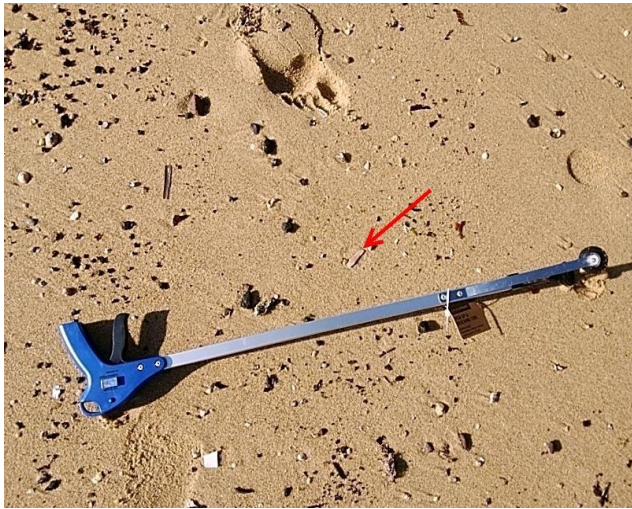
Notes: Overview of removal item within Western beach prior to removal

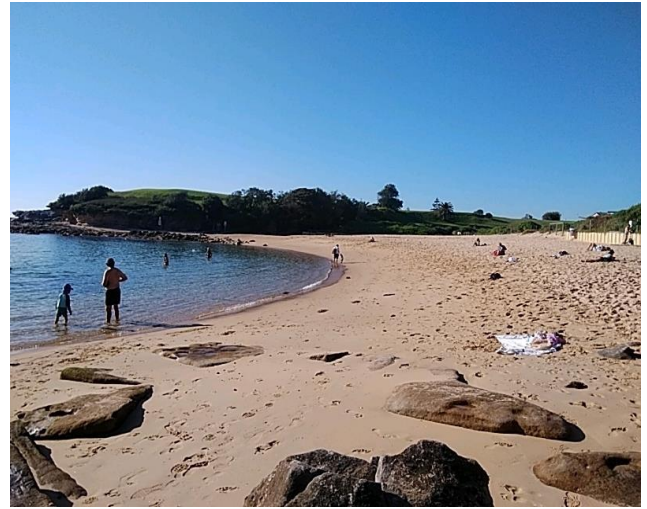
Notes: Overview of the Southern beach

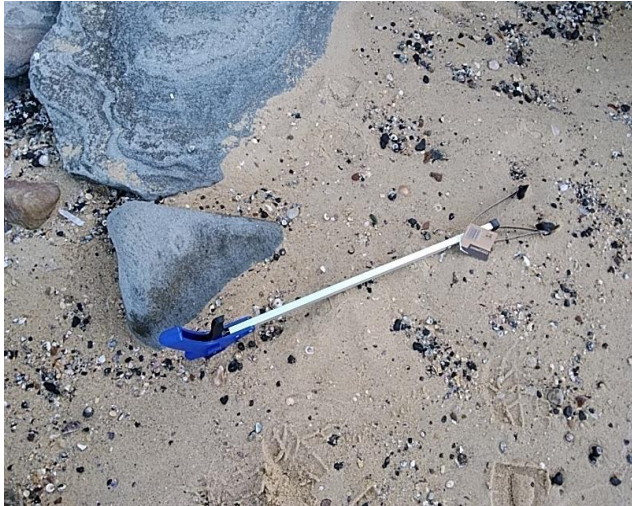
Notes: Visual inspection of removal item following removal

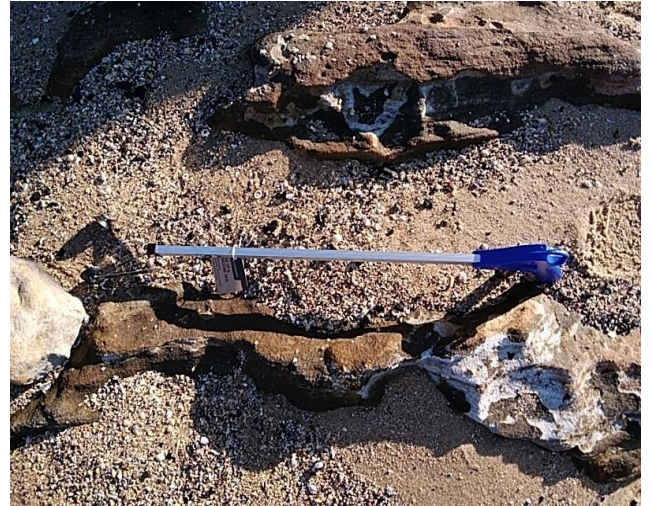
Notes: Visual inspection of removal item following removal

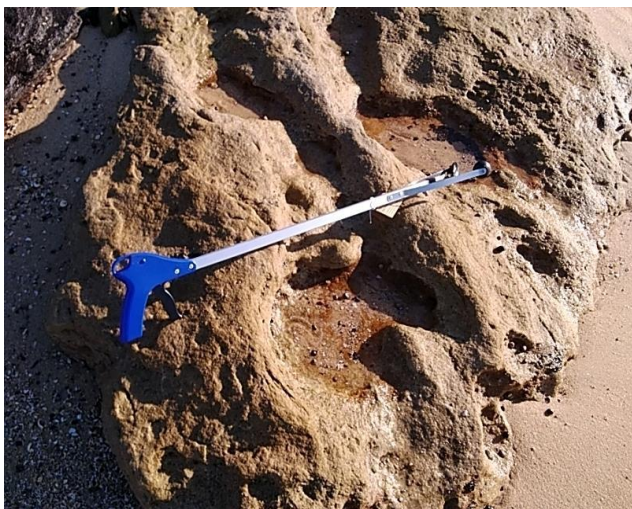
Notes: Visual inspection of removal item following removal

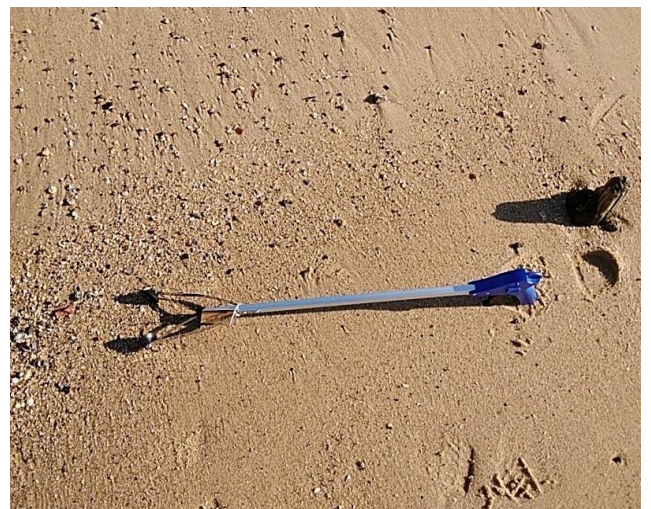
Notes: Visual inspection of removal item following removal

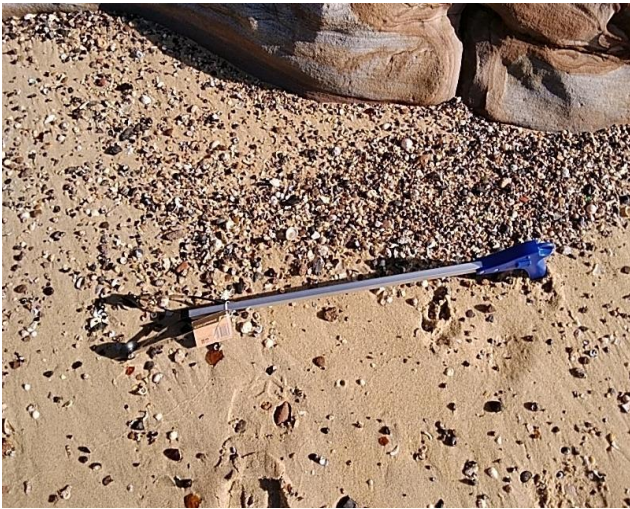
Notes: Visual inspection of removal item following removal

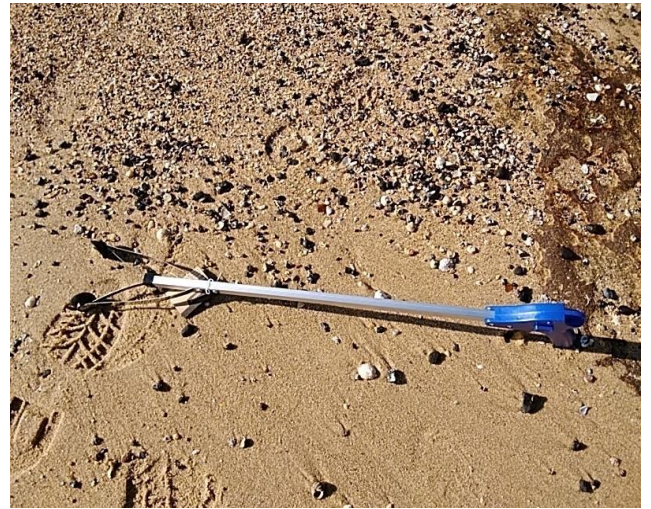
Notes: Visual inspection of removal item following removal

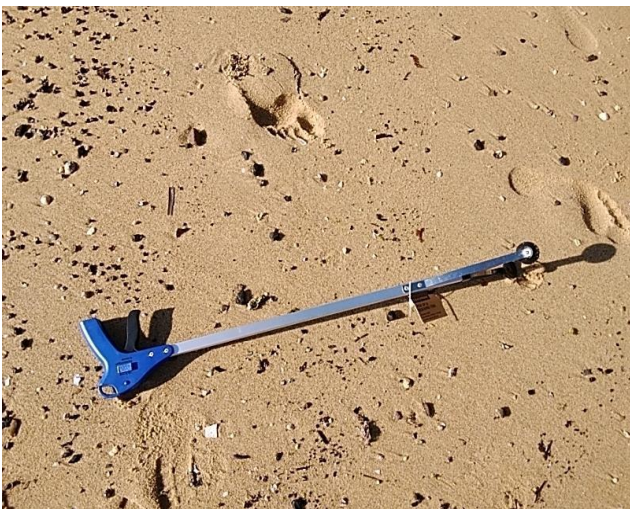
Notes: Visual inspection of removal item following removal

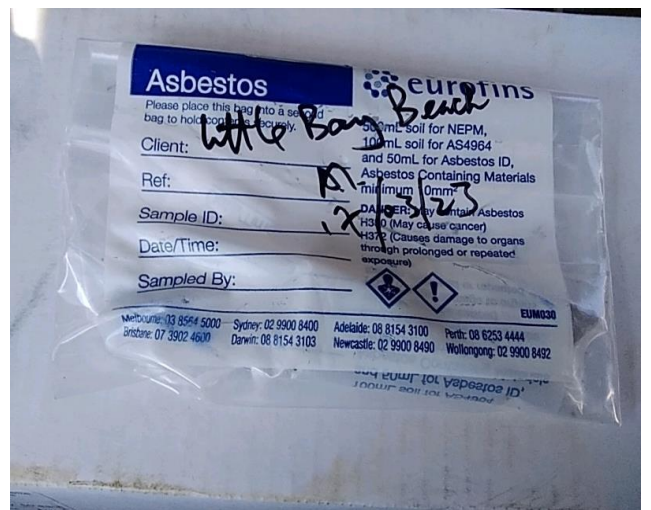
Notes: Waste disposal management
