Asbestos Containing Material Clearance Inspection

17 May 2023

Site:	Little Bay Beach
Location:	Southern, Western and Northern Little Bay Beach

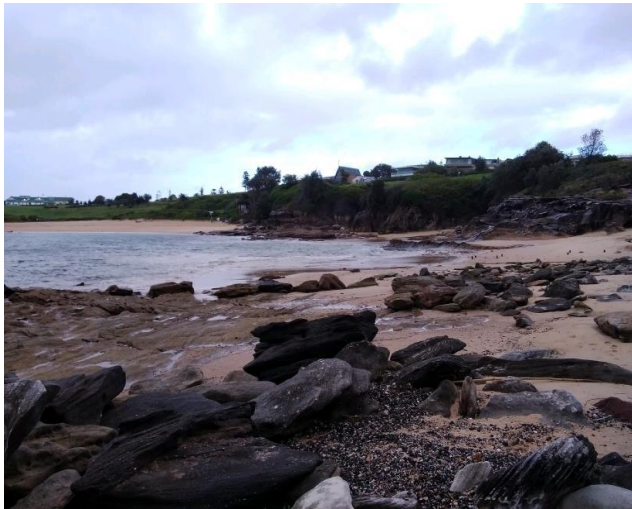
Notes: Overview of the Beach during the inspection

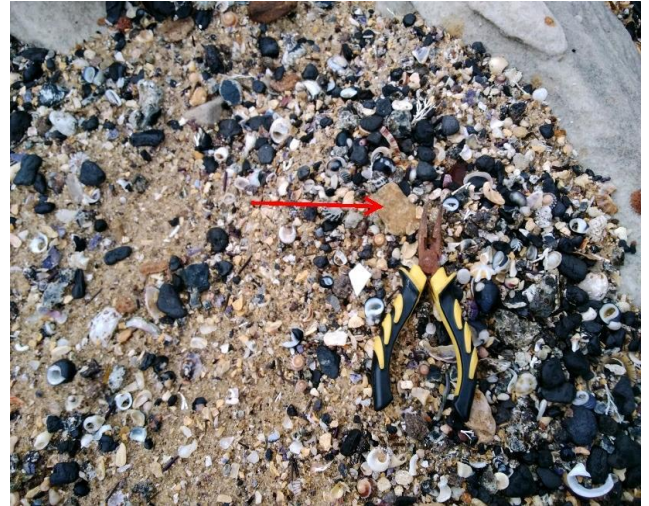
Notes: FC fragment identified on sand surface prior to emu pick - Northern section

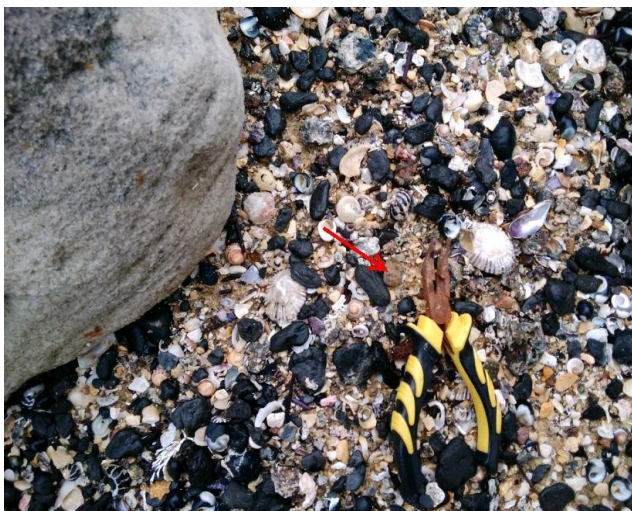
Notes: FC fragment identified on sand surface prior to emu pick - Northern section

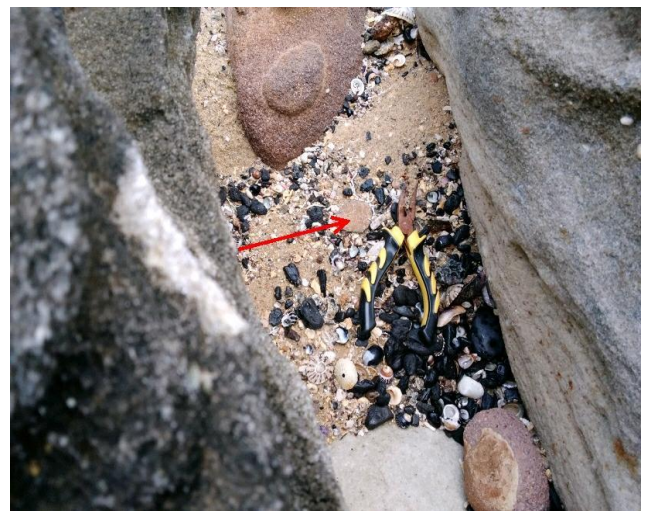
Notes: FC fragment identified on sand surface prior to emu pick - Northern section

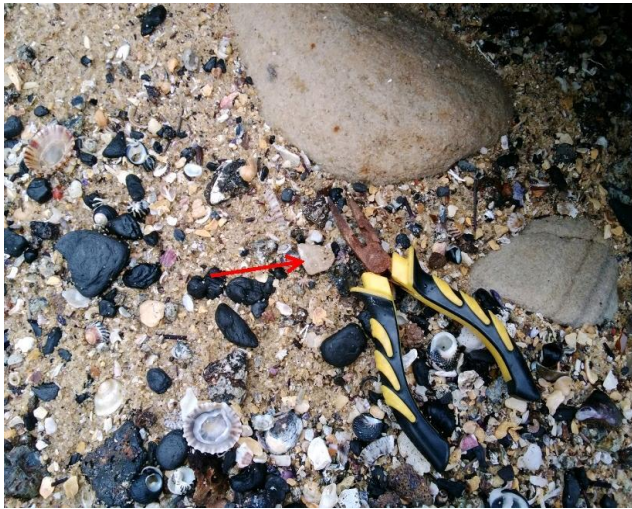
Notes: FC fragment identified on sand surface prior to emu pick - Northern section

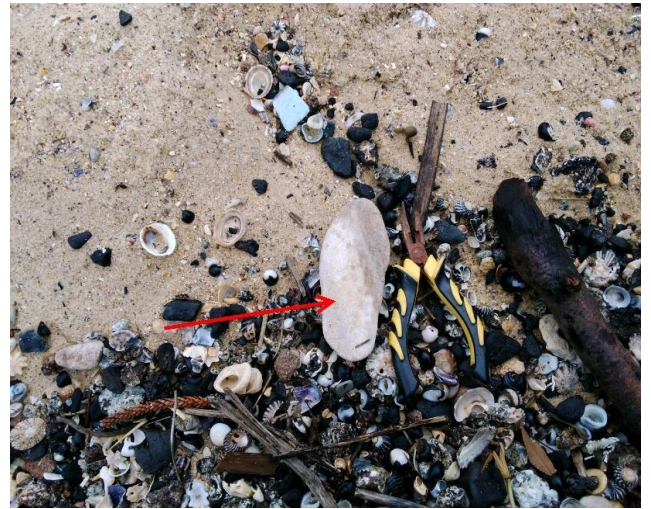
Notes: FC fragment identified on sand surface prior to emu pick - Northern section

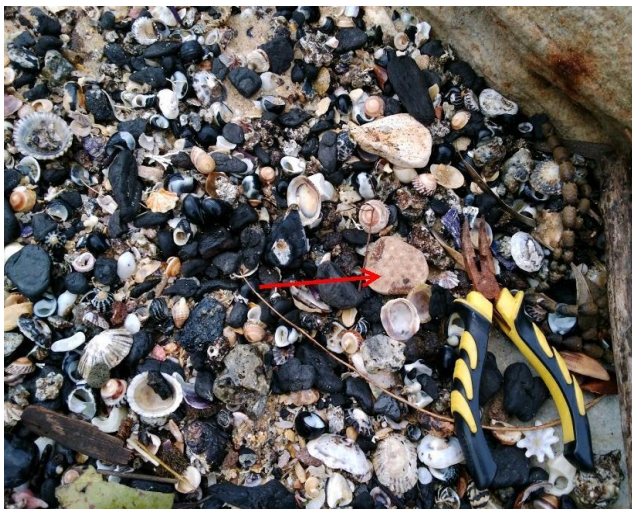
Notes: FC fragment identified on sand surface prior to emu pick - Northern section

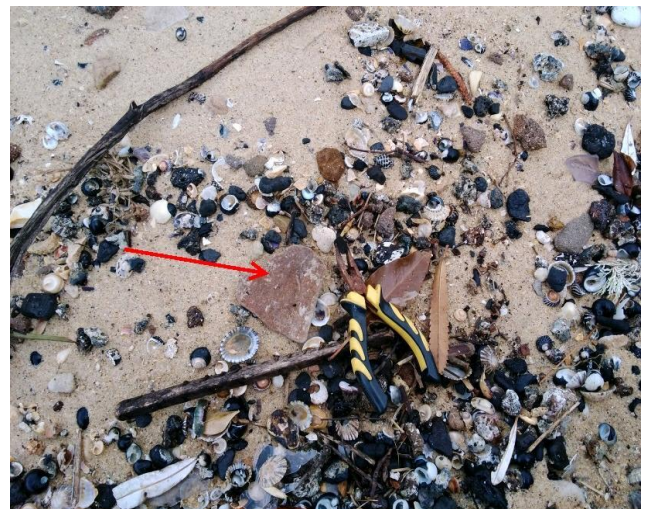
Notes: FC fragment identified on sand surface prior to emu pick - Northern section

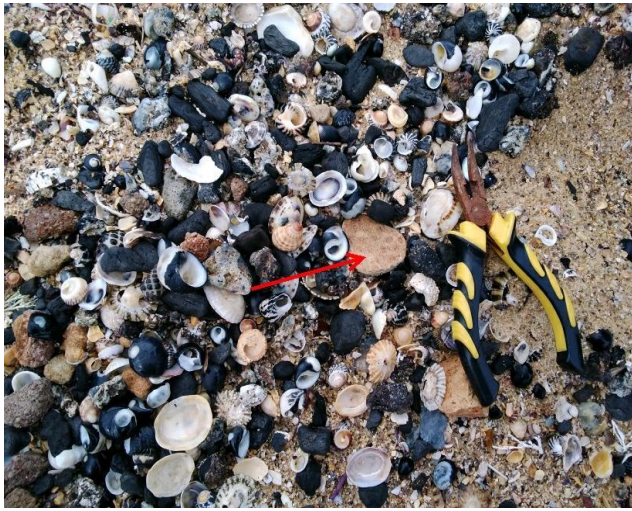
Notes: FC fragment identified on sand surface prior to emu pick - Northern section

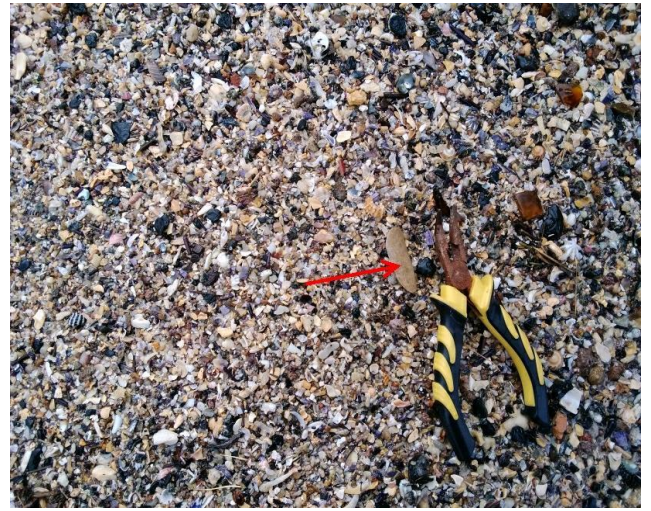
Notes: FC fragment identified on sand surface prior to emu pick - Northern section

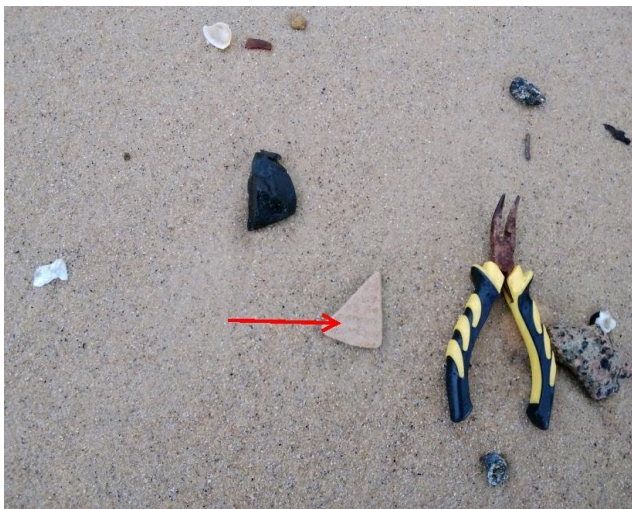
Notes: FC fragment identified on sand surface prior to emu pick - Northern section

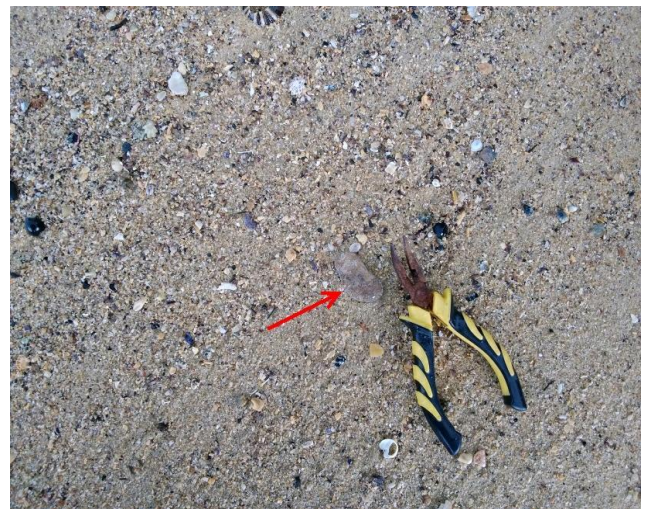
Notes: FC fragment identified on sand surface prior to emu pick - Western section

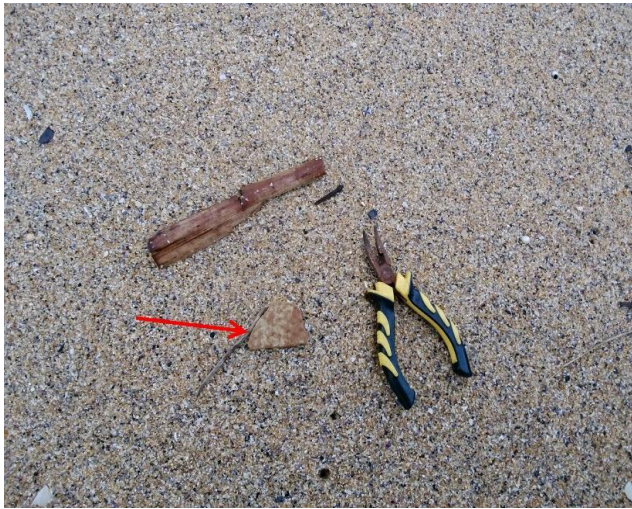
Notes: FC fragment identified on sand surface prior to emu pick - Southern section

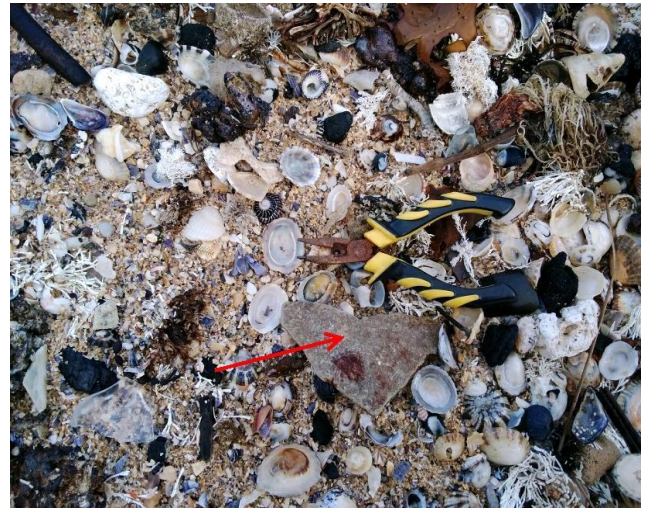
Notes: FC fragment identified on sand surface prior to emu pick - Southern section

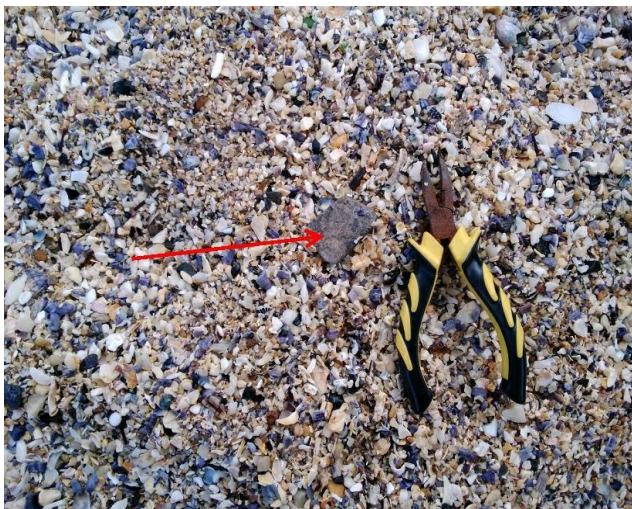
Notes: FC fragment identified on sand surface prior to emu pick - Southern section

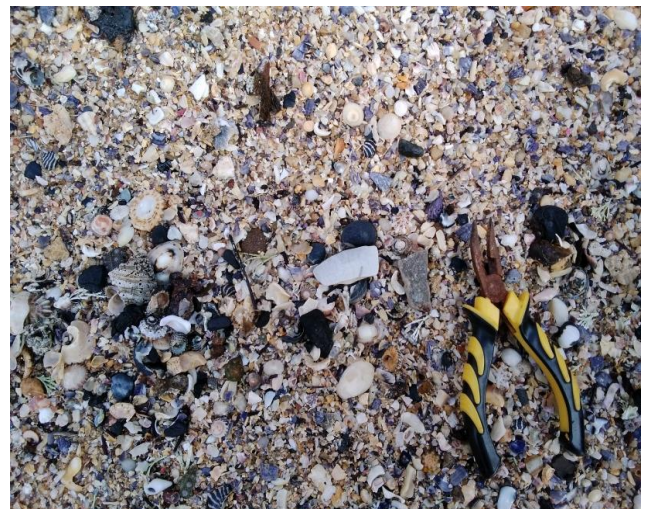
Notes: FC fragment identified on sand surface prior to emu pick - Southern section

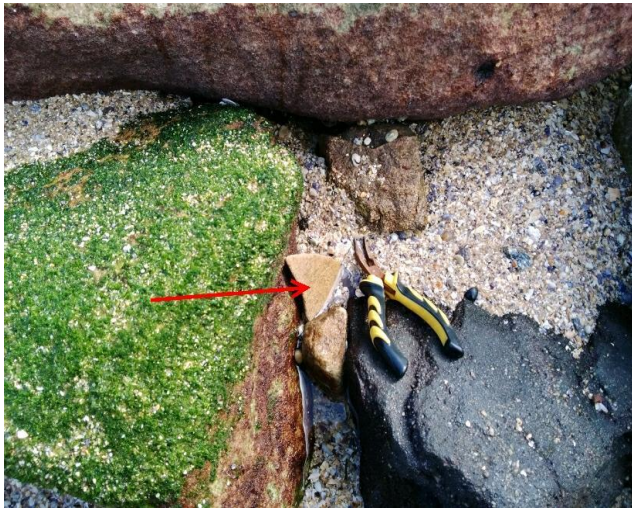
Notes: FC fragment identified on sand surface prior to emu pick - Southern section

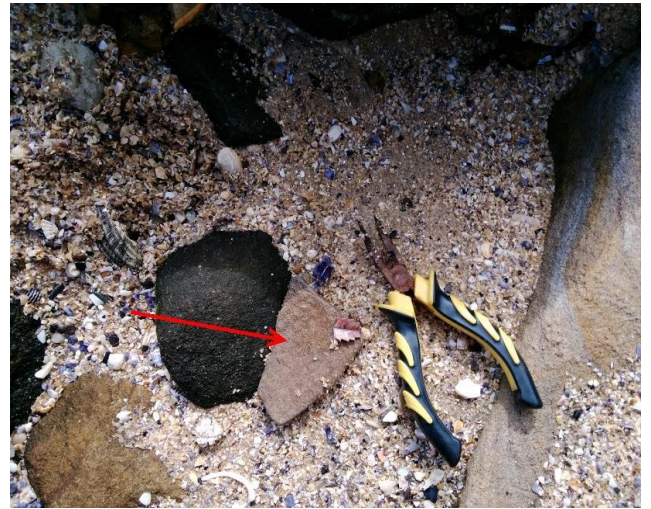
Notes: FC fragment identified on sand surface prior to emu pick - Southern section

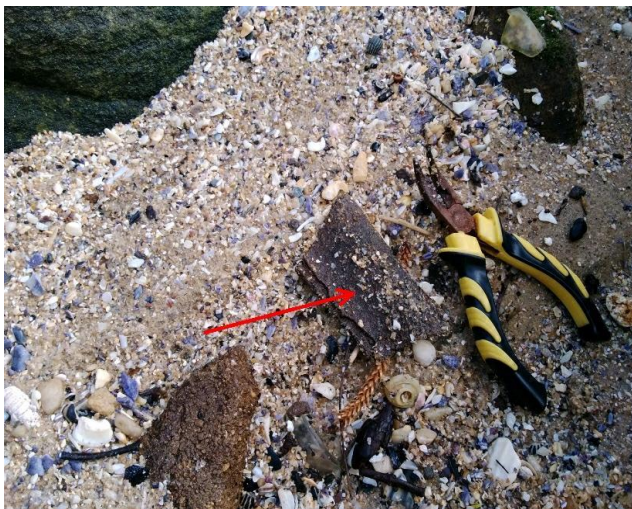
Notes: FC fragment identified on sand surface prior to emu pick - Southern section

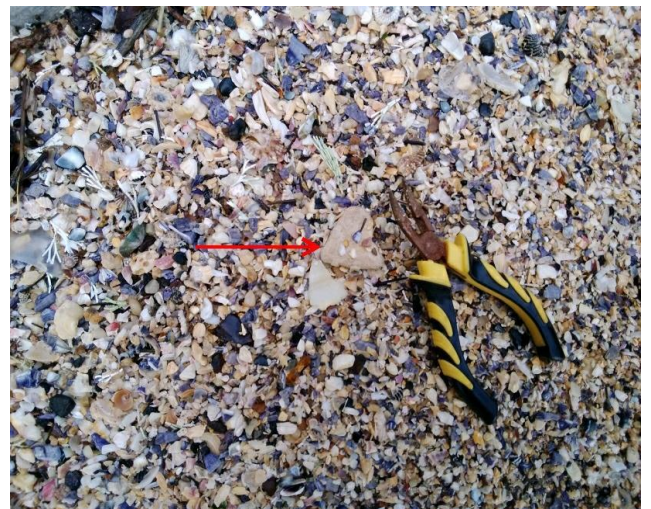
Notes: FC fragment identified on sand surface prior to emu pick - Southern section

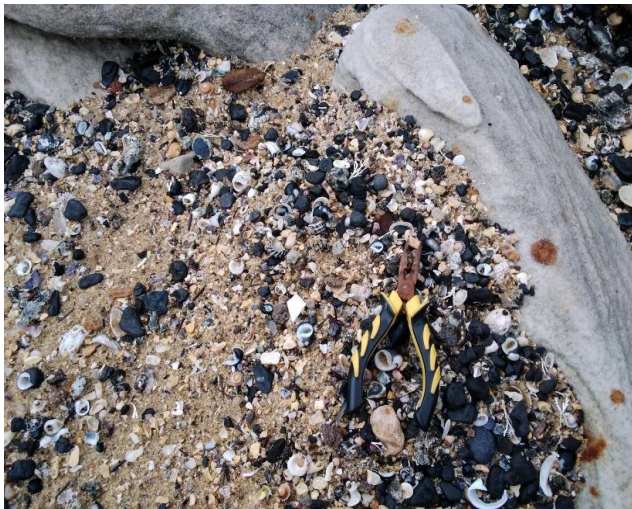
Notes: Sand surface following emu pick - Northern section

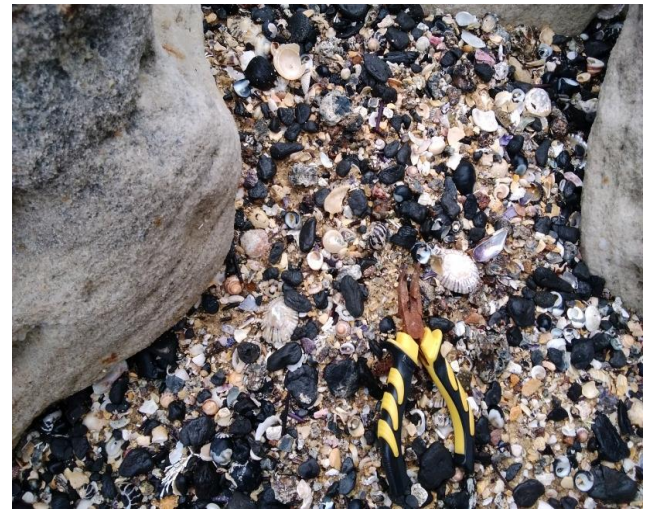
Notes: Sand surface following emu pick - Northern section

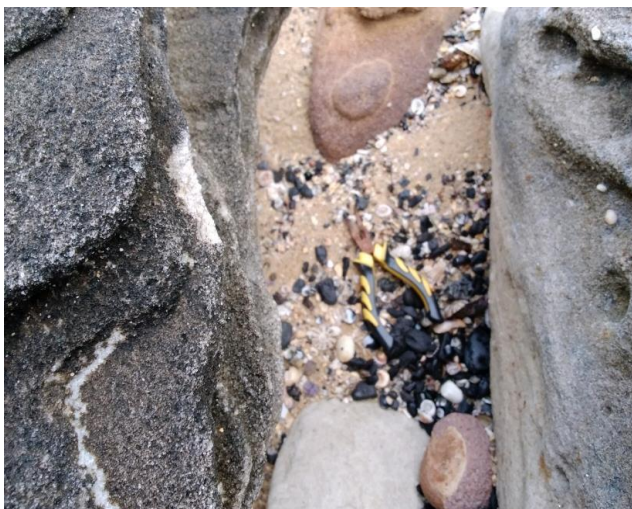
Notes: Sand surface following emu pick - Northern section

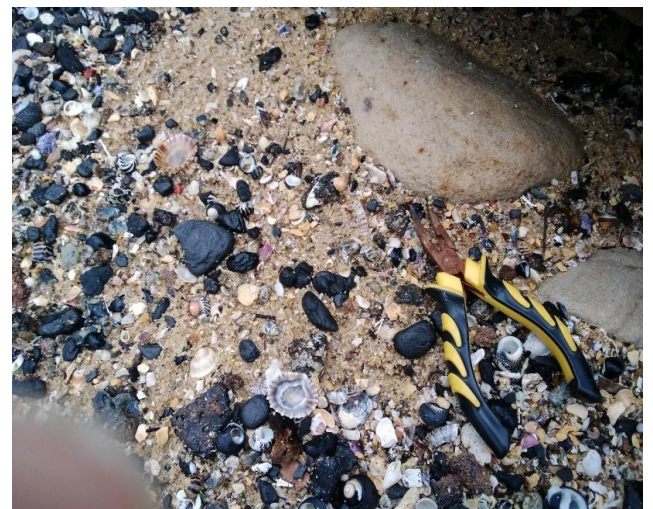
Notes: Sand surface following emu pick - Northern section

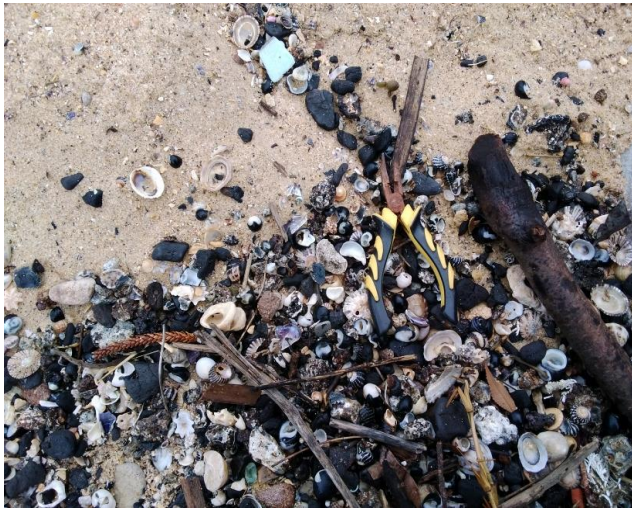
Notes: Sand surface following emu pick - Northern section

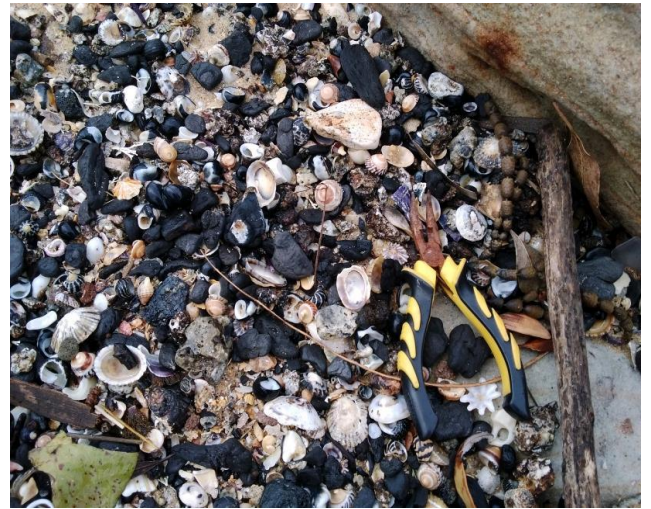
Notes: Sand surface following emu pick - Northern section

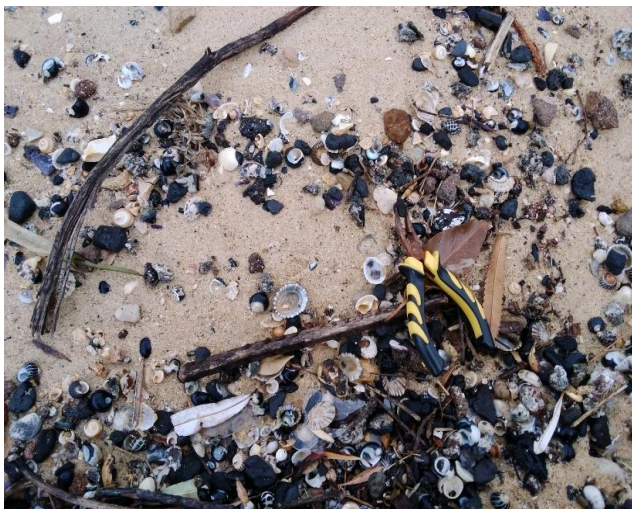
Notes: Sand surface following emu pick - Northern section

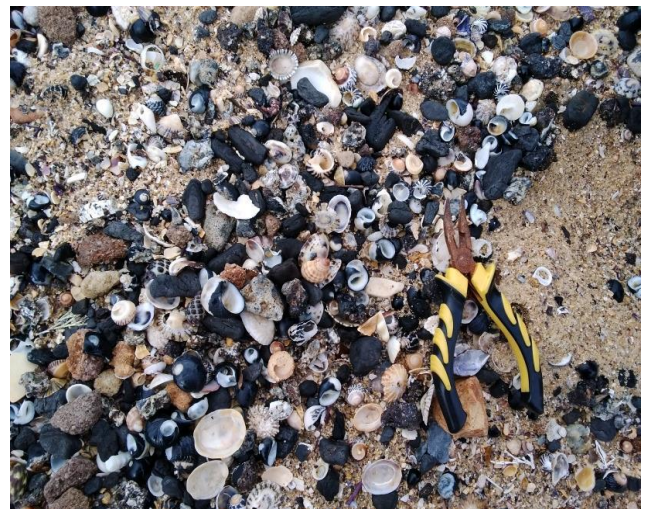
Notes: Sand surface following emu pick - Northern section

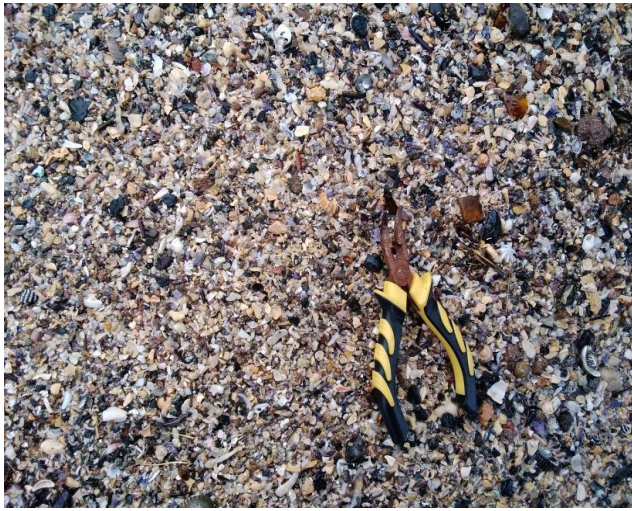
Notes: Sand surface following emu pick - Northern section

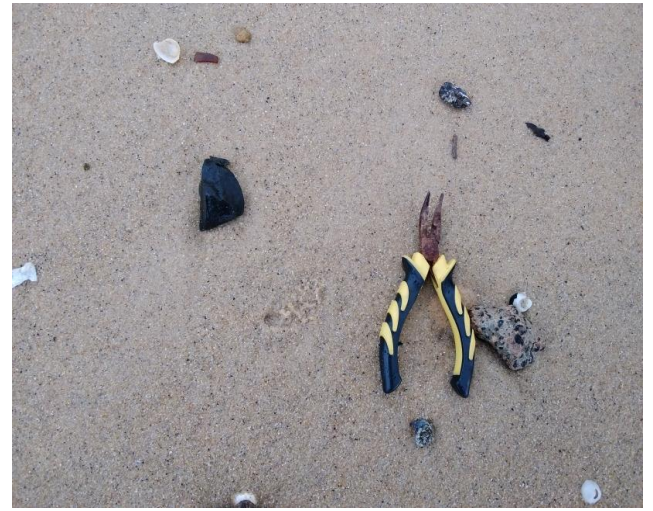
Notes: Sand surface following emu pick - Northern section

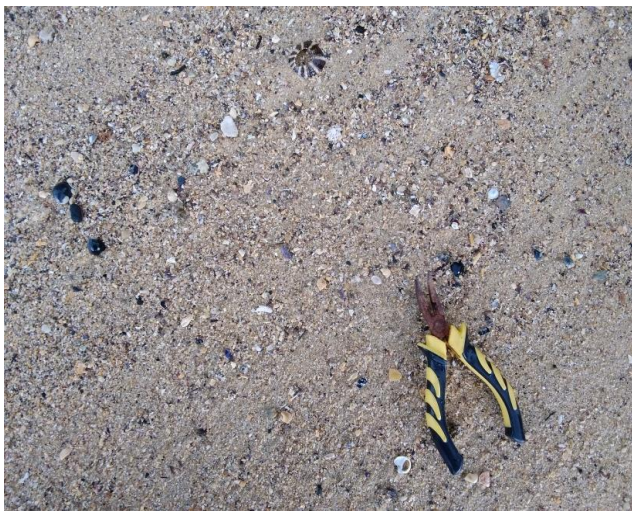
Notes: Sand surface following emu pick - Western section

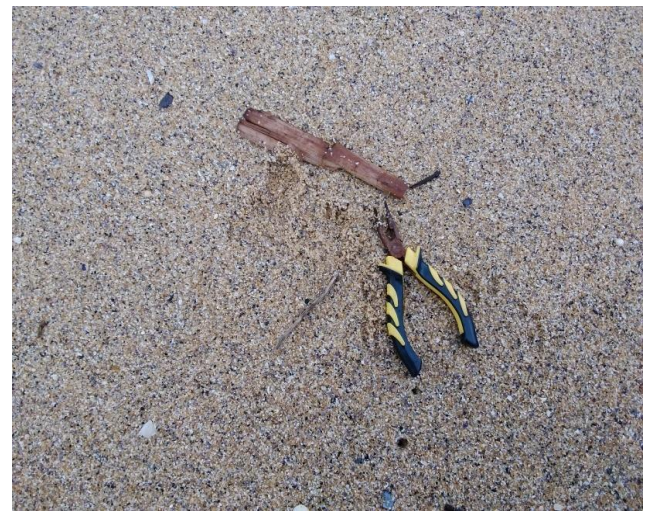
Notes: Sand surface following emu pick - Southern section

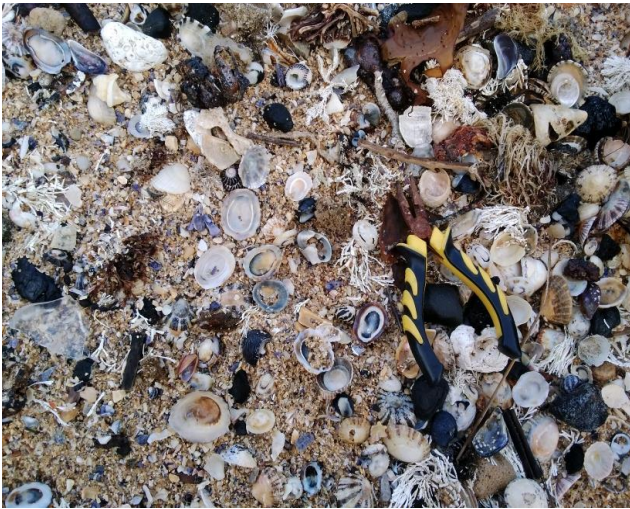
Notes: Sand surface following emu pick - Southern section

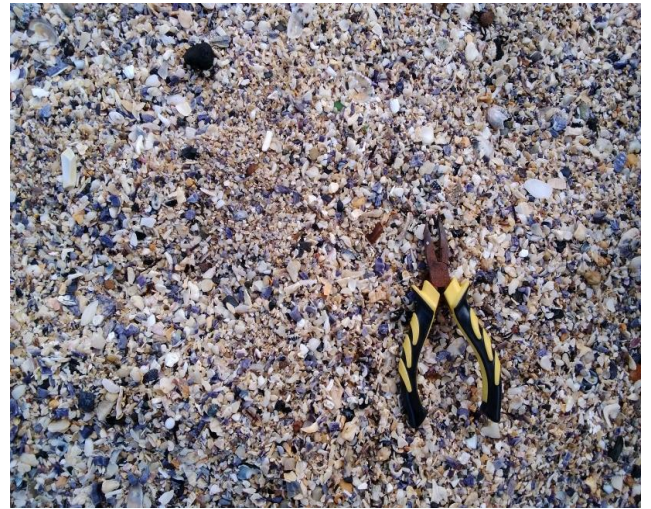
Notes: Sand surface following emu pick - Southern section

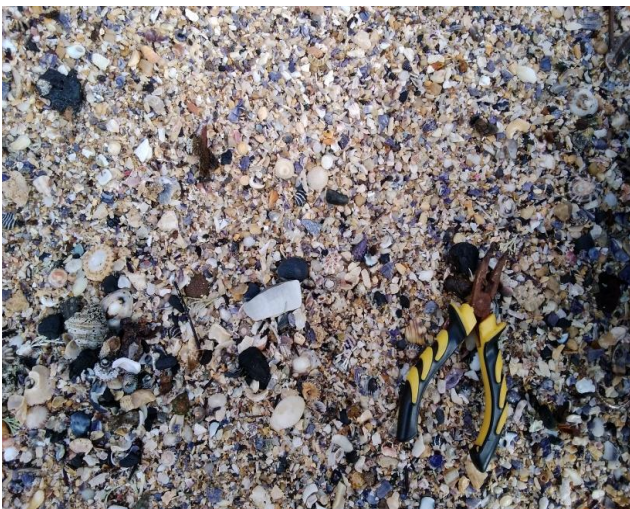
Notes: Sand surface following emu pick - Southern section

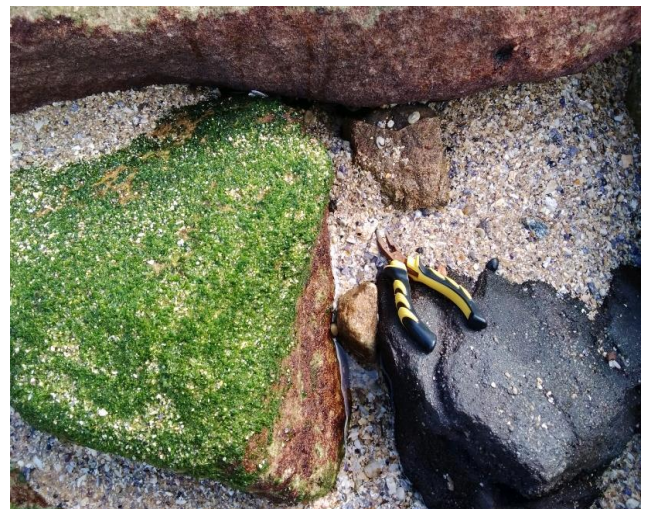
Notes: Sand surface following emu pick - Southern section

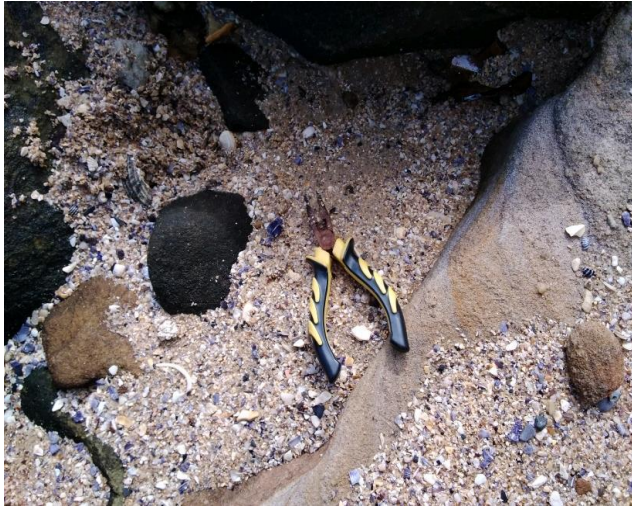
Notes: Sand surface following emu pick - Southern section

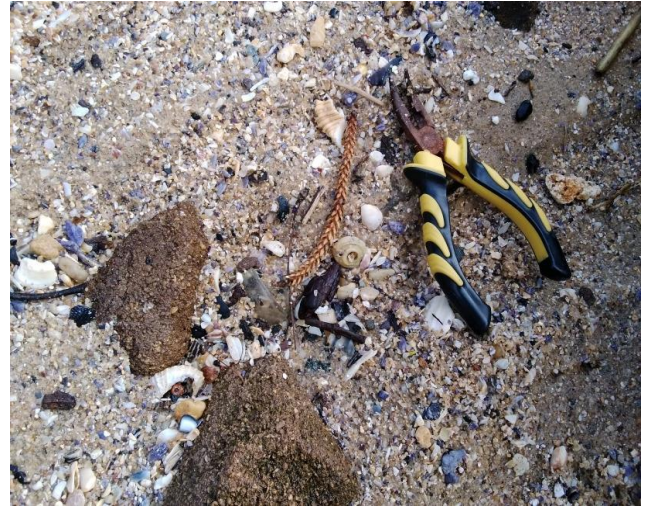
Notes: Sand surface following emu pick - Southern section

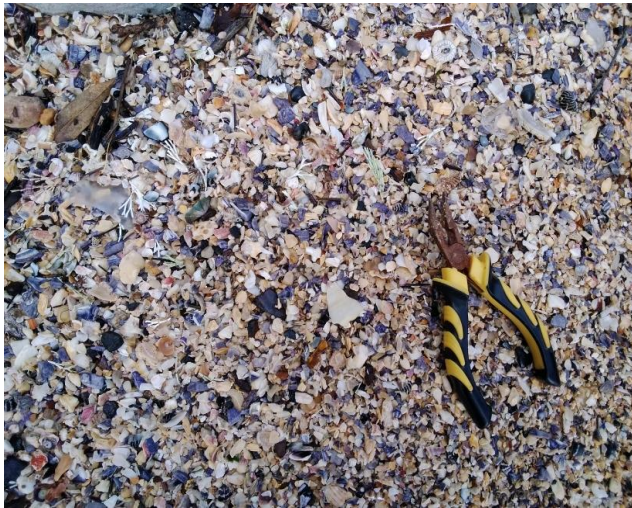
Notes: Sand surface following emu pick - Southern section

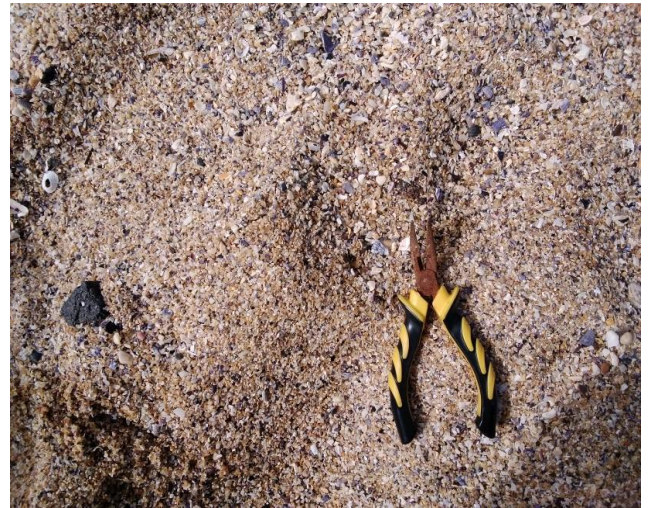
Notes: Sand surface following emu pick - Southern section
