Asbestos Containing Material Clearance Inspection

30 June 2023

Randwick City Council
30 Frances Street
Randwick NSW 2031

Site:	Little Bay Beach
Location:	Sand surfaces of beach

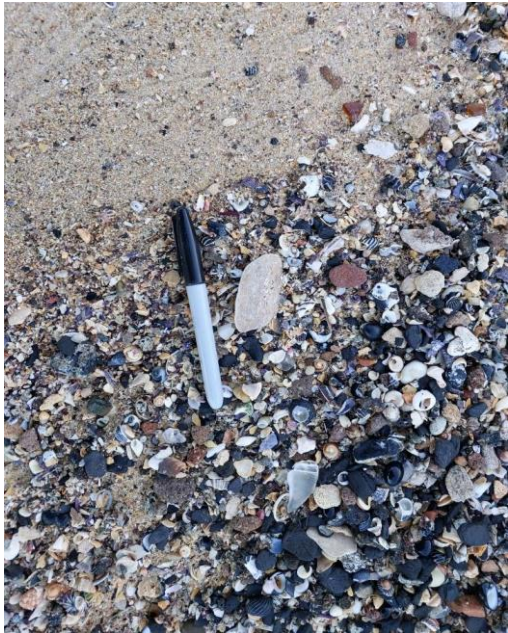
Notes: Fragment identified on Beach surface

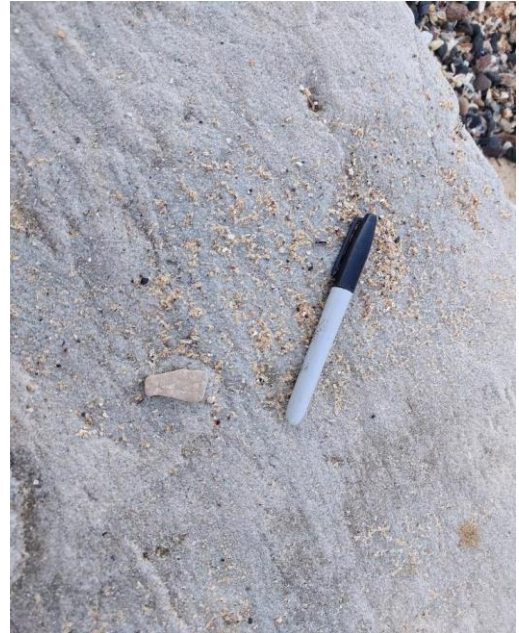
Notes: Fragment identified on Beach surface

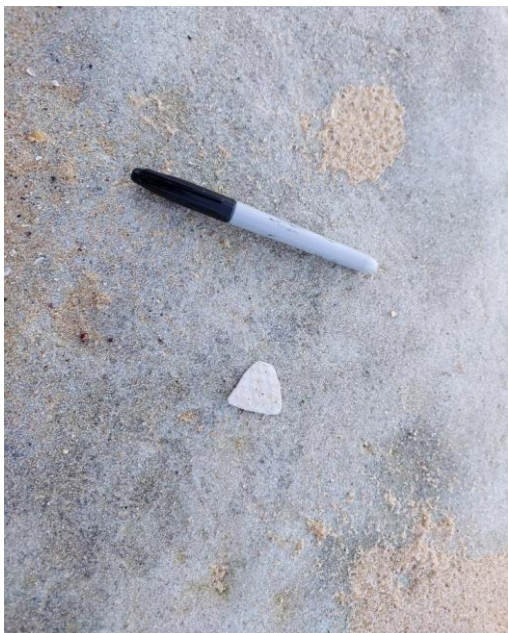
Notes: Fragment identified on Beach surface

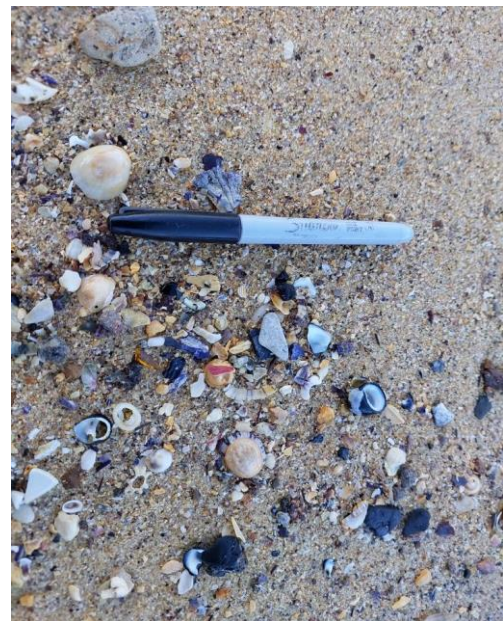
Notes: Fragment identified on Beach surface

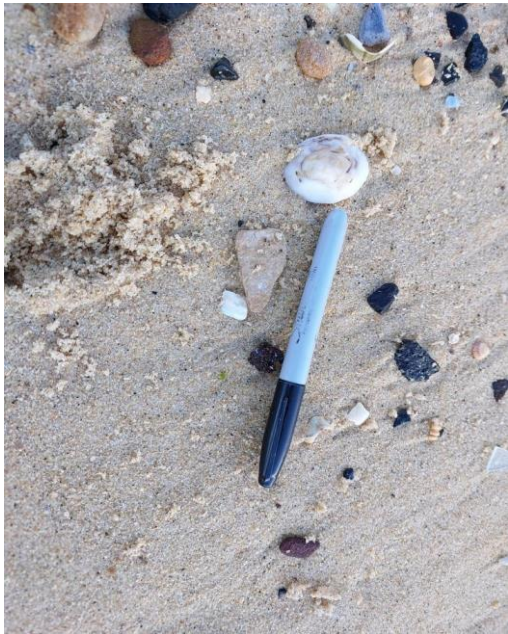
Notes: Fragment identified on Beach surface

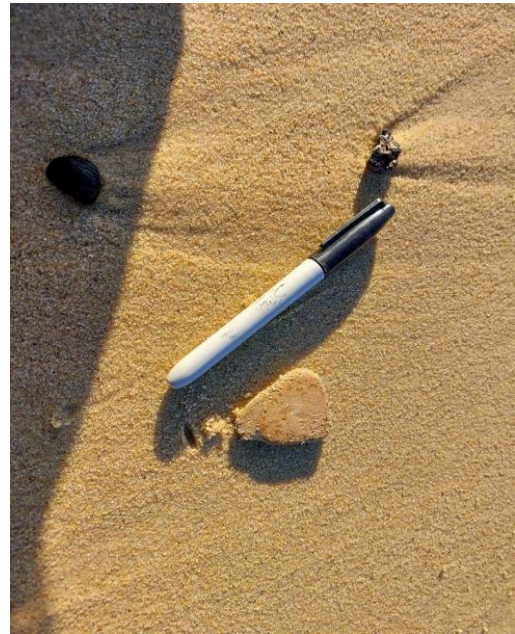
Notes: Fragment identified on Beach surface

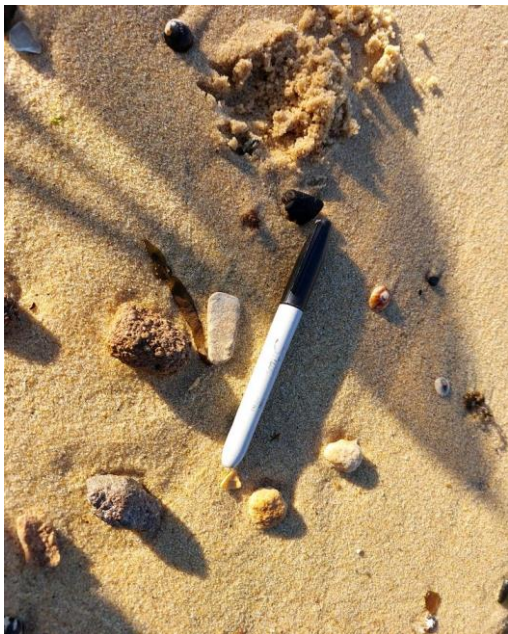
Notes: Fragment identified on Beach surface

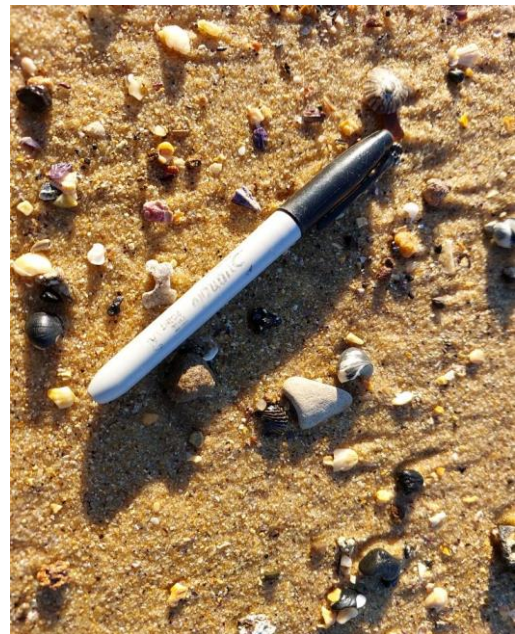
Notes: Fragment identified on Beach surface

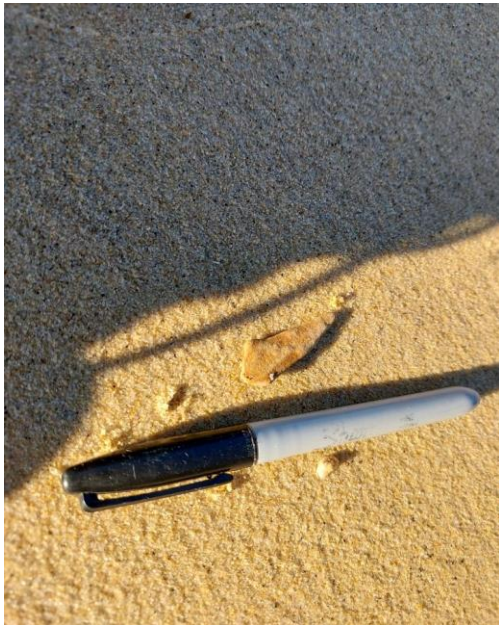
Notes: Fragment identified on Beach surface

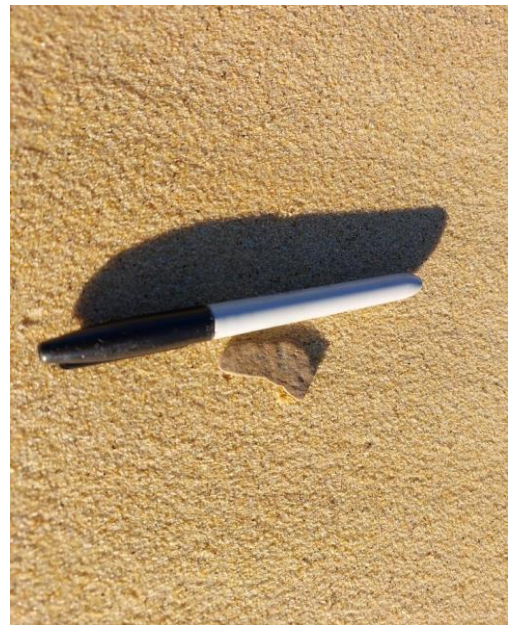
Notes: Fragment identified on Beach surface

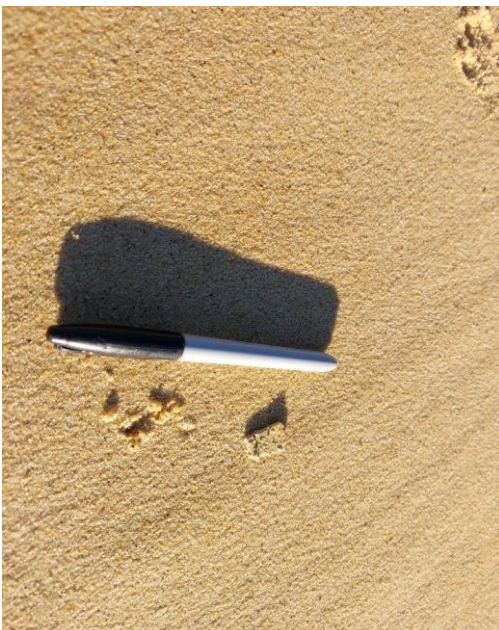
Notes: Fragment identified on Beach surface

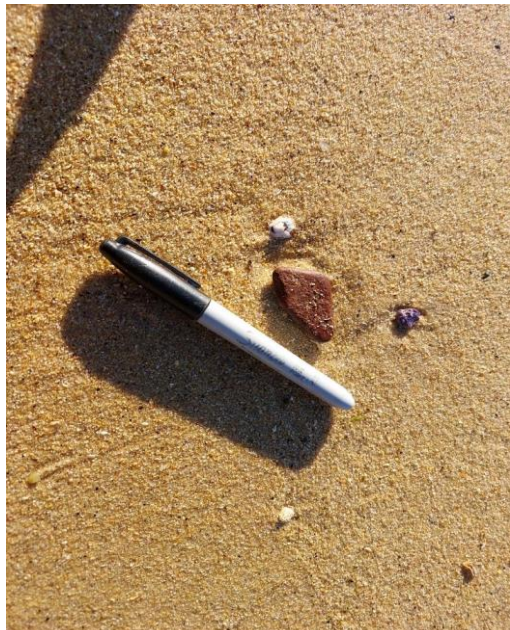
Notes: Fragment identified on Beach surface

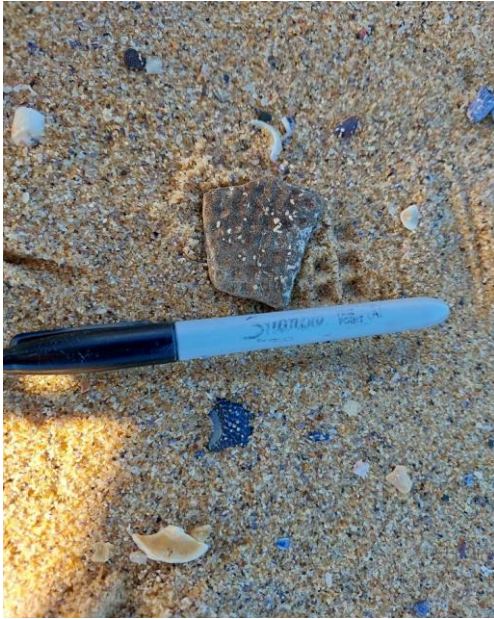
Notes: Fragment identified on Beach surface

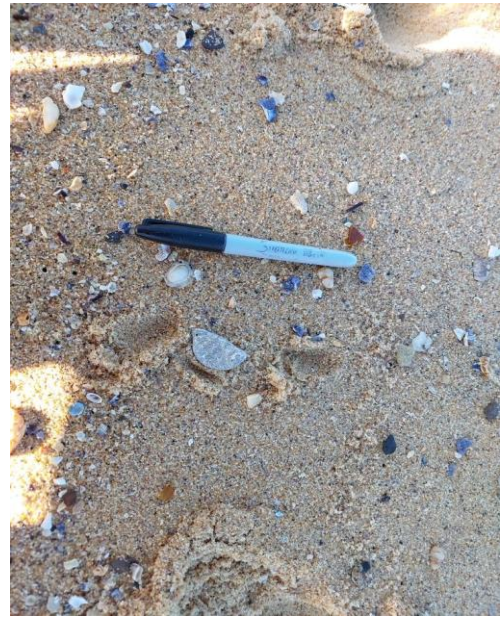
Notes: Fragment identified on Beach surface

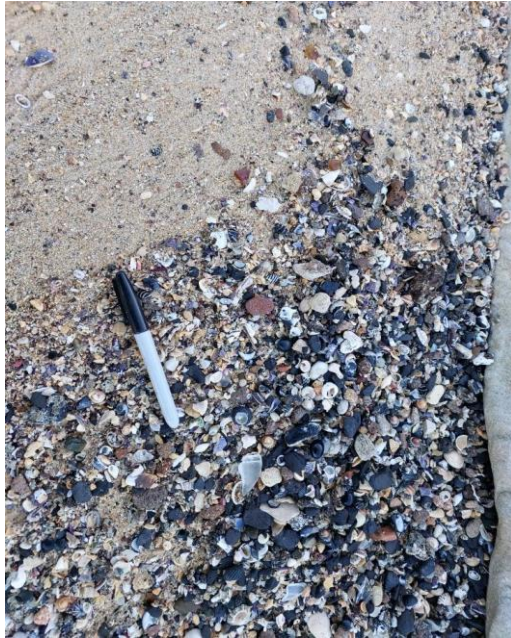
Notes: Beach surface following fragment removal

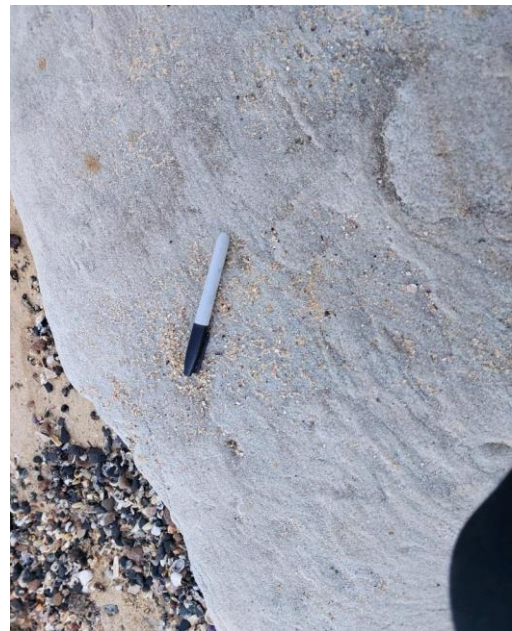
Notes: Beach surface following fragment removal

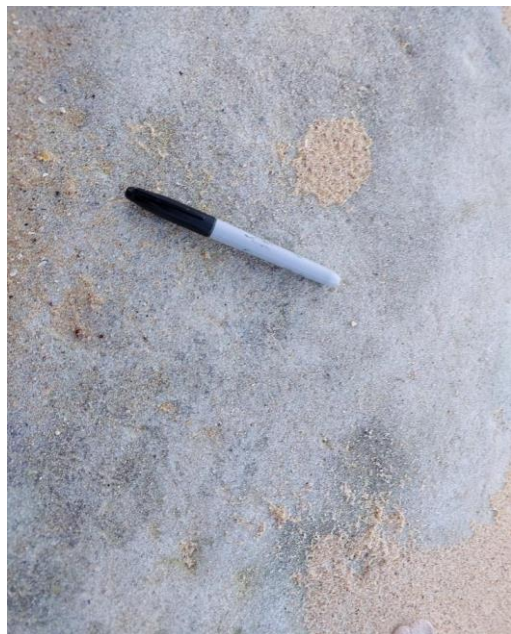
Notes: Beach surface following fragment removal

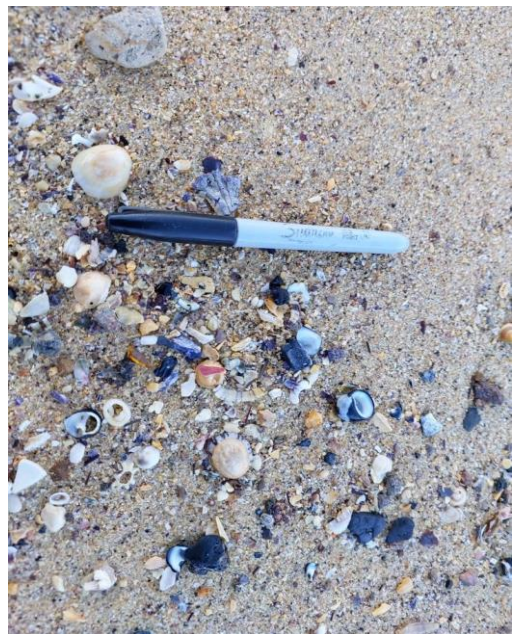
Notes: Beach surface following fragment removal

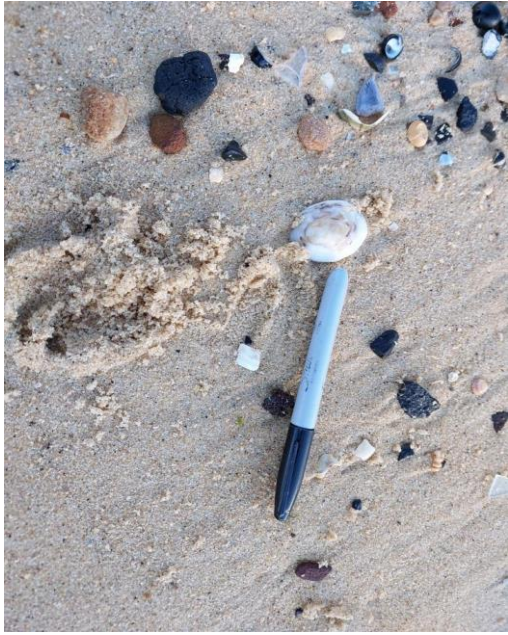
Notes: Beach surface following fragment removal

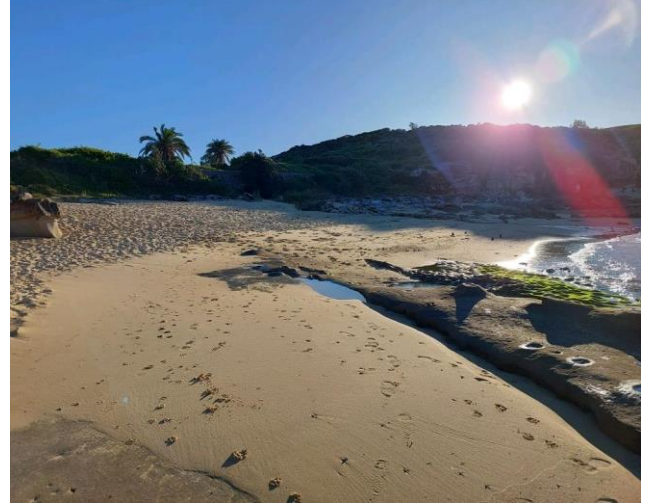
Notes: North Beach following inspection

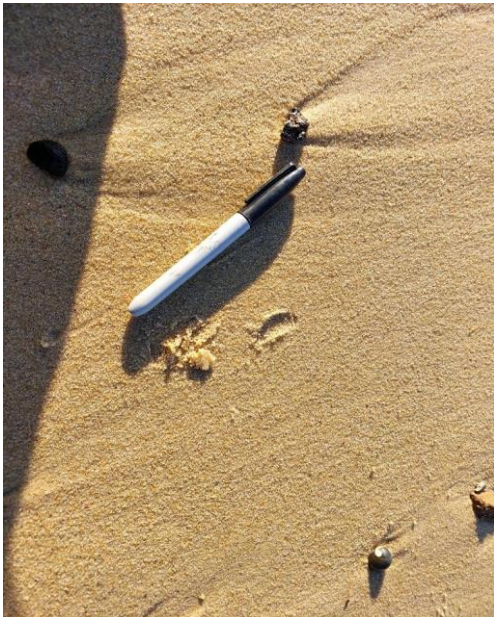
Notes: Beach surface following fragment removal

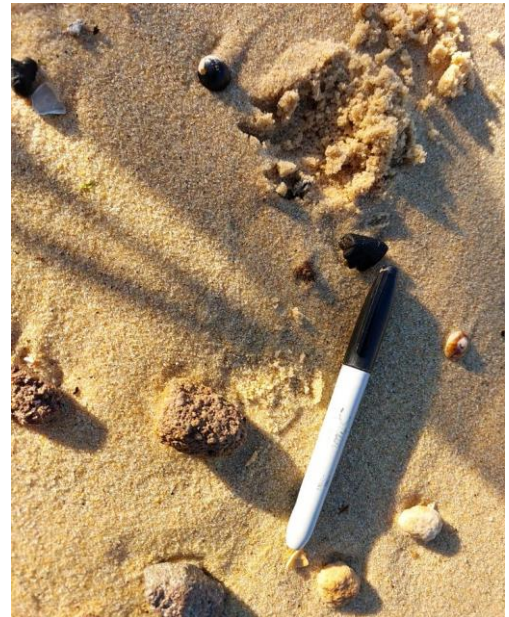
Notes: Beach surface following fragment removal

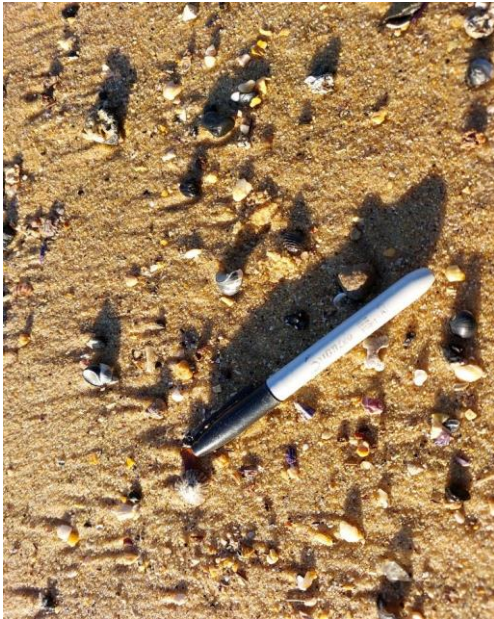
Notes: Beach surface following fragment removal

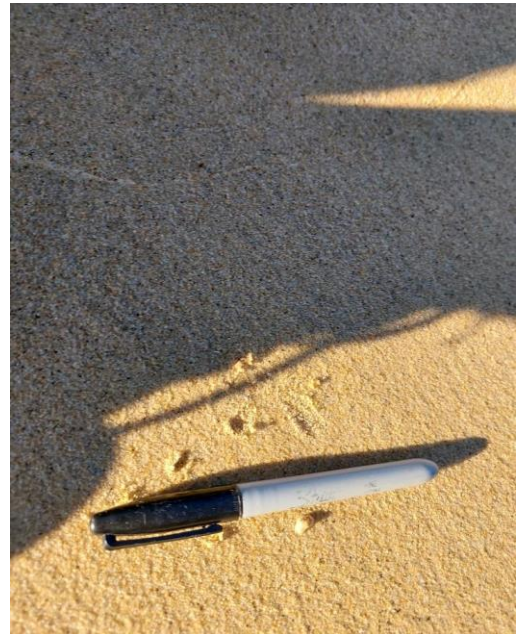
Notes: Beach surface following fragment removal

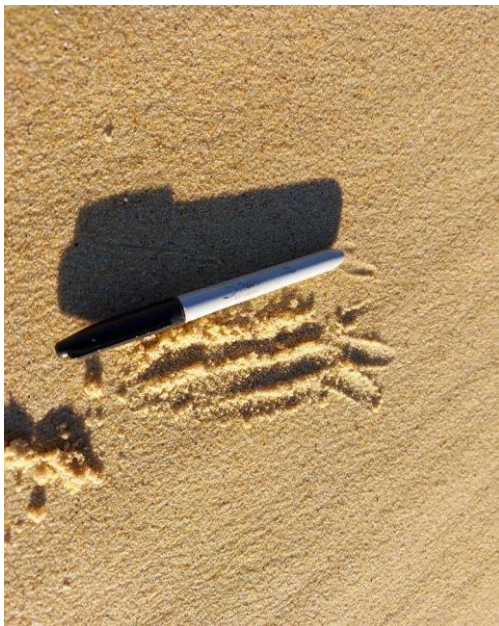
Notes: Beach surface following fragment removal

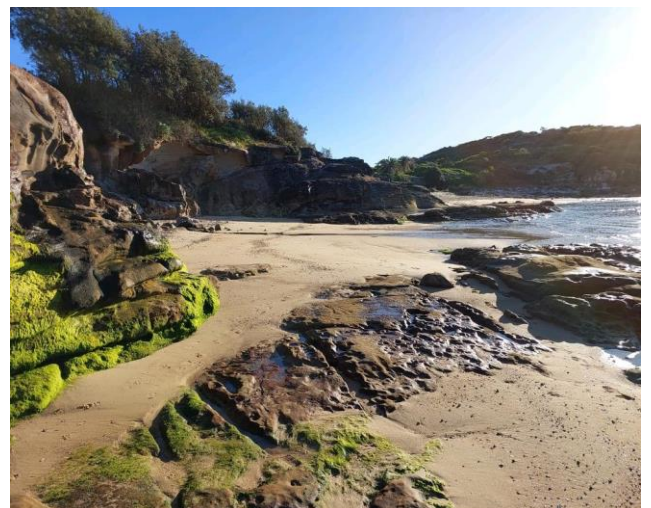
Notes: Western Beach following Inspection

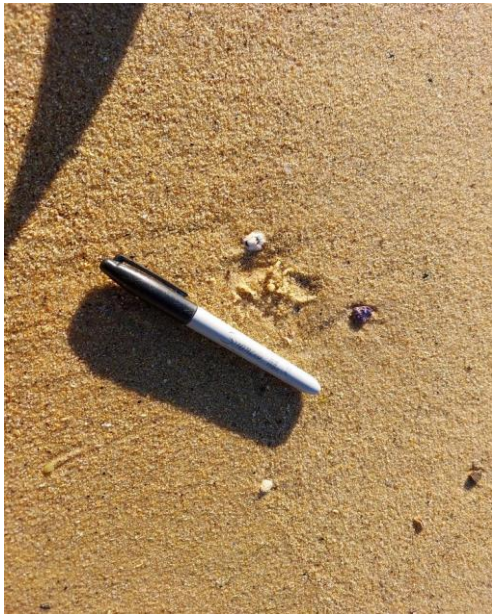
Notes: Beach surface following fragment removal

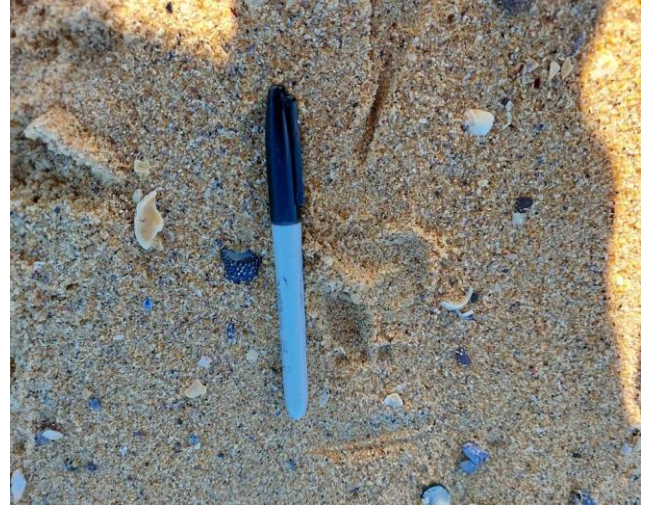
Notes: Beach surface following fragment removal

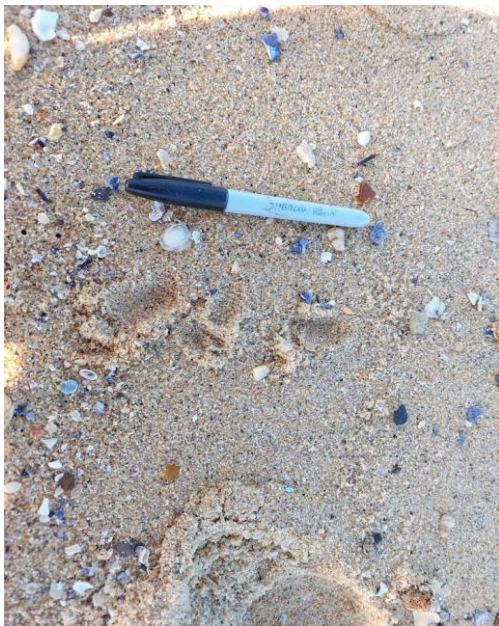
Notes: Beach surface following fragment removal

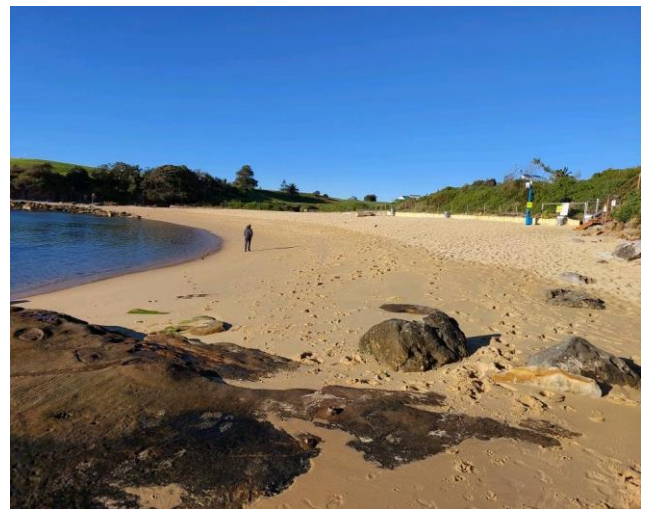
Notes: Southern beach following Inspection
