Asbestos Containing Material Clearance Inspection

3 January 2023

Site:	Little Bay Beach
Location:	Southern, Western and Northern Little Bay Beach

Requested by:	
Name	Joe Santangelo
Contact	0436839760
Email	joe.santangelo@randwick.nsw.gov.au
Site Details:	
Address	2 Coast Hospital Rd, Little Bay NSW 2036
Local Government Area	Randwick City Council

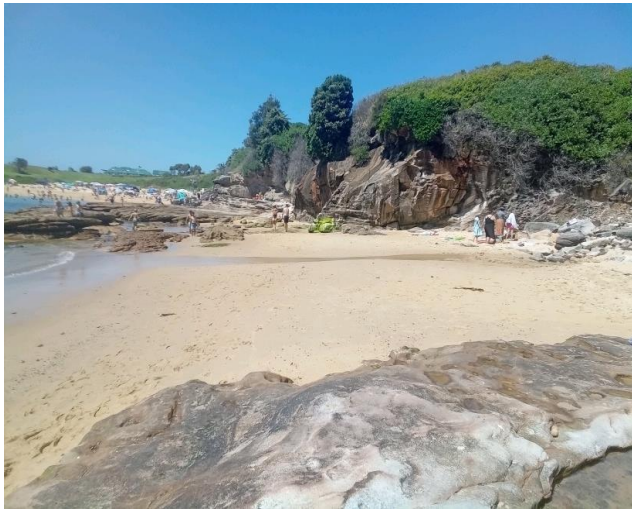
Notes: Overview of the Western beach.

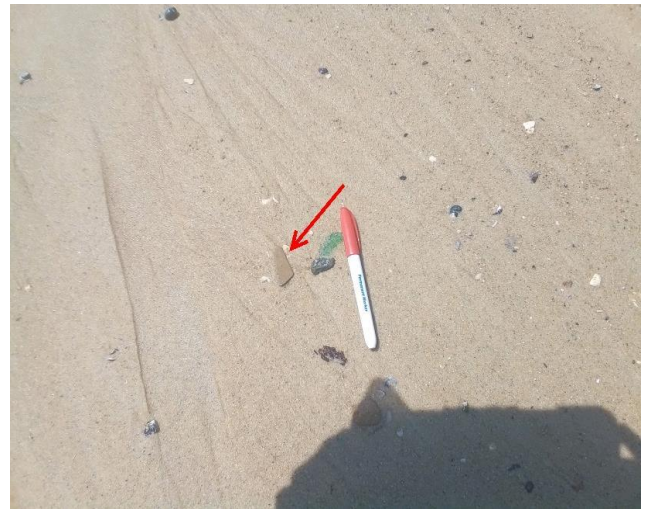
Notes: Overview of the ACM fragment prior to the removal within Western beach.

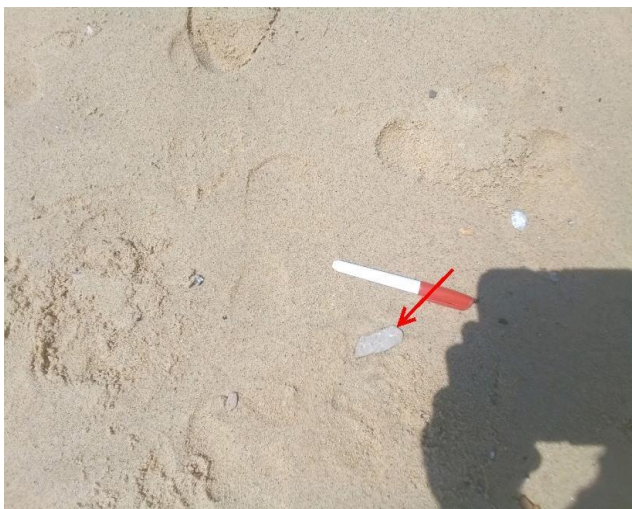
Notes: Overview of the ACM fragment prior to the removal within Western beach.

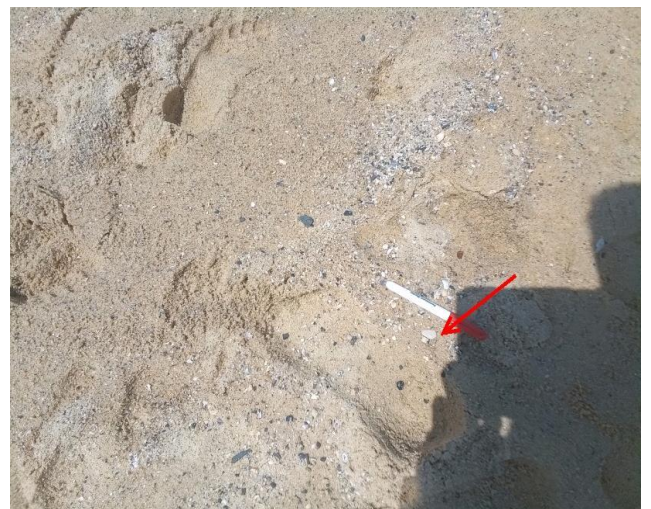
Notes: Overview of the ACM fragment prior to the removal within Western beach.

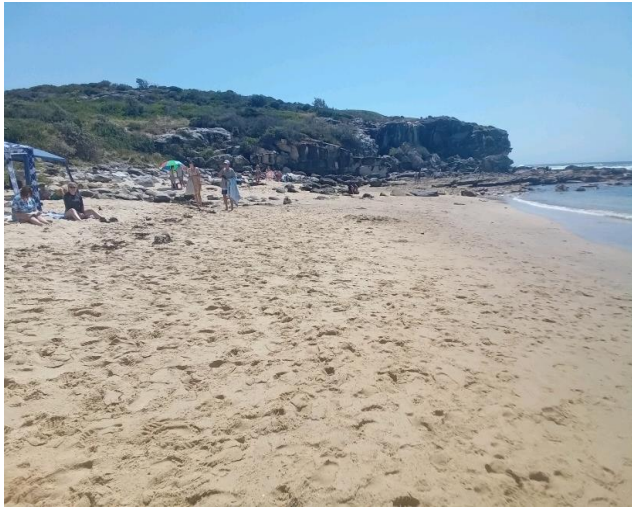
Notes: Overview of the Northern beach.

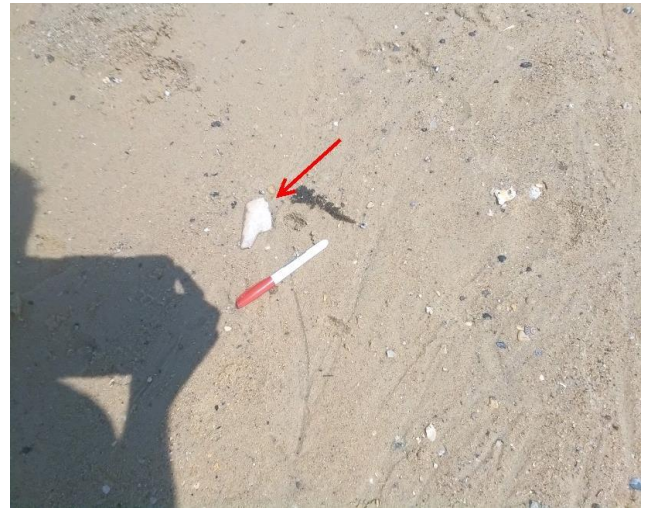
Notes: Overview of the ACM fragment prior to the removal within Northern beach.

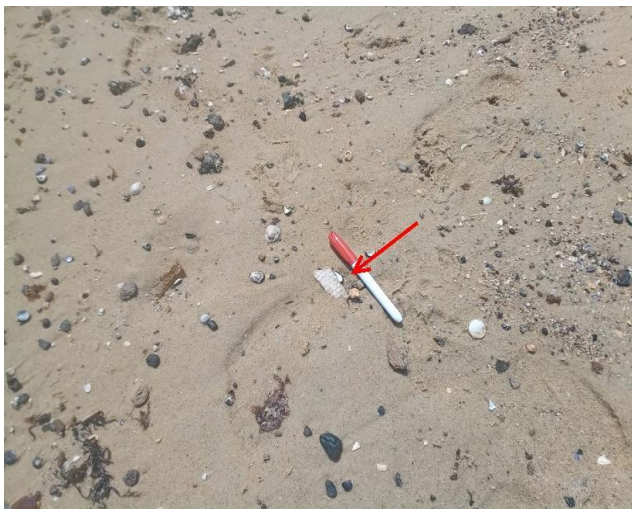
Notes: Overview of the ACM fragment prior to the removal within Northern beach.

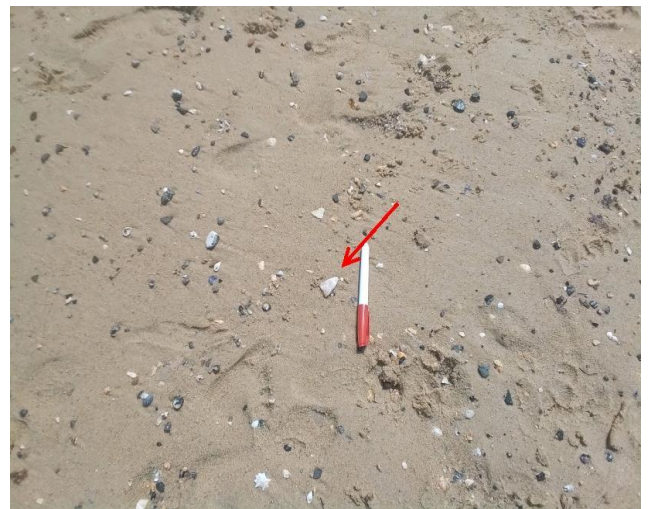
Notes: Overview of the ACM fragment prior to the removal within Northern beach.

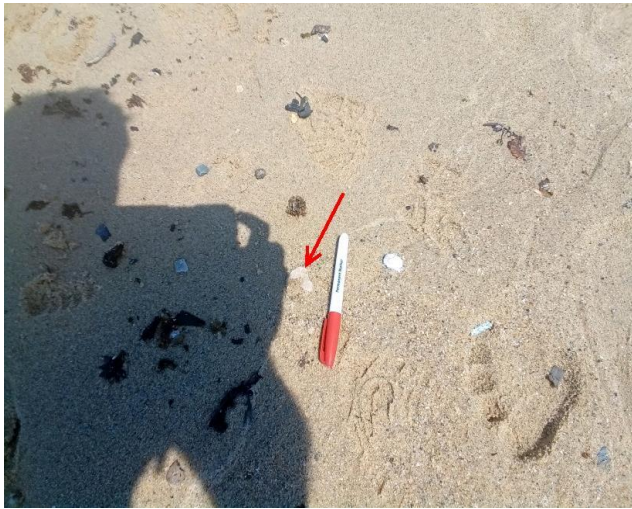
Notes: Overview of the ACM fragment prior to the removal within Northern beach.

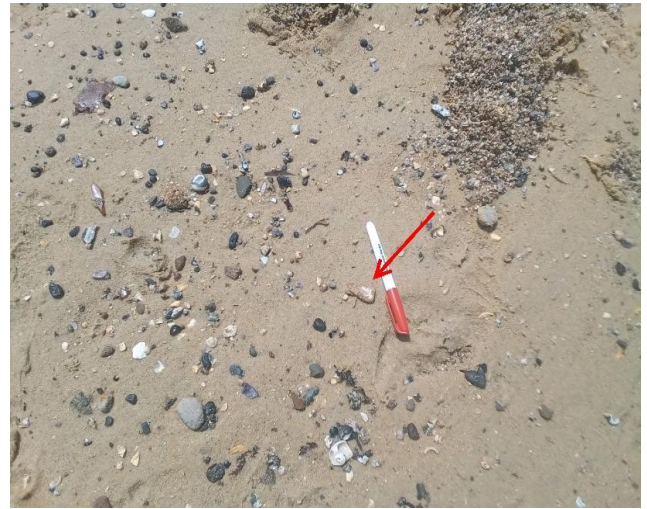
Notes: Overview of the ACM fragment prior to the removal within Northern beach.

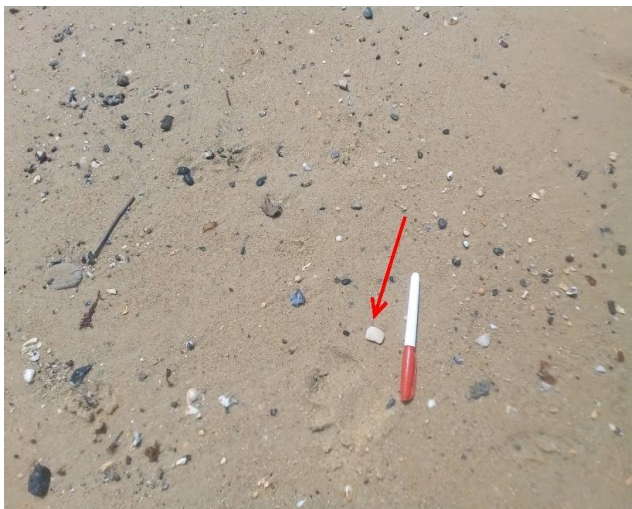
Notes: Overview of the ACM fragment prior to the removal within Northern beach.

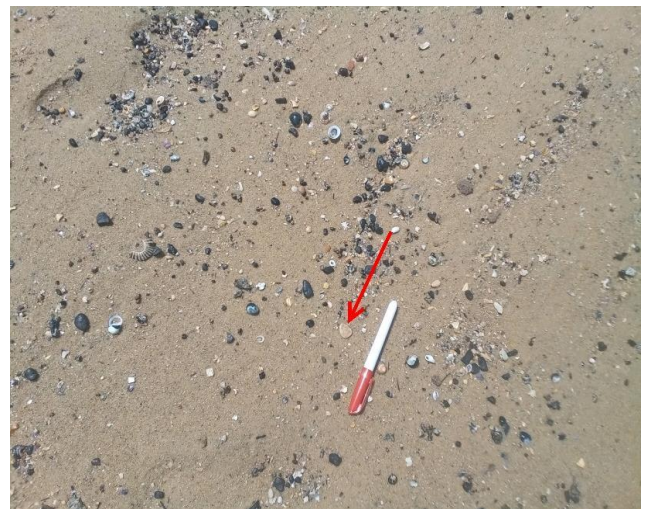
Notes: Overview of the ACM fragment prior to the removal within Northern beach.

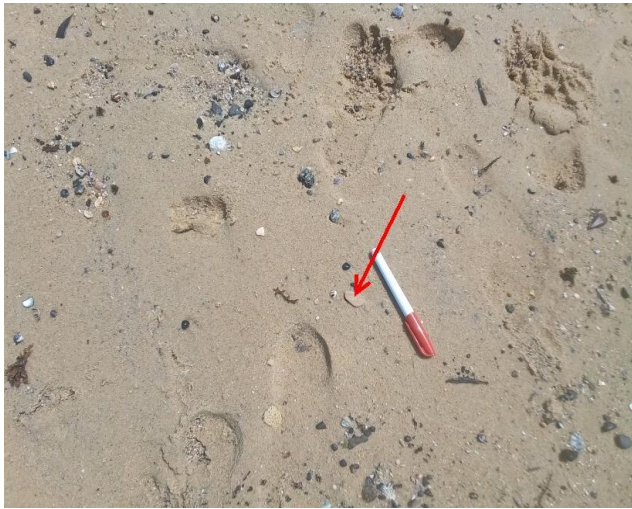
Notes: Overview of the ACM fragment prior to the removal within Northern beach.

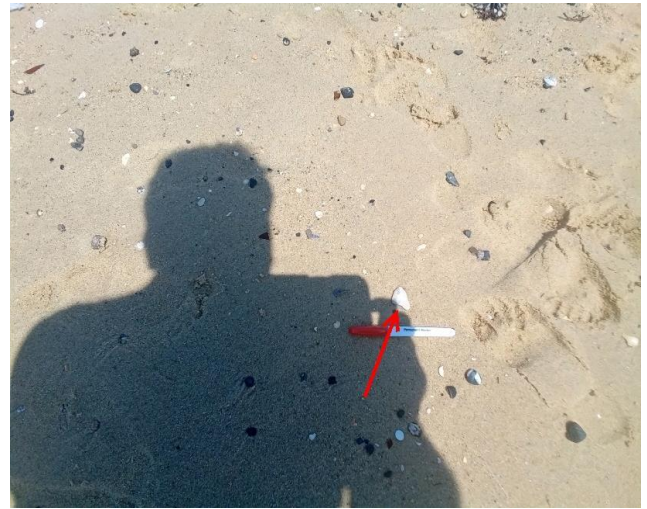
Notes: Overview of the ACM fragment prior to the removal within Northern beach.

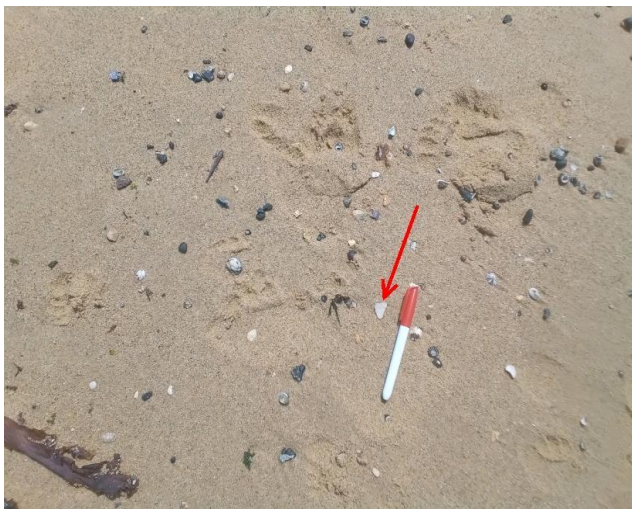
Notes: Overview of the ACM fragment prior to the removal within Northern beach.

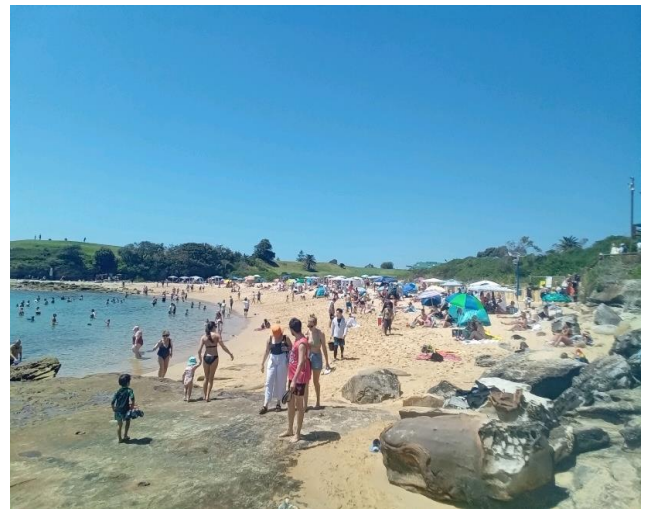
Notes: Overview of the Southern beach.

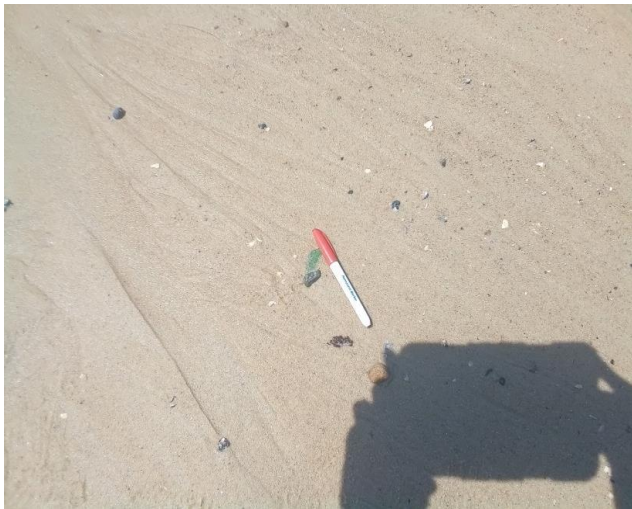
Notes: Visual surface clearance inspection following removal of ACM fragment.

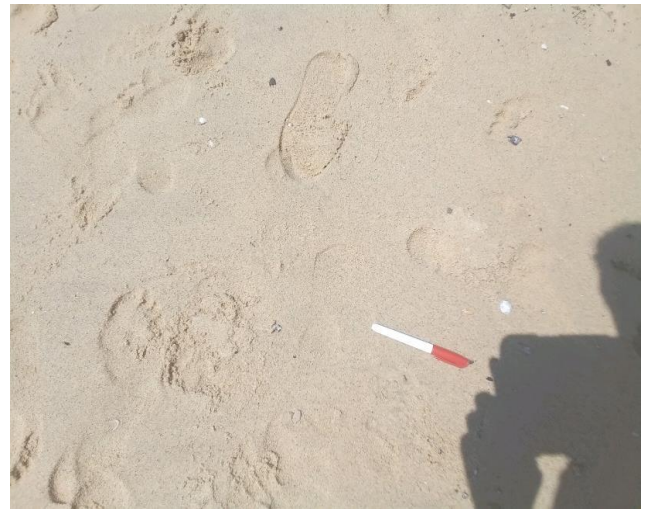
Notes: Visual surface clearance inspection following removal of ACM fragment.

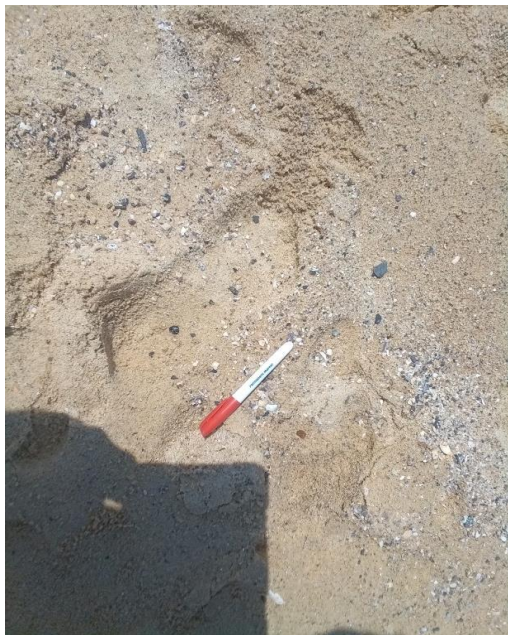
Notes: Visual surface clearance inspection following removal of ACM fragment.

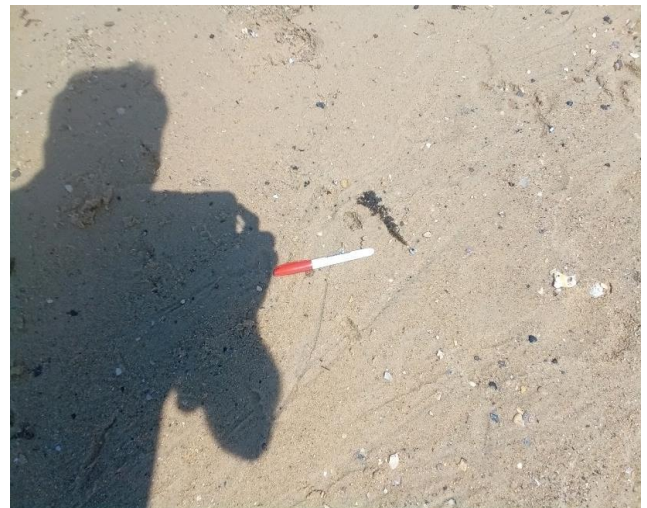
Notes: Visual surface clearance inspection following removal of ACM fragment.

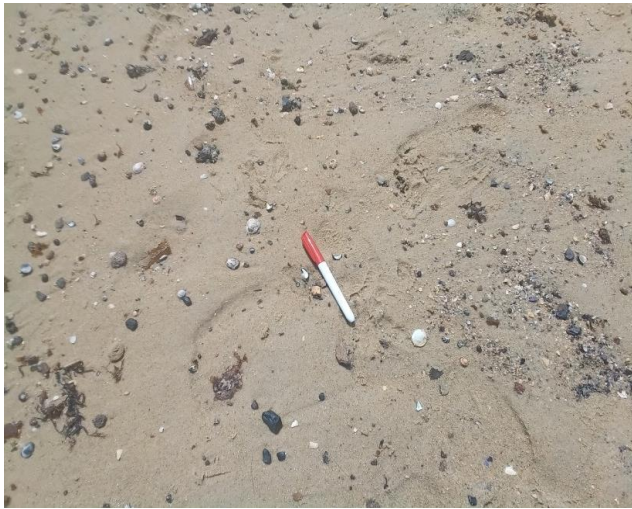
Notes: Visual surface clearance inspection following removal of ACM fragment.

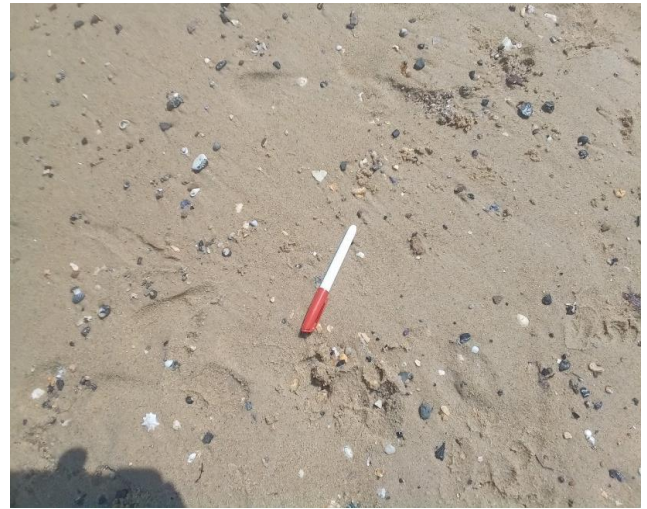
Notes: Visual surface clearance inspection following removal of ACM fragment.

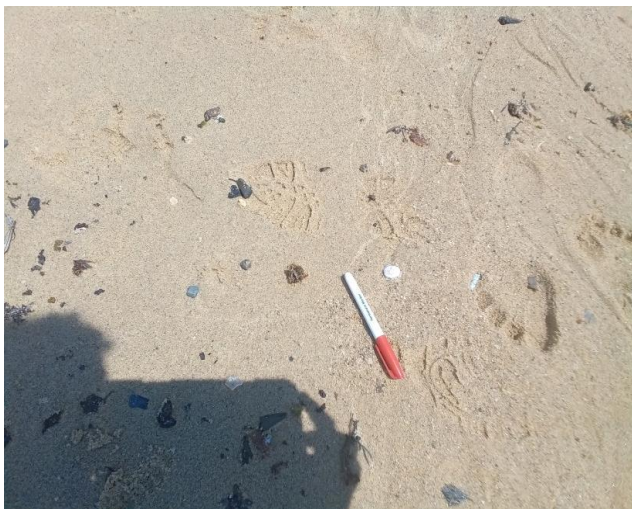
Notes: Visual surface clearance inspection following removal of ACM fragment.

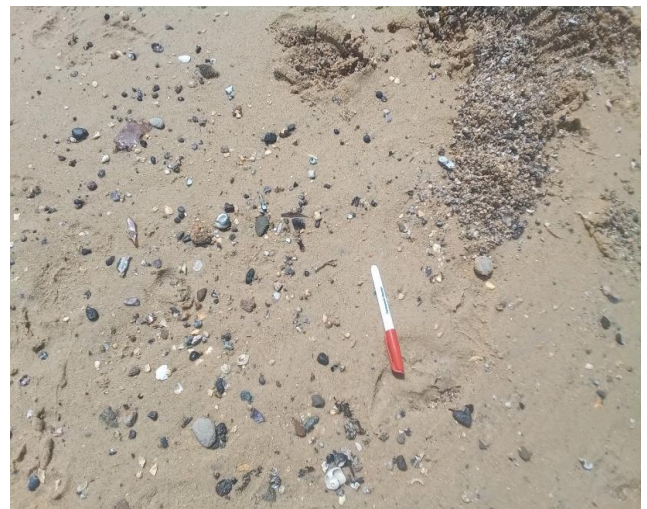
Notes: Visual surface clearance inspection following removal of ACM fragment.

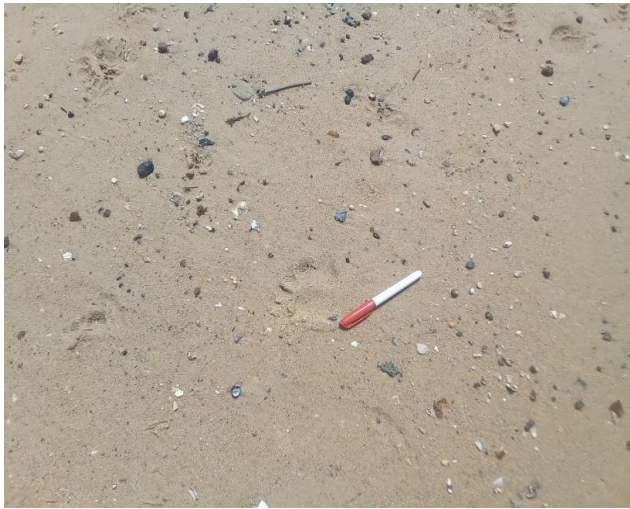
Notes: Visual surface clearance inspection following removal of ACM fragment.

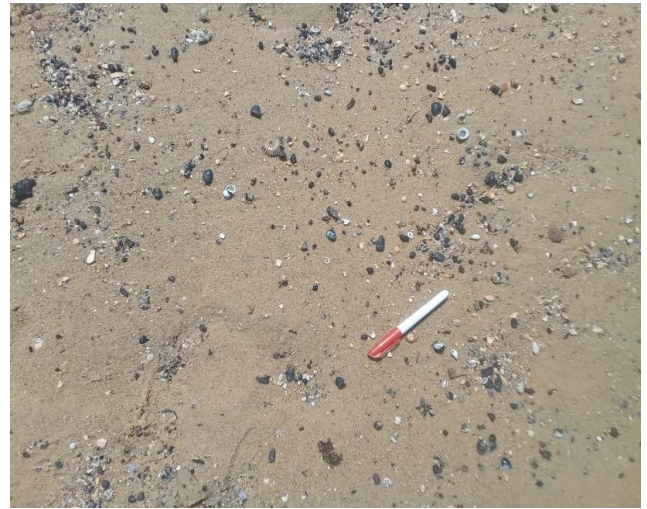
Notes: Visual surface clearance inspection following removal of ACM fragment.

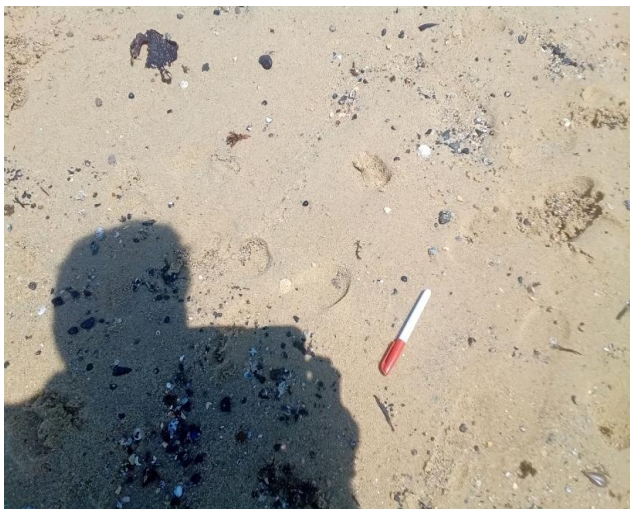
Notes: Visual surface clearance inspection following removal of ACM fragment.

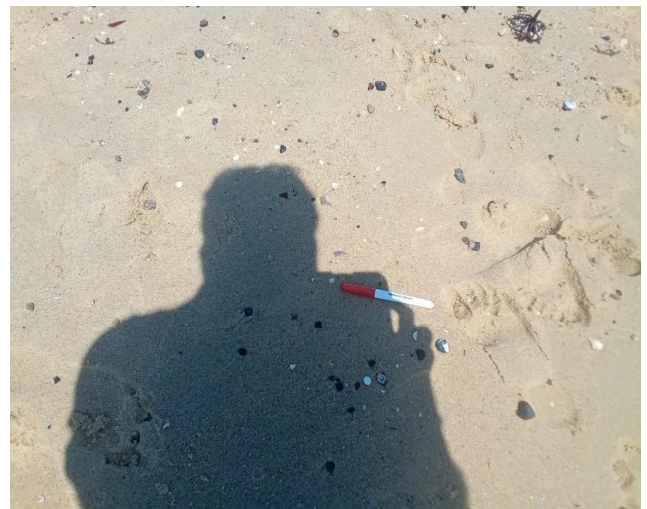
Notes: Visual surface clearance inspection following removal of ACM fragment.

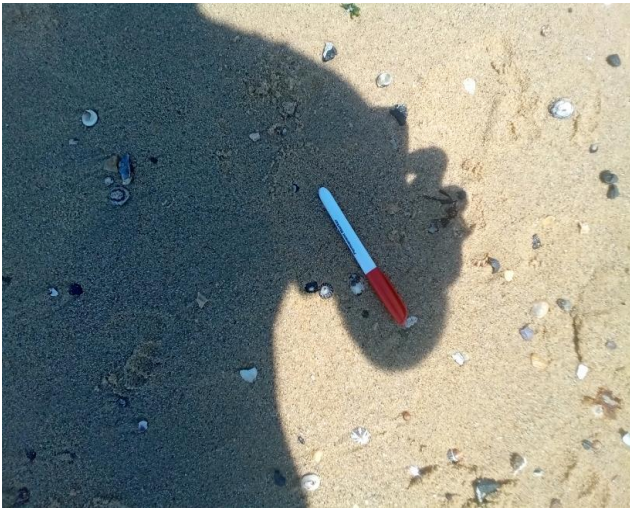
Notes: Visual surface clearance inspection following removal of ACM fragment.
