Asbestos Containing Material Clearance Inspection

31 March 2023

Site:	Little Bay Beach
Location:	Southern, Western, and Northern Little Bay Beach

Requested by:	
Name	Joe Santangelo
Contact	0436839760
Email	joe.santangelo@randwick.nsw.gov.au
Site Details:	
Address	2 Coast Hospital Rd, Little Bay NSW 2036
Local Government Area	Randwick City Council

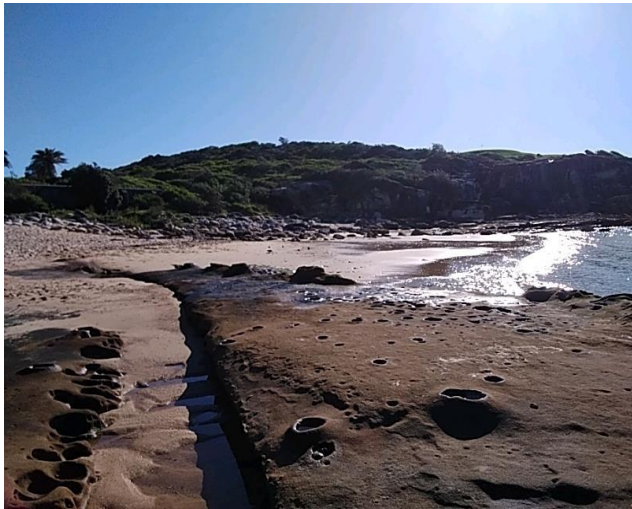
Notes: Overview of Northern Beach

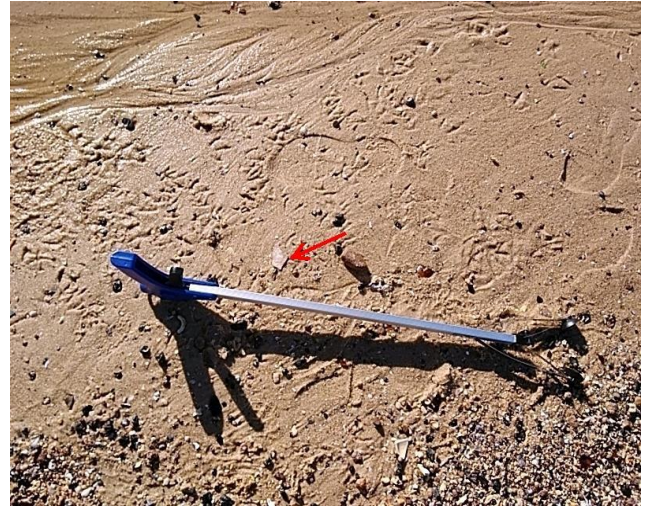
Notes: Overview of removal item within Northern beach prior to removal

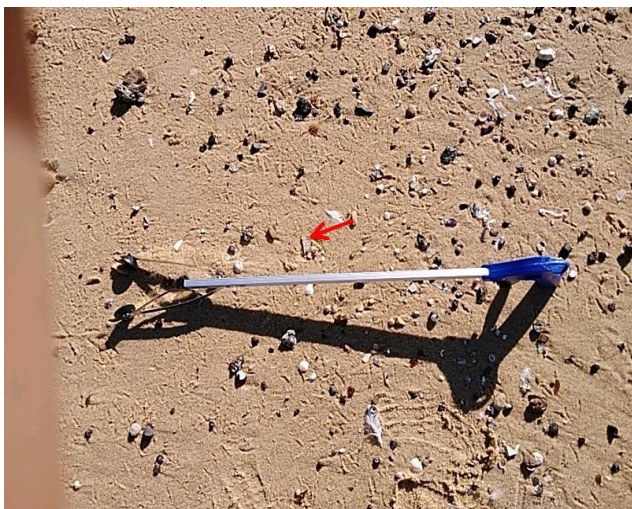
Notes: Overview of removal item within Northern beach prior to removal

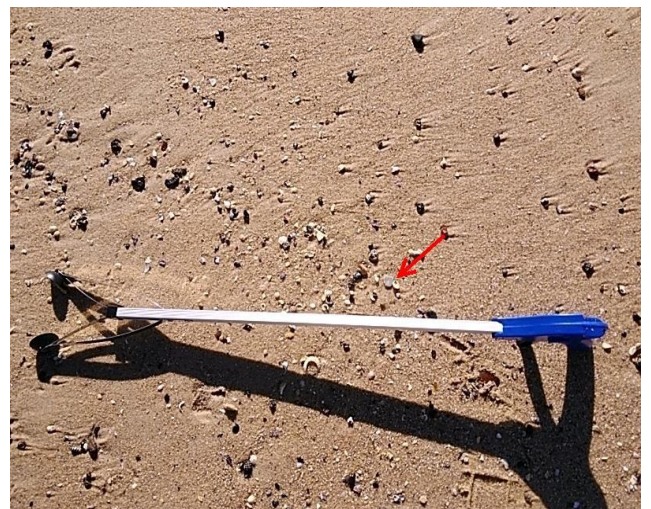
Notes: Overview of removal item within Northern beach prior to removal

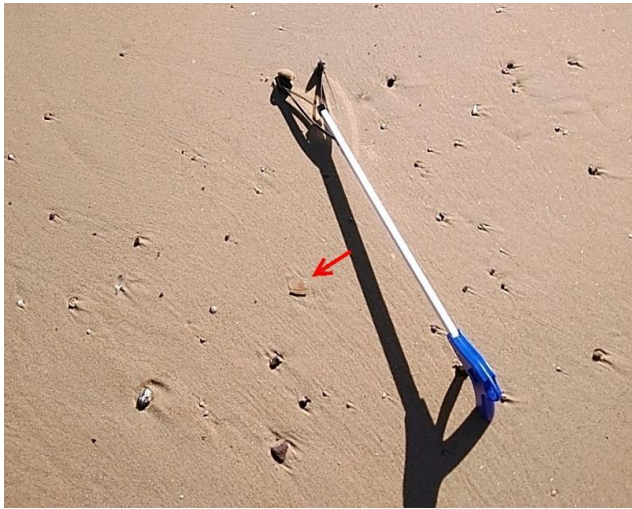
Notes: Overview of removal item within Northern beach prior to removal

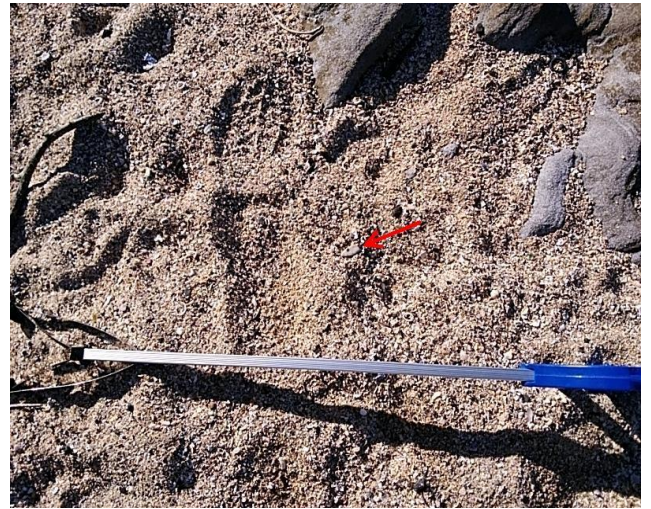
Notes: Overview of removal item within Northern beach prior to removal

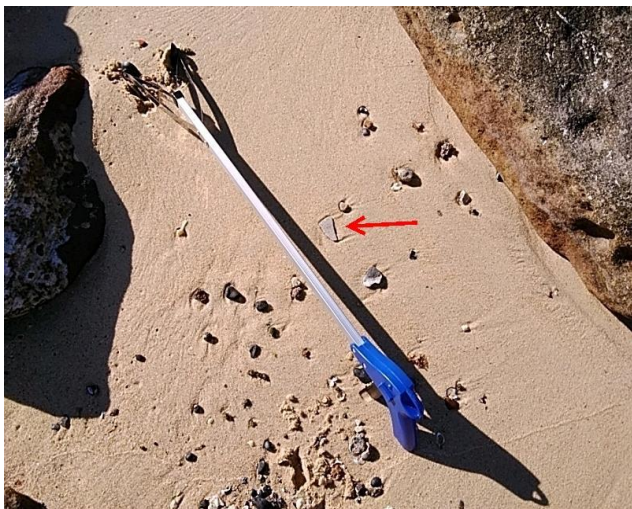
Notes: Overview of removal item within Northern beach prior to removal

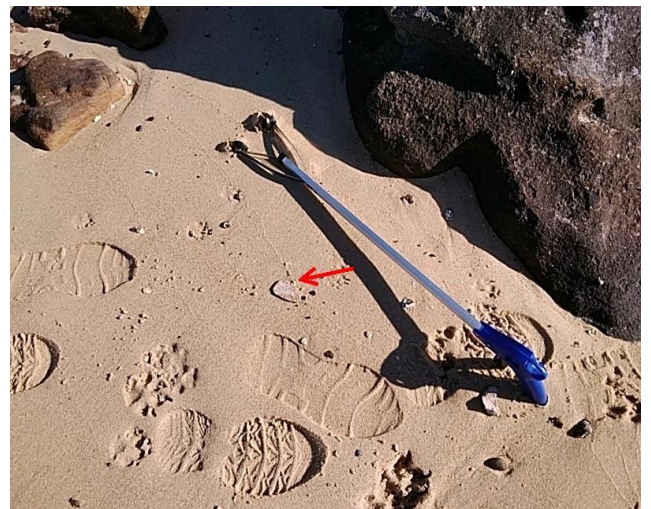
Notes: Overview of removal item within Northern beach prior to removal

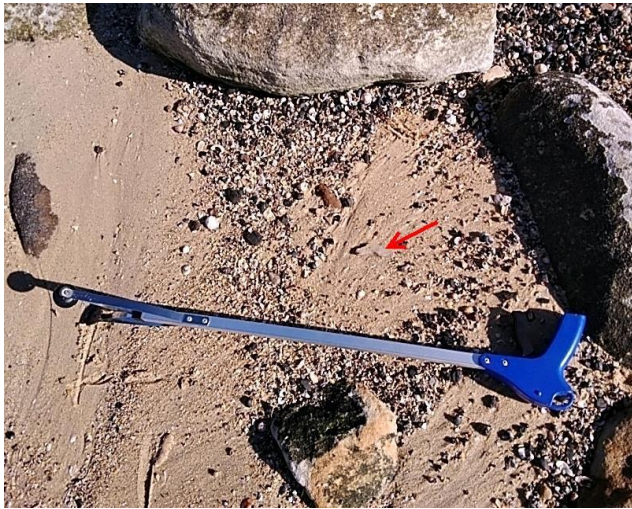
Notes: Overview of removal item within Northern beach prior to removal

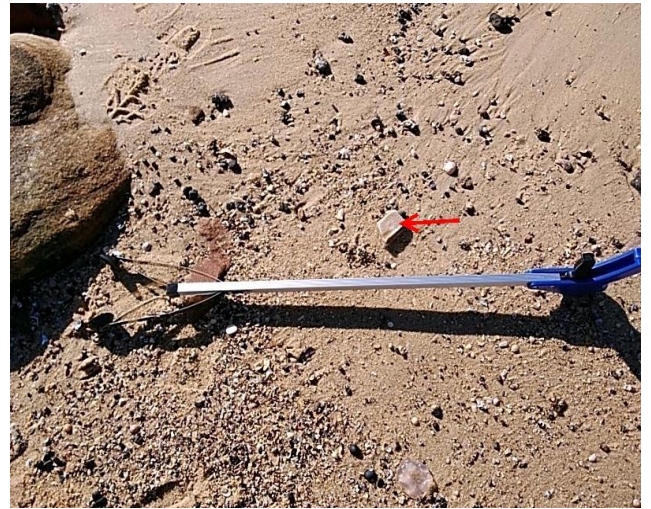
Notes: Overview of removal item within Northern beach prior to removal

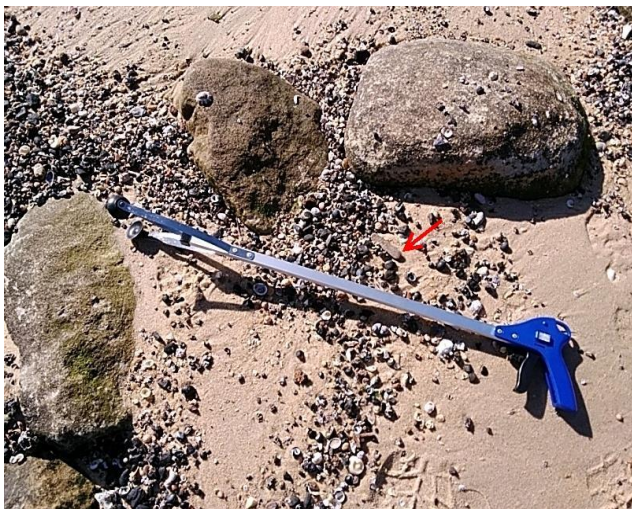
Notes: Overview of removal item within Northern beach prior to removal

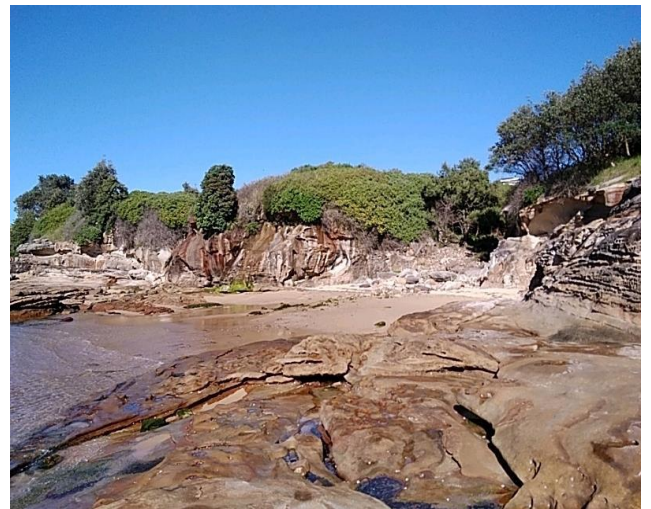
Notes: Overview of Western Beach

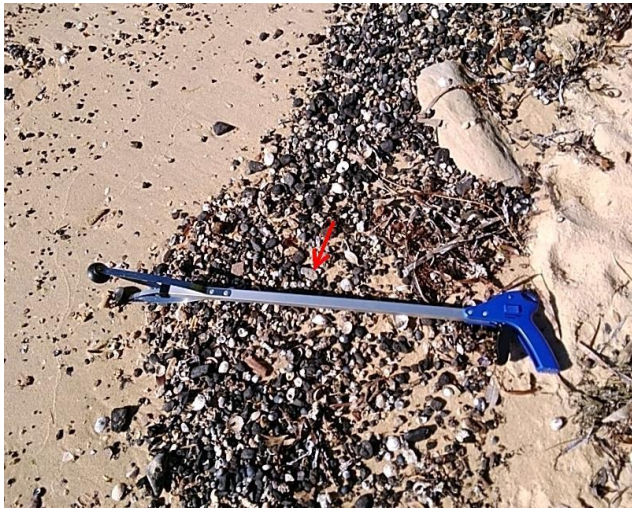
Notes: Overview of removal item within Western beach prior to removal

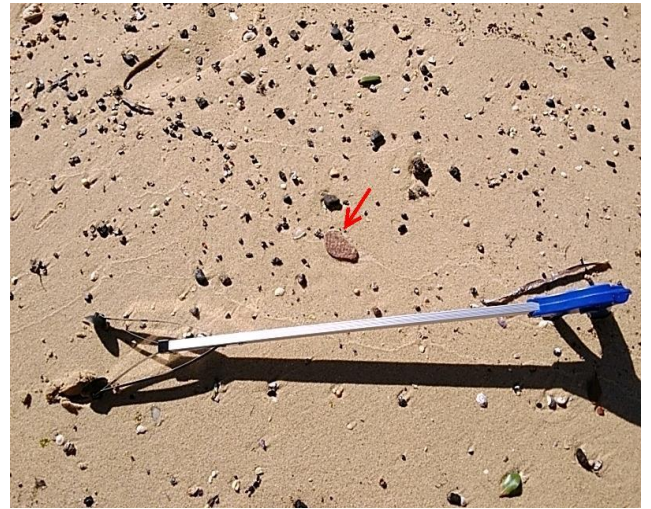
Notes: Overview of removal item within Western beach prior to removal

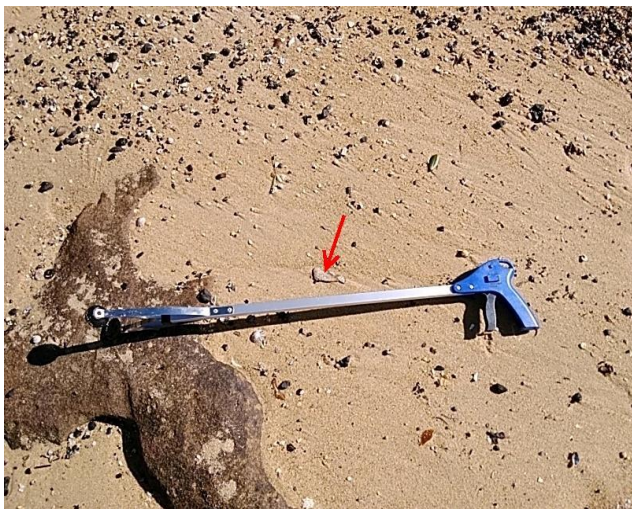
Notes: Overview of removal item within Western beach prior to removal

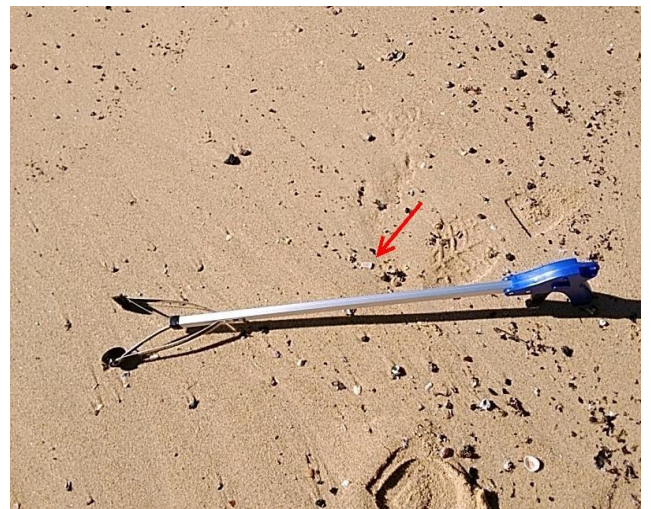
Notes: Overview of removal item within Western beach prior to removal

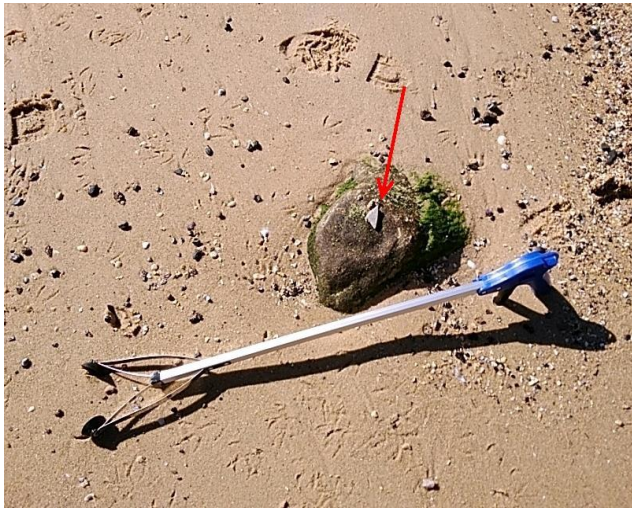
Notes: Overview of removal item within Western beach prior to removal

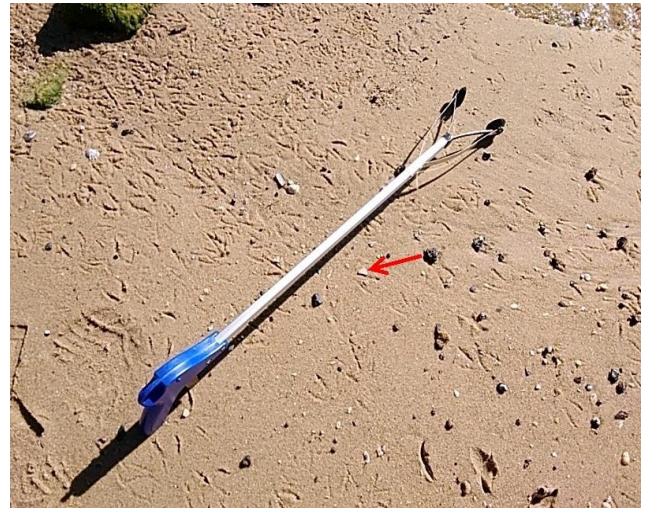
Notes: Overview of removal item within Western beach prior to removal

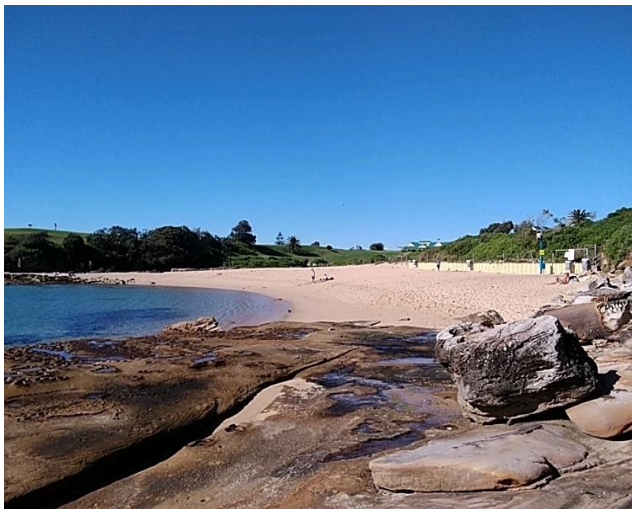
Notes: Overview of Southern Beach

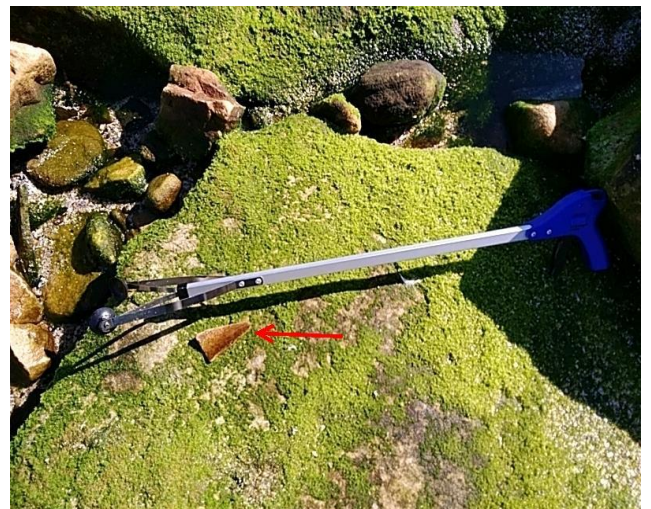
Notes: Overview of removal item within Southern beach prior to removal

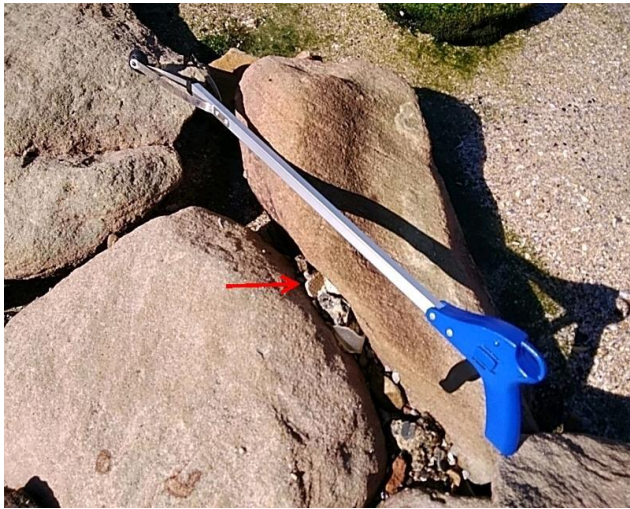
Notes: Overview of removal item within Southern beach prior to removal

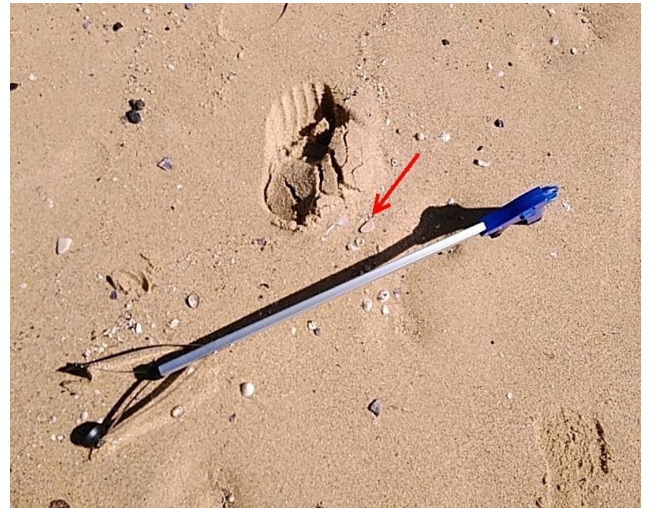
Notes: Overview of removal item within Southern beach prior to removal

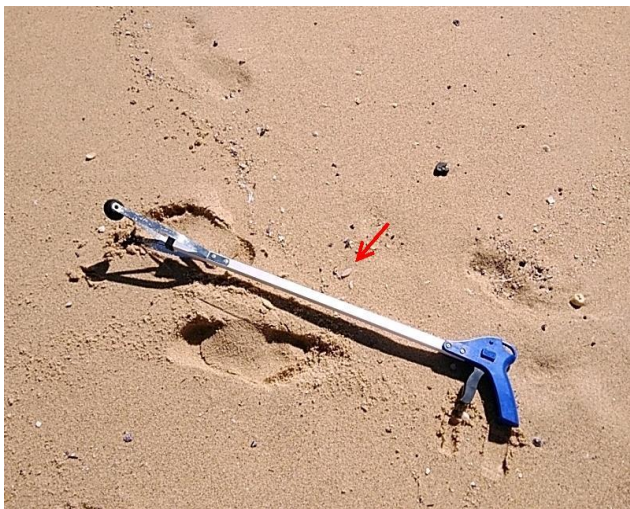
Notes: Overview of removal item within Southern beach prior to removal

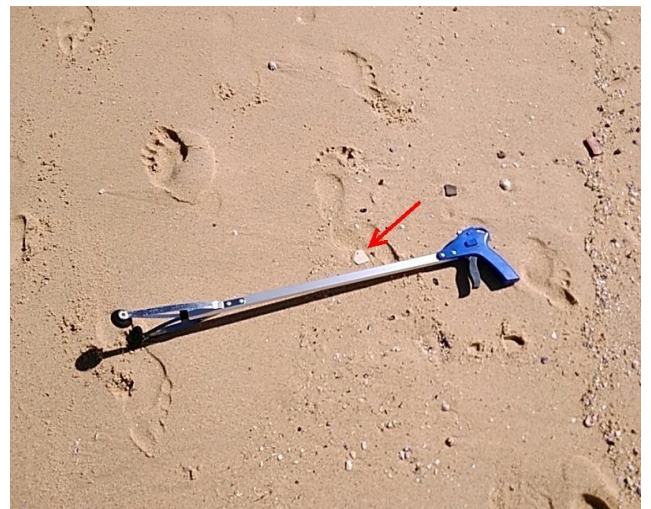
Notes: Overview of removal item within Southern beach prior to removal

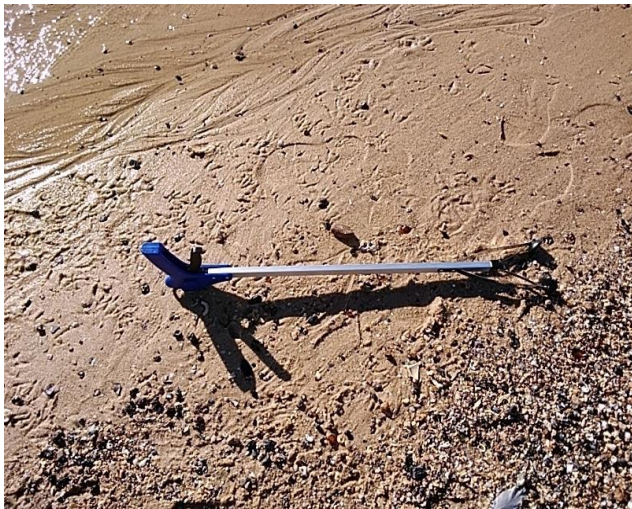
Notes: Visual inspection of removal item following removal

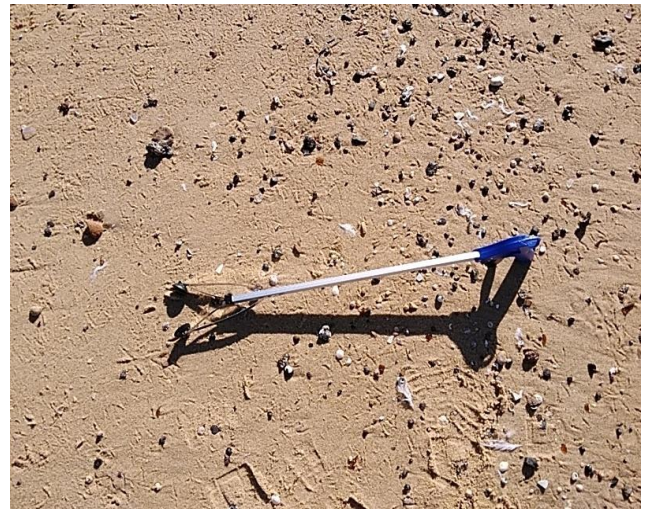
Notes: Visual inspection of removal item following removal

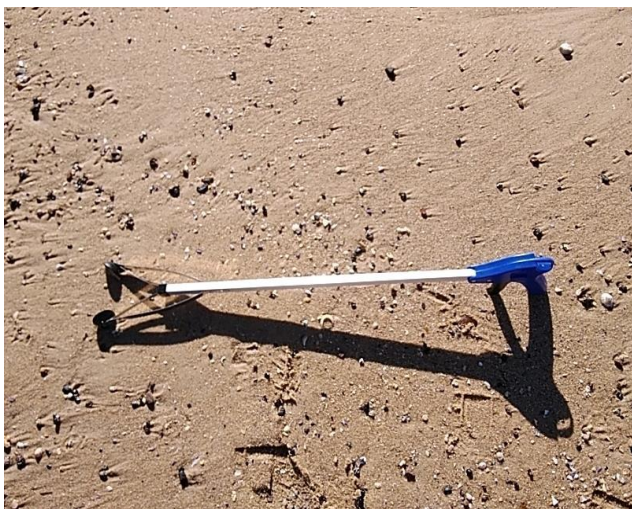
Notes: Visual inspection of removal item following removal

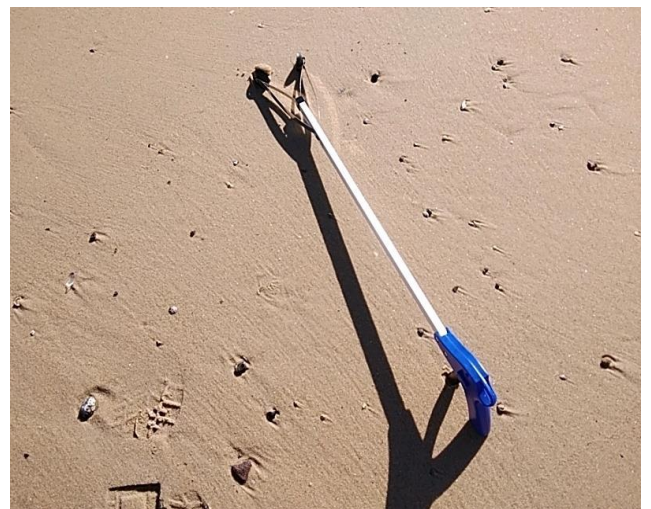
Notes: Visual inspection of removal item following removal

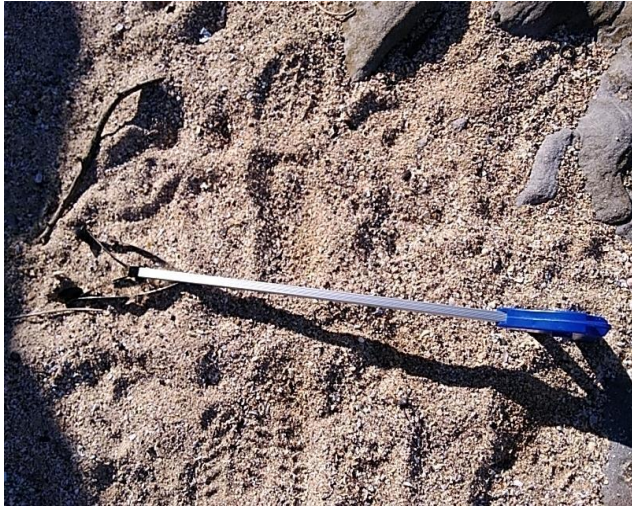
Notes: Visual inspection of removal item following removal

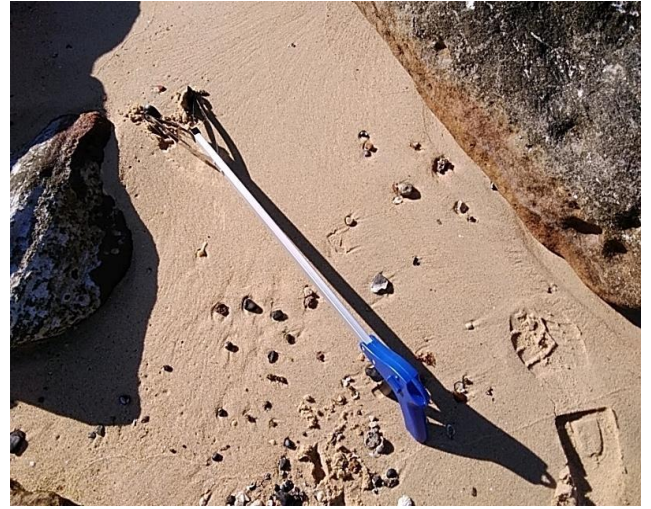
Notes: Visual inspection of removal item following removal

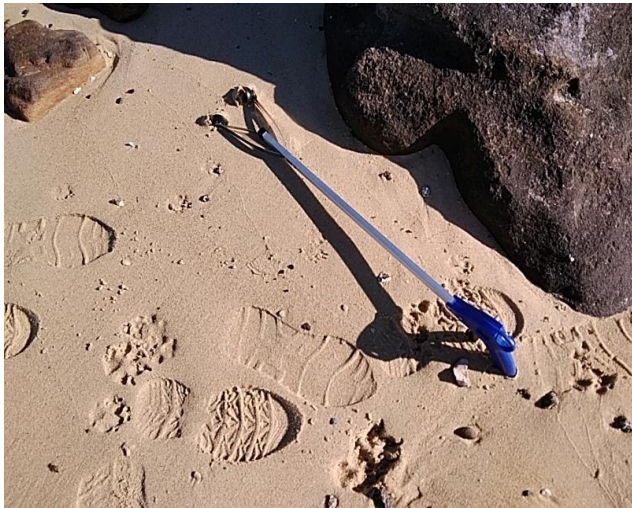
Notes: Visual inspection of removal item following removal

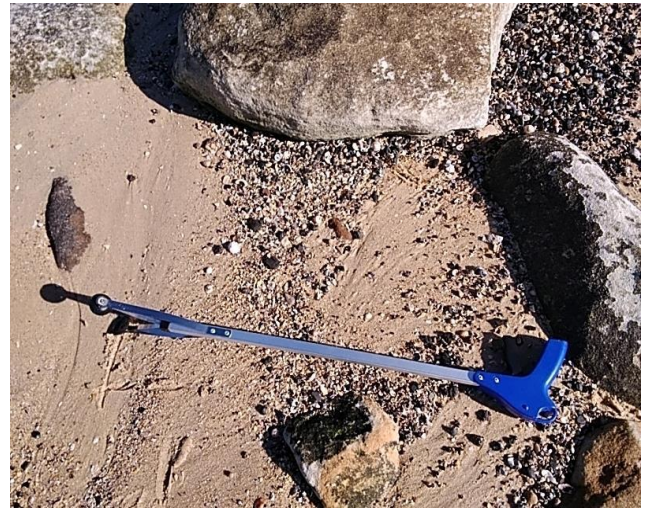
Notes: Visual inspection of removal item following removal

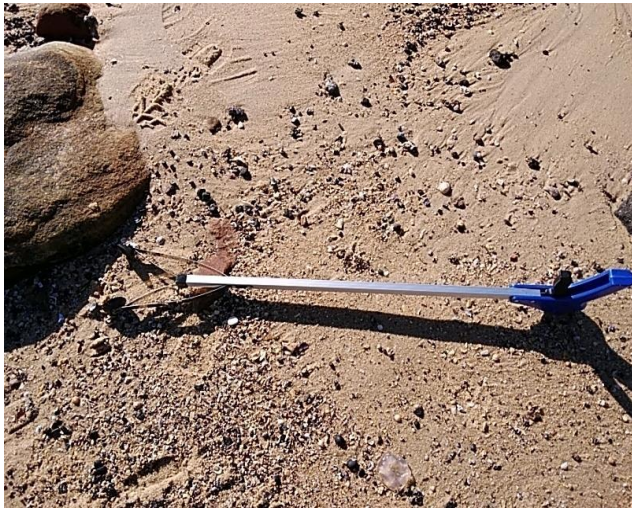
Notes: Visual inspection of removal item following removal

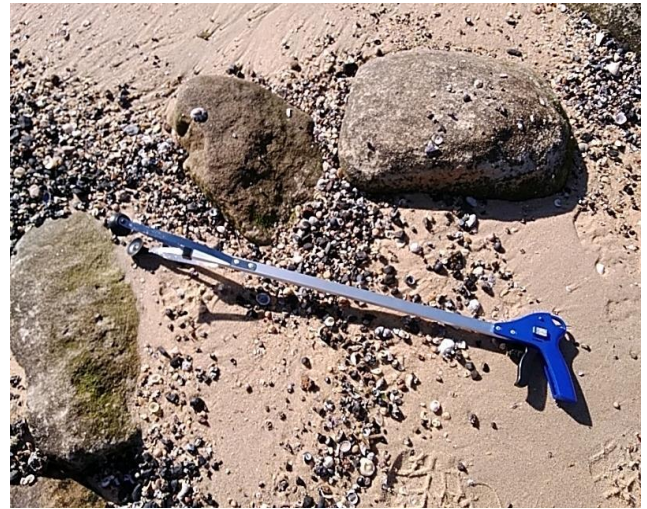
Notes: Visual inspection of removal item following removal

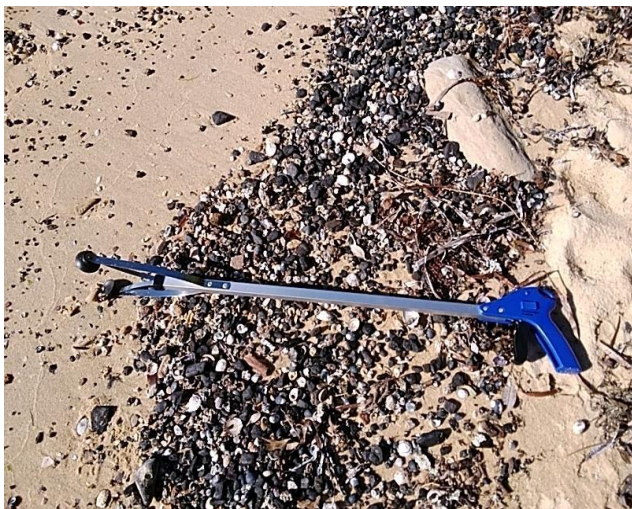
Notes: Visual inspection of removal item following removal

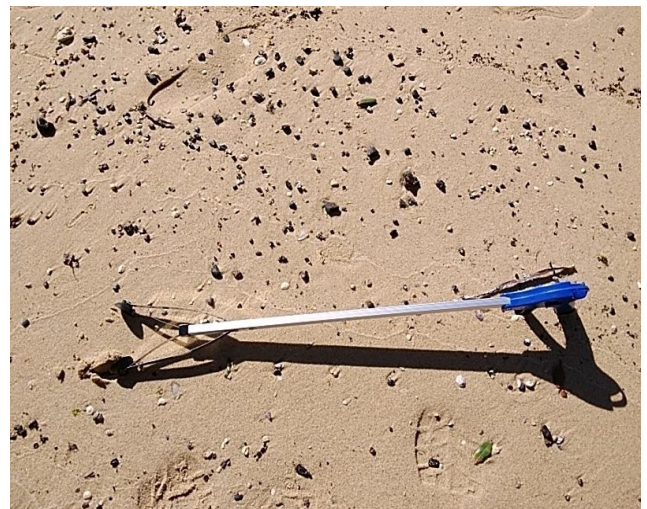
Notes: Visual inspection of removal item following removal

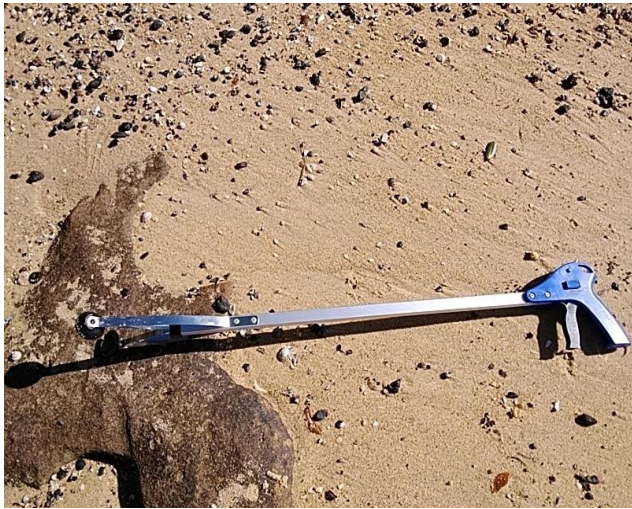
Notes: Visual inspection of removal item following removal

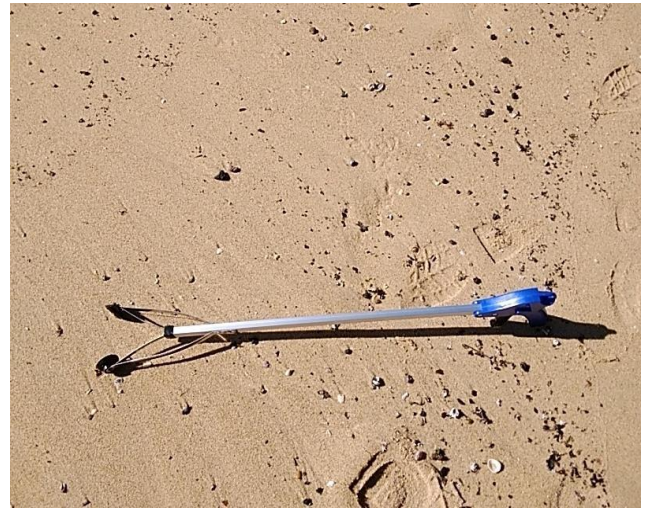
Notes: Visual inspection of removal item following removal

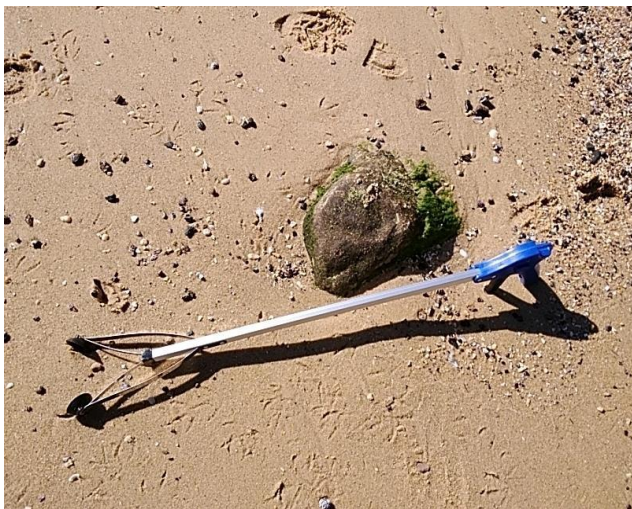
Notes: Visual inspection of removal item following removal

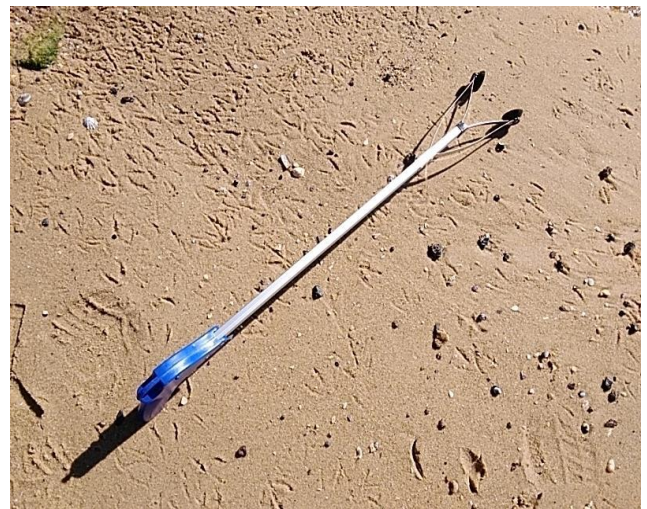
Notes: Visual inspection of removal item following removal

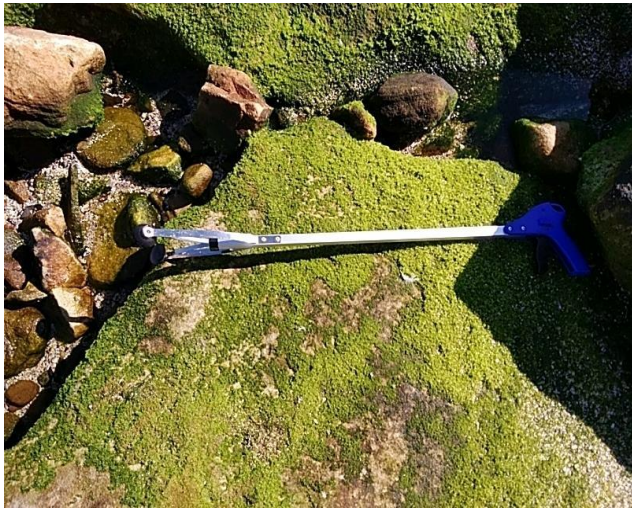
Notes: Visual inspection of removal item following removal

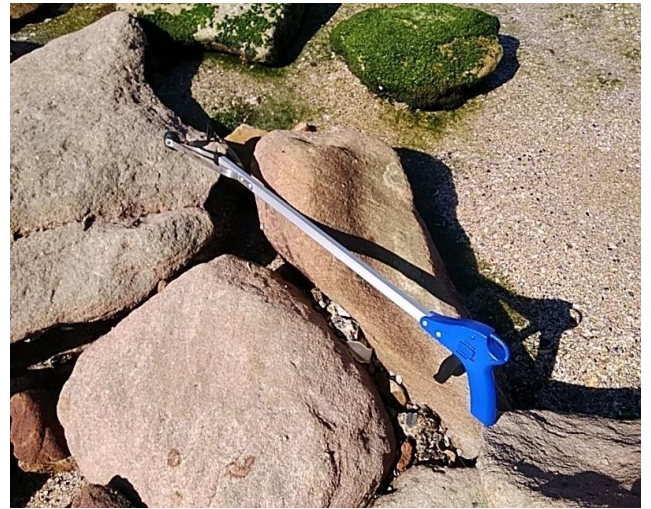
Notes: Visual inspection of removal item following removal

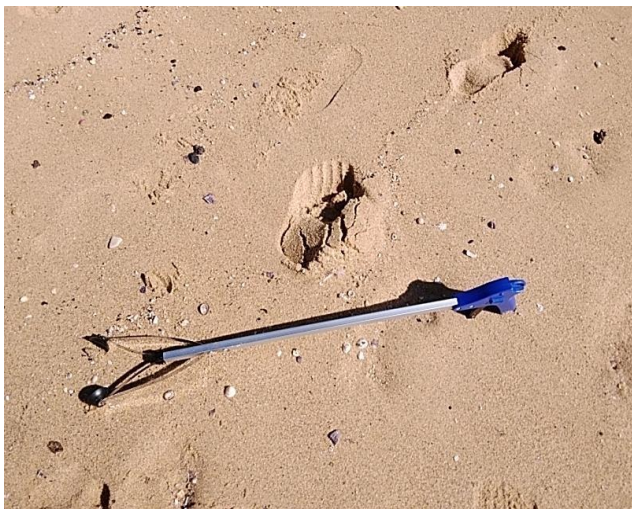
Notes: Visual inspection of removal item following removal

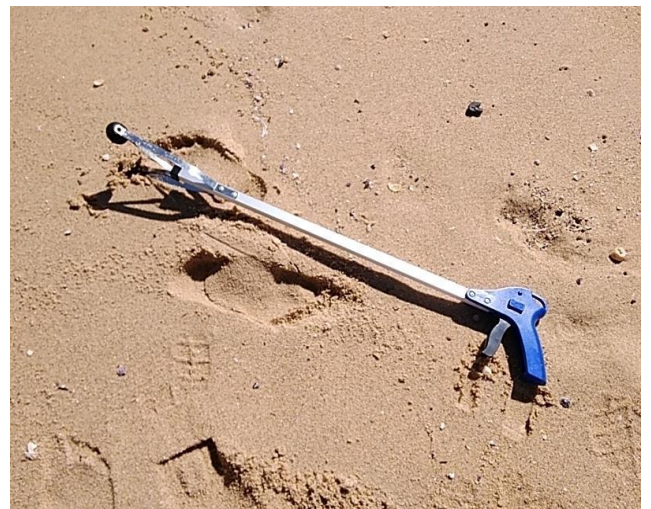
Notes: Visual inspection of removal item following removal

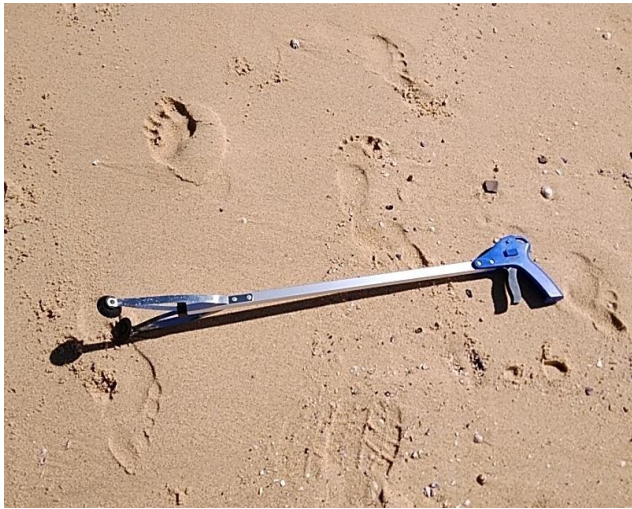
Notes: Visual inspection of removal item following removal

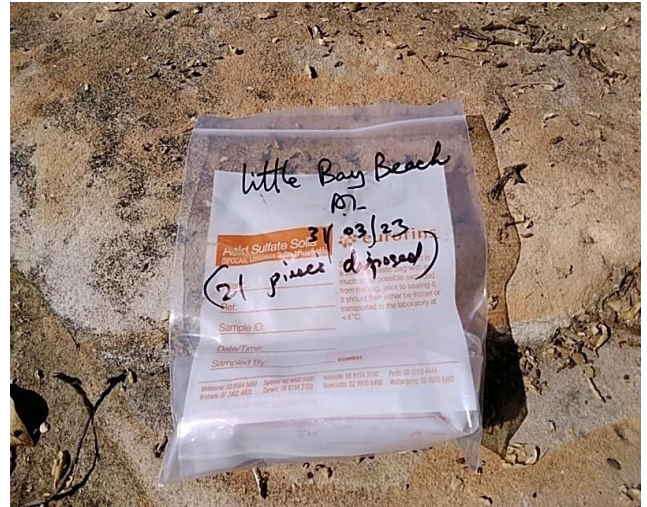
Notes: Waste disposal management
