Asbestos Containing Material Clearance Inspection

13 April 2023

Site:	Little Bay Beach
Location:	Southern, Western and Northern Little Bay Beach

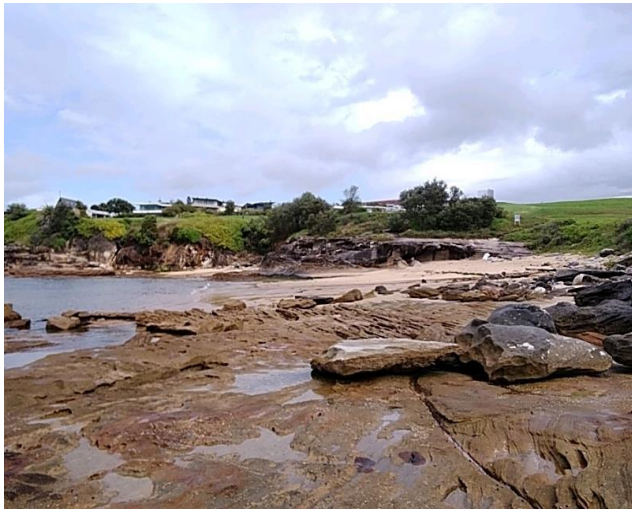
Notes: Overview of the Northern beach

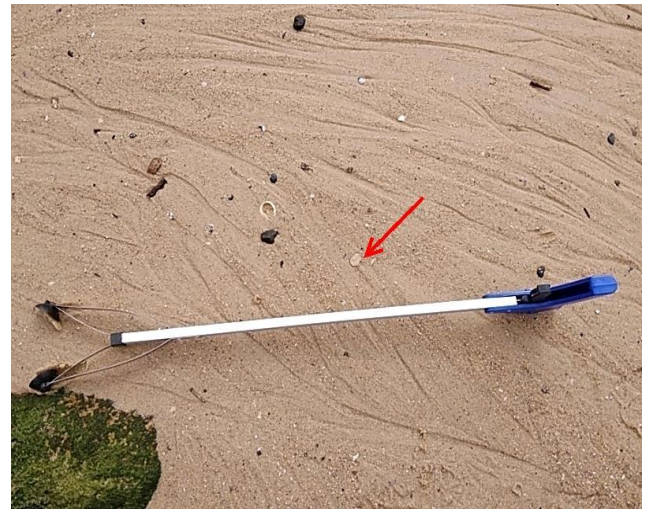
Notes: Overview of removal item within Northern beach prior to removal

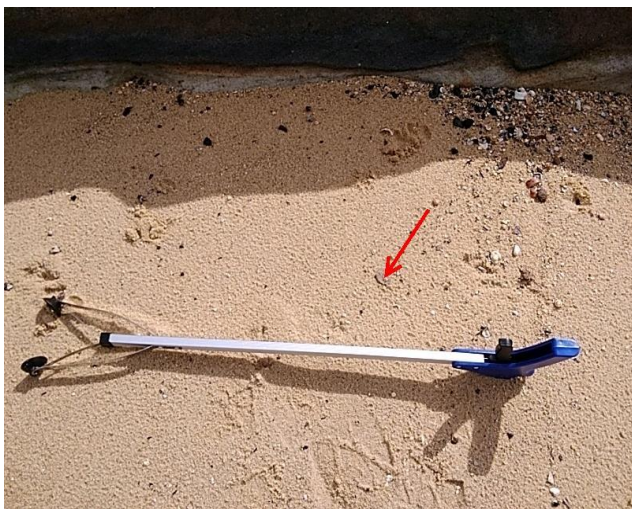
Notes: Overview of removal item within Northern beach prior to removal

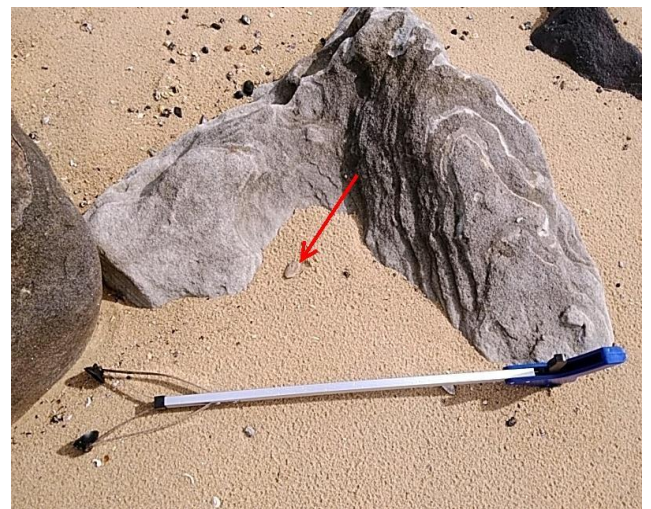
Notes: Overview of removal item within Northern beach prior to removal

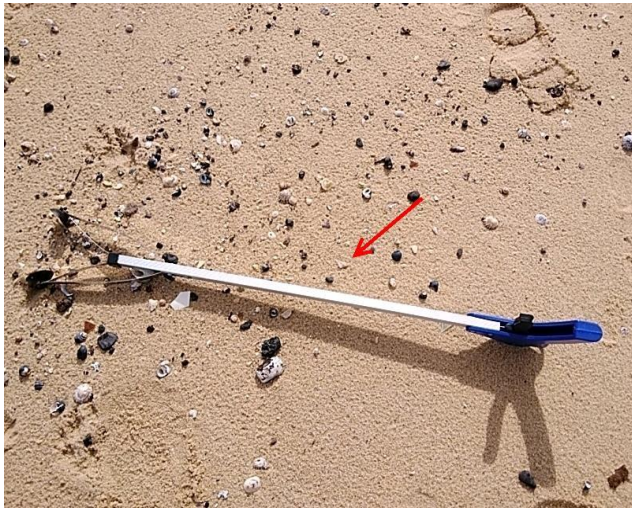
Notes: Overview of removal item within Northern beach prior to removal

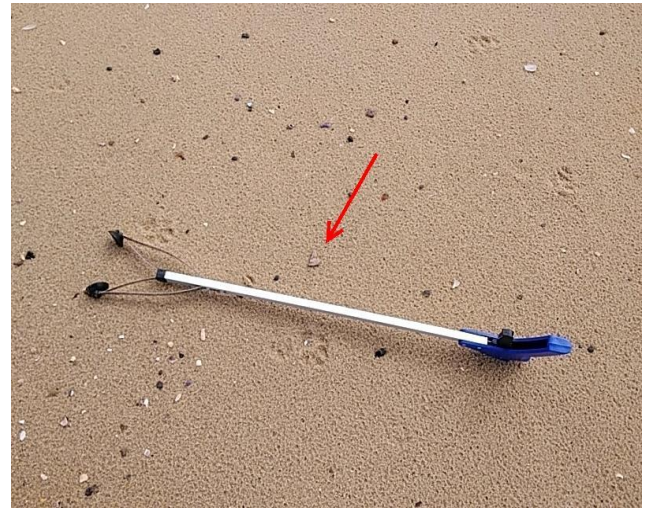
Notes: Overview of removal item within Northern beach prior to removal

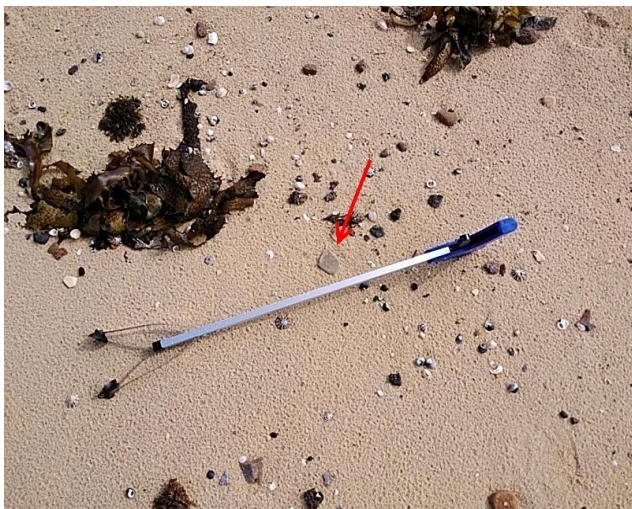
Notes: Overview of removal item within Northern beach prior to removal

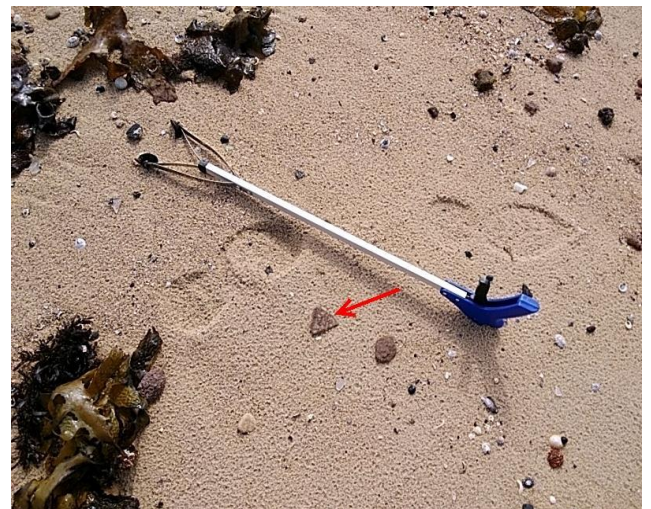
Notes: Overview of removal item within Northern beach prior to removal

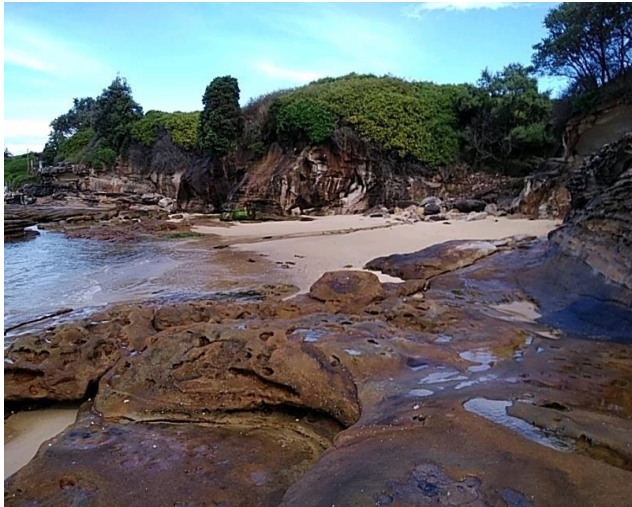
Notes: Overview of the Western beach

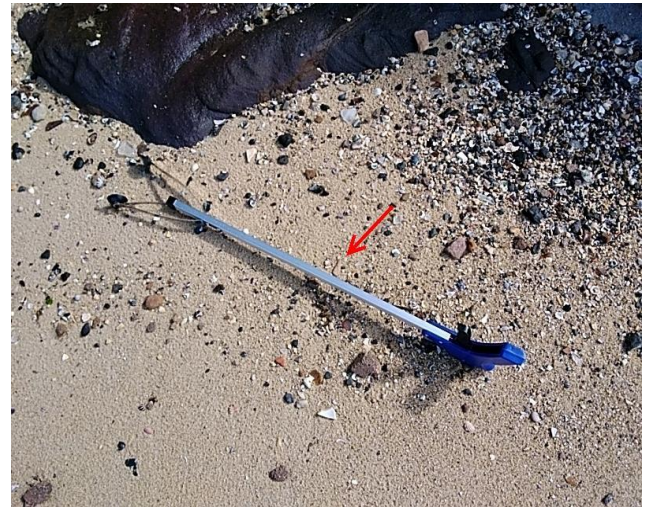
Notes: Overview of removal item within Western beach prior to removal

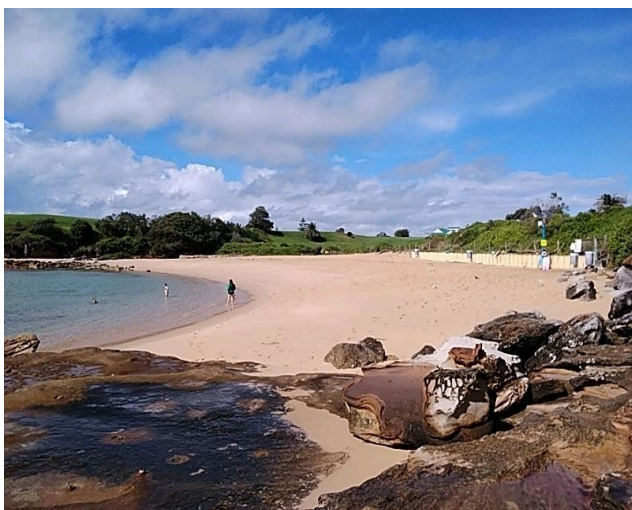
Notes: Overview of the Southern beach

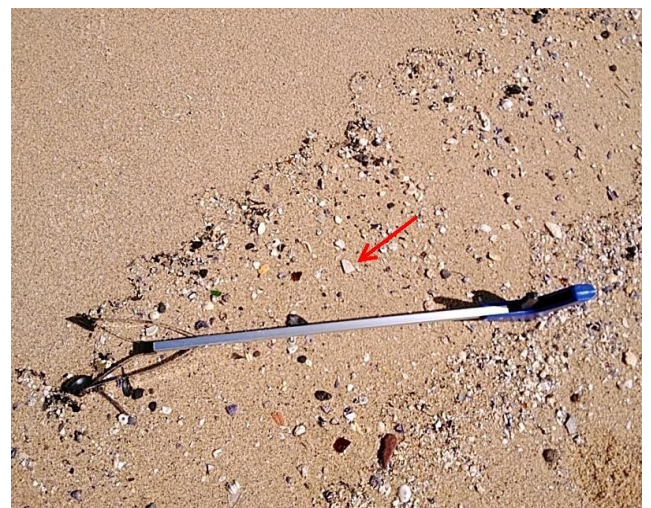
Notes: Overview of removal item within Southern beach prior to removal

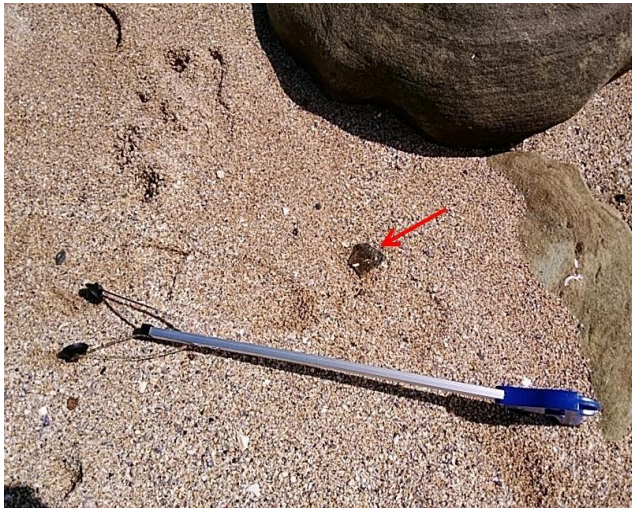
Notes: Overview of removal item within Southern beach prior to removal

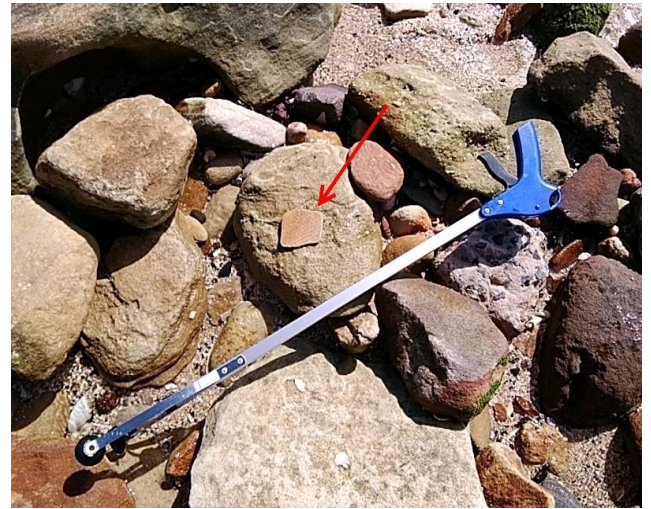
Notes: Overview of removal item within Southern beach prior to removal

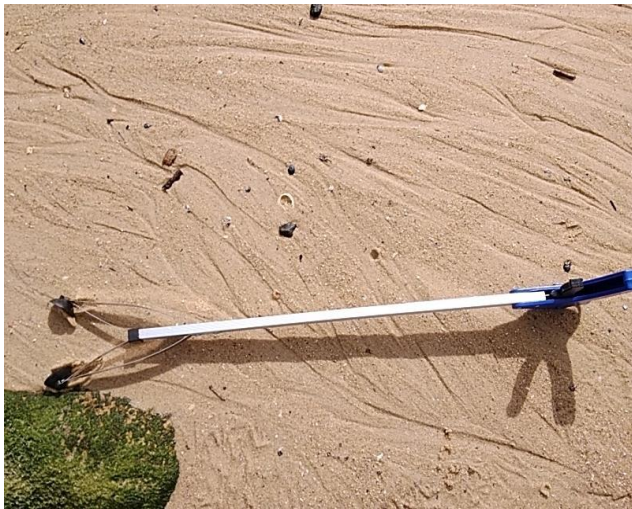
Notes: Visual inspection of removal item following removal

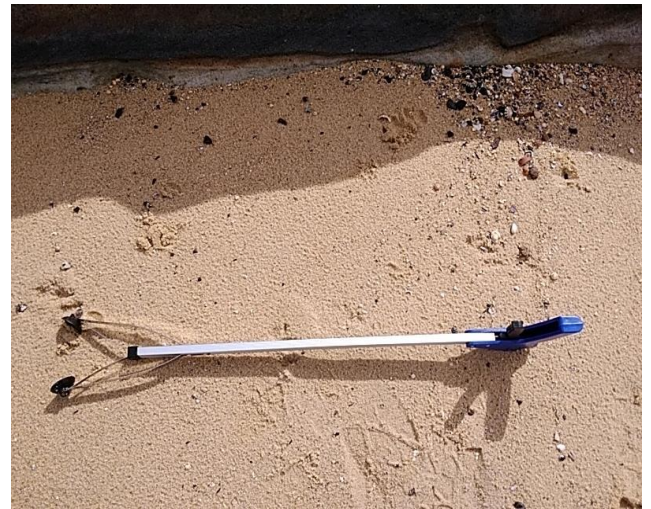
Notes: Visual inspection of removal item following removal

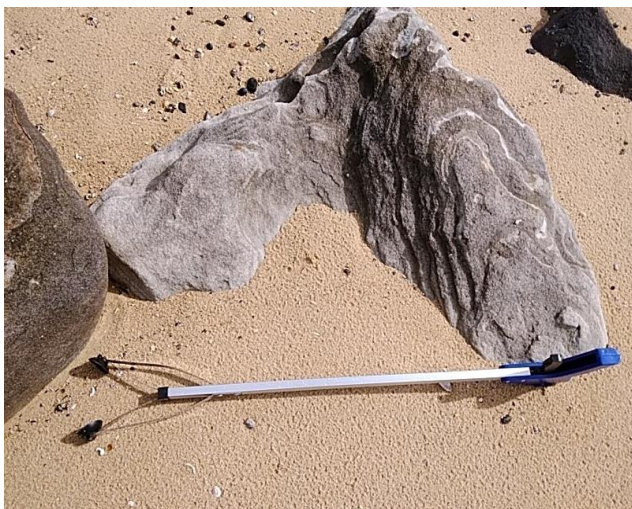
Notes: Visual inspection of removal item following removal

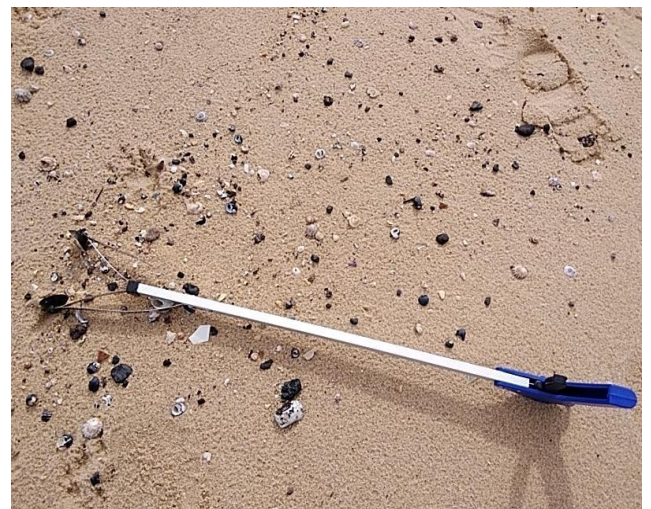
Notes: Visual inspection of removal item following removal

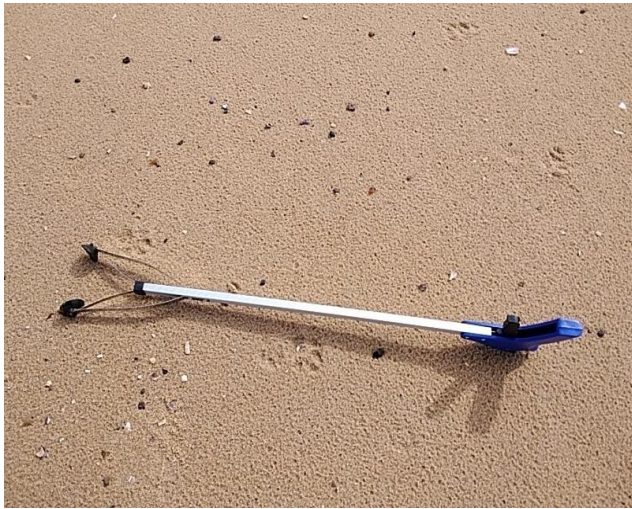
Notes: Visual inspection of removal item following removal

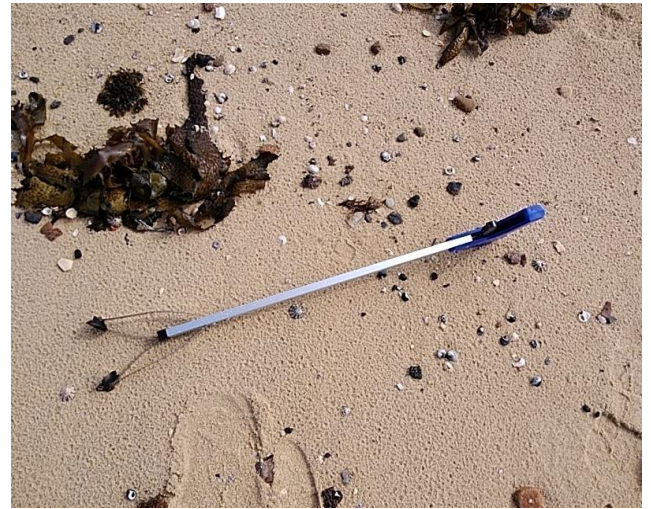
Notes: Visual inspection of removal item following removal

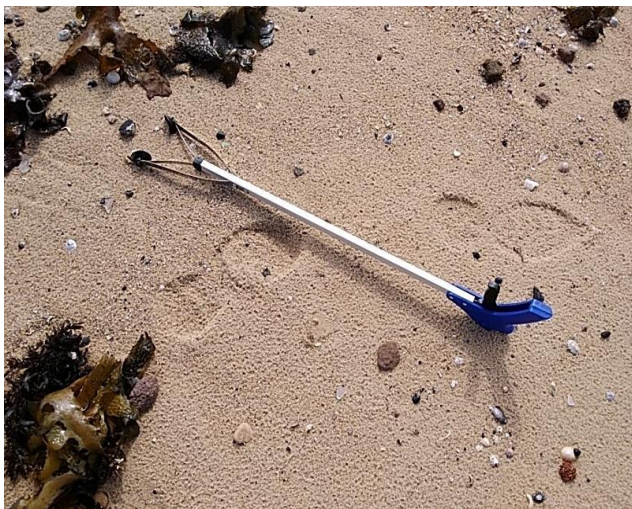
Notes: Visual inspection of removal item following removal

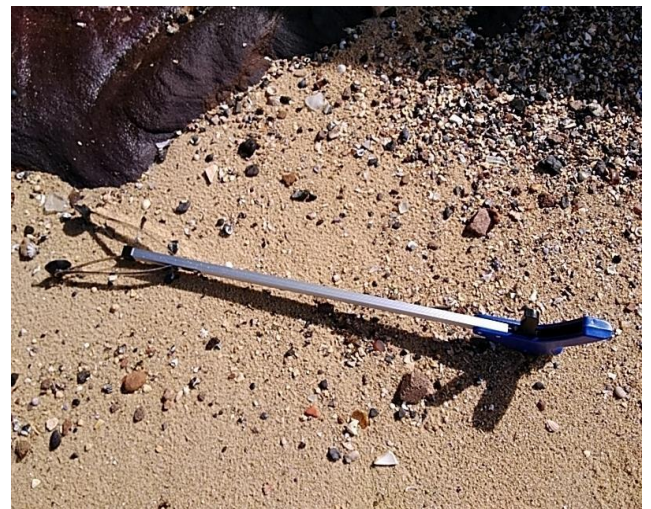
Notes: Visual inspection of removal item following removal

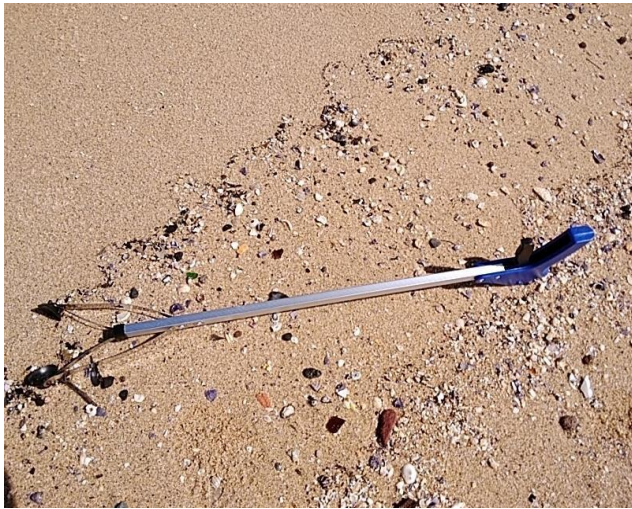
Notes: Visual inspection of removal item following removal

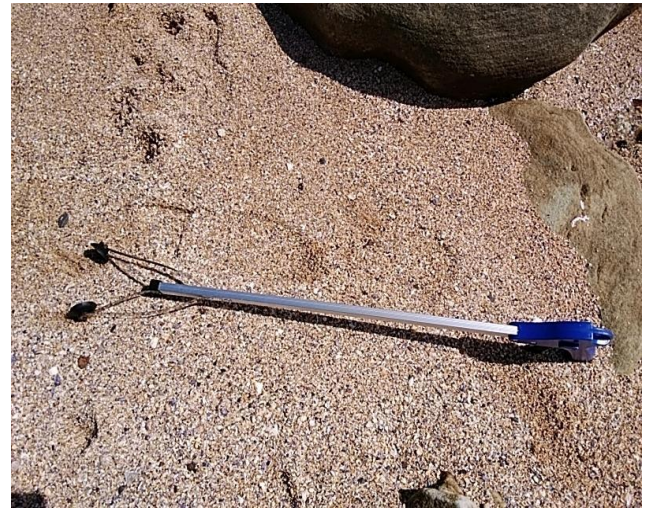
Notes: Visual inspection of removal item following removal

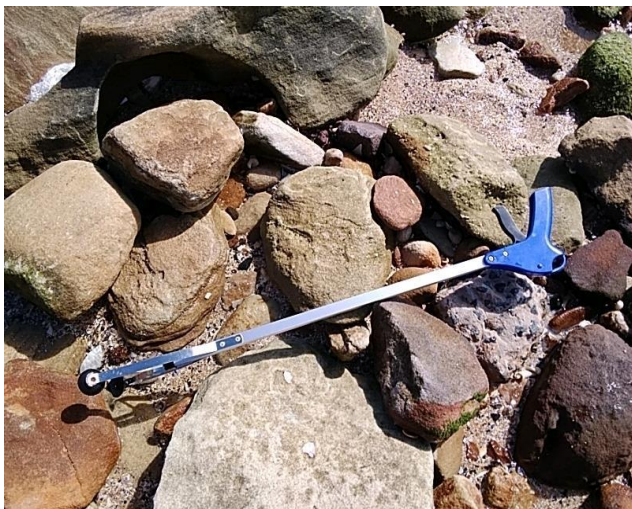
Notes: Visual inspection of removal item following removal

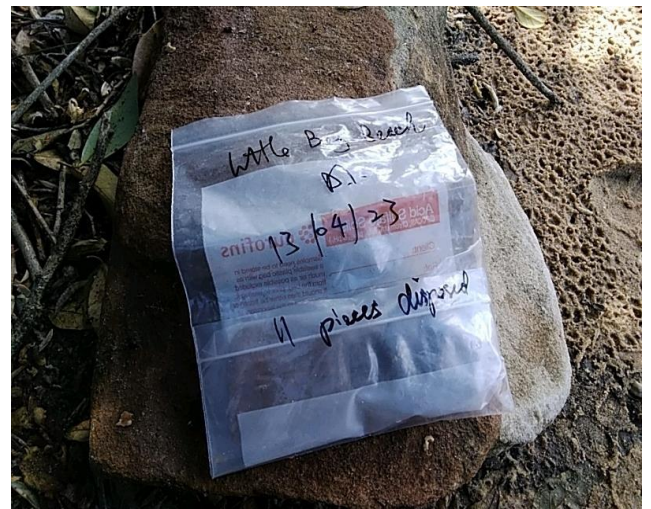
Notes: Waste disposal management (disposed of 11 pieces)
