Asbestos Containing Material Clearance Inspection

1 May 2023

Site:	Little Bay Beach
Location:	Southern, Western and Northern Little Bay Beach

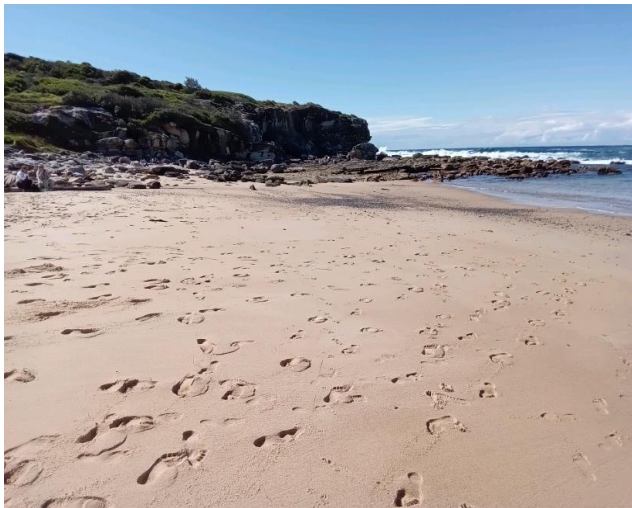
Notes: Overview of Northern Beach.

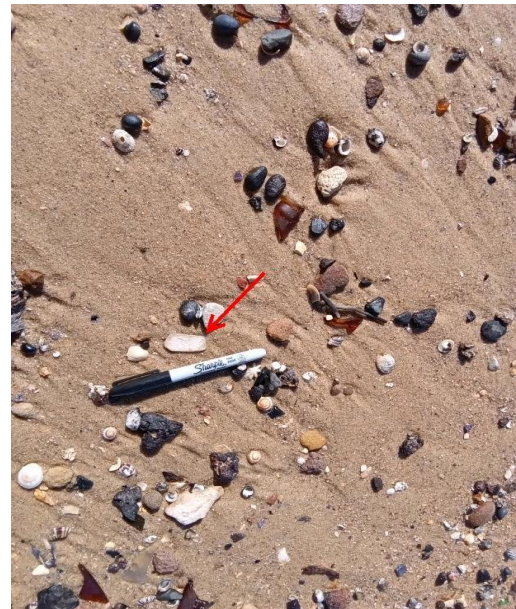
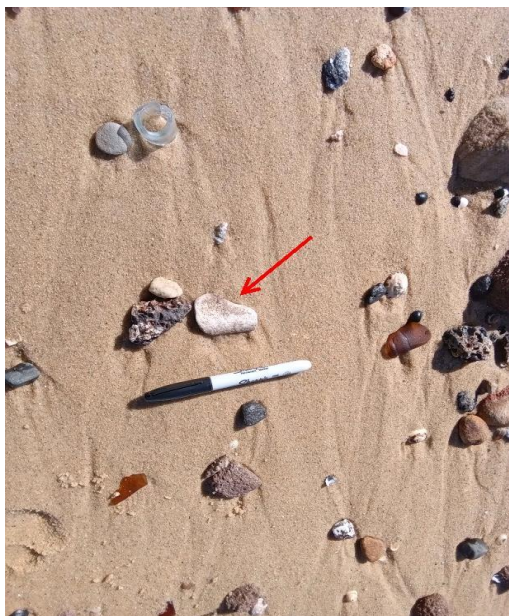
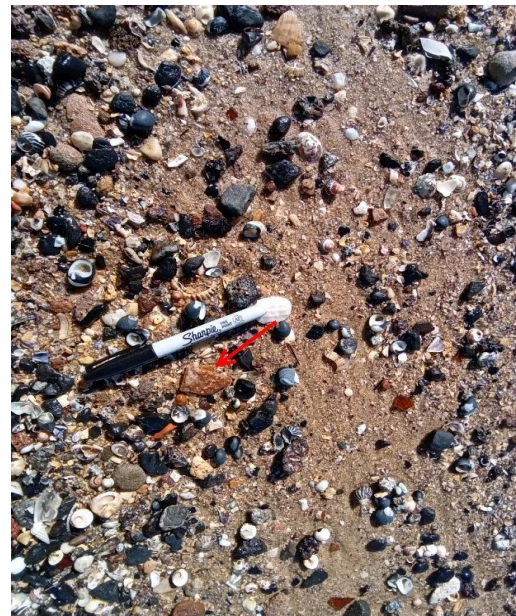
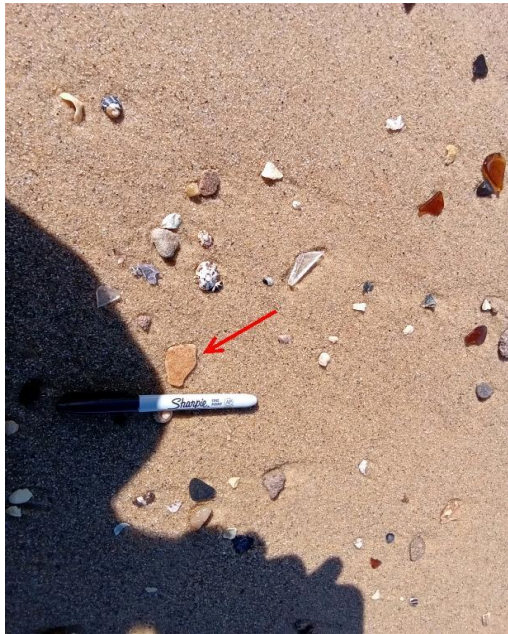
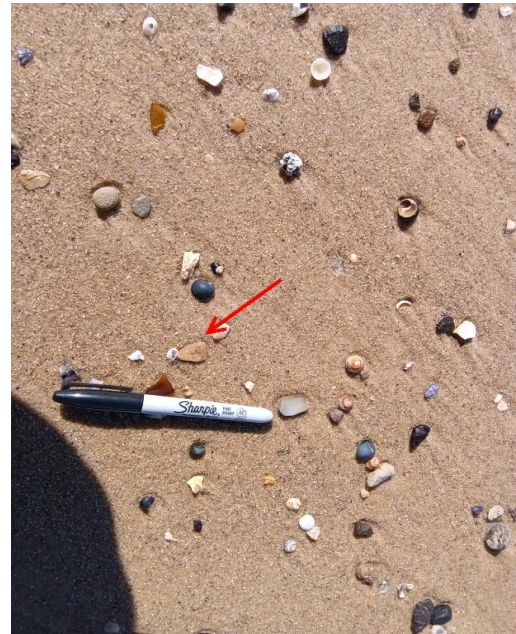
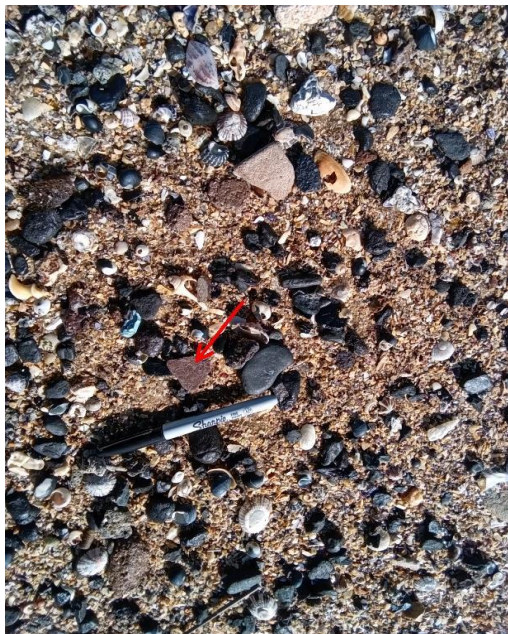
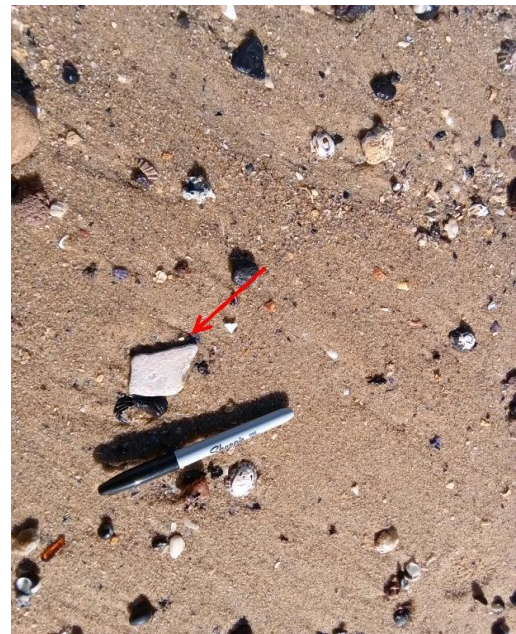
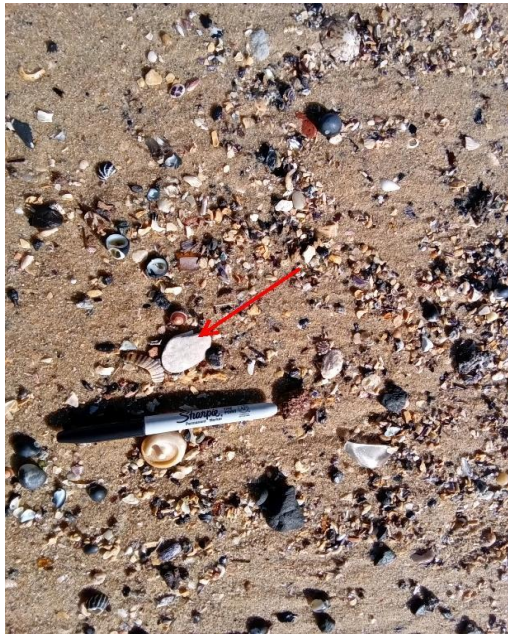
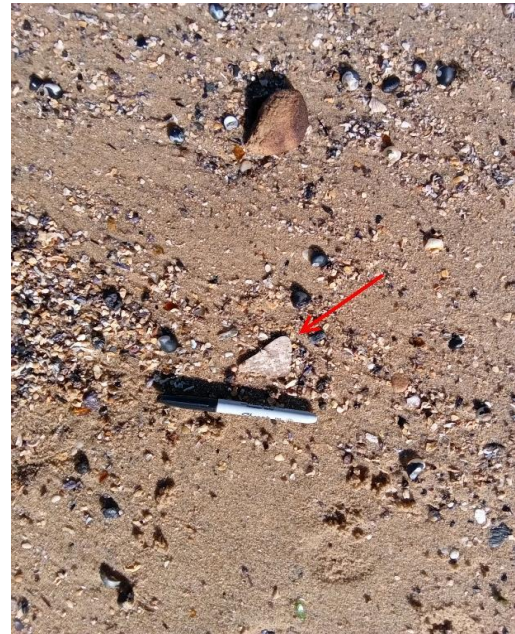
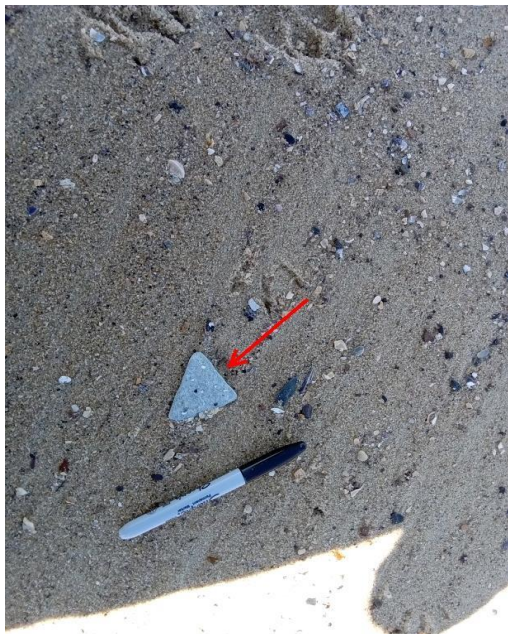
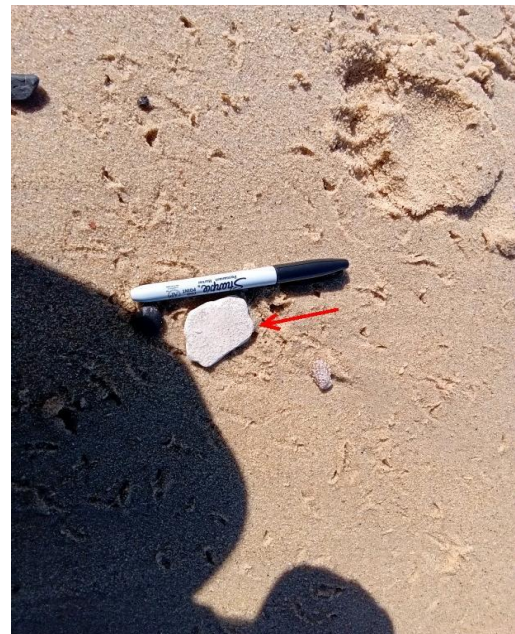
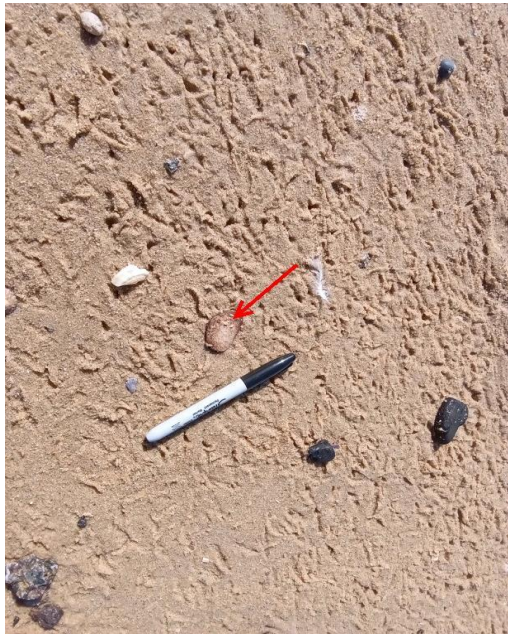
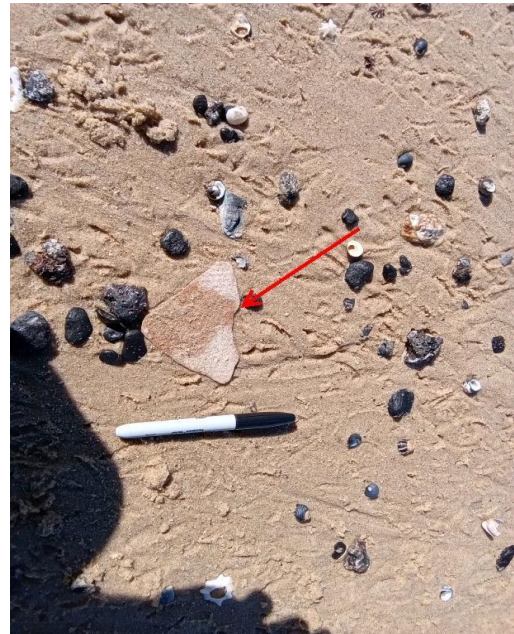
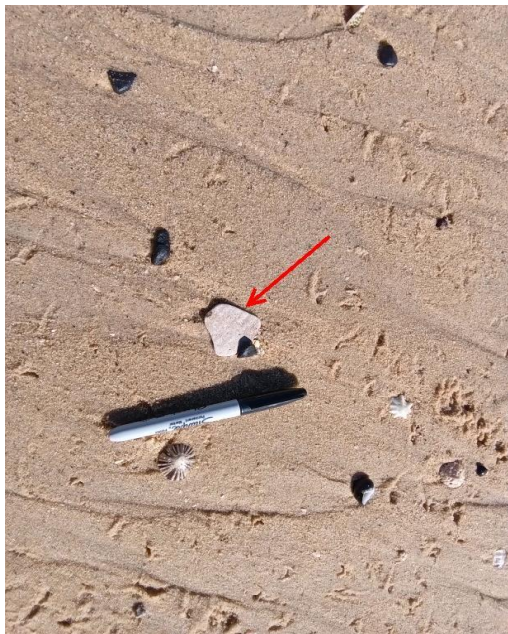
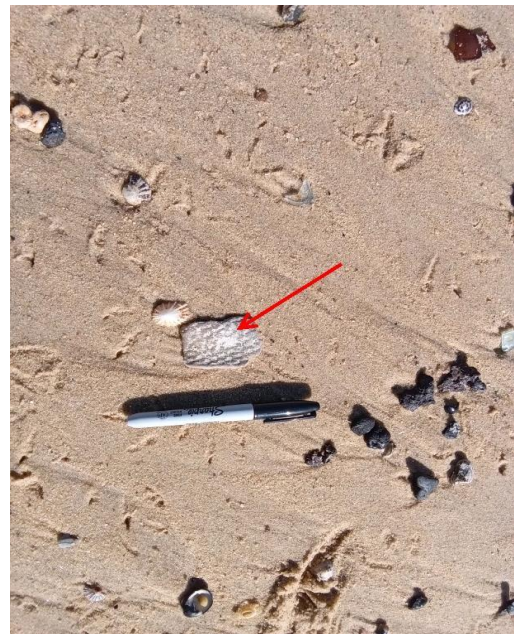
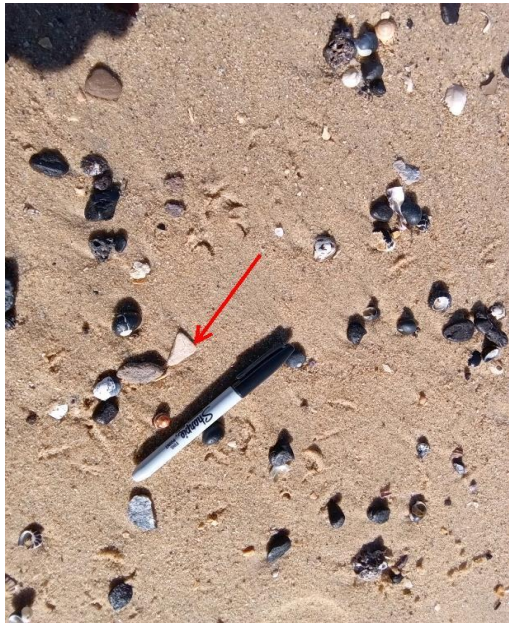
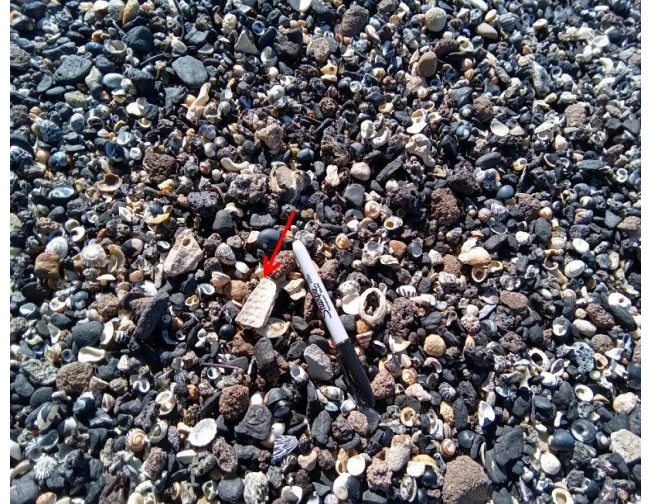
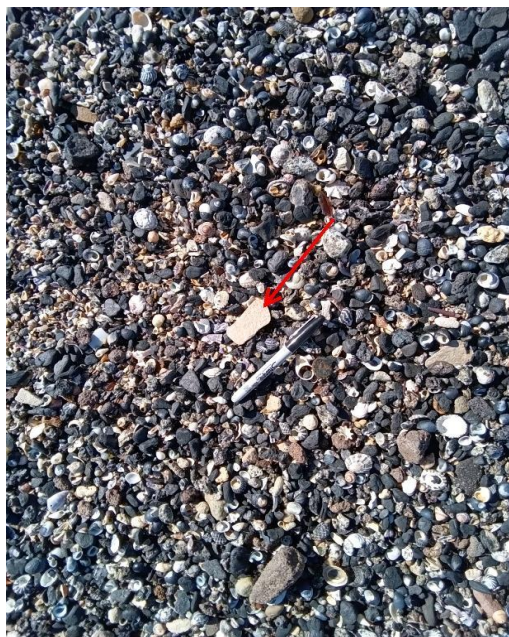
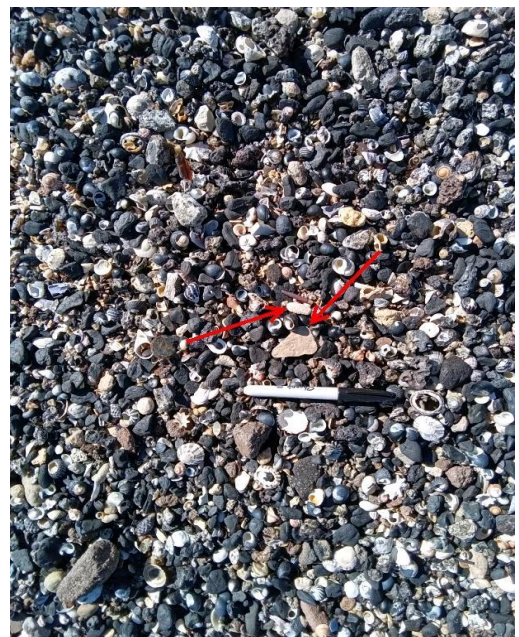
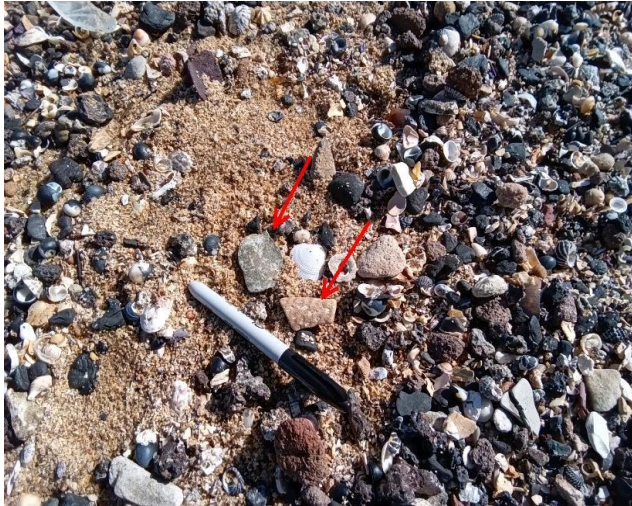
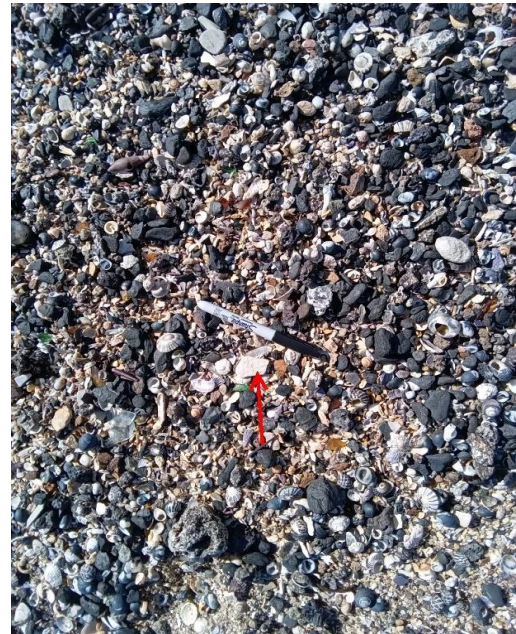
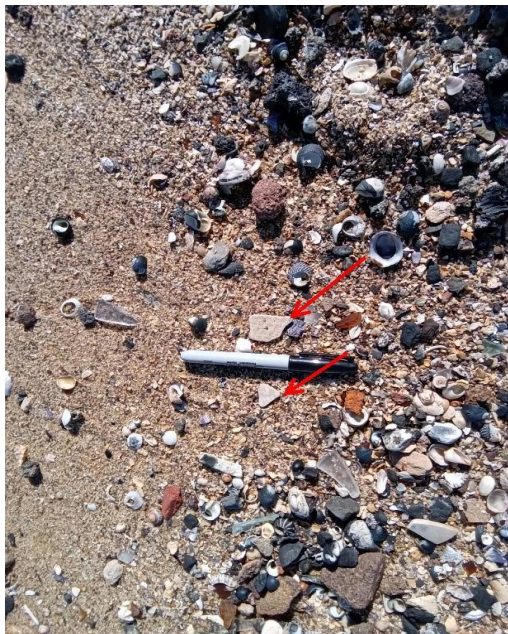
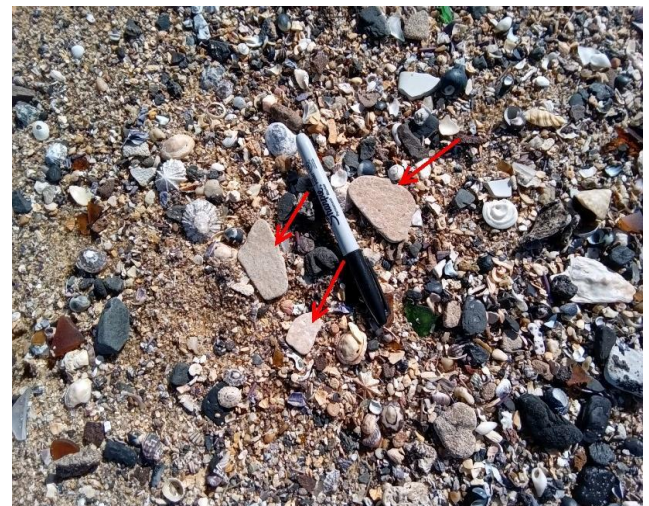
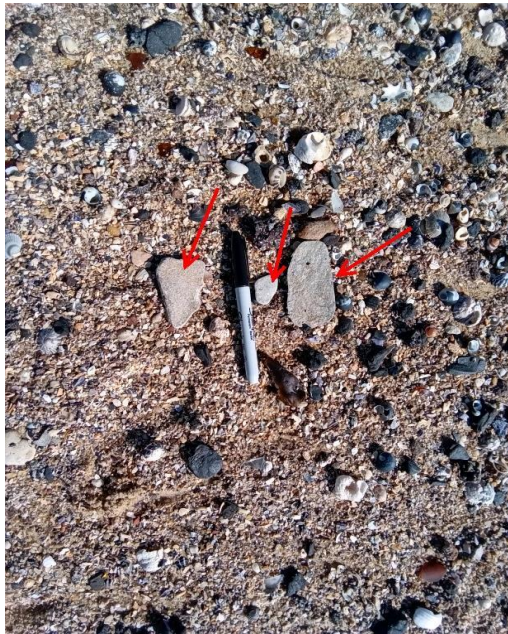
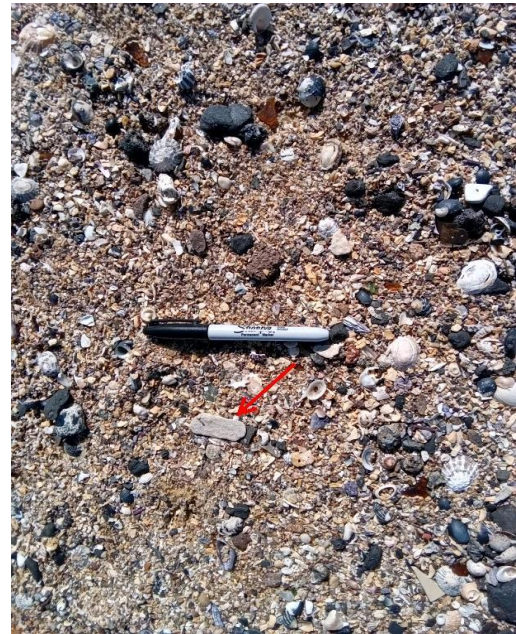
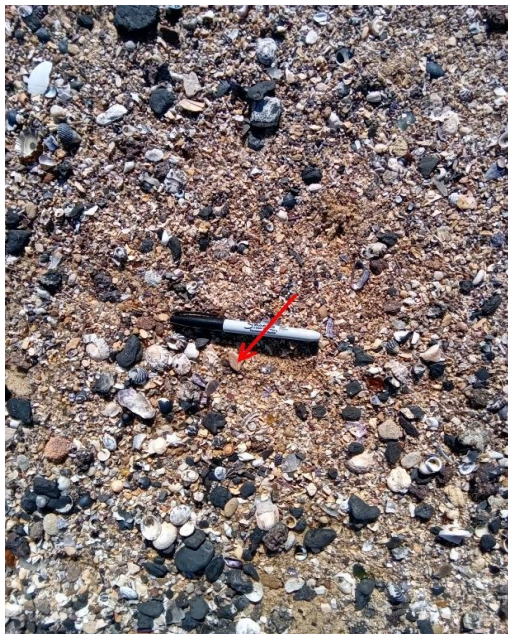
Notes: Overview of the FC fragment within Northern Beach prior to the removal.

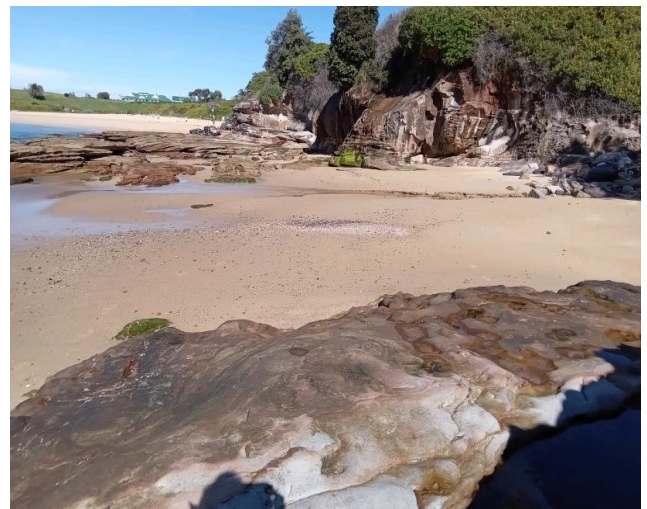
Notes: Overview of the Western Beach.

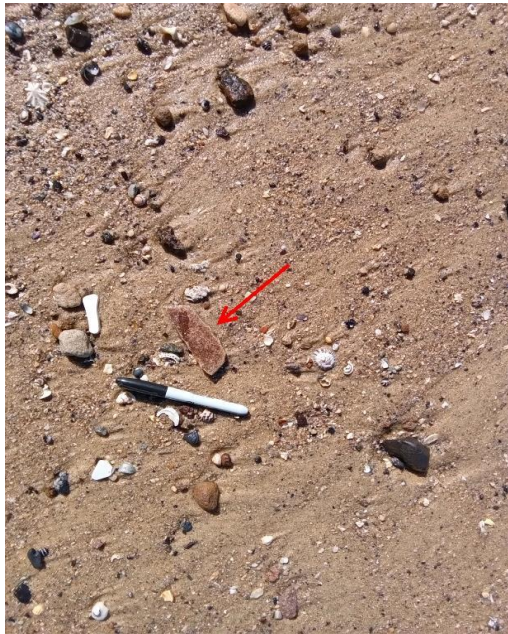
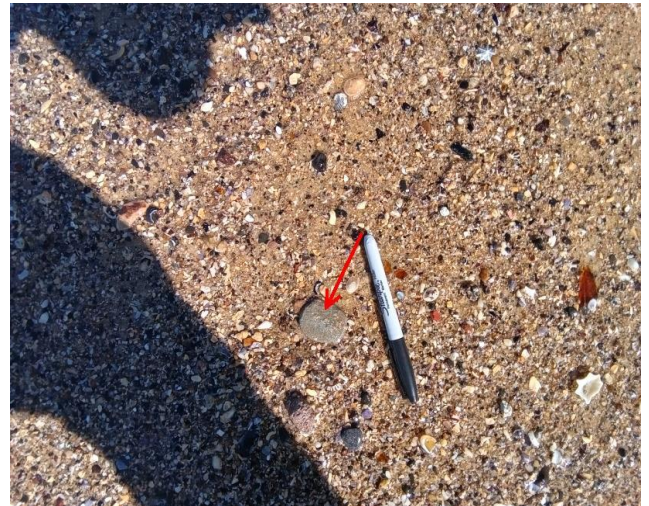
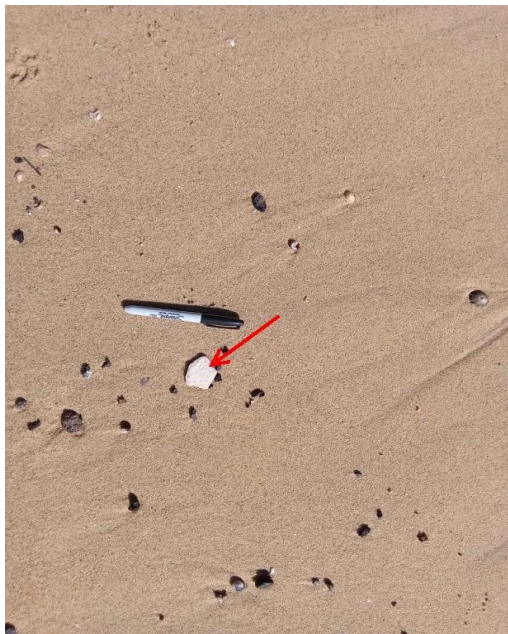
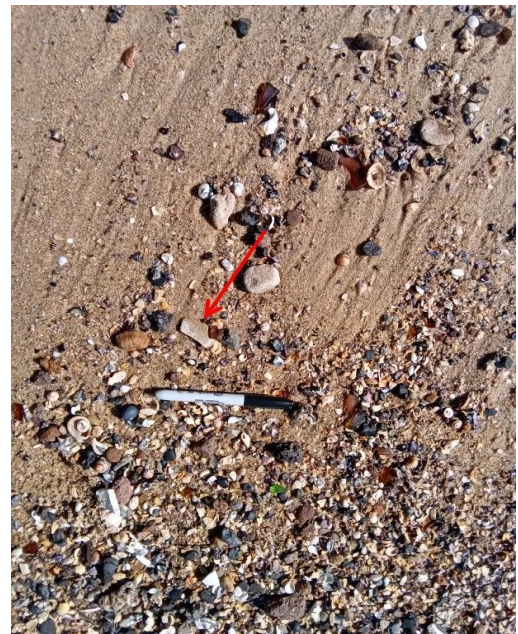
Notes: Overview of the FC fragment within Western Beach prior to the removal.

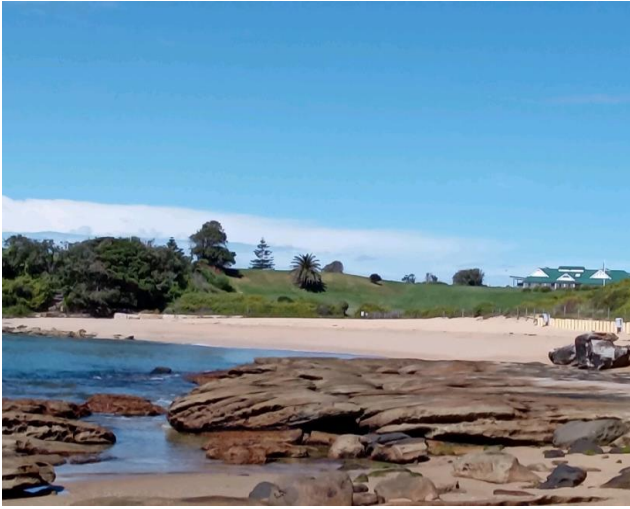
Notes: Overview of the Southern Beach, Access Closed.

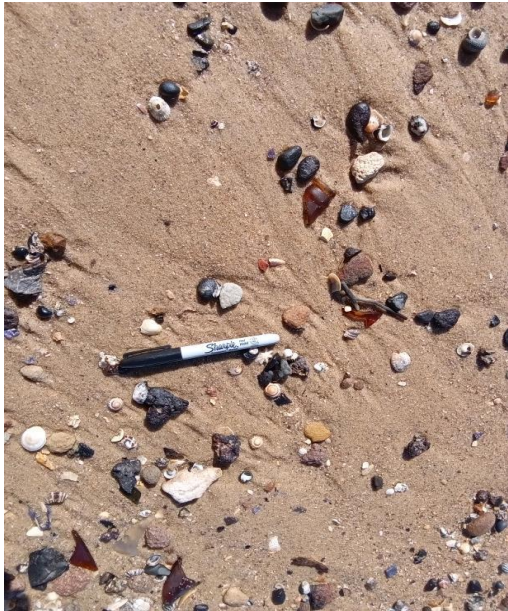
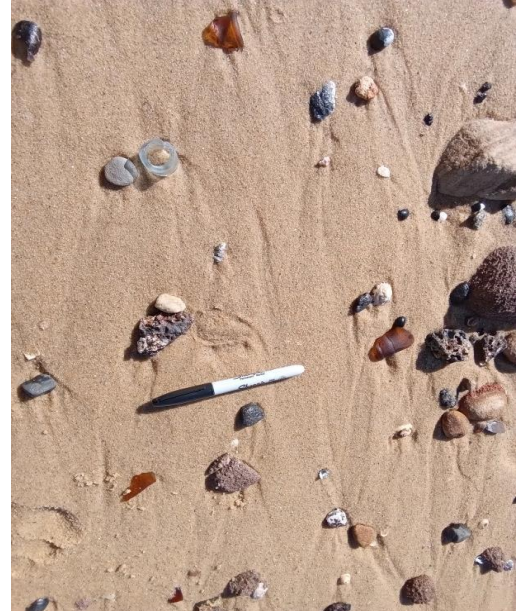
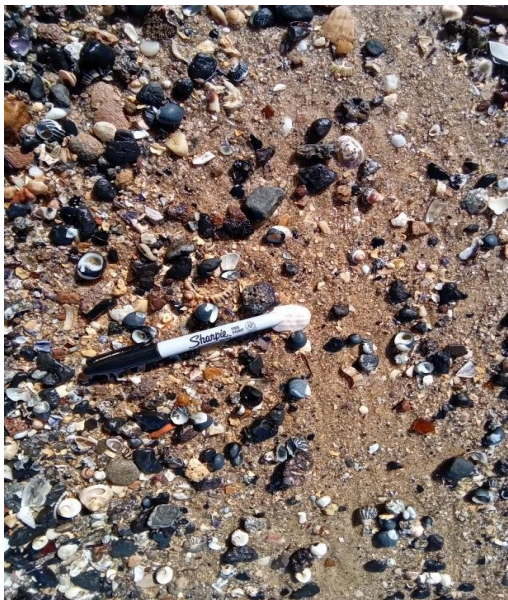
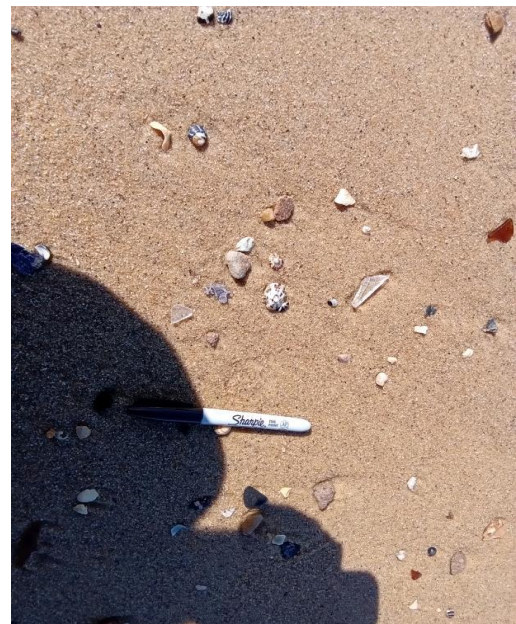
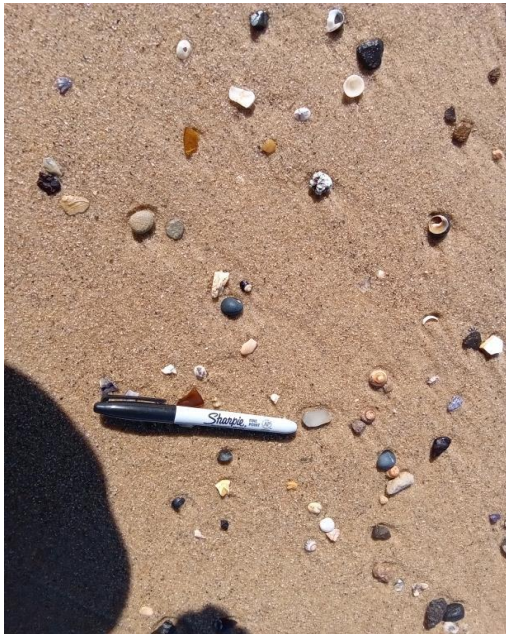
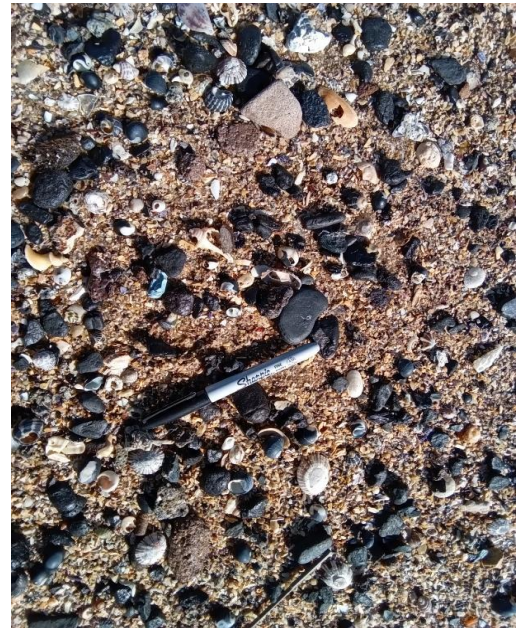
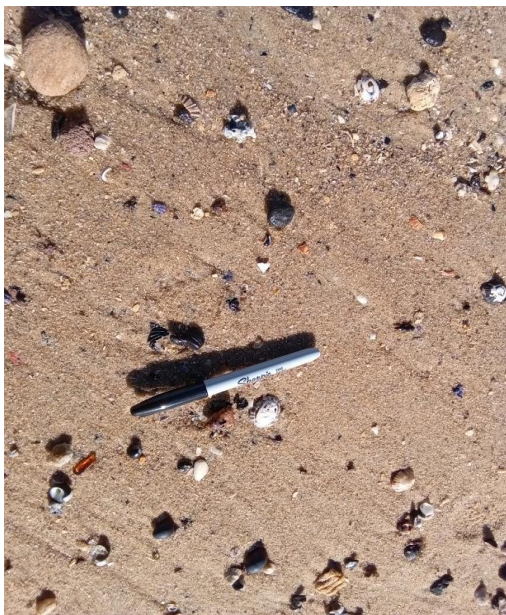
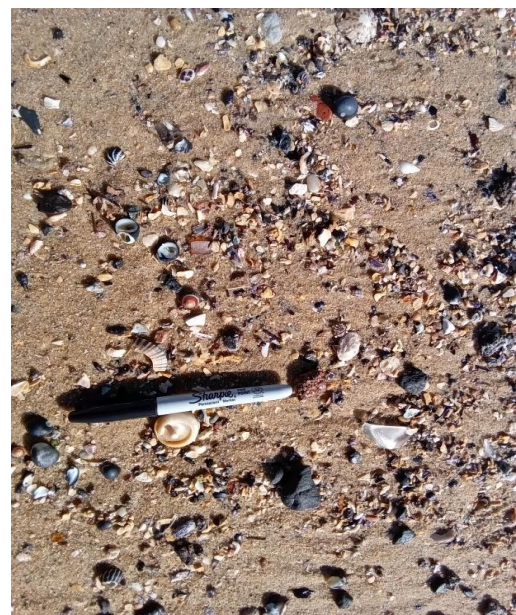
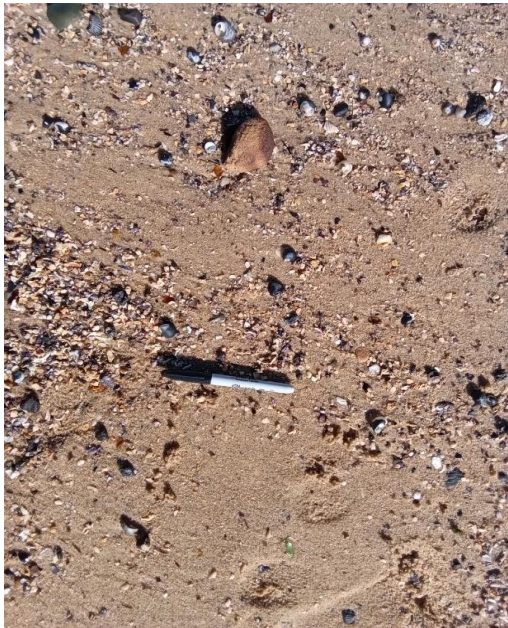
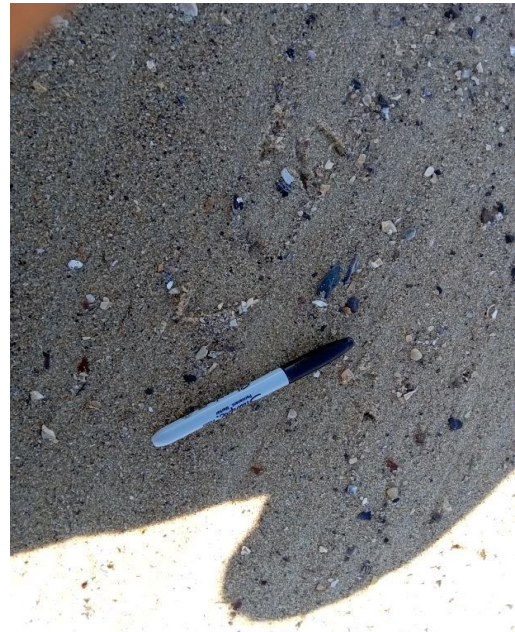
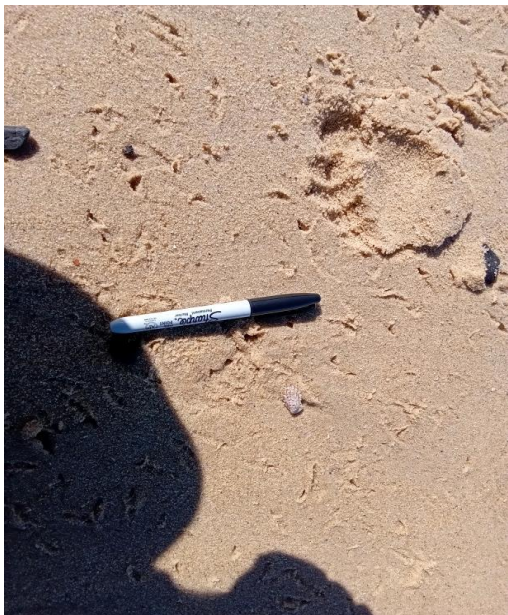
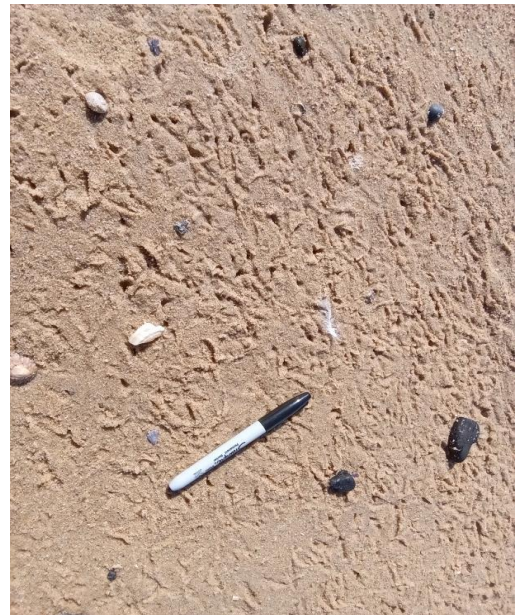
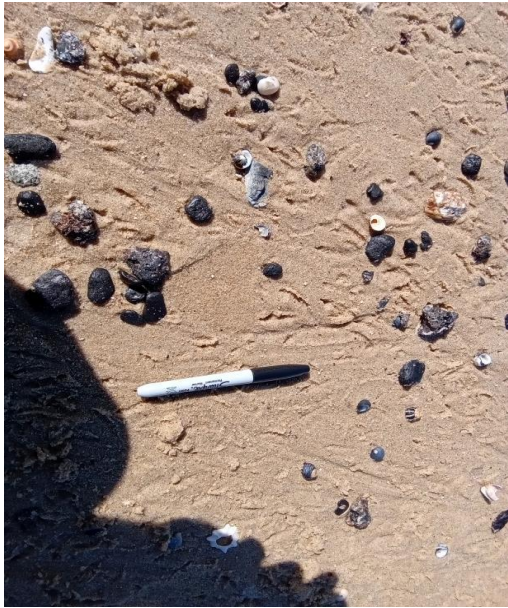
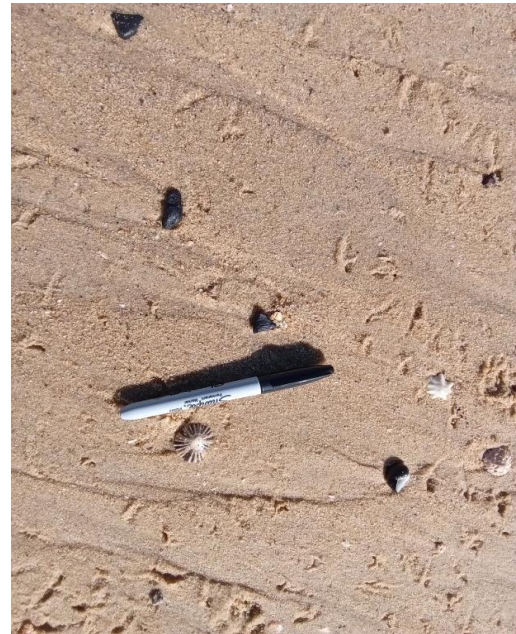
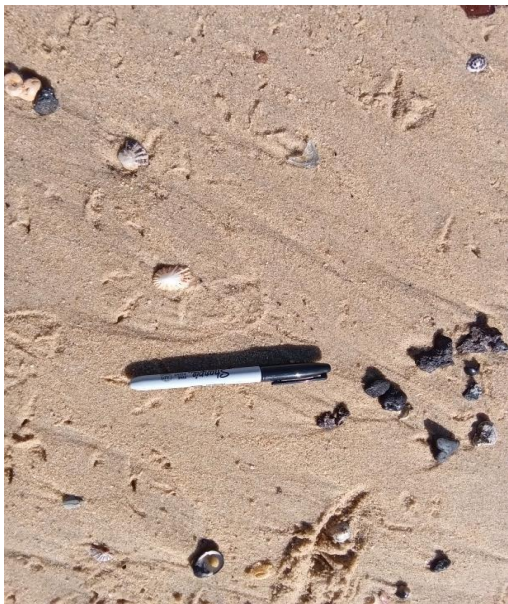
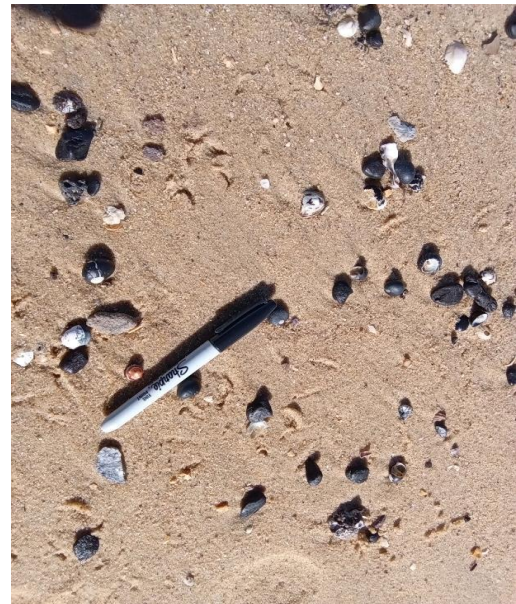
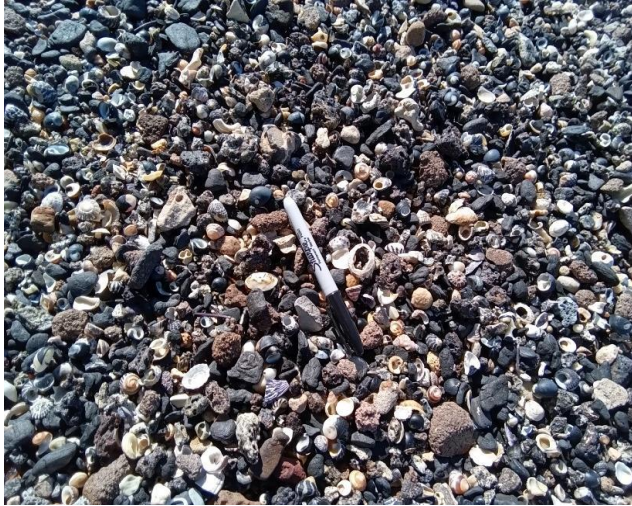
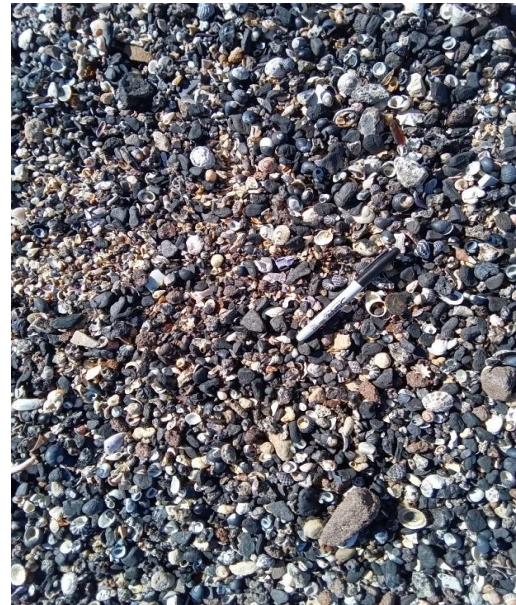
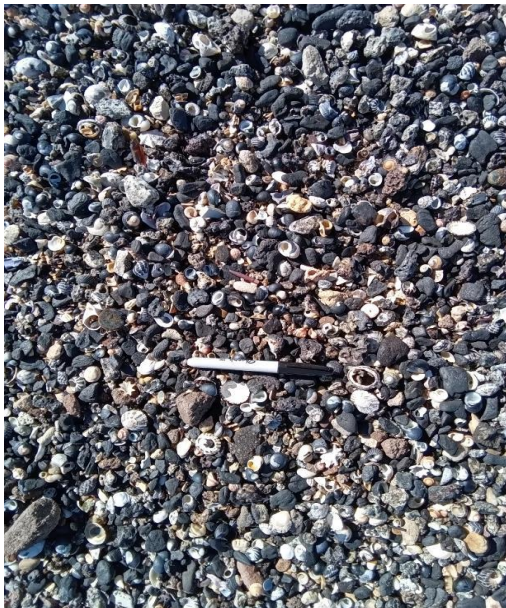
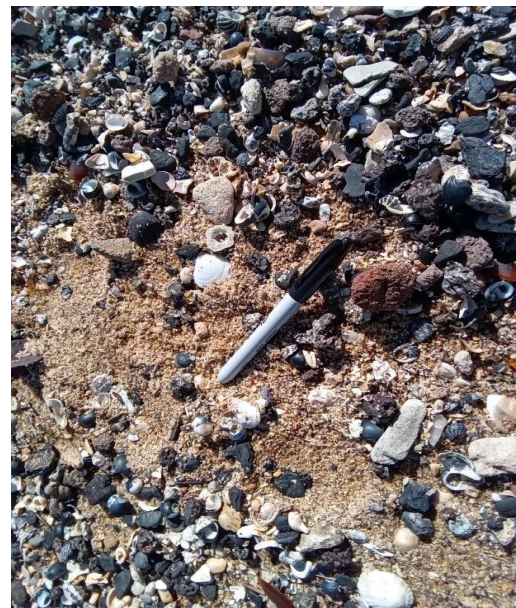
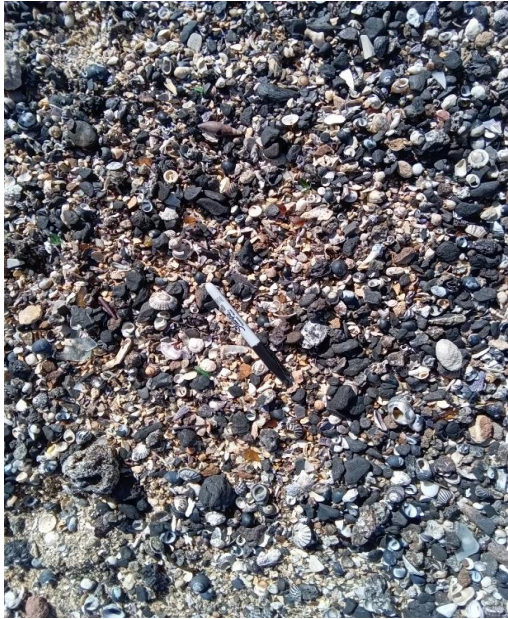
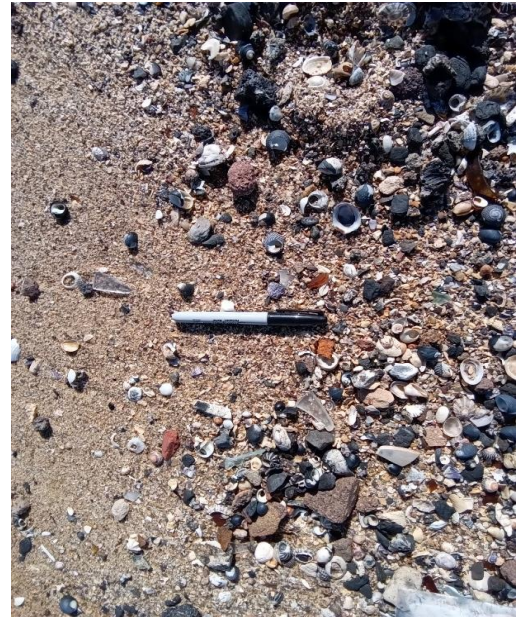
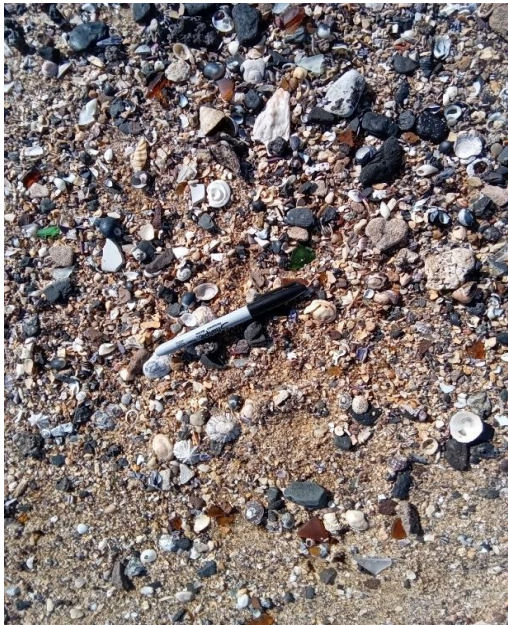
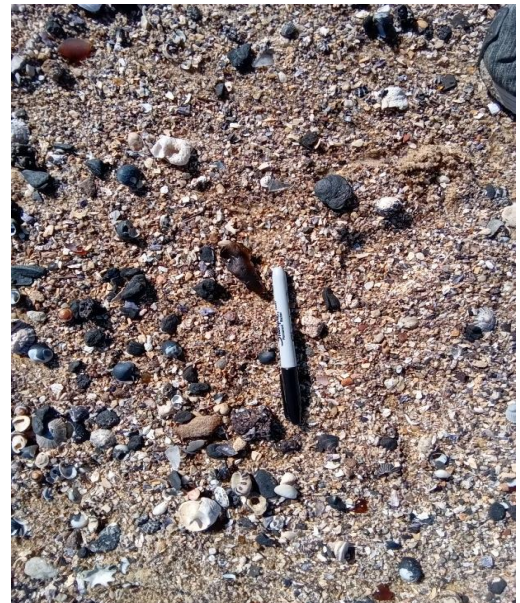
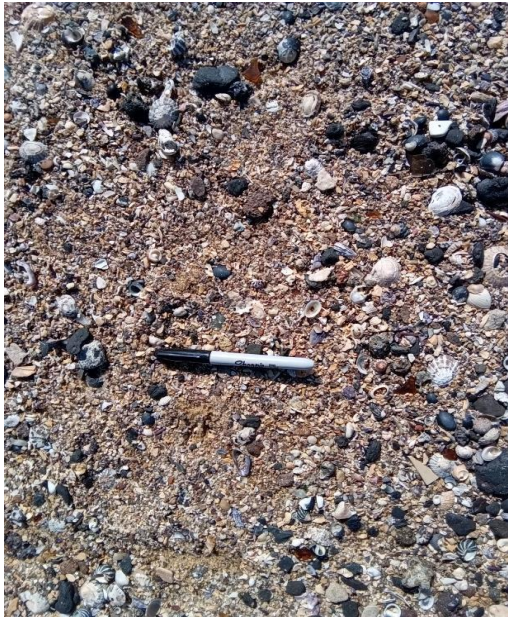
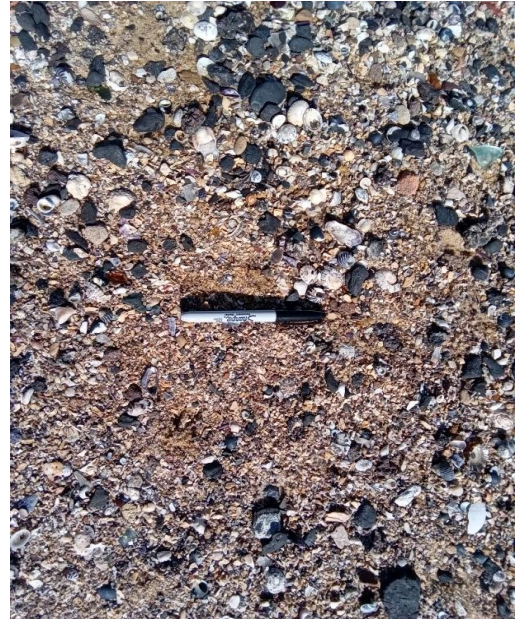
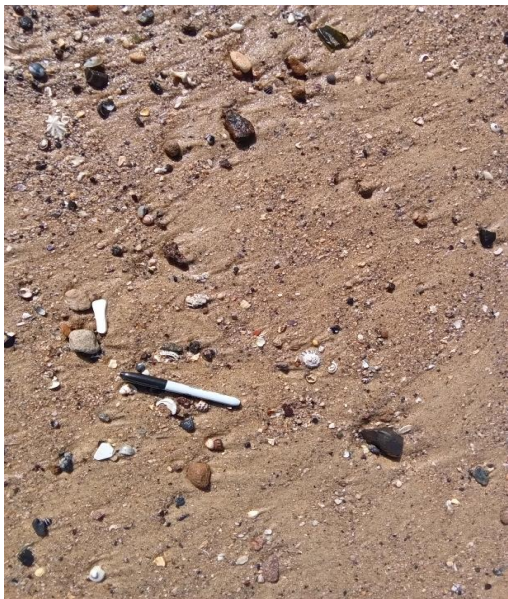
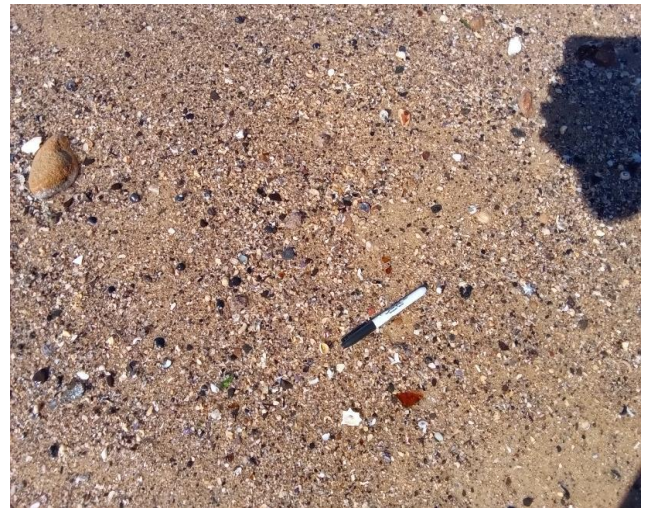
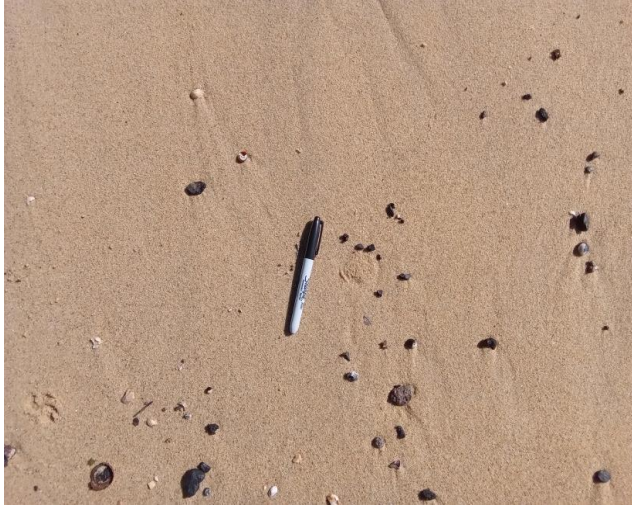
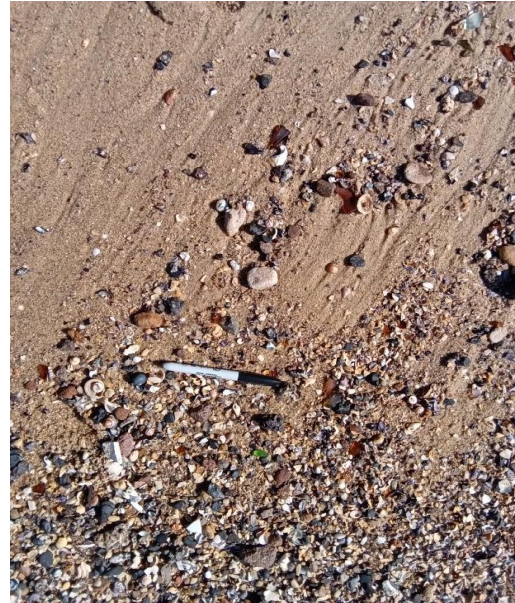
Notes: Visual clearance inspection following removal of suspected asbestos containing FC fragment.
