Asbestos Containing Material Clearance Inspection

RE: Asbestos Containing Material Clearance Inspection

Site:	Little Bay Beach
Location:	Southern, Western and Northern Little Bay Beach

Requested by:	
Name	Joe Santangelo
Contact	0436839760
Email	joe.santangelo@randwick.nsw.gov.au
Site Details:	
Address	2 Coast Hospital Rd, Little Bay NSW 2036
Local Government Area	Randwick City Council

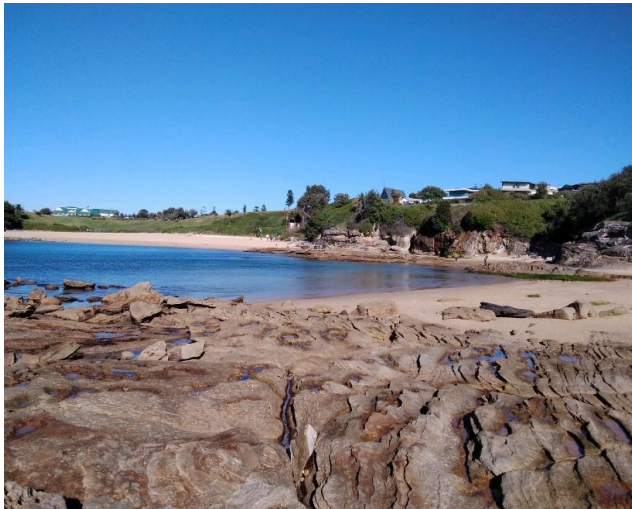
Notes: Overview of the Beach during the inspection

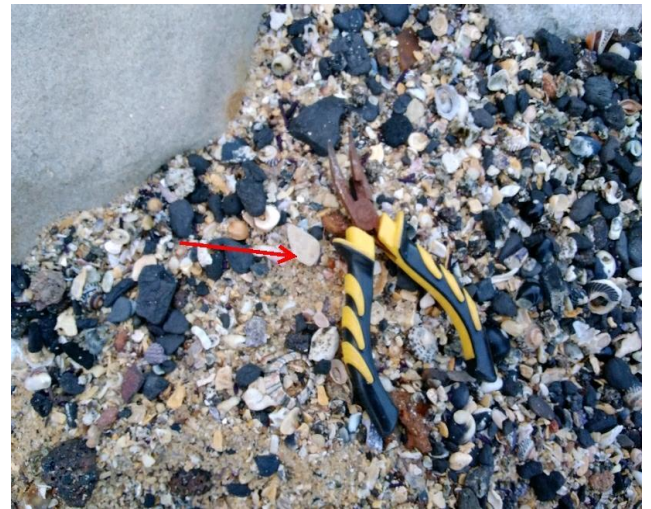
Notes: FC fragment identified on sand surface prior to emu pick - Northern section

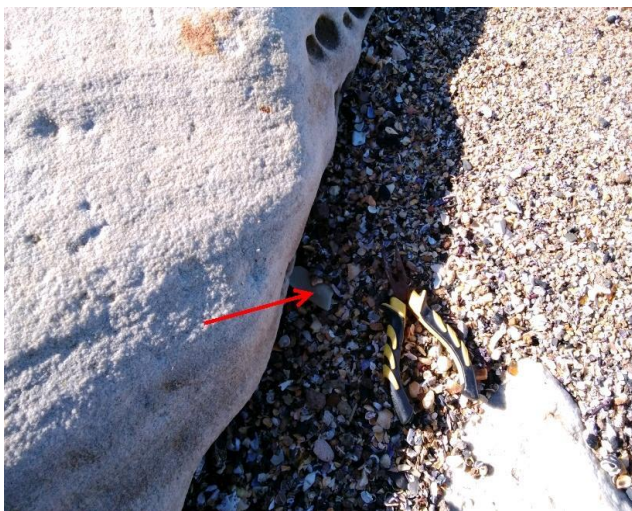
Notes: FC fragment identified on sand surface prior to emu pick - Northern section

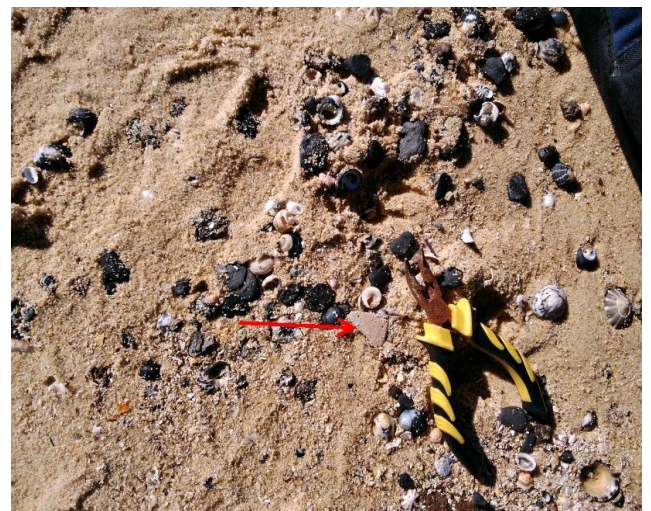
Notes: FC fragment identified on sand surface prior to emu pick - Northern section

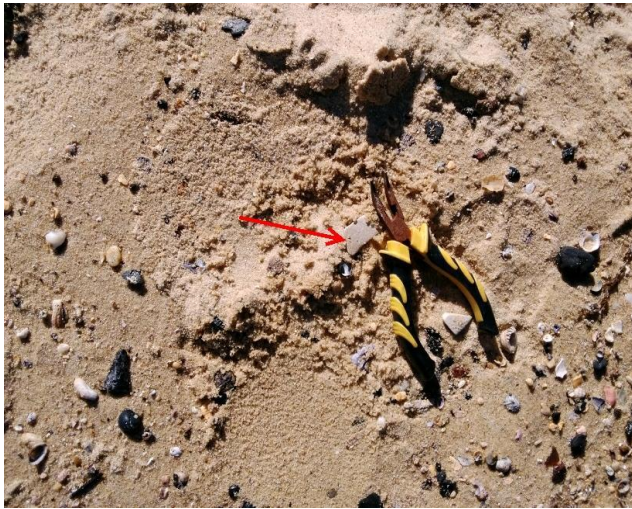
Notes: FC fragment identified on sand surface prior to emu pick - Northern section

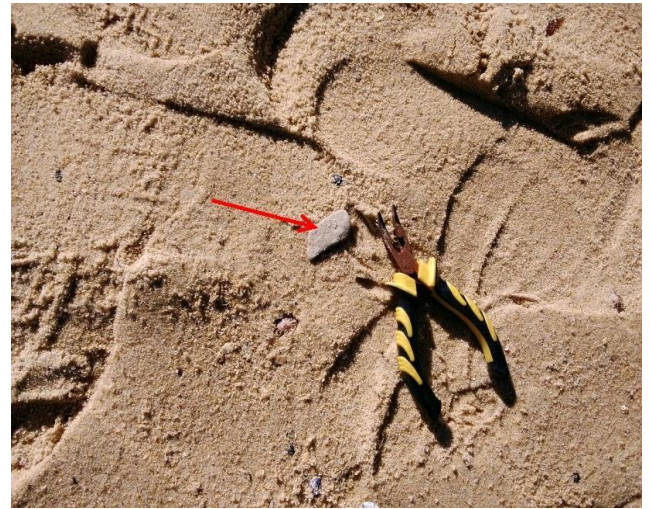
Notes: FC fragment identified on sand surface prior to emu pick - Northern section

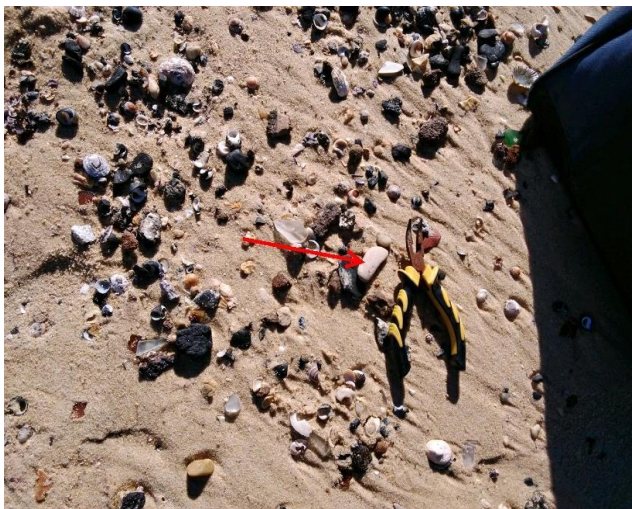
Notes: FC fragment identified on sand surface prior to emu pick - Northern section

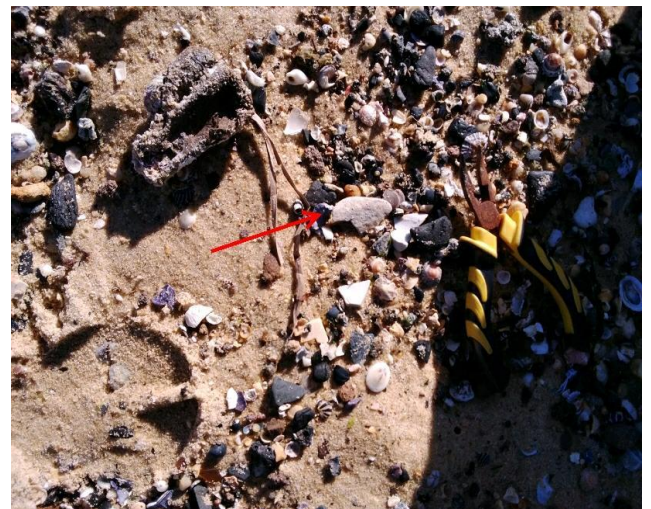
Notes: FC fragment identified on sand surface prior to emu pick - Northern section

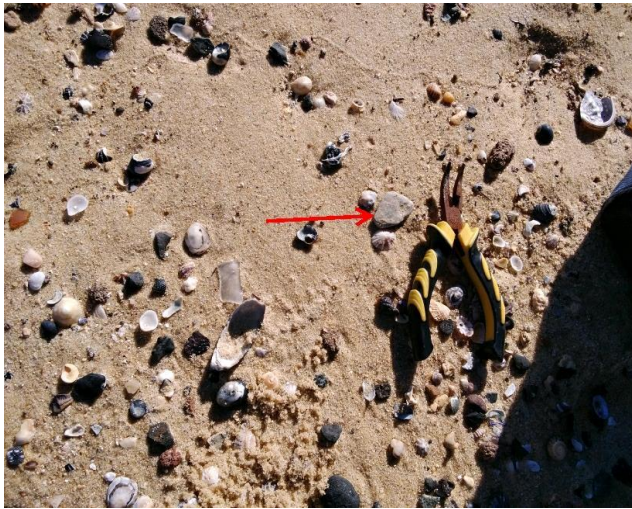
Notes: FC fragment identified on sand surface prior to emu pick - Northern section

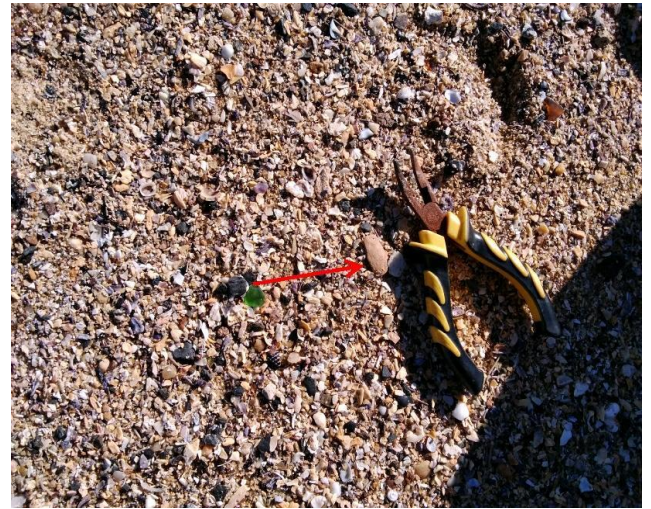
Notes: FC fragment identified on sand surface prior to emu pick - Northern section

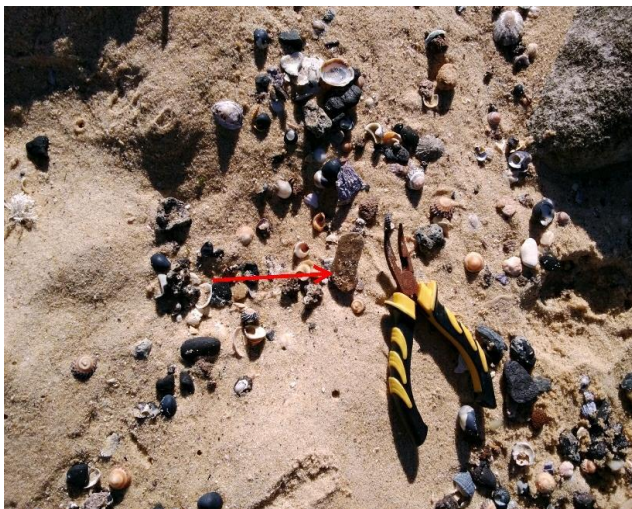
Notes: FC fragment identified on sand surface prior to emu pick - Northern section

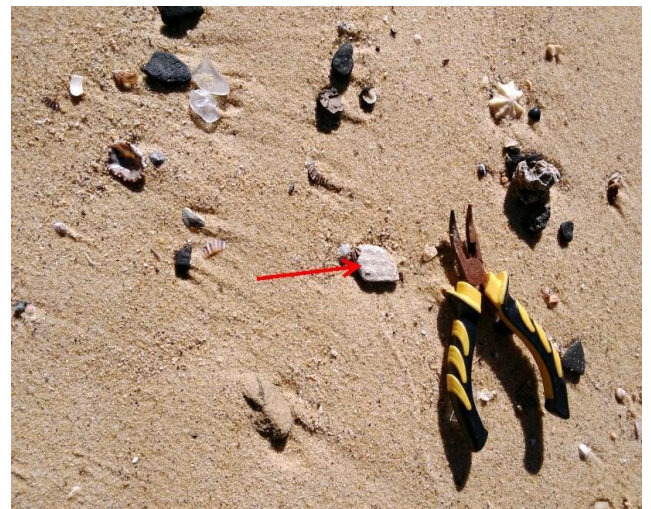
Notes: FC fragment identified on sand surface prior to emu pick - Western section

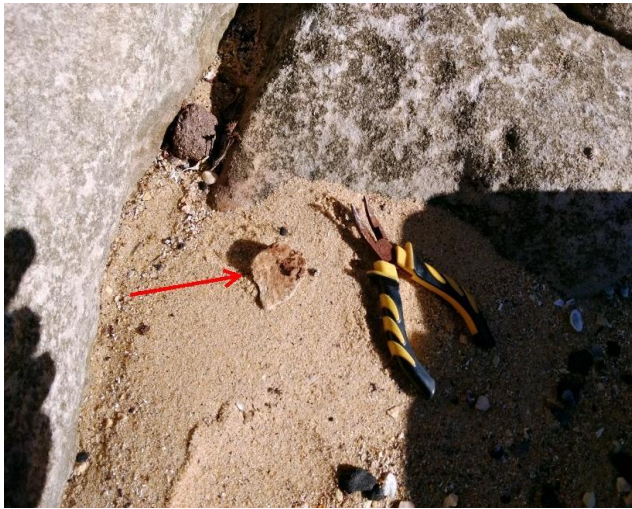
Notes: FC fragment identified on sand surface prior to emu pick - Western section

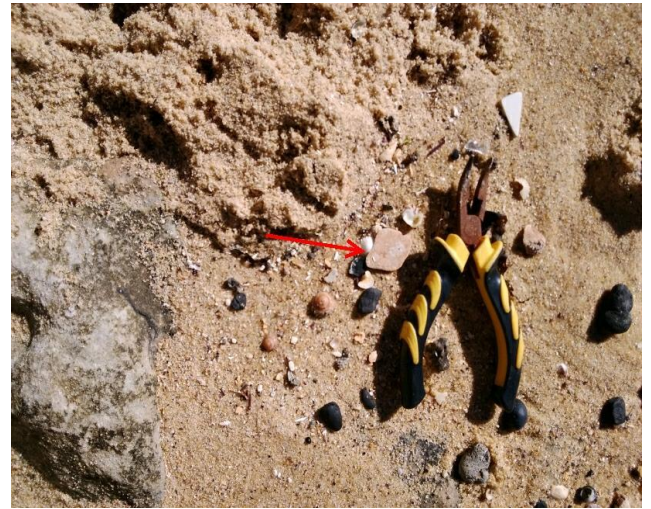
Notes: FC fragment identified on sand surface prior to emu pick - Western section

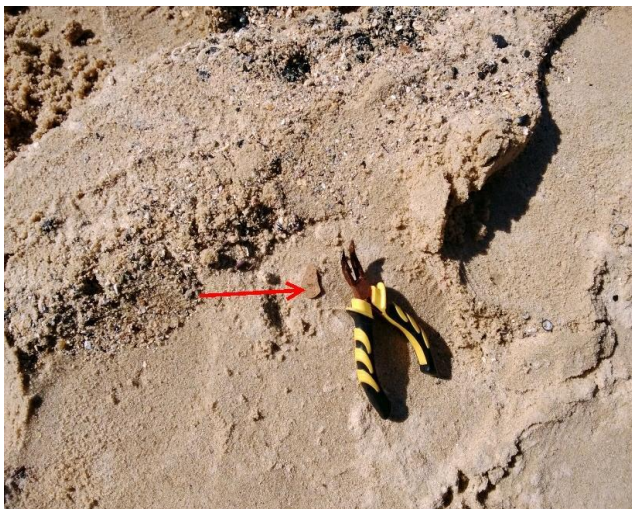
Notes: FC fragment identified on sand surface prior to emu pick - Western section

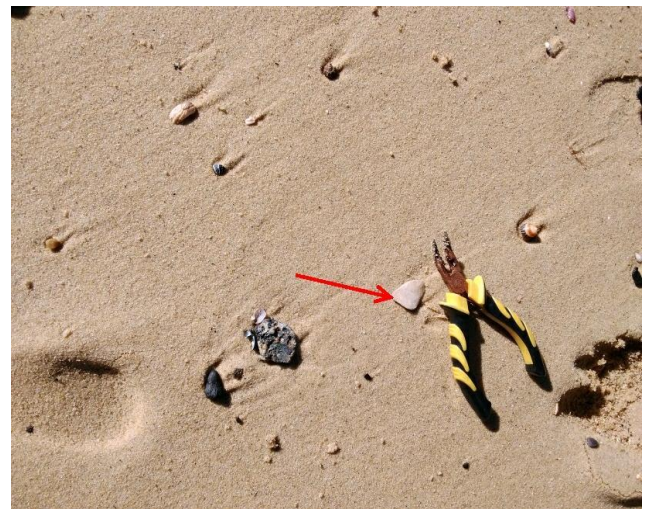
Notes: FC fragment identified on sand surface prior to emu pick - Western section

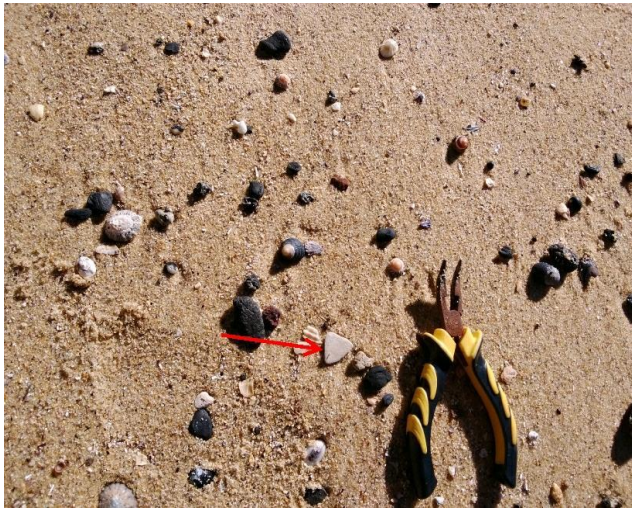
Notes: FC fragment identified on sand surface prior to emu pick - Western section

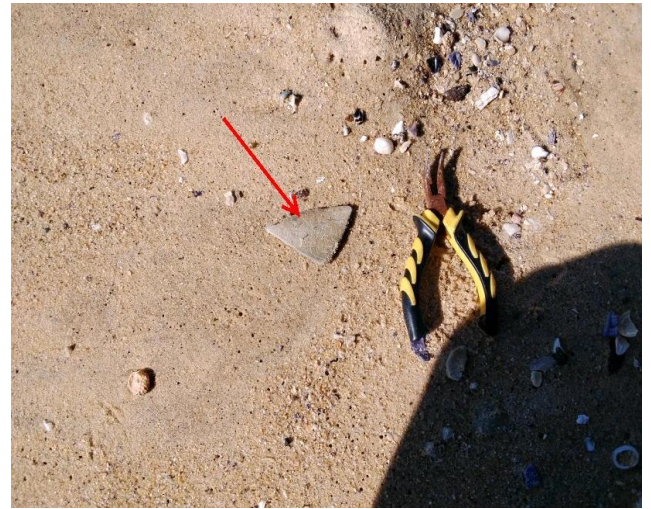
Notes: FC fragment identified on sand surface prior to emu pick - Northern section

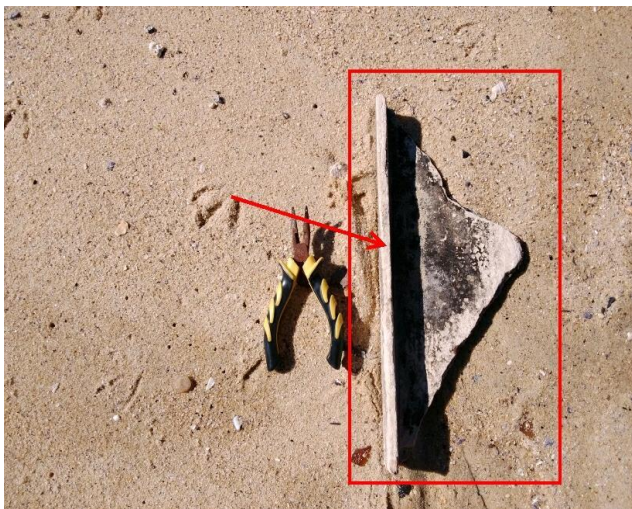
Notes: FC fragment identified on sand surface prior to emu pick - Northern section

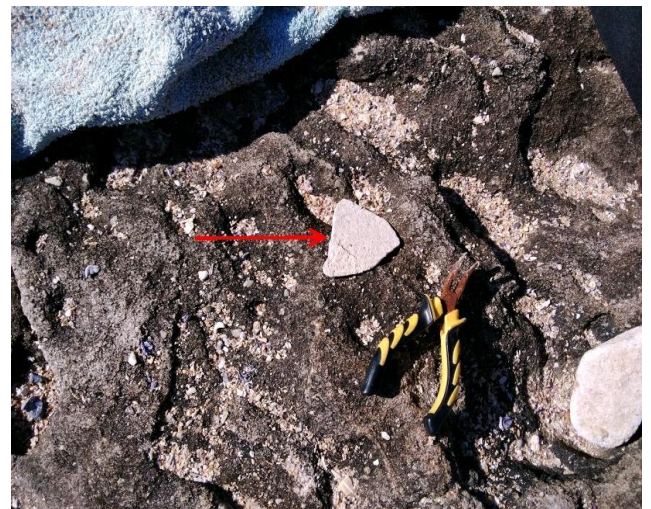
Notes: FC fragment identified on sand surface prior to emu pick - Northern section

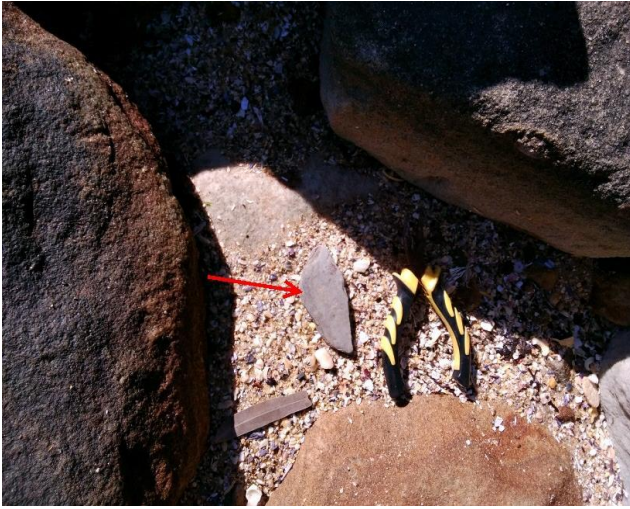
Notes: FC fragment identified on sand surface prior to emu pick - Northern section

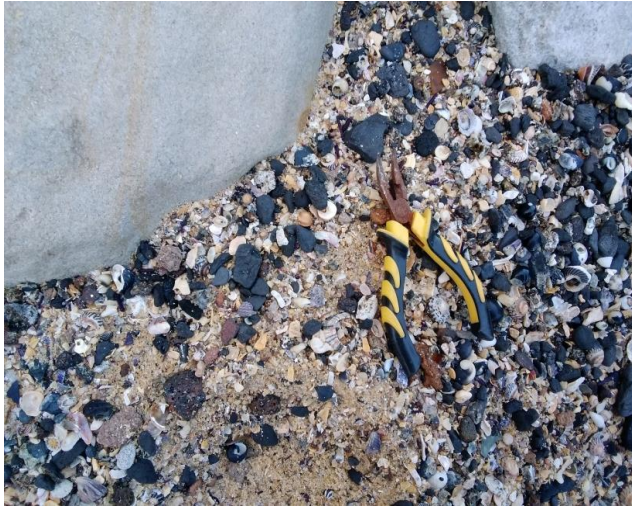
Notes: Sand surface following emu pick - Northern section

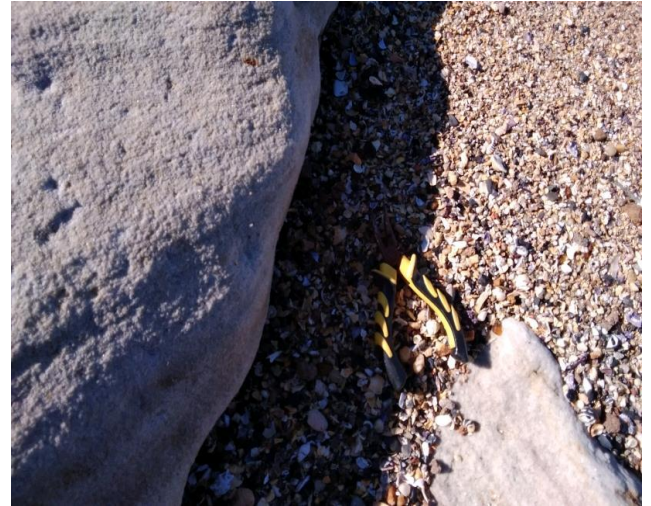
Notes: Sand surface following emu pick - Northern section

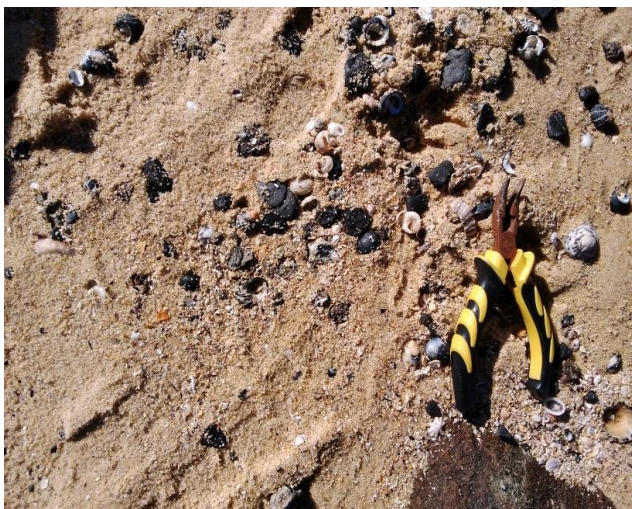
Notes: Sand surface following emu pick - Northern section

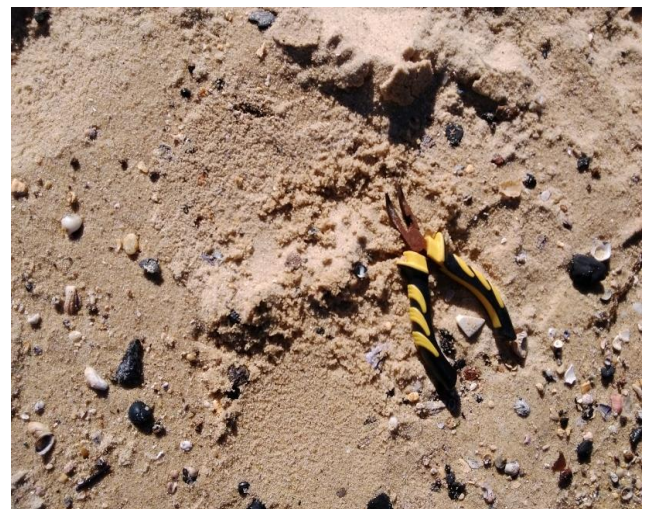
Notes: Sand surface following emu pick - Northern section

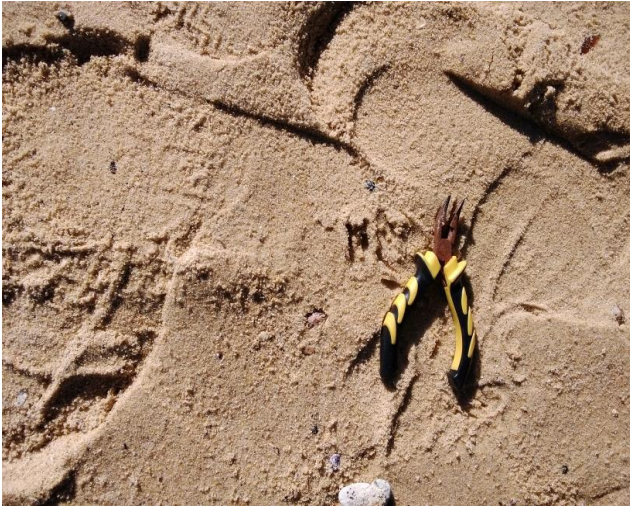
Notes: Sand surface following emu pick - Northern section

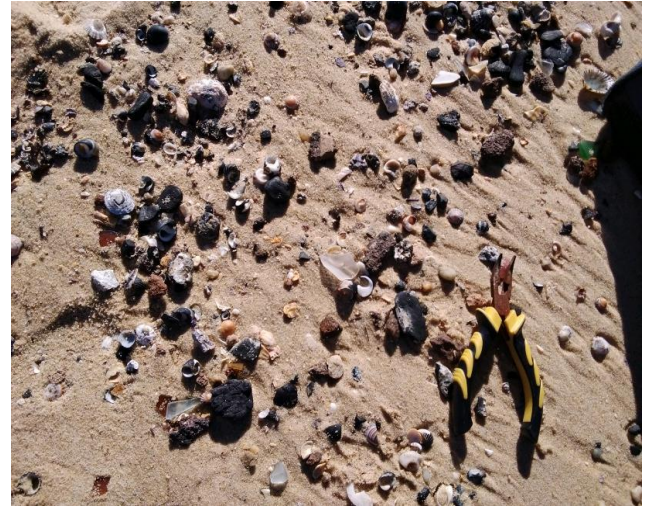
Notes: Sand surface following emu pick - Northern section

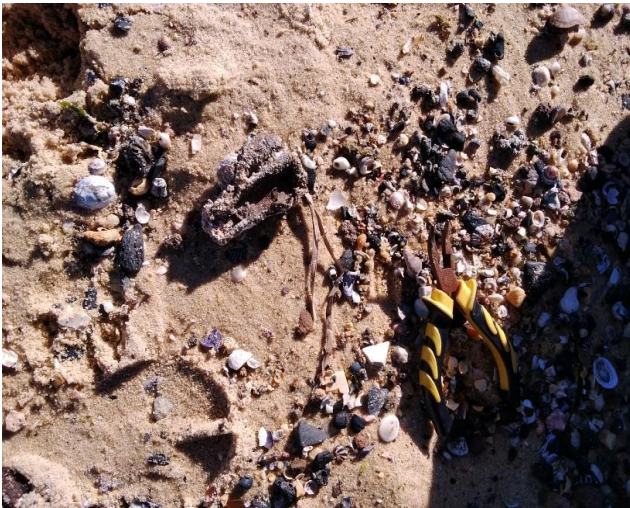
Notes: Sand surface following emu pick - Northern section

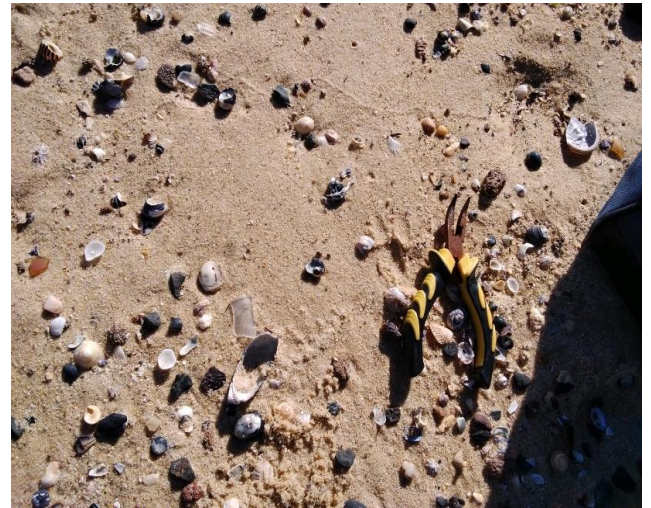
Notes: Sand surface following emu pick - Northern section

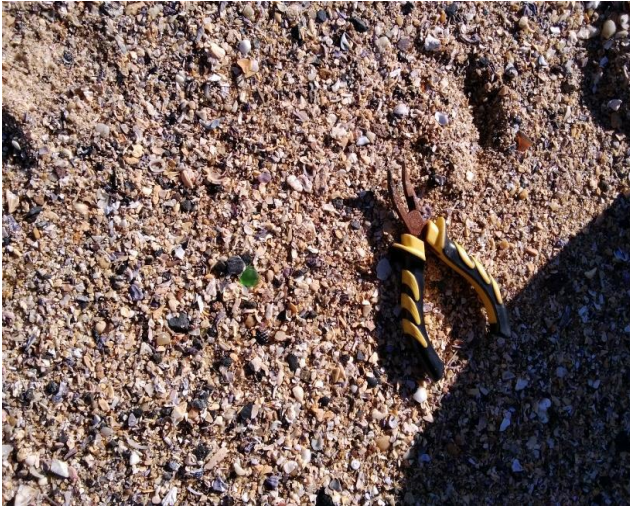
Notes: Sand surface following emu pick - Northern section

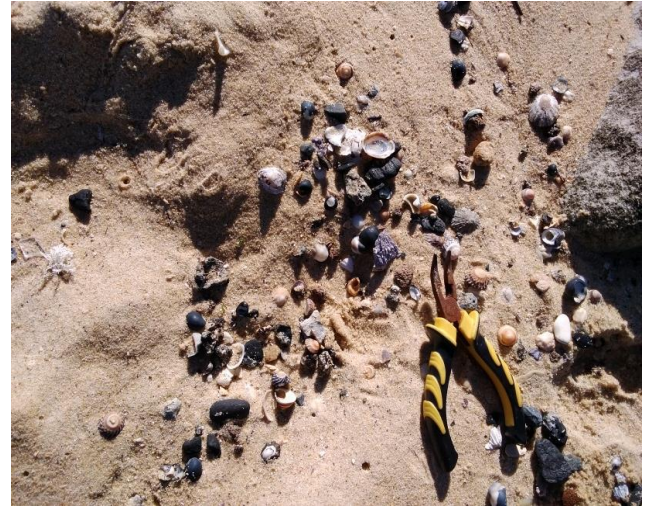
Notes: Sand surface following emu pick - Northern section

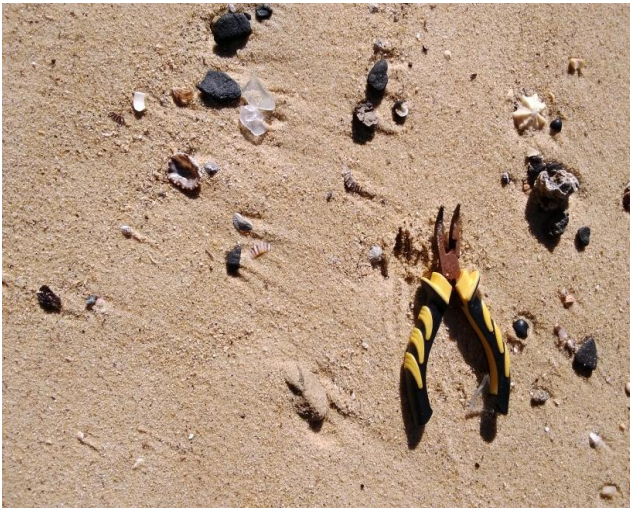
Notes: Sand surface following emu pick - Western section

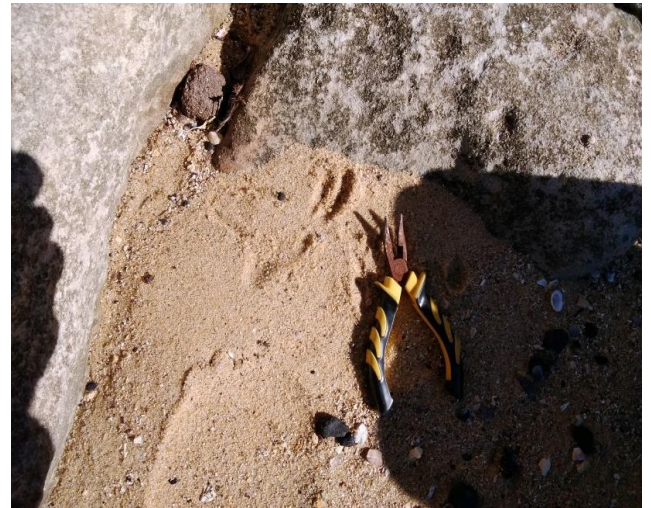
Notes: Sand surface following emu pick - Western section

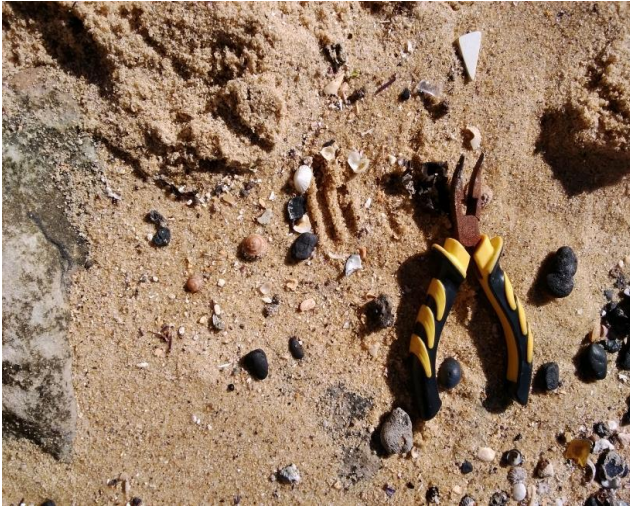
Notes: Sand surface following emu pick - Western section

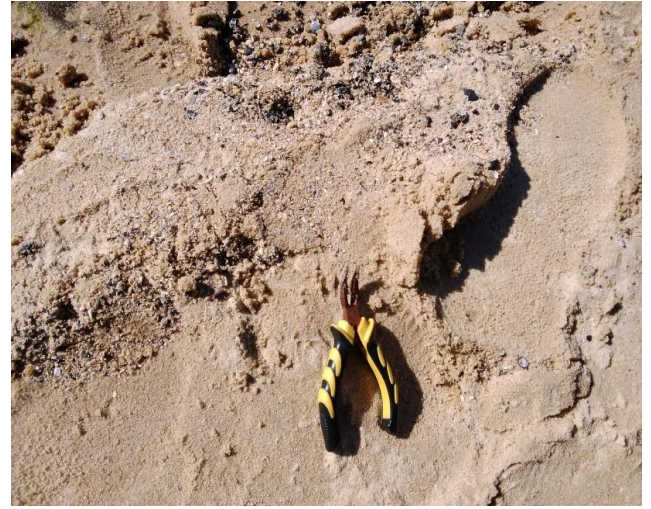
Notes: Sand surface following emu pick - Western section

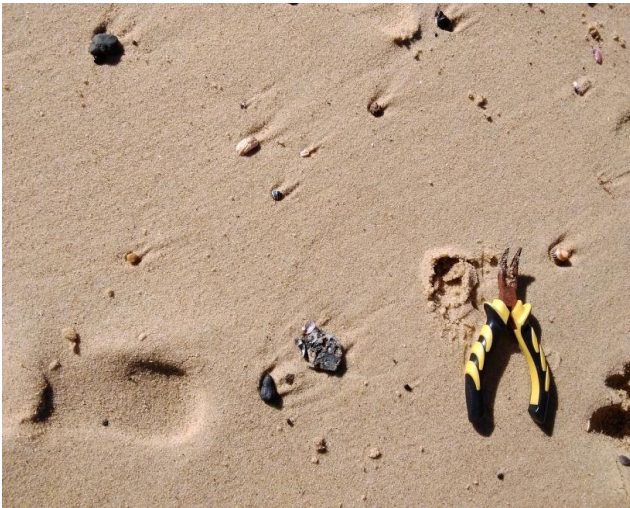
Notes: Sand surface following emu pick - Western section

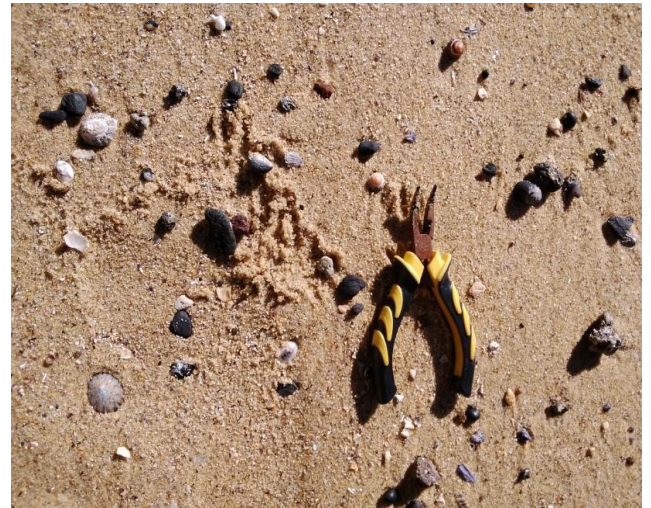
Notes: Sand surface following emu pick - Western section

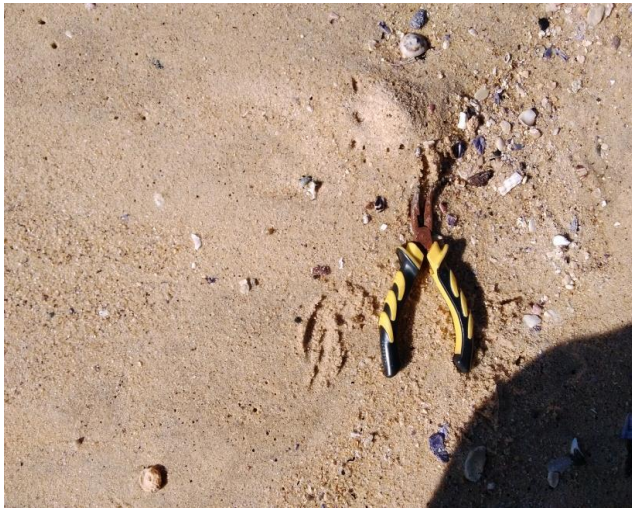
Notes: Sand surface following emu pick - Southern section

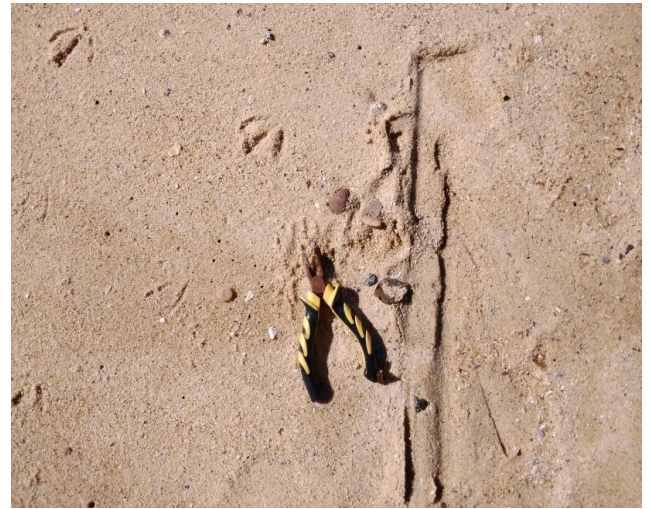
Notes: Sand surface following emu pick - Southern section

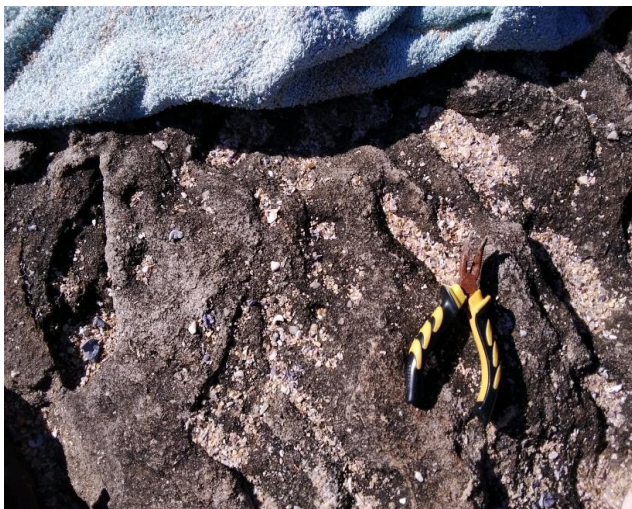
Notes: Sand surface following emu pick - Southern section

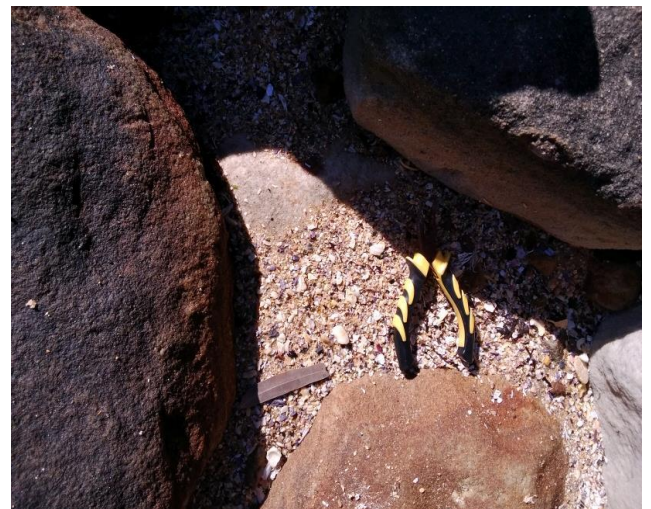
Notes: Sand surface following emu pick - Southern section
