Asbestos Containing Material Clearance Inspection

17 June 2023

Randwick City Council
30 Frances Street
Randwick NSW 2031

Site:	Little Bay Beach
Location:	Southern, Western and Northern Little Bay Beach

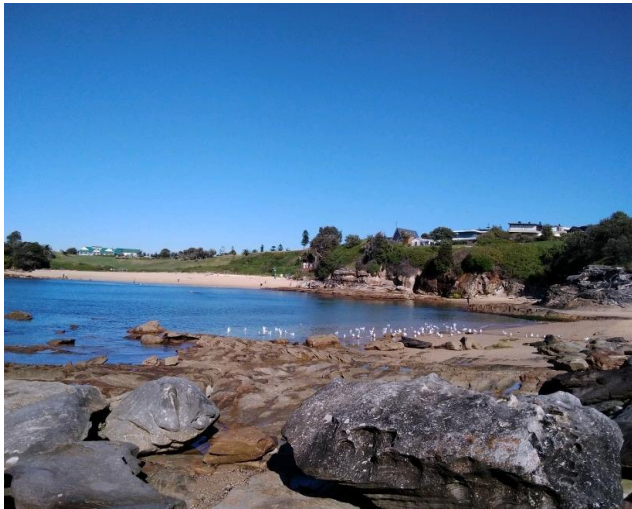
Notes: Overview of the Beach during the inspection

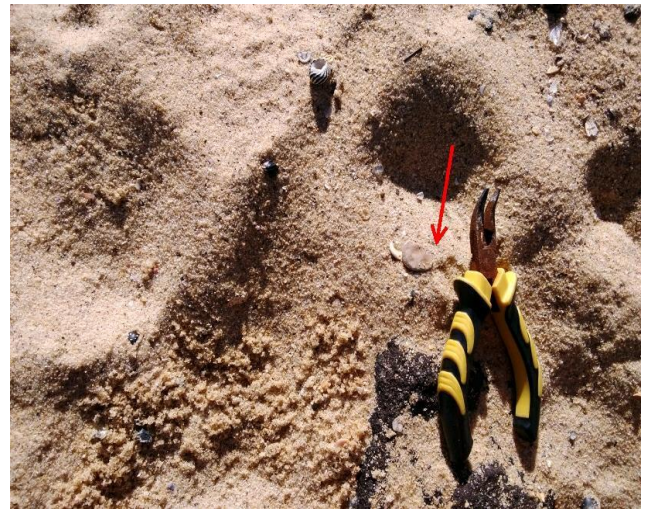
Notes: FC fragment identified on sand surface prior to emu pick - Northern section

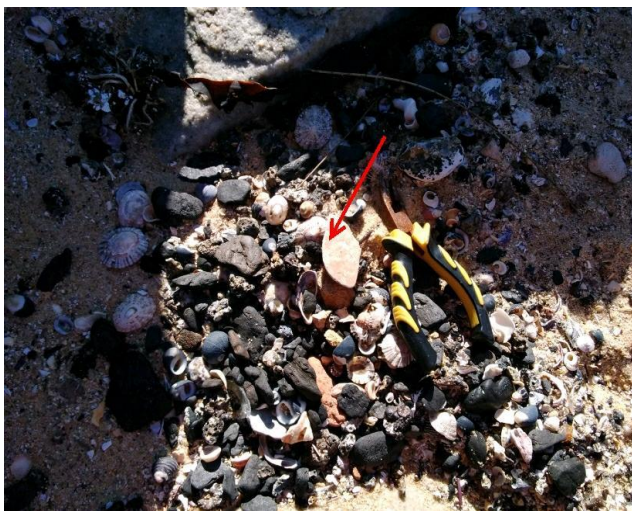
Notes: FC fragment identified on sand surface prior to emu pick - Northern section

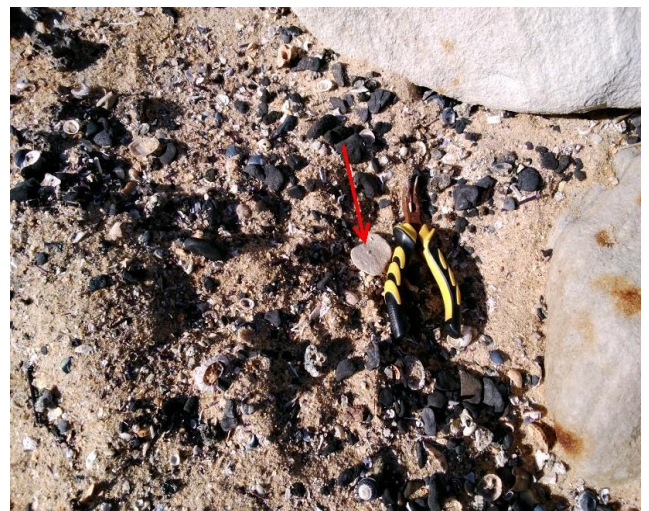
Notes: FC fragment identified on sand surface prior to emu pick - Northern section

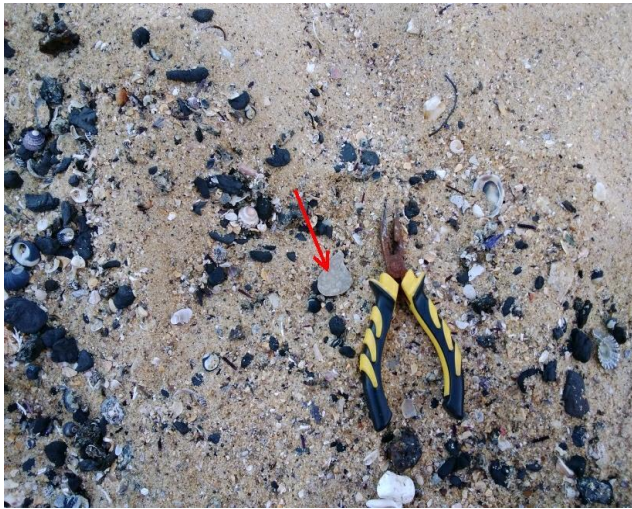
Notes: FC fragment identified on sand surface prior to emu pick - Northern section

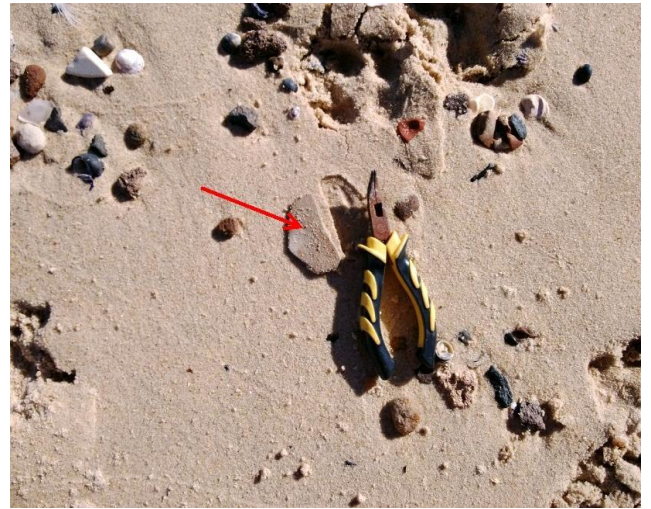
Notes: FC fragment identified on sand surface prior to emu pick - Northern section

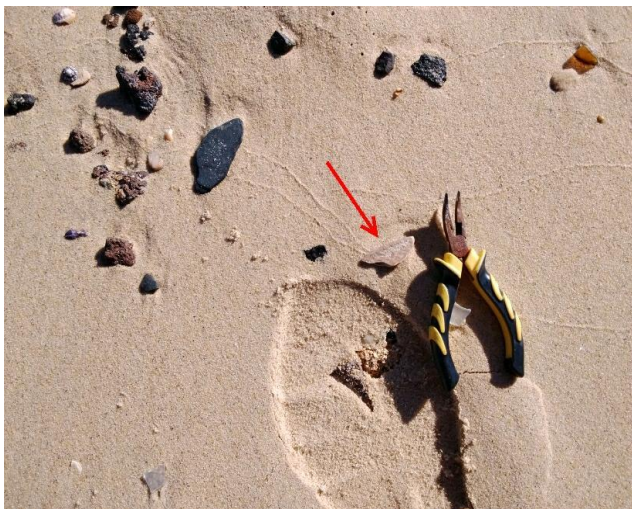
Notes: FC fragment identified on sand surface prior to emu pick - Northern section

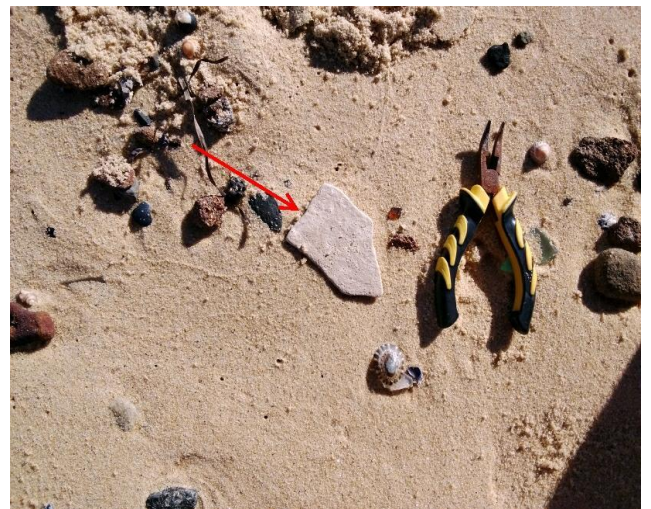
Notes: FC fragment identified on sand surface prior to emu pick - Northern section

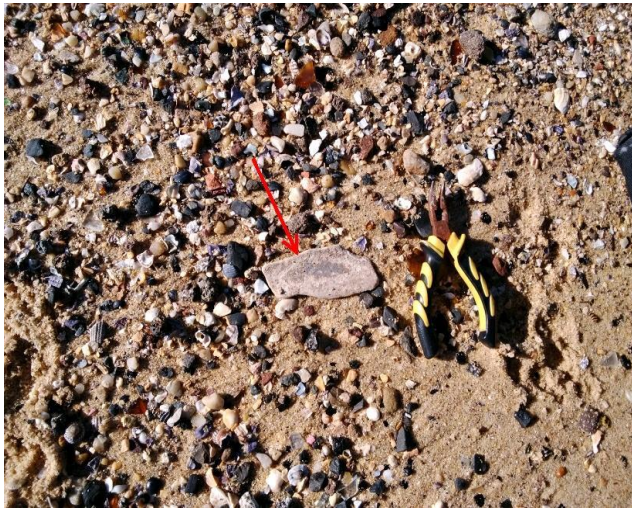
Notes: FC fragment identified on sand surface prior to emu pick - Northern section

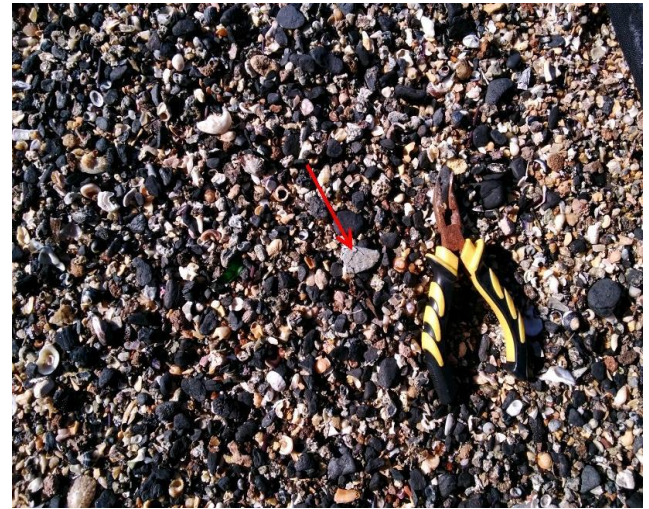
Notes: FC fragment identified on sand surface prior to emu pick - Northern section

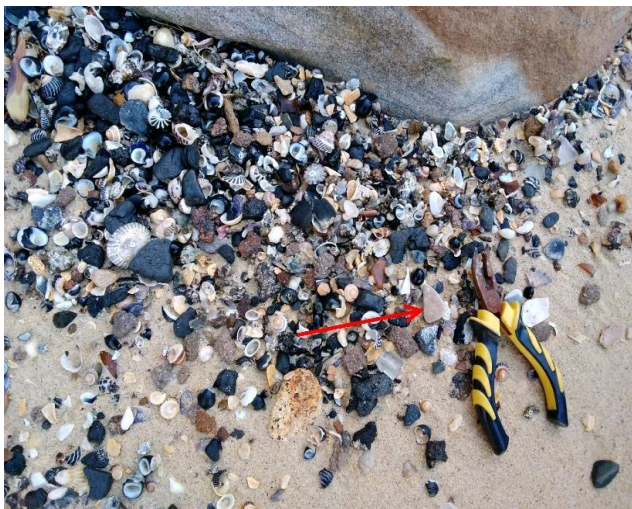
Notes: FC fragment identified on sand surface prior to emu pick - Northern section

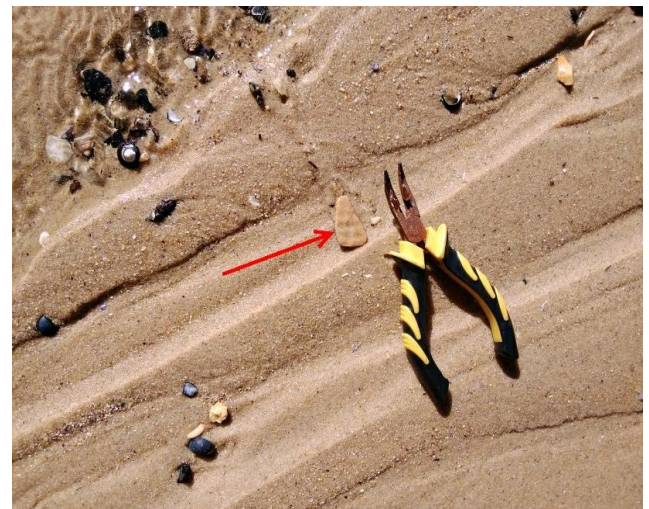
Notes: FC fragment identified on sand surface prior to emu pick - Northern section

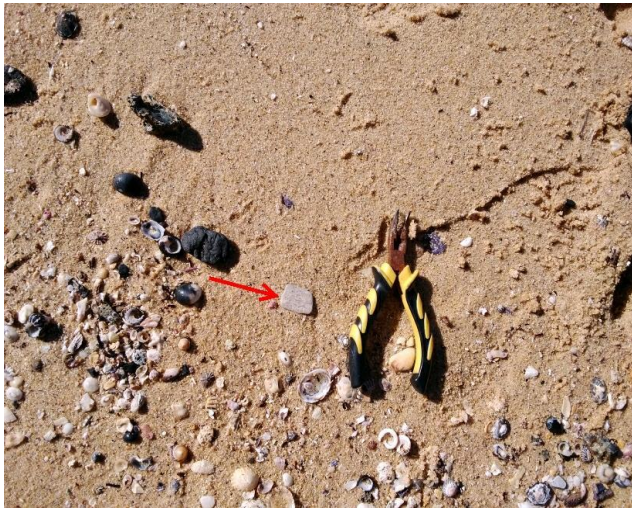
Notes: FC fragment identified on sand surface prior to emu pick - Western section

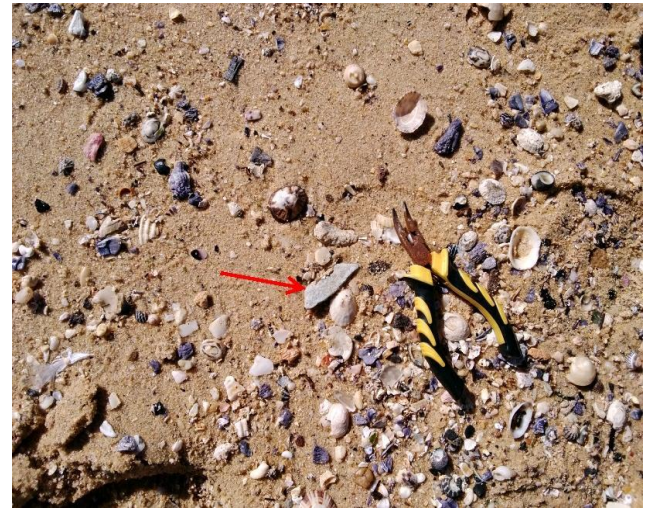
Notes: FC fragment identified on sand surface prior to emu pick - Western section

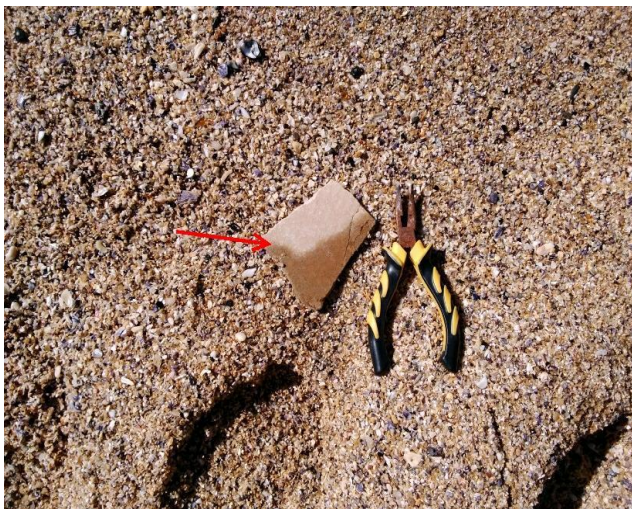
Notes: FC fragment identified on sand surface prior to emu pick - Southern section

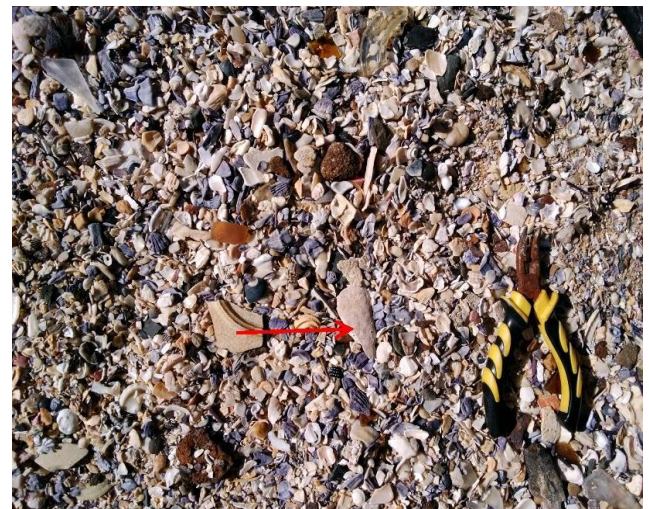
Notes: FC fragment identified on sand surface prior to emu pick - Southern section

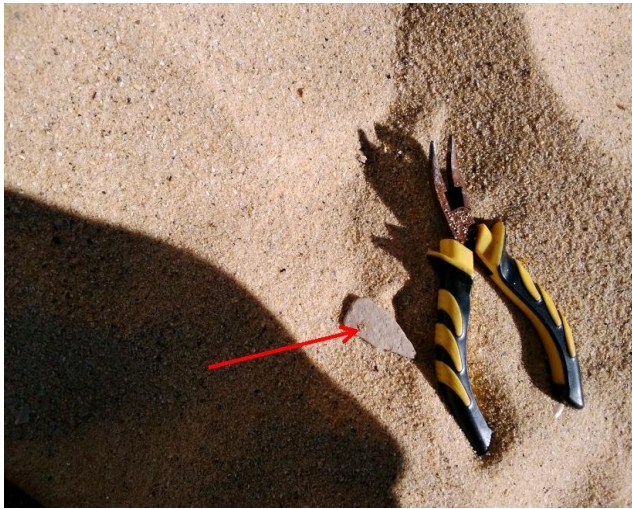
Notes: FC fragment identified on sand surface prior to emu pick - Southern section

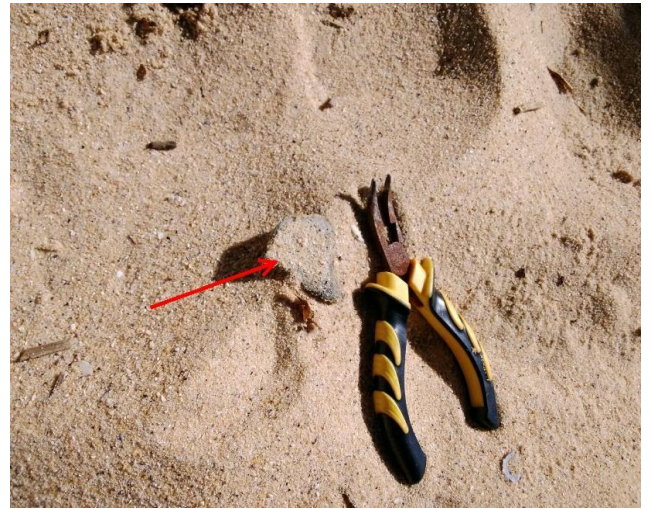
Notes: FC fragment identified on sand surface prior to emu pick - Southern section

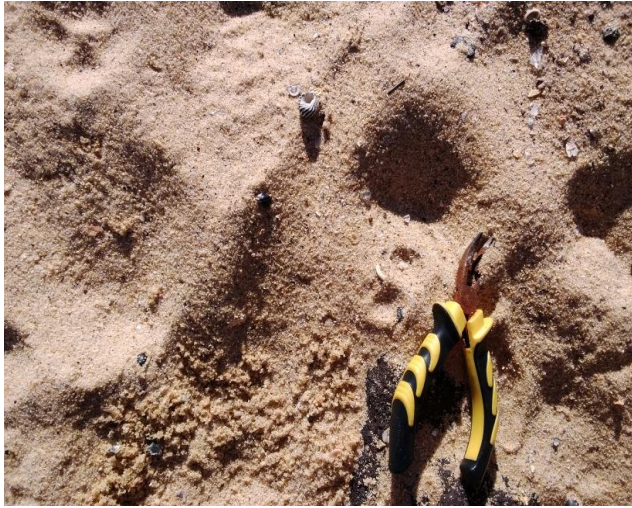
Notes: Sand surface following emu pick - Northern section

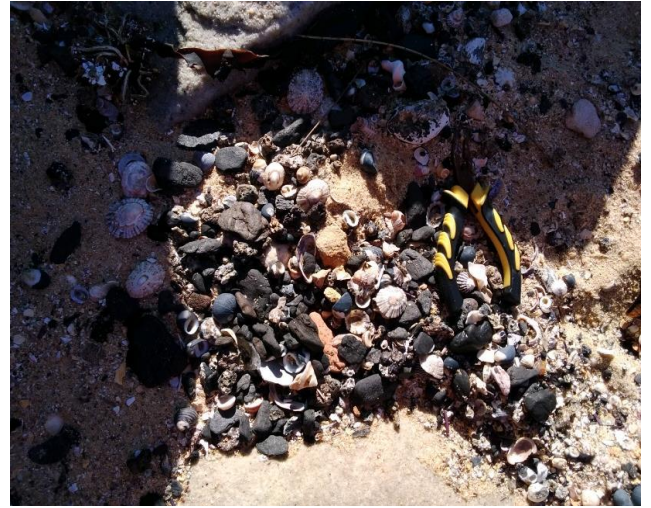
Notes: Sand surface following emu pick - Northern section

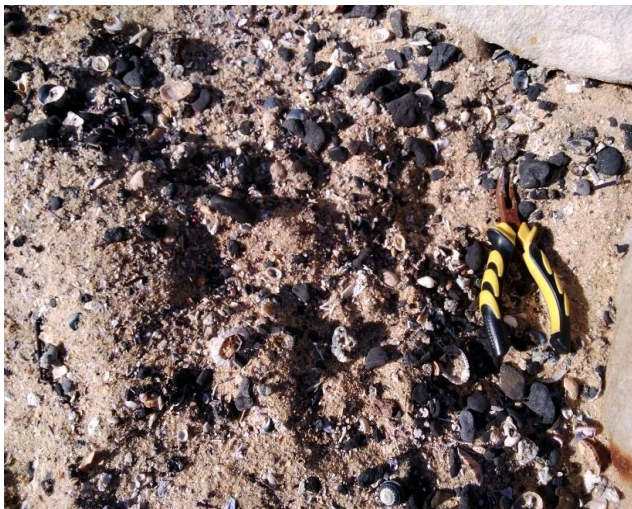
Notes: Sand surface following emu pick - Northern section

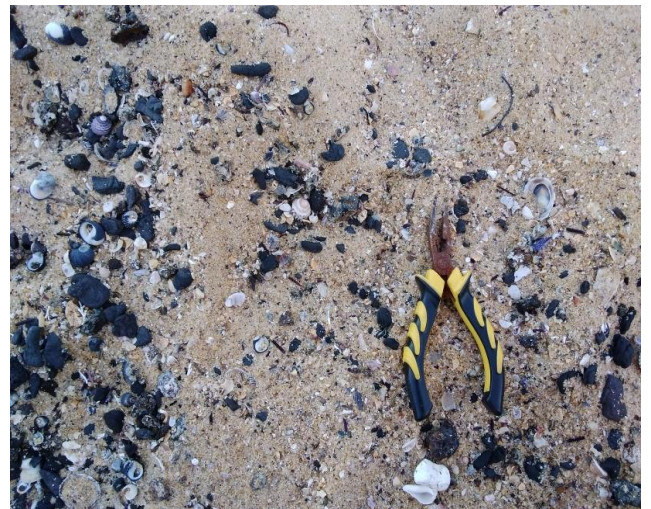
Notes: Sand surface following emu pick - Northern section

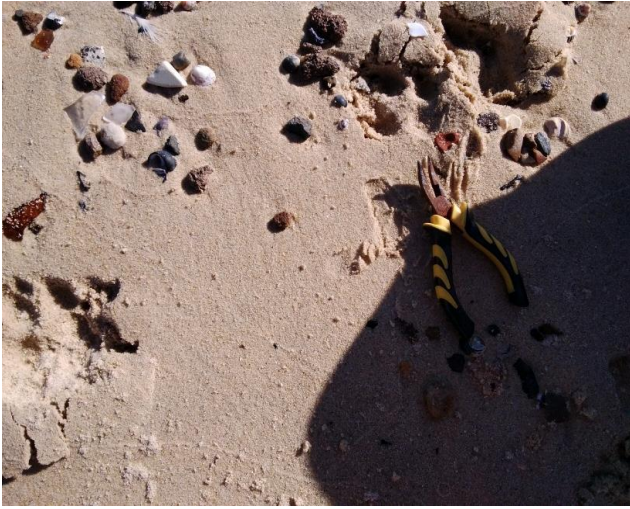
Notes: Sand surface following emu pick - Northern section

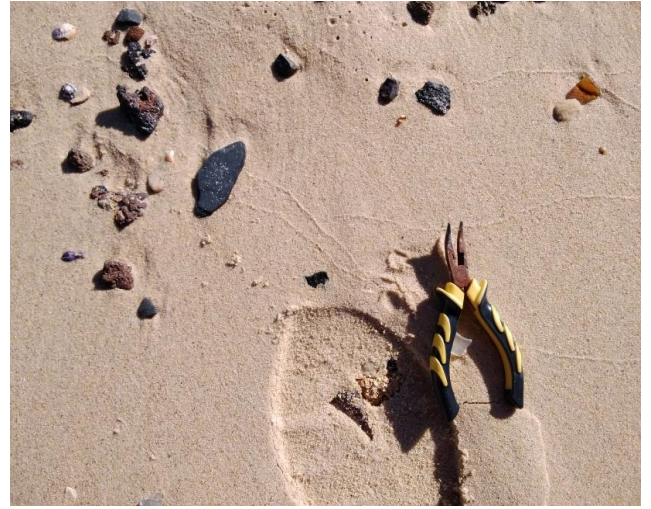
Notes: Sand surface following emu pick - Northern section

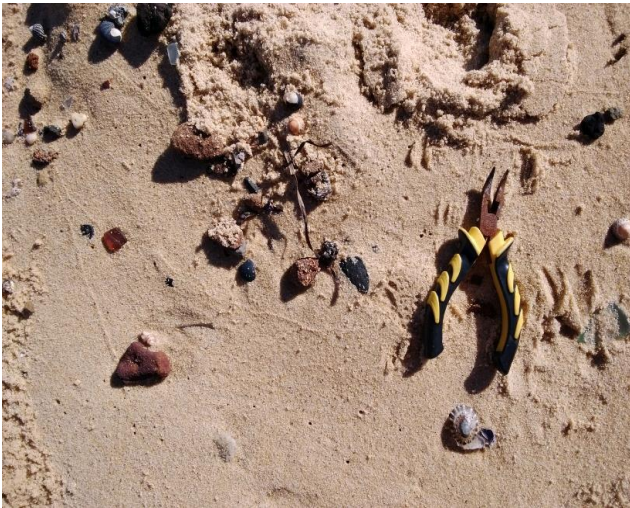
Notes: Sand surface following emu pick - Northern section

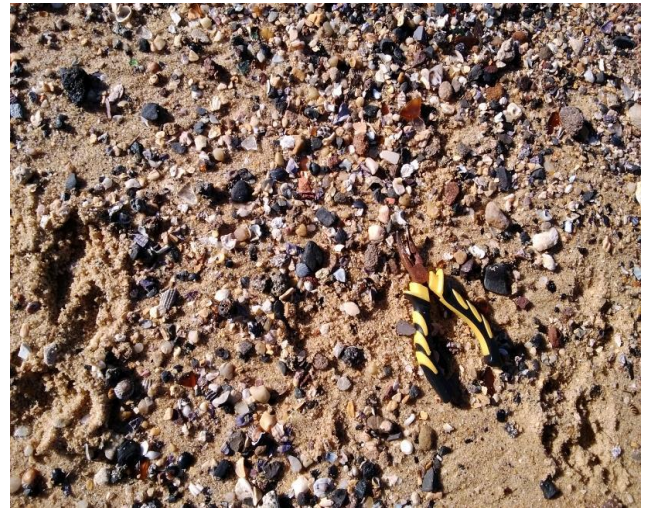
Notes: Sand surface following emu pick - Northern section

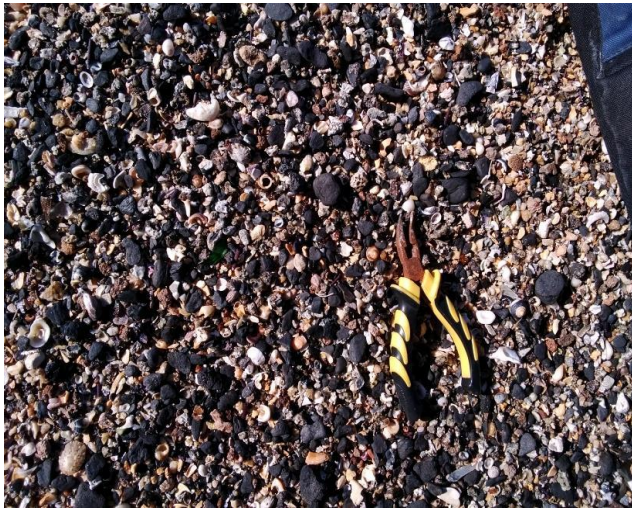
Notes: Sand surface following emu pick - Northern section

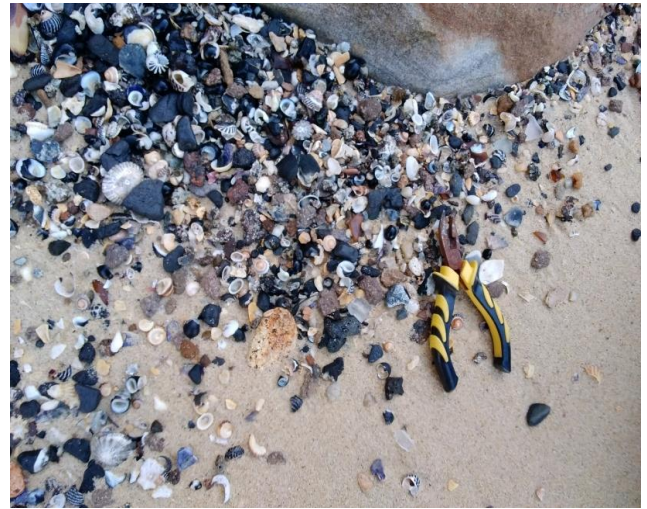
Notes: Sand surface following emu pick - Northern section

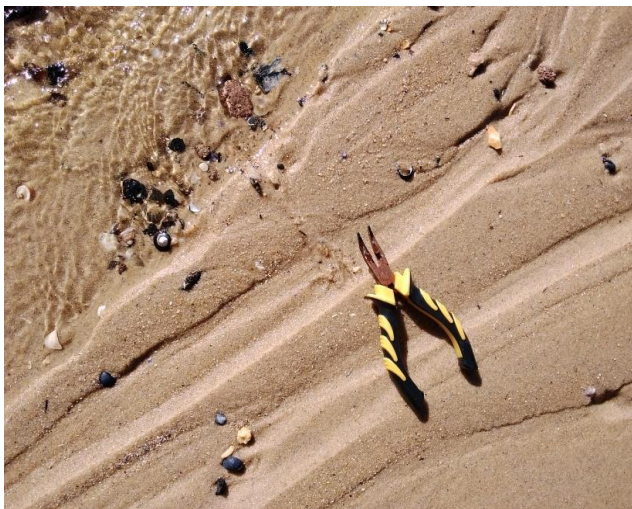
Notes: Sand surface following emu pick - Northern section

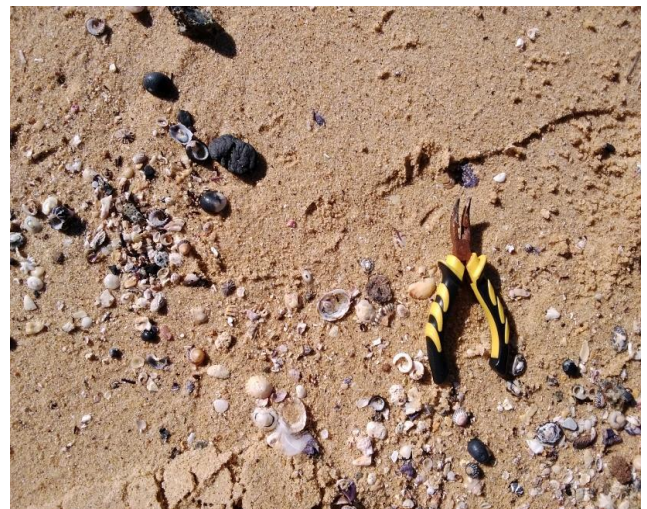
Notes: Sand surface following emu pick - Western section

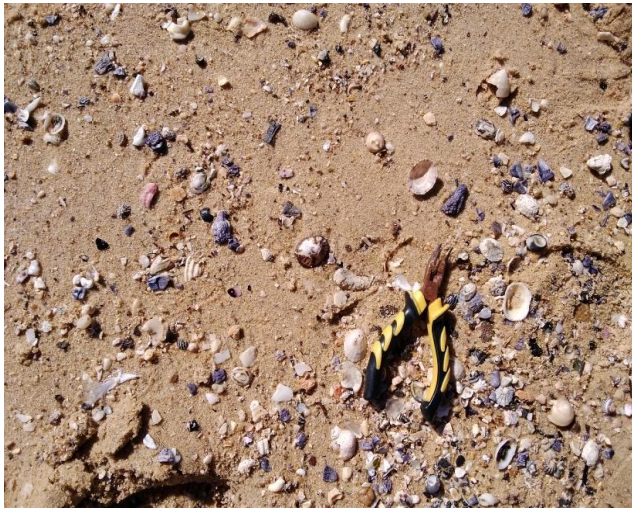
Notes: Sand surface following emu pick - Western section

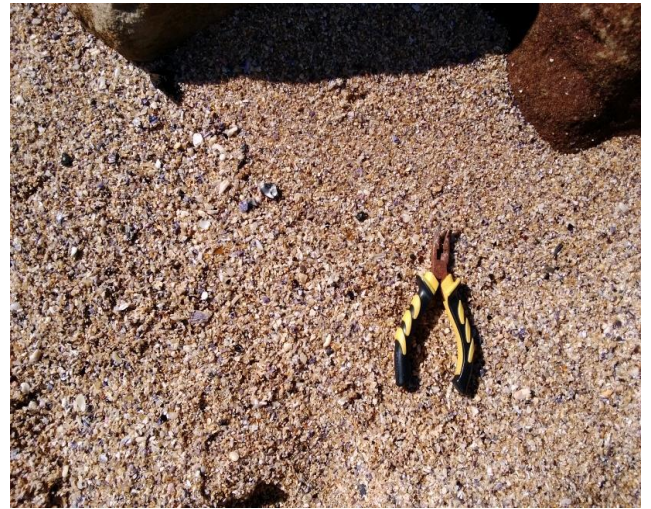
Notes: Sand surface following emu pick - Southern section

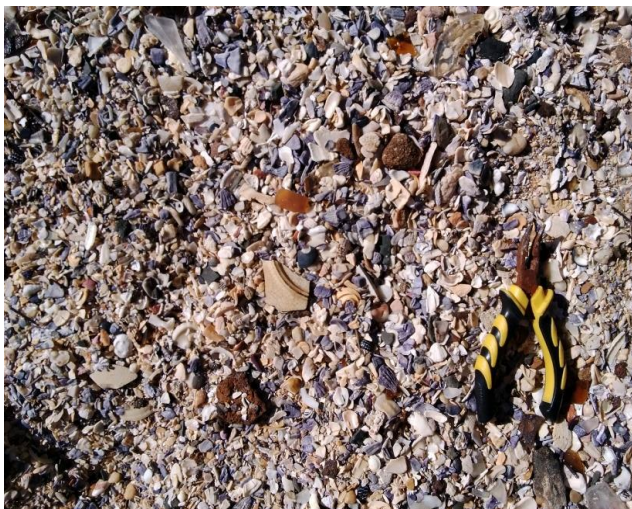
Notes: Sand surface following emu pick - Southern section

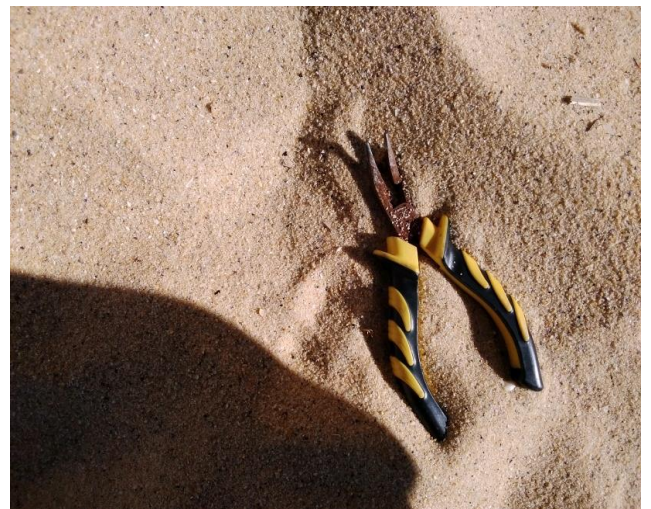
Notes: Sand surface following emu pick - Southern section

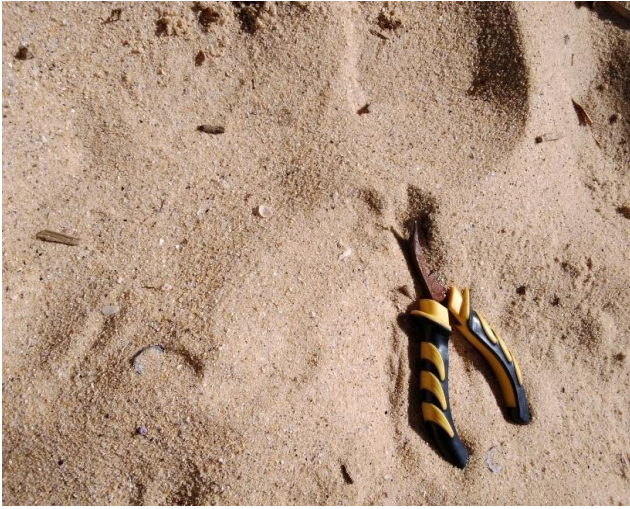
Notes: Sand surface following emu pick - Southern section
