Asbestos Containing Material Clearance Inspection

10 June 2023

Site:	Little Bay Beach
Location:	Southern, Western and Northern Little Bay Beach

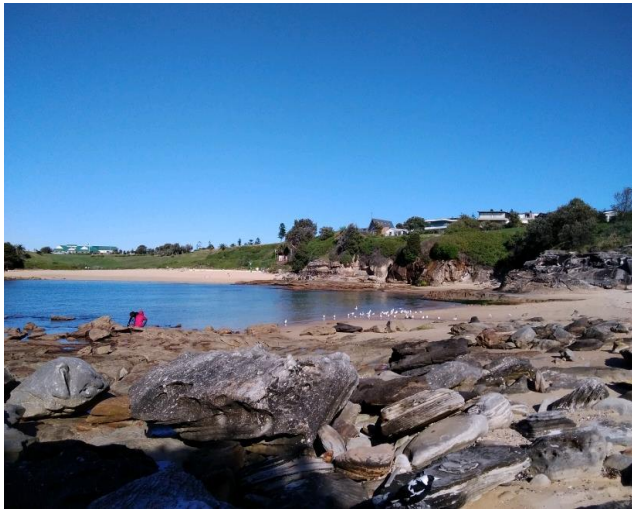
Notes: Overview of the Beach during the inspection

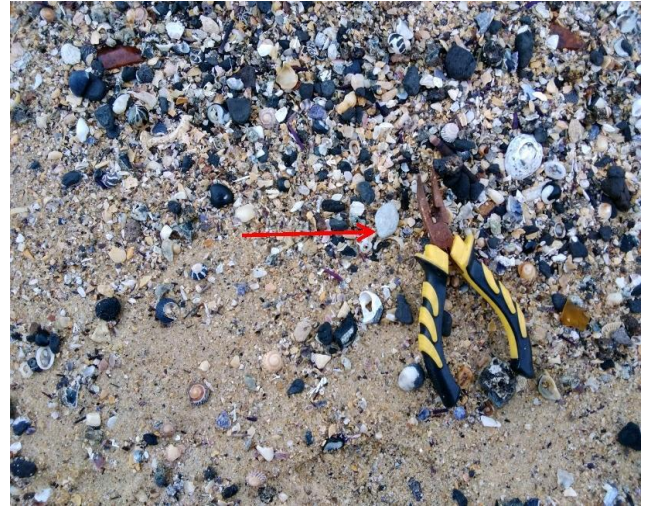
Notes: FC fragment identified on sand surface prior to emu pick - Northern section

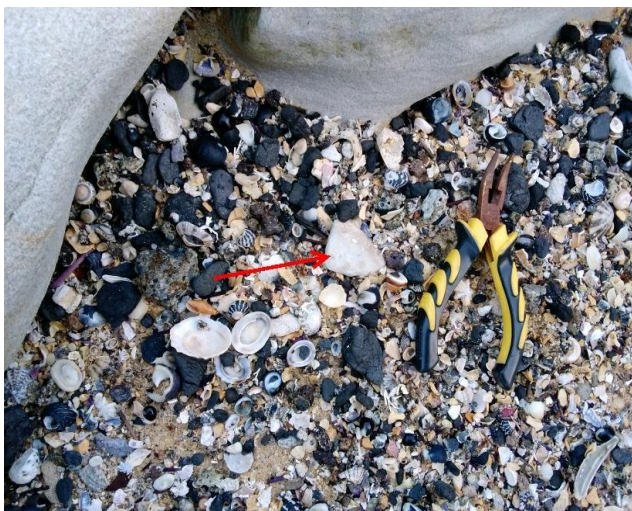
Notes: FC fragment identified on sand surface prior to emu pick - Northern section

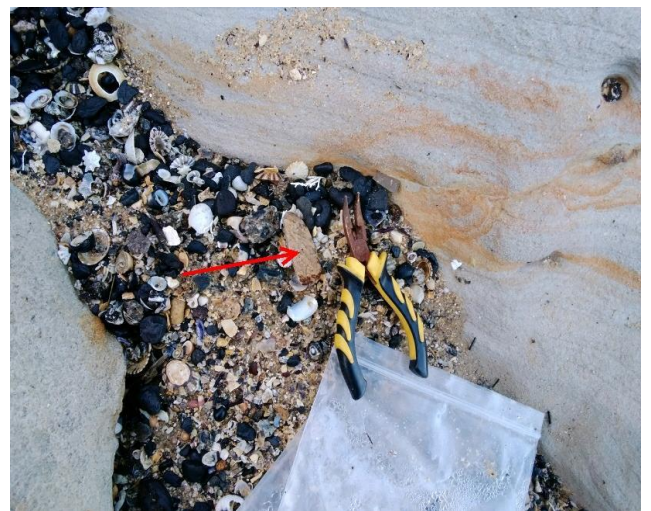
Notes: FC fragment identified on sand surface prior to emu pick - Northern section

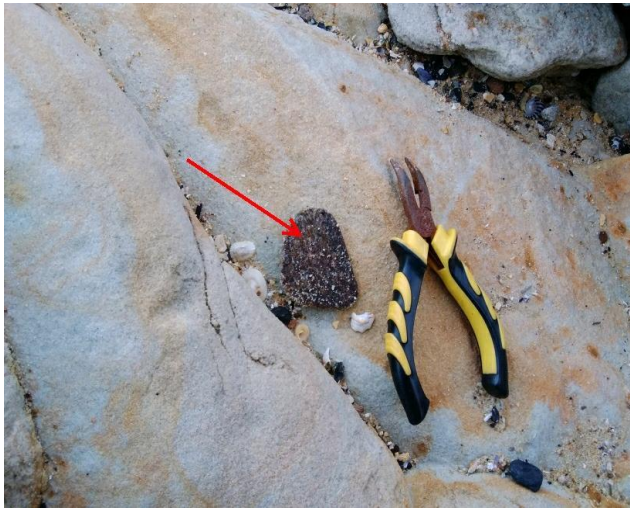
Notes: FC fragment identified on sand surface prior to emu pick - Northern section

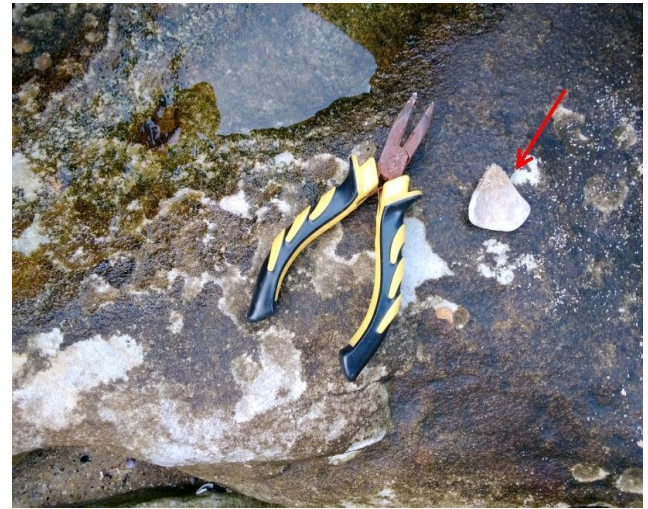
Notes: FC fragment identified on sand surface prior to emu pick - Northern section

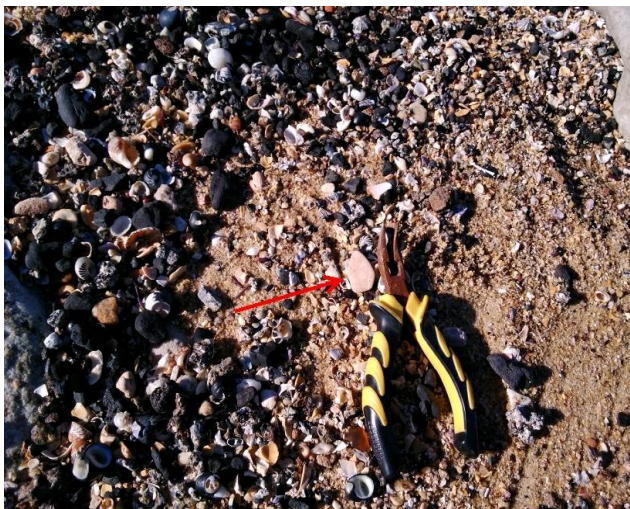
Notes: FC fragment identified on sand surface prior to emu pick - Northern section

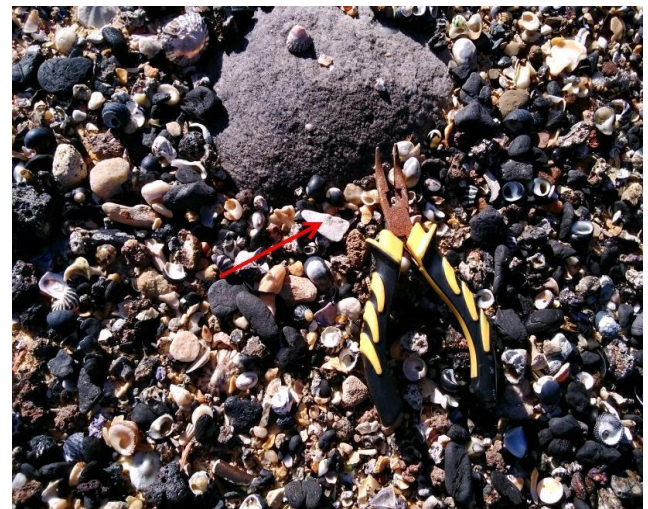
Notes: FC fragment identified on sand surface prior to emu pick - Northern section

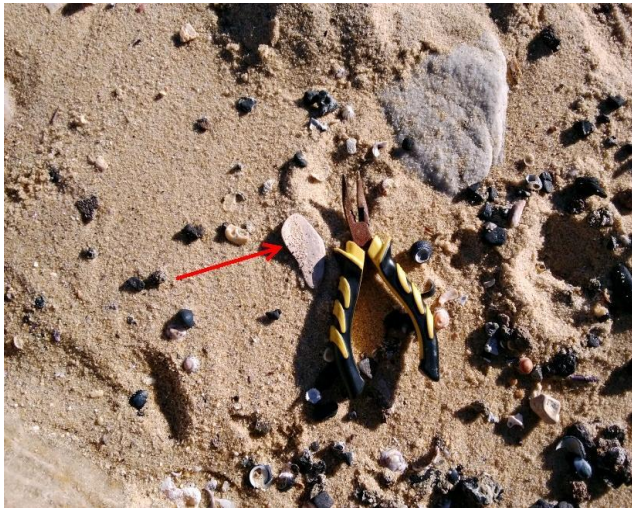
Notes: FC fragment identified on sand surface prior to emu pick - Northern section

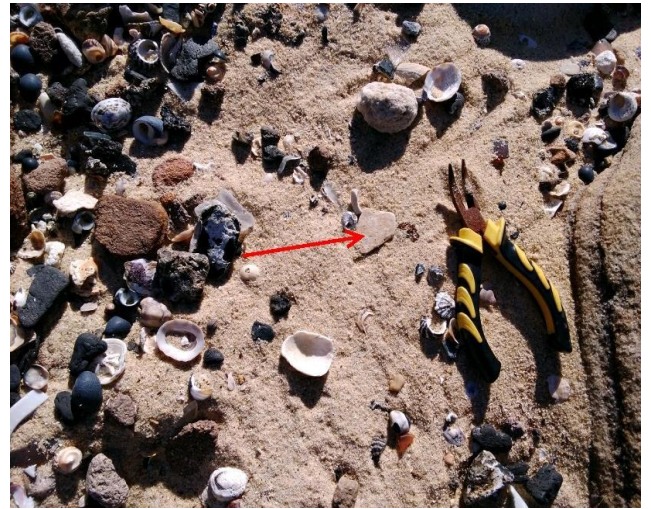
Notes: FC fragment identified on sand surface prior to emu pick - Northern section

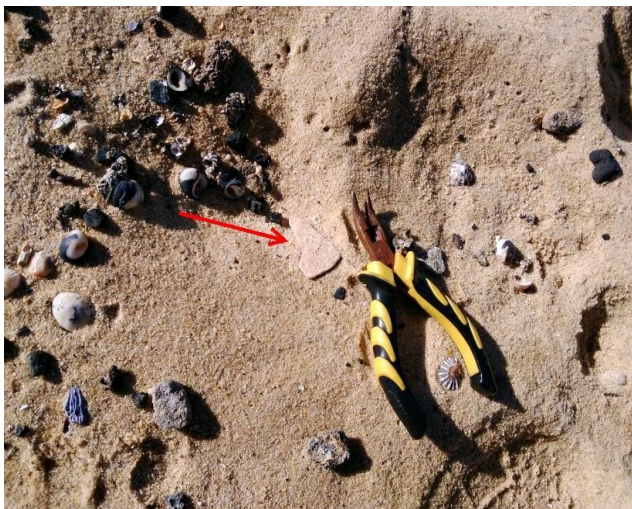
Notes: FC fragment identified on sand surface prior to emu pick - Northern section

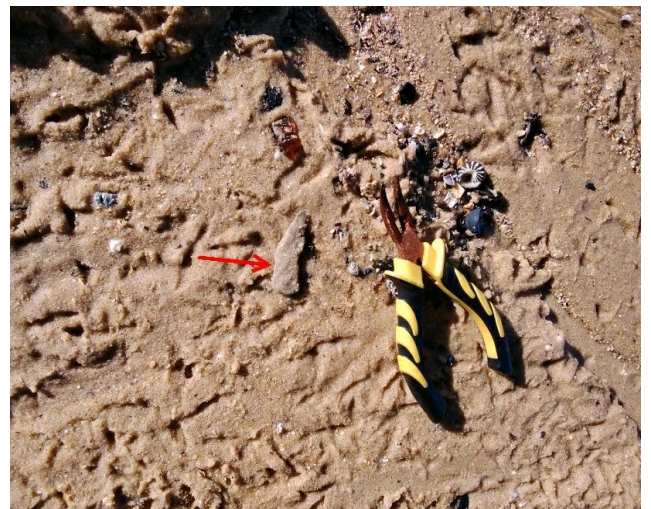
Notes: FC fragment identified on sand surface prior to emu pick - Northern section

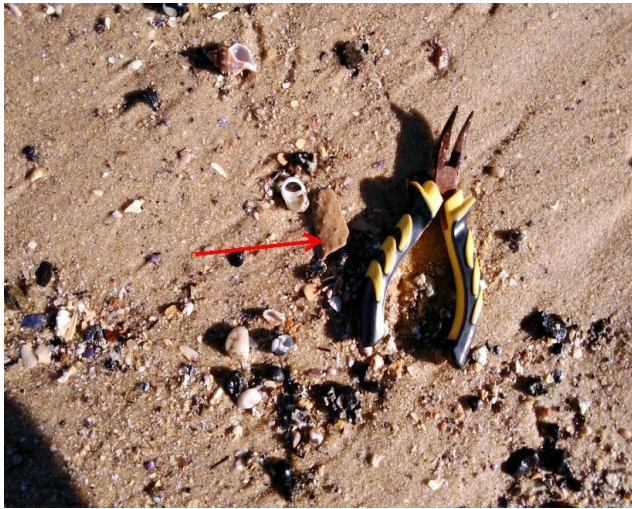
Notes: FC fragment identified on sand surface prior to emu pick - Northern section

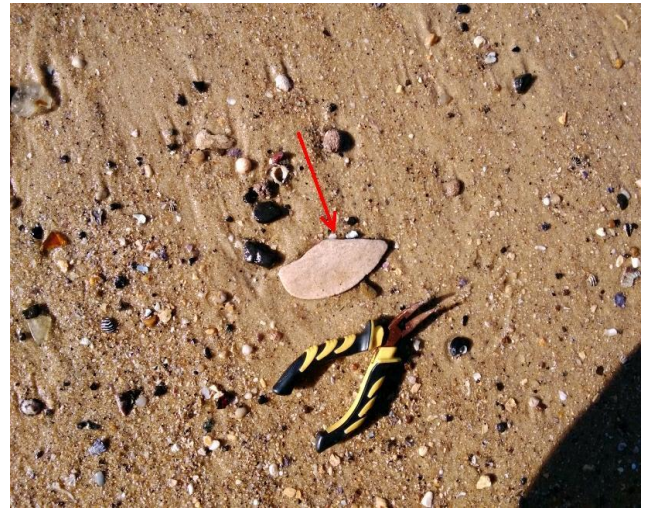
Notes: FC fragment identified on sand surface prior to emu pick - Western section

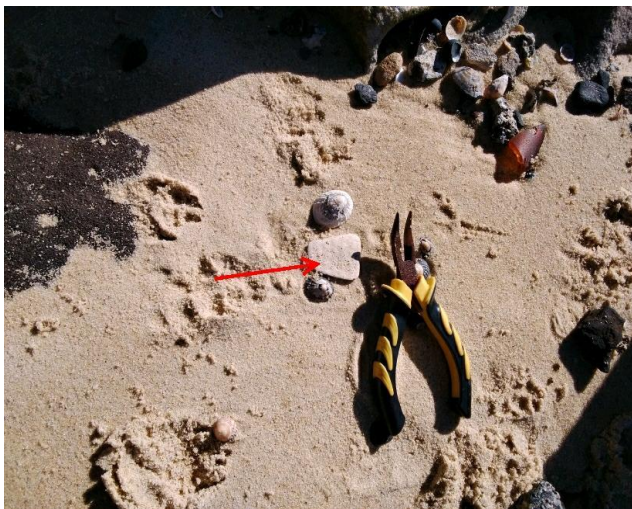
Notes: FC fragment identified on sand surface prior to emu pick - Western section

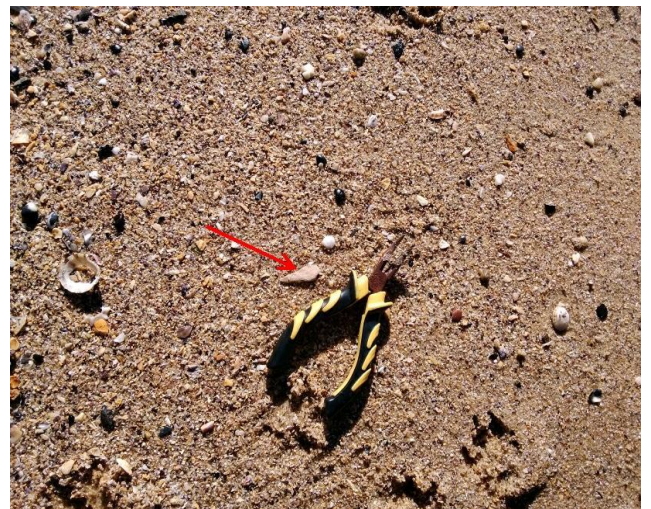
Notes: FC fragment identified on sand surface prior to emu pick - Western section

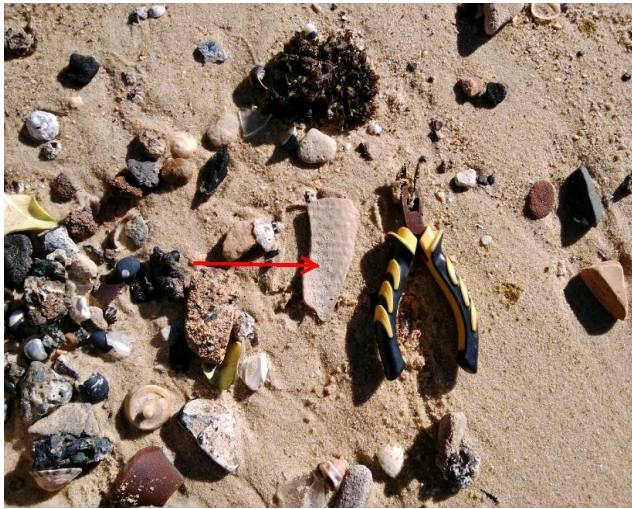
Notes: FC fragment identified on sand surface prior to emu pick - Western section

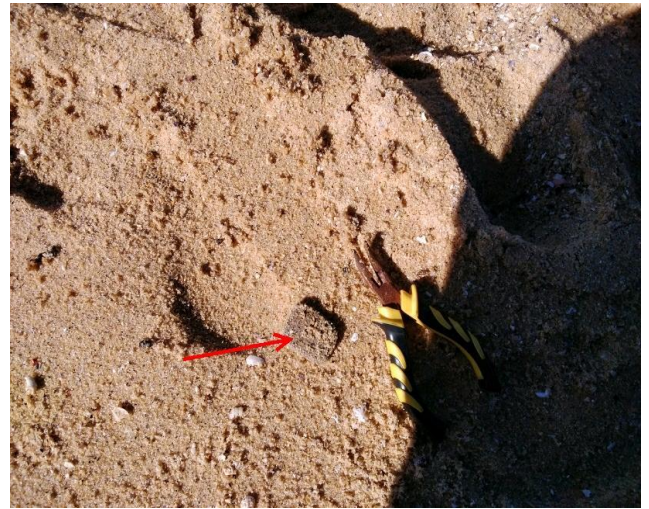
Notes: FC fragment identified on sand surface prior to emu pick - Southern section

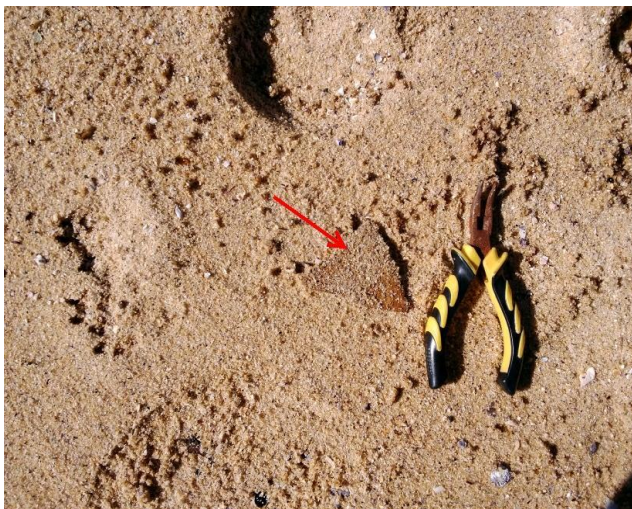
Notes: FC fragment identified on sand surface prior to emu pick - Southern section

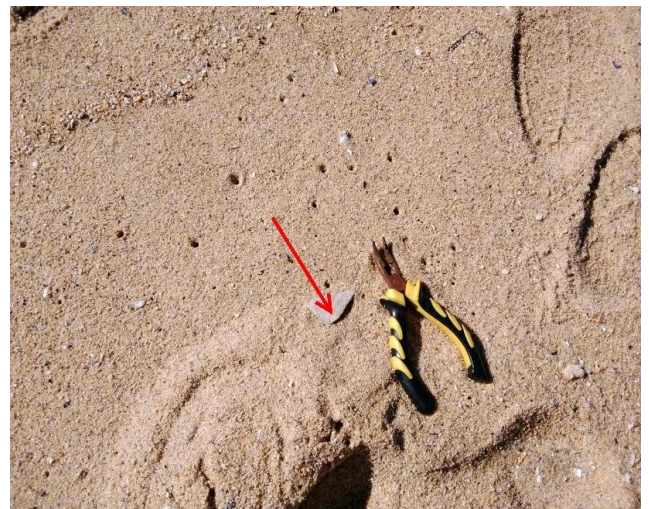
Notes: FC fragment identified on sand surface prior to emu pick - Southern section

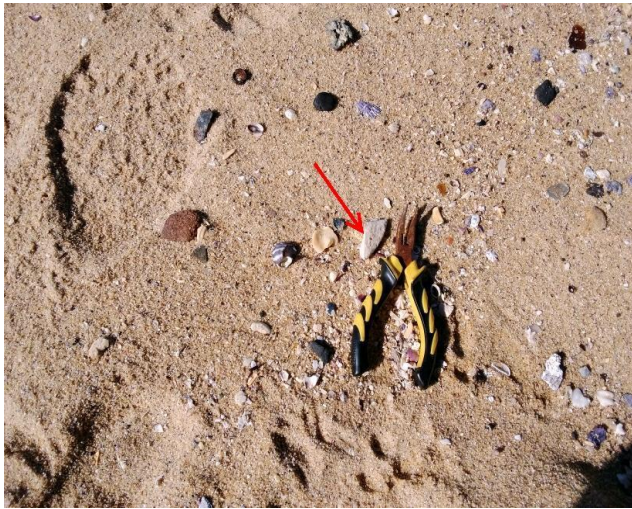
Notes: FC fragment identified on sand surface prior to emu pick - Southern section

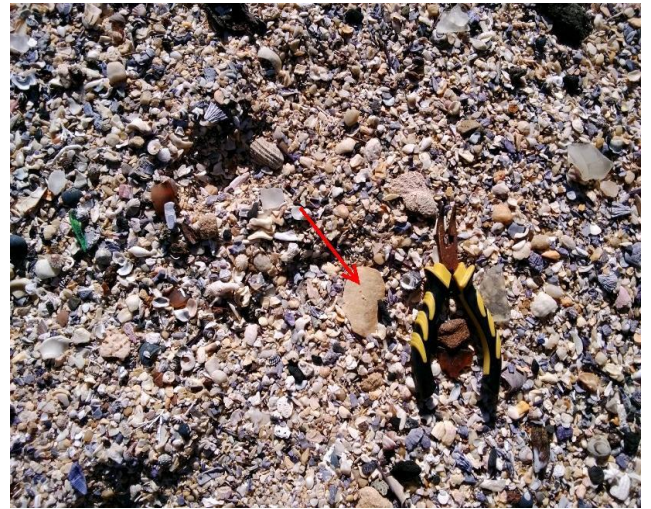
Notes: FC fragment identified on sand surface prior to emu pick - Southern section

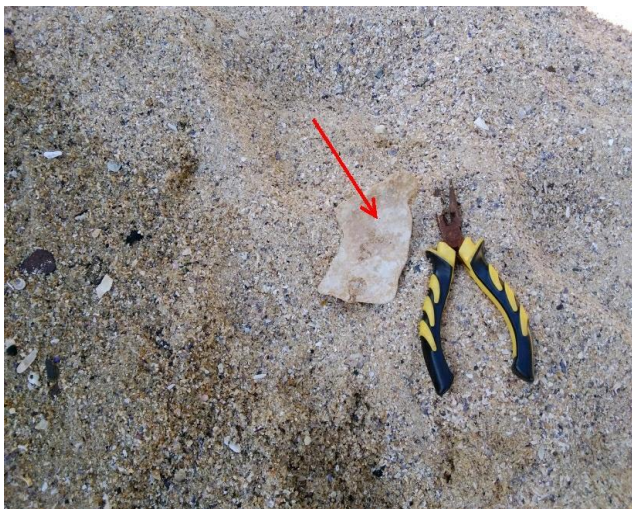
Notes: FC fragment identified on sand surface prior to emu pick - Southern section

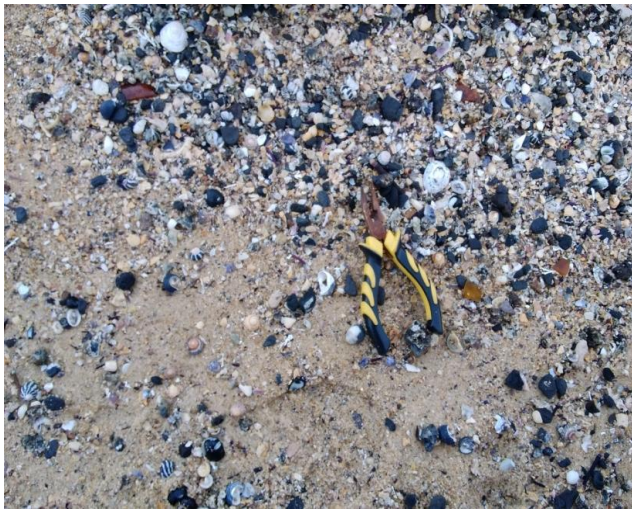
Notes: Sand surface following emu pick - Northern section

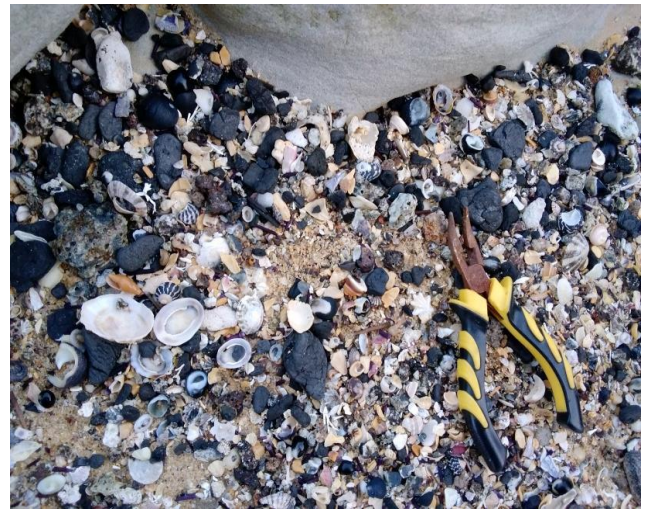
Notes: Sand surface following emu pick - Northern section

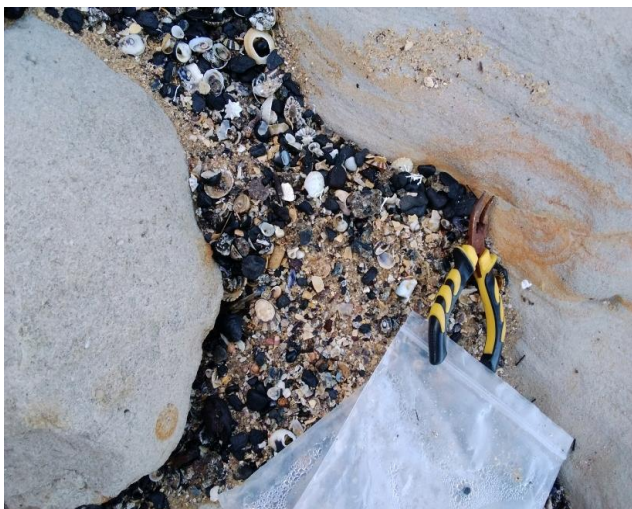
Notes: Sand surface following emu pick - Northern section

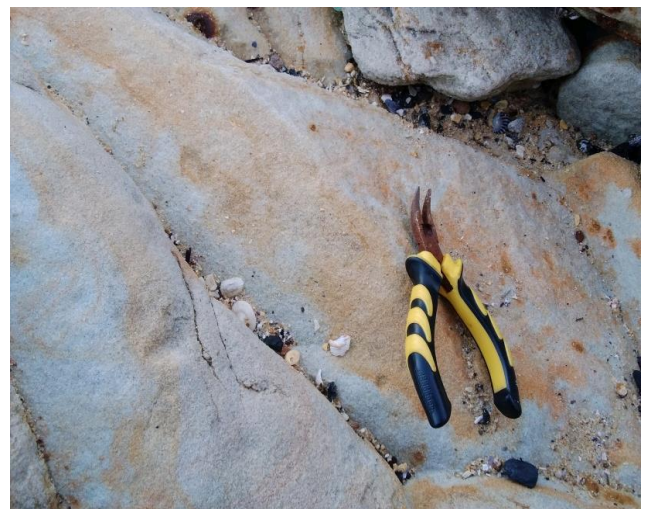
Notes: Sand surface following emu pick - Northern section

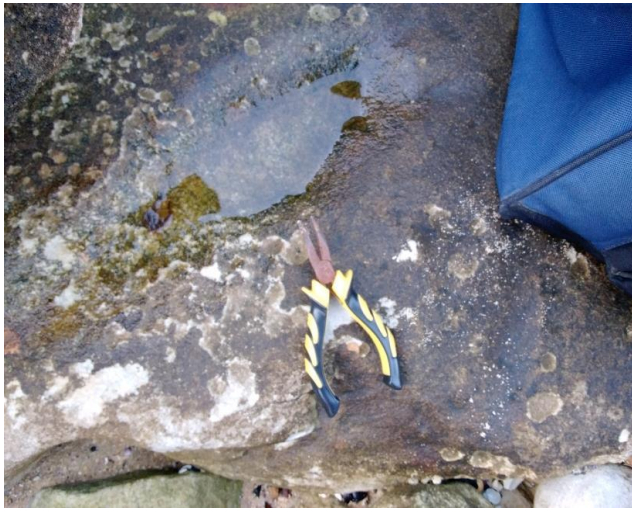
Notes: Sand surface following emu pick - Northern section

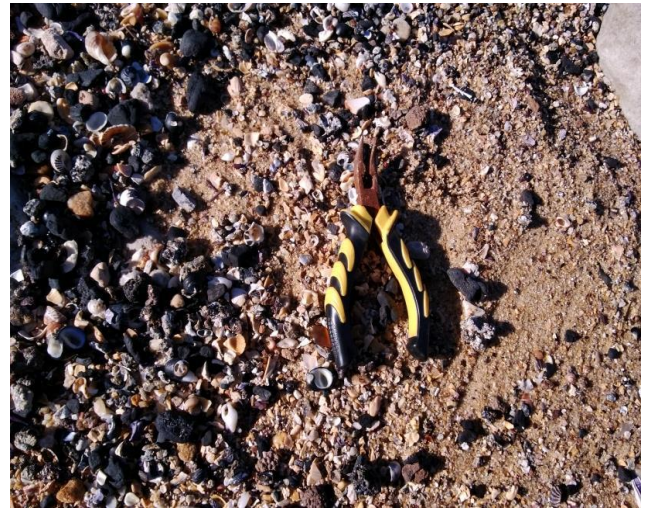
Notes: Sand surface following emu pick - Northern section

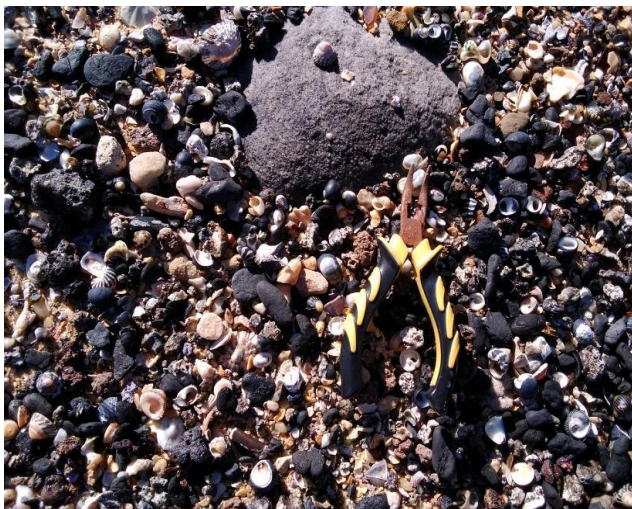
Notes: Sand surface following emu pick - Northern section

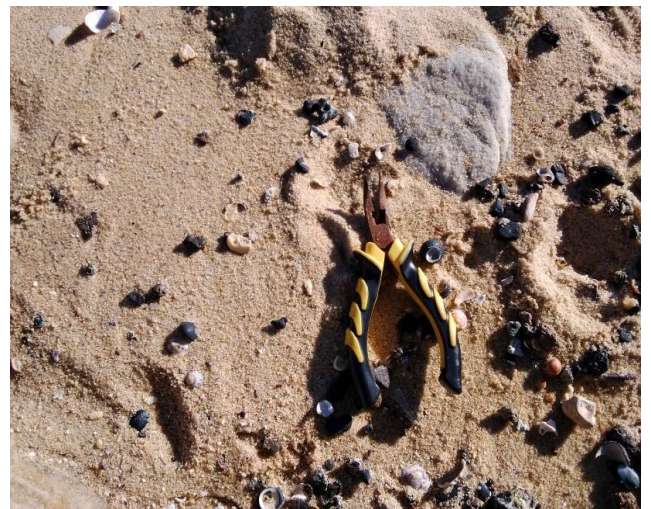
Notes: Sand surface following emu pick - Northern section

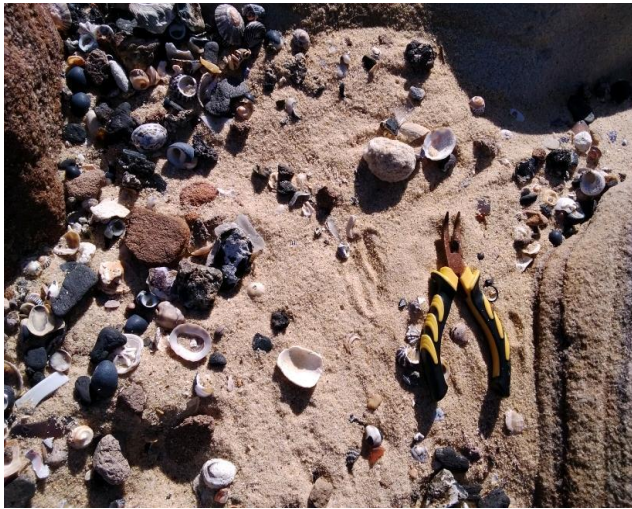
Notes: Sand surface following emu pick - Northern section

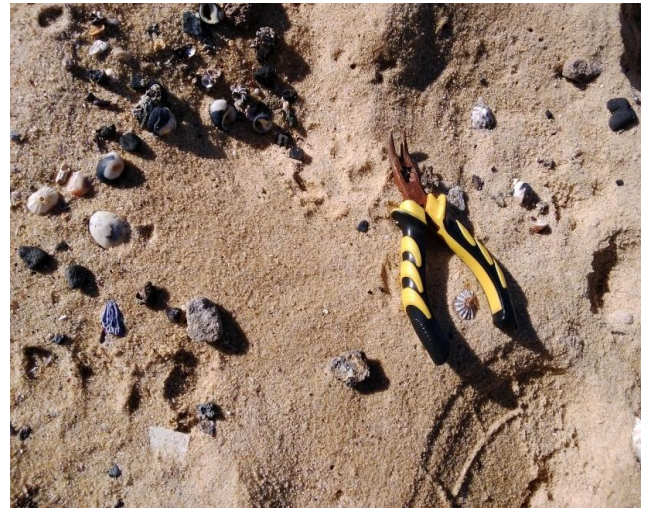
Notes: Sand surface following emu pick - Northern section

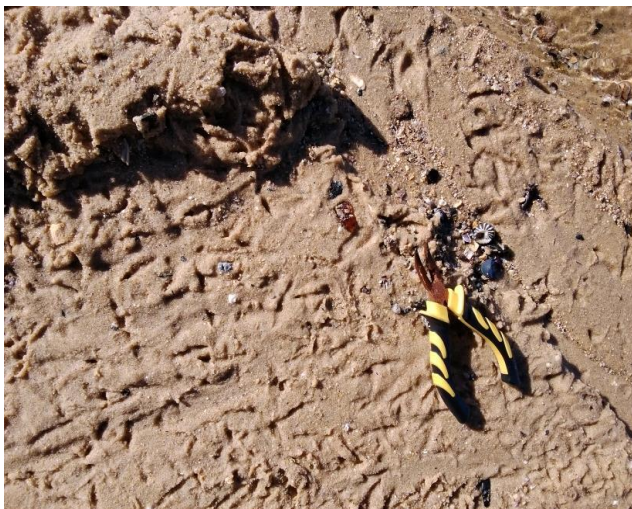
Notes: Sand surface following emu pick - Northern section

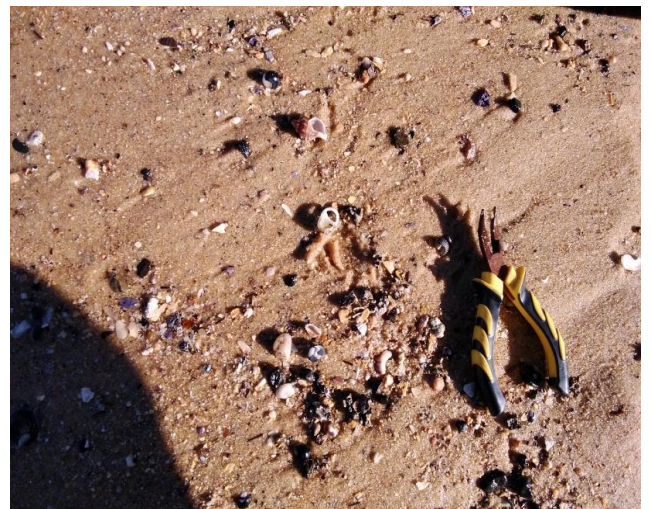
Notes: Sand surface following emu pick - Northern section

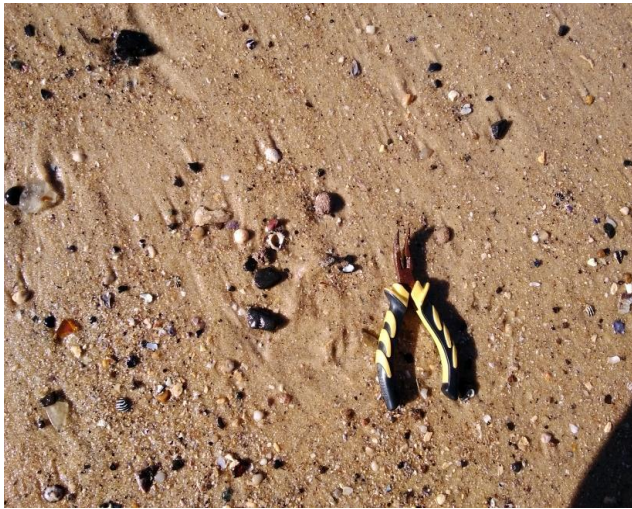
Notes: Sand surface following emu pick - Western section

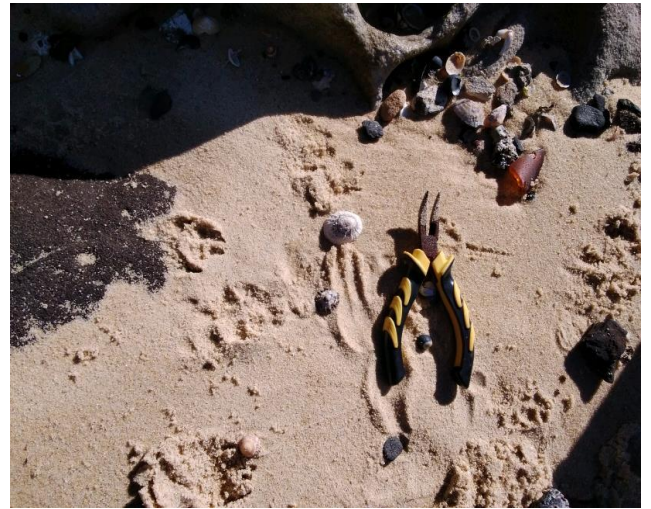
Notes: Sand surface following emu pick - Western section

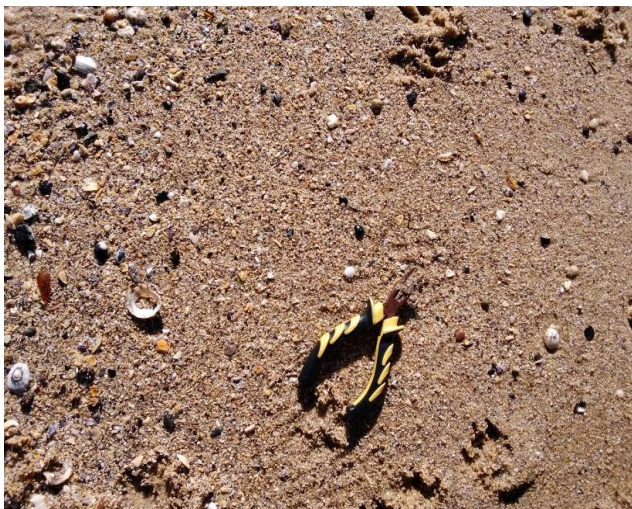
Notes: Sand surface following emu pick - Western section

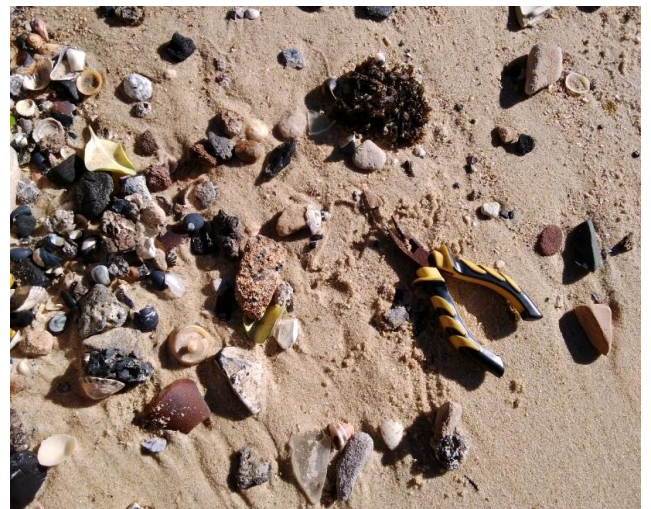
Notes: Sand surface following emu pick - Western section

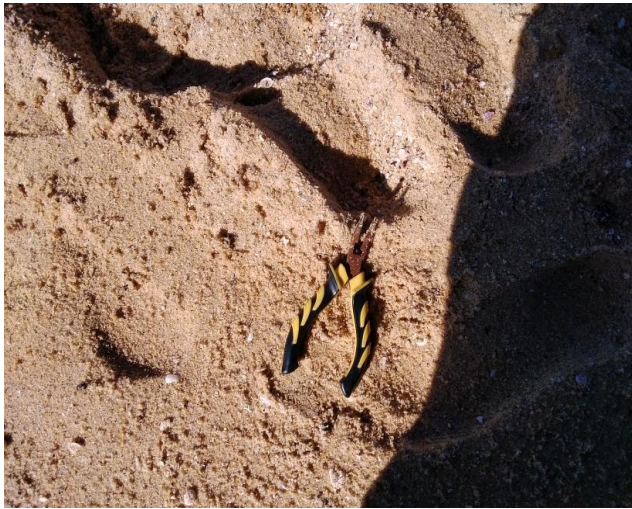
Notes: Sand surface following emu pick - Western section

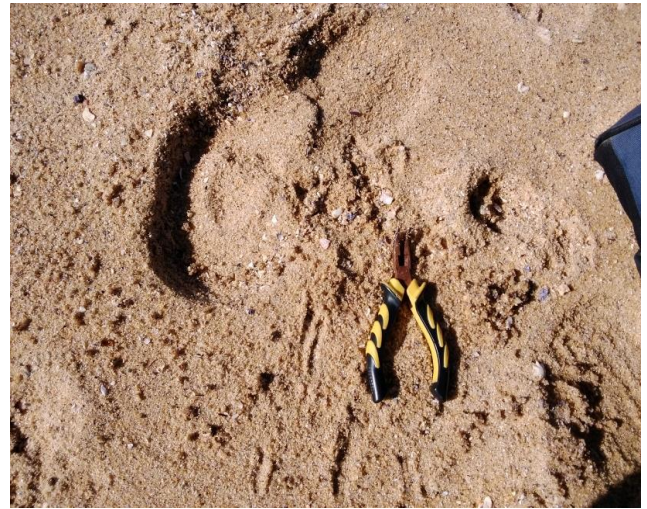
Notes: Sand surface following emu pick - Southern section

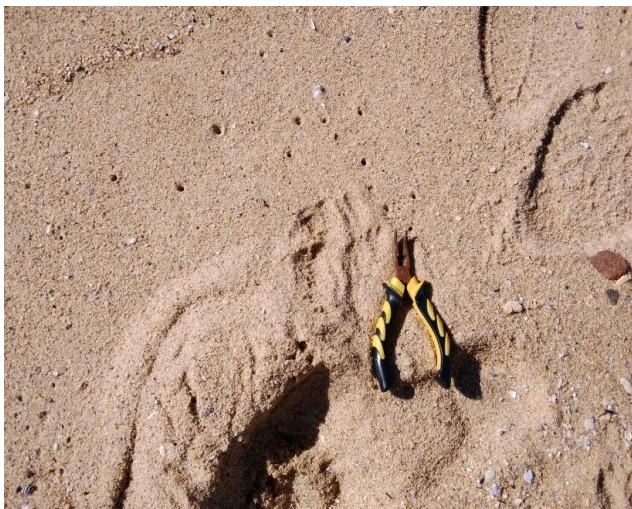
Notes: Sand surface following emu pick - Southern section

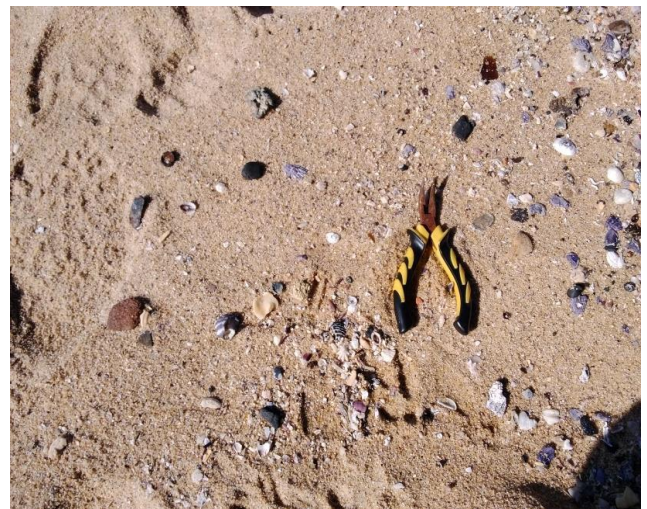
Notes: Sand surface following emu pick - Southern section

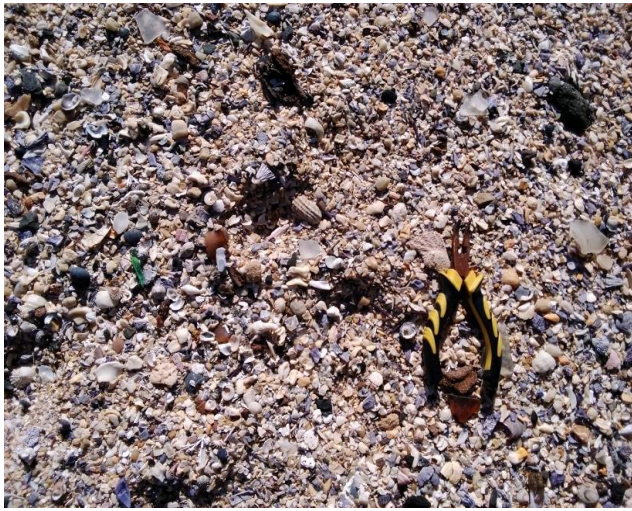
Notes: Sand surface following emu pick - Southern section

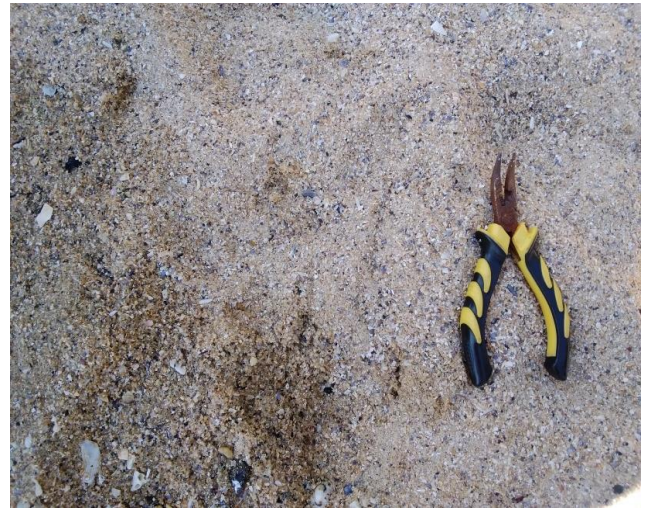
Notes: Sand surface following emu pick - Southern section
