Asbestos Containing Material Clearance Inspection

28 December 2022

Site:	Little Bay Beach
Location:	Southern, Western and Northern Little Bay Beach

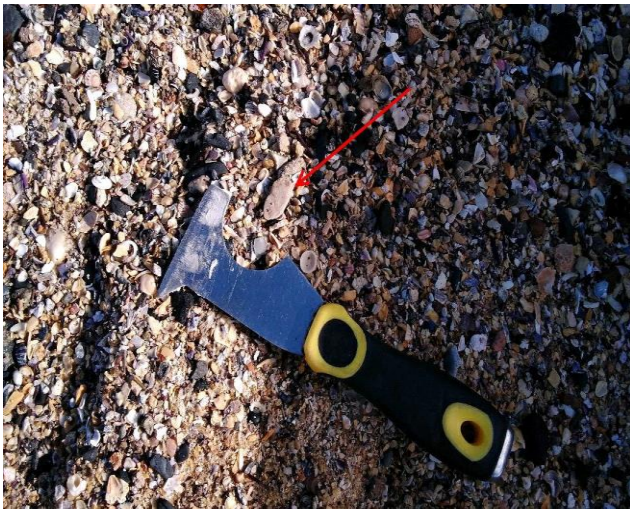
Notes: FC fragment identified on sand surface prior to emu pick - Northern section

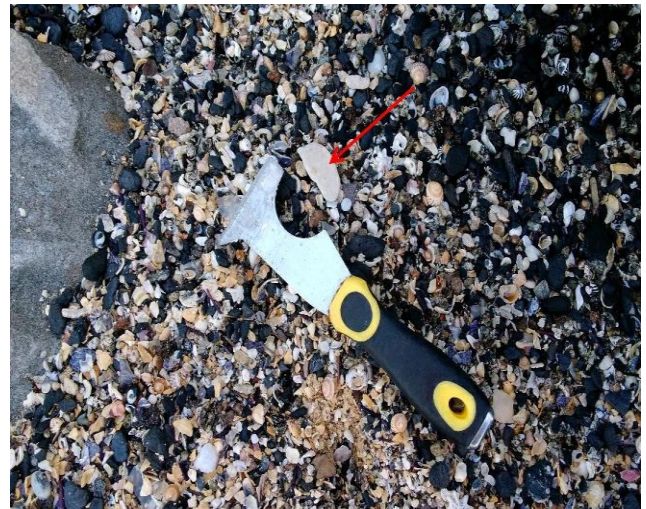
Notes: FC fragment identified on sand surface prior to emu pick - Northern section

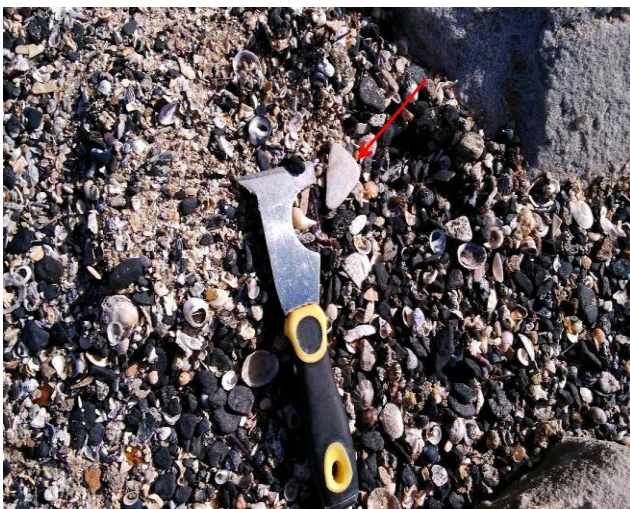
Notes: FC fragment identified on sand surface prior to emu pick - Northern section

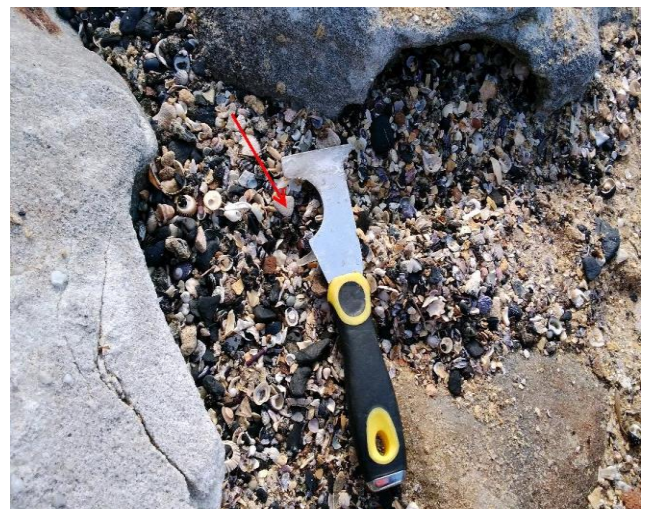
Notes: FC fragment identified on sand surface prior to emu pick - Northern section

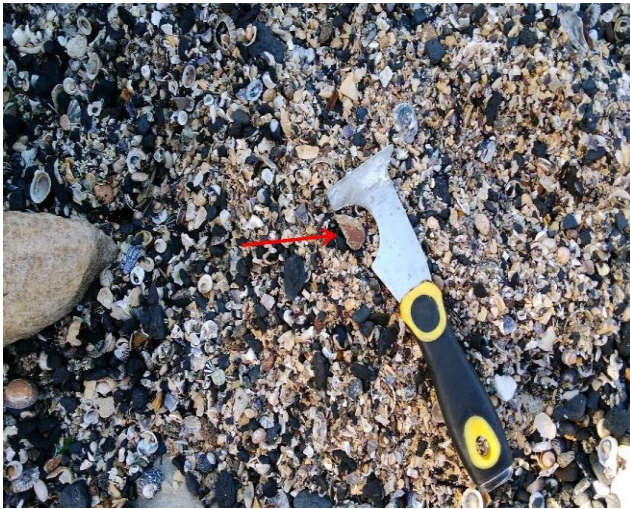
Notes: FC fragment identified on sand surface prior to emu pick - Northern section

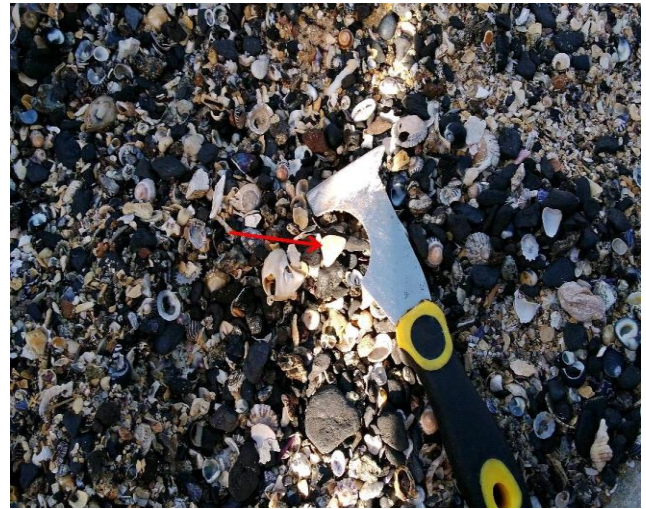
Notes: FC fragment identified on sand surface prior to emu pick - Northern section

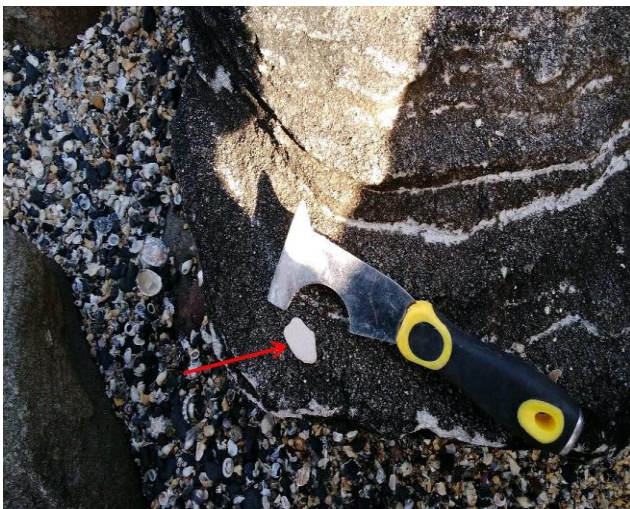
Notes: FC fragment identified on sand surface prior to emu pick - Northern section

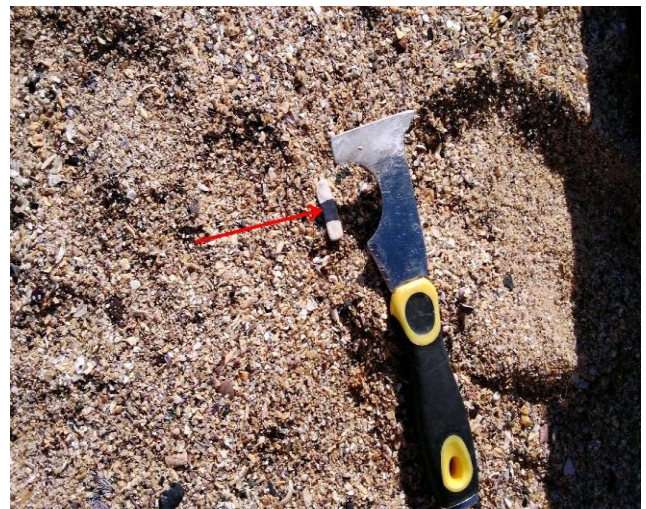
Notes: FC fragment identified on sand surface prior to emu pick - Northern section

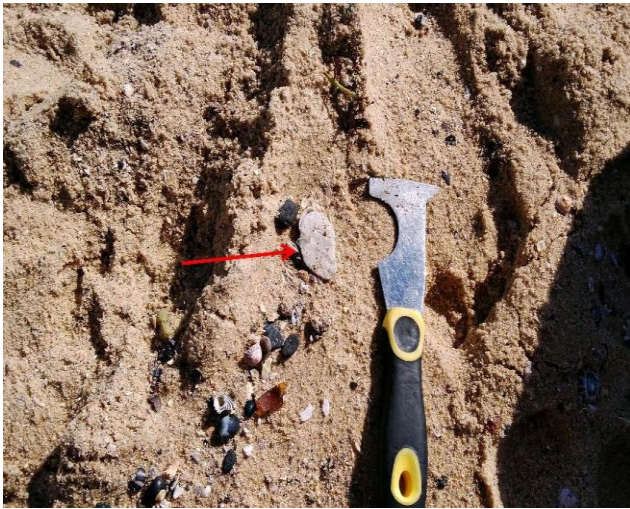
Notes: FC fragment identified on sand surface prior to emu pick - Northern section

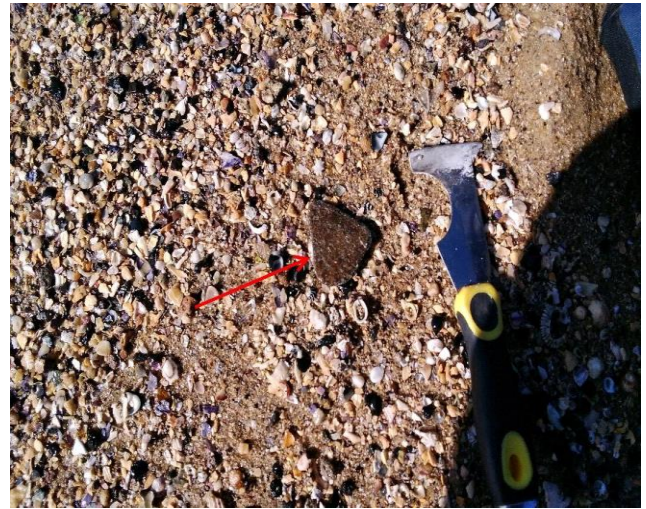
Notes: FC fragment identified on sand surface prior to emu pick - Northern section

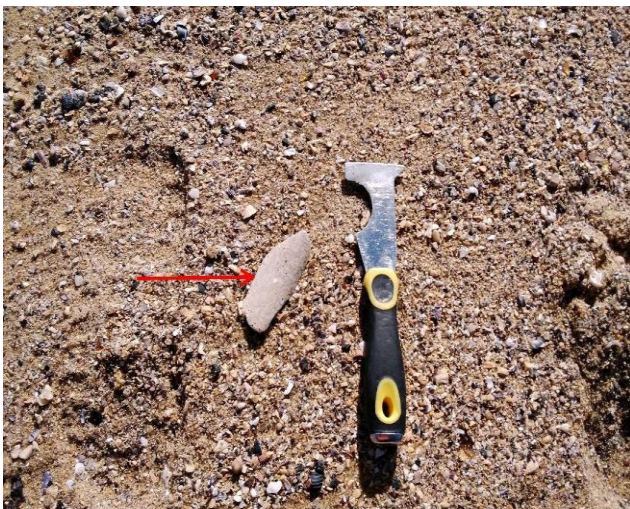
Notes: FC fragment identified on sand surface prior to emu pick - Northern section

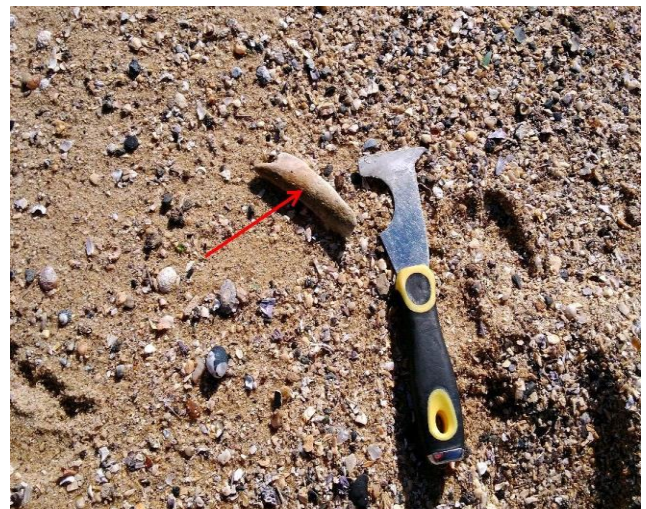
Notes: FC fragment identified on sand surface prior to emu pick - Northern section

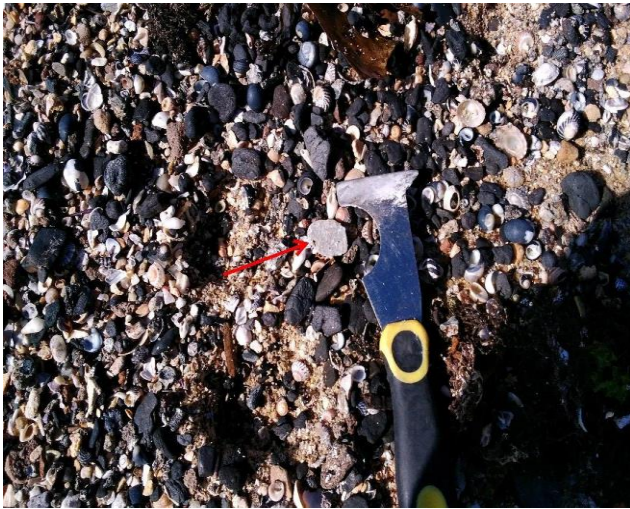
Notes: FC fragment identified on sand surface prior to emu pick - Northern section

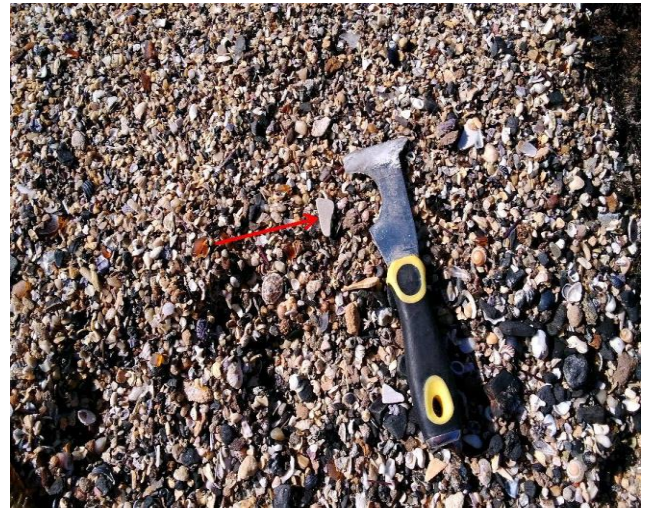
Notes: FC fragment identified on sand surface prior to emu pick - Northern section

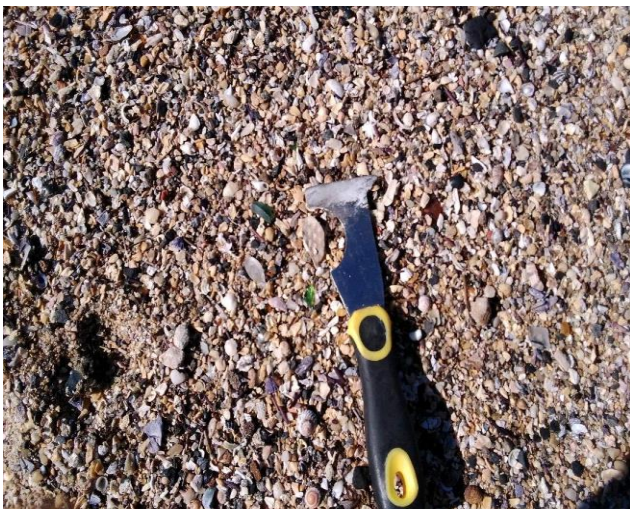
Notes: FC fragment identified on sand surface prior to emu pick - Southern section

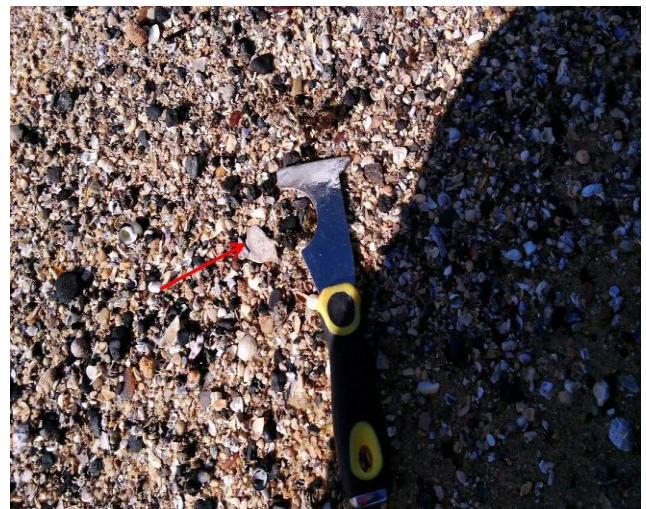
Notes: FC fragment identified on sand surface prior to emu pick - Southern section

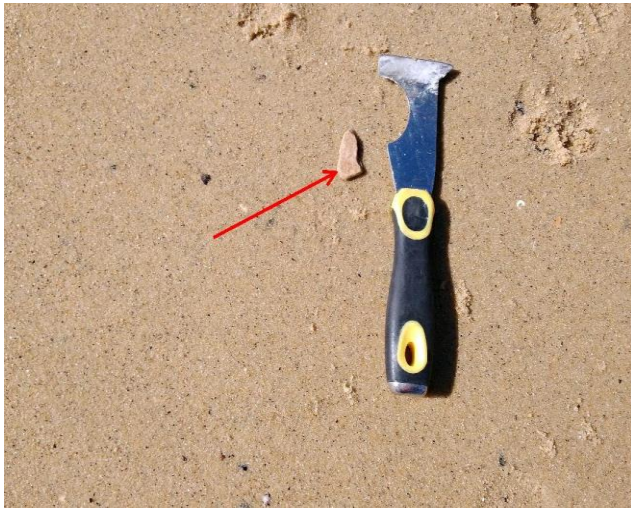
Notes: FC fragment identified on sand surface prior to emu pick - Southern section

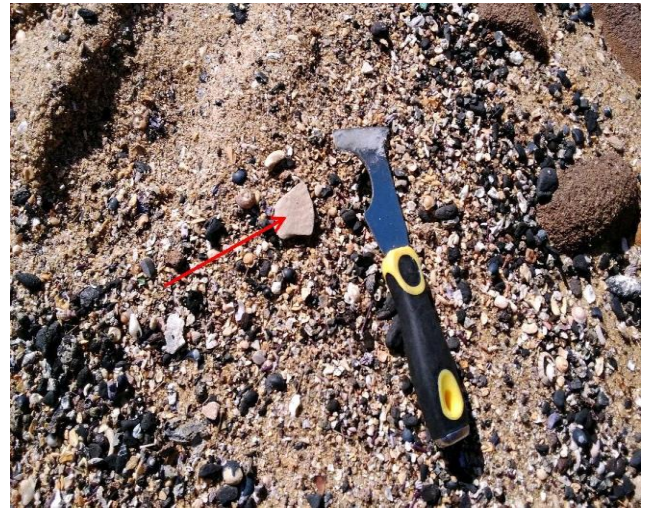
Notes: FC fragment identified on sand surface prior to emu pick - Southern section

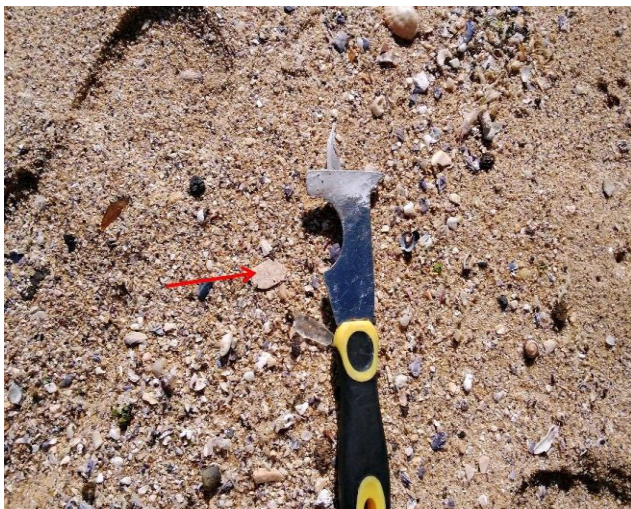
Notes: FC fragment identified on sand surface prior to emu pick - Southern section

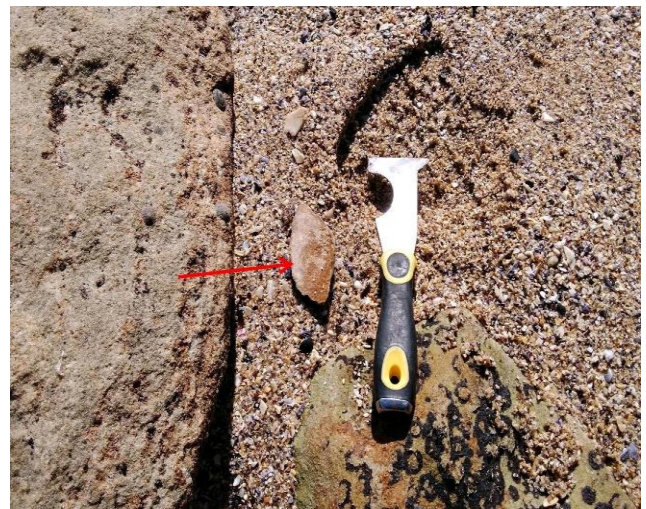
Notes: FC fragment identified on sand surface prior to emu pick - Southern section

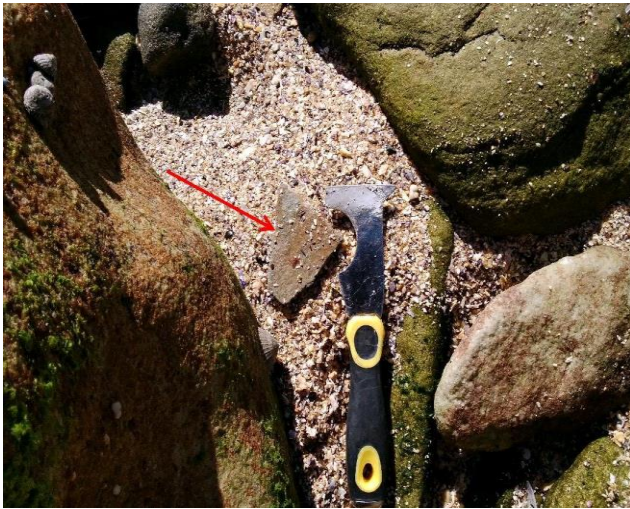
Notes: FC fragment identified on sand surface prior to emu pick - Southern section

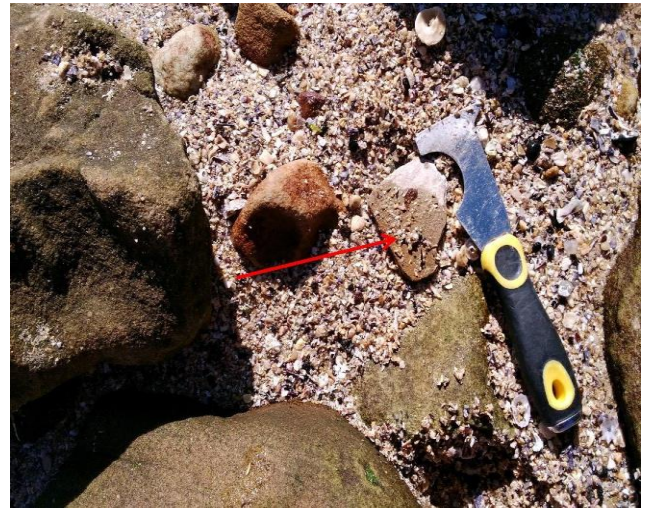
Notes: FC fragment identified on sand surface prior to emu pick - Southern section

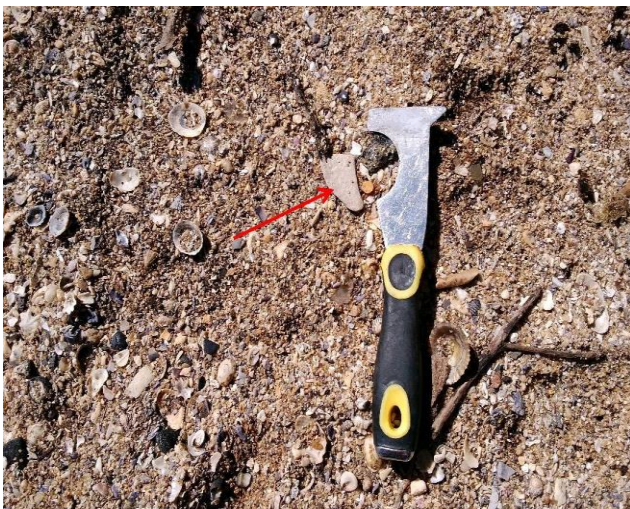
Notes: FC fragment identified on sand surface prior to emu pick - Southern section

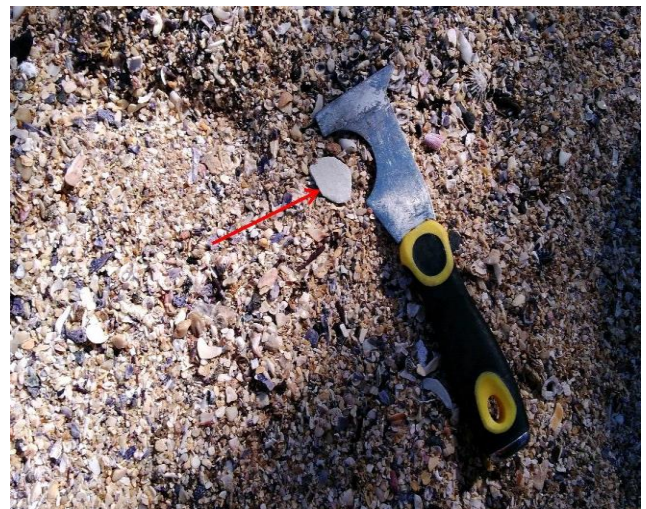
Notes: FC fragment identified on sand surface prior to emu pick - Southern section

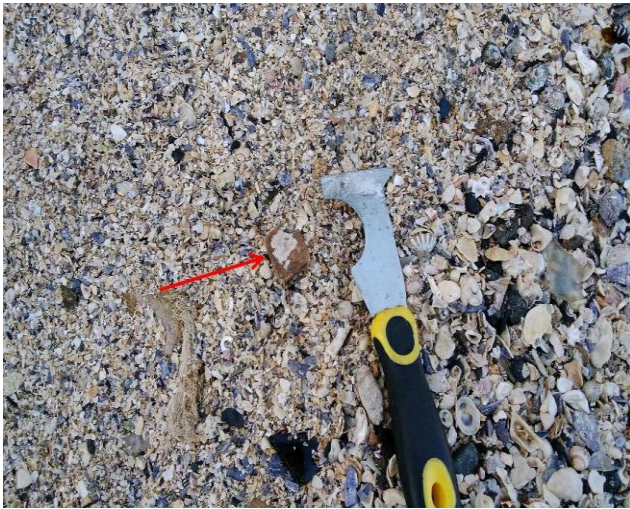
Notes: FC fragment identified on sand surface prior to emu pick - Southern section

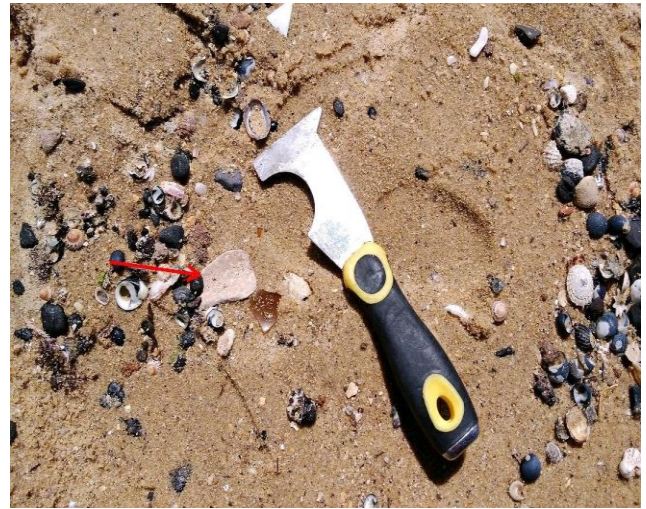
Notes: FC fragment identified on sand surface prior to emu pick - Northern section

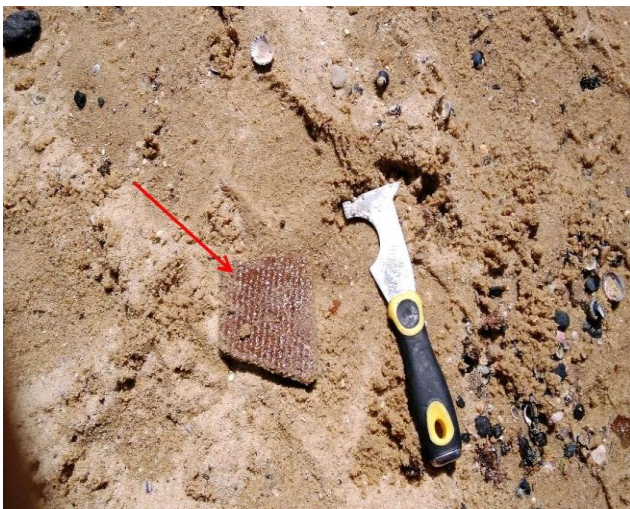
Notes: FC fragment identified on sand surface prior to emu pick - Northern section

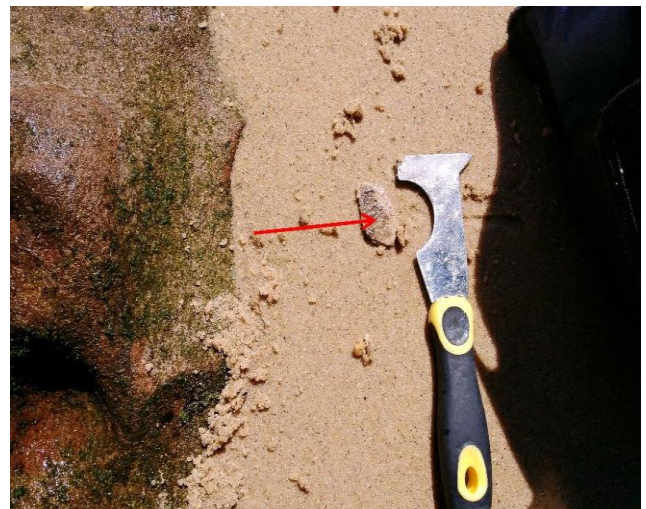
Notes: FC fragment identified on sand surface prior to emu pick - Northern section

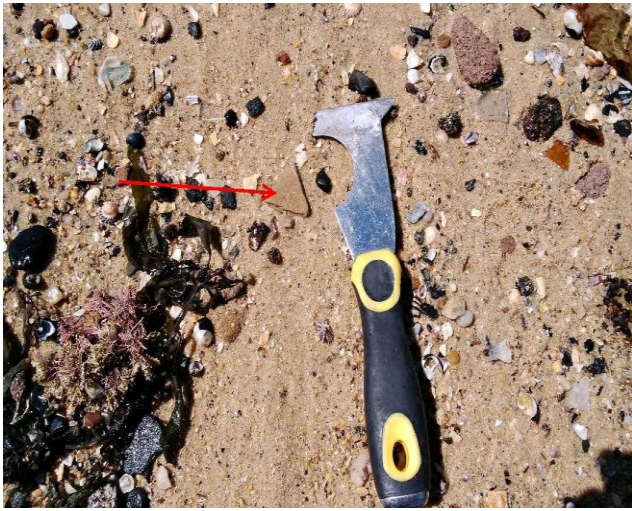
Notes: FC fragment identified on sand surface prior to emu pick - Northern section

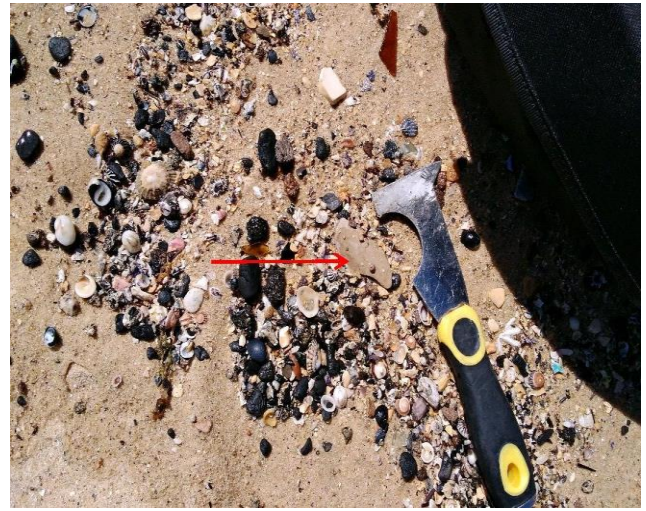
Notes: FC fragment identified on sand surface prior to emu pick - Northern section

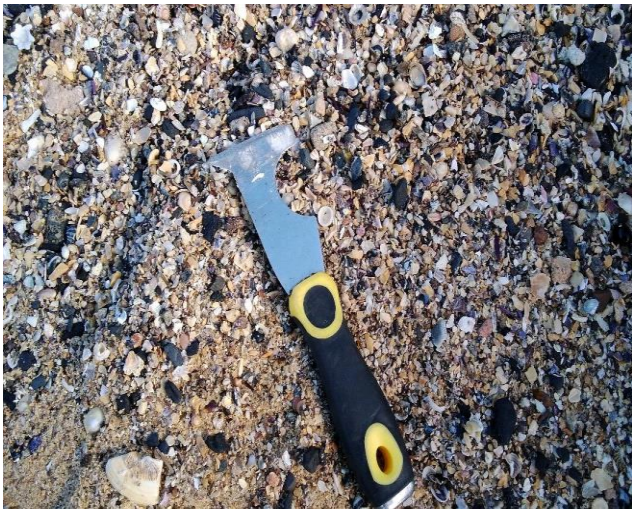
Notes: Sand surface following emu pick - Northern section

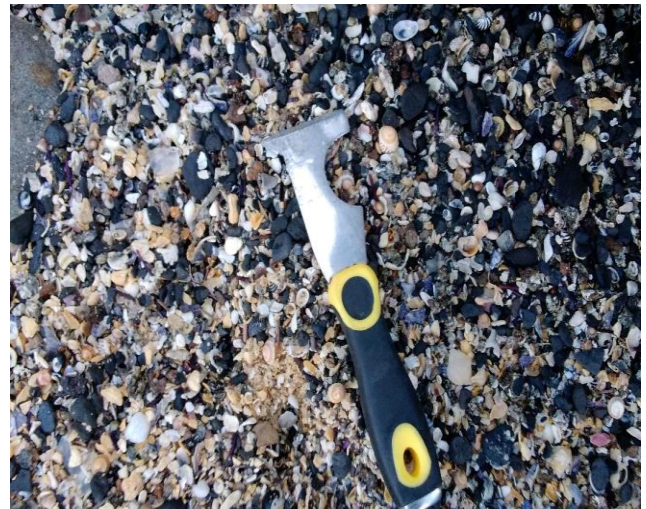
Notes: Sand surface following emu pick - Northern section

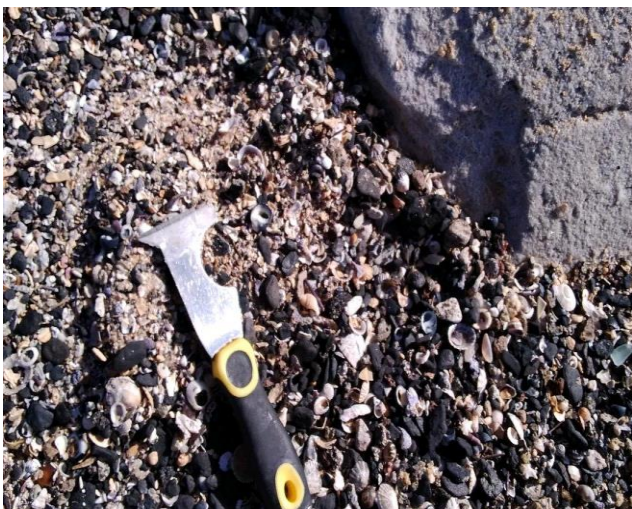
Notes: Sand surface following emu pick - Northern section

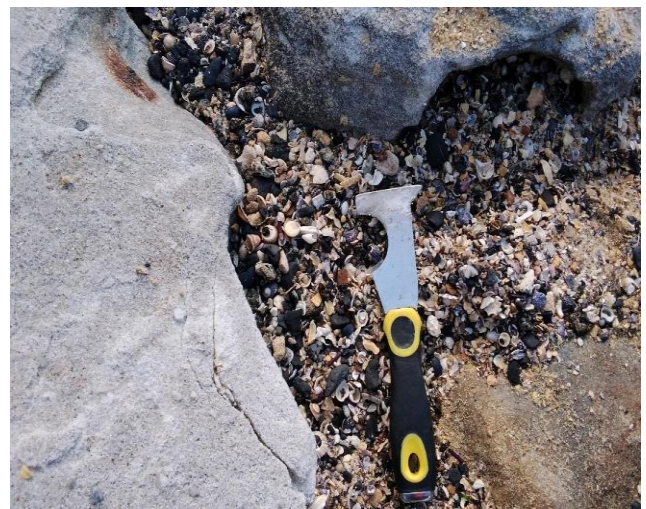
Notes: Sand surface following emu pick - Northern section

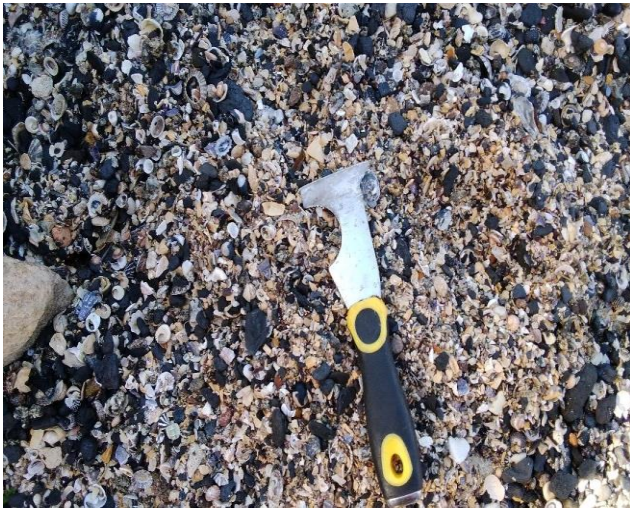
Notes: Sand surface following emu pick - Northern section

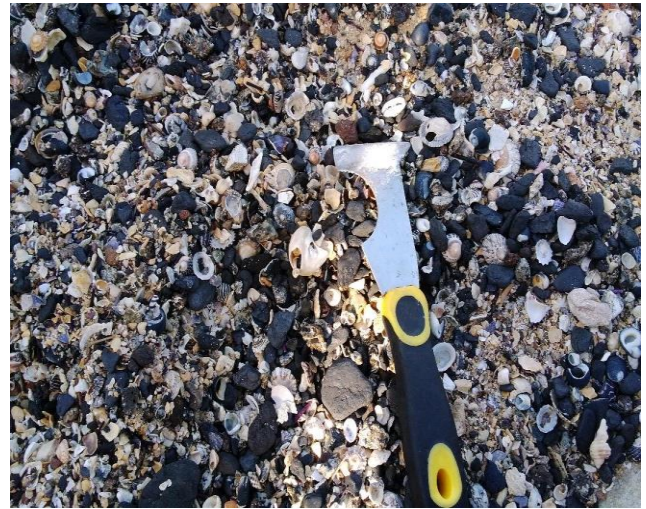
Notes: Sand surface following emu pick - Northern section

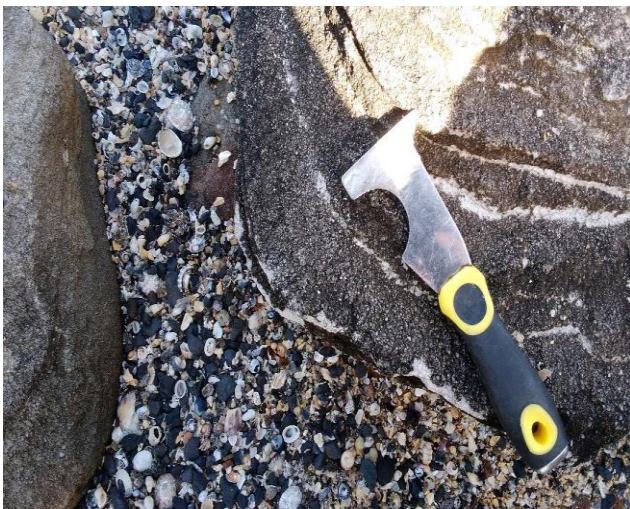
Notes: Sand surface following emu pick - Northern section

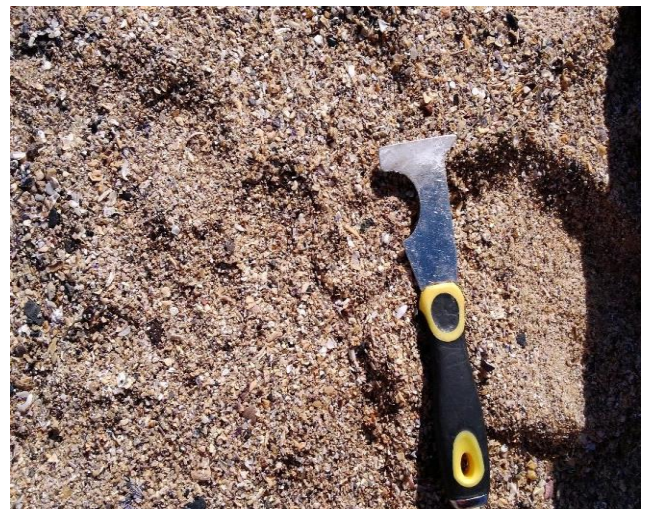
Notes: Sand surface following emu pick - Northern section

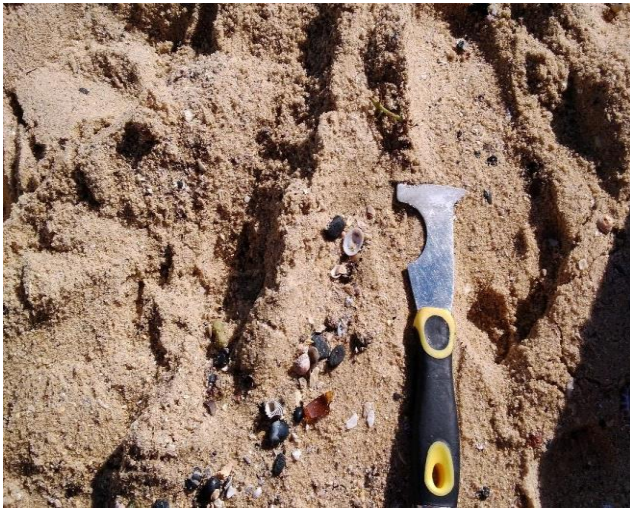
Notes: Sand surface following emu pick - Northern section

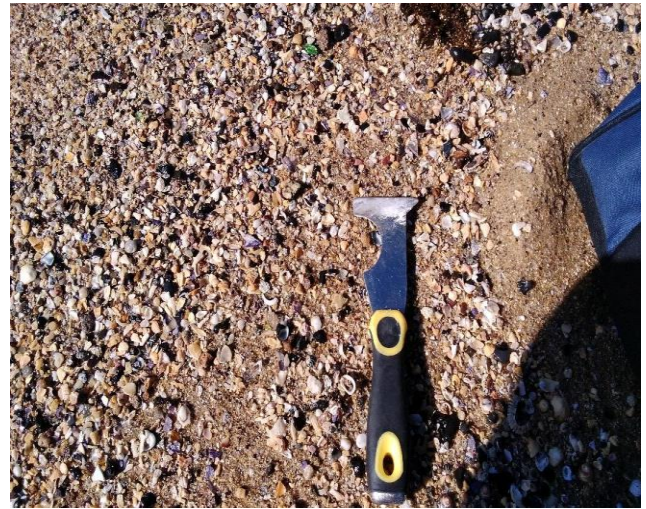
Notes: Sand surface following emu pick - Northern section

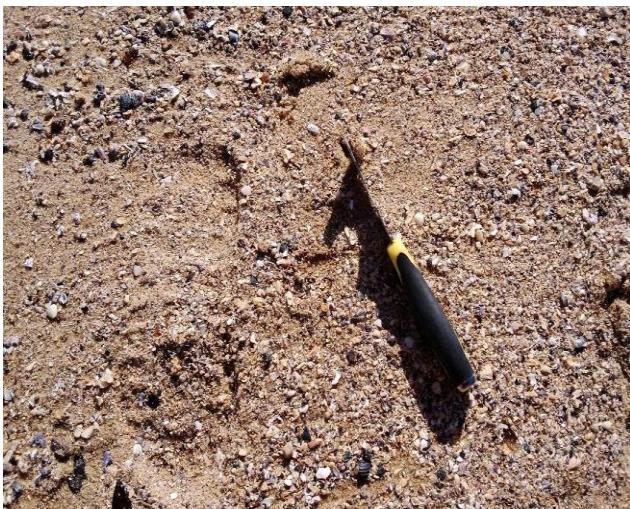
Notes: Sand surface following emu pick - Northern section

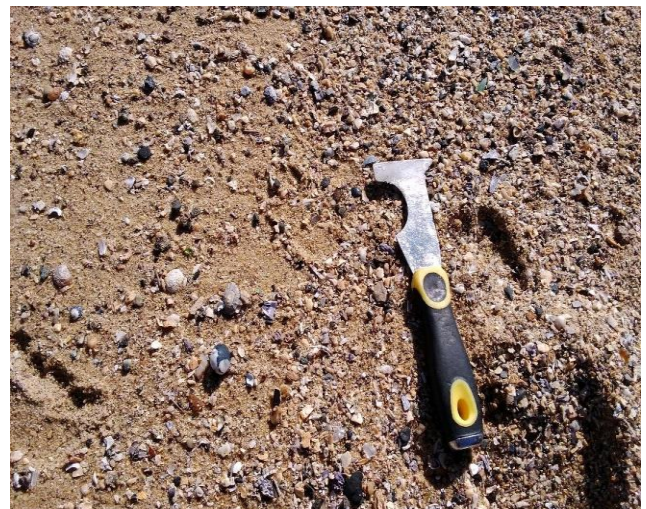
Notes: Sand surface following emu pick - Northern section

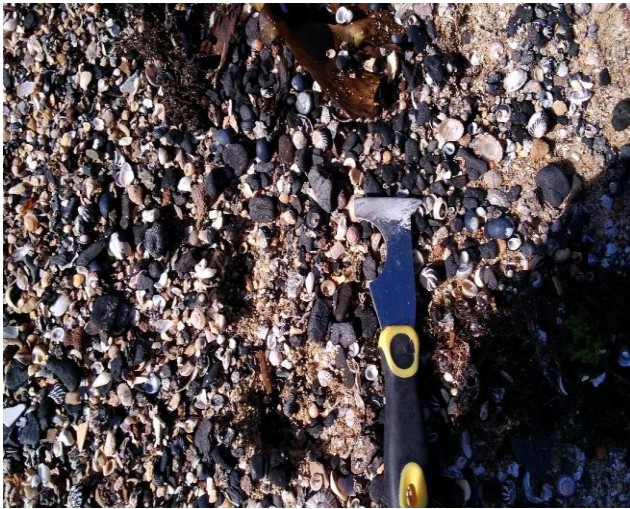
Notes: Sand surface following emu pick - Northern section

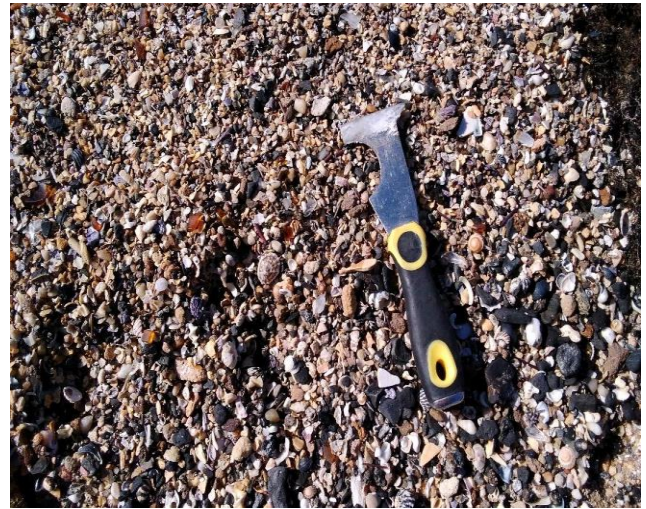
Notes: Sand surface following emu pick - Northern section

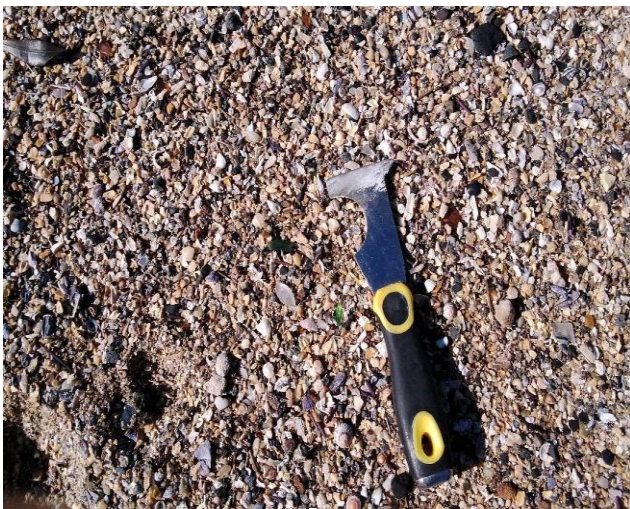
Notes: Sand surface following emu pick - Southern section

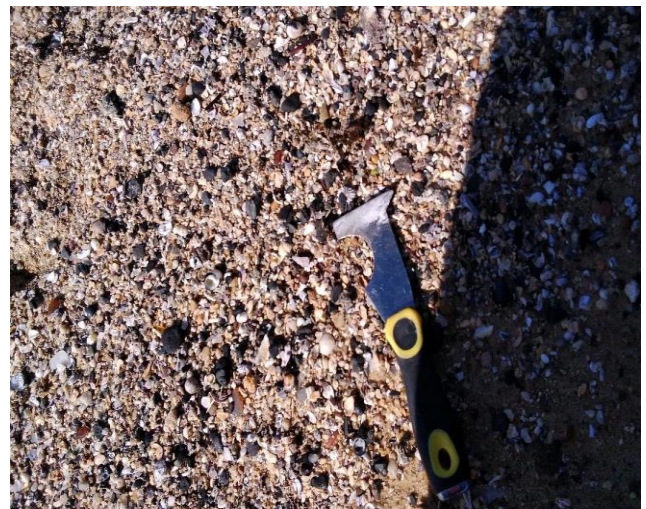
Notes: Sand surface following emu pick - Southern section

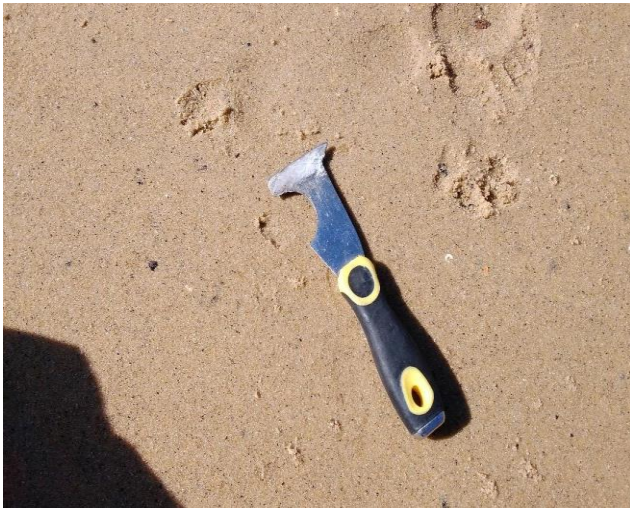
Notes: Sand surface following emu pick - Southern section

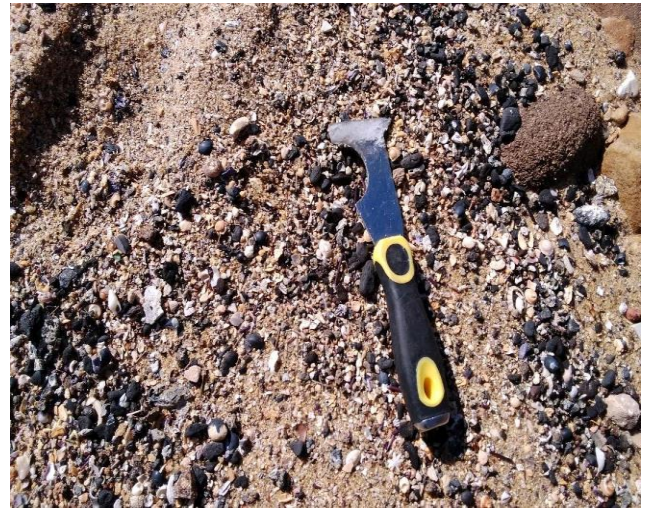
Notes: Sand surface following emu pick - Southern section

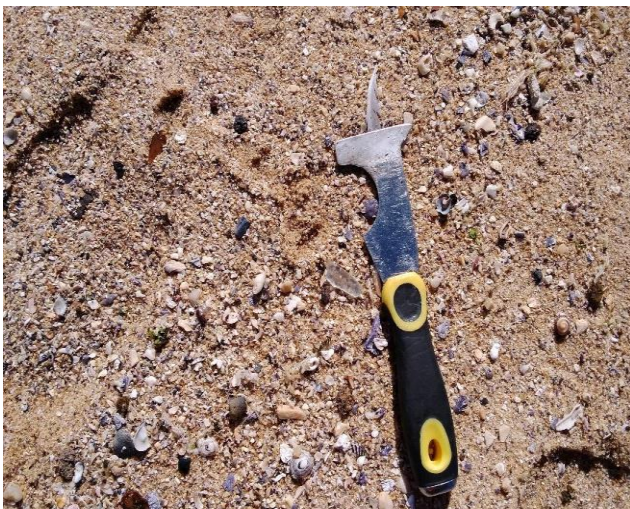
Notes: Sand surface following emu pick - Southern section

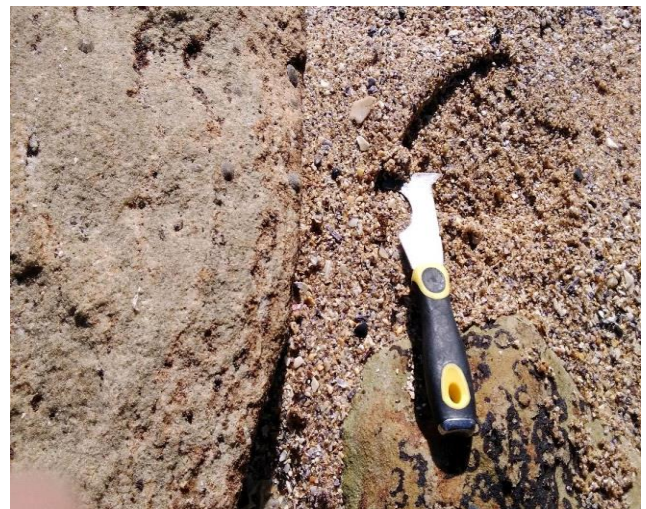
Notes: Sand surface following emu pick - Southern section

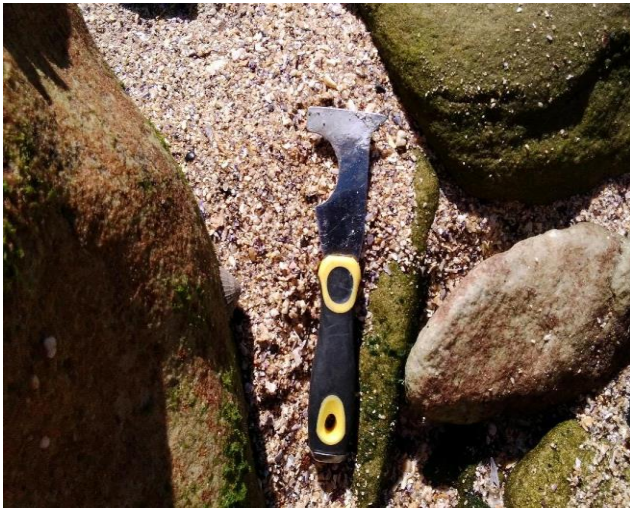
Notes: Sand surface following emu pick - Southern section

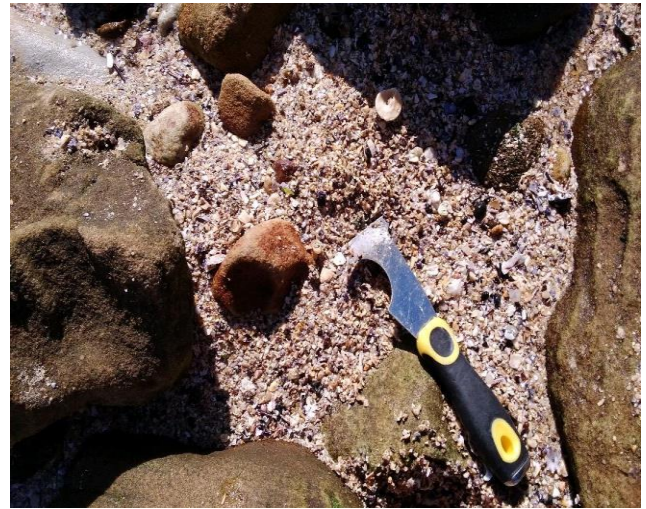
Notes: Sand surface following emu pick - Southern section

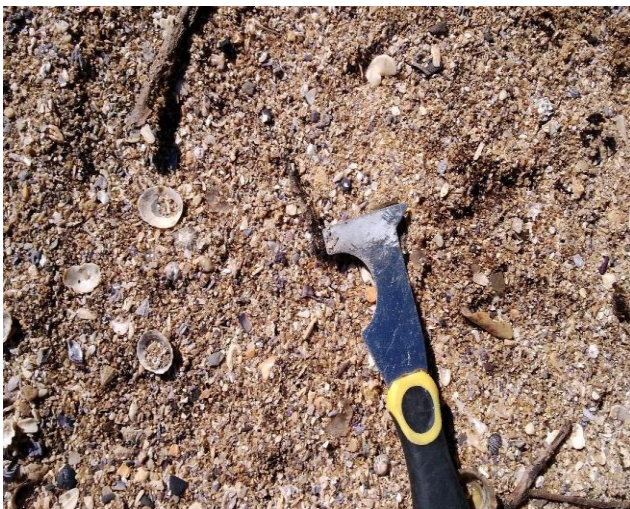
Notes: Sand surface following emu pick - Southern section

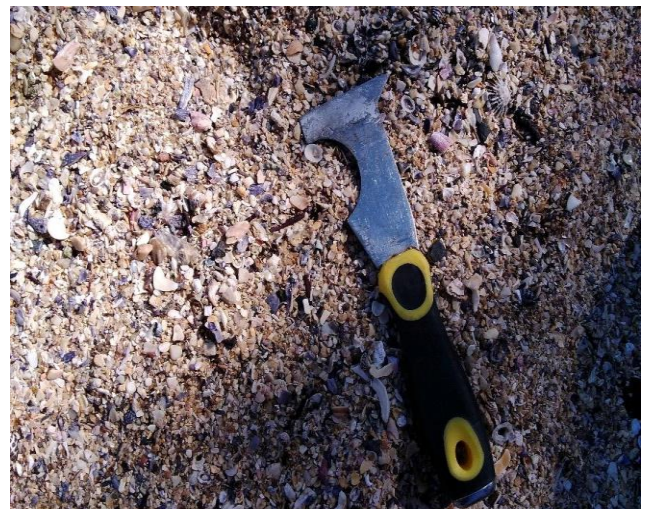
Notes: Sand surface following emu pick - Southern section

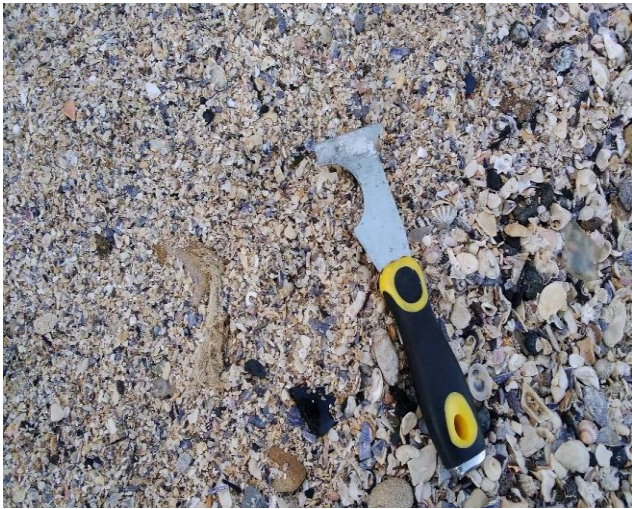
Notes: Sand surface following emu pick - Southern section

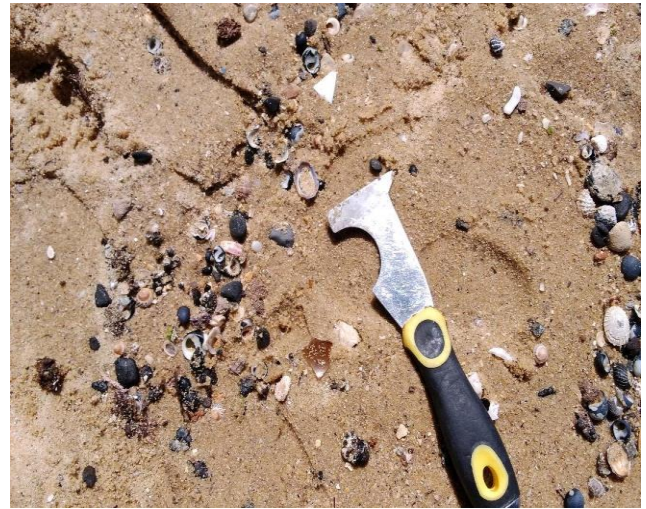
Notes: Sand surface following emu pick - Northern section

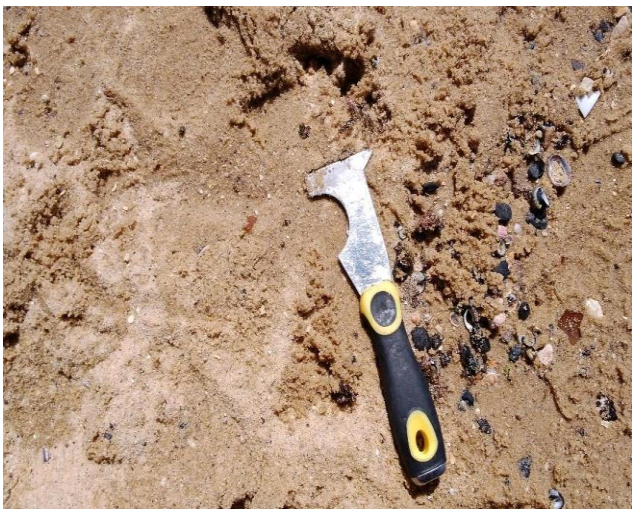
Notes: Sand surface following emu pick - Northern section

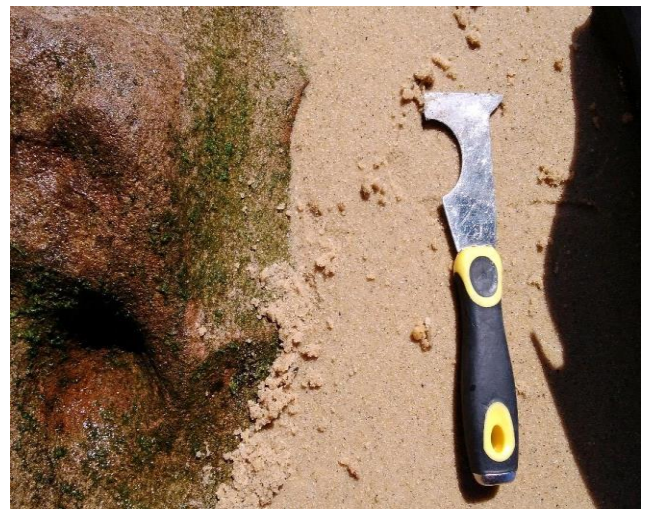
Notes: Sand surface following emu pick - Northern section

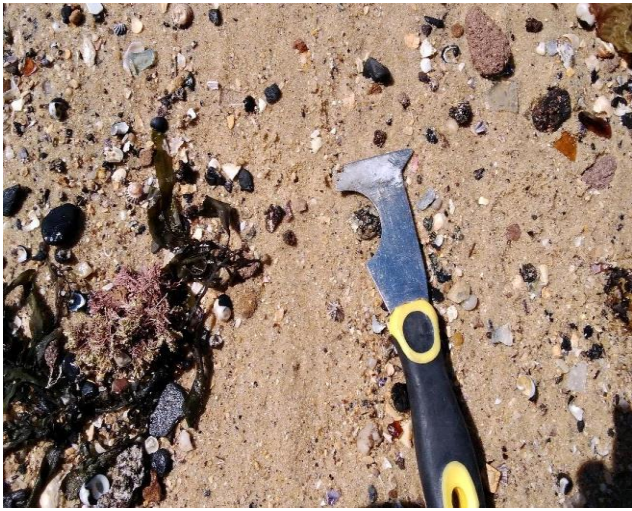
Notes: Sand surface following emu pick - Northern section

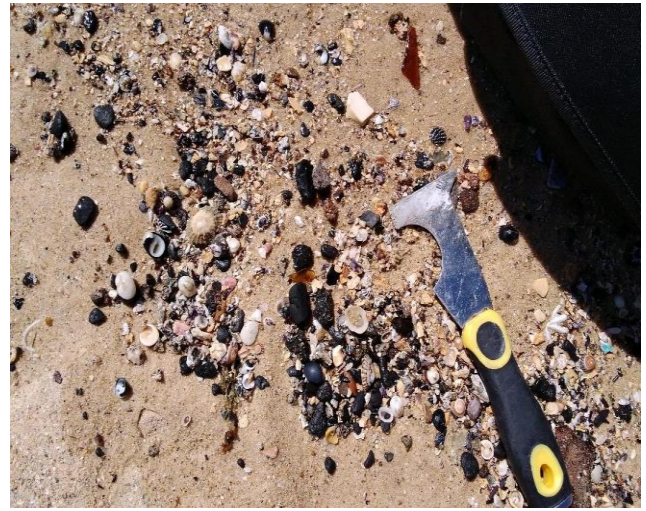
Notes: Sand surface following emu pick - Northern section
