Asbestos Containing Material Clearance Inspection

31 January 2023

Site:	Little Bay Beach
Location:	Southern, Western and Northern Little Bay Beach

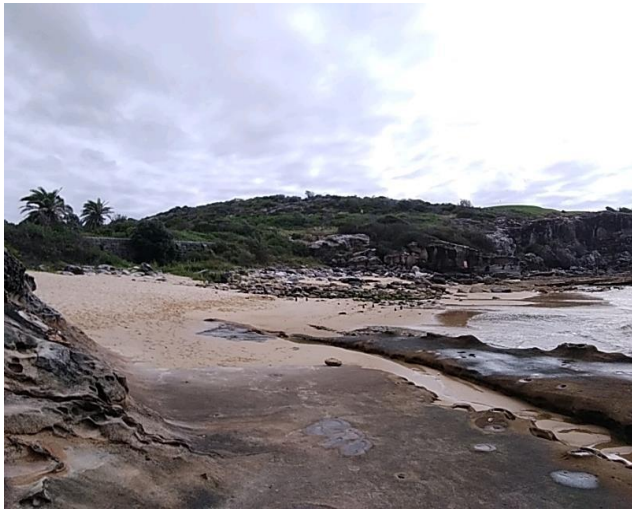
Notes: Overview of the Northern beach

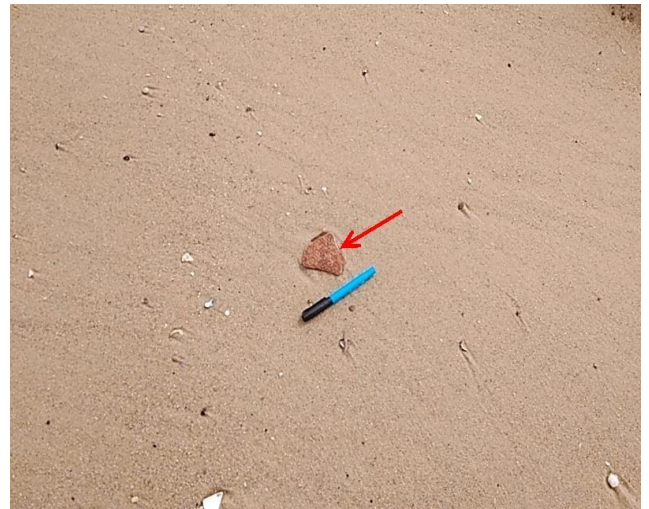
Notes: Overview of the ACM fragment prior to the removal within Northern beach.

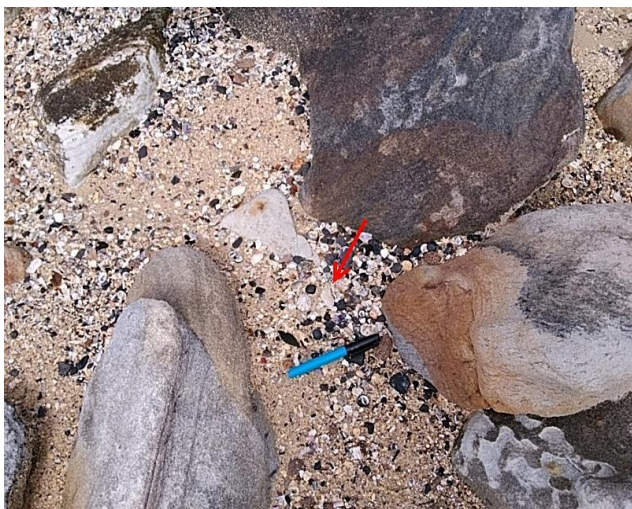
Notes: Overview of the ACM fragment prior to the removal within Northern beach.

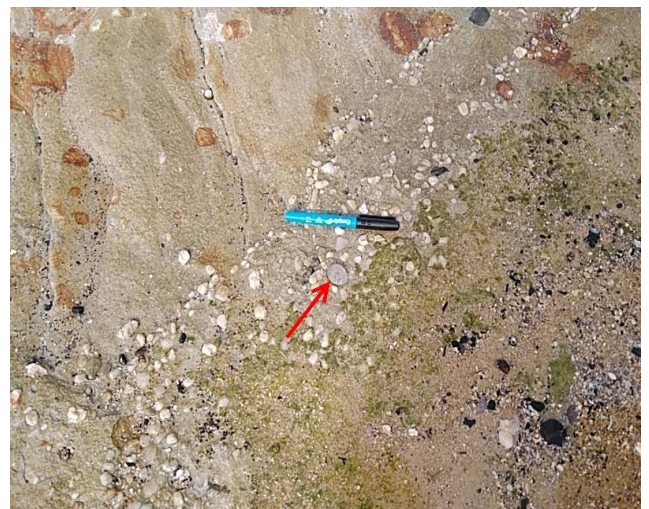
Notes: Overview of the ACM fragment prior to the removal within Northern beach.

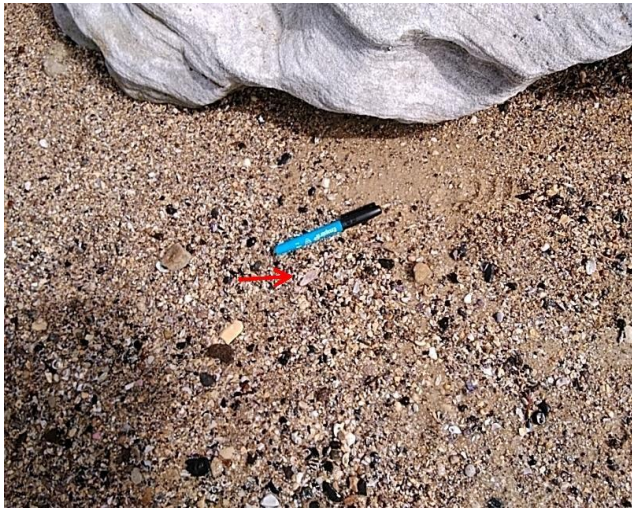
Notes: Overview of the ACM fragment prior to the removal within Northern beach.

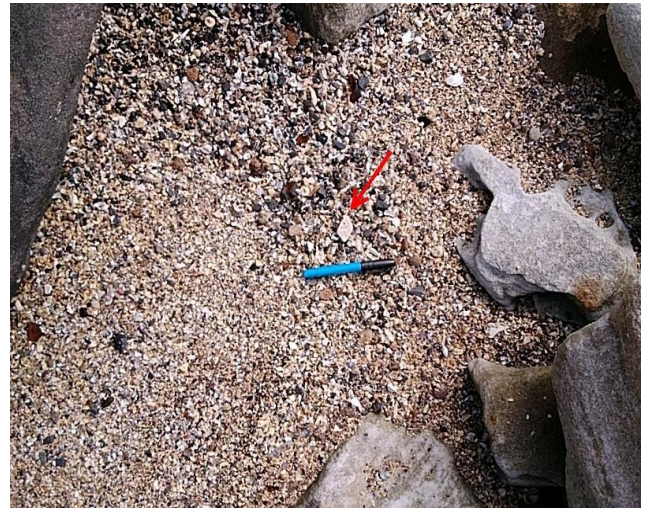
Notes: Overview of the ACM fragment prior to the removal within Northern beach.

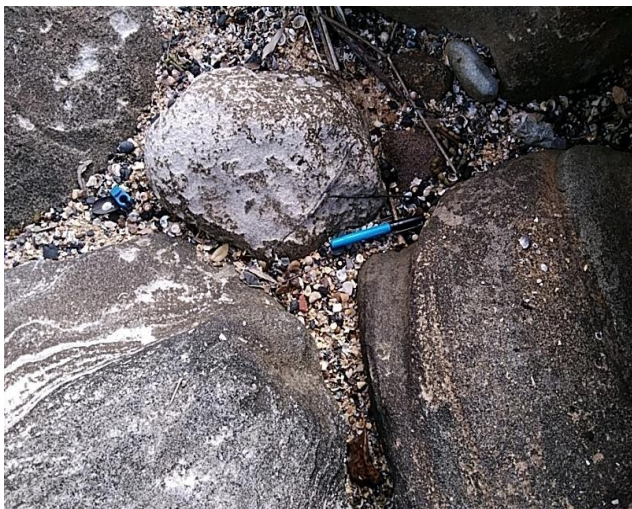
Notes: Overview of the ACM fragment prior to the removal within Northern beach.

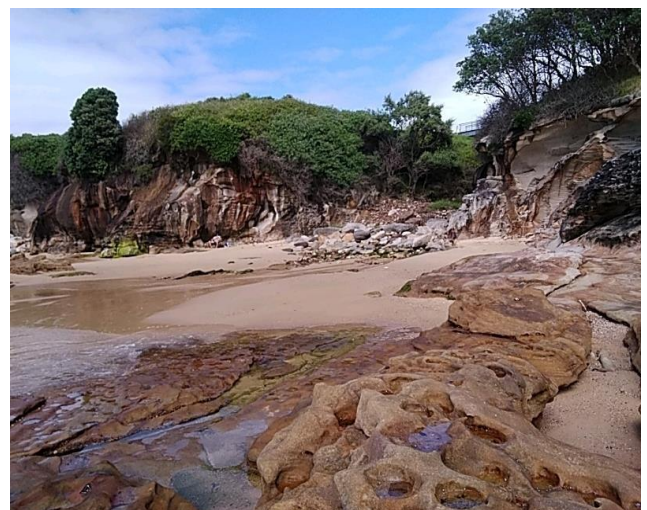
Notes: Overview of the Northern beach

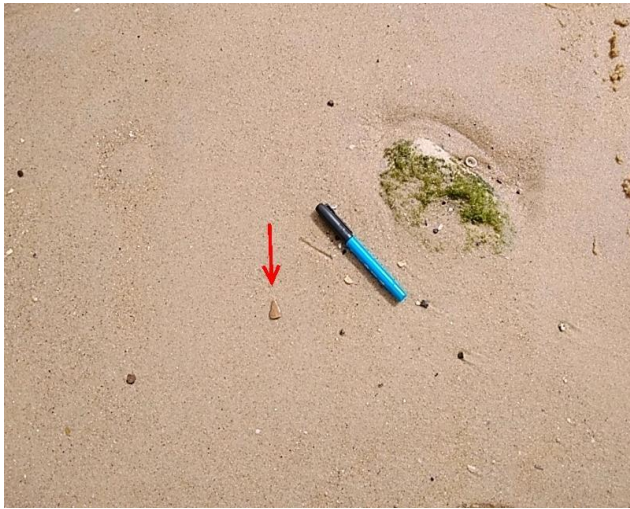
Notes: Overview of the ACM fragment prior to the removal within Western beach.

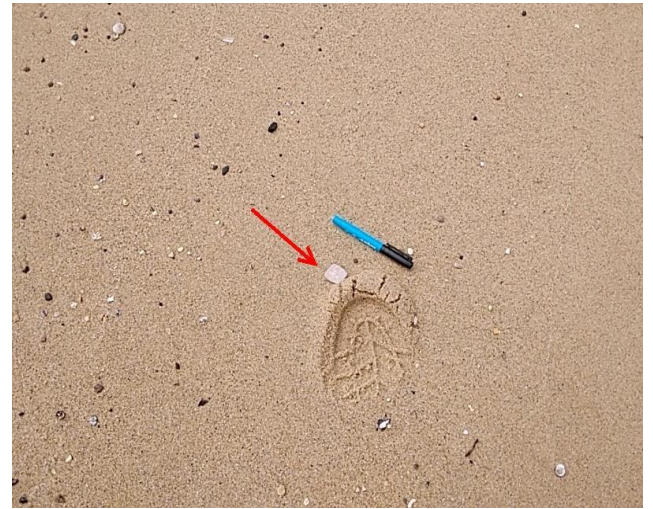
Notes: Overview of the ACM fragment prior to the removal within Western beach.

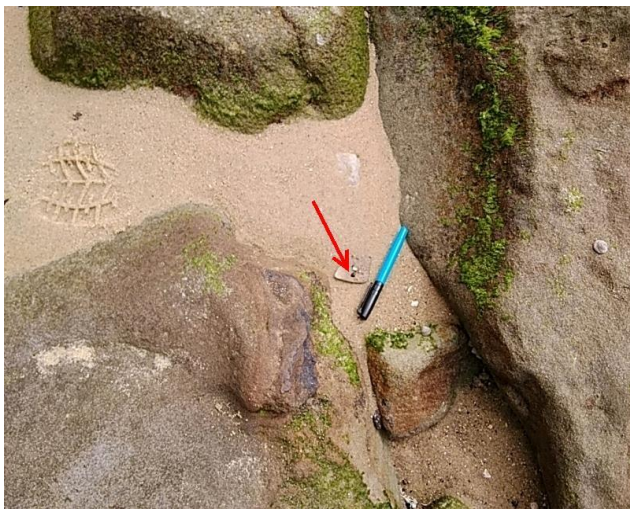
Notes: Overview of the ACM fragment prior to the removal within Western beach.

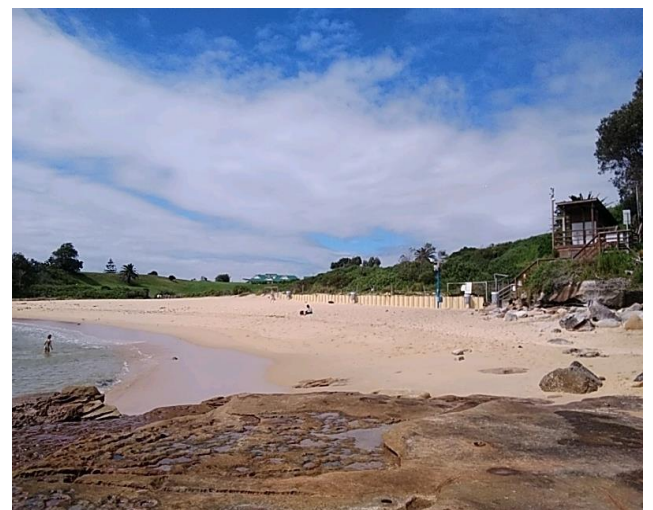
Notes: Overview of the Southern beach

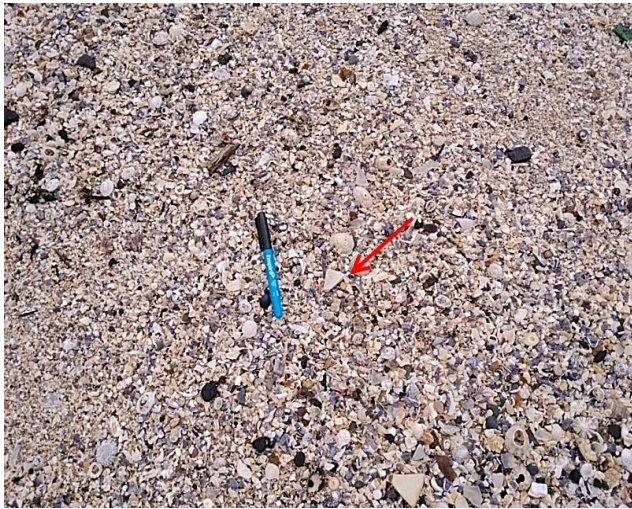
Notes: Overview of the ACM fragment prior to the removal within Southern beach.

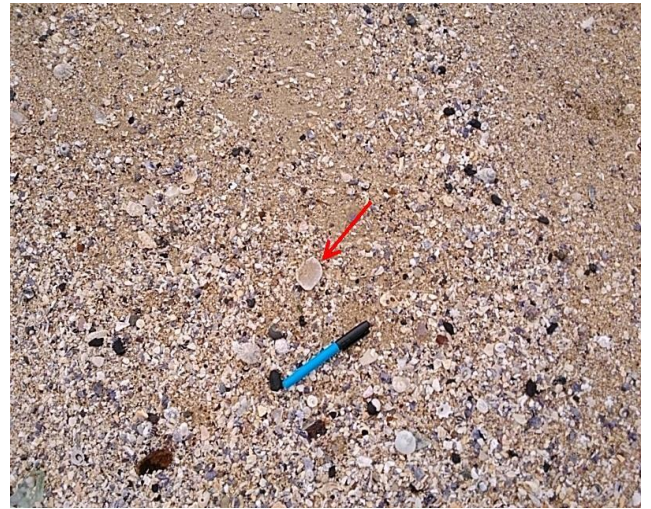
Notes: Overview of the ACM fragment prior to the removal within Southern beach.

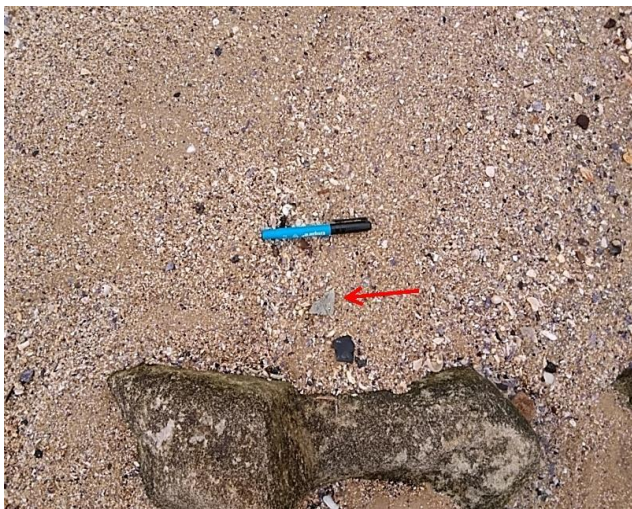
Notes: Overview of the ACM fragment prior to the removal within Southern beach.

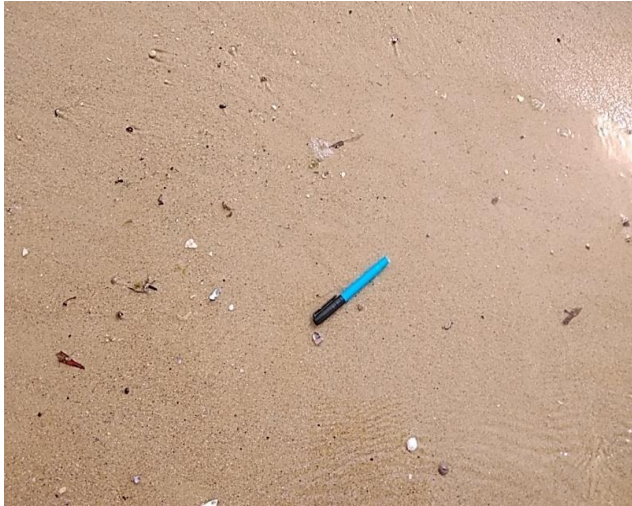
Notes: Overview of surface following removal of fragment

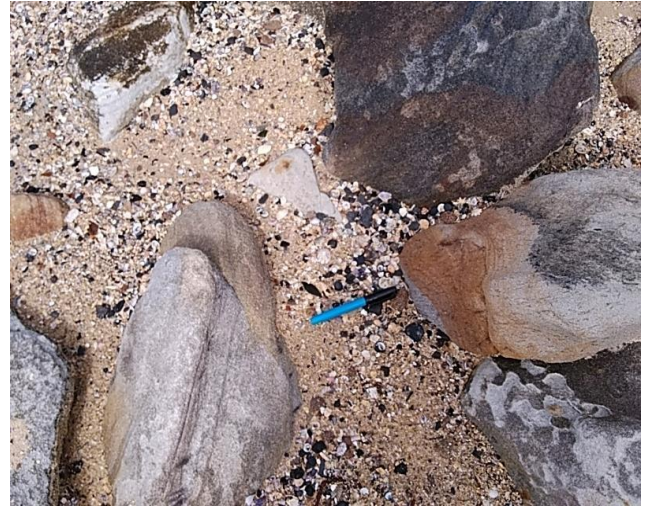
Notes: Overview of surface following removal of fragment

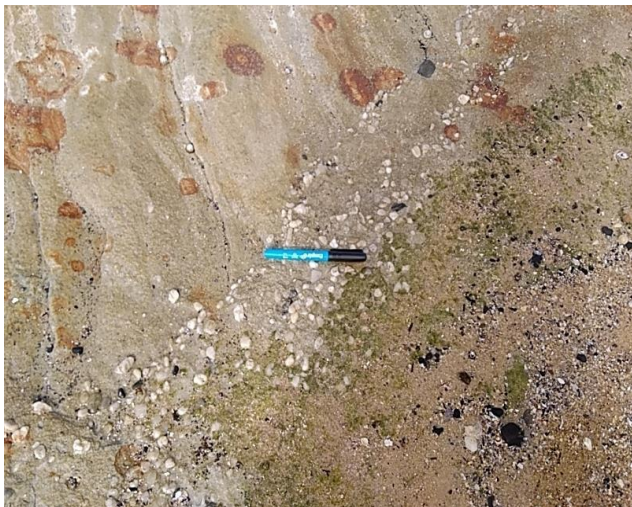
Notes: Overview of surface following removal of fragment

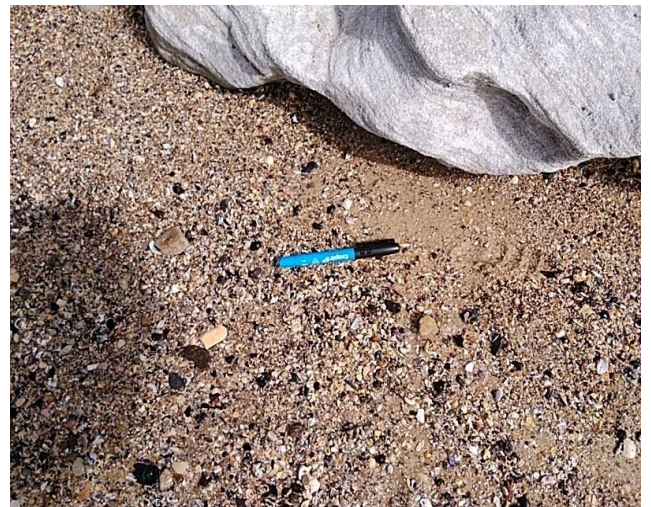
Notes: Overview of surface following removal of fragment

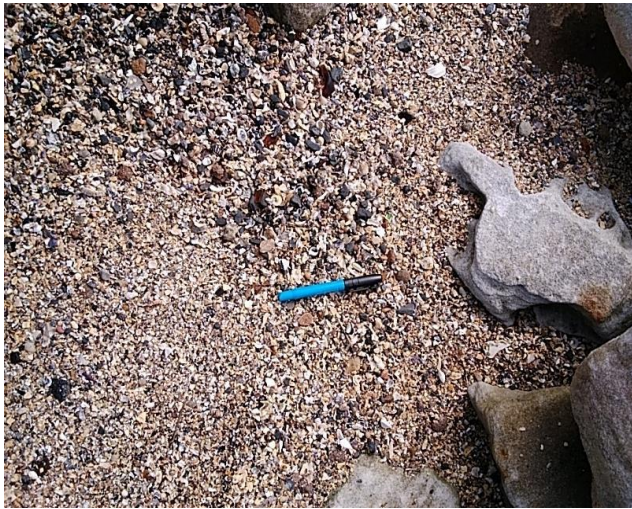
Notes: Overview of surface following removal of fragment

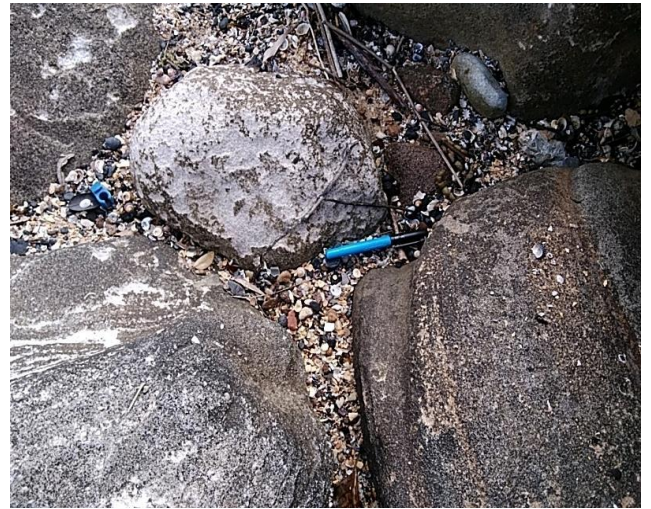
Notes: Overview of surface following removal of fragment

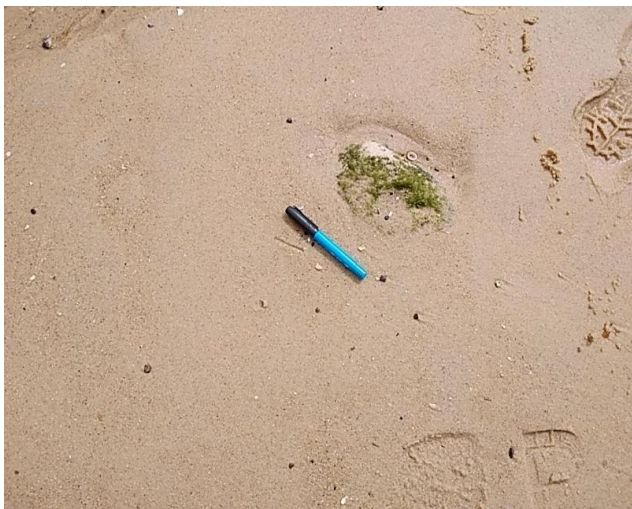
Notes: Overview of surface following removal of fragment

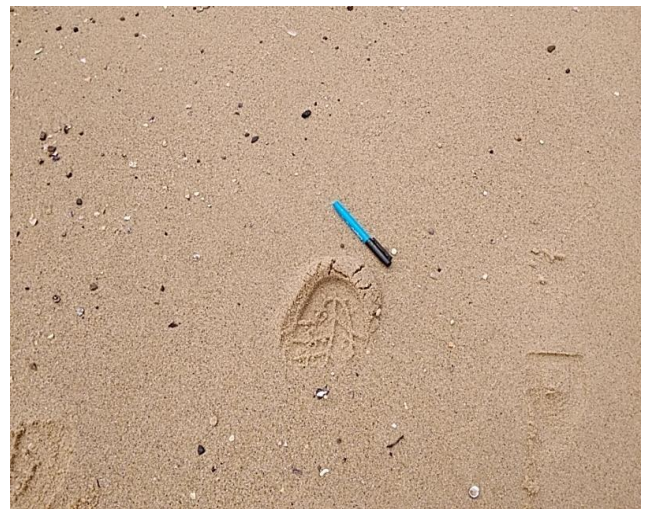
Notes: Overview of surface following removal of fragment

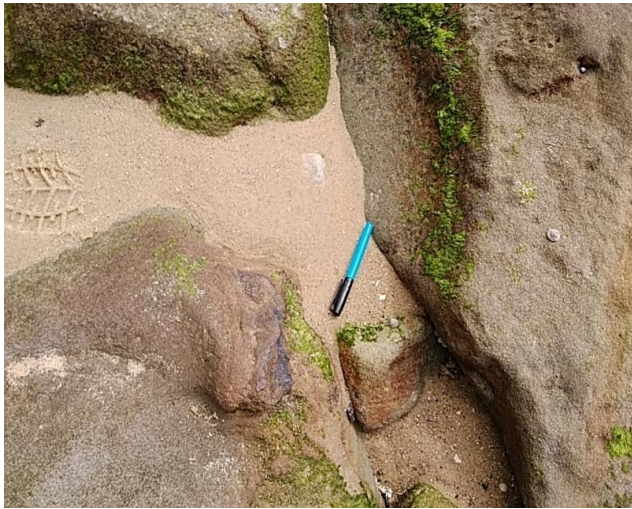
Notes: Overview of surface following removal of fragment

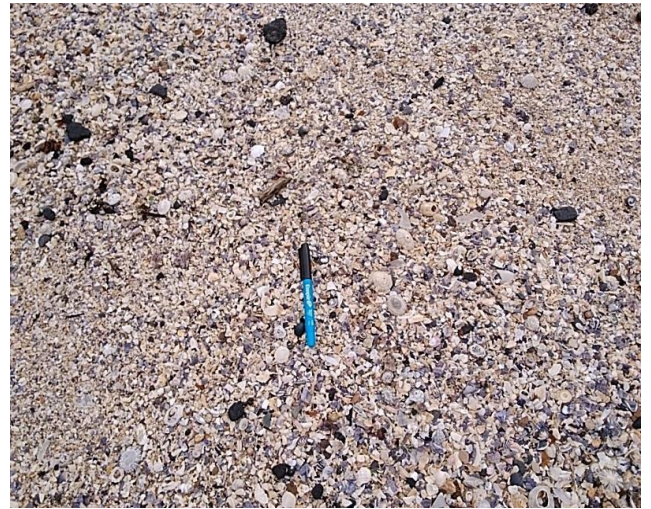
Notes: Overview of surface following removal of fragment

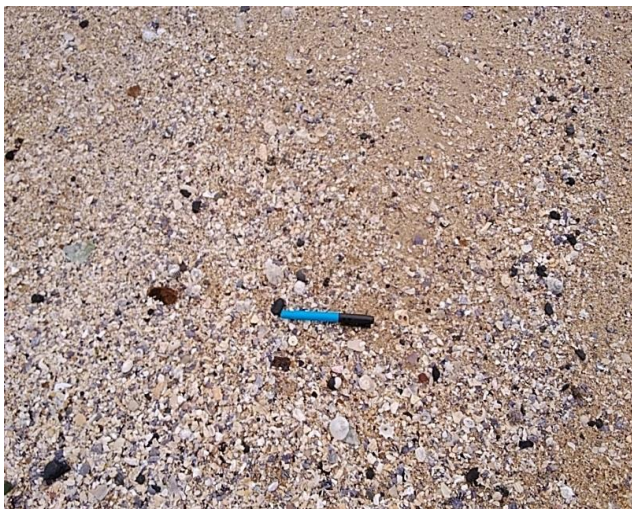
Notes: Overview of surface following removal of fragment

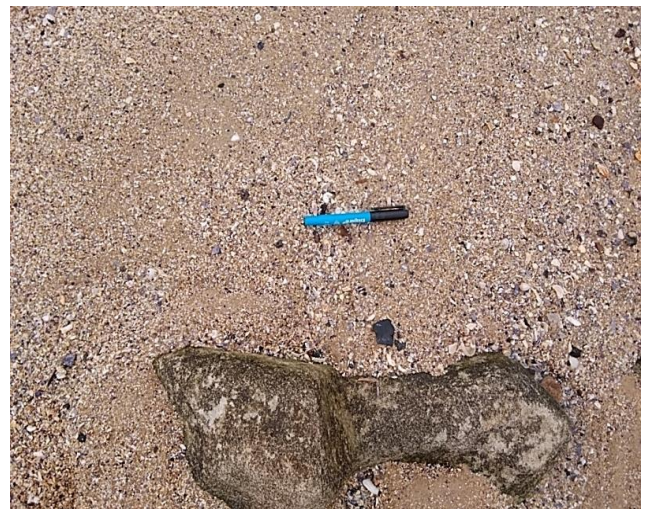
Notes: Overview of surface following removal of fragment
