Asbestos Containing Material Clearance Inspection

3 June 2023

Randwick City Council
30 Frances Street
Randwick NSW 2031

Site:	Little Bay Beach
Location:	Southern, Western and Northern Little Bay Beach

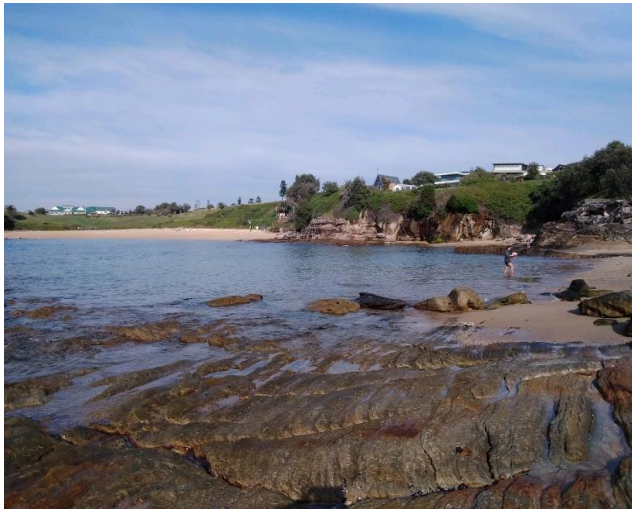
Notes: Overview of the Beach during the inspection

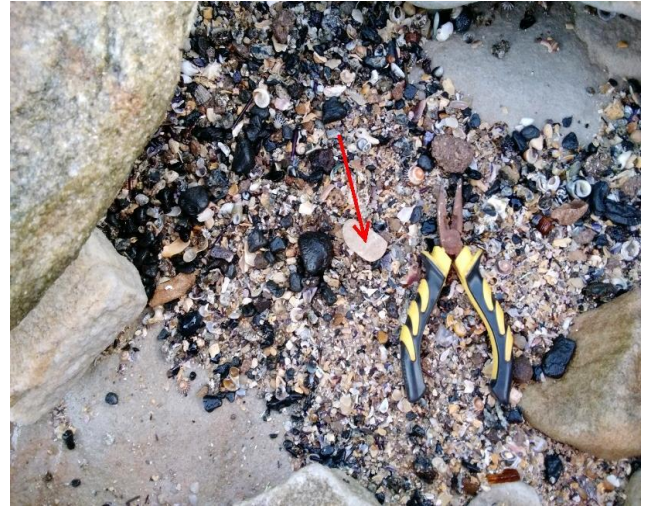
Notes: FC fragment identified on sand surface prior to emu pick - Northern section

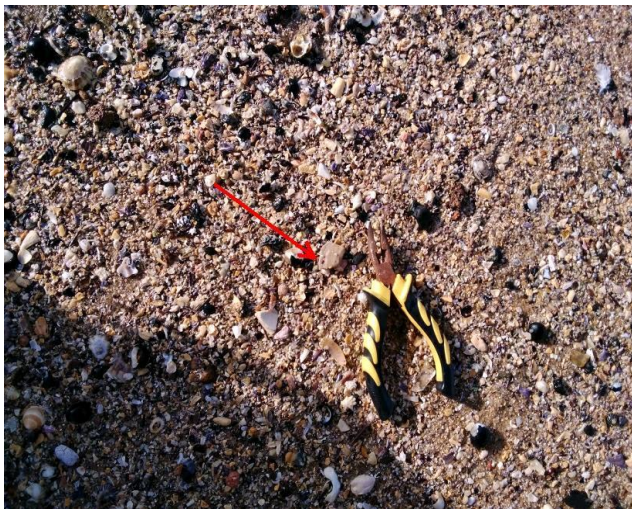
Notes: FC fragment identified on sand surface prior to emu pick - Northern section

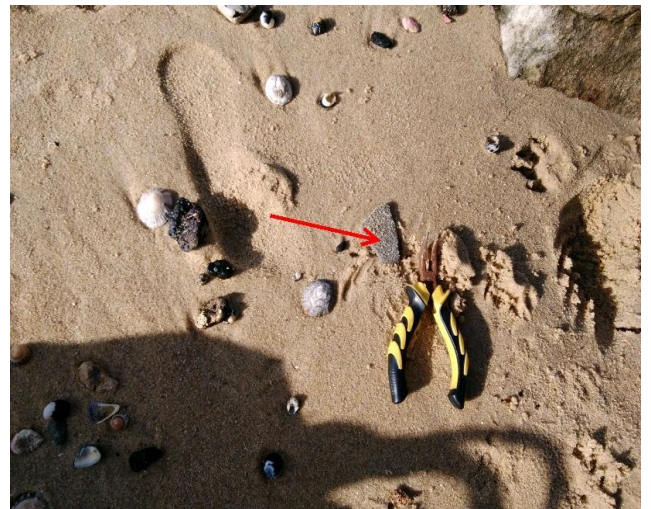
Notes: FC fragment identified on sand surface prior to emu pick - Northern section

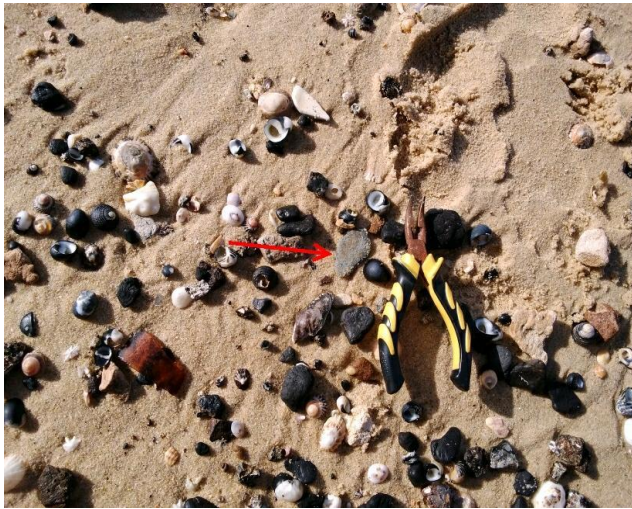
Notes: FC fragment identified on sand surface prior to emu pick - Northern section

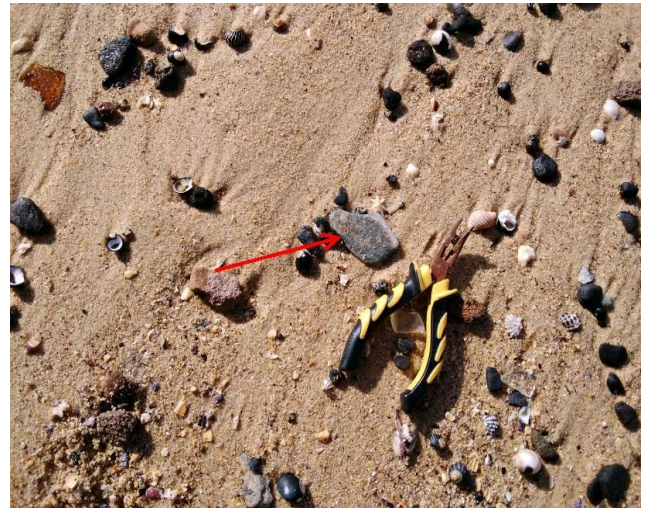
Notes: FC fragment identified on sand surface prior to emu pick - Northern section

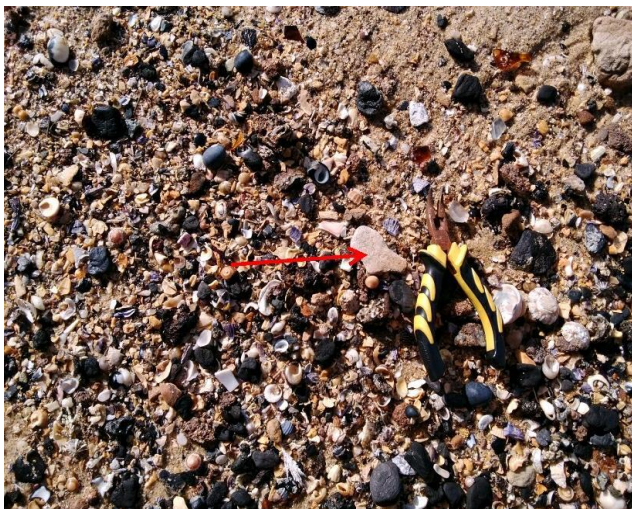
Notes: FC fragment identified on sand surface prior to emu pick - Western section

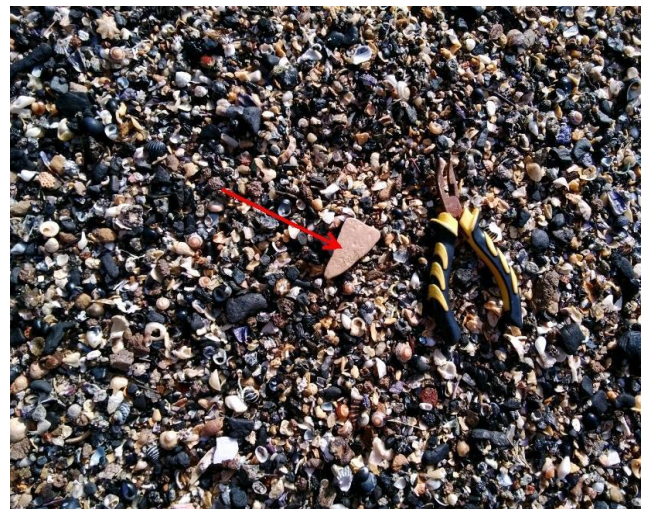
Notes: FC fragment identified on sand surface prior to emu pick - Western section

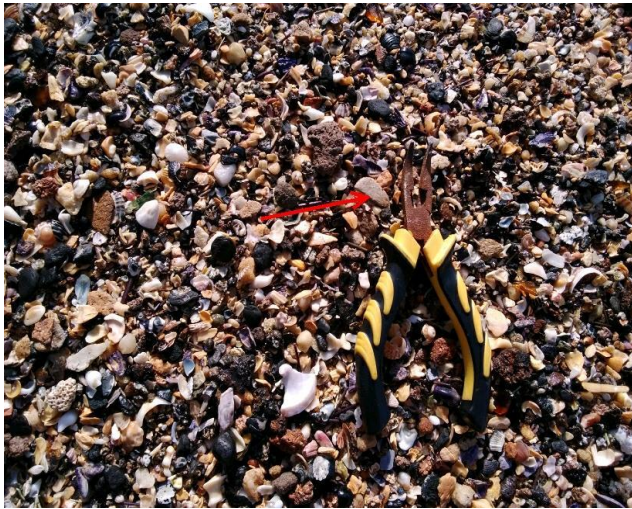
Notes: FC fragment identified on sand surface prior to emu pick - Western section

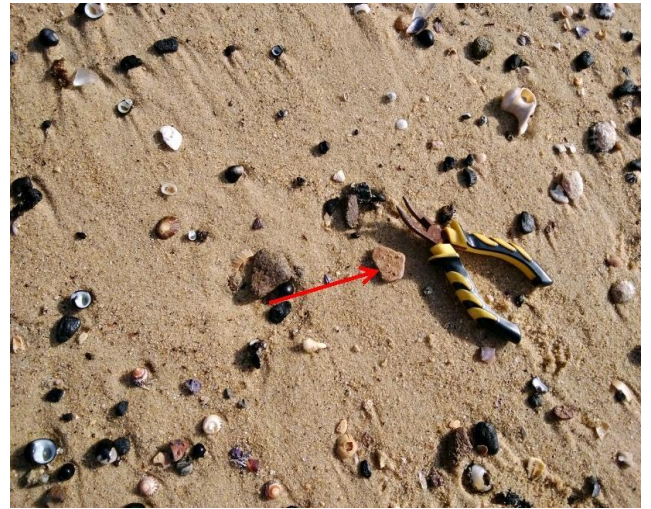
Notes: FC fragment identified on sand surface prior to emu pick - Western section

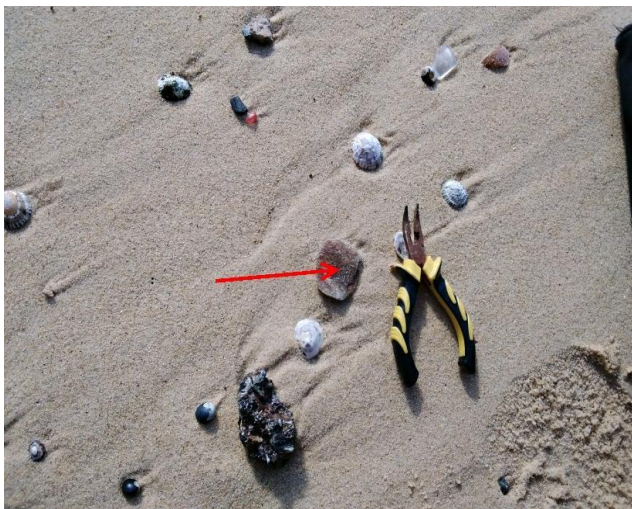
Notes: FC fragment identified on sand surface prior to emu pick - Western section

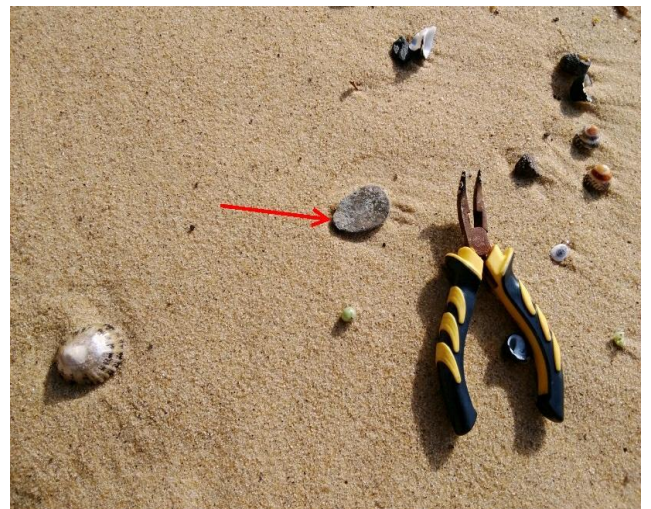
Notes: FC fragment identified on sand surface prior to emu pick - Western section

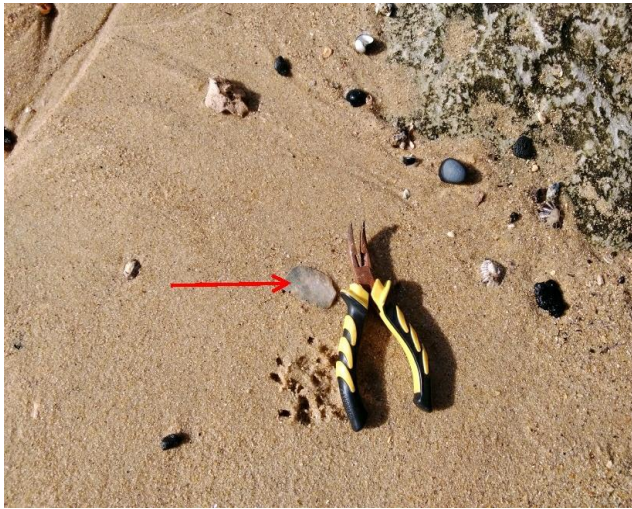
Notes: FC fragment identified on sand surface prior to emu pick - Western section

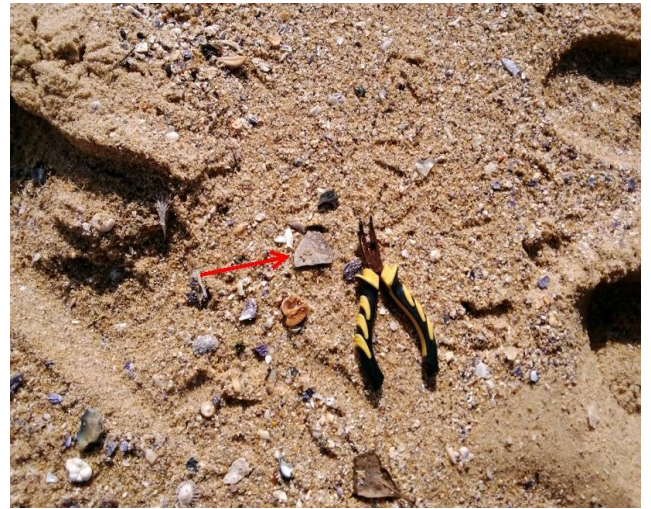
Notes: FC fragment identified on sand surface prior to emu pick - Southern section

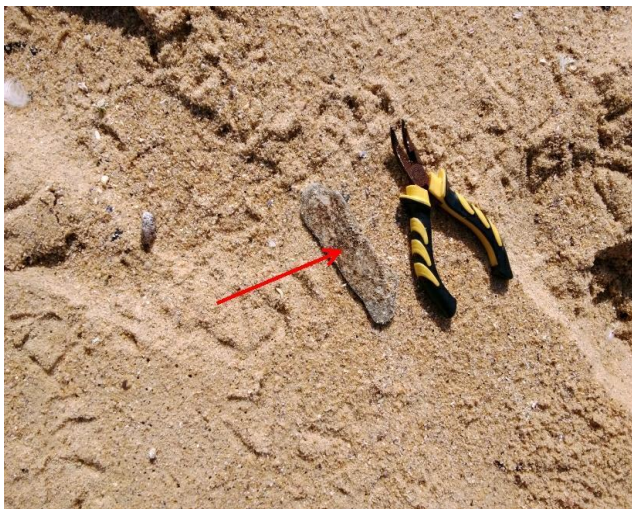
Notes: FC fragment identified on sand surface prior to emu pick - Southern section

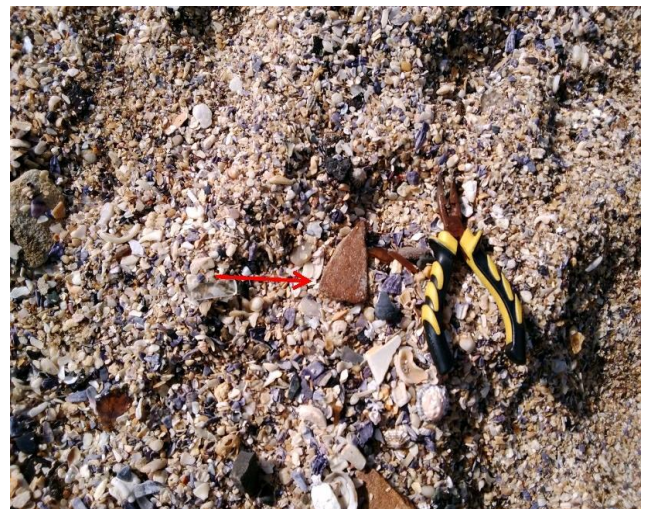
Notes: FC fragment identified on sand surface prior to emu pick - Southern section

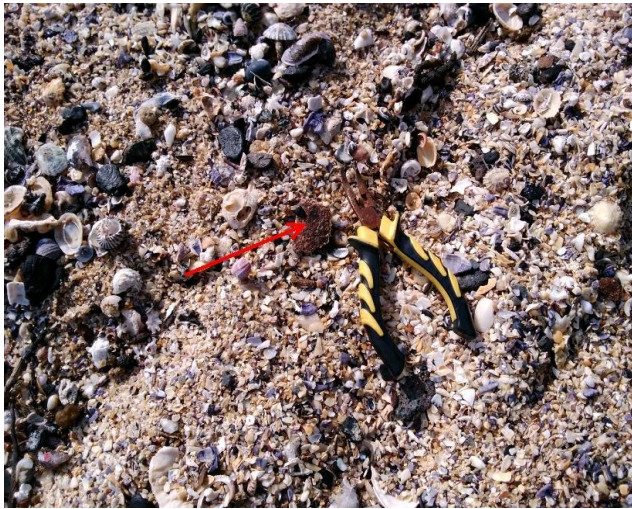
Notes: FC fragment identified on sand surface prior to emu pick - Southern section

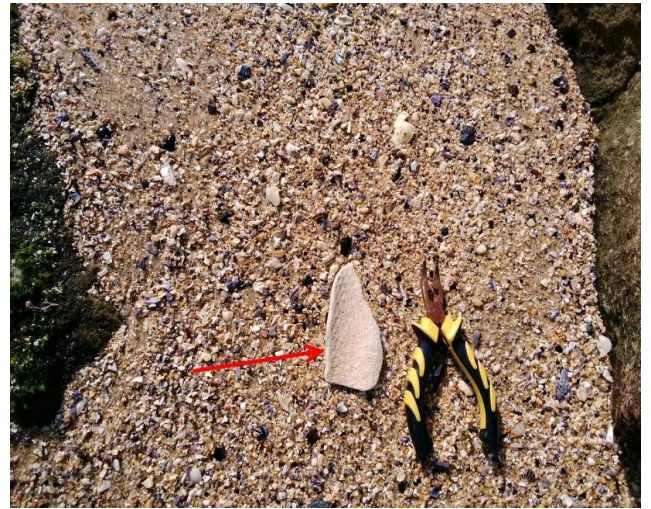
Notes: FC fragment identified on sand surface prior to emu pick - Southern section

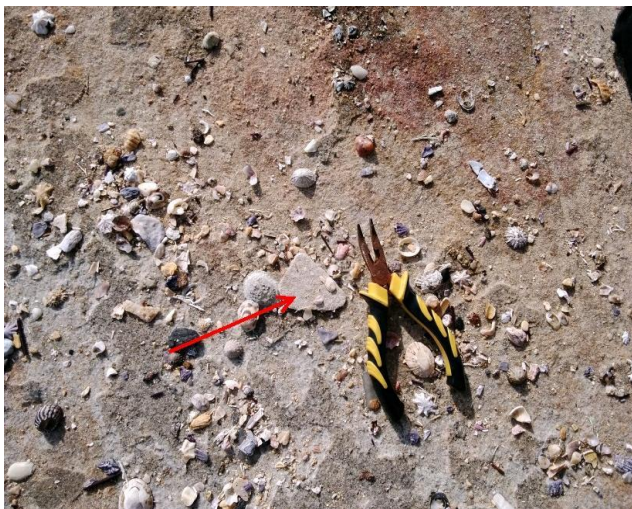
Notes: FC fragment identified on sand surface prior to emu pick - Southern section

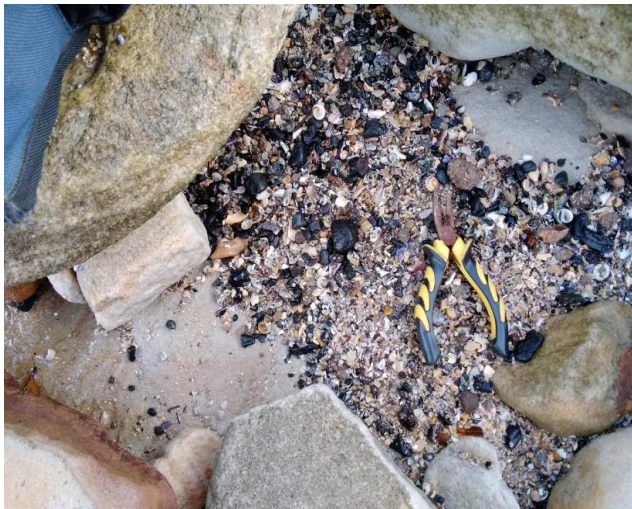
Notes: Sand surface following emu pick - Northern section

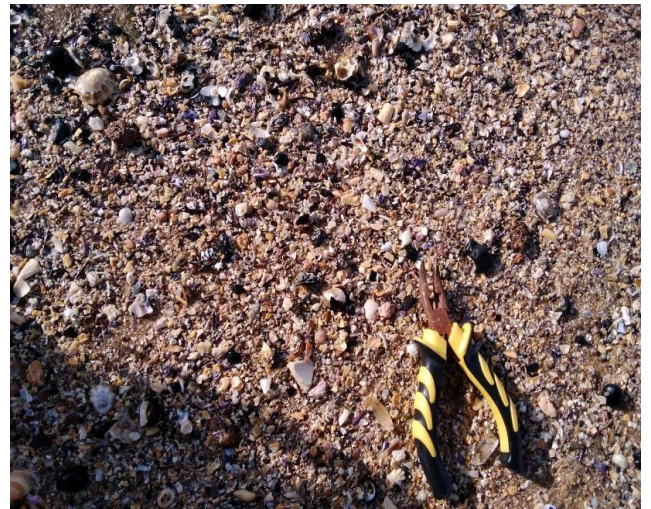
Notes: Sand surface following emu pick - Northern section

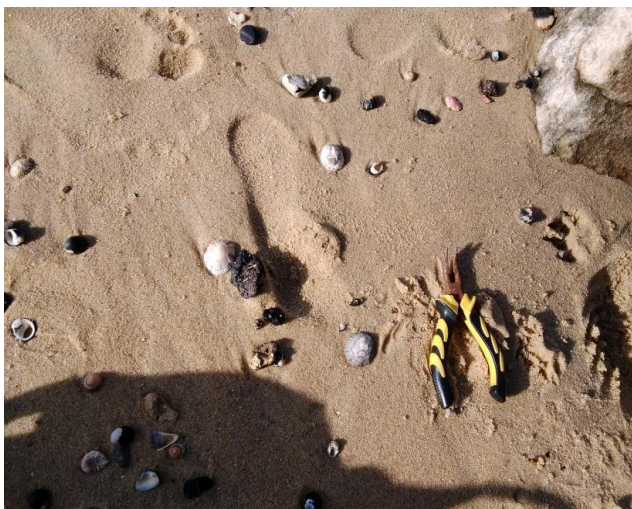
Notes: Sand surface following emu pick - Northern section

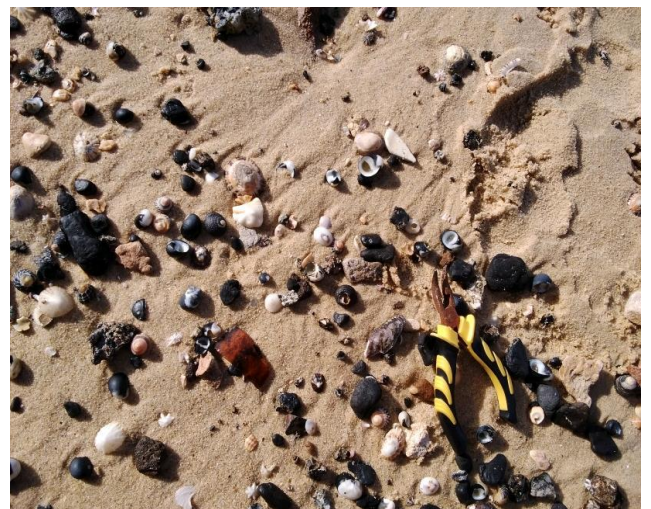
Notes: Sand surface following emu pick - Northern section

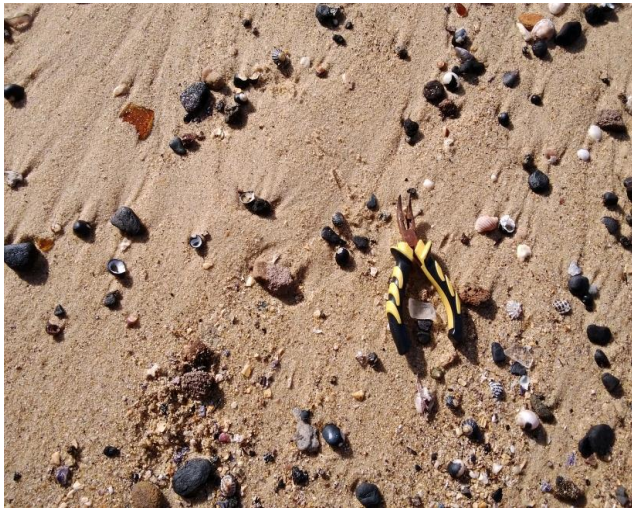
Notes: Sand surface following emu pick - Northern section

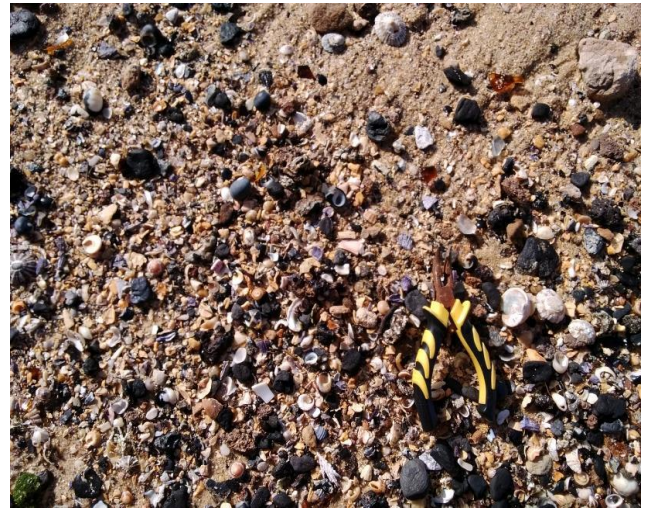
Notes: Sand surface following emu pick - Western section

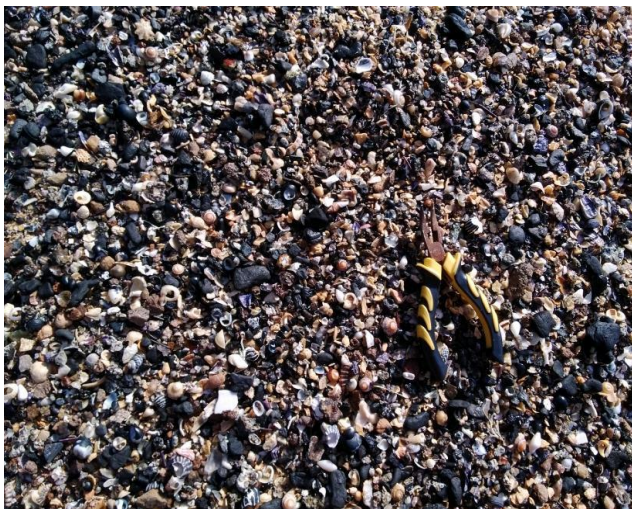
Notes: Sand surface following emu pick - Western section

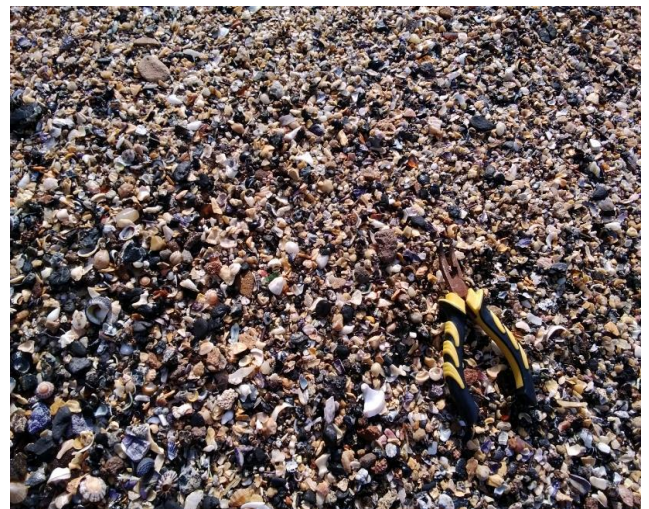
Notes: Sand surface following emu pick - Western section

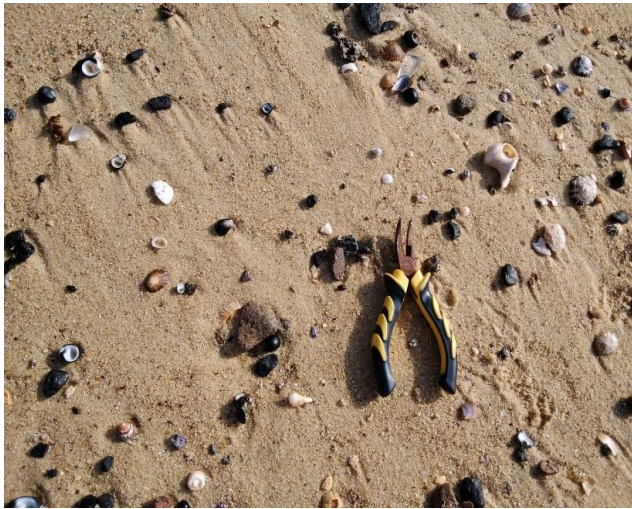
Notes: Sand surface following emu pick - Western section

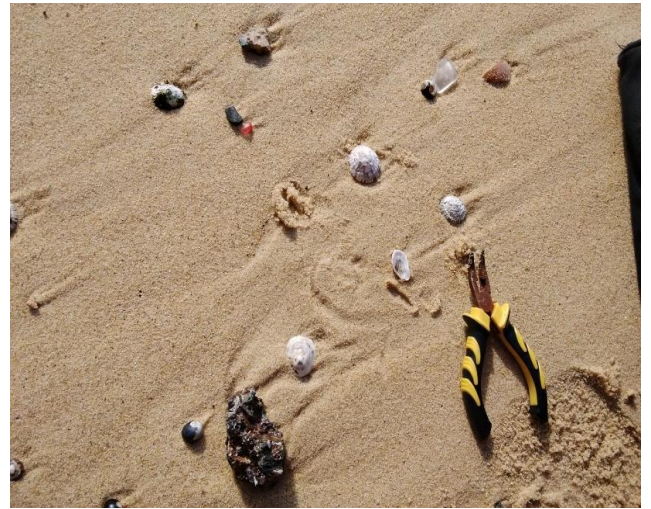
Notes: Sand surface following emu pick - Western section

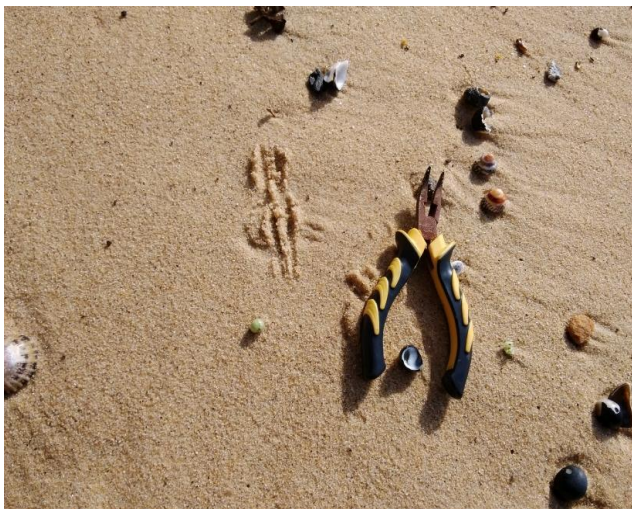
Notes: Sand surface following emu pick - Western section

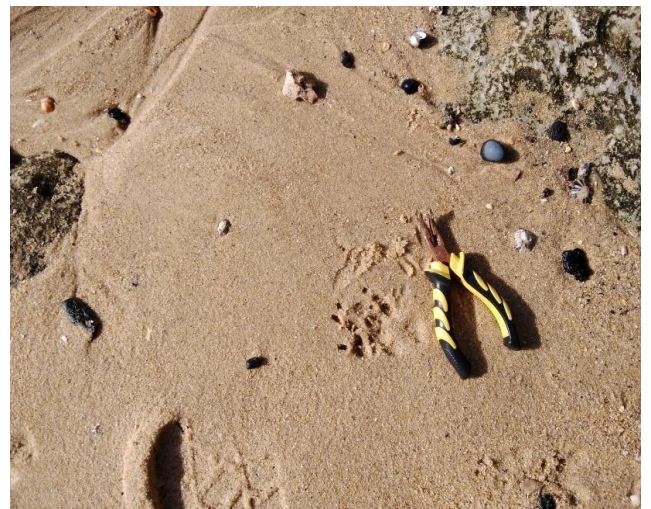
Notes: Sand surface following emu pick - Western section

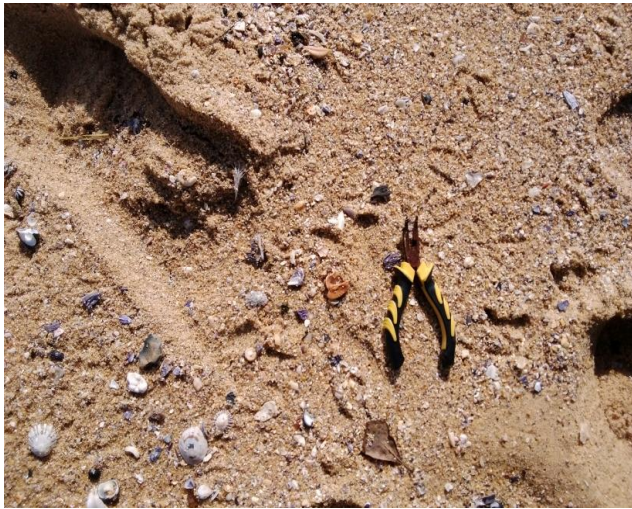
Notes: Sand surface following emu pick - Southern section

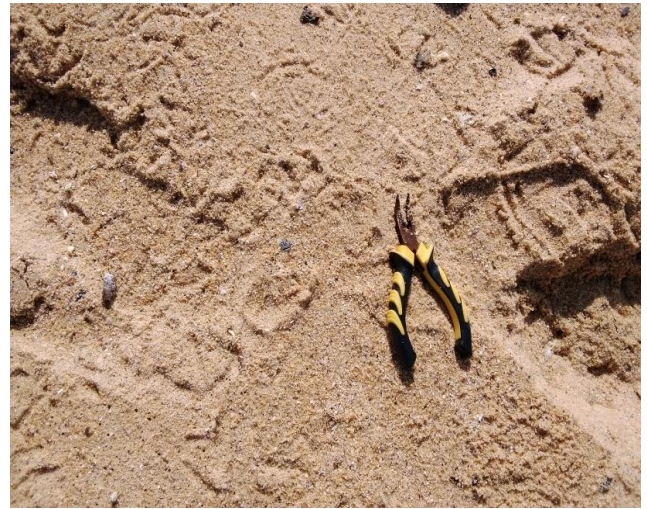
Notes: Sand surface following emu pick - Southern section

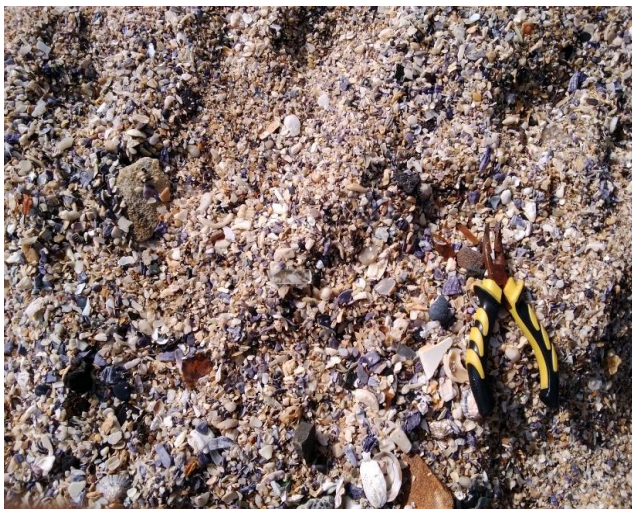
Notes: Sand surface following emu pick - Southern section

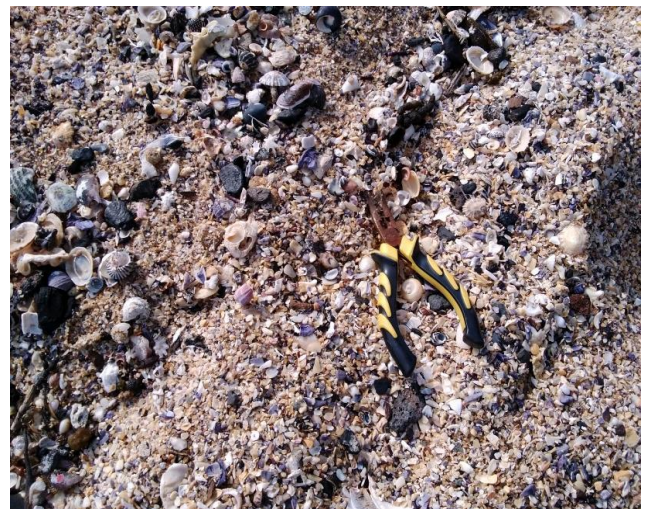
Notes: Sand surface following emu pick - Southern section

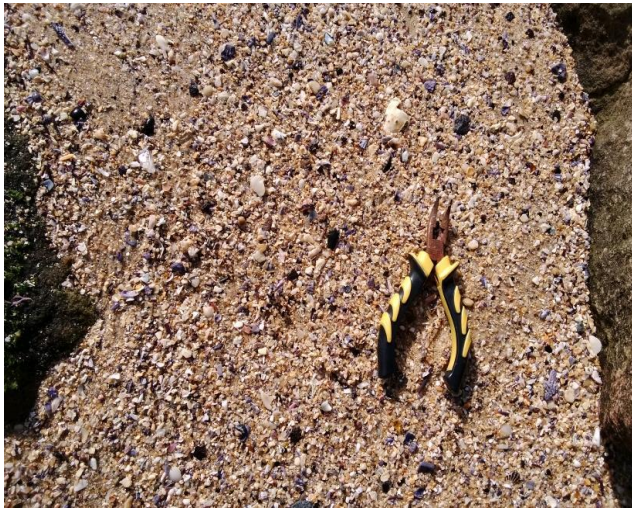
Notes: Sand surface following emu pick - Southern section

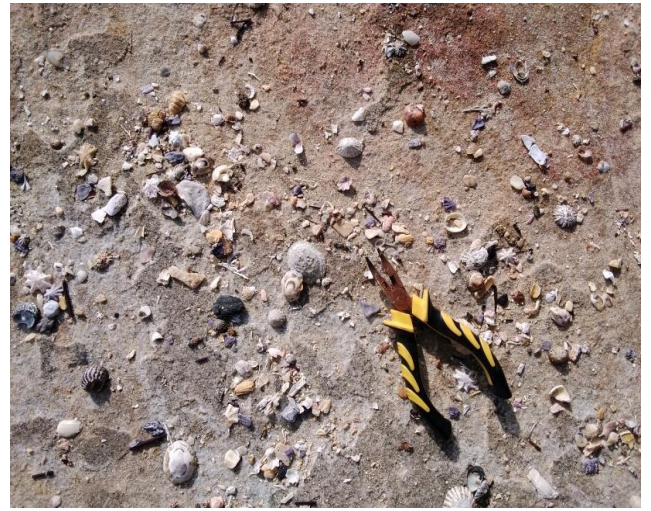
Notes: Sand surface following emu pick - Southern section

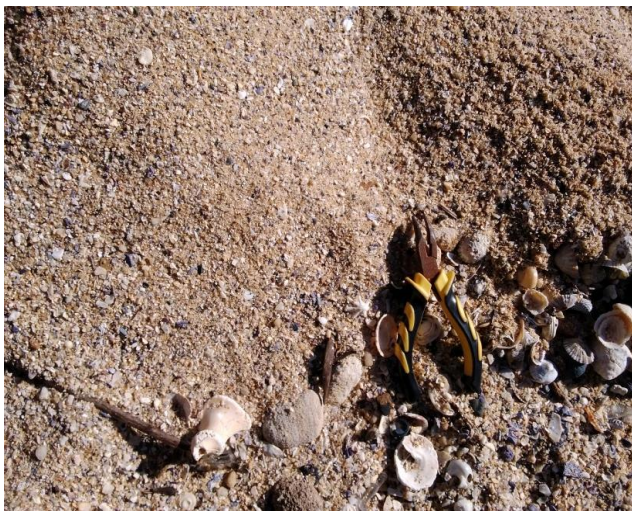
Notes: Sand surface following emu pick - Southern section
