# Asbestos Containing Material Clearance Inspection

<b>Site:</b>	Little Bay Beach
<b>Location:</b>	Southern, Western and Northern Little Bay Beach

<b>Requested by:</b>	
Name	Joe Santangelo
Contact	0436839760
Email	joe.santangelo@randwick.nsw.gov.au
<b>Site Details:</b>	
Address	2 Coast Hospital Rd, Little Bay NSW 2036
Local Government Area	Randwick City Council

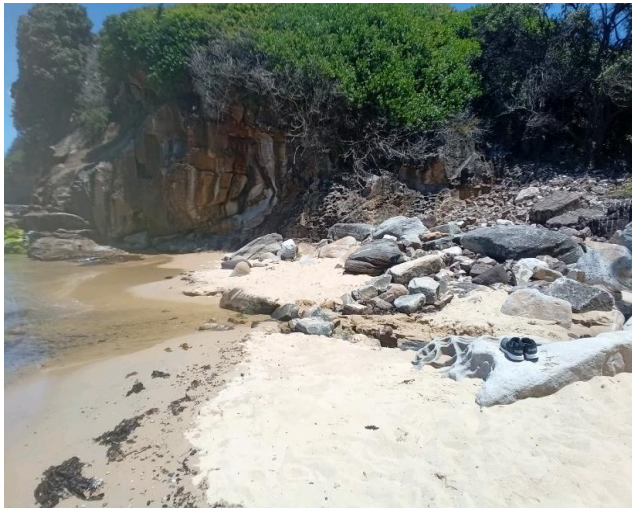
**Notes:** Overview of Western beach.

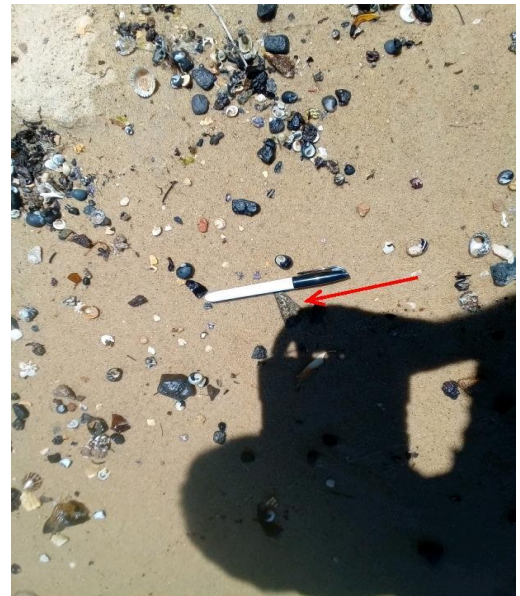
**Notes:** Overview of ACM fragment within Western beach.

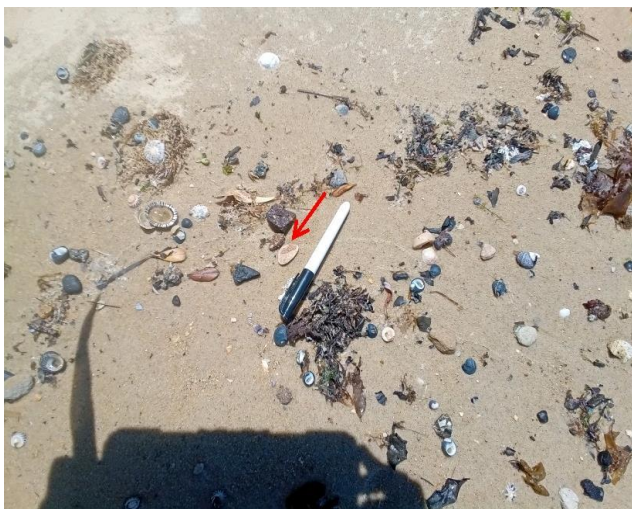
**Notes:** Overview of ACM fragment within Western beach.

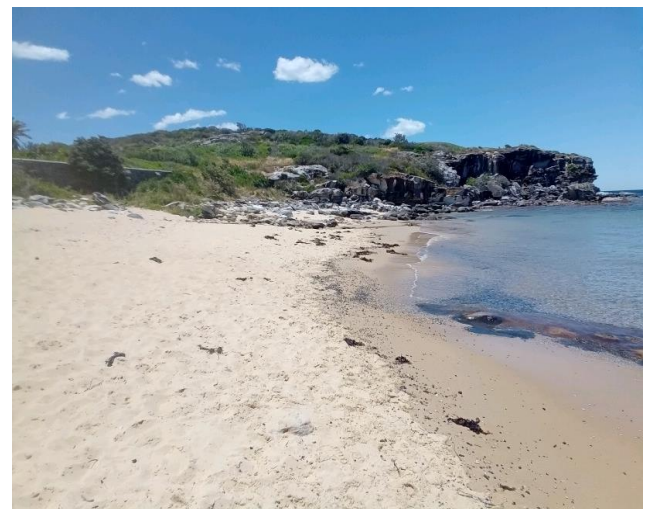
**Notes:** Overview of Northern beach.

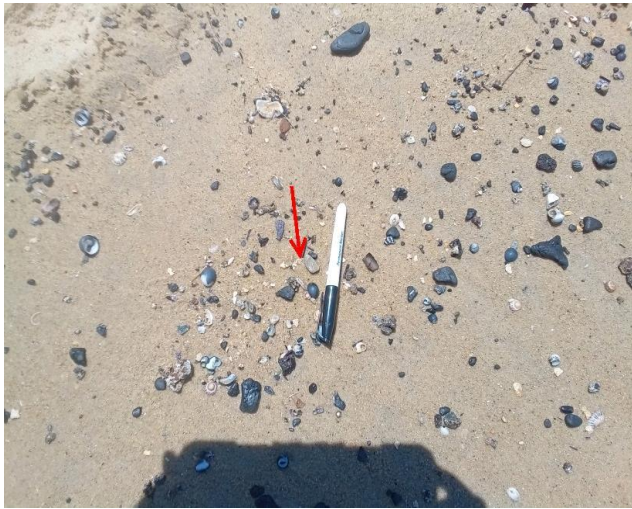
**Notes:** Overview of ACM fragment within Northern beach.

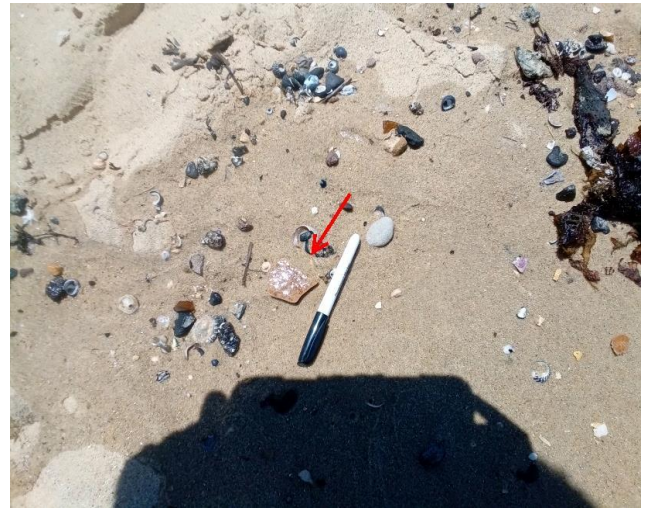
**Notes:** Overview of ACM fragment within Northern beach.

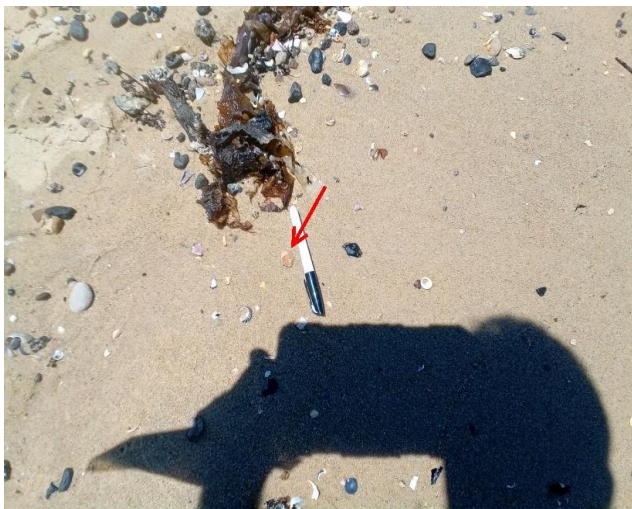
**Notes:** Overview of ACM fragment within Northern beach.

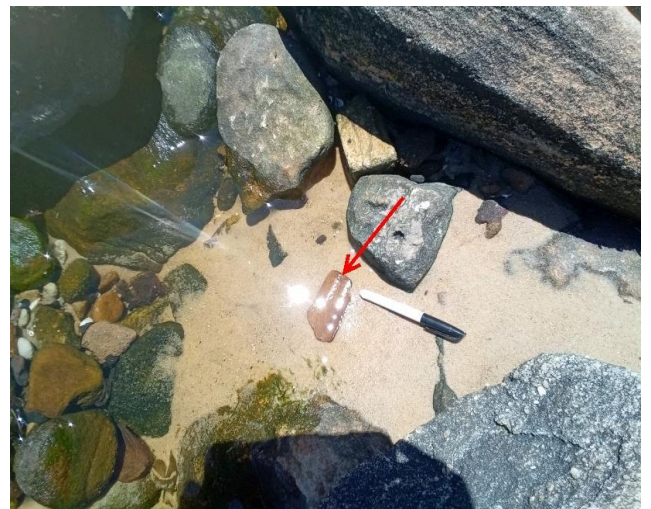
**Notes:** Overview of ACM fragment within Northern beach.

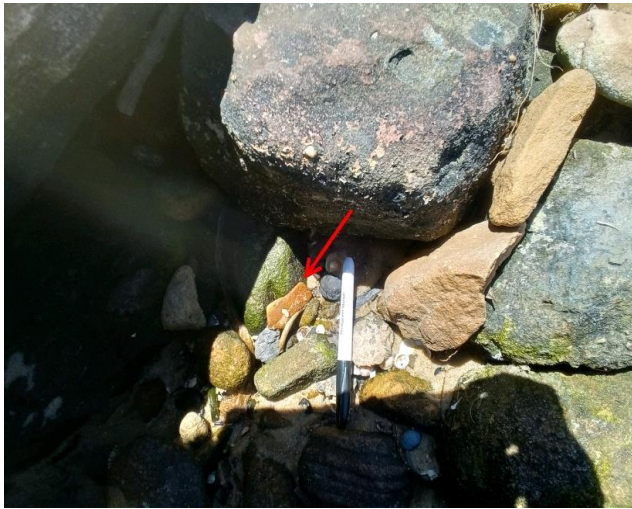
**Notes:** Overview of ACM fragment within Northern beach.

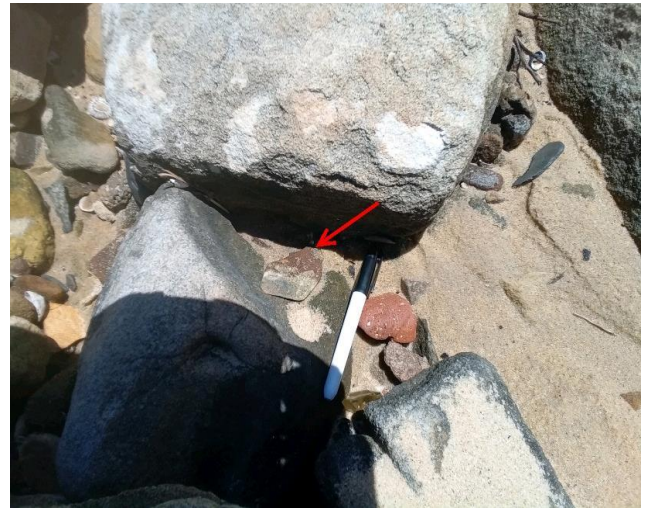
**Notes:** Overview of ACM fragment within Northern beach.

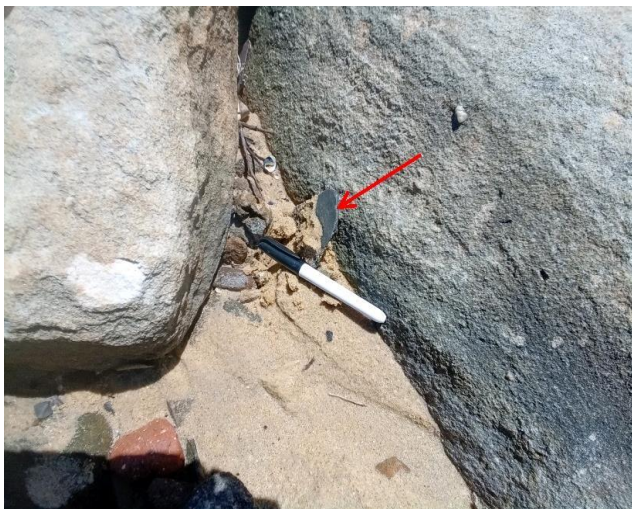
**Notes:** Overview of ACM fragment within Northern beach.

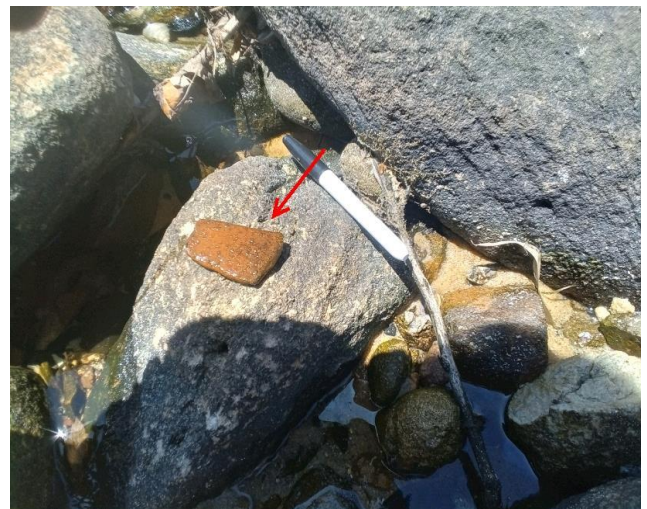
**Notes:** Overview of ACM fragment within Northern beach.

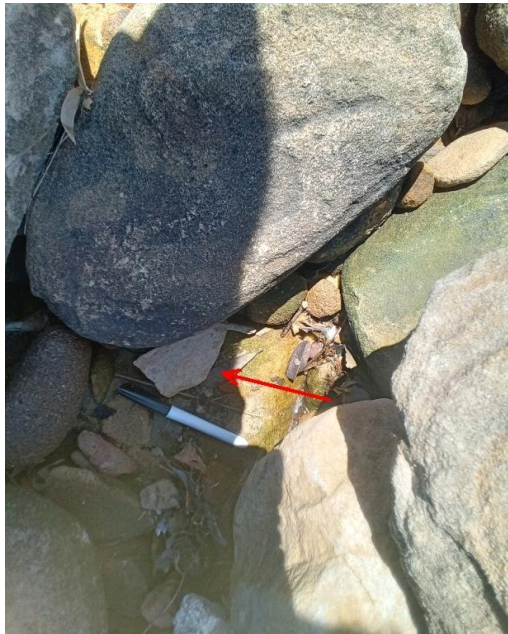
**Notes:** Overview of ACM fragment within Northern beach.

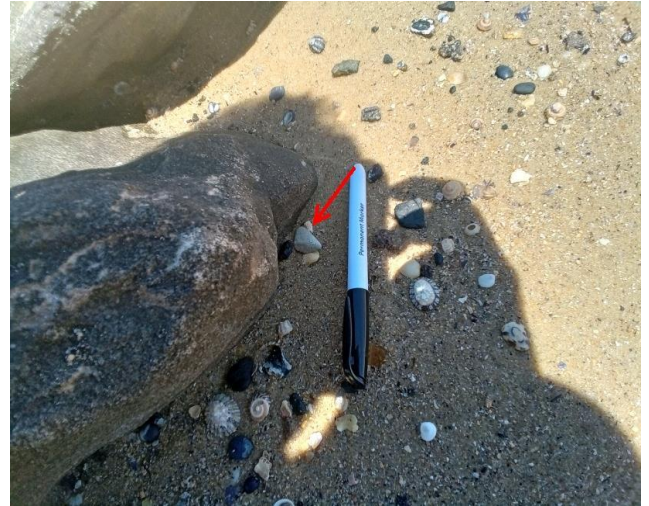
**Notes:** Overview of ACM fragment within Northern beach.

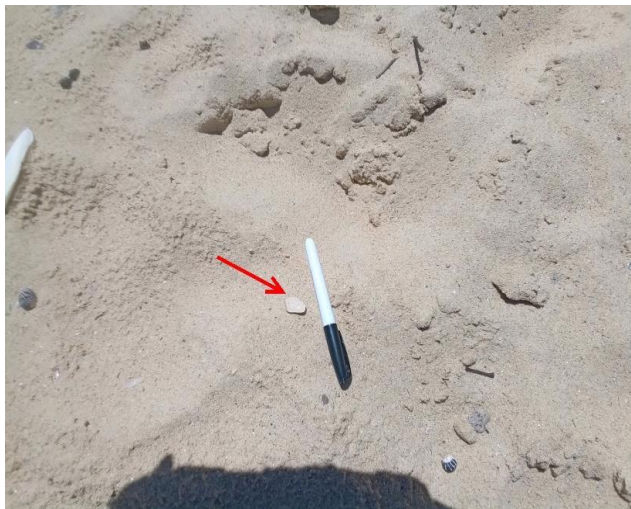
**Notes:** Overview of ACM fragment within Northern beach.

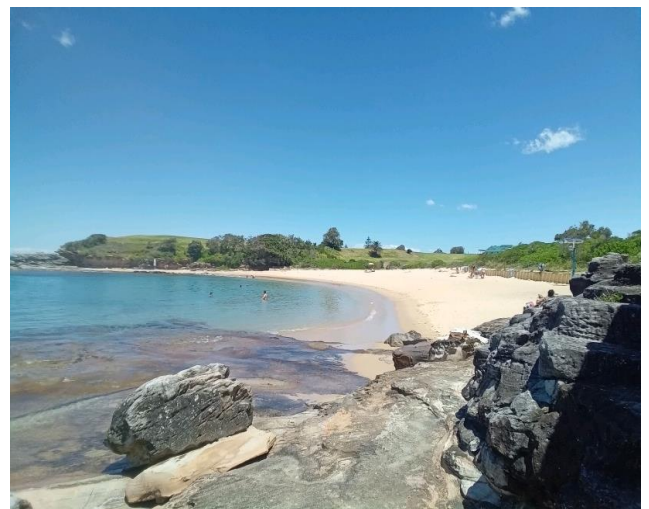
**Notes:** Overview of Southern beach.

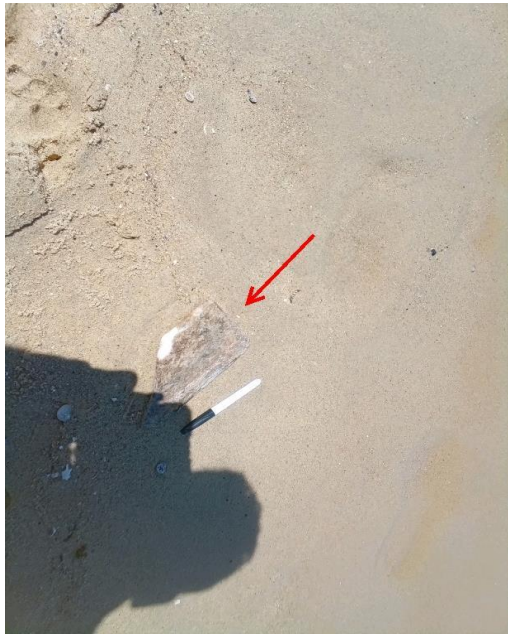
**Notes:** Overview of ACM fragment within Southern beach.

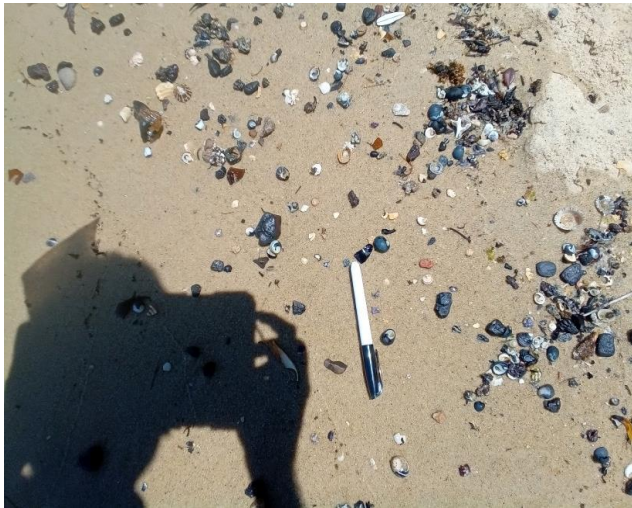
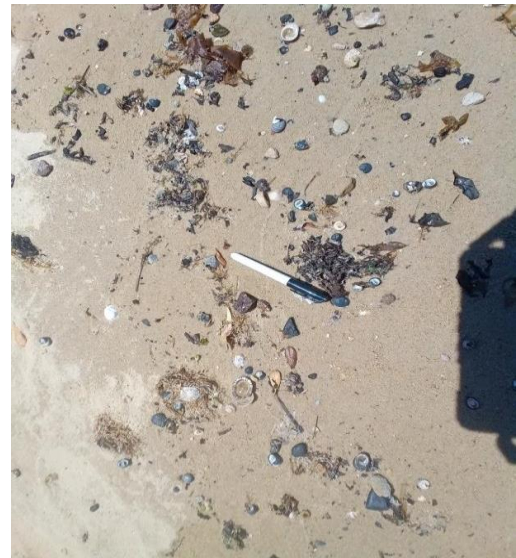
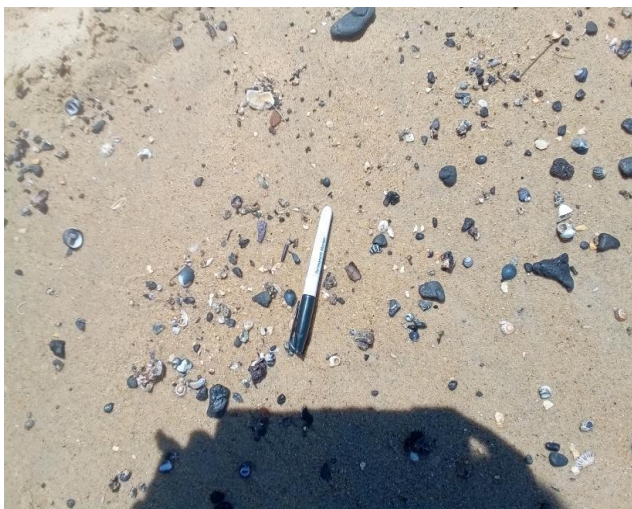
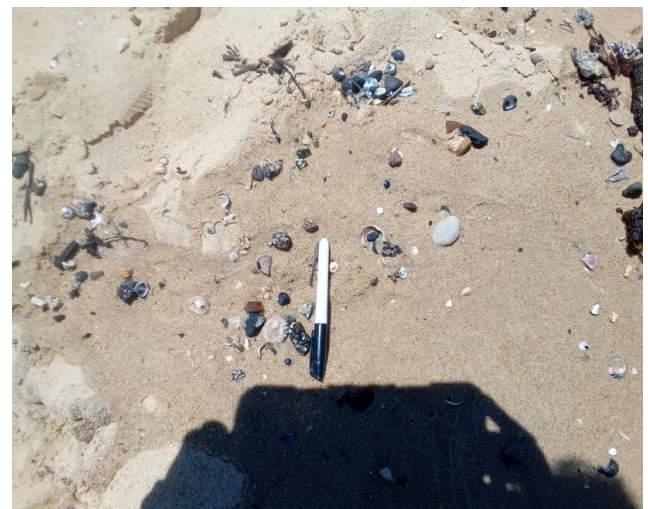
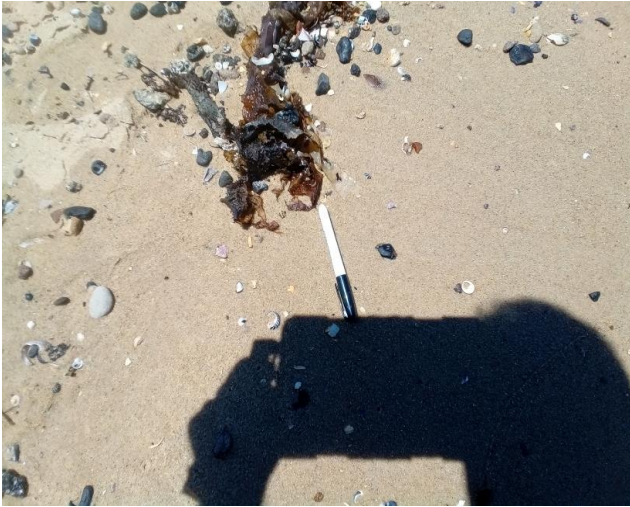
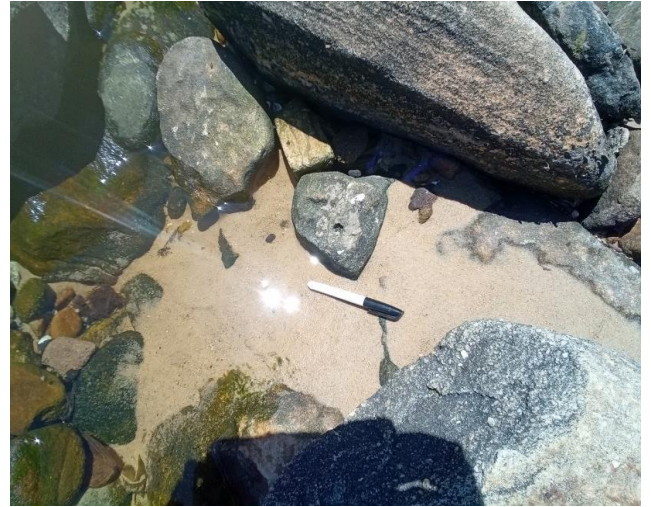
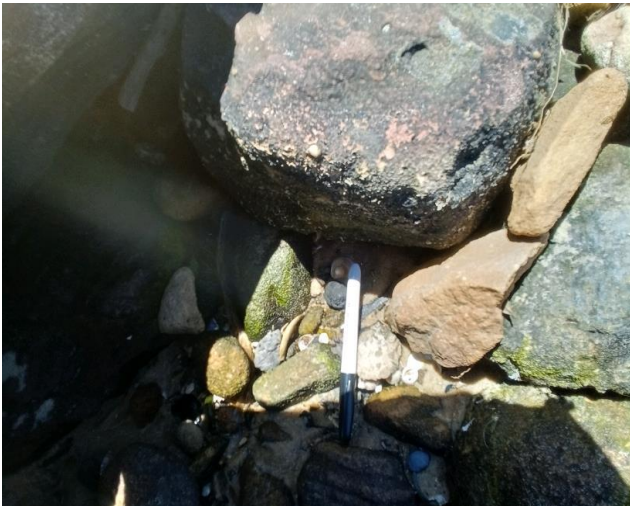
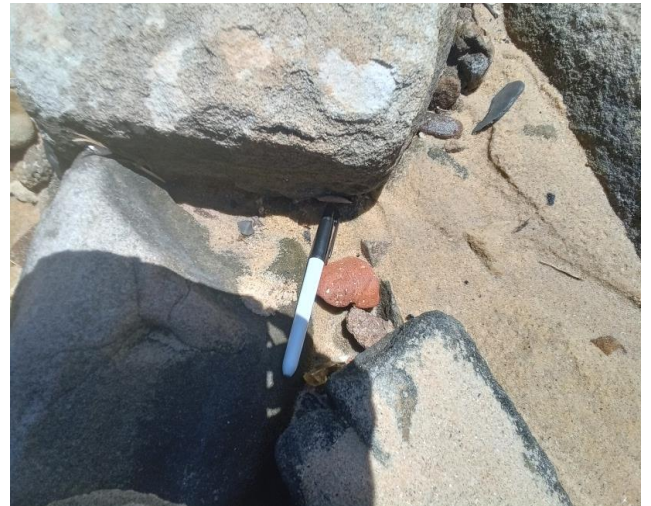
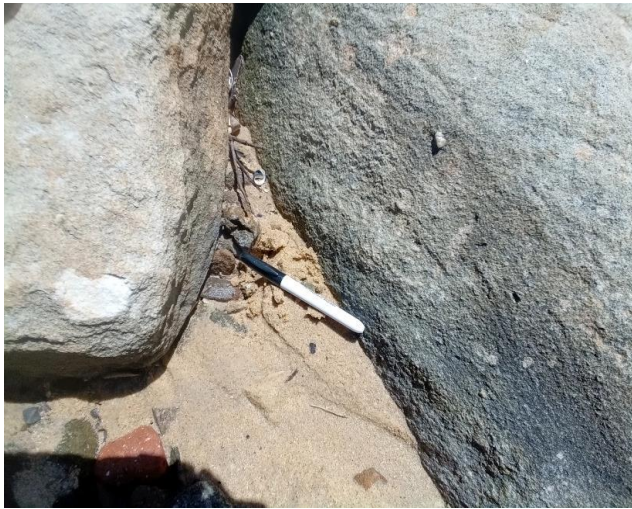
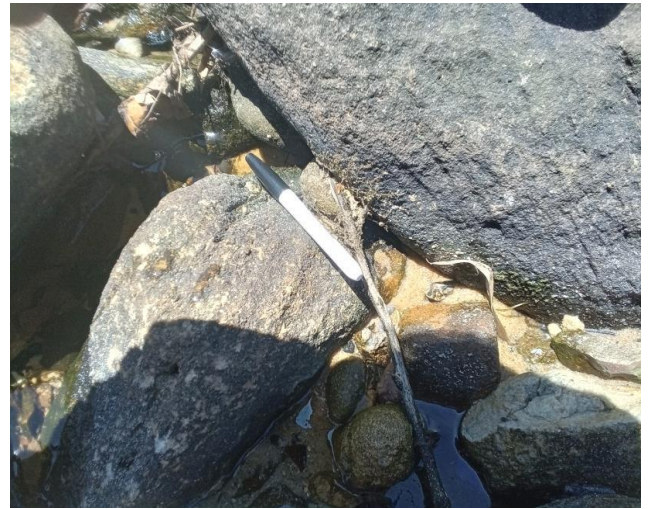
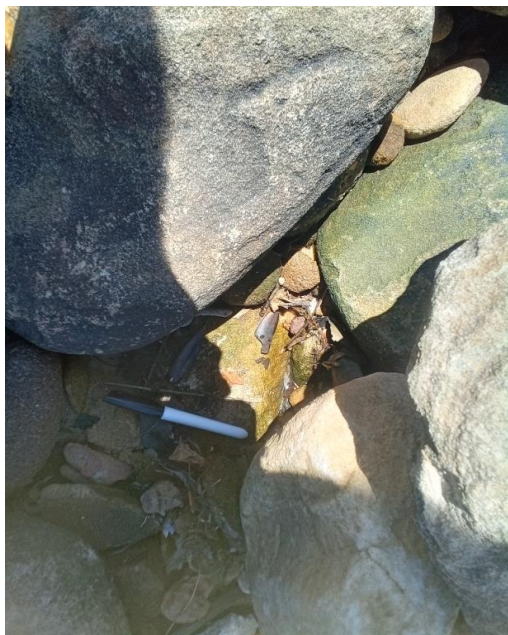
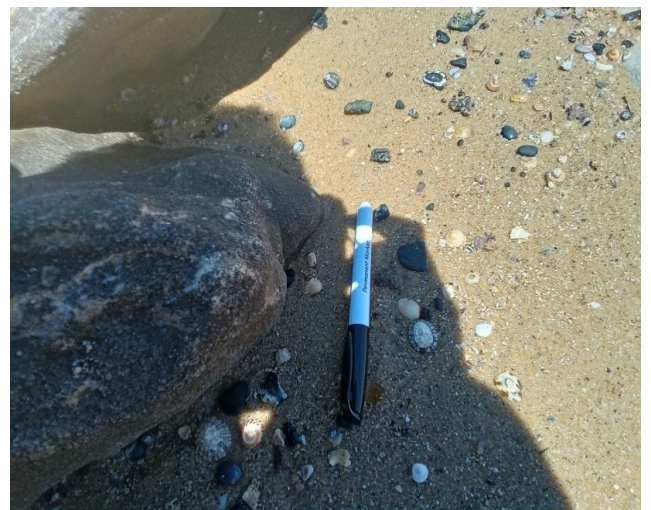
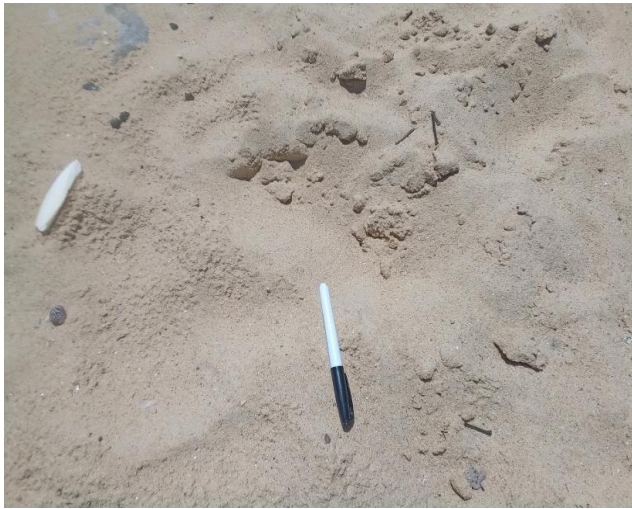
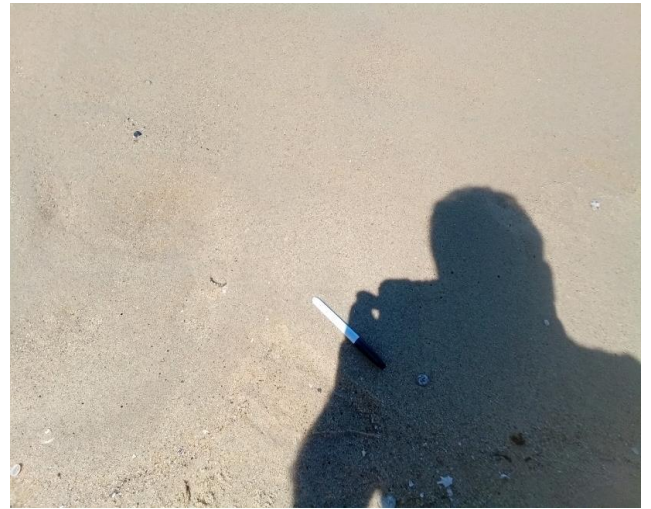
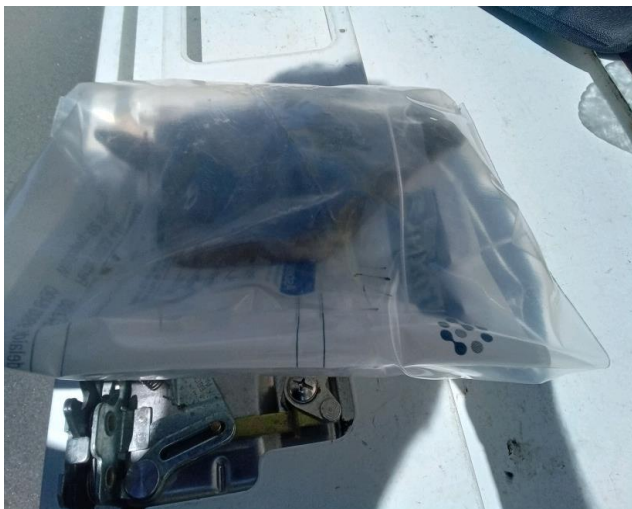
**Notes:** Visual surface clearance inspection following removal of ACM fragment.
