Asbestos Containing Material Clearance Inspection

6 January 2023

Site:	Little Bay Beach
Location:	Southern, Western and Northern Little Bay Beach

Requested by:	
Name	Joe Santangelo
Contact	0436839760
Email	joe.santangelo@randwick.nsw.gov.au
Site Details:	
Address	2 Coast Hospital Rd, Little Bay NSW 2036
Local Government Area	Randwick City Council

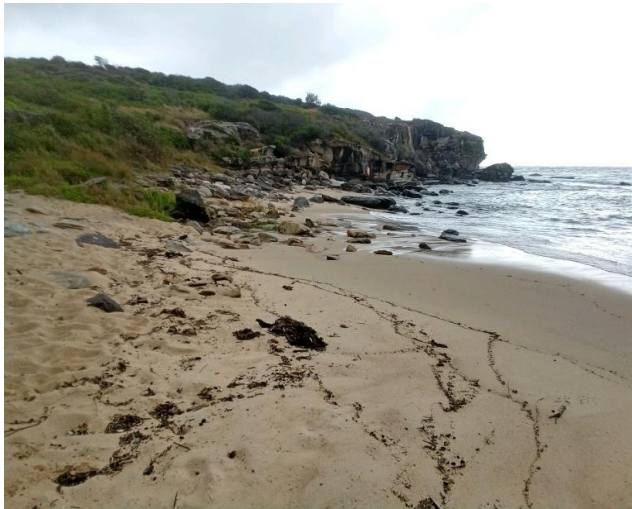
Notes: Overview of the Northern beach.

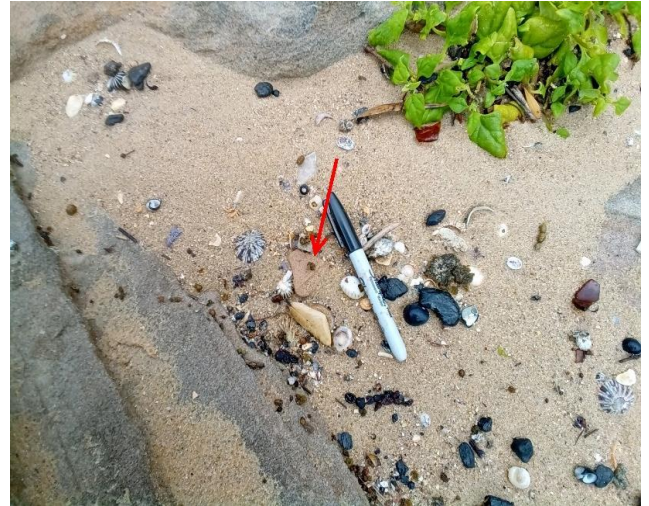
Notes: Overview of the ACM fragment prior to the removal within Northern beach.

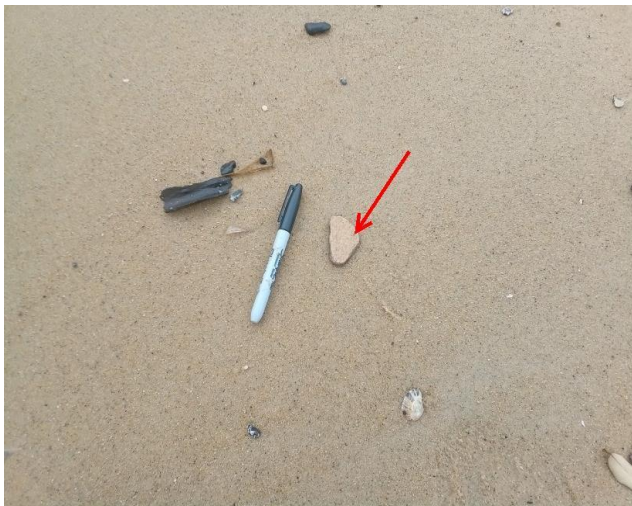
Notes: Overview of the ACM fragment prior to the removal within Northern beach.

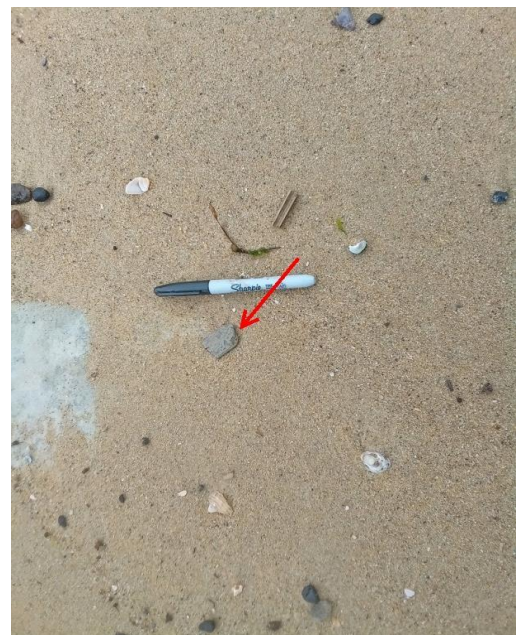
Notes: Overview of the ACM fragment prior to the removal within Northern beach.

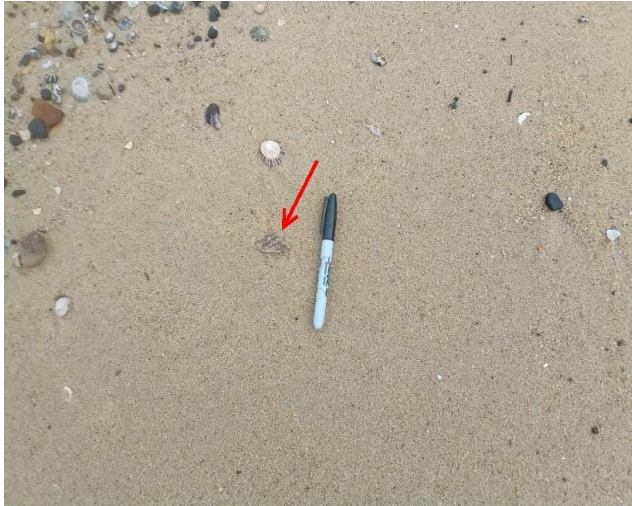
Notes: Overview of the ACM fragment prior to the removal within Northern beach.

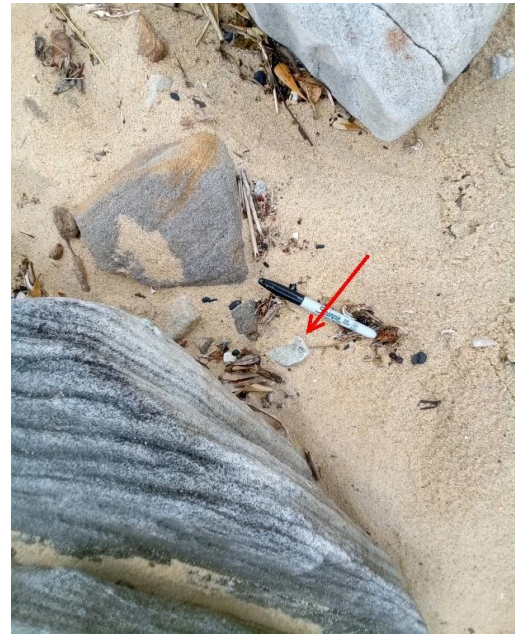
Notes: Overview of the ACM fragment prior to the removal within Northern beach.

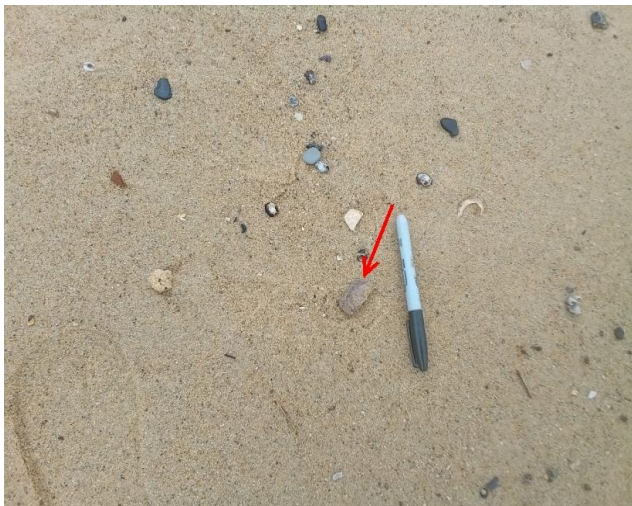
Notes: Overview of the ACM fragment prior to the removal within Northern beach.

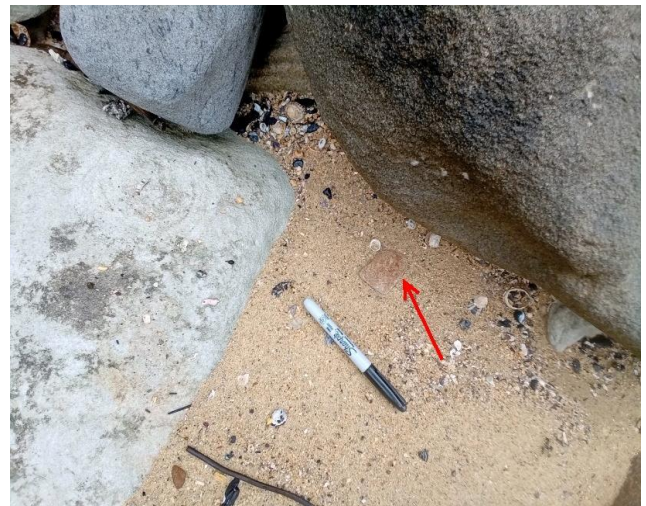
Notes: Overview of the ACM fragment prior to the removal within Northern beach.

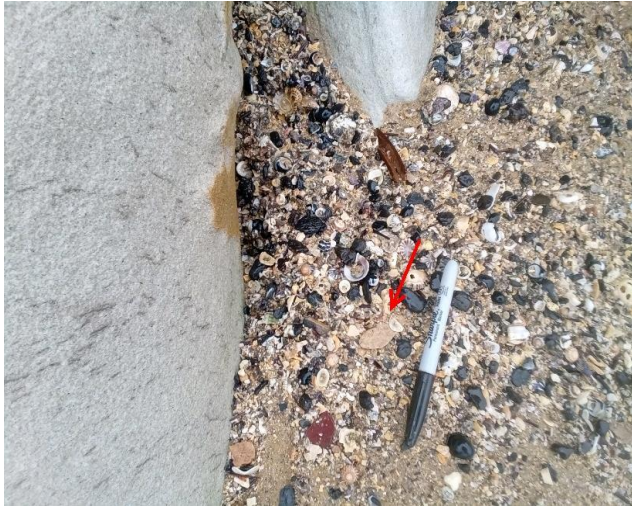
Notes: Overview of the ACM fragment prior to the removal within Northern beach.

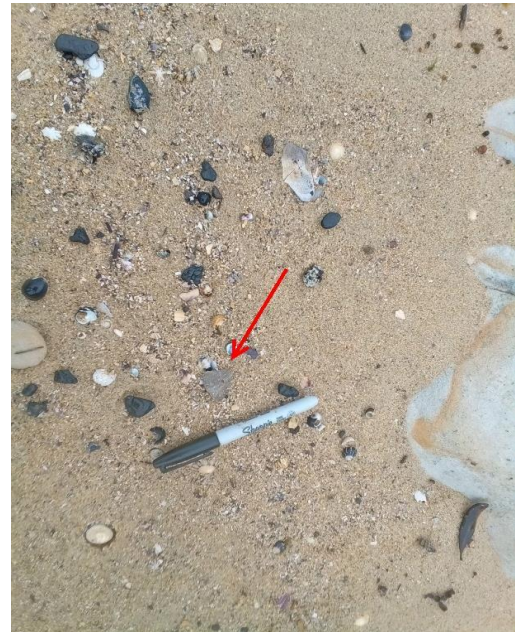
Notes: Overview of the ACM fragment prior to the removal within Northern beach.

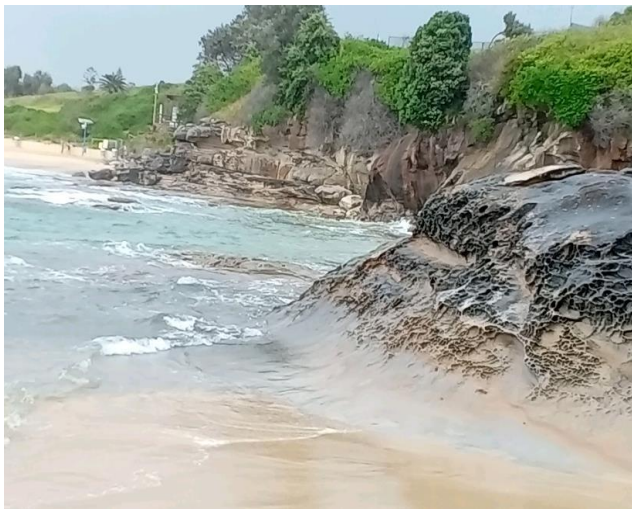
Notes: Overview of the Western beach.

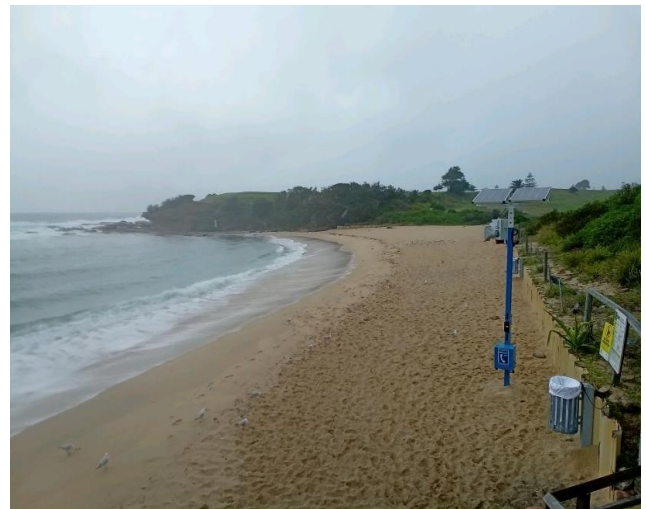
Notes: Overview of the Southern beach.

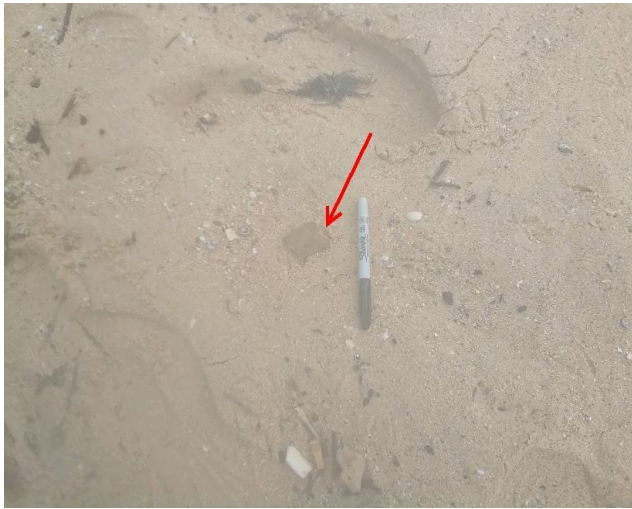
Notes: Overview of the ACM fragment prior to the removal within Southern beach.

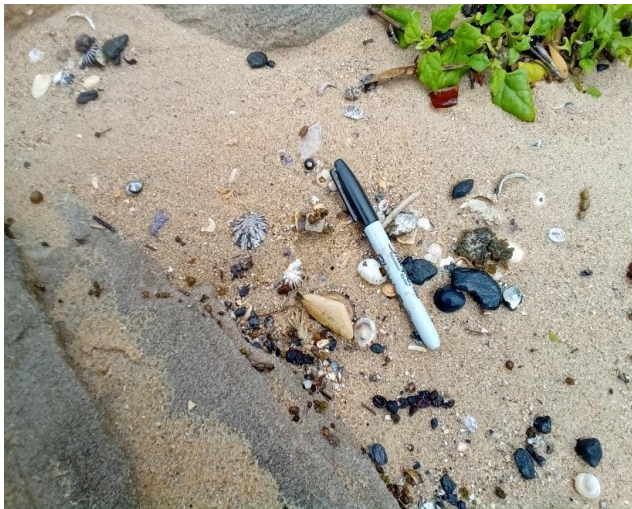
Notes: Visual surface clearance inspection following removal of ACM fragment.

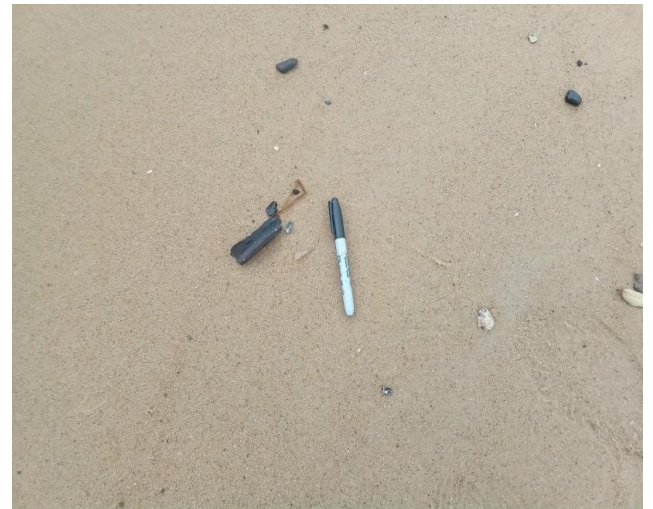
Notes: Visual surface clearance inspection following removal of ACM fragment.

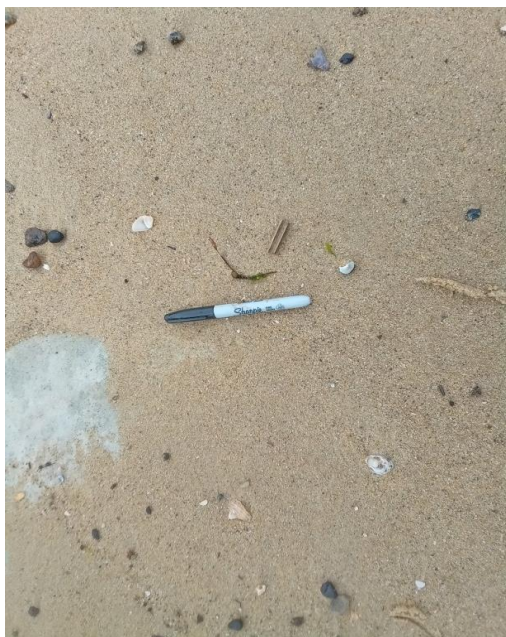
Notes: Visual surface clearance inspection following removal of ACM fragment.

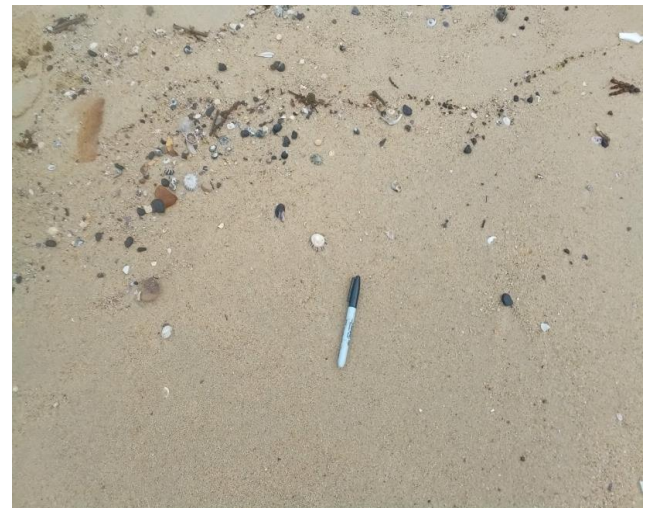
Notes: Visual surface clearance inspection following removal of ACM fragment.

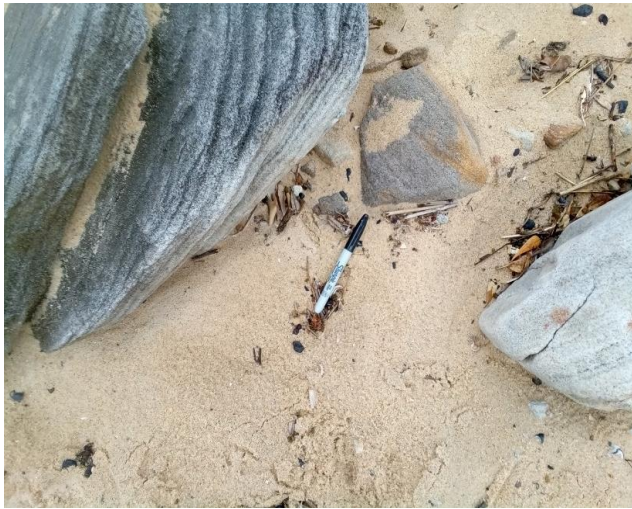
Notes: Visual surface clearance inspection following removal of ACM fragment.

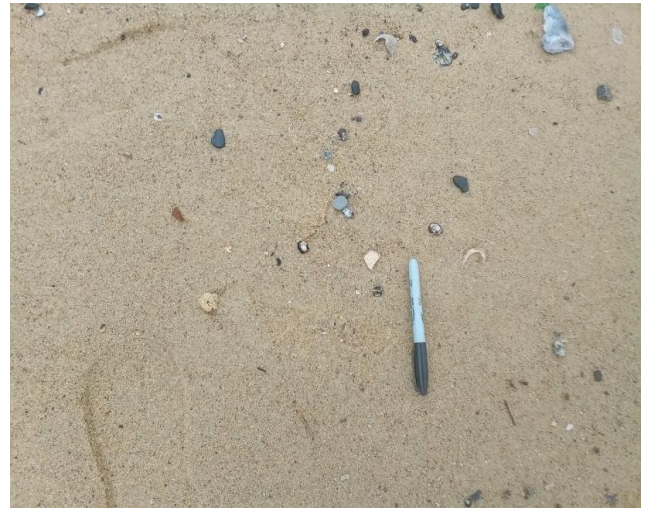
Notes: Visual surface clearance inspection following removal of ACM fragment.

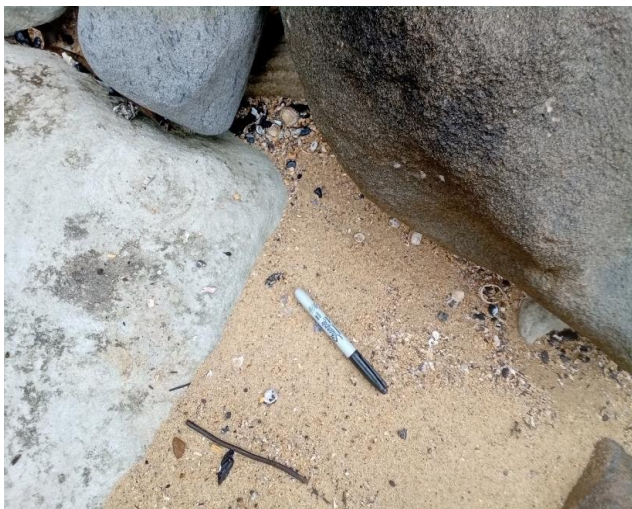
Notes: Visual surface clearance inspection following removal of ACM fragment.

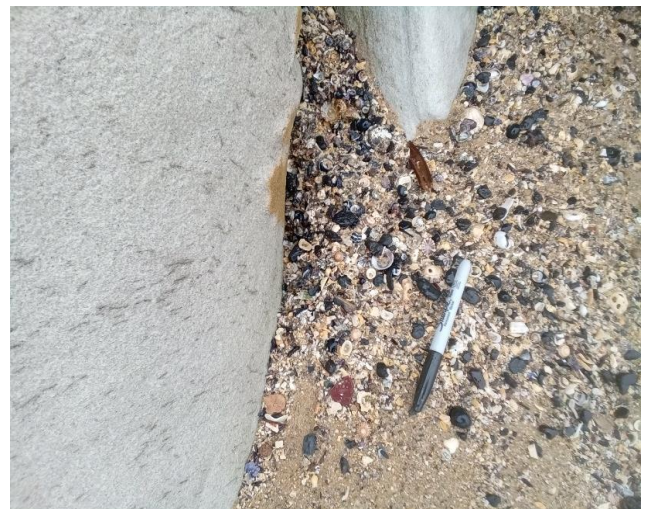
Notes: Visual surface clearance inspection following removal of ACM fragment.

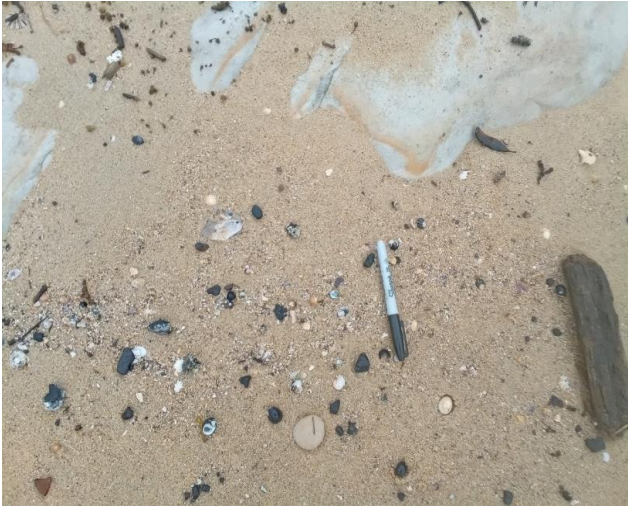
Notes: Visual surface clearance inspection following removal of ACM fragment.

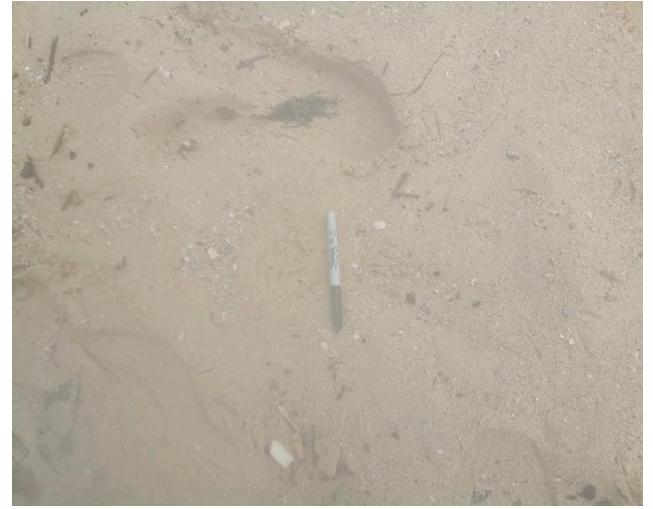
Notes: Visual surface clearance inspection following removal of ACM fragment.
