Asbestos Containing Material Clearance Inspection

30 March 2023

RE: Asbestos Containing Material Clearance Inspection

Site:	Little Bay Beach
Location:	Southern, Western and Northern Little Bay Beach

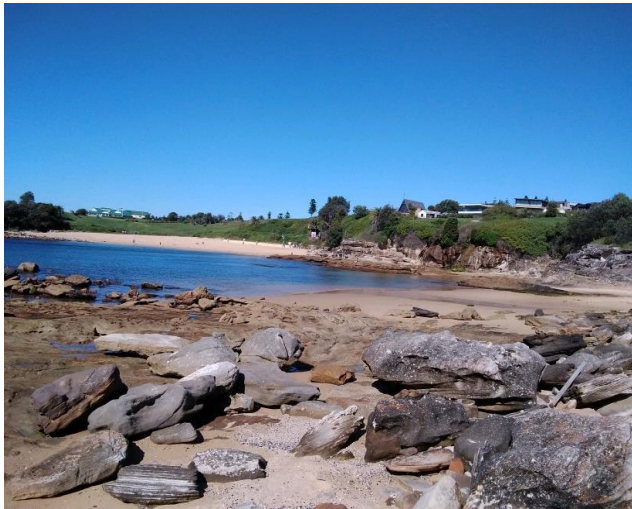
Notes: Overview of the Beach prior to the inspection

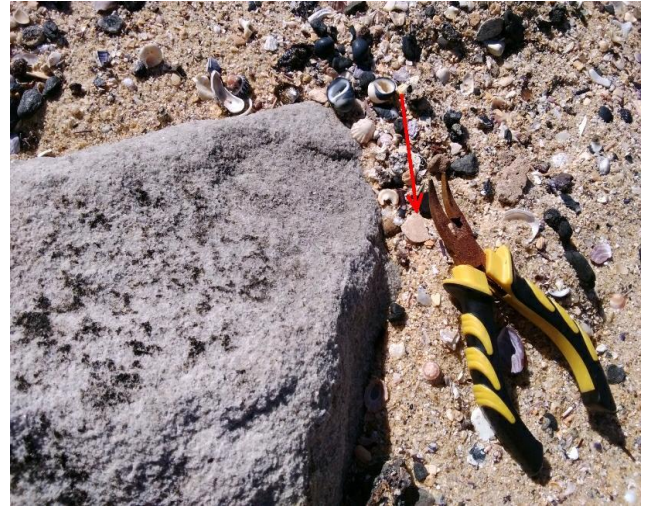
Notes: FC fragment identified on sand surface prior to emu pick - Northern section

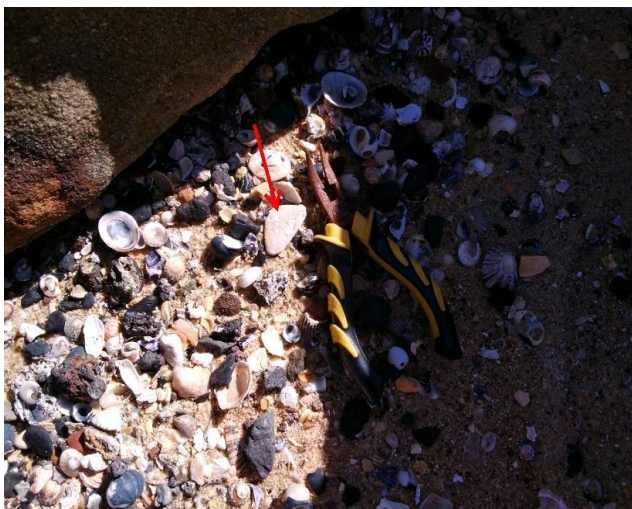
Notes: FC fragment identified on sand surface prior to emu pick - Northern section

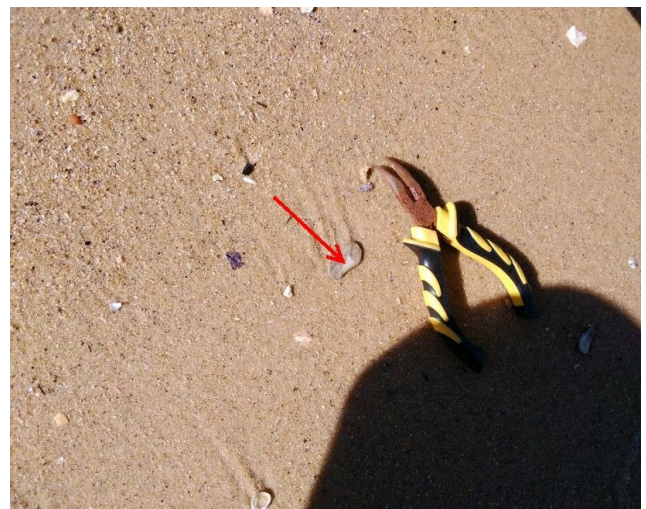
Notes: FC fragment identified on sand surface prior to emu pick - Northern section

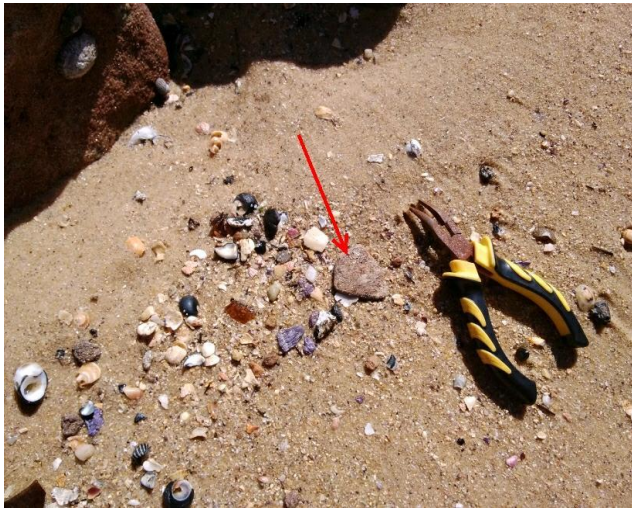
Notes: FC fragment identified on sand surface prior to emu pick - Northern section

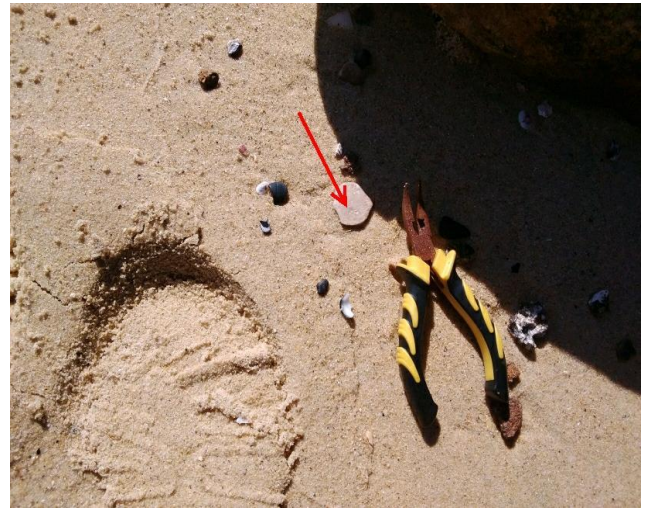
Notes: FC fragment identified on sand surface prior to emu pick - Northern section

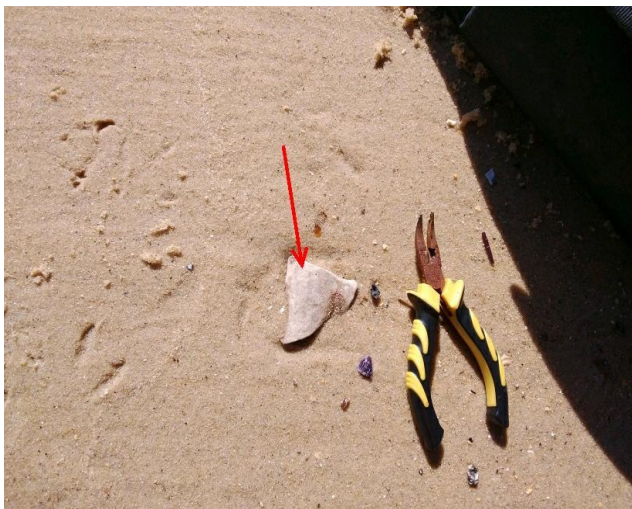
Notes: FC fragment identified on sand surface prior to emu pick - Northern section

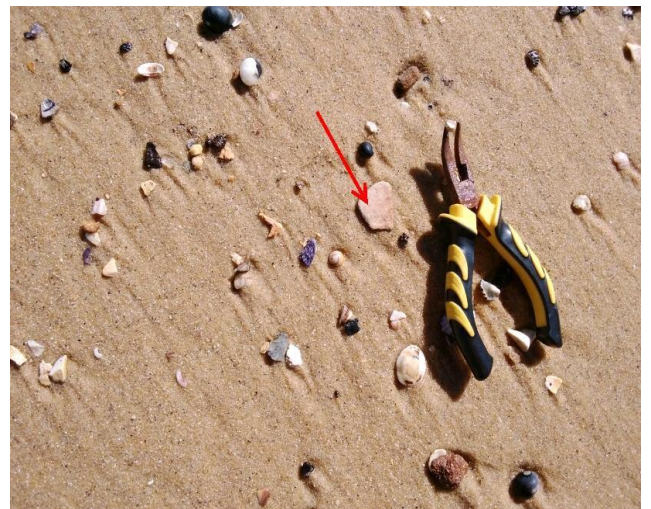
Notes: FC fragment identified on sand surface prior to emu pick - Northern section

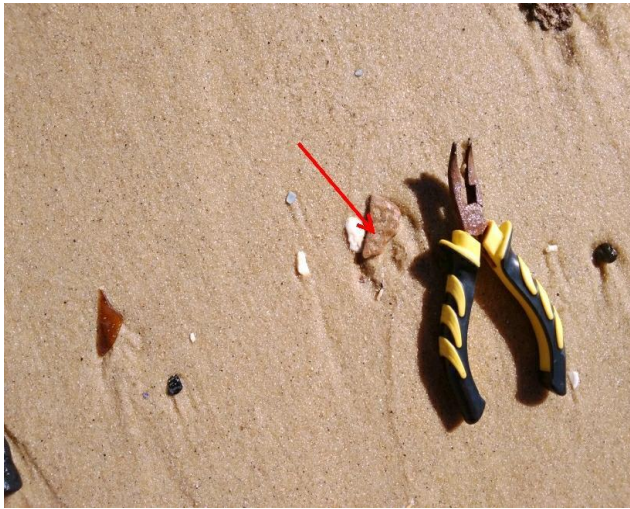
Notes: FC fragment identified on sand surface prior to emu pick - Northern section

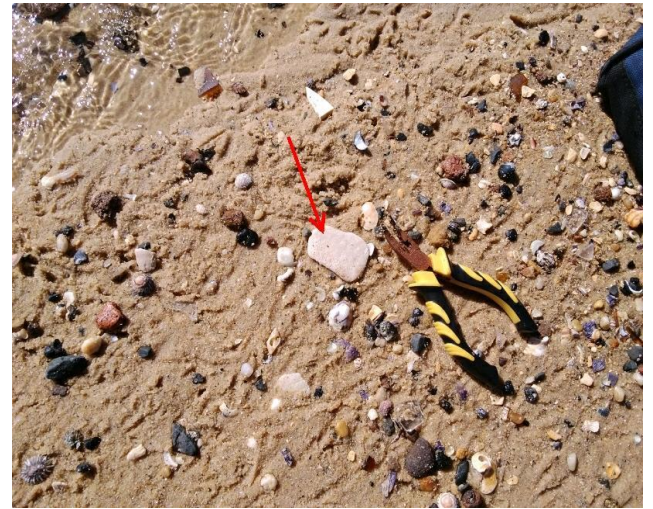
Notes: FC fragment identified on sand surface prior to emu pick - Northern section

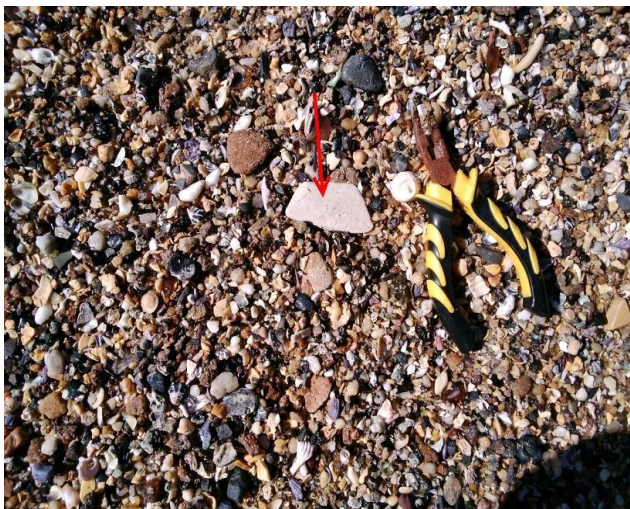
Notes: FC fragment identified on sand surface prior to emu pick - Northern section

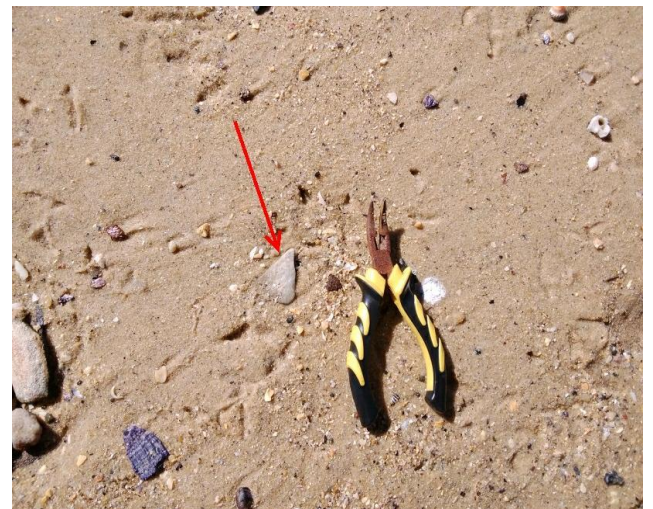
Notes: FC fragment identified on sand surface prior to emu pick - Northern section

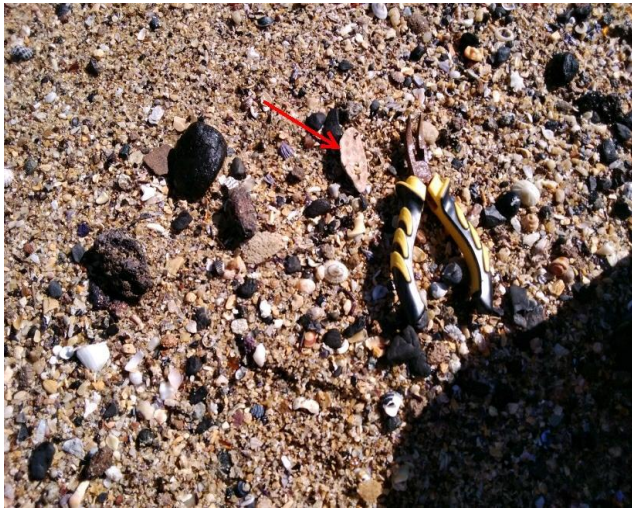
Notes: FC fragment identified on sand surface prior to emu pick - Northern section

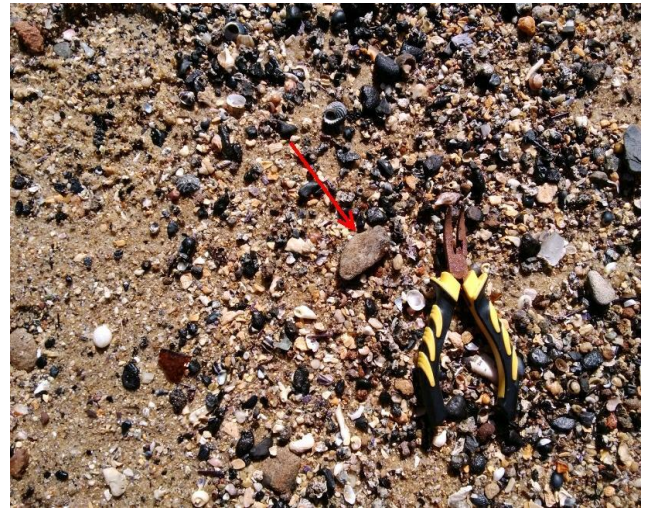
Notes: FC fragment identified on sand surface prior to emu pick - Western section

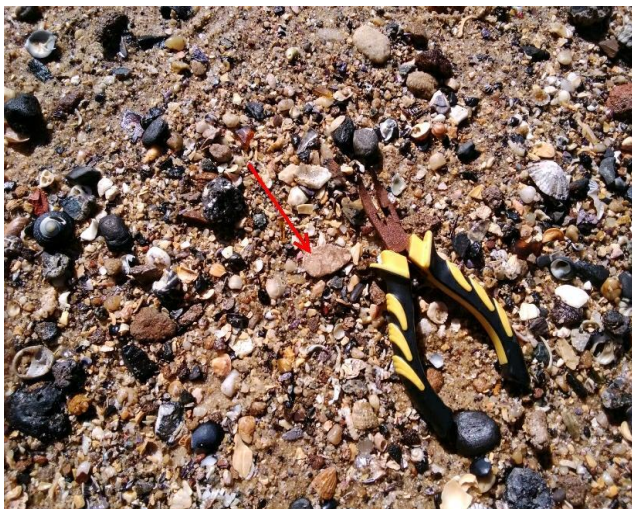
Notes: FC fragment identified on sand surface prior to emu pick - Western section

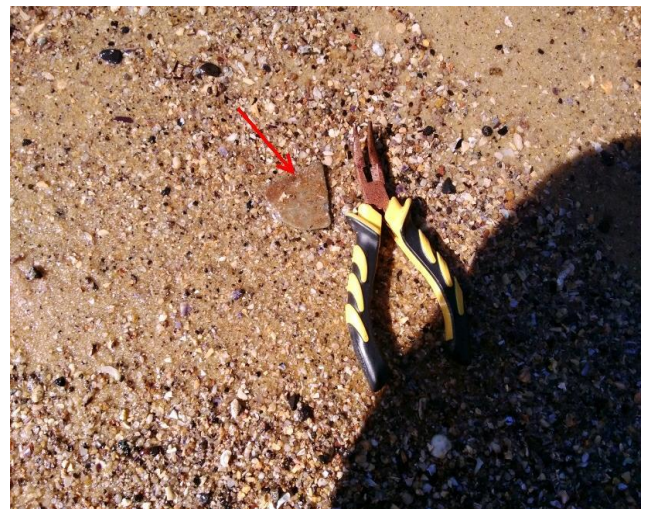
Notes: FC fragment identified on sand surface prior to emu pick - Western section

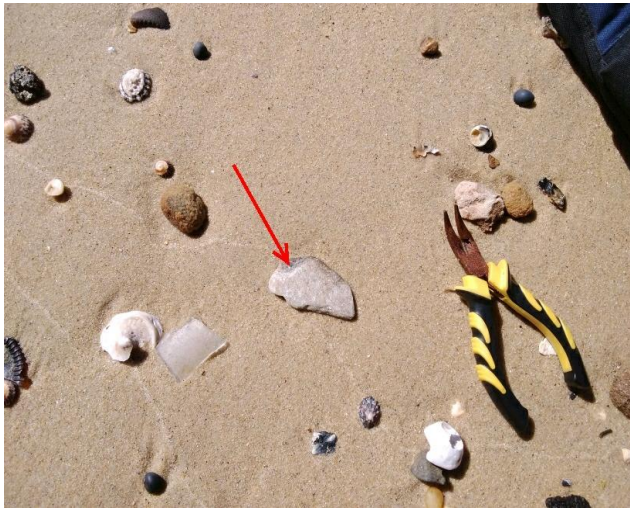
Notes: FC fragment identified on sand surface prior to emu pick - Western section

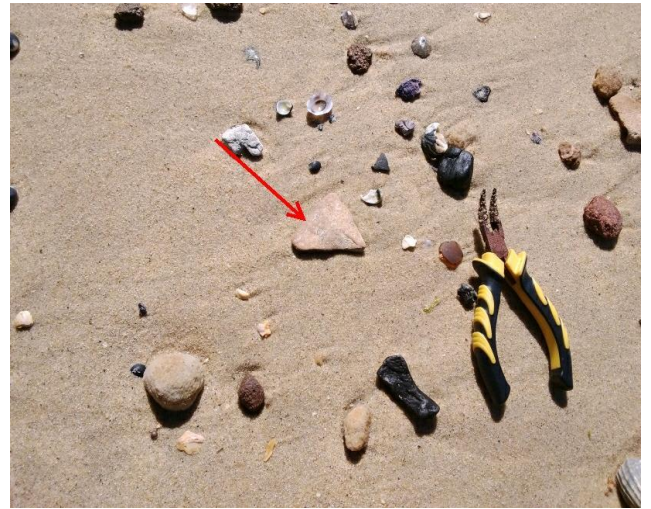
Notes: FC fragment identified on sand surface prior to emu pick - Western section

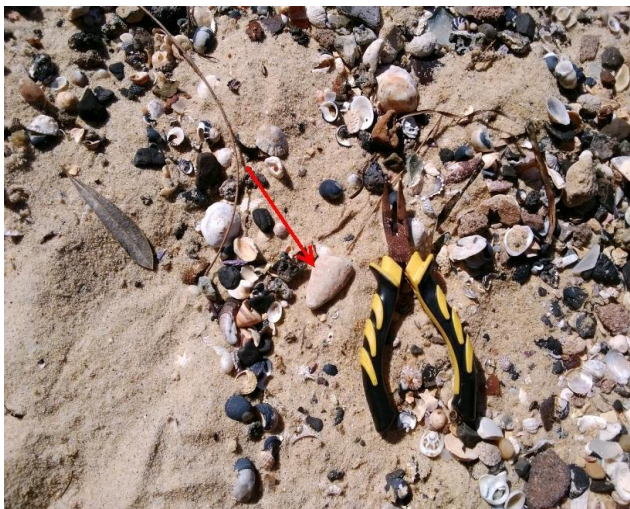
Notes: FC fragment identified on sand surface prior to emu pick - Western section

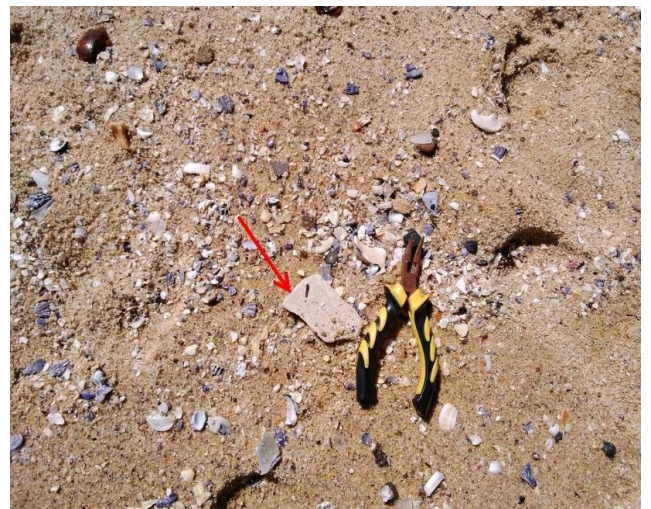
Notes: FC fragment identified on sand surface prior to emu pick - Southern section

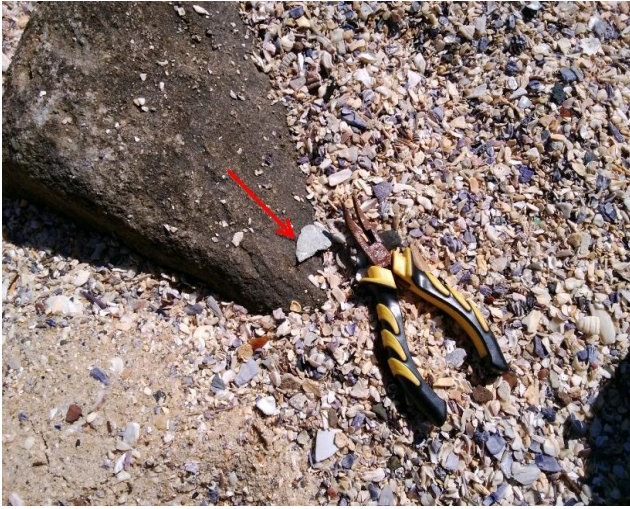
Notes: FC fragment identified on sand surface prior to emu pick - Southern section

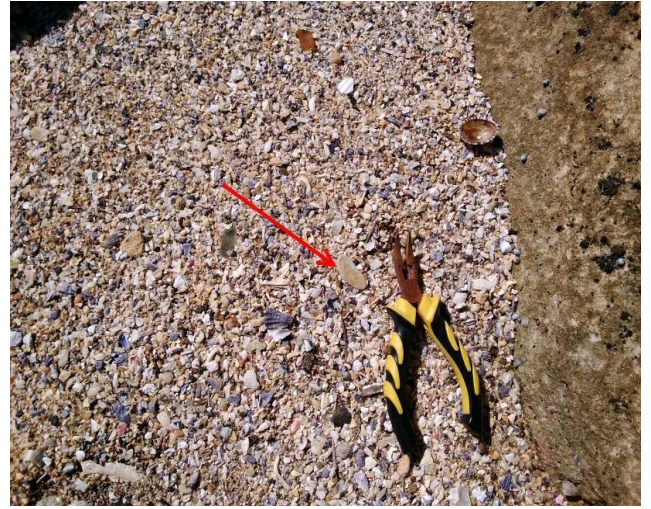
Notes: FC fragment identified on sand surface prior to emu pick - Southern section

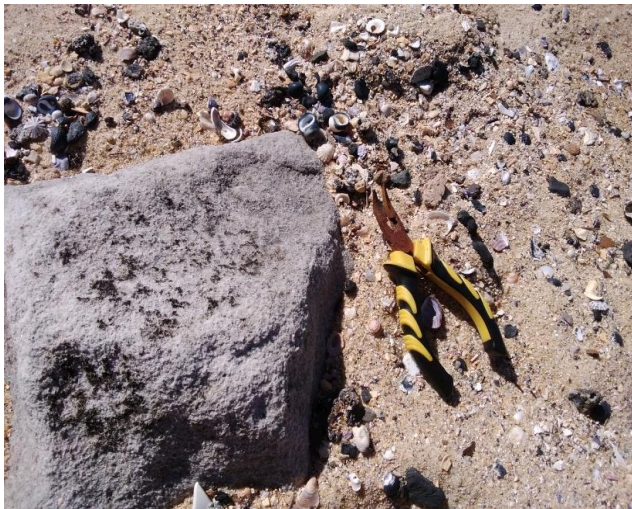
Notes: Sand surface following emu pick - Northern section

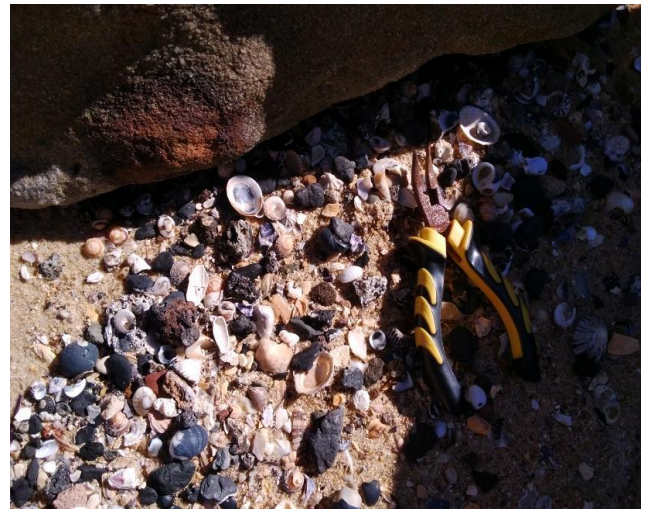
Notes: Sand surface following emu pick - Northern section

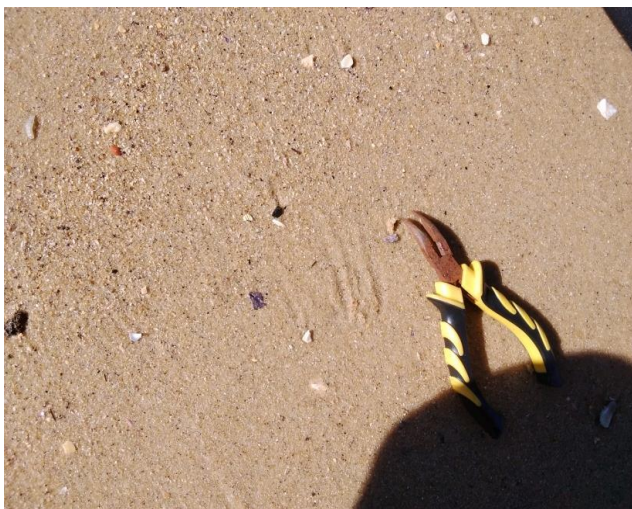
Notes: Sand surface following emu pick - Northern section

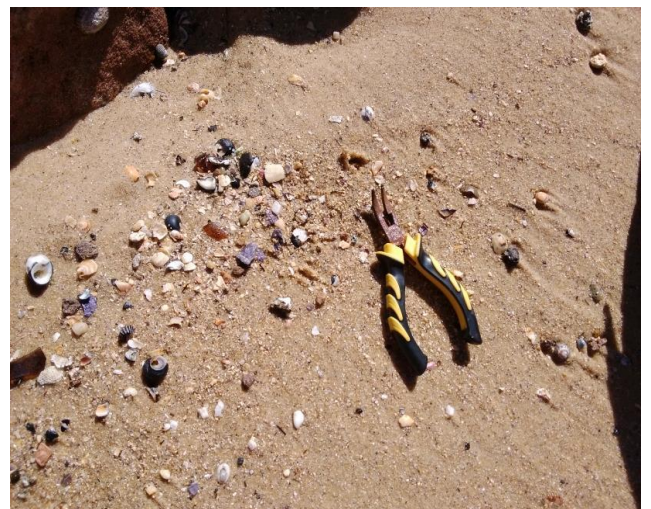
Notes: Sand surface following emu pick - Northern section

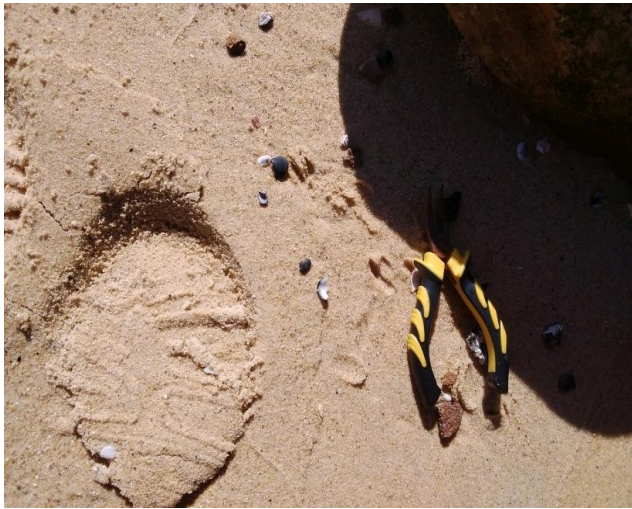
Notes: Sand surface following emu pick - Northern section

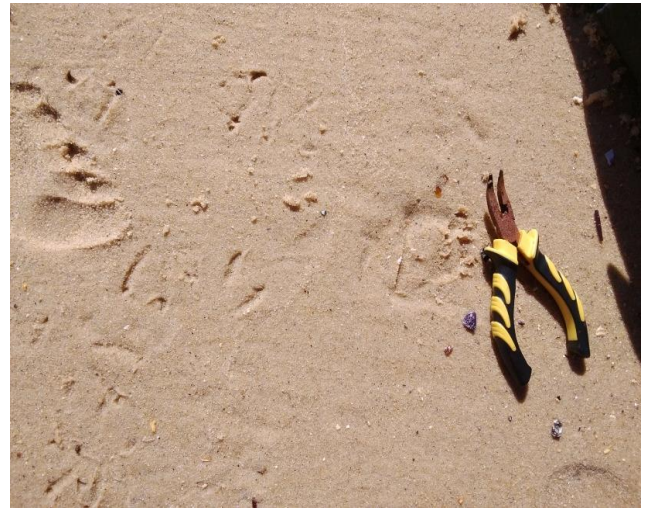
Notes: Sand surface following emu pick - Northern section

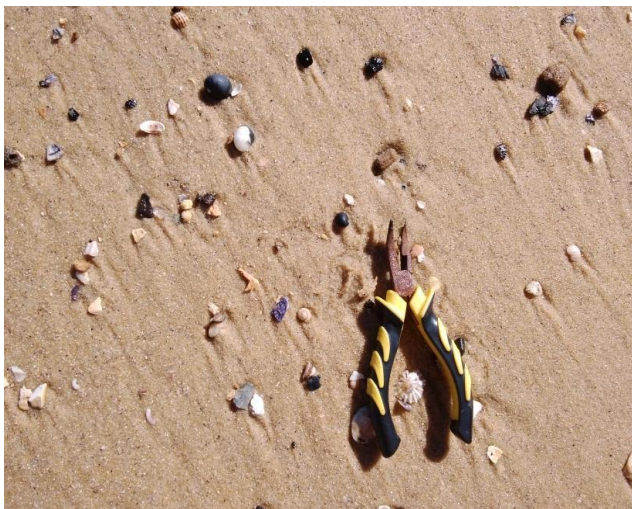
Notes: Sand surface following emu pick - Northern section

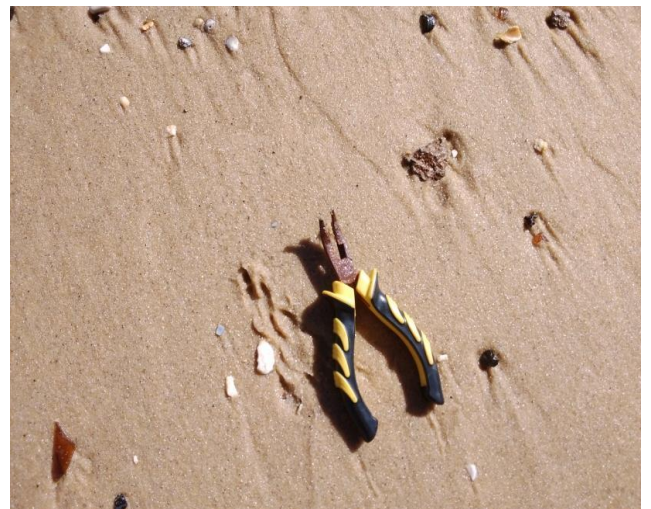
Notes: Sand surface following emu pick - Northern section

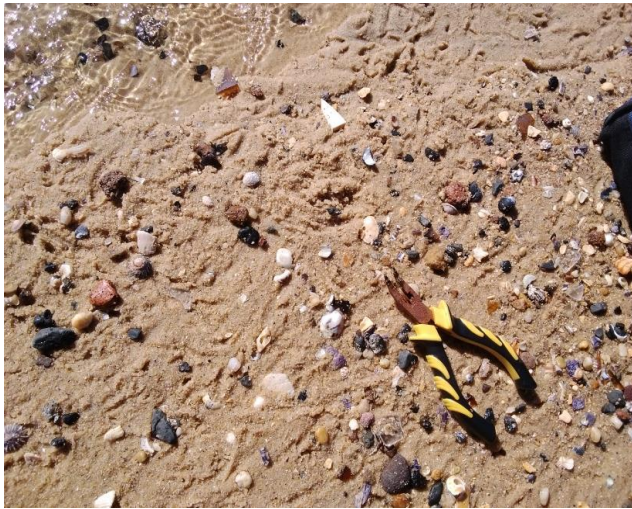
Notes: Sand surface following emu pick - Northern section

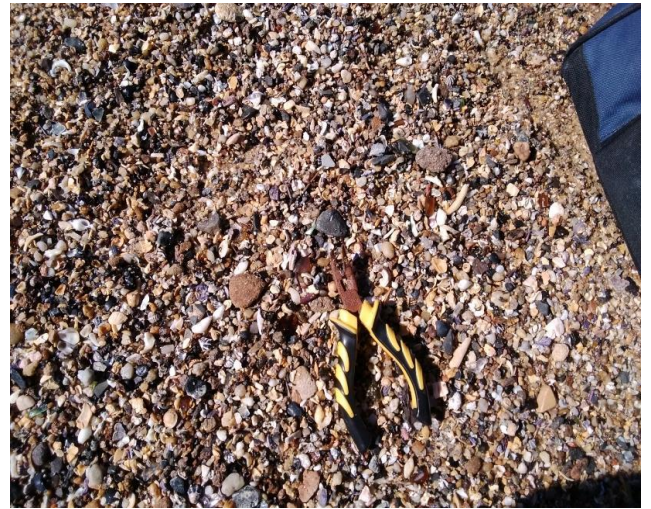
Notes: Sand surface following emu pick - Northern section

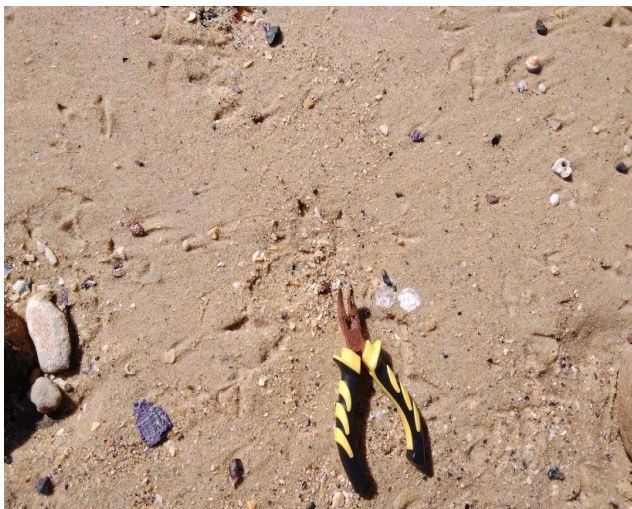
Notes: Sand surface following emu pick - Northern section

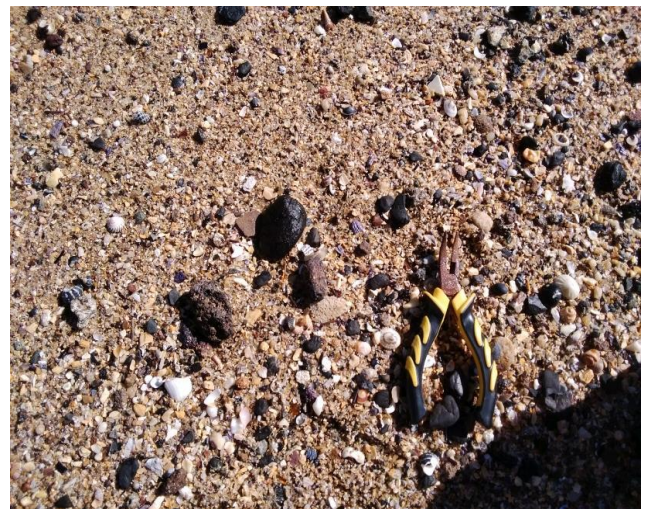
Notes: Sand surface following emu pick - Northern section

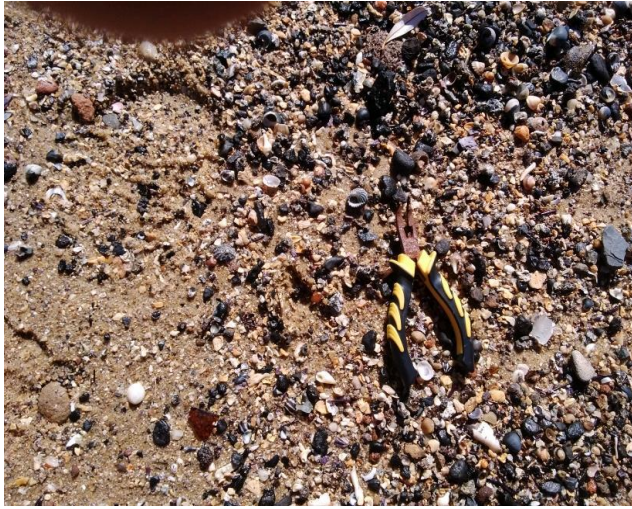
Notes: Sand surface following emu pick - Western section

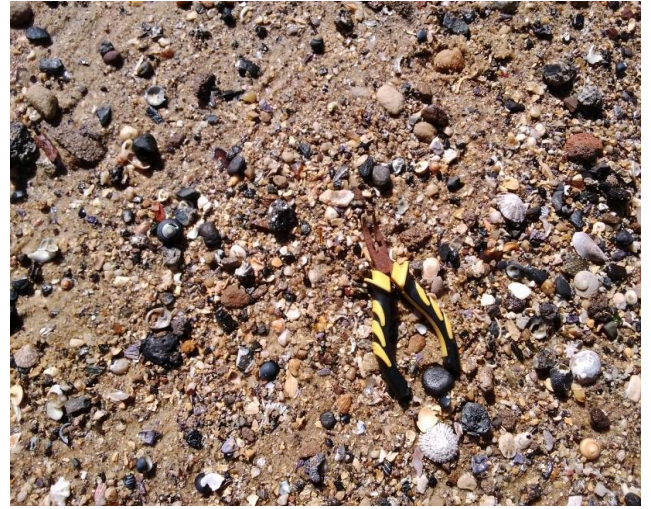
Notes: Sand surface following emu pick - Western section

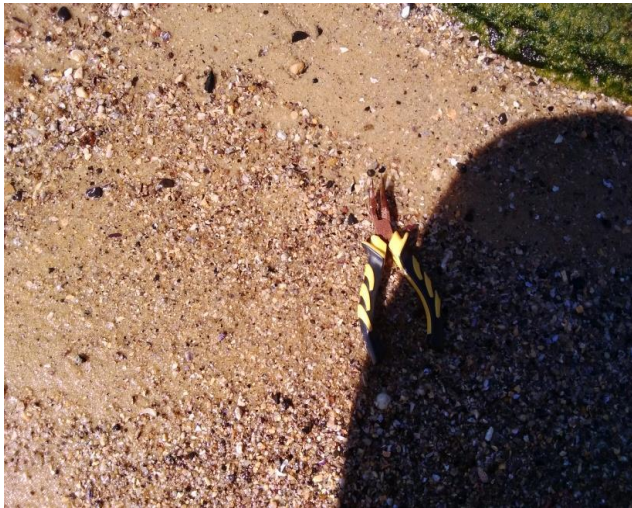
Notes: Sand surface following emu pick - Western section

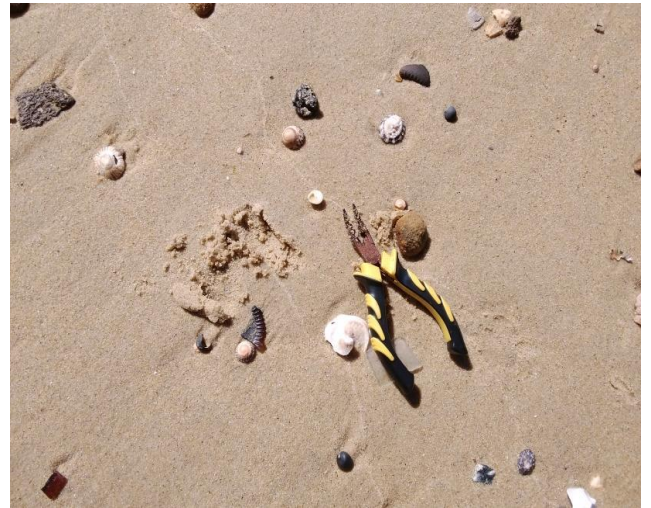
Notes: Sand surface following emu pick - Western section

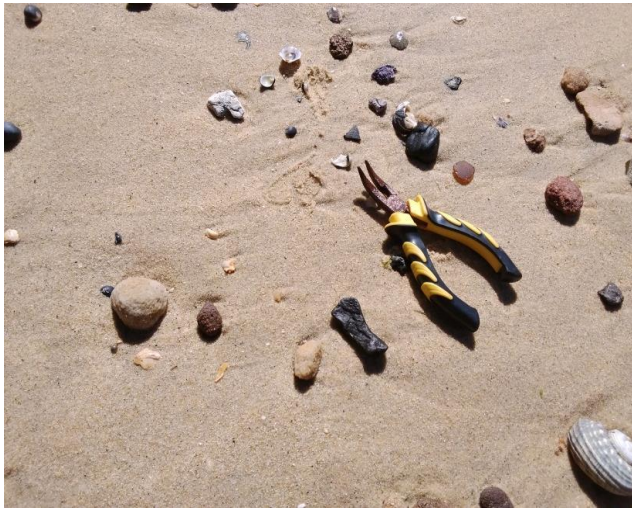
Notes: Sand surface following emu pick - Western section

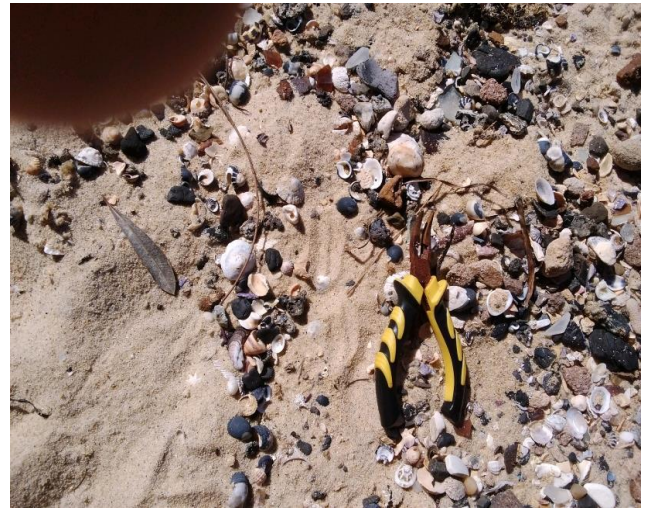
Notes: Sand surface following emu pick - Western section

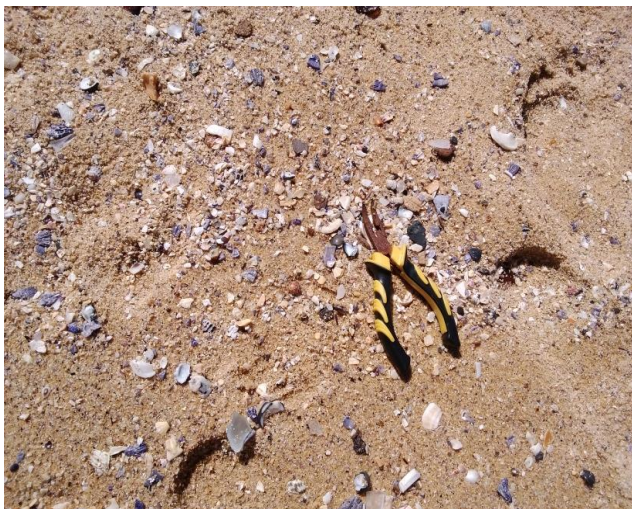
Notes: Sand surface following emu pick - Southern section

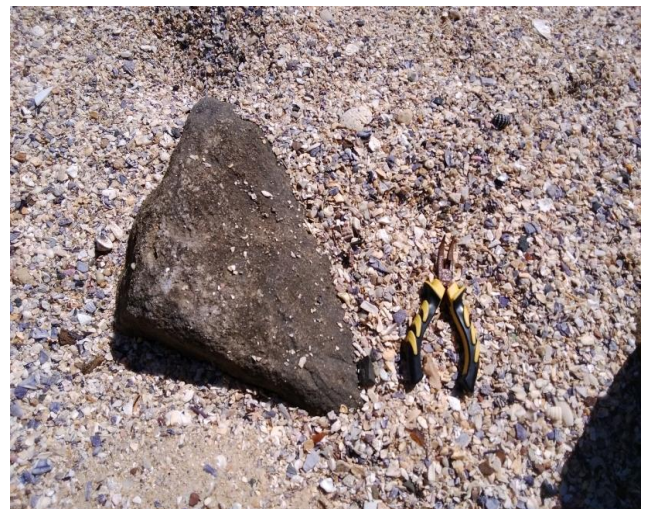
Notes: Sand surface following emu pick - Southern section

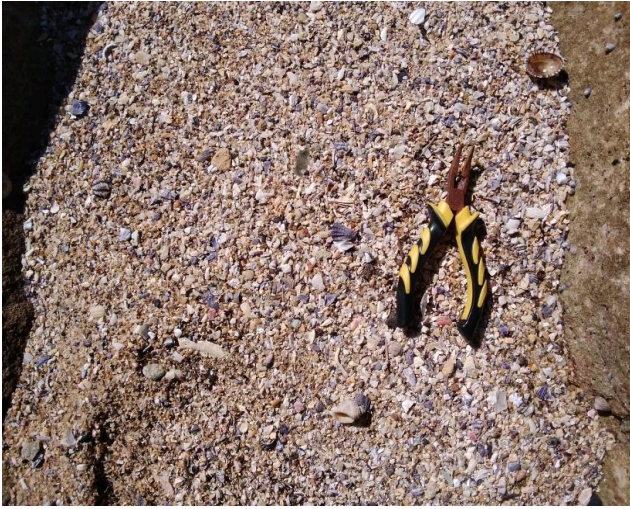
Notes: Sand surface following emu pick - Southern section
