# Asbestos Containing Material Clearance Inspection

6 April 2023

<b>Site:</b>	Little Bay Beach
<b>Location:</b>	Southern, Western and Northern Little Bay Beach

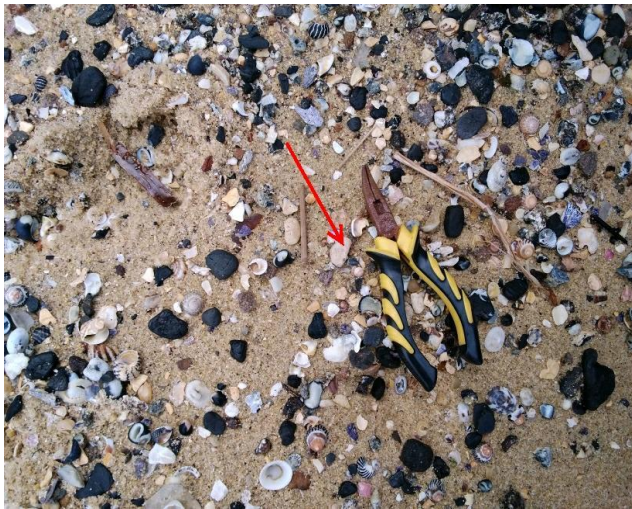
**Notes:** FC fragment identified on sand surface prior to emu pick - Northern section

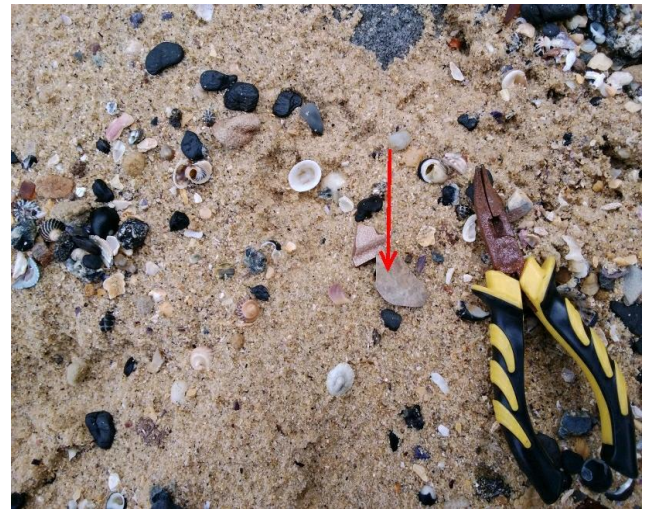
**Notes:** FC fragment identified on sand surface prior to emu pick - Northern section

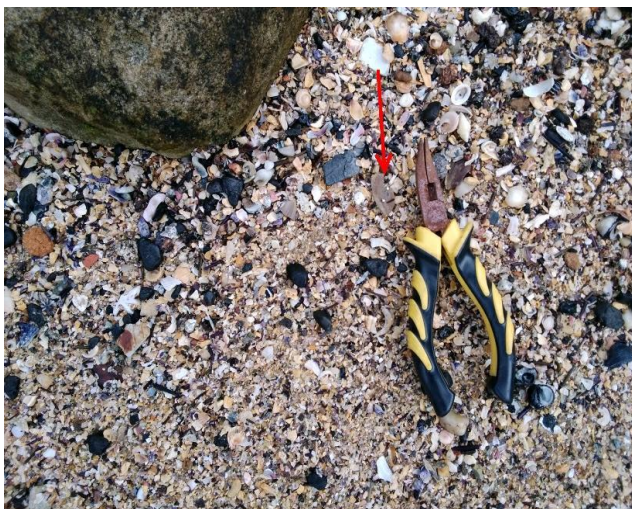
**Notes:** FC fragment identified on sand surface prior to emu pick - Northern section

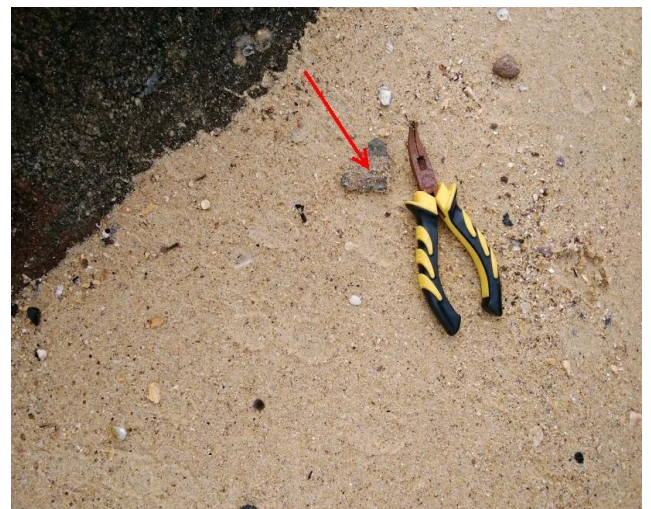
**Notes:** FC fragment identified on sand surface prior to emu pick - Northern section

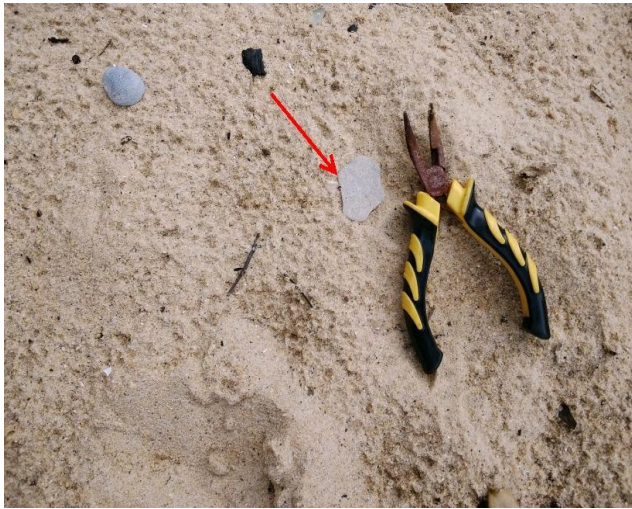
**Notes:** FC fragment identified on sand surface prior to emu pick - Northern section

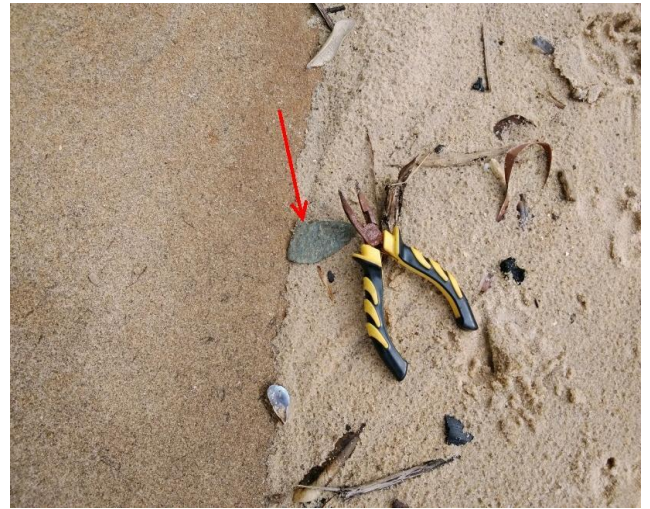
**Notes:** FC fragment identified on sand surface prior to emu pick - Northern section

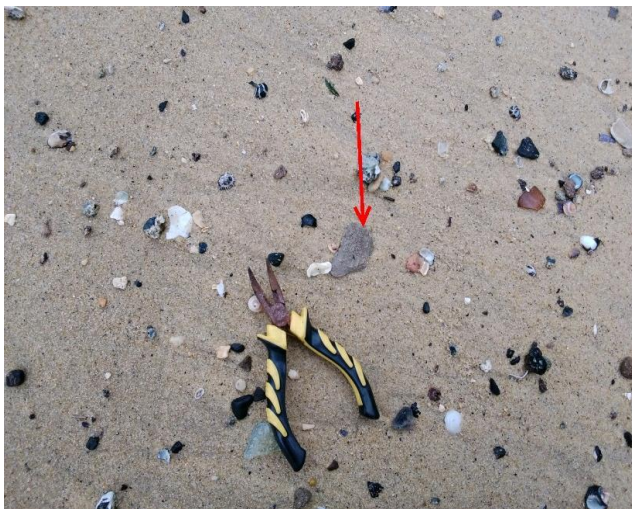
**Notes:** FC fragment identified on sand surface prior to emu pick - Western section

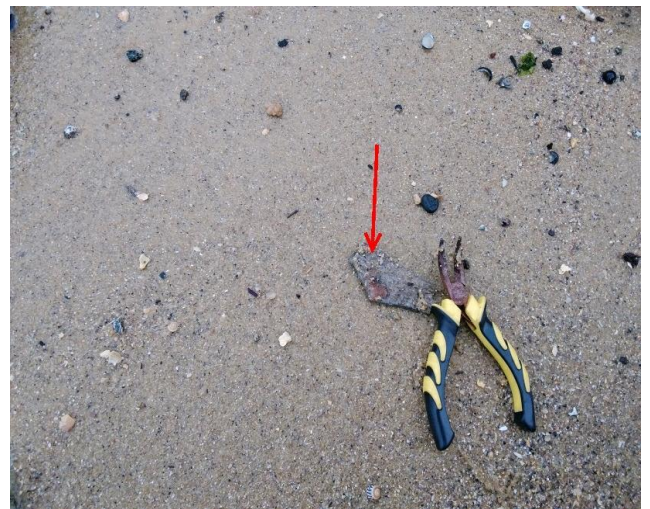
**Notes:** FC fragment identified on sand surface prior to emu pick - Western section

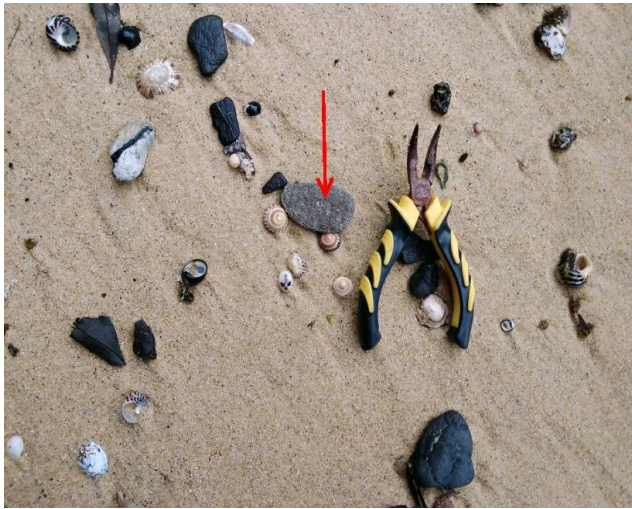
**Notes:** FC fragment identified on sand surface prior to emu pick - Western section

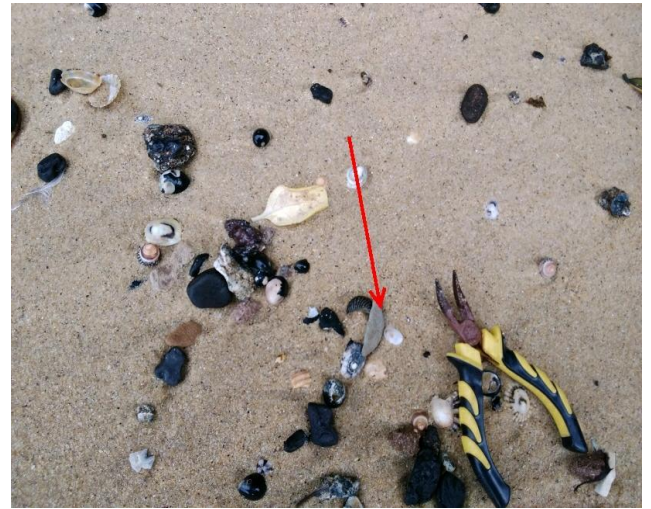
**Notes:** FC fragment identified on sand surface prior to emu pick - Western section

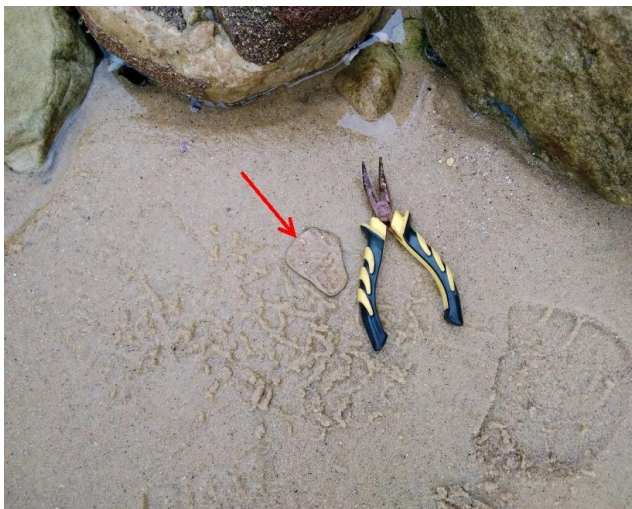
**Notes:** FC fragment identified on sand surface prior to emu pick - Southern section

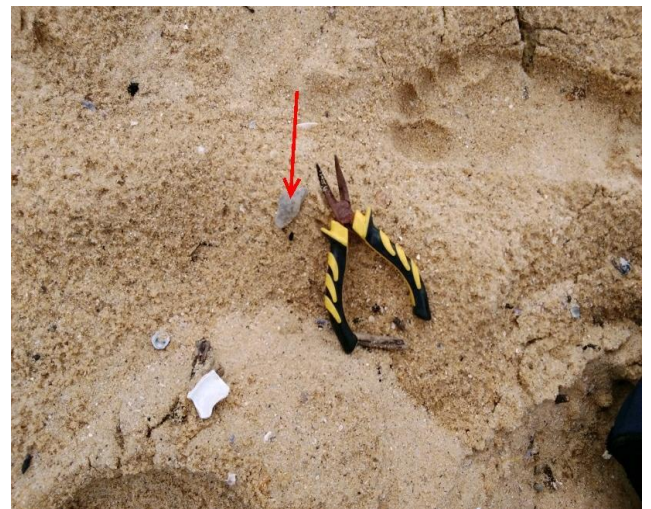
**Notes:** FC fragment identified on sand surface prior to emu pick - Southern section

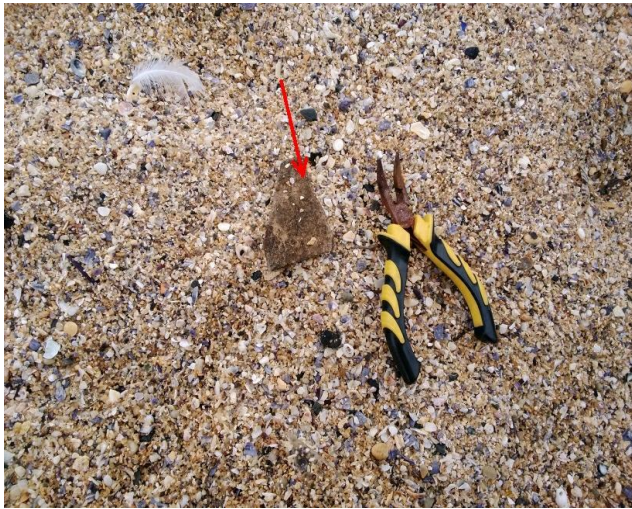
**Notes:** FC fragment identified on sand surface prior to emu pick - Southern section

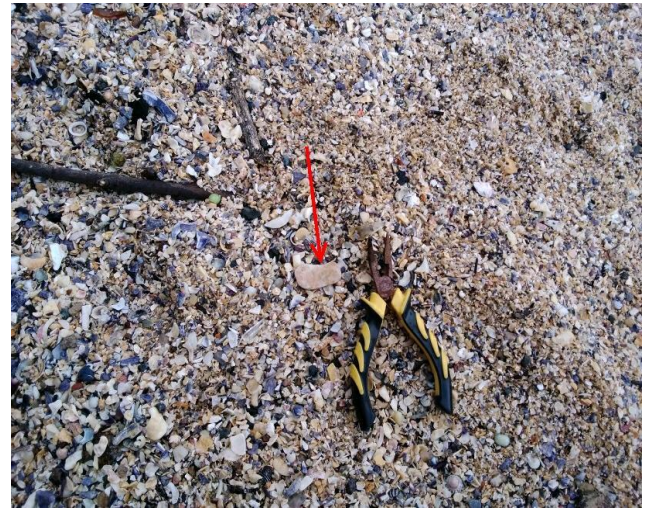
**Notes:** FC fragment identified on sand surface prior to emu pick - Southern section

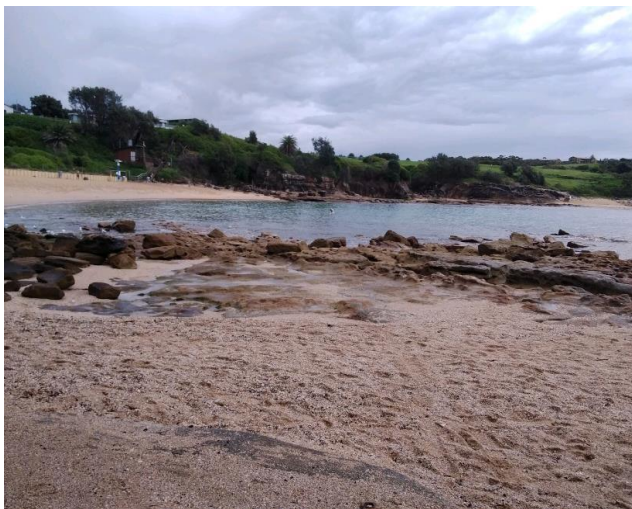
**Notes:** Overview of the Beach during inspection

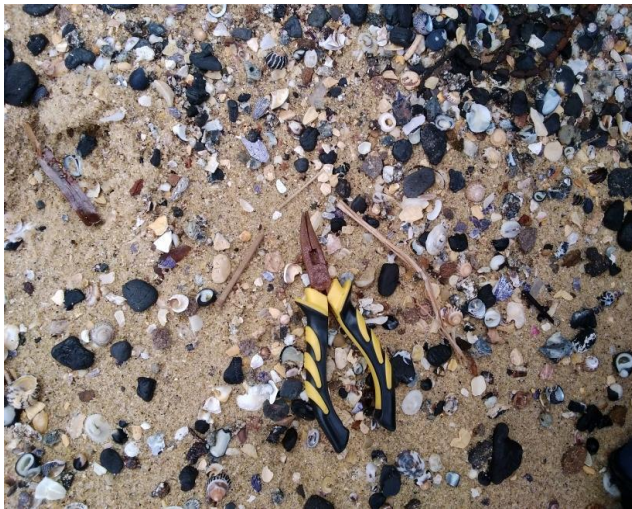
**Notes:** Sand surface following emu pick - Northern section

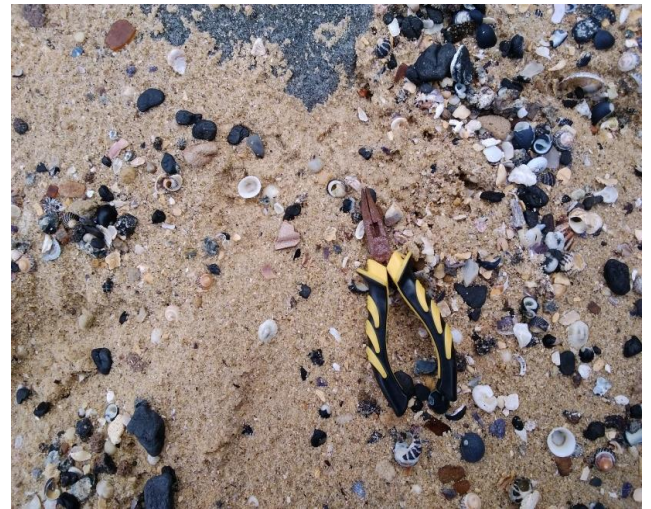
**Notes:** Sand surface following emu pick - Northern section

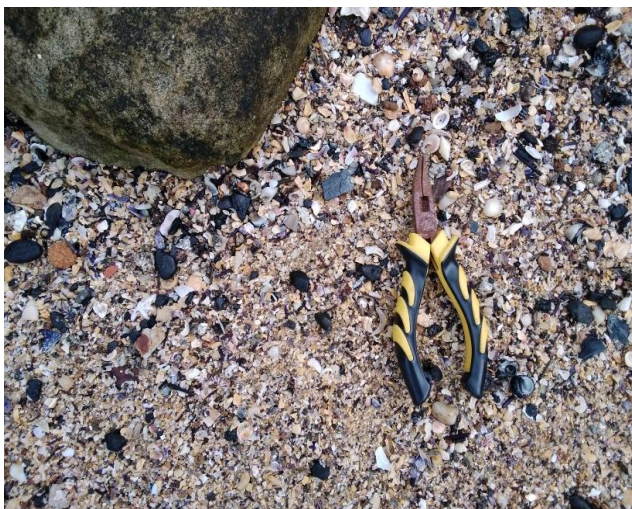
**Notes:** Sand surface following emu pick - Northern section

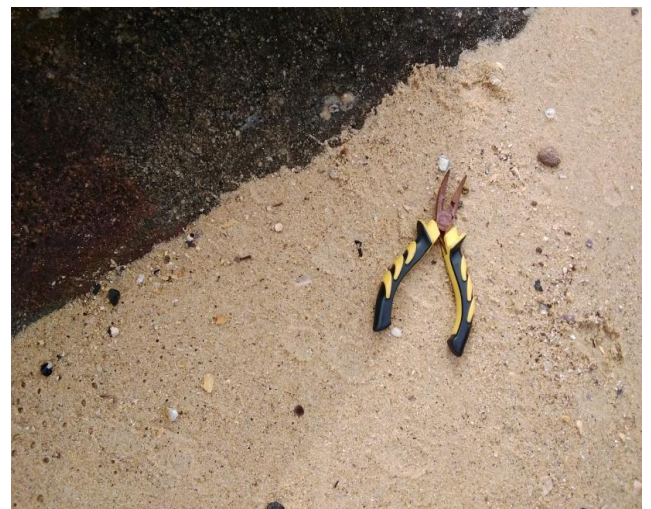
**Notes:** Sand surface following emu pick - Northern section

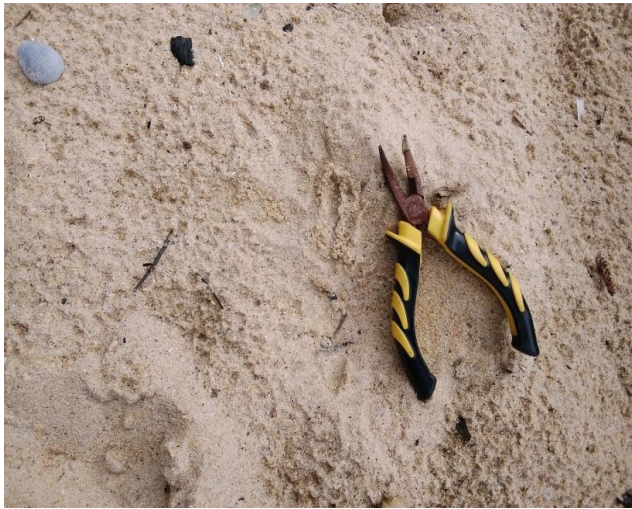
**Notes:** Sand surface following emu pick - Northern section

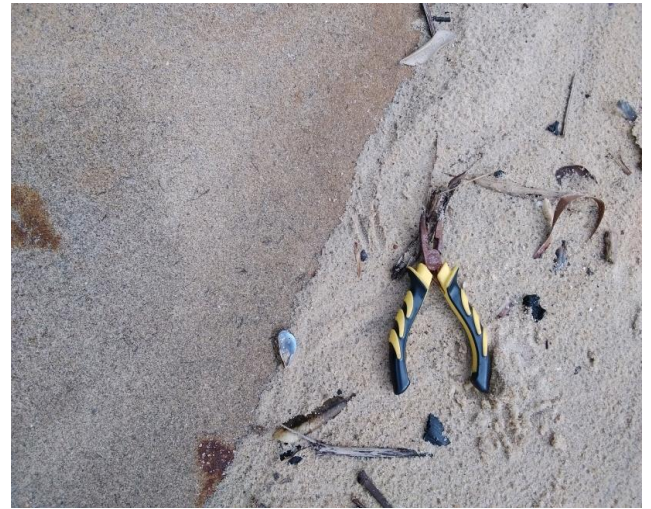
**Notes:** Sand surface following emu pick - Northern section

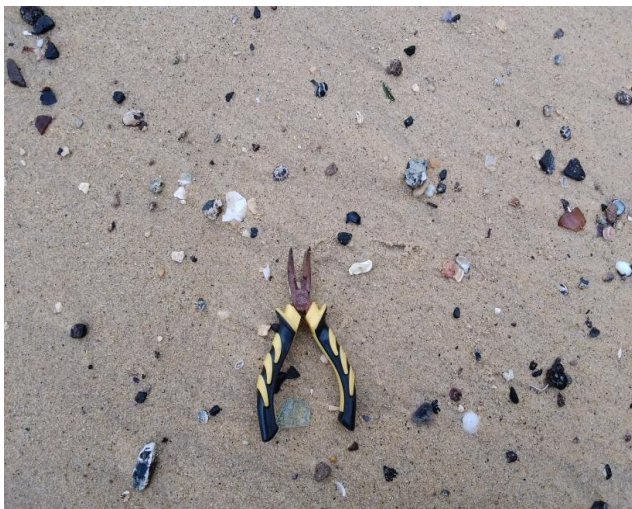
**Notes:** Sand surface following emu pick - Western section

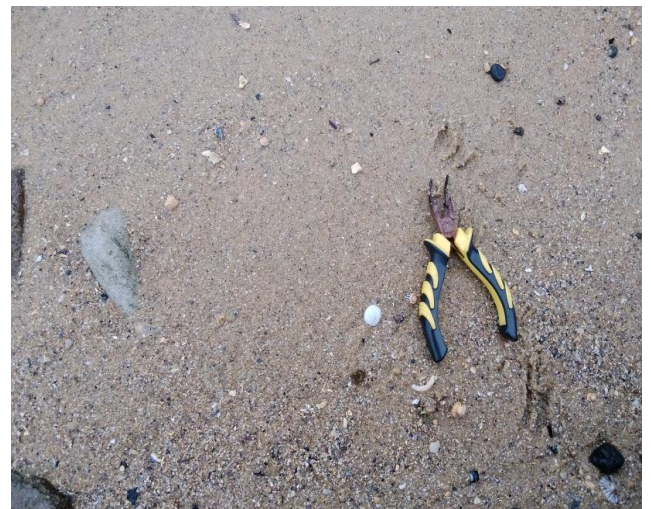
**Notes:** Sand surface following emu pick - Western section

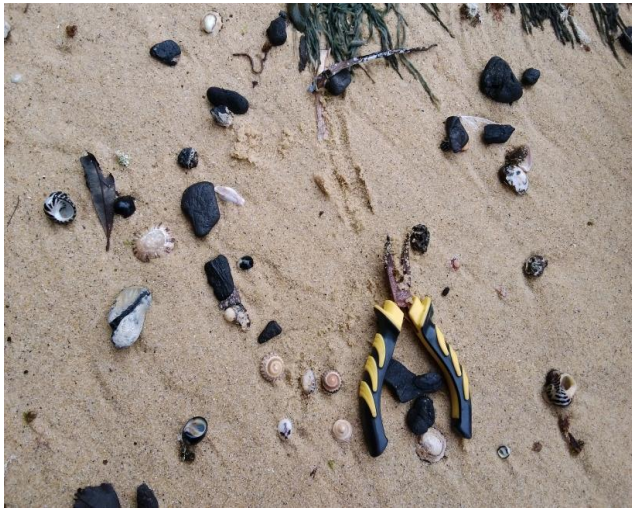
**Notes:** Sand surface following emu pick - Western section

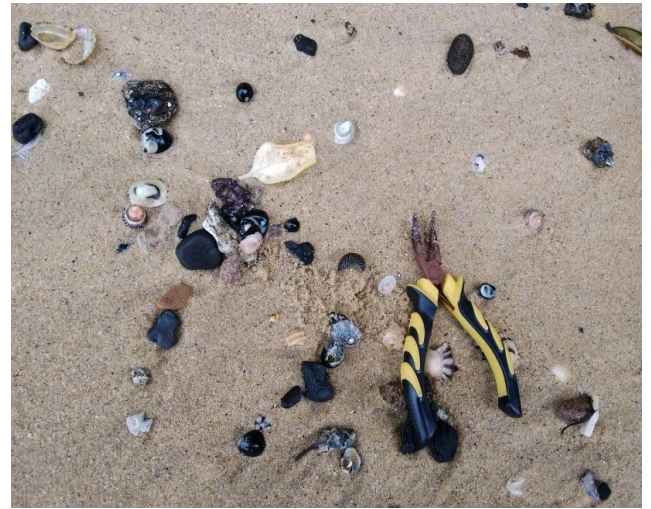
**Notes:** Sand surface following emu pick - Western section

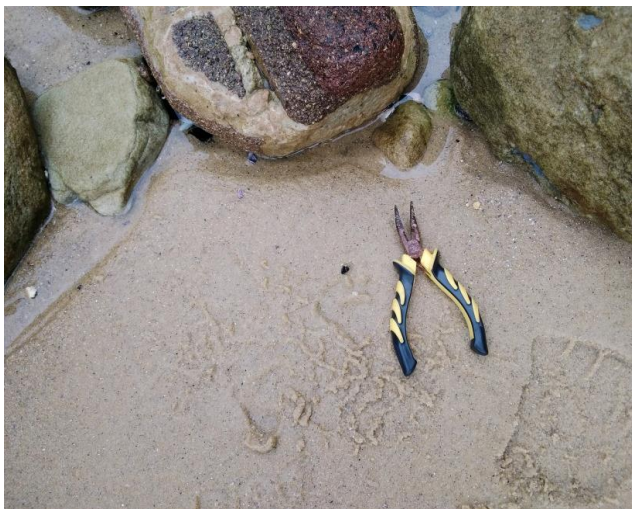
**Notes:** Sand surface following emu pick - Southern section

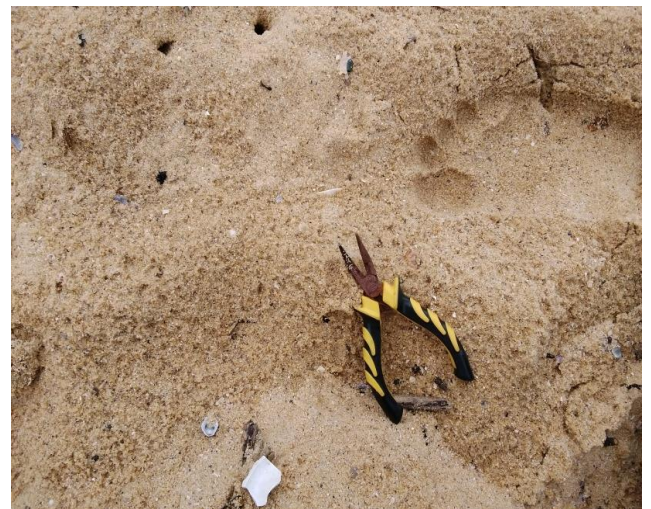
**Notes:** Sand surface following emu pick - Southern section

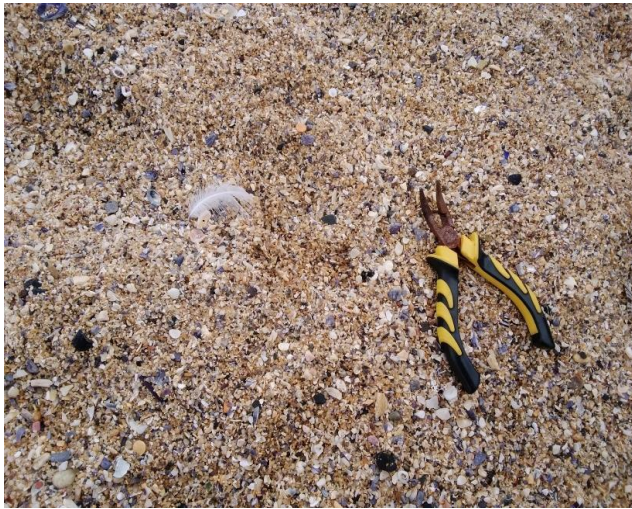
**Notes:** Sand surface following emu pick - Southern section

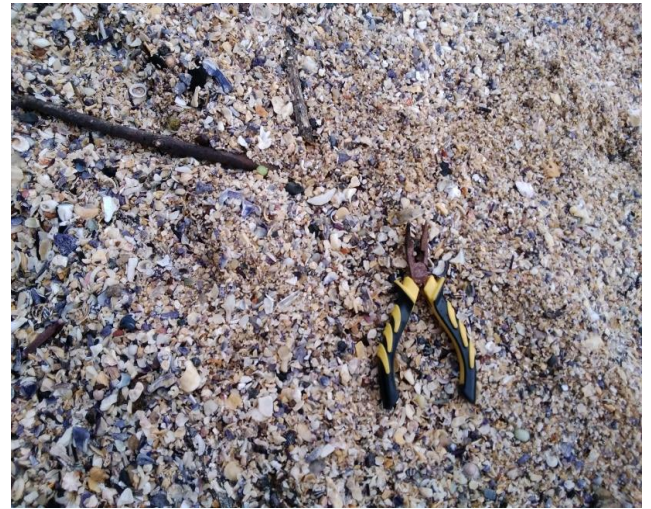
**Notes:** Sand surface following emu pick - Southern section
