Asbestos Containing Material Clearance Inspection

18 May 2023

Site:	Little Bay Beach
Location:	Southern, Western and Northern Little Bay Beach

Requested by:	
Name	Joe Santangelo
Contact	0436839760
Email	joe.santangelo@randwick.nsw.gov.au
Site Details:	
Address	2 Coast Hospital Rd, Little Bay NSW 2036
Local Government Area	Randwick City Council

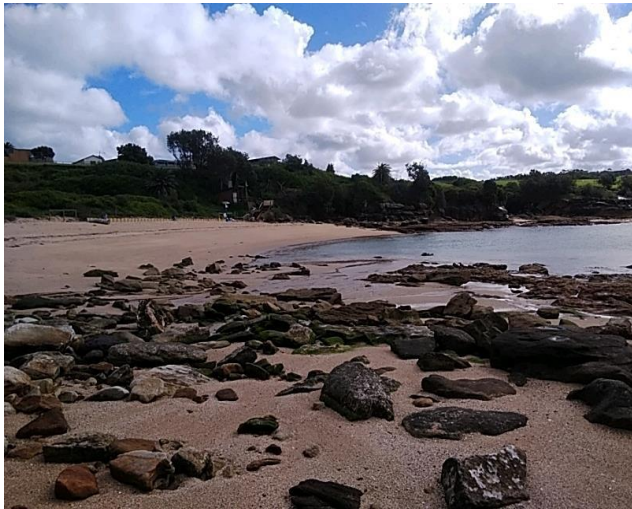
Notes: Overview of Southern Beach

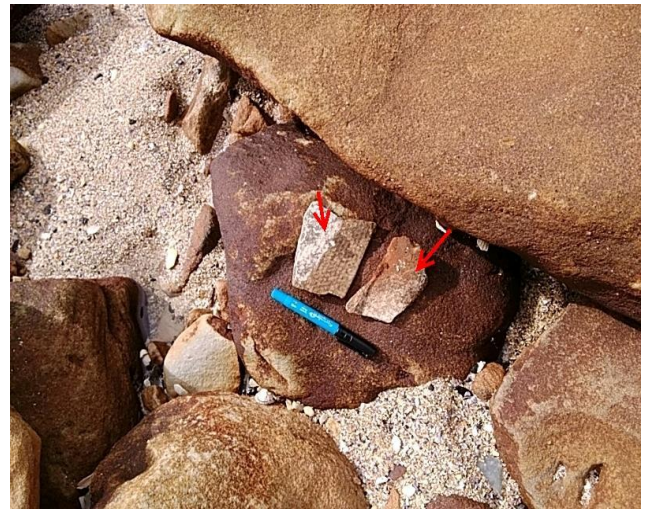
Notes: Overview of removal item within Southern beach prior to removal

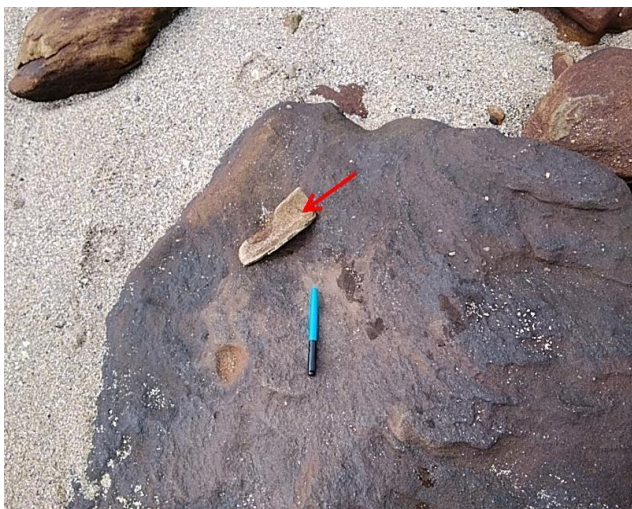
Notes: Overview of removal item within Southern beach prior to removal

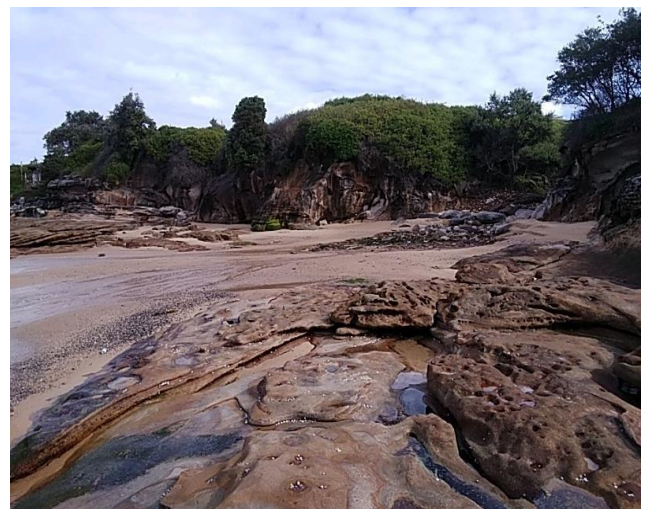
Notes: Overview of Western Beach

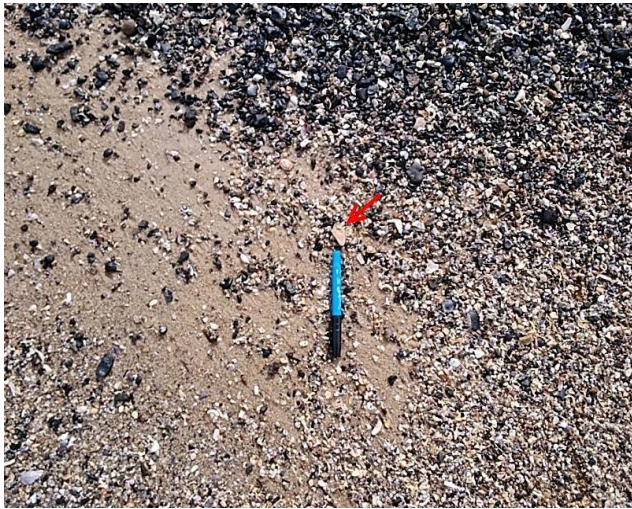
Notes: Overview of removal item within Western beach prior to removal

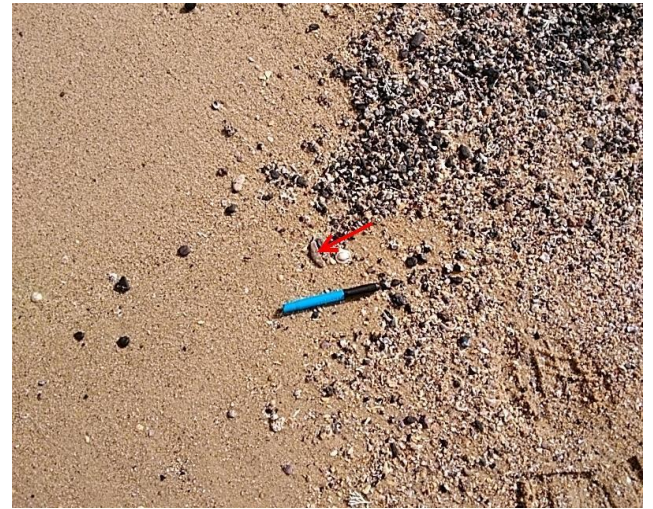
Notes: Overview of removal item within Western beach prior to removal

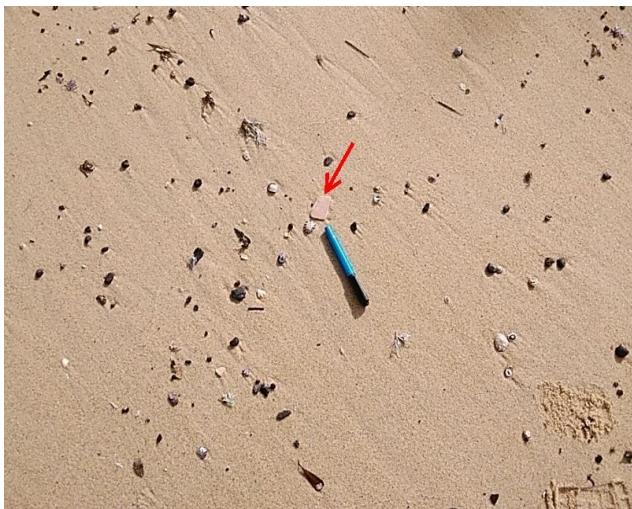
Notes: Overview of removal item within Western beach prior to removal

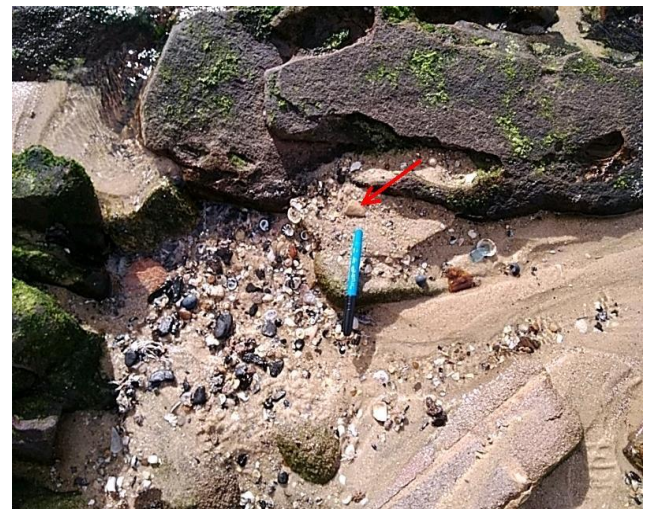
Notes: Overview of removal item within Western beach prior to removal

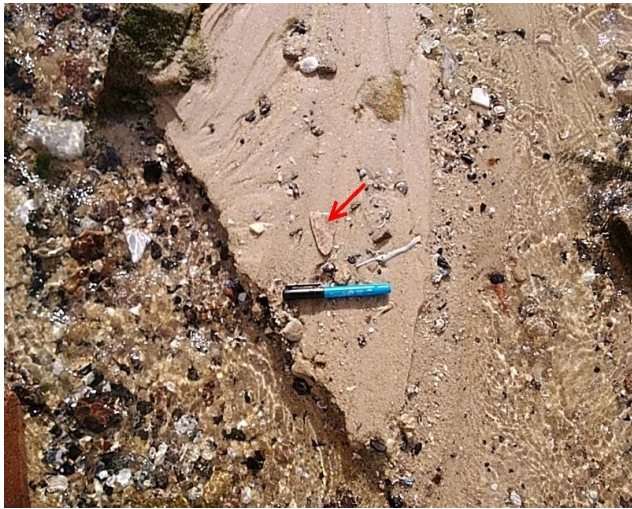
Notes: Overview of removal item within Western beach prior to removal

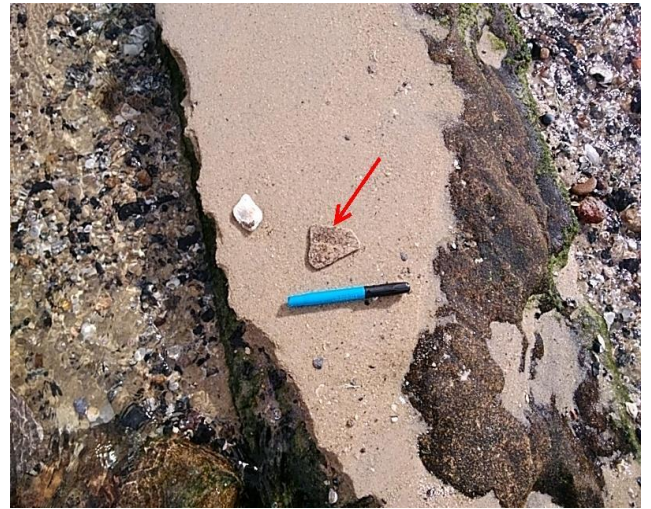
Notes: Overview of removal item within Western beach prior to removal

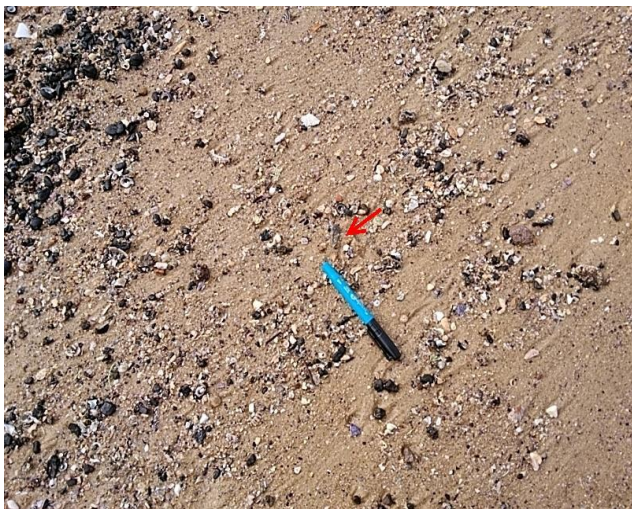
Notes: Overview of removal item within Western beach prior to removal

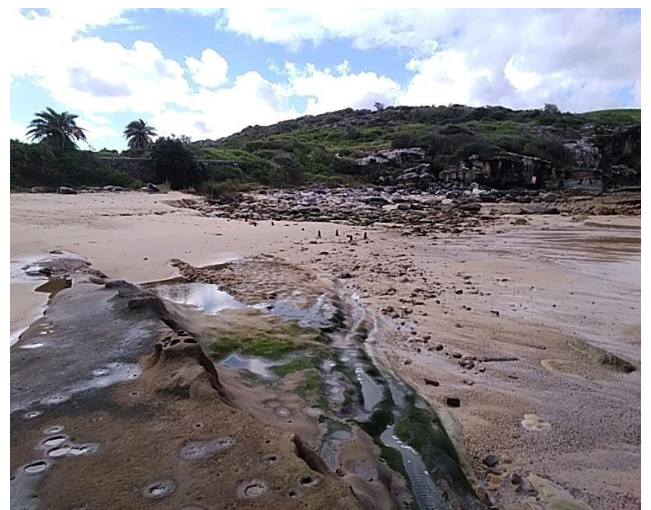
Notes: Overview of Northern Beach

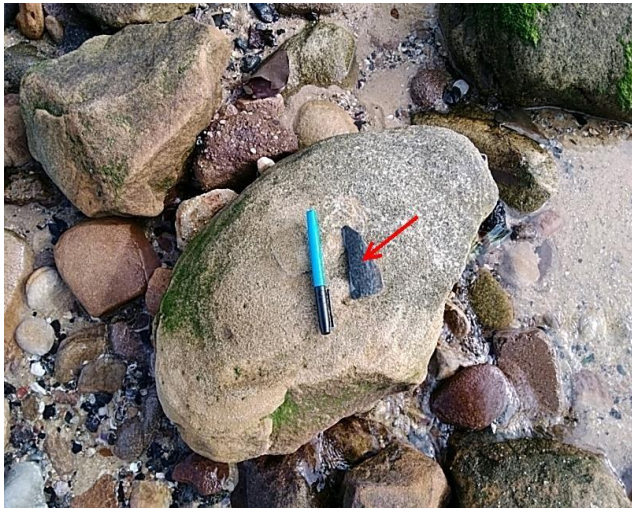
Notes: Overview of removal item within Northern beach prior to removal

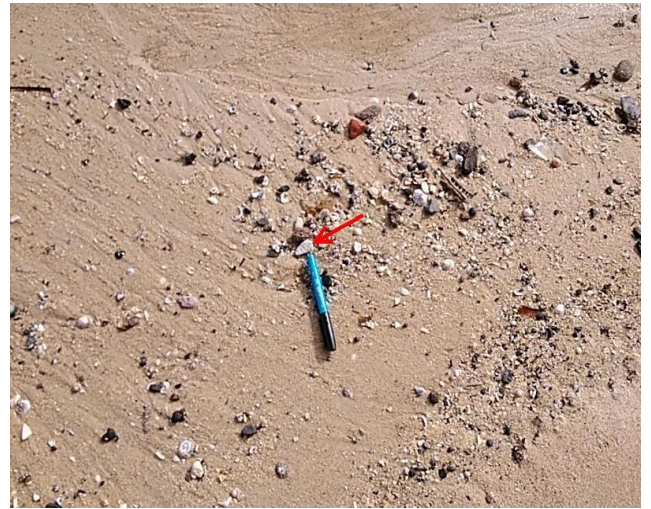
Notes: Overview of removal item within Northern beach prior to removal

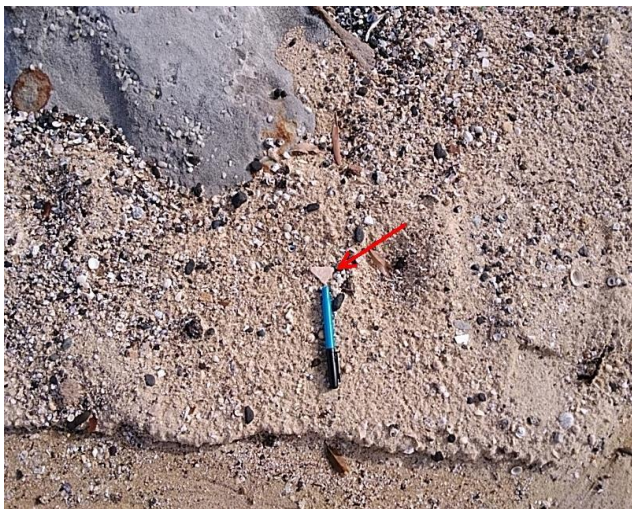
Notes: Overview of removal item within Northern beach prior to removal

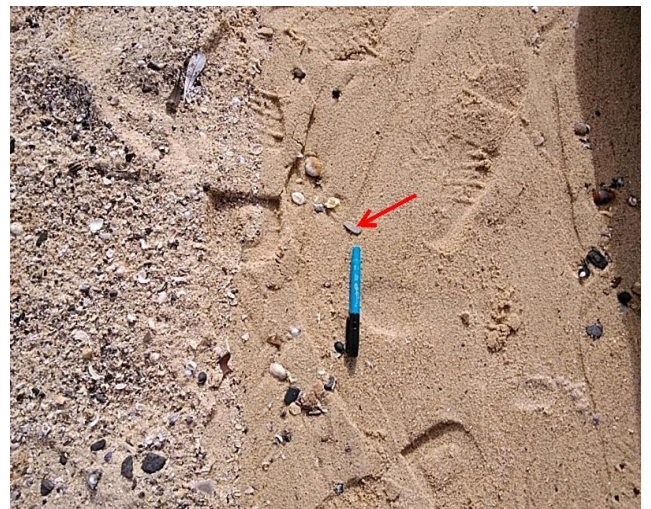
Notes: Overview of removal item within Northern beach prior to removal

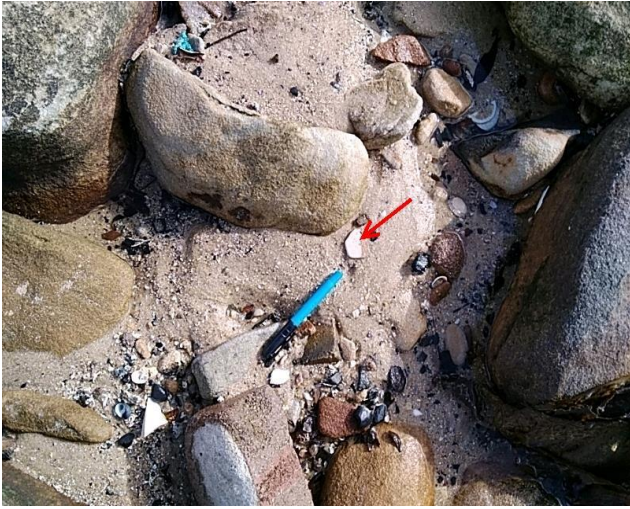
Notes: Overview of removal item within Northern beach prior to removal

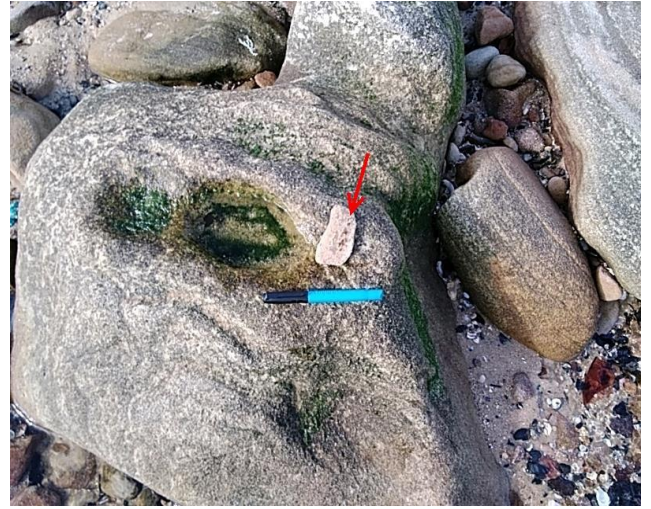
Notes: Overview of removal item within Northern beach prior to removal

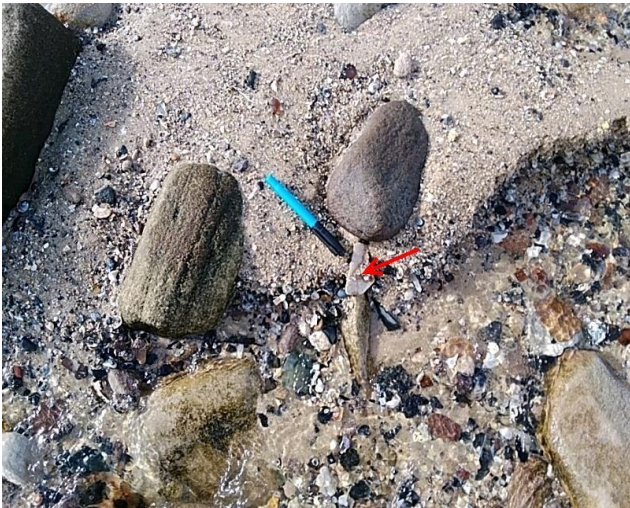
Notes: Overview of removal item within Northern beach prior to removal

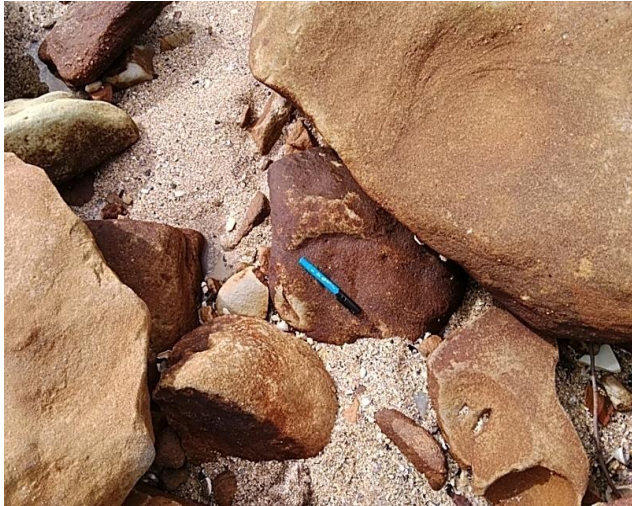
Notes: Visual inspection of removal item following removal

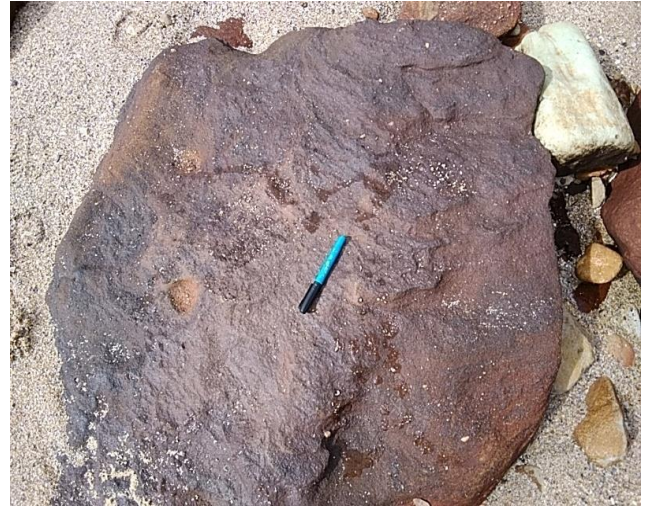
Notes: Visual inspection of removal item following removal

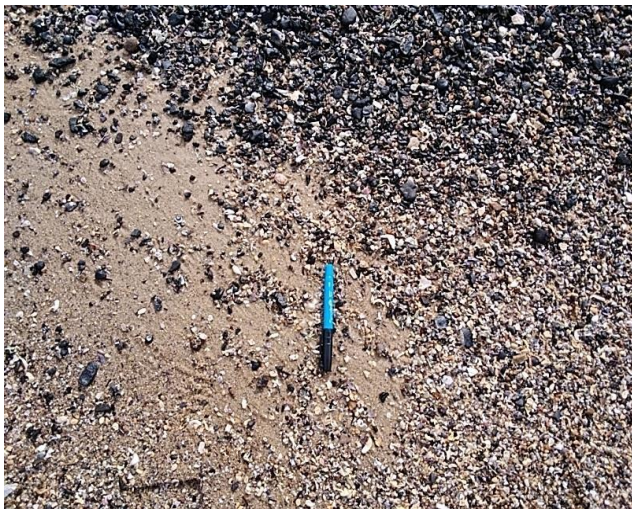
Notes: Visual inspection of removal item following removal

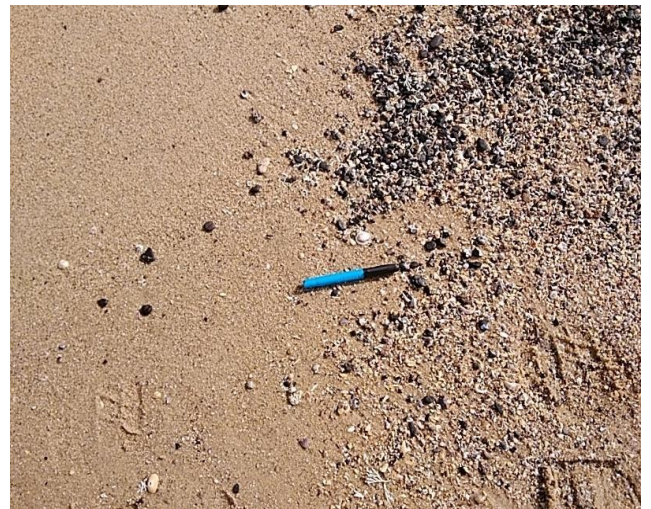
Notes: Visual inspection of removal item following removal

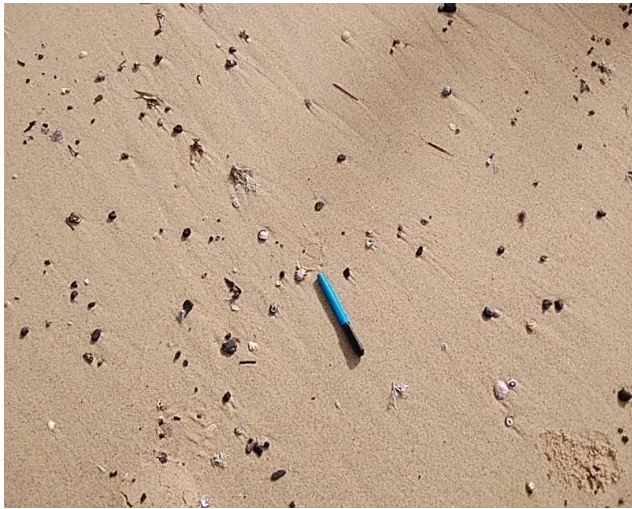
Notes: Visual inspection of removal item following removal

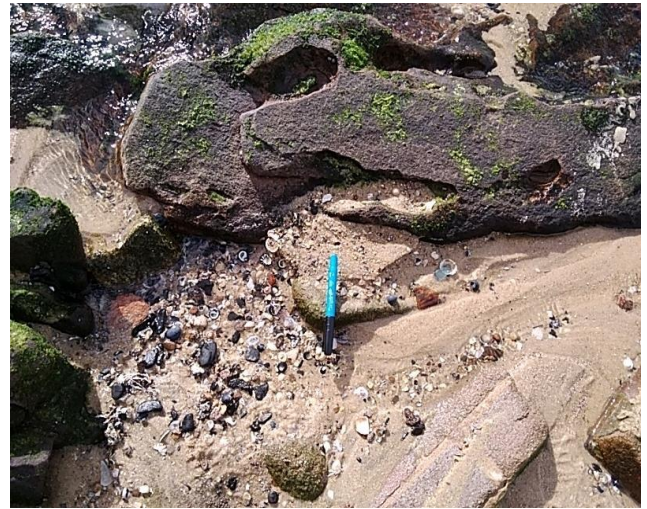
Notes: Visual inspection of removal item following removal

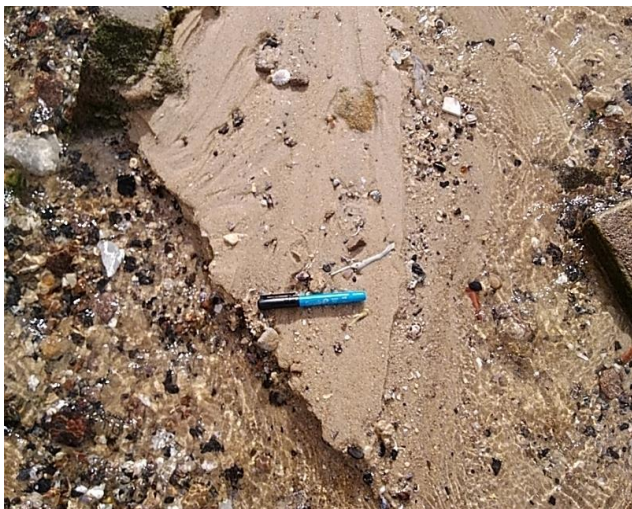
Notes: Visual inspection of removal item following removal

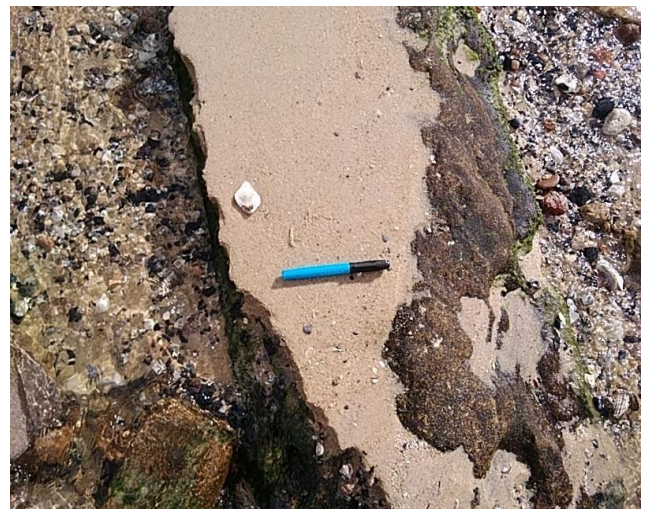
Notes: Visual inspection of removal item following removal

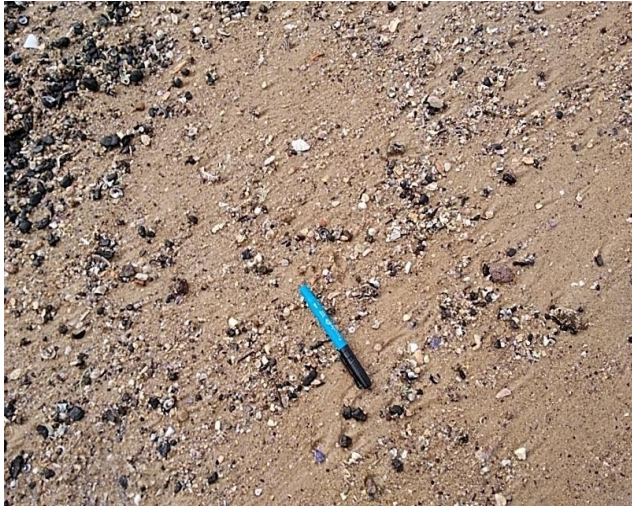
Notes: Visual inspection of removal item following removal

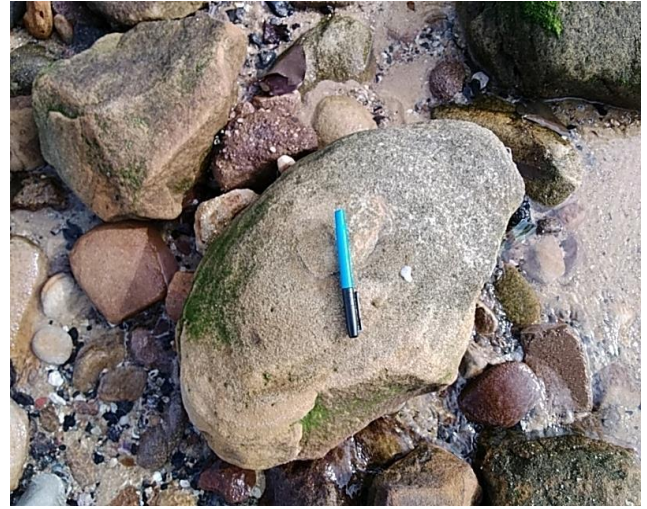
Notes: Visual inspection of removal item following removal

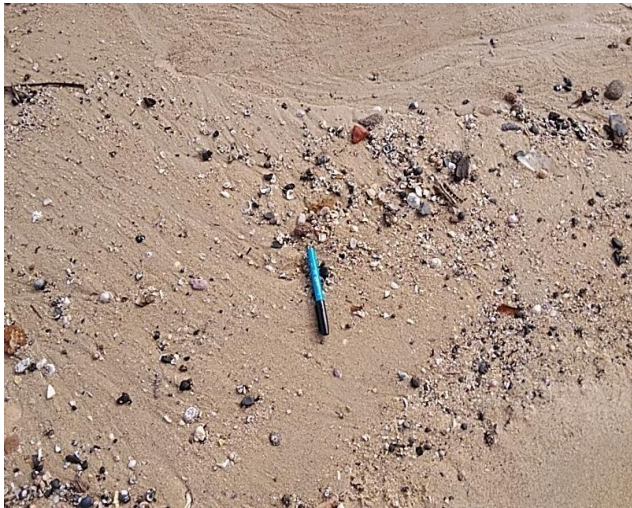
Notes: Visual inspection of removal item following removal

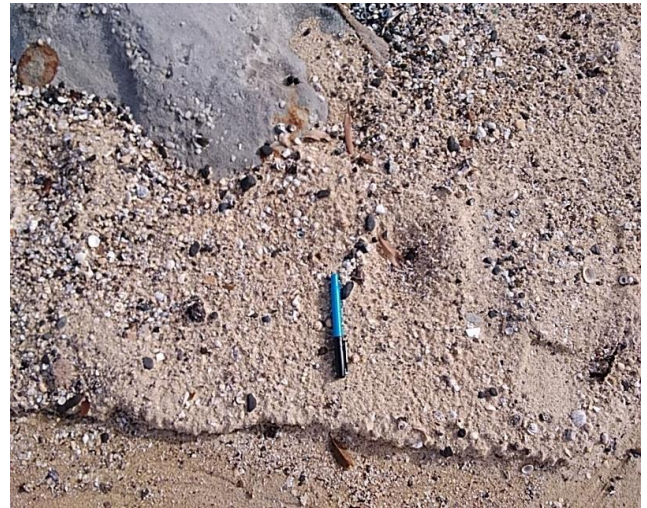
Notes: Visual inspection of removal item following removal

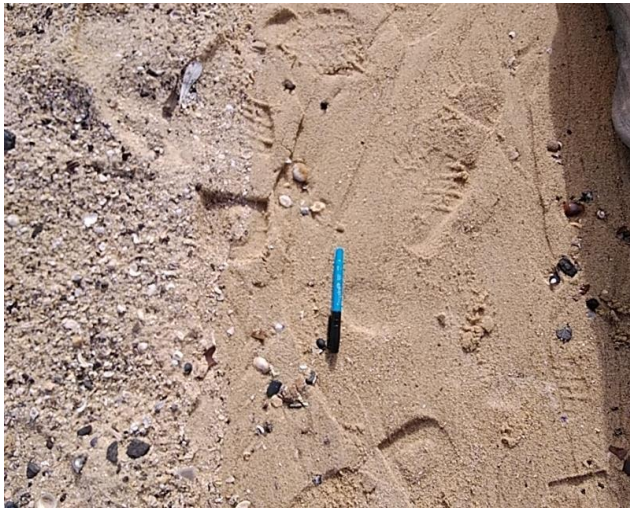
Notes: Visual inspection of removal item following removal

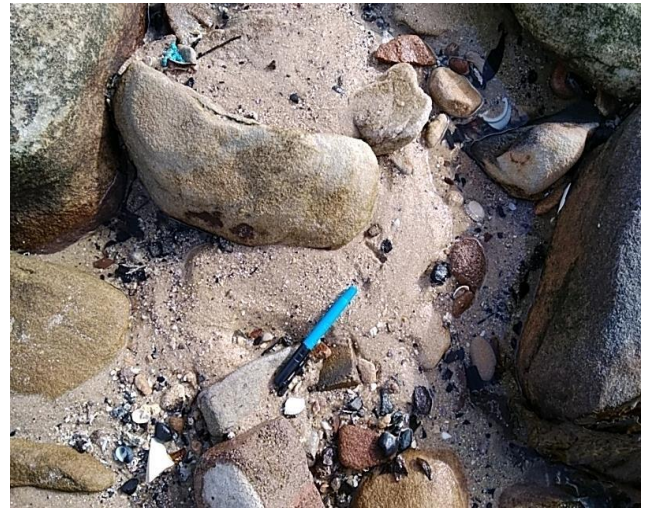
Notes: Visual inspection of removal item following removal

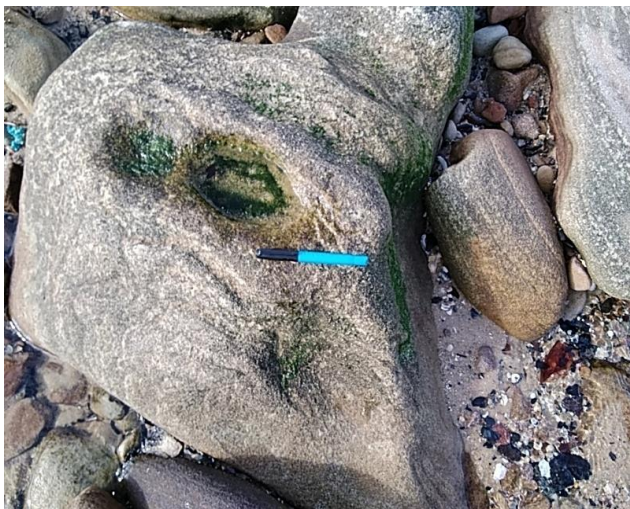
Notes: Visual inspection of removal item following removal

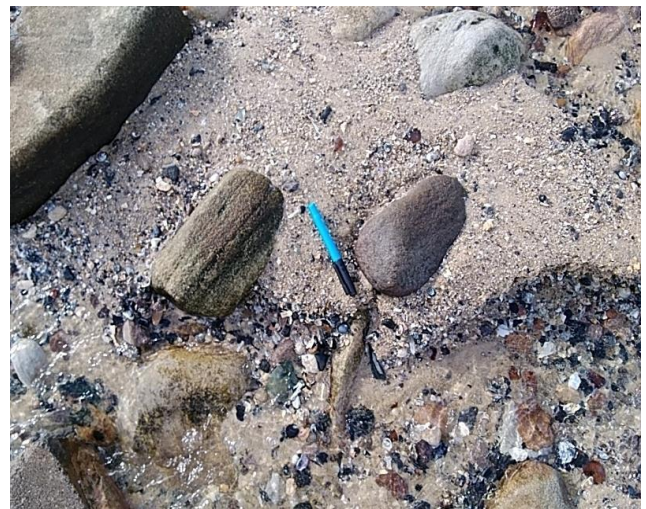
Notes: Visual inspection of removal item following removal

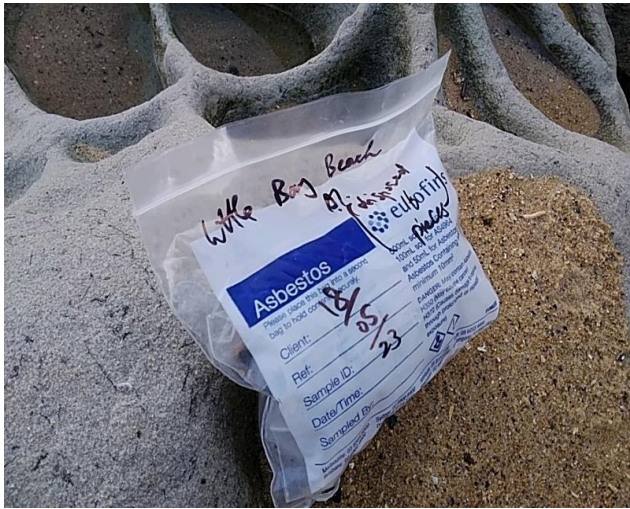
Notes: Waste disposal management
