Asbestos Containing Material Clearance Inspection

22 June 2023

Site:	Little Bay Beach
Location:	Southern, Western and Northern Little Bay Beach

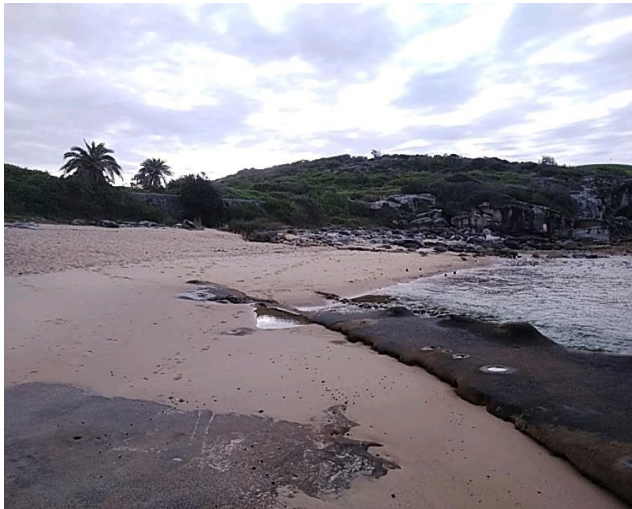
Notes: Overview of Northern beach

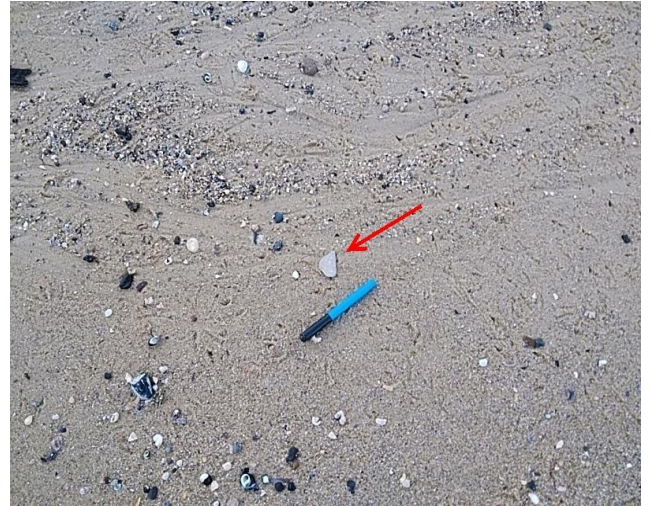
Notes: Overview of removal item within Northern beach prior to removal

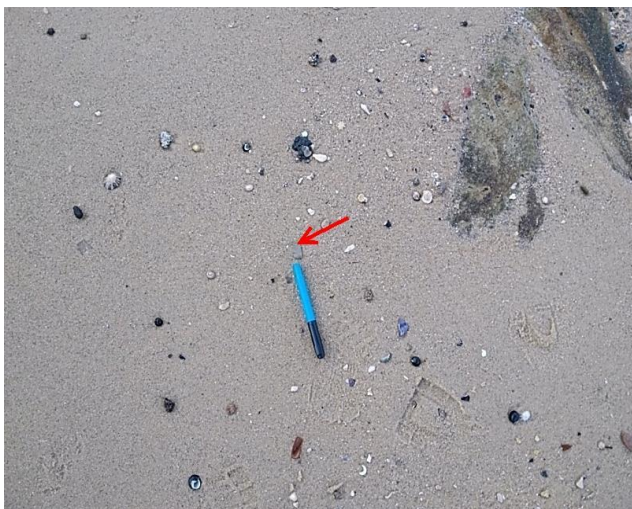
Notes: Overview of removal item within Northern beach prior to removal

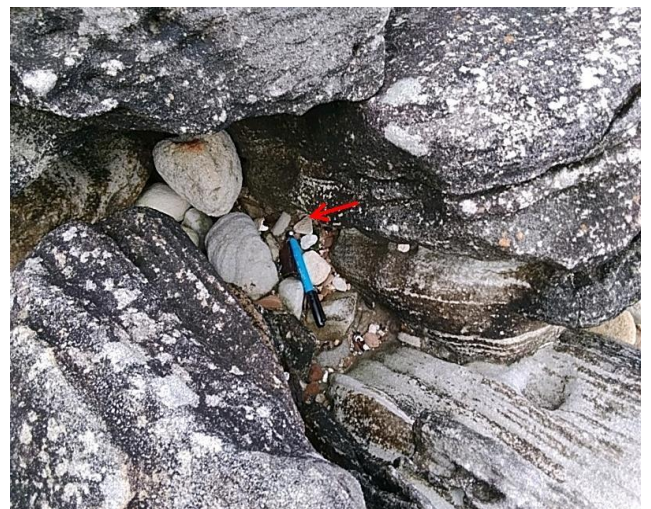
Notes: Overview of removal item within Northern beach prior to removal

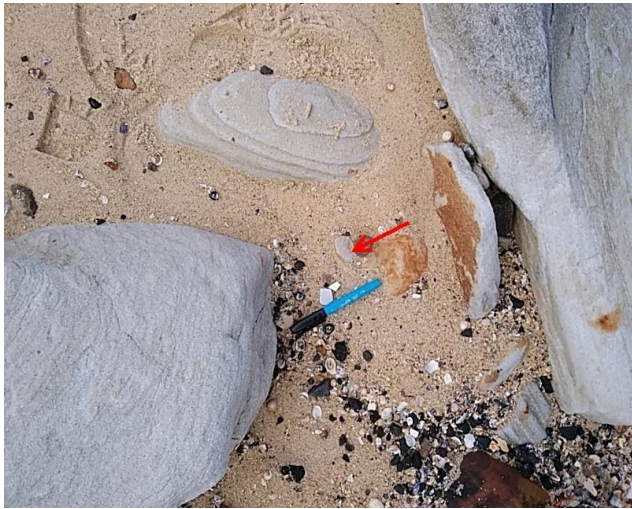
Notes: Overview of removal item within Northern beach prior to removal

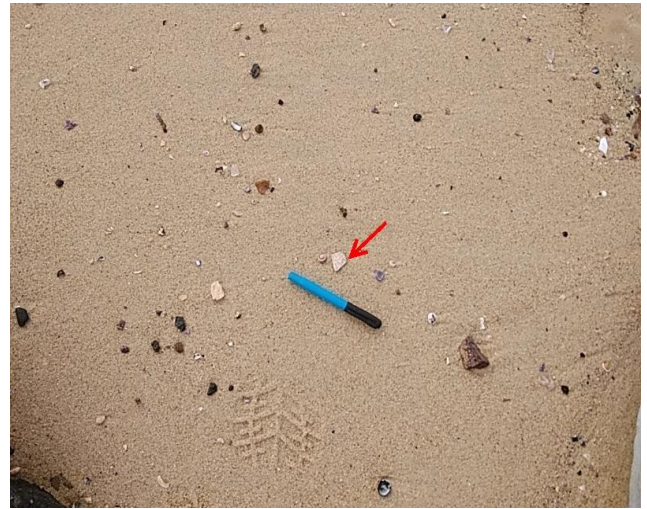
Notes: Overview of removal item within Northern beach prior to removal

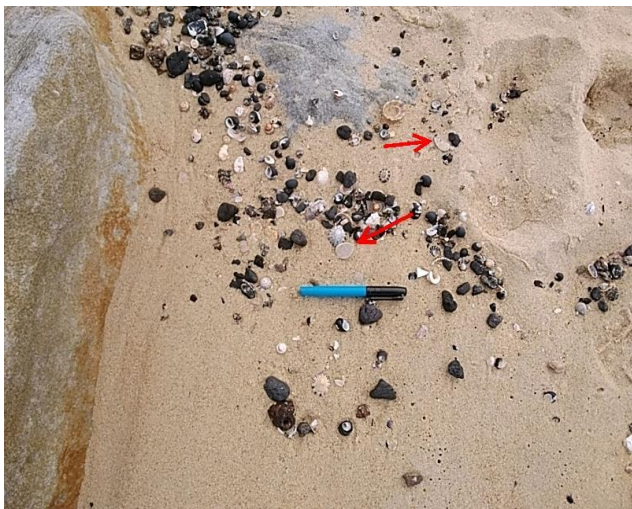
Notes: Overview of removal item within Northern beach prior to removal

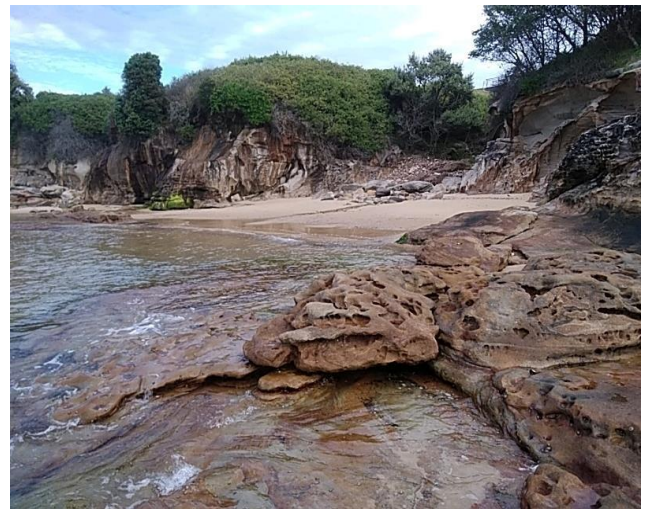
Notes: Overview of Western beach

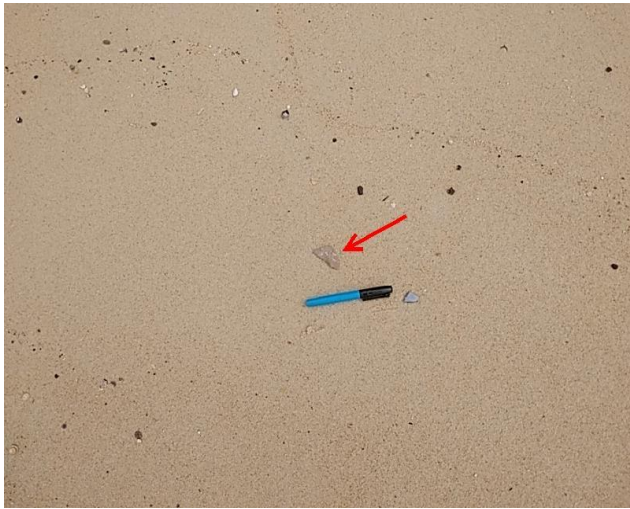
Notes: Overview of removal item within Western beach prior to removal

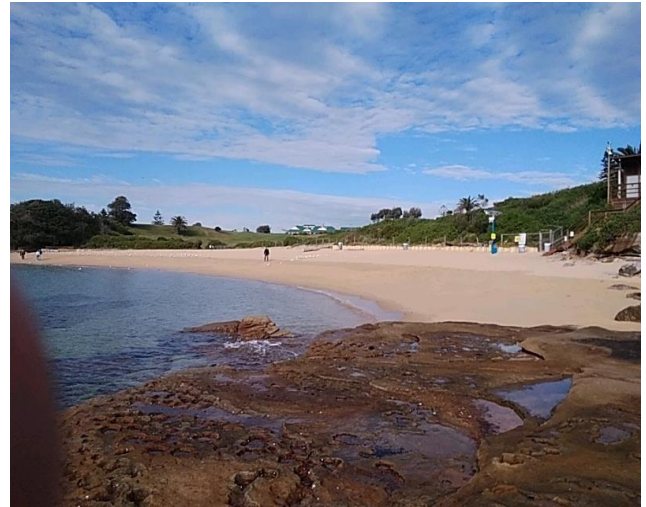
Notes: Overview of Southern beach

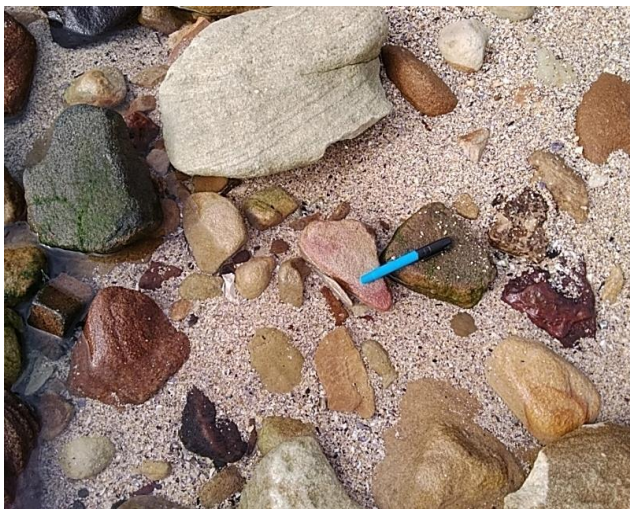
Notes: Overview of removal item within Southern beach prior to removal

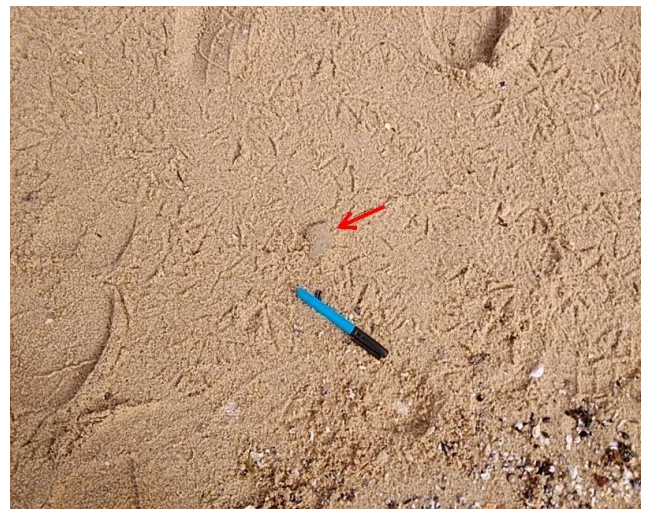
Notes: Overview of removal item within Southern beach prior to removal

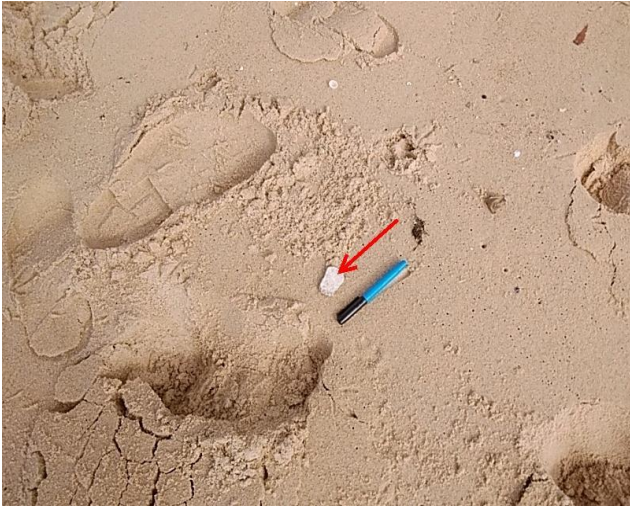
Notes: Overview of removal item within Southern beach prior to removal

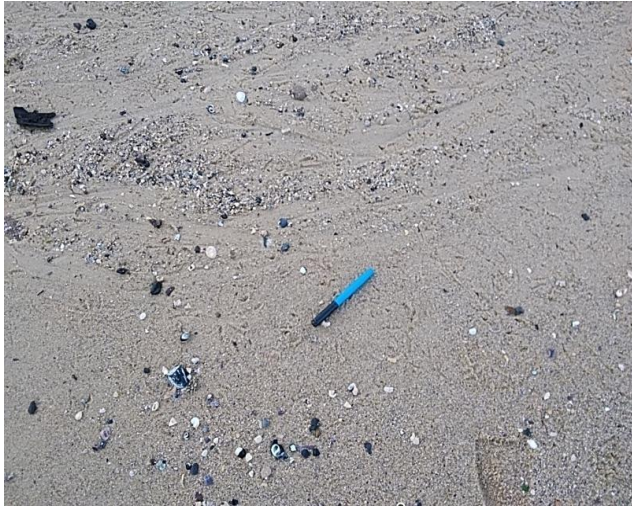
Notes: Visual inspection of removal item following removal

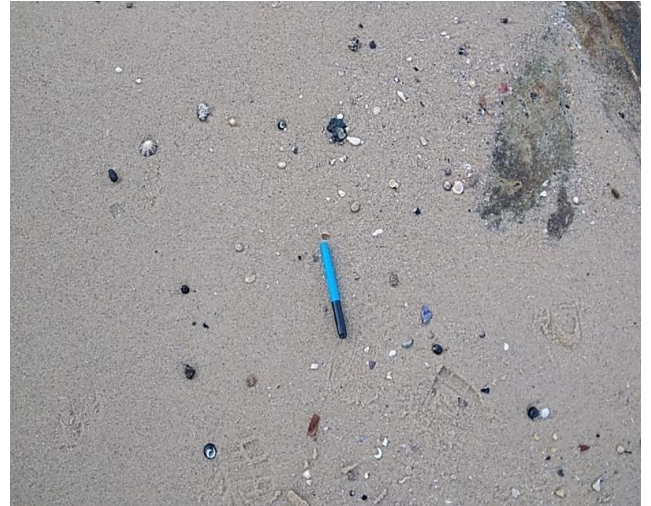
Notes: Visual inspection of removal item following removal

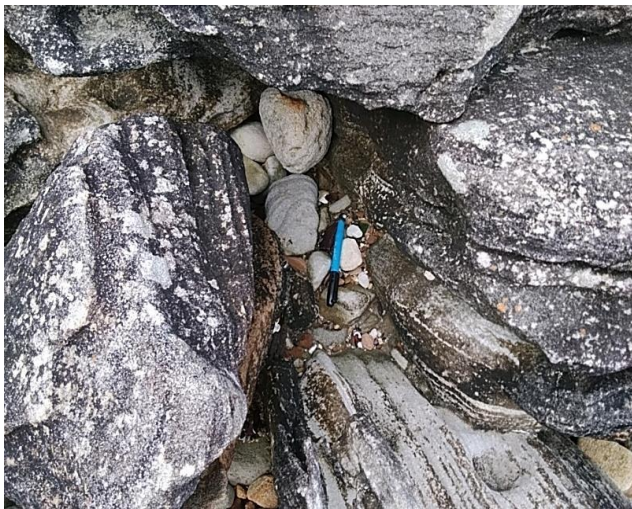
Notes: Visual inspection of removal item following removal

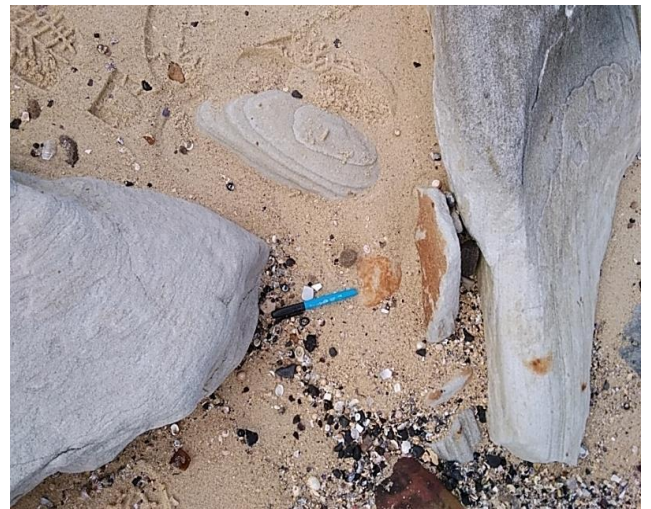
Notes: Visual inspection of removal item following removal

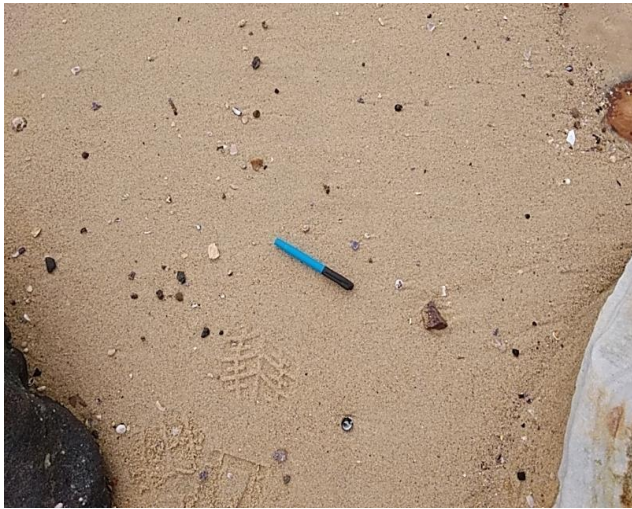
Notes: Visual inspection of removal item following removal

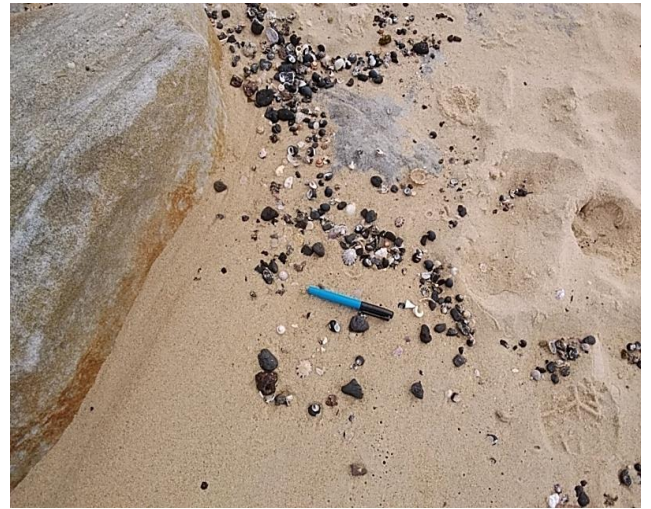
Notes: Visual inspection of removal item following removal

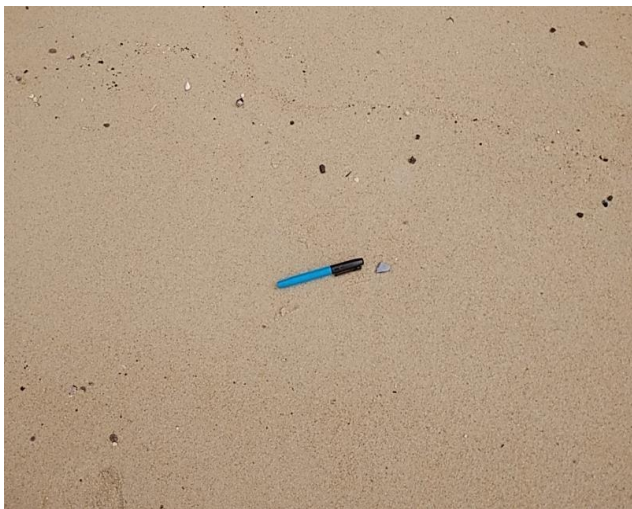
Notes: Visual inspection of removal item following removal

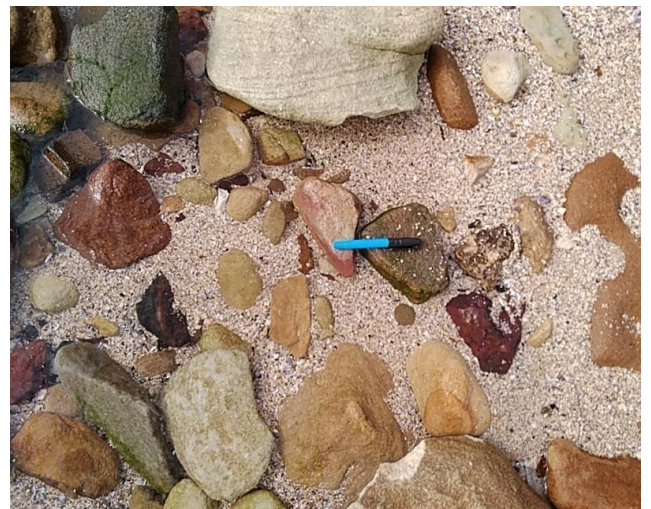
Notes: Visual inspection of removal item following removal

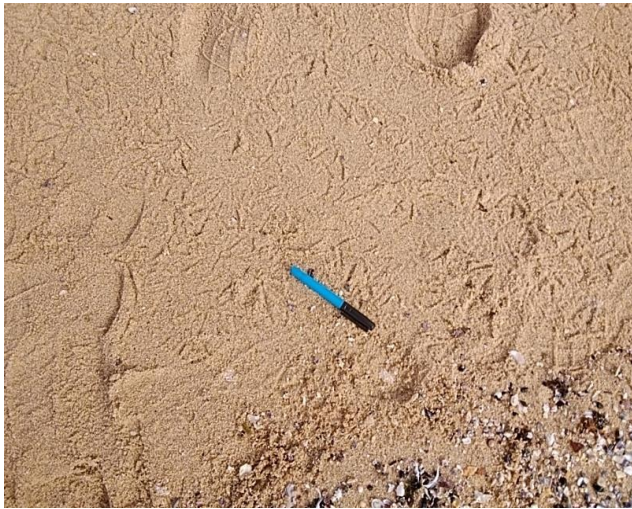
Notes: Visual inspection of removal item following removal

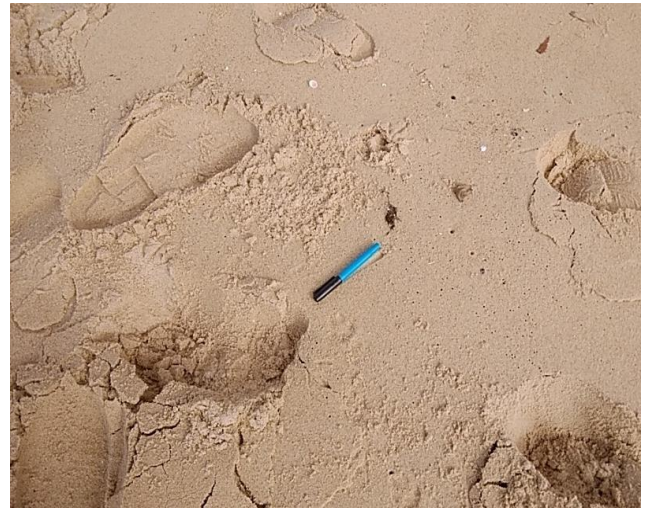
Notes: Visual inspection of removal item following removal

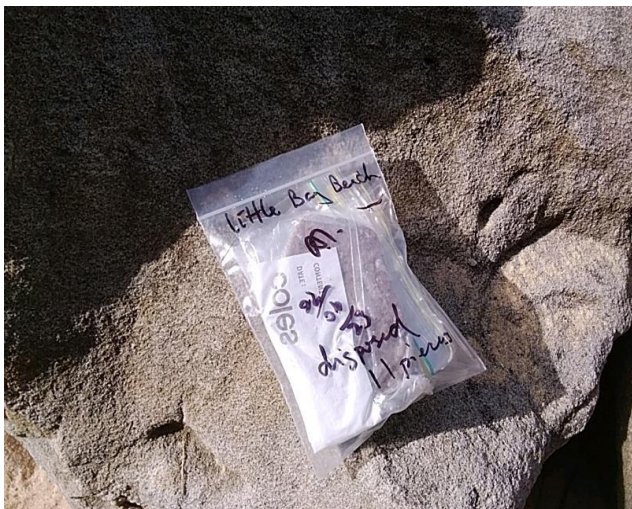
Notes: Waste disposal management
