Asbestos Containing Material Clearance Inspection

13 June 2023

Site:	Little Bay Beach
Location:	Southern, Western and Northern Little Bay Beach

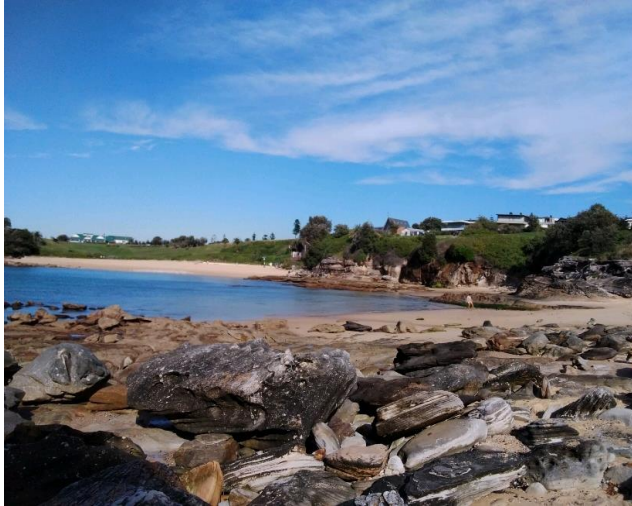
Notes: Overview of the Beach during the inspection

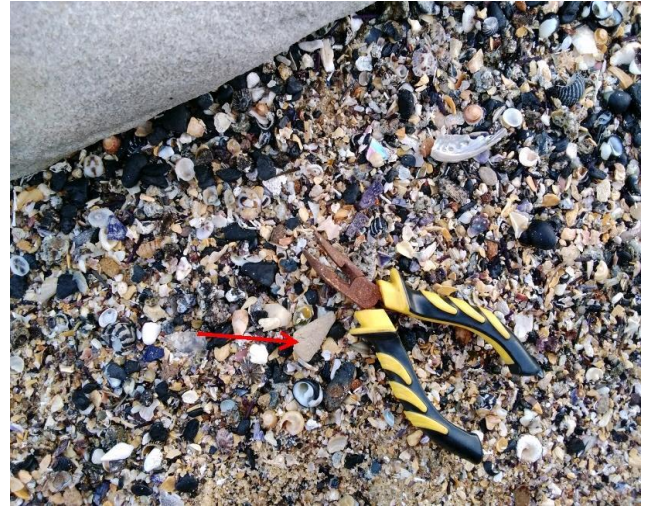
Notes: FC fragment identified on sand surface prior to emu pick - Northern section

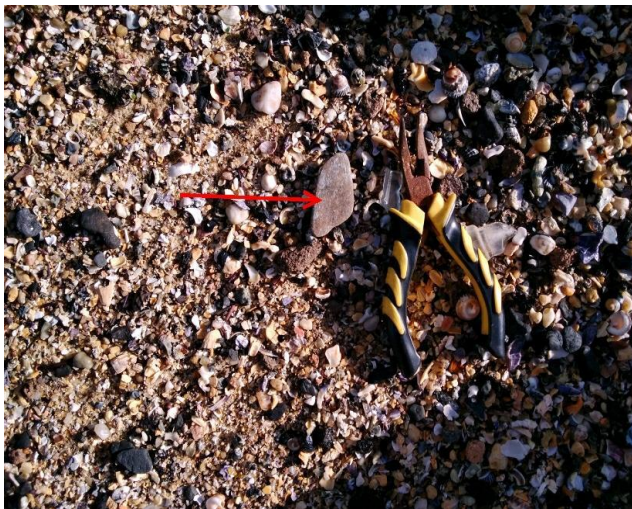
Notes: FC fragment identified on sand surface prior to emu pick - Northern section

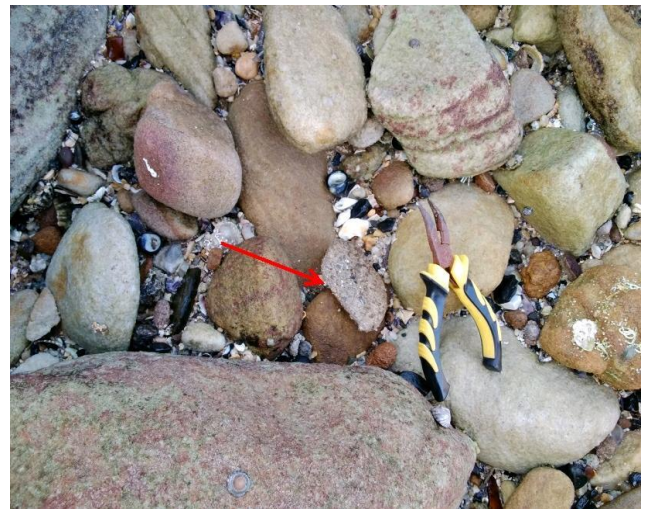
Notes: FC fragment identified on sand surface prior to emu pick - Northern section

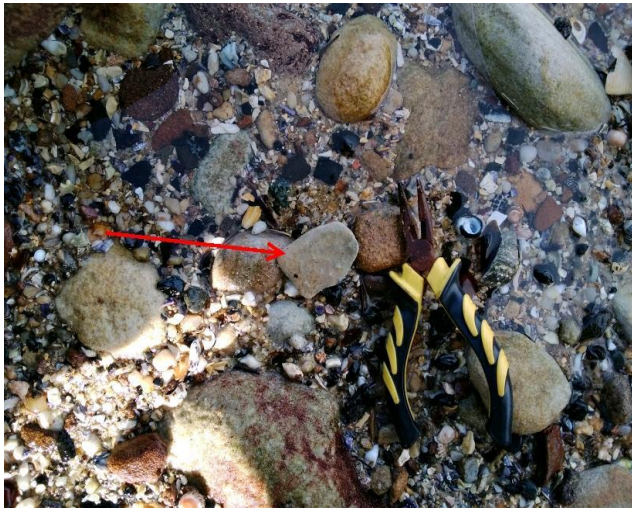
Notes: FC fragment identified on sand surface prior to emu pick - Northern section

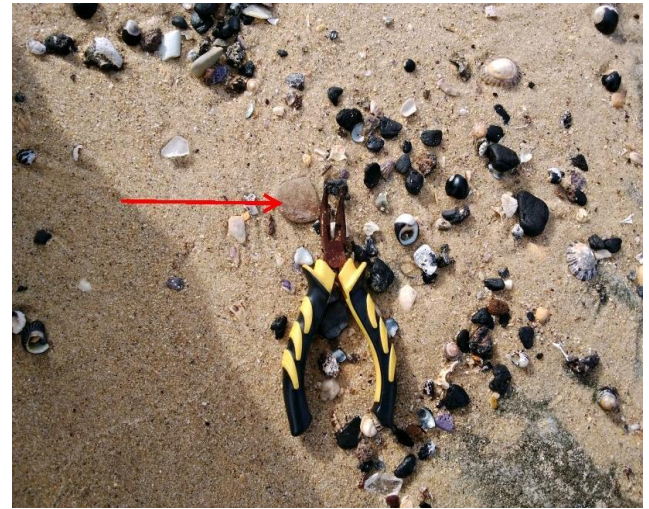
Notes: FC fragment identified on sand surface prior to emu pick - Northern section

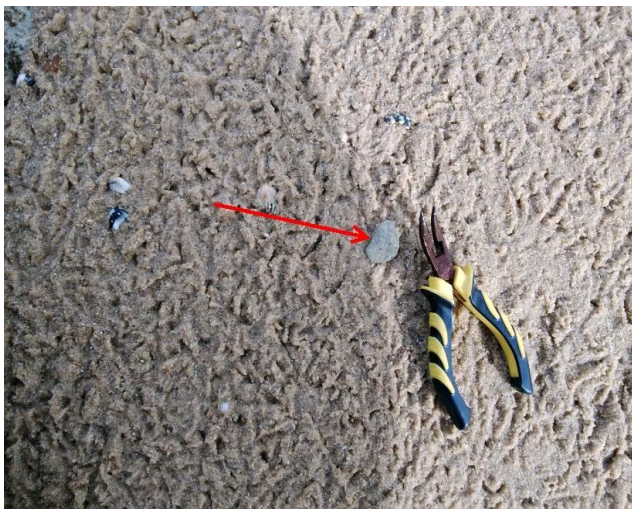
Notes: FC fragment identified on sand surface prior to emu pick - Northern section

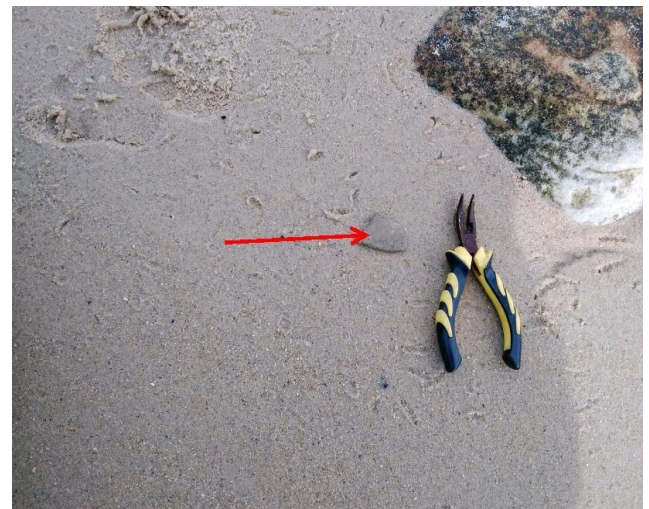
Notes: FC fragment identified on sand surface prior to emu pick - Northern section

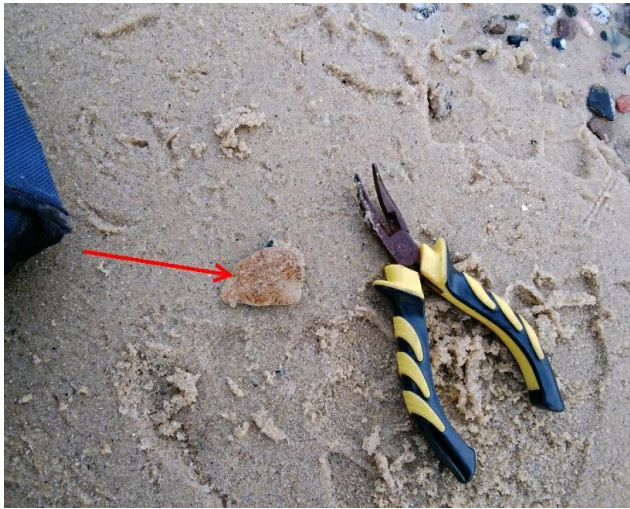
Notes: FC fragment identified on sand surface prior to emu pick - Northern section

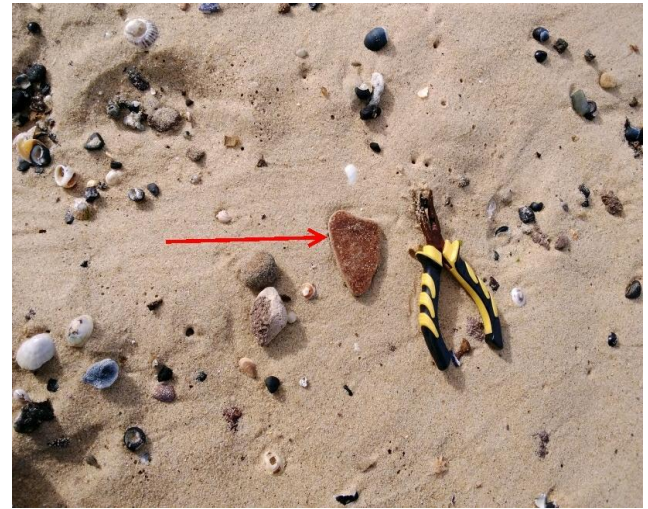
Notes: FC fragment identified on sand surface prior to emu pick - Northern section

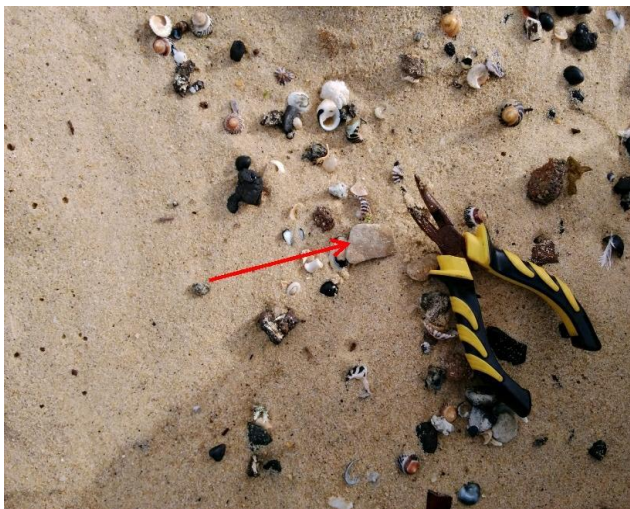
Notes: FC fragment identified on sand surface prior to emu pick - Northern section

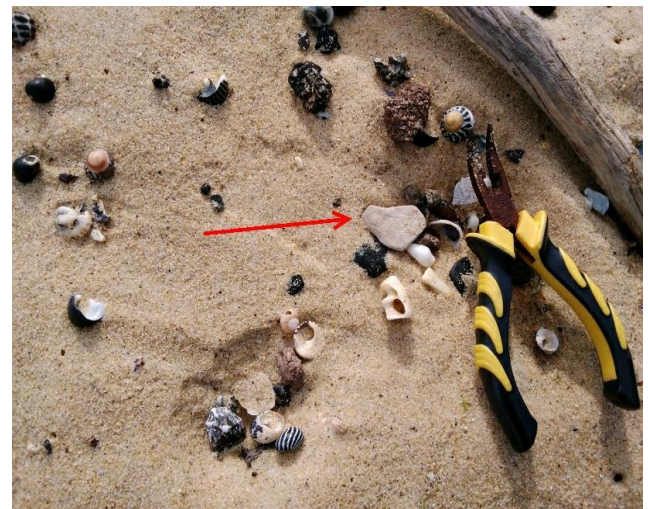
Notes: FC fragment identified on sand surface prior to emu pick - Northern section

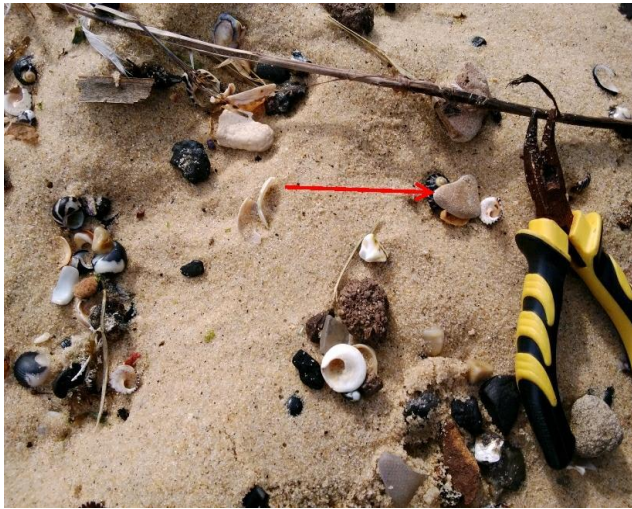
Notes: FC fragment identified on sand surface prior to emu pick - Northern section

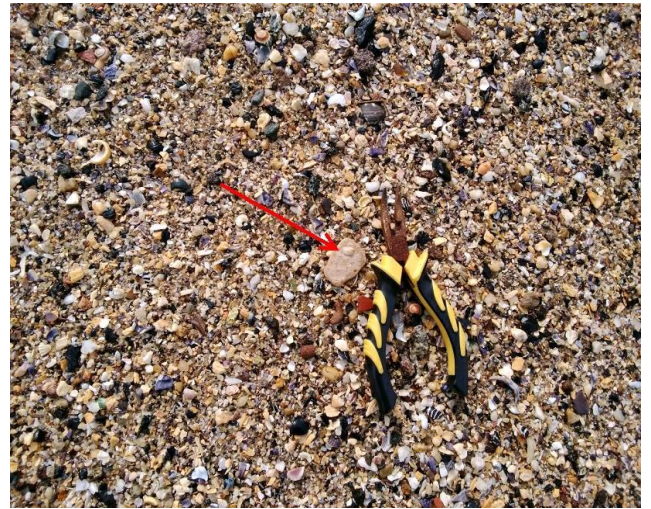
Notes: FC fragment identified on sand surface prior to emu pick - Northern section

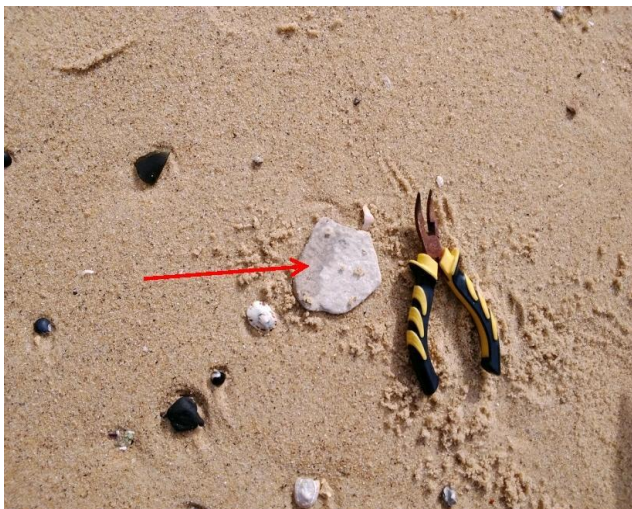
Notes: FC fragment identified on sand surface prior to emu pick - Western section

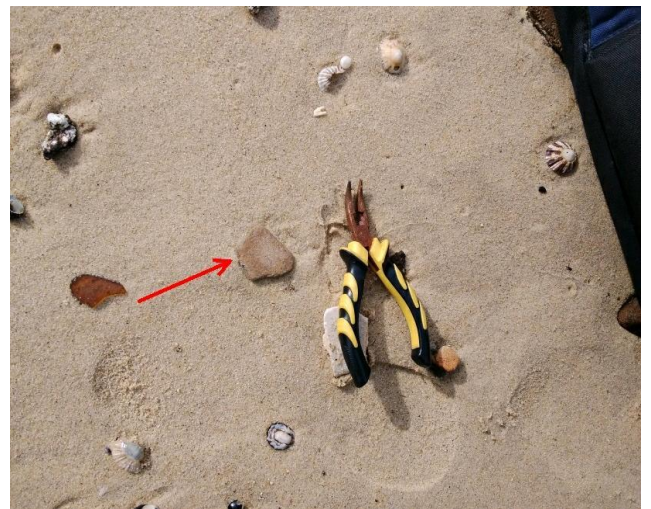
Notes: FC fragment identified on sand surface prior to emu pick - Western section

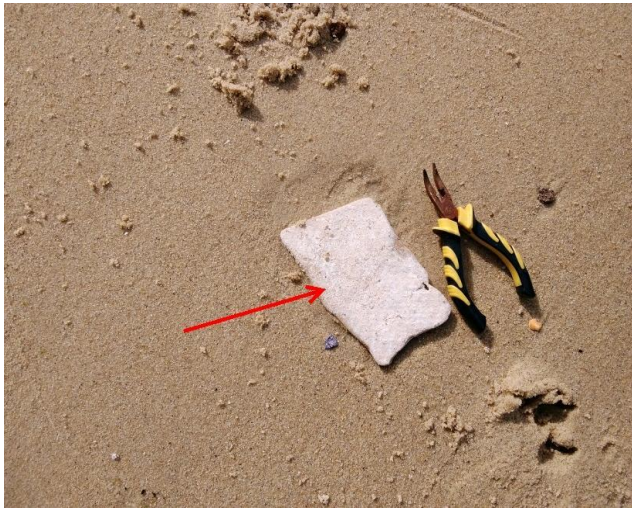
Notes: FC fragment identified on sand surface prior to emu pick - Western section

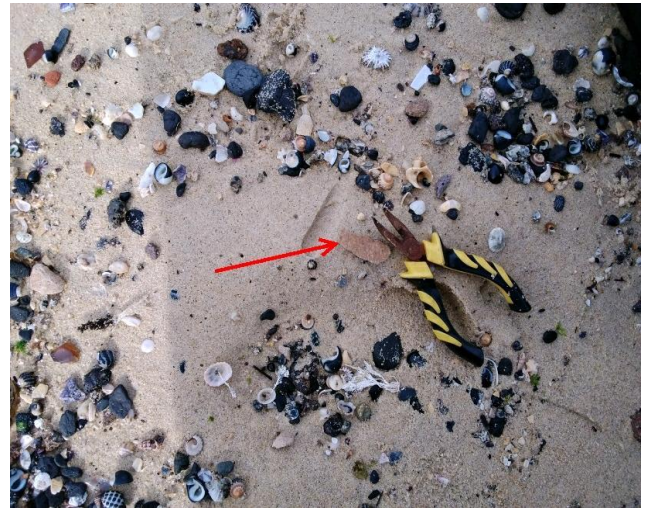
Notes: FC fragment identified on sand surface prior to emu pick - Southern section

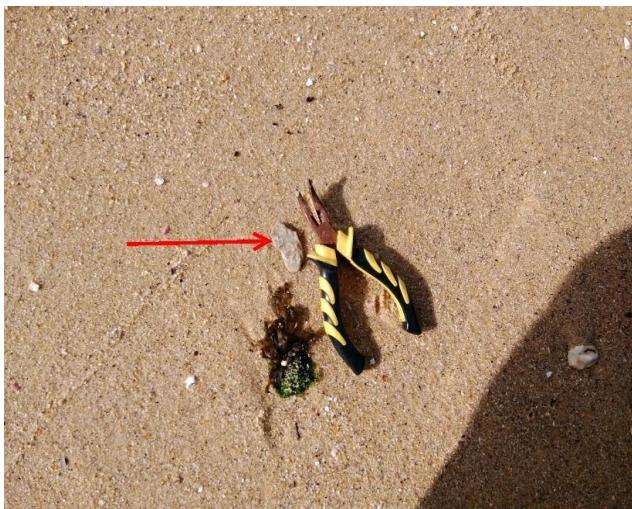
Notes: FC fragment identified on sand surface prior to emu pick - Southern section

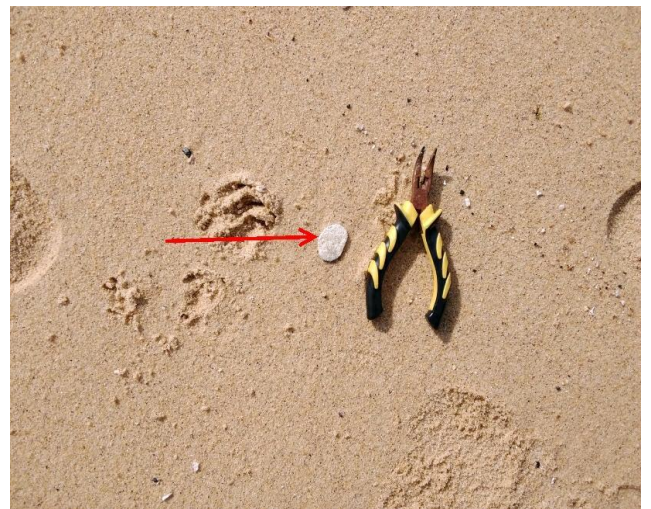
Notes: FC fragment identified on sand surface prior to emu pick - Southern section

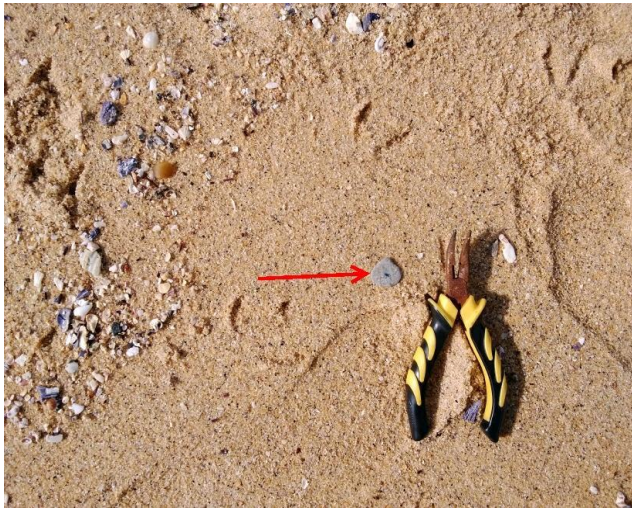
Notes: FC fragment identified on sand surface prior to emu pick - Southern section

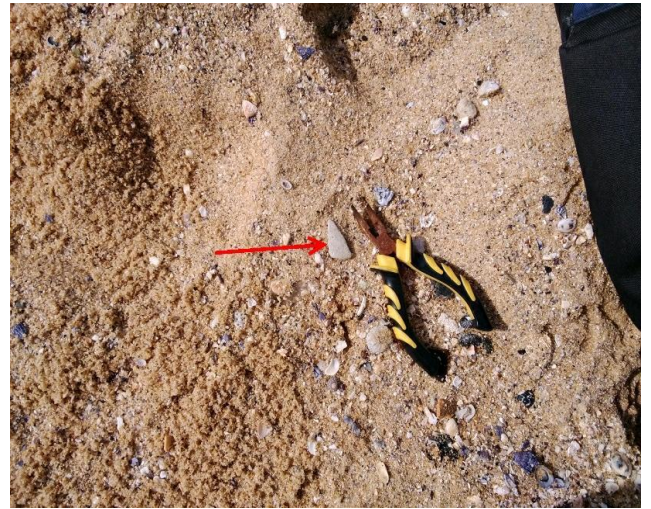
Notes: FC fragment identified on sand surface prior to emu pick - Southern section

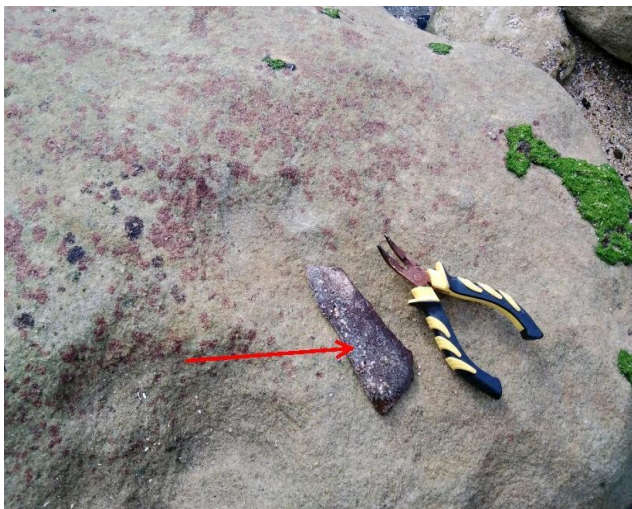
Notes: FC fragment identified on sand surface prior to emu pick - Southern section

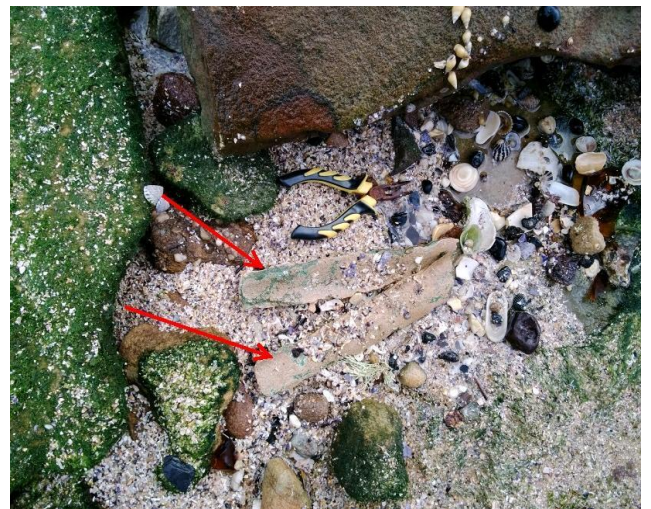
Notes: FC fragment identified on sand surface prior to emu pick - Southern section

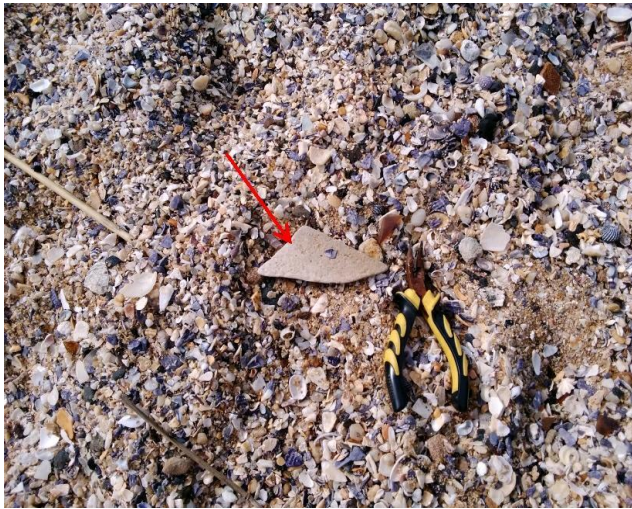
Notes: FC fragment identified on sand surface prior to emu pick - Southern section

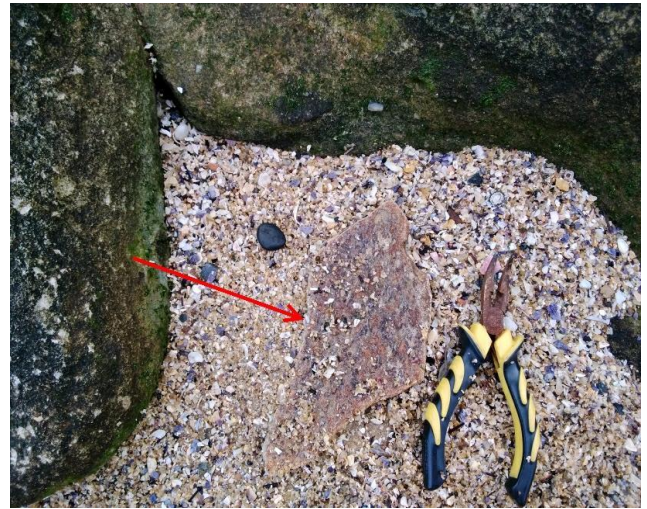
Notes: FC fragment identified on sand surface prior to emu pick - Southern section

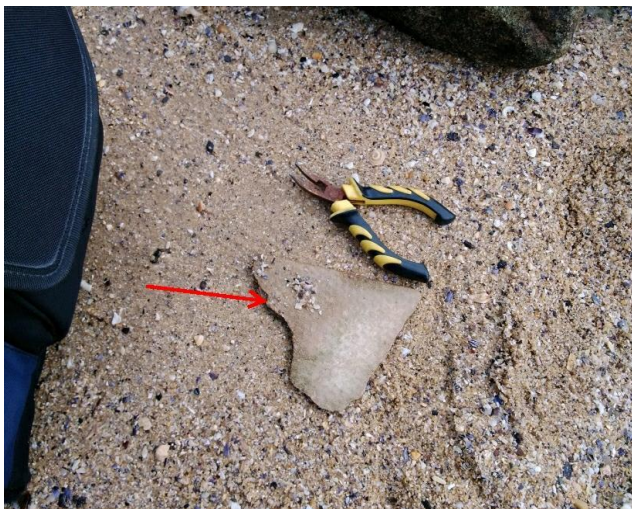
Notes: FC fragment identified on sand surface prior to emu pick - Southern section

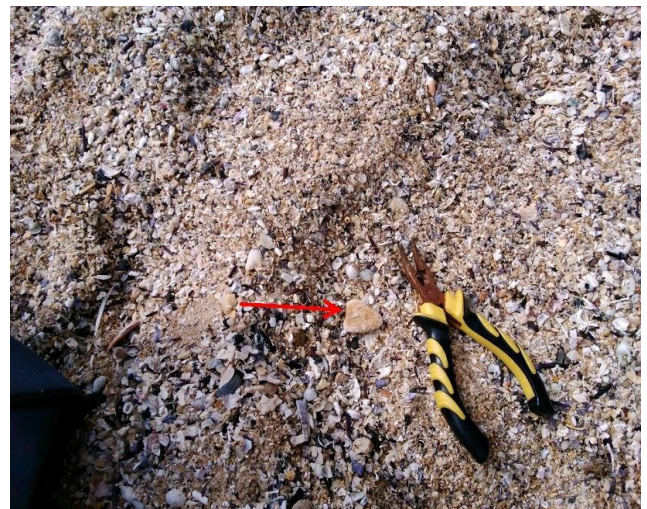
Notes: FC fragment identified on sand surface prior to emu pick - Southern section

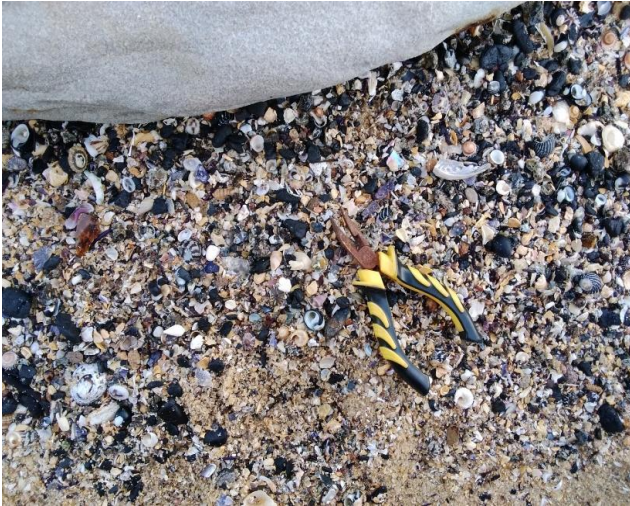
Notes: Sand surface following emu pick - Northern section

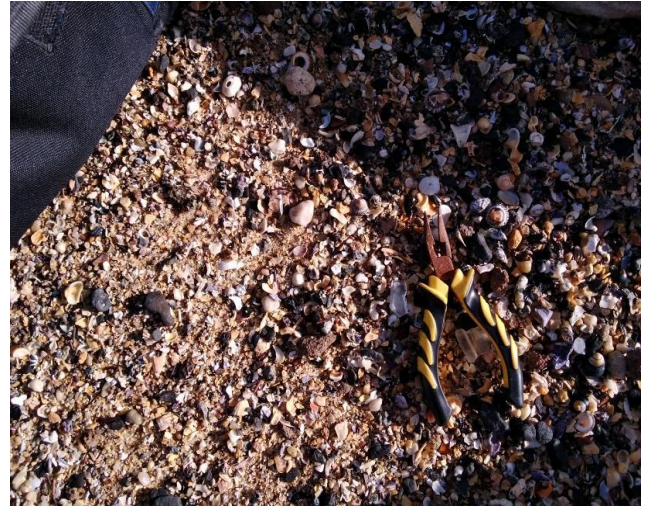
Notes: Sand surface following emu pick - Northern section

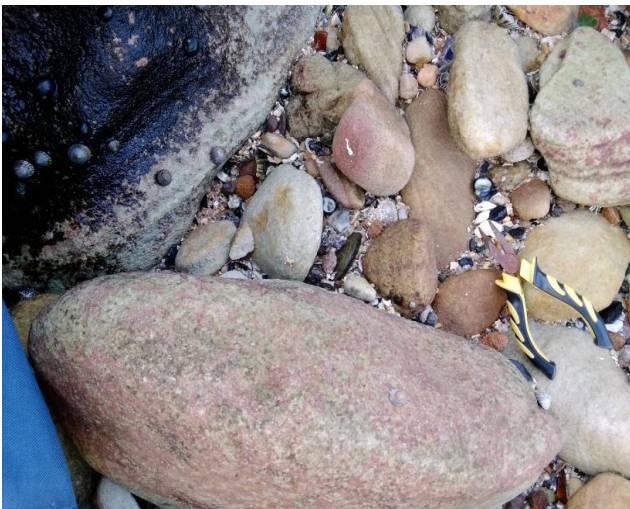
Notes: Sand surface following emu pick - Northern section

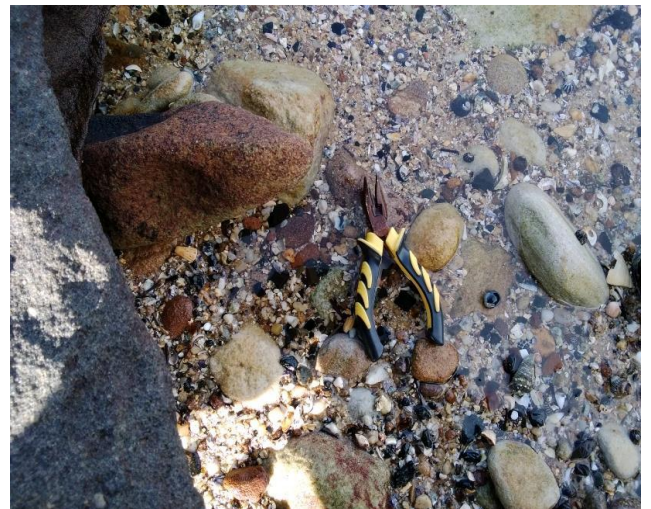
Notes: Sand surface following emu pick - Northern section

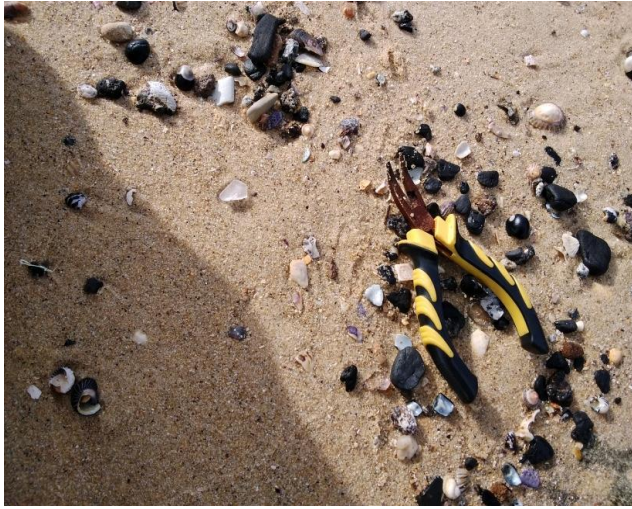
Notes: Sand surface following emu pick - Northern section

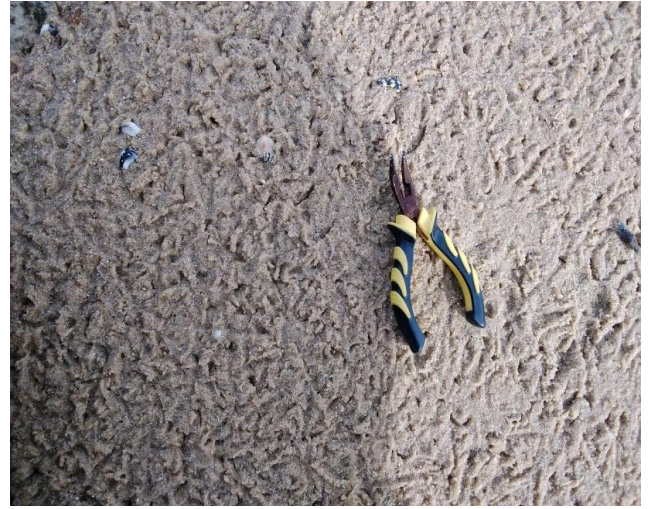
Notes: Sand surface following emu pick - Northern section

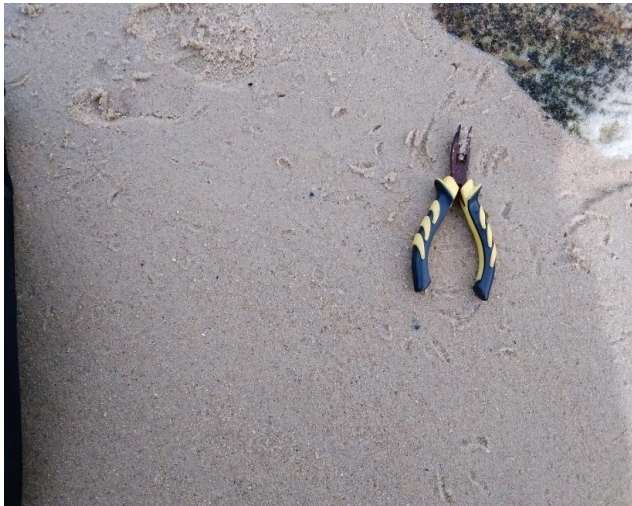
Notes: Sand surface following emu pick - Northern section

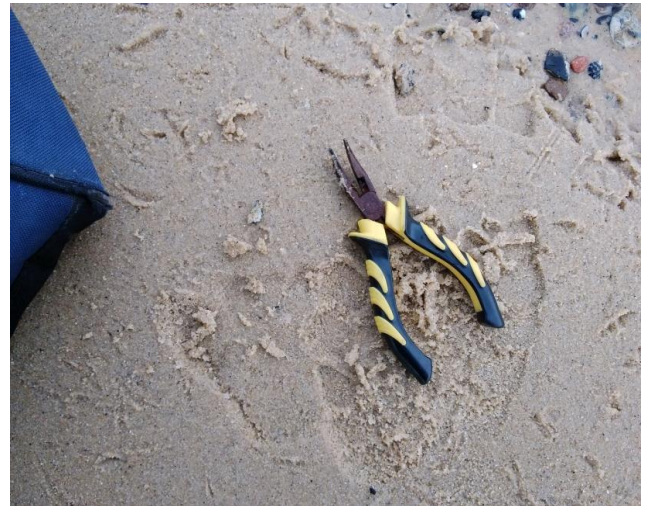
Notes: Sand surface following emu pick - Northern section

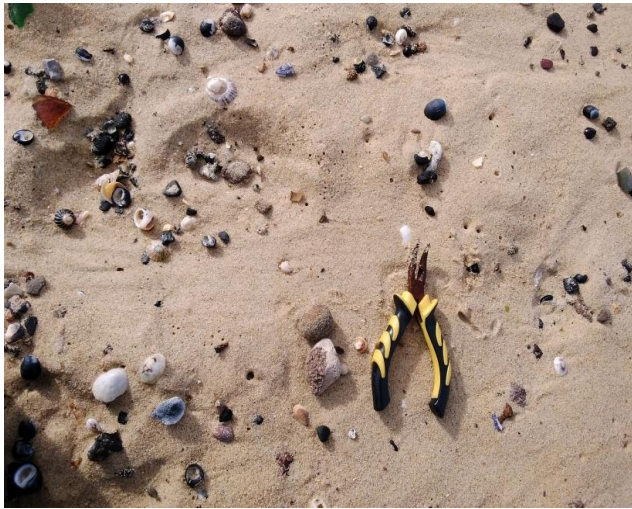
Notes: Sand surface following emu pick - Northern section

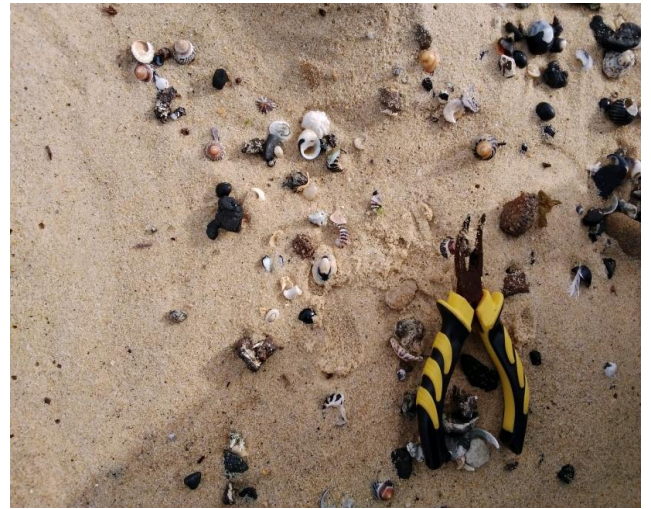
Notes: Sand surface following emu pick - Northern section

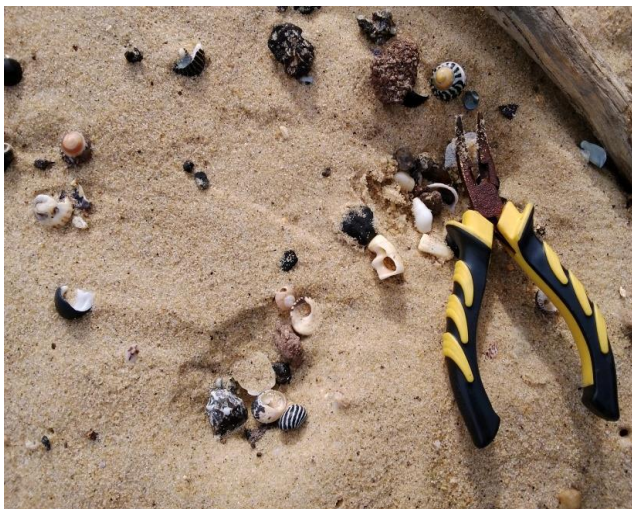
Notes: Sand surface following emu pick - Northern section

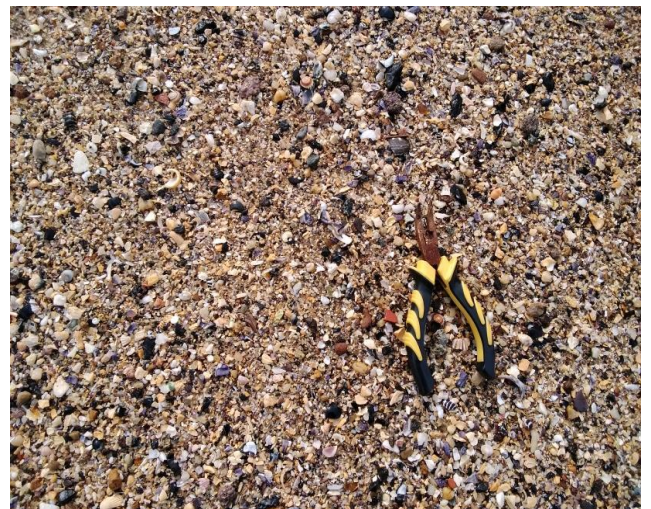
Notes: Sand surface following emu pick - Northern section

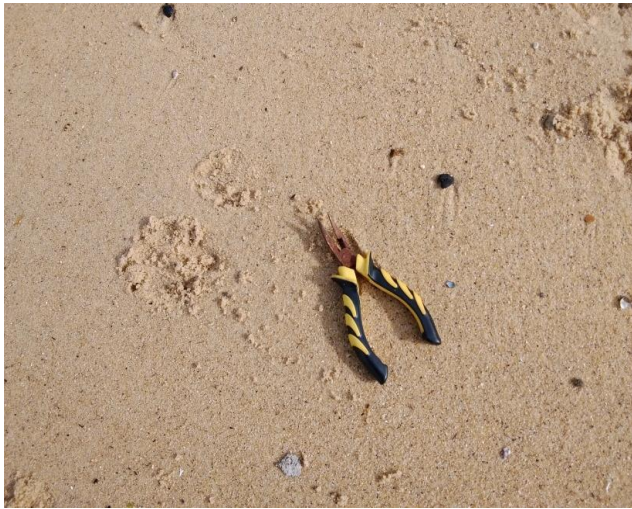
Notes: Sand surface following emu pick - Northern section

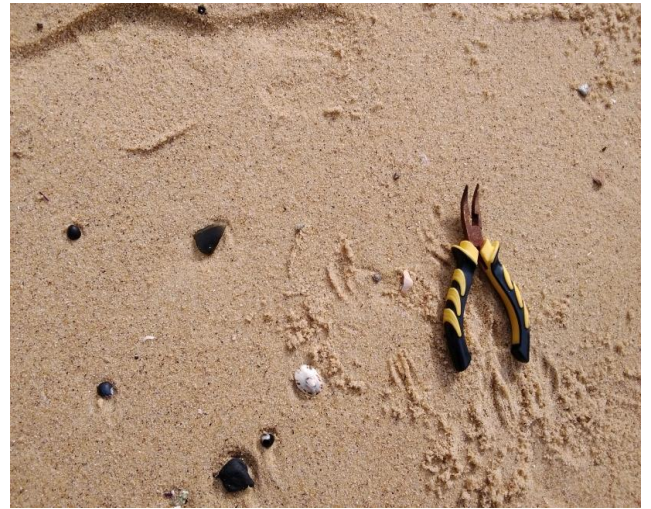
Notes: Sand surface following emu pick - Northern section

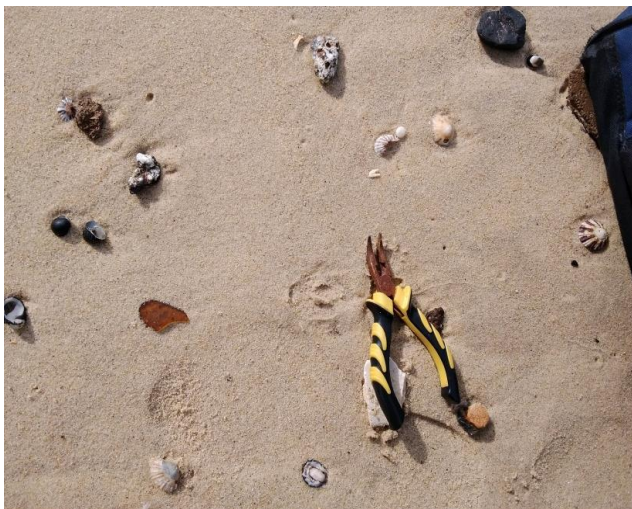
Notes: Sand surface following emu pick - Western section

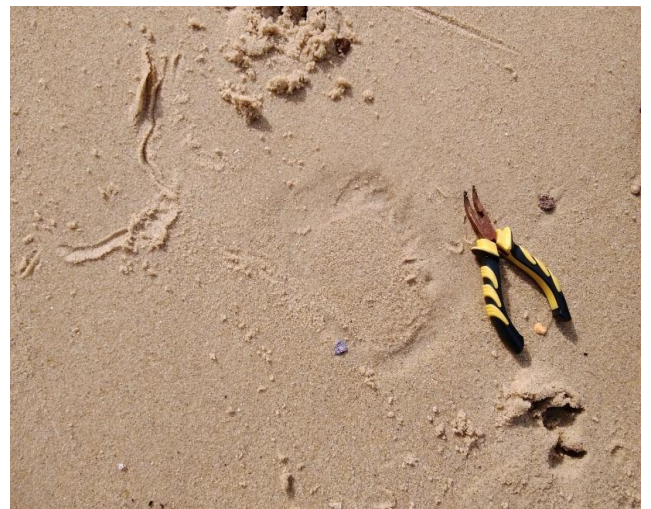
Notes: Sand surface following emu pick - Western section

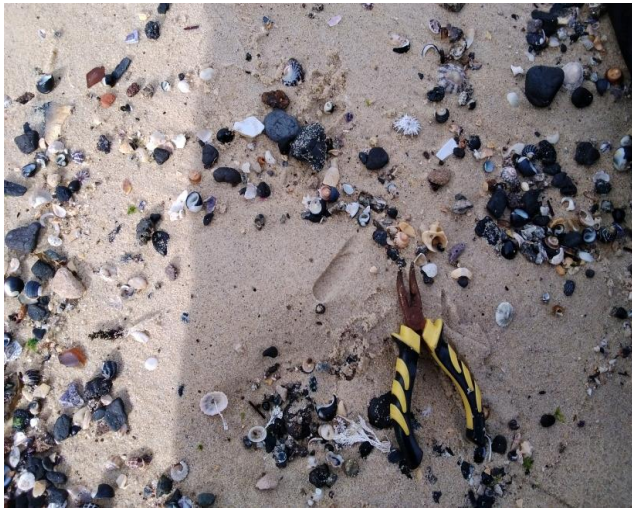
Notes: Sand surface following emu pick - Western section

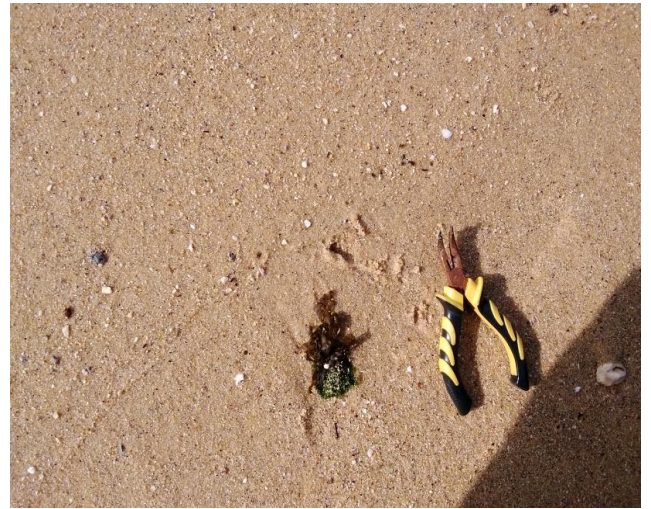
Notes: Sand surface following emu pick - Southern section

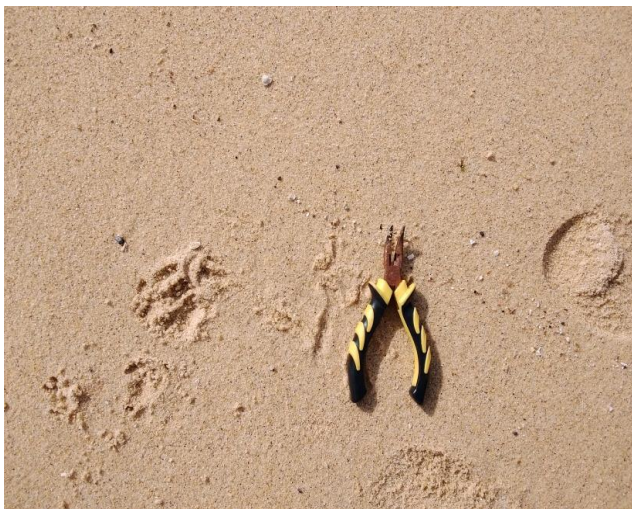
Notes: Sand surface following emu pick - Southern section

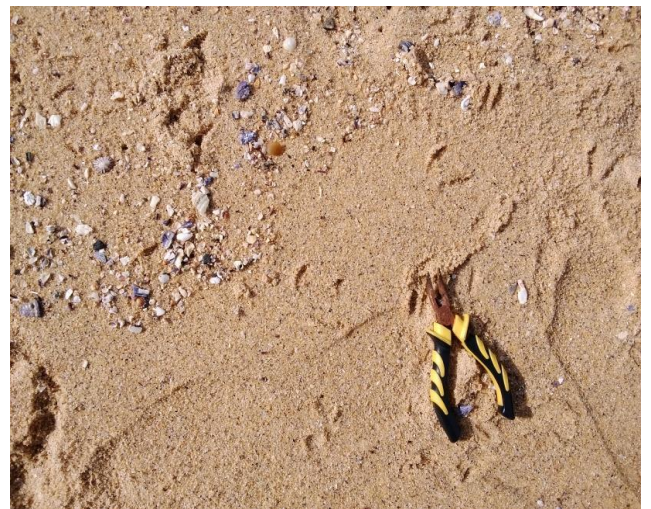
Notes: Sand surface following emu pick - Southern section

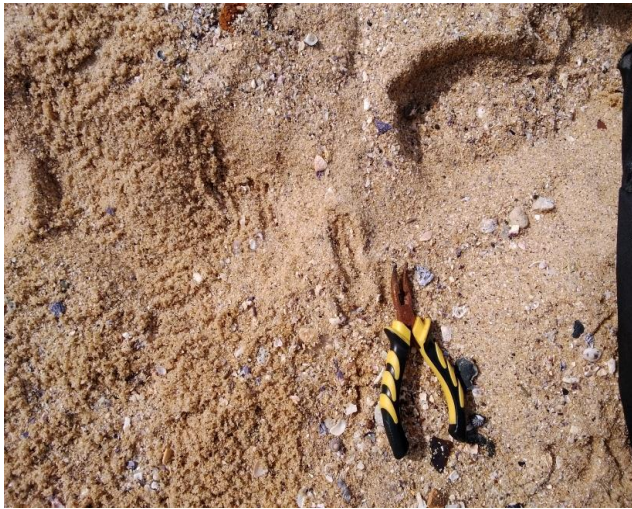
Notes: Sand surface following emu pick - Southern section

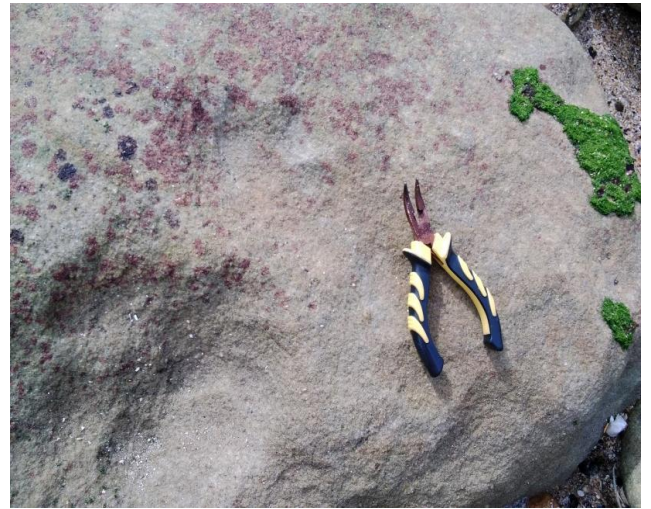
Notes: Sand surface following emu pick - Southern section

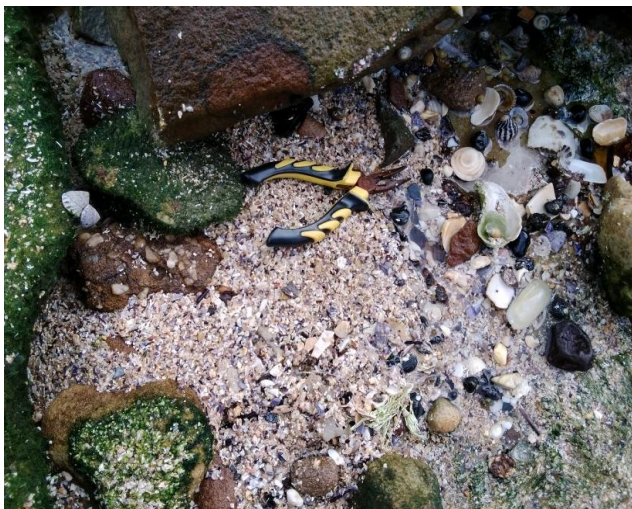
Notes: Sand surface following emu pick - Southern section

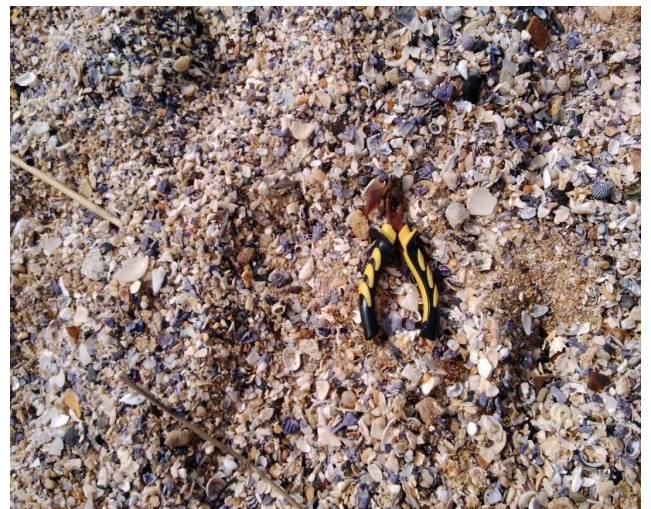
Notes: Sand surface following emu pick - Southern section

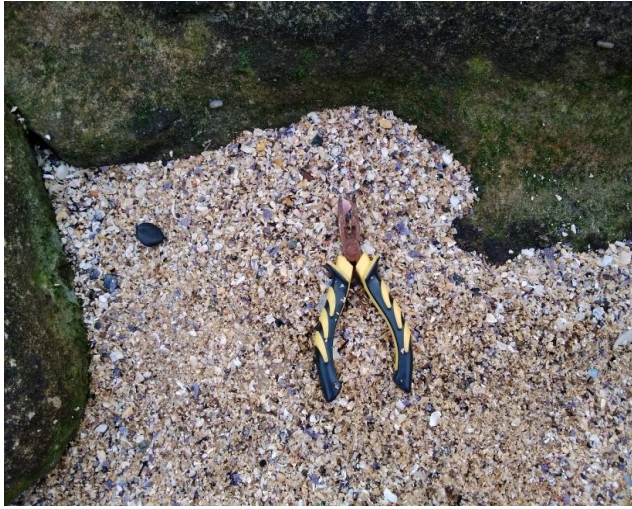
Notes: Sand surface following emu pick - Southern section

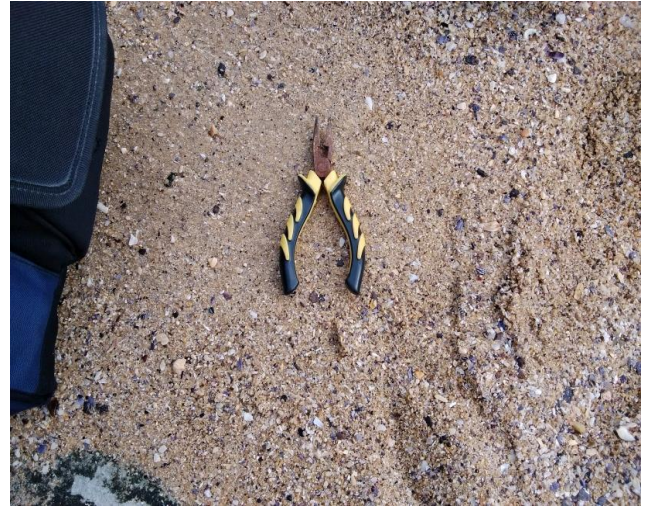
Notes: Sand surface following emu pick - Southern section

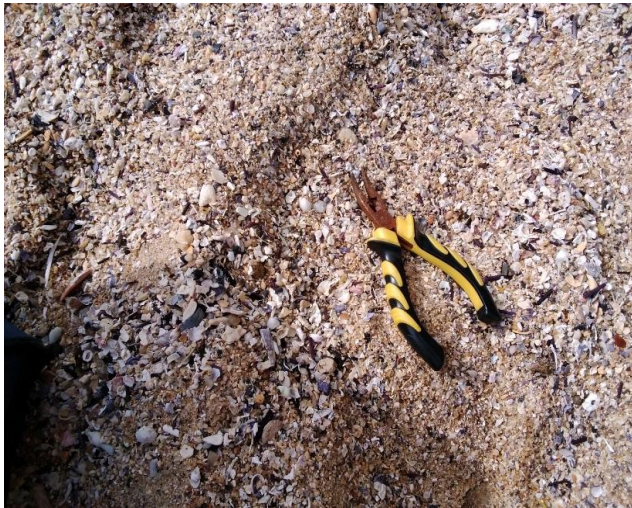
Notes: Sand surface following emu pick - Southern section
