# Asbestos Containing Material Clearance Inspection

3 December 2022

<b>Site:</b>	Little Bay Beach
<b>Location:</b>	Southern, Western and Northern Little Bay Beach

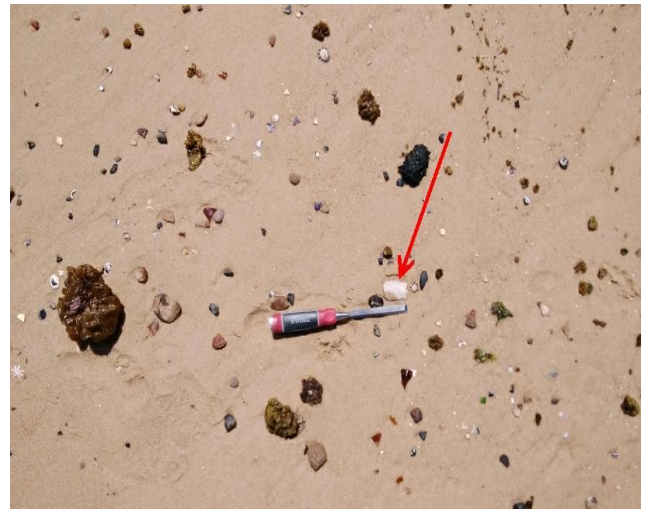
**Notes:** FC fragment identified on sand surface prior to emu pick - Northern section

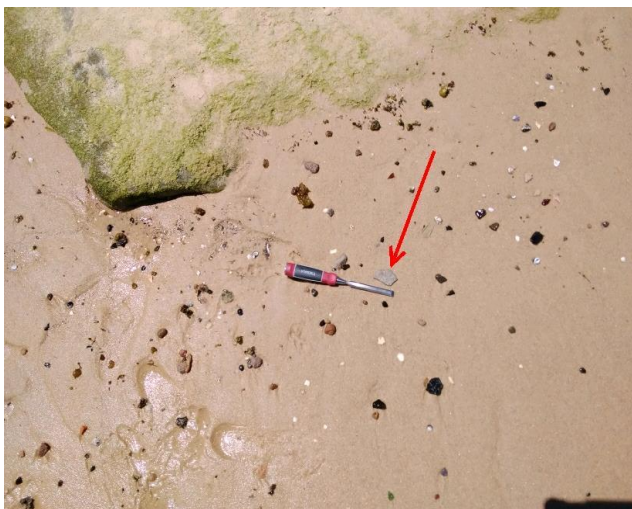
**Notes:** FC fragment identified on sand surface prior to emu pick - Northern section

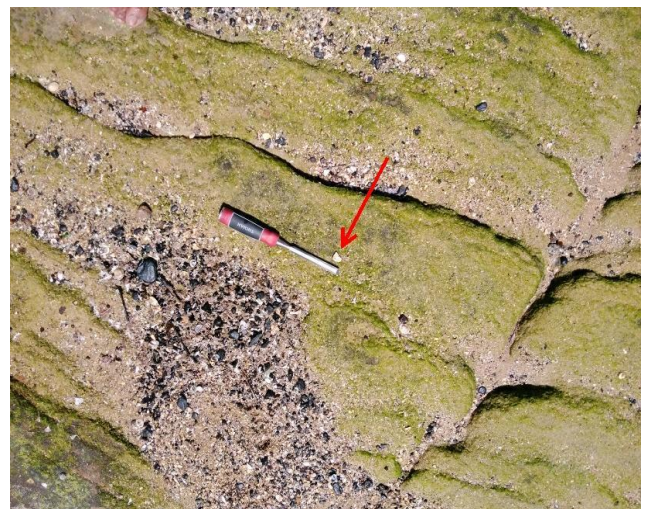
**Notes:** FC fragment identified on sand surface prior to emu pick - Northern section

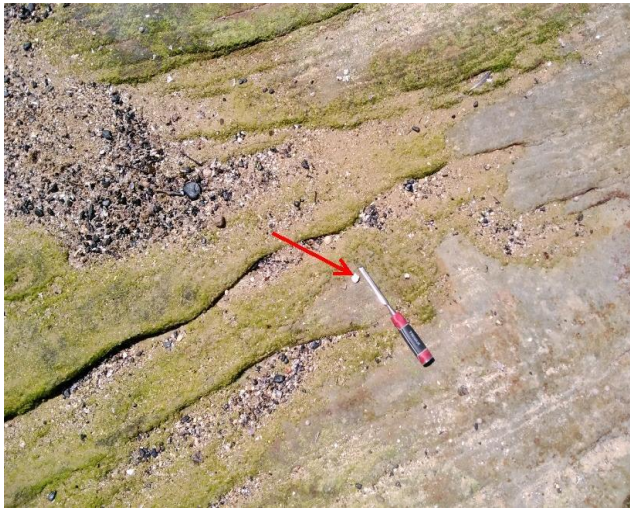
**Notes:** FC fragment identified on sand surface prior to emu pick - Northern section

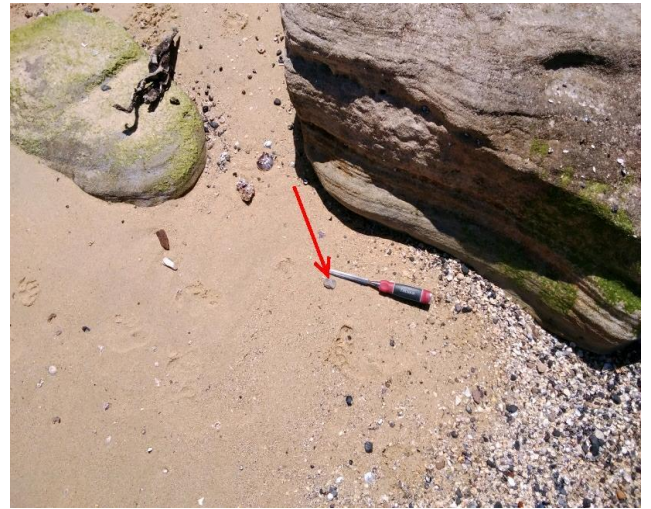
**Notes:** FC fragment identified on sand surface prior to emu pick - Northern section

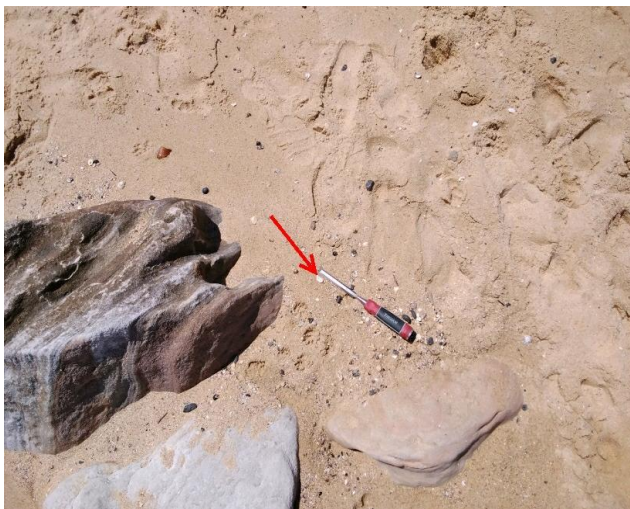
**Notes:** FC fragment identified on sand surface prior to emu pick - Northern section

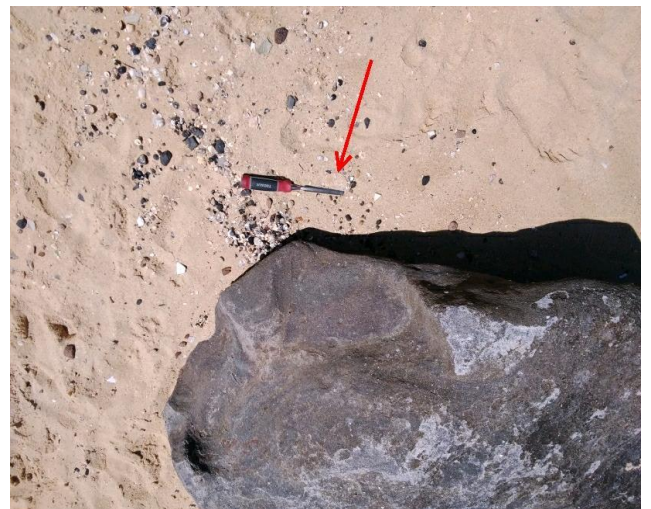
**Notes:** FC fragment identified on sand surface prior to emu pick - Northern section

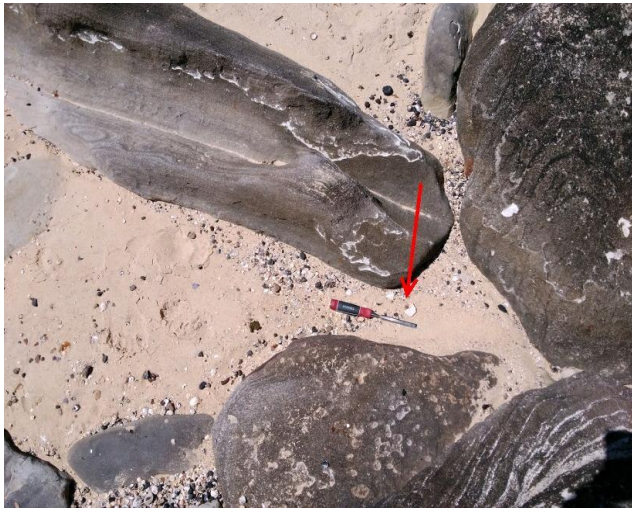
**Notes:** FC fragment identified on sand surface prior to emu pick - Northern section

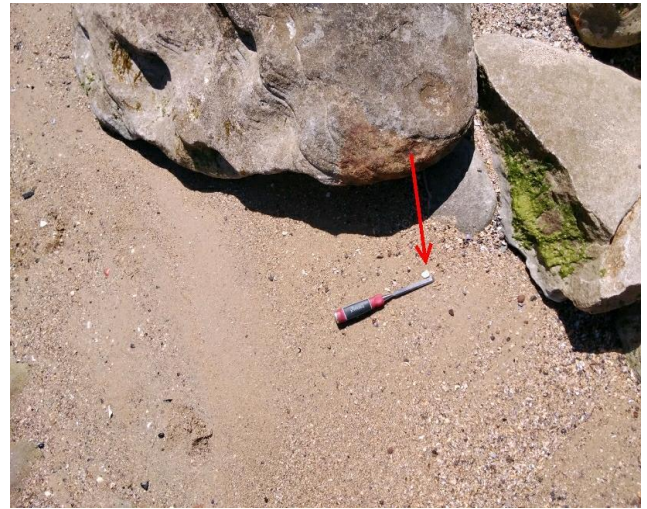
**Notes:** FC fragment identified on sand surface prior to emu pick - Northern section

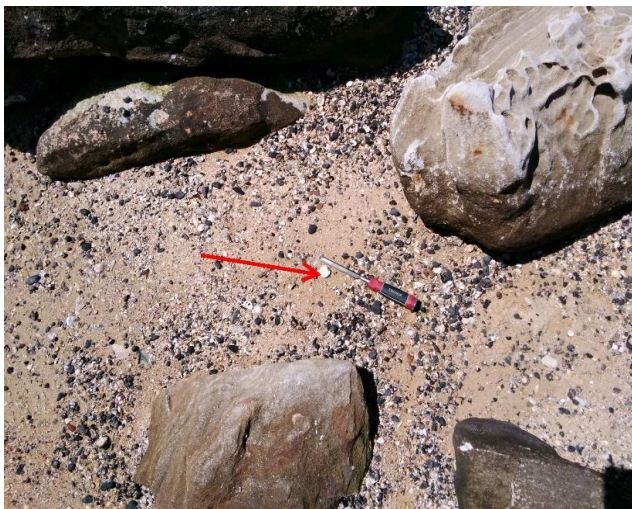
**Notes:** FC fragment identified on sand surface prior to emu pick - Northern section

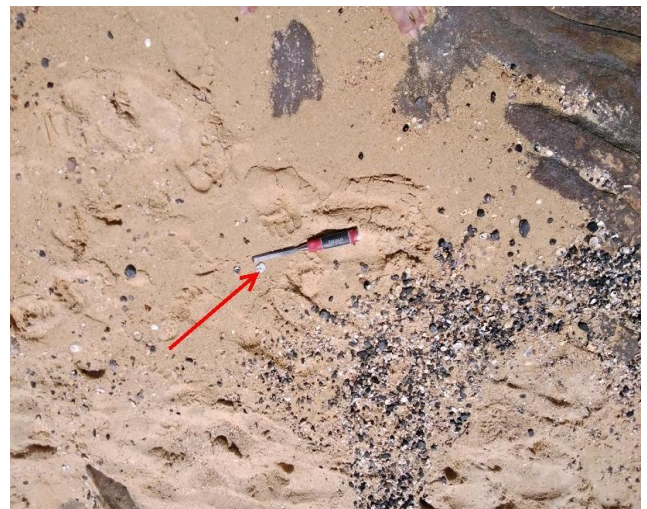
**Notes:** FC fragment identified on sand surface prior to emu pick - Northern section

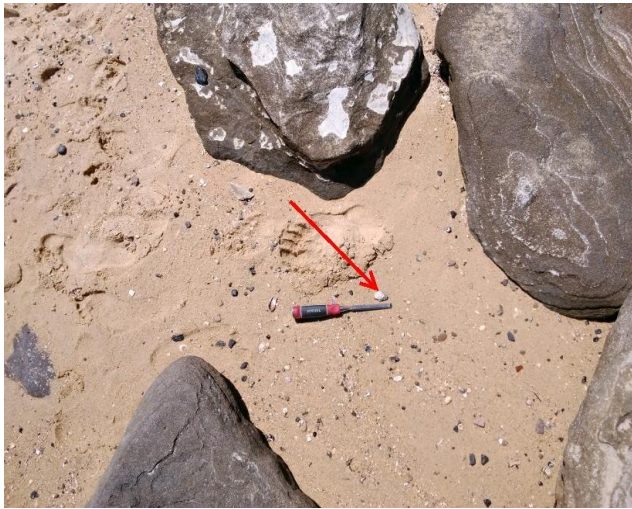
**Notes:** FC fragment identified on sand surface prior to emu pick - Northern section

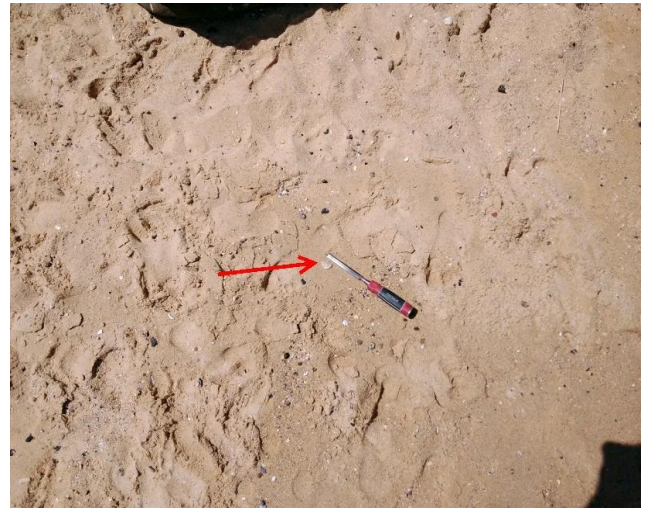
**Notes:** FC fragment identified on sand surface prior to emu pick - Northern section

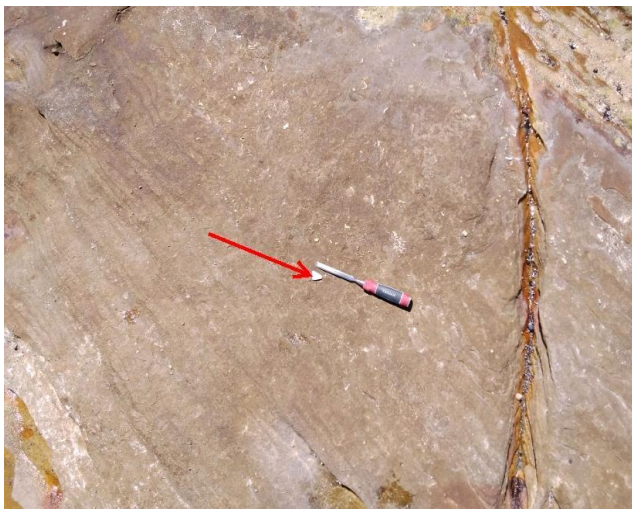
**Notes:** FC fragment identified on sand surface prior to emu pick - Northern section

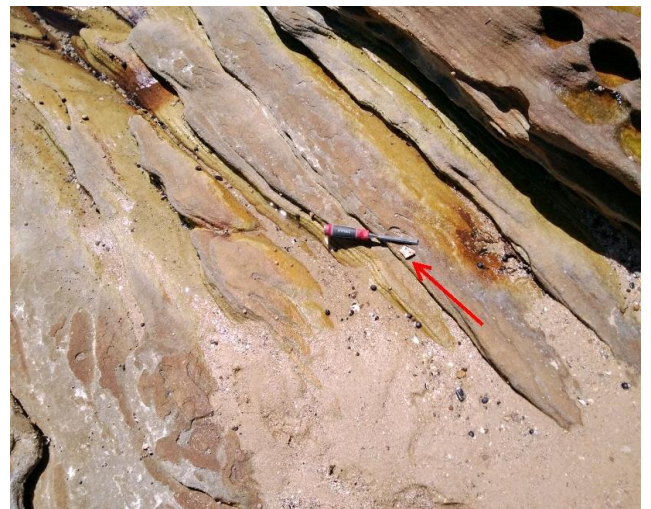
**Notes:** FC fragment identified on sand surface prior to emu pick - Northern section

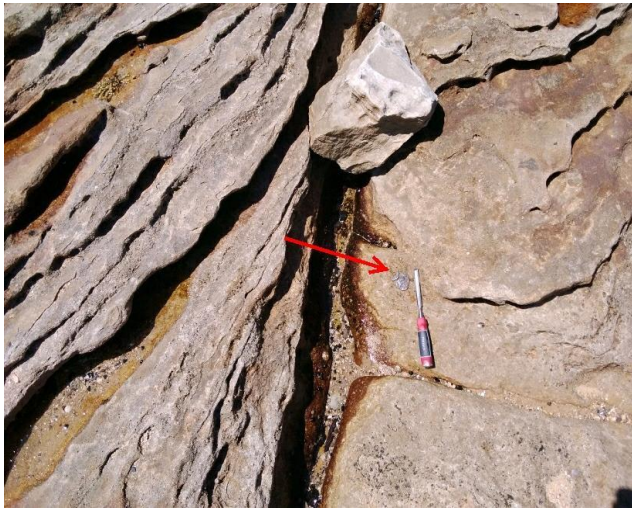
**Notes:** FC fragment identified on sand surface prior to emu pick - Northern section

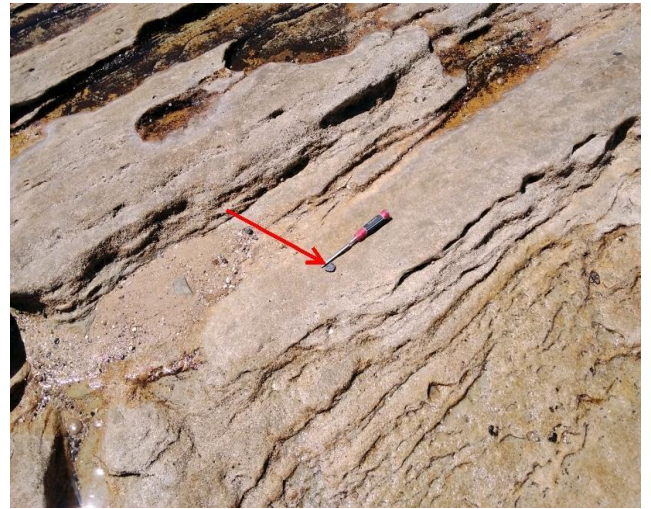
**Notes:** FC fragment identified on sand surface prior to emu pick - Northern section

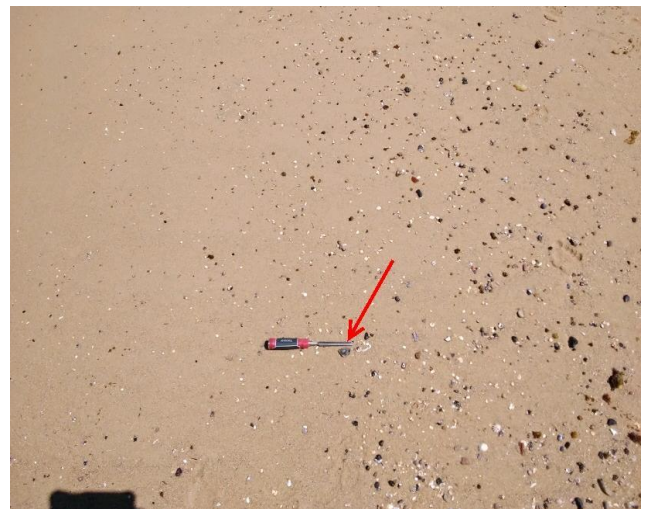
**Notes:** FC fragment identified on sand surface prior to emu pick - Western section

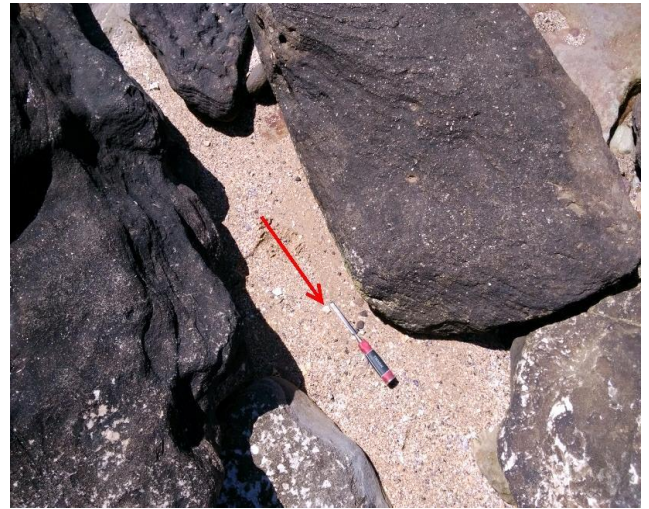
**Notes:** FC fragment identified on sand surface prior to emu pick - Southern section

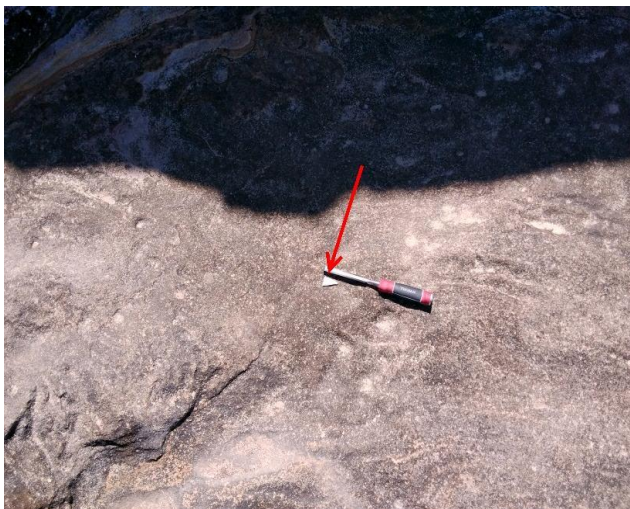
**Notes:** FC fragment identified on sand surface prior to emu pick - Southern section

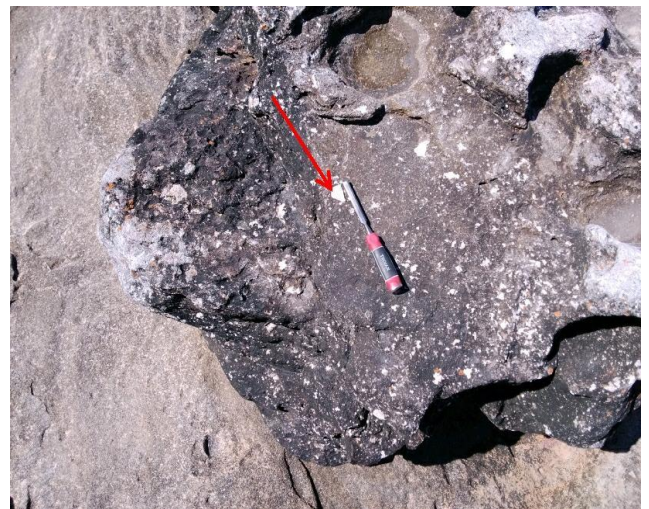
**Notes:** FC fragment identified on sand surface prior to emu pick - Southern section

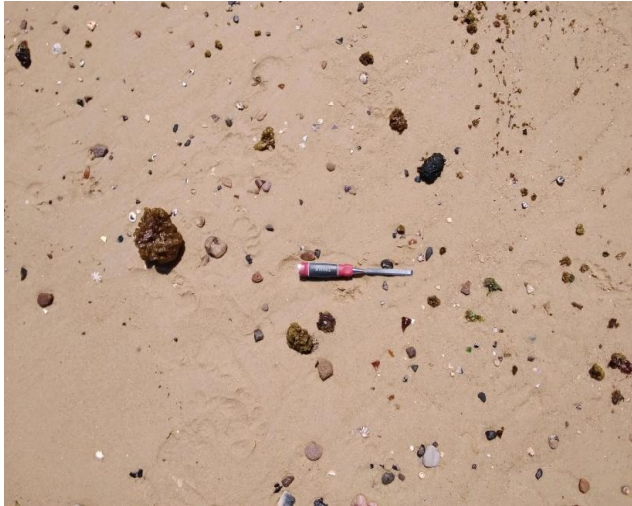
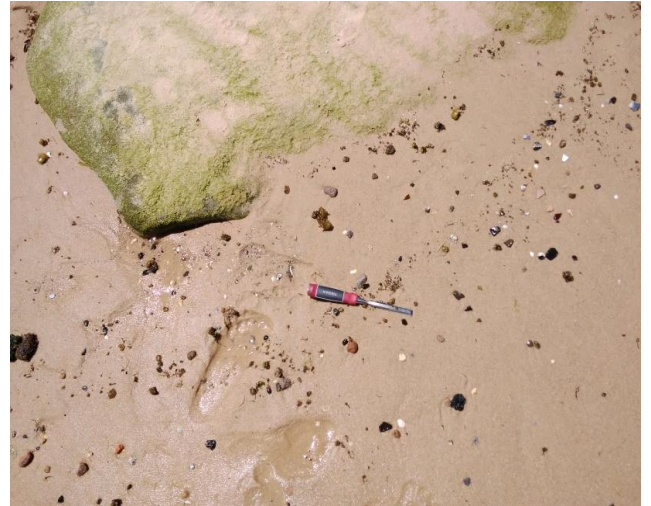
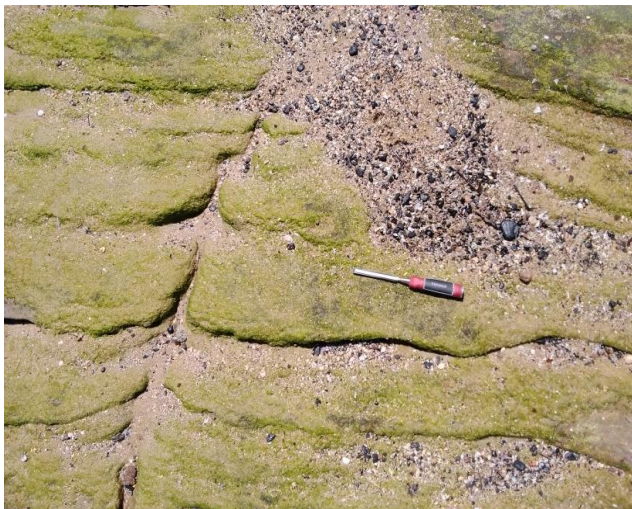
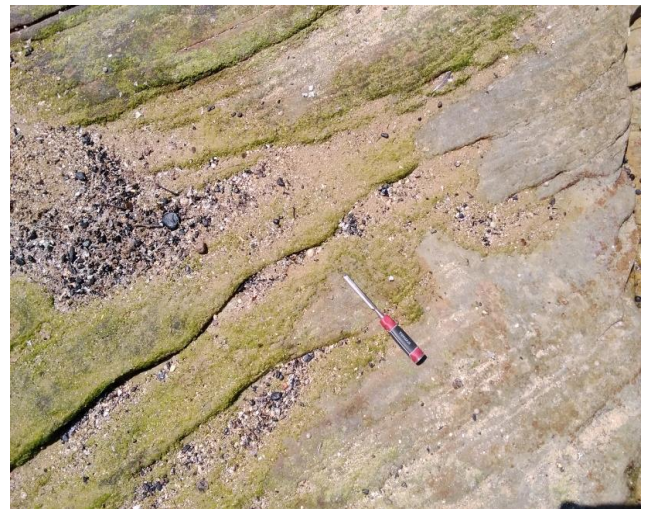
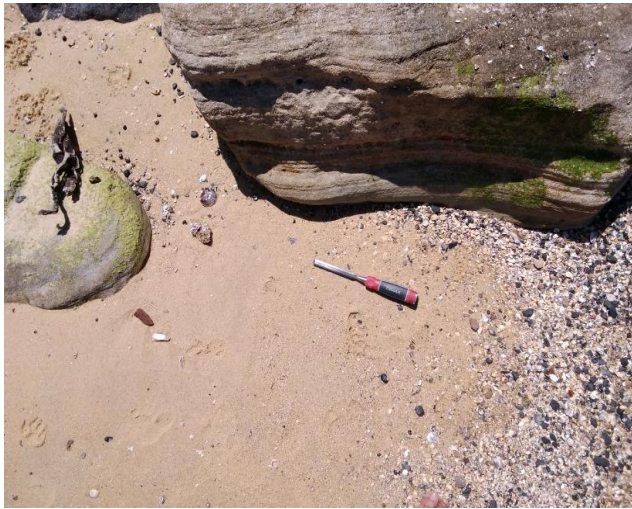
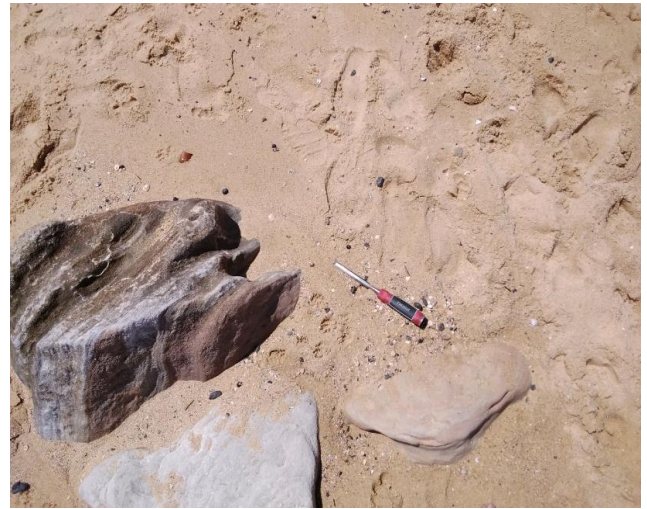
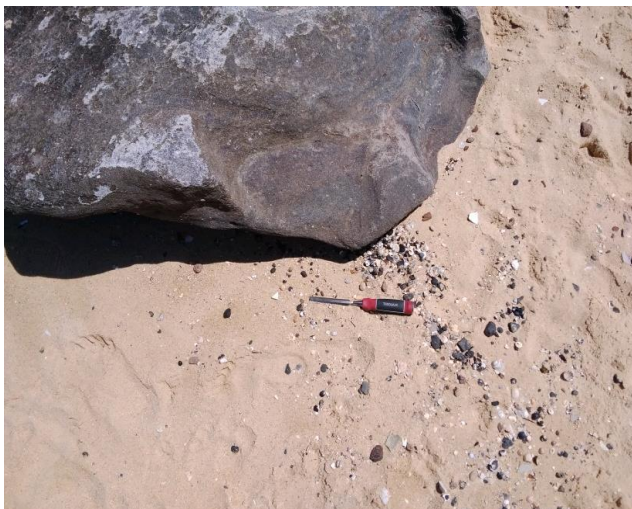
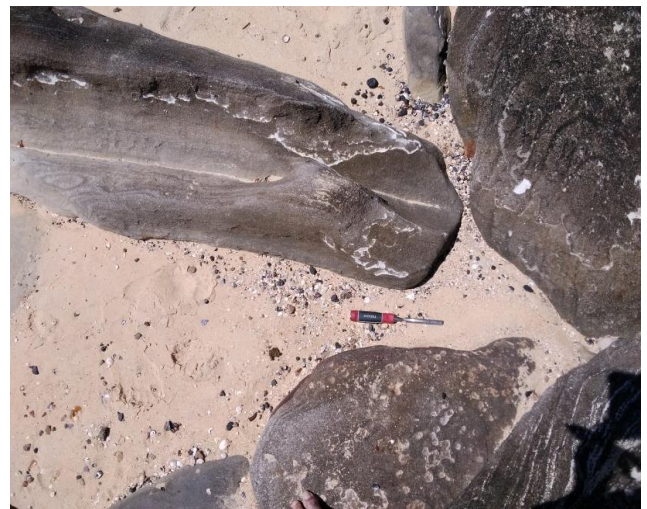
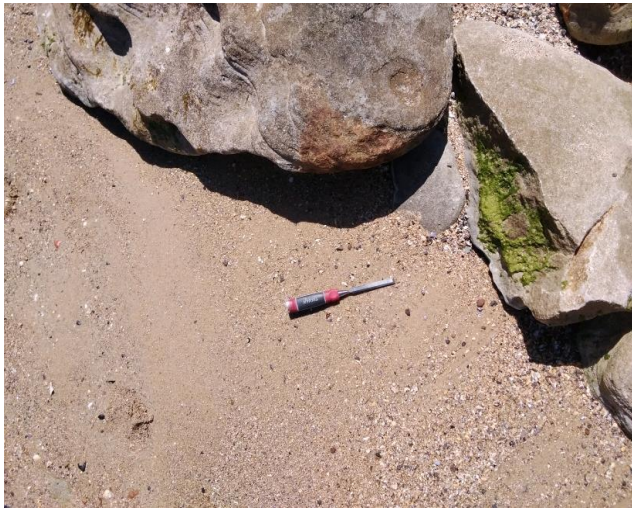
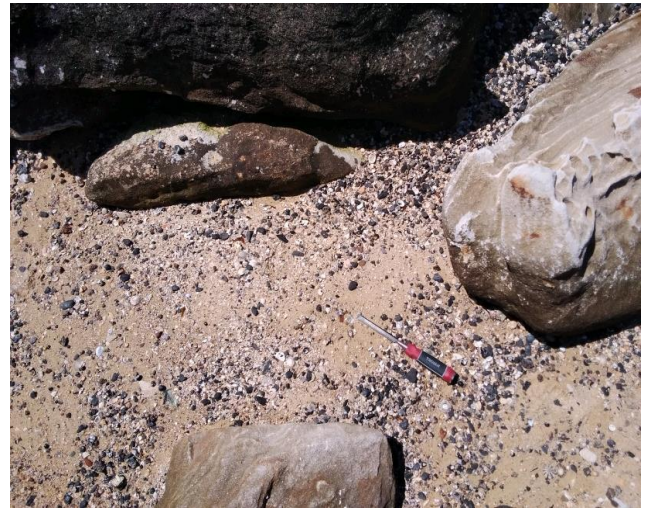
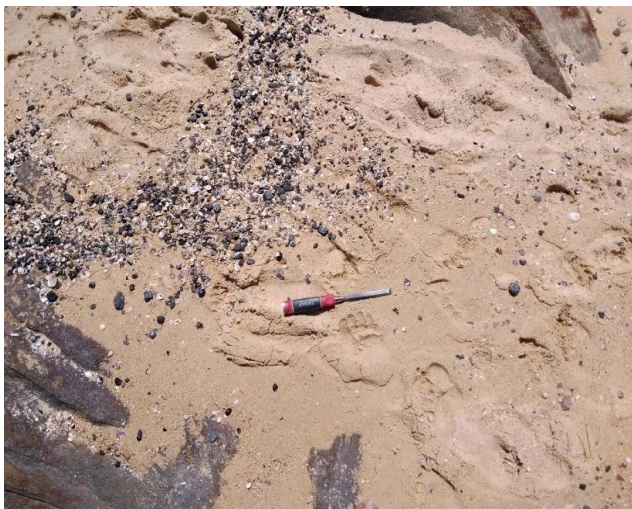
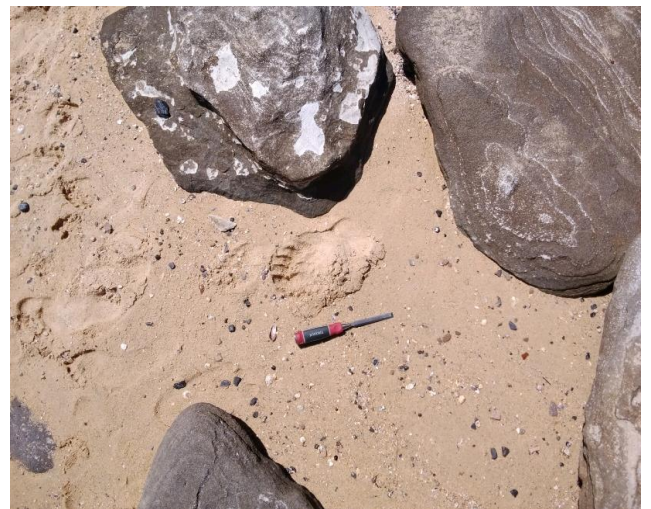
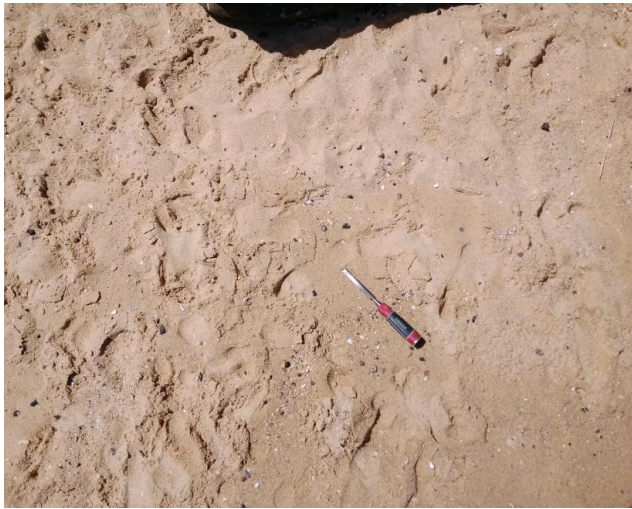
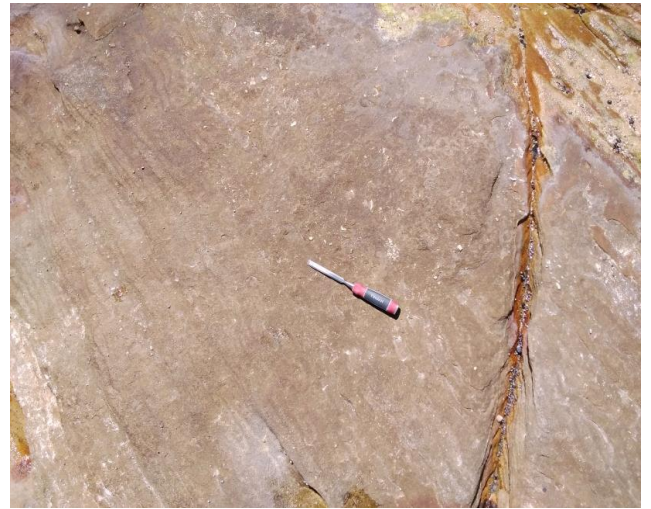
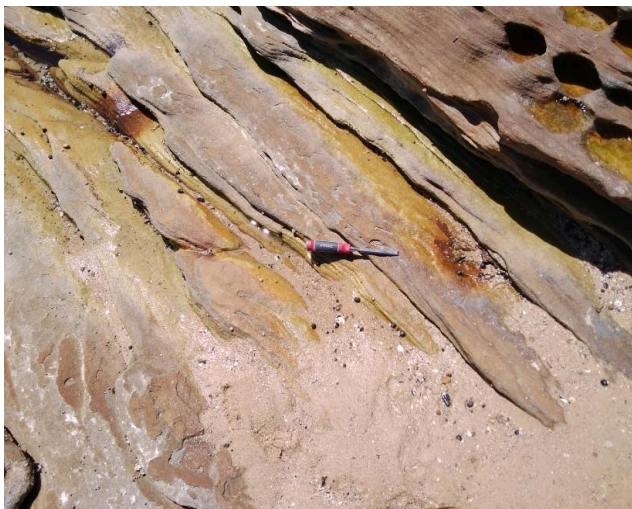
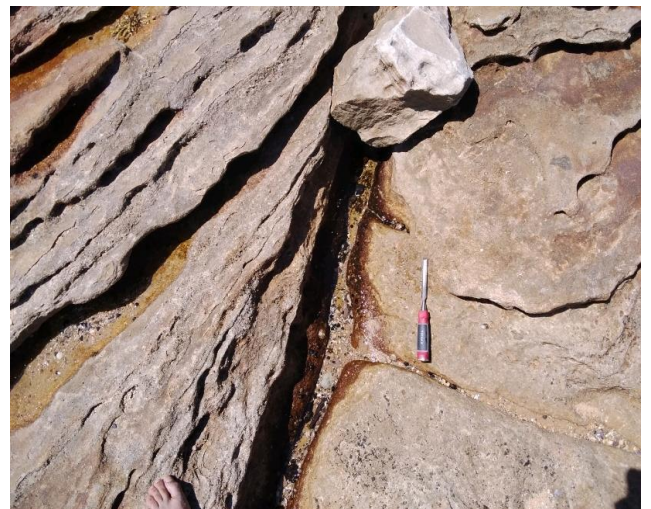
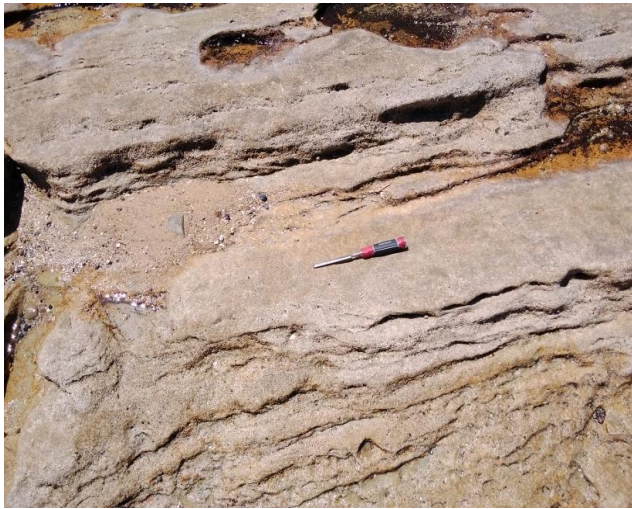
**Notes:** Sand surface following emu pick - Northern section

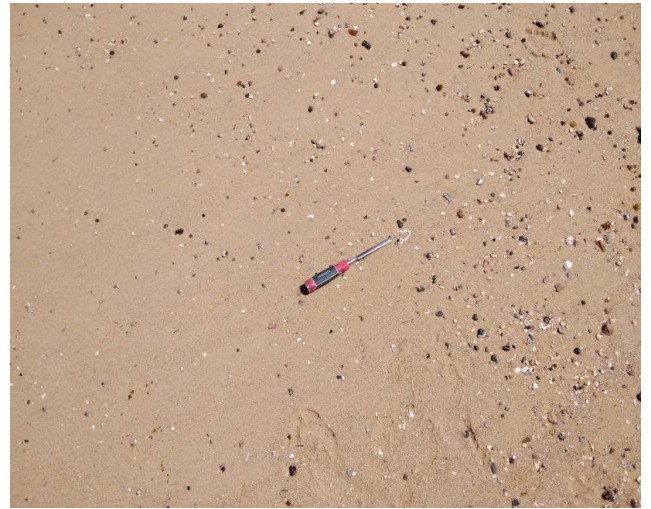
**Notes:** Sand surface following emu pick - Western section

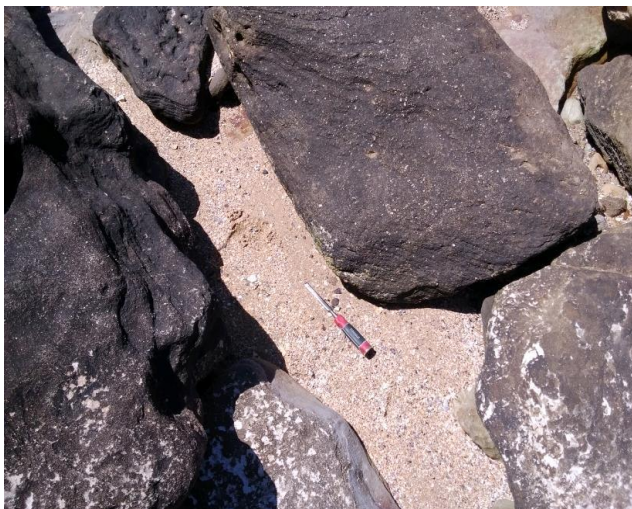
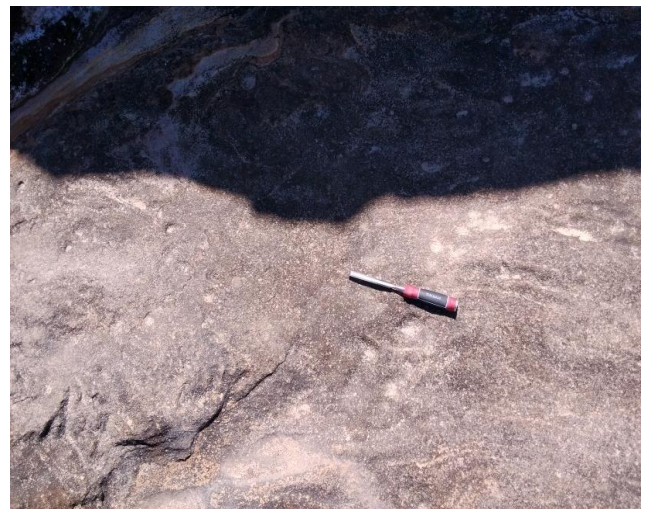
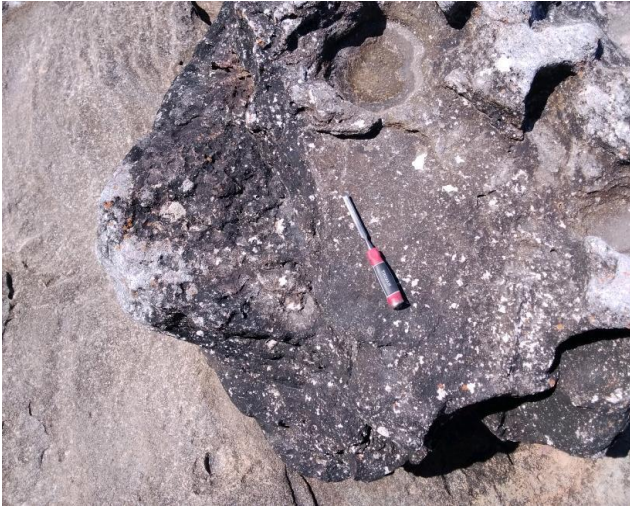
**Notes:** Sand surface following emu pick - Southern section
