# Asbestos Containing Material Clearance Inspection

28 January 2023

**Randwick City Council**  
30 Frances Street  
Randwick NSW 2031

<b>Site:</b>	Little Bay Beach
<b>Location:</b>	Southern, Western and Northern Little Bay Beach

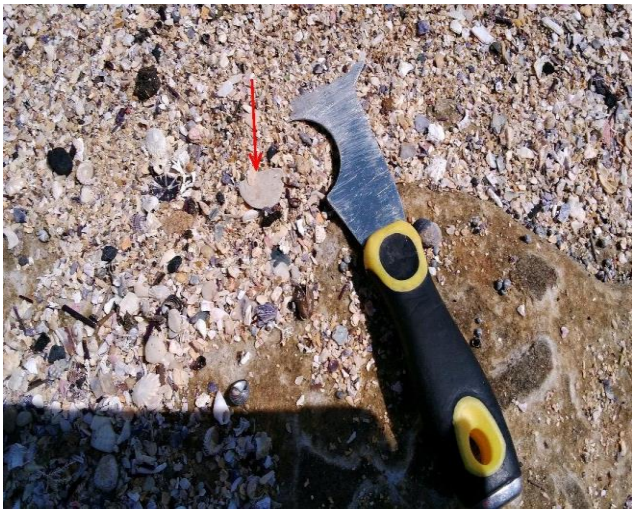
**Notes:** FC fragment identified on sand surface prior to emu pick - Southern section

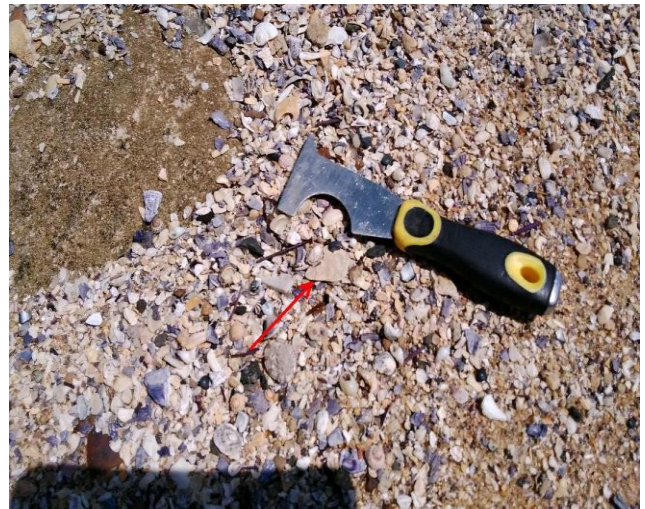
**Notes:** FC fragment identified on sand surface prior to emu pick - Southern section

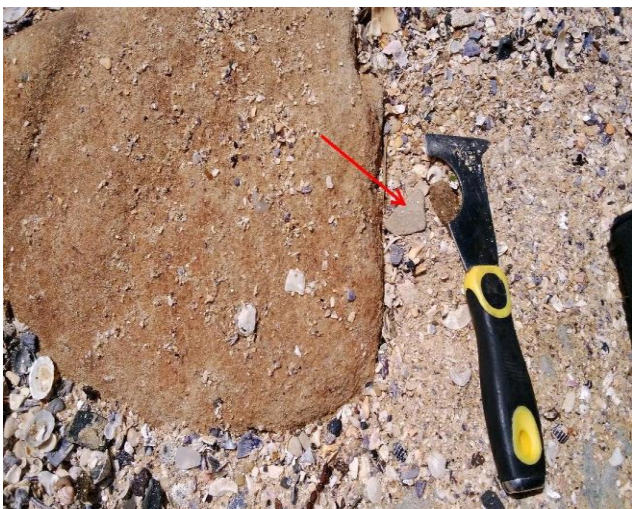
**Notes:** FC fragment identified on sand surface prior to emu pick - Southern section

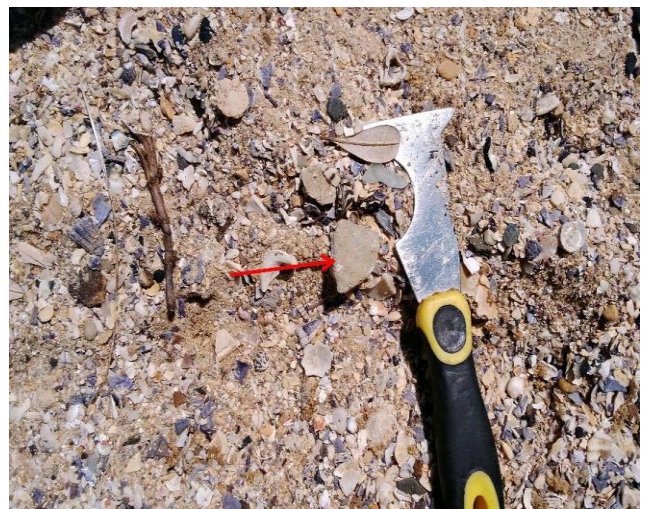
**Notes:** FC fragment identified on sand surface prior to emu pick - Southern section

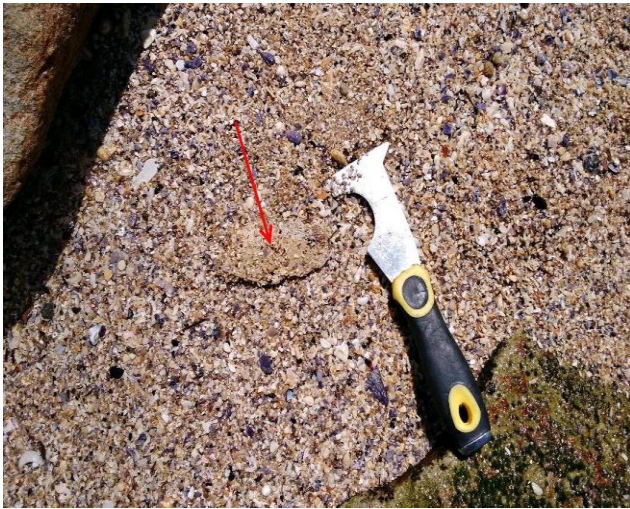
**Notes:** FC fragment identified on sand surface prior to emu pick - Southern section

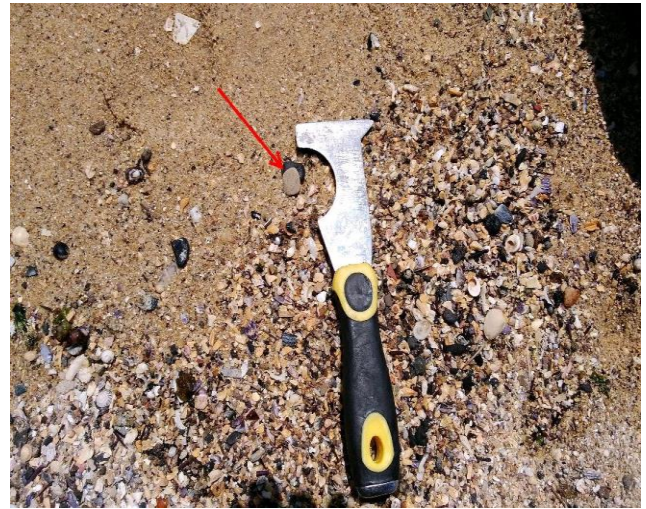
**Notes:** FC fragment identified on sand surface prior to emu pick - Southern section

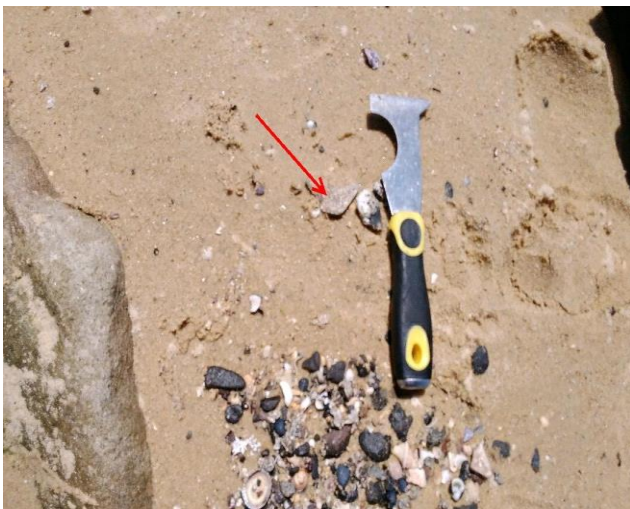
**Notes:** FC fragment identified on sand surface prior to emu pick - Southern section

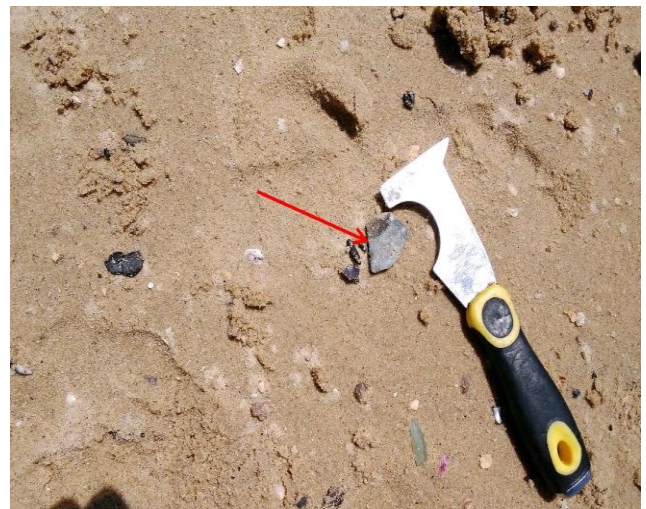
**Notes:** FC fragment identified on sand surface prior to emu pick - Southern section

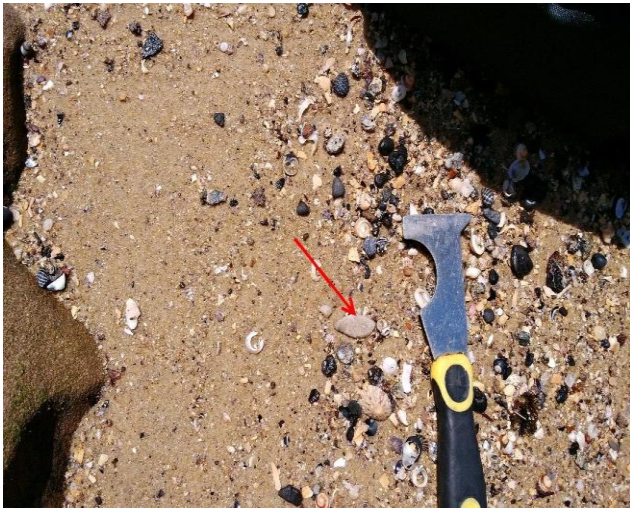
**Notes:** FC fragment identified on sand surface prior to emu pick - Northern section

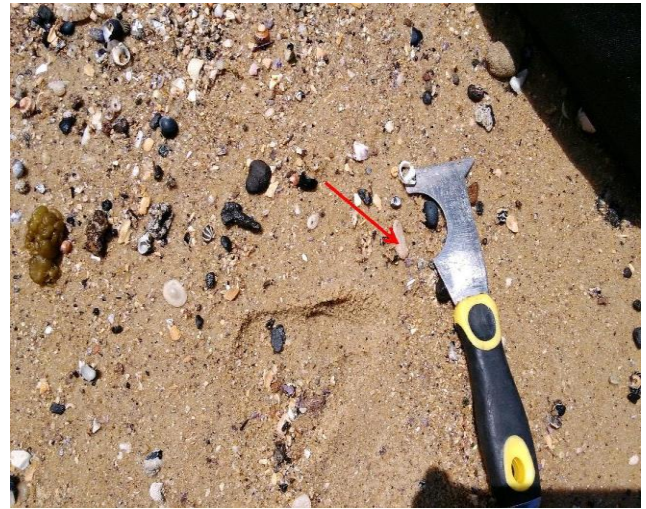
**Notes:** FC fragment identified on sand surface prior to emu pick - Northern section

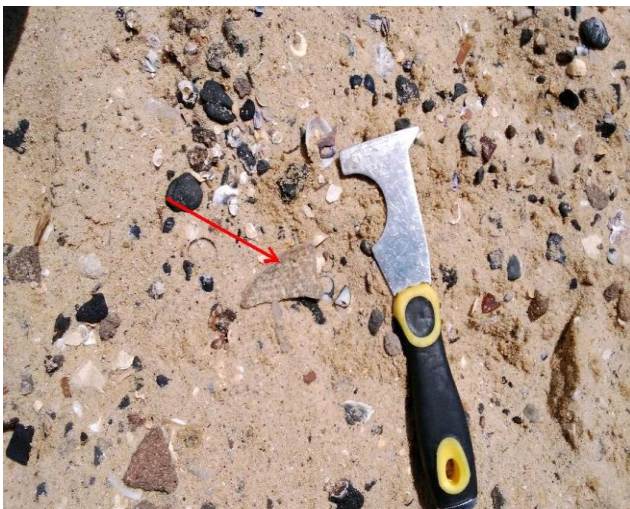
**Notes:** FC fragment identified on sand surface prior to emu pick - Northern section

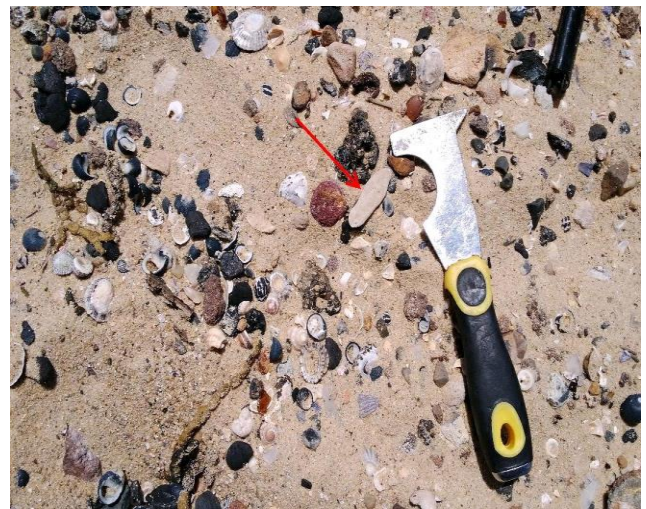
**Notes:** FC fragment identified on sand surface prior to emu pick - Northern section

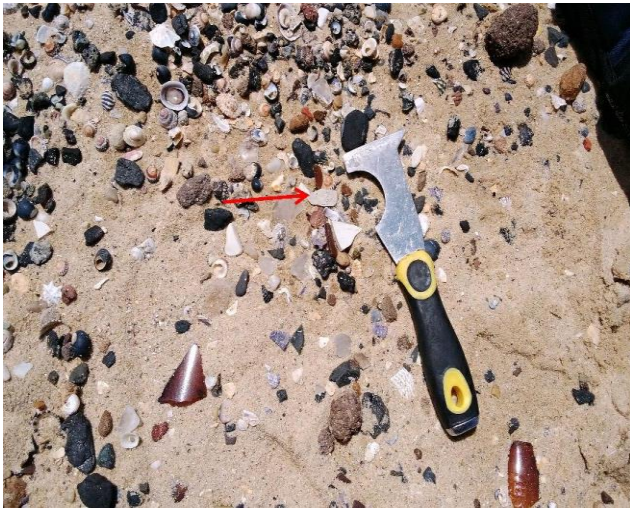
**Notes:** FC fragment identified on sand surface prior to emu pick - Northern section

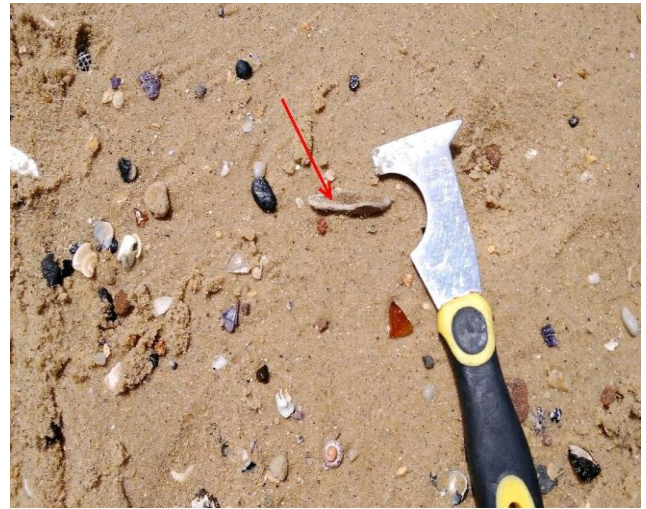
**Notes:** FC fragment identified on sand surface prior to emu pick - Northern section

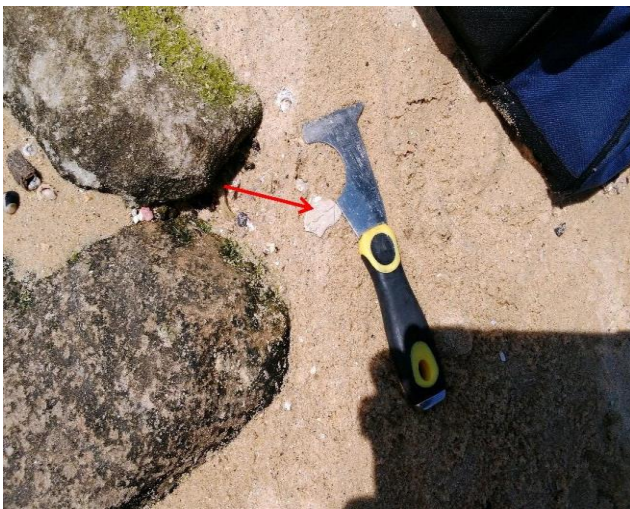
**Notes:** FC fragment identified on sand surface prior to emu pick - Northern section

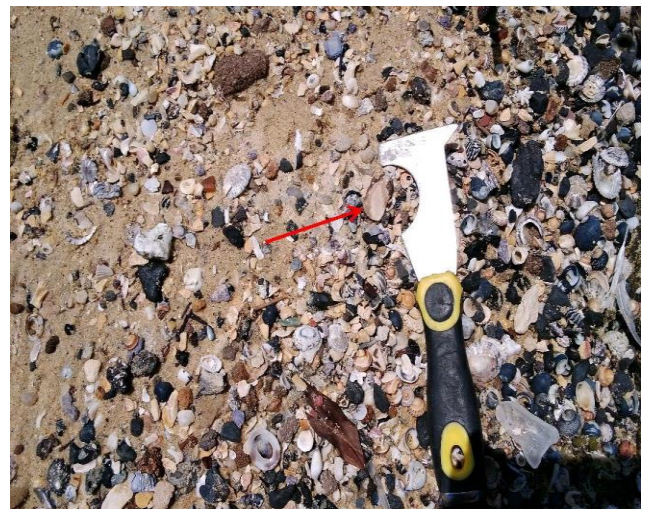
**Notes:** FC fragment identified on sand surface prior to emu pick - Northern section

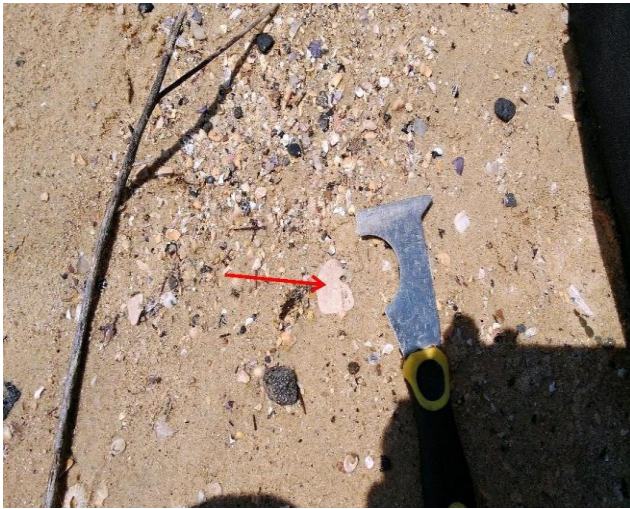
**Notes:** FC fragment identified on sand surface prior to emu pick - Northern section

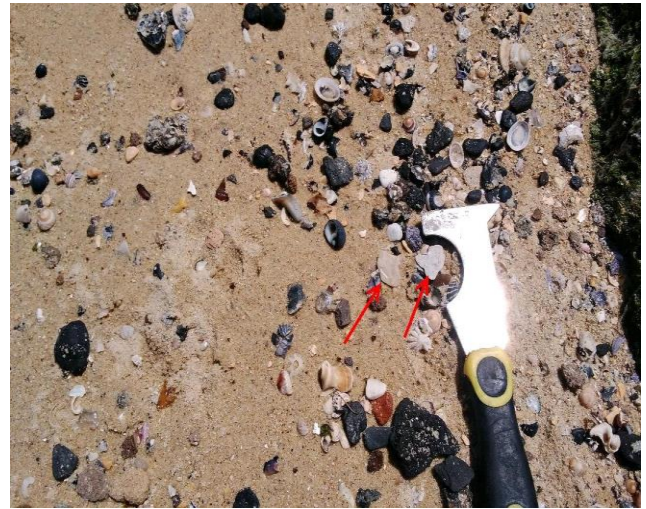
**Notes:** FC fragment identified on sand surface prior to emu pick - Northern section

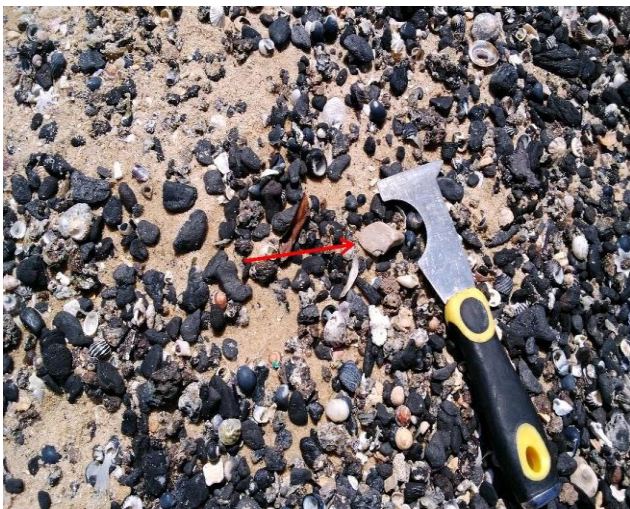
**Notes:** FC fragment identified on sand surface prior to emu pick - Northern section

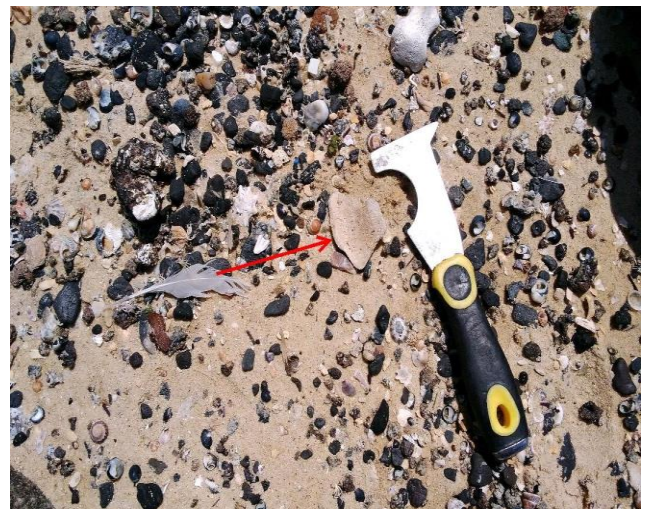
**Notes:** FC fragment identified on sand surface prior to emu pick - Northern section

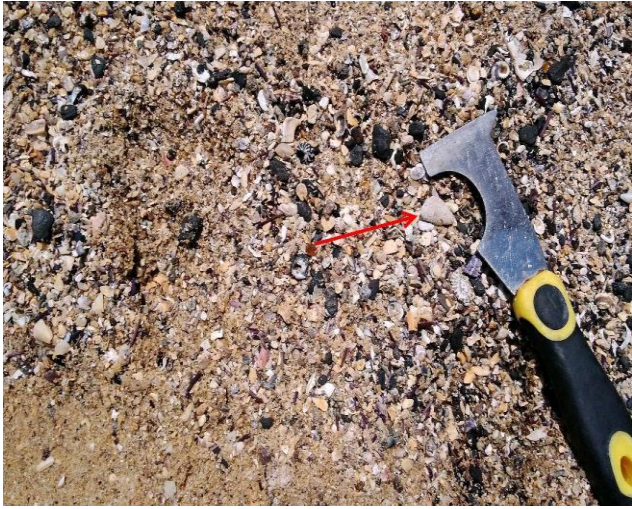
**Notes:** FC fragment identified on sand surface prior to emu pick - Northern section

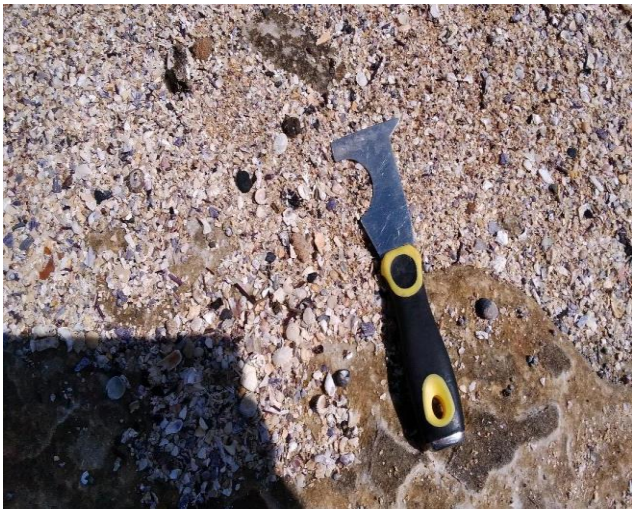
**Notes:** Sand surface following emu pick - Southern section

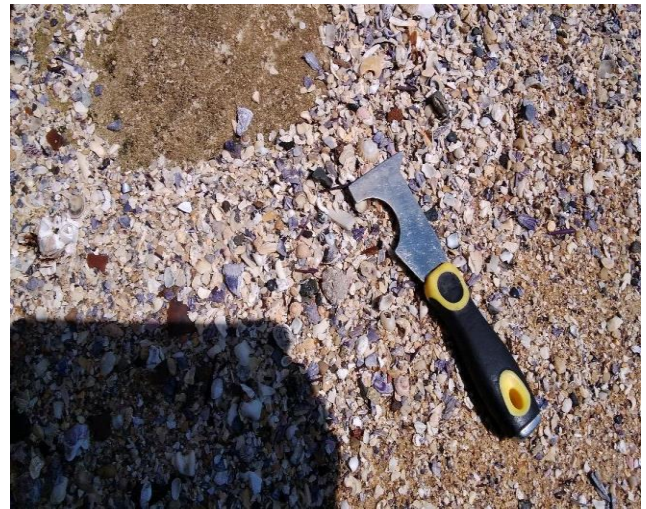
**Notes:** Sand surface following emu pick - Southern section

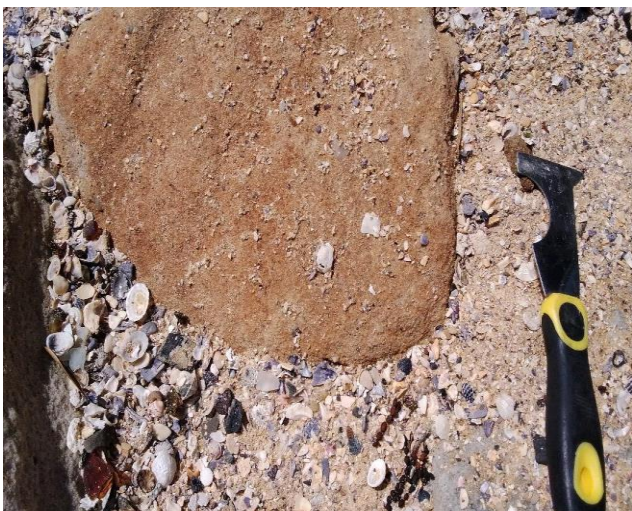
**Notes:** Sand surface following emu pick - Southern section

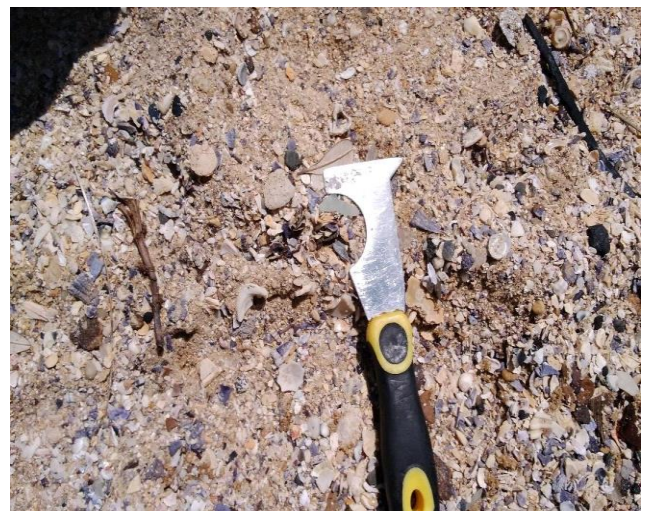
**Notes:** Sand surface following emu pick - Southern section

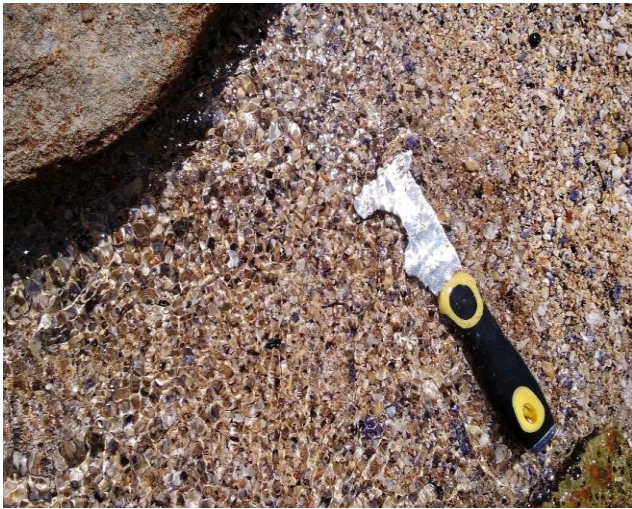
**Notes:** Sand surface following emu pick - Southern section

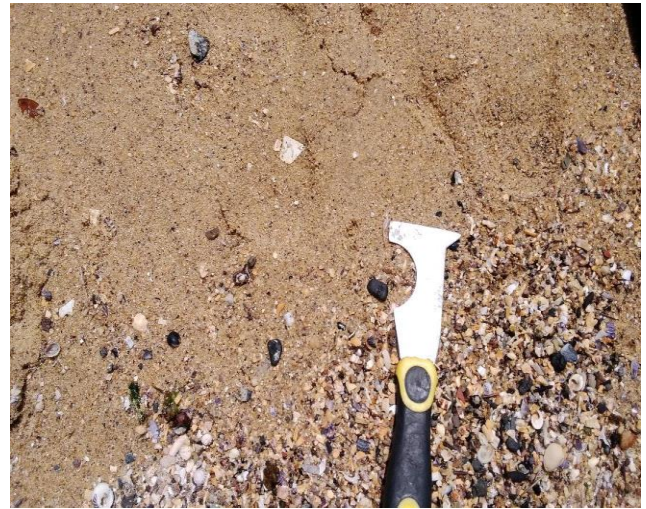
**Notes:** Sand surface following emu pick - Southern section

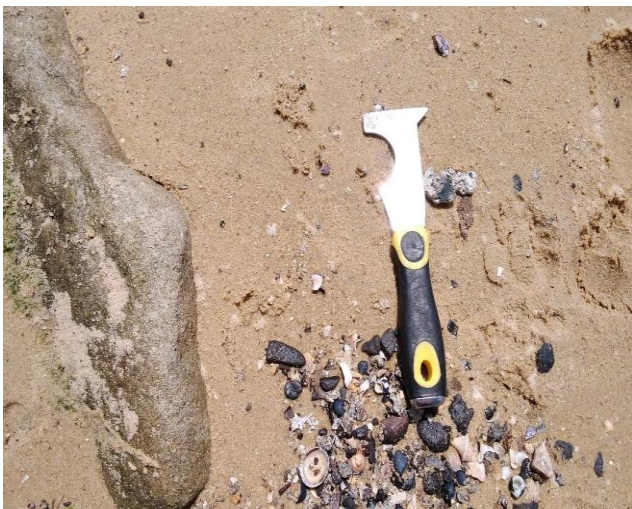
**Notes:** Sand surface following emu pick - Southern section

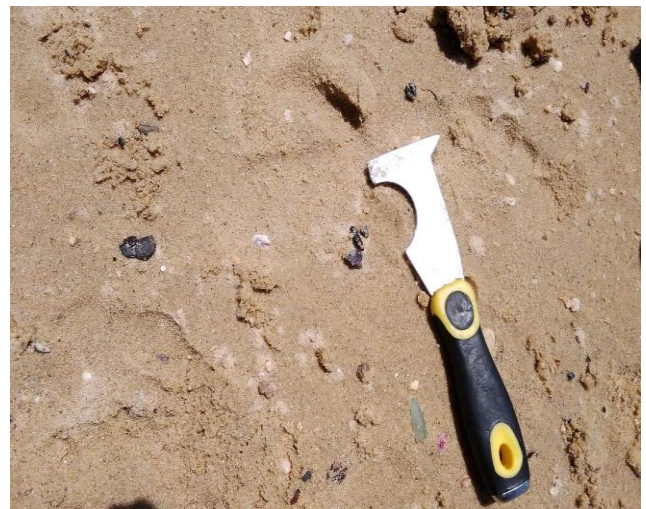
**Notes:** Sand surface following emu pick - Southern section

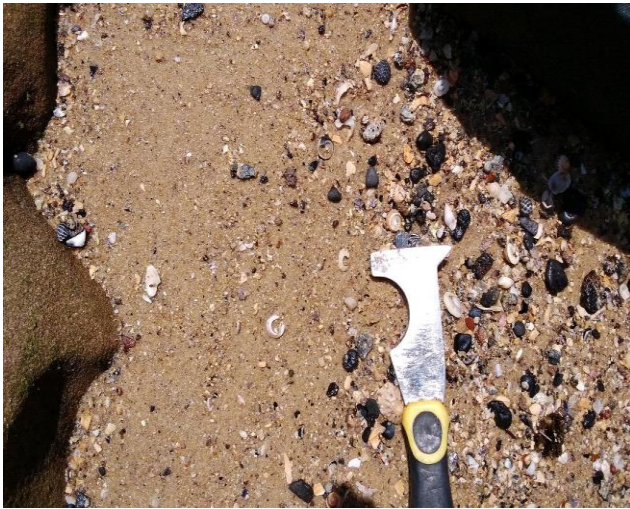
**Notes:** Sand surface following emu pick - Northern section

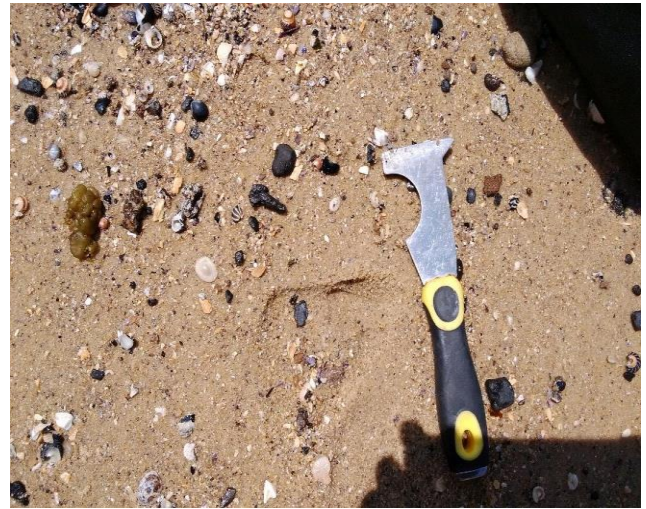
**Notes:** Sand surface following emu pick - Northern section

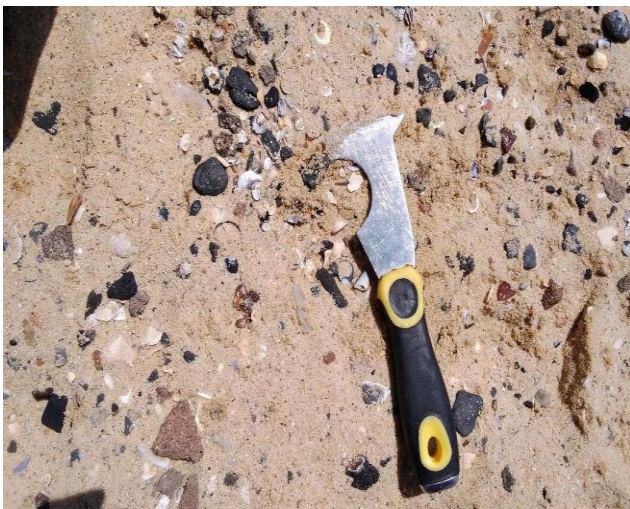
**Notes:** Sand surface following emu pick - Northern section

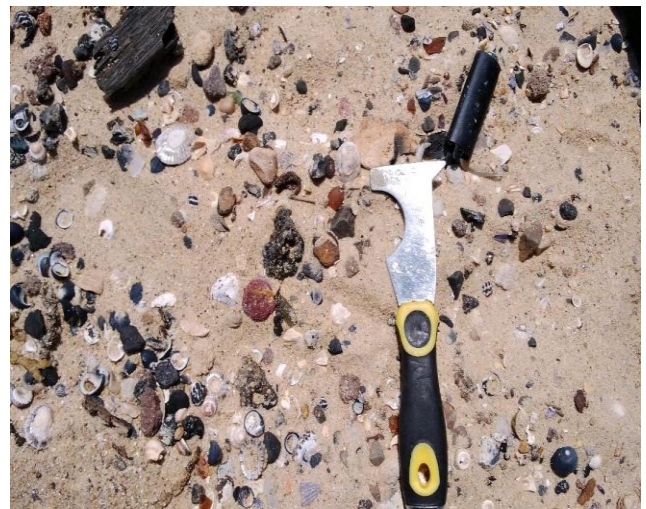
**Notes:** Sand surface following emu pick - Northern section

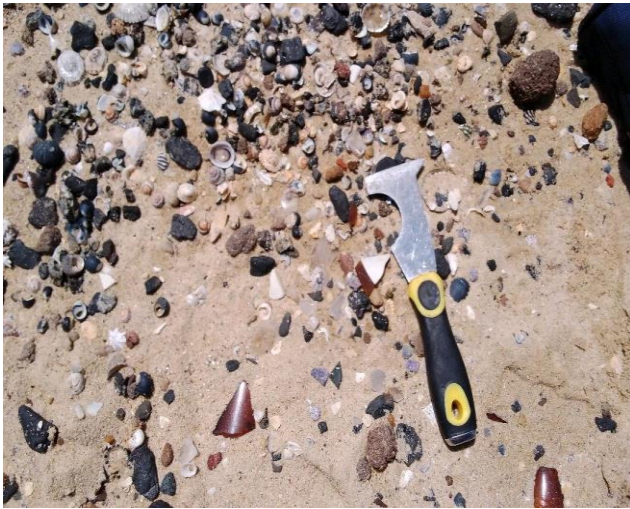
**Notes:** Sand surface following emu pick - Northern section

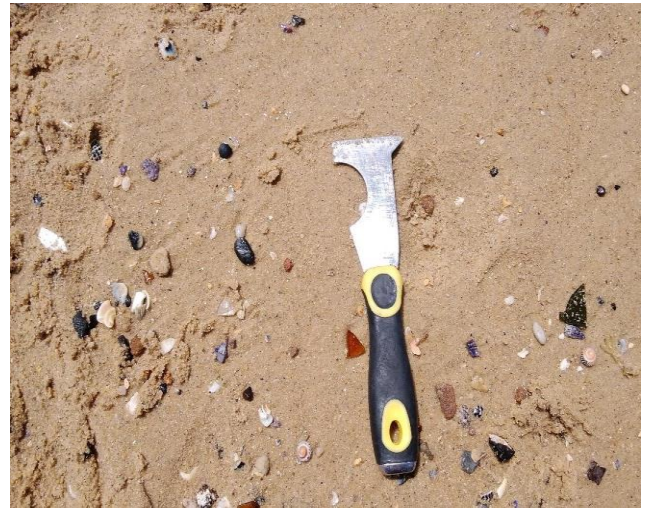
**Notes:** Sand surface following emu pick - Northern section

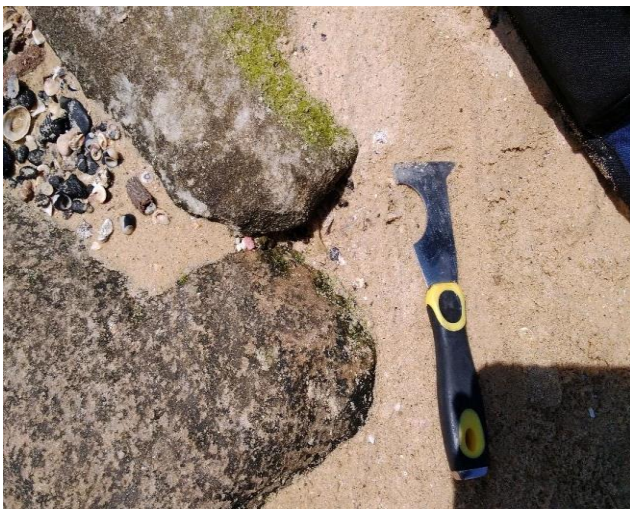
**Notes:** Sand surface following emu pick - Northern section

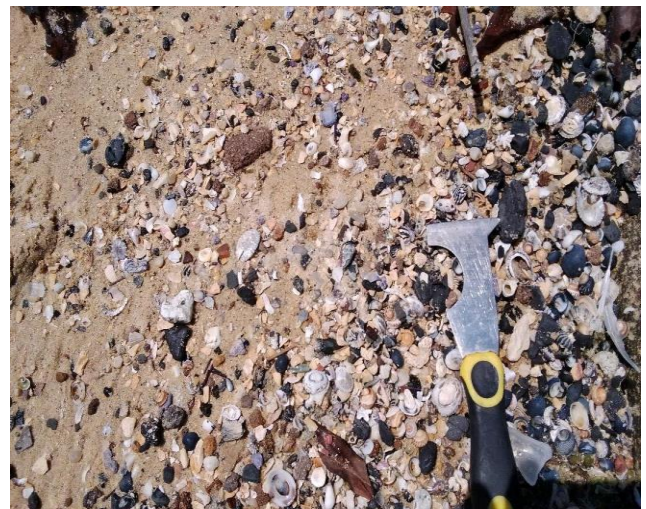
**Notes:** Sand surface following emu pick - Northern section

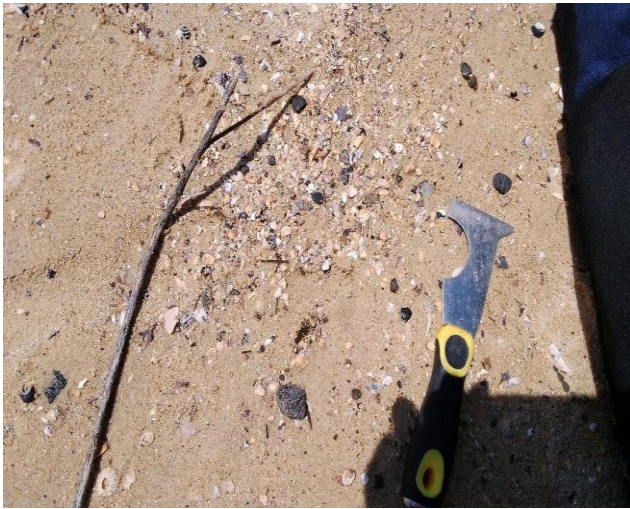
**Notes:** Sand surface following emu pick - Northern section

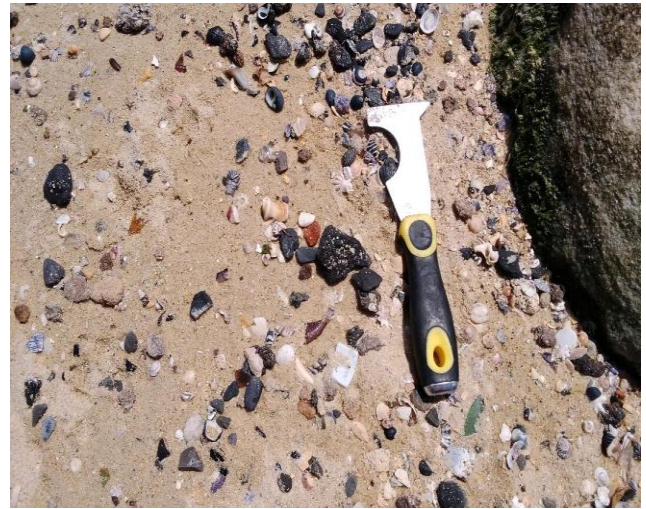
**Notes:** Sand surface following emu pick - Northern section

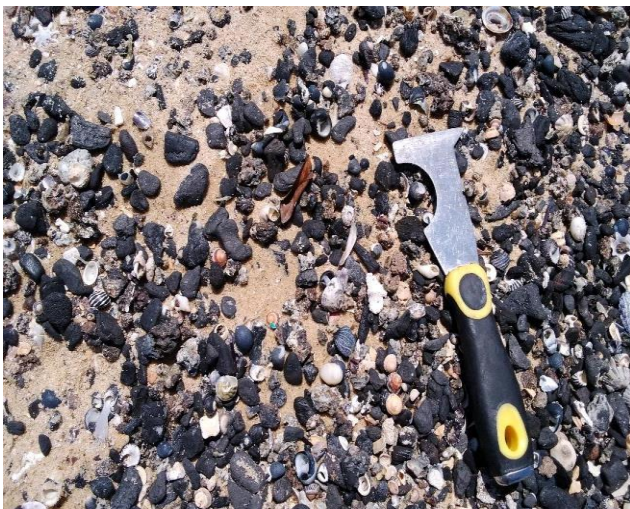
**Notes:** Sand surface following emu pick - Northern section

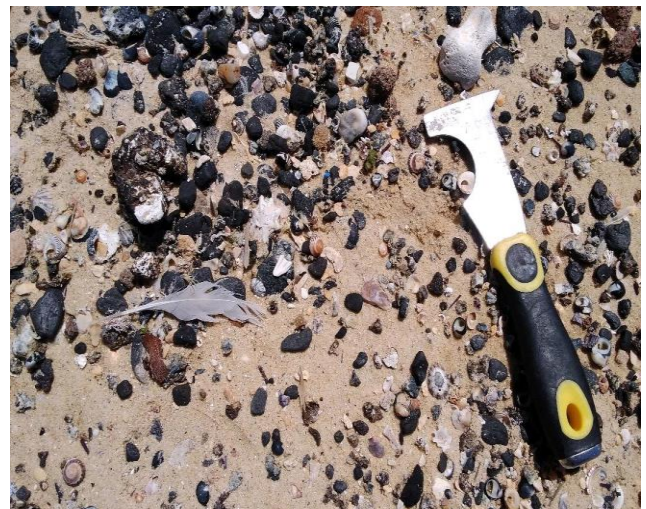
**Notes:** Sand surface following emu pick - Northern section

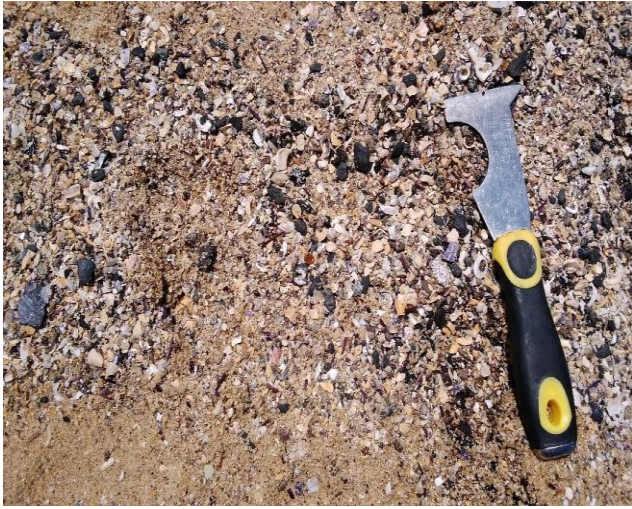
**Notes:** Sand surface following emu pick - Northern section
