Asbestos Containing Material Clearance Inspection

9 February 2023

Site:	Little Bay Beach
Location:	Southern, Western and Northern Little Bay Beach

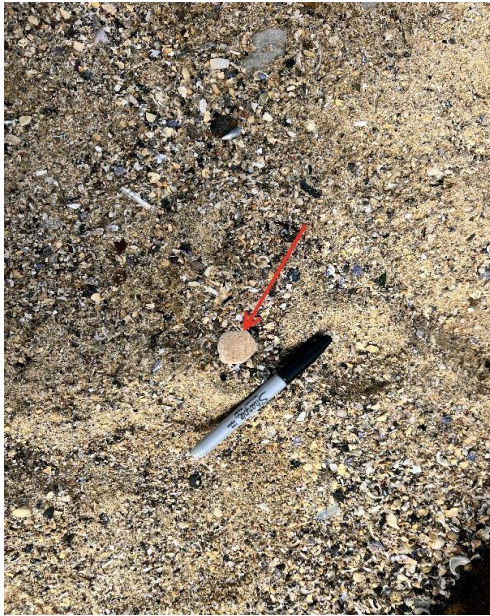
Notes: Overview of the FC Sheeting fragment within Northern Beach.

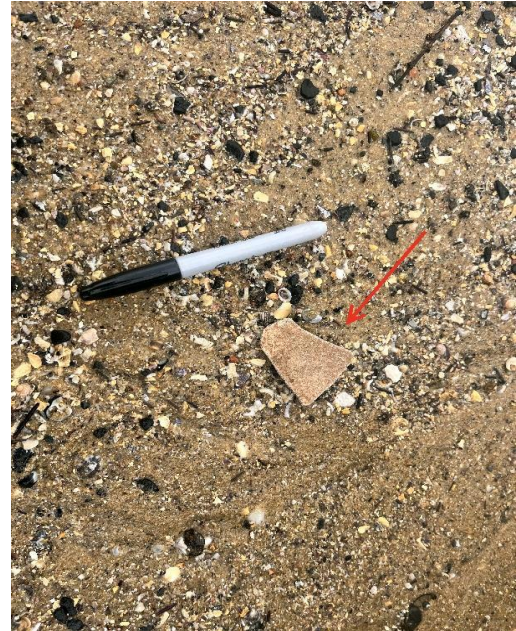
Notes: Overview of the FC Sheeting fragment within Northern Beach.

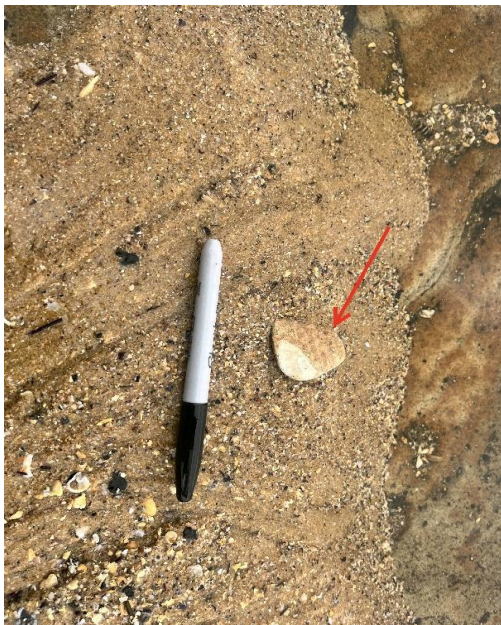
Notes: Overview of the FC Sheeting fragment within Northern Beach.

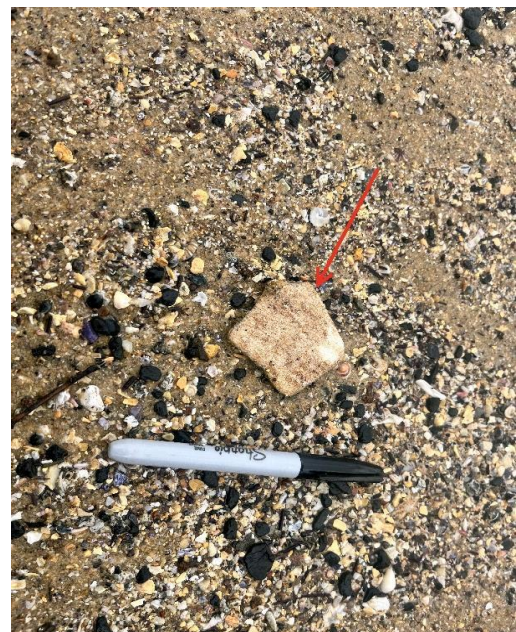
Notes: Overview of the FC Sheeting fragment within Northern Beach.

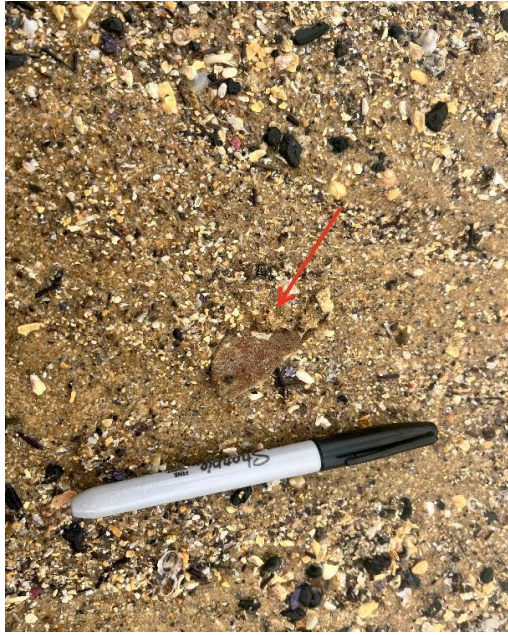
Notes: Overview of the FC Sheeting fragment within Northern Beach.

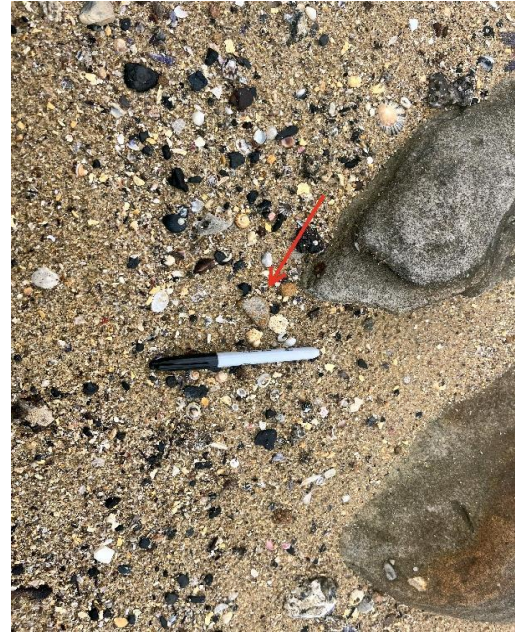
Notes: Overview of the FC Sheeting fragment within Northern Beach.

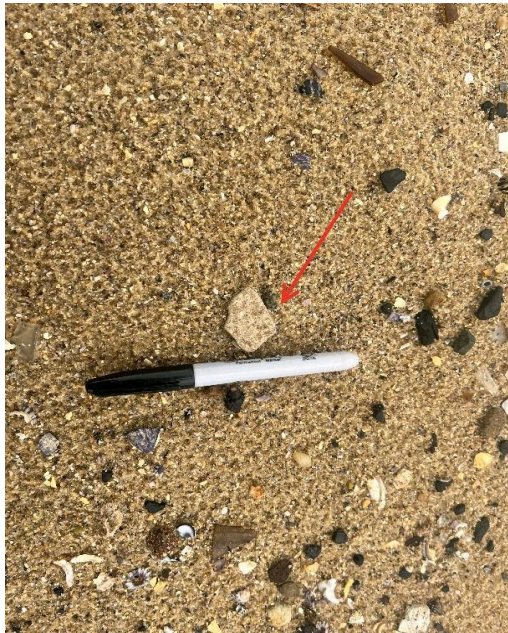
Notes: Overview of the FC Sheeting fragment within Southern Beach.

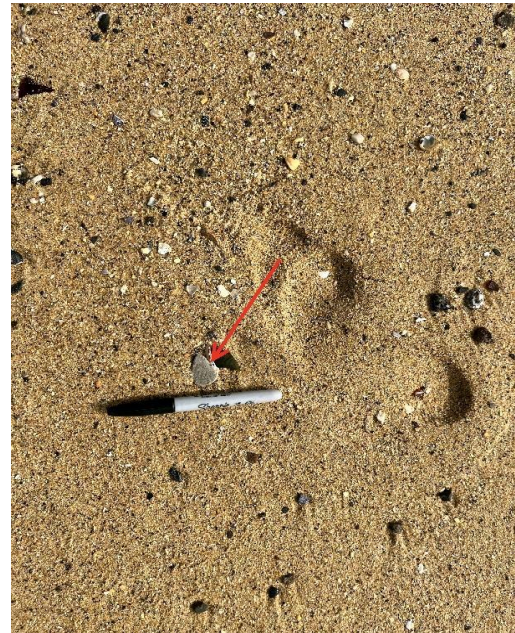
Notes: Overview of the FC Sheeting fragment within Southern Beach.

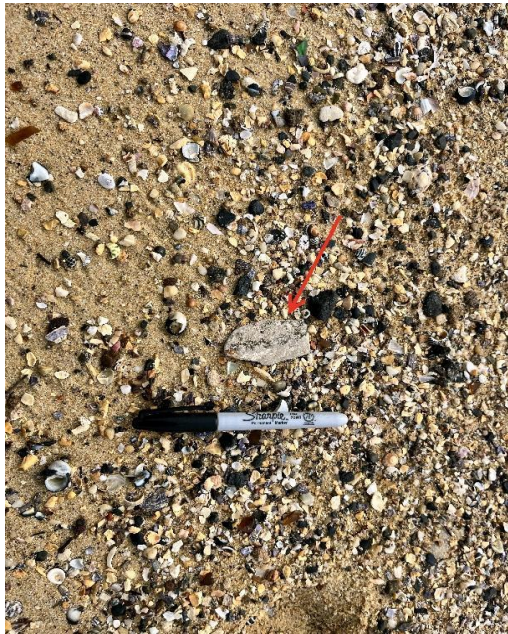
Notes: Overview of the FC Sheeting fragment within Southern Beach.

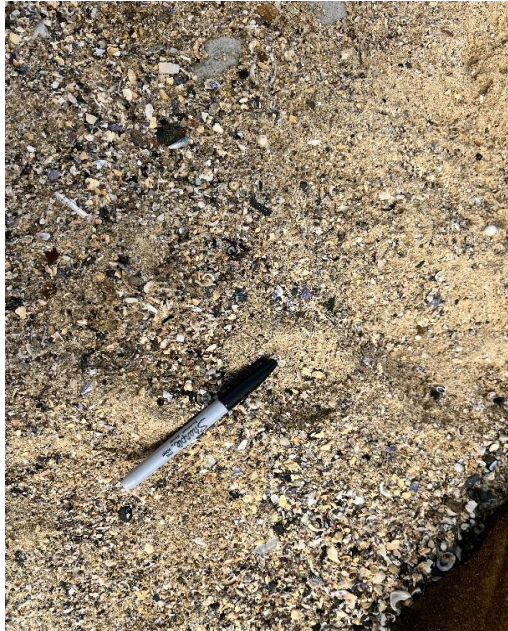
Notes: Surface following fragment removal

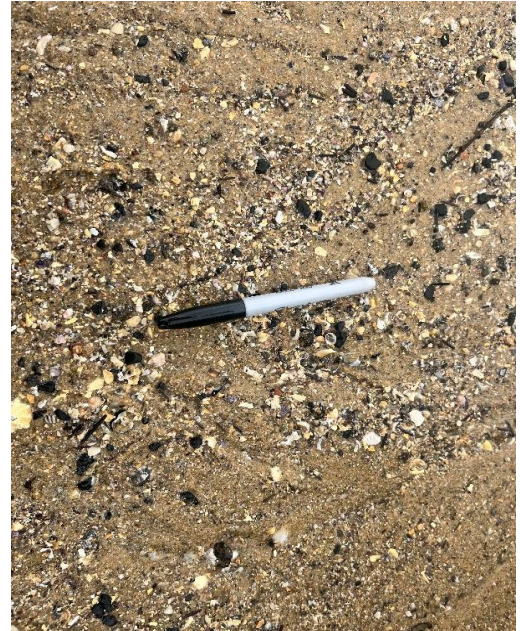
Notes: Surface following fragment removal

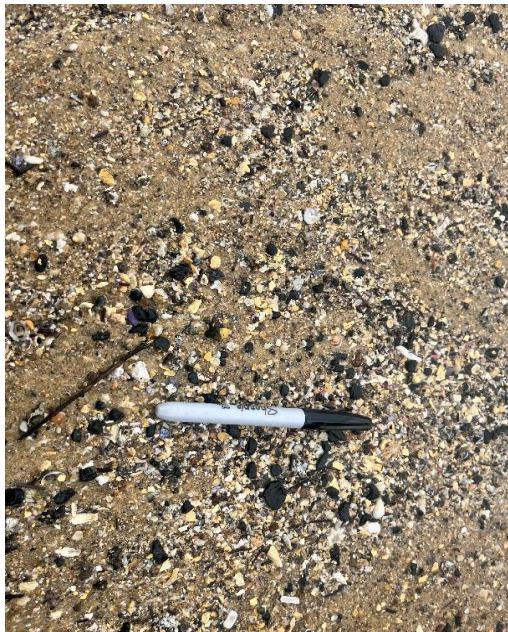
Notes: Surface following fragment removal

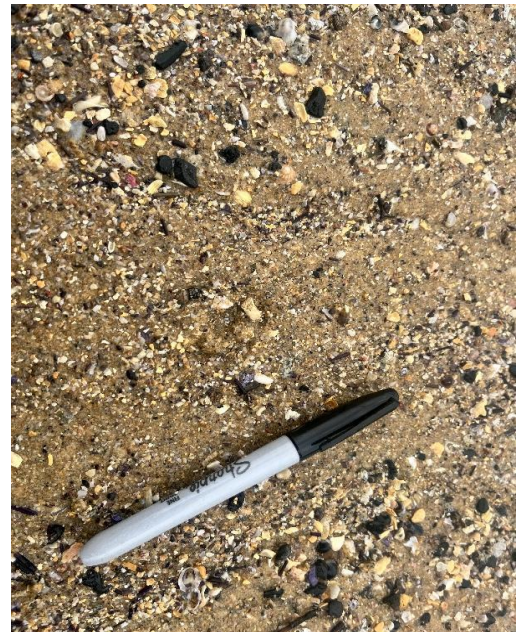
Notes: Surface following fragment removal

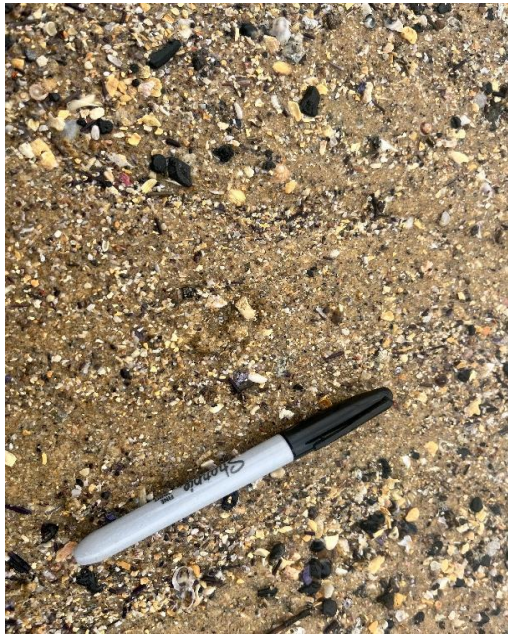
Notes: Surface following fragment removal

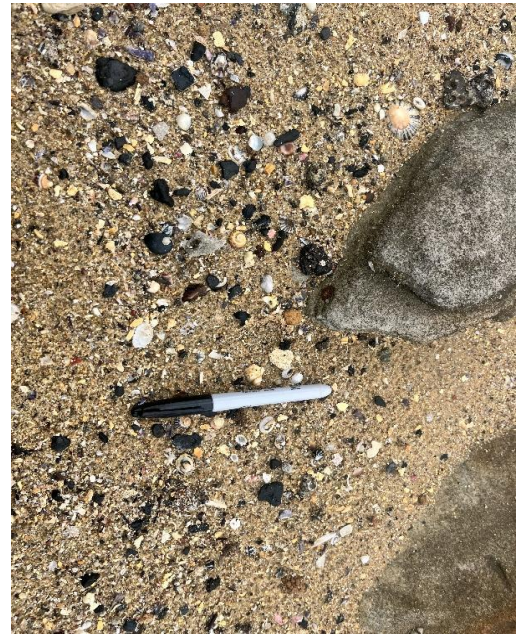
Notes: Surface following fragment removal

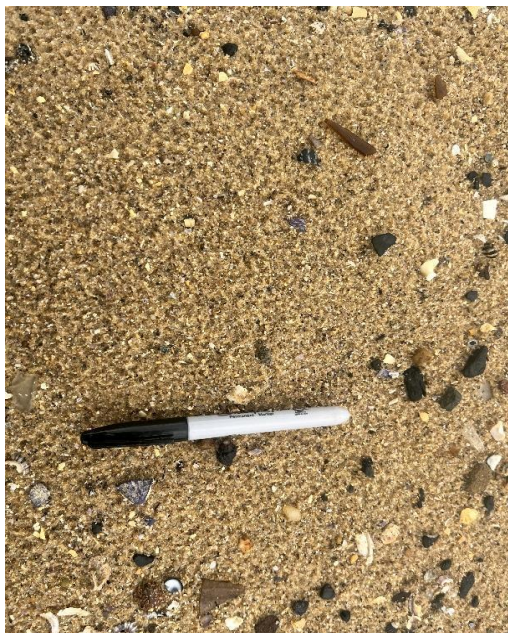
Notes: Surface following fragment removal

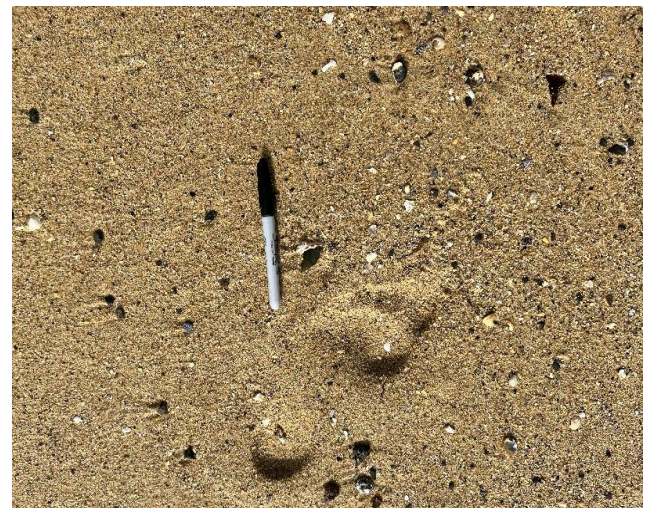
Notes: Surface following fragment removal

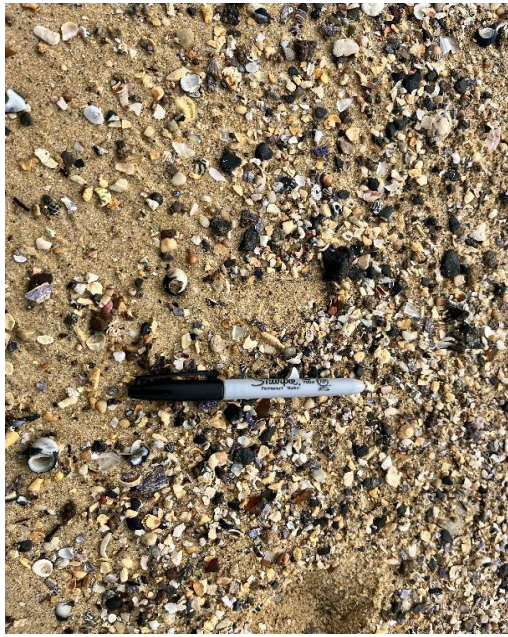
Notes: Surface following fragment removal
