Asbestos Containing Material Clearance Inspection

11 March 2023

Site:	Little Bay Beach
Location:	Southern, Western and Northern Little Bay Beach

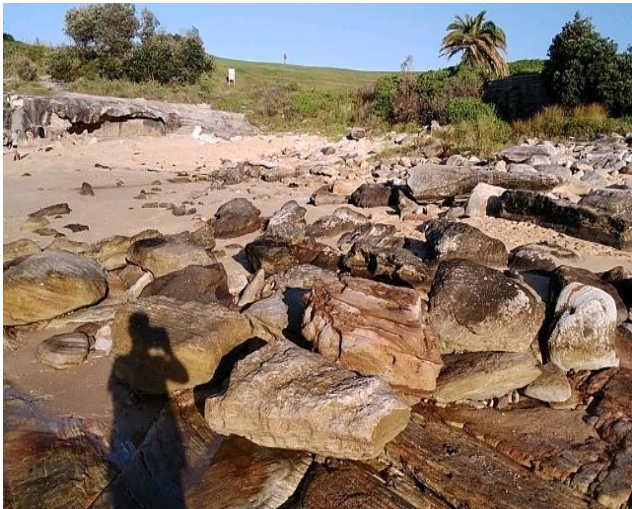
Notes: Northern beach on day of inspection

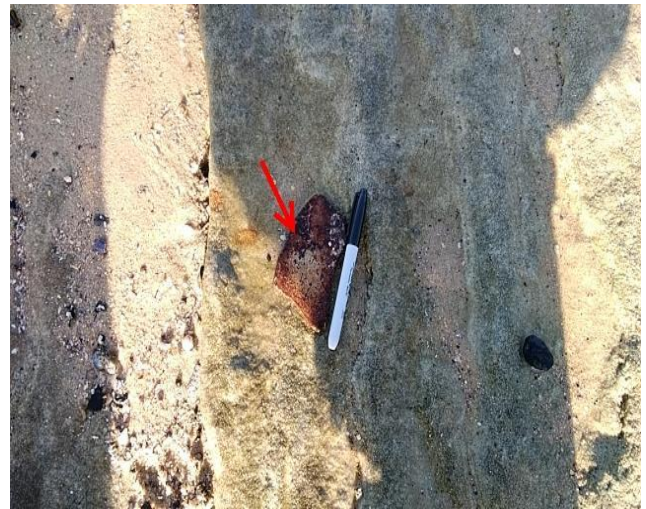
Notes: Suspected fragment prior to removal (northern beach)

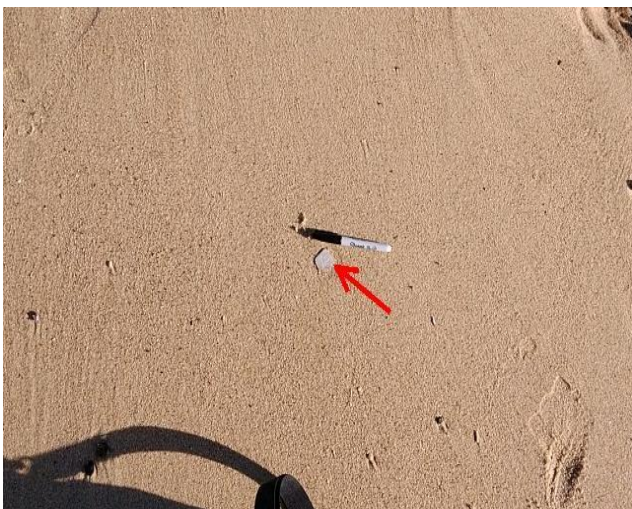
Notes: Suspected fragment prior to removal (northern beach)

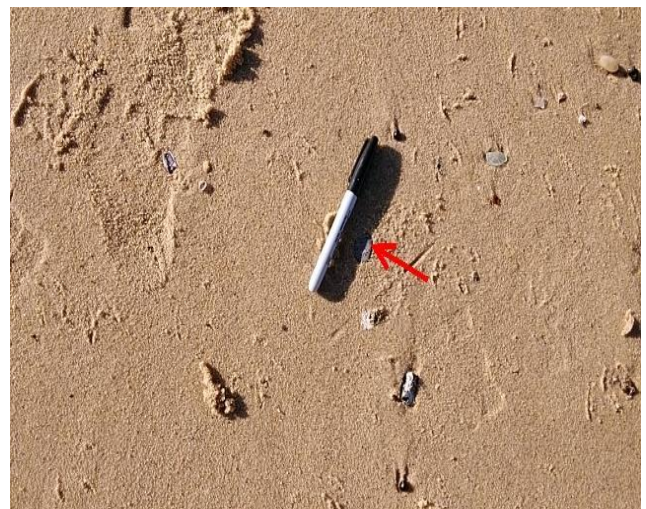
Notes: Suspected fragment prior to removal (northern beach)

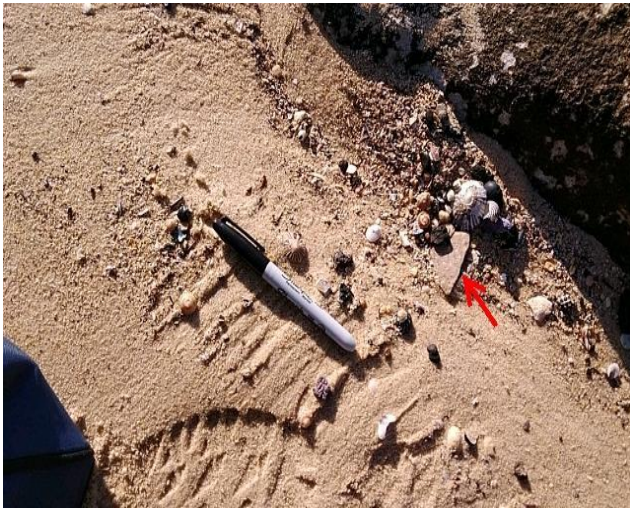
Notes: Suspected fragment prior to removal (northern beach)

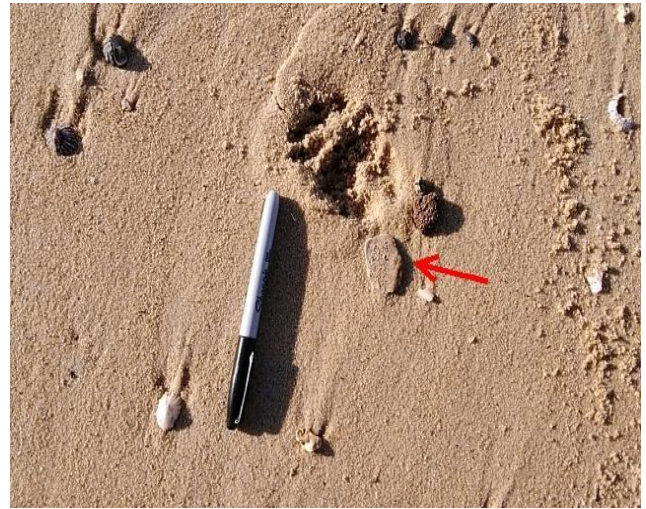
Notes: Suspected fragment prior to removal (northern beach)

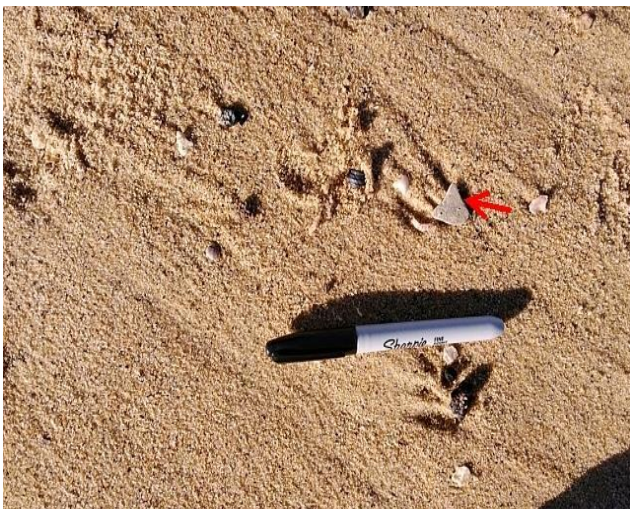
Notes: Suspected fragment prior to removal (northern beach)

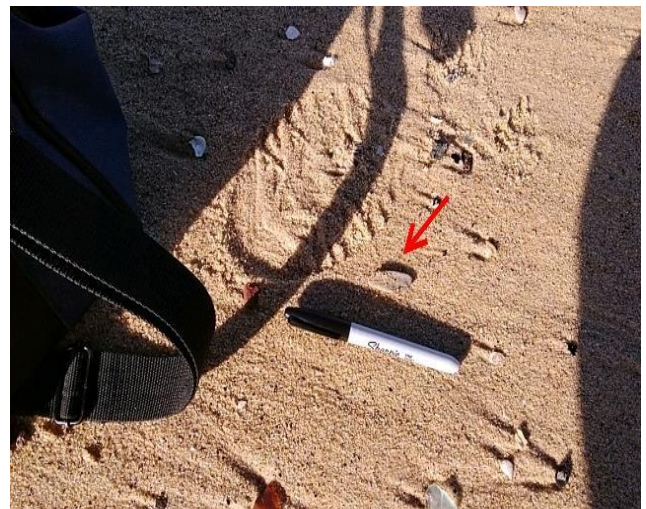
Notes: Suspected fragment prior to removal (northern beach)

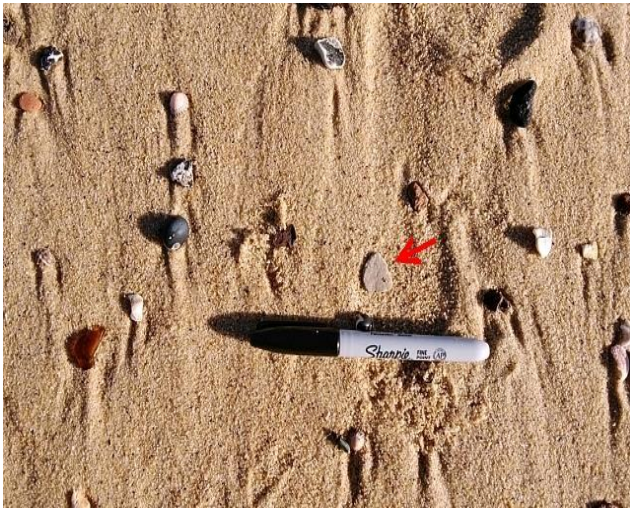
Notes: Suspected fragment prior to removal (northern beach)

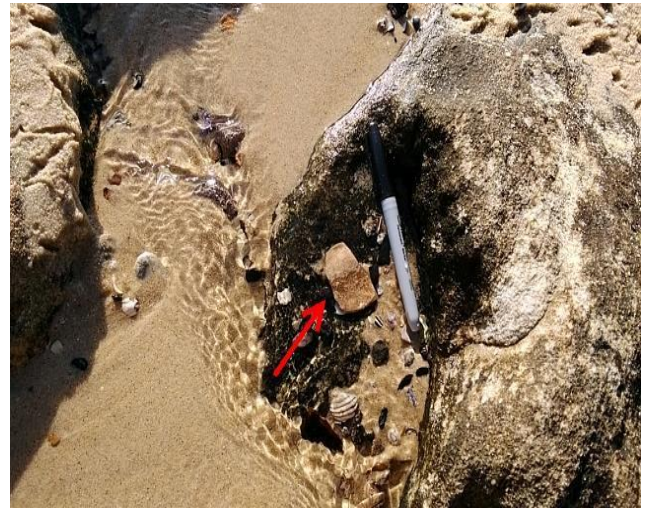
Notes: Suspected fragment prior to removal (northern beach)

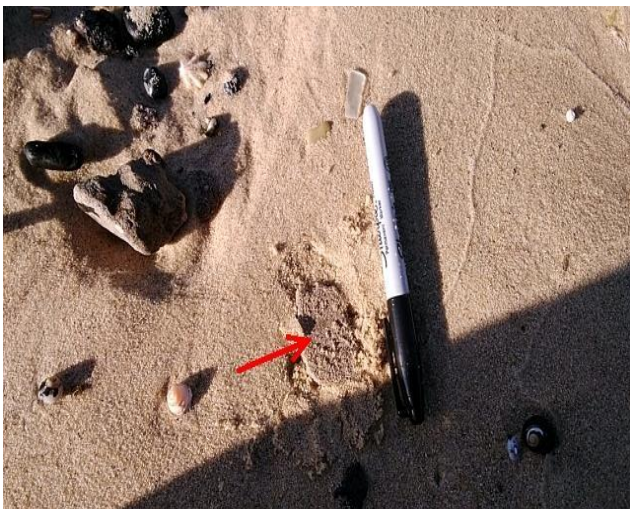
Notes: Suspected fragment prior to removal (northern beach)

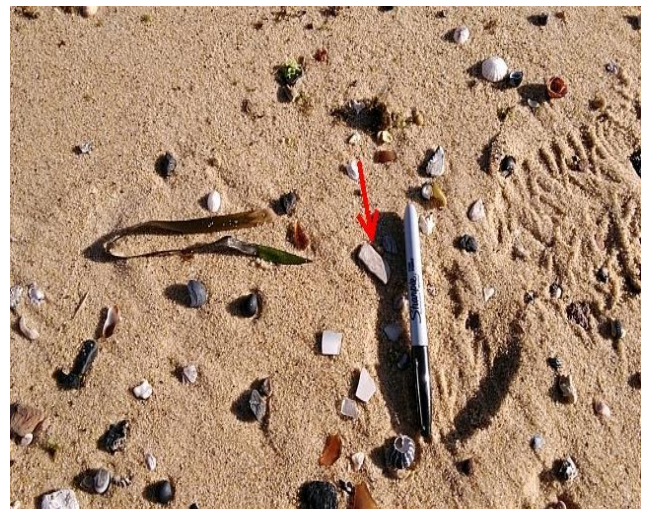
Notes: Suspected fragment prior to removal (northern beach)

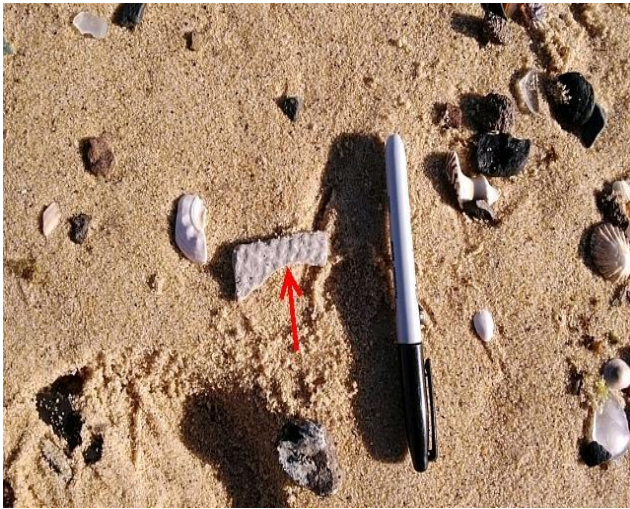
Notes: Suspected fragment prior to removal (northern beach)

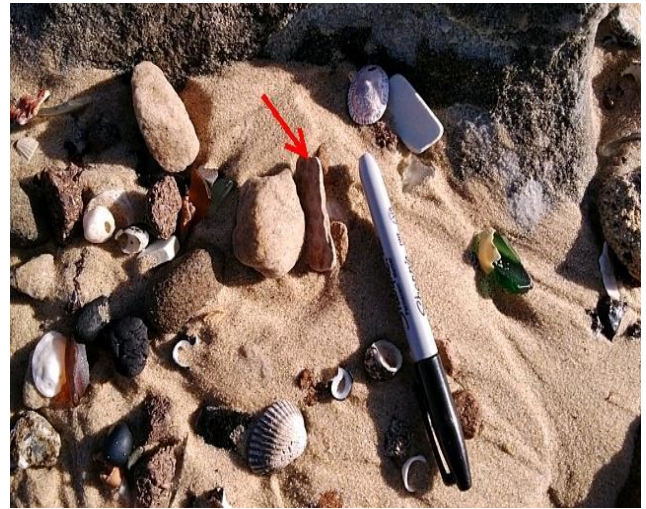
Notes: Suspected fragment prior to removal (northern beach)

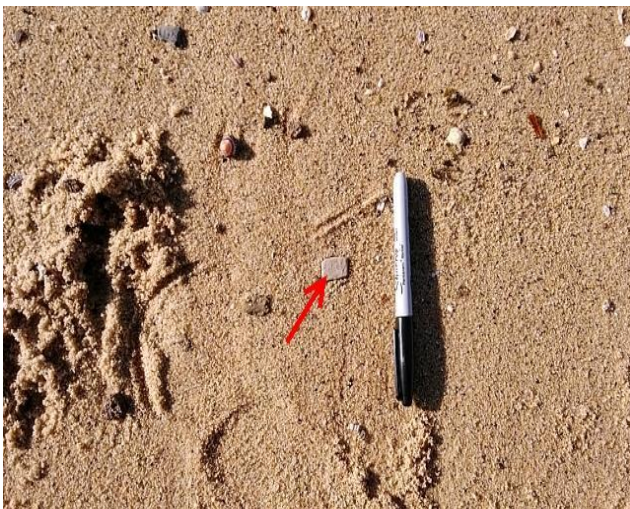
Notes: Suspected fragment prior to removal (northern beach)

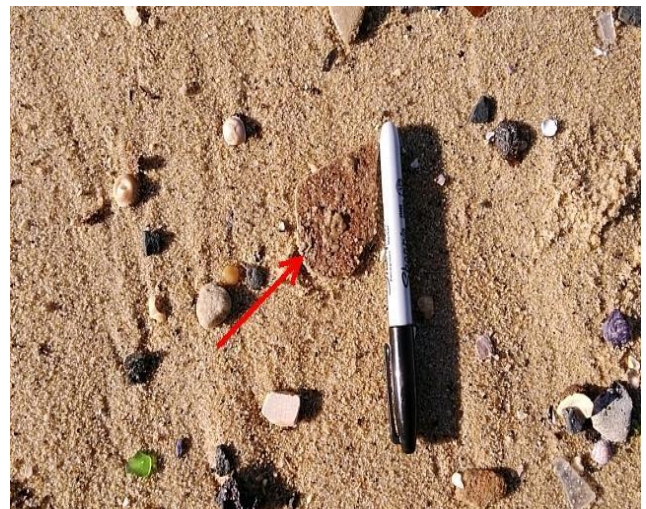
Notes: Suspected fragment prior to removal (northern beach)

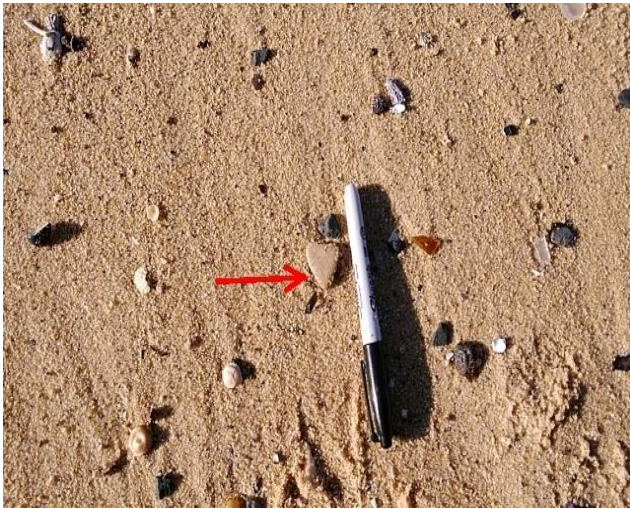
Notes: Suspected fragment prior to removal (northern beach)

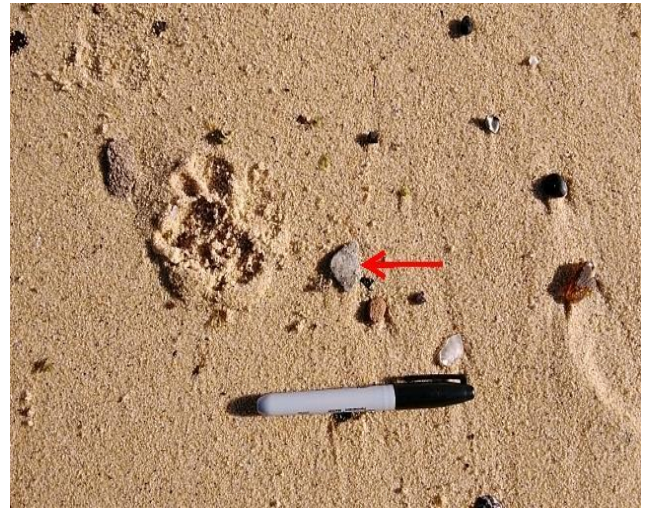
Notes: Suspected fragment prior to removal (northern beach)

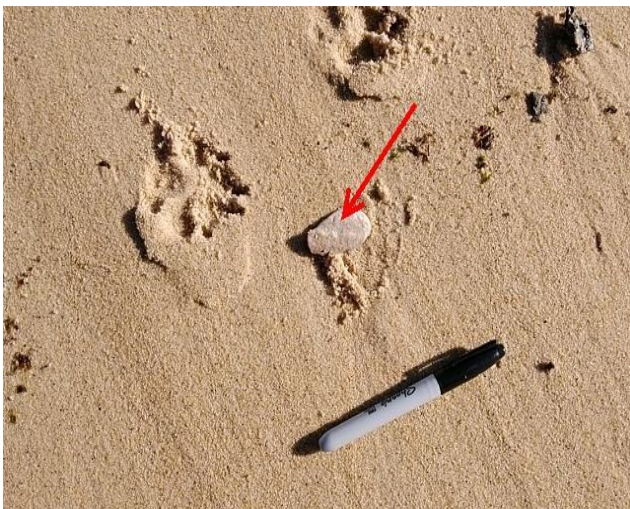
Notes: Suspected fragment prior to removal (northern beach)

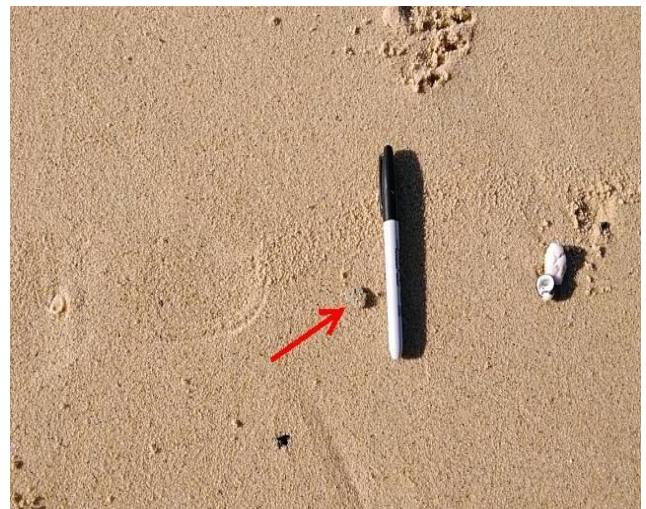
Notes: Suspected fragment prior to removal (northern beach)

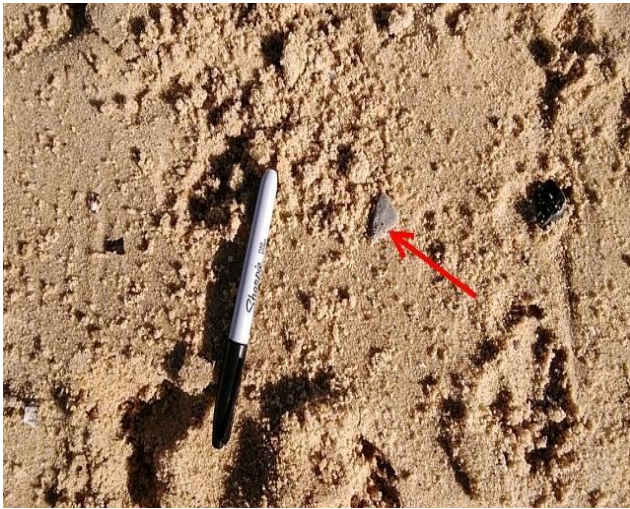
Notes: Suspected fragment prior to removal (northern beach)

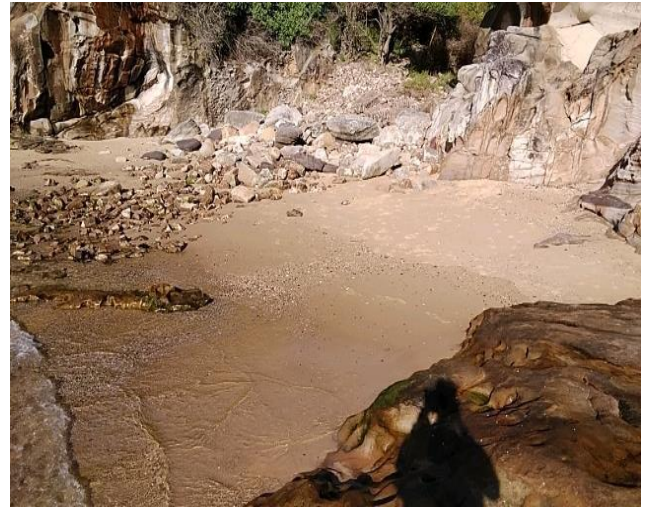
Notes: Western Beach on day of inspection

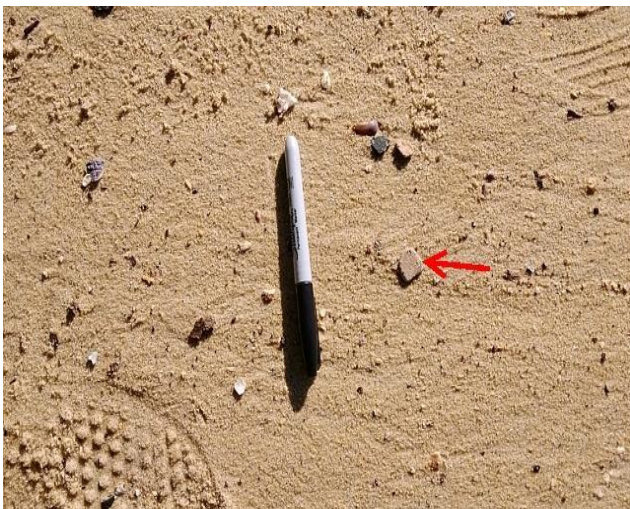
Notes: Suspected fragment prior to removal (western beach)

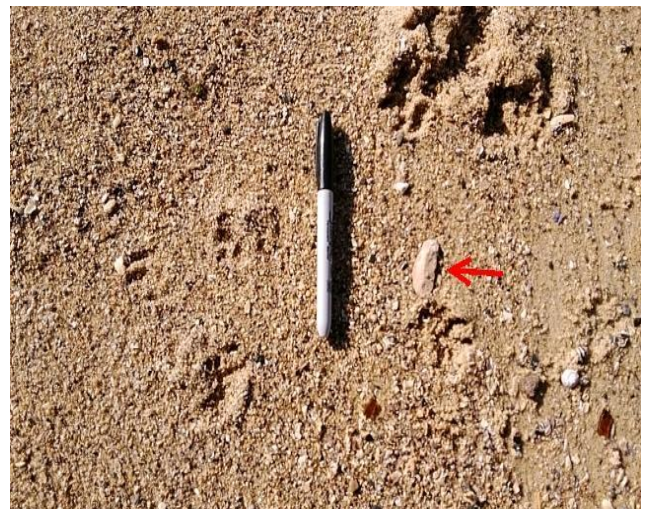
Notes: Suspected fragment prior to removal (western beach)

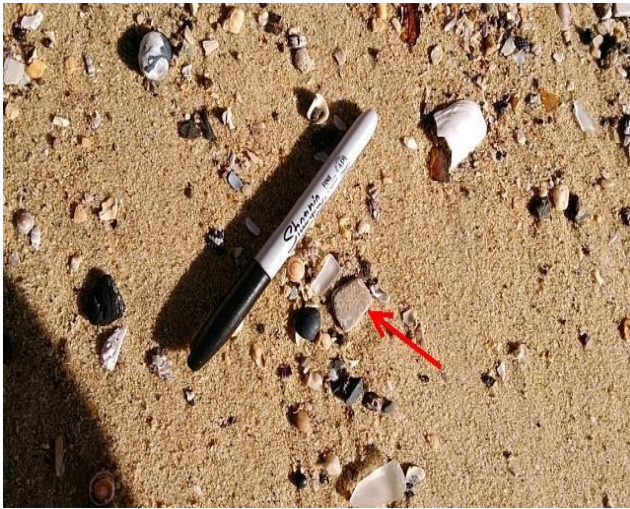
Notes: Suspected fragment prior to removal (western beach)

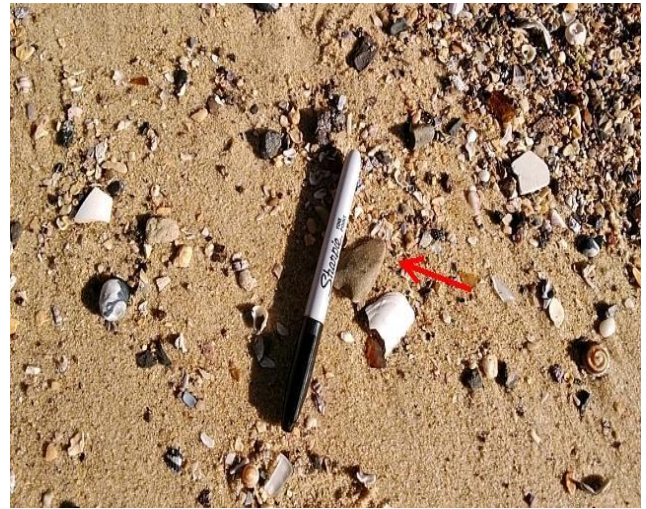
Notes: Suspected fragment prior to removal (western beach)

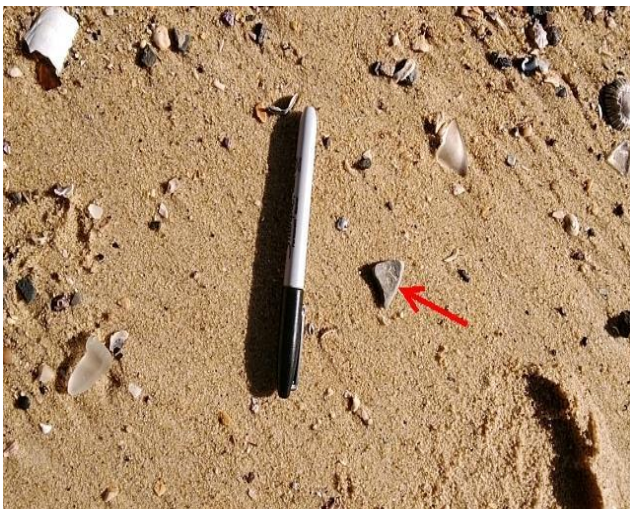
Notes: Suspected fragment prior to removal (western beach)

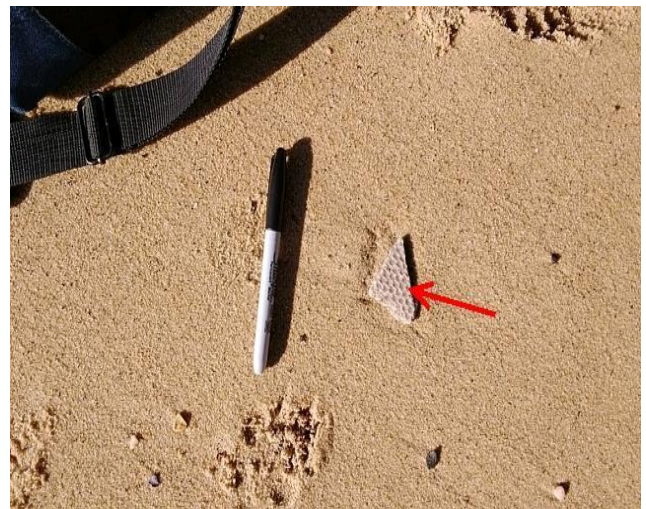
Notes: Suspected fragment prior to removal (western beach)

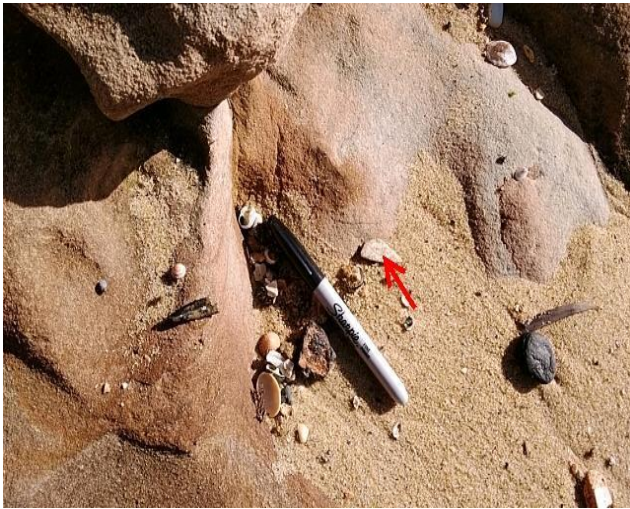
Notes: Suspected fragment prior to removal (western beach)

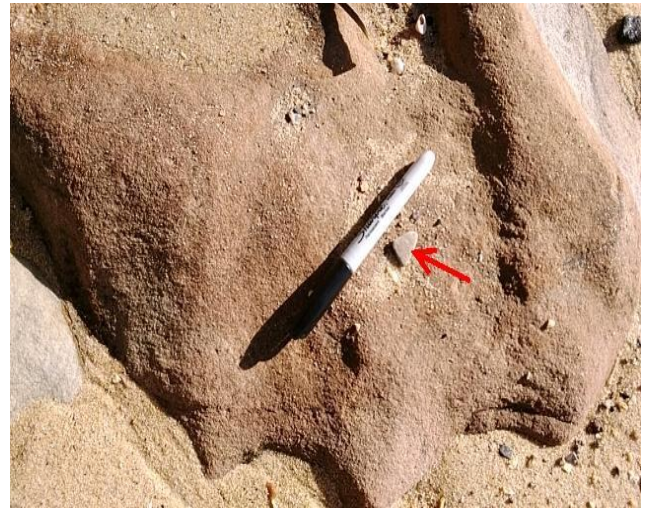
Notes: Suspected fragment prior to removal (western beach)

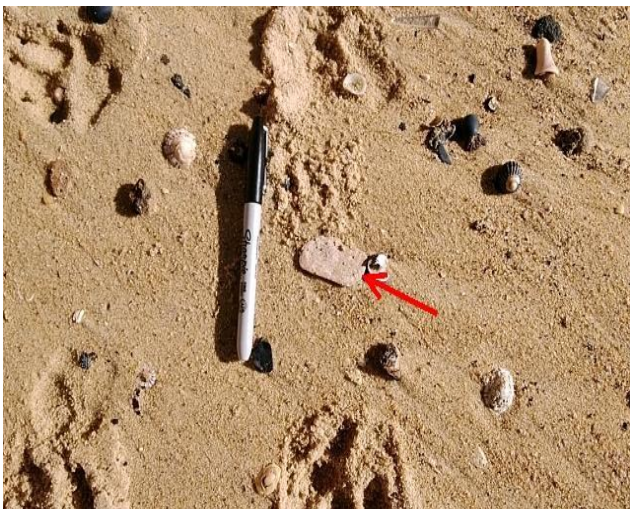
Notes: Suspected fragment prior to removal (western beach)

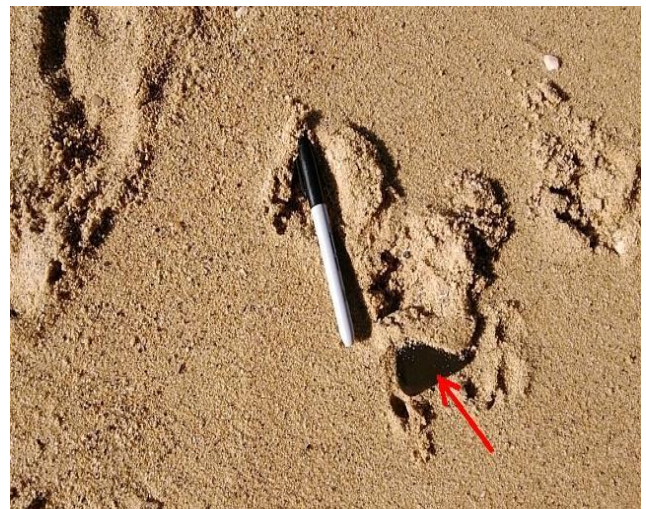
Notes: Suspected fragment prior to removal (western beach)

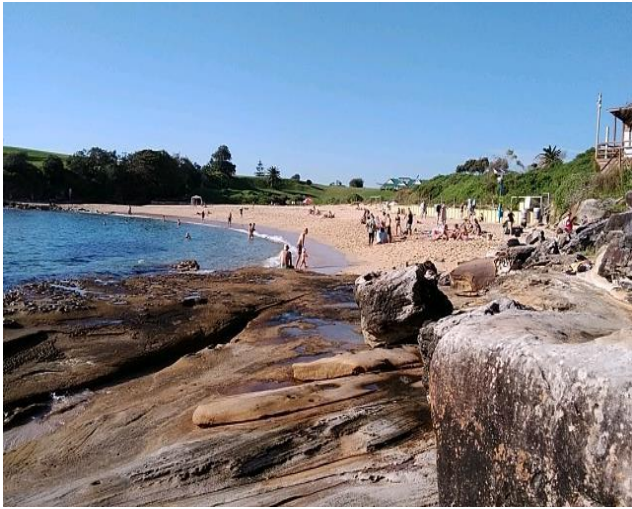
Notes: Southern beach on the day of inspection

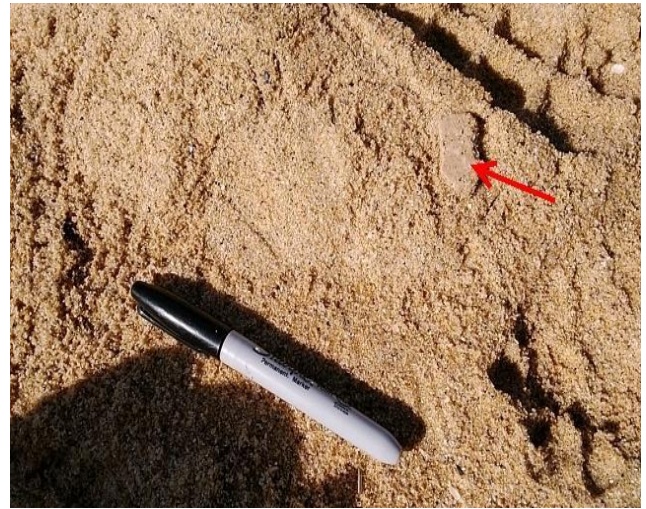
Notes: Suspected fragment prior to removal (southern beach)

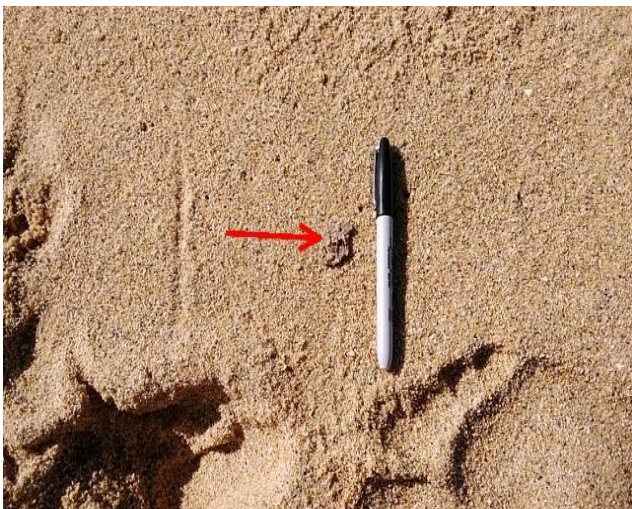
Notes: Suspected fragment prior to removal (southern beach)

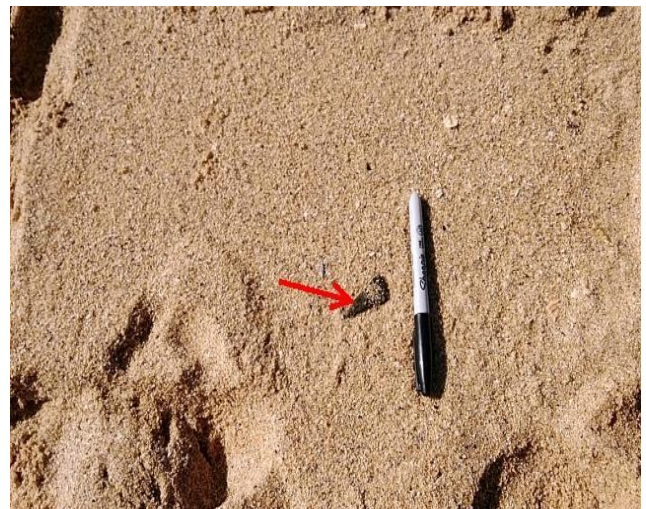
Notes: Suspected fragment prior to removal (southern beach)

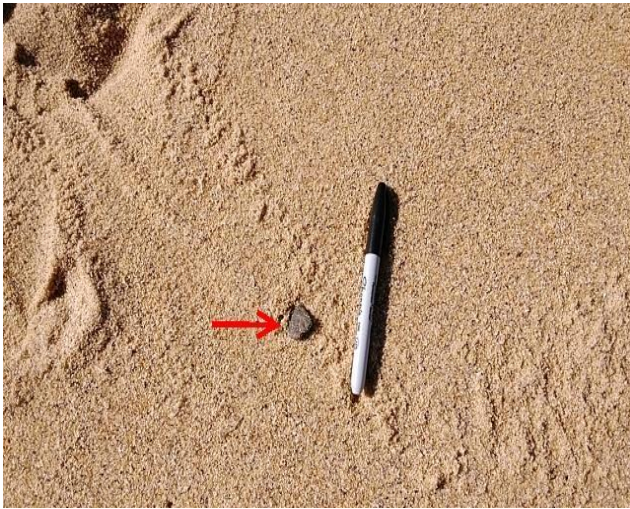
Notes: Suspected fragment prior to removal
(southern beach)

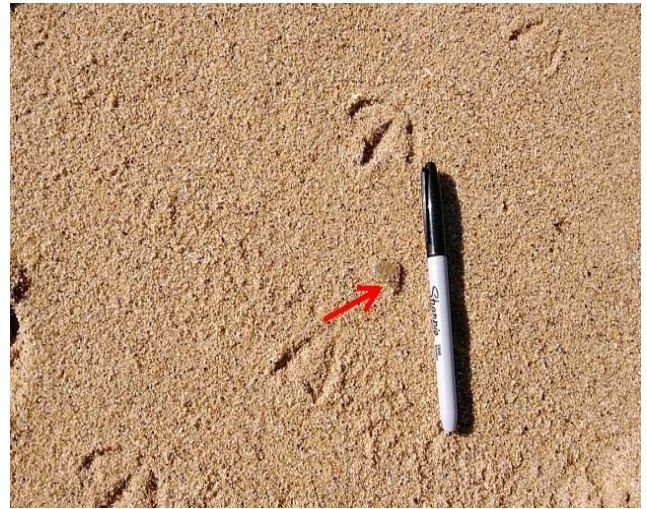
Notes: Suspected fragment prior to removal
(southern beach)

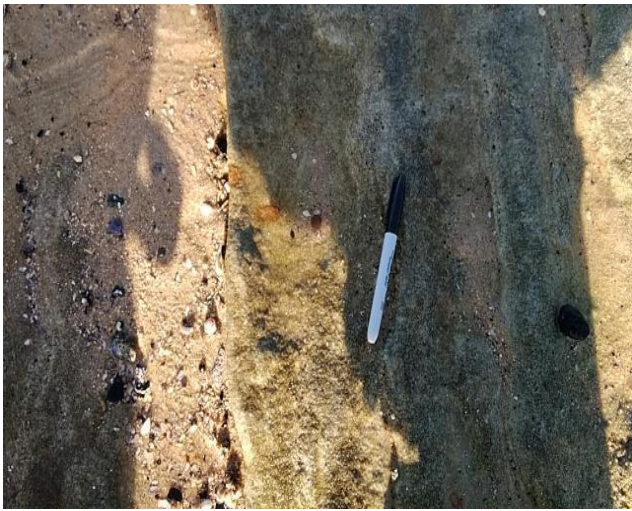
Notes: Northern beach surface following fragment removal

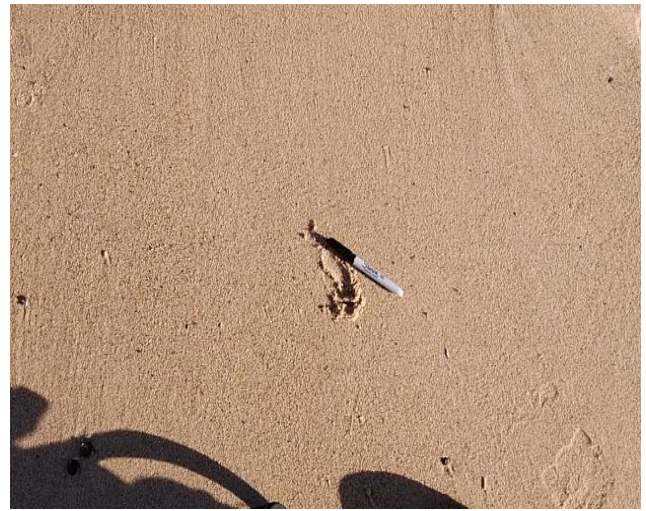
Notes: Northern beach surface following fragment removal

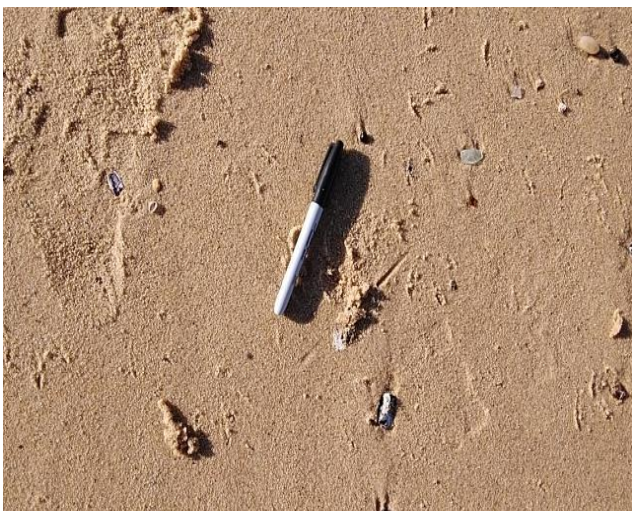
Notes: Northern beach surface following fragment removal

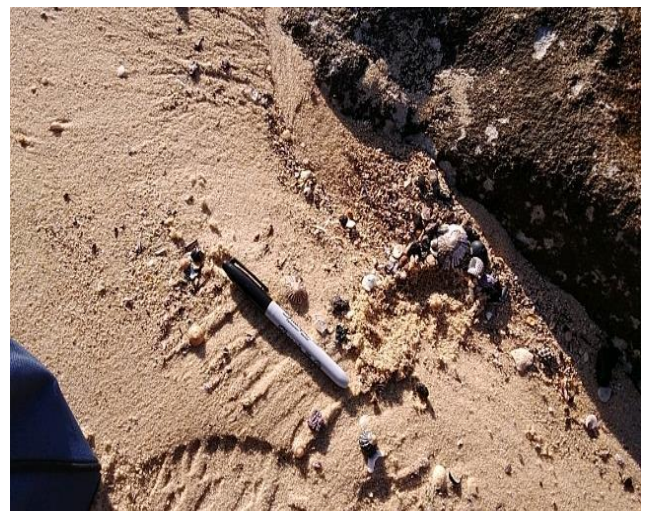
Notes: Northern beach surface following fragment removal

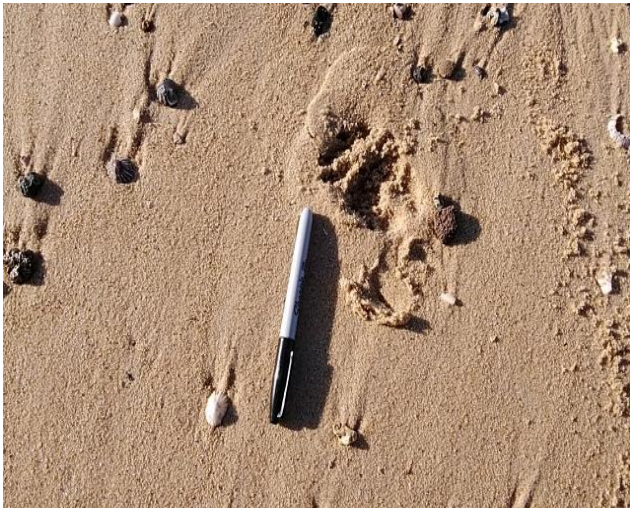
Notes: Northern beach surface following fragment removal

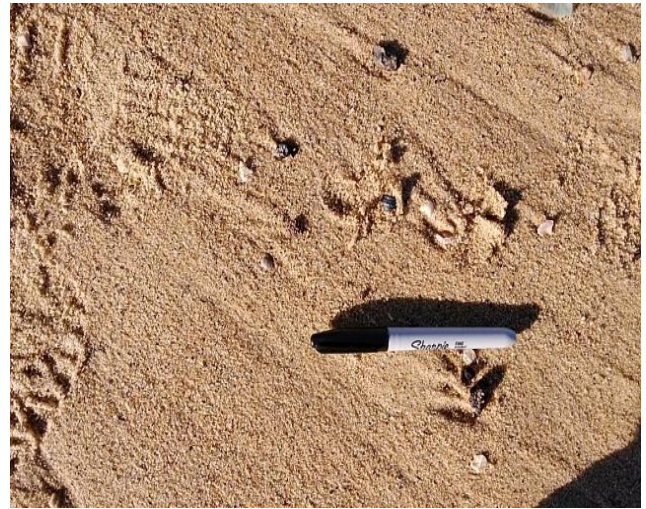
Notes: Northern beach surface following fragment removal

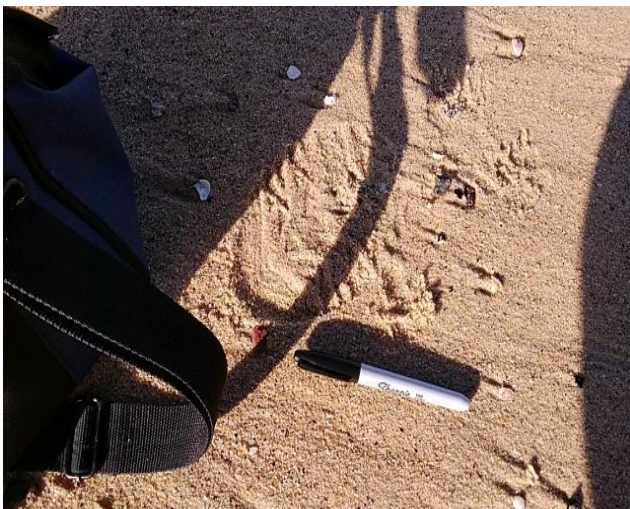
Notes: Northern beach surface following fragment removal

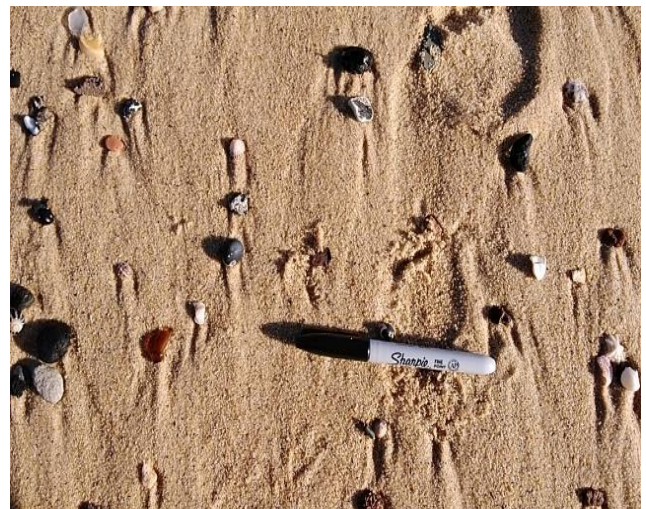
Notes: Northern beach surface following fragment removal

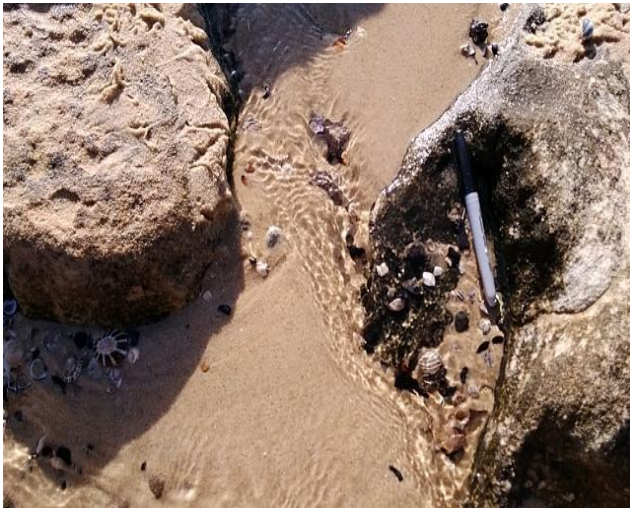
Notes: Northern beach surface following fragment removal

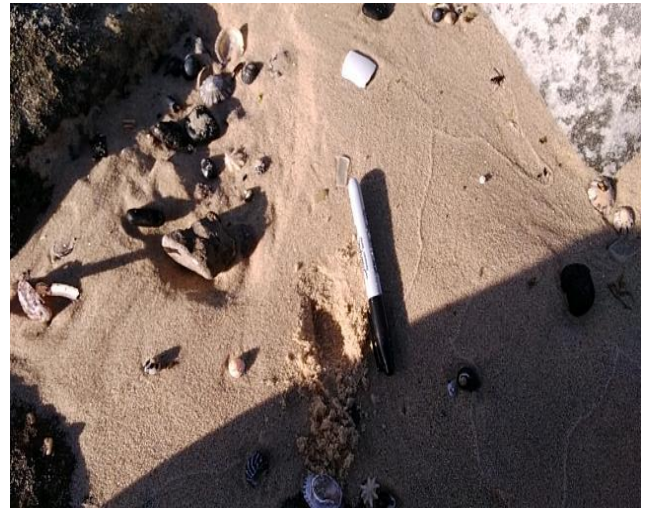
Notes: Northern beach surface following fragment removal

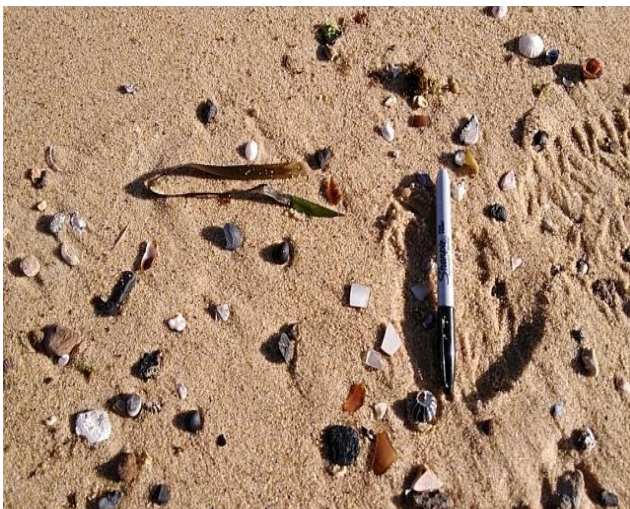
Notes: Northern beach surface following fragment removal

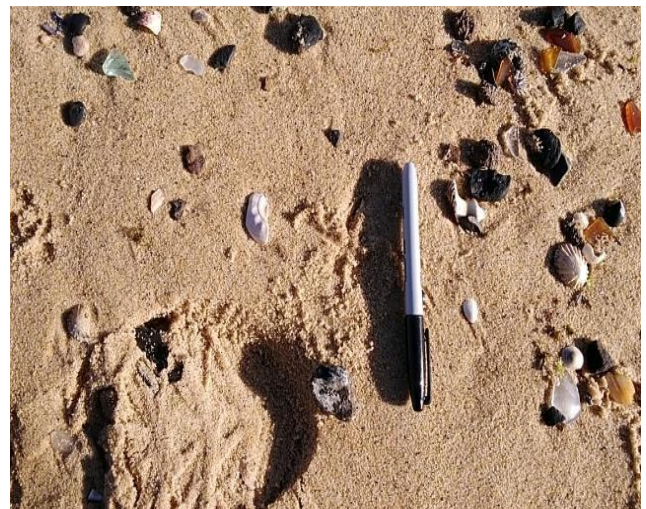
Notes: Northern beach surface following fragment removal

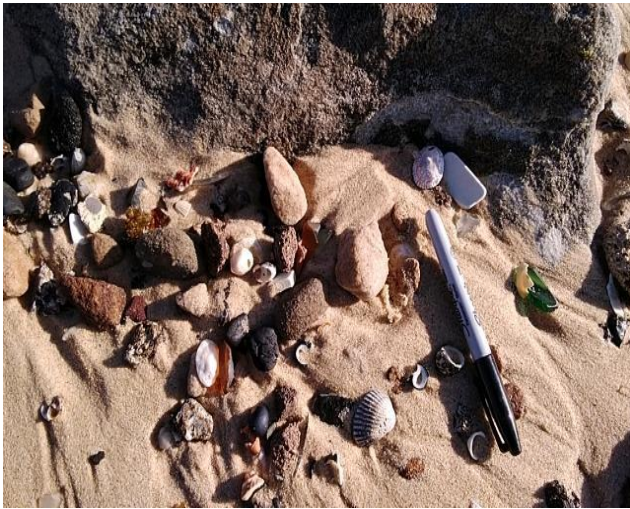
Notes: Northern beach surface following fragment removal

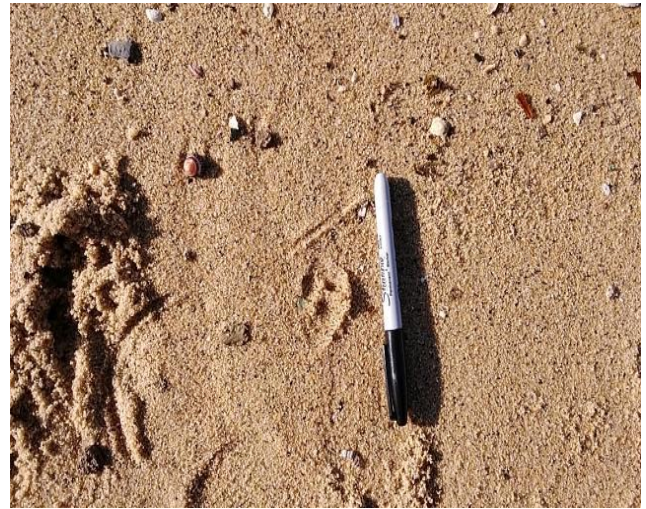
Notes: Northern beach surface following fragment removal

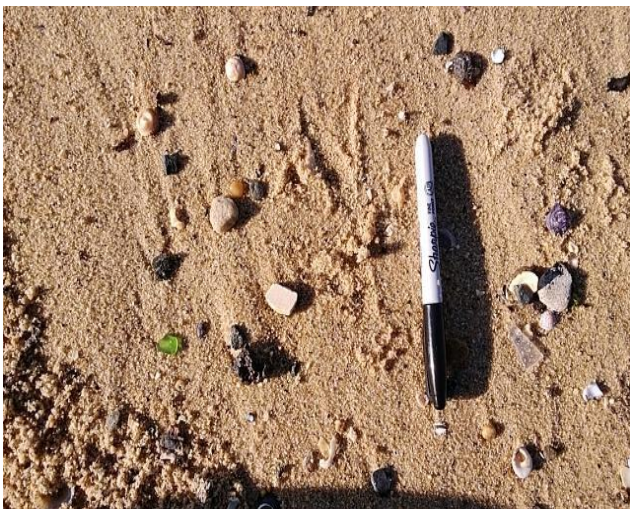
Notes: Northern beach surface following fragment removal

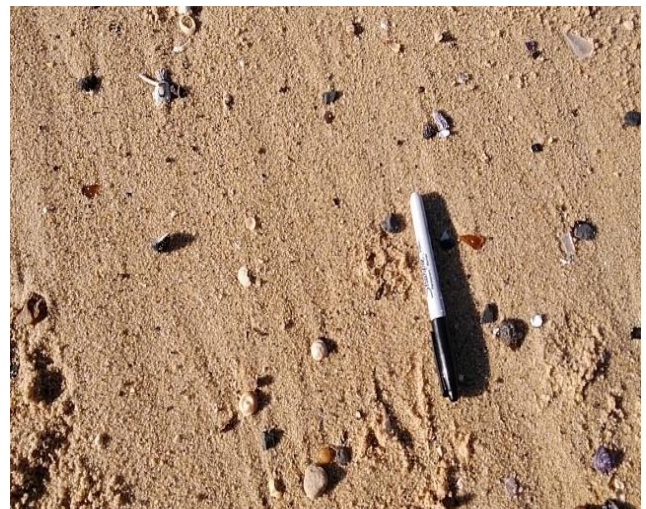
Notes: Northern beach surface following fragment removal

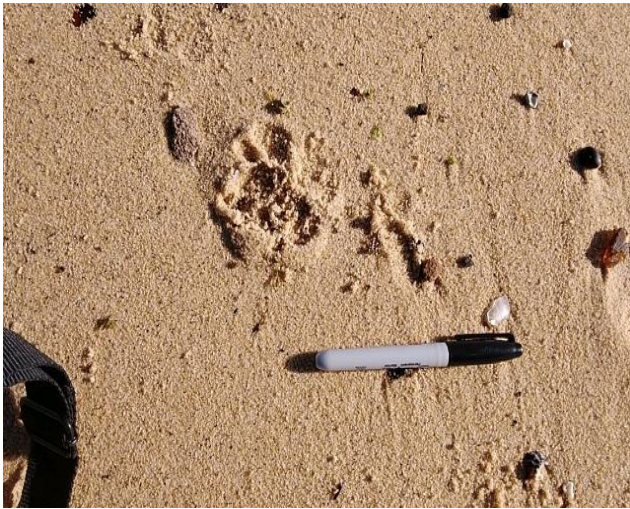
Notes: Northern beach surface following fragment removal

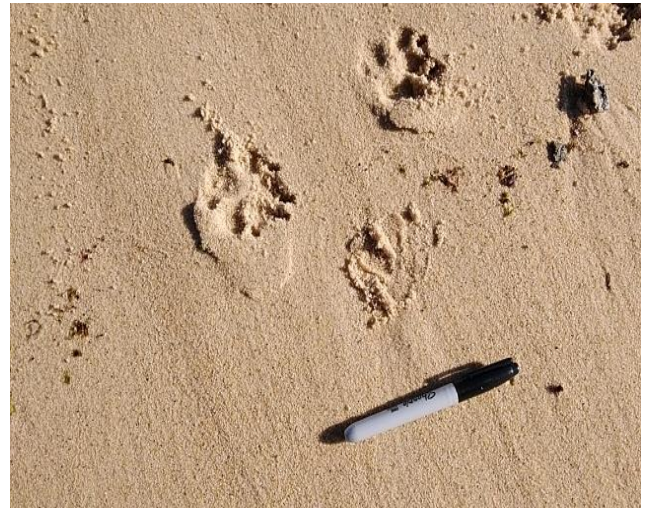
Notes: Northern beach surface following fragment removal

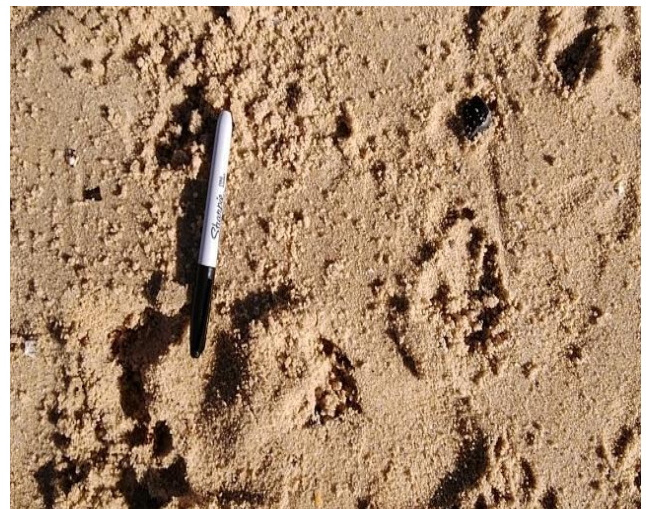
Notes: Northern beach surface following fragment removal

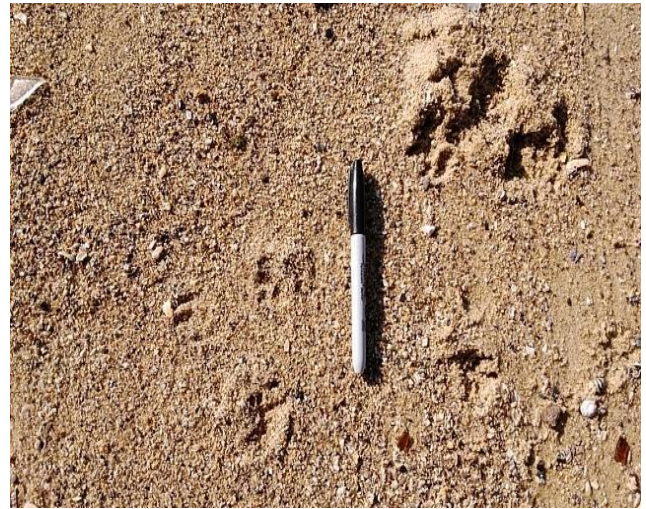
Notes: Western beach surface following fragment removal

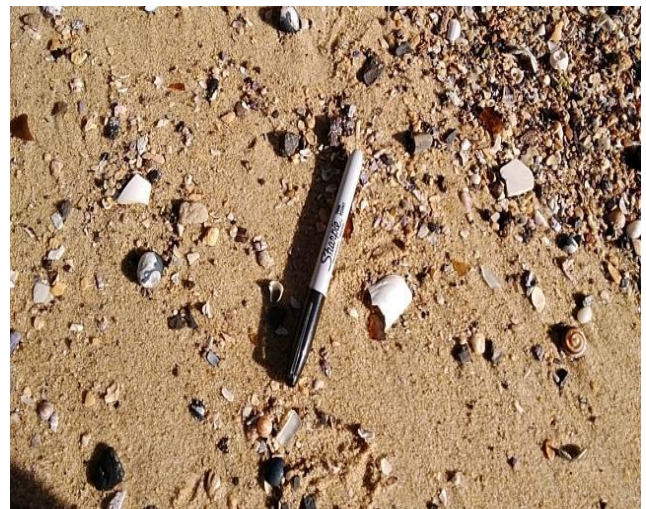
Notes: Western beach surface following fragment removal

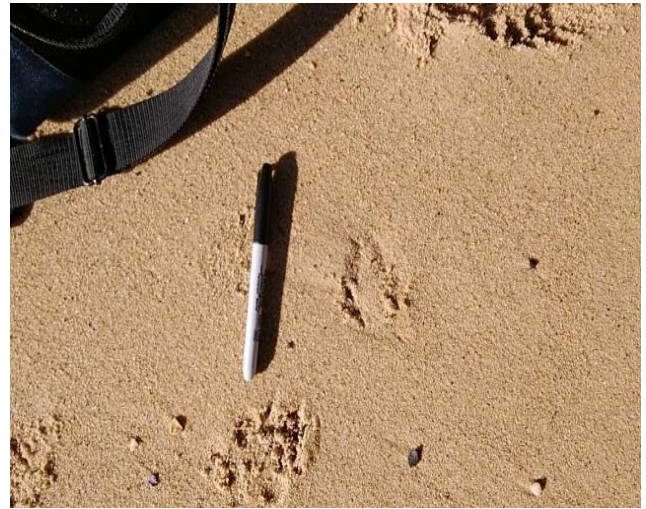
Notes: Western beach surface following fragment removal

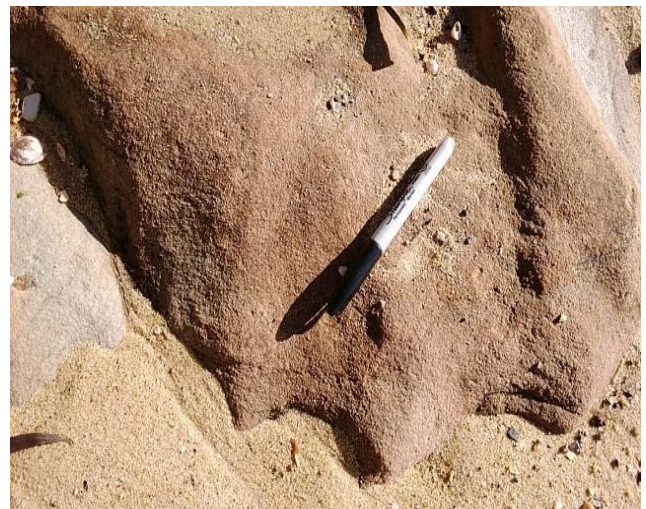
Notes: Western beach surface following fragment removal

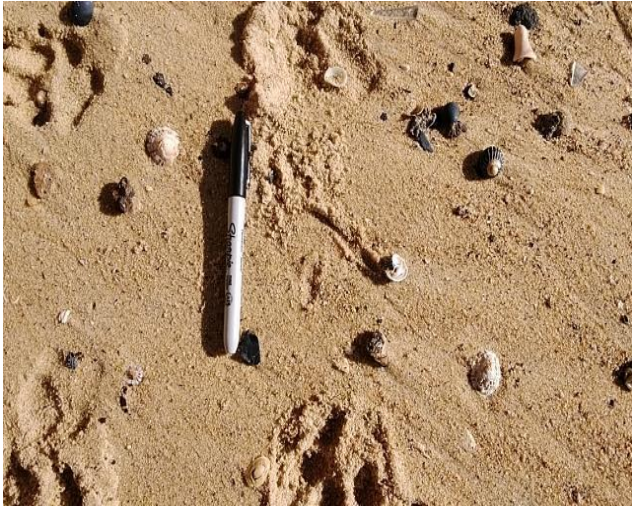
Notes: Western beach surface following fragment removal

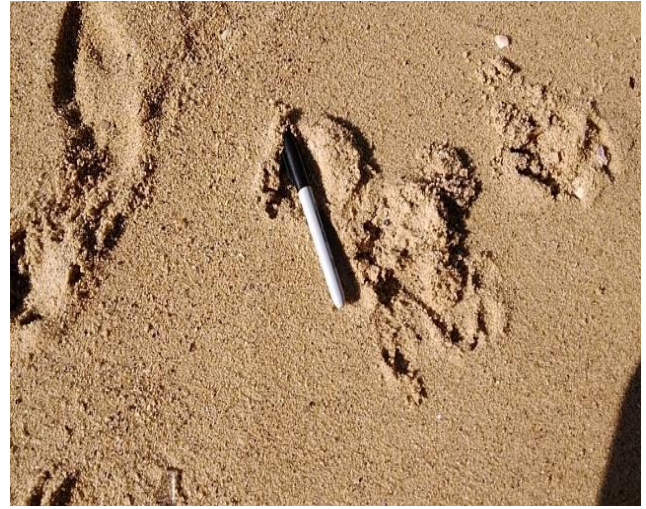
Notes: Western beach surface following fragment removal

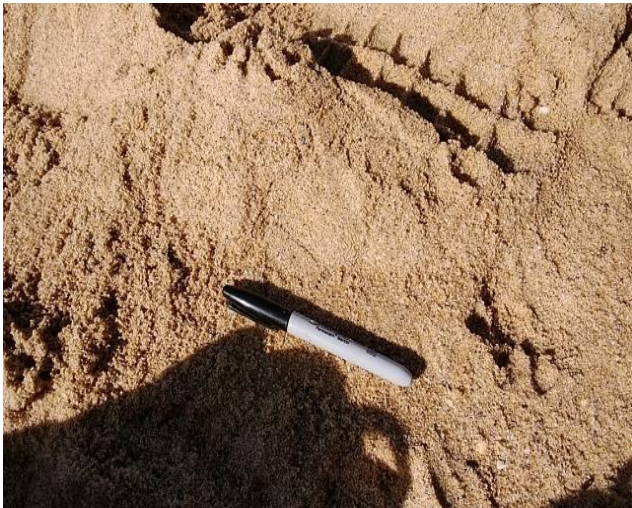
Notes: Southern beach surface following fragment removal

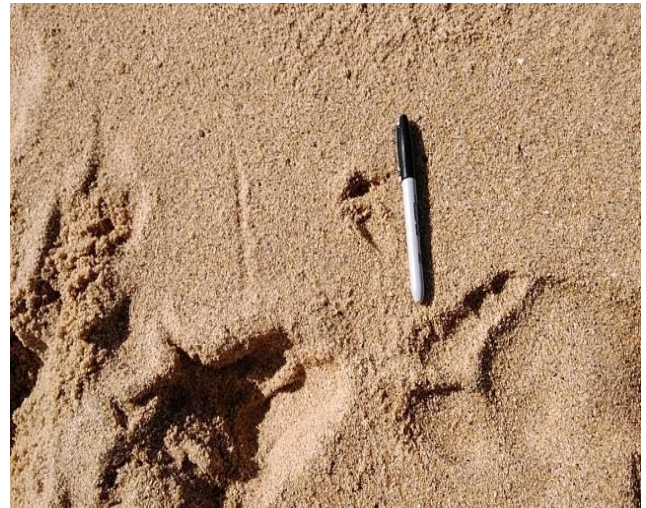
Notes: Southern beach surface following fragment removal

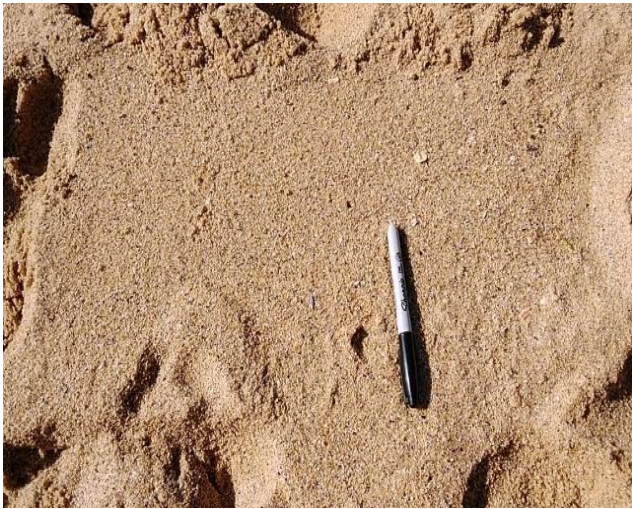
Notes: Southern beach surface following fragment removal

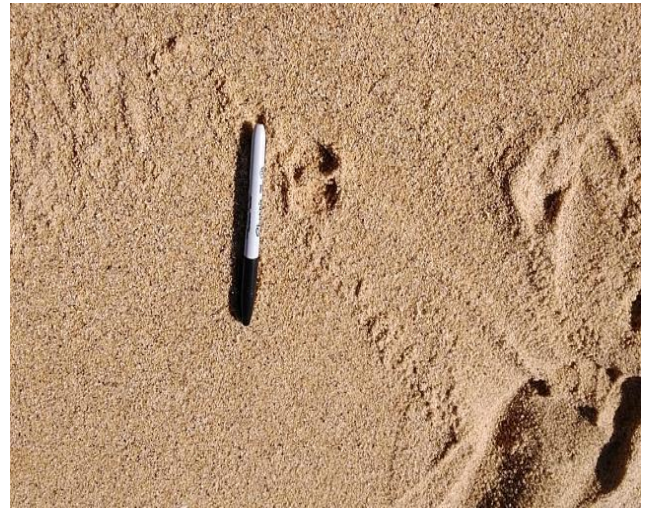
Notes: Southern beach surface following fragment removal

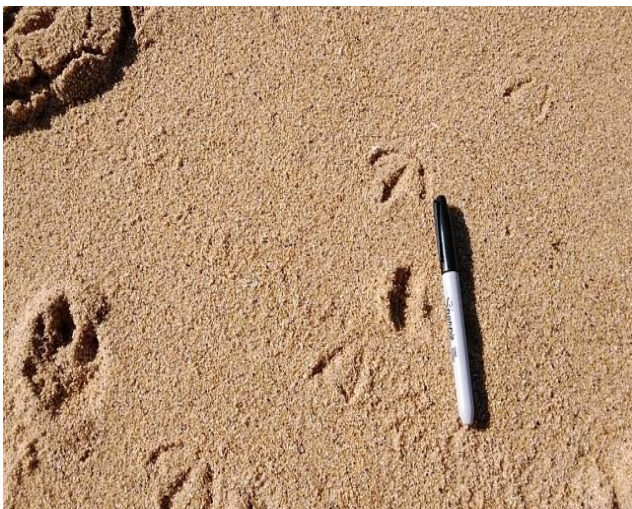
Notes: Southern beach surface following fragment removal
